# National Park Service Cultural Landscapes Inventory 2022

**Bluffs Coffee Shop and Service Station**  
**Blue Ridge Parkway**

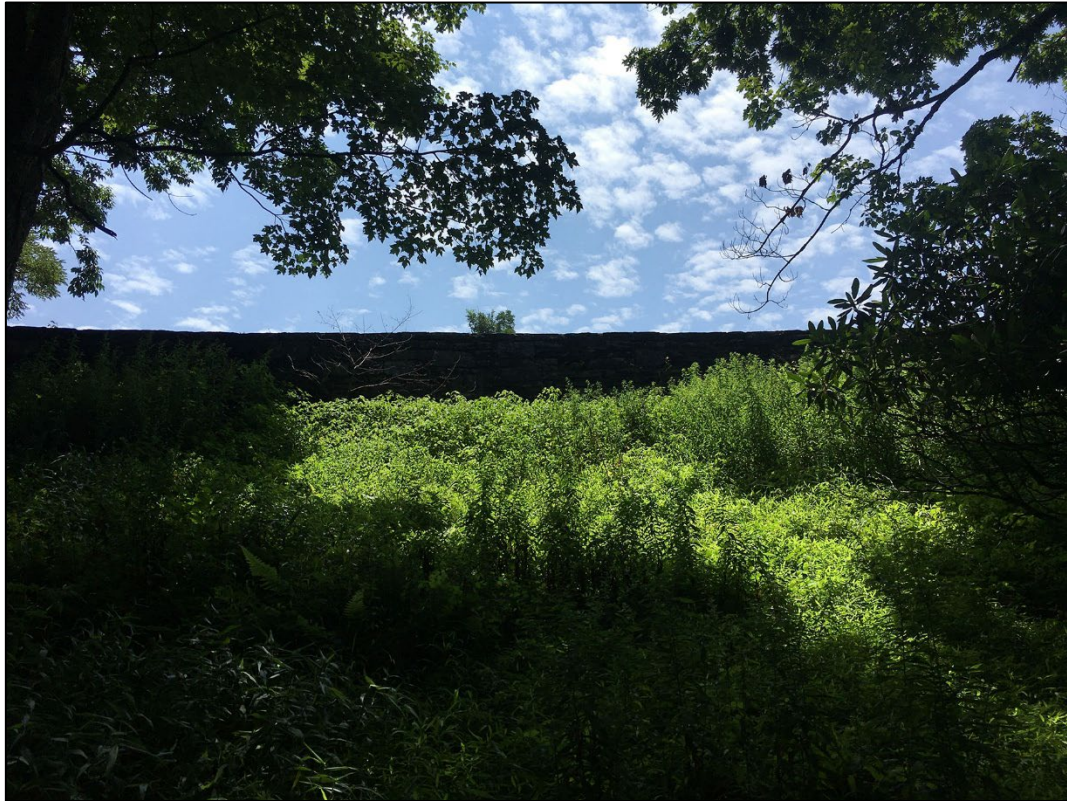
*Fig 8-1. View of stone retaining wall from abandoned segregated picnic area, facing south (2021)*

**Stone Retaining Walls:** A 360-foot-long stone masonry retaining wall runs along the northern edge of the eastern parking lot. This wall is approximately 10 feet tall and two feet wide and was used to create a level parking area on an otherwise steep sloping site. The wall is the oldest structure on the site being part of the first phase of construction in this area of the Bluffs. Incorporated into the wall on either end and in the center of the wall, sets of stone stairs descend into the abandoned picnic area. The wall and stairs appear to be in good structural condition, but have become obscured by vegetation and organic matter.

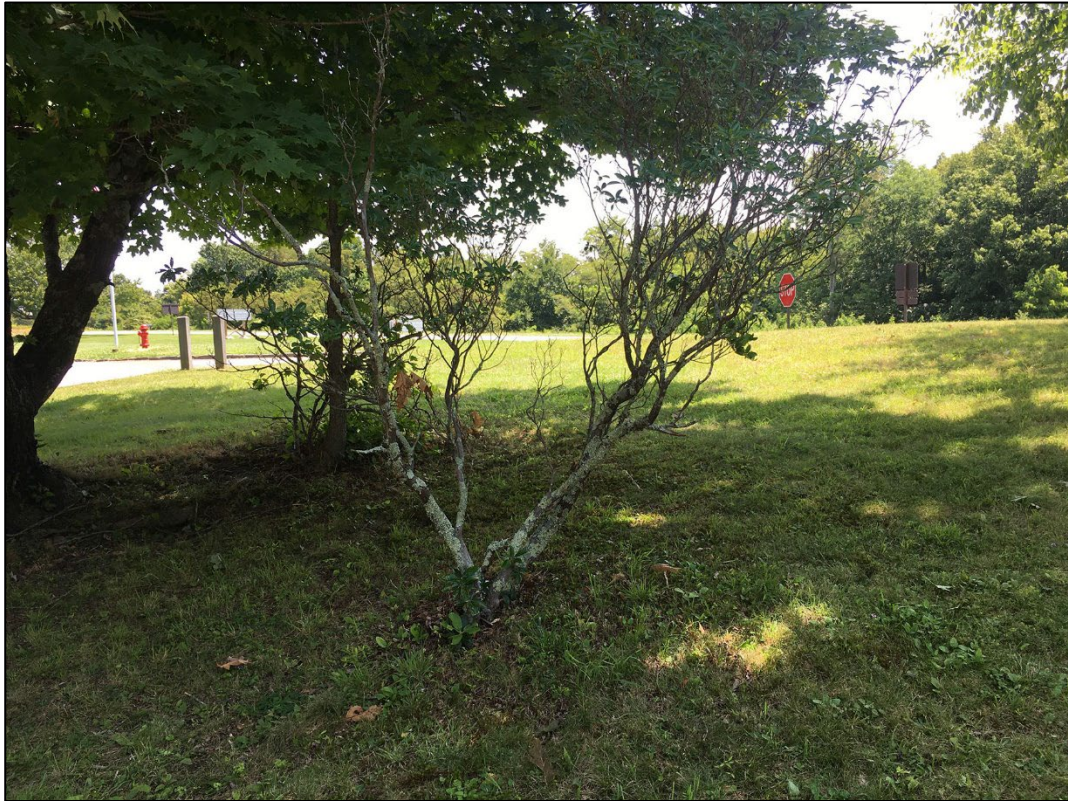
*Fig 8-4. Declining mountain laurel near west parking lot (2021)*

The condition of the vegetation in this component landscape is fair. The intended character and species composition of the hardwood canopy and flowering understory shrubs and trees which covers the abandoned picnic area and forms a backdrop to the concessions buildings persists and remains in good condition. The majority of this area has been heavily invaded by Japanese stiltgrass, however. In places, this invasion has obscured features like fireplaces and asphalt pathways. The lawns around the Restaurant, Gift Shop, Parking Lots and Entry Drives are manicured and well-maintained. There are far fewer shrub plantings and specimen trees than had been originally specified in this area, however. Further, some of the remaining shrubs and specimen trees appear to be declining.

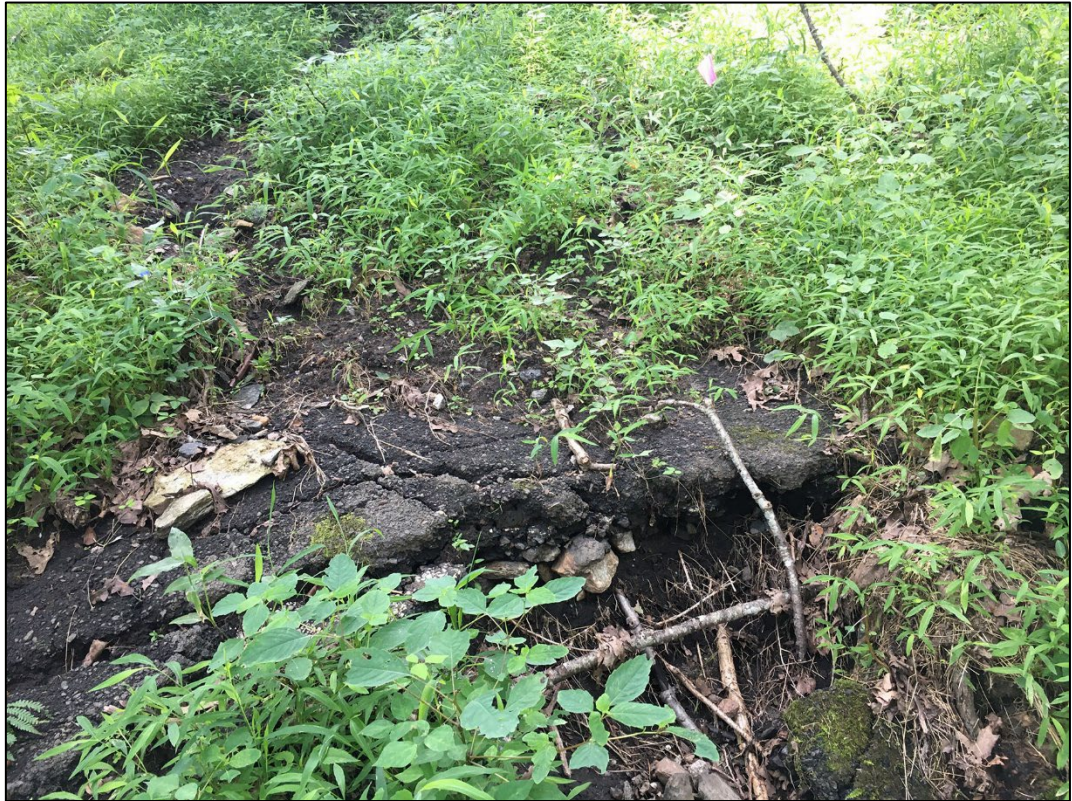
Pedestrian circulation also exists in the abandoned picnic area. Approximately 4,000 feet of asphalt path was constructed in this area to connect the parking lot with the various amenities of the picnic area. Since being abandoned, these paths are nearly invisible. Due to lack of maintenance and the associated accumulation of organic material these paths are degraded and are therefore in poor condition.

*Fig 8-6. Asphalt slabs and fragments. Remnants of pathway system in abandoned segregated picnic area (2021)*

| Seq. No. | Type | Impact Type – Other | Internal Source? | External Source? | Narrative | Date Identified |
|---|---|---|---|---|---|---|
| | Neglect | | | | The system of asphalt pathways built to provide circulation throughout the Woods Picnic Area is severely deteriorated. By and large, the pathways are no longer visible and appear to either have been obscured by vegetation, sediment deposition, and duff buildup or destroyed by weathering and erosion. Partial segments of the pathway network are still visible in some area as the Picnic area. These segments no longer clearly relate to one another, however, and are actively deteriorating. | 08/03/2021 |

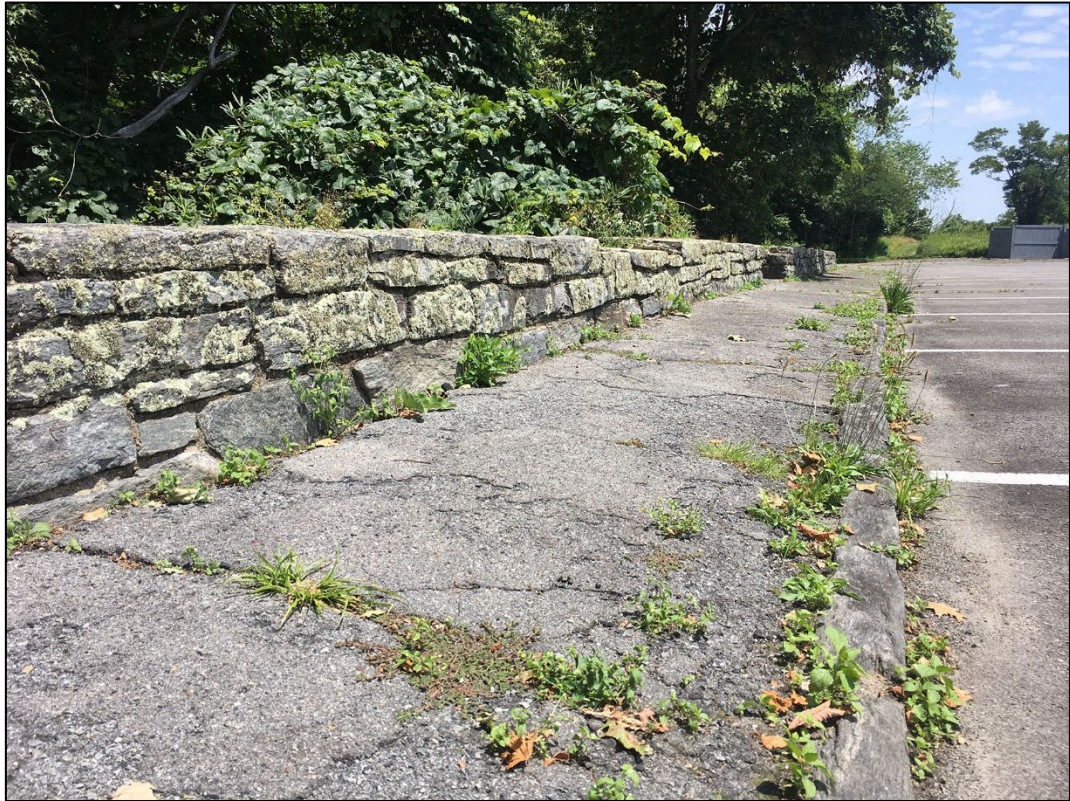
Pedestrian circulation in the parking lots is provided along the northern edge of both lots with a four-foot-wide asphalt walk. As with the asphalt condition in the driving lanes and parking spaces, the asphalt surface of the sidewalks is worn and in fair condition.

*Fig 8-10. View of asphalt sidewalk along north end of east parking lot. Cracking and other wear evident (2021)*

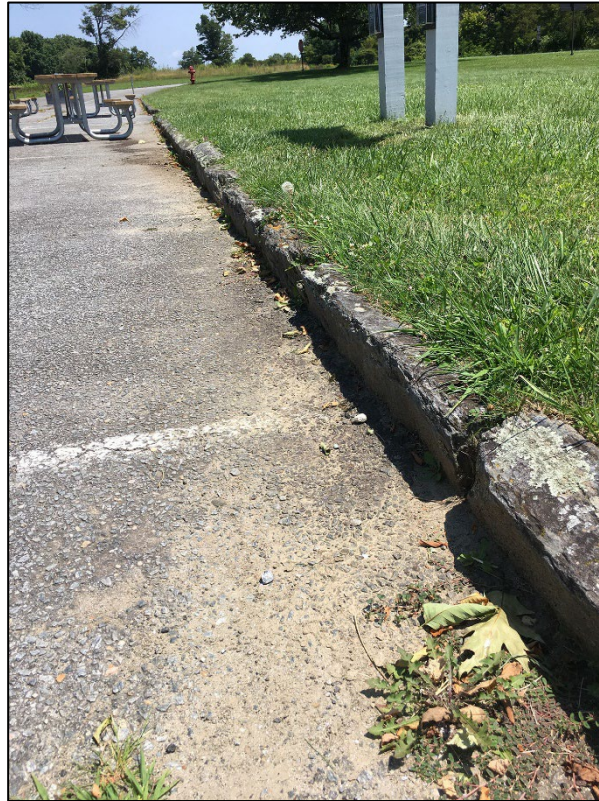
*Fig 8-14. Stone curbing on south side of central access lane near Bluffs Coffee Shop (2021)*

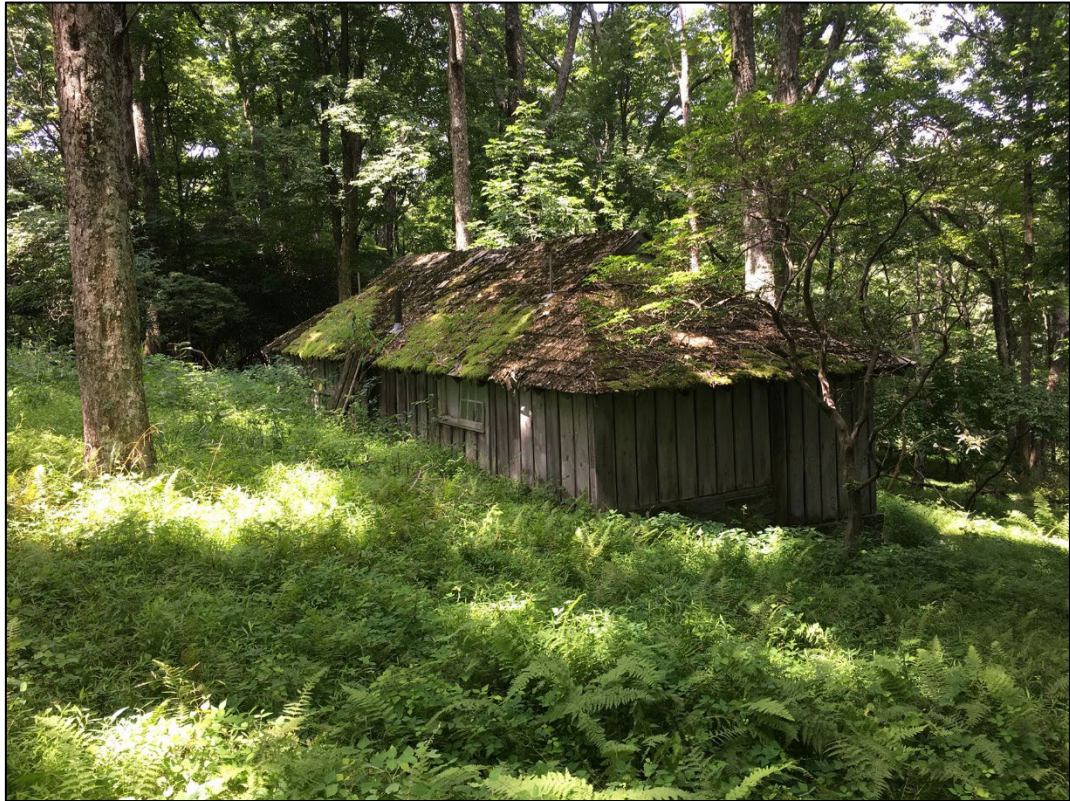
and Camp Store are separated by a gated asphalt-paved service road. The condition of these buildings is fair. This is due mostly to the poor condition of Comfort Station #101 the oldest building on the property. The Coffee Shop and Gift Shop/Camp Store are in good condition.

*Fig 8-20. Oblique view of Comfort Station #101, south façade, facing northwest. Mature specimen mountain laurel visible on left side of frame (2021)*

The condition of the buildings and structures in this component landscape is fair. Comfort Station #101 has been abandoned and is exhibiting clear signs of neglect. The Coffee Shop, and Gift Shop / Camp Store are well maintained and structurally sound. Exterior renovations and improvements have been in keeping with the original look and feeling of the building as it was constructed in 1949. The Gift Shop and Camp Store is well-maintained and structurally sound. Exterior renovations and improvements have been in keeping with the original look and feeling of the building as it was constructed in 1949. The stone retaining wall remains structurally sound but has begun to show its age.

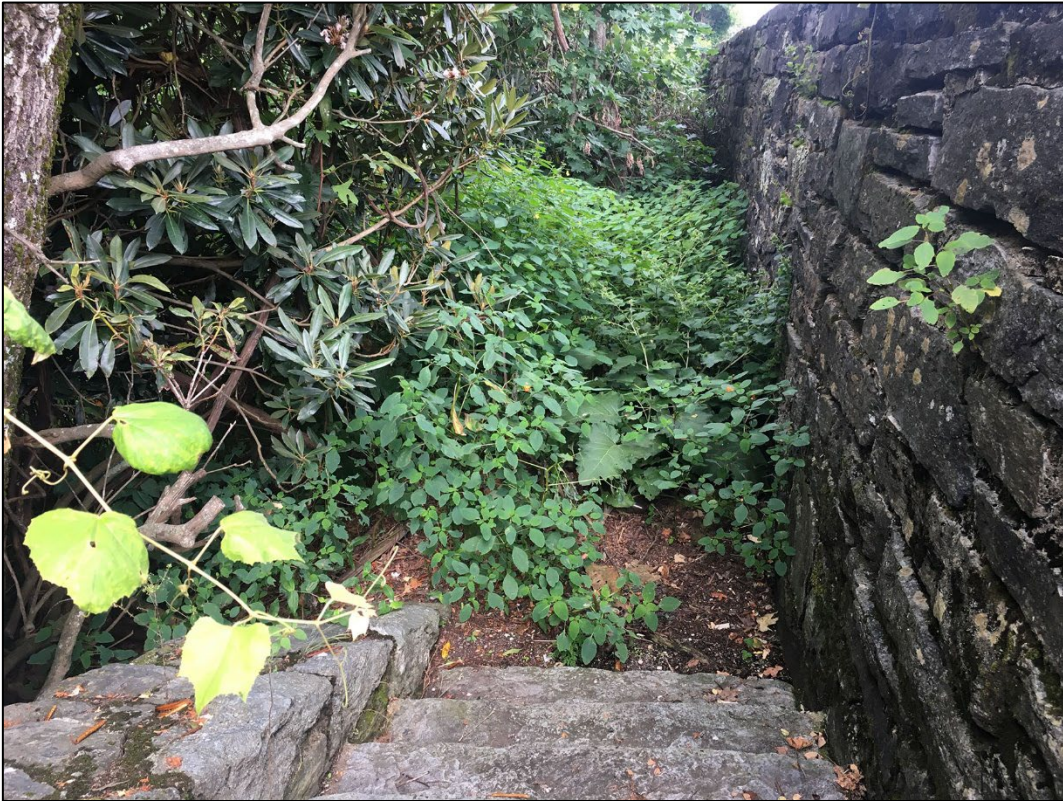
*Fig 8-21. View down stone steps leading to abandoned segregated picnic area. Path blocked by heavy overgrowth of jewelweed, rhododendron, oak seedlings, and other vegetation (2021)*

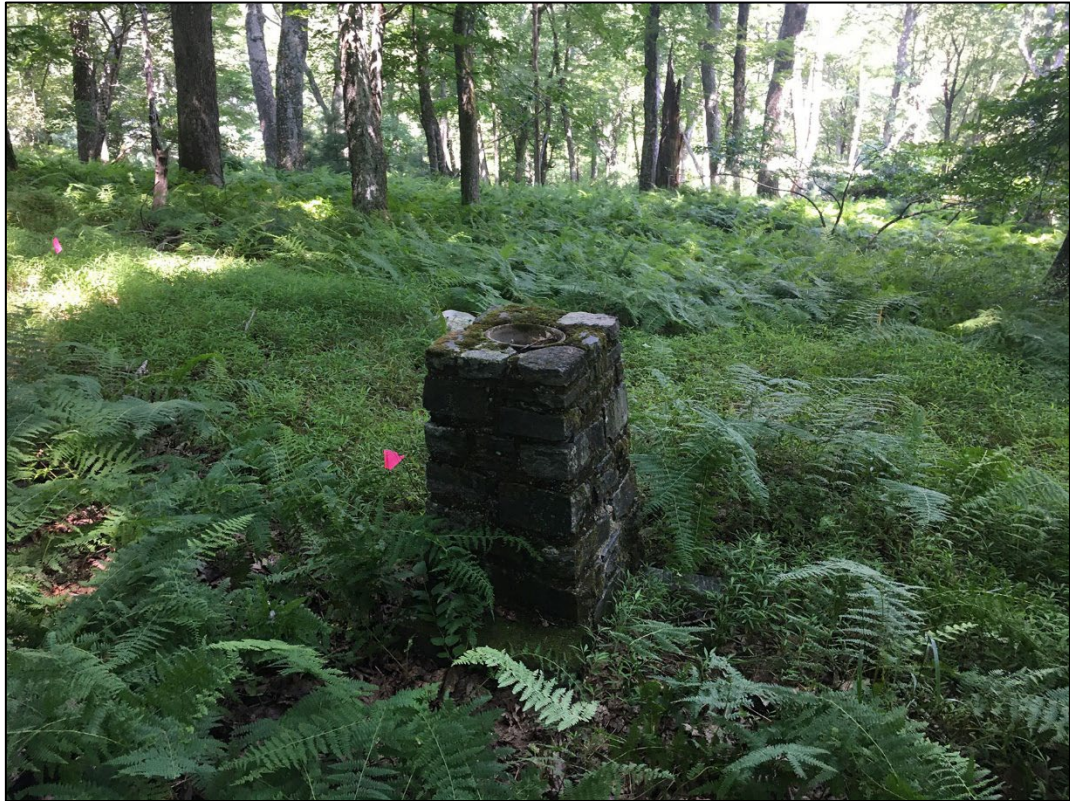
**Woods Picnic Area Drinking Fountains:** There are five drinking fountains in the picnic area and one located on the northeastern corner of the western parking lot. All six fountains are examples of the second generation of Parkway drinking fountains. The fountains are made of the original mortared stone bases. A stone stair elevates small visitors to an appropriate height to access the fountain. The top of the fountain contains an inset metal bowl with central drain and fountain head. Structurally, the masonry stone base is in good condition, but the fountains have long been out of service.

*Fig 8-23. Stone drinking fountain in abandoned segregated picnic area (2021)*

The condition of the small-scale features in this component landscape is poor. All stone drinking fountains originally specified for this area are still intact and in their original locations, but are no longer operational. Most of the stone picnic tables and fireplaces originally specified for the Woods Picnic Area appear to still be standing but remain in varying states of deterioration or disrepair. All signage for this component landscape is legible and appear well-maintained. The refuse containment area in the North Parking Area is well-maintained and functional. Finally, the drop inlets in the east and west parking lots are generally in good condition.

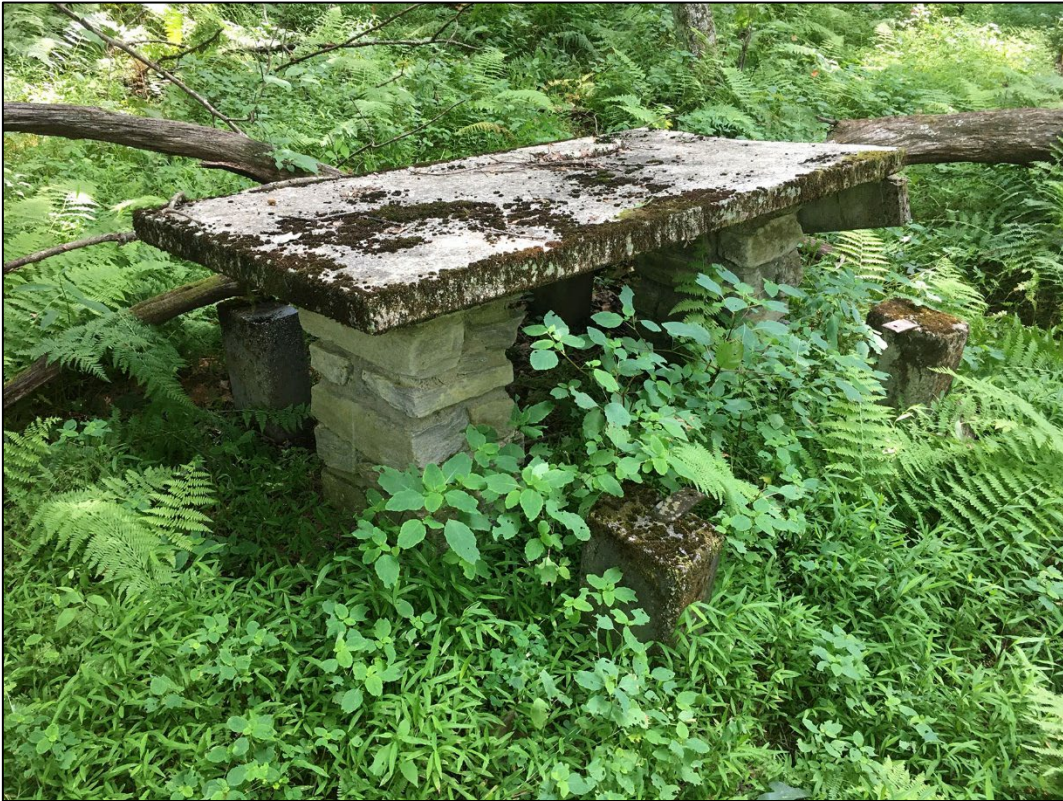
*Fig 8-24. Mostly intact stone picnic table in abandoned segregated picnic area partially obscured by vegetation (2021)*

| | Neglect | | | | All stone picnic tables originally specified for the Woods Picnic Area appear to still be standing but remain in varying states of deterioration or disrepair. Many have collapsed or are on the verge of collapsing. Some are buried under fallen trees - in many cases, fallen woody debris has split or shattered the original concrete tabletops. | 08/03/2021 |

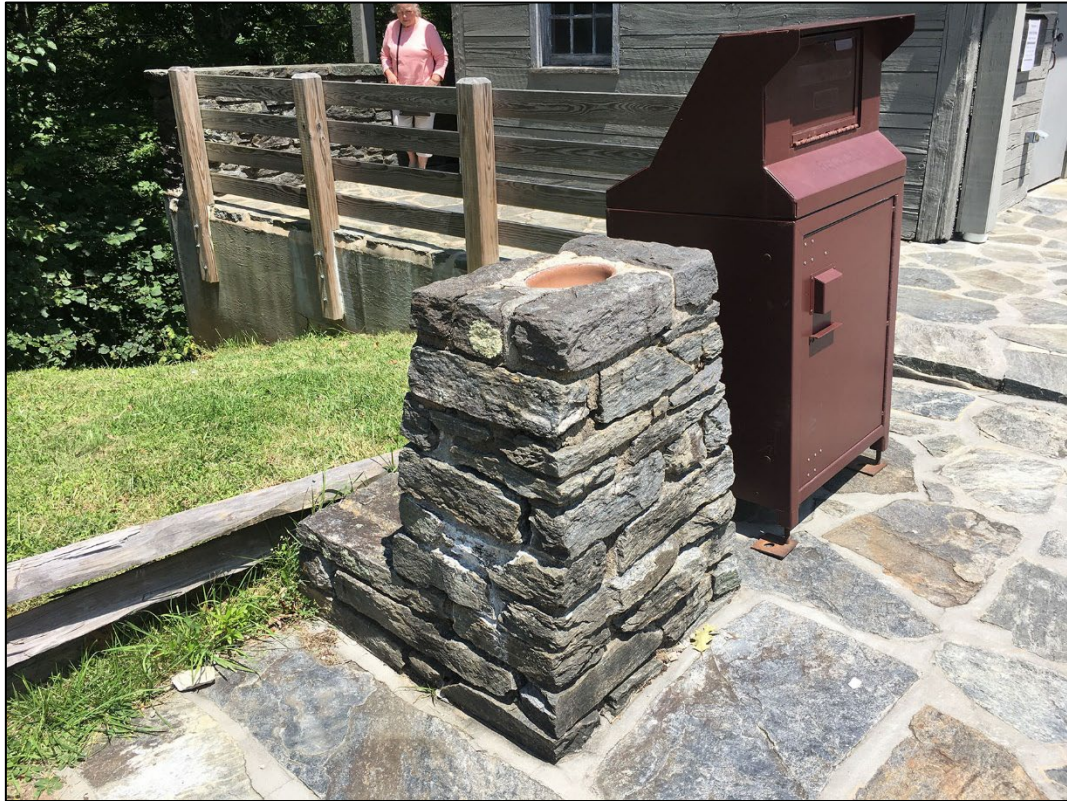
*Fig 8-25. Stone drinking fountain near southwest corner of Bluffs Gift Shop (2021)*

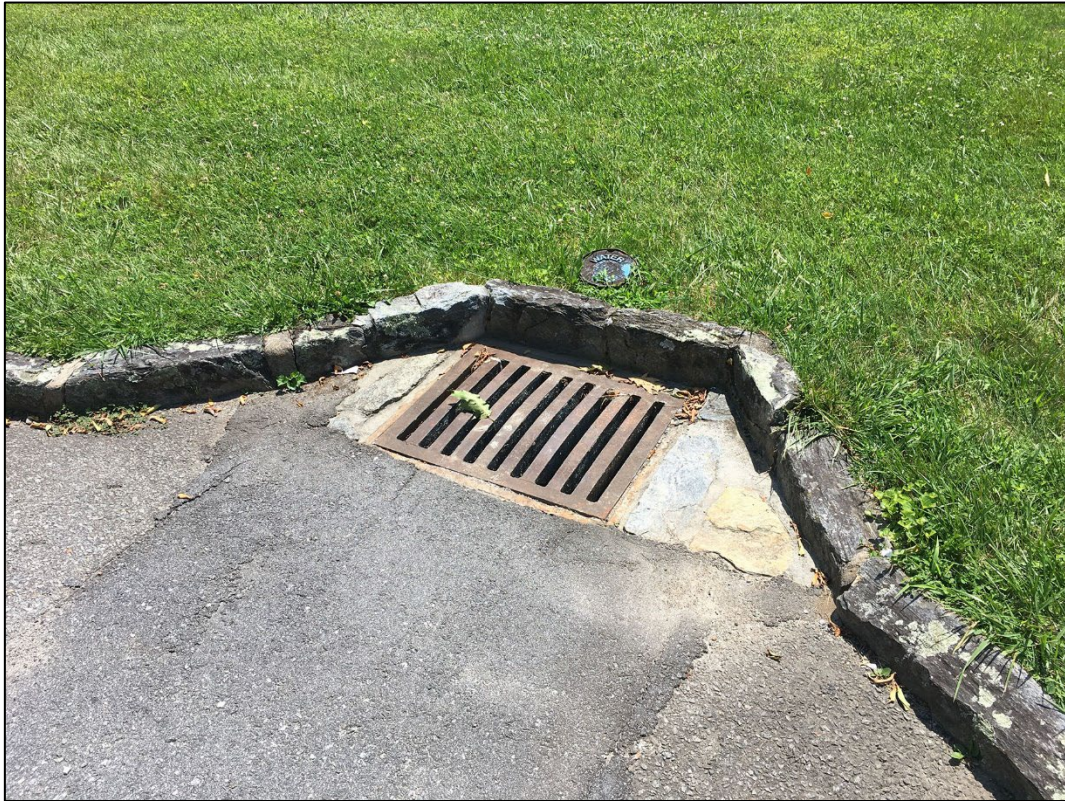
*Fig 8-26. Drop inlet on south side of central access lane (2021)*

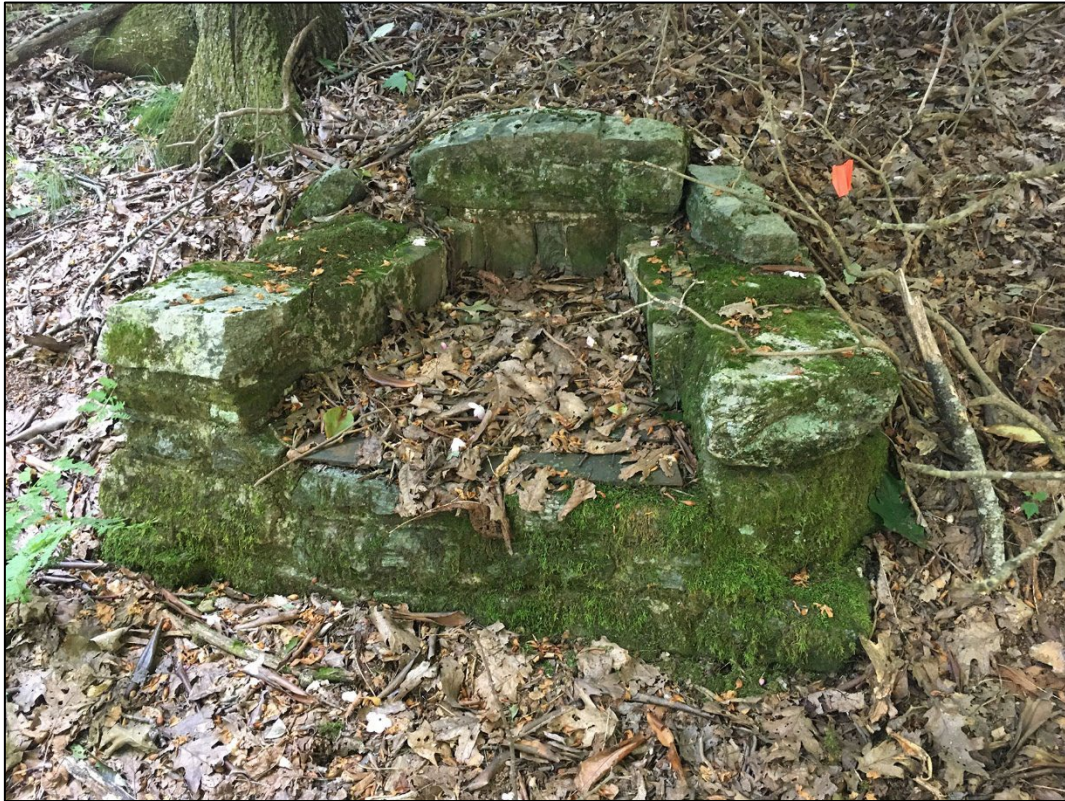
*Fig 8-28. Structurally intact stone fireplace in abandoned segregated picnic area (2021)*

| | Neglect | | | | Most stone fireplaces specified for the Woods Picnic Area are still present but remain in varying states of deterioration or disrepair. Many have been obscured by encroaching vegetation – notably thick invasions of Japanese stiltgrass – or are buried beneath fallen woody debris. | 08/03/2021 |
