# National Park Service Cultural Landscapes Inventory 2022

**Bluffs Picnic Area**  
**Blue Ridge Parkway**

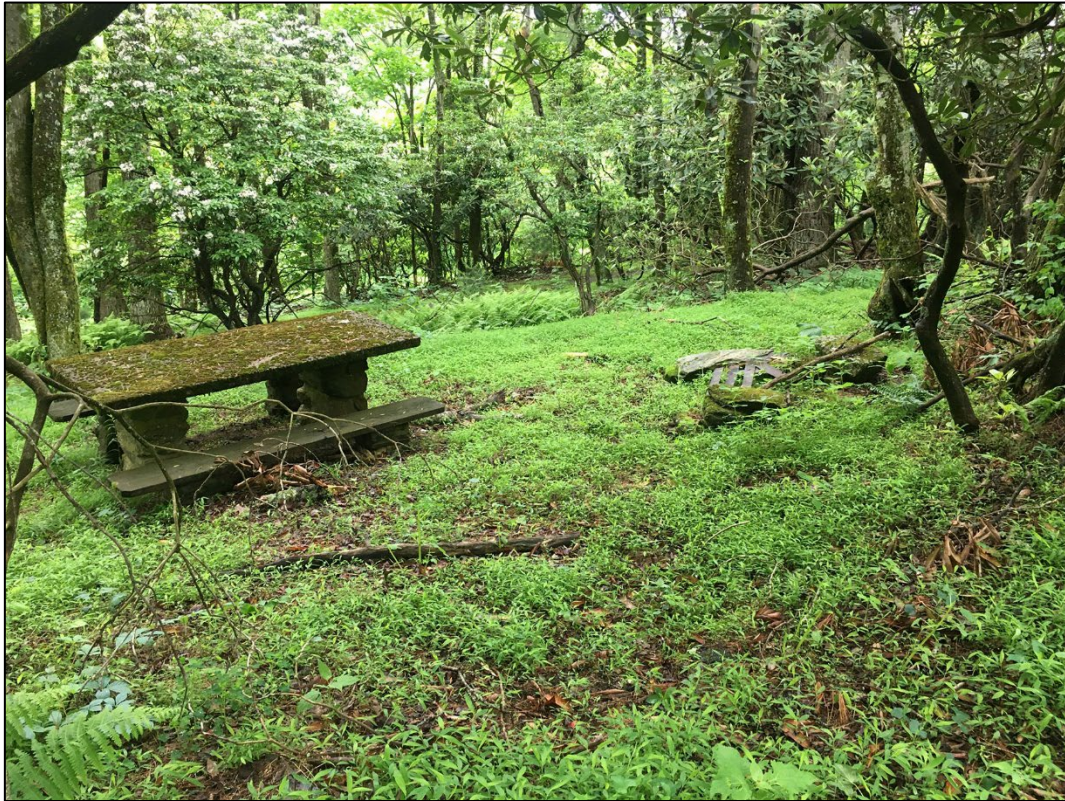
*Fig 8-3. C. 1939 picnic site with intact stone table, benches, and fireplace. Heavy Japanese stiltgrass infestation. Camera facing north (2021)*

In 1939, 36 picnic sites were built under the tree and mountain laurel canopy on the northern and western sides of Ridge Road. Additionally, there were many picnic sites formerly located on the southern side of Ridge Road at its original 1939 terminus. Most of these sites were obliterated when the road was extended in the 1950s. While these sites were lost, the character of a shaded picnic area persists today. Many of the forested picnic sites on the north side of Ridge Road have been abandoned, however, and have become obscured by Japanese stiltgrass (*Microstegium vimineum*), moss, and other encroaching vegetation.

All of the aforementioned features are in generally good condition. There are some exceptions, however, resulting from impacts relating to disease and invasive species encroachment. Evidence of hemlock wooly adelgid is apparent on several mature hemlocks (*Tsuga canadensis*). There are also dead rosebay rhododendron in the understory around many northeastern sites. Some red maples (*A. rubrum*) are exhibiting signs of decline. Most evident, however, is the aggressive encroachment of invasive species, namely Japanese stiltgrass and garlic mustard (*Alliaria*

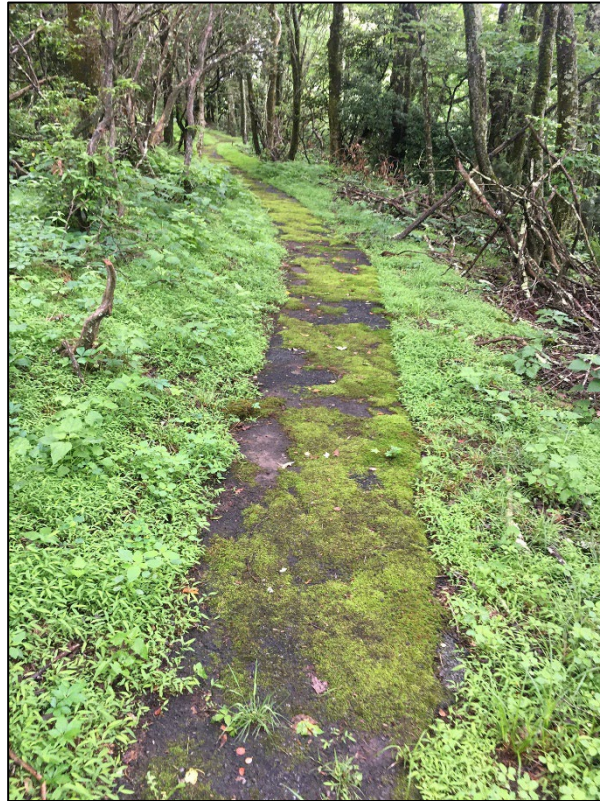
*Fig 8-10. Moss-covered c. 1939 asphalt trail segment bordered by heavy infestation of Japanese stiltgrass. Camera facing southwest (2021)*

Pedestrian circulation is provided by paved asphalt trails throughout the picnic area. These trails were constructed over the course of two distinct phases of development. The first phase of trail development took place during Prewar Planning and Construction Era (1933-1942). These earlier sections of trail are located within the first half mile of Ridge Road. Completed in 1939 and originally featuring earthen surfacing, these trails were eventually paved in the mid-20th century. These c.-1939 trails are in fair condition, but are visibly worn and damaged by erosion and exposure. With the extension of Ridge Road, a portion of these trails were obliterated in the 1950s, but most remain in place and retain their integrity. Stone steps and log interrupters are still in place.

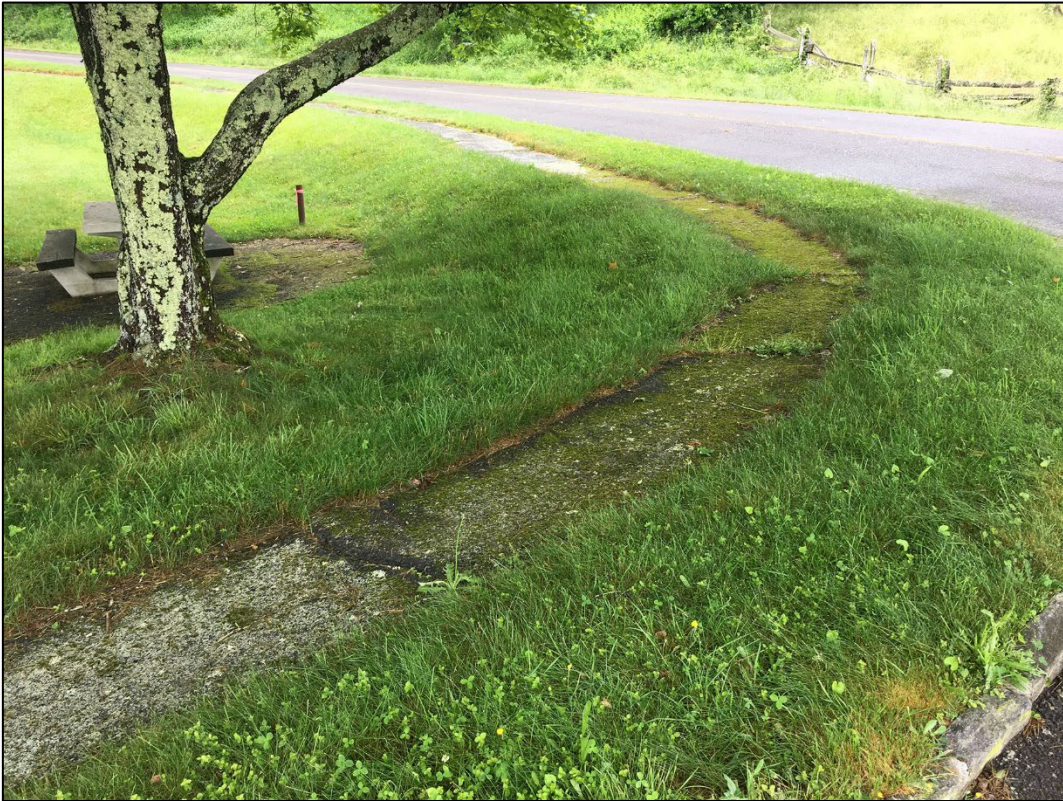
*Fig 8-11. Curved Mission 66-era asphalt trail with moderate moss growth. Camera facing northeast (2021)*

The second phase of trail development at Bluffs Picnic Area took place during Mission 66 era (1956-1966). Sited located along the stretch of Ridge Road south of Comfort Station #104, these trails feature 3-foot-wide paths and provide approximately 500 feet of pedestrian circulation. These c.-1950s trails remain in fair condition, with some wear and missing asphalt. Trails built south of the second comfort station – and post-dating 1955 - do not contribute to the national significance of the parkway, but may have historical significance as they relate to “Mission 66”-era projects and initiatives.

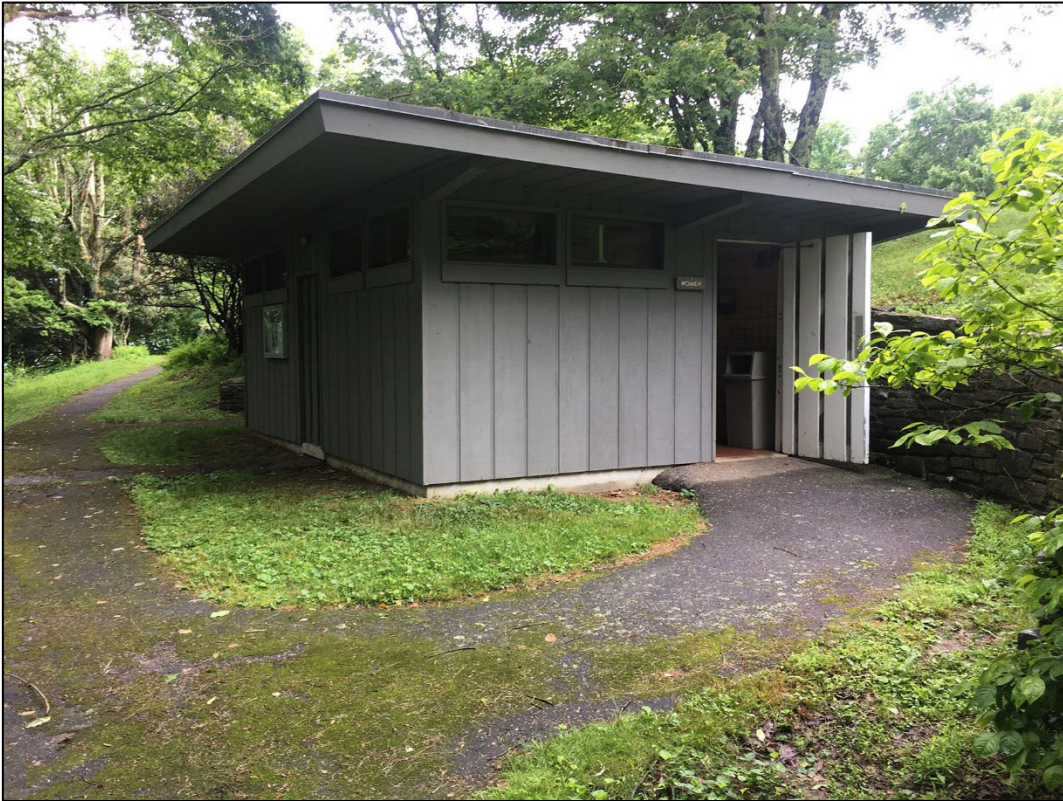
*Fig 8-15. Oblique view of Comfort Station # 104. Camera facing north (2021)*

Built in the utilitarian style, Comfort Station #104 is a stylistic departure from #102. The entrance faces south toward the wooded slope beyond. The 16-foot wide by 24-foot-long building is single-story, wood-framed, and rectangular in plan with restroom facilities and a janitor's closet. It has a concrete foundation and concrete block walls clad in plywood sheets milled to look like vertical wood siding and painted grey. The building is covered by a low-slope wood-framed roof with enclosed eaves and clad with sheet metal. Small rectangular one-light fixed windows located above eye level are provided in each of the two facilities to bring natural light into the building. These windows have concrete sills clad with wood. Doors are constructed of vertical wood planks and are stained gray to match the rest of the wood on the building. The doors are designed with wide gaps between the planks through which the interior wood cross-braced framing is visible. The building remains in good condition with no additions.

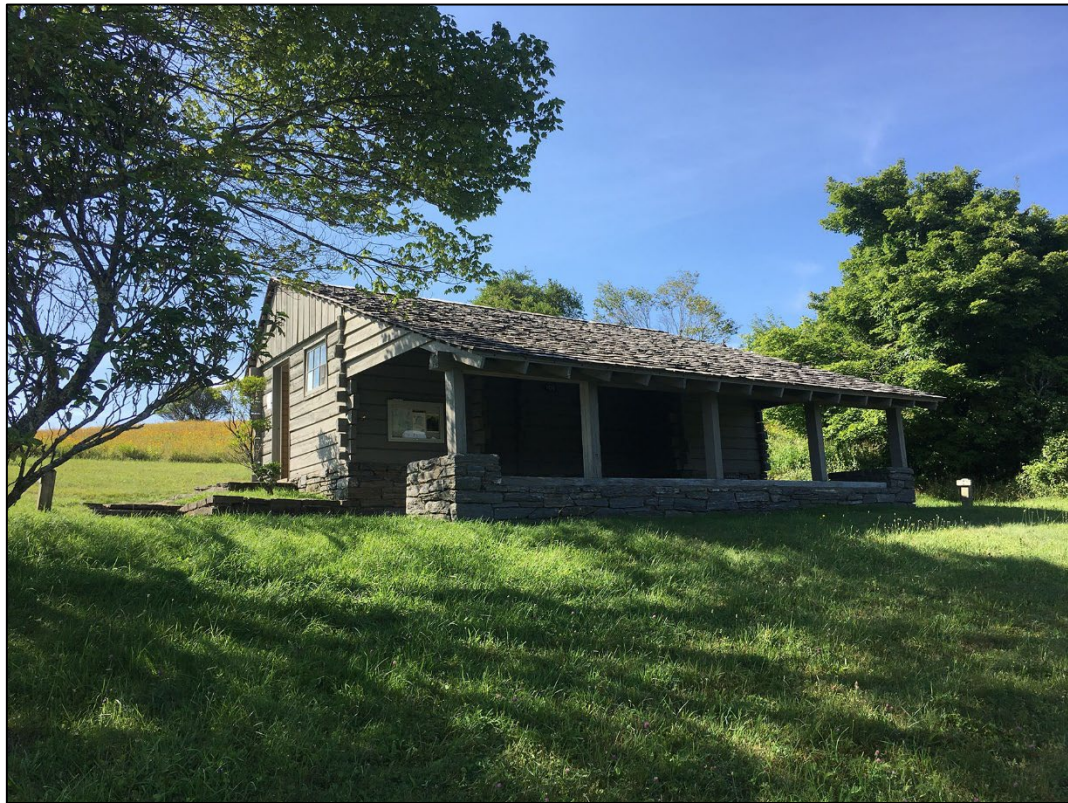
*Fig 8-16. Oblique view of Comfort Station #102. Camera facing southwest (2021)*

Built in the Adirondack style in the early 1940s, Comfort Station #102 is different in material and style than the other Doughton Park comfort stations of the same era. The walls of the building are constructed of squared and stained logs with flush-mounted vertical wood boards covering the gables. Additionally, the 23 feet wide by 30 feet long building features a stone foundation, hinged six light sash windows, and a wood shake roof. The building is single-story, wood-framed, and rectangular in plan with restroom facilities and a covered porch that serves as a scenic overlook. The building has a stone foundation, sawn log framing with half dovetail joints, and a wood-framed wood shake gable roof with exposed framing. The end gables are clad with wood plank siding and the entire building is painted grey.

This building remains in good condition with no additions or repairs and is a contributing resource that relates to the original design of the Blue Ridge Parkway. It is a highly characteristic and intact example of its building type on the Parkway (WJE 2016, A-227).

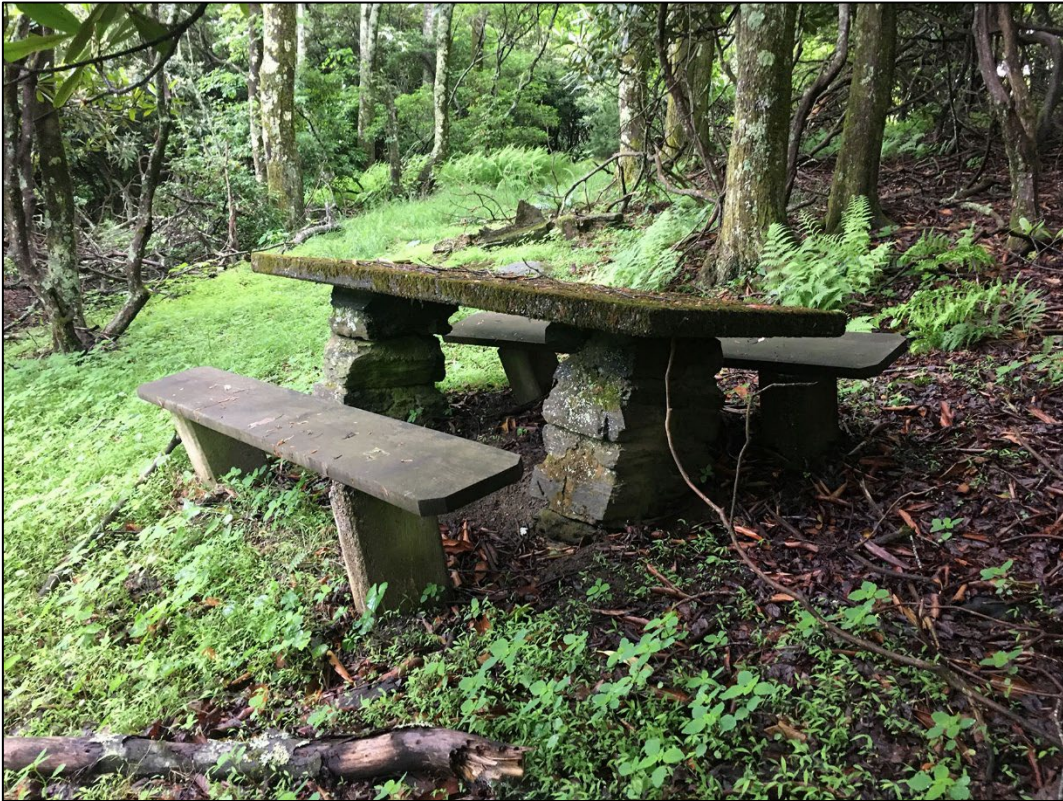
*Fig 8-20. Stone picnic table in forested area downslope of Comfort Station #102. Partially collapsed. Camera facing northeast (2021)*

Approximately 13 Prewar Planning and Construction Era Picnic Sites are concentrated in the wooded picnic area near Comfort Station #102. These sites feature Park Rustic style picnic tables with wood plank seats and concrete tabletops with stacked stone piers. These sites also feature rustic-style fireplaces constructed with U-shaped stone walls topped with a metal grate cooking surfaces. Many of these original units are still located within the wooded picnic area. Repairs, often making use of new types of materials, have been made to most units. The general condition of these units is good. Current materials differ from those associated with the original installation, however.

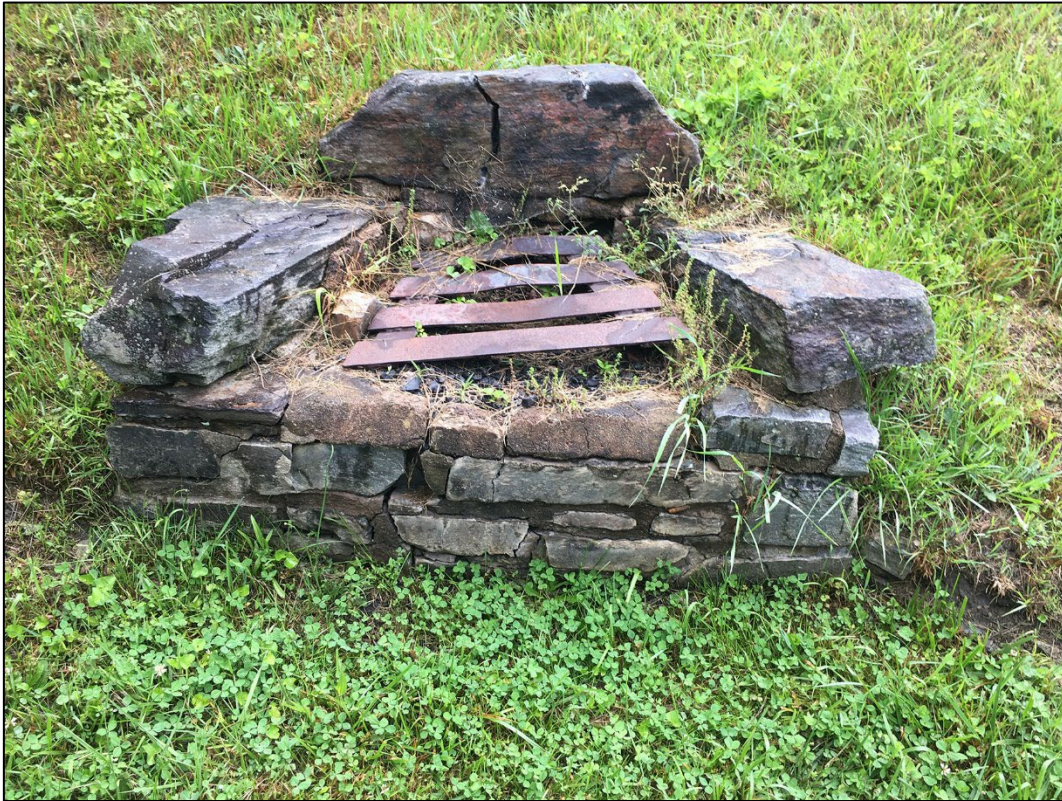
*Fig 8-21. Fully intact stone fireplace southwest of Mission 66-era picnic site. Camera facing northeast (2021)*

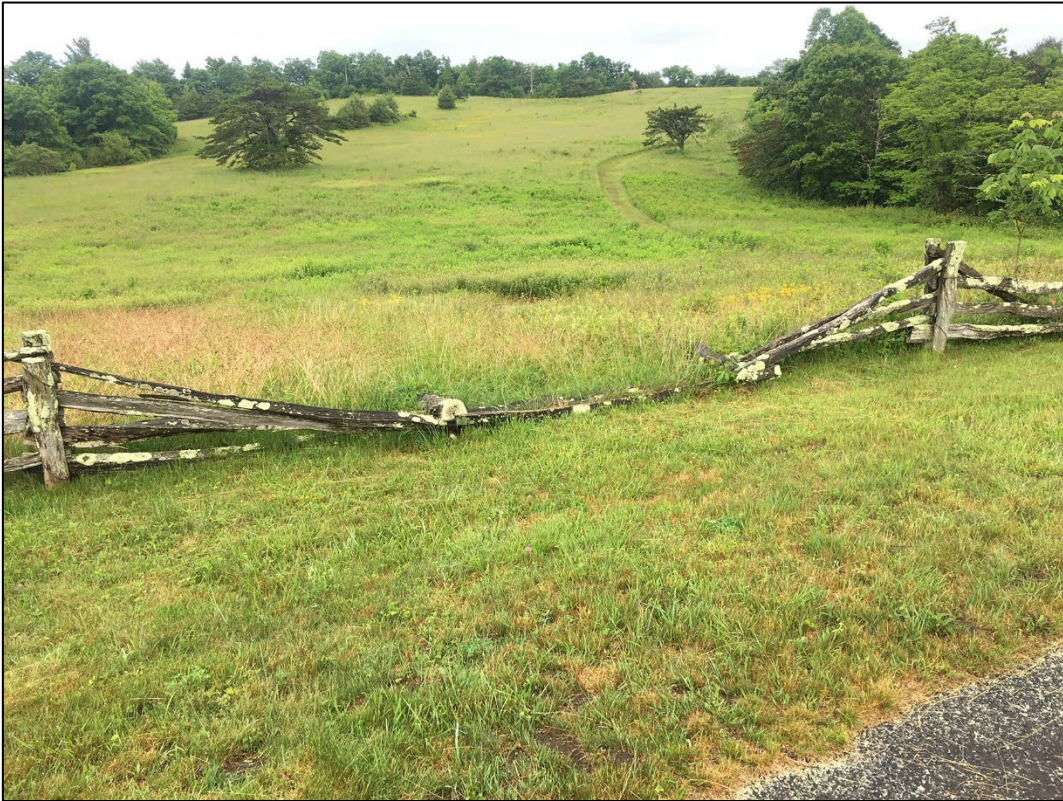
*Fig 8-22. Section of collapsed split rail fencing near south meadow. Camera facing south (2021)*

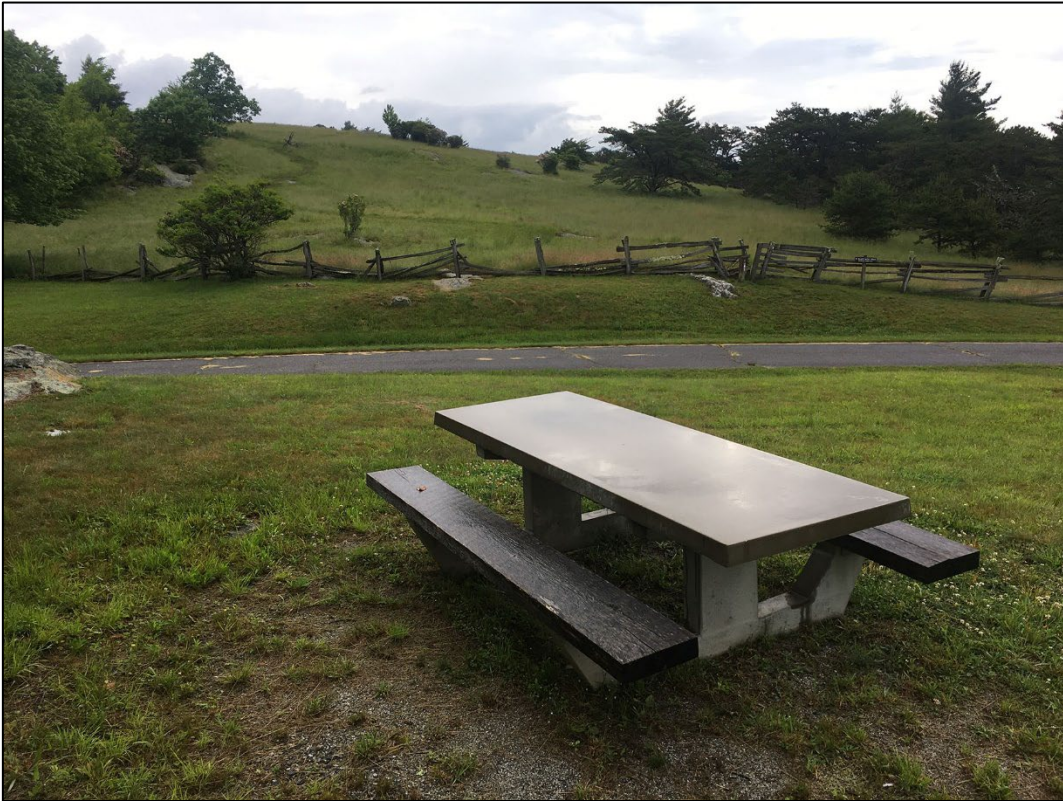
*Fig 8-24. Pre-cast concrete picnic table at south terminus of Ridge Road. Segment of Bluff Mountain Trail leading into east meadow visible in background. Camera facing northeast (2021)*

The third-generation picnic sites have since been replaced by a fourth generation that differs from the contemporary styles previously noted in the 2006 CLR. The picnic tables associated with these sites are of a sleeker, more modern design and constructed of precast concrete. Like their third-generation predecessors, they generally do not feature fireplaces, grills, or formalized path systems.

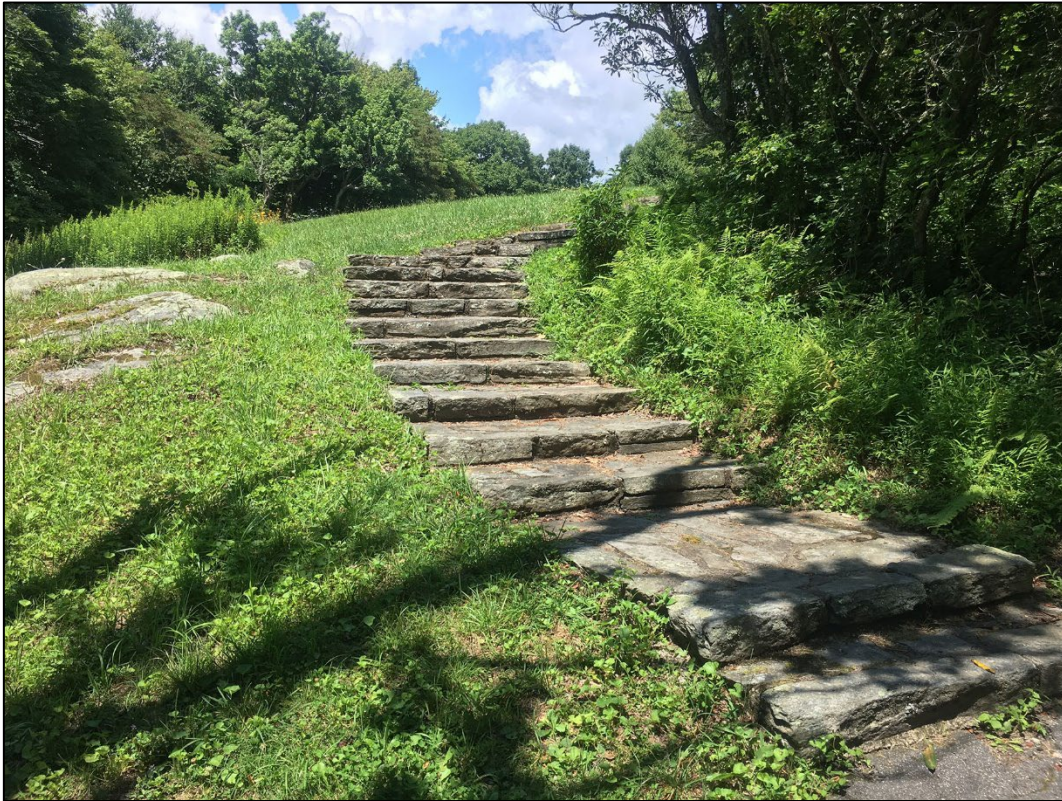
*Fig 8-27. Set of 12 stone steps near Comfort Station #104 in fair condition, with deteriorated mortar joints. Camera facing northeast (2021)*

Stone Steps: Two sets of stone steps were constructed at Bluffs Picnic Area, with each set intended to serve each of the two comfort stations. In total, there are 24 individual stone steps between the two sets. The first set of steps can be found near the entrance to the Picnic Area and curves upslope toward Comfort Station #102. This set consists of 12 steps in total and appears to be in good condition, with no notable structural problems. Another set of stone steps can be found north of Comfort Station #104. This set curves downslope from the adjacent parking area toward Comfort Station #104 and consists of 12 individual steps. These steps appear to be in fair condition, with visibly deteriorating mortar joints.

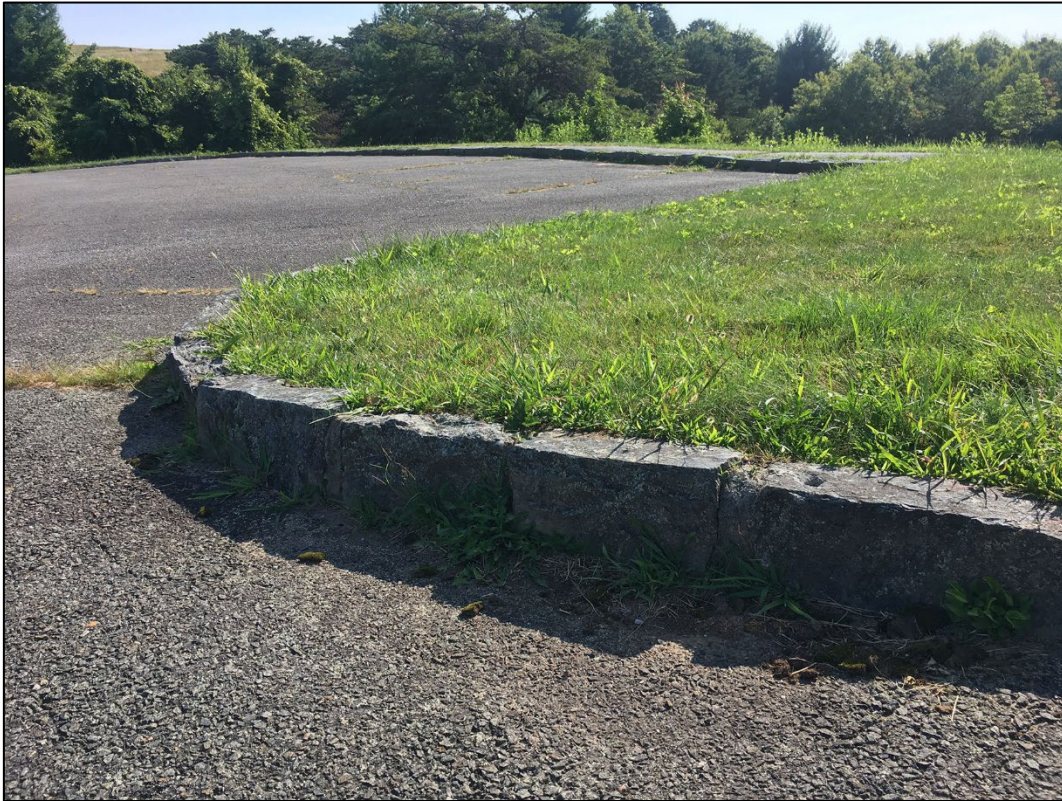
*Fig 8-29. Close-up of stone curbing at south meadow parking bay. Camera facing northeast (2021)*

wear and signs of age. The stone curbing around each parking bay is somewhat obscured from years of asphalt resurfacing. Other than an additional parking area, the road retains its original form and design, and contributes to the national significance of the parkway as an NHL.
