# National Park Service Cultural Landscapes Inventory 2022

**Brinegar Cabin**  
**Blue Ridge Parkway**

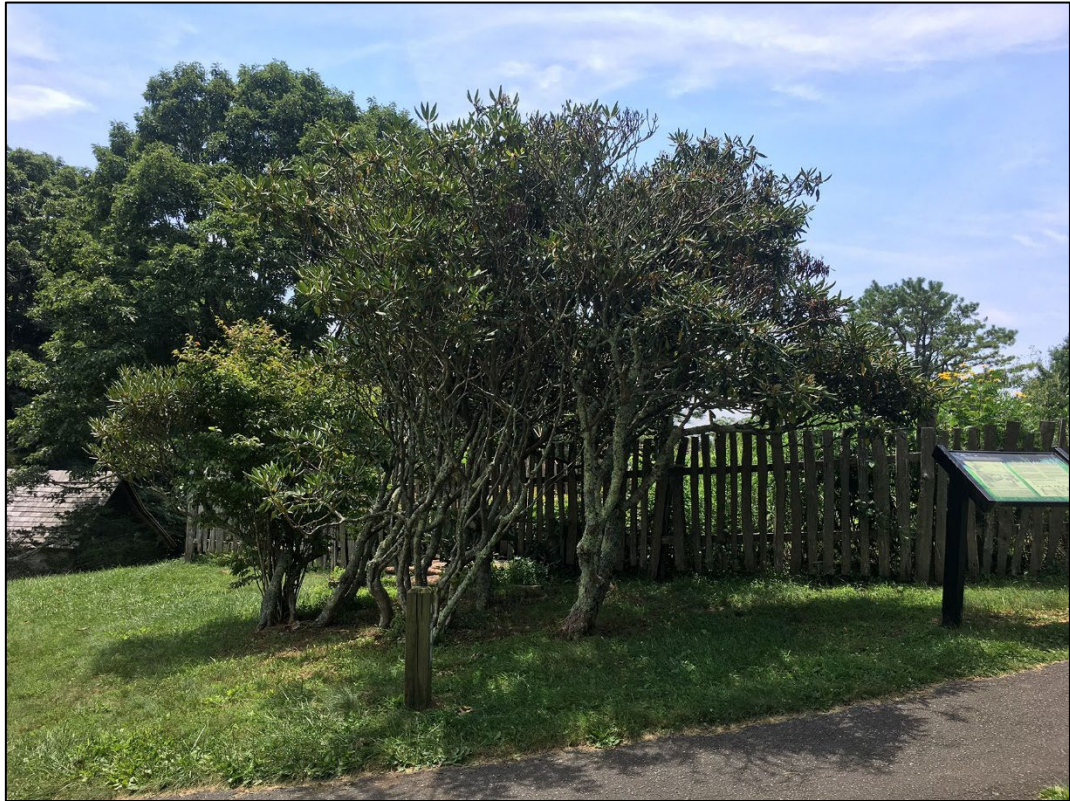
*Fig 8-8. Declining rhododendron shrub bay along pedestrian path at Brinegar Cabin (2021)*

is generally good. The most notable impacts are associated with rhododendron plantings that appear to have been removed, as well as an existing bay of rhododendron that has been in decline for several years. The original spatial organization that had characterized the Brinegar family complex remains intact. The 2006 CLR recommends continued site maintenance and rehabilitation of small-scale stone features. Besides this need for minor repairs, specific restoration, and on-going maintenance, Brinegar Cabin continues to convey the history of the Appalachian farmstead and the design elements of the Blue Ridge Parkway.

| Seq. No. | Type | Impact Type – Other | Internal Source? | External Source? | Narrative | Date Identified |
|---|---|---|---|---|---|---|
| | Disruption/Loss of Plant Species | | Yes | No | Some rhododendron plantings noted on prior existing conditions graphics appear to have been removed. This is evident along the pedestrian path, where the stumps from these plantings are still visible. | 08/06/2021 |

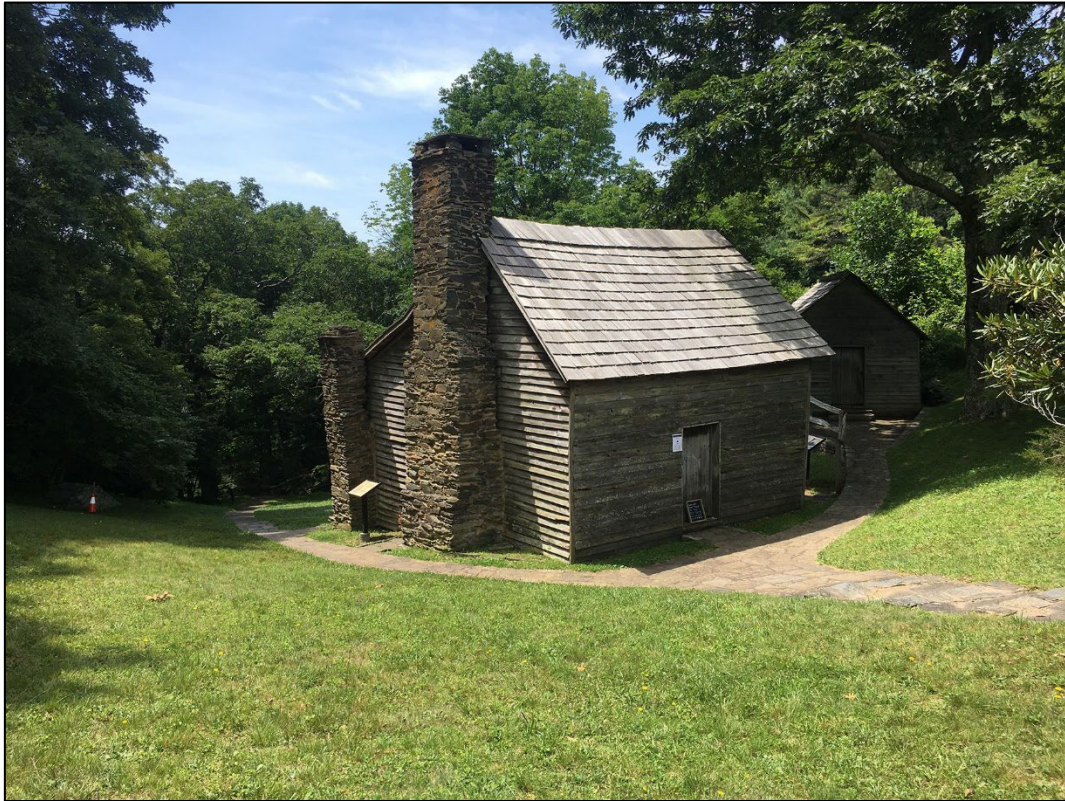
**Brinegar Cabin:** The Brinegar family's 1889 Cabin is located approximately 60 feet southeast of the interpretive garden and 125 feet south of the Parkway. This one-and-a-half story Cabin sits on a dry laid fieldstone foundation. The Cabin is composed of the original 1889 one-room log building, now sided with wood clapboard, a wood-framed gable roof with exposed framing and clad in wood shakes, and a clapboard-covered rear shed addition. According to the Brinegar Cabin Historic American Buildings Survey, the Cabin measures 25 feet across the eastern and western facades by 19 feet across the southern and northern sides with a small covered rear porch measuring nine feet in width and four feet, six inches in depth. Typical fenestration includes wood-framed four-over-two double-hung windows. Door openings are wood-framed and have vertical plank doors. The southern facade features the Cabin's front door on an otherwise blank clapboard wall. Two stone chimneys and a single double-hung window compose the eastern facade. A set of stone stairs lead onto the rear wooden porch. The Cabin's northern facade features the rear covered porch and back door. Double-hung windows flank the rear door. A single double-hung window is found on the western facade. The Cabin sits in its original location and is a contributing resource that relates to the original design of the Blue Ridge Parkway (WJE 2016, A-213).

*Fig 8-20. Brinegar Cabin, north façade (2021)*

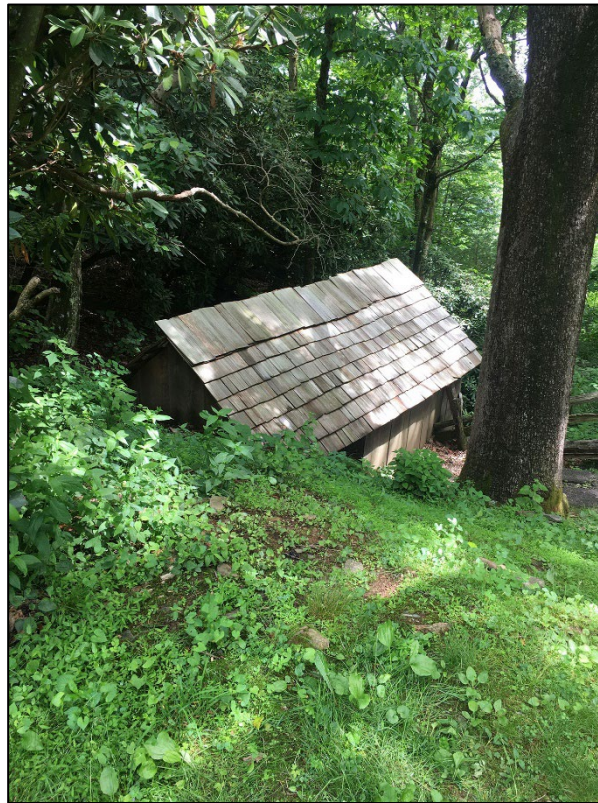
building is 16 feet by 8 feet, 2 inches. consists of a dry laid fieldstone foundation, wood-framed structure with vertically oriented wood plank siding, and wood-framed wood shake gable roof. The building is accessed through a wood-framed door opening. The northern room has a flagstone floor, is open on the western side, and contains the spring basin, which is located in the northern corner of the room. The southern room has an earthen floor, is enclosed, and contains the milk trough. The Springhouse sits in its original location and is a contributing resource that relates to the original design of the Blue Ridge Parkway. It remains open for visitors to explore (WJE 2016, A-215).

*Fig 8-22. Brinegar Spring House oblique view, facing south (2021)*

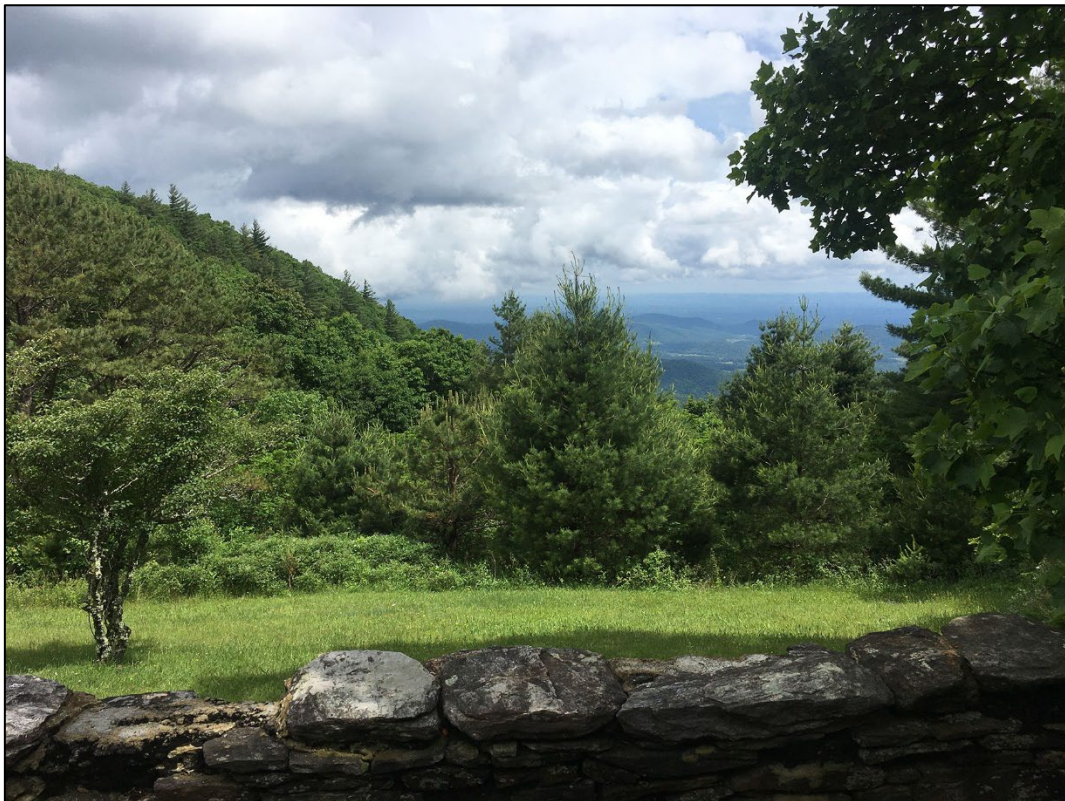
The Brinegar Cabin site contains one major vista. From the parking lot, visitors overlook the former orchard and into the distant mountains of North Carolina. The parking lot provides a wonderful vantage to look into the distant landscape, while also allowing the visitor to gain orientation of the Cabin site upon arrival. NPS contractors clear the vista of vegetation on a three-year cycle in order to retain the planned scene. The condition of the vista is good.

*Fig 8-23. View from Brinegar parking lot, facing southeast (2021)*

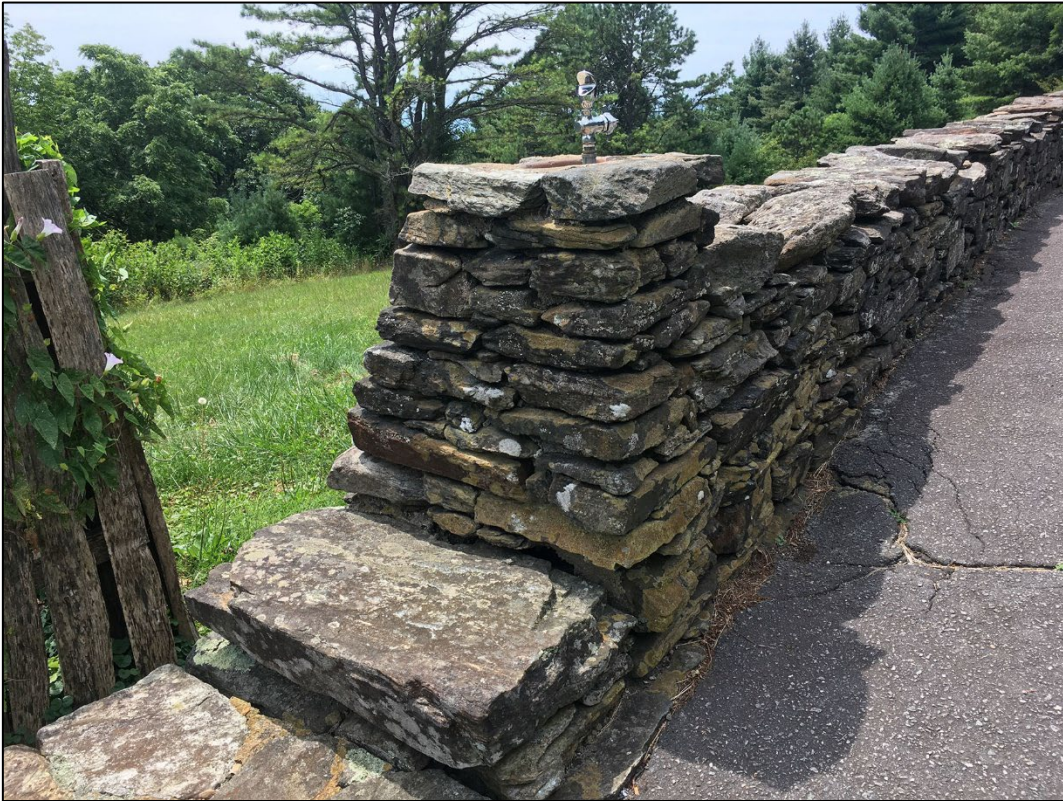
**Drinking Fountain:** A drinking fountain is incorporated as an extension of the parking lot retaining wall, with the top of the fountain rising an additional foot in height from the top of the wall. Two stone stairs elevate small visitors to an appropriate height to access the fountain. The top of the fountain contains an inset metal bowl with central drain and fountain head. Structurally, the masonry stone base is in good condition and the fountain was still operable as of 2021, albeit with noticeably low water pressure.

*Fig 8-24. Drinking fountain in Brinegar Cabin parking lot (2021)*

| | Inappropriate Maintenance | | Yes | No | The stone drinking fountain has been equipped with a modern stainless-steel spigot. While necessary to accommodate present-day usage, this addition technically compromises the feature's historic integrity to a minor degree. | 06/11/2021 |

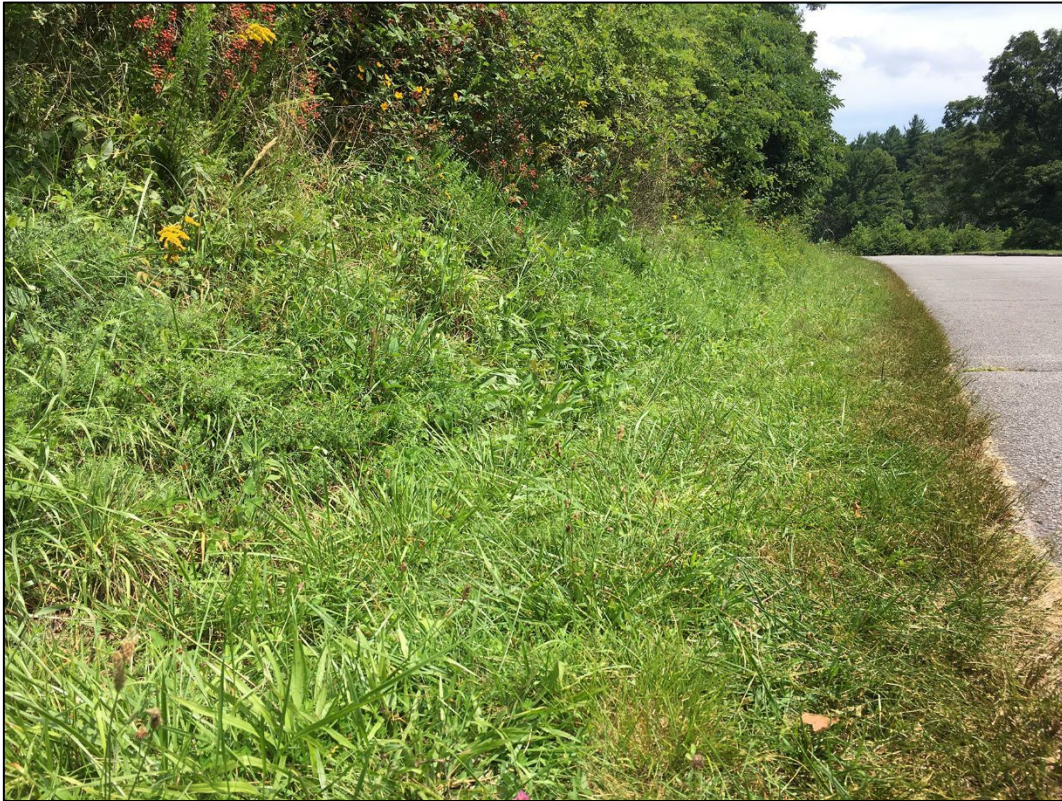
**Stone Gutter:** Approximately 300 feet of rubble stone gutter wraps from the entrance into the parking lot along the entrance driving lane. Rustic stone cobbles are mortared to form a one foot deep gutter. The condition of the gutter is fair due to encroaching vegetation in the mortar joints of the gutter

*Fig 8-25. Stone gutter along Brinegar Cabin parking lot. Obscured by vegetation (2021)*

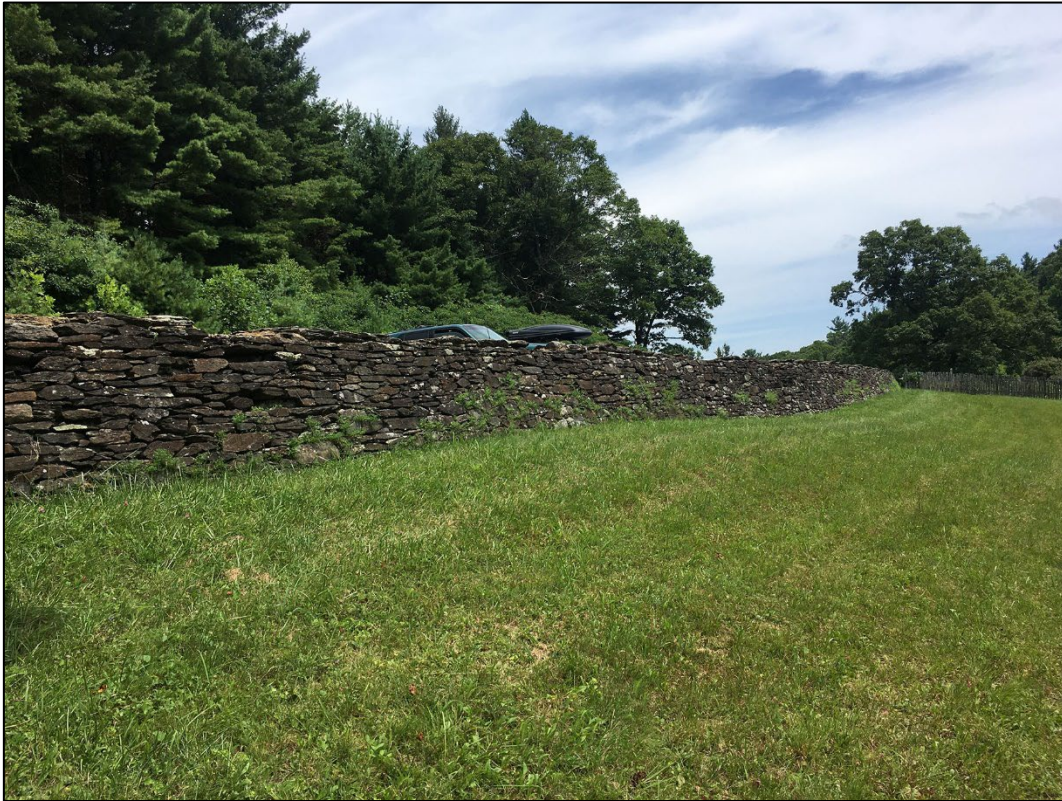
**Parking Lot Stone Retaining Walls:** A total of 225 linear feet of mortared stone wall is present along the southeastern and western edges of the parking lot. The wall is composed of long, thin, horizontally stacked stone that is very similar in character to the foundations of the existing buildings. The walls are 3 feet thick, 2-1/2 feet tall on the parking lot side, and an average of 4 feet tall on the field-facing side. While the structural integrity of the wall appears to be intact, many spots are missing capstones.

*Fig 8-27. View of stone retaining wall from orchard site. Elevation view, facing northwest. (2021)*

| | Visitation | | No | Yes | Several sections of the stone retaining wall separating the parking lot from the former orchard site are either missing stones or have been dislodged. This damage appears to be attributable either to accidental contact from vehicles or from prior visitors pushing or climbing on the wall. | 06/11/2021 |

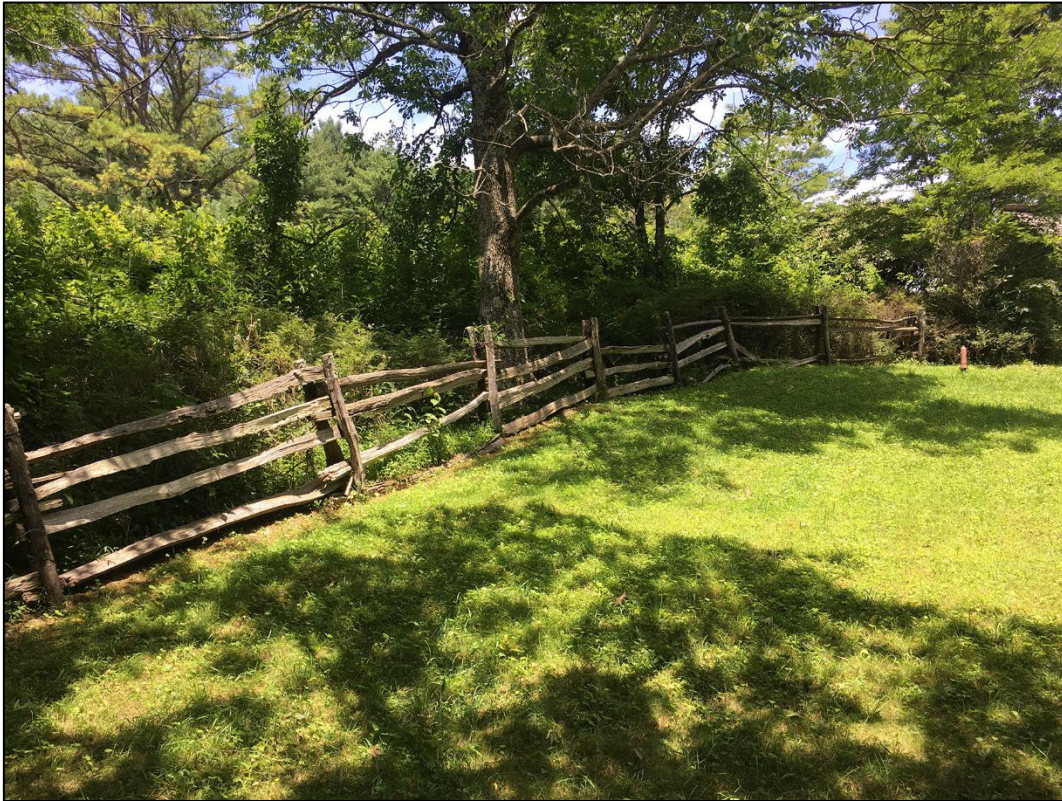
*Fig 8-29. Split rail fencing near Brinegar Shed and Cabin, intact (2021)*

| Seq. No. | Type | Impact Type – Other | Internal Source? | External Source? | Narrative | Date Identified |
|---|---|---|---|---|---|---|
| | Deferred Maintenance | | Yes | No | Several sections of split rail fencing have collapsed and are in need of repair. | 06/11/2021 |
