# National Park Service Cultural Landscapes Inventory 2022

**Doughton Park Campground**  
**Blue Ridge Parkway**

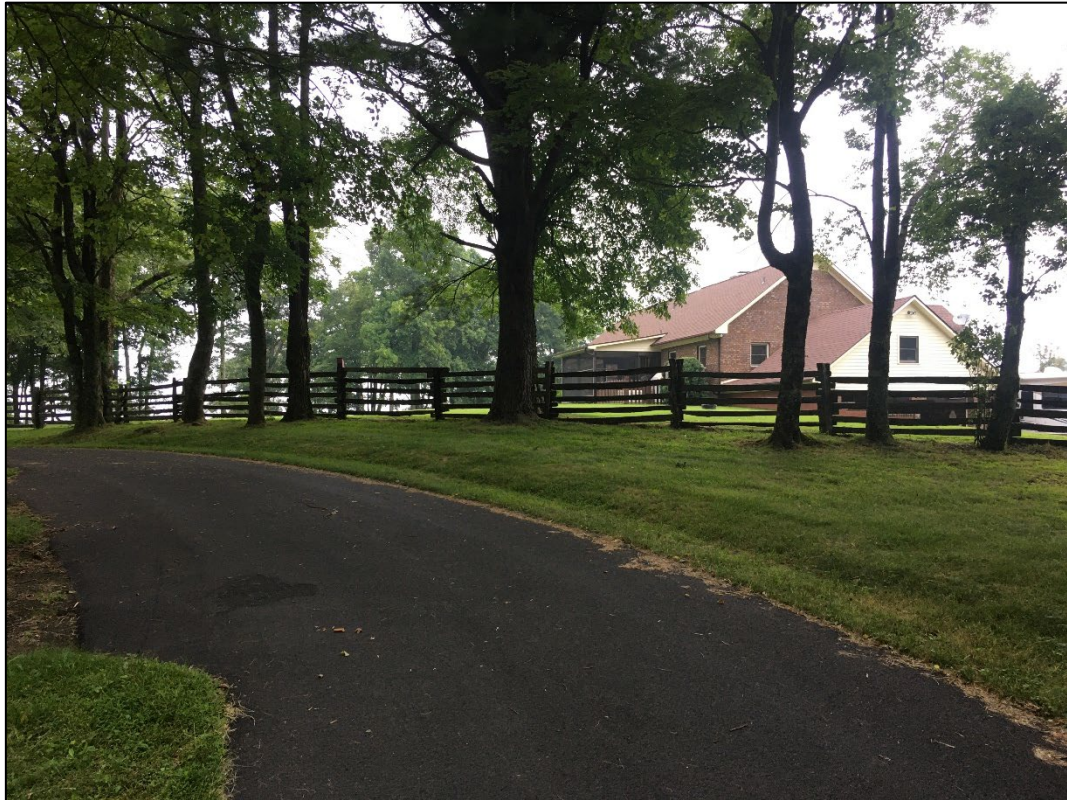
The eastern (1964) spur of the campground on 'parkway right' is immediately adjacent to the NPS boundary. Adjacent residential development impacts views from this area.

*Fig 4-1. Residential development adjacent to Loop E campsites*

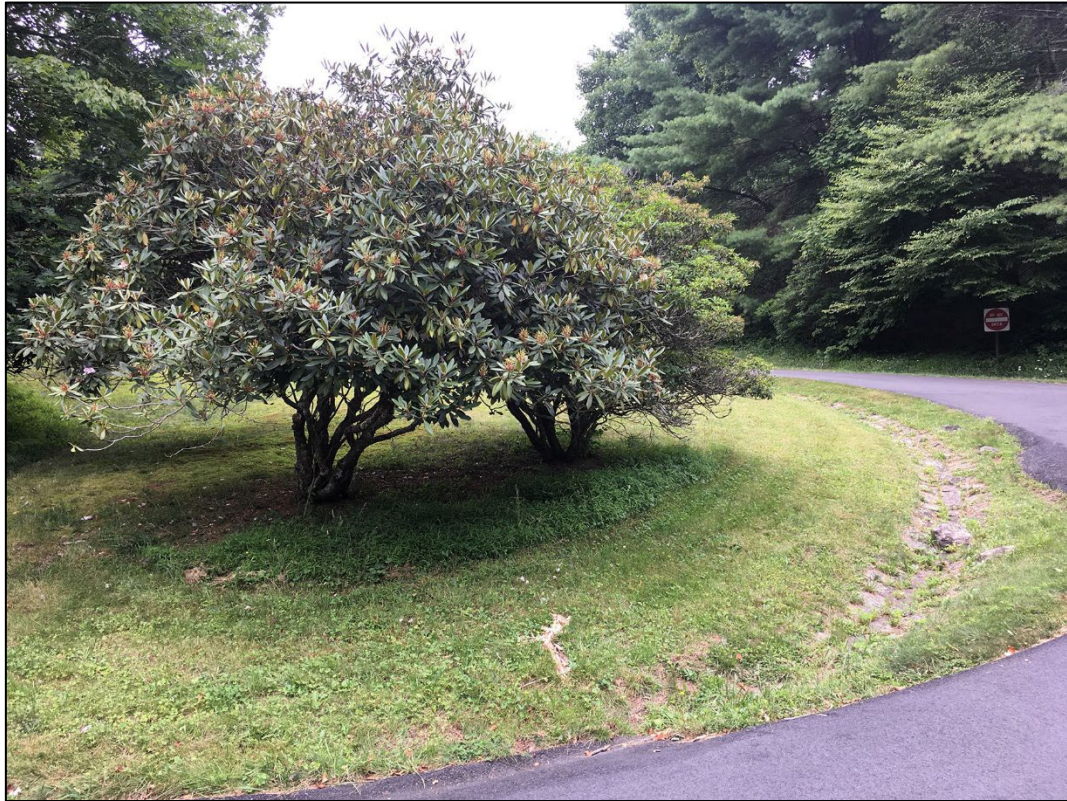
*Fig 8-1. Mature mountain laurel and rhododendron bay near campground entry kiosk, example #2. Camera facing southwest (2021)*

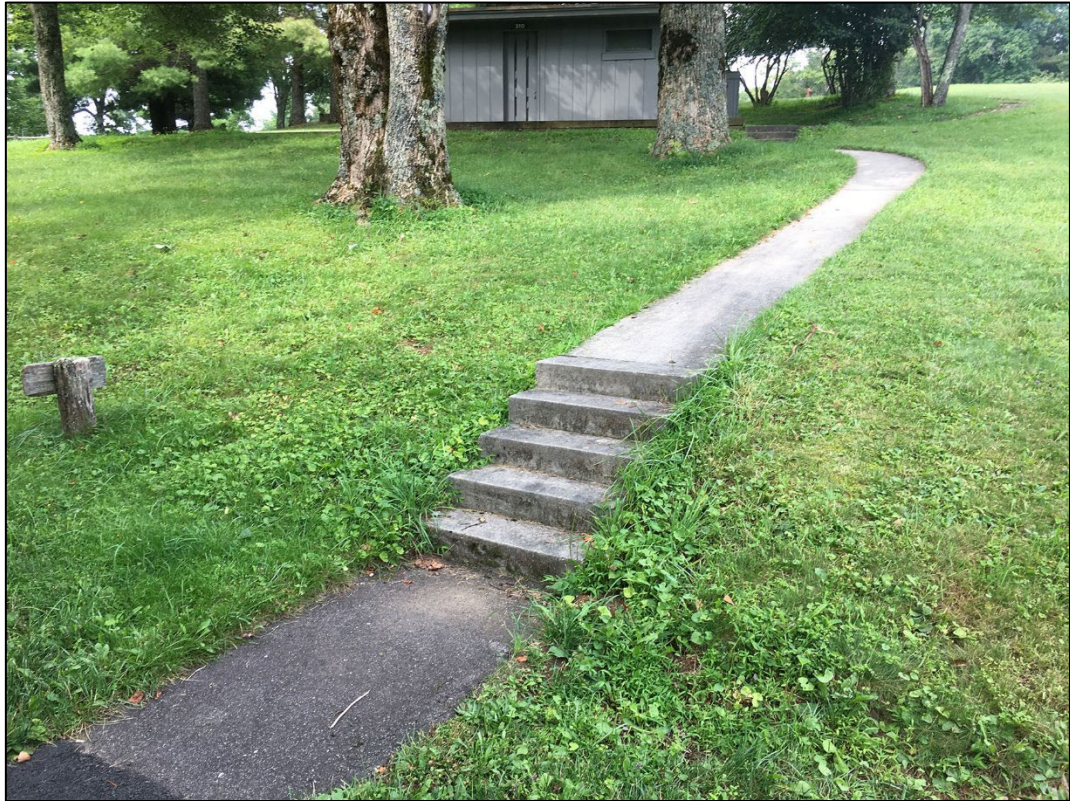
*Fig 8-4. Concrete steps near Comfort Station #396. Camera facing southwest (2021)*

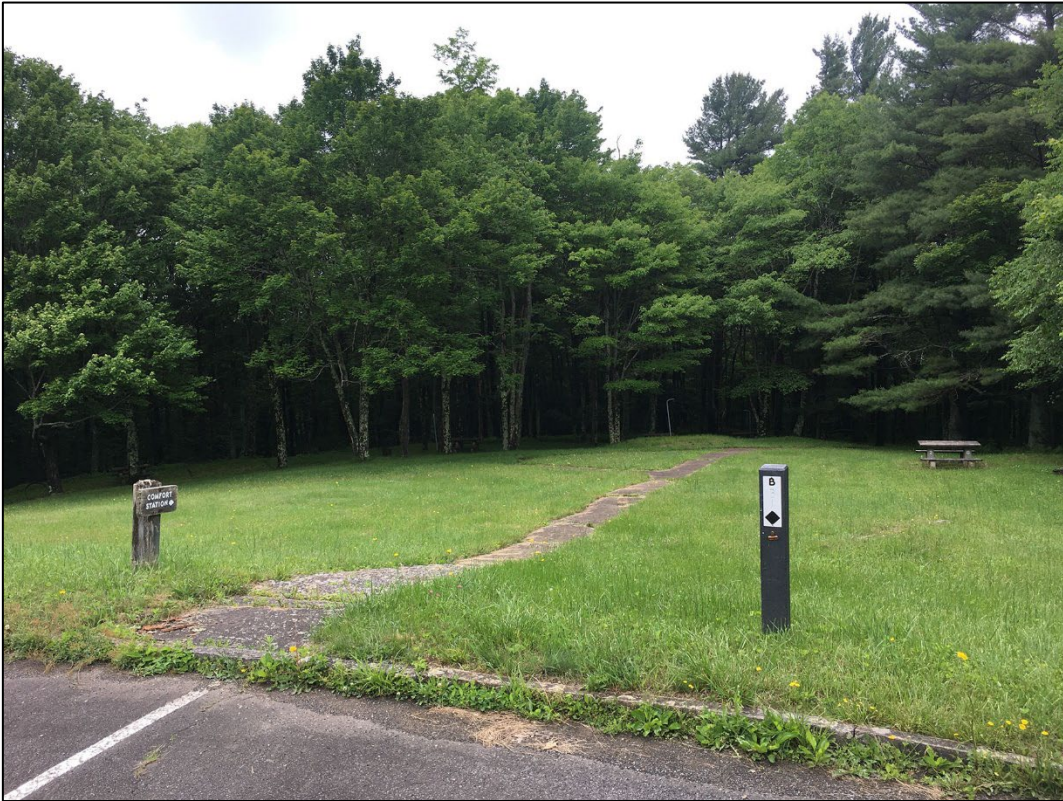
*Fig 8-5. Paved asphalt pathway leading toward Comfort Station #370 (not pictured). Camera facing northeast (2021)*

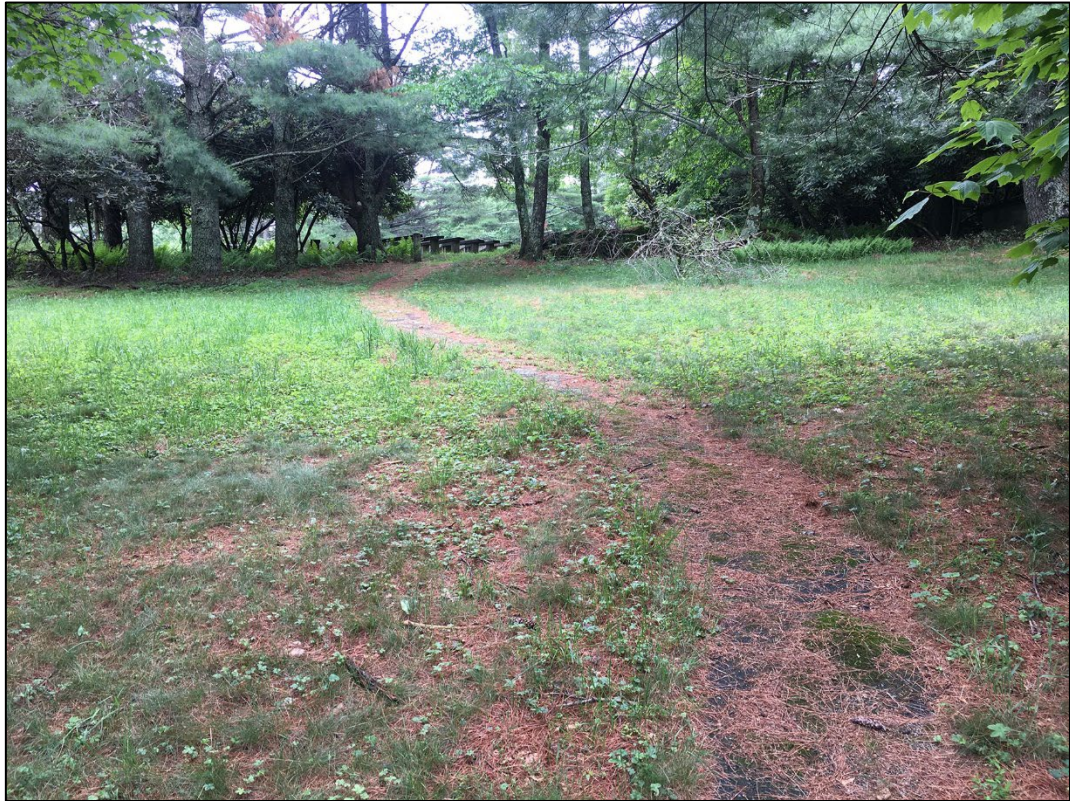
*Fig 8-6. Paved asphalt pathway leading to Loop B amphitheater. Moderately obscured by pine needles. Camera facing southeast (2021)*

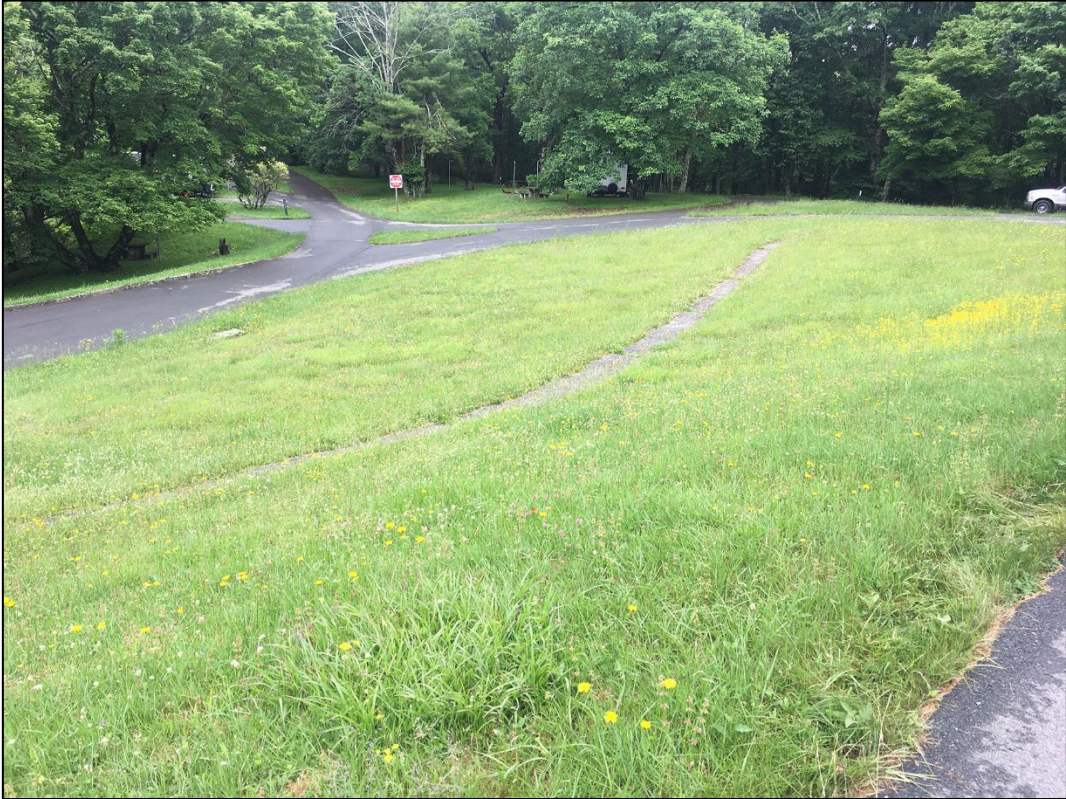
*Fig 8-7. Paved asphalt pathway near Loop C (Trailer Campground). Camera facing south (2021)*

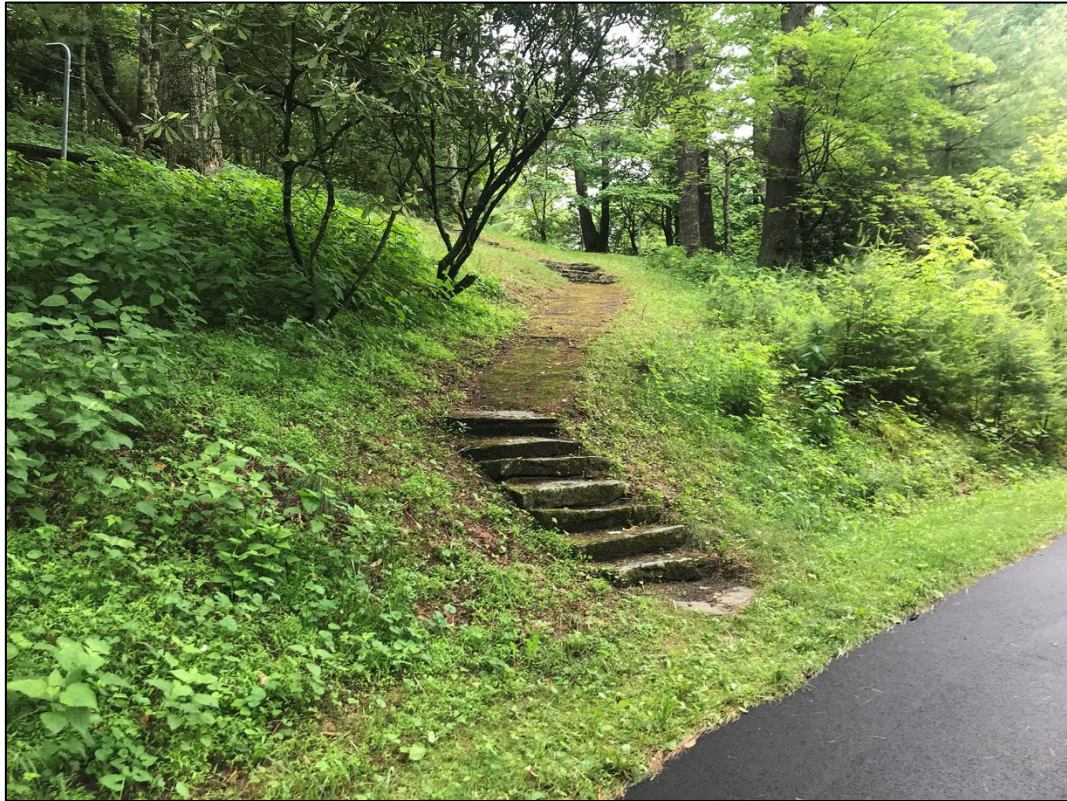
*Fig 8-8. Circa-1942 stone steps and asphalt pathway leading to campsite along Loop D (2021)*

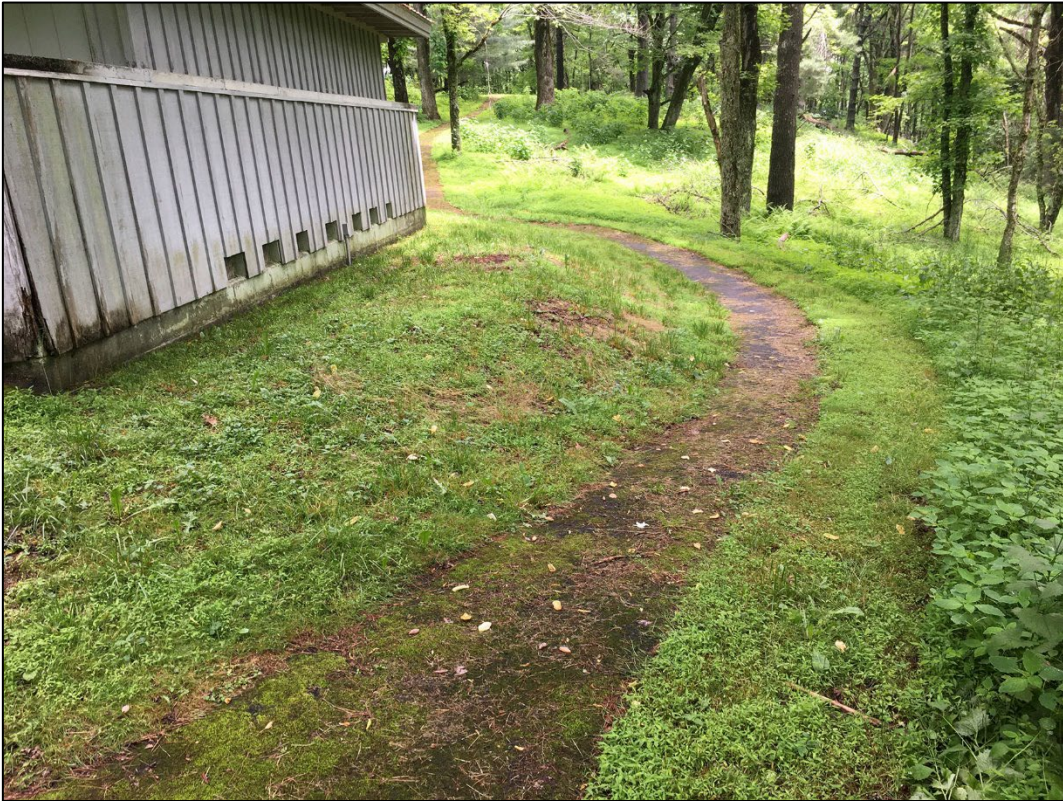
*Fig 8-9. Paved asphalt pathway near Comfort Station #370. Moderate moss growth. Camera facing northwest (2021)*

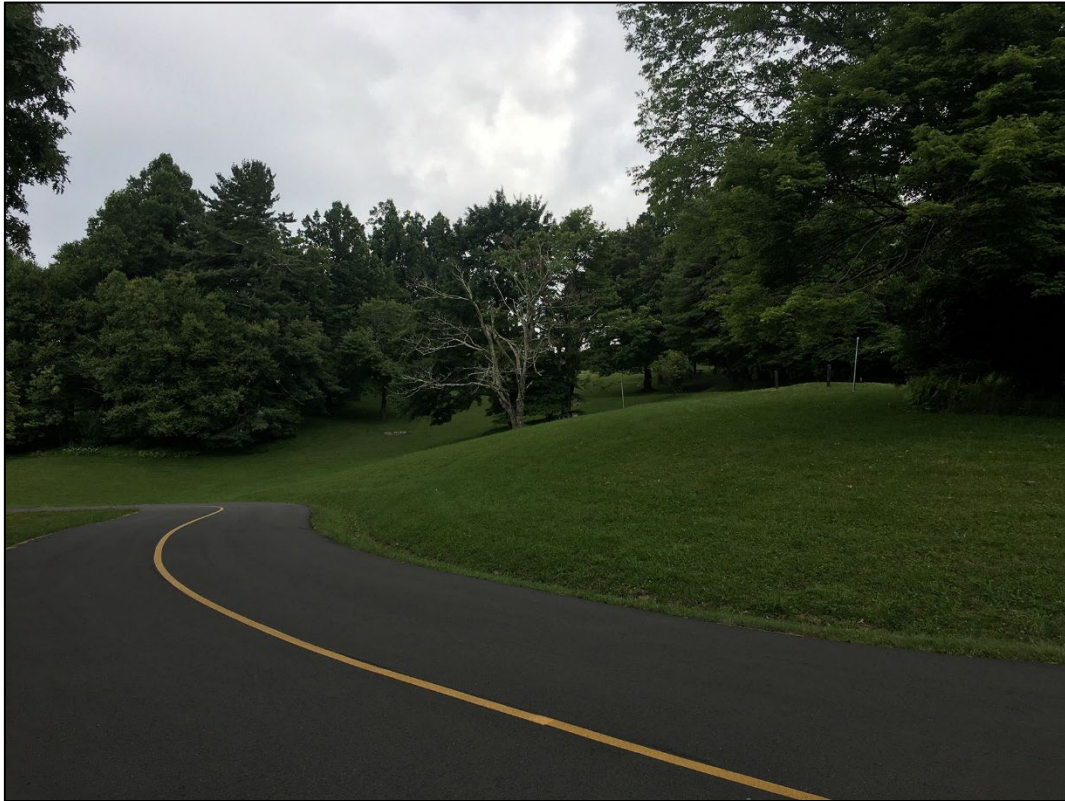
*Fig 8-11. Outer Loop A road in good condition with new paving and fresh paint. Camera facing southeast (2021)*

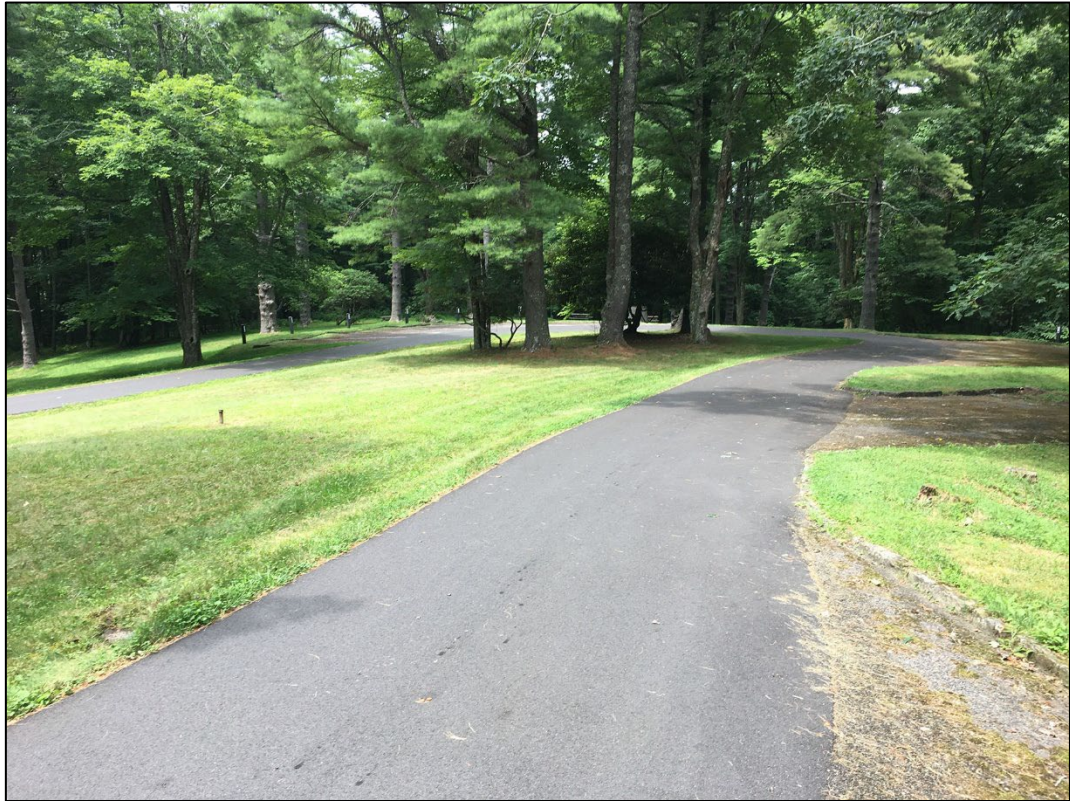
*Fig 8-14. Loop D road in good condition, example #2. Camera facing north (2021)*

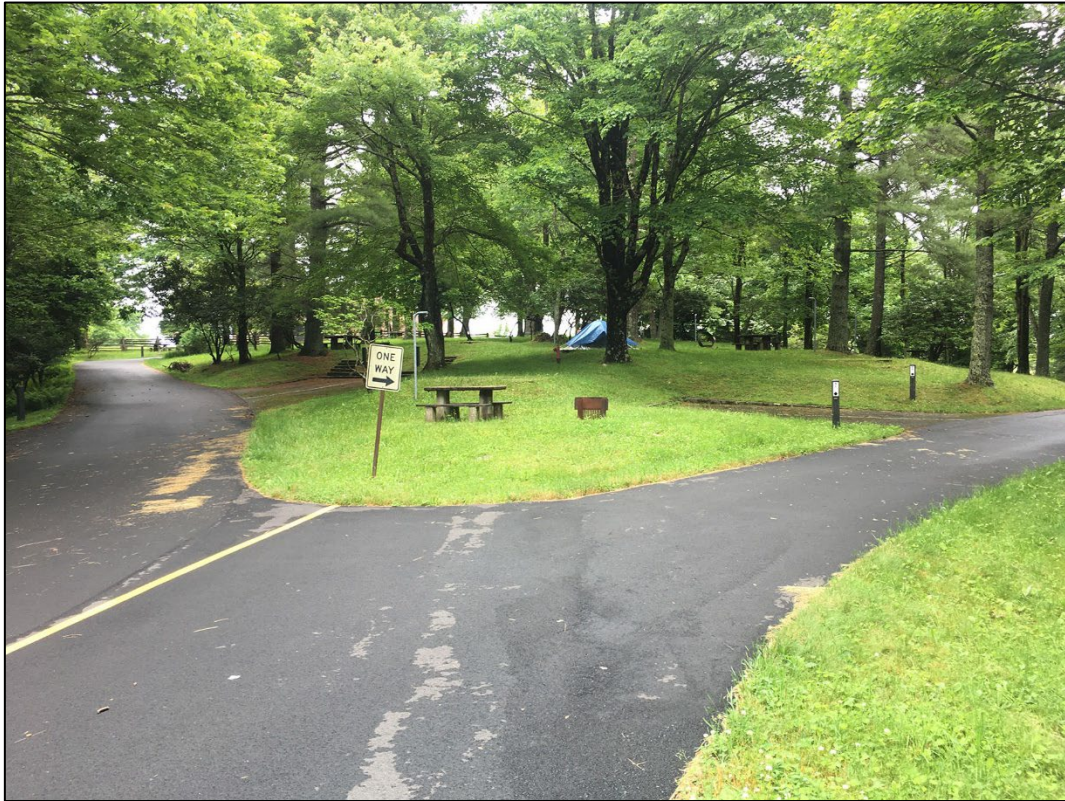
*Fig 8-15. Fork in Loop E road. Road in good condition. Camera facing northeast (2021)*

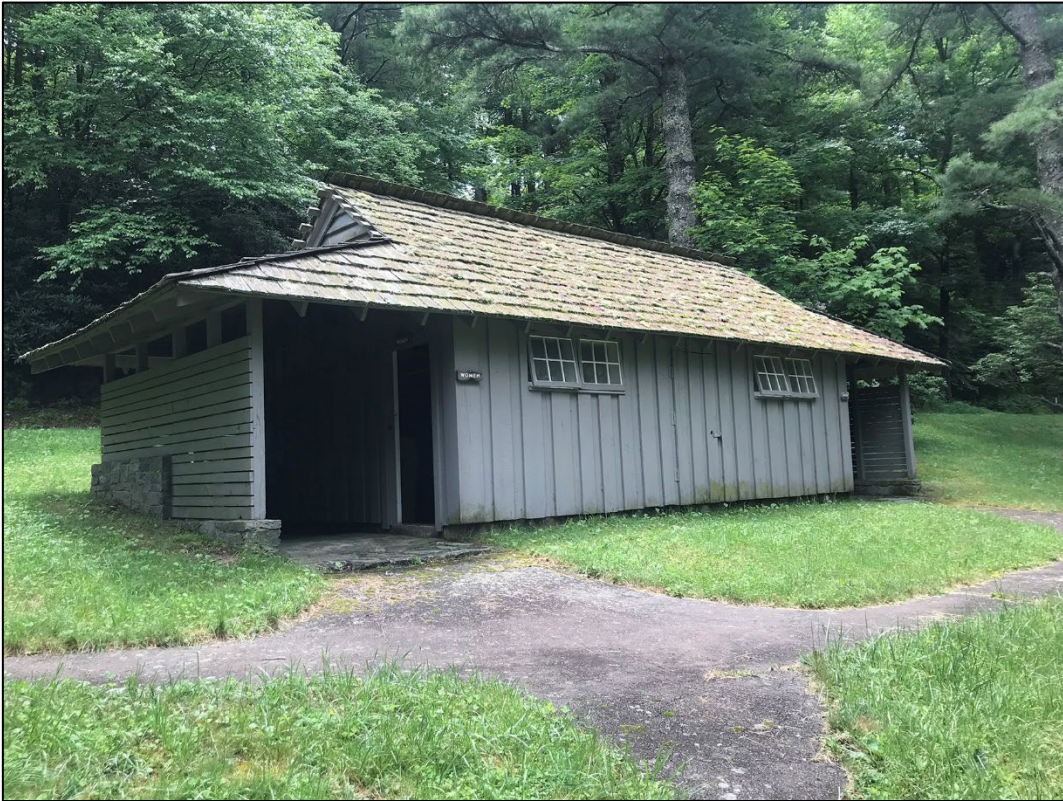
Comfort Station #98: Comfort Station #98 is located at the center of campground Loop C, also called the Tent Loop. The building is situated on a mown-turf clearing within a densely wooded deciduous forest on a steep-sloped hillside approximately ten feet from the paved loop roadway. The comfort station is accessed from an asphalt-paved walkway that extends from the loop road. The building is single-story and wood-framed, with a rectangular plan. It houses restroom facilities and a janitor's closet. The building consists of a concrete foundation, board and batten siding painted gray, and a wood-shake hip roof with gablets. The roof is characterized by

exposed wood rafters and wide overhanging eaves that are supported at the ends by a wood-framed screen wall. The screen wall is composed of wood posts set on a stone foundation. The wall framing is clad with horizontal boards separated by a 1-inch-wide joint, through which the framing is visible. The side elevations of the building have two wood-framed window openings, each consisting of paired six-light hopper windows. There are three entrances to the building: one at each end that provides access through a covered vestibule to the separate restroom facilities, and one centered on the back elevation leading to the janitor's closet. The restroom entrances are accessed by stone steps and an entrance stoop enclosed by the wood-framed screen wall and overhanging roof. Each entrance door is composed of vertically oriented board batten siding. Comfort Station #98 is a contributing resource that relates to the original design of the Blue Ridge Parkway. It is a highly characteristic and intact example of a rustic-style building on the Parkway (WJE 2016, A-217).

*Fig 8-18. Oblique view of Comfort Station #98, west façade. Camera facing southeast (2021)*

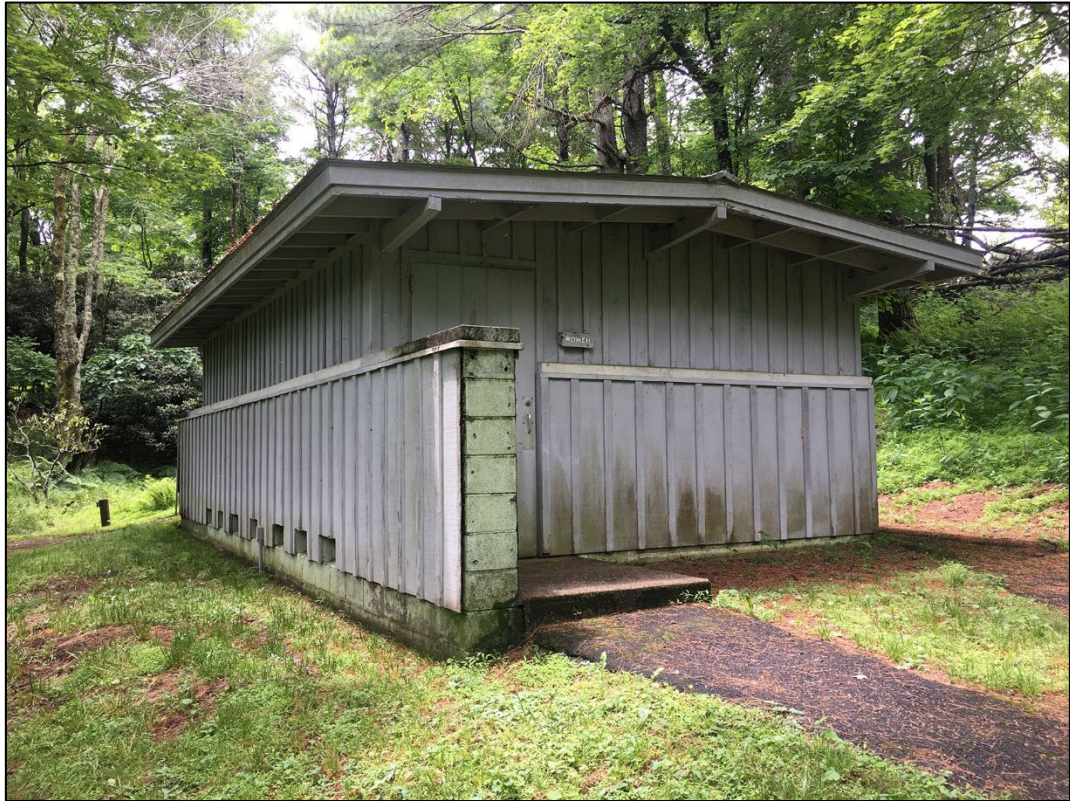
Comfort Station # 370: Built in 1963, Comfort Station #370 is located north of the entrance to Loop E. The building is situated in a wooded area on a steep-sloped hillside within a deciduous forest approximately fifty feet from the paved loop roadway. The comfort station is accessed from a concrete sidewalk that extends from the loop road and is surrounded on three sides by a concrete apron. The building is single-story, load-bearing, and rectangular in plan. It houses restroom facilities and a janitor's closet. The building has a concrete foundation, concrete block walls clad with grooved plywood and painted gray, and a wood-frame low-slope gable roof with exposed rafters, built-up roofing, and copper flashing. On the front elevation is a 5-foot-tall partial-height concrete block wing wall that extends approximately 5 feet from either end of the building. It is capped with a concrete coping and clad with grooved plywood. Two wood-framed hopper windows with concrete sills and obscure glazing are located on each elevation. There are three entrances to the building: one at each of the end elevations that provides access to the separate restroom facilities and one centered on the back elevation that provides access to the janitor's closet. Each entrance has a vertically oriented wood plank door. The doors are designed with wide gaps between the planks through which the interior wood cross-braced door framing is visible. Comfort Station #370 is a contributing resource that relates to the original design of the

*Fig 8-19. Oblique view of Comfort Station #370, north façade. Camera facing southeast (2021)*

| | Exposure to Elements | | Yes | No | The exterior of Building #370 is visibly weathered. The bases of its board-and-batten siding has developed a visible patina of mildew and has begun to deteriorate in some places. The concrete masonry units making up the building's foundation and exterior walls have also developed a thick layer of lichen where it is not covered by board-and-batten siding. The building retains its function as a comfort station, however, and otherwise appears to be structurally sound. | 08/03/2021 |

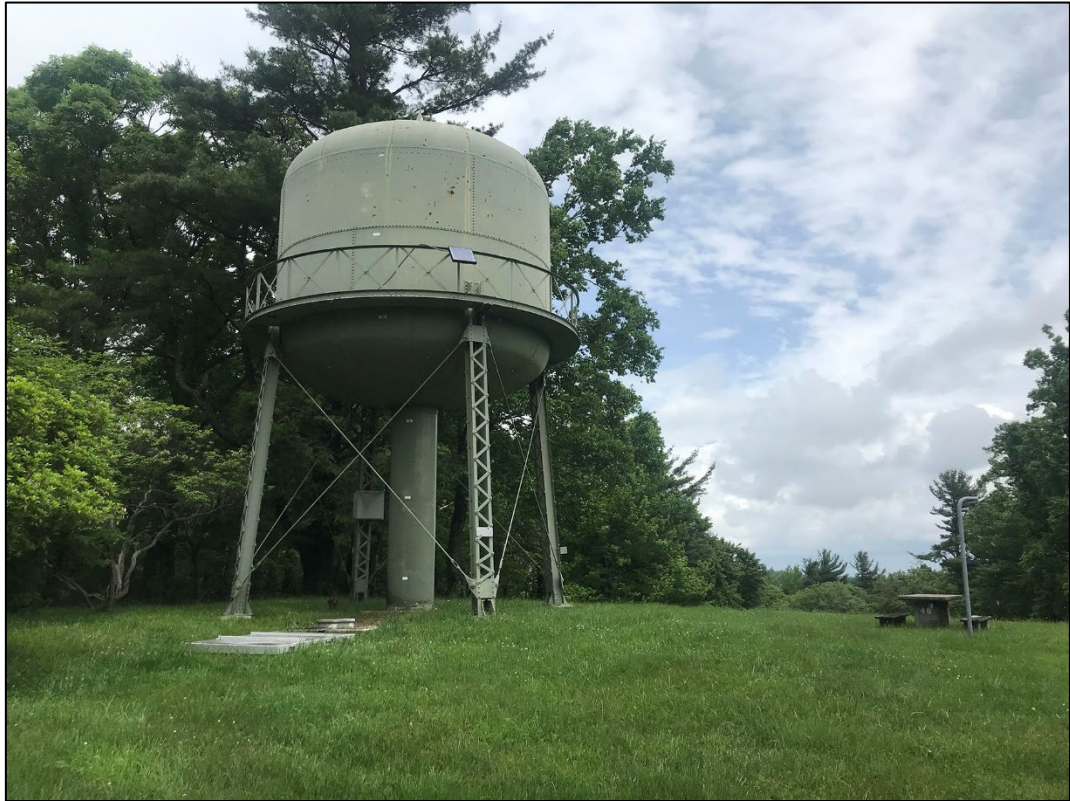
Water Tank: A water tank for the Campground area is located at the high point in the center of Loop A. The structure was completed in 1939 and has serviced the Campground since then. The tank sits atop an approximately 30-foot-tall steel tower. The tank remains in good condition.

*Fig 8-21. Oblique view of c. 1939 water tank. Camera facing northeast (2021)*

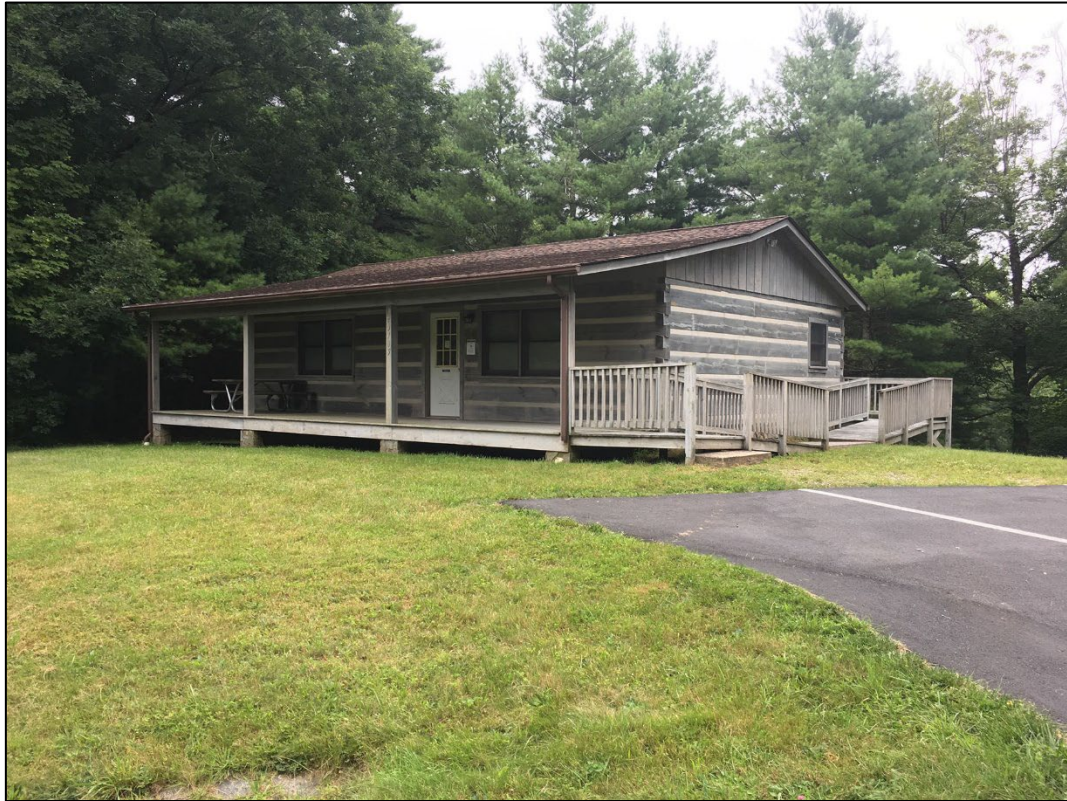
Tent Campground Host Cabin: In 1992, a topographic survey was conducted for the NPS to site the existing Host Cabin. This manufactured log building is situated on the top of the slope on the left side of the entry drive. The Cabin is a one-story log-framed structure of contemporary construction, rectangular in plan, which houses seasonal park employees. The building has a concrete block foundation with stone veneer, exposed milled-log framing stained grey, and a wood-framed asphalt shingle gable roof with hanging gutters. The milled-log framing has half-dovetail joints and an exterior insulation and finishing system (EIFS) faux daubing. The end gables of the roof are clad with vertical grooved plywood. At the front elevation of the building is a wood-framed covered porch with asphalt shingle shed roof. Typical fenestration consists of aluminum one-over-one double-hung windows. Typical doors are aluminum-framed with glazing. This cabin is a non-contributing resource due to its recent construction date. It can be accessed by a gravel drive on the northwest side and is in good condition (WJE 2016, A-222).

*Fig 8-23. Oblique view of Host Cabin, north façade. Camera facing southeast (2021)*

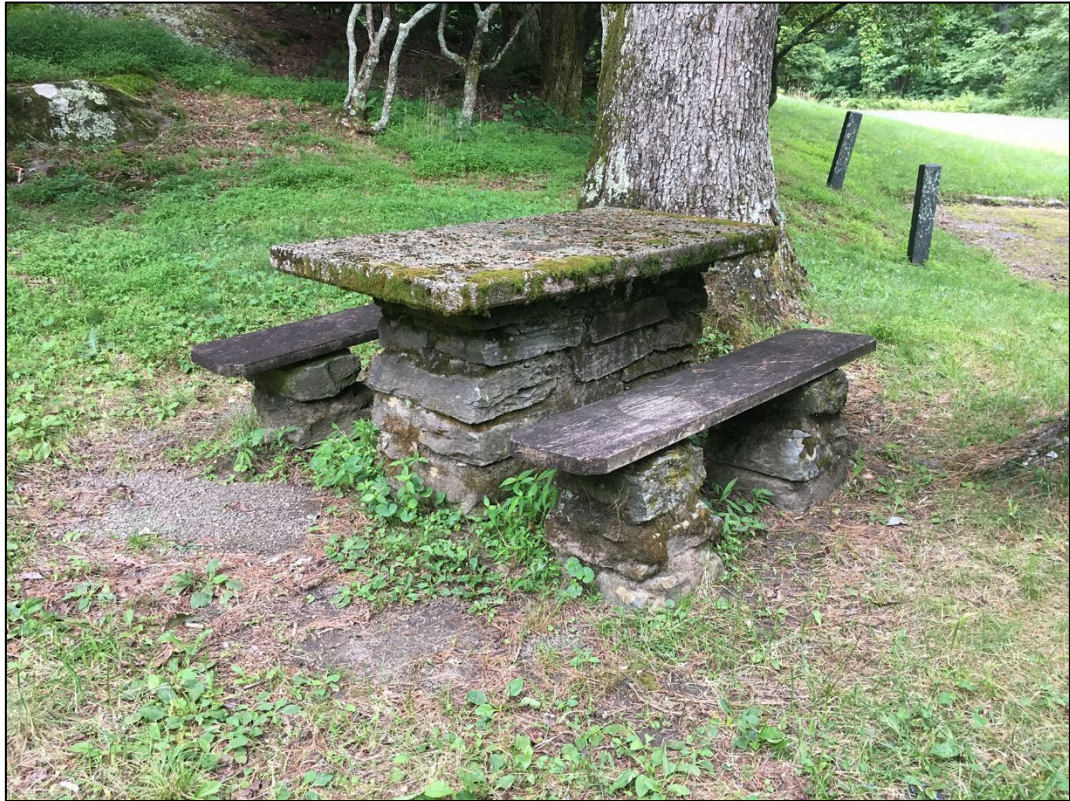
*Fig 8-24. Example of Prewar Planning and Construction Era picnic table. Park Rustic style with original stone (2021)*

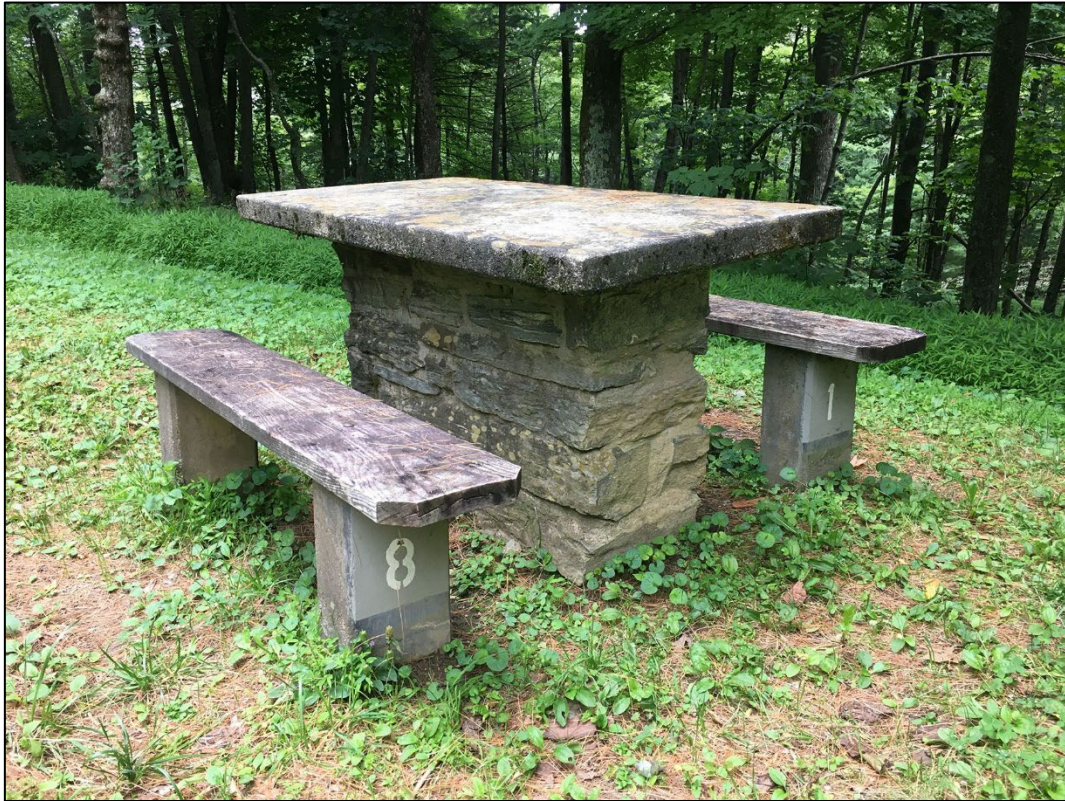
*Fig 8-25. Example of Prewar Planning and Construction Era picnic table. Park Rustic style with concrete block replacement piers (2021)*

| | Removal/Replacement | | Yes | No | Approximately 112 picnic tables are located in areas of Doughton Campground that were first developed during the Prewar Planning and Construction Era (1933 to 1942). Presumably, these picnic tables would have originally been built in the Park Rustic style, with stone bases and bench piers, concrete tabletops, and wooden benches. Today, only 2 intact examples of the Park Rustic style remain, both of which are found along Loop D in what appears to be one of the less-used areas of the campground. Seven modified examples of the Park Rustic style exist which retain their original stone bases but whose bench piers have been replaced with concrete blocks or, in at least one example, wood blocks. The | 08/03/2021 |

| | | | | | remainder of the picnic tables located in Prewar Planning and Construction-era areas of the campground retain a similar design to the originals but have since been modified in such a way that all original stone components have been replaced with concrete blocks. These modifications represent a com | |

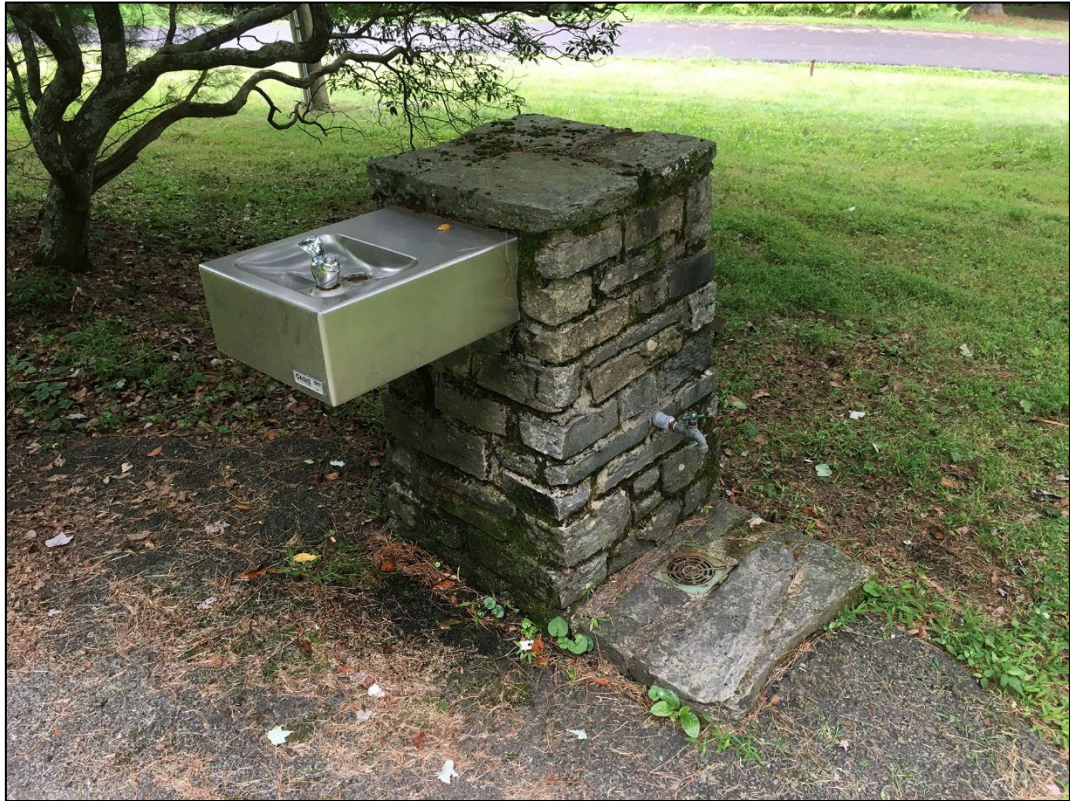
*Fig 8-30. Stone drinking fountain with contemporary stainless-steel spigot near Loop D. Camera facing west (2021)*

| | Removal/Replacement | | Yes | No | Over the course of its history, at least 13 drinking fountains were installed throughout Doughton Campground. Today, only four survive. One is located in Loop A, another is in Loop D, a third is in Loop C, and the fourth is attached to the exterior of Building #370. Of the four, three are second-generation stone fountains installed before 1955. All three of these fountains have been modified to make them more ADA-accessible. | 08/03/2021 |

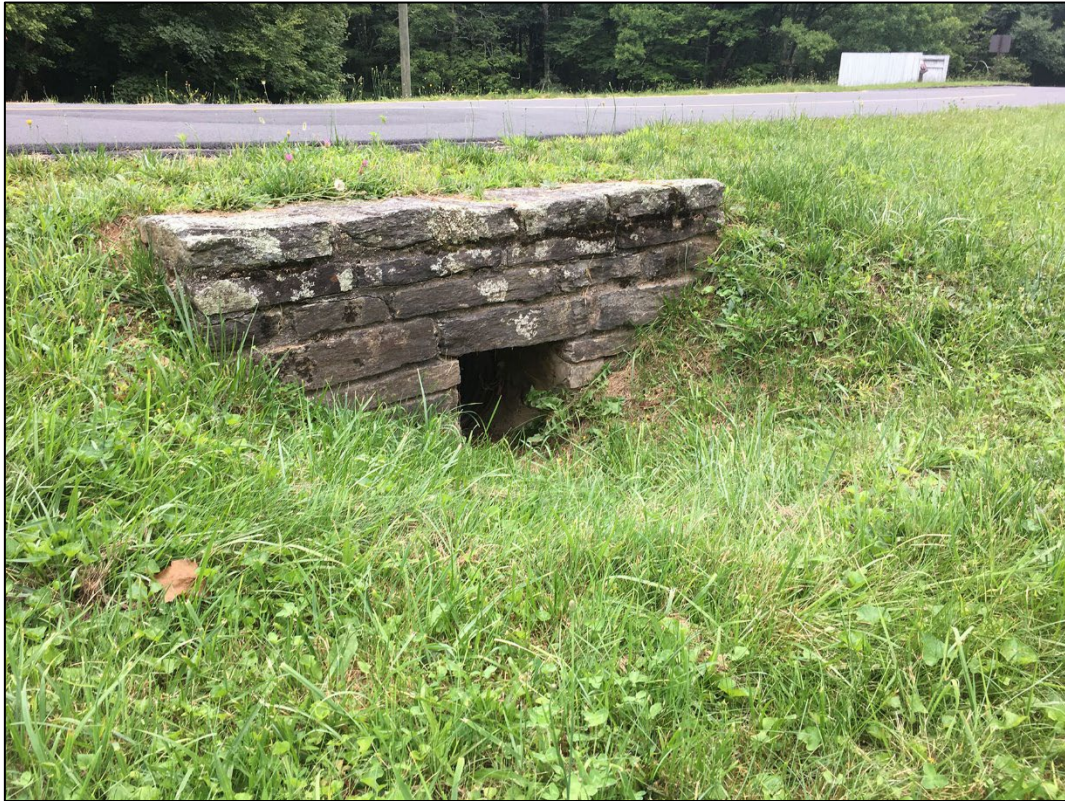
*Fig 8-31. Stone headwall near Outer Loop A. Camera facing northeast (2021)*

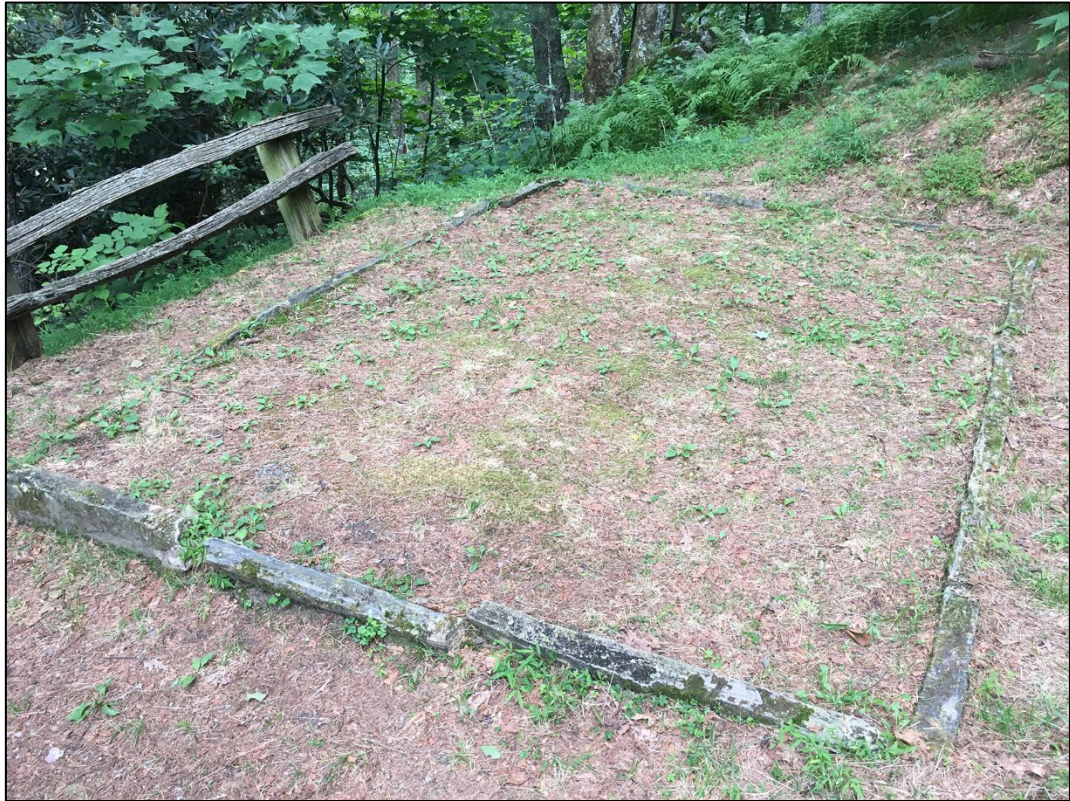
*Fig 8-34. C. 1942 stone-lined tent pad near Loop D. Camera facing north (2021)*

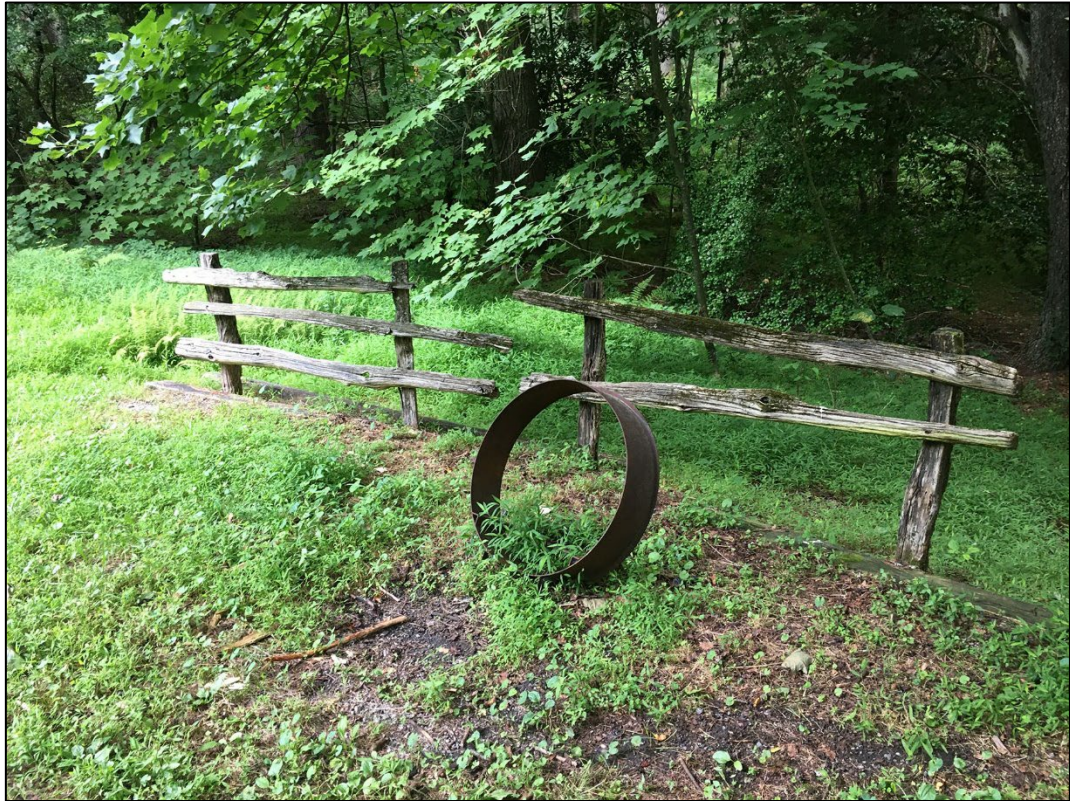
*Fig 8-38. Deteriorating split rail fencing near trailer campsite along Loop C. Camera facing west (2021)*

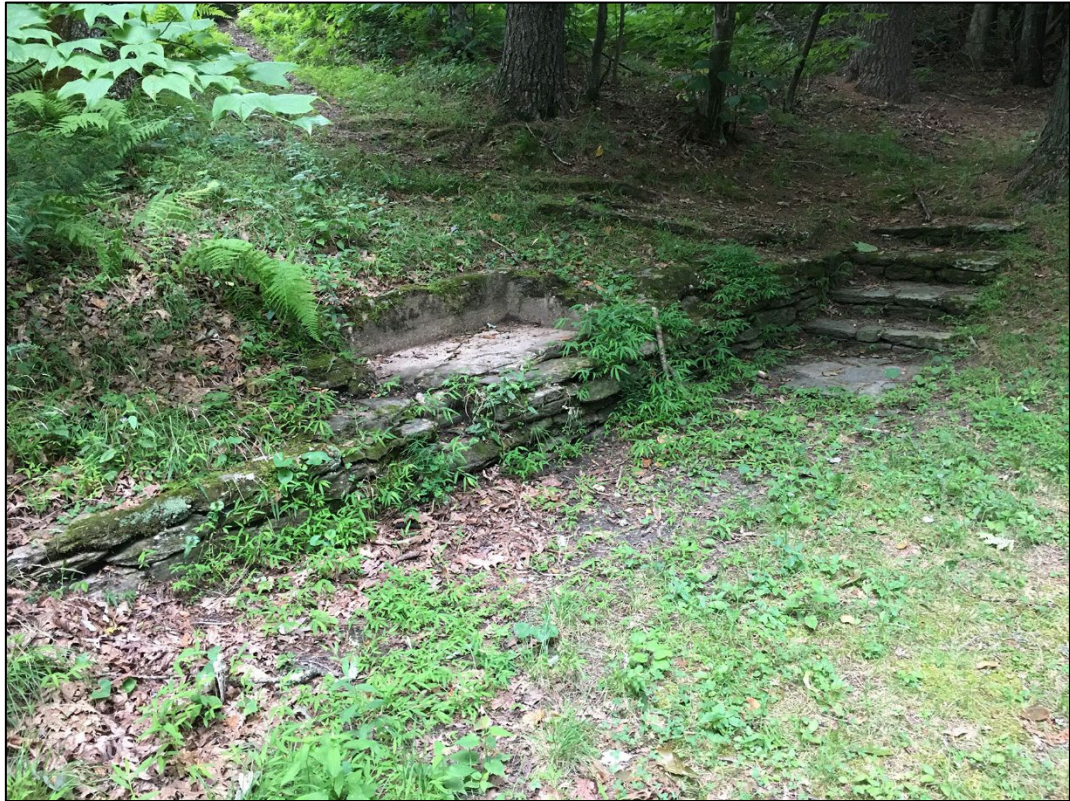
Horse Watering Trough: Remnants of a stone mortared horse watering trough are located south of Loop D beside campsite # 75. This horse trough was originally connected to a rustic stone drinking fountain and stairs. The drinking fountain was likely removed from the feature during the late 1980s and early 1990s. While the trough remains, it is in fair condition.

*Fig 8-40. Intact c. 1940 stone horse trough, partially obscured by vegetation and moss growth. Camera facing southeast (2021)*

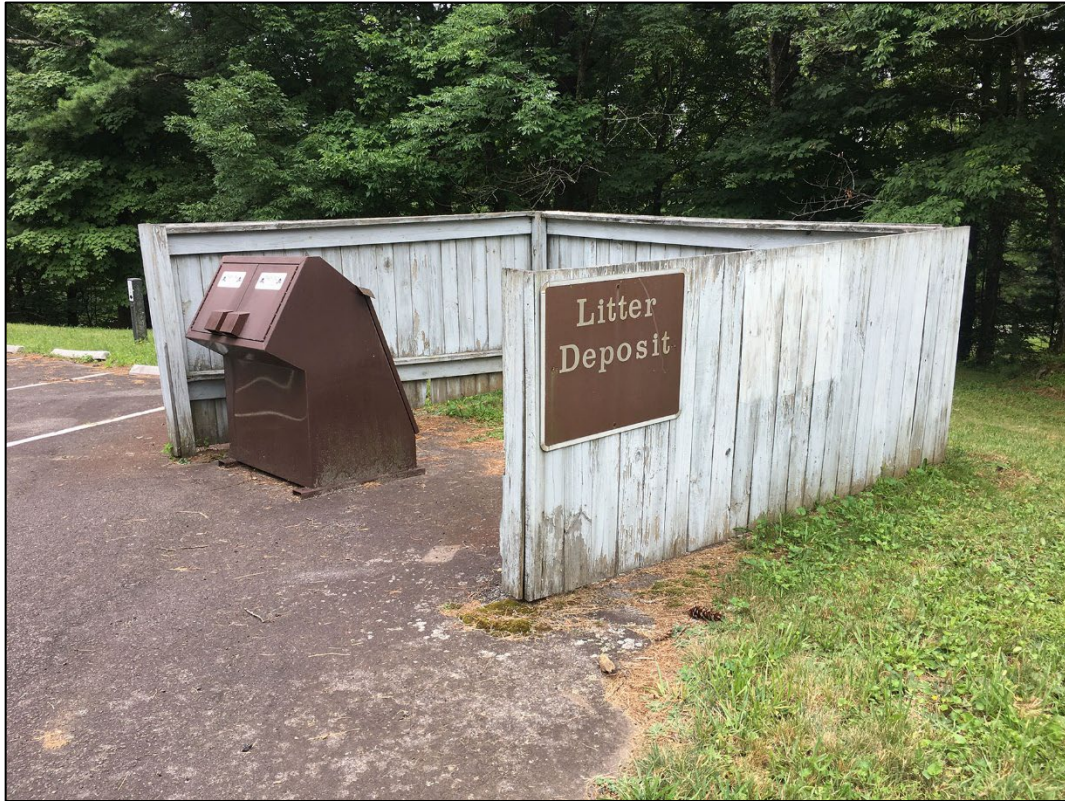
Refuse Disposal Stations: Both areas of the Campground contain a fenced space for trash and recyclables. In the trailer area it is located beside the Sanitary Dump Station. In the tent camping area it is located just south of the entrance to Loop E. Each station contains a trash dumpster within the wooden fence for visual buffer and a wooden recycling bin attached to the outer wall. In 2006, the wooden recycling bins were replaced with metal bins.

*Fig 8-41. Refuse disposal station with bear-proof trash receptacle along Outer Loop A, near junction with Loop E.  
Camera facing north (2021)*
