NON-DESTRUCTIVE ARCHEOLOGY
at
SLIDING ROCK RUIN an experiment
in the methodology of the conservation
ethic

Larry V. Nordby
Supervisory Archeologist
Southwest Cultural Resources Center
National Park Service

December 1981

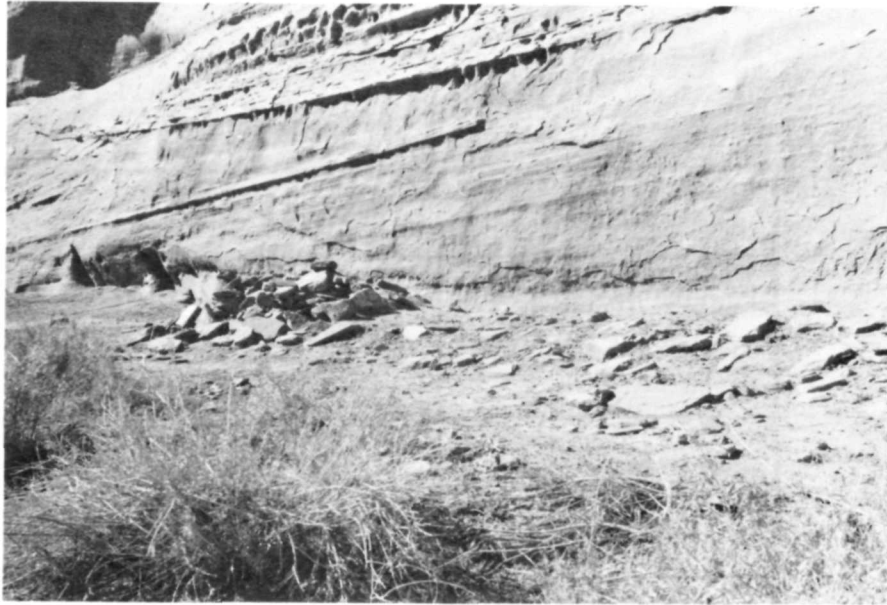
Figure 5: Remnants of rooms at the top of the talus below Mindeleff's Site 31, facing West. Site may contain a Navajo burial.

Mindeleff (Ibid.: 150, Fig. 61) also shows two contiguous rooms at the top of the talus below Site 31. The walls of these rooms are no longer distinguishable, having collapsed into a pile of rubble. Nearby is a second rubble mound which marks the presence of one or two additional rooms. Since these are located in a very shallow shelter, sheep and goat traffic probably contributed to their downfall. Other than noting their presence, nothing can be inferred about the mounds, although one may contain a Navajo burial. Figures 5 and 6 show their present condition. Mindeleff's base map (Ibid.: Plate XLIII) also shows three structures at the top of the talus below Site 32. He does not mention them anywhere in his text and there are none there now, nor are their remains visible.

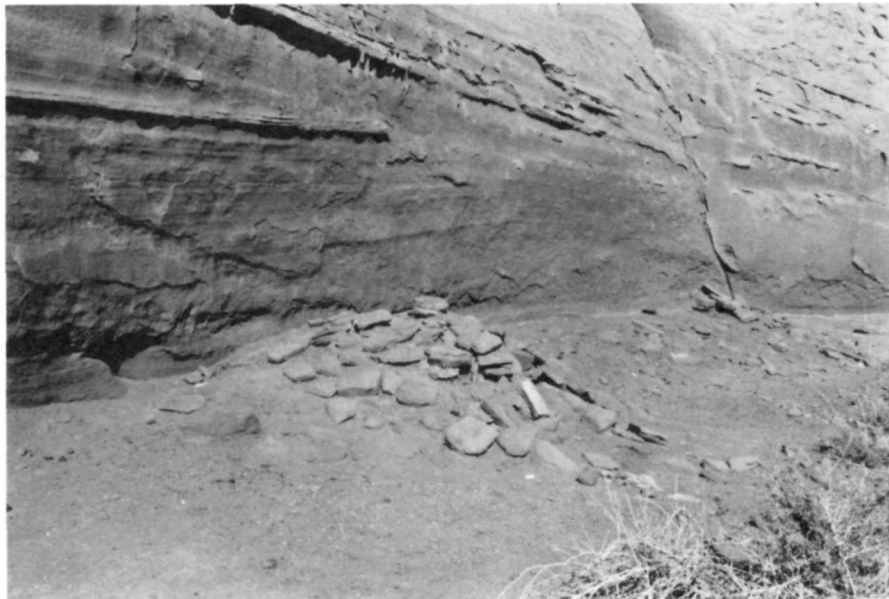
Figure 6: Remains of rooms at the top of the talus, below Mindeleff's Site 31, facing north.

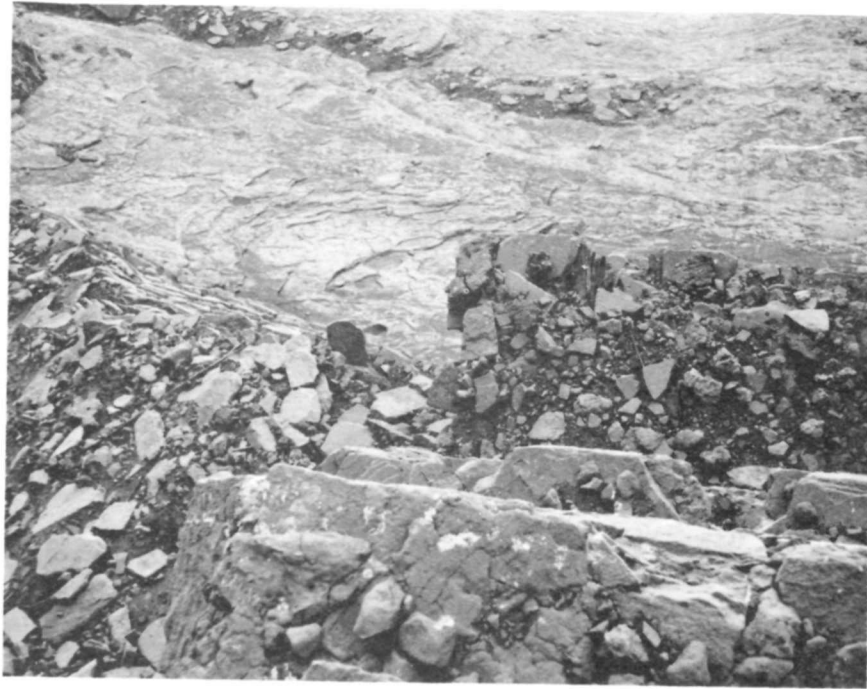
Figure 37, View down along face of retaining walls. Note unfinished face at left, multiple terracing of walls, and incorporated logs.

Walls 3, 4, and 5 are mortared, with a finished facade produced more by judicious stone selection than by pre-emplacment

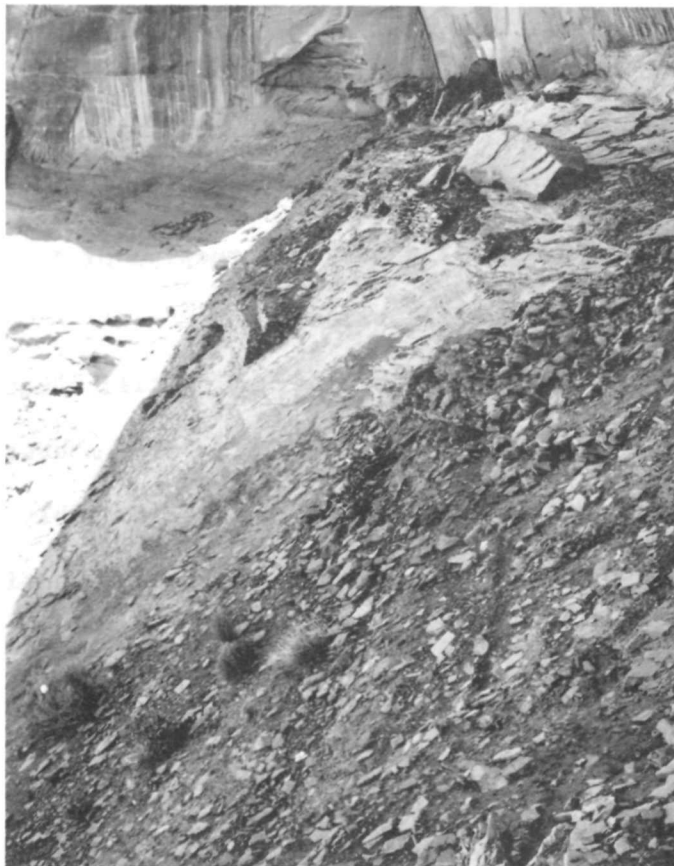
Figure 38:
Sections of un-
fallen retaining
walls located
downslope from
Room 12-15 area.
