**CLASSIFIED STRUCTURE FIELD INVENTORY REPORT**  
(Attach 4" x 5" Black and White Photograph)

REGION RMRO PARK/AREA NAME Canyonlands Natl. Park PARK NUMBER 1340  
STRUCTURE NAME Kirk's Cabin STRUCTURE NUMBER NEED - 28  
LOCATION OF STRUCTURE Upper Salt Creek Canyon PARK LOCATION CODE PG  
NATIONAL REGISTER \_\_\_\_\_ DATE:   /  /   MANAGEMENT CATEGORY: (A) (B) (C) (D)  
NPS LEGAL INTEREST Fee MANAGEMENT AGREEMENT: NO

# Kirk's Cabin Complex

## Canyonlands National Park

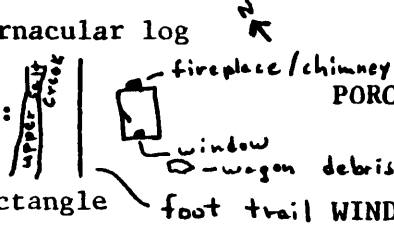
SITE (INCLUDE ORIENTATION OF STRUCTURE): PORCHES: n/a  
OVERALL BUILDING PLAN (FOOTPRINT): rectangle WINDOWS: 1 opening - square  
OVERALL DIMENSIONS: 18'x22'4"  
COMPOSITION (NPS 28 CODE): WD DOORS: 1 opening, metal hinges in door frame  
STORIES: 1 ADDITIONS: None  
FOUNDATION: random and rough cut fieldstone  
WALLS: hewn log, false cornered notches, mud & pole daubing & chinking, partially held together with 1" diameter wood pegs INTERIOR PLAN: open  
ROOF: low end gabled, 2 center ridge poles, pole & soil INTERIOR FINISHES: rough hewn log/dirt floor ceiling is inside of pole roof

Hikers & camper use of interior may potentially damage or destroy this resource.

NOTE: The structure may have been significantly rebuilt and altered by volunteer stabilization efforts in 1976. Also, post-survey NPS patrols indicate that two walls have been severely damaged by visitors during 1986.

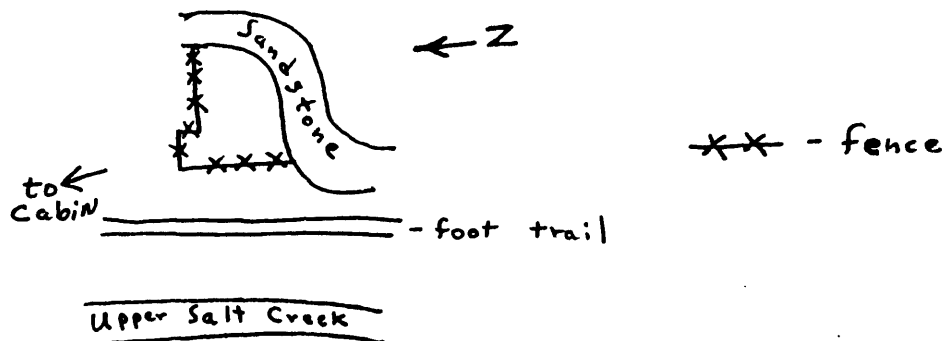
The site retains integrity of location, but is badly deteriorated. Its function  
is only marginally apparent from the physical remains.

Type: FE  
 Materials: WD  
 Dimensions: 120'x150' approx.

The site is a corral built by constructing two post and pole fences and using natural sandstone walls for the other two sides. The posts are made of 2 poles pegged together and the fence was of horizontally laid poles.

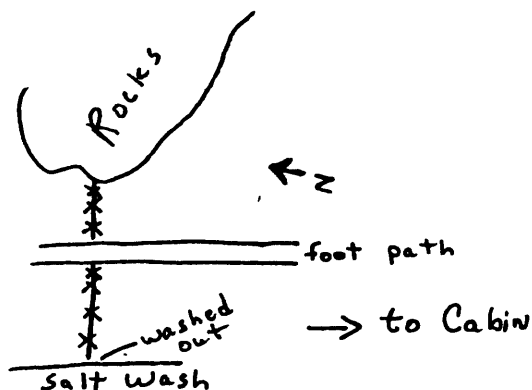
Dimensions: 1'x185' approximate

This is a fence built to denote the edge of Kirk's pasture in the same twin post and pole manner he built his corral (NEED - 29). It was later partially remade into a standard single post barbed wire fence.

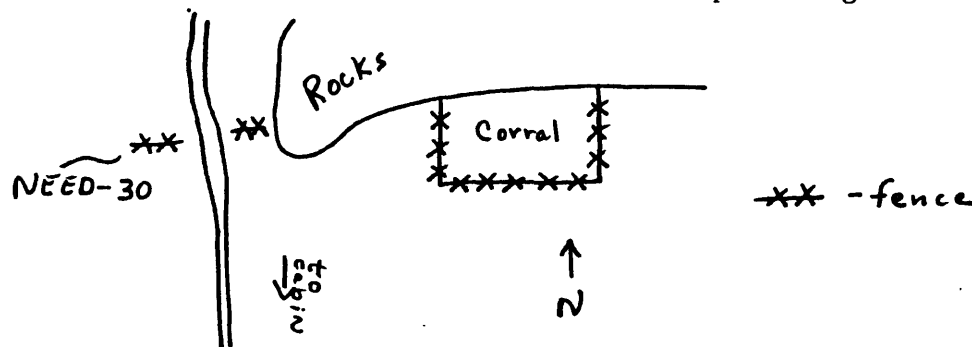
Type: FE  
Materials: WD/MT  
Dimensions: 45' x 110' (approx.)

This is a twin post and pole corral with fences on three sides and a rock wall for the fourth. Its construction is similar to the other Kirk's corral and Kirk's fence, except that no pegs were used. Instead, wire held the posts together.

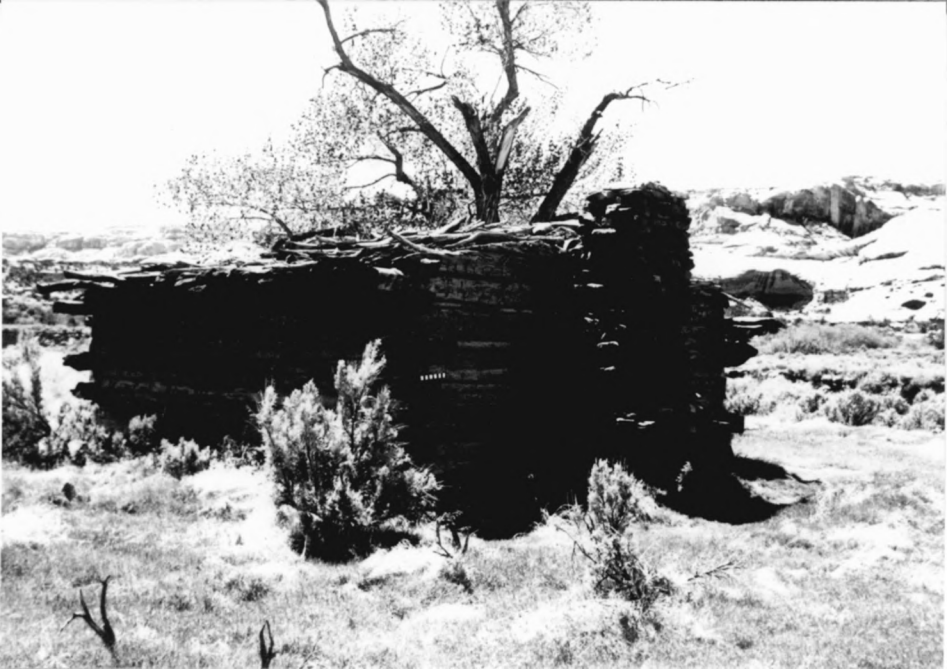
Roll 8, #8

HS-NEED-28

KIRK'S CABIN REAR

REAR N side

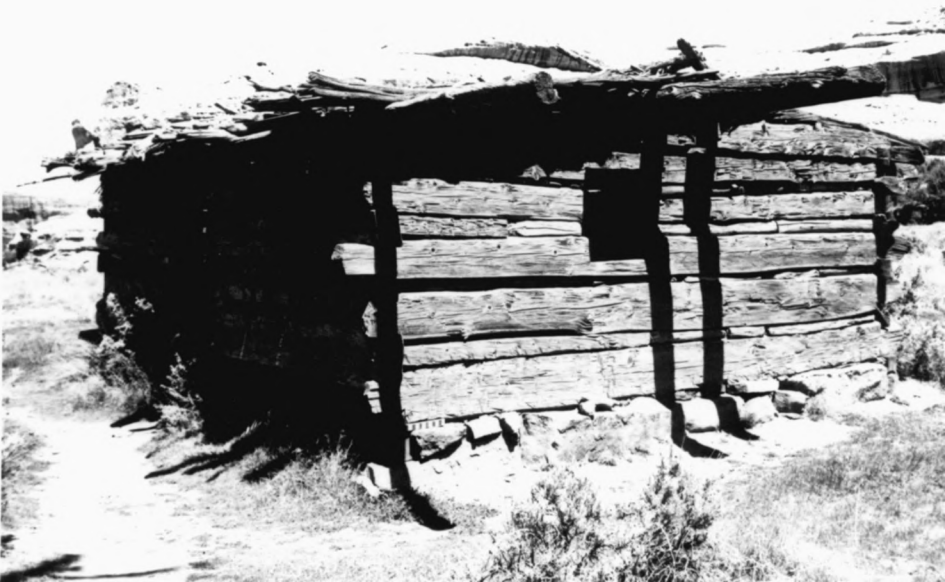
Roll 8, #9

LOG No HS-NEED-28  
Photo No \_\_\_\_\_  
Subject KIRK'S CABIN/FRONT  
Description of View FRONT / S. S. side  
SW to NE  
Location of Subject CANTONLANDS  
Location of Negative RMRO.  
By S. Melis Date 9/86

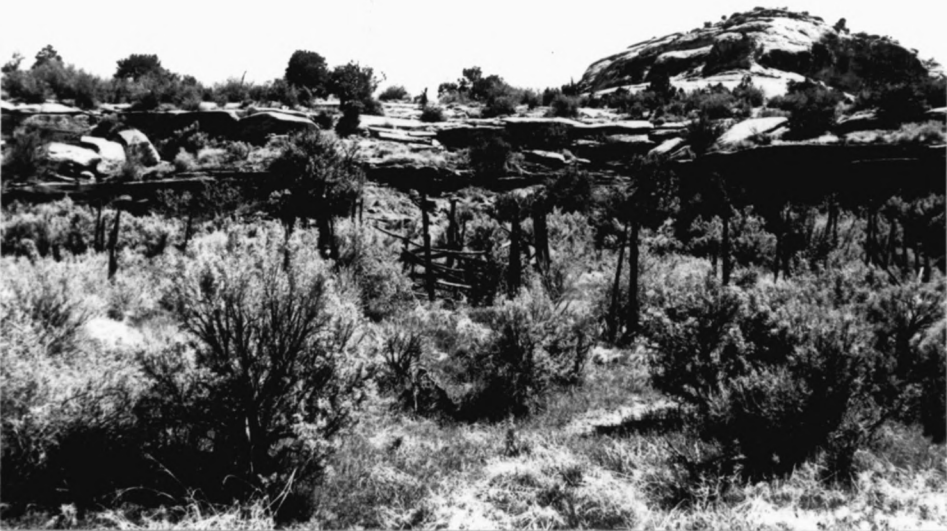
Roll 8, #12

LOG No HS-NEED-29  
Photo No \_\_\_\_\_  
Subject CORRAL  
GENERAL  
Description of View \_\_\_\_\_  
Location of Subject CANYONLANDS  
Location of Negative RMPD  
By S. MEHLIS Date 9/46

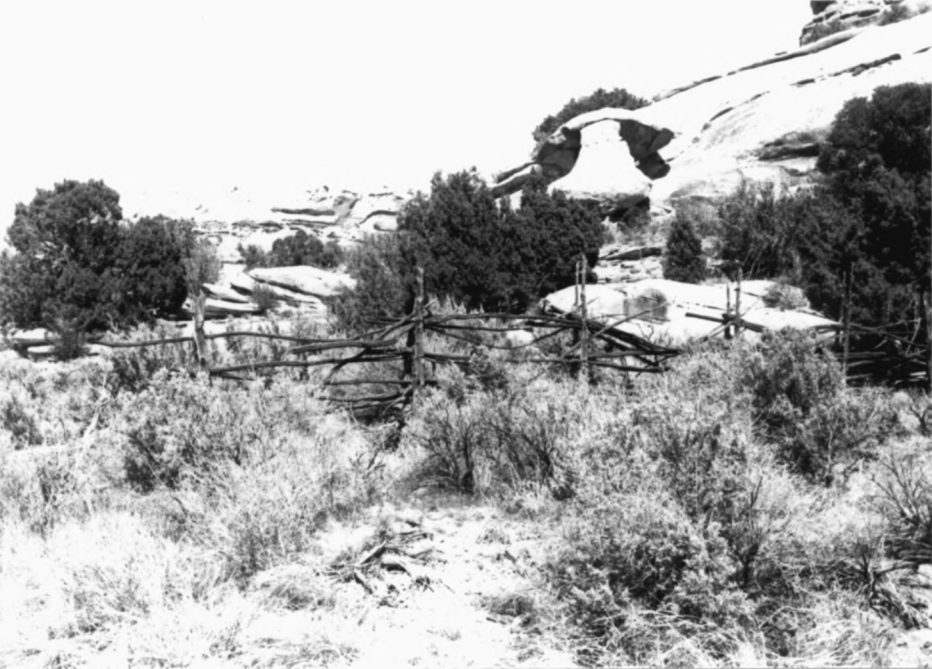
Photo No. CARE # 14

LCS No. NEED-30

Subject Kirk's Fence

Descrip. of View SAC General, WDS

The fence, due to erosion, which has removed a portion of it, and later  
modifications by grazers, no longer has more than marginal physical  
integrity other than its location.

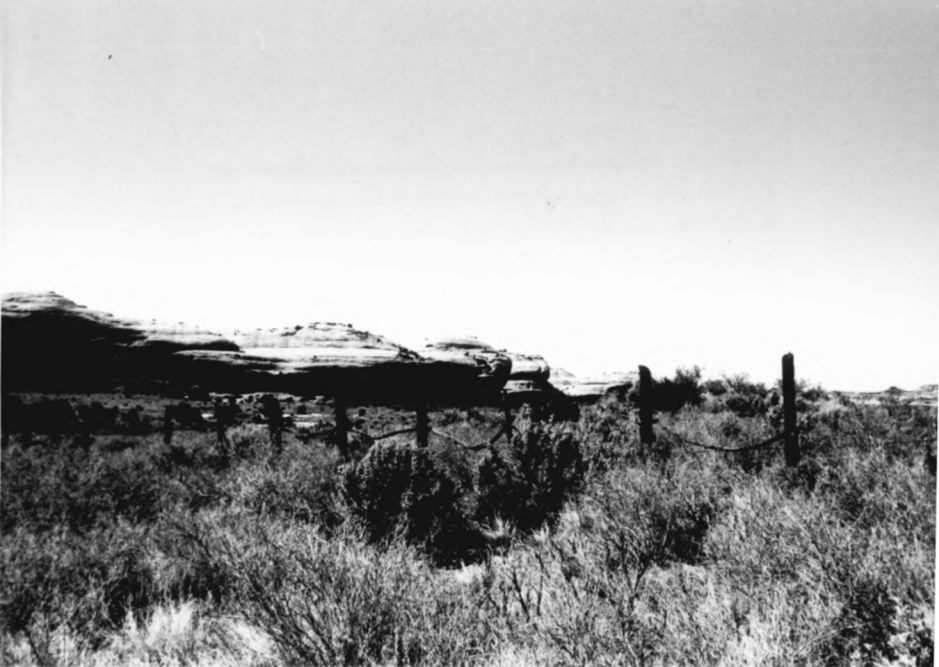
Roll 8, #15

LOG No 15-NEED-30

Subject FENCE

Description of View GENERAL  
NE to SW

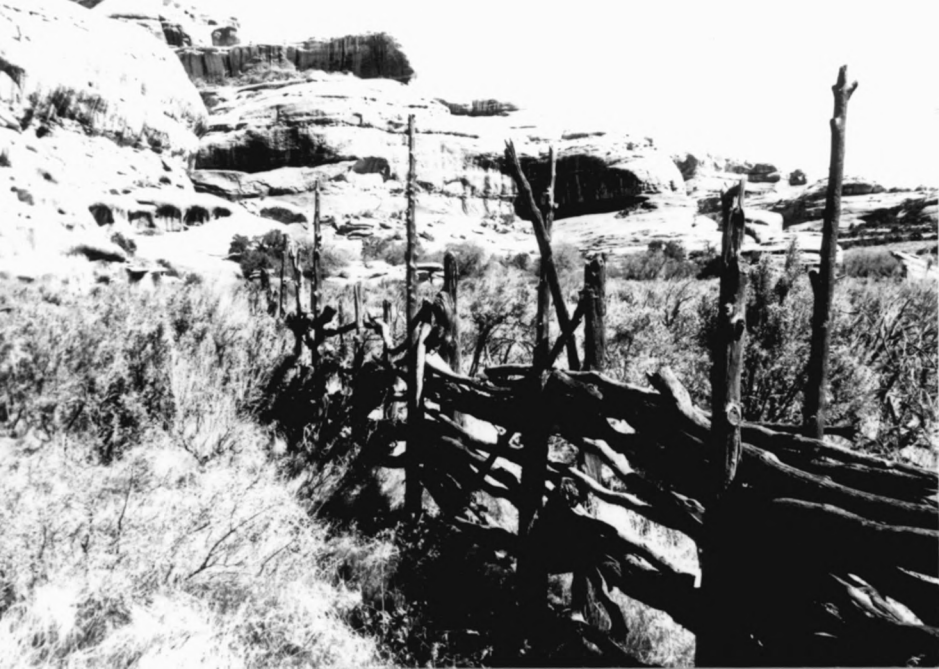
Roll 8, #16

LOG No HS-NEED-31

Subject SECOND CORRAL

Description of View DETAIL OF FENCE  
W to E

The structure retains locational integrity and enough physical integrity to  
make its function apparent. However, it appears to have been modified  
and expanded at various times.

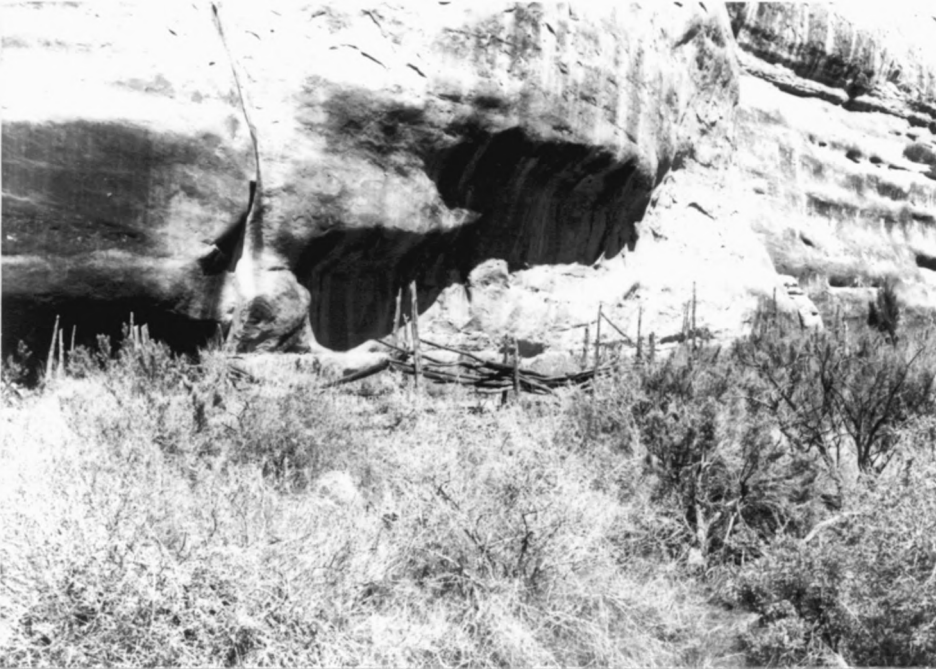
LCS No. NEER-31  
Photo No. CN-24-17  
Subject Site Second Corral

Descrip. of View Site General W.D.S.E  
Location of Subject Campground NE
