UNITED STATES DEPARTMENT OF THE INTERIOR  
NATIONAL PARK SERVICE**NATIONAL REGISTER OF HISTORIC PLACES  
INVENTORY -- NOMINATION FORM**

The Caverns Historic District

Carlsbad Caverns National Park Headquarters Area

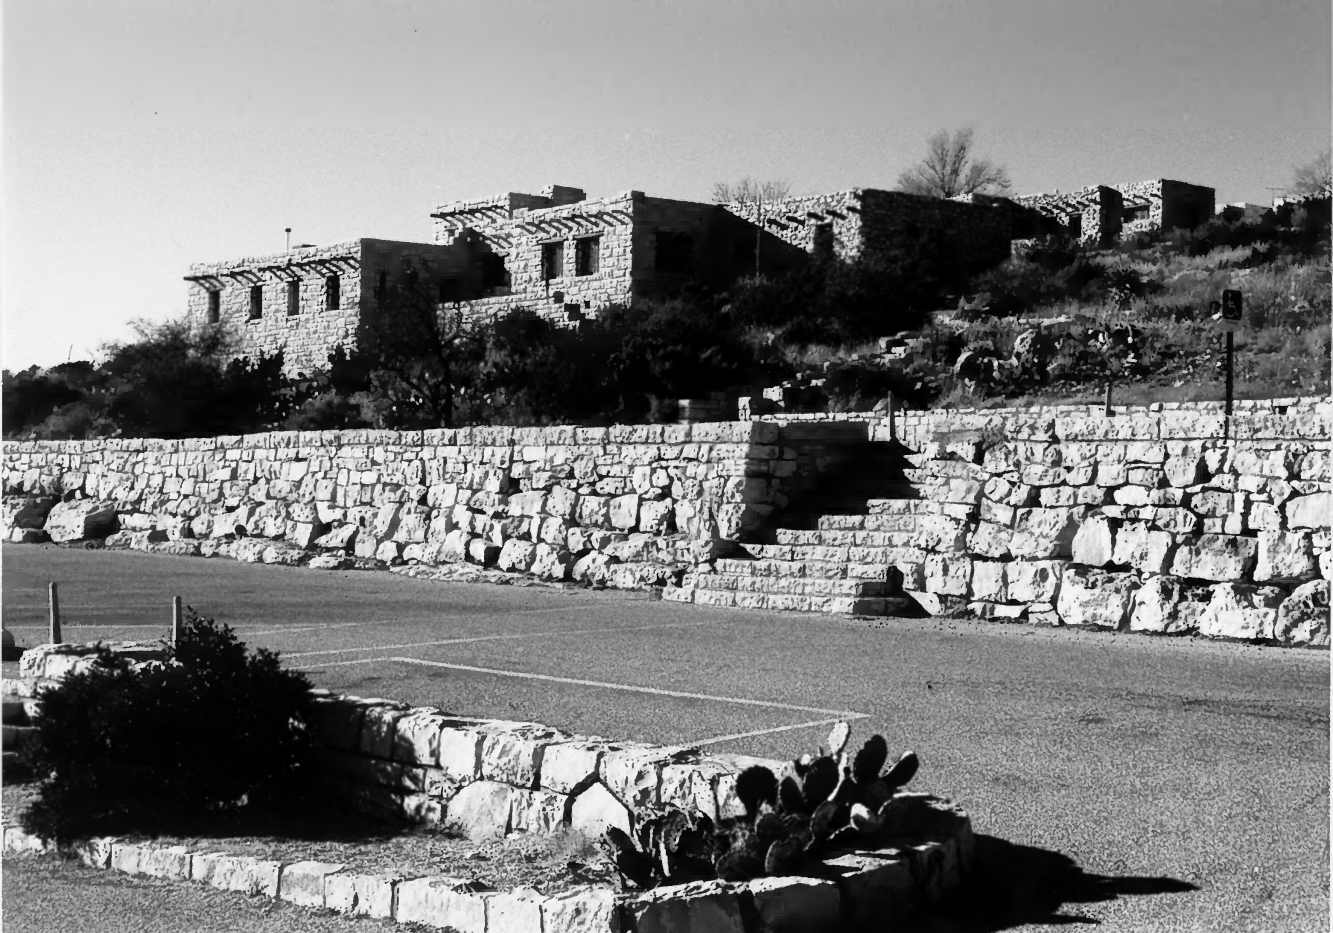
1. Bunk House and Mess Hall, NPS  
Bldg #16. Looking northwest from  
parking terraces. (Significant)

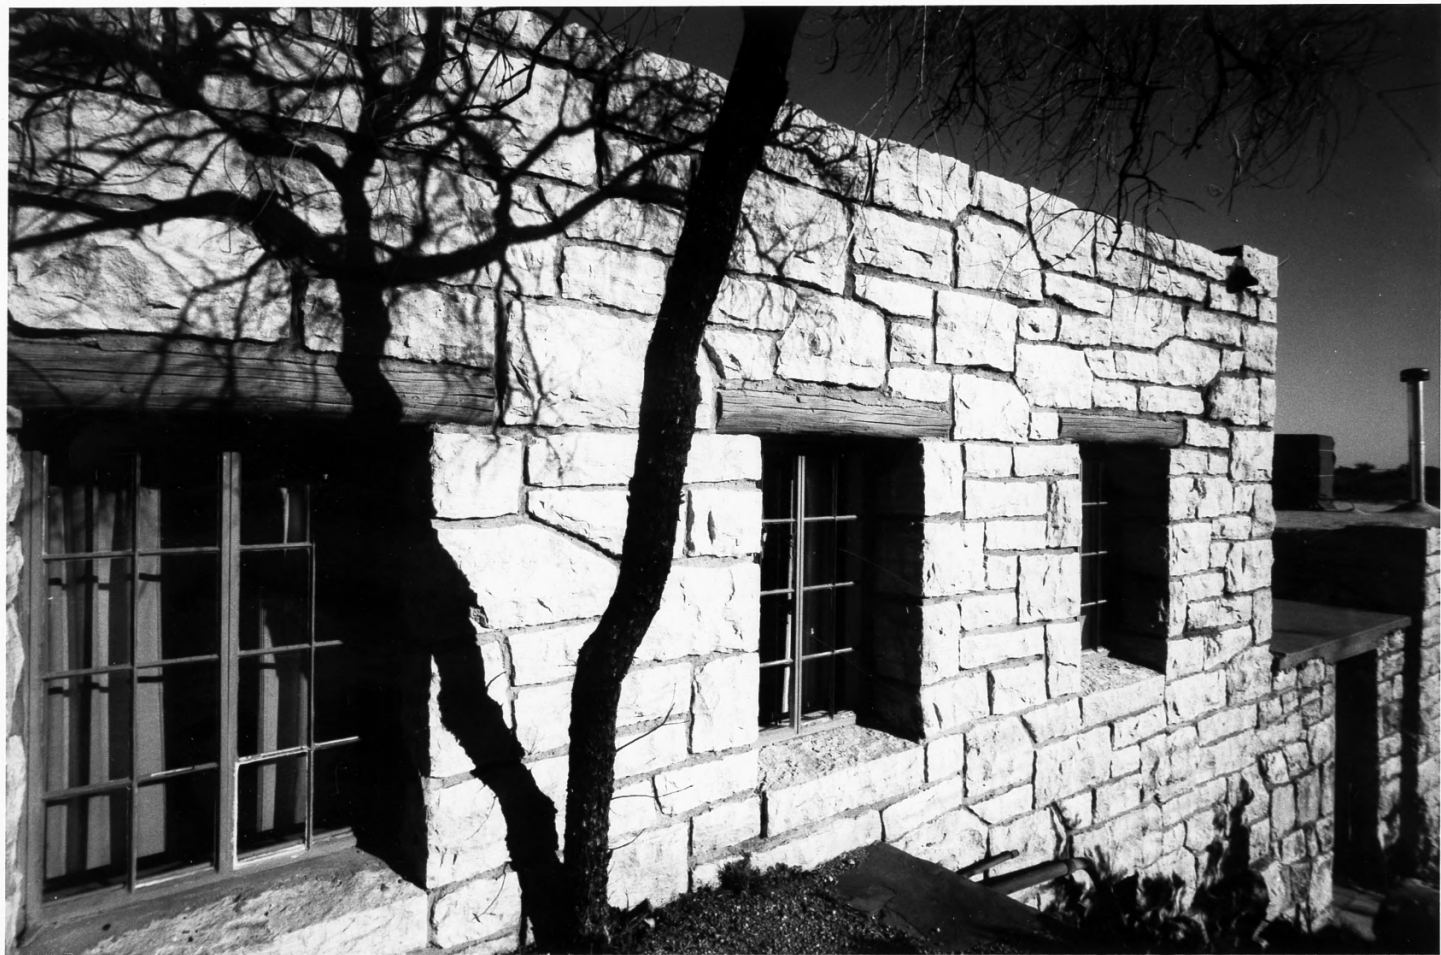
The bunk house and mess hall, which was adjoined to the west and south walls of the residence, was constructed of more carefully dressed, coursed stone with steel casement windows having 8 lites to each sash and surmounted by decorative halved log lintels. Specifications called for the flat roof to be covered with asbestos felt and asphalt. The roof was recently sprayed with urethane foam. The stone walls are parapeted above the roof line, and decorative vigas project from 12" to 16" beyond the face of the walls at the front and rear of each wing. The foundations are bedrock.

1. Bunk House and Mess Hall, NPS  
Bldg #16. West side, rough-cut  
limestone walls, steel casement  
windows, halved log lintels. (Sig.)

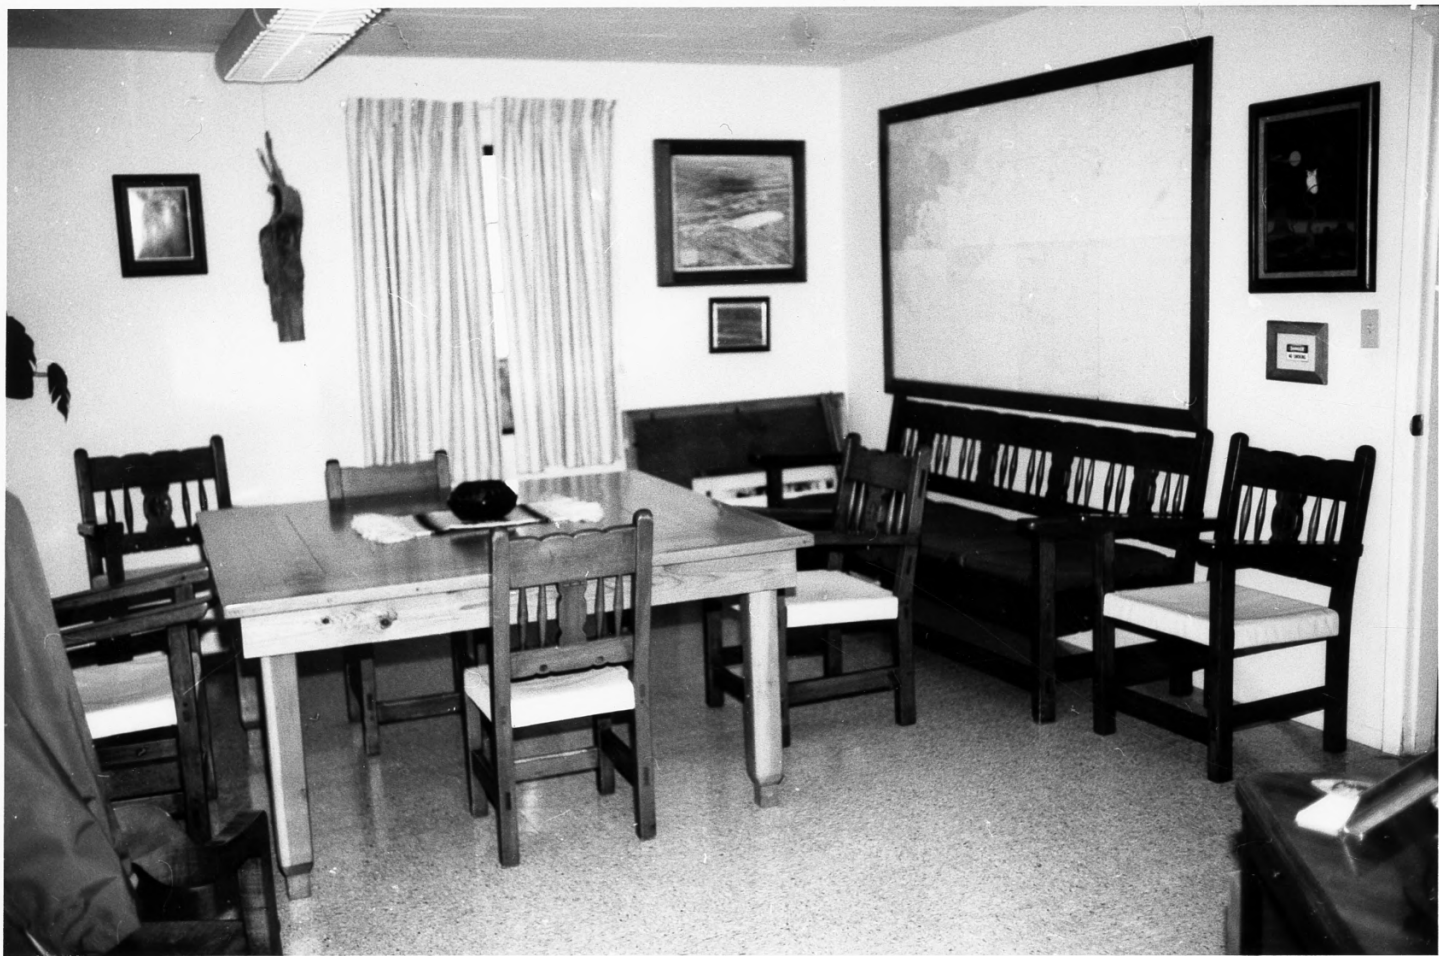
1. Bunk House and Mess Hall, NPS  
Bldg #16. Interior of Unit Manager's Office with New Mexican Colonial Style furnishings made for building. (Significant)

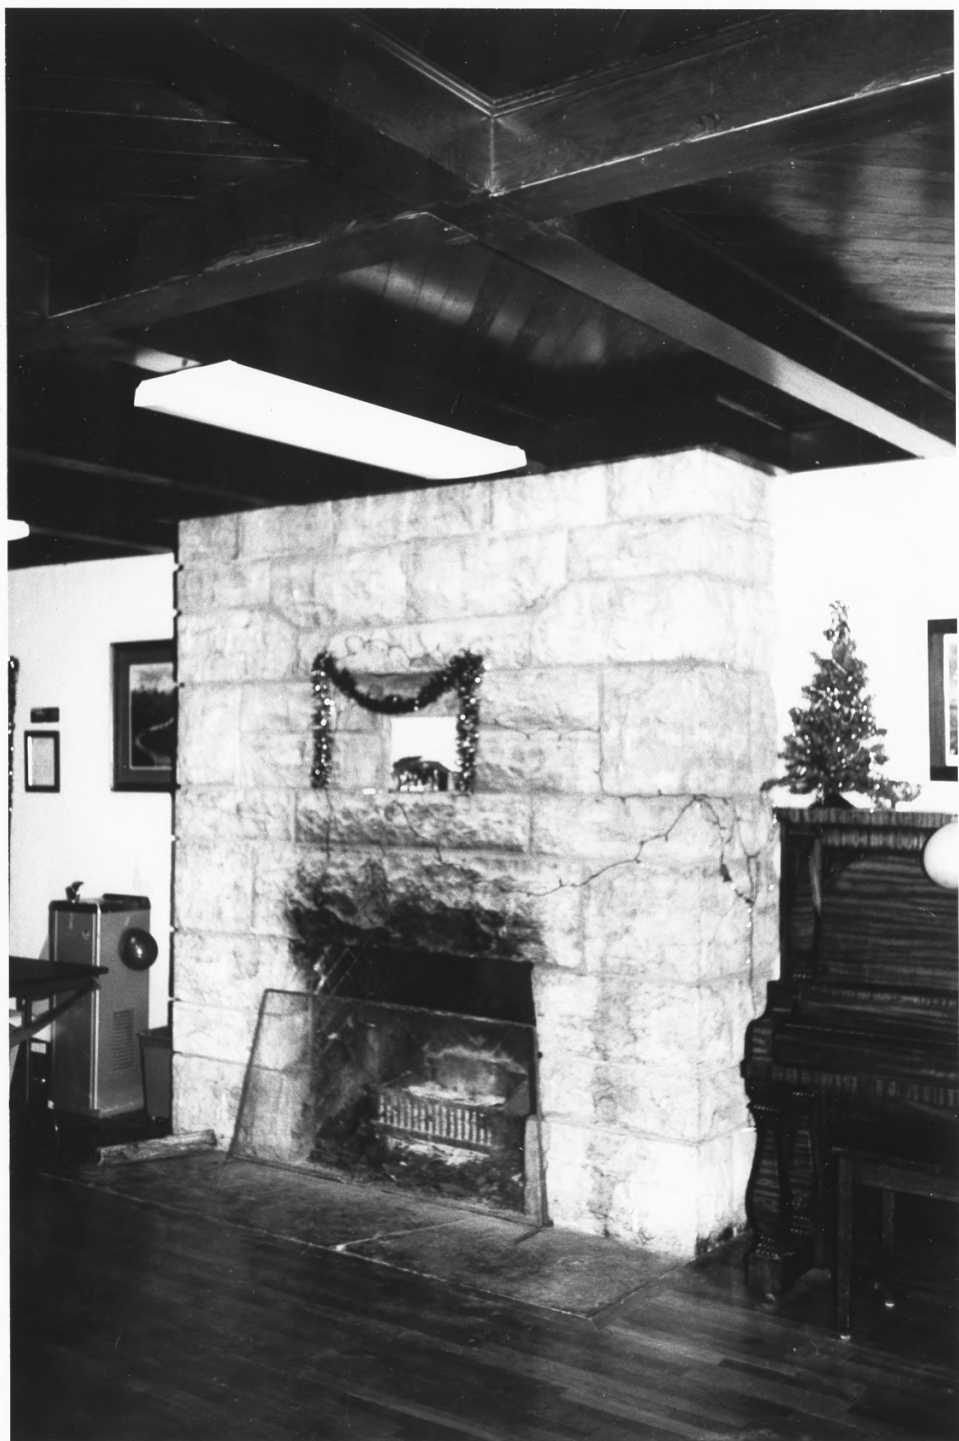
1. Bunk House and Mess Hall, NPS Bldg #16. Interior of lobby showing limestone fireplace, beamed, herring bone pattern ceiling. (Significant)

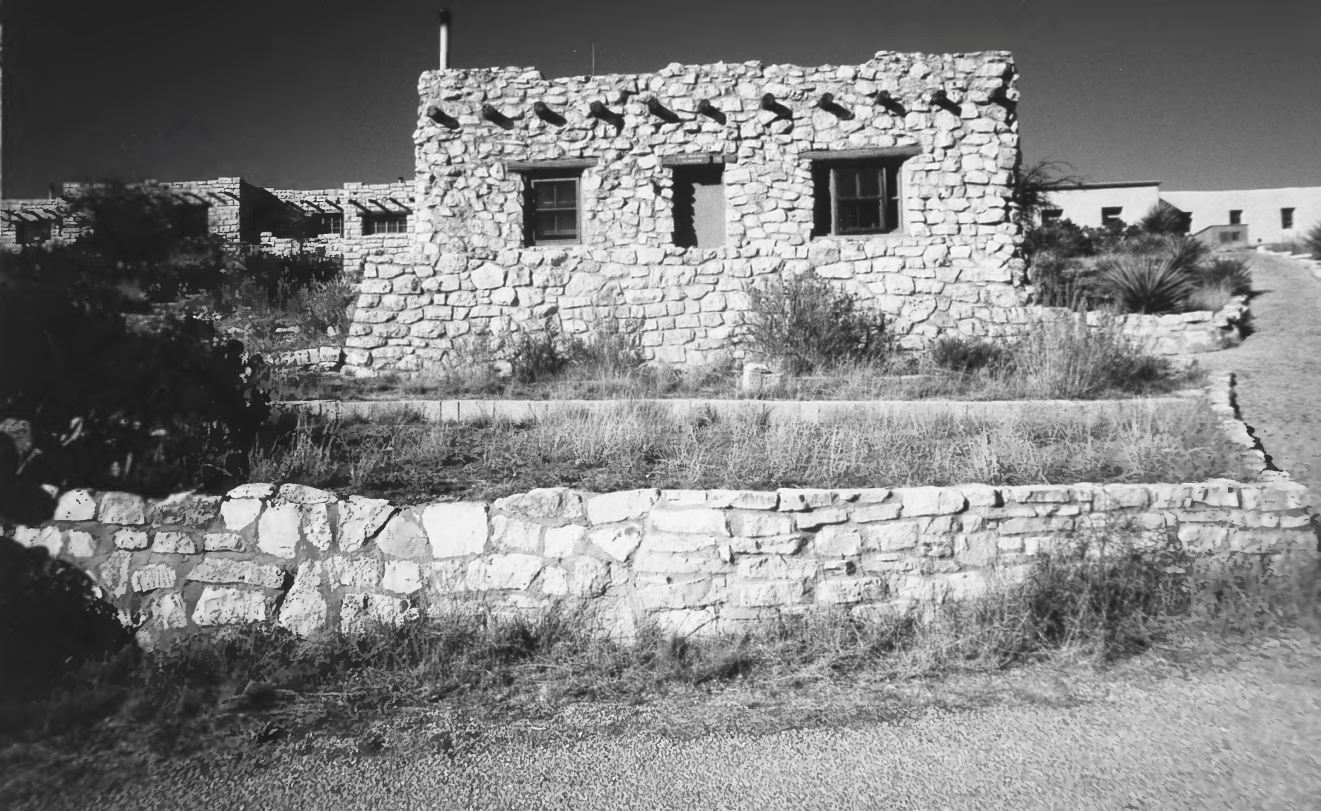
2. Employee Residence, NPS Bldg #6.  
(Significant)

Both the entrance door in the center of the facade and a side door are recent plywood replacements. The entrance is flanked by windows; the window to the east of the door is flanked by sidelites. The building is fronted by a terraced flagstone porch with stone steps. Interior is divided into 4 rooms and bath; interior walls are plastered; floors are wood on sills; ceilings are tongue-and-groove boards. The building is in need of repairs but is occupied.

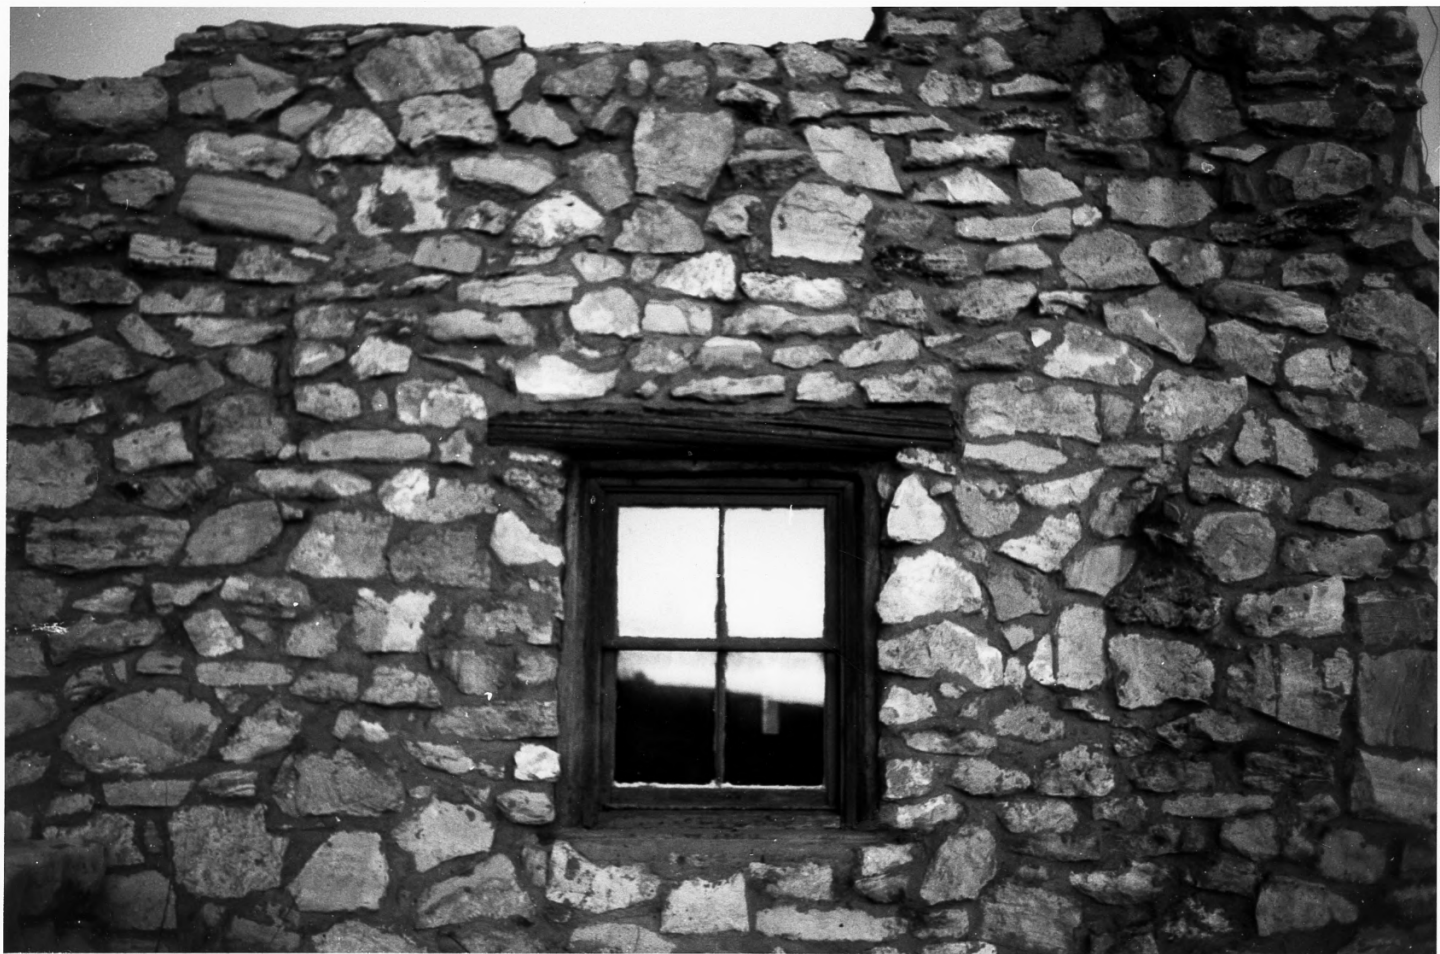
2. Employee Residence, NPS Bldg #6.

West side showing random rubble  
limestone masonry, "broken"  
masonry at roofline, wooden window  
with halved log lintel. (Significant

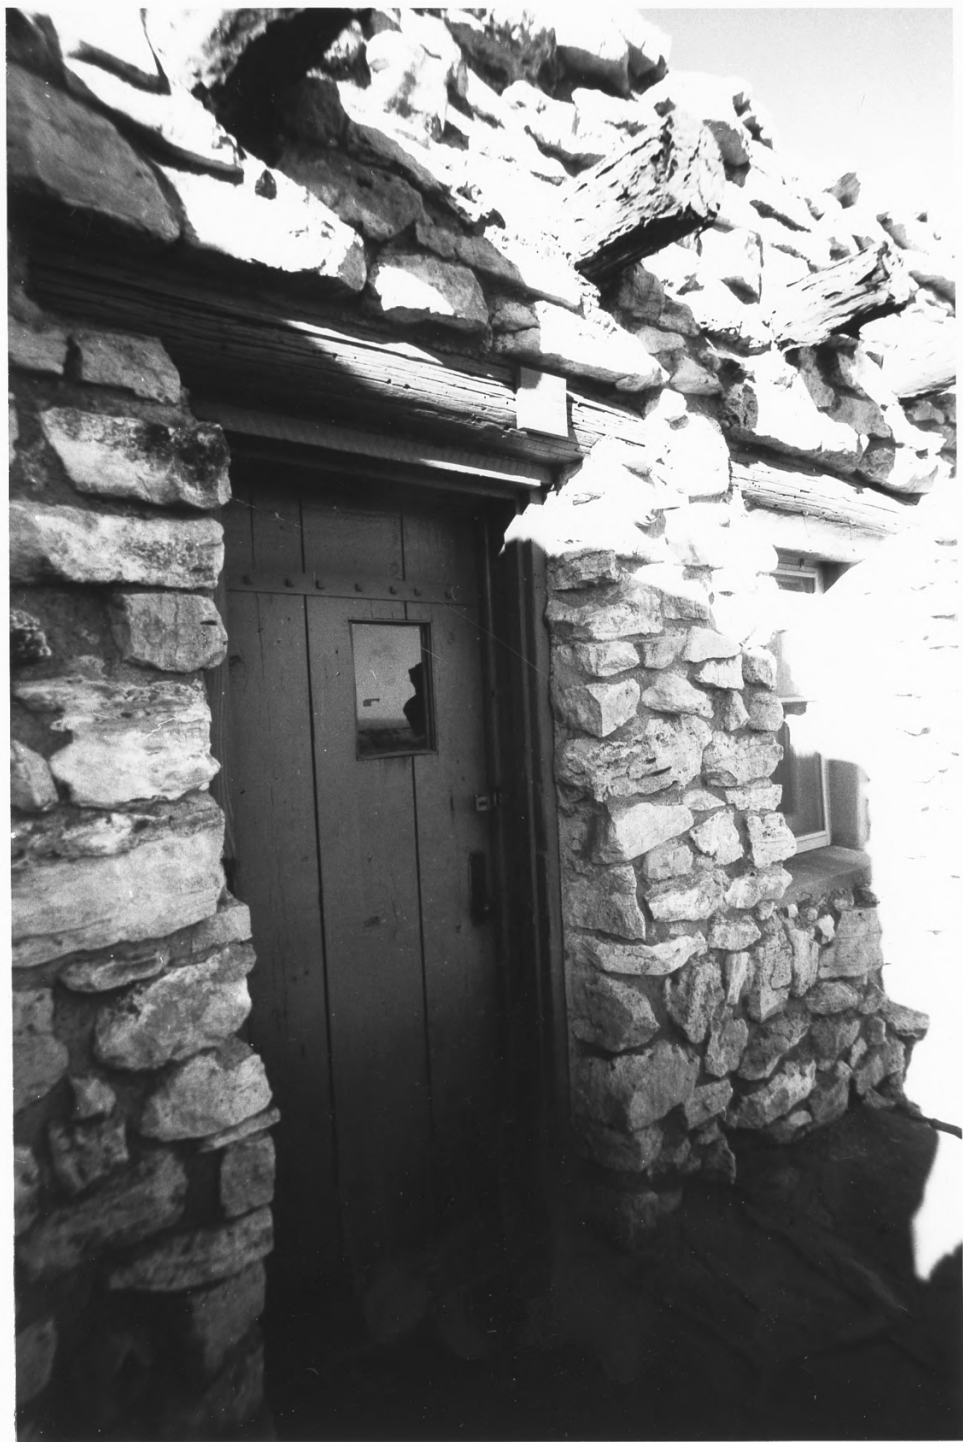
The entrance doors are located in the center of the original houses. Bldg #7 retains its original door of wide tongue-and-groove planks tied together with wrought-iron straps and containing a small glass pane. The side door of Bldg #7 is a plywood replacement. The doors of Bldg #8 are also plywood replacements. The doors of Bldg #9 are original, with a small glass pane. Most of the doors are fronted by screen doors which are recent additions. Some original interior doors survive, and these are constructed of sugar pine random width tongue-and-groove planks tied together with oak splines. The wood framing of the additions is Douglas fir, and the floors are finished with Oregon pine. The interior walls and ceilings are composed of plaster over metal lath.

Building #7 is in fair condition, and in need of repairs. Buildings #8 and #9 are in good condition.

3. Employee Residence, NPS Bldg #7.  
Front entrance, S facade. (Sig.)

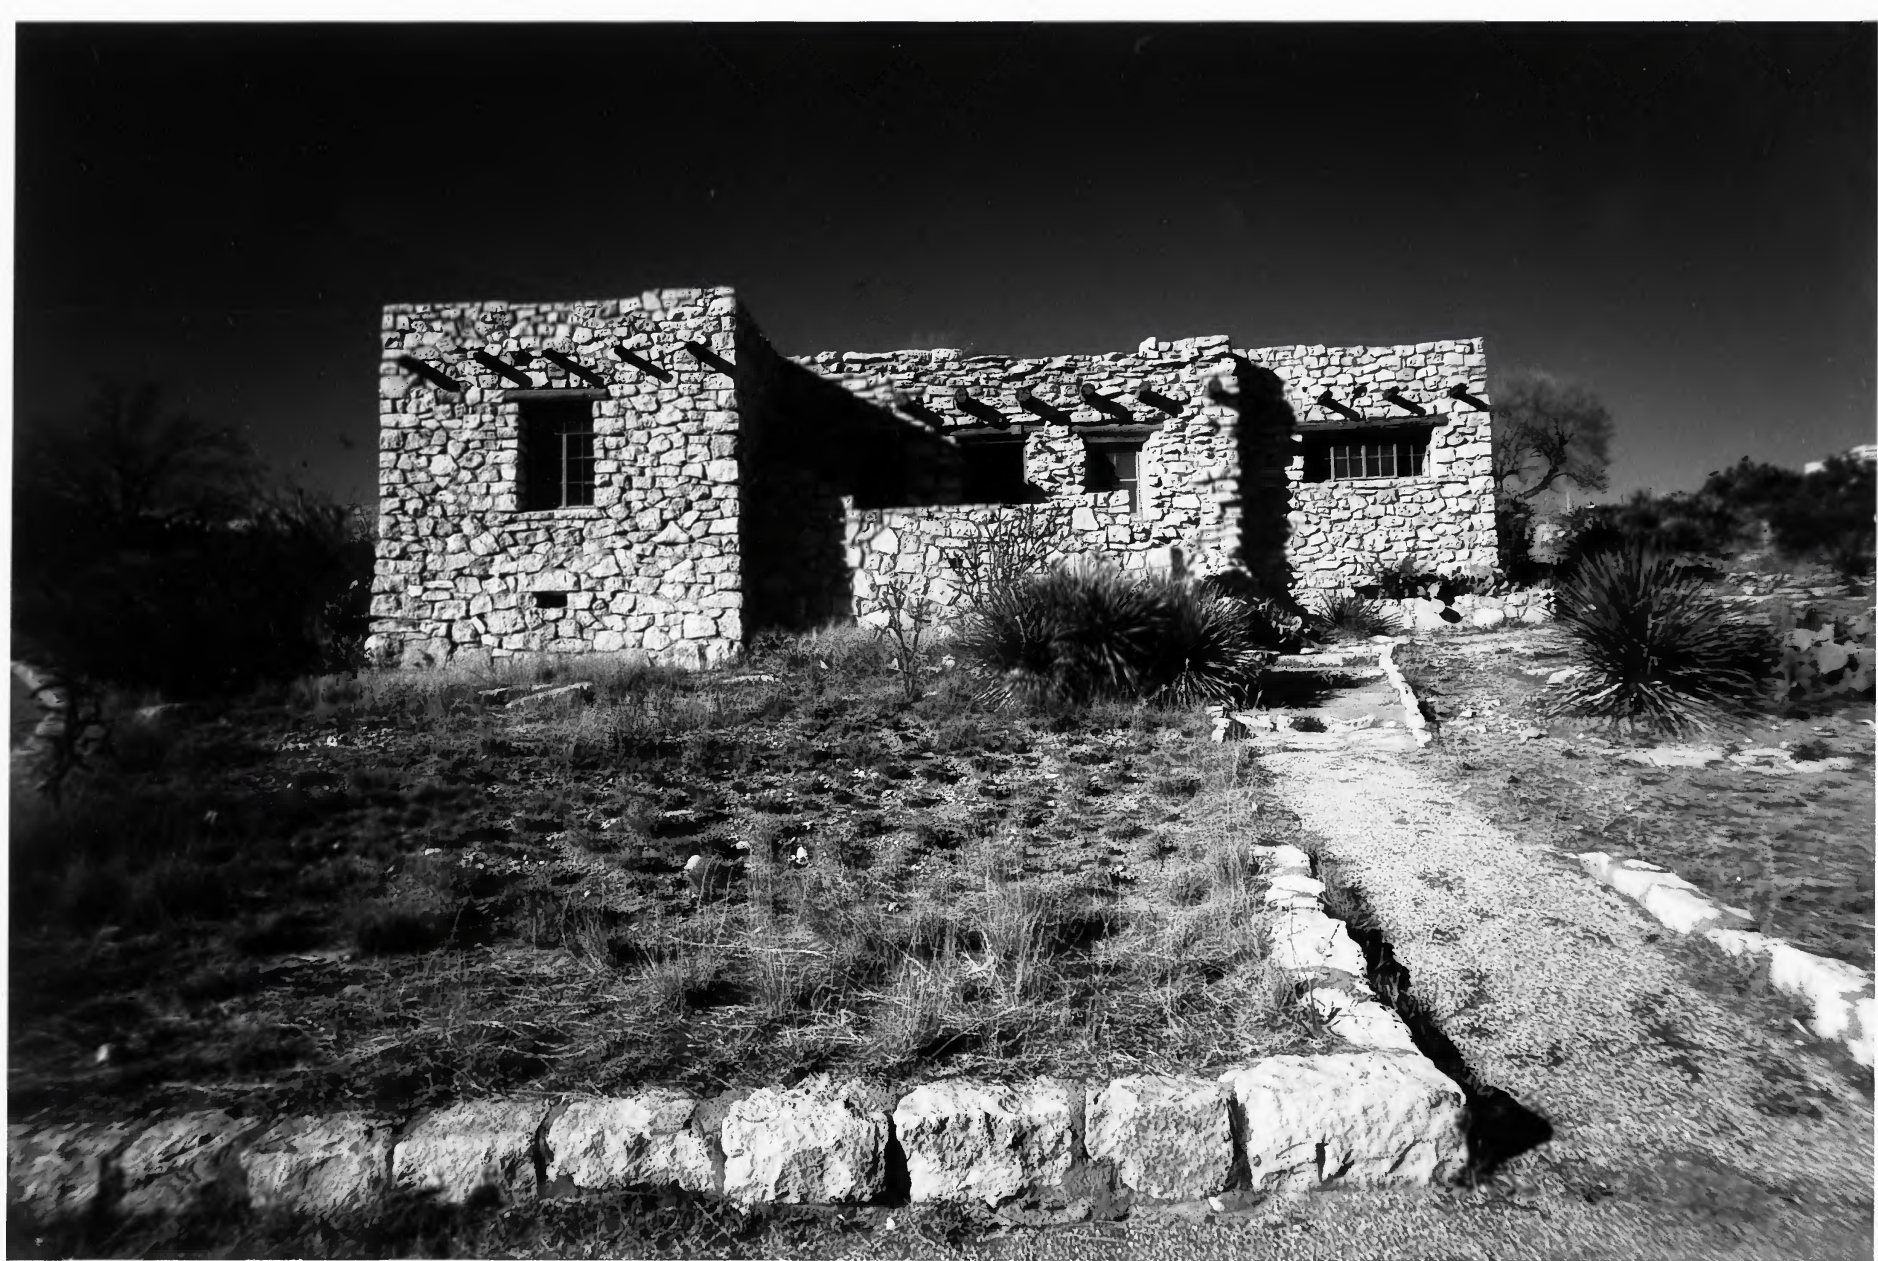
3. Employee Residence, NPS Bldg #7.  
Looking NNW. (Significant)

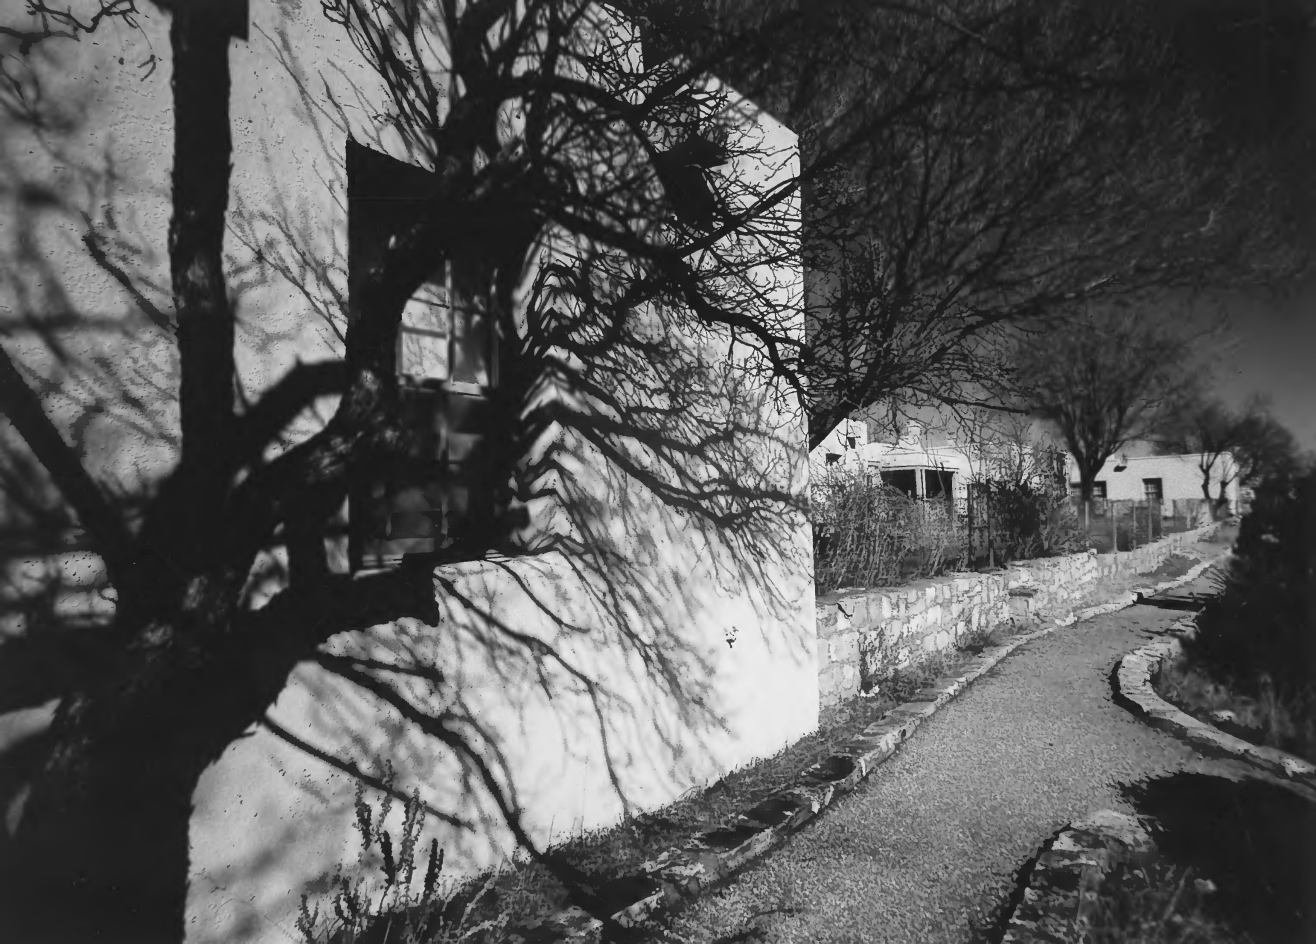
9. Multiple Dwelling Unit #1, NPS  
Bldg #25 (foreground) (Significant)
10. Multiple Dwelling Unit #2, NPS  
Bldg #28 (background) (Significant)

Looking NE along rock bordered path  
in front of buildings, showing stone  
wall terrace.

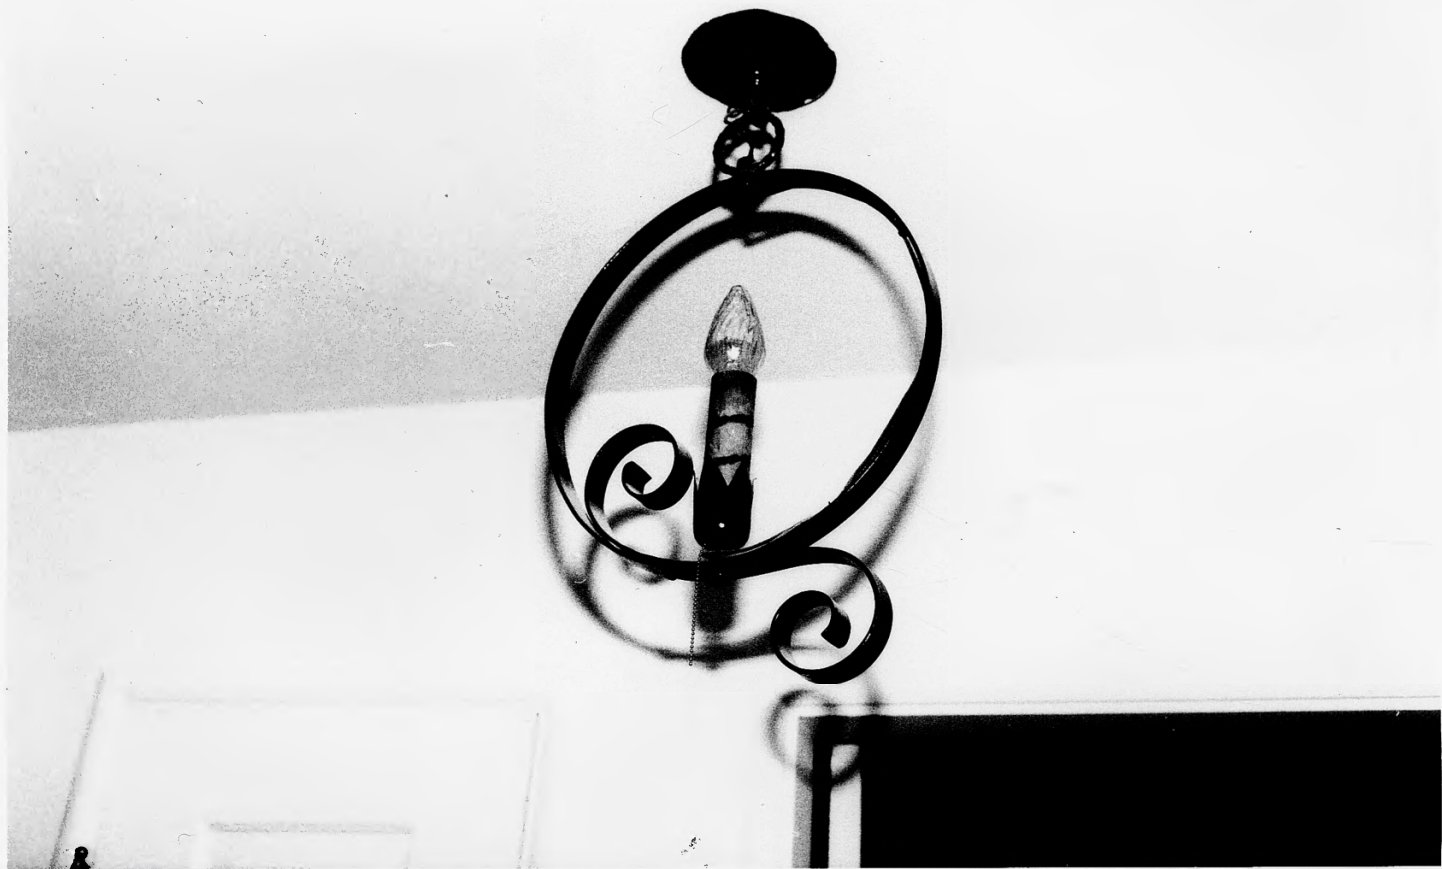
10. Multiple Dwelling Unit #2, NPS  
Bldg #28, Unit C. (Significant)

Interior wrought-iron light fixture.

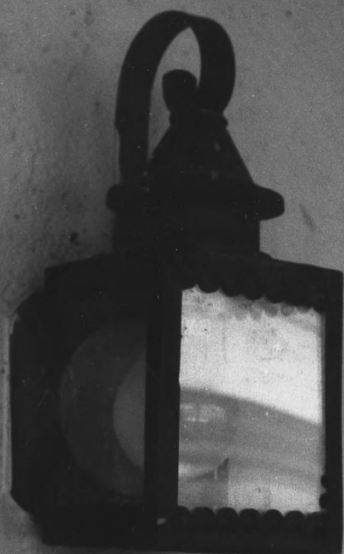
10. Multiple Dwelling Unit #2, NPS  
Bldg #28, Unit B. (Significant)

Exterior wrought-iron light  
fixture.

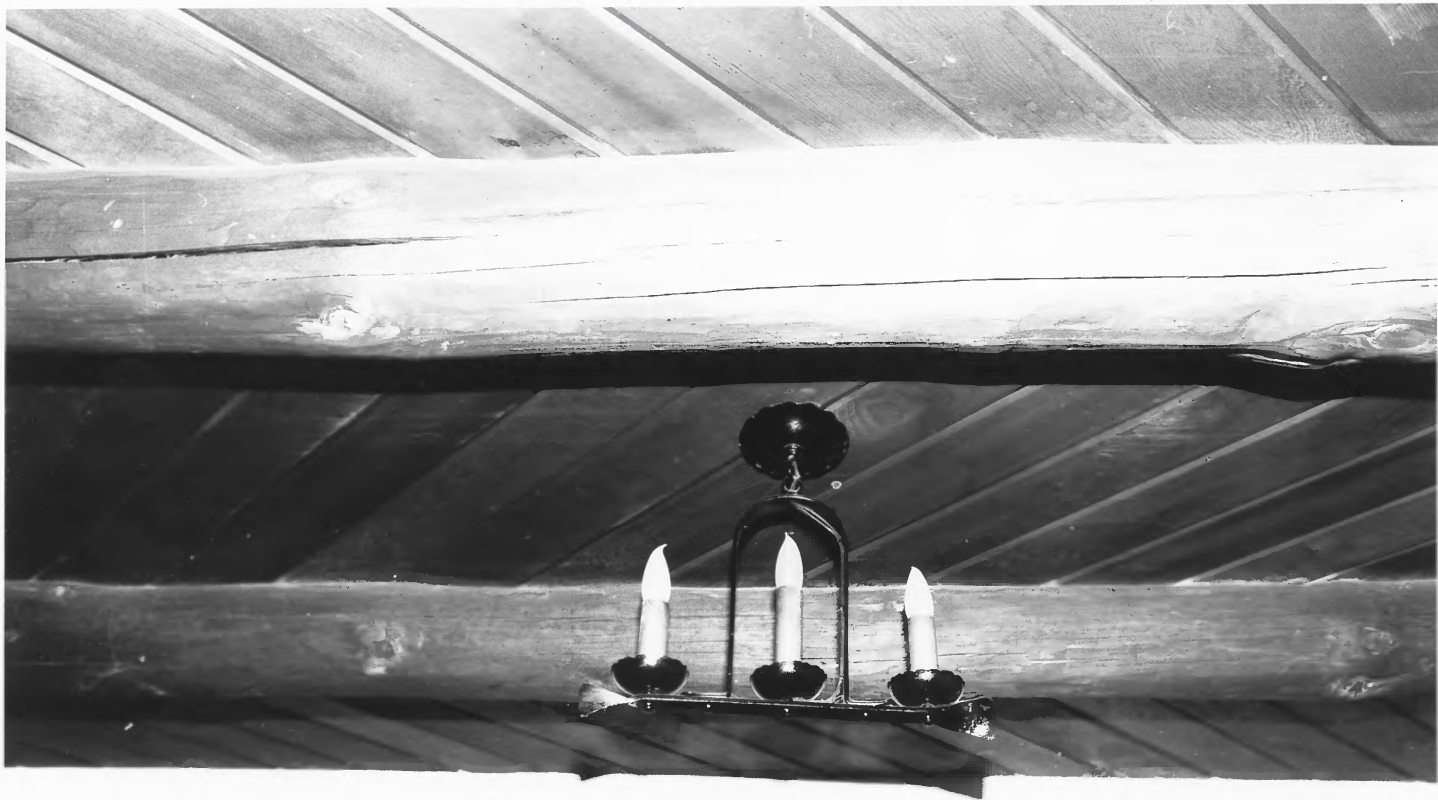
10. Multiple Dwelling Unit #2, NPS  
Bldg #28, Unit C. (Significant)

Interior refinements include exposed vigas and herringbone pattern planks in the ceilings of the livingrooms, decorative iron light fixtures, and panelled doors. The interior walls are covered with plaster over metal lath, the floors are of wood laid on joists. The buildings are in good condition.

Interior wrought-iron light fixture, vigas and herringbone pattern boards of livingroom ceiling.

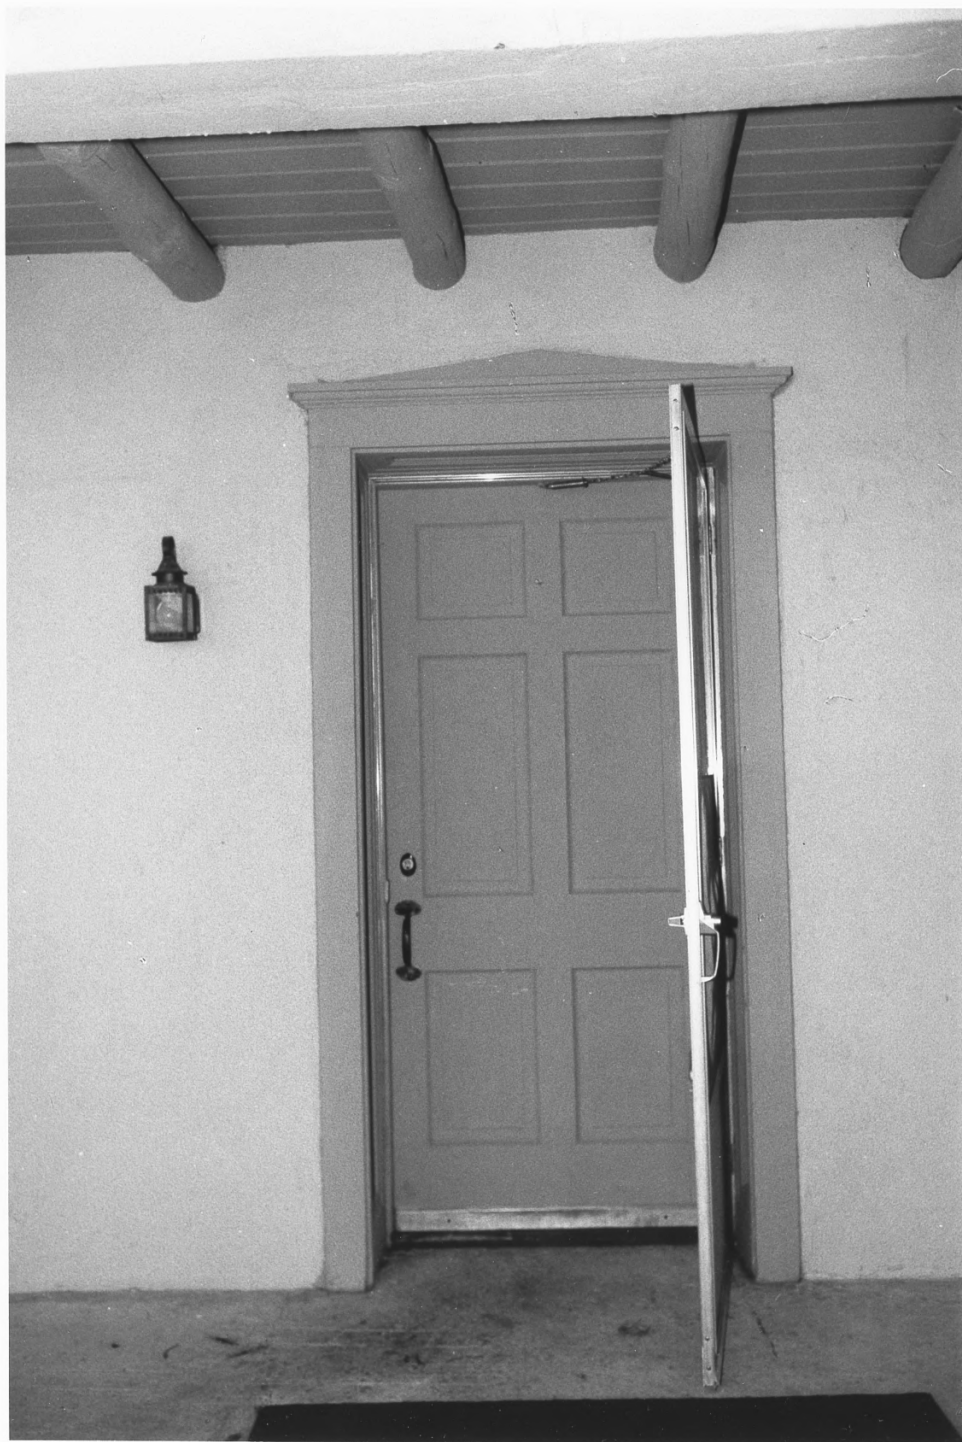
10. Multiple Dwelling Unit #2, NPS  
Bldg #28, Unit B. (Significant)

Some of the entrance doors retain their pedimented lintels. The wooden doors are original and are composed of 6 moulded panels. Aluminum screen doors have recently been placed in front of the wooden doors. Some original decorative iron light fixtures remain in the portals. The facades facing the downward slope of the hillside were originally fronted by low stuccoed walls that enclosed three yard areas. These walls have been removed. The attached garages that face the service road contain metal pull-down doors that are replacements for the original wooden doors.

Door under portal, showing pedimented lintel, vigas in ceiling, wrought-iron light fixture.

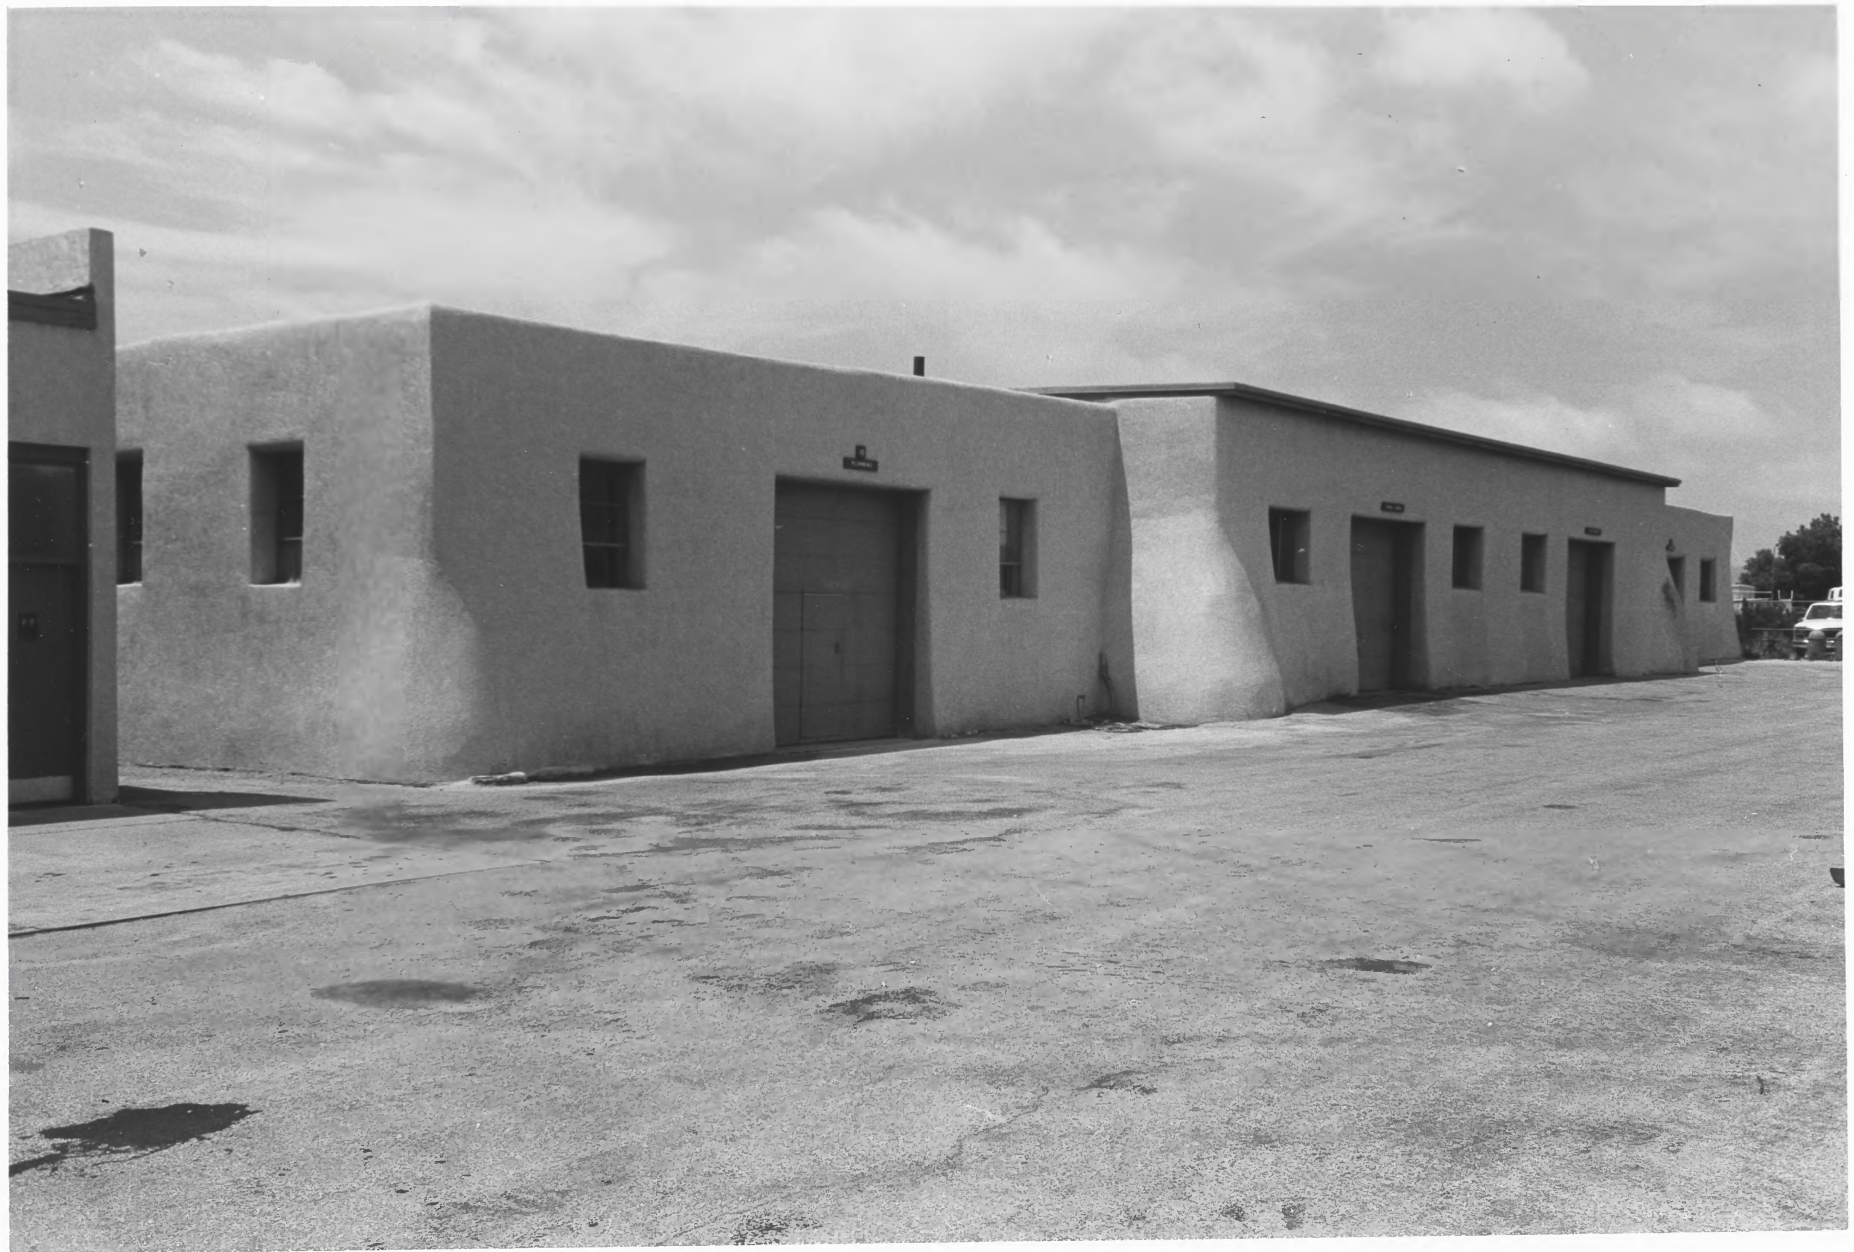
Pueblo Revival Style; one-story; rock faced random rubble battered walls with buttresses at the corners, covered with beige-colored stucco in 1963. The building is rectangular in plan; the original center structure measures about 75' x 42'; the wings added at either side measure about 35' x 25'. The interior walls are concrete block, and the exterior stone work was laid against the concrete block walls. The foundations are stone, and the floors are concrete. The roof of the center structure was

Three diesel generators totaling 180 KW power were housed in the original powerhouse, or center portion of the structure. They served as the only source of electric power for the park until 1949 when commercial lines were brought in. Thereafter, the structure was adapted to other uses. The building is in good condition.

11. Power House, NPS Bldg #10.  
Front, looking SW. (Significant)

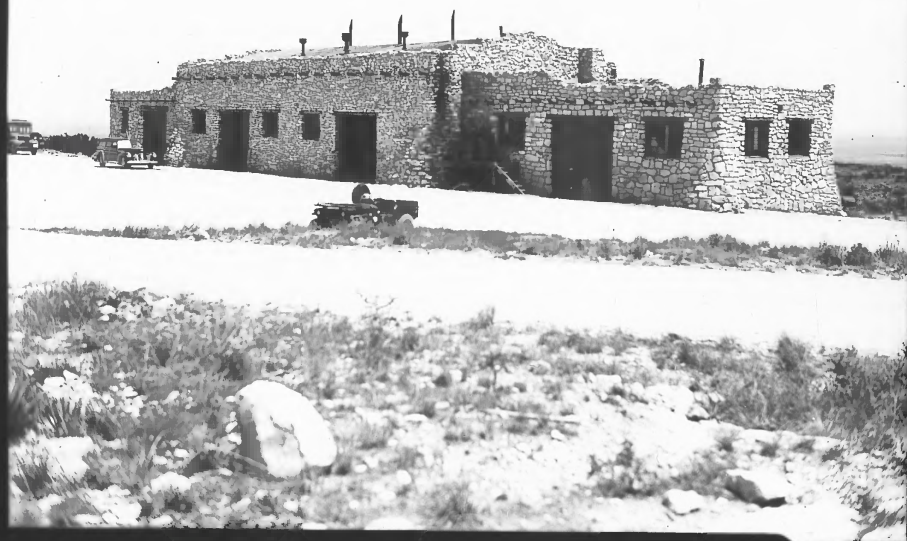
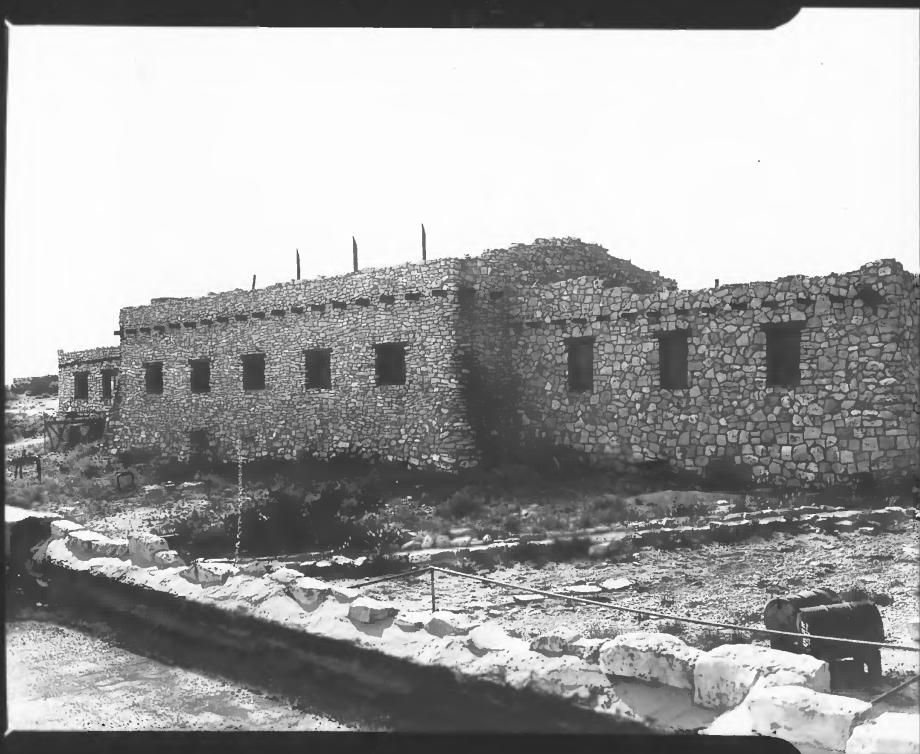
11. Powerhouse, NPS Bldg #10.  
(Significant)

originally a low gabled wooden truss roof, covered with corrugated iron. The rock side walls of the center building were gabled, and both front and sides were parapeted in a manner which simulated the masonry of a broken ruin. The wings were constructed with flat roofs and were given the same broken masonry parapets. Both the center building and the wings originally had vigas projecting below the parapets on both front and rear facades. The roofs were altered in 1959; the parapets and vigas were removed, reducing the visual height of the structure, and the gabled roof of the center building was replaced with a flat metal roof. The new roof slightly overhangs the front and rear of the center structure.

Top: front, looking SE.
