UNITED STATES DEPARTMENT OF THE INTERIOR  
NATIONAL PARK SERVICE**NATIONAL REGISTER OF HISTORIC PLACES  
INVENTORY -- NOMINATION FORM**

The Caverns Historic District

Carlsbad Caverns National Park Headquarters Area

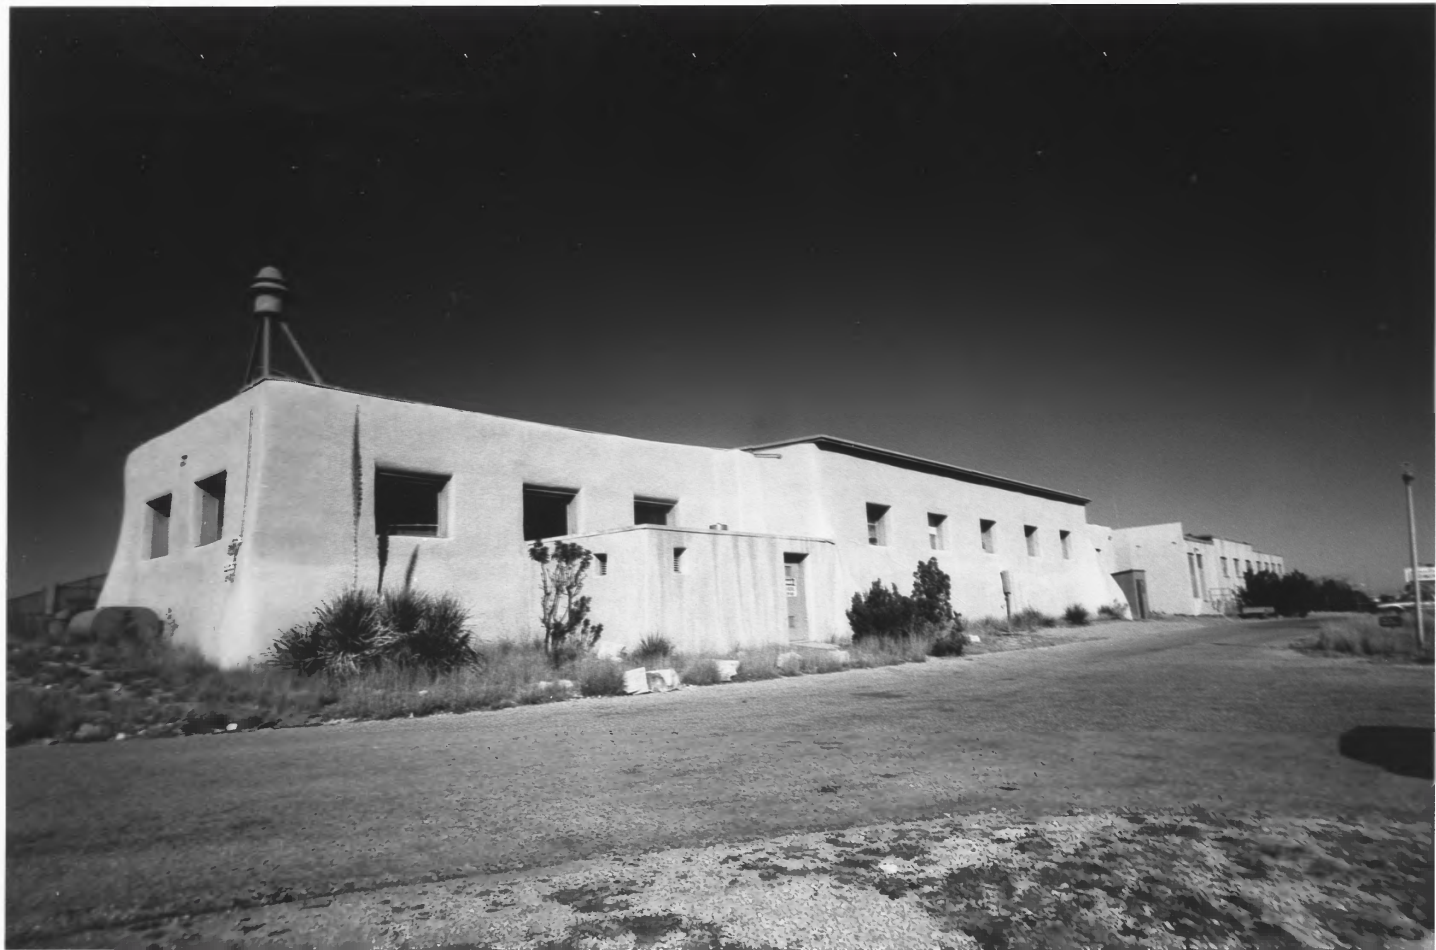
11. Power House, NPS Bldg #10.  
Rear, looking NE. (Significant)  
The Caverns Historic District  
Carlsbad vicinity, New Mexico

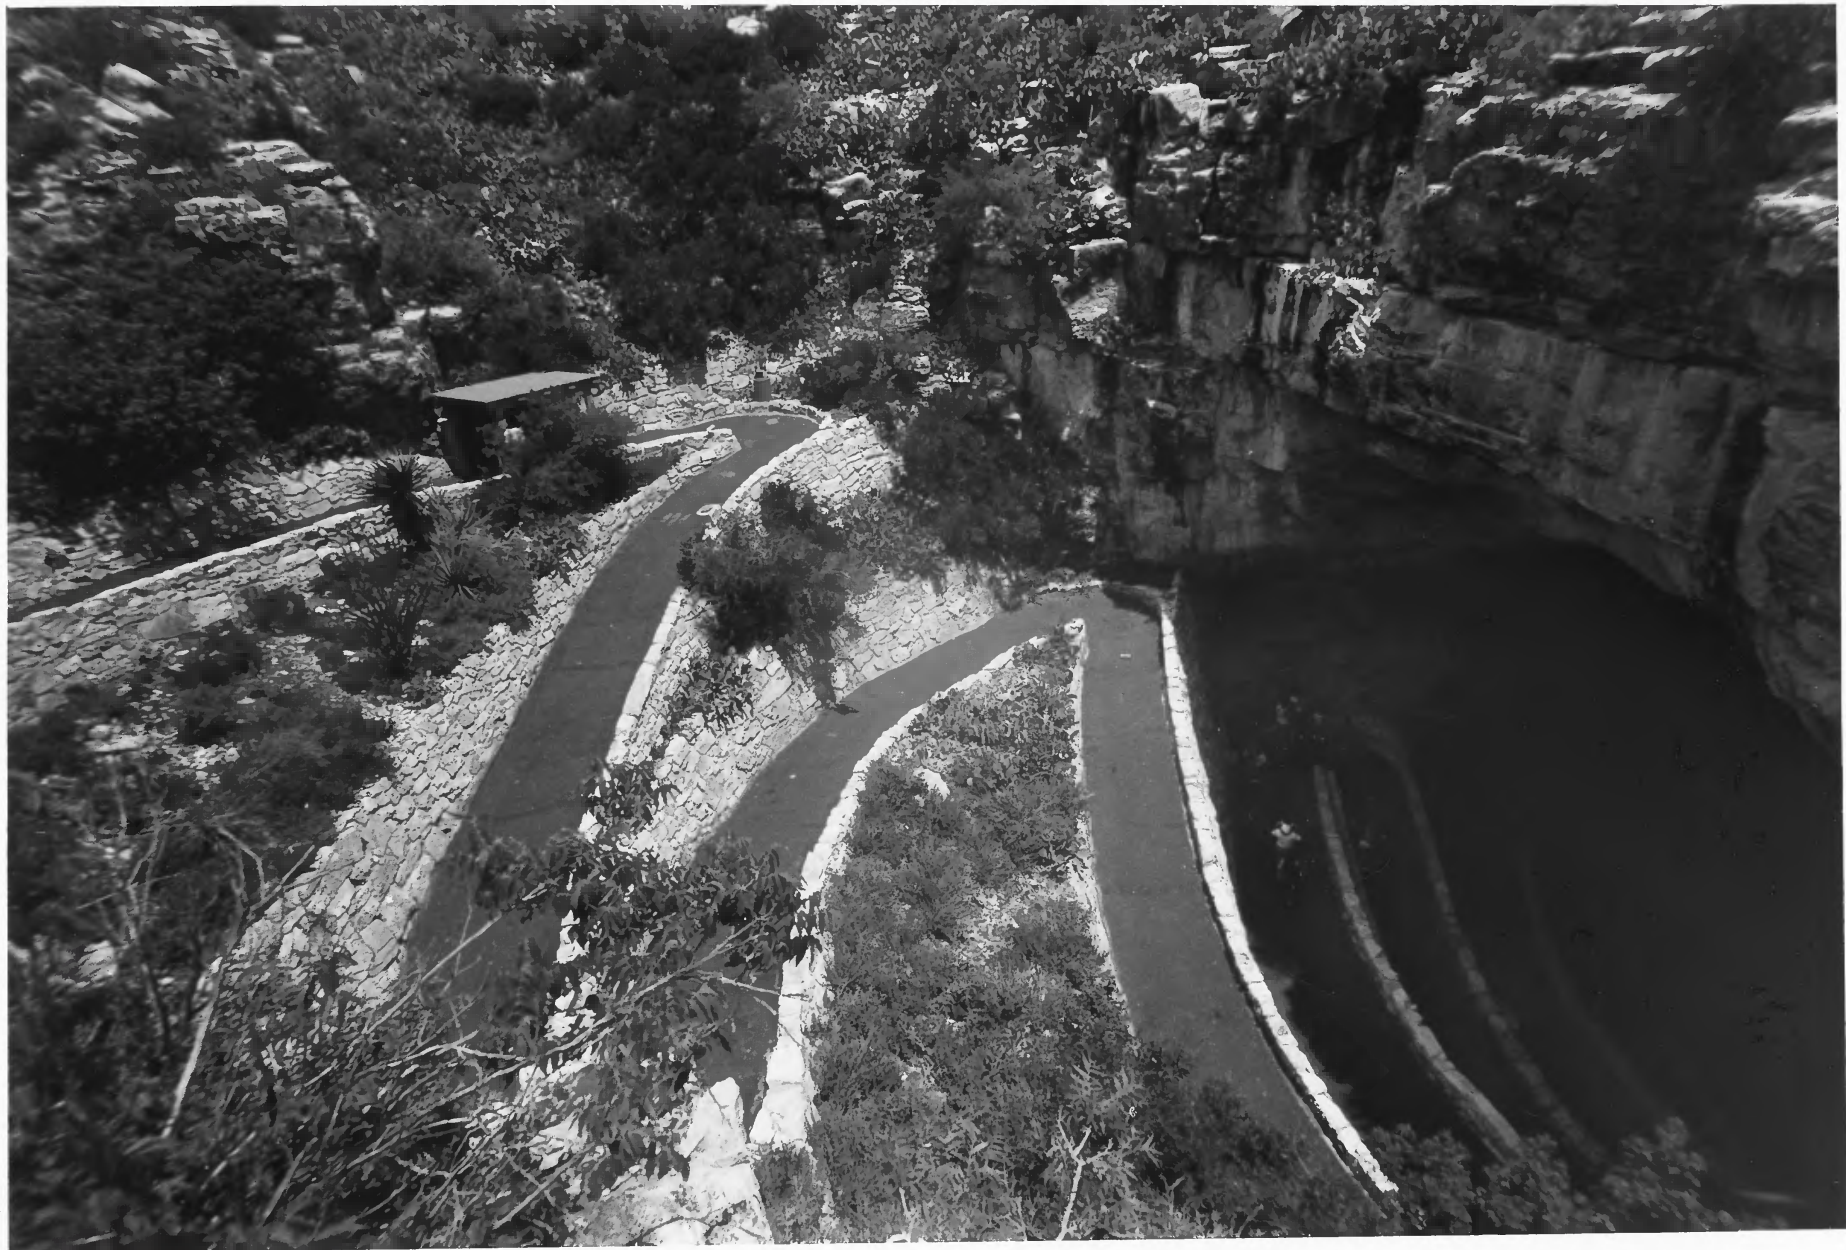
Switchback trail into the natural cave entrance, looking down from rim of roof of cave, showing limestone retaining walls (Significant).

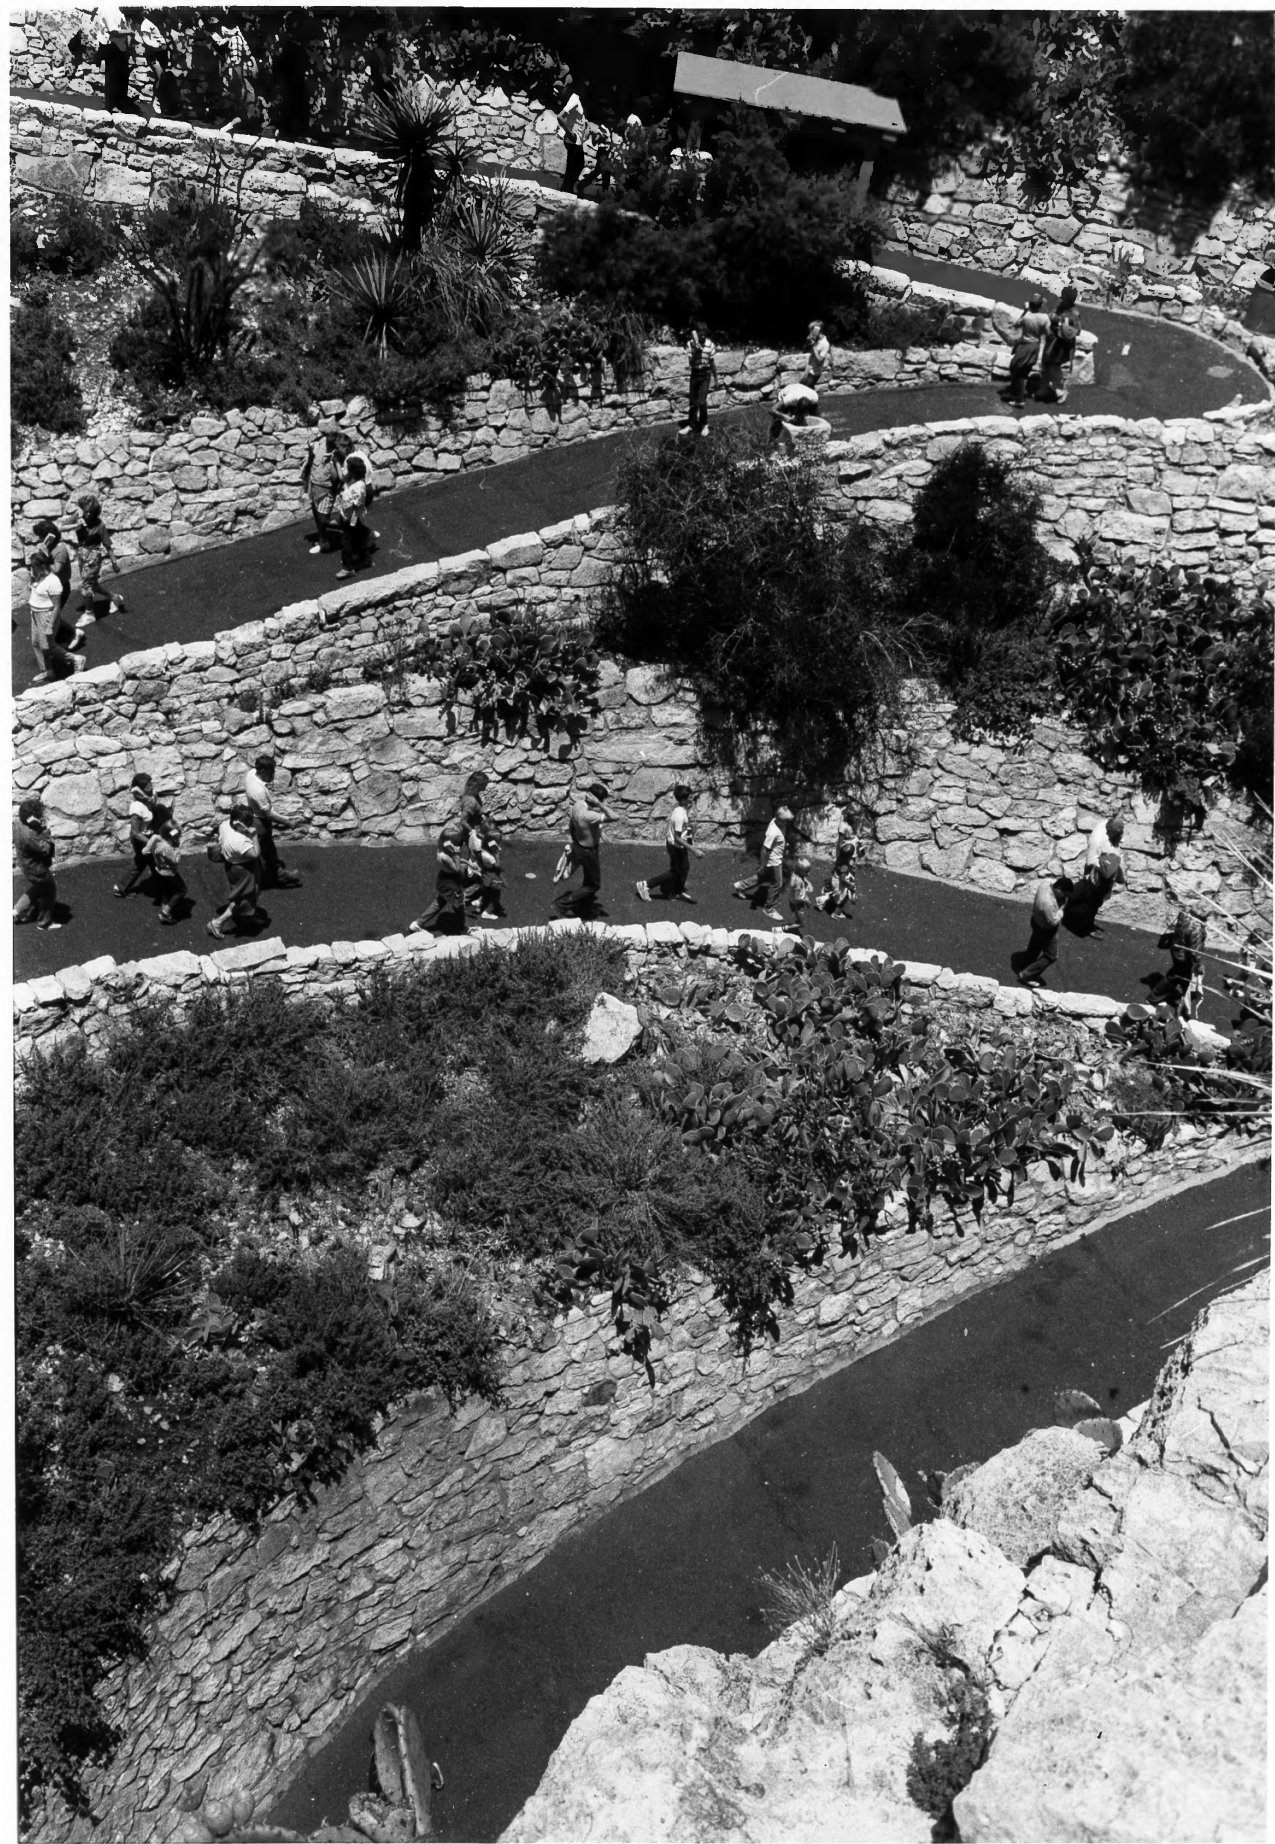
Switchback trail into the natural  
cave entrance, looking down from  
rim of roof of cave, showing lime-  
stone retaining walls (Significant)

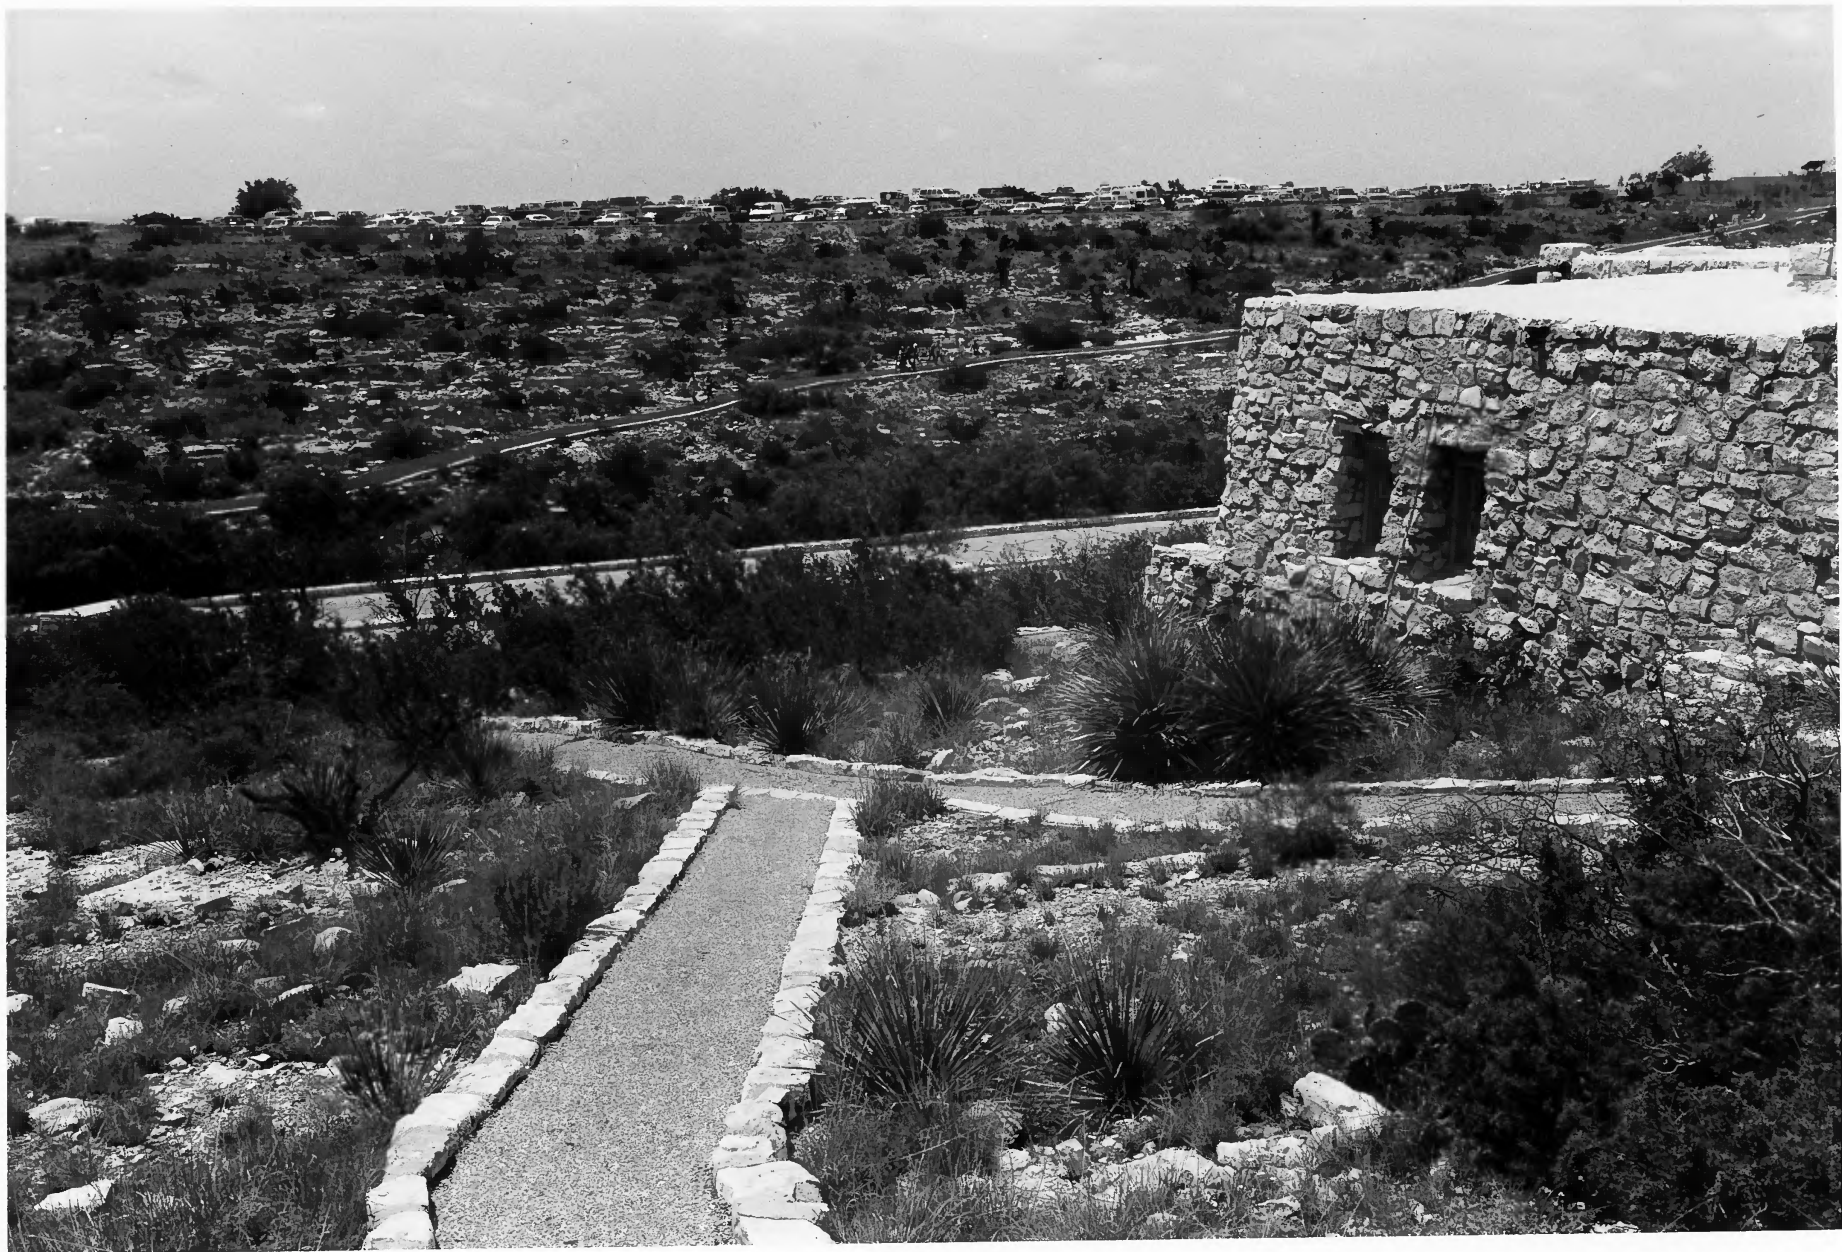
Footpaths on north slope of Bat Cave Draw, showing rock borders and asphalted limestone pebble surfaces. In center is parking lot. On opposite slope is footpath to Elevator Bldg (now Visitor Center). At right is (1) Bunk House and Mess Hall, NPS Bldg #16, east end which is an earlier random rubble guide's residence incorporated into the bldg.

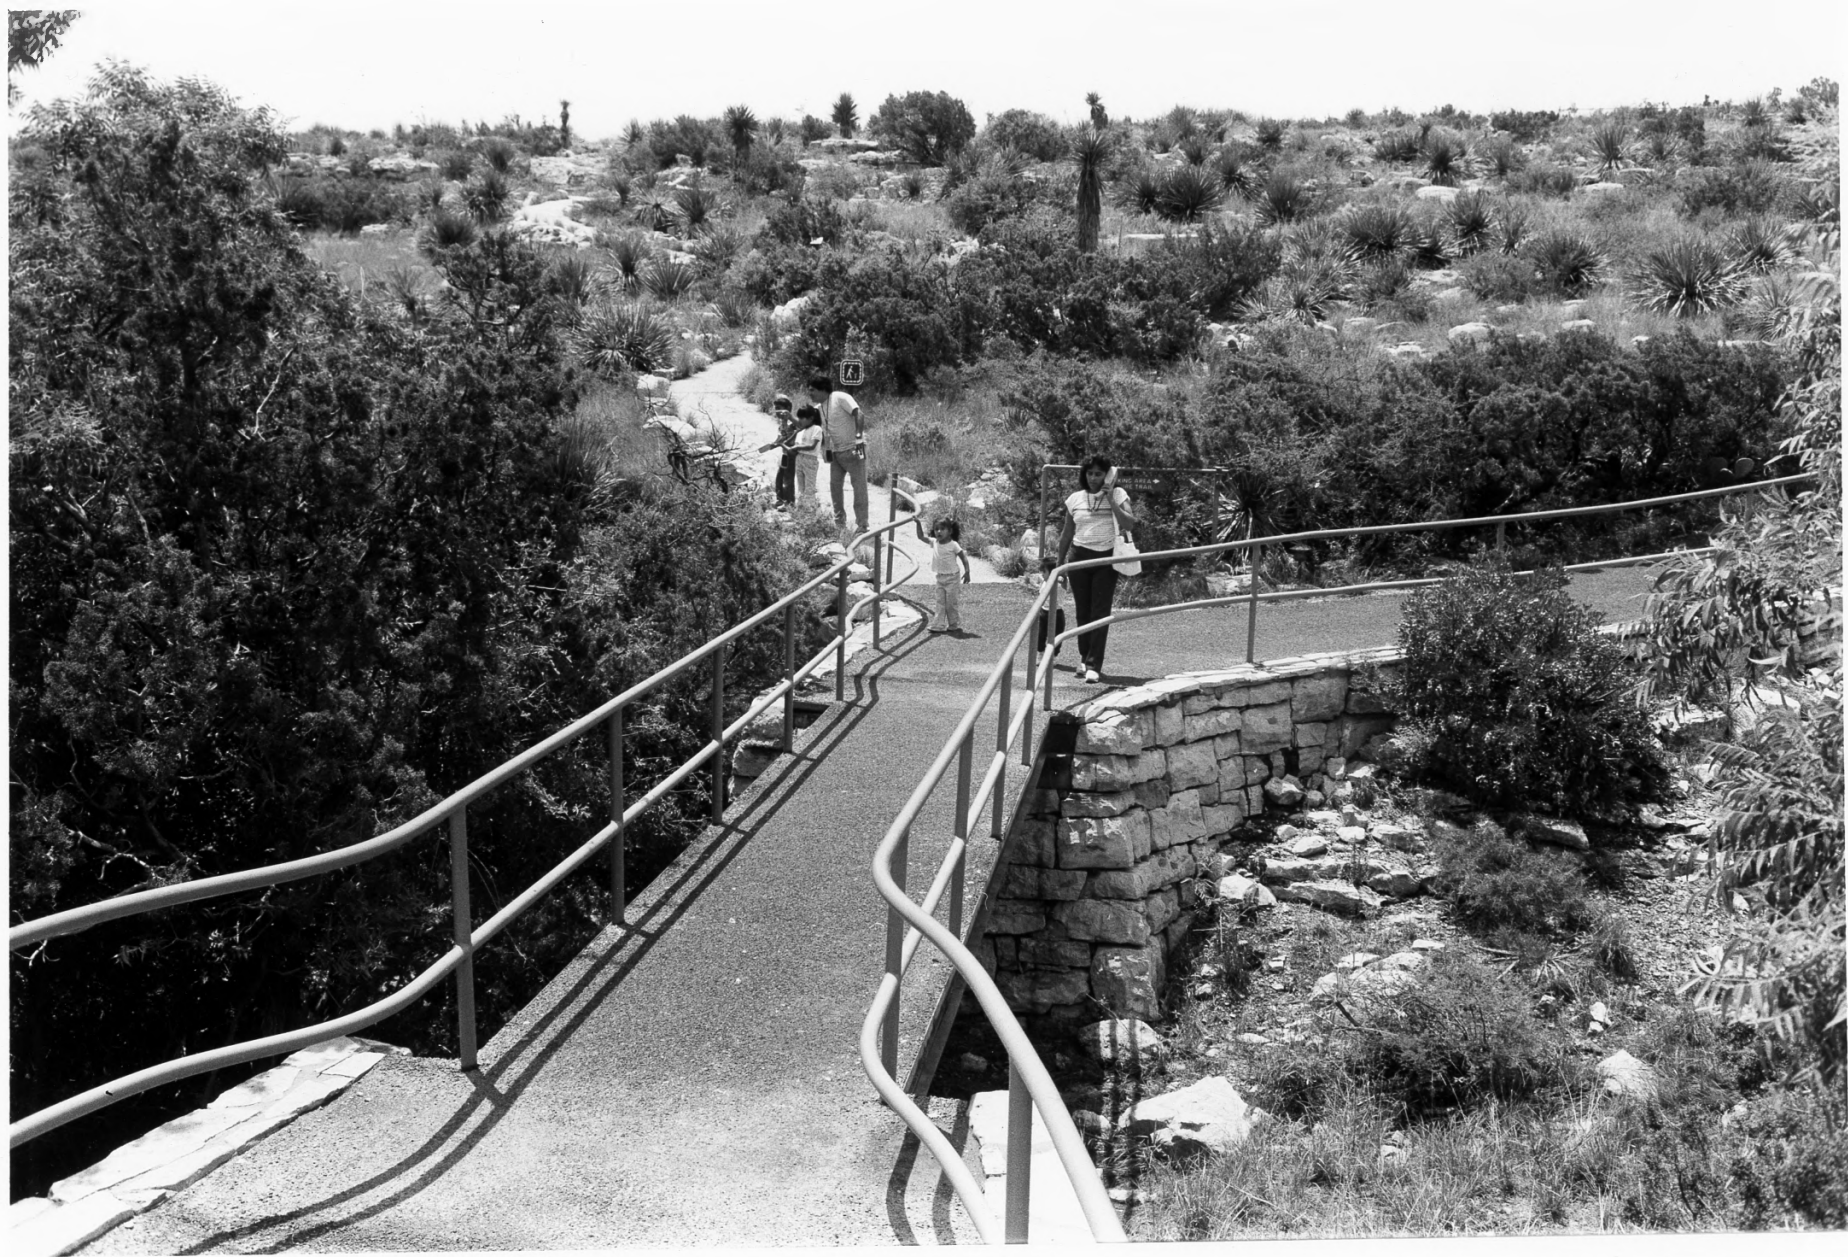
Foot bridge over Bat Cave Draw,  
showing masonry abutments. (Signi-  
ficant) In background is Nature  
Trail (Supporting).

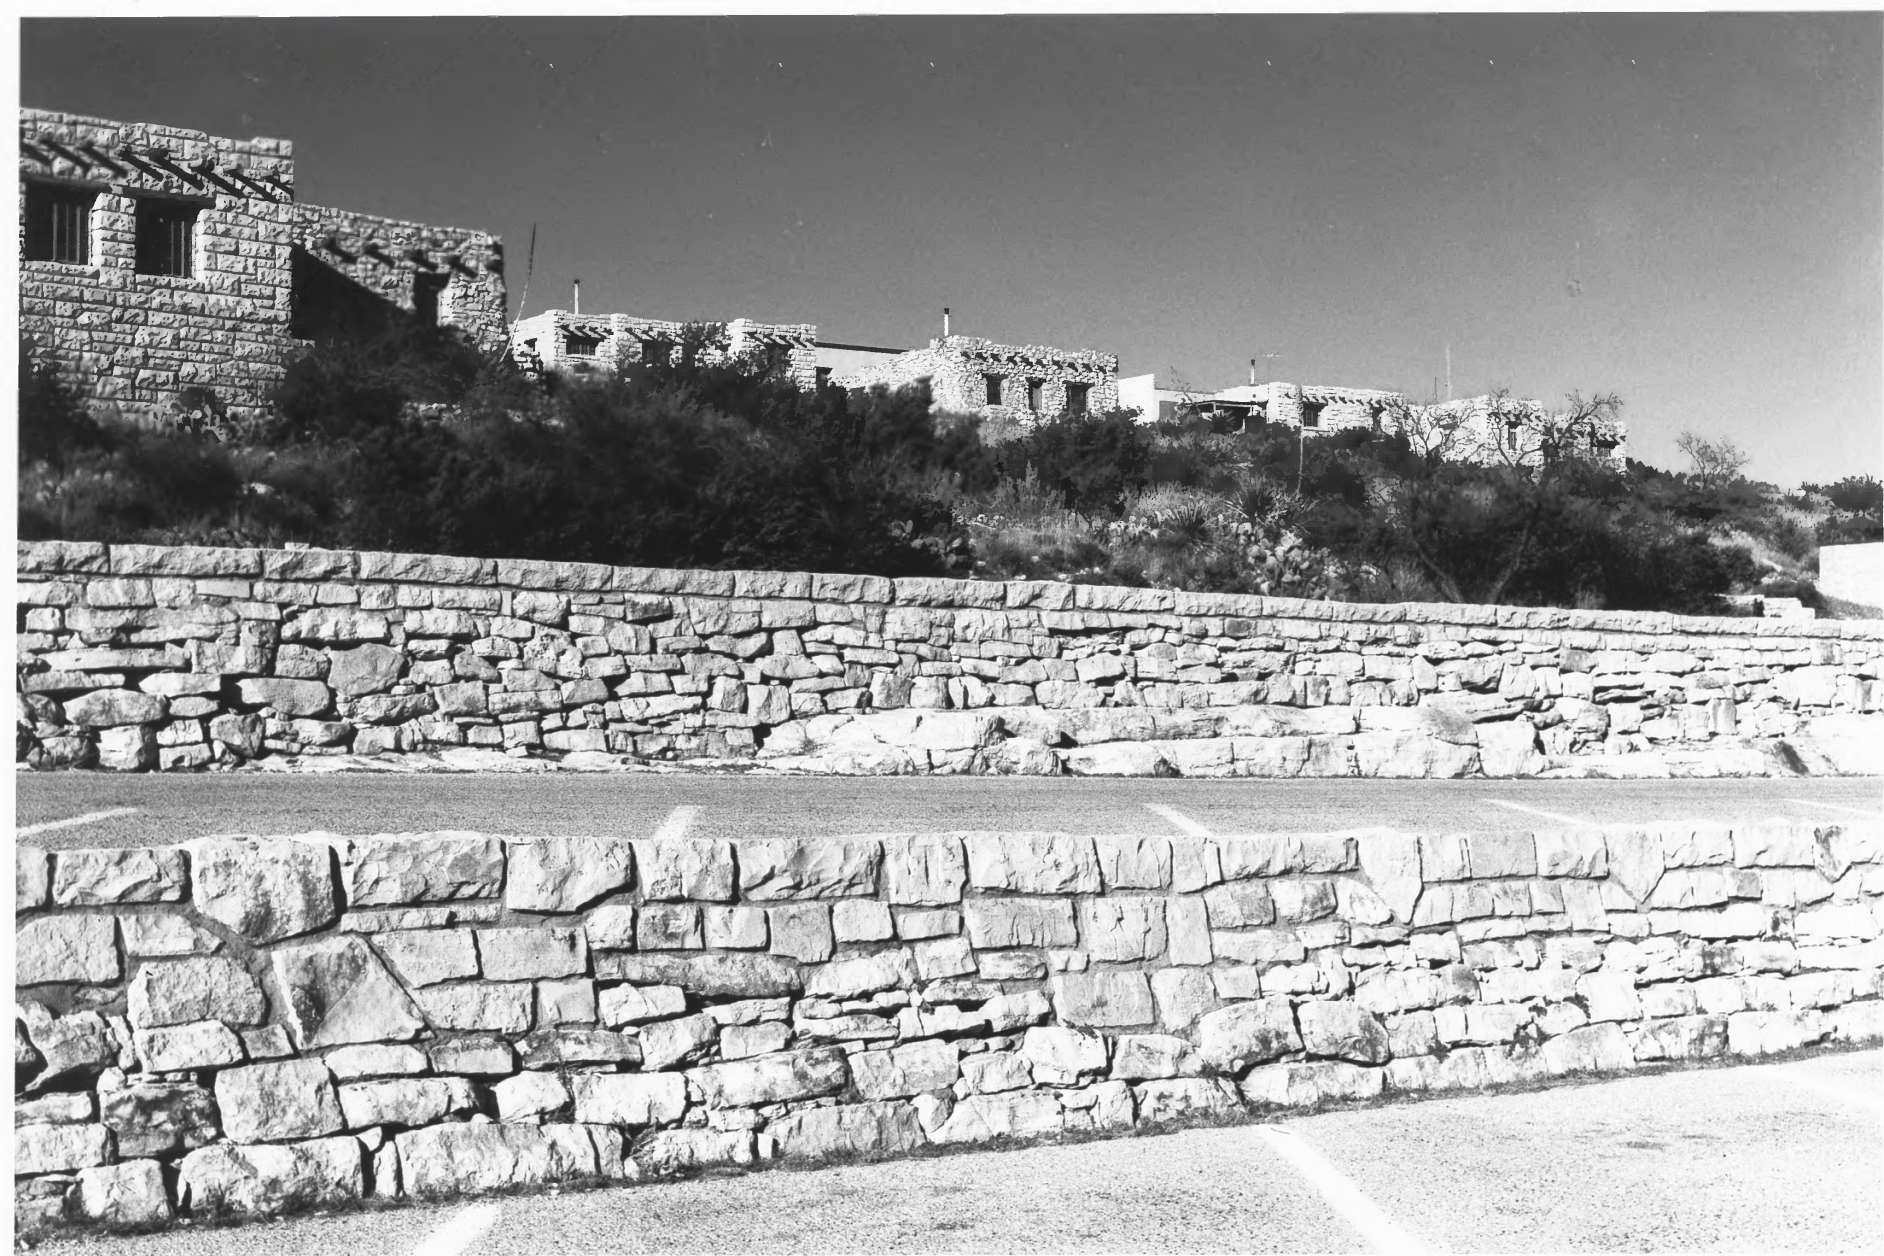
Parking terrace, showing limestone retaining walls, and building on slope of draw. Looking N. (Sig.)
