National Park Service  
Cultural Landscapes Inventory

2018

Williamsport  
Chesapeake and Ohio Canal National Historical Park

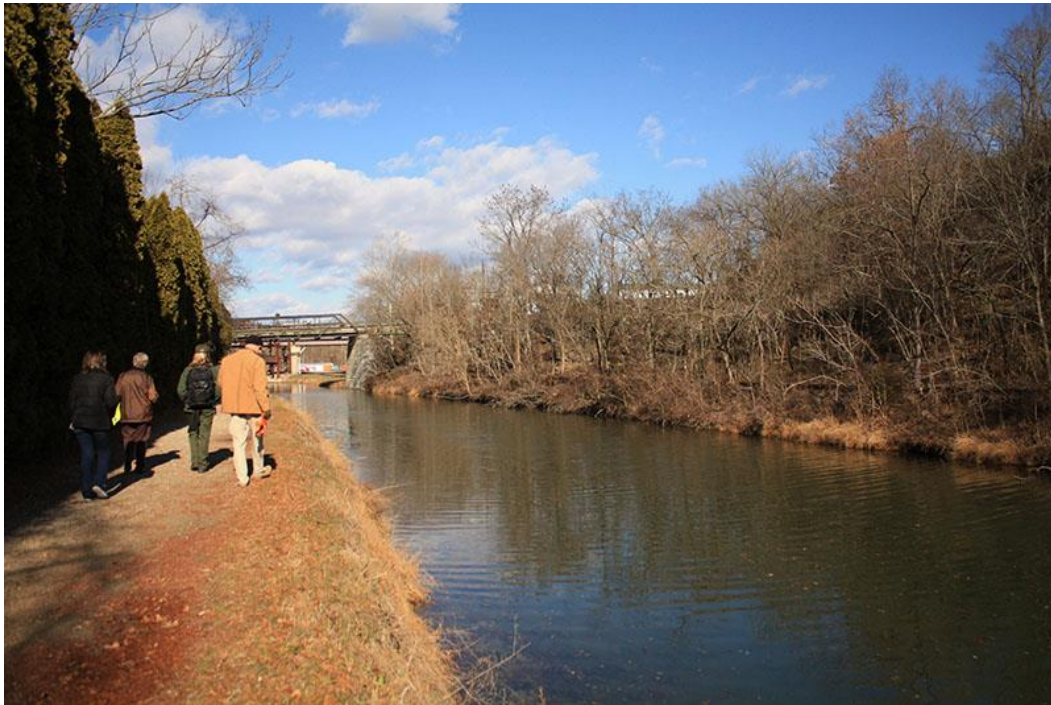
*The condition of the vegetation lining the canal prism (NCR CLP 2018).*

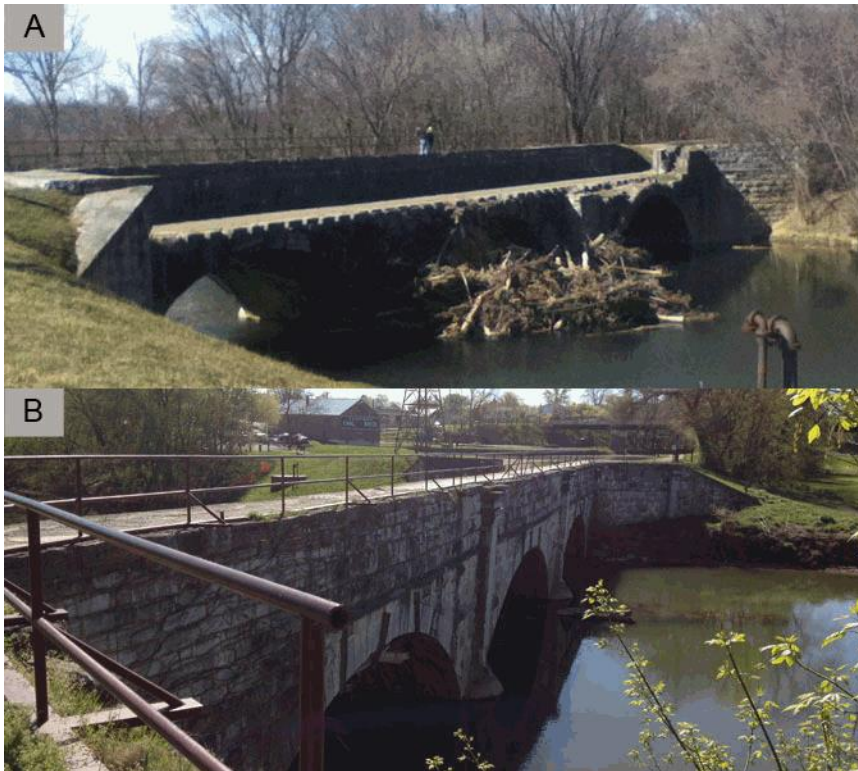
*A: 2012. Berm side of aqueduct looking upstream (NPS/NCR)*

*B: 2012. Towpath side of aqueduct looking downstream (NCR/NPS)*

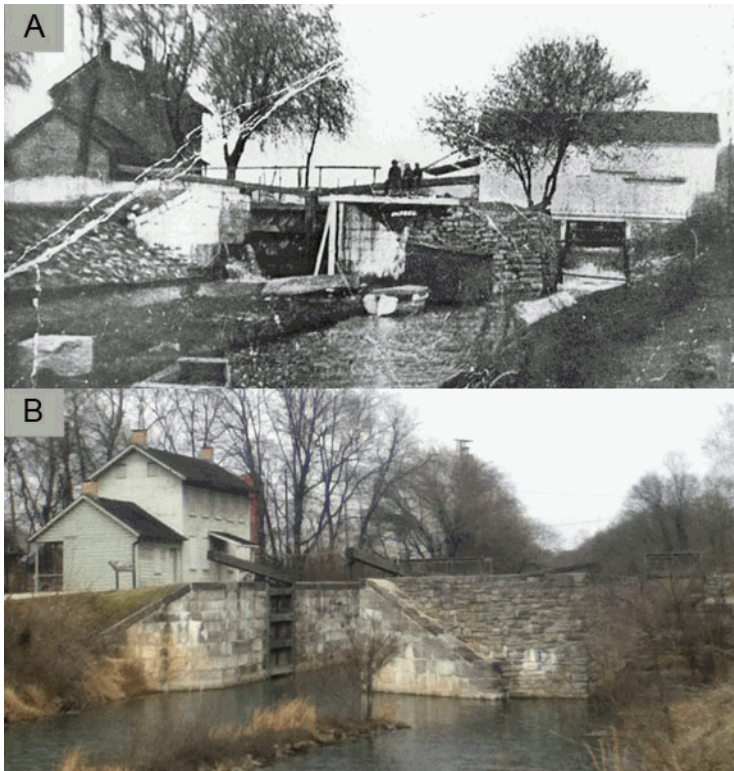
*A: c.1919. Upstream view of Lock 44, bypass flume, lockhouse, and the carpenter's shop  
(CHOH Historic Photo Collection)*

*B: 2012. Same view (NPS/NCR)*

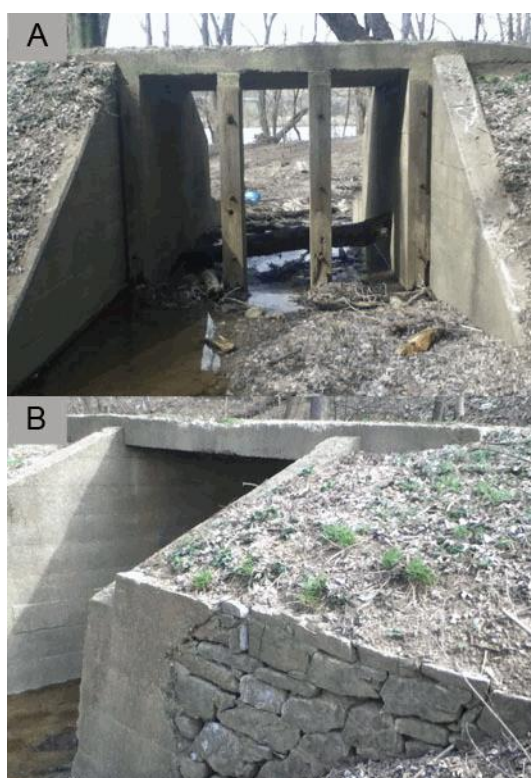
*A: 2012. View of wasteweir (mile 98.90) looking toward Potomac River (NPS/NCR)*

*B: 2012. Original stone used to construct wasteweir being exposed on towpath side (NPS/NCR)*

| CE 1900 | Reconstructed | A new concrete waste weir, built to replace the original stone weir at mile 98.90, has three openings, each about 30 inches wide with a height of about 8 feet 6 inches. The original waste weir had wooden wicket gates or stop planks. |

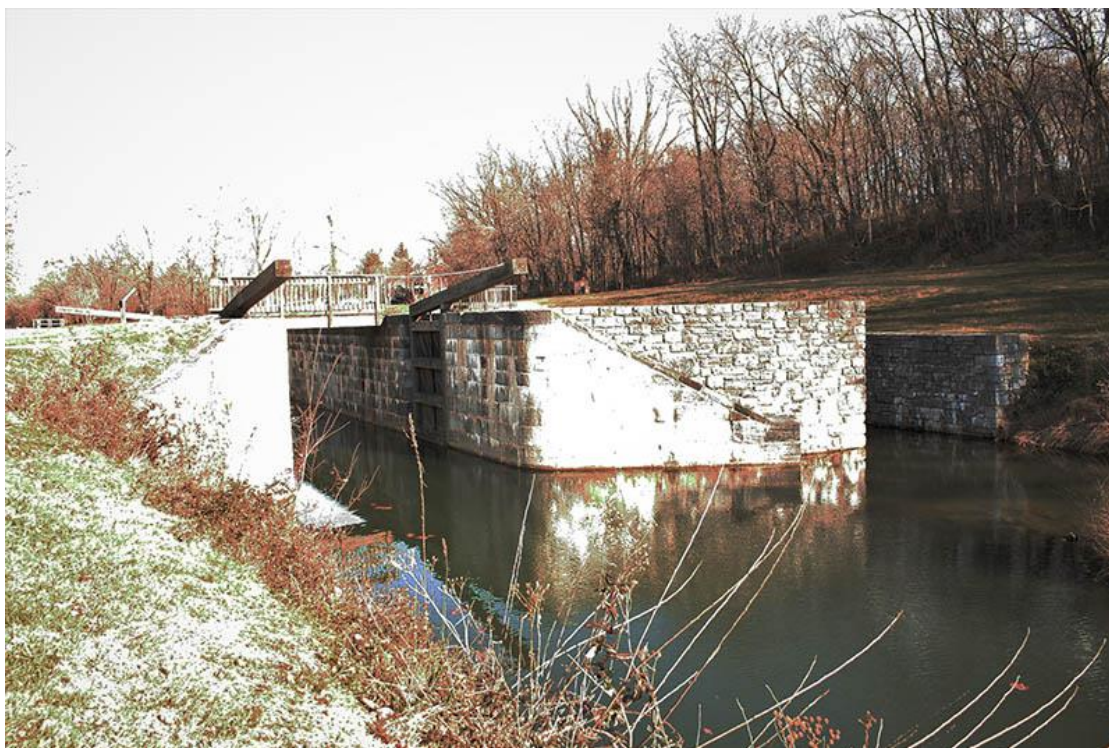
*Lock 44 (NCR CLP 2018).*

In 2013, the park began repair work on Lock 44. The lock failed to retain the proper water levels due to leakage through the timber floor of the lock. The foundation of the structure was rehabilitated with the installation of new mitre sills, additional timber flooring material, and grout between the existing foundation timbers. Additional measures were taken to ensure the water tightness of the structure. Beyond modifications to the lock floor, a sheet pile cut off wall was installed in the prism. The wall included a concrete cap. The additional wall in the prism ensured that the lock was watertight. Beyond the lock, the prism wall was to be relined with clay in order to once again seal the feature to retain water the length of the constructed water feature. The project was necessary to once again “restore” canal operations at Williamsport. This project was included in the 2012 Restoration of Canal Operations EA (PEPC 48453).

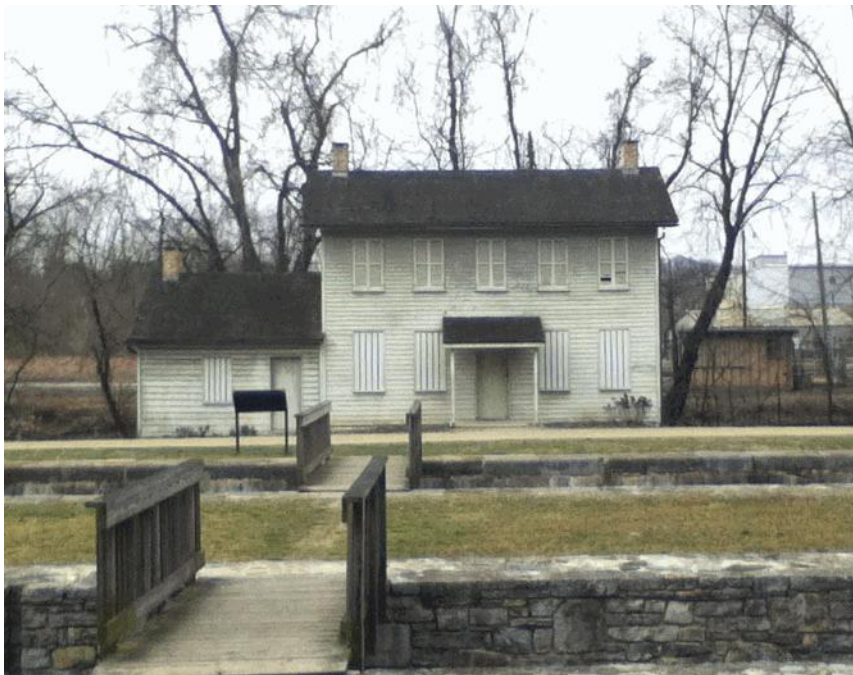
2012. Lockkeeper's house at Lock 44. View of front façade from berm side. Note bypass flume in foreground and lock in the center (NPS/NCR)

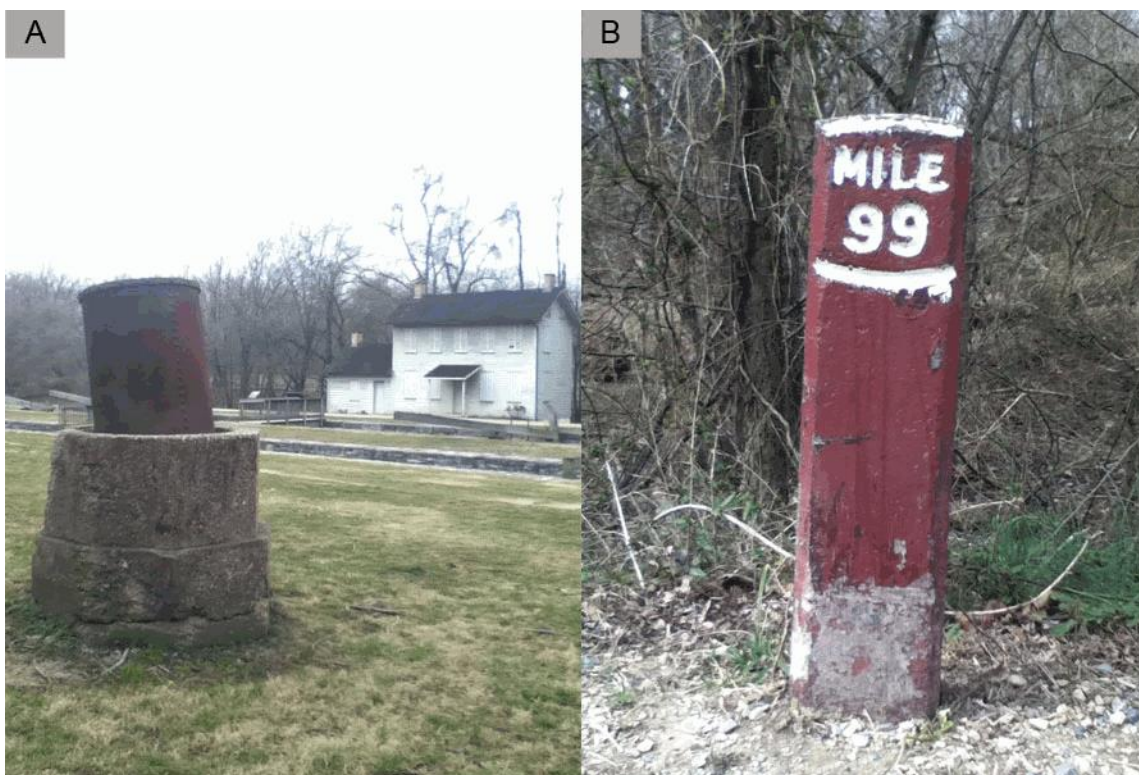
*A: 2012. View of creosote vat facing Lock 44 (NPS/NCR)*

*B. 2012. NPS mile marker (NPS/NCR)*

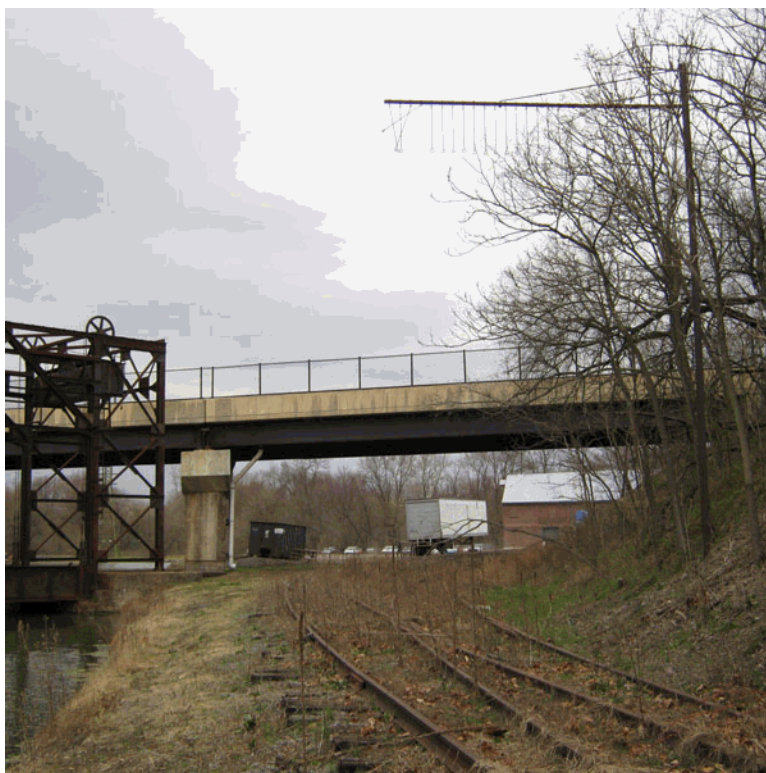
*2012. Upstream view of tell-tale post above Western Maryland Railroad track remnants (NPS/NCR)*
