National Park Service  
Cultural Landscapes Inventory  
2001

The Watchman  
Crater Lake National Park

CULTURAL LANDSCAPES INVENTORY (CLI) PROGRAM  
2009 Condition Assessment Update for:

Watchman Observation Station and Watchman Trail  
Crater Lake National Park

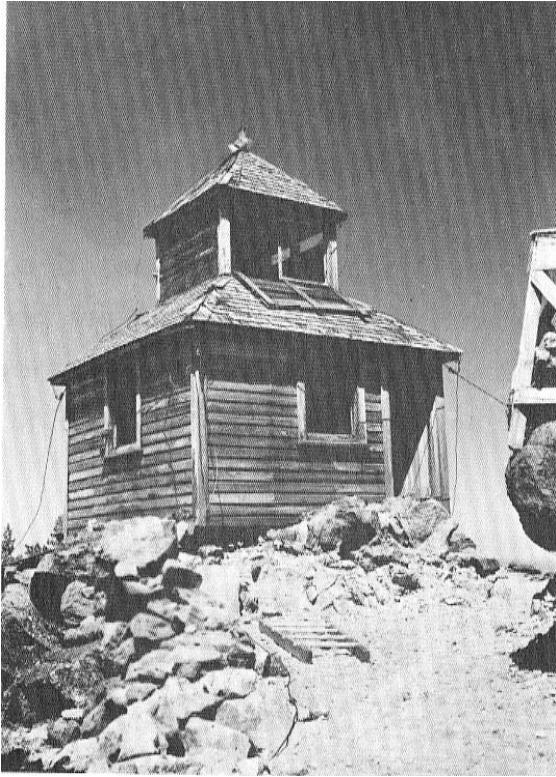
*Historic photograph showing Watchman Fire Lookout. This building was replaced by Watchman Observation Station (Historic Resource Study, 1984).*

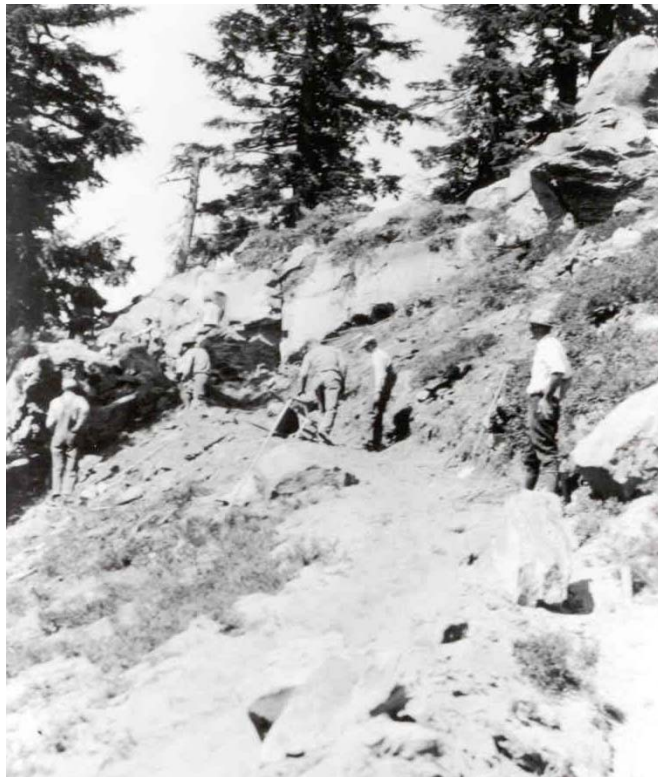
Historic photograph of Discovery Point Trail construction in 1932 (CRLA archives).

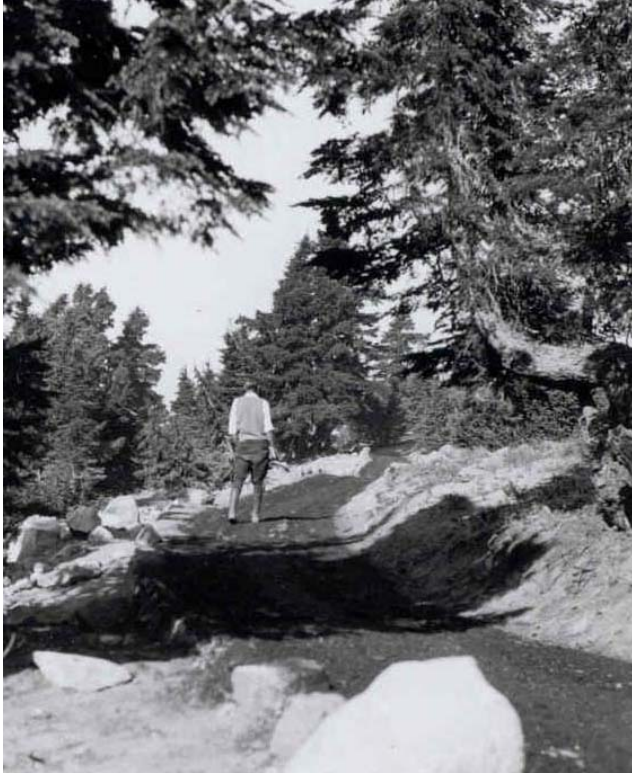
*Historic photograph showing Watchman Trail after it has been oiled to reduce dust, 1932 (CRLA archives).*

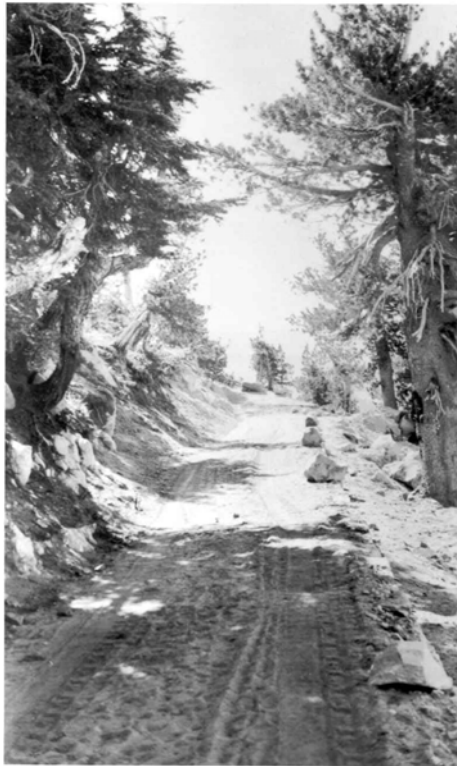
*Historic photograph showing Watchman Trail is lined with rock on the down slope side of the trail, 1932 (CRLA archives).*

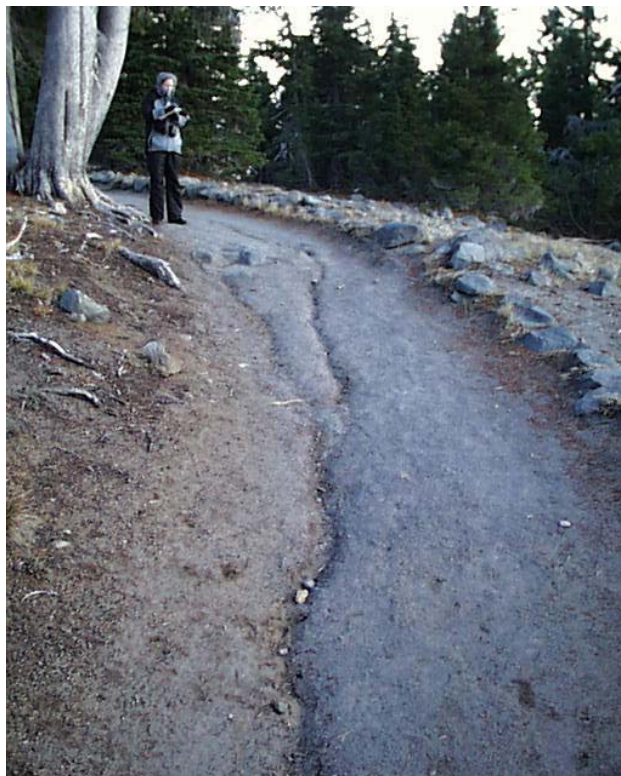
*Contemporary photograph showing Watchman Trail and erosion caused by harsh climatic conditions at Crater Lake National Park (CCSO 2001).*

Damage to Watchman Observation Station and Watchman Trail is caused by harsh climatic conditions at Watchman Peak.

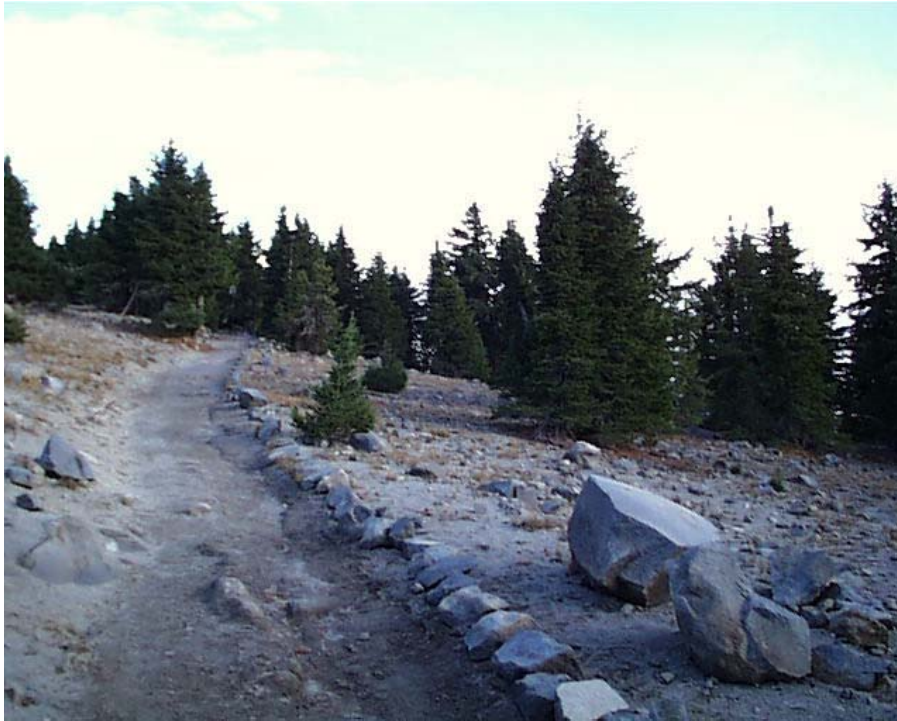
*Contemporary photograph showing Watchman Trail. The trail is 5' wide and lined with stones during the historic period to mark its edge on the down slope (CCSO 2001).*

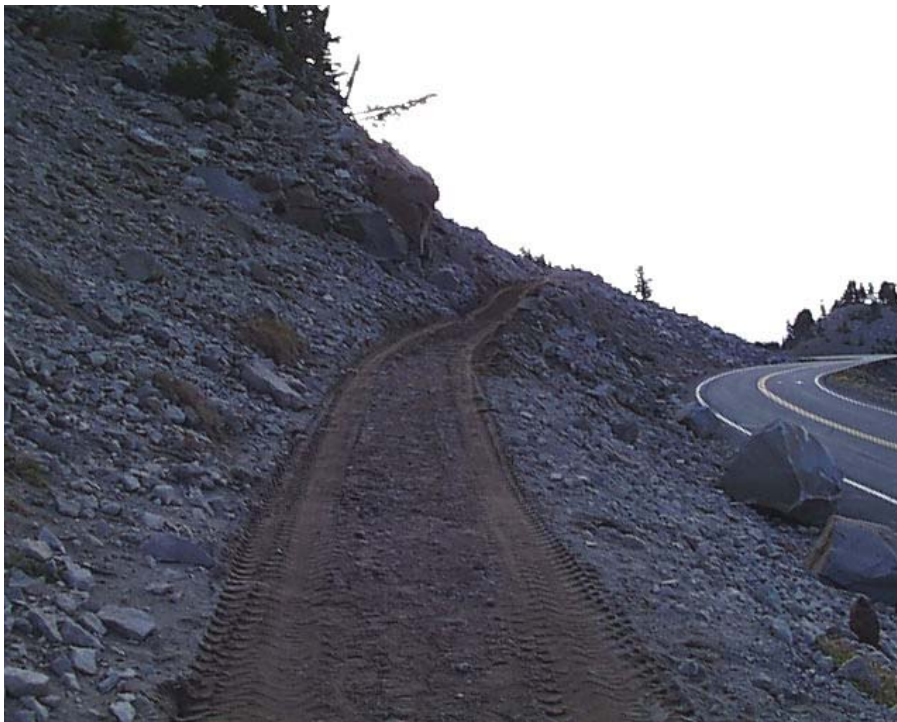
*Contemporary photograph showing Watchman Trail. The trail is wider along this 200 yard segment as it traces the original alignment of Rim Road (CCSO 2001).*

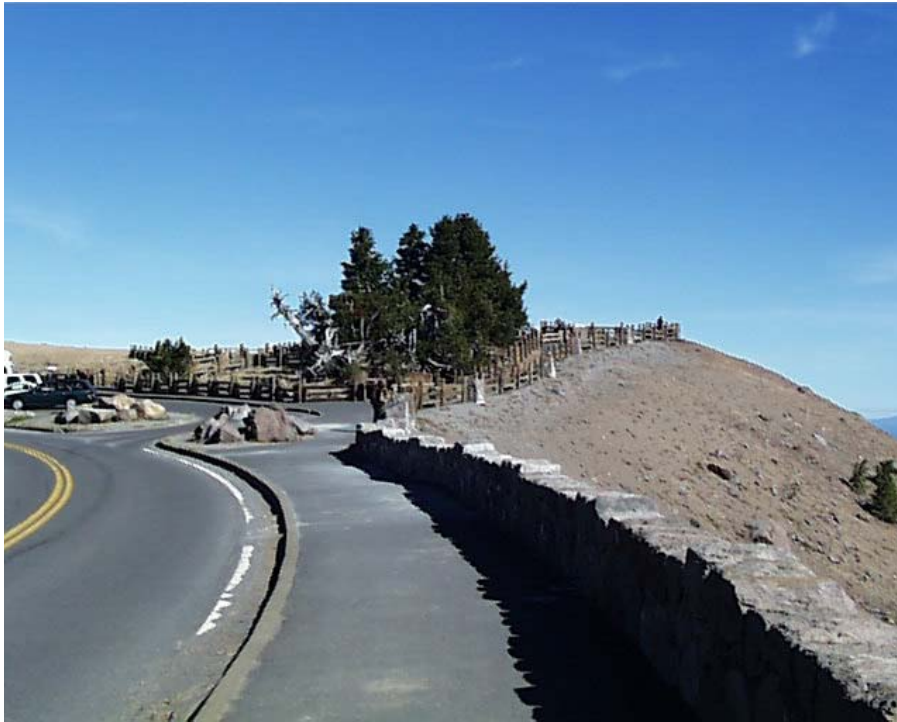
*Contemporary photograph showing parking lot located at Watchman Overlook, 7600' (CCSO 2001).*

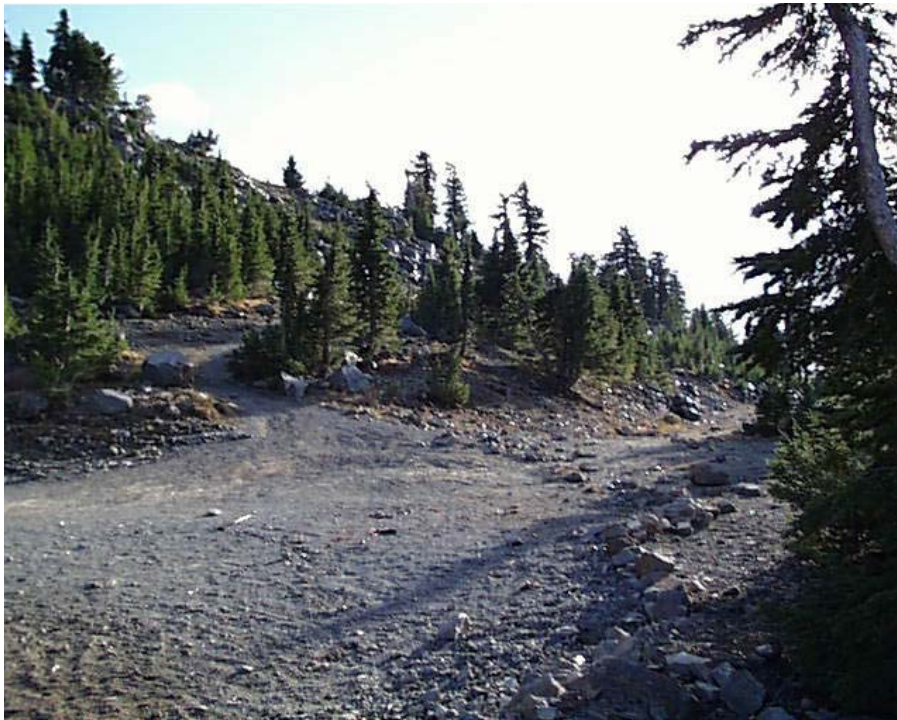
*Contemporary photograph showing Watchman Trail spurring to the left from the original alignment of Rim Road which continues to the right (CCSO 2001).*

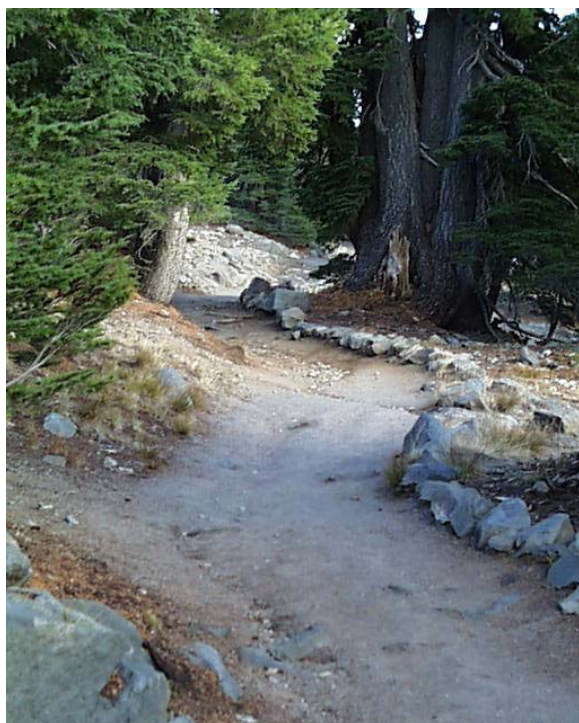
*Contemporary photograph illustrating how Watchman Trail was historically aligned to avoid Whitebark pines and Mountain hemlocks (CCSO 2001).*

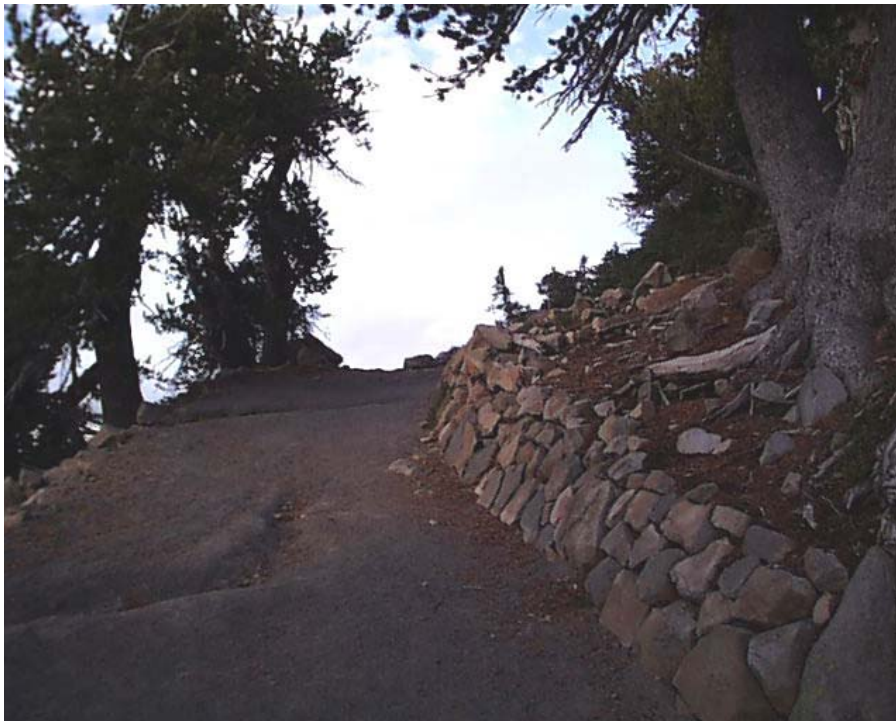
*Contemporary photograph showing dry-laid retaining wall along Watchman Trail. This is a typical example of wall found along the trail (CCSO 2001).*

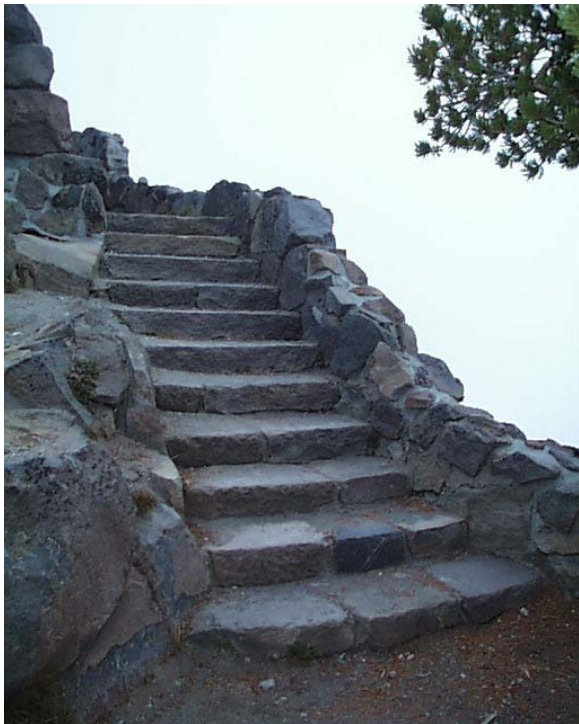
*Contemporary photograph showing rock steps and cheek walls. This is located near Watchman Observation Station (CCSO 2001).*

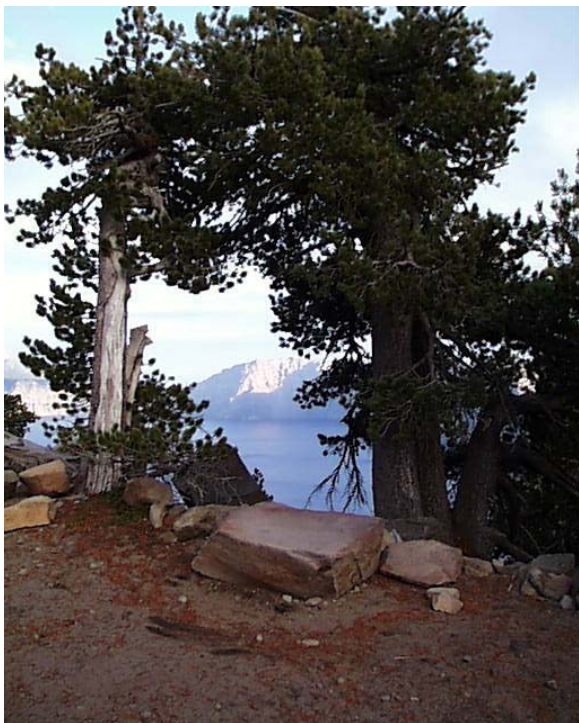
*Contemporary photograph showing stone slab bench beneath Whitebark pines. This was placed during the historic period (CCSO 2001).*

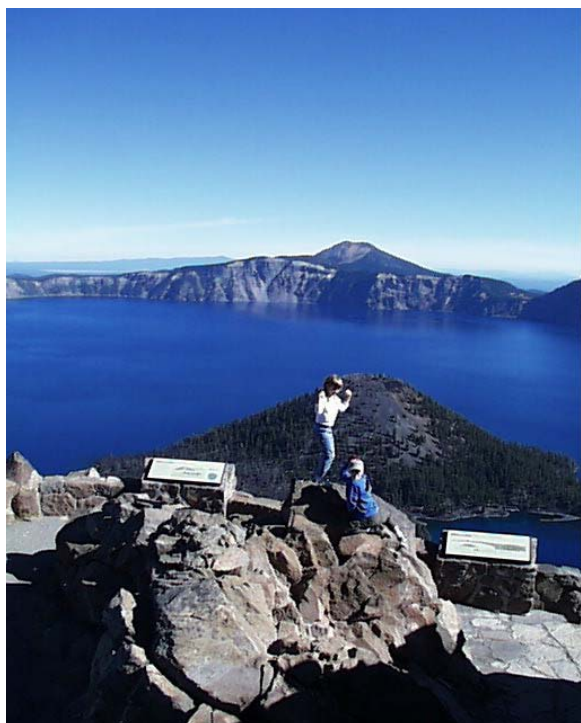
*Contemporary photograph showing stone parapet located adjacent to Watchman Observation Station. Note interpretive signs (CCSO 2001).*

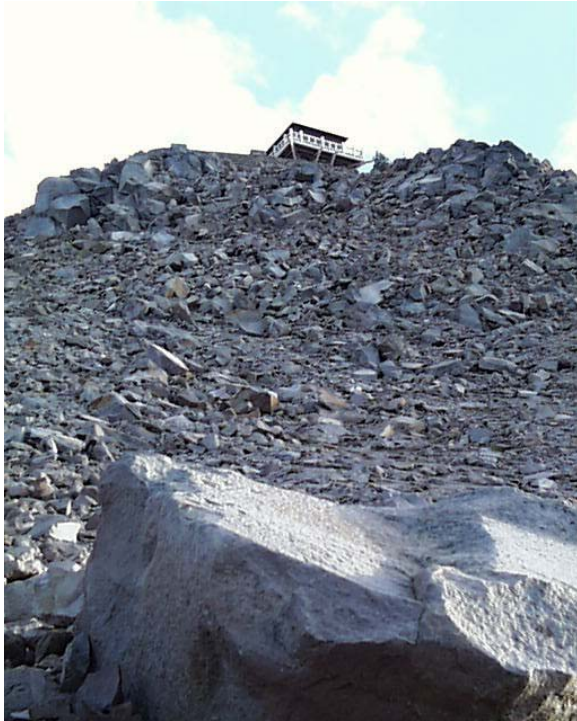
*Contemporary photograph showing Watchman Observation Station at the top of the peak (CCSO 2001).*

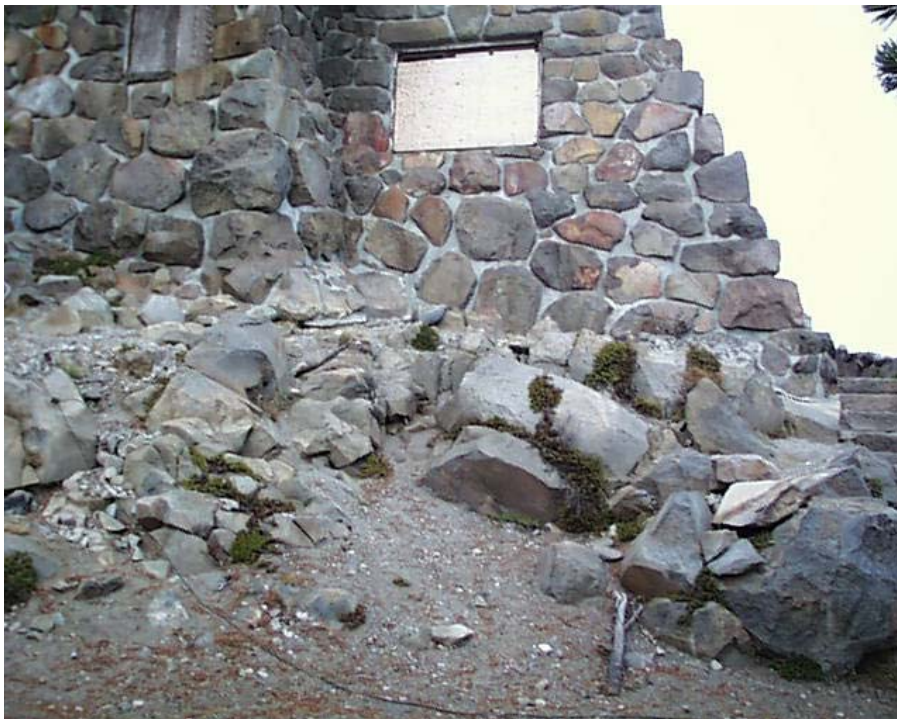
*Contemporary photograph showing detail of Watchman Observation Station's foundation (CCSO 2001).*

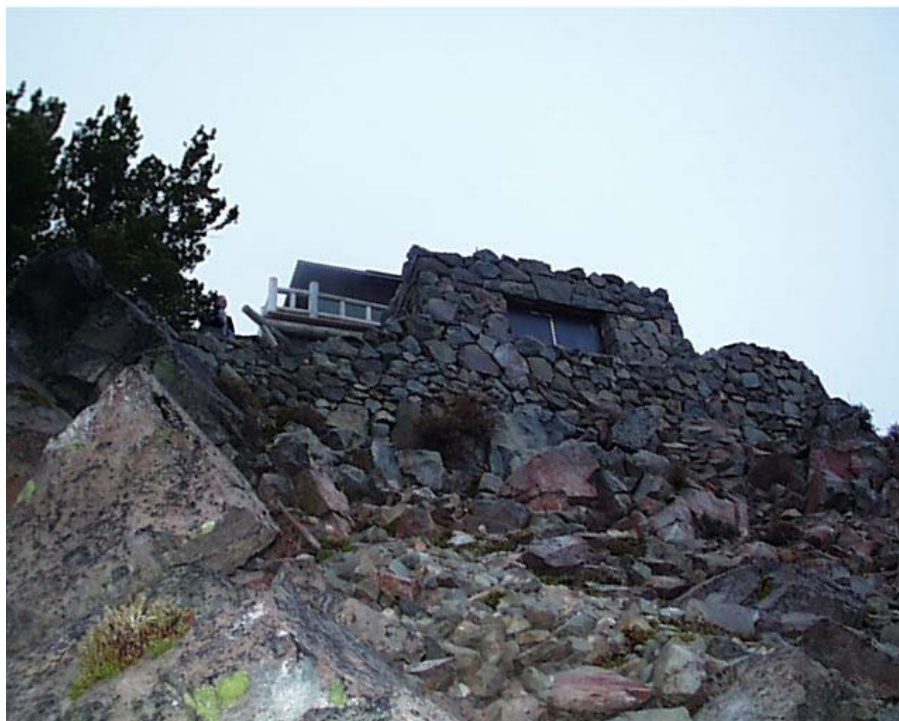
*Contemporary photograph showing how Watchman Observation Station seems to rise from the peak, fully integrated within its context (CCSO 2001).*
