CRATER LAKE ADMINISTRATIVE COMPLEX, MESS HALL  
(Bank House, Confield Building)  
Kamasa Valley, Rim Drive off State Hwy. 62  
Crater Lake National Park  
Crater Lake  
Klamath County  
Oregon

HABS No. OR-<sup>163</sup>~~144~~-C

WRITTEN HISTORICAL AND DESCRIPTIVE DATA

CRATER LAKE ADMINISTRATIVE COMPLEX,  
MESS HALL

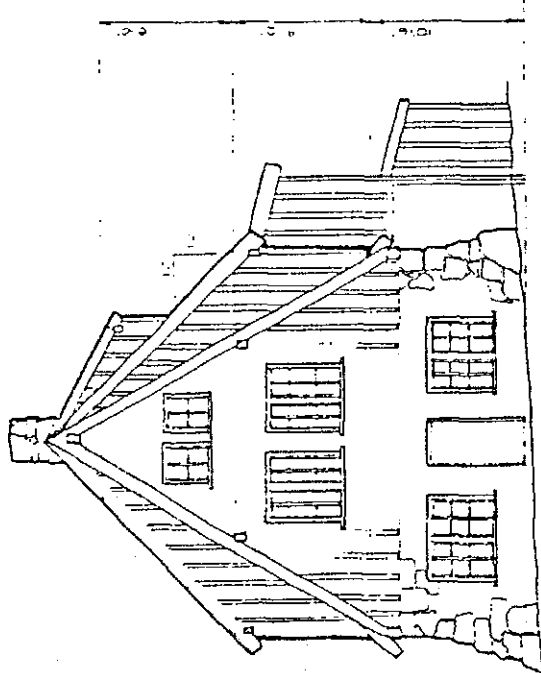
Side Elevation

existing mess hall

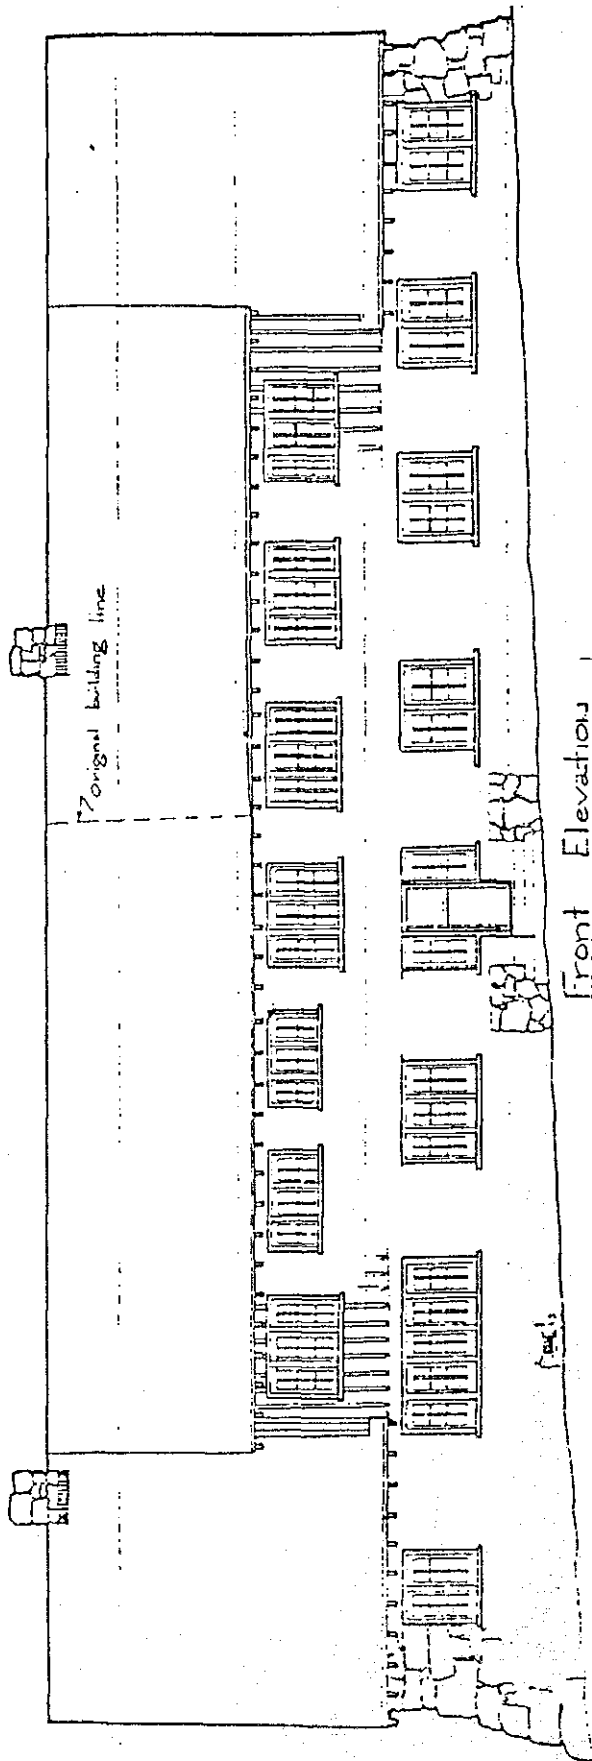
Front Elevation

Original building line

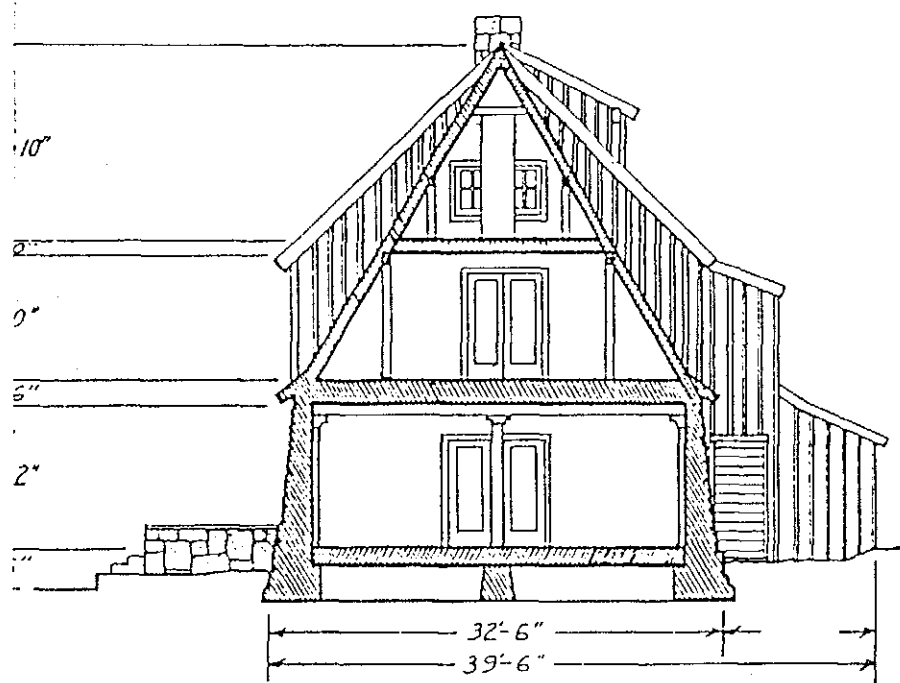
SECTION THROUGH MESS HALL

| MATERIAL OF CONSTRUCTION (include structural systems)<br>Stone masonry bearing walls to 2nd floor level supporting wood stud bearing walls to the plate line of the roof framing; concrete foundation | | |

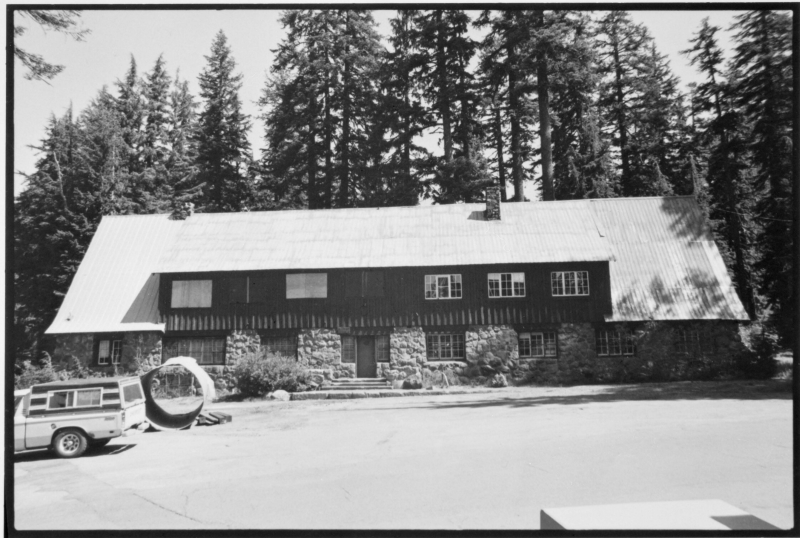
| OR- <sup>162</sup> <del>144</del> -C-1 | VIEW OF SOUTH FACADE, LOOKING NORTH |

| EXTERIOR FEATURES OF NOTE 1-1/2 stories (3 floors): steeply-pitched gable roof covered in wood shakes; prominent central shed roof dormer on south elevation; large shed roof dormer with small shed roof dormer on top on north elevation; lower level sided in native stone; upper level at gable ends and dormers sided in vertical board and batten; interior rough-cut stone chimneys on ridge line and south slope; 1-story shed addition on east; multi-paned wooden case-ment sash; main entry on south has heavy wood door with glass above and wrought-iron hardware; | | |

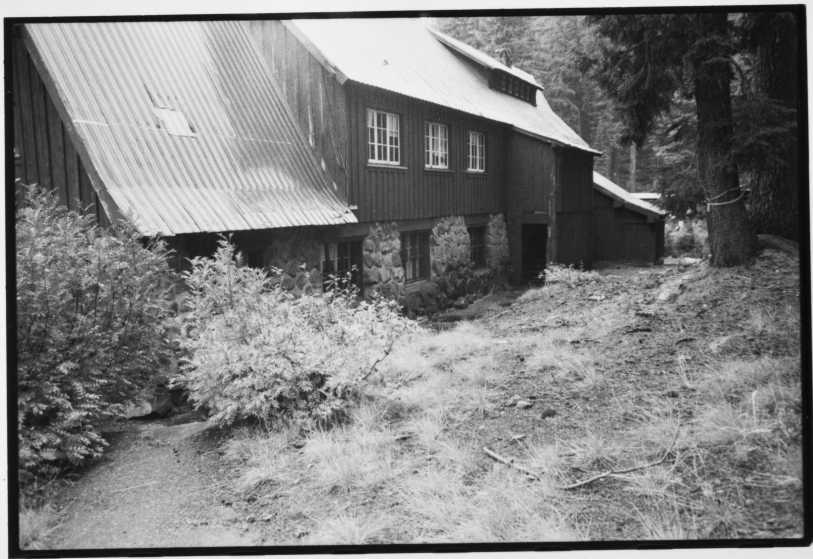
HAAS NO. 22-142-C-2.

| OR- <sup>162</sup> <del>144</del> -C-2 | VIEW OF NORTH FACADE, LOOKING WEST |

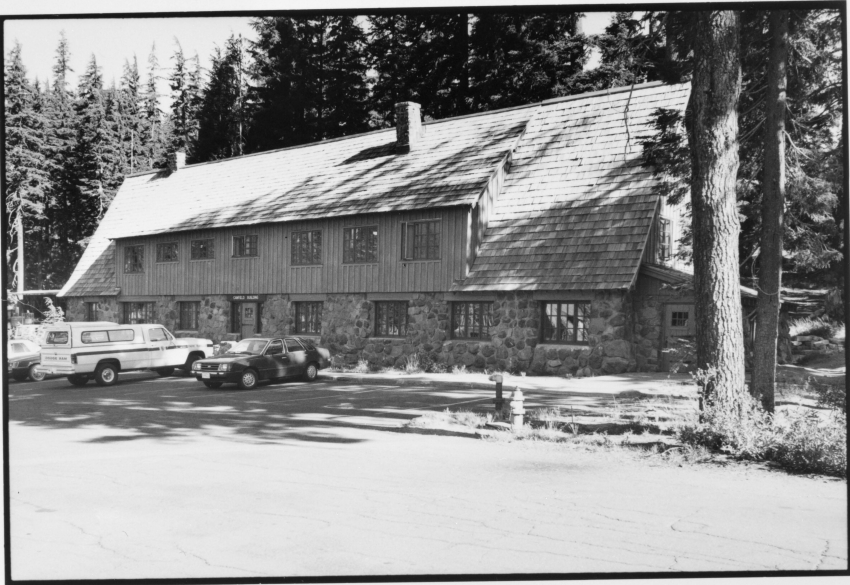
HAAS N. CR. 144 G. 10

| OR- <sup>162</sup> <del>144</del> -C-3 | VIEW OF SOUTH FACADE, LOOKING NORTHWEST |

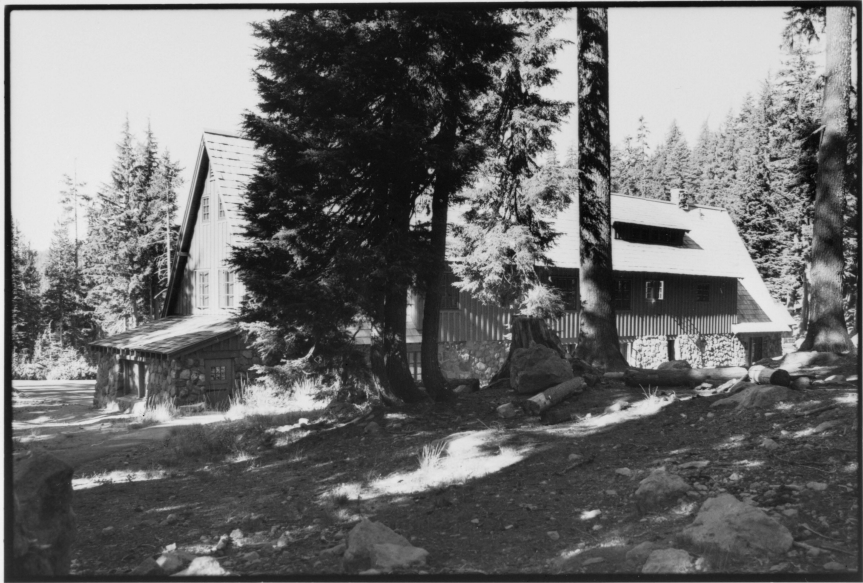
HABS NO. OR-168-C-4

| OR- <sup>162</sup> <del>144</del> -C-4 | VIEW OF NORTH FACADE, LOOKING WEST |

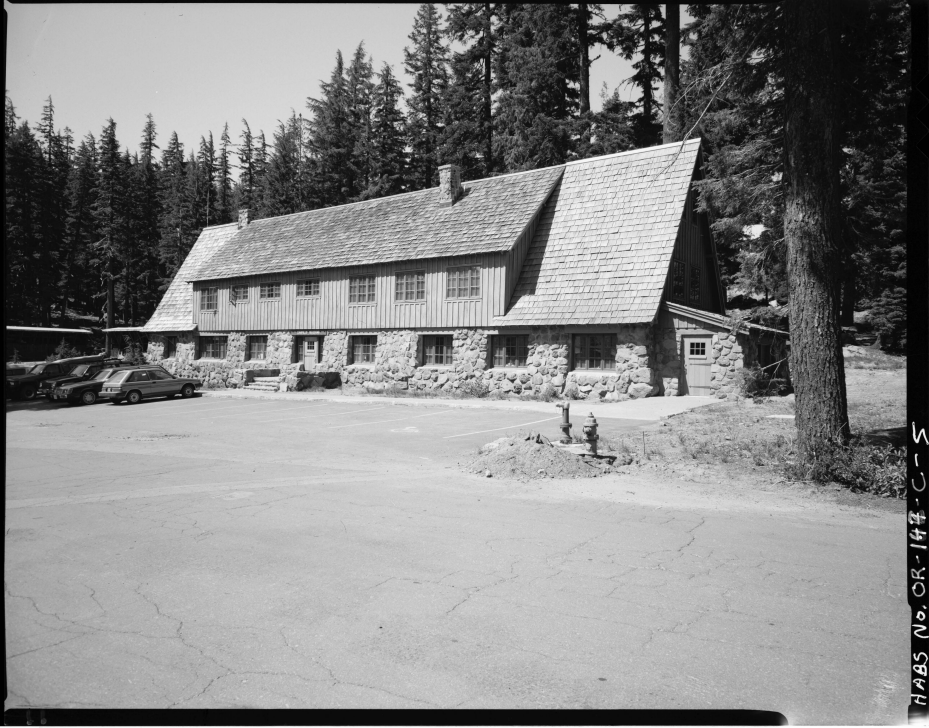
HABS No. OR-142-C-5

| OR- <sup>162</sup> <del>144</del> -C-5 | VIEW OF SOUTH FACADE, LOOKING NORTHWEST |
