CRATER LAKE NATIONAL PARK  
HISTORIC HEADQUARTERS LANDSCAPE  
RESTORATION & MANAGEMENT

*Iain Robertson, Associate Professor  
Department of Landscape Architecture  
University of Washington*

*March 2010*

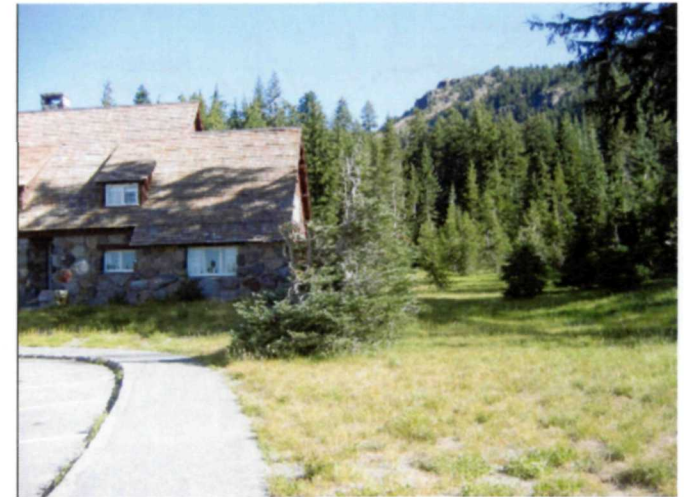
Photo 1 Wet, lush meadow adjacent to the Administration Building in the flat bottom of Munson valley.

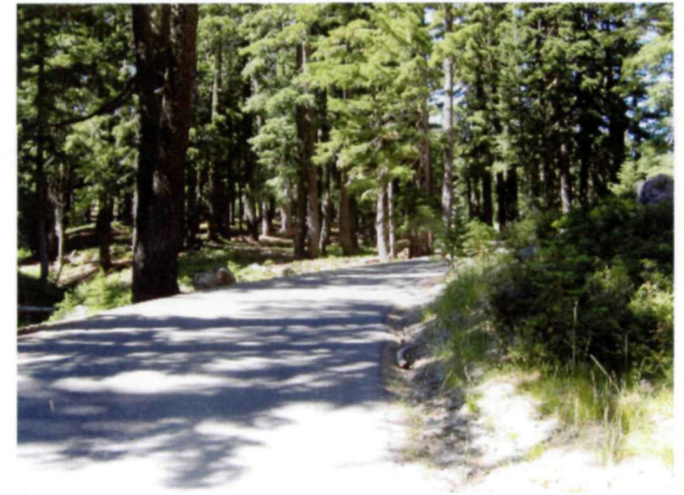
Photo 2 Old-growth Hemlock Fir forest: Dry soils and shade create a sparse understory and a forest with an open character.

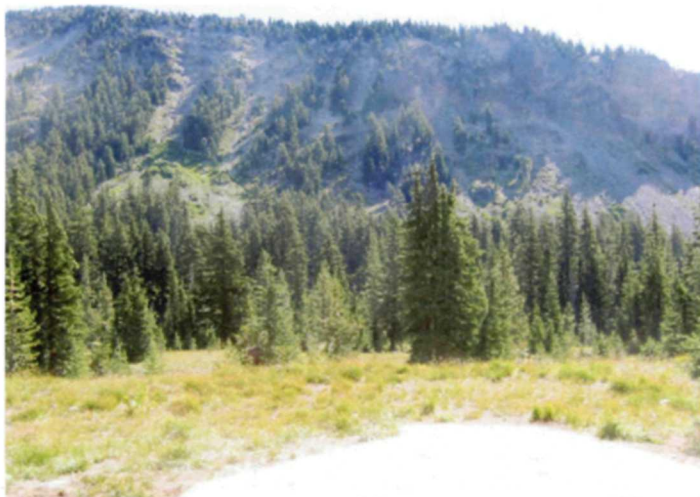
Photo 3 View across the dry meadow from the Superintendent's Residence to Garfield Ridge. Forest trees invading thin herbaceous cover.

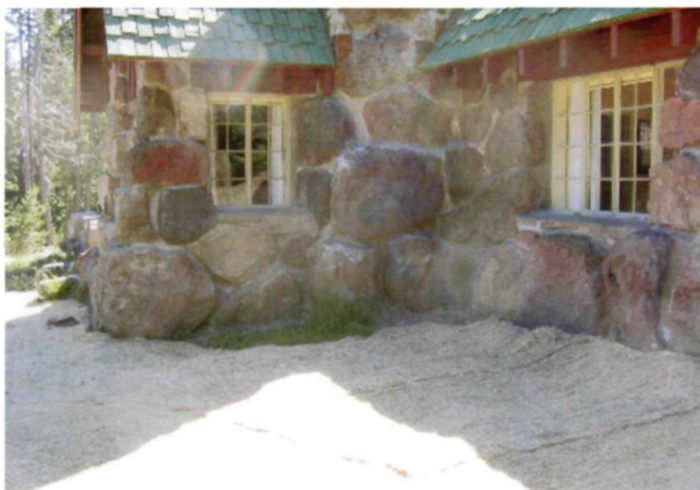
Photo 4 Superintendent's Residence: removal of grout debris, filling around base of walls and pipes, and removal of unnecessary erosion control matting will integrate the building into the surrounding landscape.

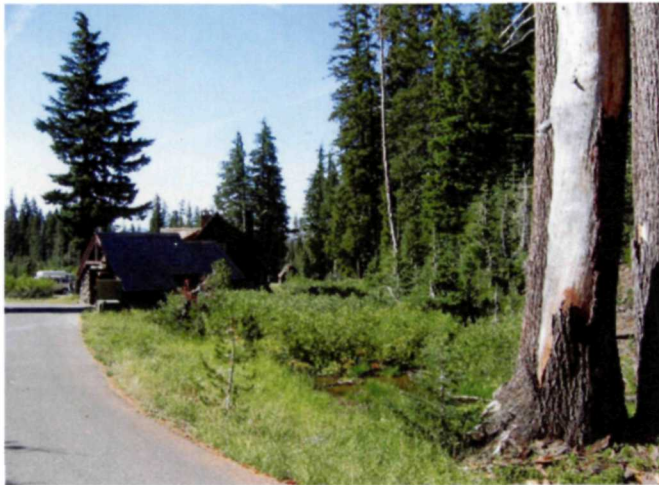
Photo 6 Dense, light green and luscious riparian vegetation on Munson Creek behind the Visitor Information Center at the low end of the Historic District

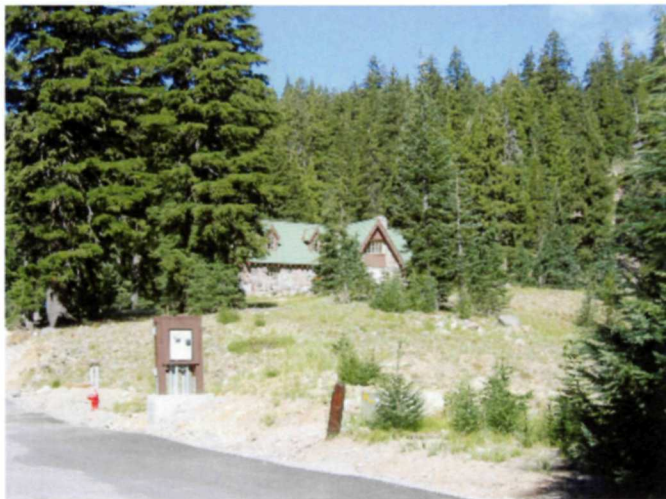
Photo 7 Riparian vegetation contrasts sharply with the thin aridity of meadow vegetation at the upper end of the District.

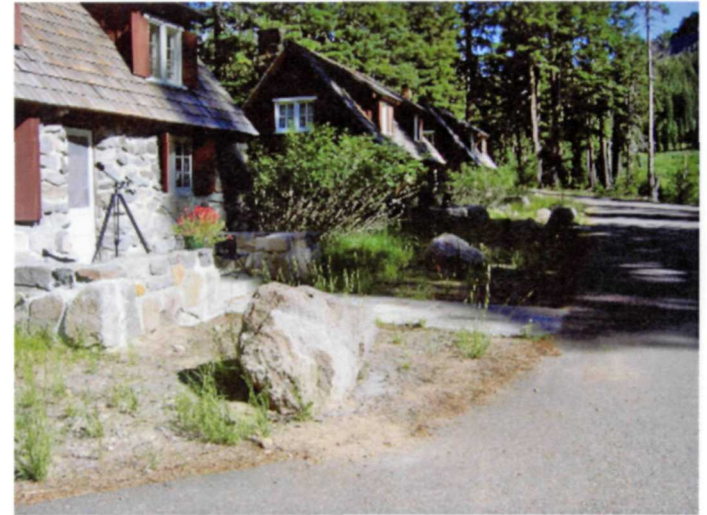
Photo 8 Rocks along cottage row where road width was reduced. Seemingly randomly placed rocks tend to attract attention and thwart attempts to have rustic buildings merge into the landscape setting.

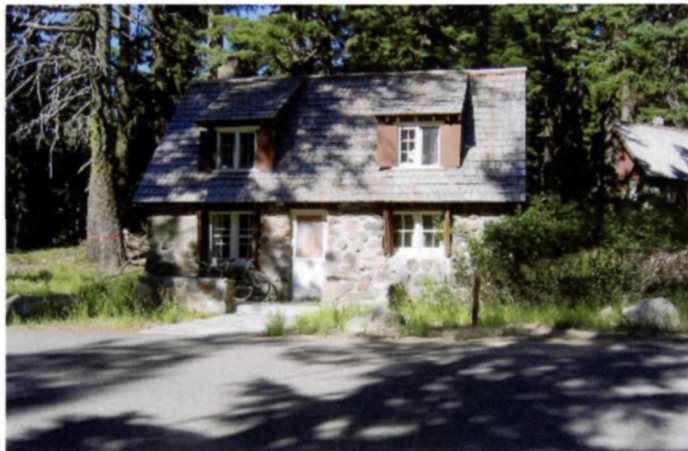
Photo 10 Notice how effectively tree shadows add a beneficial camouflage effect to building facades and roads.

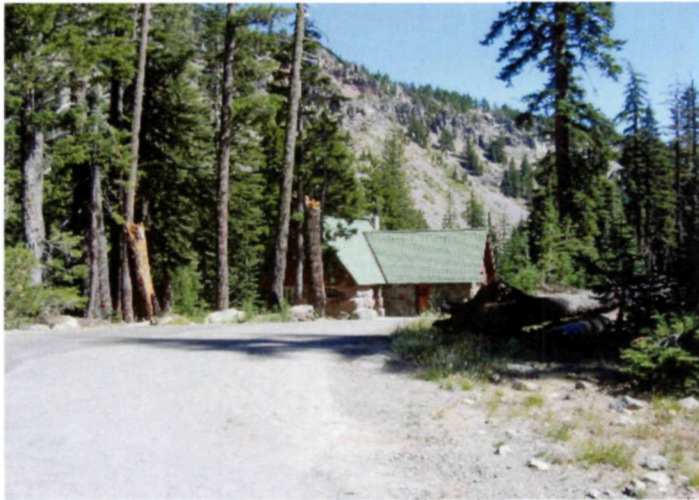
Photo 11 Naturalist's residence setting. An intermixture of dead snags, dying trees, mature & youthful trees, & regeneration from saplings to and seedlings are characteristic of dynamic old-growth forests.

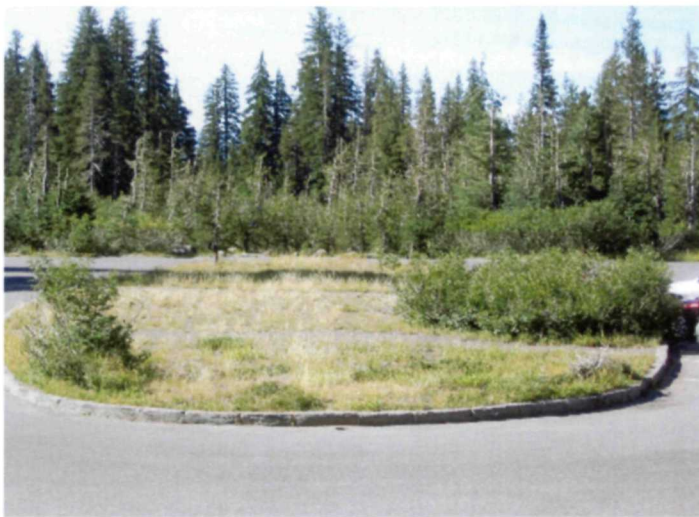
Photo 12 Forest thicket (predominantly lodgepole pine) south of ellipse on former road bed. Thickets of different ages and species composition are characteristic of disturbed areas throughout the Historic District.

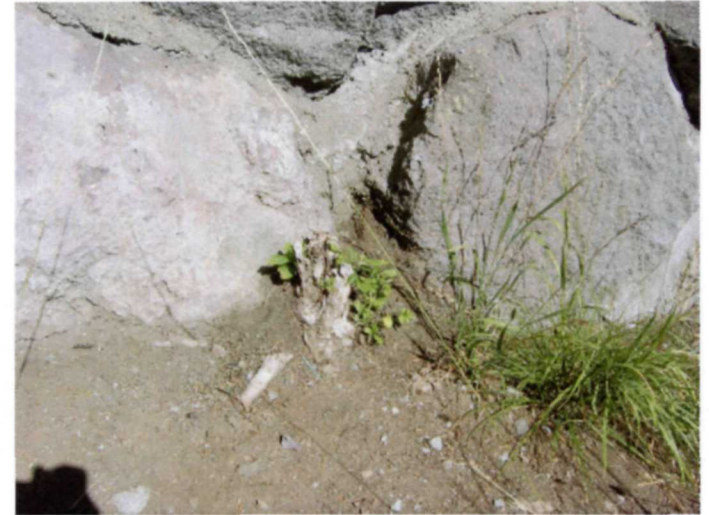
Photo 13 Sambucus stump at Superintendent's house: historic remnant shrubs should be protected with wire to discourage browsing. Avoid filling or disturbing roots.

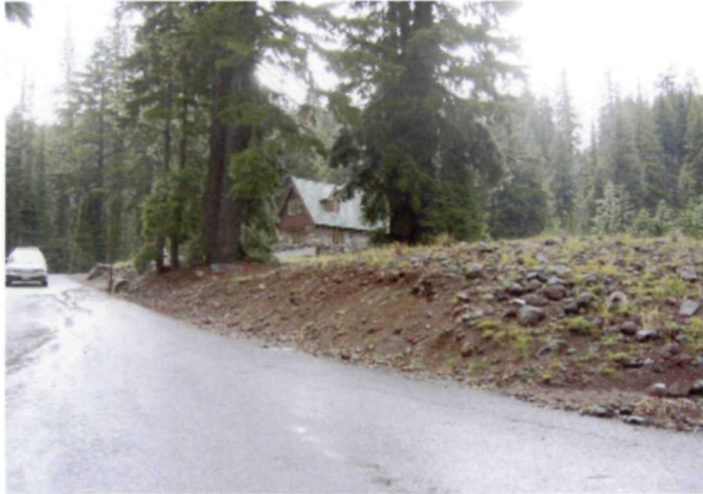
Photo 14 Cut bank along road at upper end of Historic District. Regrading banks such as this provided fill material for use throughout the district and eases the slope to merge with surrounding grades.

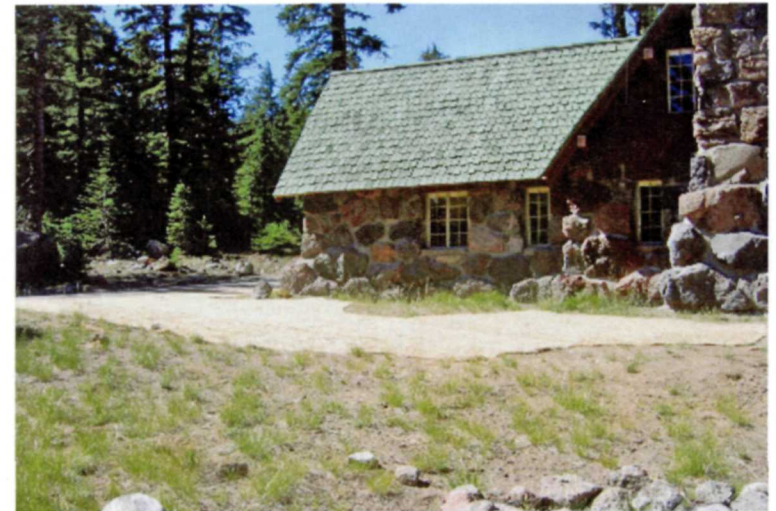
Photo 16 Typical straw erosion control mats on disturbed areas suppressing plant regeneration. Where there is little risk of erosion or disturbance to plants growing through them they should be removed or covered with 1-2 inches of fill material.

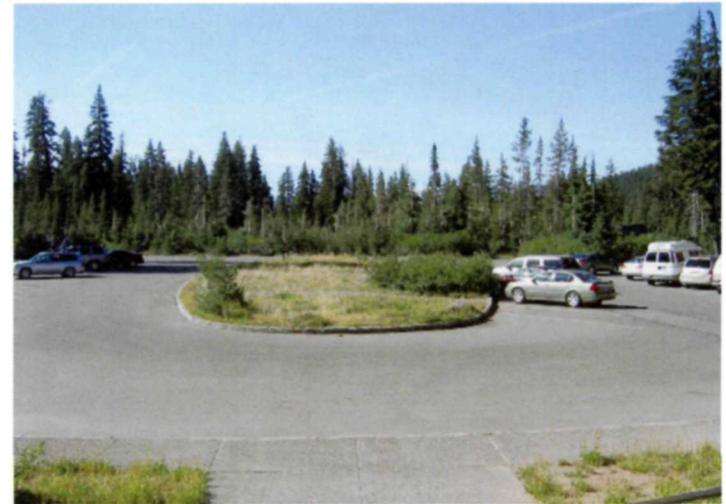
Photo 17 View down axis of Ellipse from Administration Building showing diagonal desire lines across the ellipse from parking on left to Visitor Information Center on right.

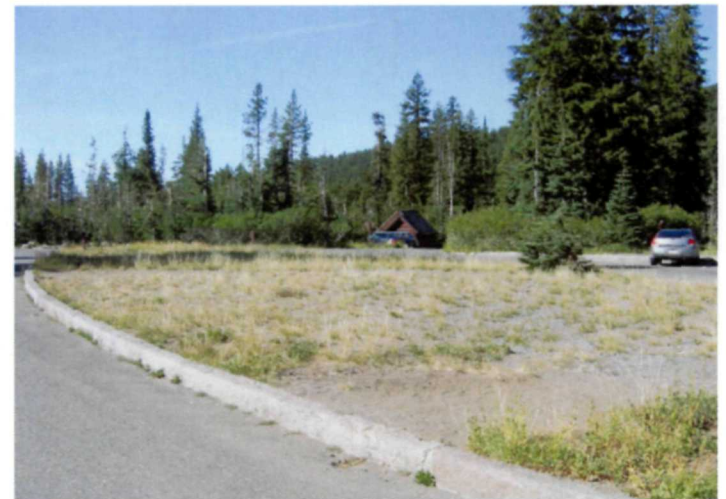
Photo 18 There are fewer remnant shrub and tree clumps at the south end of the ellipse and herbaceous cover is thinner too. Resolving circulation problems should reduce trampling and should encourage plant regeneration.

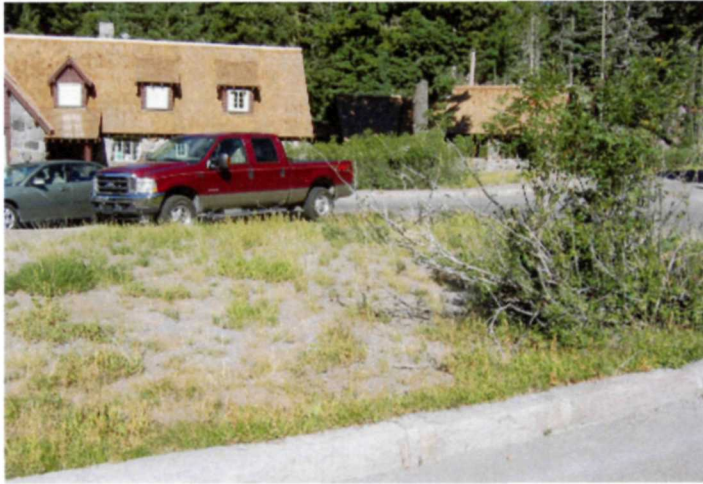
Photo 19 Shrubs around the perimeter of the ellipse damaged by abrasive action of snow removal. Replanting of shrubs in these areas is inappropriate. Fir trees in the ellipse seem more resistant to damage.

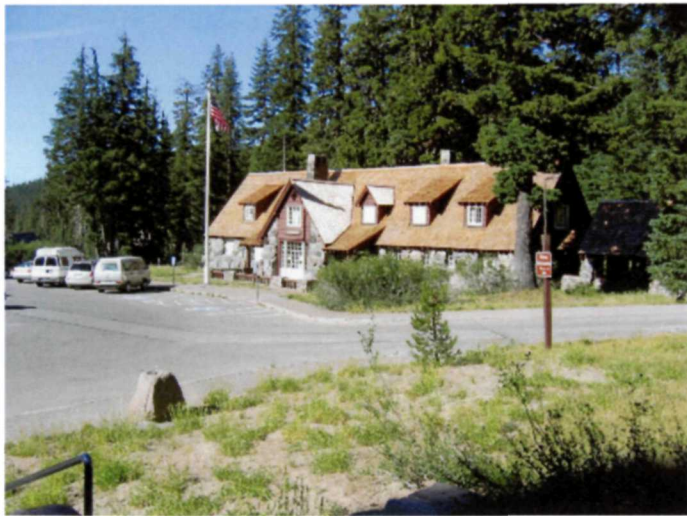
Photo 20 The Visitor Information Center faces an expansive, uncluttered open space and has a tall forest backdrop behind.

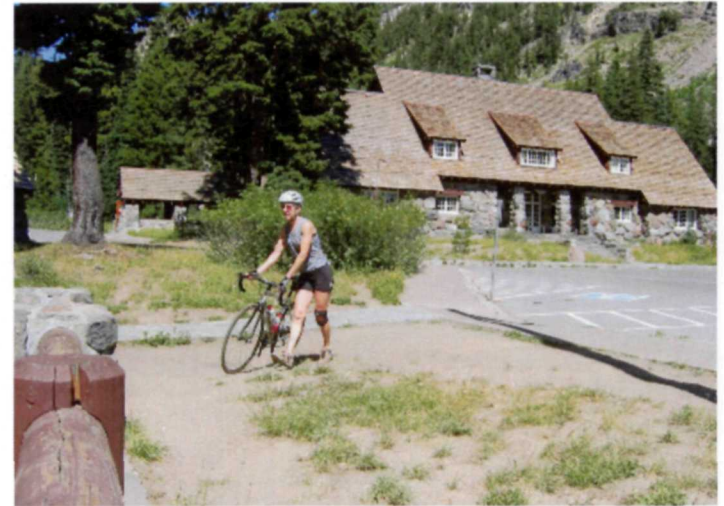
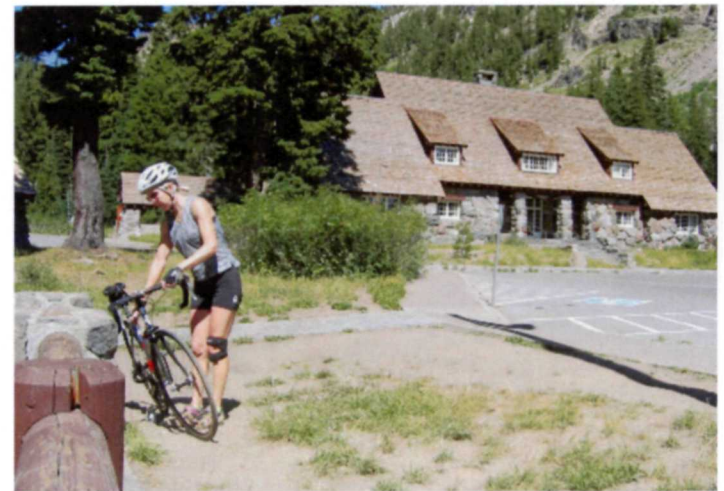
Photos 21-23 Leaning bicycles against the terrace post and rail fence or simply cutting the corner: irresistible desire lines for visitors.

A large percentage of Center users cut across the corners of the plant bed between it and the sidewalk to enter the building. Bicyclists were observed walking bicycles across the bed and resting them along the railing around the paved terrace rather than walking them round and leaving them on the terrace. The current paths configuration of paths makes these visitor circulation patterns 'sensible'. The hope that by installing plants we can change these circulation patterns and make visitors use existing paths is unrealistic. A decision must be made about where maintaining the 'historic integrity' of the paths and terrace needs to give place to the dictates of current circulation patterns.

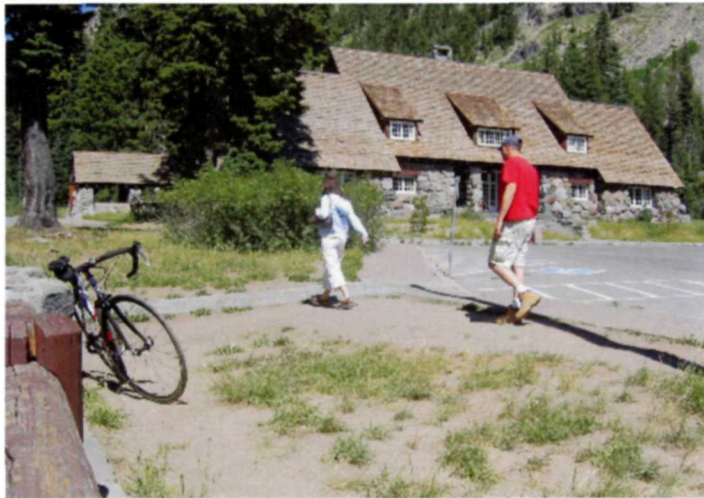
Photo 23 Slight mounding and planting of a small clump of firs would encourage visitors to keep to the path. Better still relocate the path to conform to desire line to front door.

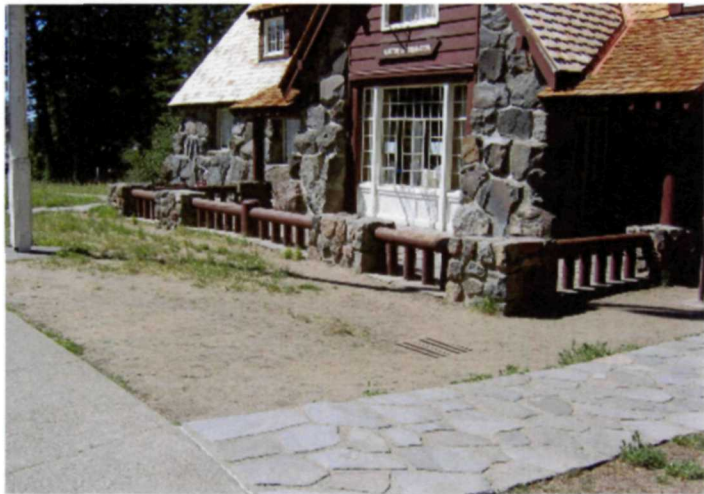
Photo 24 The bare and trampled bed in front of the Center conveys inappropriate messages about Crater Lake National Park, right on the Park's front doorstep.

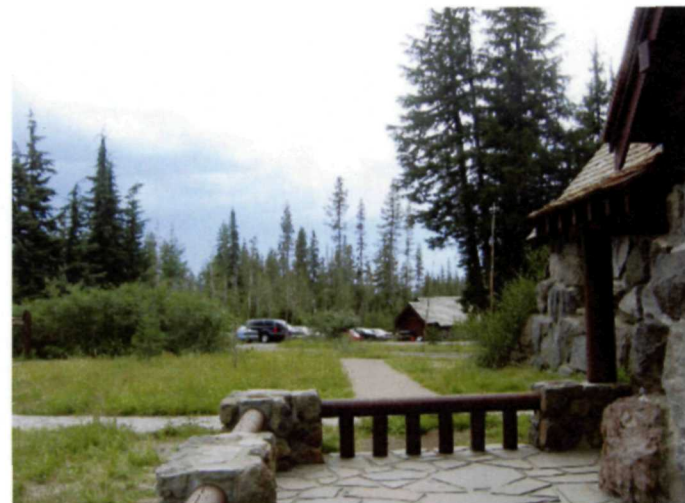
Photo 25 The view from the terrace to the start of the Historic District trail suggests that "you can't get there from here" rather than extends an invitation.

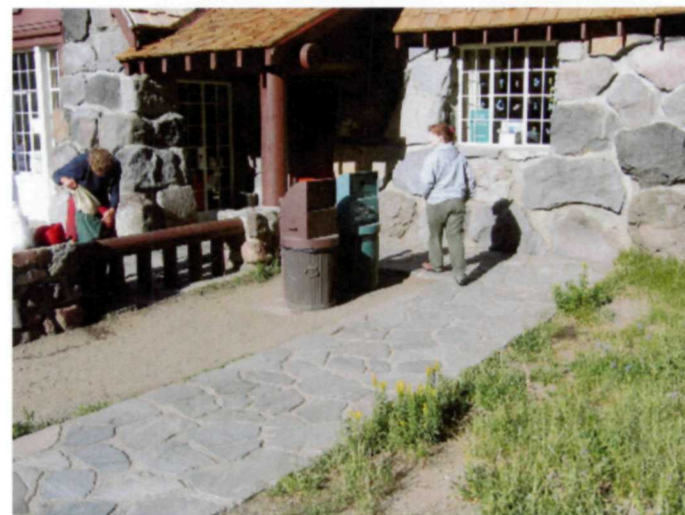
Photo 26 Turning the two trash cans through a right angles might make travel between them and the terrace wall slightly less 'desirable' but is unlikely to resolve the trampling problem.

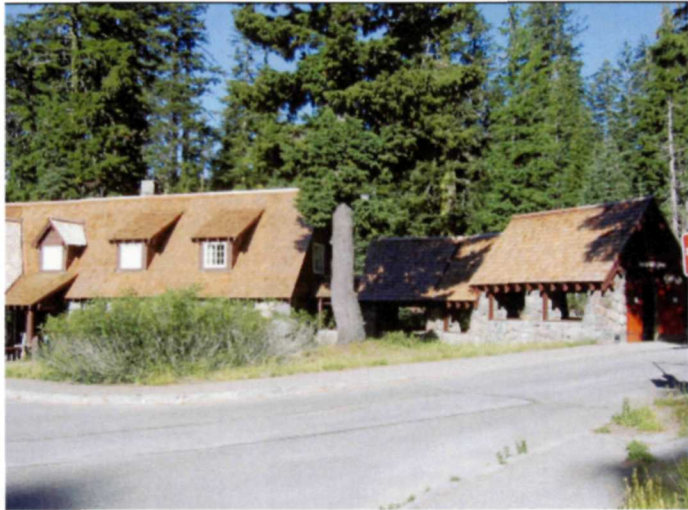
Photo 27 Existing paths provide direct, convenient, logical access to the Center from the Administration Building

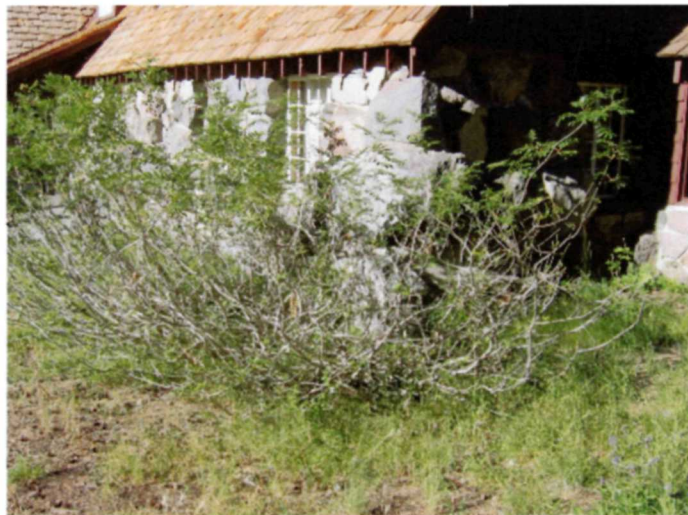
Photo 28 The large, heavily browsed Sorbus shrub blocks views but is less effective at integrating the rustic style building into its surrounding landscape than the tall hemlock tree which mirrors the forest backdrop and casts 'camouflage' shadows across the building's facade and roof.

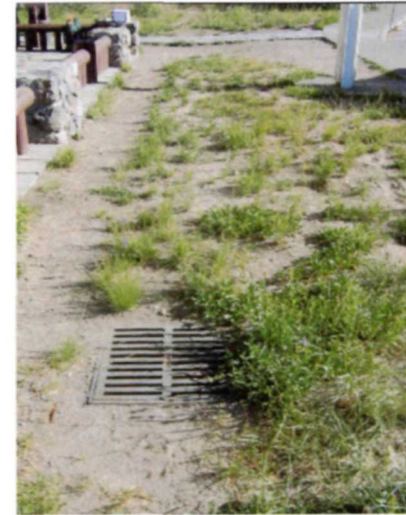
Photo 29 The less trampled south end of the central plant bed has a 'desire line' along the terrace wall. Patchy grass and forbs cannot be restored until desire lines are eliminated. The two large drains may contribute to vegetation sparsity by making the bed drier.

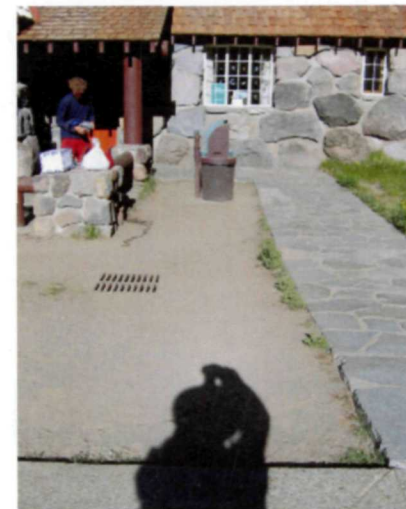
Photo 30 Moving garbage cans at end of bed could reduce cutting across bed but make cans more obtrusive.

The two trash/recycle cans at the Center's entrance are set 2' into the plant bed from the path to the front door requiring users to step into the plant bed to use them. Not surprisingly the ground around them is bare. There is a 3' gap between the back of the cans and the log railing enclosing the terrace. Exiting visitors are tempted to walk to the sidewalk behind the cans and straight across the plant bed rather than continue 8'-9' beyond the cans to the path to the sidewalk. Turning the cans through a right angle will make them a more effective barrier and moving them closer to the entrance path will also discourage, but is unlikely to completely deter, visitors from cutting across the plant bed. This change would not affect the site's historic integrity as it would consist of repositioning the recently-added garbage cans. However, solving the circulation problem in this way leaves aside the larger question of whether trash cans at

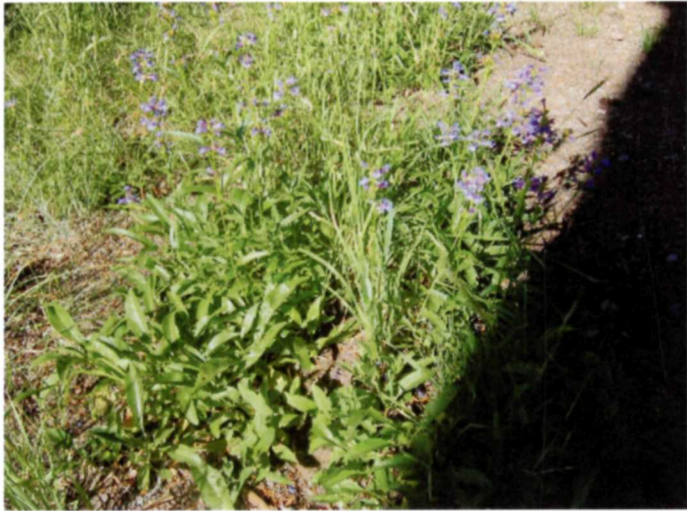
Photo 31 Penstemon is one of the native forbs growing successfully in front of the Visitor Information Center

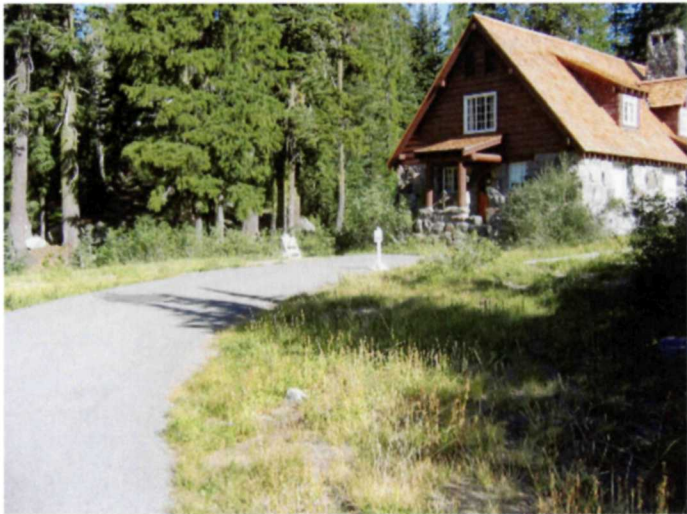
Photo 32 The *Prunus emarginata* on the south end of the Visitor Information Center shows no signs of deer browse and is thus a better choice for replanting than *Sorbus* or *Sambucus*.

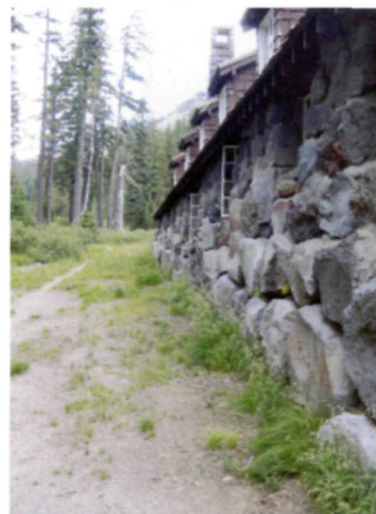
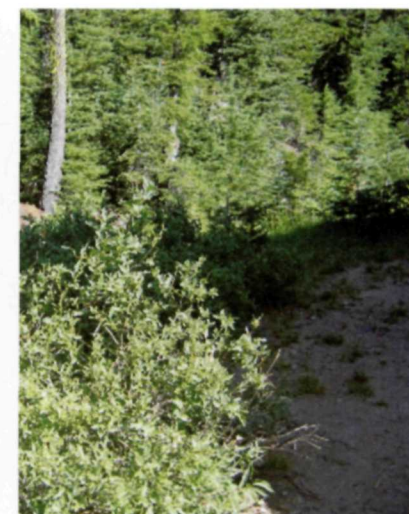
Photos 33-34 The corridor-shaped space at the back of the Visitor center is flanked by the rustic building wall on one side and riparian vegetation on the other.

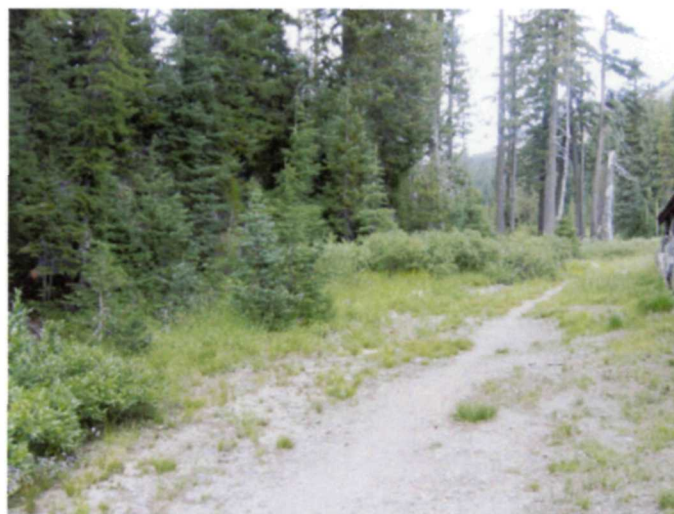
Photo 35 The poorly-defined path disperses users and increases trampling throughout the area between the VIC and Munson Creek.

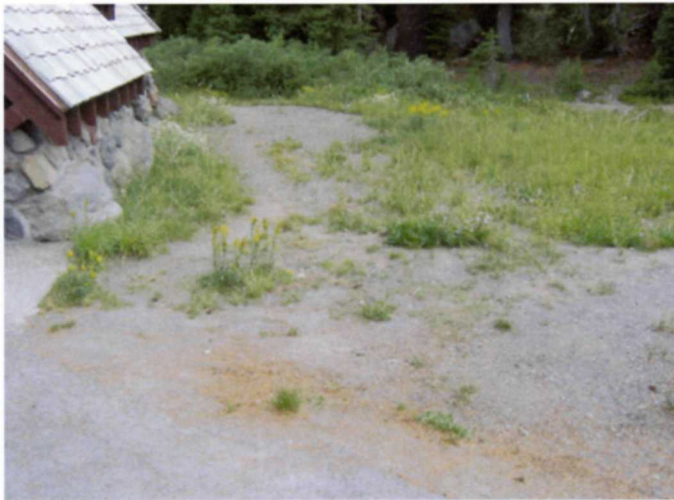
Photos 36-37 Extensive regrading and clearing of construction debris is required throughout the area particularly at the north end in the vicinity of the snow tunnel.

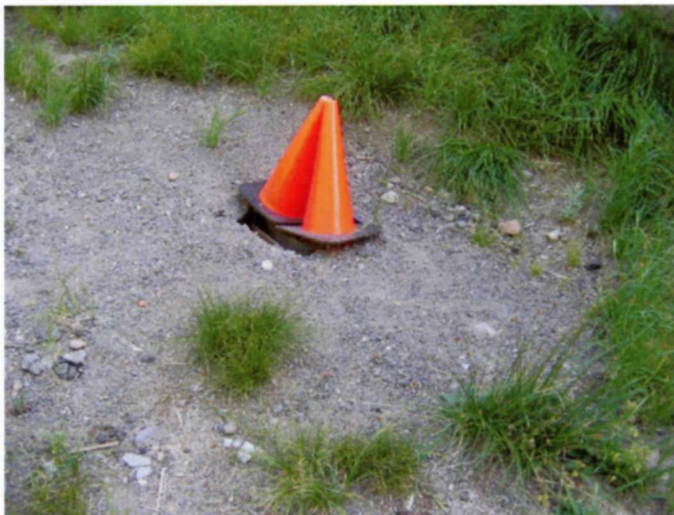
Photo 37 Holes remaining from earlier utility work should be capped or filled. Orange cones are not a long-term nor aesthetically pleasing solution.

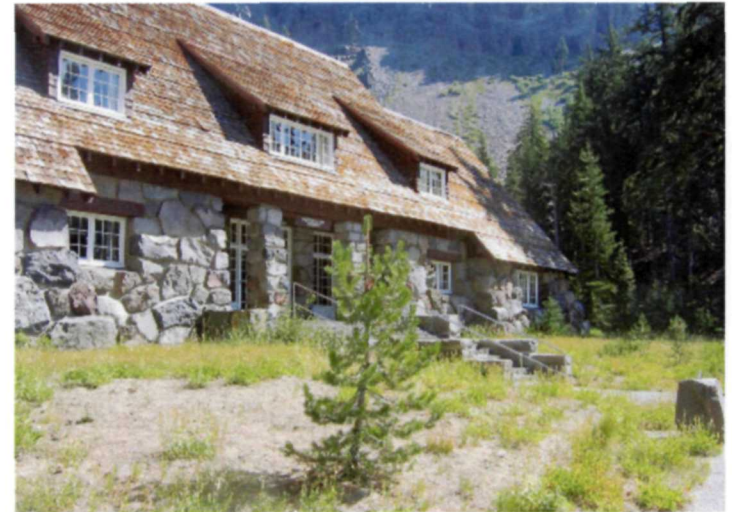
Photo 38 Firs at the corner of the Administration building effectively integrate it with the adjacent hemlock fir forest. Lodgepole pines in front of the building appear to be self-sown. Much of the bare ground is the result of gopher activity.

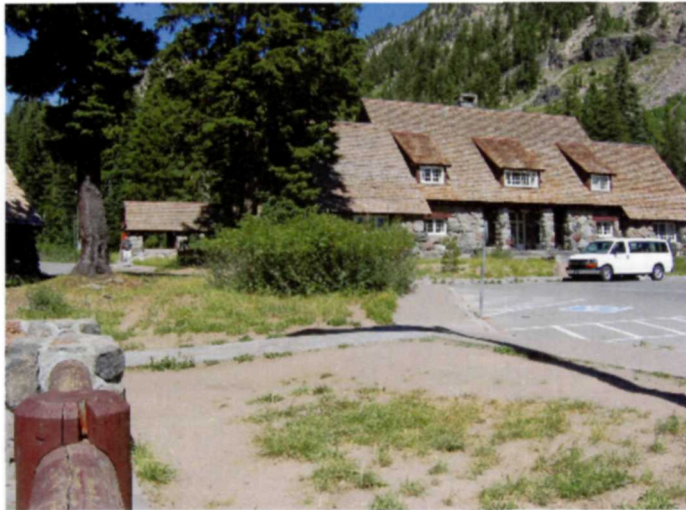
Photo 39 Maintaining the Administration Building's uncluttered openness is desirable. However a few clumps of firs and hemlocks would provide future 'camouflage' shadows.

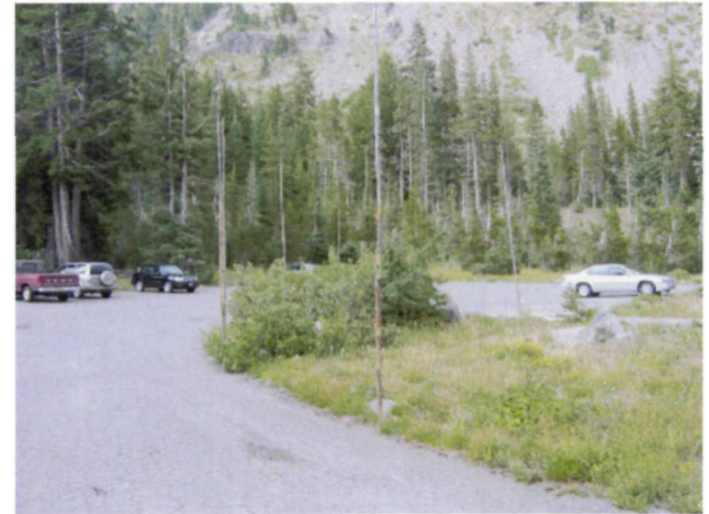
Photos 40-41 Plant small clumps of firs and hemlocks around the large staff parking lot and in the bed between it and the Building.

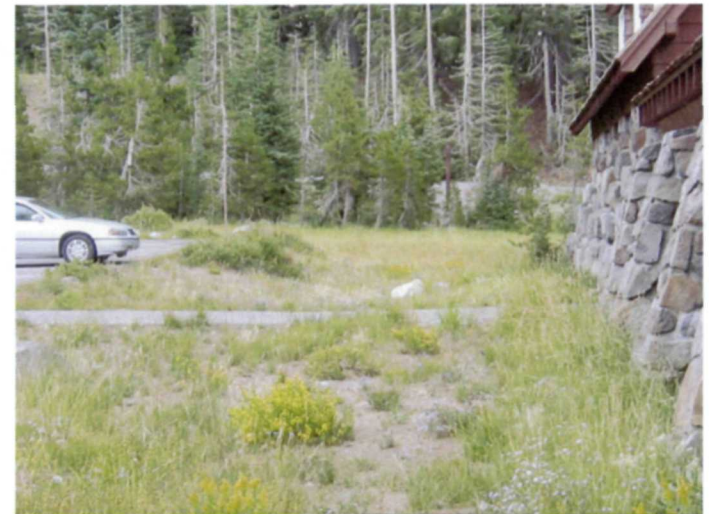
Photo 41 Thin vegetation behind the Administration Building probably resulting from vehicle damage. Planted clumps of firs should not obscure views from windows or be located close to the wall.

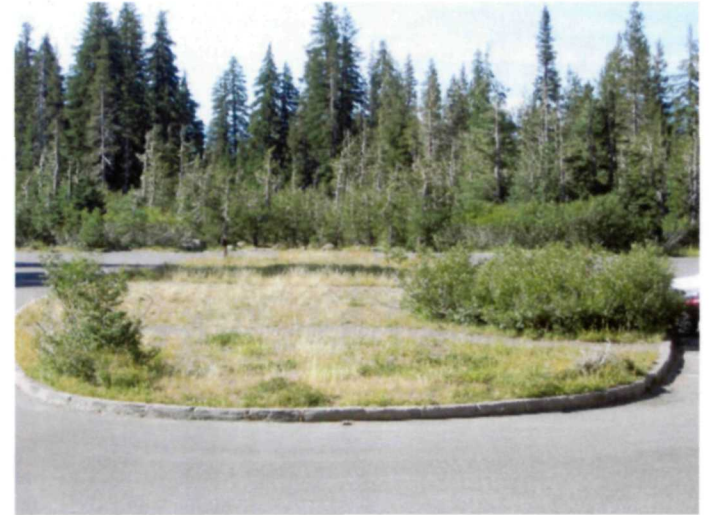
Photo 42 Active management of the thicket south of the ellipse should encourage regeneration of a fir hemlock forest. The thicket is an excellent source of fir and hemlock trees for replanting throughout the historic district.

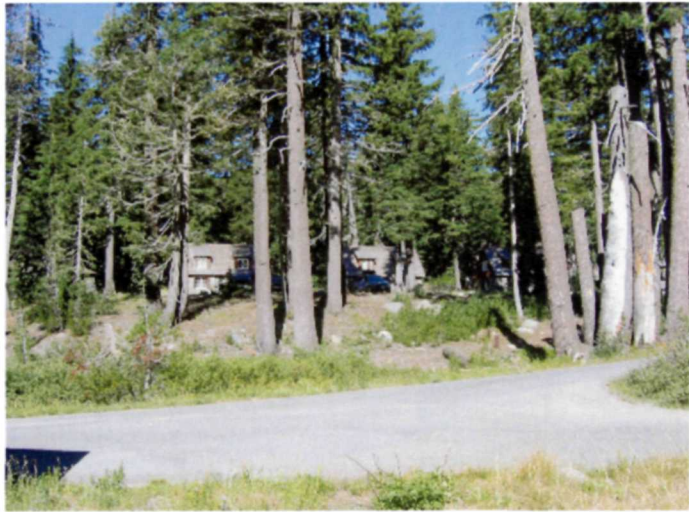
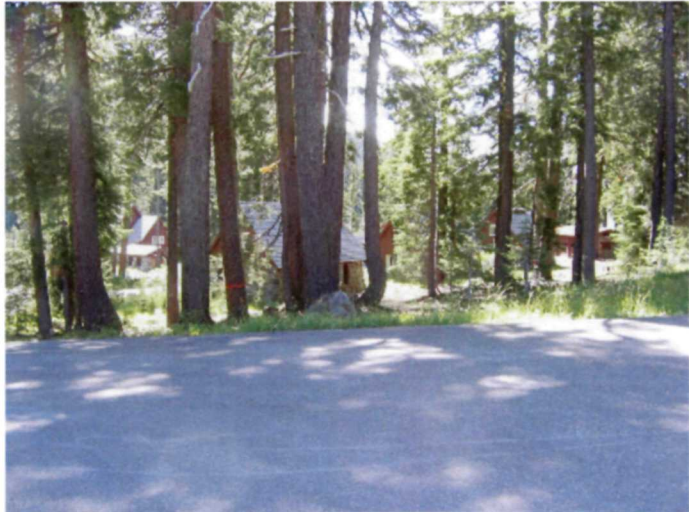
Photo 44

Photos 43-44 Typical “filtered” views of rustic cottages in mature fir hemlock forest with relatively open understory. Note how tall trees dominate the landscape and partially conceal structures.

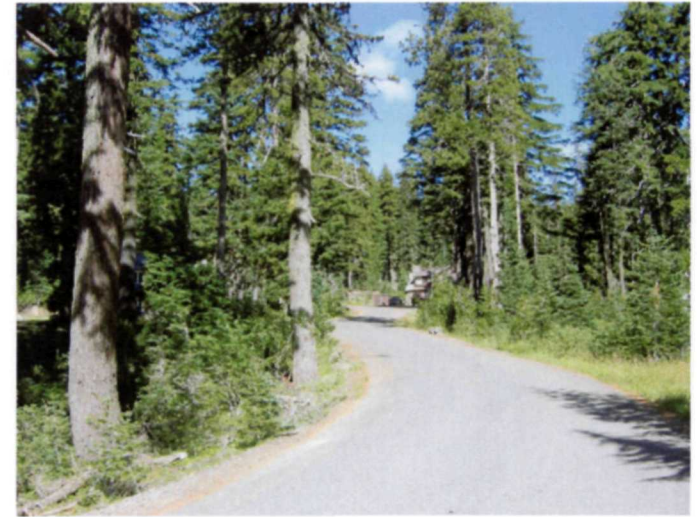
Photo 45 Forest regeneration is evident along road edges where there is more light and moisture and the ground has been disturbed. Managing the density of regenerating thickets is essential to maintain the historic landscape's open character.

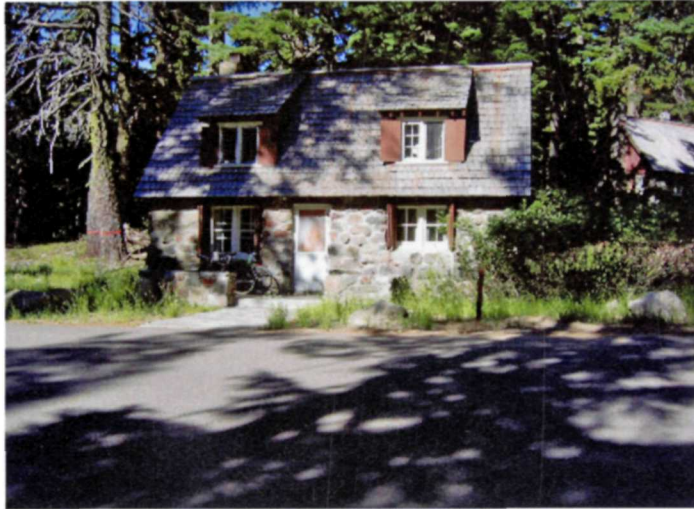
Photo 46 Typical rustic cottage (House 30) with low wall enclosing small terrace. Note heavily browsed historic *Sorbus* clump and dying surrounding forest trees.

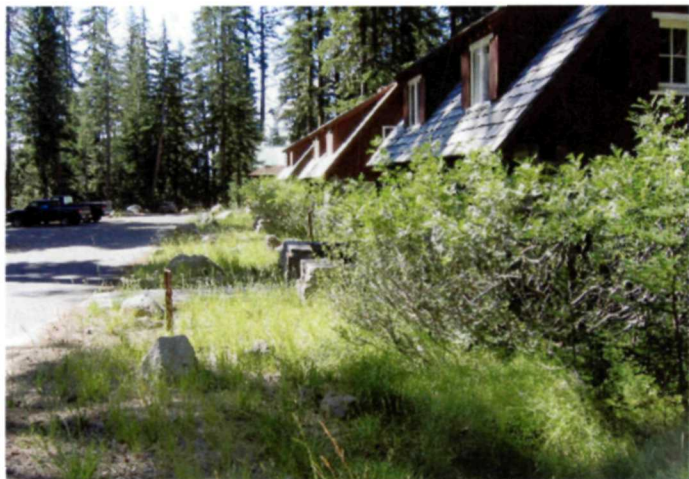
Photo 47 Cottage row along spur road note green roof of Dormitory building (old Hospital) at end.

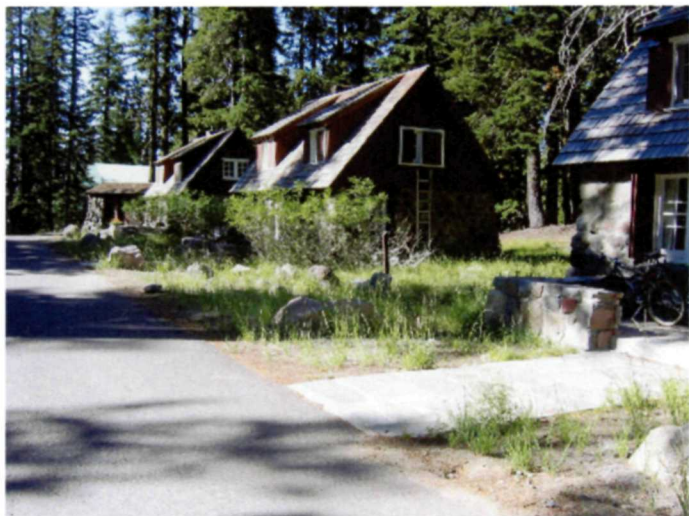
Photo 48 Cottage row showing heavily grazed Sorbus clumps at building corners and haphazardly scattered rocks where road was narrowed. Addition of fir and hemlock trees in this location and between cottages will integrate them into the forest setting.

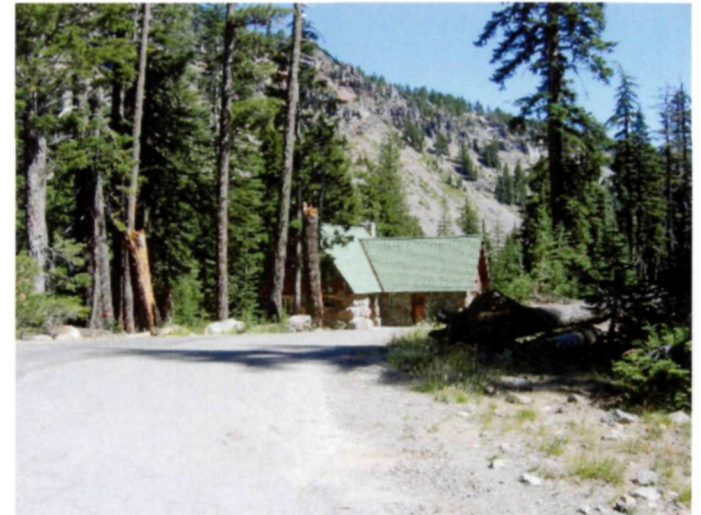
Photo 49 From a distance the Naturalist's House appears to be well-integrated into its rugged landscape and forest setting

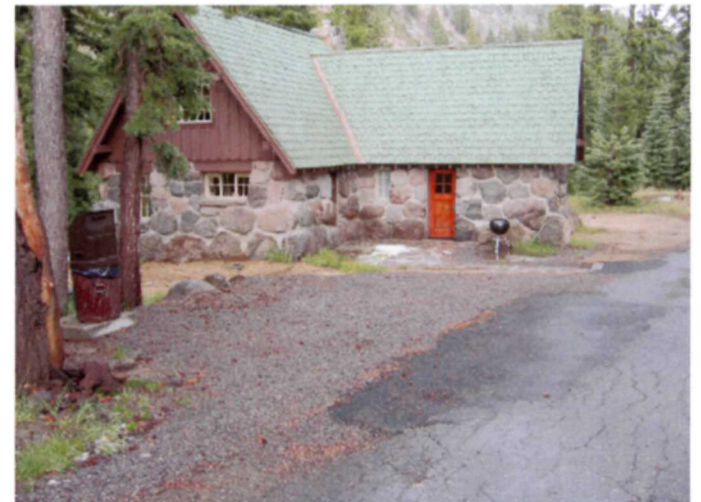
Photo 50 Arriving at the house it appears isolated from the forest and dominated by the proximity of the road and gravel parking area.

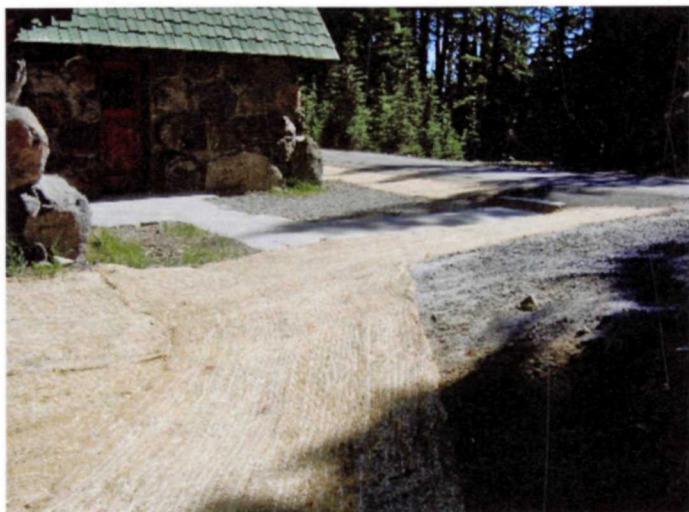
Photo 51 It is unsurprising that the access path, inconvenient, illogical and with a dangerous step is unused and users of the house walk straight cross the gravel and erosion matting to the door.

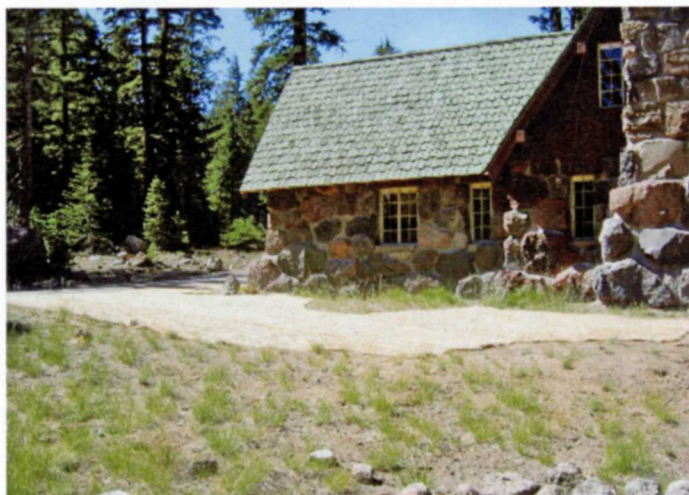
Photo 52 A 'sea' of erosion matting surrounds the building much of it on flat areas where erosion is unlikely. It appears to suppress rather than encourage natural tree, forb and grass regeneration.

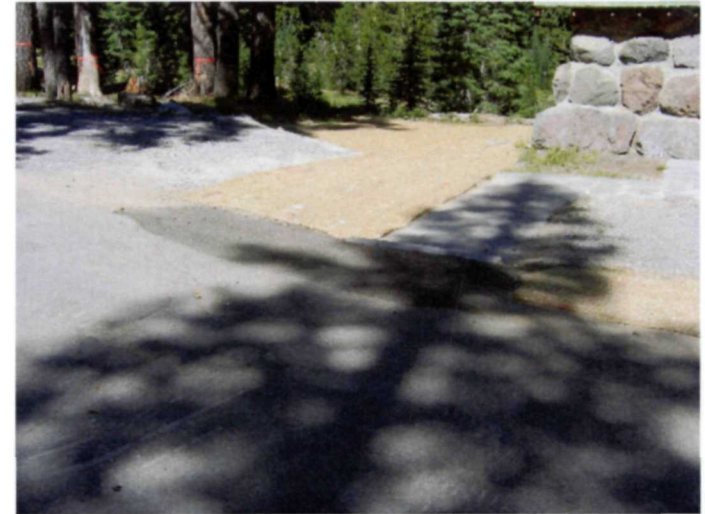
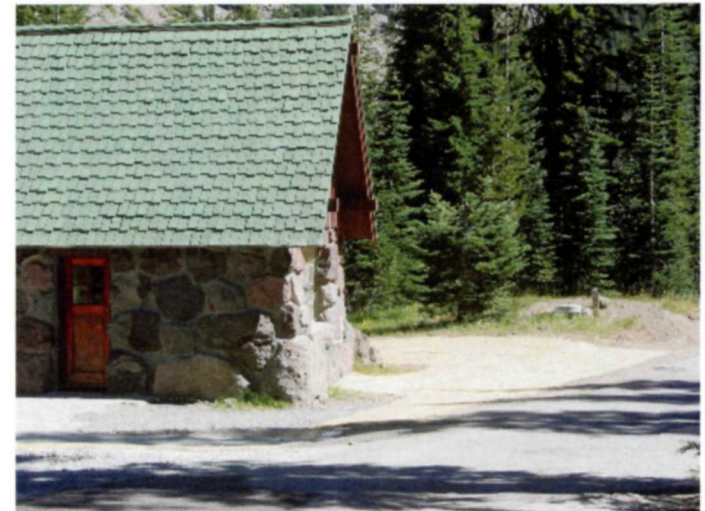
Photos 53-54 Extensive regrading, fill and asphalt removal is needed between the Naturalist's Residence and road. The gravel parking area should be removed, the road narrowed and moved away from the building, the flagstone path straightened and step removed, and the ground mounded and planted between building and road.

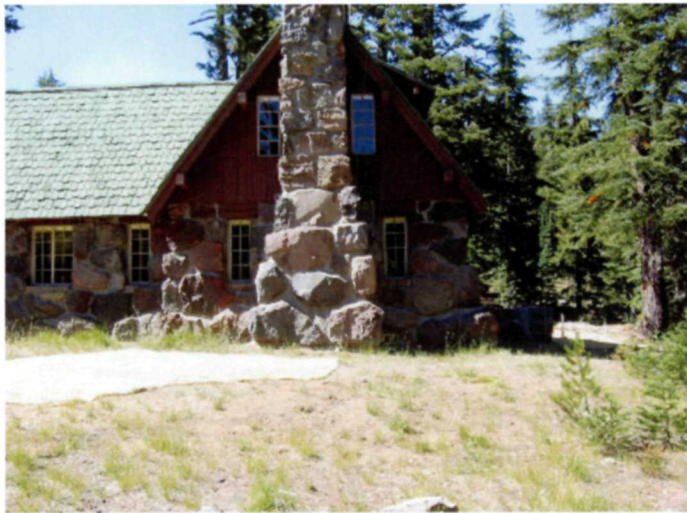
Photo 55 Fill is necessary particularly along the base of the chimney to prevent the large boulders from appearing to 'float' above surrounding grade.

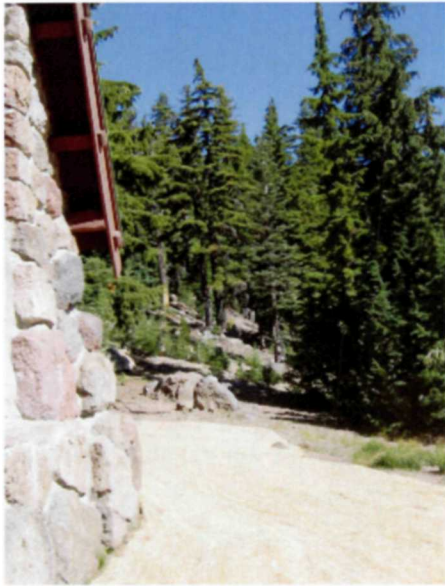
Photo 56 The Superintendent's Residence faces onto an expansive meadow to the east (not in view) but the forest comes closer to it on other faces such as this view to the north.

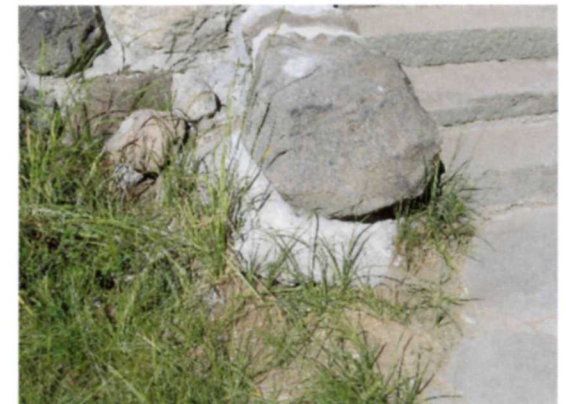
Photo 58 Detail of concrete shim holding up boulder at steps. Fill material should completely cover concrete so that boulder appears to merge into ground.

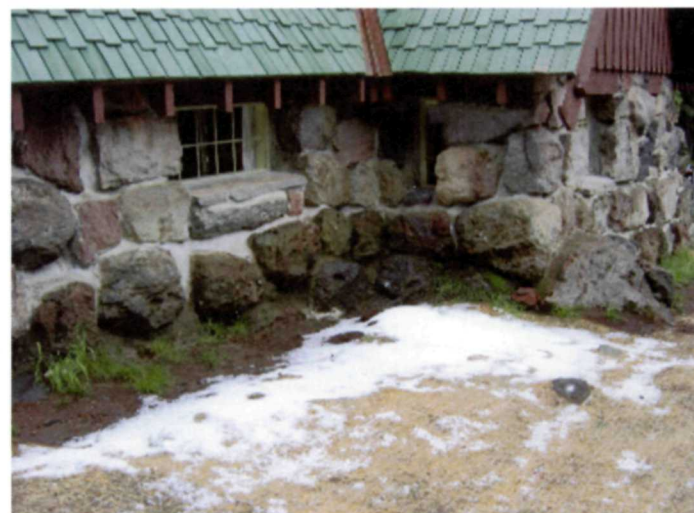
Photo 59 Erosion where roof runoff is concentrated requires extensive fill and small stones at drip line to break force of water.

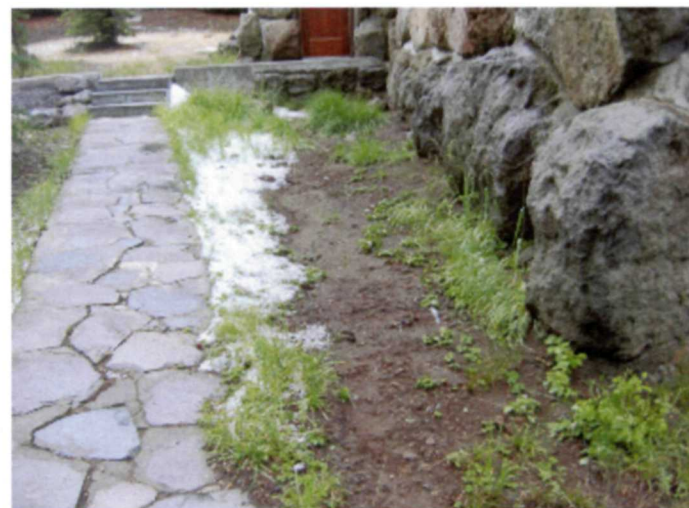
Photo 60 Erosion along west side of house requires fill to divert water away from building.

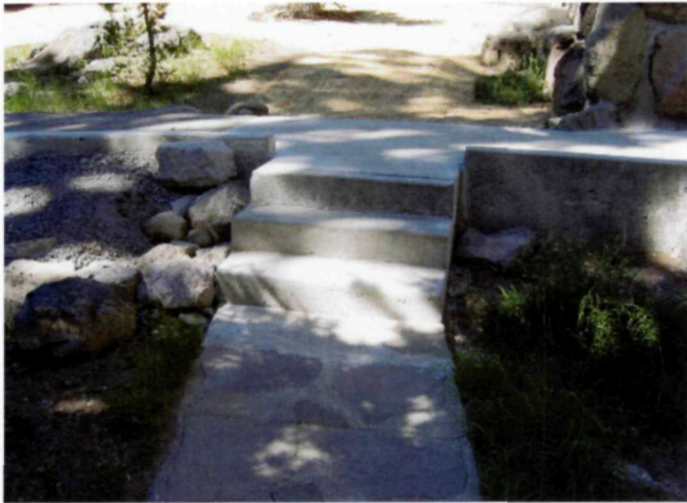
Photos 61-64 Extensive fill, in some locations several feet deep, and carefully placed large boulders adjacent to steps are needed to resolve the raw grading around the new steps and handicapped access ramp.

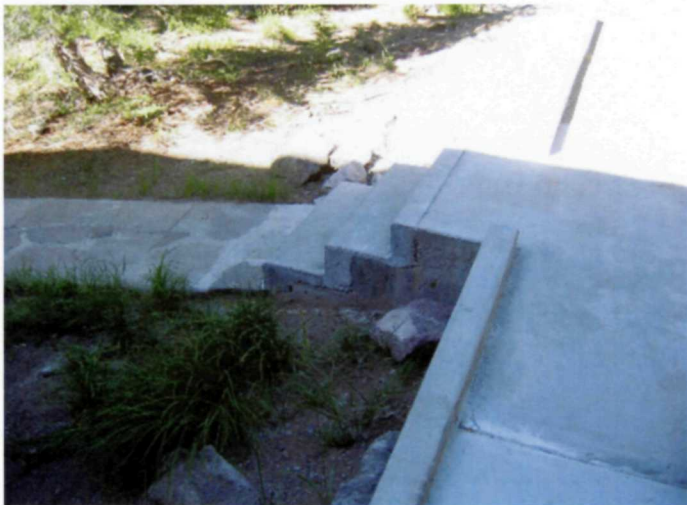
Photo 62 Fill to reduce the obtrusiveness of the awkward steps
