CRATER LAKE NATIONAL PARK  
HISTORIC HEADQUARTERS LANDSCAPE  
RESTORATION & MANAGEMENT

*Iain Robertson, Associate Professor  
Department of Landscape Architecture  
University of Washington*

*March 2010*

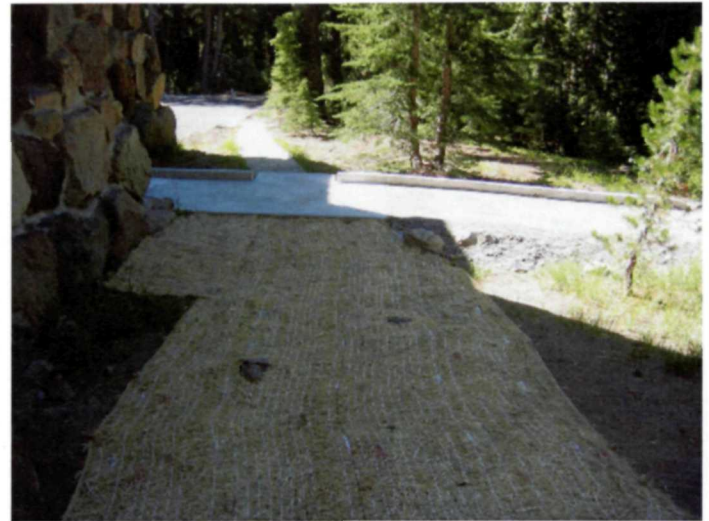
Photos 63 Extensive fill, in some locations several feet deep, and carefully placed large boulders adjacent to steps are needed to resolve the raw grading around the new steps and handicapped access ramp.

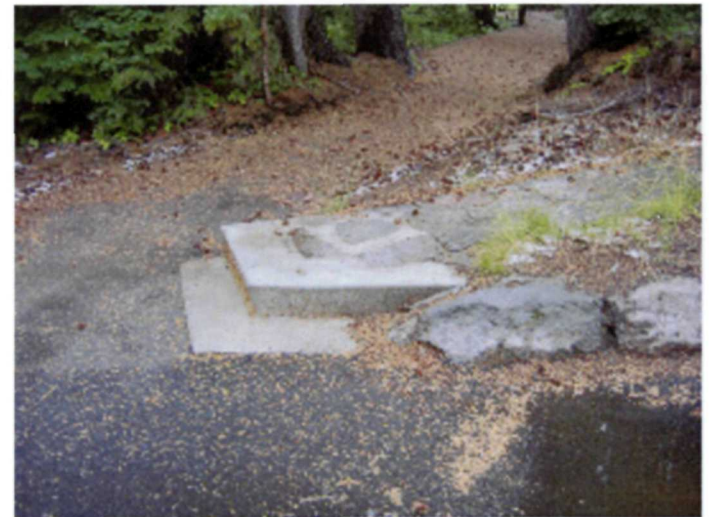
Photo 64 Dangerous tripping hazard step at end of path should be removed.

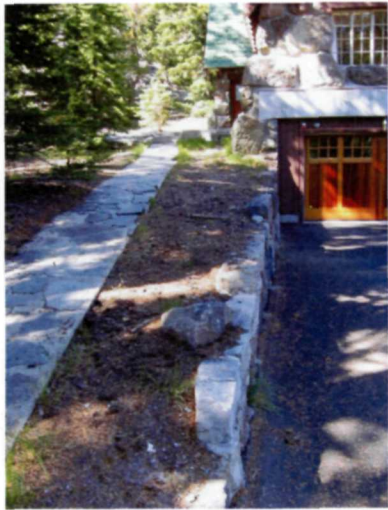
Photo 65 Mound along length of bed to redirect runoff across path and away from retaining wall.

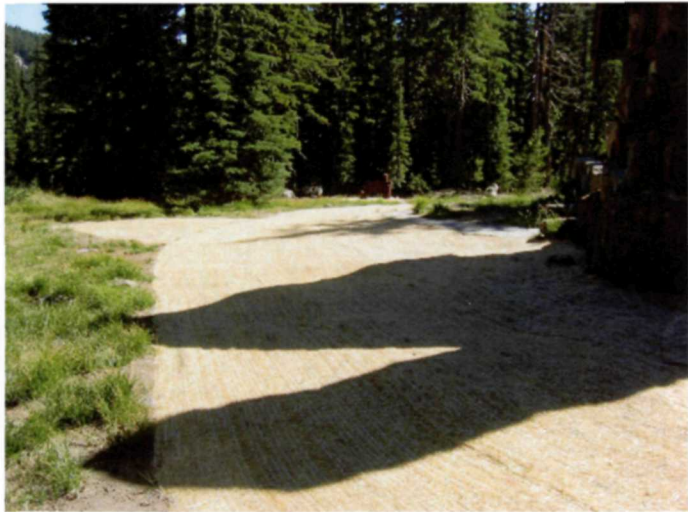
Photo 66 Erosion matting on flat surfaces is unnecessary. In this location on the meadow face, fill is needed to conceal pipes and to remove the hummocky ground surface.

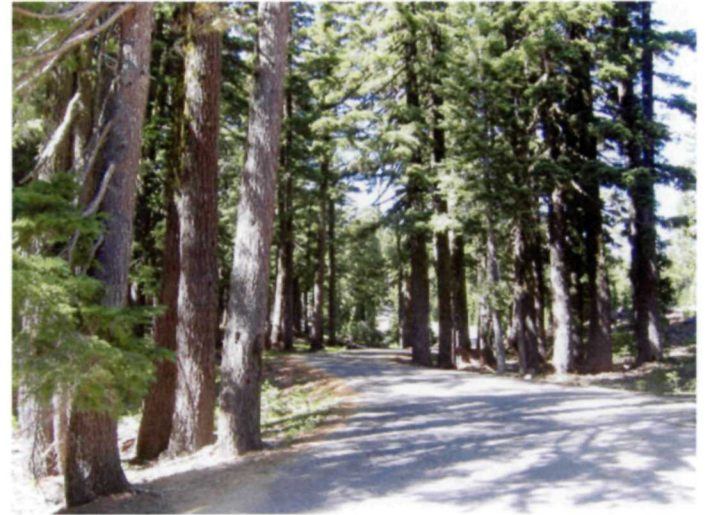
Photo 67 Road through forest shows well-graded profile of shoulders.

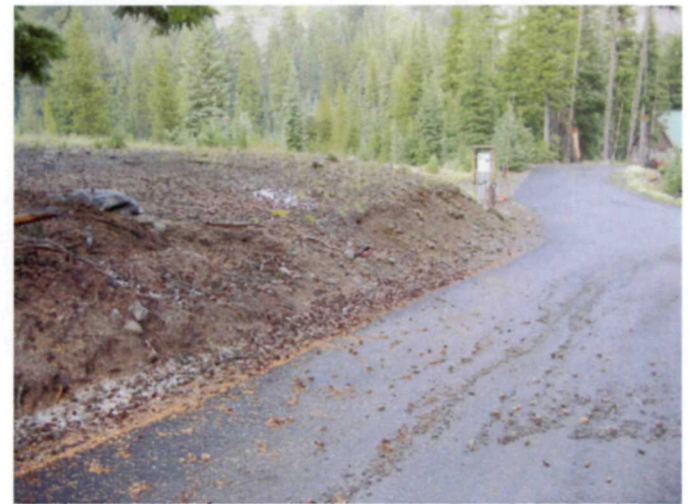
Photo 68 Steep and eroding cut bank needs to be cut back to merge with meadow surface.

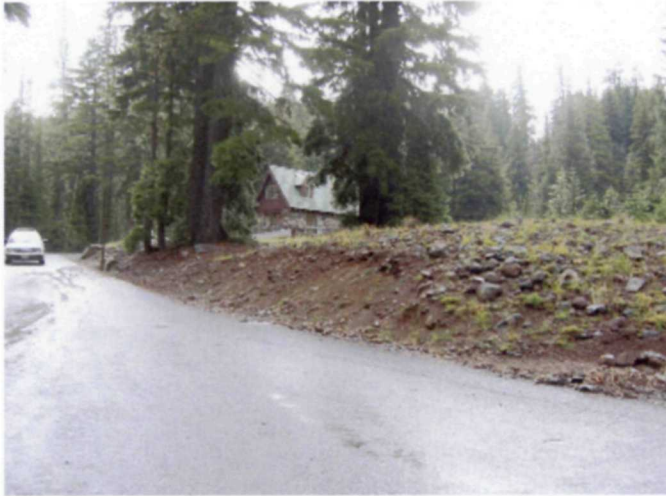
Photo 69 Steep bank dominates the view looking up to Superintendent's Residence

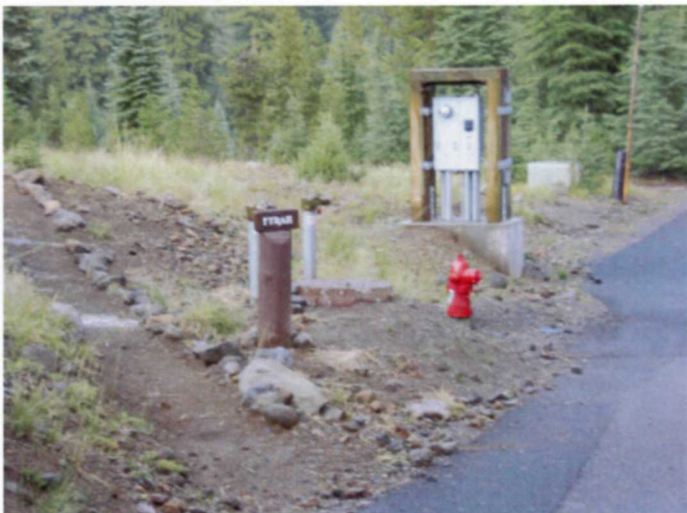
Photo 70 Fill and smooth transitions to conceal trail edge, utility vaults and concrete foundation of electricity meter.

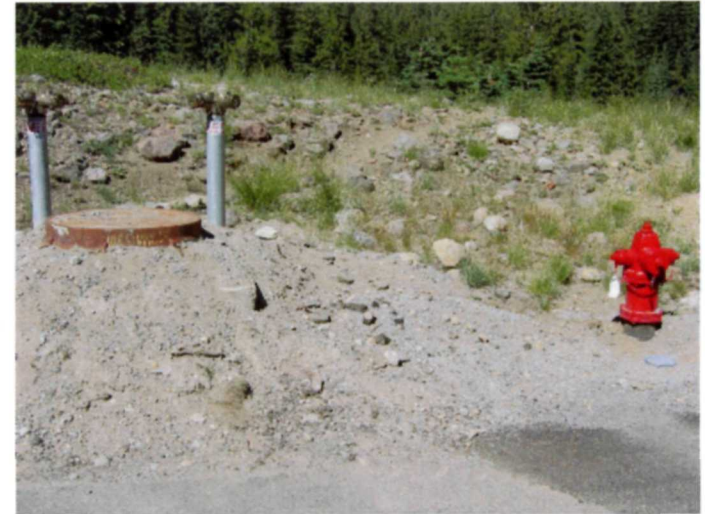
Photo 71 Exposed rim of manhole and crushed rock attract attention to an object that should be as unobtrusive as possible

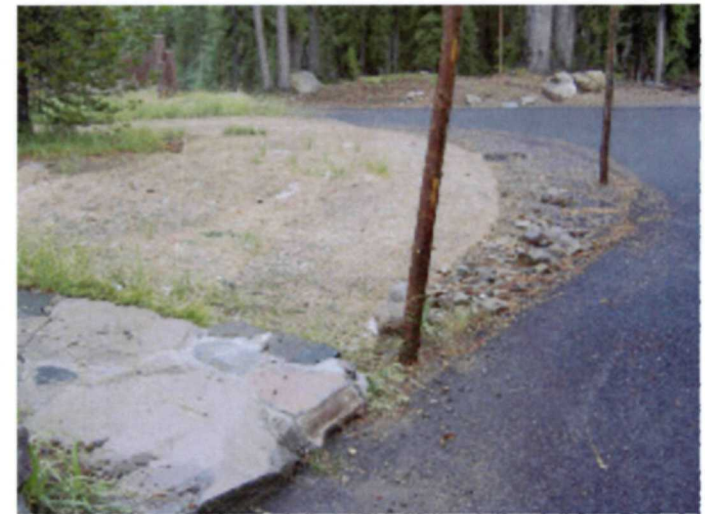
Photo 72 remove step from path to Superintendent's house and regrade swale.
