**NATIONAL REGISTER OF HISTORIC PLACES  
INVENTORY -- NOMINATION FORM**

CRATER LAKE LODGE

CRATER LAKE NATIONAL PARK

CRATER LAKE LODGE (BUILDING NO. 565)

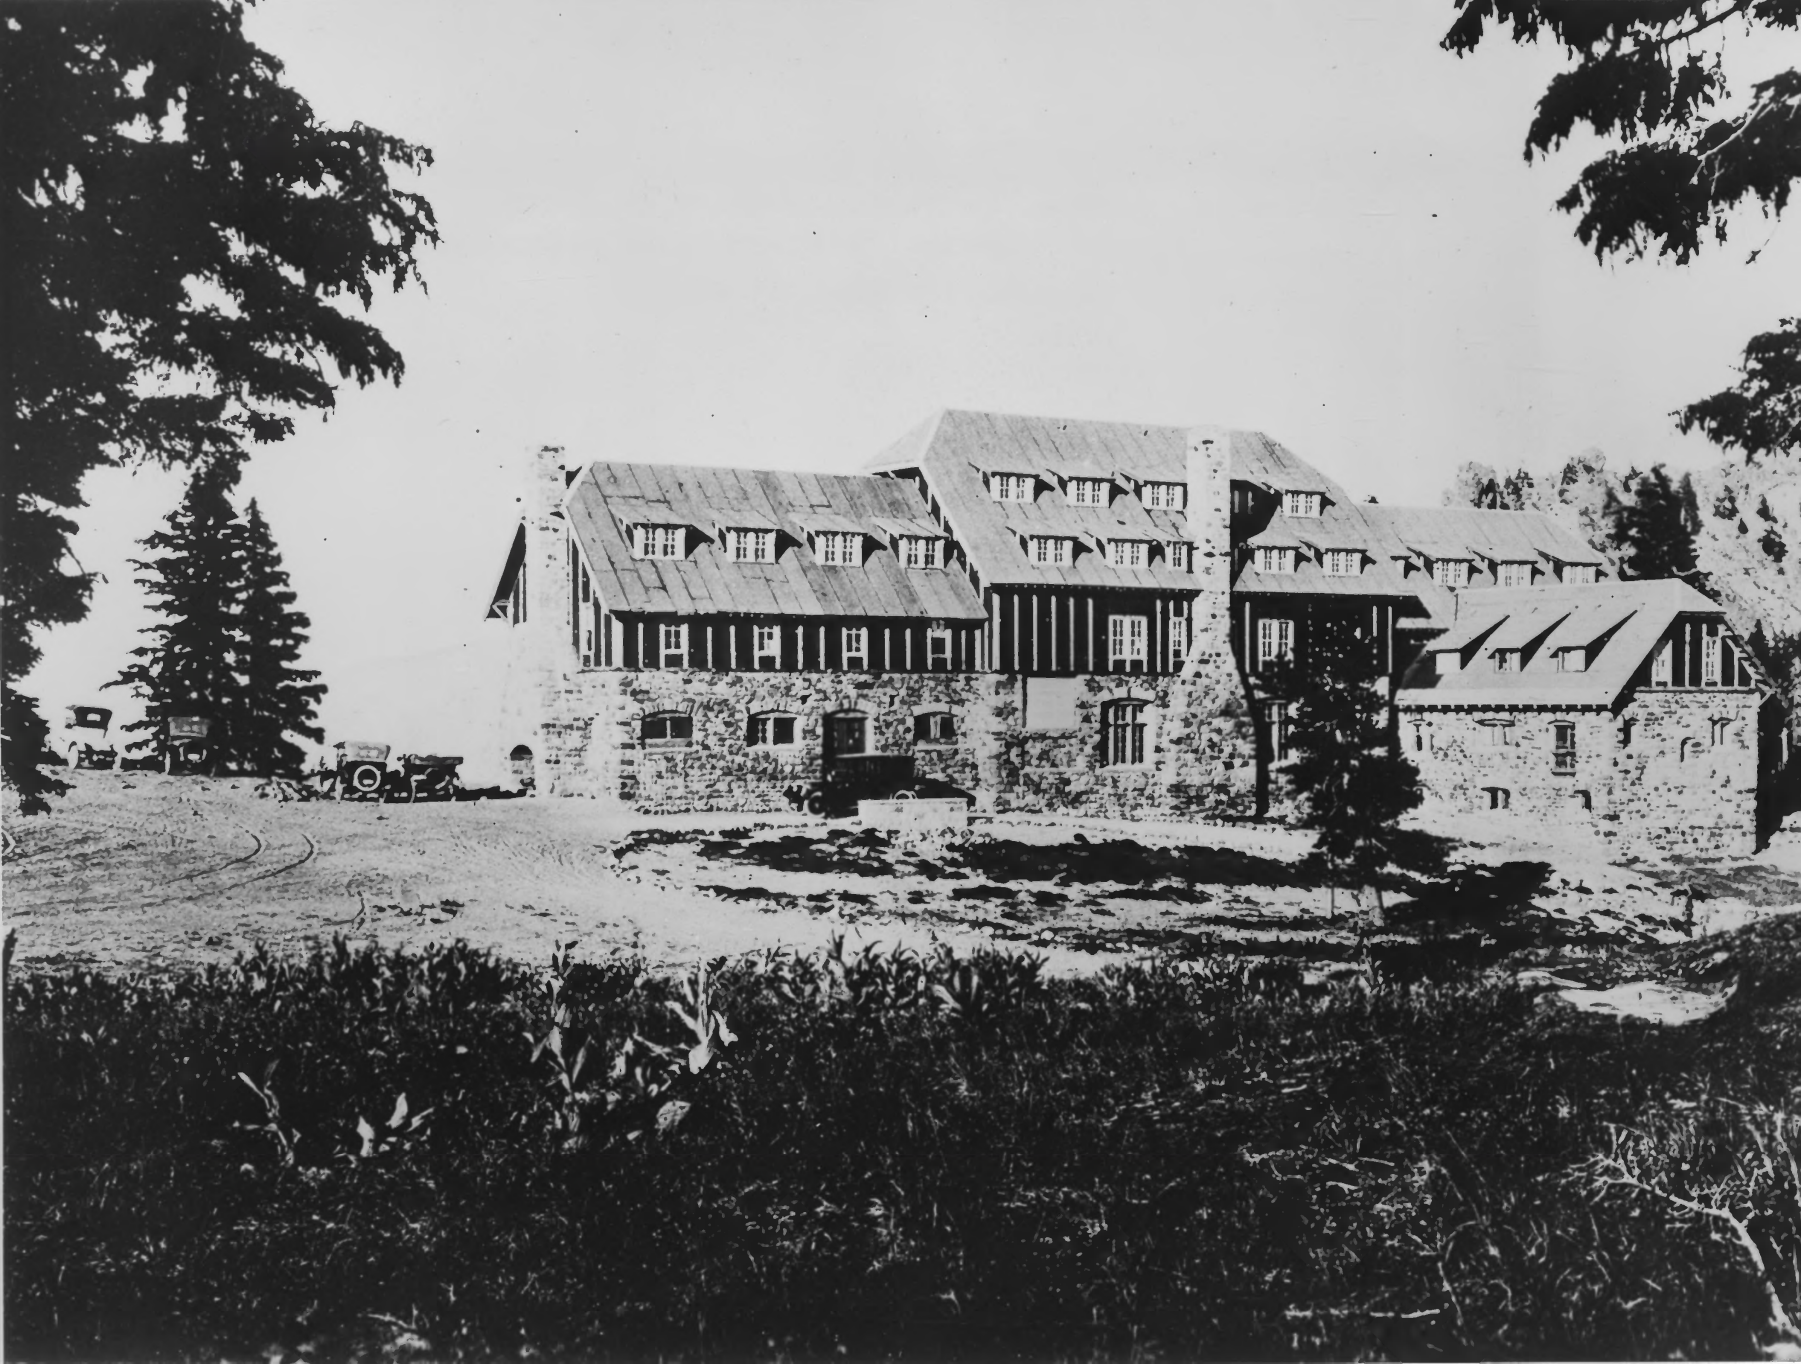
CRATER LAKE LODGE, VIEWED FROM THE, SOUTH -  
SOUTHWEST, NOTE UNFINISHED APPEARANCE OF EXTERIOR  
PROBABLY TAKEN CIRCA 1915

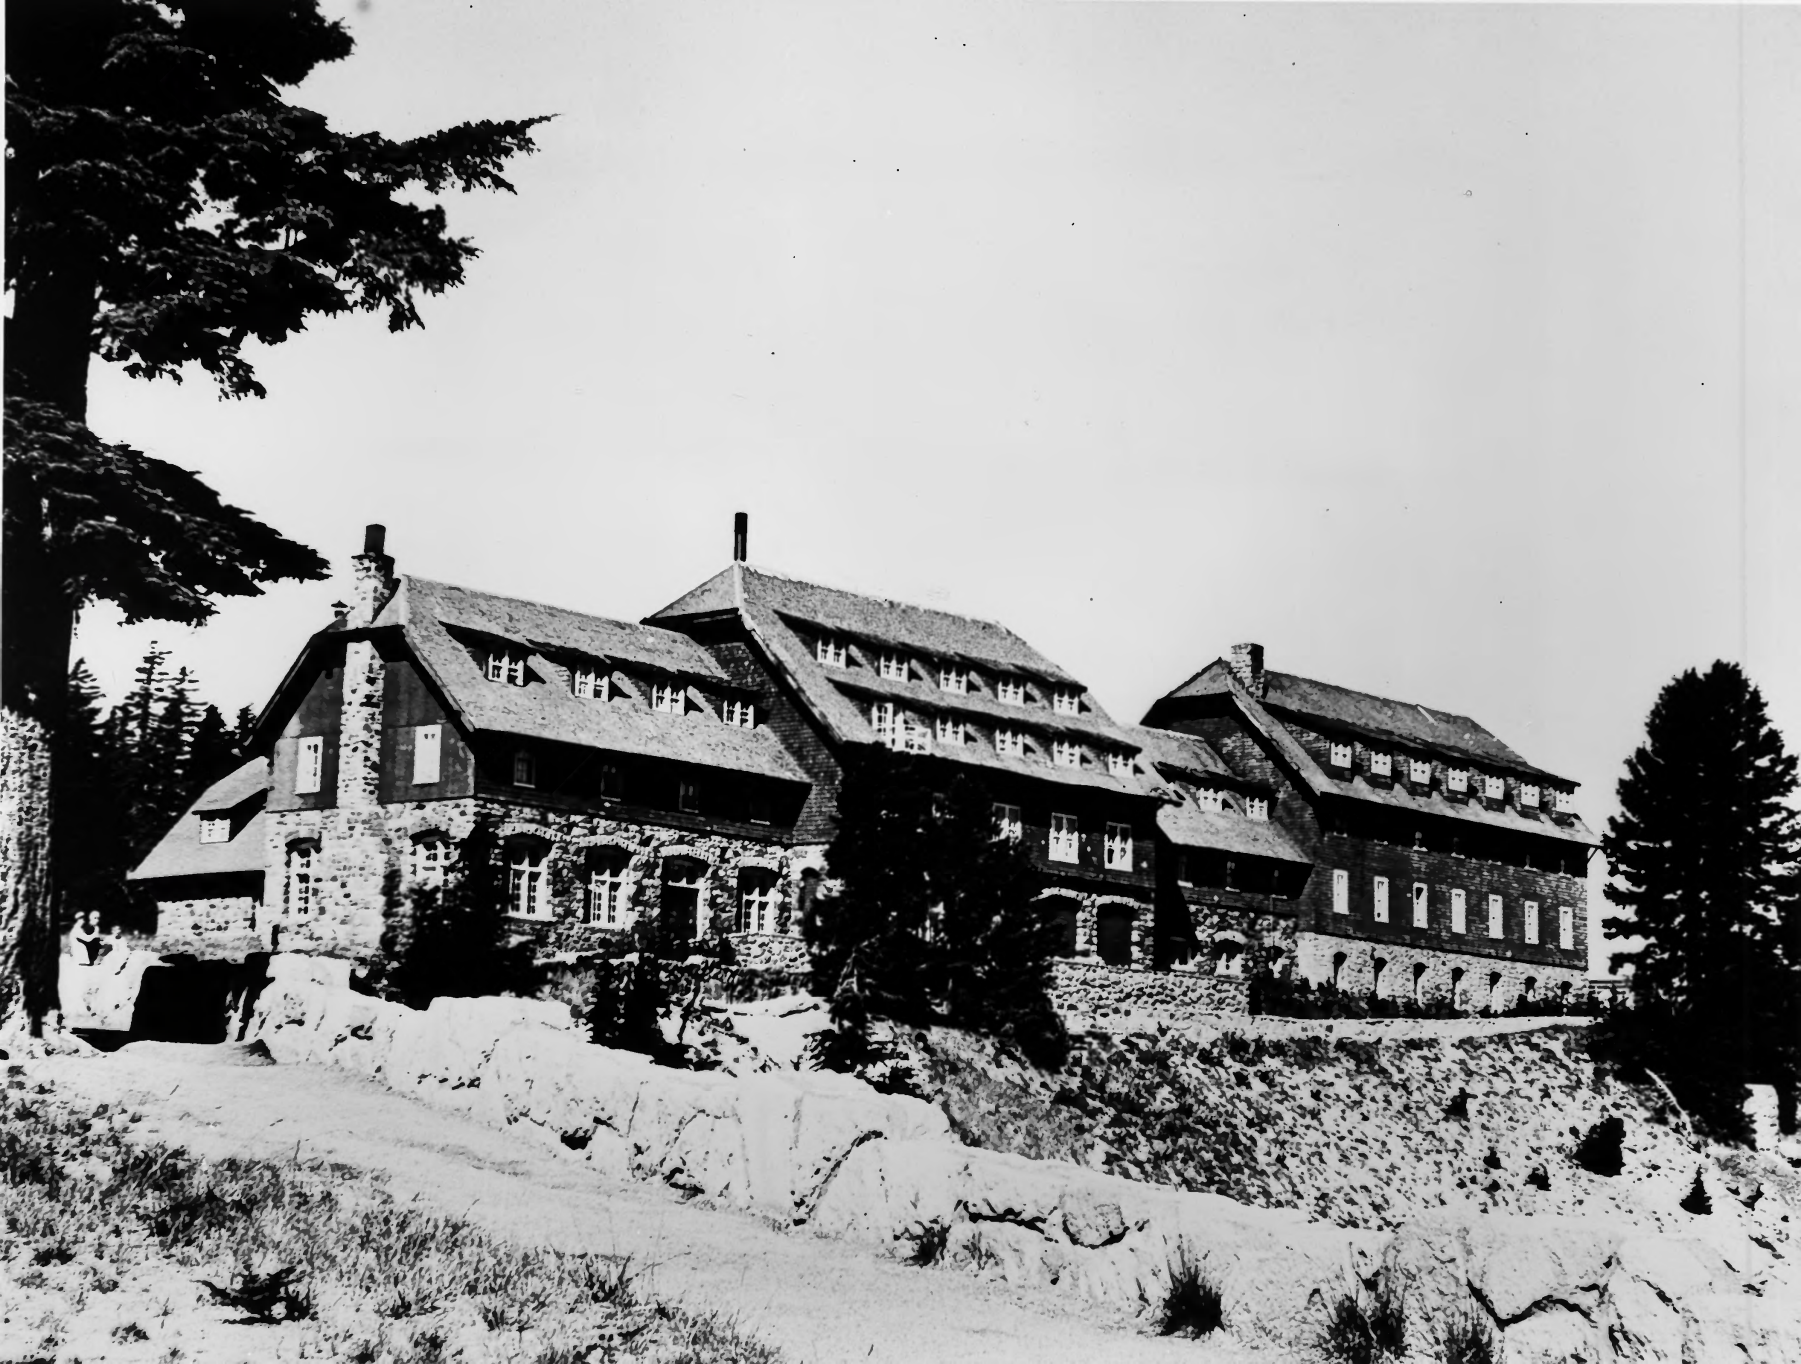
CRATER LAKE LODGE (BUILDING NO. 565)

AS THE LODGE APPEARS TODAY  
PROBABLY TAKEN 1950-60's

NOTE PLYWOOD ON EAST WALL

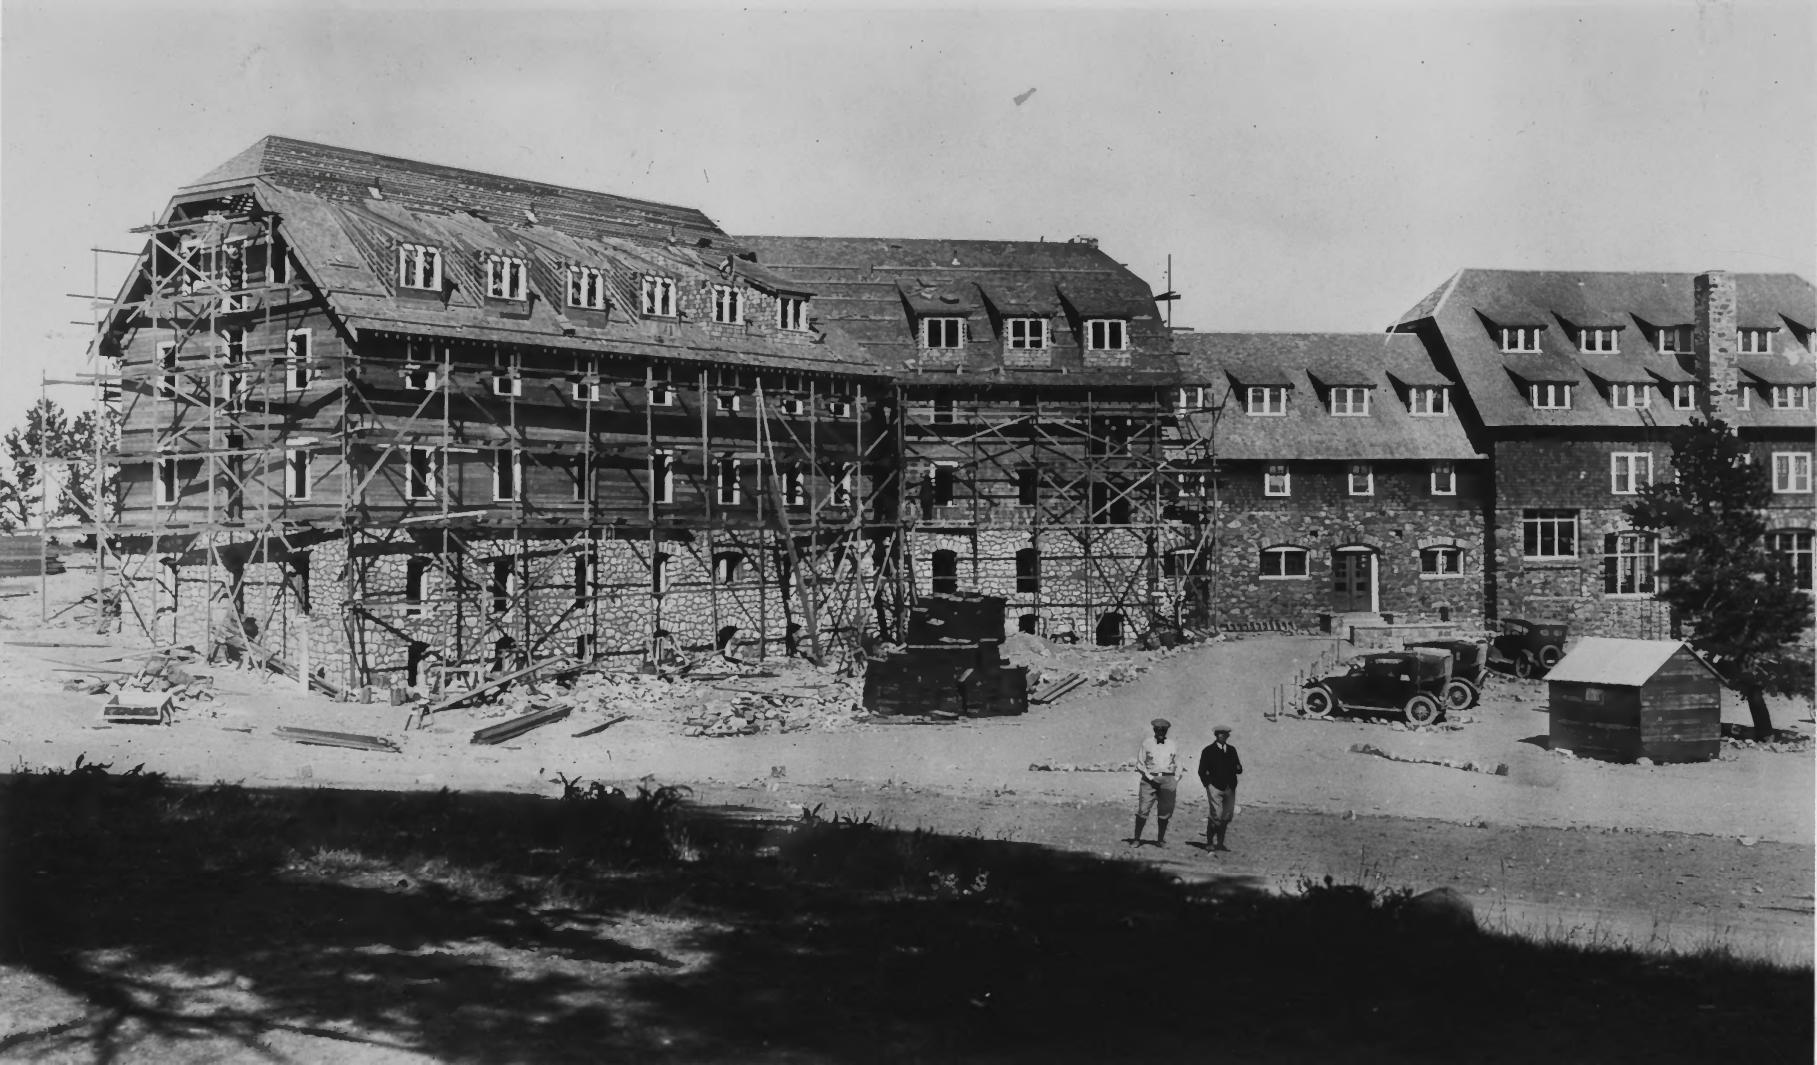
CRATER LAKE LODGE (BUILDING NO. 565)

CRATER LAKE LODGE ANNEX ADDITIONS UNDER  
CONSTRUCTION, LOOKING FROM THE SOUTHWEST CIRCA 1923

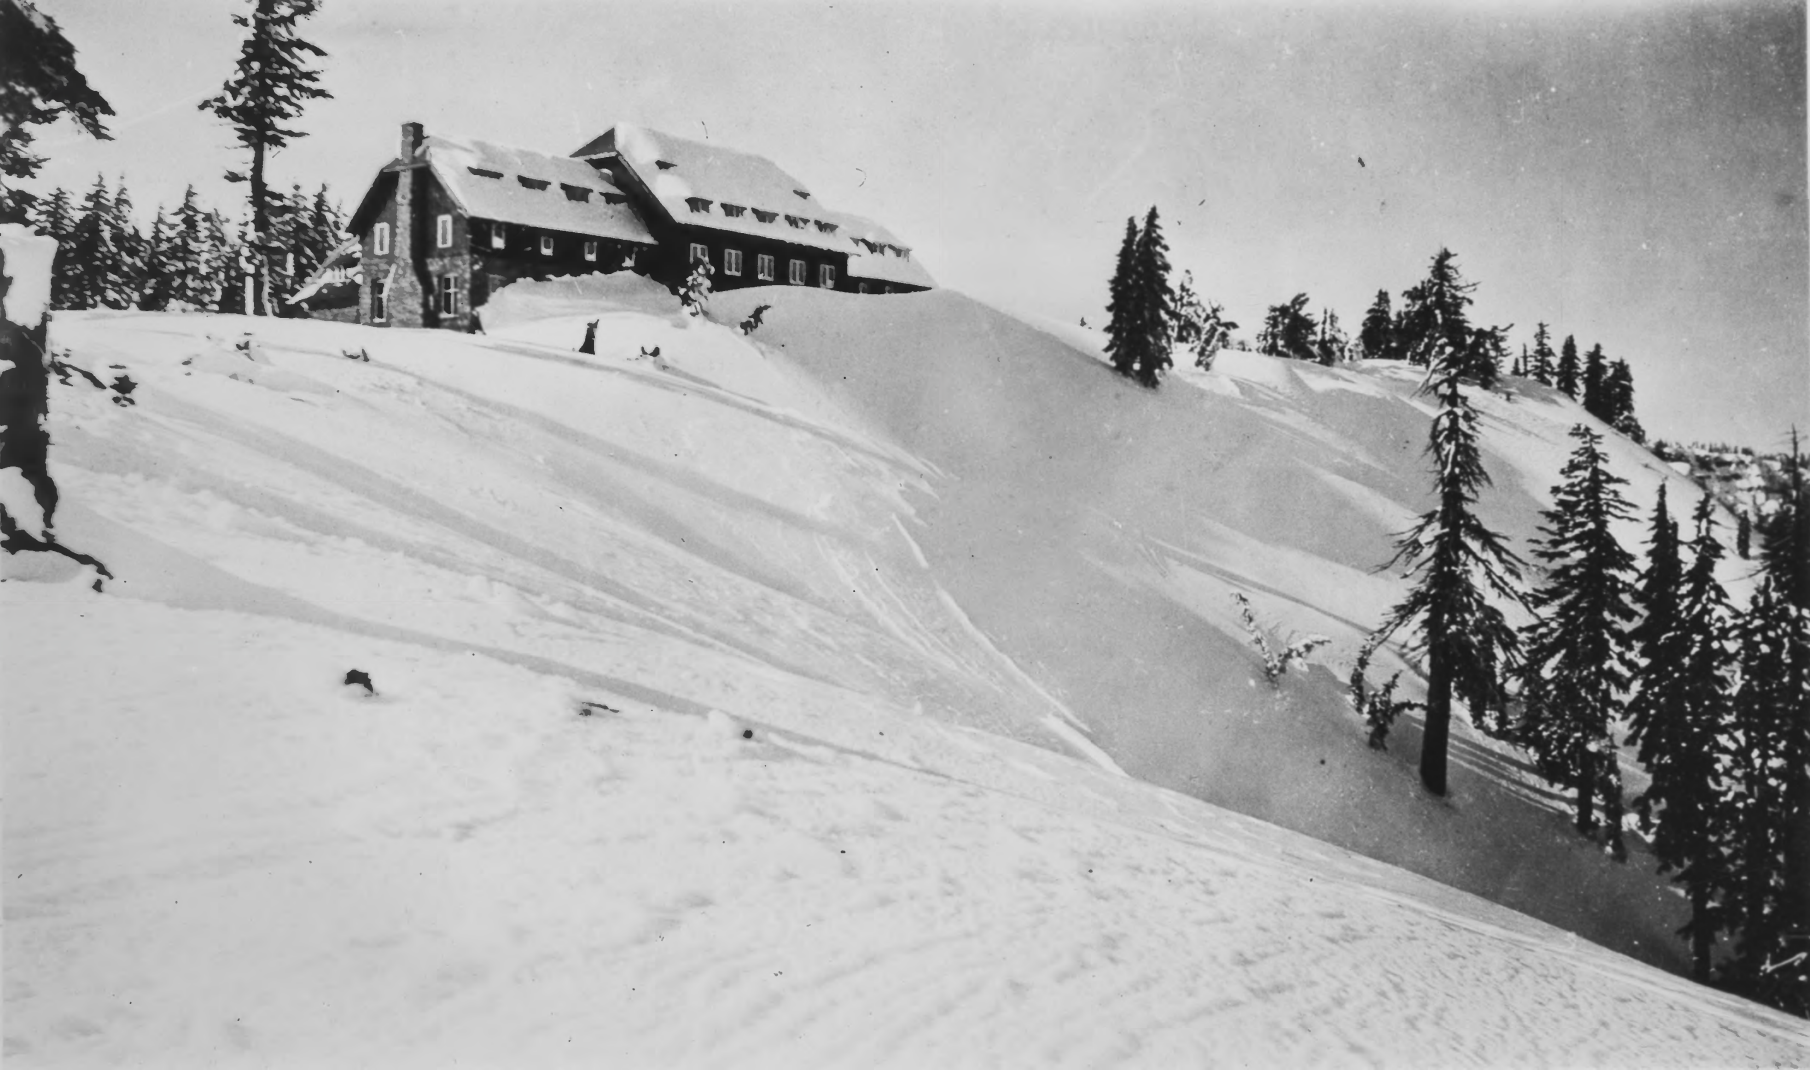
CRATER LAKE LODGE (BUILDING NO. 565)

CRATER LAKE LODGE LOOKING FROM NORTHEAST,  
PRIOR TO ANNEX ADDITIONS, BUT AFTER SHINGLE  
SIDING, PROBABLY CIRCA 1921

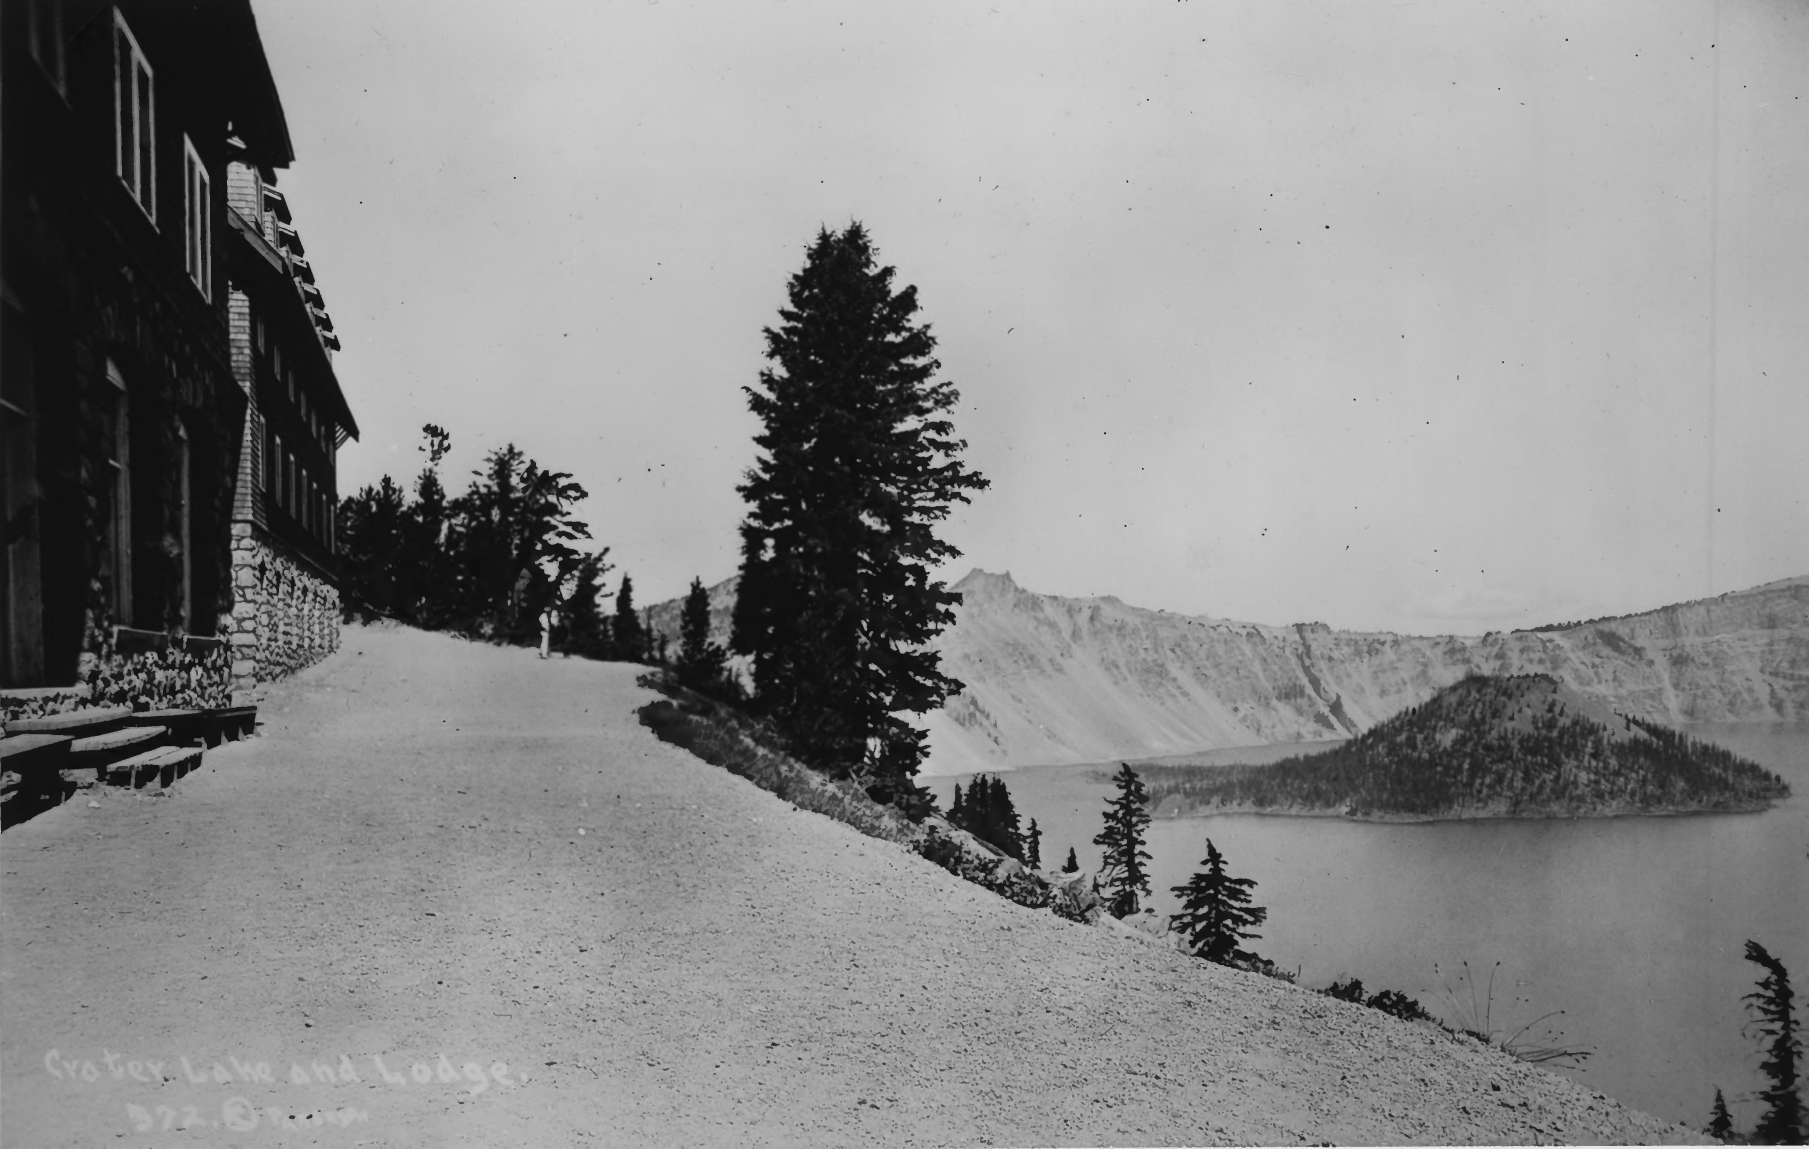
CRATER LAKE LODGE (BUILDING NO. 565)

CRATER LAKE LODGE LOOKING WEST ALONG  
NORTH FACAD OF THE LODGE, NOTE THIS WAS  
PRIOR TO CONSTRUCTION OF PATIO AND RIM WALK WALL  
PRE ~~NEW~~ NEW DEAL ERA

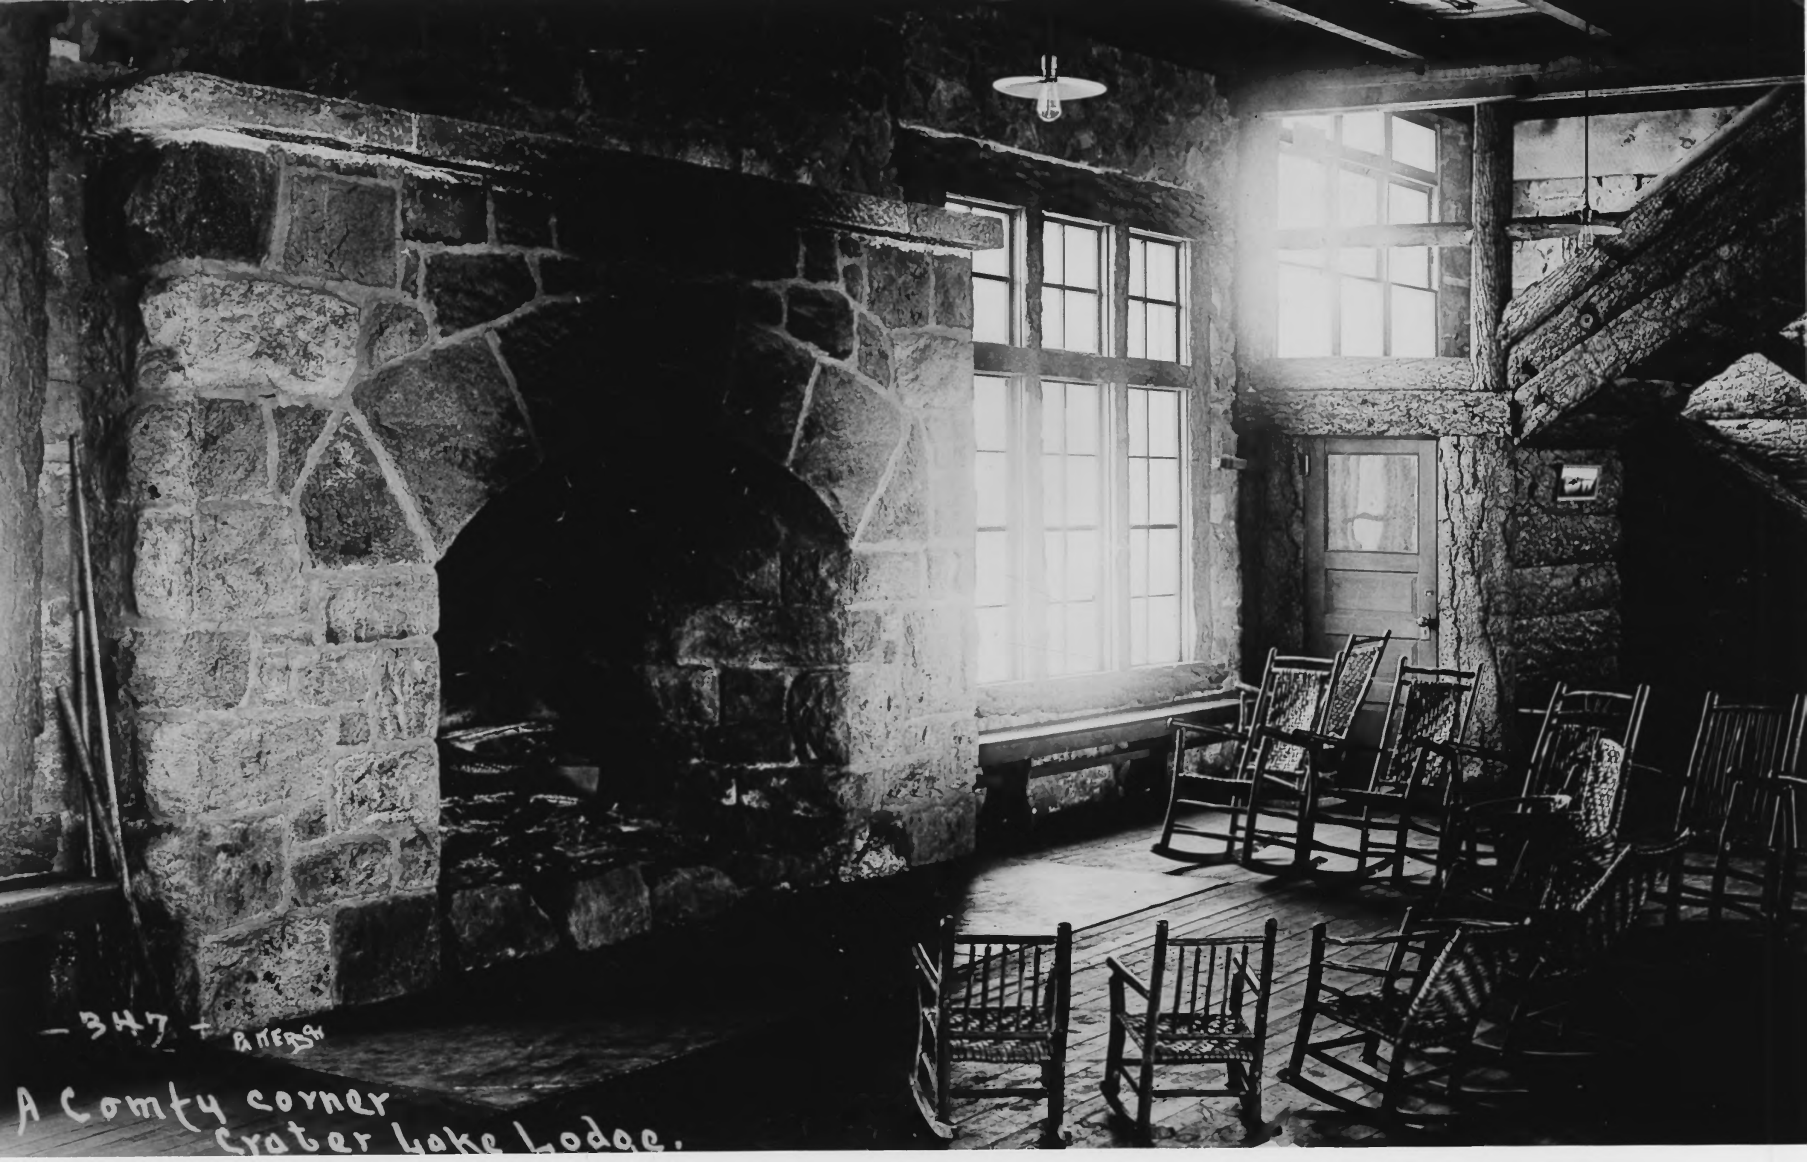
CRATER LAKE LODGE (BUILDING NO. 565)

CRATER LAKE LODGE, INTERIOR VIEW OF LOUNGE  
FIREPLACE, LOOKING FROM NORTHEAST. NOTE  
LIGHTING FIXTURES. PROBABLY EARLY, AT LEAST  
1940's OR EARLIER

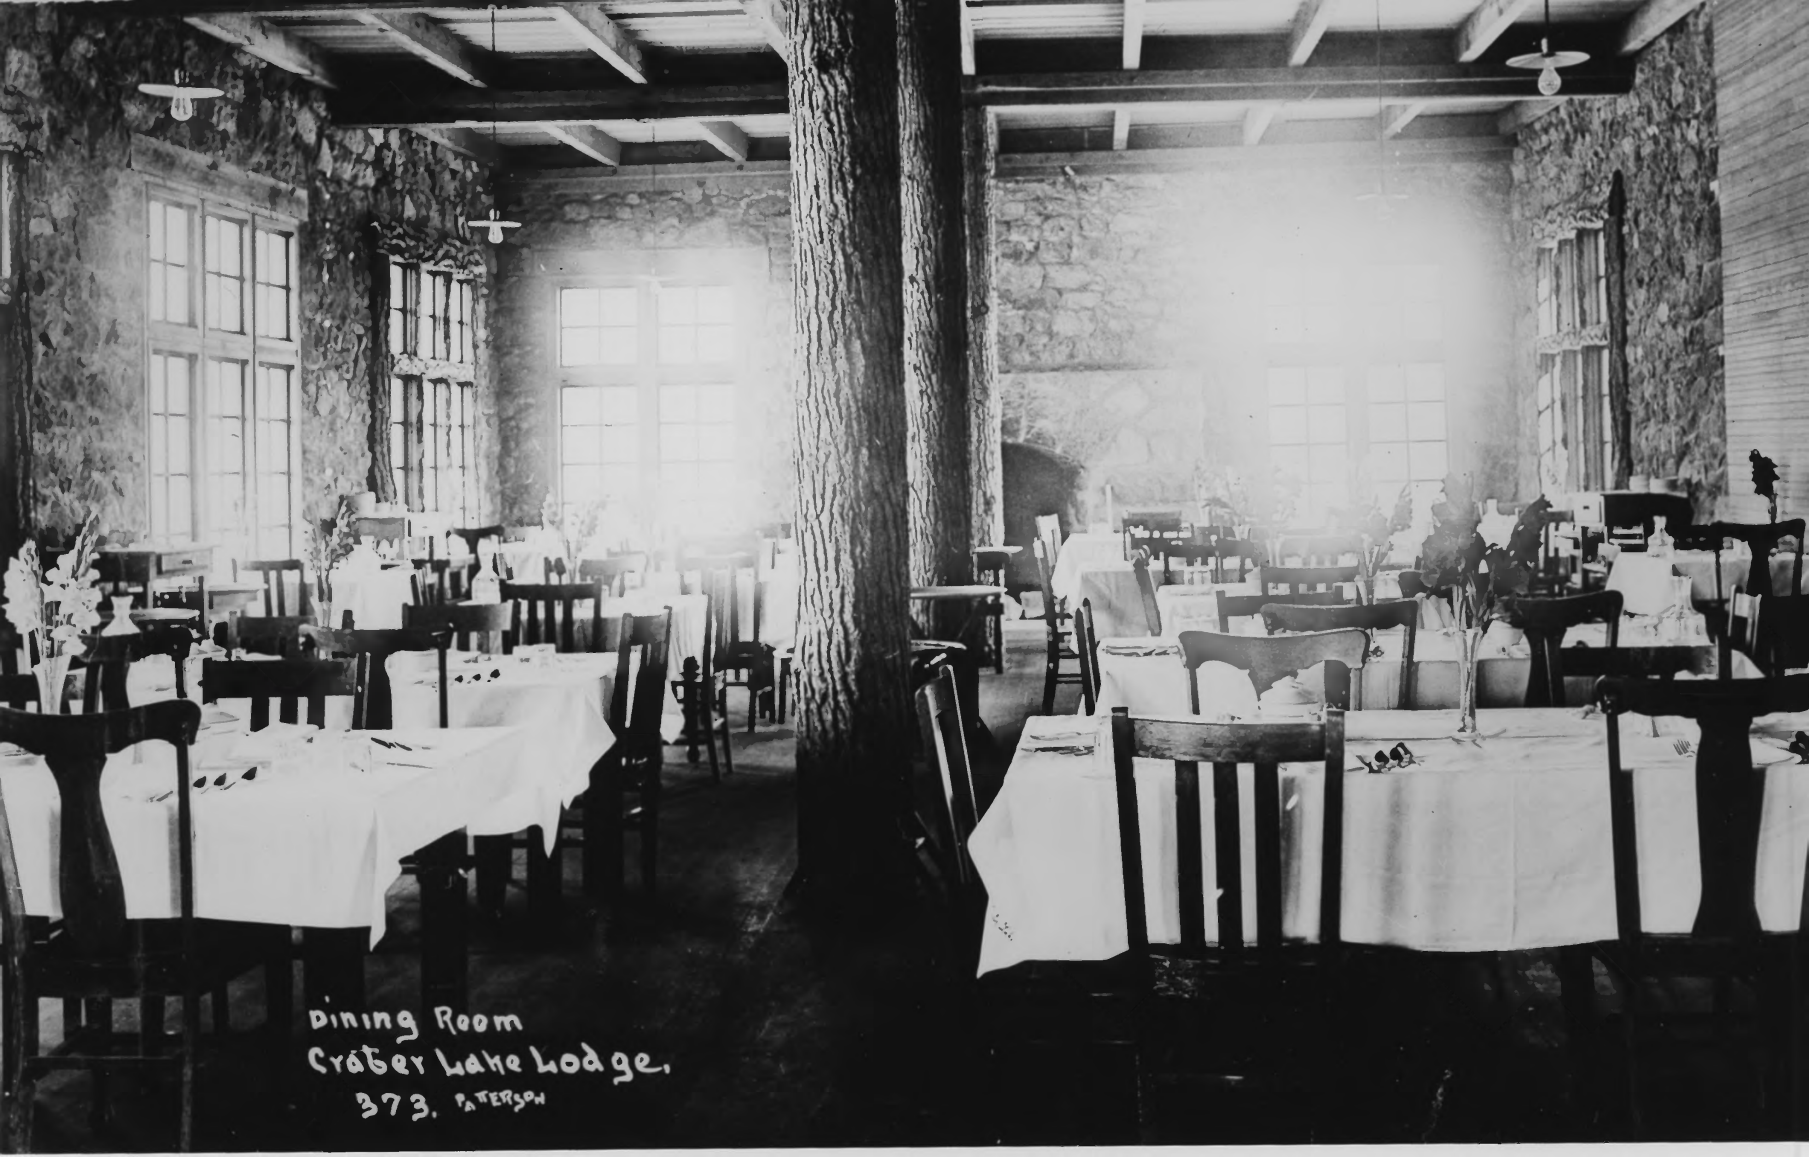
CRATER LAKE LODGE (BUILDING NO. 565)

EARLY VIEW OF DINING HALL LOOKING EAST  
NOTE EARLY LIGHT FIXTURES

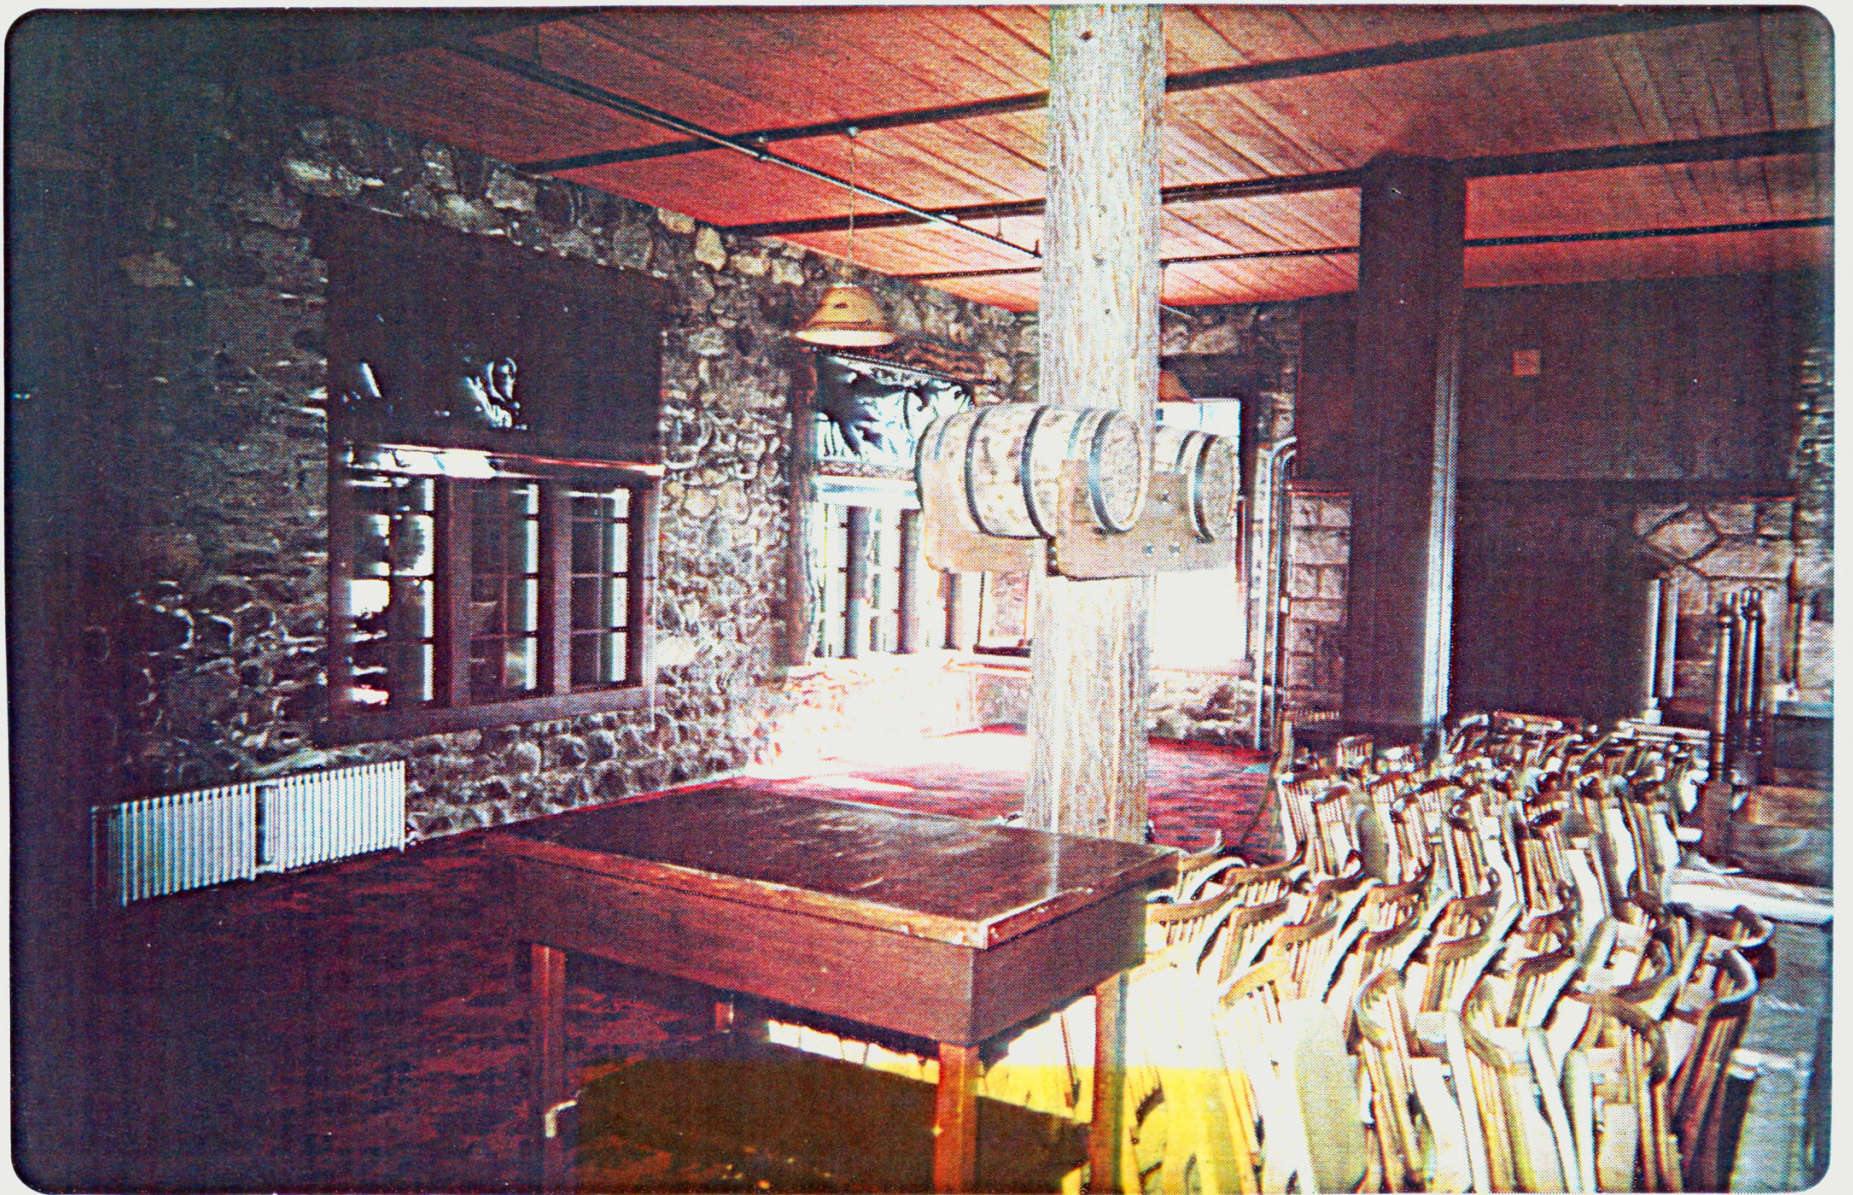
CRATER LAKE LODGE (BUILDING NO. 565)

CRATER LAKE LODGE, DINING HALL LOOKING NORTHEAST, 1980

Note enclosed log post and carpeting
