# National Register of Historic Places Registration Form

## 1. Name of Property Munson Valley Historic District (Boundary Decrease)

# **CULTURAL LANDSCAPE RECOMMENDATIONS**

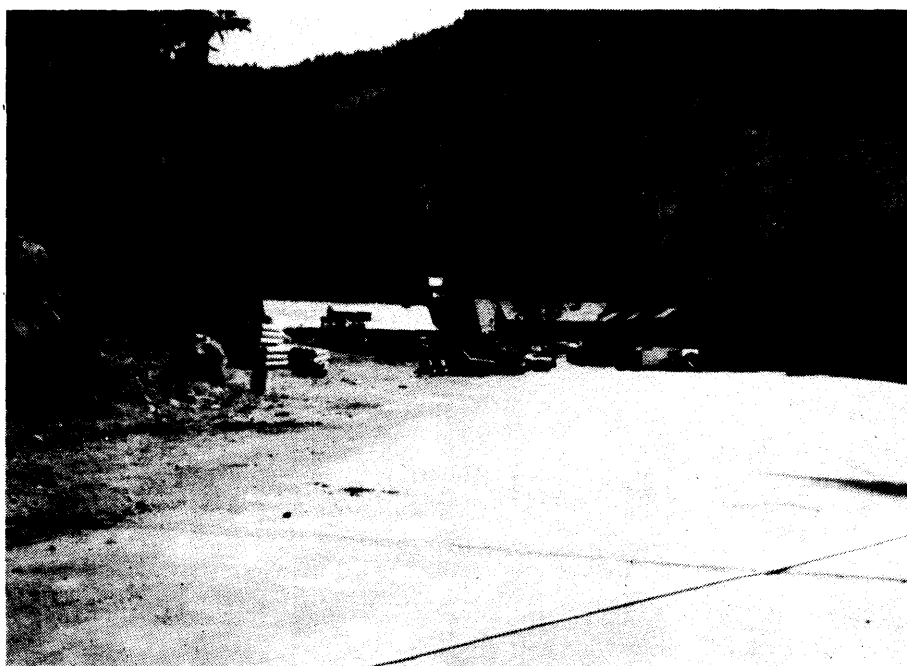
Maintenance area, looking north, 1990

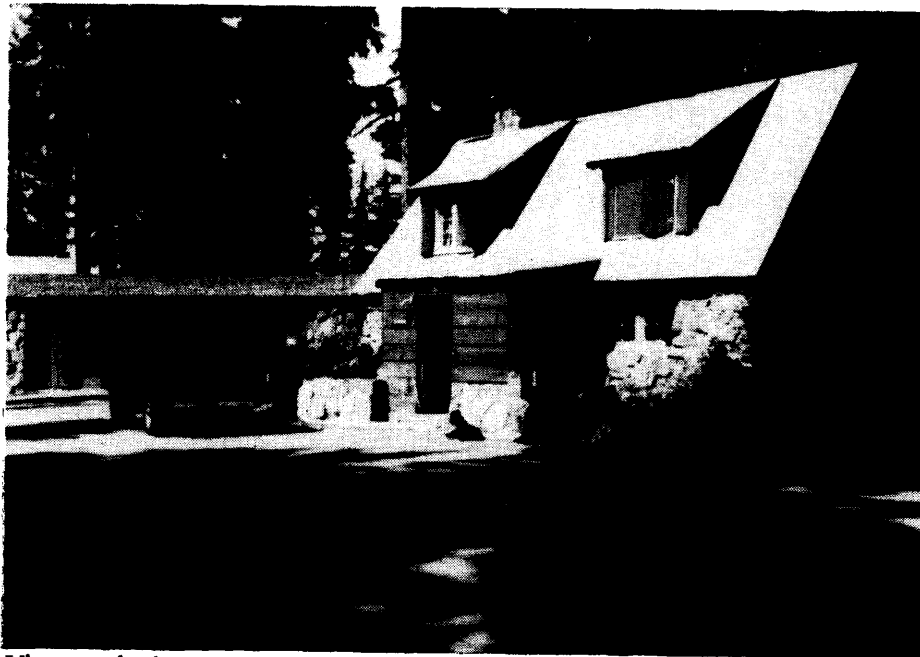
View south along spur road showing typical post WW II snow tunnel addition and widened road bed, 1990

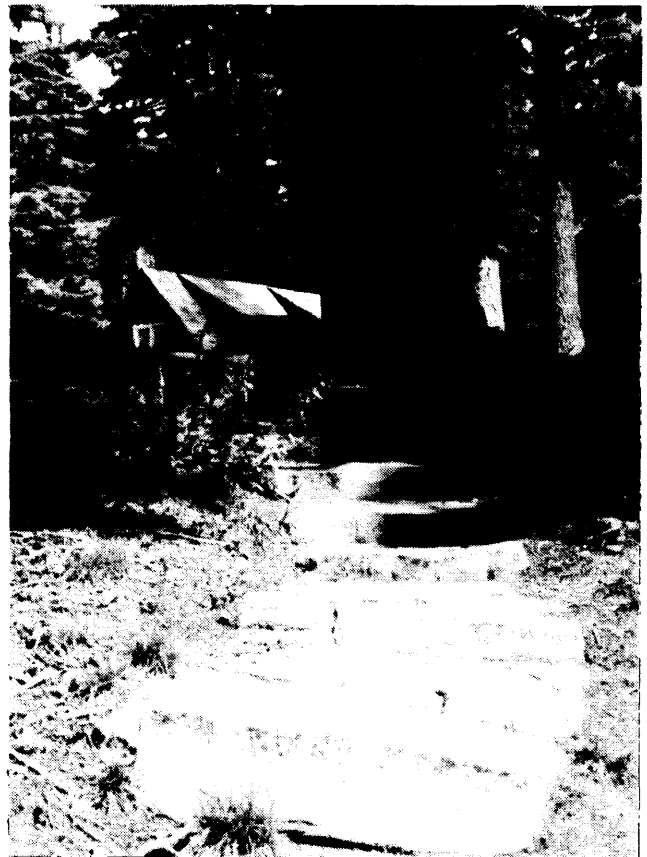
Stone steps to the lower group of employee residences.

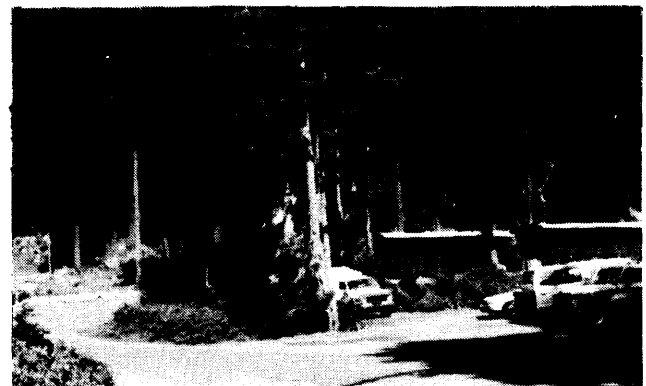
Planting "island" between the Messhall and Warehouse.

4. Reestablishment of stone curbing surrounding the planted "island" between the Mess Hall and Warehouse should be considered.

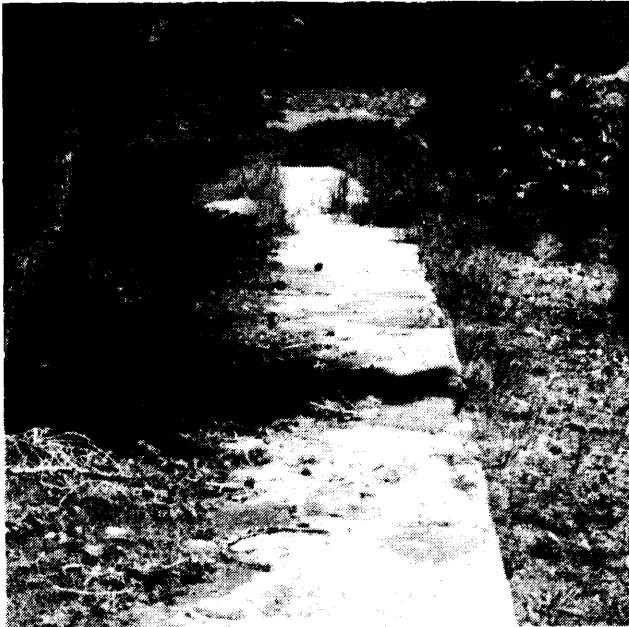
West flagstone walkway at the Superintendent's Residence.

1. Retain original circulation patterns.
2. The condition of all flagstone walkways, stone steps and the Munson Creek bridge should be assessed and an appropriate maintenance strategy for stabilization and preservation determined as noted under the maintenance and management recommendations..

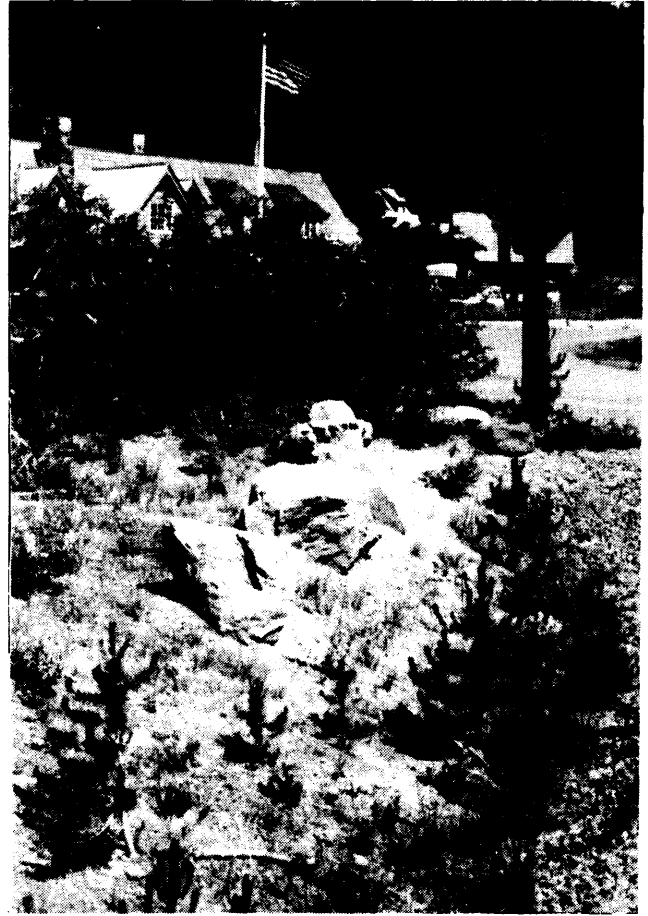
Extant boulders once used as a traffic control device for the old entrance to the plaza.

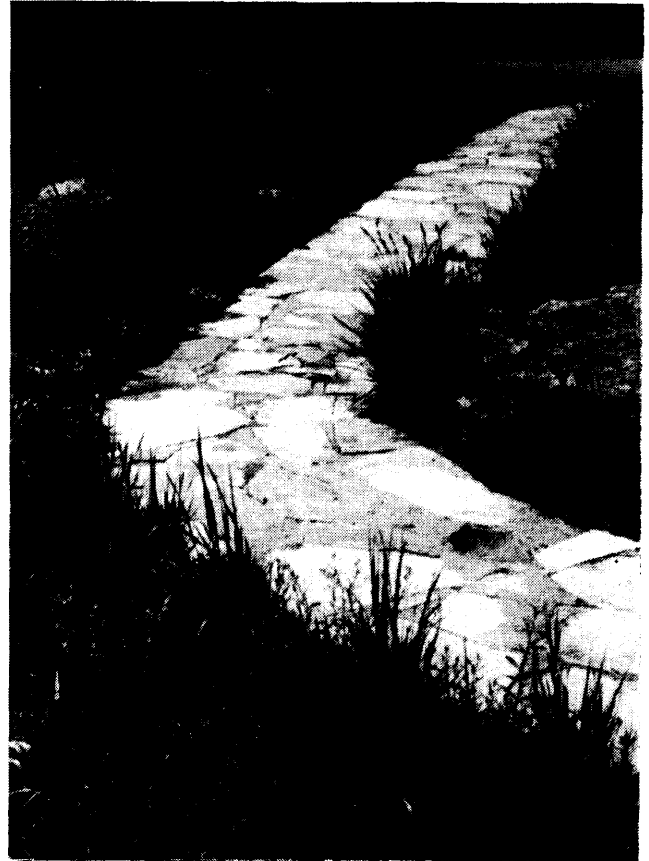
Flagstone walkway, Superintendent's Residence, west entrance.
