National Park Service
U.S. Department of the Interior

Restoration of Historic Features Cumberland Gap National Historical Park

Wilderness Road
1780-1810

Research methodology for the
"Rediscovery" of historically significant
resources: Procedures developed to
determine their original topography of the
historic saddle of Cumberland Gap and
identify the vertical and horizontal
alignment of the historic road.

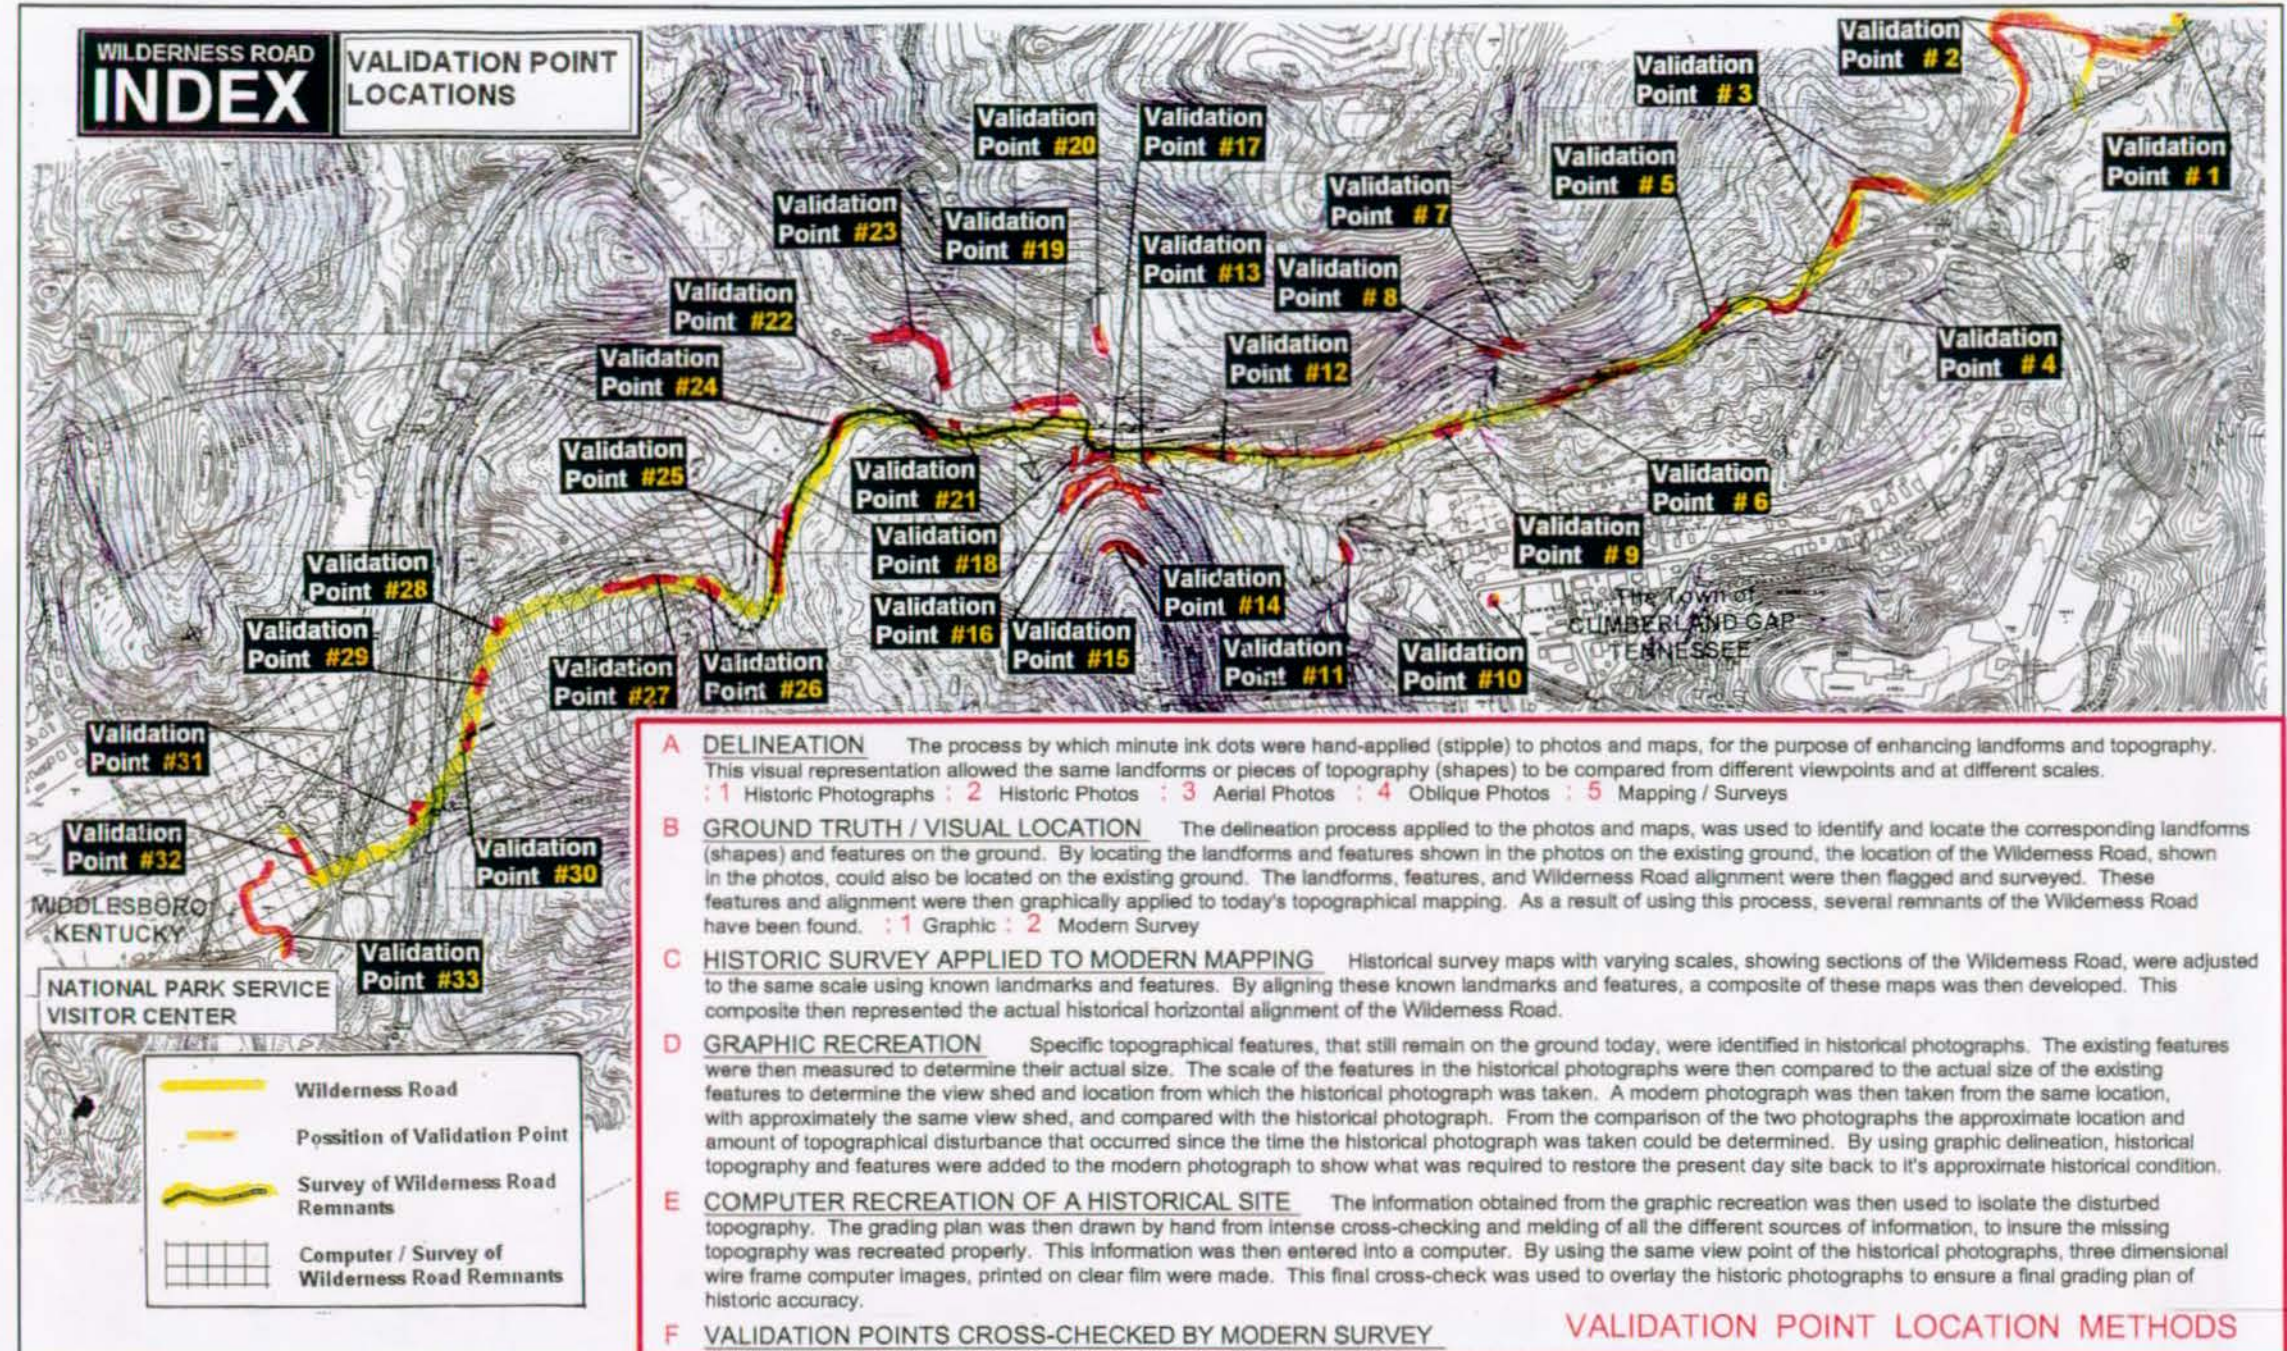
WILDERNESS ROAD INDEX VALIDATION POINT LOCATIONS

- A DELINEATION** The process by which minute ink dots were hand-applied (stipple) to photos and maps, for the purpose of enhancing landforms and topography. This visual representation allowed the same landforms or pieces of topography (shapes) to be compared from different viewpoints and at different scales.
: 1 Historic Photographs : 2 Historic Photos : 3 Aerial Photos : 4 Oblique Photos : 5 Mapping / Surveys

- B GROUND TRUTH / VISUAL LOCATION** The delineation process applied to the photos and maps, was used to identify and locate the corresponding landforms (shapes) and features on the ground. By locating the landforms and features shown in the photos on the existing ground, the location of the Wilderness Road, shown in the photos, could also be located on the existing ground. The landforms, features, and Wilderness Road alignment were then flagged and surveyed. These features and alignment were then graphically applied to today's topographical mapping. As a result of using this process, several remnants of the Wilderness Road have been found. : 1 Graphic : 2 Modern Survey

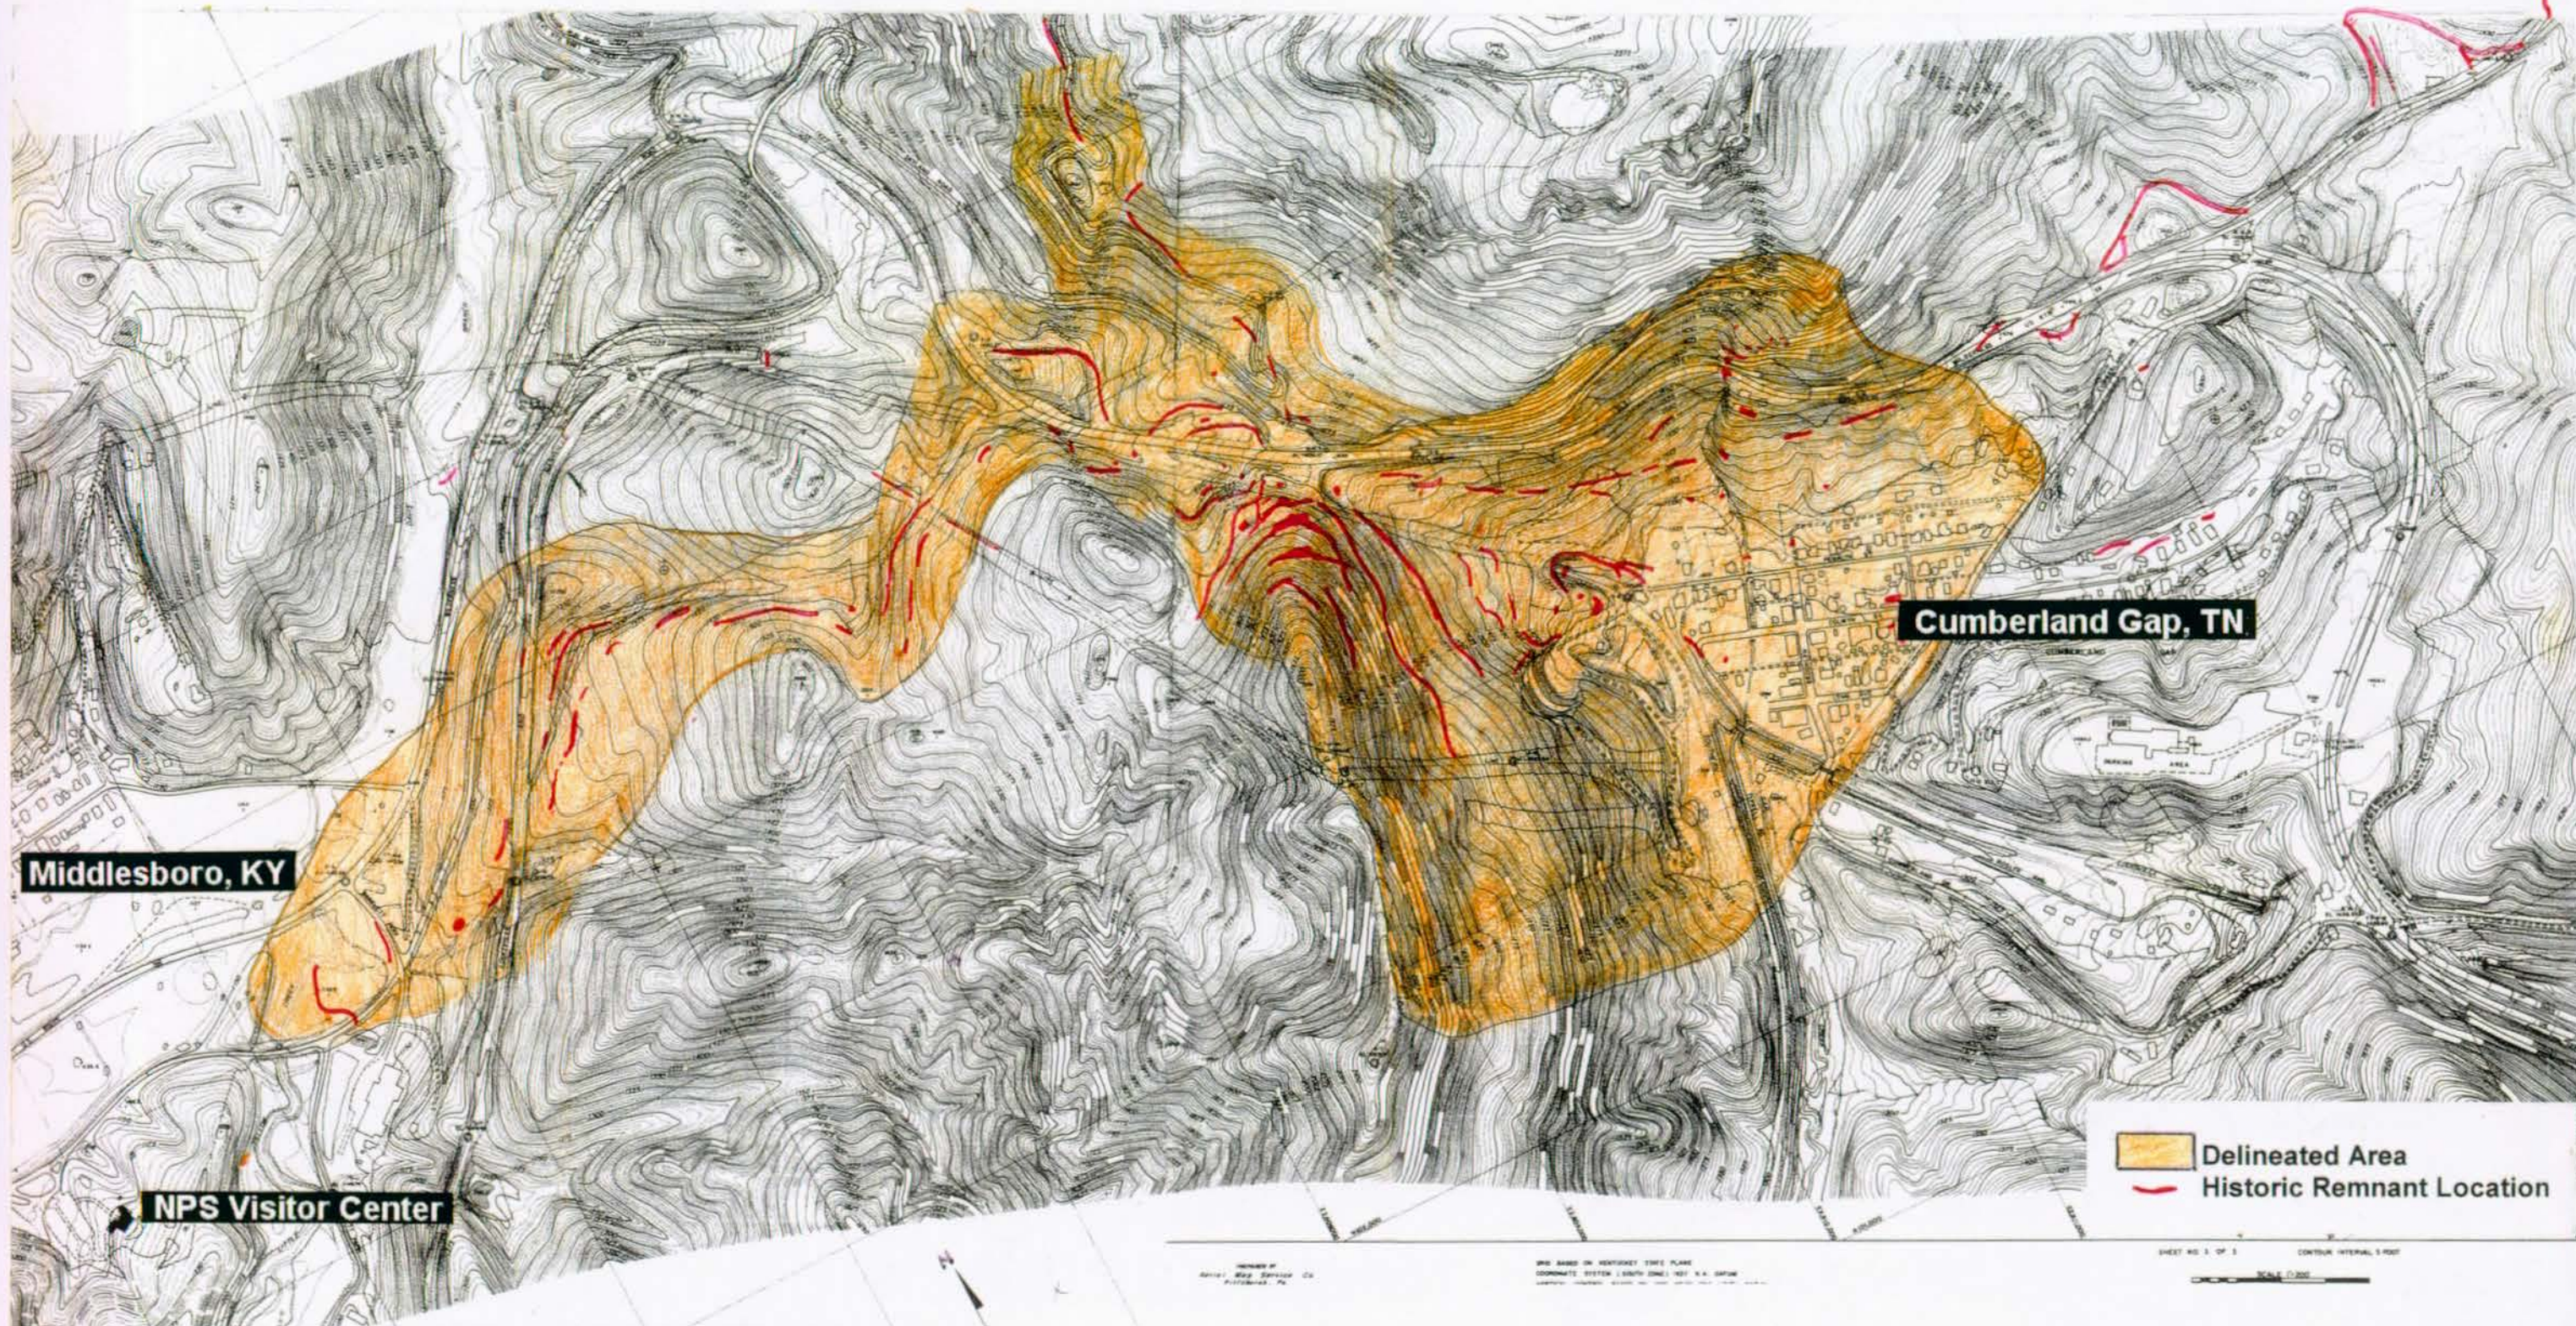
HISTORIC REMNANT LOCATIONS

This sheet shows the total area hand-delineated, plus the physical locations of historic road remnants still on the ground today. These remnants were used to find and crosscheck the Wilderness Road location, and were instrumental in the rehabilitation of the topography at the Gap. Using the remnants facilitated the determination as to whether or not topography and the Wilderness Road had been disturbed from their original configurations.

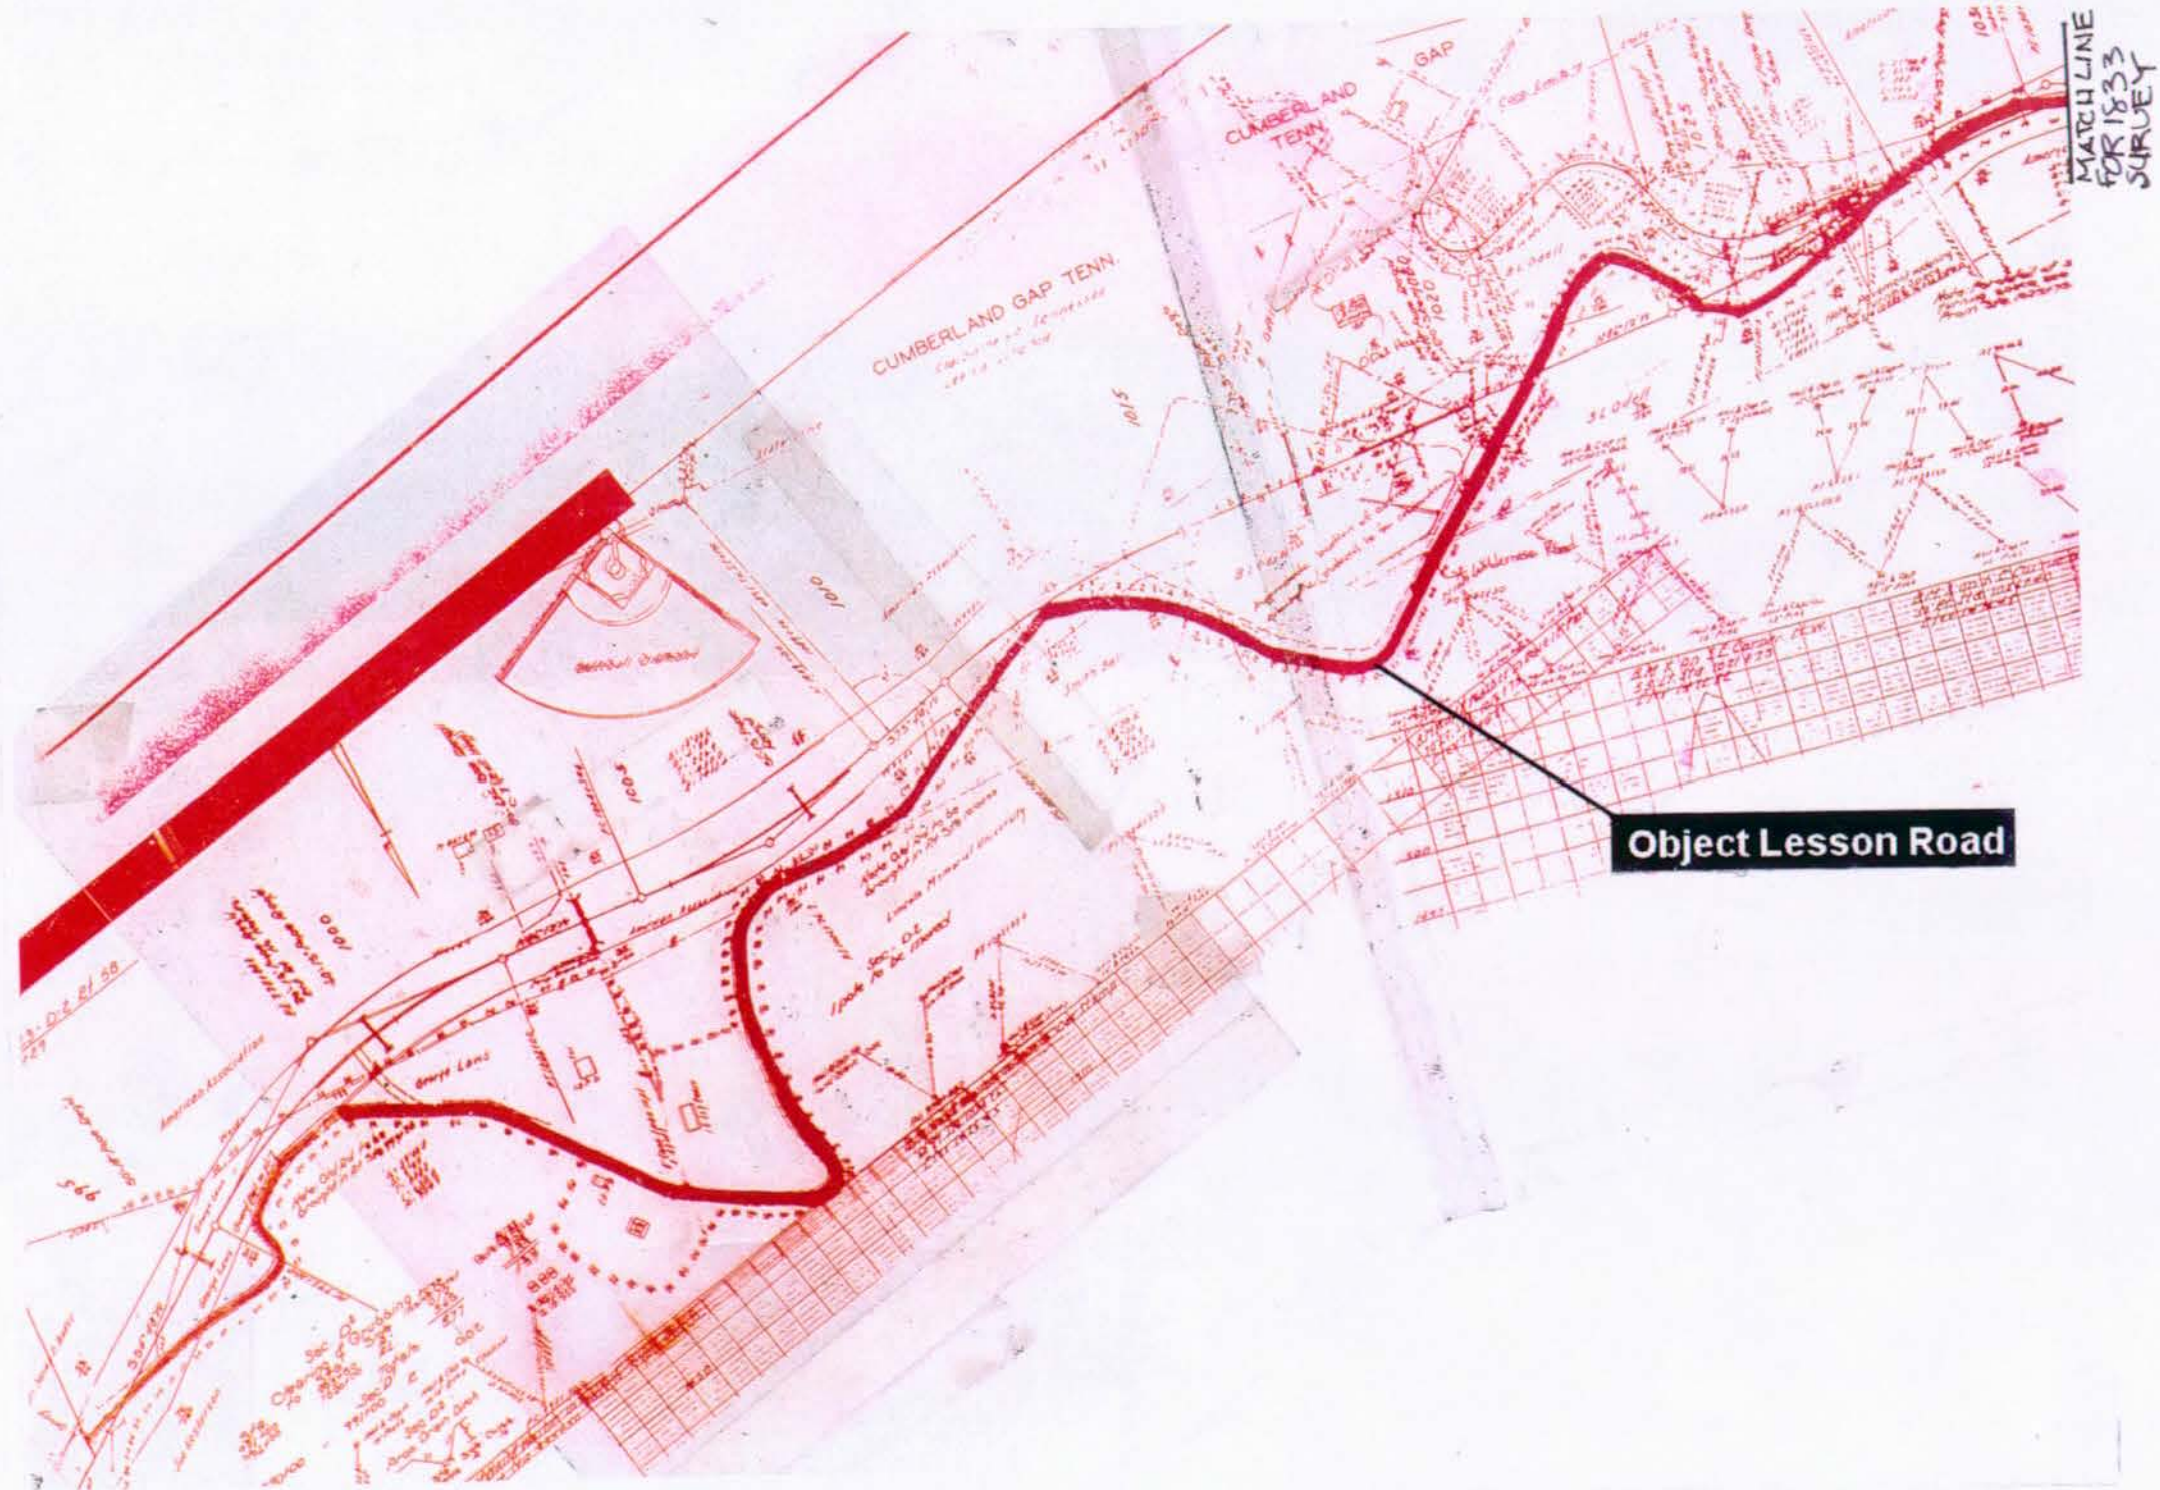
This photograph was taken during the Civil War about 1862. The view is looking Northwest, from what is now the town of Cumberland Gap, Tennessee.

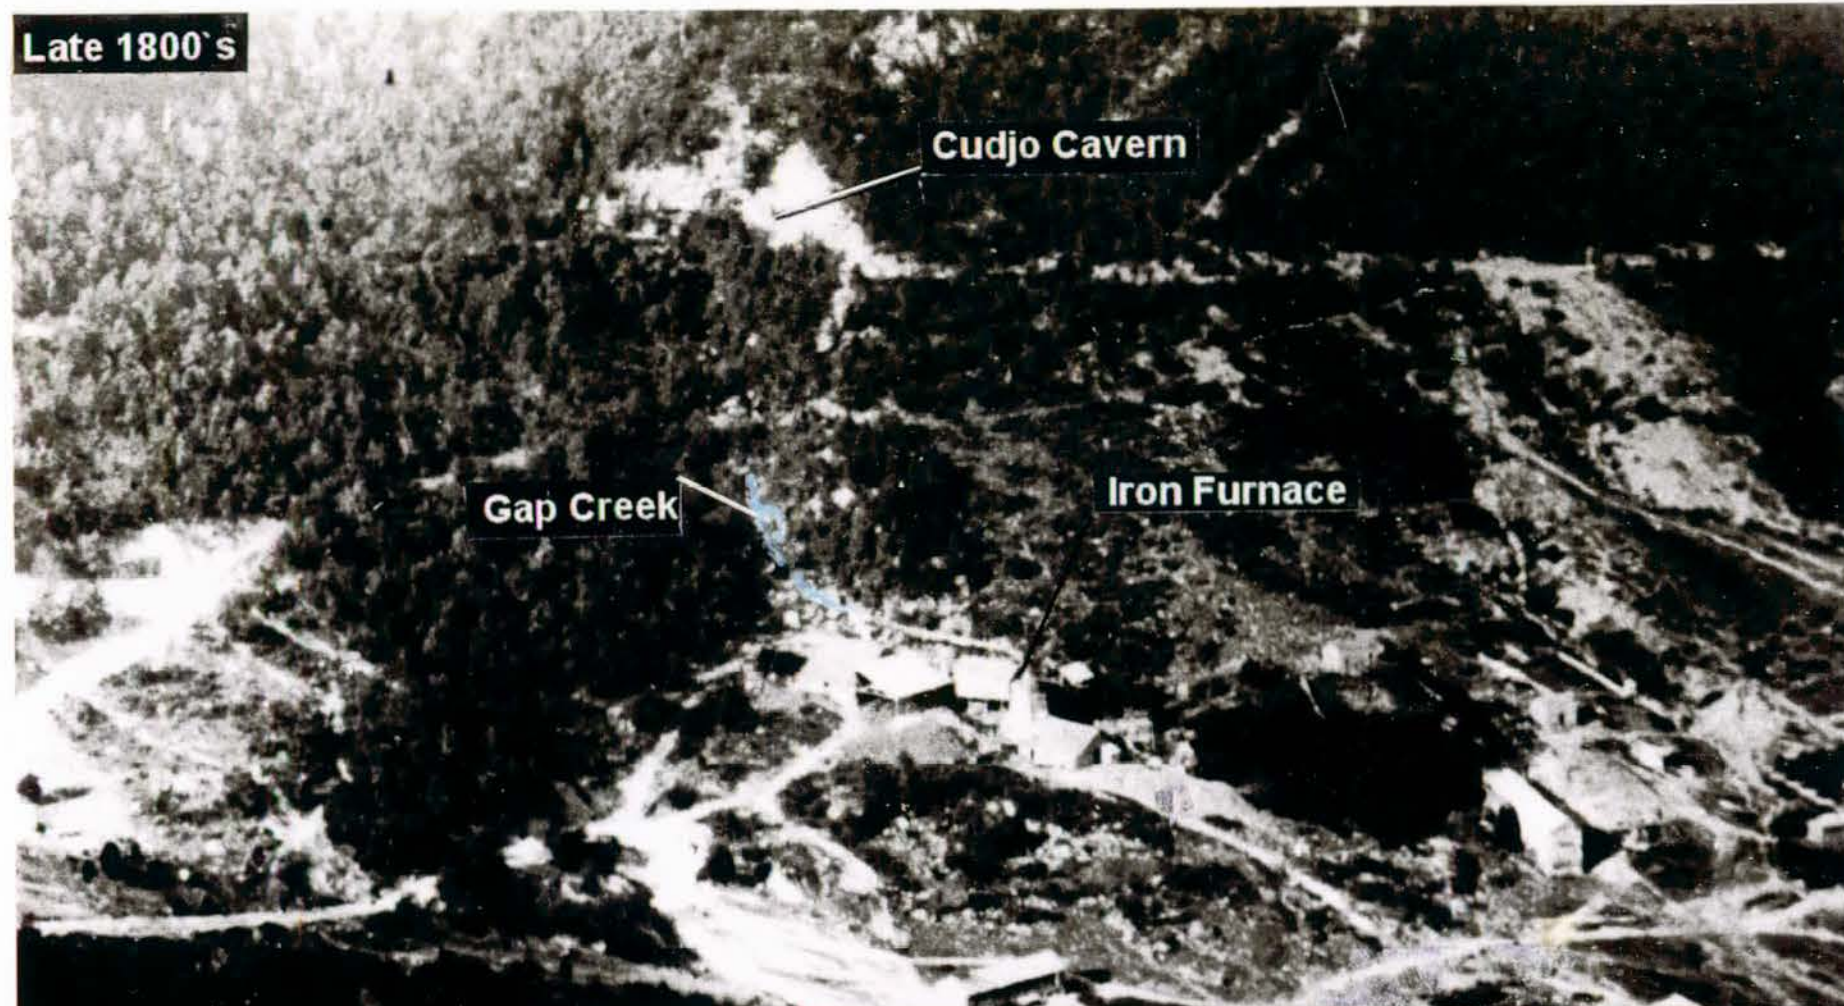
Photograph of original Cudjo Cavern entrance and the geological feature over Gap Creek. The original cavern entrance was removed by road construction. This geological feature became known as a collapsed feature, lost to surface erosion and the karst process.

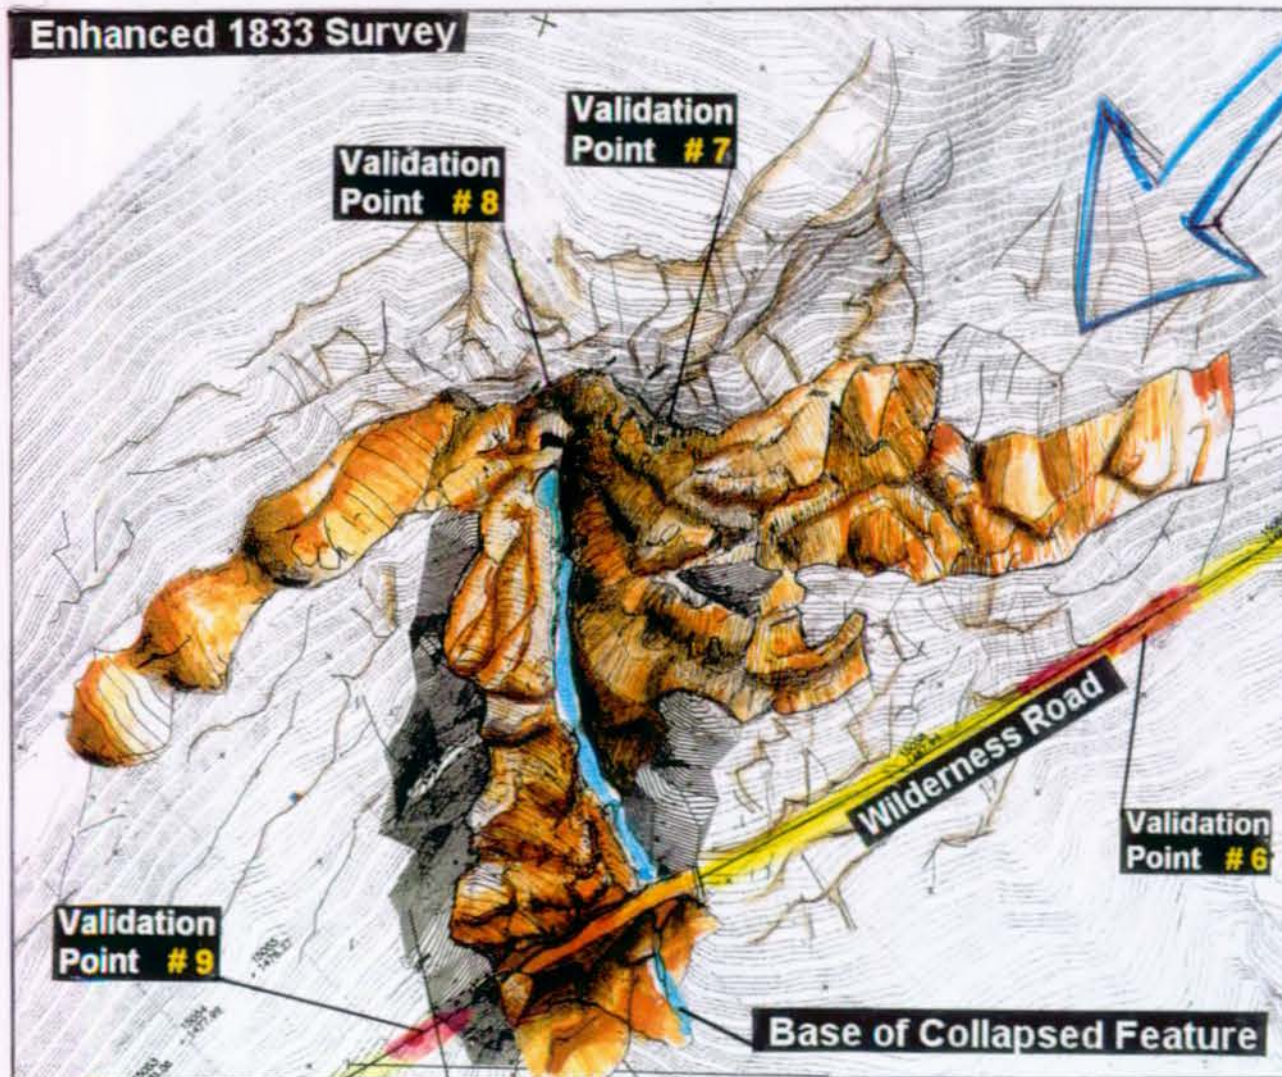
Enhanced 1833 Survey – This sheet shows a hand-enhanced version of the 1833 survey, overlaid on modern topography. The shape and position of the original cavern entrance, and the geological feature over Gap Creek, meshes perfectly with modern survey work.

The 1833 survey is believed to be the base map used for the later construction of the initial alignment of U.S. Route 25E. The first road on the higher alignment was built sometime after 1833, but before 1862. The original cave entrance was not removed by road building until the late 1800's, the same approximate time frame as when the geological feature over Gap Creek failed.

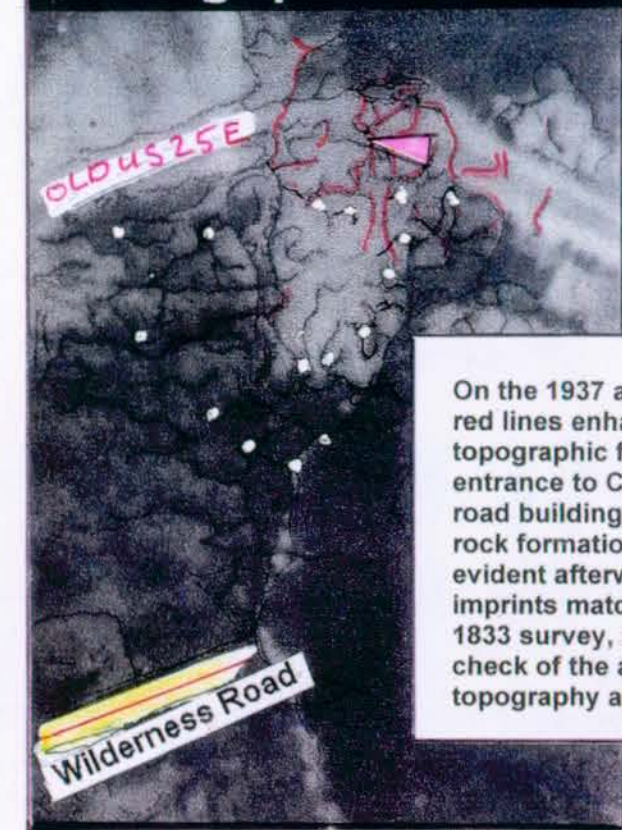
On the 1937 aerial photograph to the left, red lines enhance the delineation of topographic features around the original entrance to Cudjo Cavern. Even though road building on U.S. Route 25E removed rock formations, their "imprint" remains evident afterwards. These delineated imprints match the same features from the 1833 survey, providing yet another cross-check of the accuracy of the missing topography and cavern entrance.

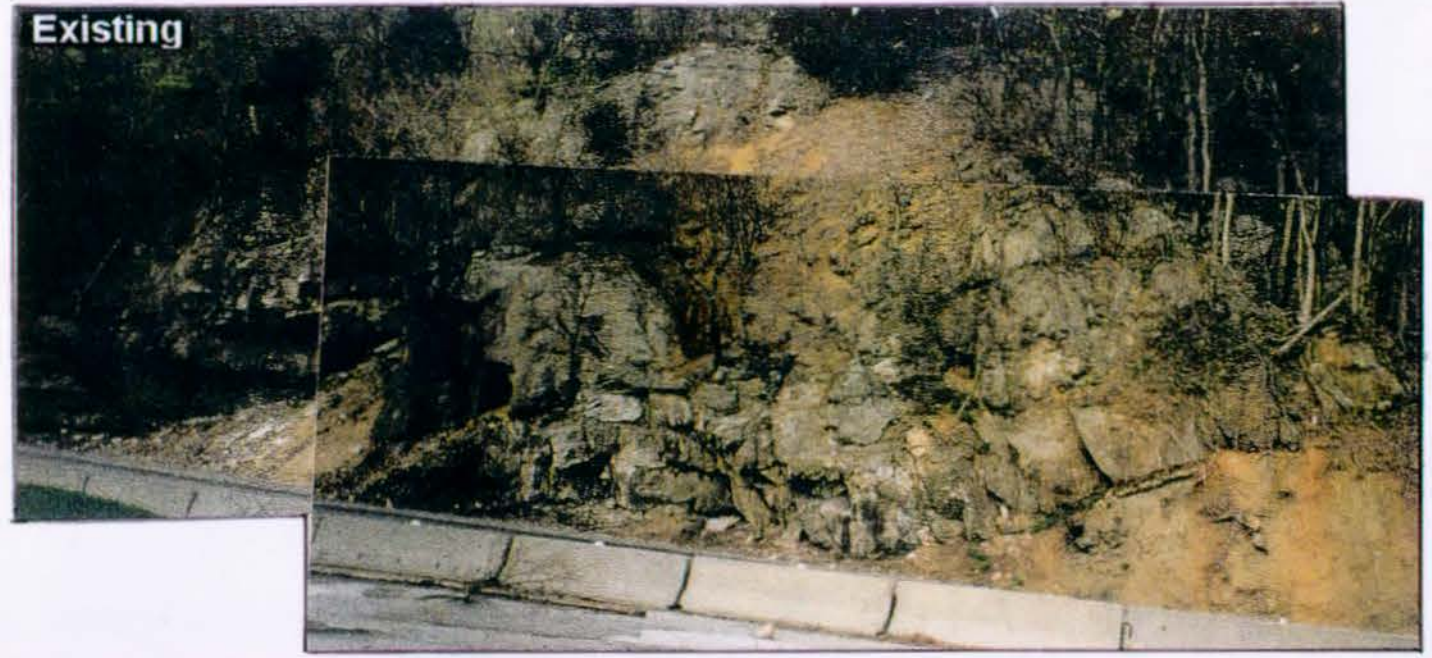
These views of the face of Cudjo Cavern show not only the delineated precision of the missing topography, but also the original location of the cave entrance. The highlighted rock formations are interchangeable from image to image, from a current photograph on the right, to the early 1800's obscura view on the left.

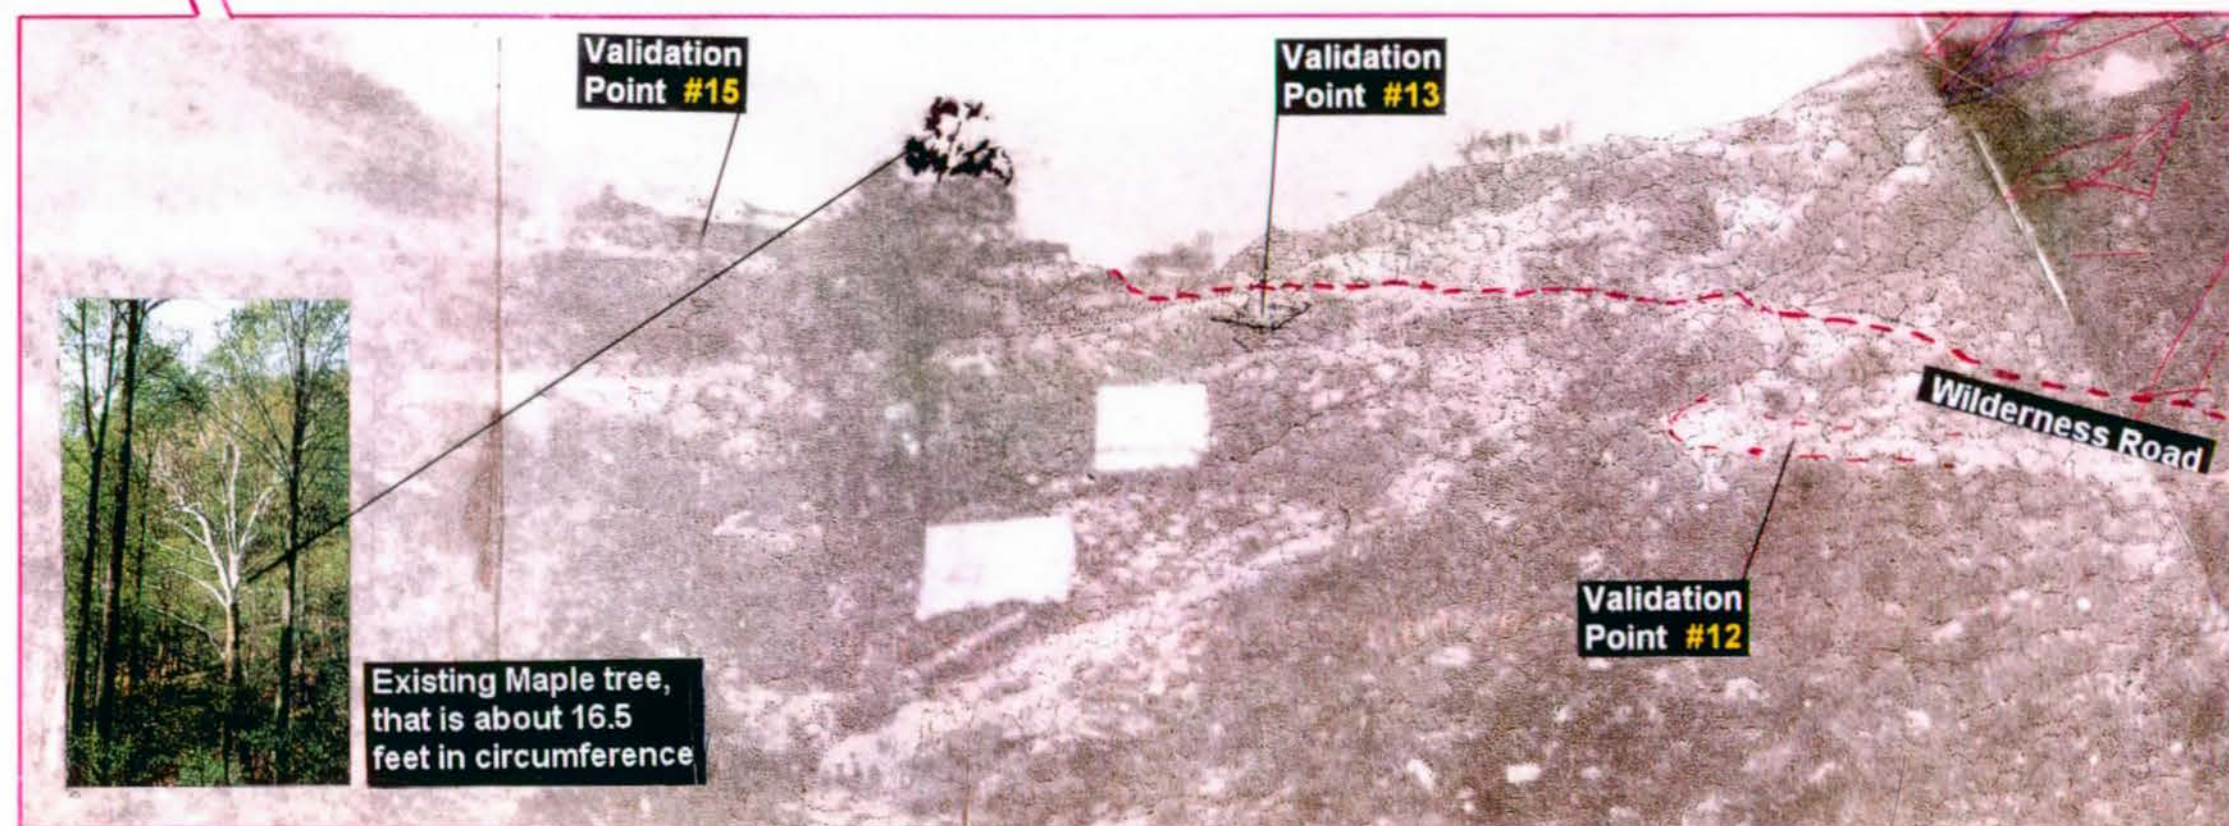
Validation Point #11

Existing tree, visable in photograph above is a Red Oak (about 12.5 ft. in circumference) and gives another location cross check.

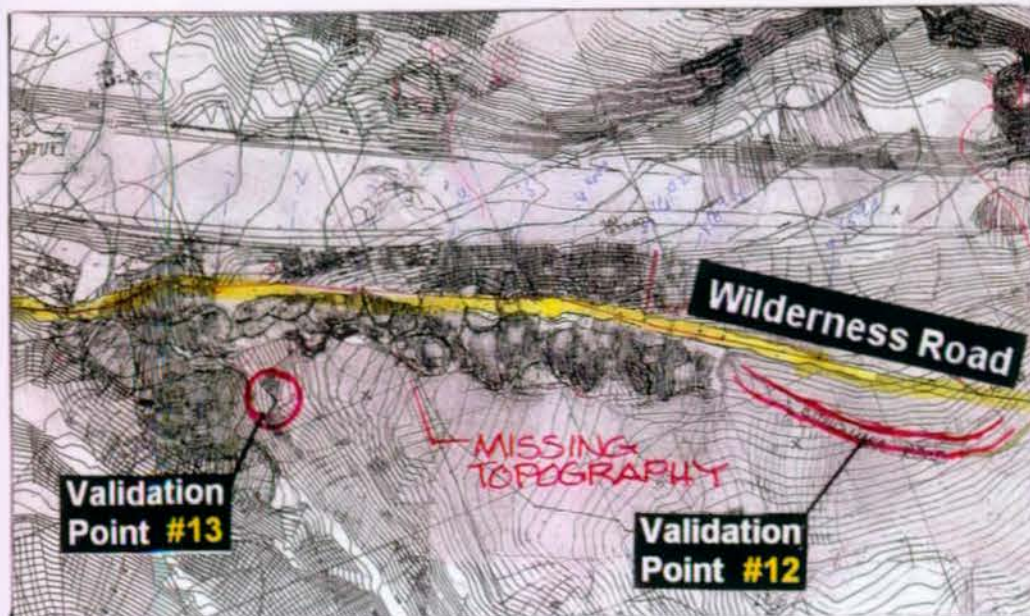
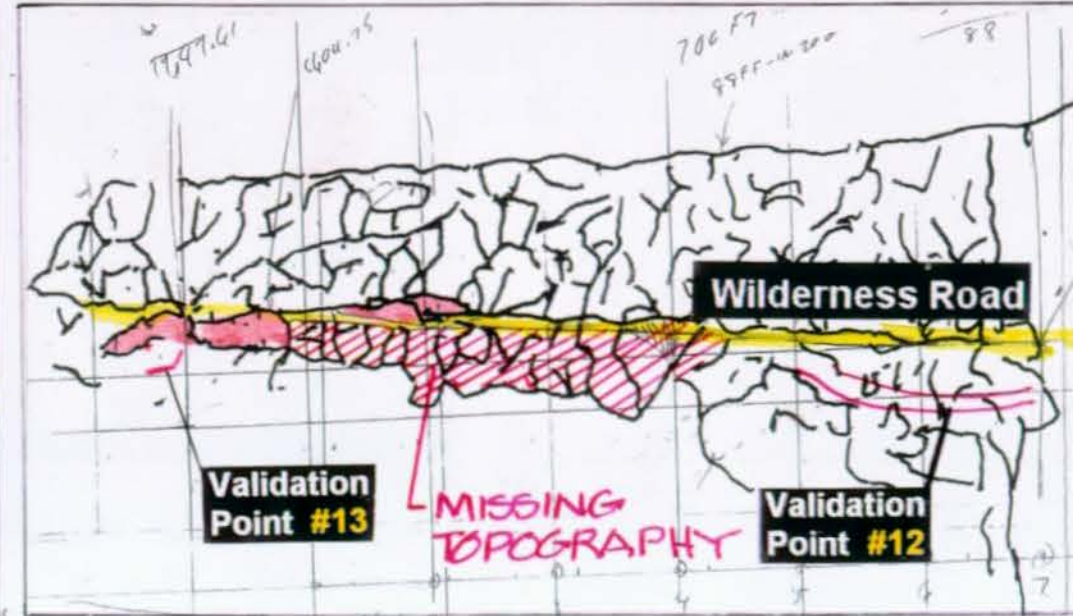
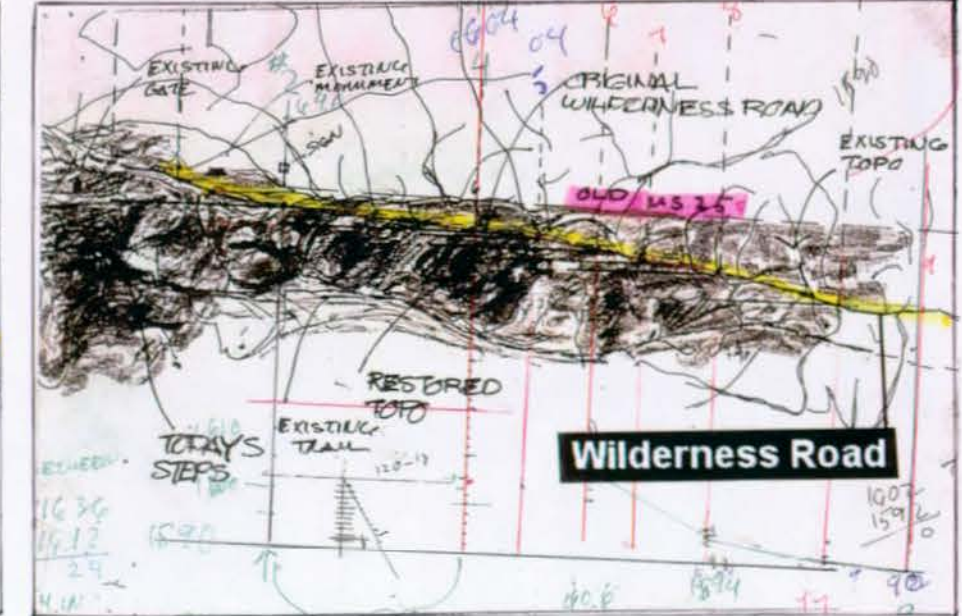
This page illustrates how delineation was used to identify the shape of the missing topography, to the approach of the saddle. The delineation was cross checked with historic survey, historic photographs, aerials, and modern field photographs. These shapes are applied to a mechanical drawing technique, then added to the grading plan.

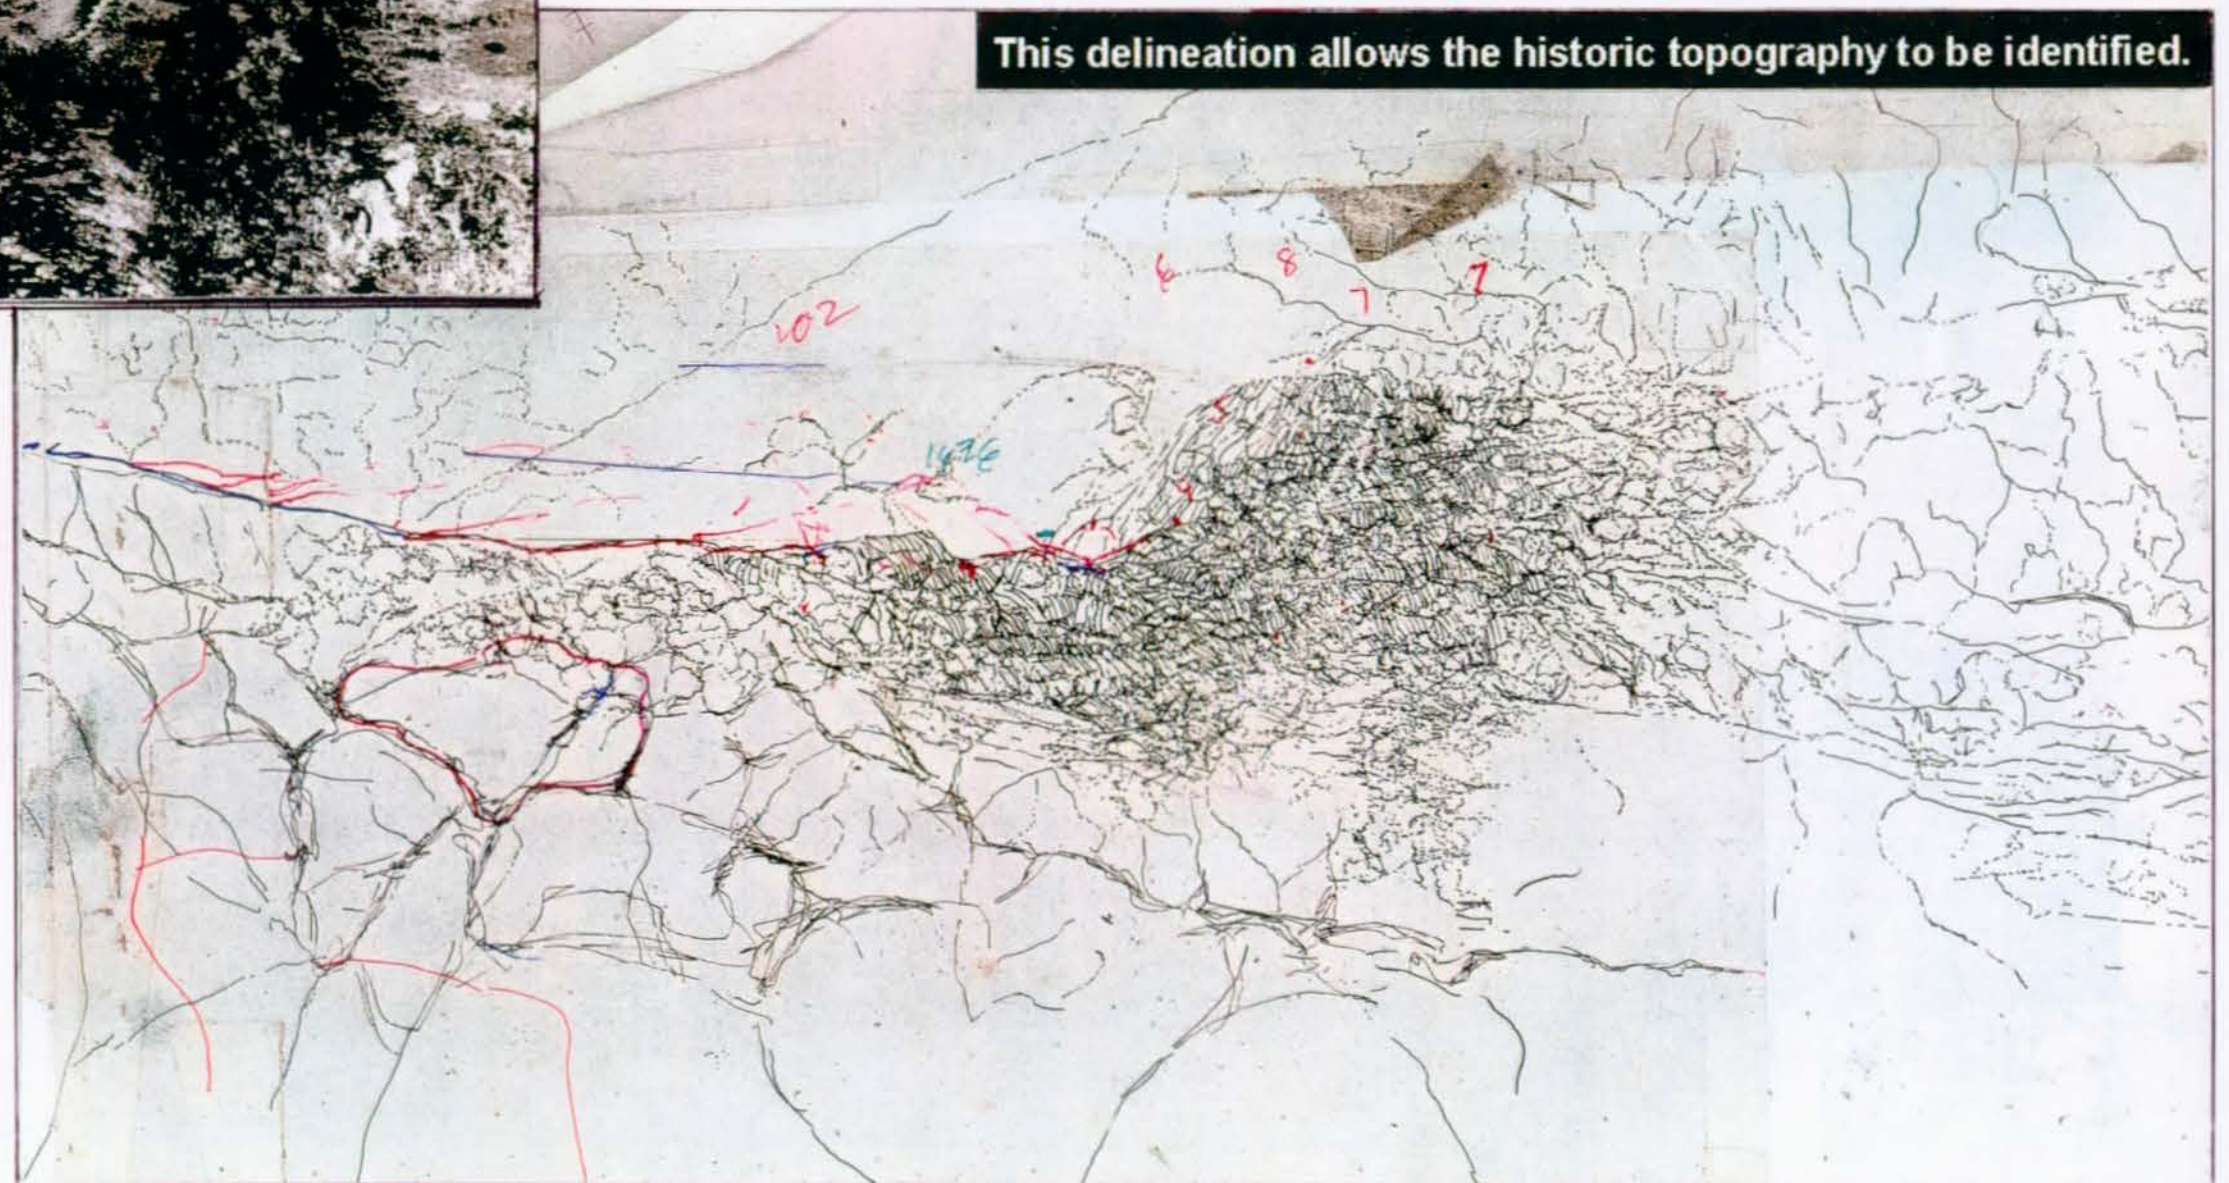
This delineation allows the historic topography to be identified.
