National Park Service
U.S. Department of the Interior

Restoration of Historic Features Cumberland Gap National Historical Park

Wilderness Road
1780-1810

Research methodology for the
"Rediscovery" of historically significant
resources: Procedures developed to
determine their original topography of the
historic saddle of Cumberland Gap and
identify the vertical and horizontal
alignment of the historic road.

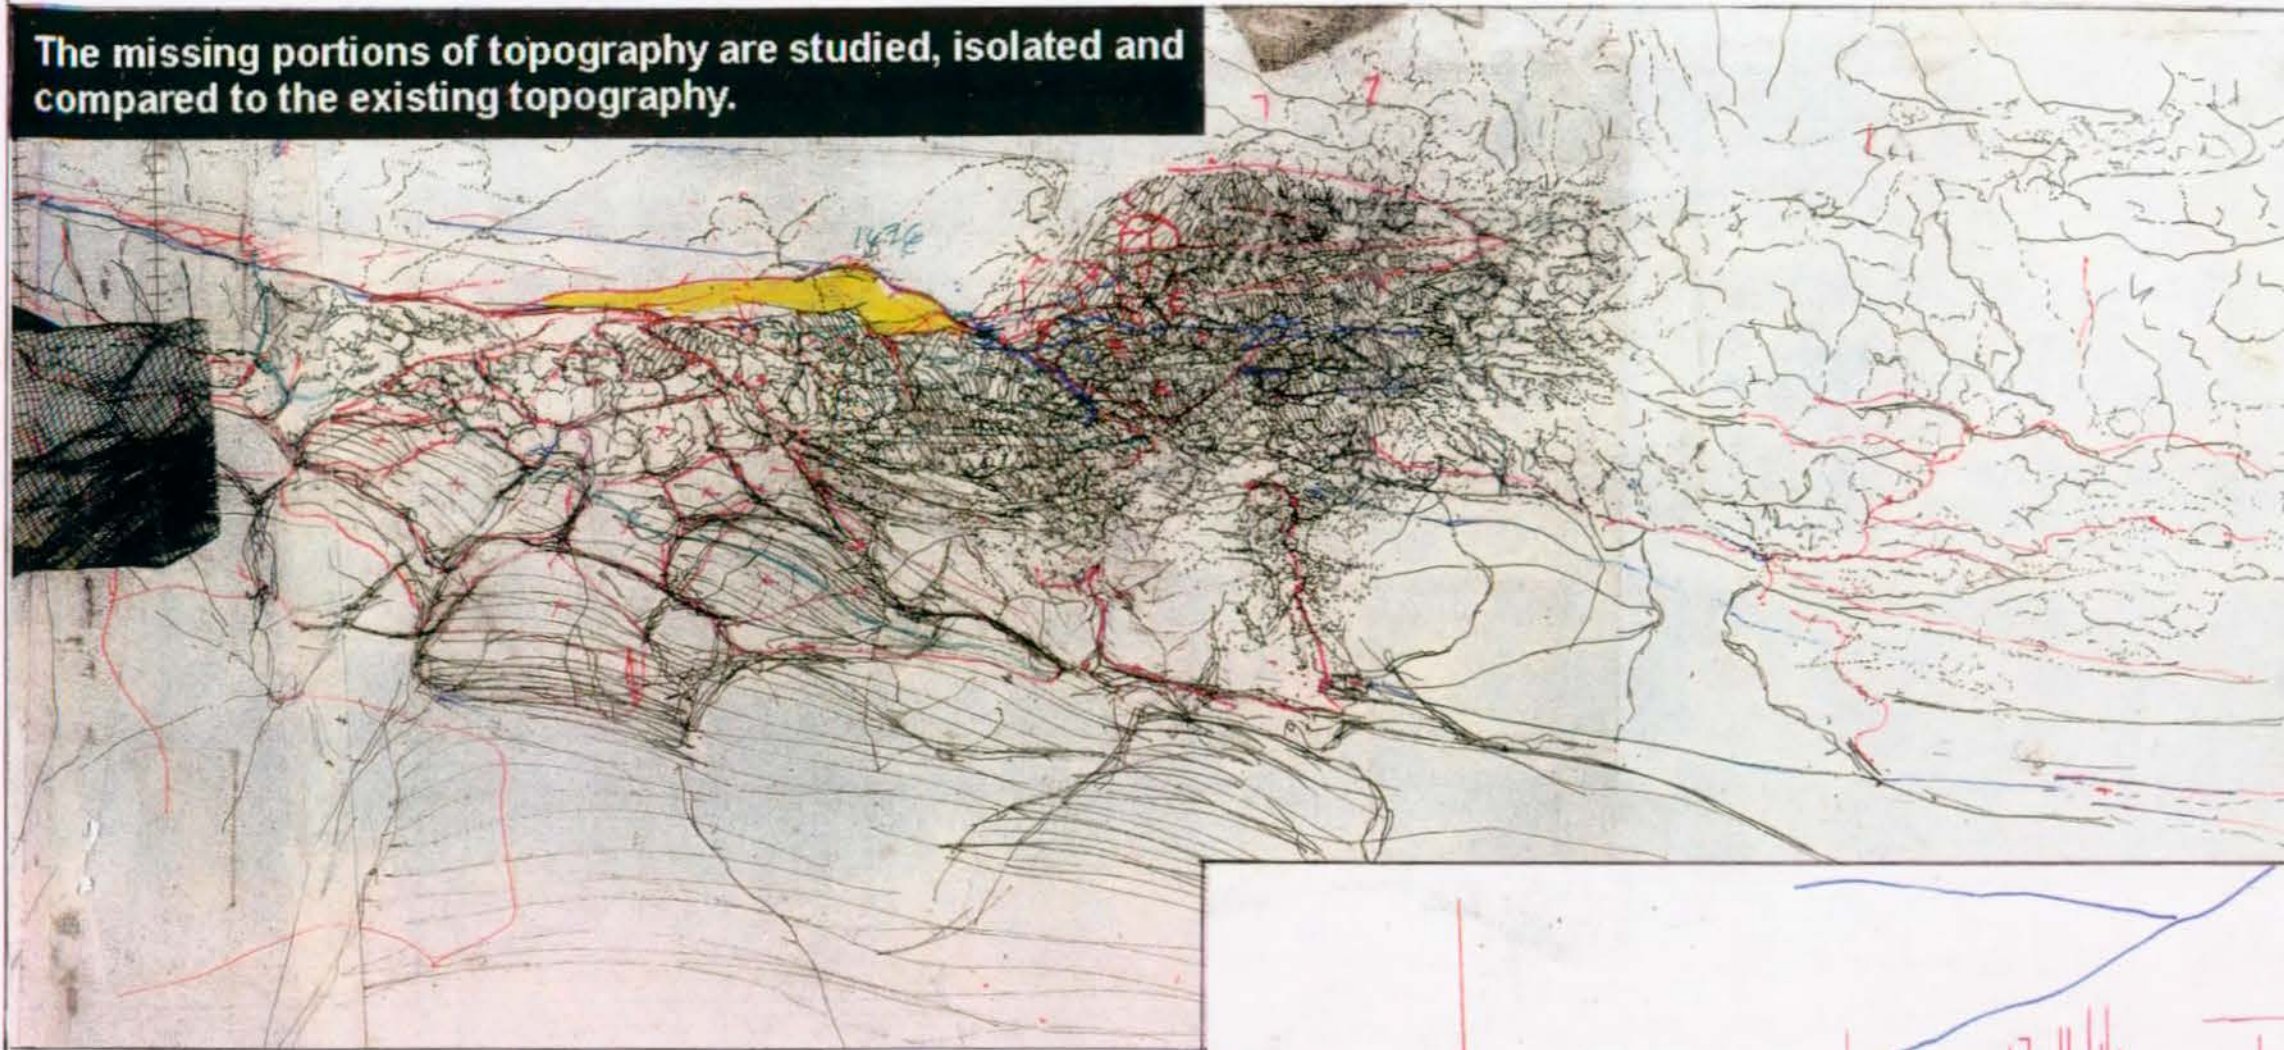
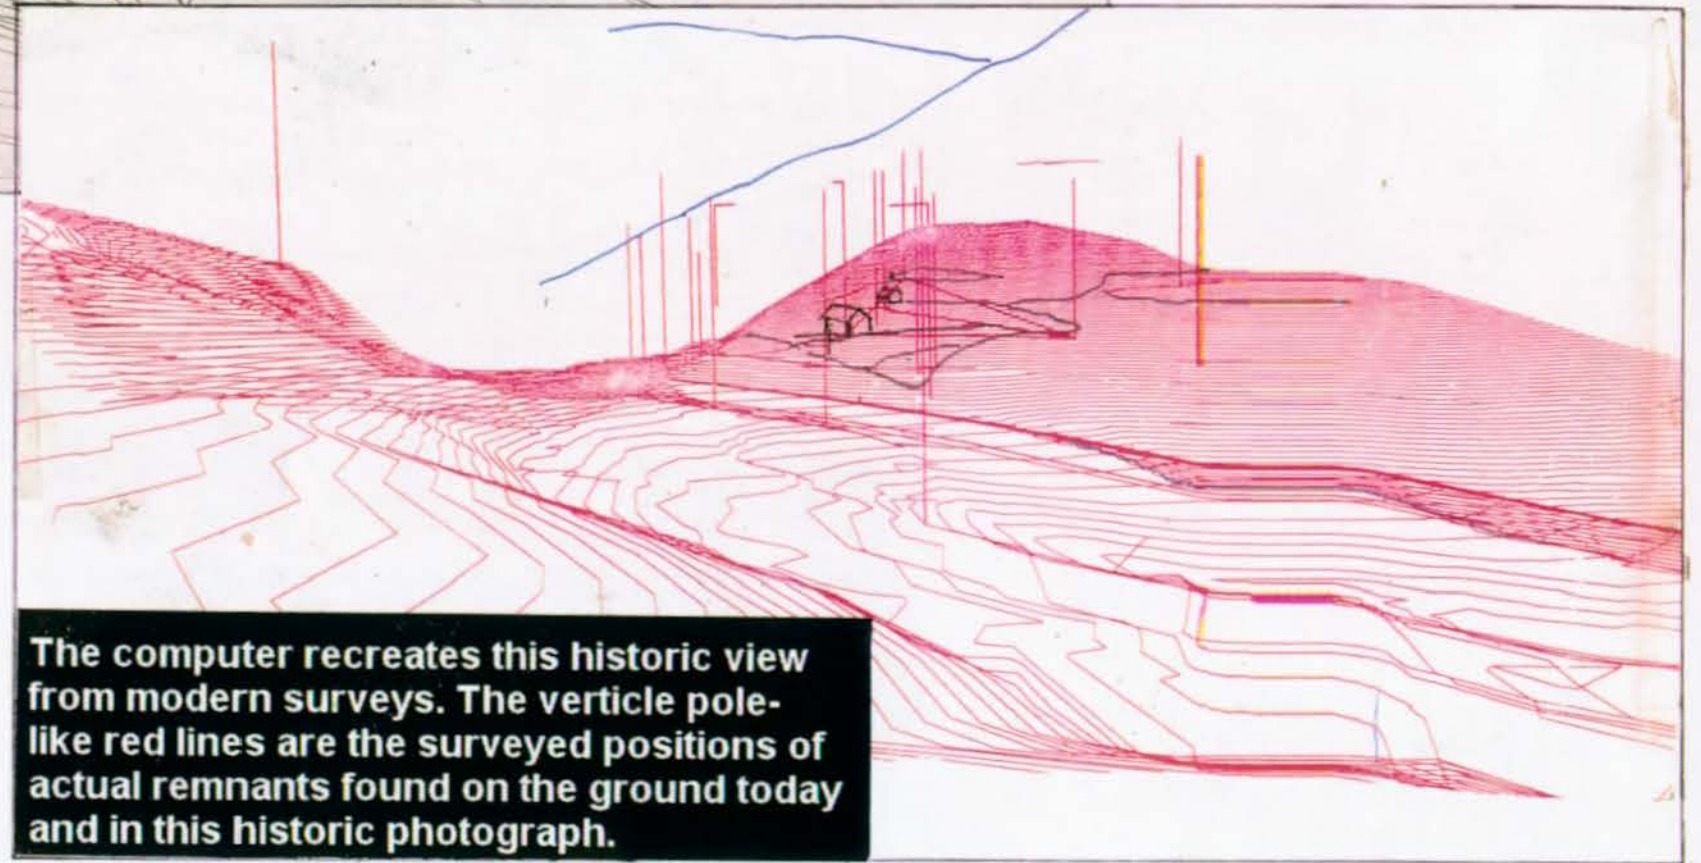
The missing portions of topography are studied, isolated and compared to the existing topography.

The computer recreates this historic view from modern surveys. The verticle pole-like red lines are the surveyed positions of actual remnants found on the ground today and in this historic photograph.

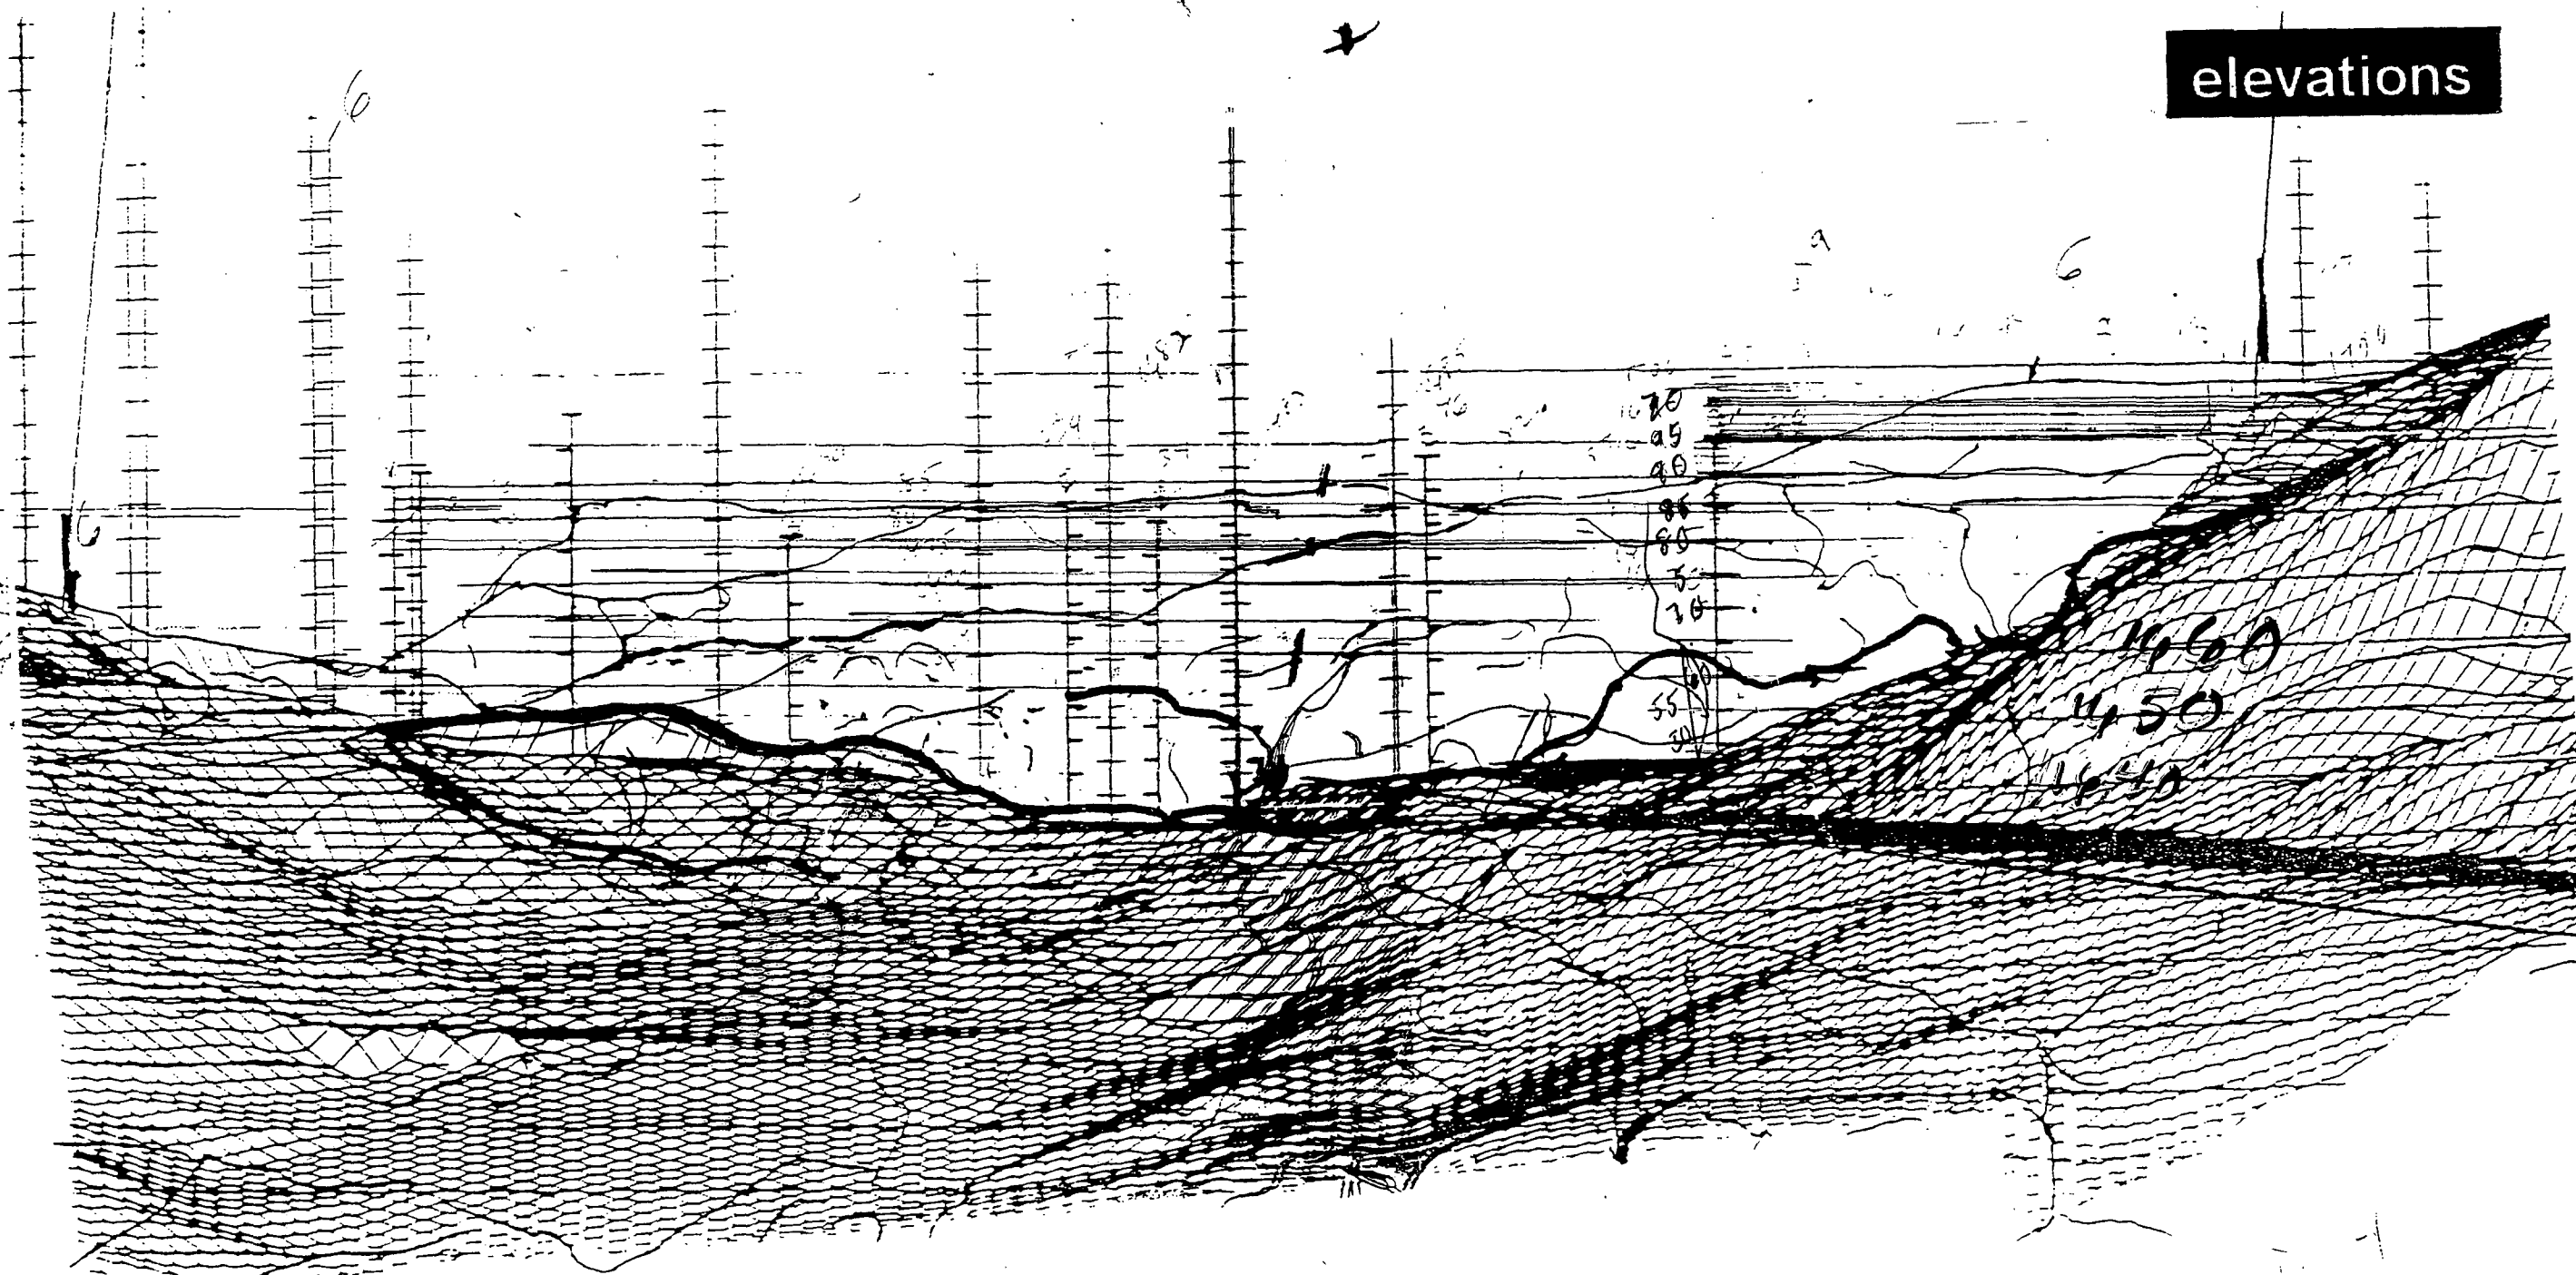
Historic elevations were determined by mechanically drawing intersecting points from a composite of the computer wireframe and major landforms delineated from the 1862 Civil War photograph.

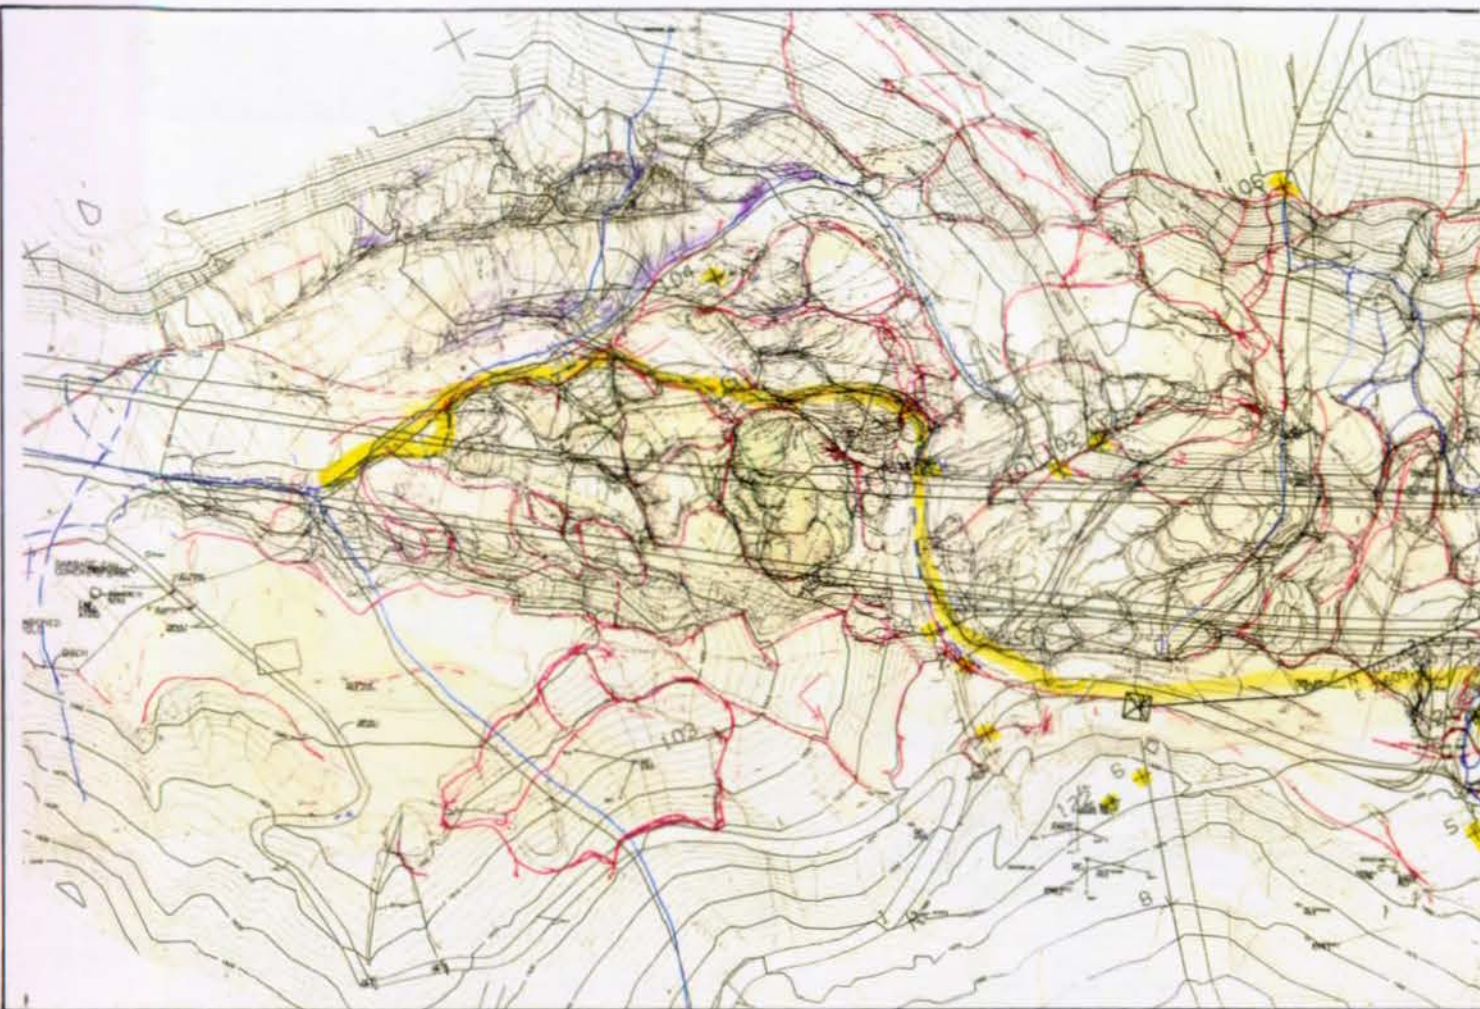
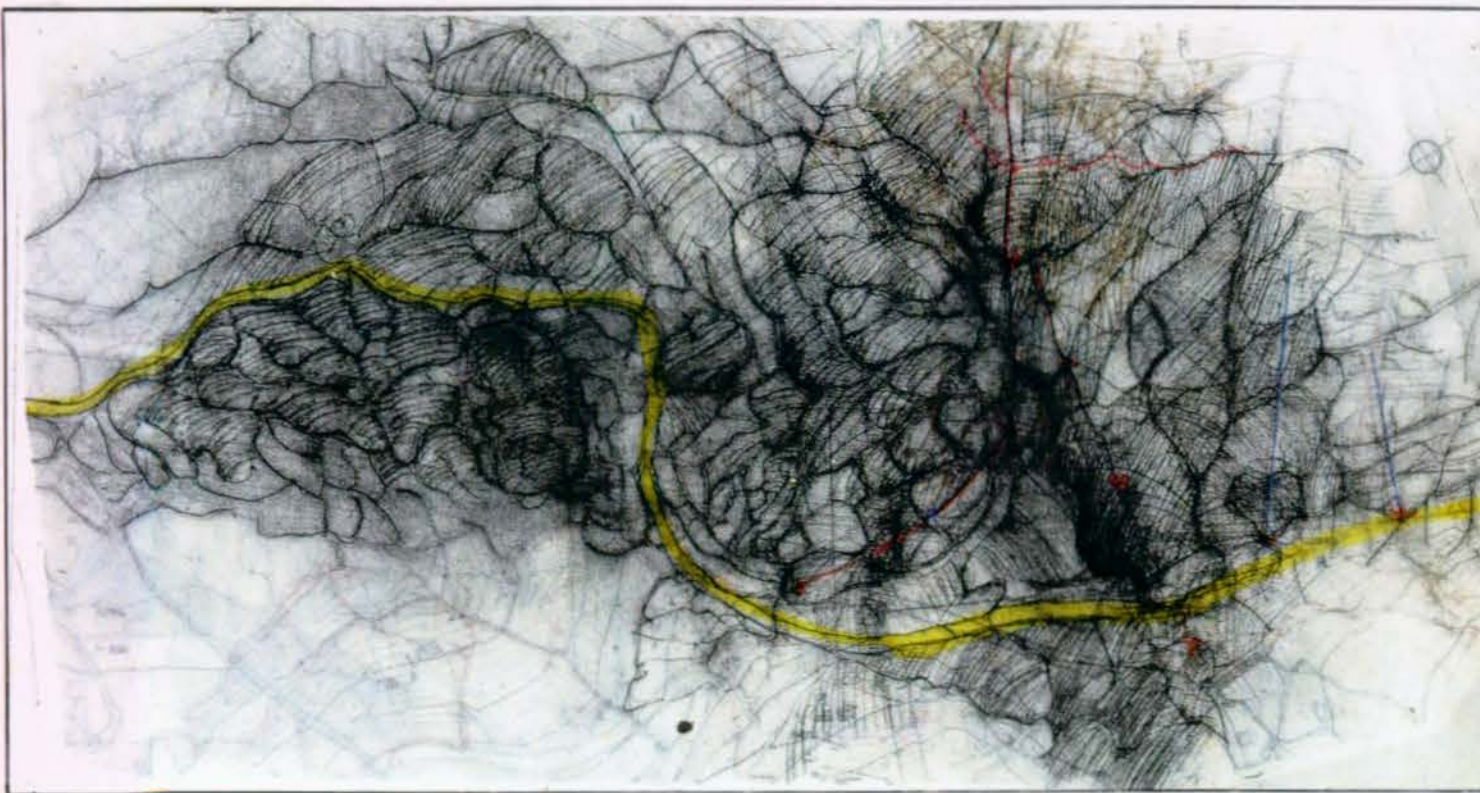
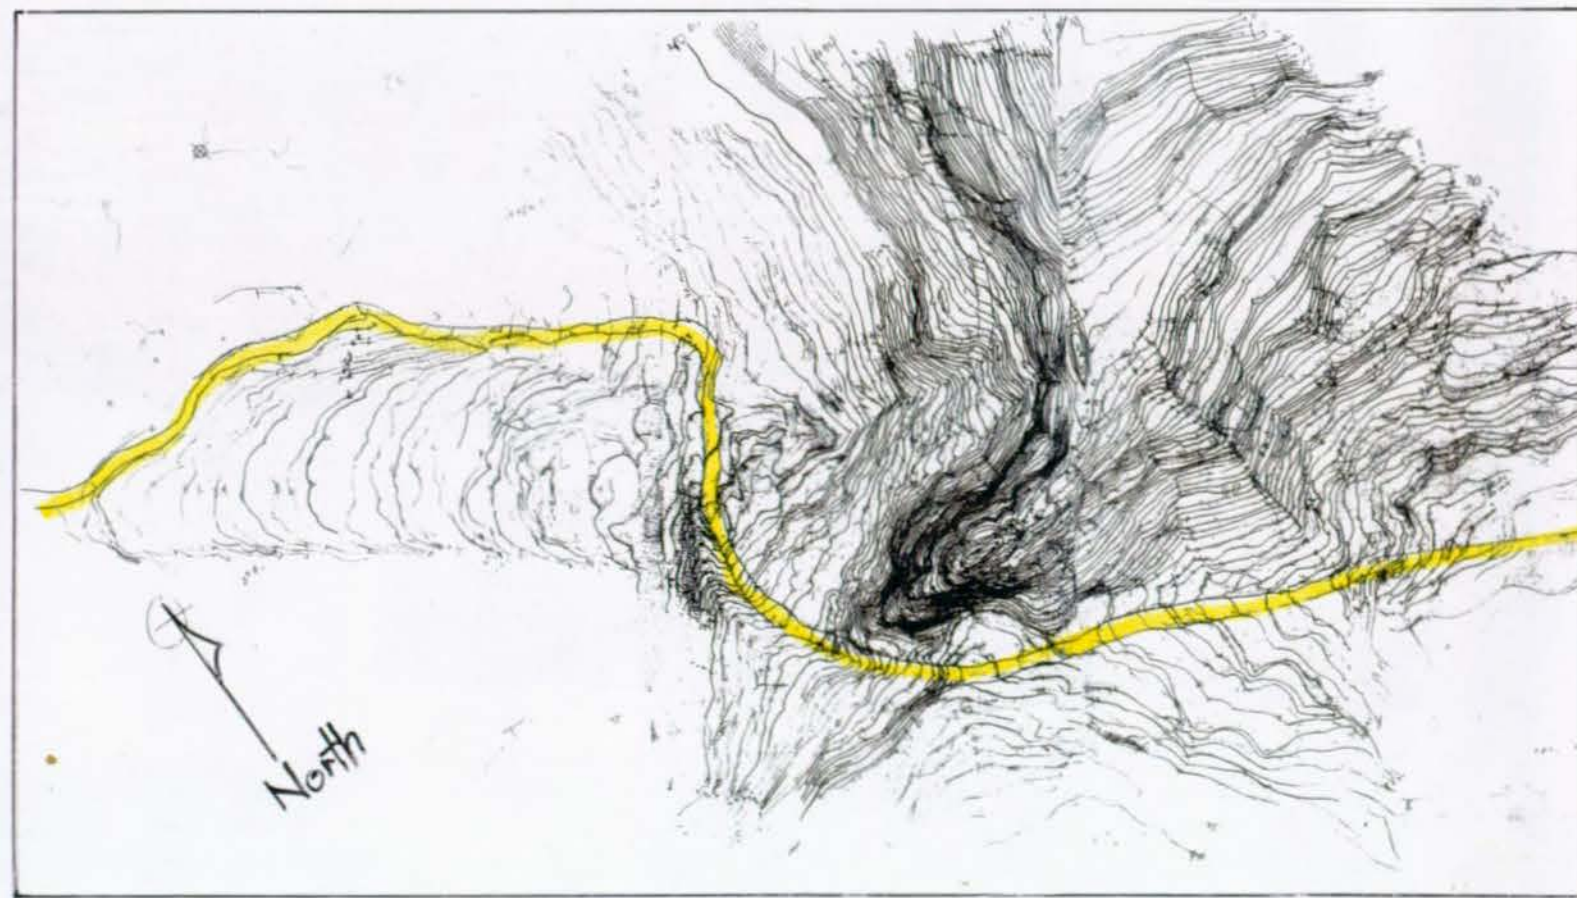
saddle plan view

All three plan view images on this sheet are oriented with Virginia/Tennessee to the right side, Kentucky to the left, and north at the top. The shapes in the left hand images evolved into the contour map on the right hand side. Determining what topography was missing resulted from intense cross checking and melding of all the different sources of information - historic and recent surveys, photographs, and maps; field discovery; graphic enhancement and delineation in the studio. This sheet shows three stages of refinement overlaying modern surveys, which were eventually put into a format that could be computerized. Once the information was in the computer, the three-dimensional wireframe output was then cross checked against the historic photographs for accuracy. The final result was a grading plan in 1790 contours which were added into Federal Highway Administration contract drawings.

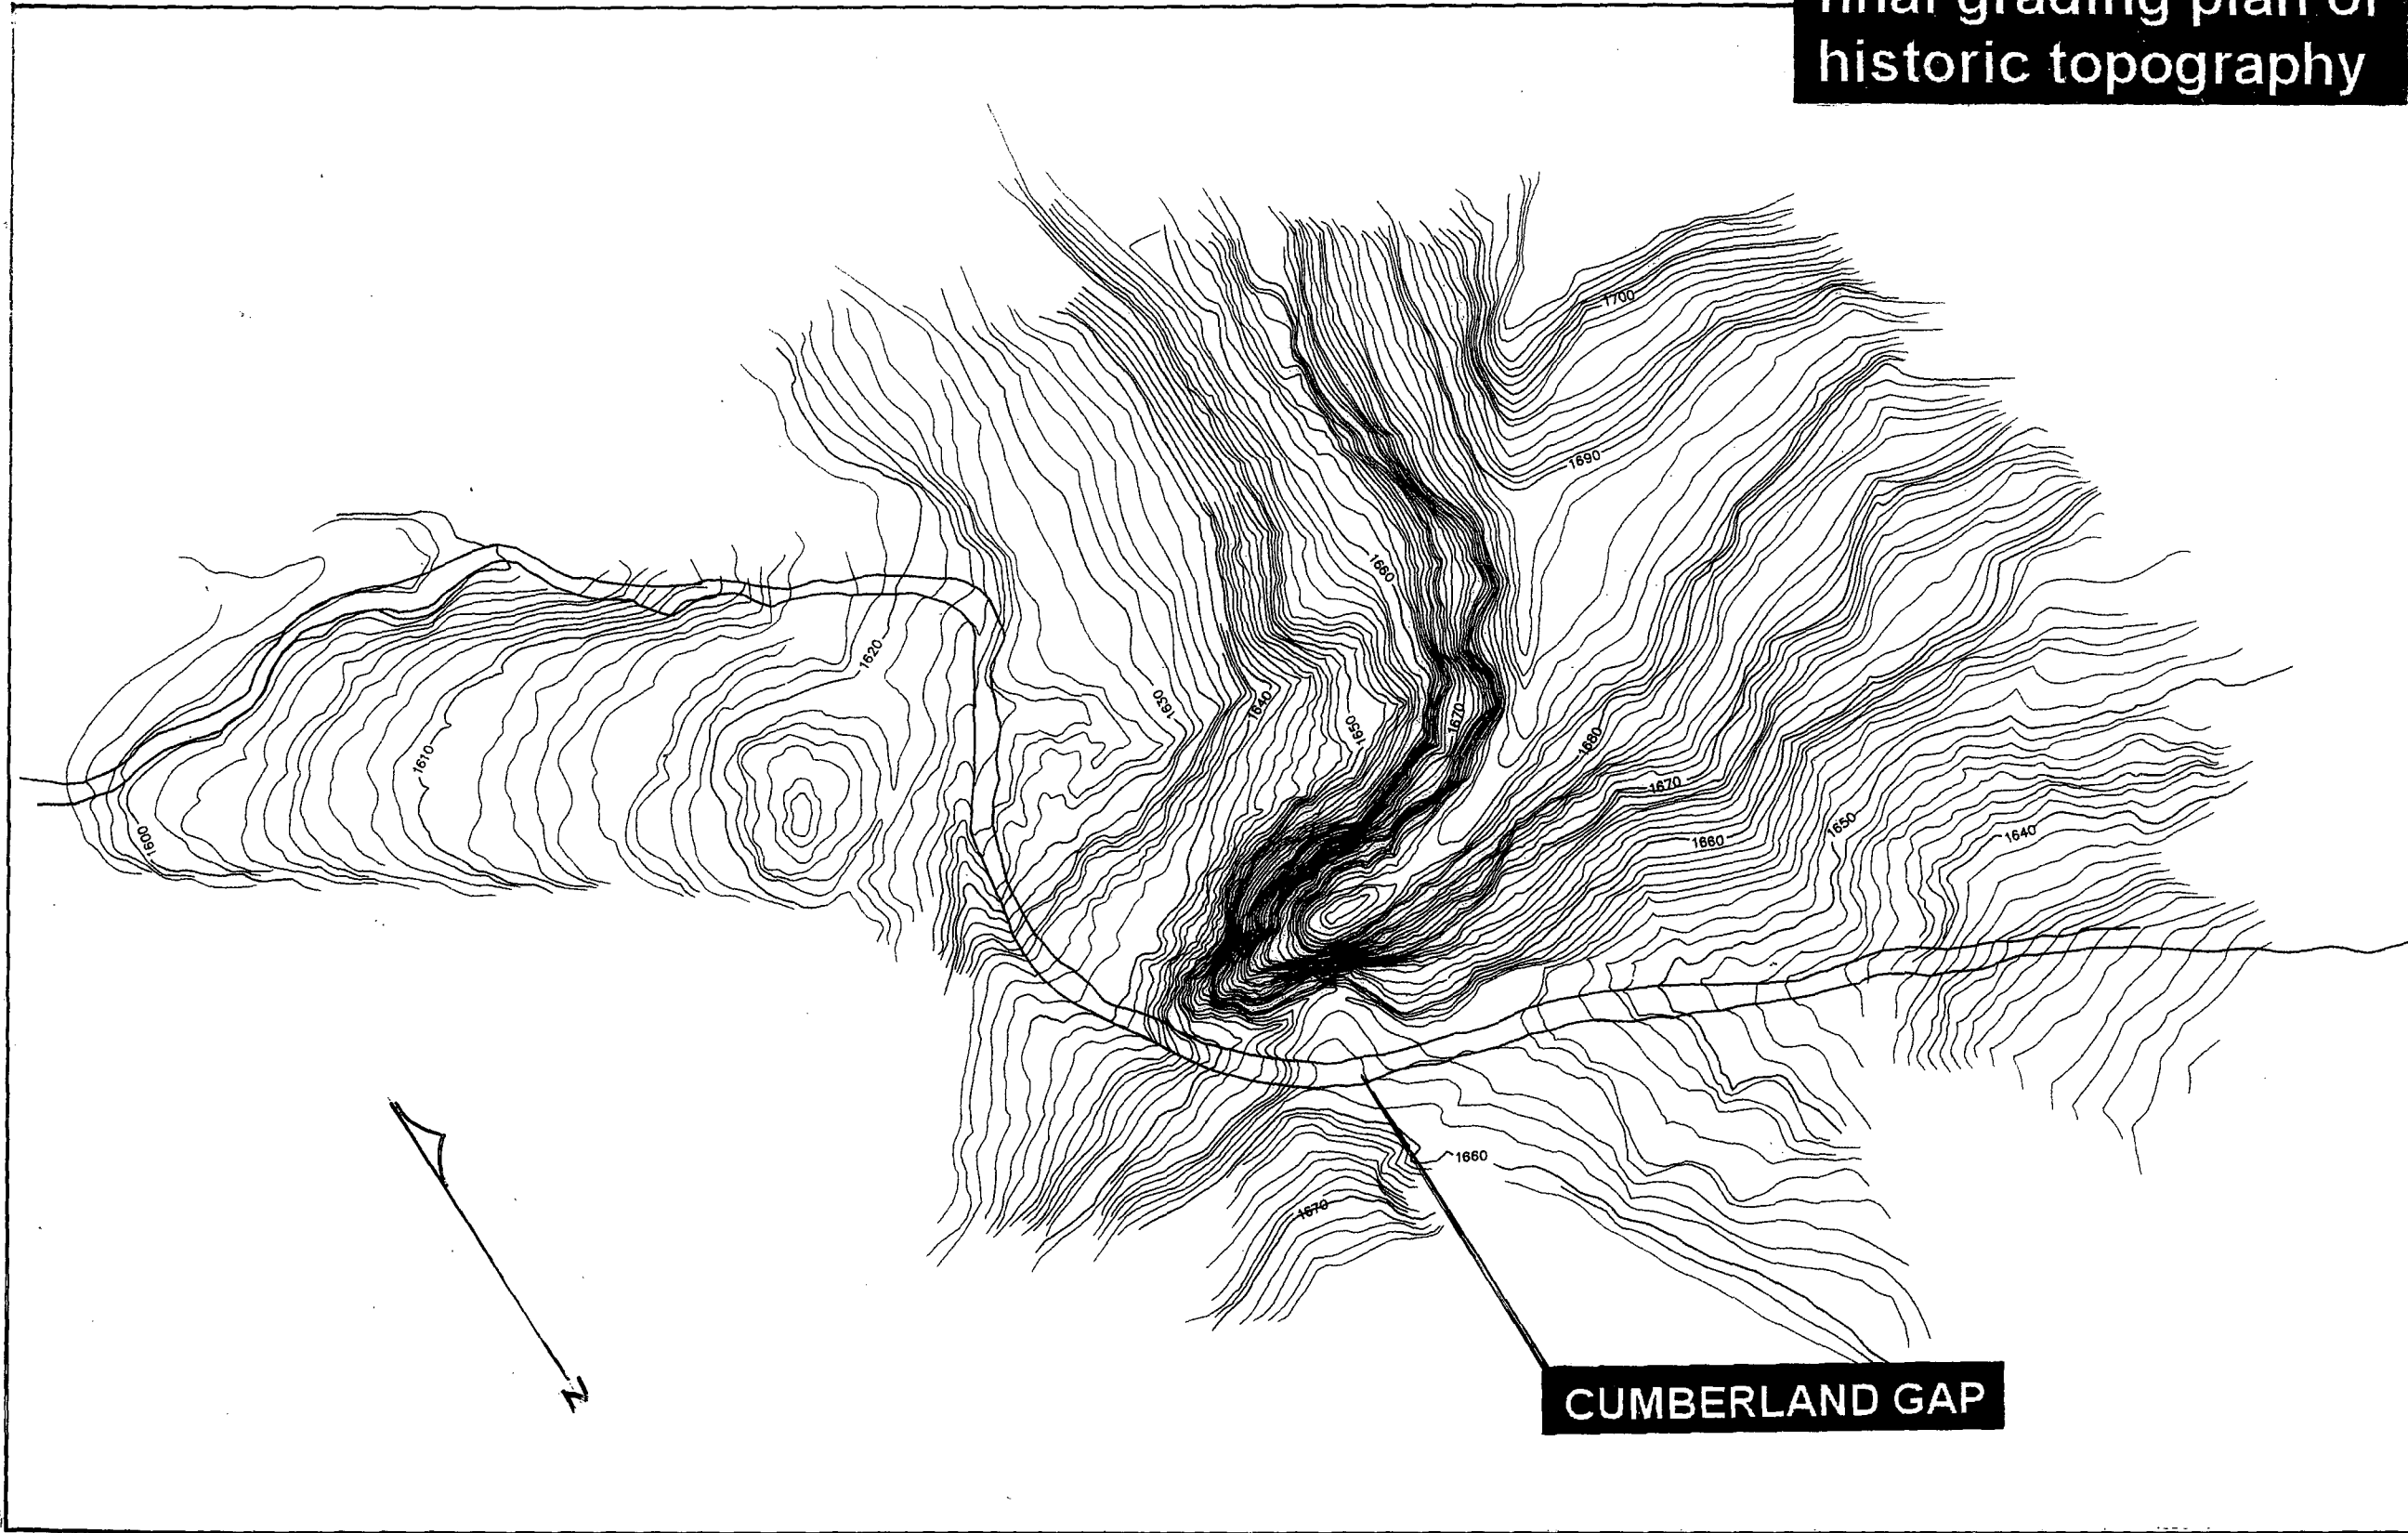
final grading plan of
historic topography

This final step of refinement shows how accurate the (graphic) rehabilitation of the Gap is. The grading plan from the previous sheet has been transformed into a computerized wireframe image. The image is shown from the same viewpoint as the 1862 Civil War photograph, from Tennessee, looking northwest to the Gap and toward Kentucky. This view nearly matches the red horizon line taken from the 1862 photograph. Considering the age and quality of the source materials, tempered by 200 years of erosion and man-caused landscape modifications, this slight deviation, caused by the computer's skewed viewpoint, is as accurate as anyone will ever achieve.

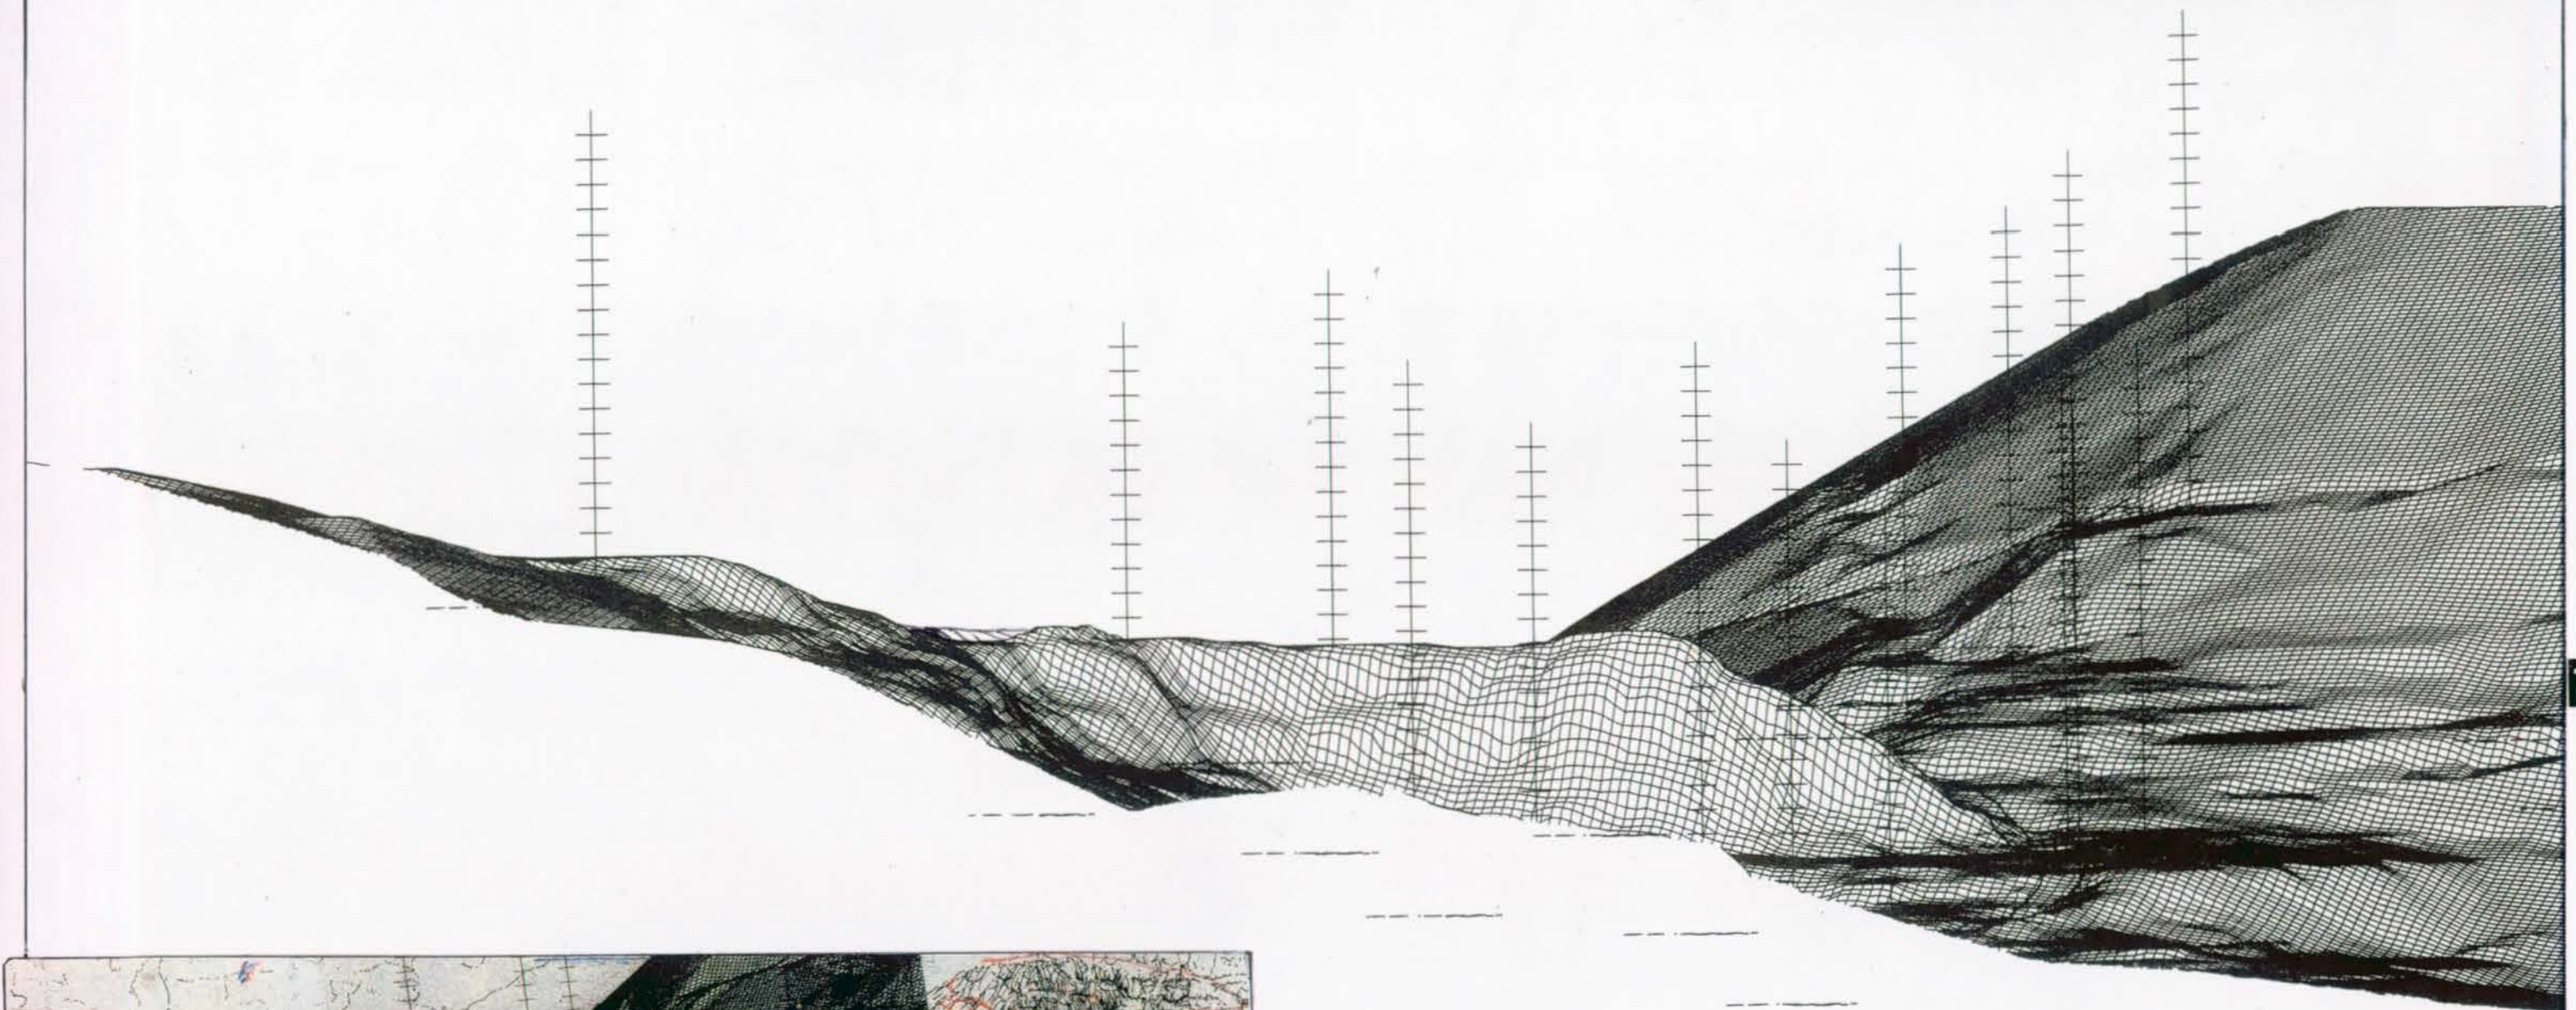
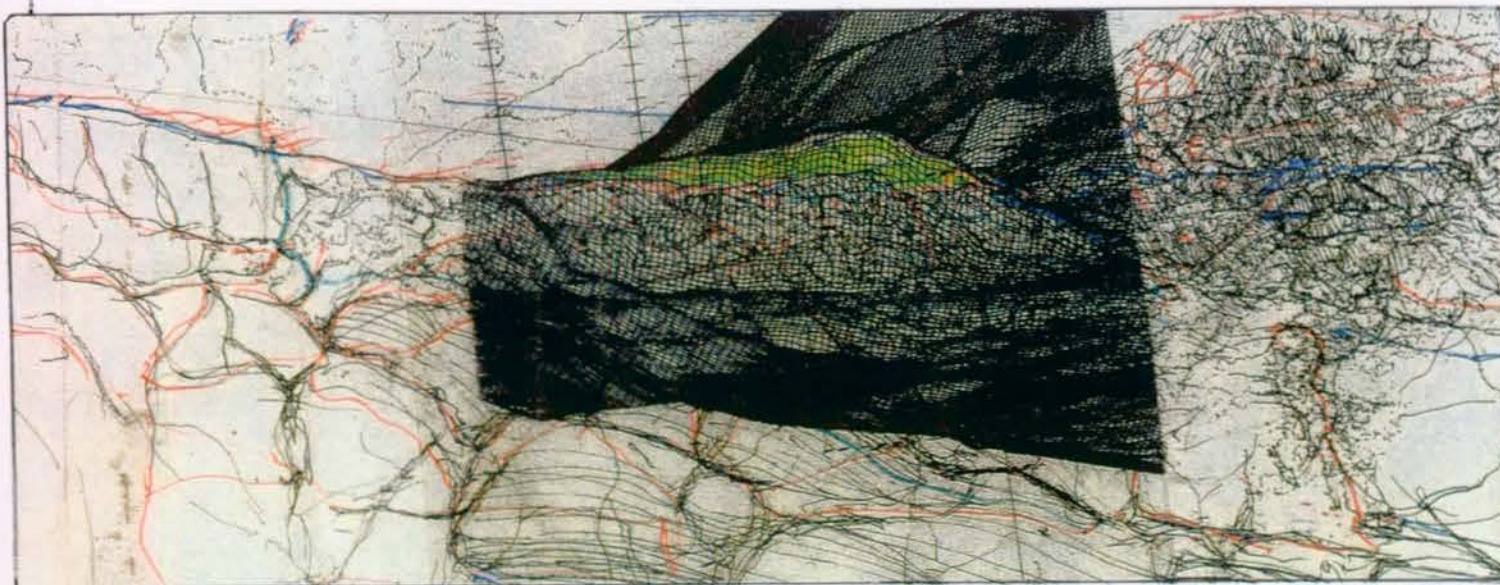
view south to the saddle
COMPUTER CHECKS FINAL GRADING PLAN

The Kentucky side was also checked by the computer to insure that the grading plan was not only historically correct from the Virginia/Tennessee side of the Gap but that it also matched the Kentucky side of the mountain.

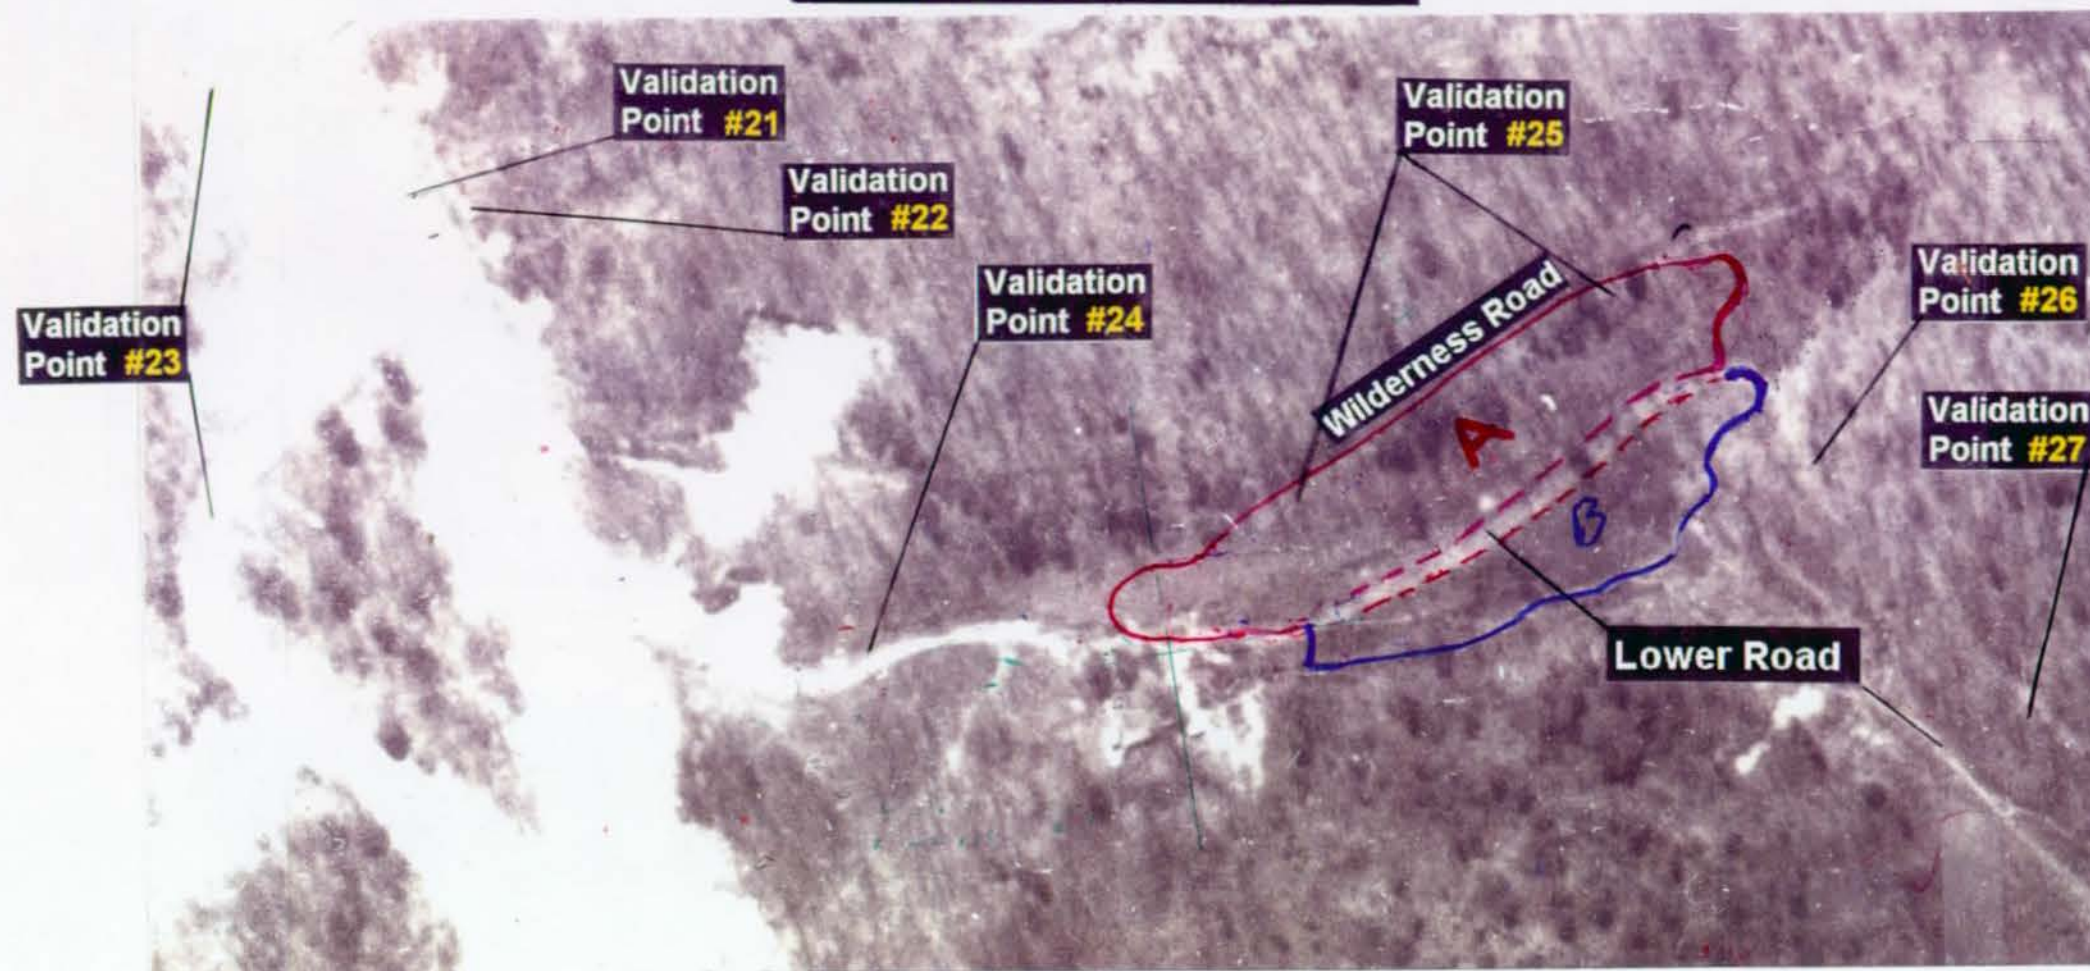
Lower road access was not possible for wagons without the removal of a large amount of earth, which permitted entry to the lower drainage. Even more restrictive was the steepness of the descent from the lower road. Railroad construction probably cut off the slow natural descent around 1880. By this time, more modern road building methods had been developed, and the lower road was built. Another basic reason is that no historic mapping matching any ground evidence has been found. The alignment, without more modern construction to compensate for the steepness, would have resulted in many curves in the configuration.
