**NATIONAL REGISTER OF HISTORIC PLACES
INVENTORY -- NOMINATION FORM**

HISTORIC Abraham Ulyatt House

Abraham Ulyatt House, Valley View, Cuyahoga County, Ohio

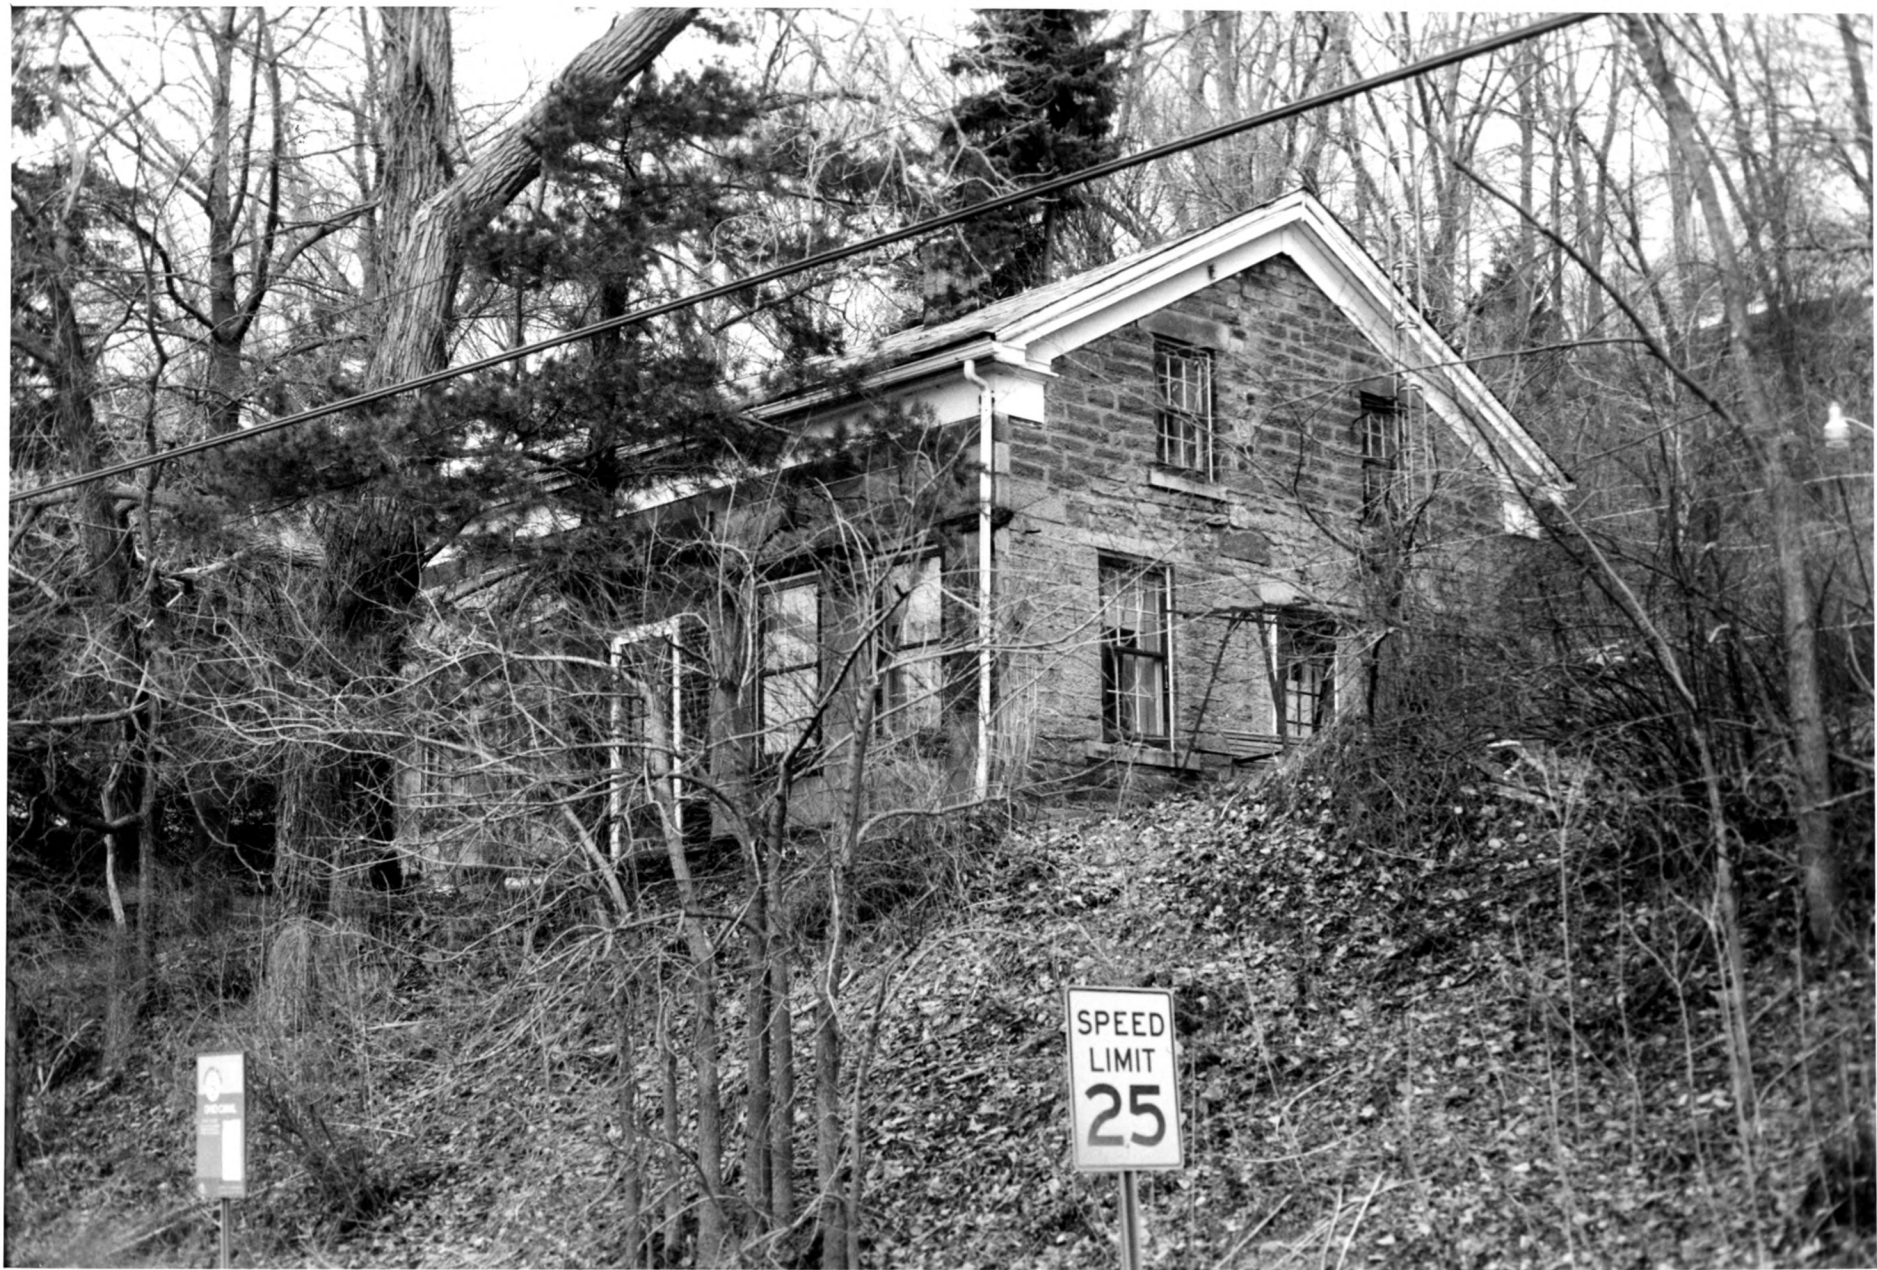
Ulyatt House photo #1 of 4

Facade and south elevation looking
northeast

The Abraham Ulyatt House is a one-and-one-half-story rectangular sandstone house in the Greek Revival style. The house has a five-bay facade with a central entrance. It has a wide, plain frieze and a gable roof with gable returns. The roof is covered with asphalt shingles. The house is constructed of plain ashlar sandstone and has a cut stone water table with beveled edge. The house is built into the side of a hill over a spring, traces of which still may be seen in the basement. The windows are double-hung, with 6/6 lights, and have dressed stone sills and lintels.

Curiously, the top third of the rear (east) wall is made of clapboard siding; one can only speculate that the builder had to finish the house with wood in the least conspicuous place. The south elevation features a central door flanked by windows. Irregular stonework above the door and windows indicates that, the present owner claims, there once was a porch that extended the full width of this wall.

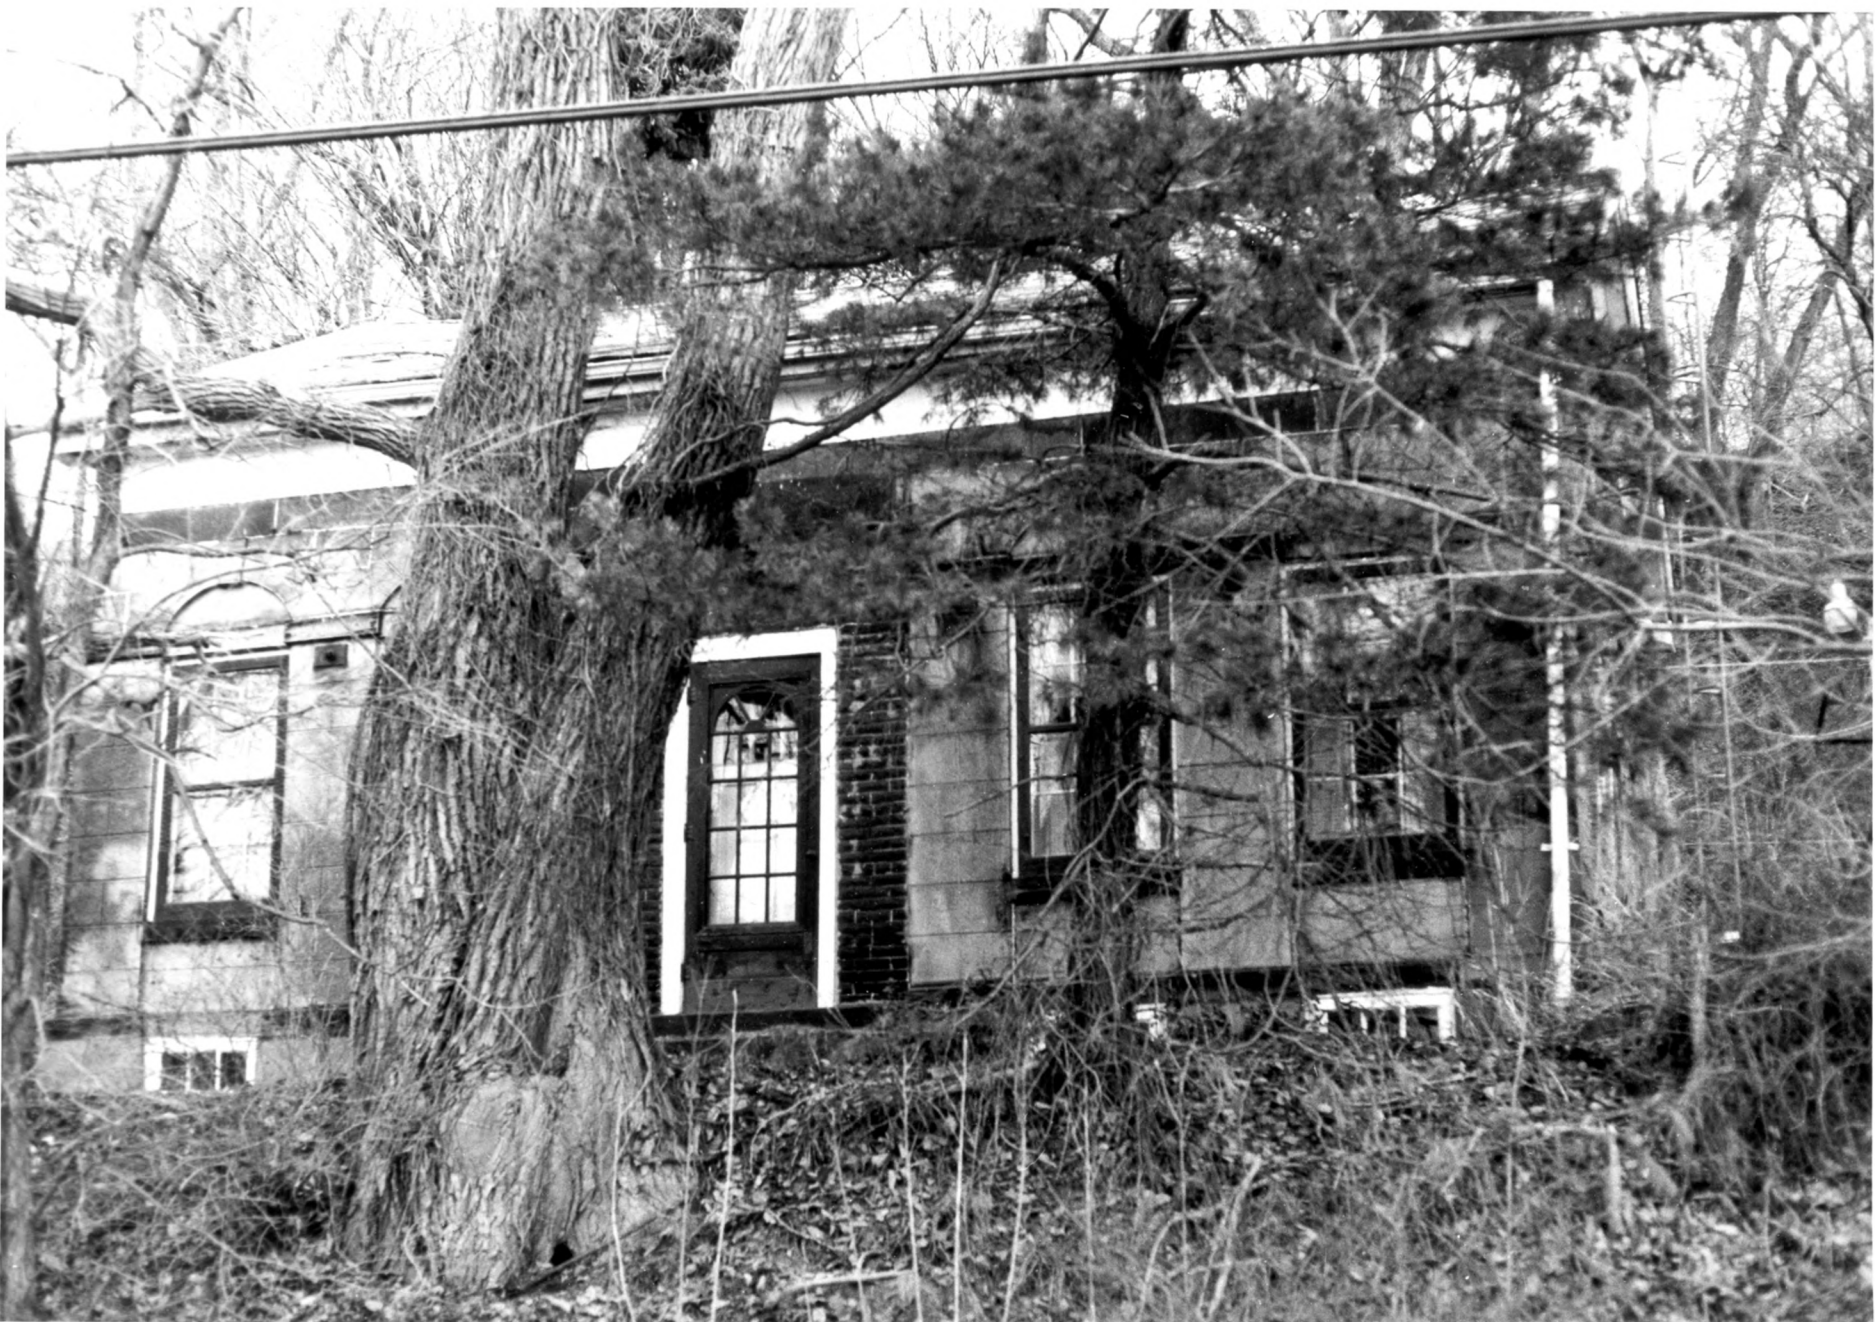
Ulyatt House photo #2 of 4

Facade looking northeast

The facade features tooled stone with margins. The entrance originally had a transom and flanking pilasters. According to the present owner, the pilasters became loose and fell off sometime during the early 1900s and were never replaced; the present red brick was used to fill the void and to close up the transom light.¹ Above this is a projecting molded cornice set beneath a projecting stone lintel. In relief are simplified acroteria flanking a central gable. Flanking the door are paired double-hung windows with 6/6 lights that are connected by a continuous lintel. The windows are set within round arch recesses. The round arches contain voussoirs with projecting keystones. There are smooth stone transoms. The windows are divided by stone pilasters. The pilasters have been chiseled with an ashlar pattern to give the appearance of having been laid individually with mortar.

The design of the facade is especially notable for its originality. The windows are recessed within round arches that contain voussoirs and projecting keystones. Pilasters dividing the windows are chiseled with an ashlar pattern to give the effect of individual stones laid with mortar. Such features suggest that the house was designed by a person with considerable talent and imagination.

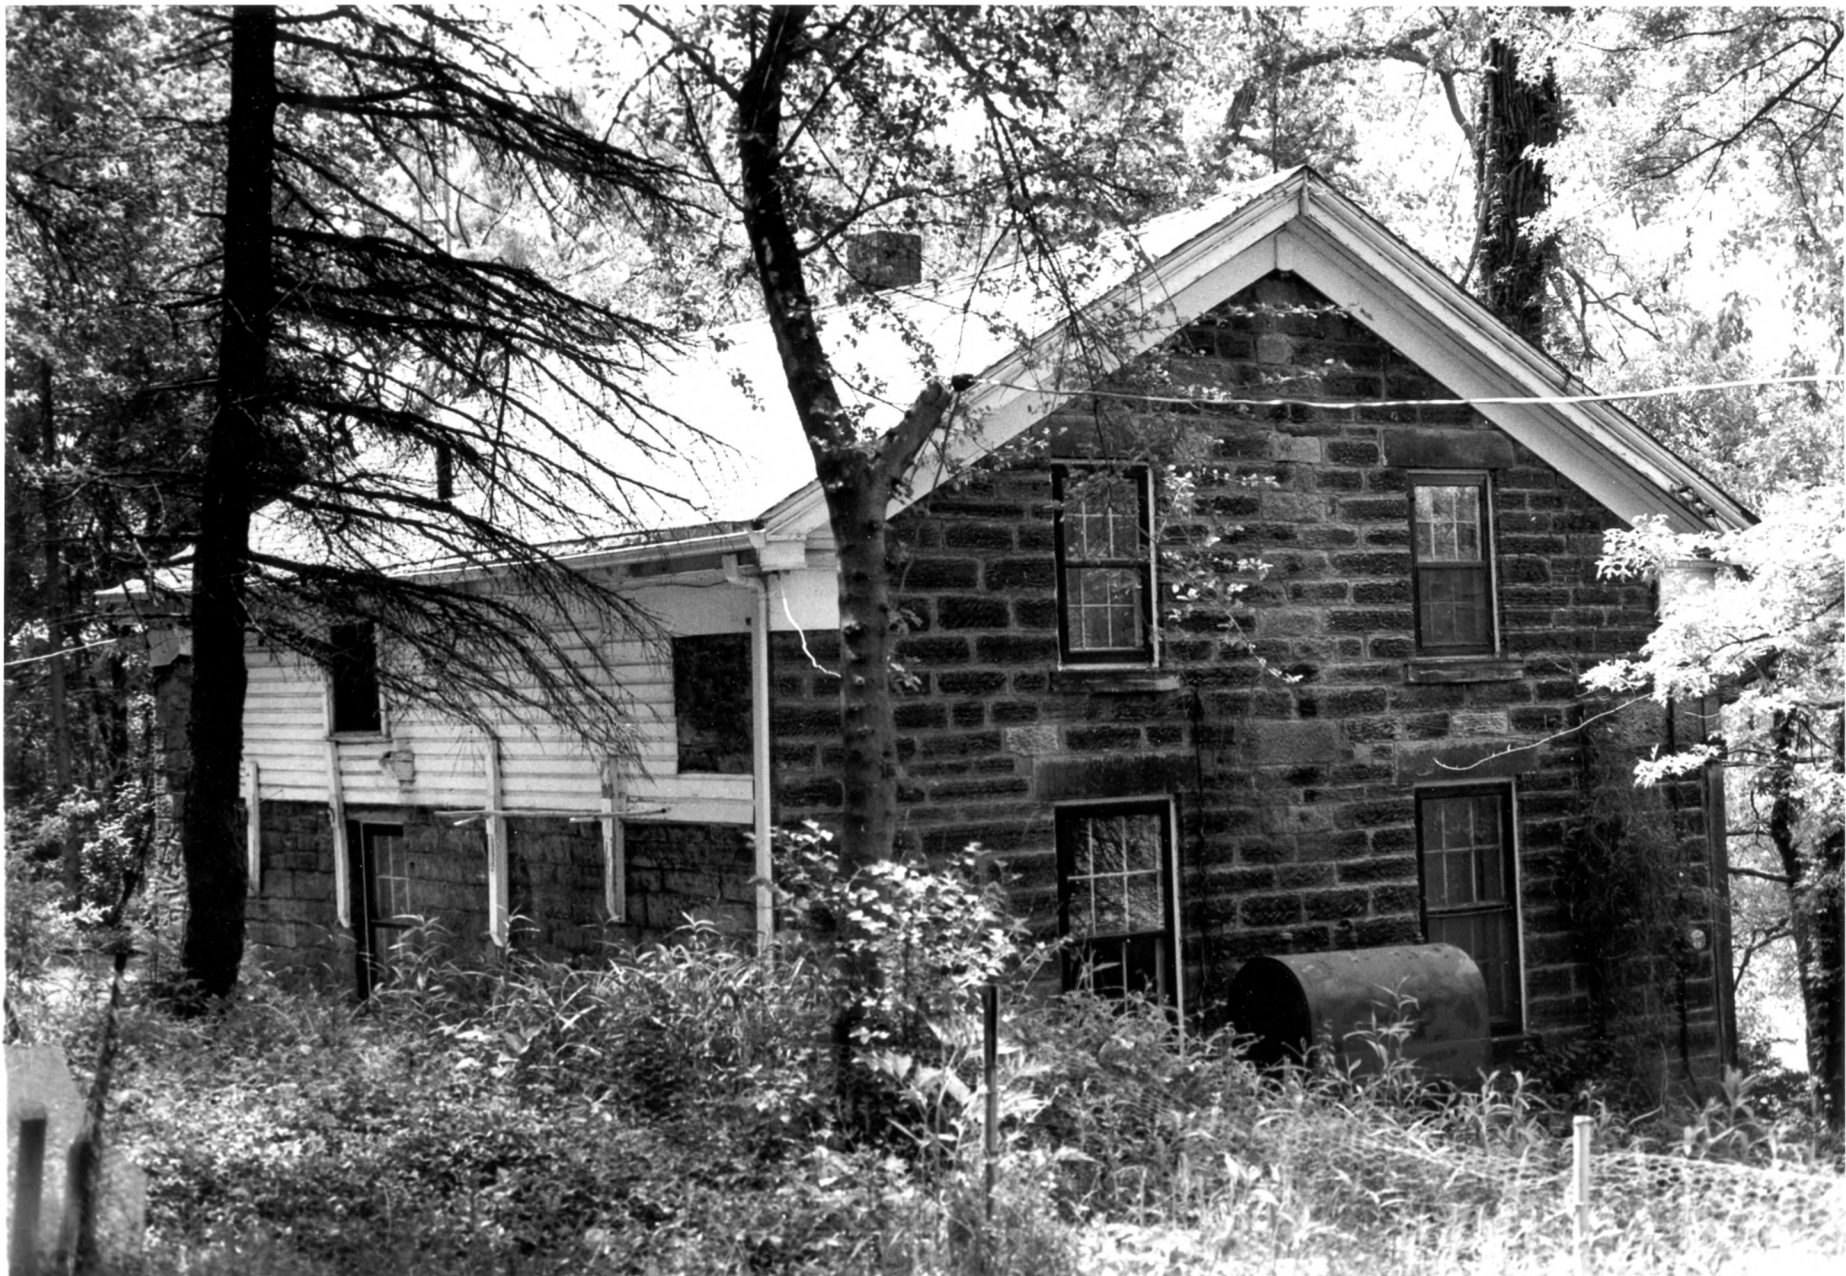
Ulyatt House photo #4 of 4

North and east elevations looking
southeast

The Ulyatt House is an anomaly, however, for while the facade is quite refined--even elegant--the rest of the house is rather crude. The rear and side walls suggest a rustic stone cabin. One-third of the rear wall is finished with clapboard siding instead of stone. The stonework beneath the half-story windows in the south wall is rough and irregular. There was once a porch here, and the stone may have been covered (with stucco, for example), or the builder may have intended eventually to construct an addition to the house.
