**NATIONAL REGISTER OF HISTORIC PLACES
INVENTORY -- NOMINATION FORM**

HISTORIC Daniel Tilden house

STREET & NUMBER 2325 Stine Road

Tilden, Daniel, House, Peninsula, Summit County, Ohio

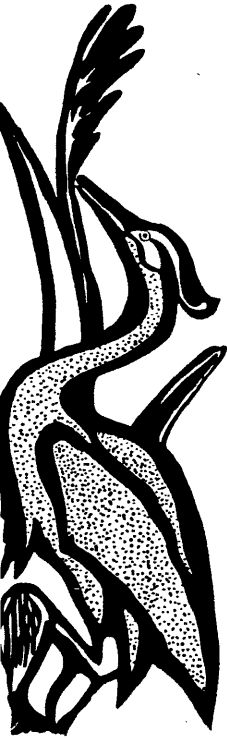
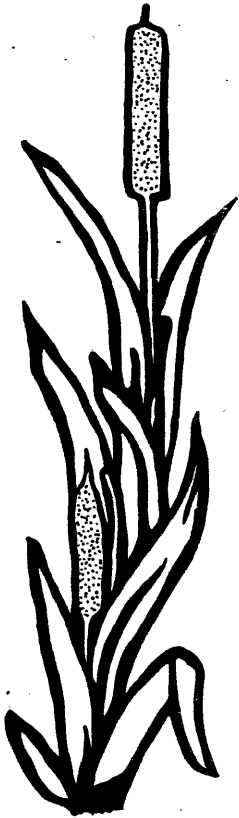
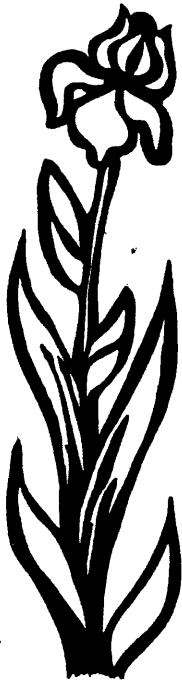
1 TYPICAL MOLDING CARVINGS
N.T.S.

NOTE THESE CARVINGS ARE TO BE USED AS THE HOUSE ARE ALIKE

With the exception of the additions mentioned above, the interior plan configuration has not been altered. Each doorway and window is framed in an elaborate casing of decorative white oak. The wood is purported to have been cut from the site, sawn in Cleveland, and then carved back on the site. The bases of many of these massive casings feature hand-carved and wood-burned depictions of natural scenes (birds, flowers, etc.) no two of which are identical. Much of the original door and window hardware also remains throughout the house.

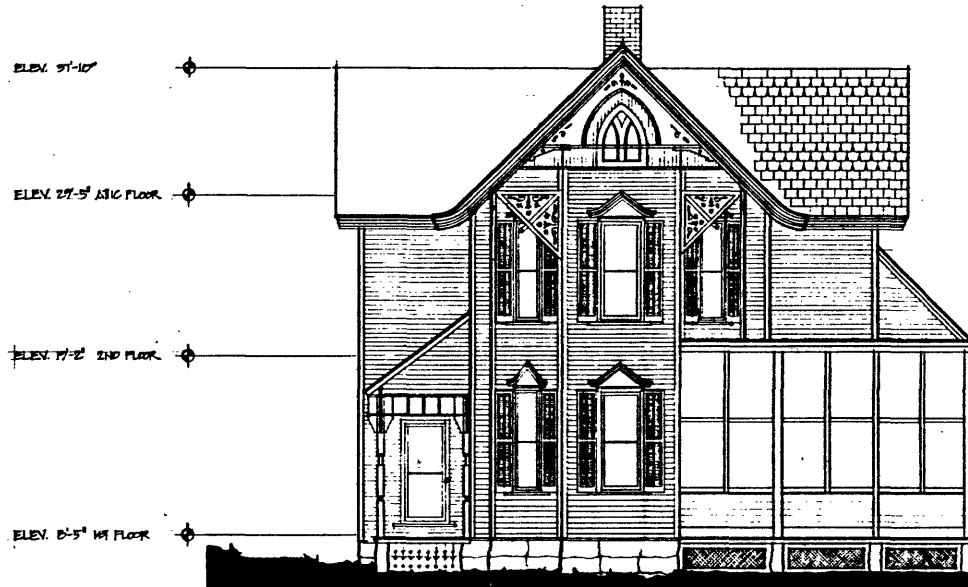
1 SOUTH ELEVATION
SCALE 1/8" = 1'-0"

- ALL ROOFS SLATE EXCEPT GARAGE
- CHIMNEY IN NEED OF REPAIR
- VARIOUS EXTERIOR DETAILS IN NEED OF REPAIR
- BARNSTONE FOUNDATIONS
- ALL GUTTERS & DRAINSPOUTS IN NEED OF REPLACEMENT

The roof of the house is slate. The original portion of the building features a subtle imbrication of alternating rows of rectangular and hexagonal slates; this decorative pattern of roof slates is repeated in the 1888 addition. Asphalt shingles cover the roof of the garage. The exterior of the entire structure is covered with horizontal coved shiplap siding. The foundations of the house are large blocks of coursed sandstone; the garage foundation is concrete.

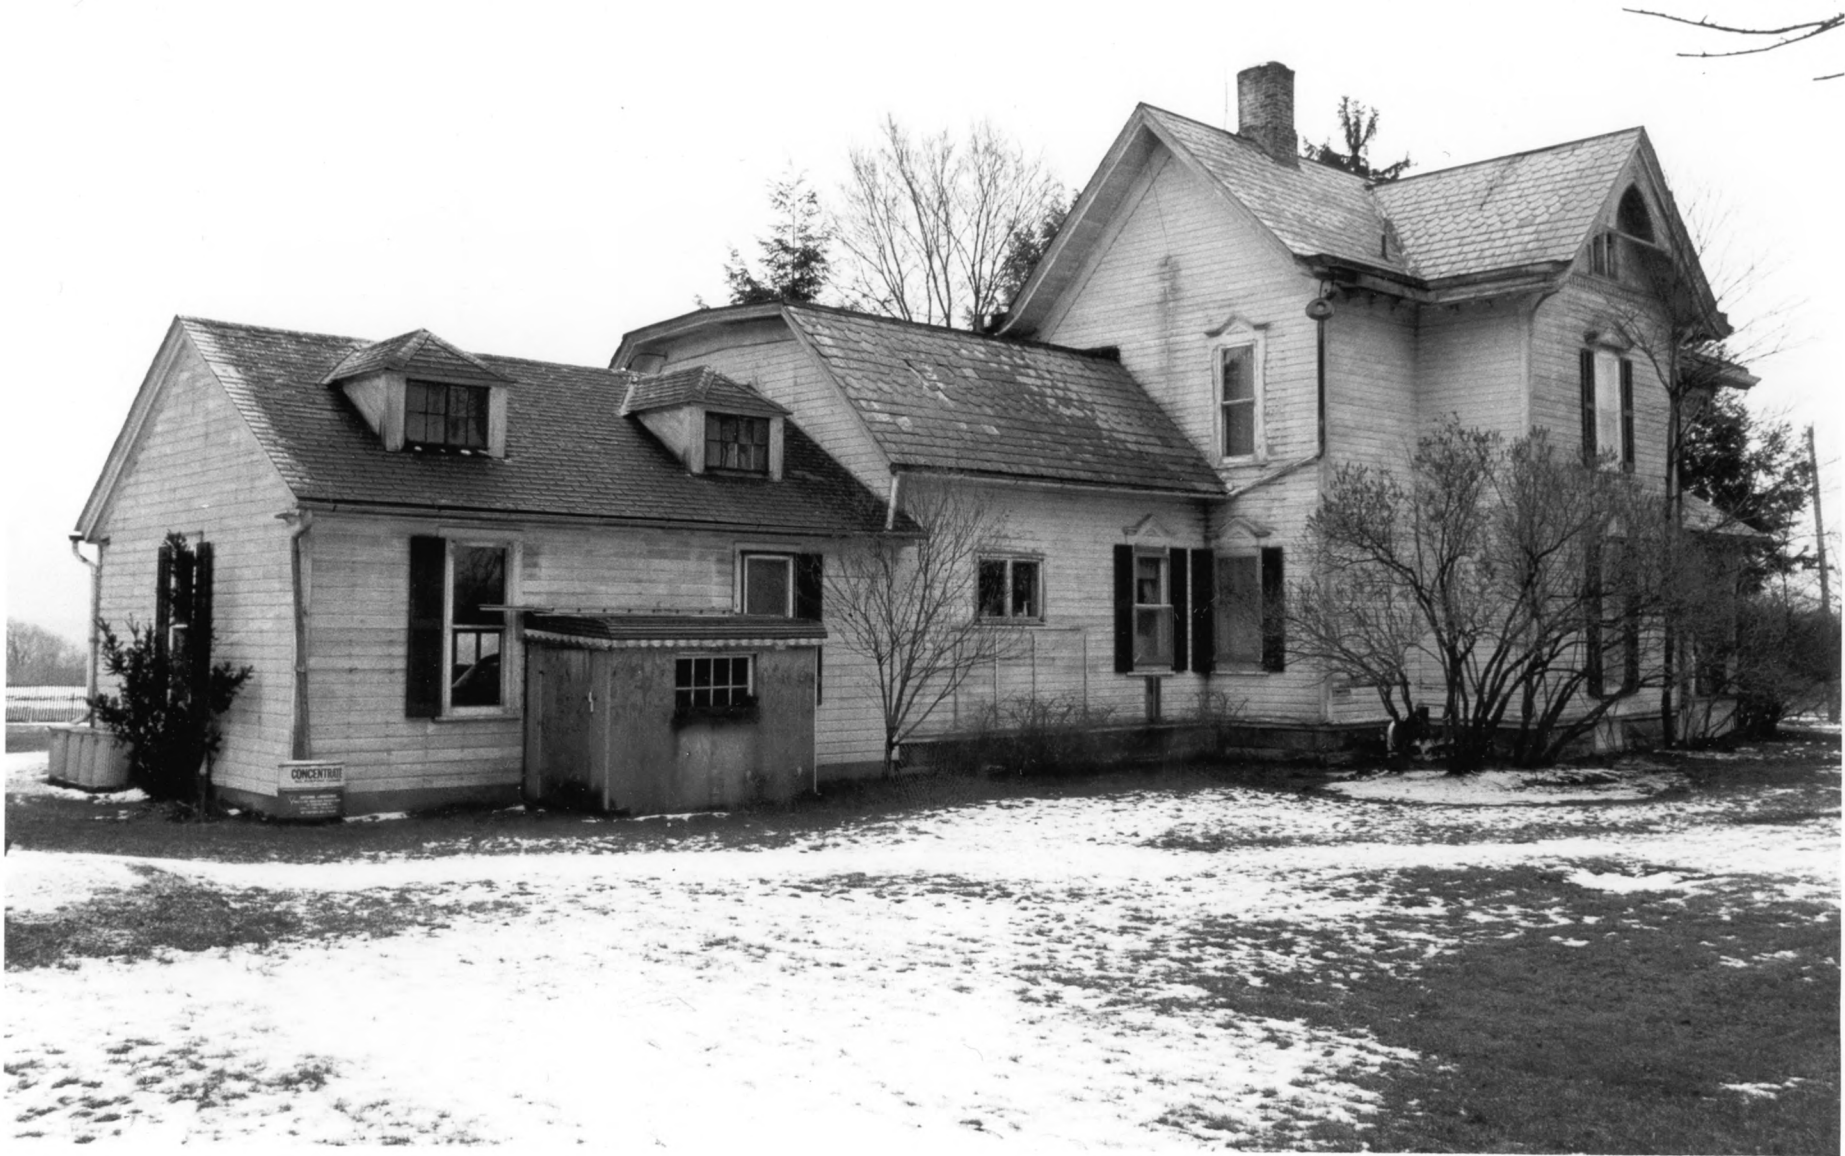
PHOTO 1

Northwest corner of Daniel
Tilden house showing the
original structure and the
two subsequent additions.

The Daniel Tilden house is a large, two-story, wood-frame residence constructed in the Victorian eclectic style popular throughout the country in the latter part of the nineteenth century. The original portion of the house, constructed in 1872, consists of a cruciform plan which is echoed in the cross-gable roof. The existing kitchen was added to the northeast corner of the original structure in 1888; this single-story addition has a modified gambrel roof. In the 1950s a garage was added to the north of the kitchen addition; the garage has a gable roof with two dormers on both the east and west elevations. A screened-in porch was added to the southeast corner of the building, probably at the same time that the garage was constructed. There is a full basement under the entire structure, except for the garage.

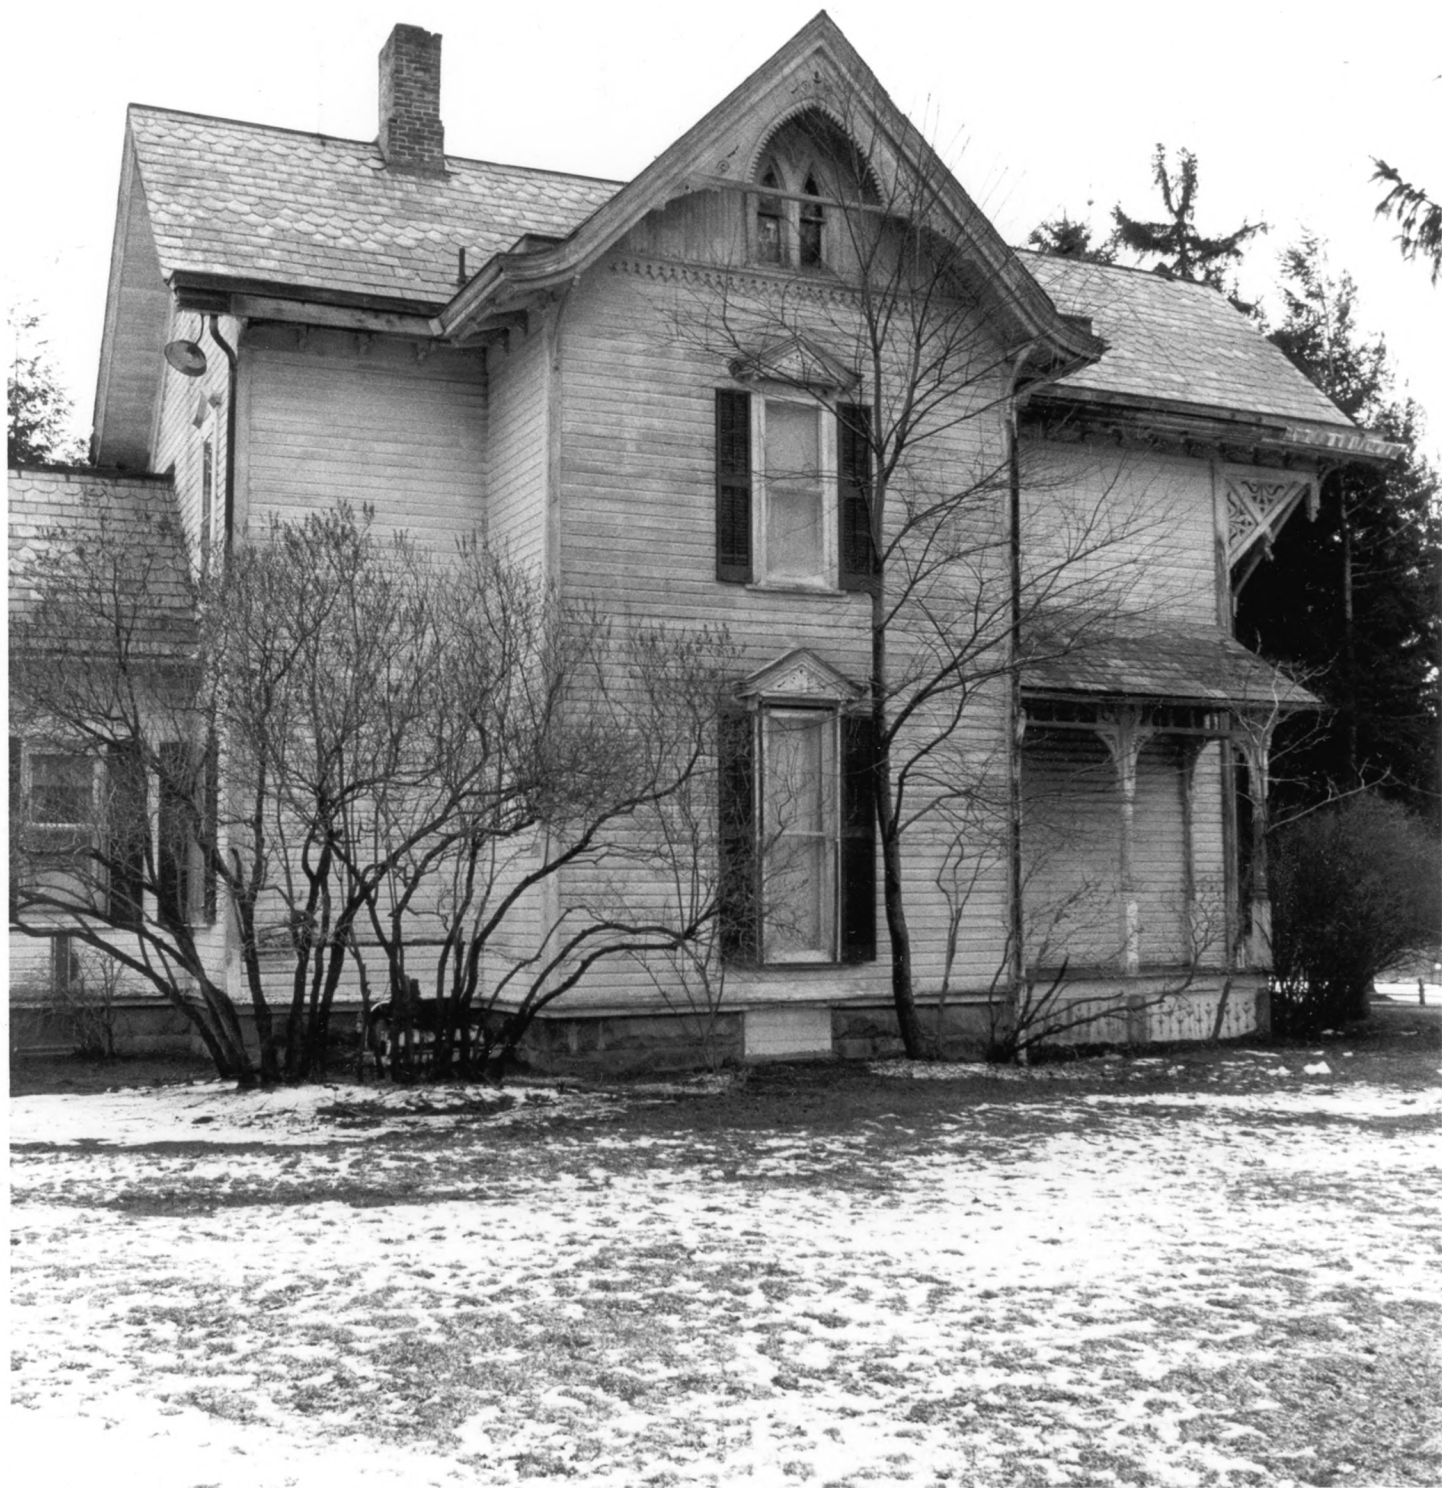
PHOTO 2

West side view of Daniel
Tilden house.

Photo #2 West gable end
of original building

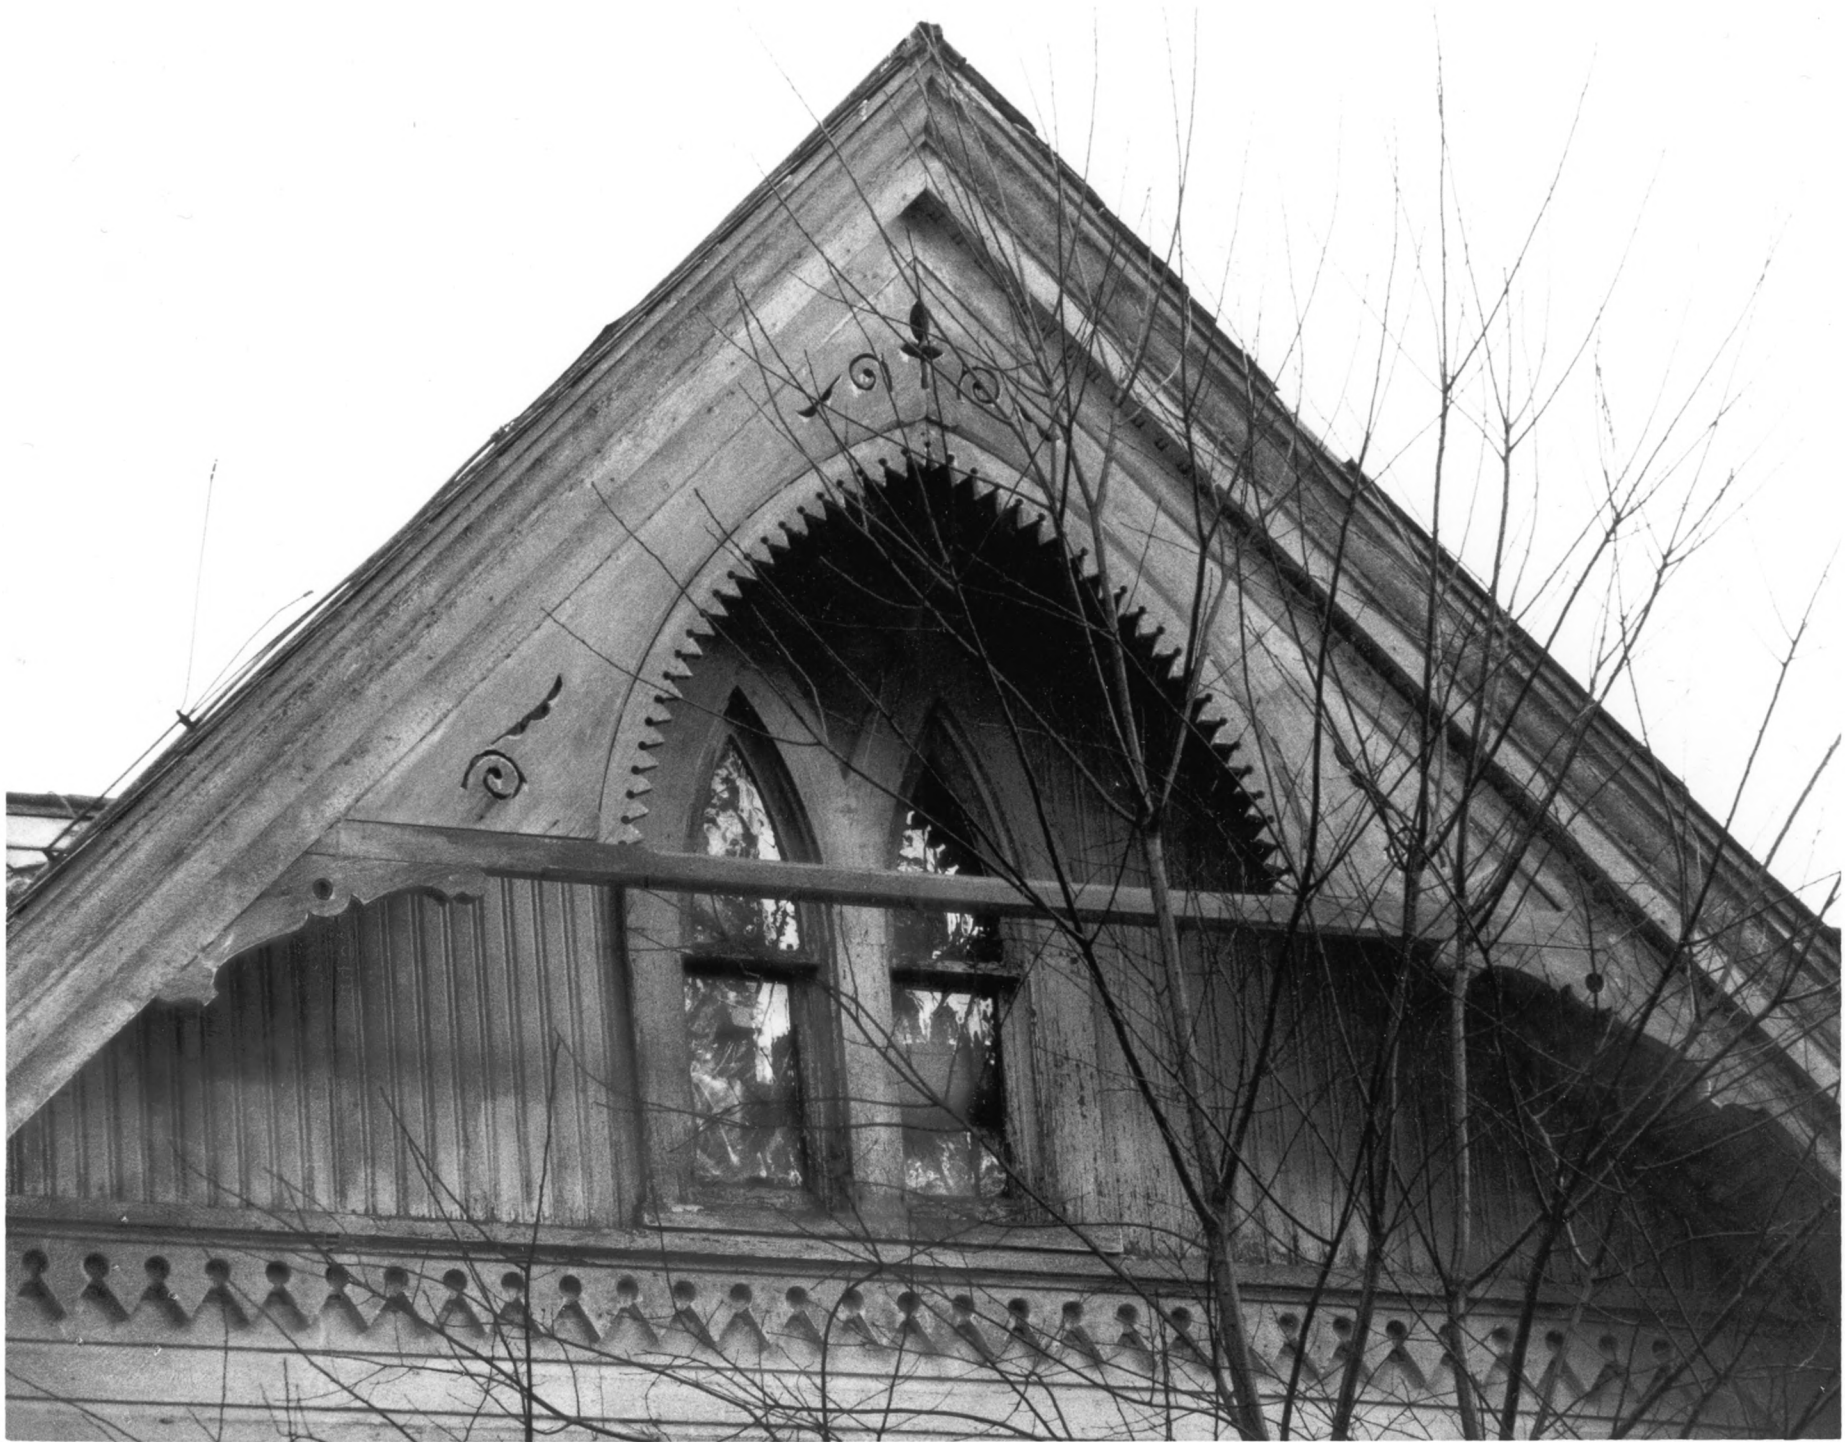
PHOTO 3 Enlarged view of decorative
gable on western side of
Daniel Tilden house.

Photo #3 Detailed view
of west gable

The windows on the body of the original structure feature highly decorative pedimented window hoods which include incised scrollwork. Similar window treatment is also found in the 1888 addition; this ornamentation may very well have been re-used from the windows on the original building which were obscured by this addition. These windows are equipped with louvered shutters. The south, east, and west gable ends are sheathed in vertical boards at the attic level and contain a pointed arch window at that level. These three gables are trimmed with wide bargeboard with incised scrollwork, the overall form of which frames and echoes the pointed arch attic window. This bargeboard includes exposed stick work and drilled brackets. The south gable contains a two-story bay which is terminated at the roof line with exposed diagonal stick work and panels of incised scrollwork. The north gable, which faces away from the main road, has no ornamentation or fenestration.

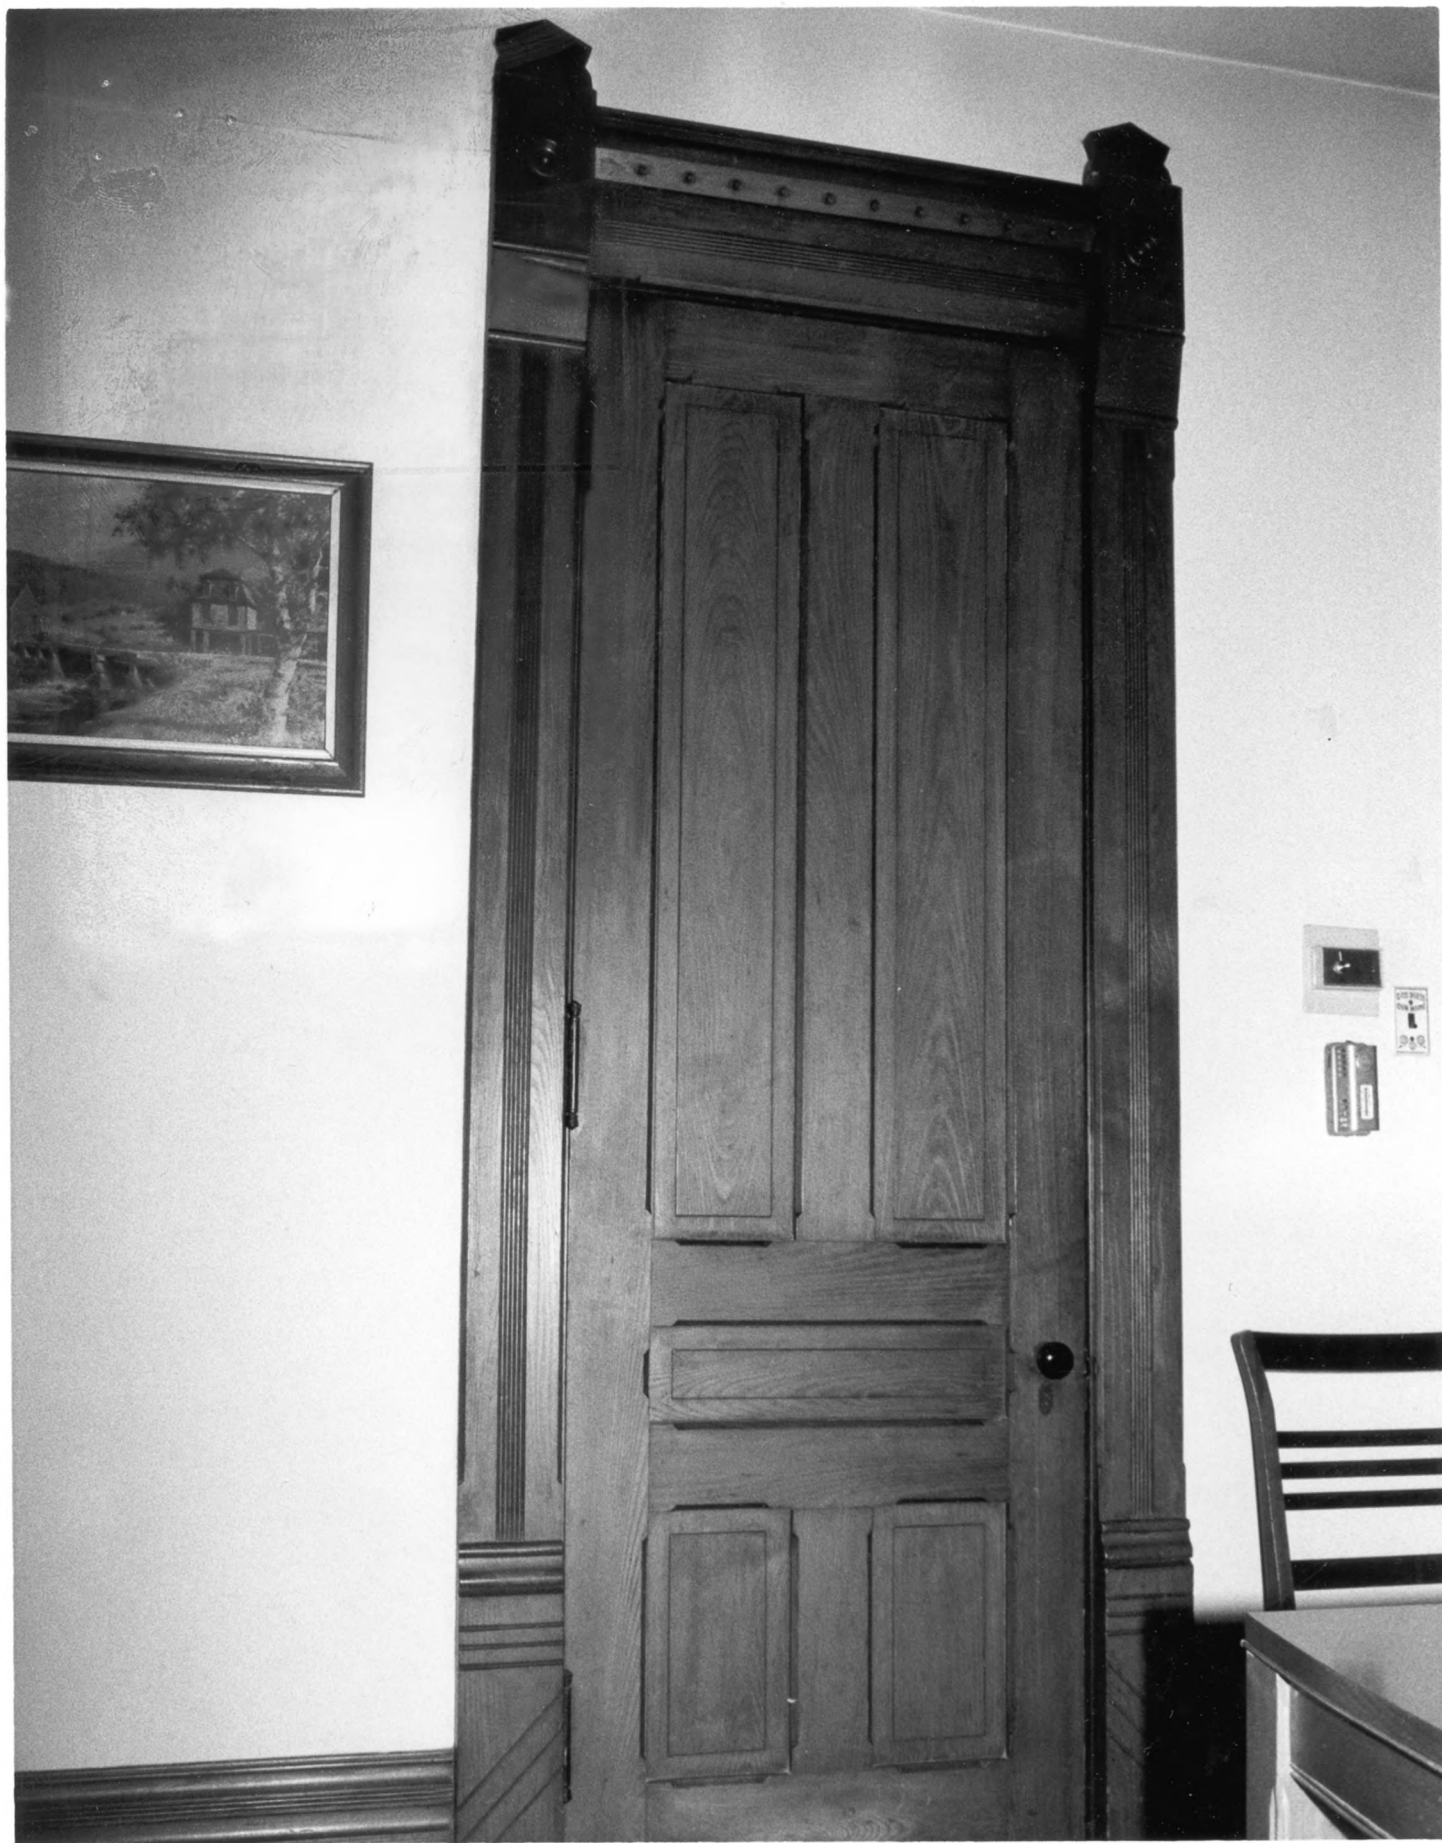
PHOTO 4 Overall view of typical
interior door and casing
of Daniel Tilden house.

Photo #4 Door leading from
dining room into kitchen

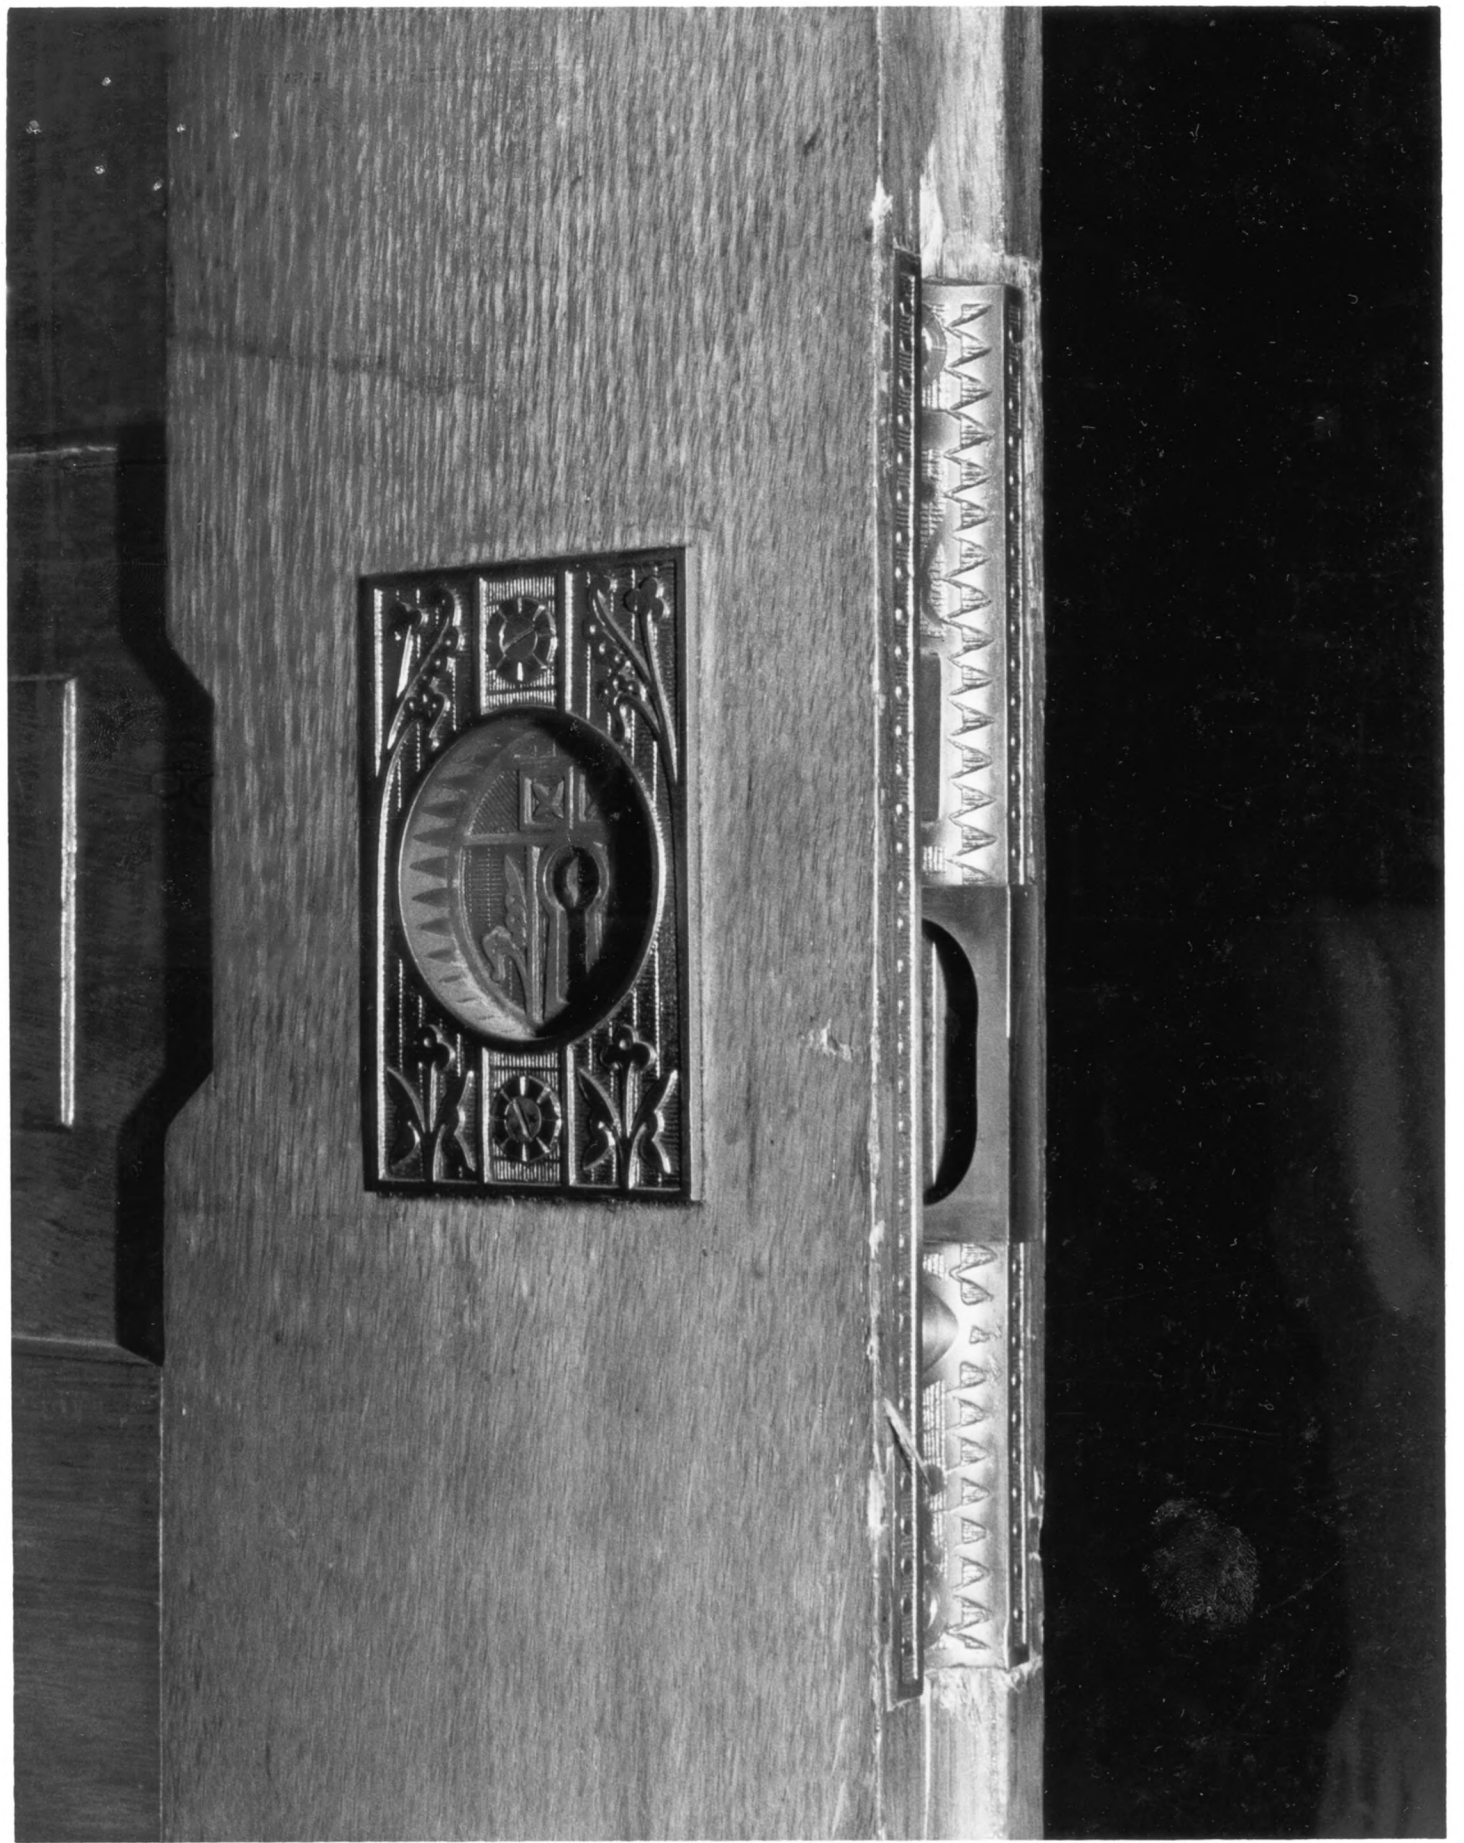
PHOTO 5 Detail view of locking
mechanism of pocket door
in parlor of Daniel Tilden
house.

Photo #5 Detailed view of
locking mechanism of
pocket doors in living room

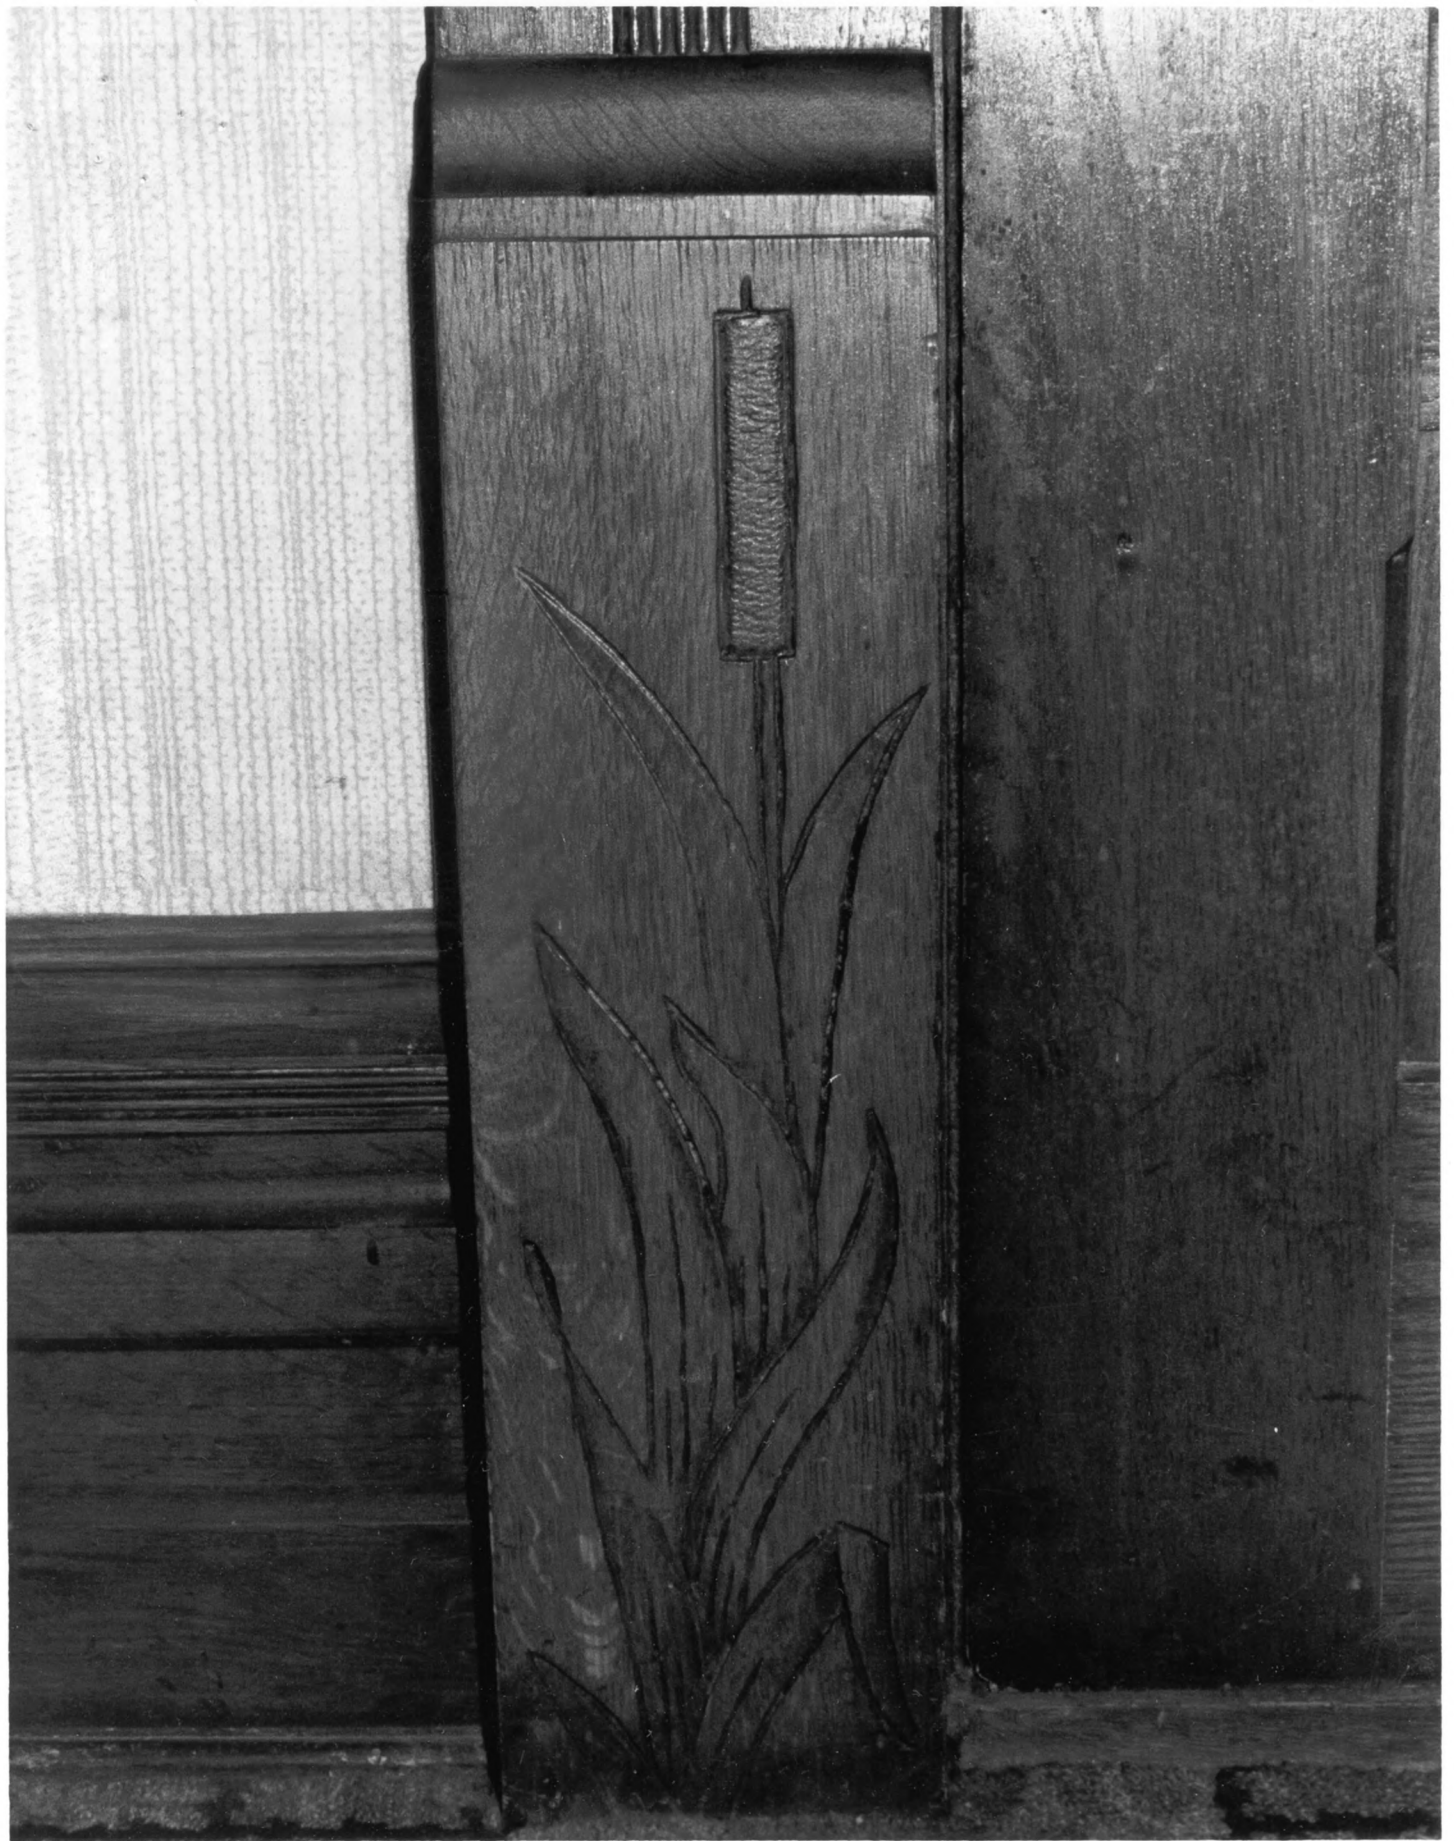
PHOTO 6 Detail view of plinth at
base of typical interior
door casing of Daniel Tilden
house.

Photo #6 Detailed view of
hand carved plinth on
dining room doorway leading
to hallway

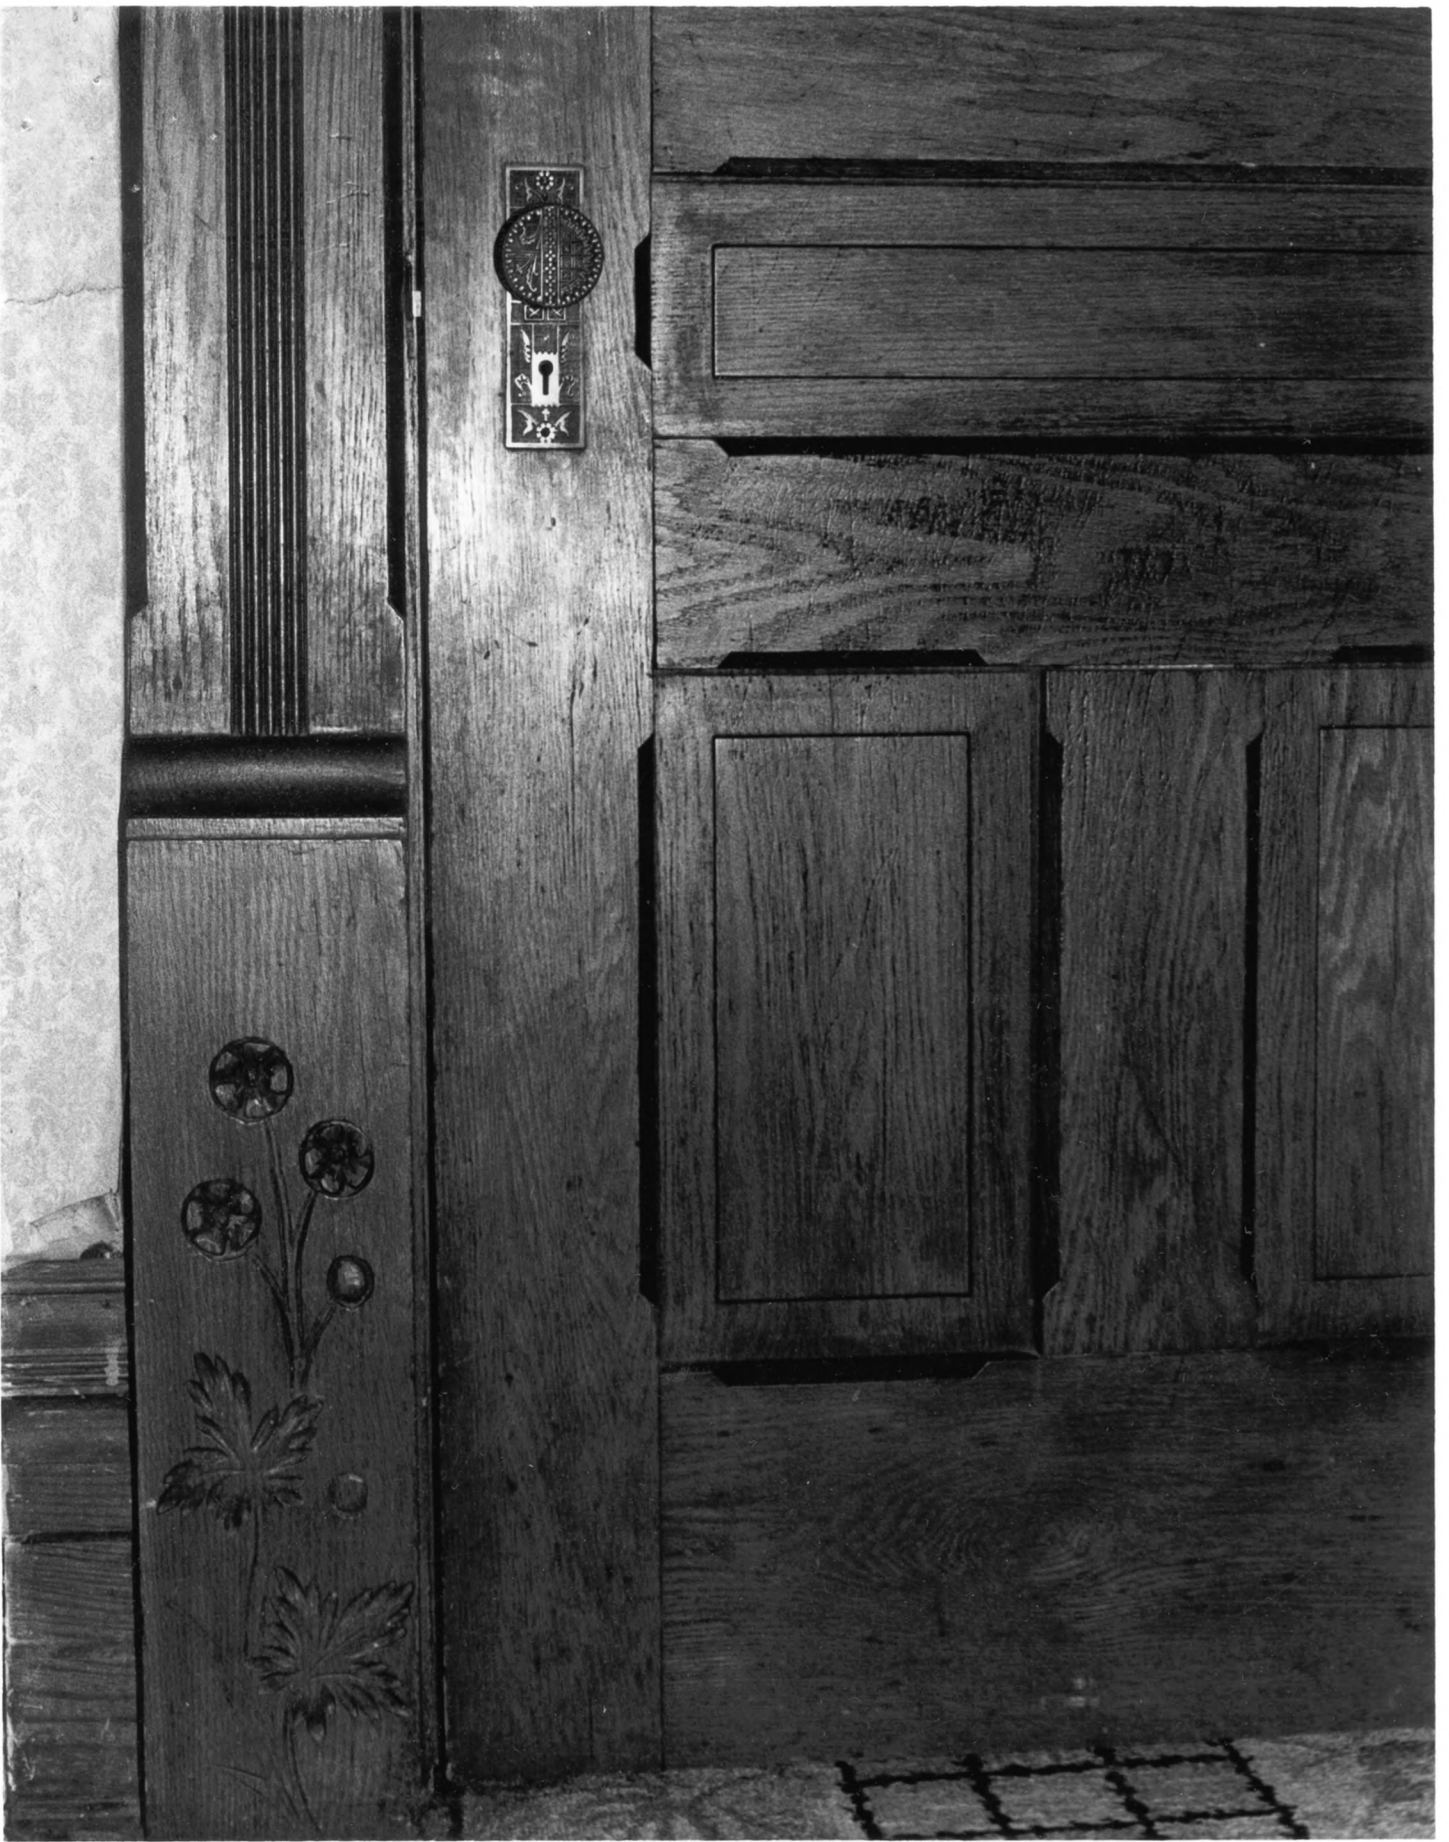
PHOTO 7 Detail view of plinth and
door knob of typical interior
door and casing of Daniel
Tilden house.

Photo #7 Detailed view of
typical door and casing
