Subject: Determination of Eligibility and Effect for Slippery Creek Mine Cabin (MMK-00116)

### 1. Name of Property

**Historic name:** Slippery Creek Mine Cabin

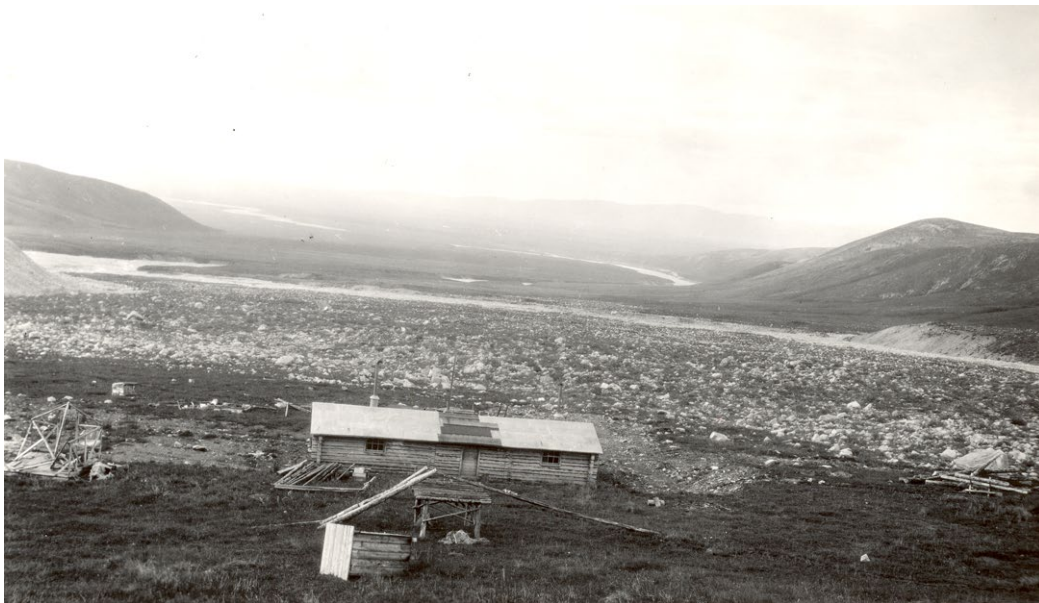
*Figure 2: Slippery Creek Mine cabin, looking north. 1941; photographer unknown. DENA Archives*

Figure 2. Slippery Creek Mine cabin, looking north. 1941; photographer unknown. DENA Archives

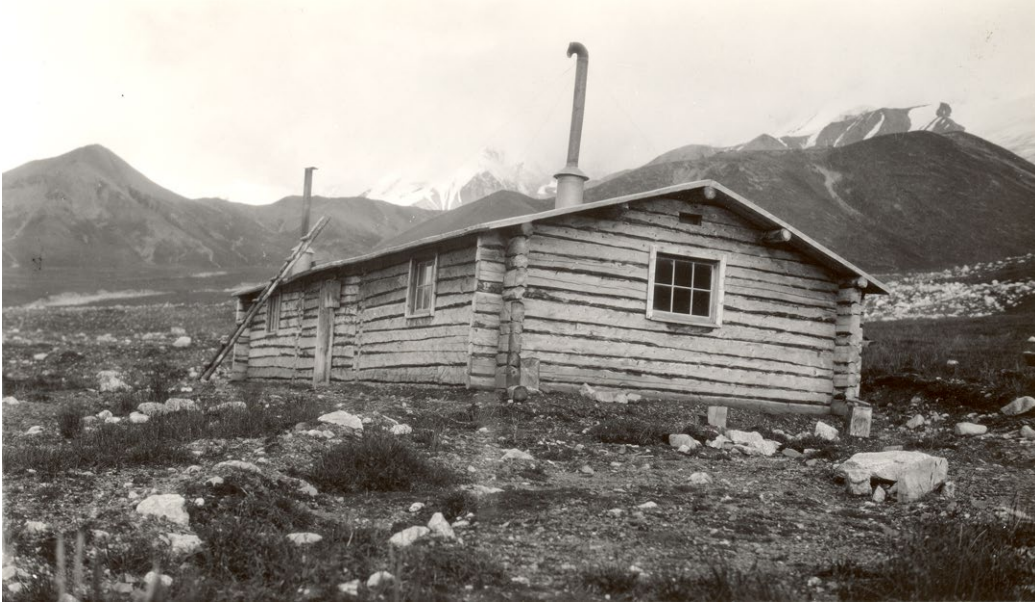
*Figure 3: Slippery Creek Mine cabin, looking east. 1941; photographer unknown. DENA Archives*

Figure 3. Slippery Creek Mine cabin, looking east. 1941; photographer unknown. DENA Archives

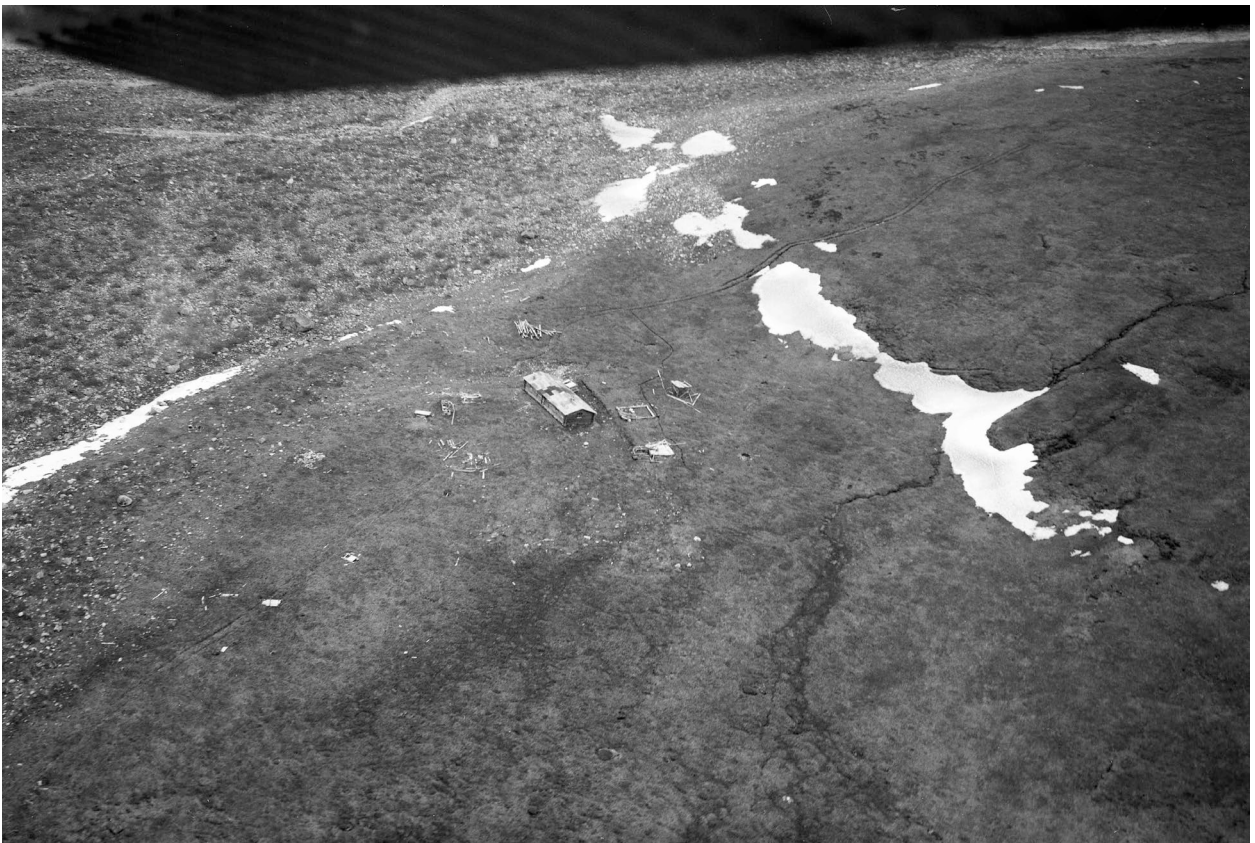
*Figure 4: Slippery Creek Mine cabin, aerial view. 1941; photographer unknown though likely Dunkle flying. DENA Archives*

Figure 4. Slippery Creek Mine cabin, aerial view. 1941; photographer unknown though likely Dunkle flying. DENA Archives

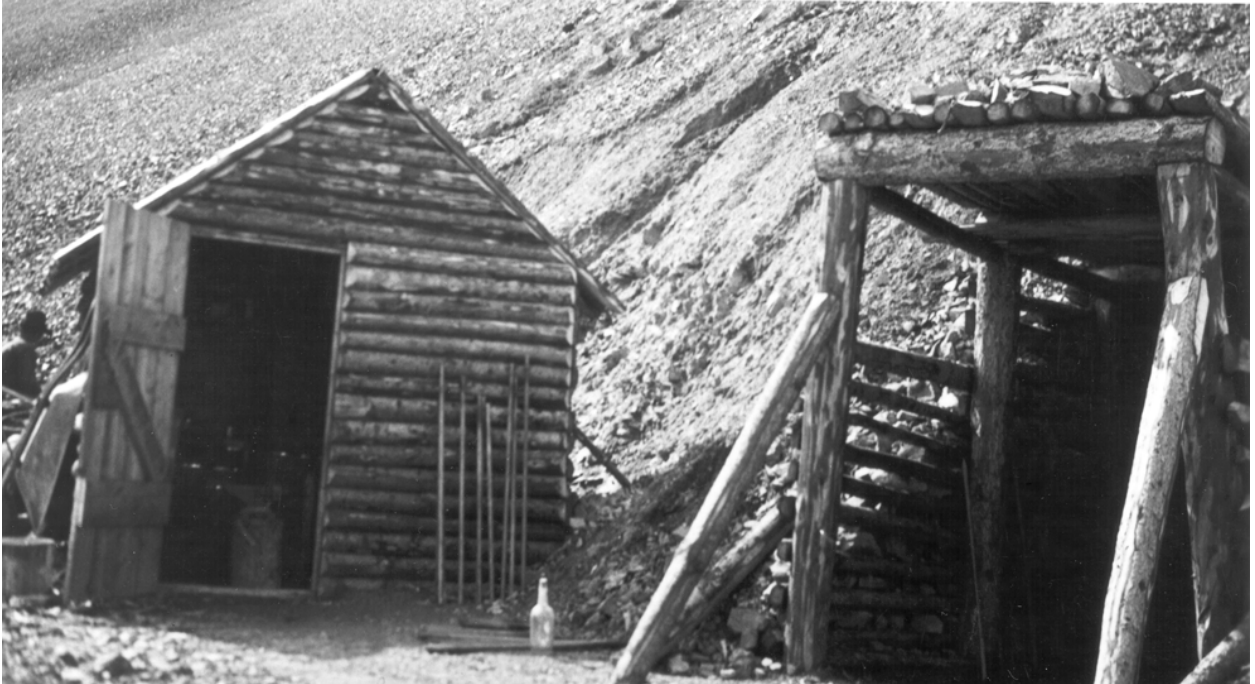
*Figure 5: Structures on Mineral Mountain at the adit. Date and photographer unknown. Structures removed during site remediation. DENA Archives*

Figure 5. Structures on Mineral Mountain at the adit. Date and photographer unknown. Structures removed during site remediation. DENA Archives

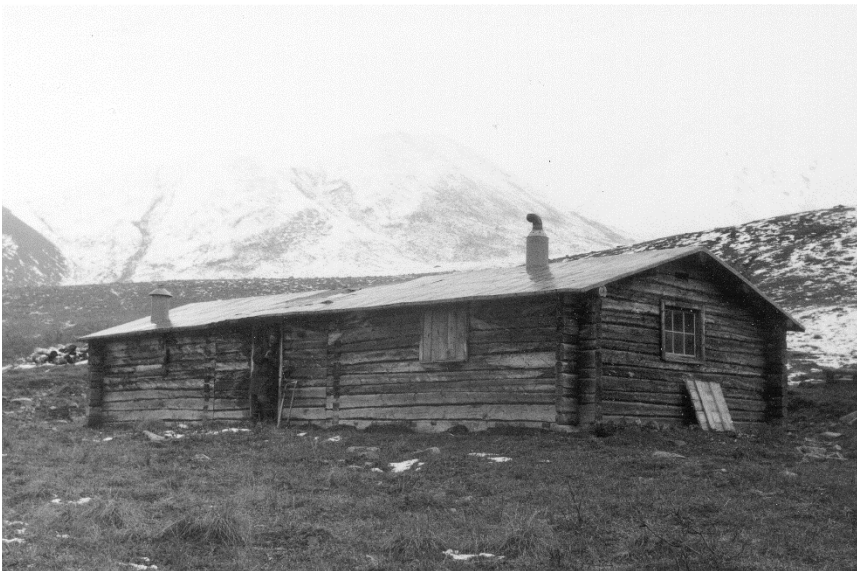
*Figure 6: Slippery Creek Mine Cabin, looking southeast with unidentified person in doorway. Merry-Travers, 1965. DENA Archives*

Figure 6. Slippery Creek Mine Cabin, looking southeast with unidentified person in doorway. Merry-Travers, 1965. DENA Archives

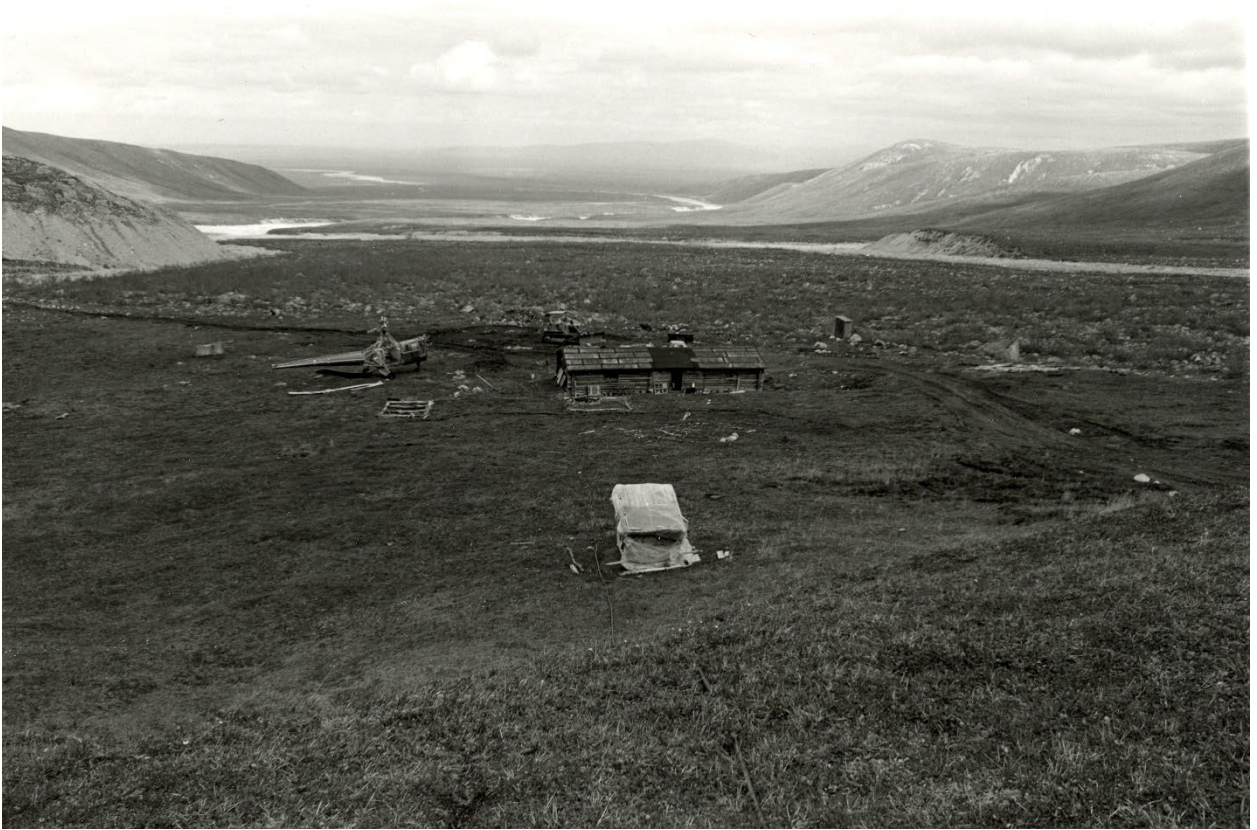
*Figure 7: Cabin and site overview, looking north. Buskirk, 1976.*

Not mentioned in the narrative but evident in the accompanying photographs are what appears to be an outhouse to the northeast of the cabin, and the remains of what may have been wooden frames or a partial corduroy road to the southwest. West of the cabin there is also the wreckage of a helicopter, though no information could be found about how it came to be there or when it was removed. The cabin itself does not exhibit any changes.

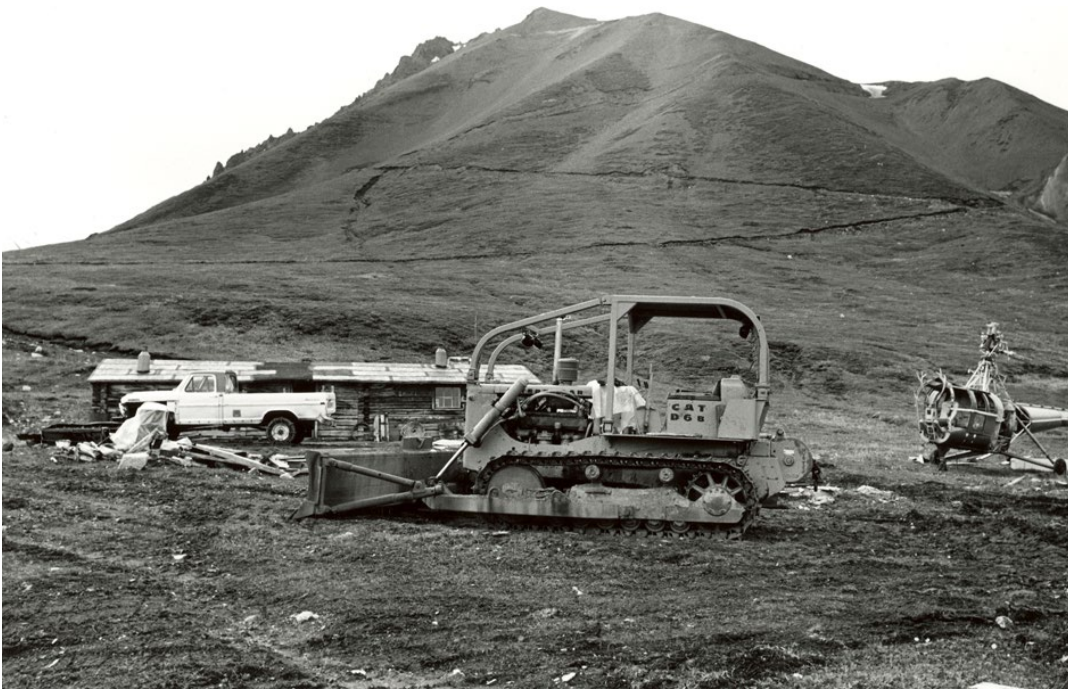
*Figure 8: Slippery Creek mining operations, looking south. Cabin and equipment in the foreground; switchback road up Mineral Mountain in background. Buskirk, 1976.*

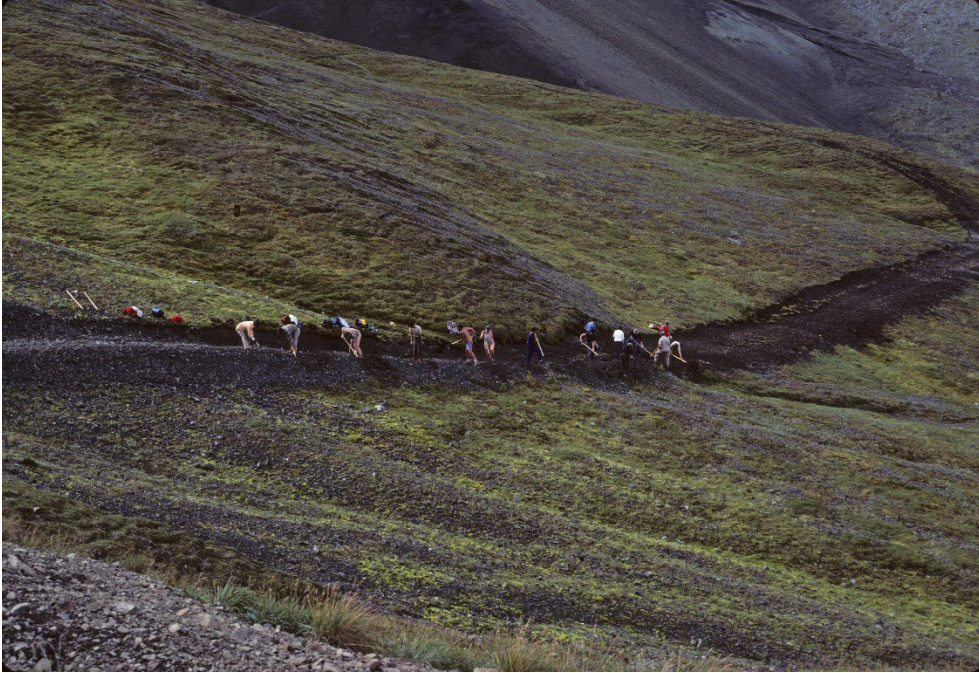
*Figure 11: First phase of Mineral Mountain road reclamation. 1983; photographer unknown. DENA Archives*

In the 1980s, the park undertook a mining reclamation project at Slippery Creek to remove other site features including: a switchback road up the north face of Mineral Mountain; an adit at the top of the road; a road to an airstrip about two miles north of the site; and the airstrip. Other than the cabin, remaining existing features post-date the period of significance or have deteriorated so that they no longer have integrity. These include: two Caterpillar bulldozers; several oil drums; the remains of an air compressor; what may be lumber sled frames (alternatively posited as sill log foundations for canvas wall tents of the initial camp)<sup>2</sup>; a partial corduroy road; and an earth-integrated wooden cooler box. Near the collapsed adit, the remains of what was once the structural support around the mine opening are still visible down the hill, while a wooden equipment shed is no longer extant. Some human-made terracing to create the building site is still discernable immediately behind (south) of the cabin.

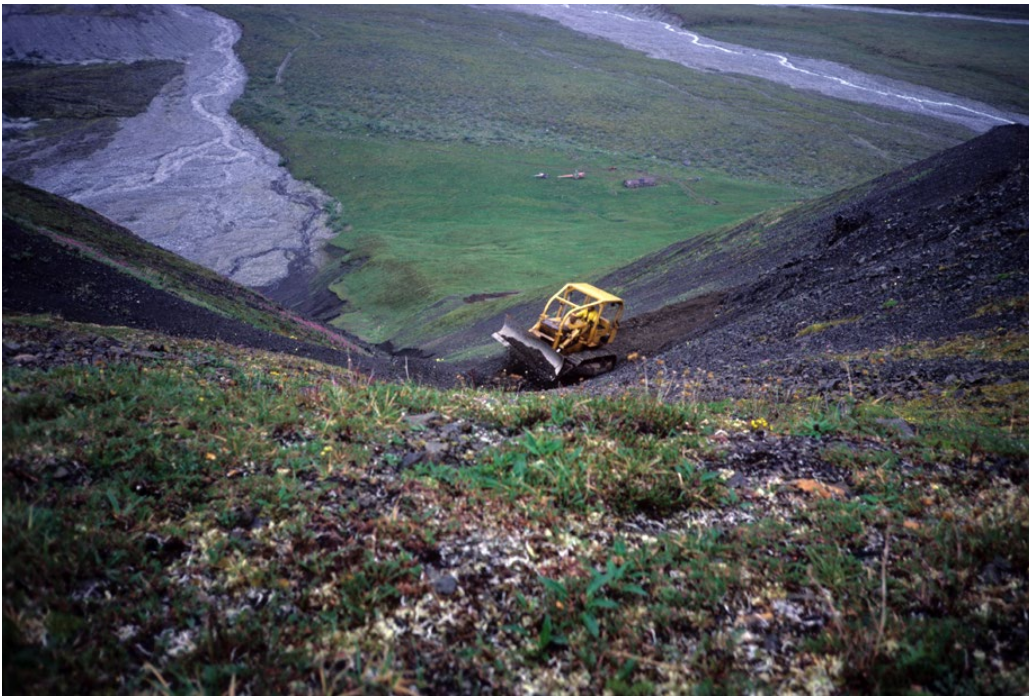
*Figure 12: Second phase of Mineral Mountain road reclamation, using the D-6 cat. 1987; photographer unknown. DENA Archives*

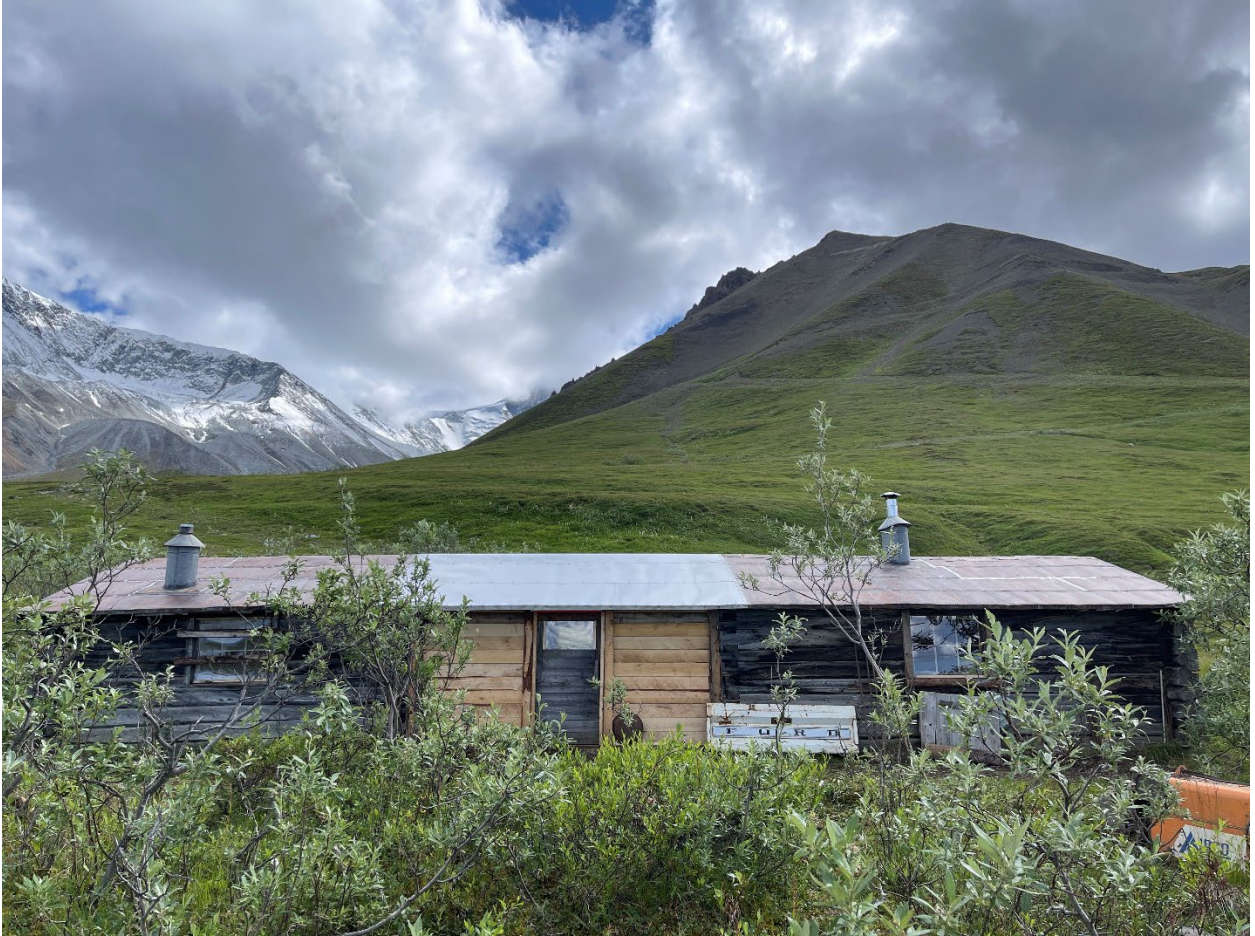
*Photograph 2: Front elevation of Slippery Creek Mine Cabin after initial stabilization completed, 2025.*

The front (north) façade displays the unique construction of the cabin with the two originally separate cabins (which now function as rooms) on either end with the central enclosed storage bay in between. It contains two windows, one on each room, and a door that opens into the middle bay. All windows are fixed, consisting of a single 6-light sash set horizontally into the wall and framed with 1"x4" dimensional lumber. Doors on the cabin are a variation of a horizontal plank board and batten door. The enclosed center bay is easily identified by the infill log sections or panels, which do not align exactly with the log coursing on either side, as well as the corner joins of the cabins/rooms.

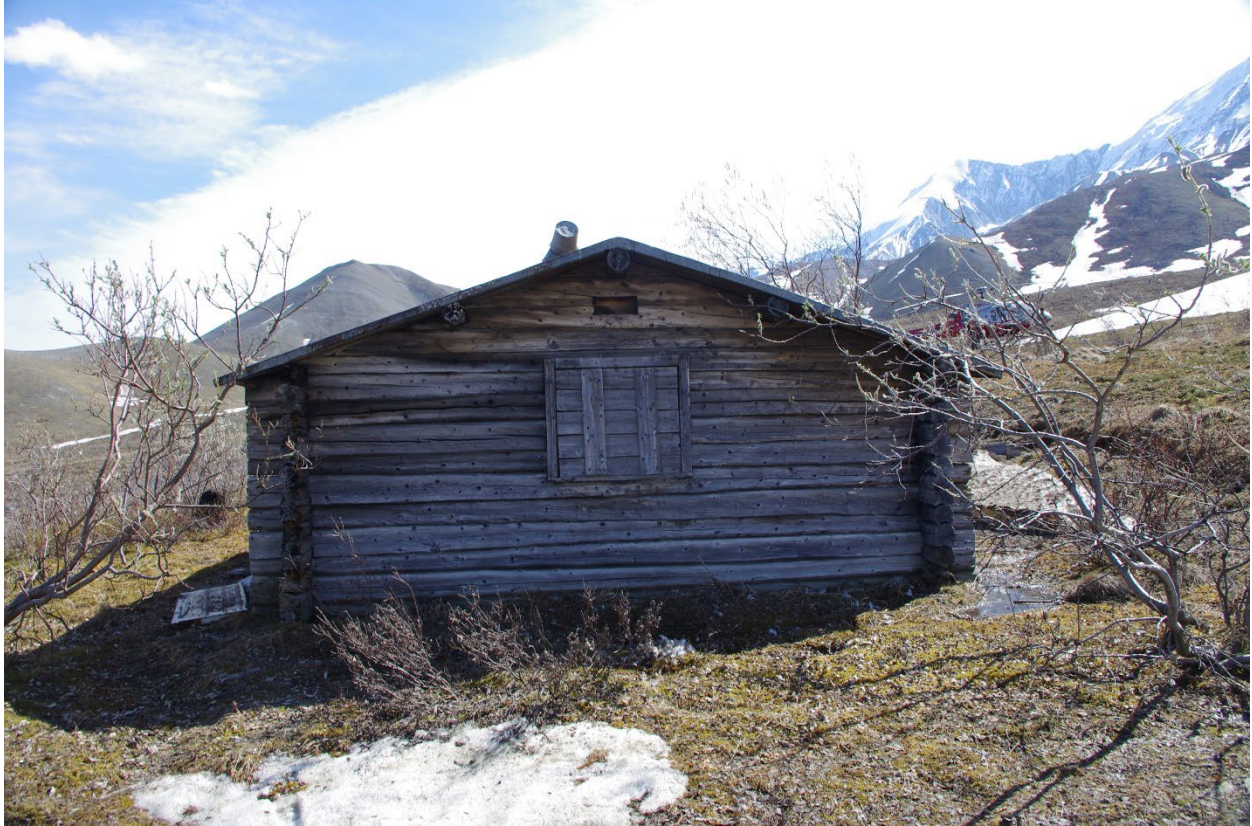
*Photograph 3: East gable elevation of the Slippery Creek Mine Cabin, 2022.*

The eastern façade contains a single window with the sash missing. The gable ends of the cabin additionally have operable vents, covered on the interior with a sliding wooden shutter.

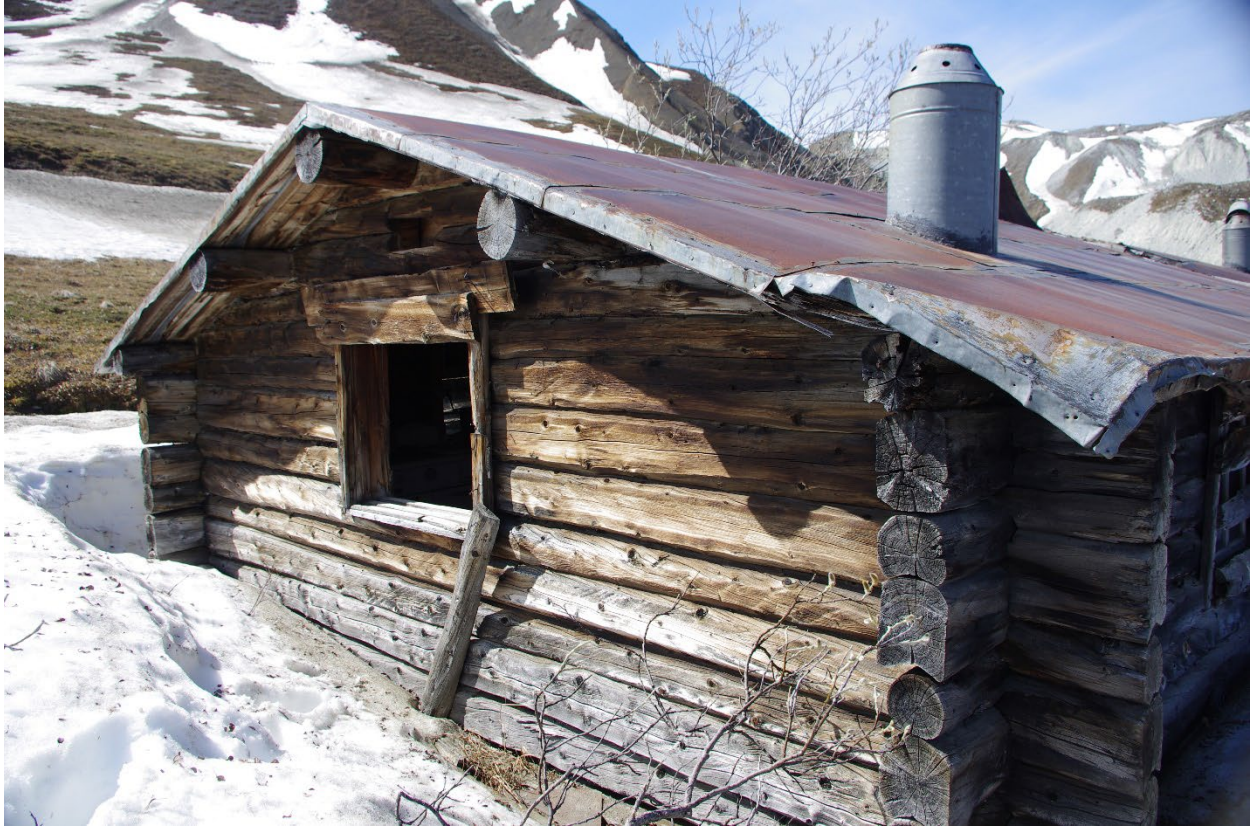
*Photograph 4: West gable elevation of the Slippery Creek Mine Cabin, 2022.*

The southern façade employs the same pattern of fenestration as the front of the building. The western façade contains the same single window as the eastern; this has a plank cover fitted into the opening with the sash in place behind. Likewise, the same vent is cut in the gable end above the window. The log ends on this exposure show the most deterioration.

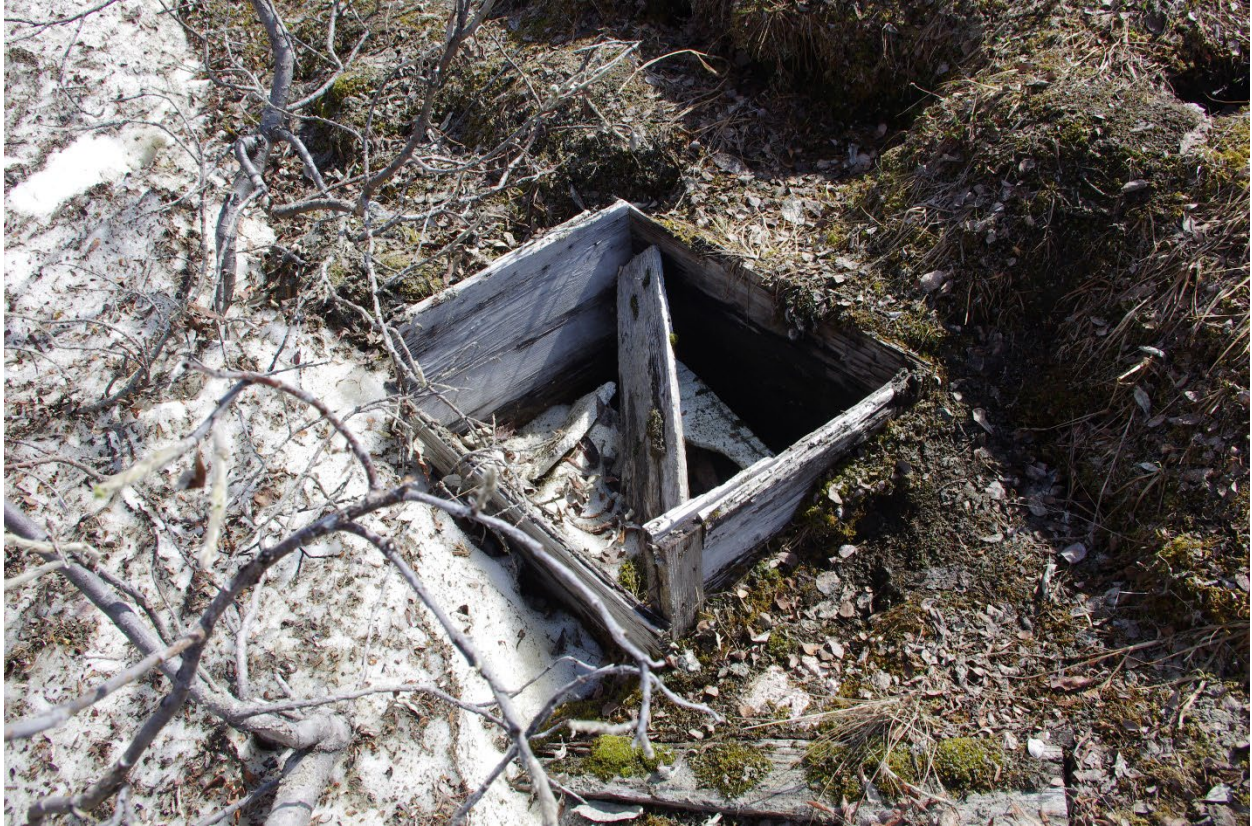
*Photograph 5: Cold Storage Box on the southern/uphill side of the Slippery Creek Mine Cabin.*

Small, approximately 1'6"x2', wood plank box set in the base of the terrace in the back of the Slipper Creek Mine Cabin site. Open to the elements, previously had a board and batten flat roof.
