National Park Service  
Cultural Landscapes Inventory  
2004

Cow Creek Historic District  
Death Valley National Park

Level II  
Cultural Landscape Inventory  
Death Valley National Park

# COW CREEK HISTORIC DISTRICT

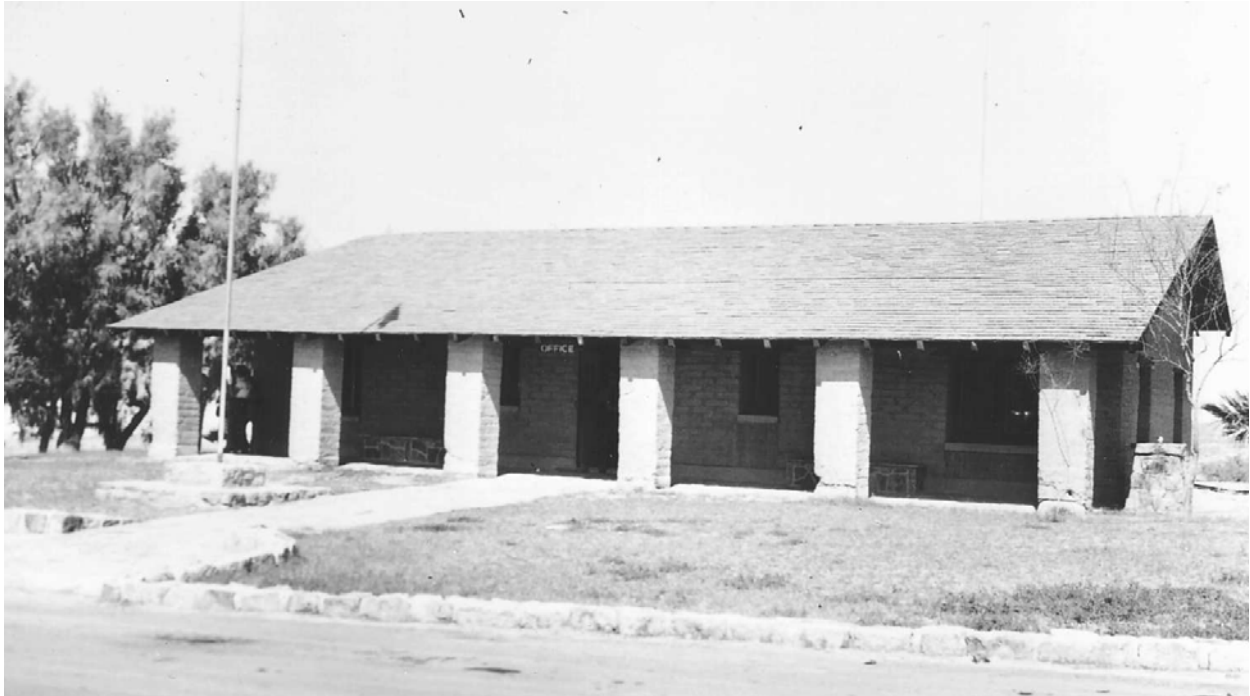
*History #4: Administration building before replacement of adobe columns, looking north. ( PGSO, ARG digital file #38677, no date)*

In 1934, the resident engineer recommended that the administration building be placed on the west side of the highway, facing east, which would remove it from other park activities and make it more accessible to visitors (see photo, History #4). He also proposed a small museum building to house perishable exhibits to be constructed on the east side of the highway, facing the administration building, with an open plaza big enough to exhibit old wagons and other large objects of historical value. There would also be an area landscaped with native plants and various specimens of rocks for exhibit. A proposed museum and plaza was not executed at Cow Creek but was remarkably similar to the building program developed for the Mission 66 visitor center constructed at Furnace Creek. In 1934-35 the utility area, called the "corporation yard," was constructed between the two CCC camps. It contained a service garage, radio hut, blacksmith shop, wash rack, and power plant housing.

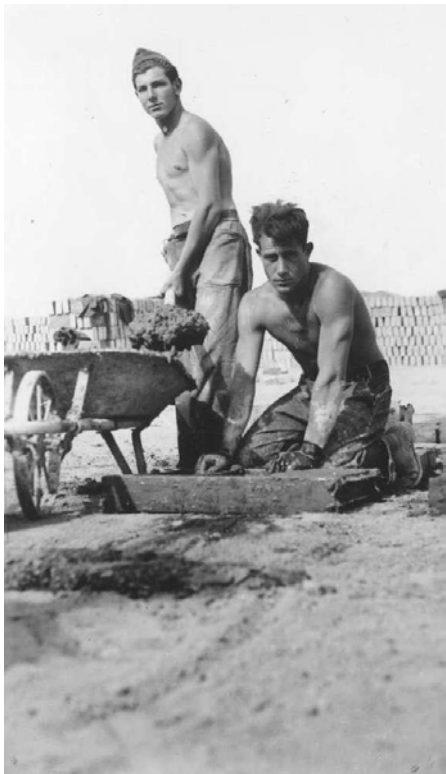
*History #7: Adobe brick making. (Death Valley National Park archives, Acc. #651.54, DEVA #733, 1934)*

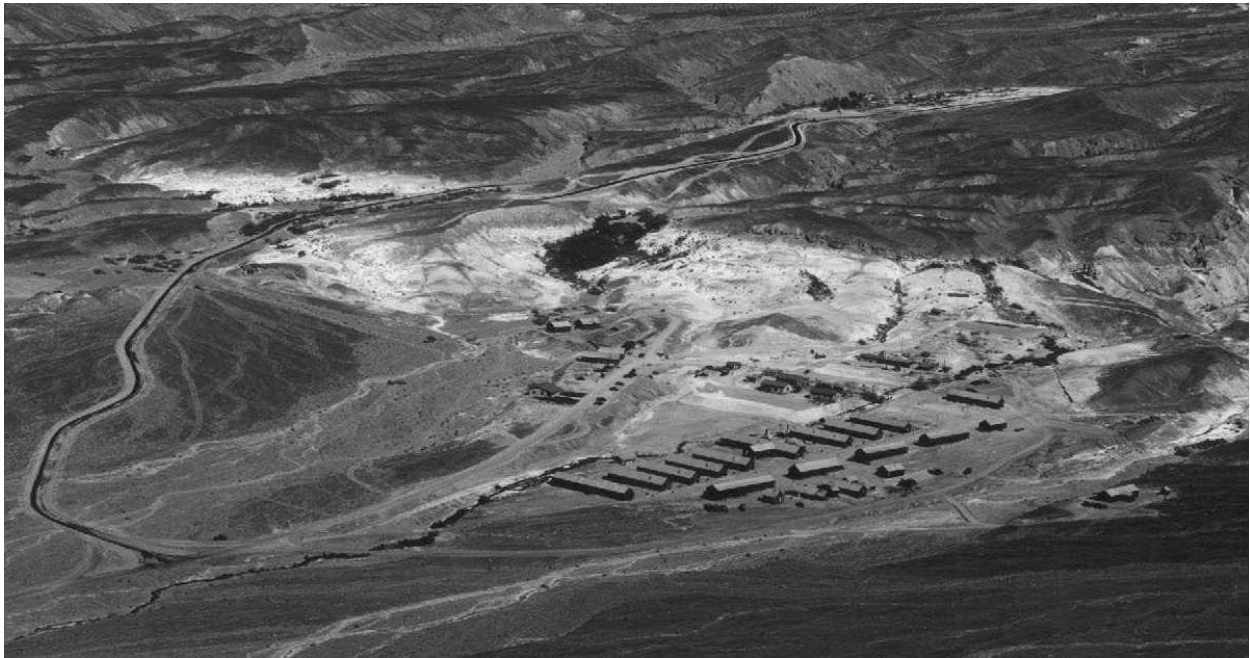
*History #9: Aerial view of Camp Cow Creek. (Death Valley National Park archives, no Acc. #, no DEVA #, ca. 1939)*

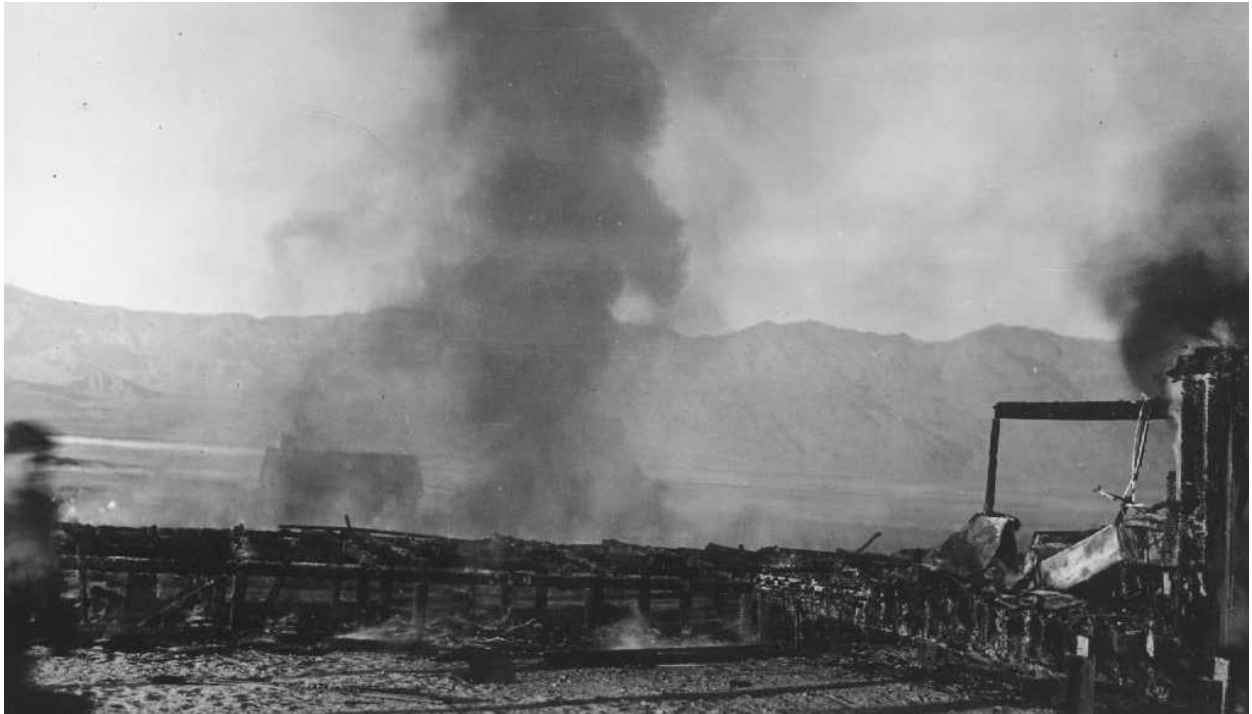
History #10: Remains of the blacksmith shop after a fire, looking west. (Death Valley National Park archives, Acc. #725.1, no DEVA #, 1951)

The removal of the former CCC camp buildings began in the early 1950s. In 1951 the blacksmith shop burned down (see photo, History #9). In 1952, four equipment sheds in Cow Camp and the lath house in Park Village were removed. By 1954, the remains of the Funeral Range camp were removed or razed, and a storage building (CC-118) was renovated. A contract was awarded for the sale of twelve CCC barracks from the Funeral Range camp. The amount of \$556 was received from Mr. Curtis Cline of Tonopah, Nevada, who completed the removal work in March 1954. In the same year the park maintenance crew removed two adobe comfort stations from the site. Adobe blocks that were left by the CCC were used to construct a new comfort station northeast of the administration building. (Superintendent's Report, 1954, Death Valley National Park, California, Department of the Interior, Unprocessed Archives, Cow Creek, Curatorial & Research Facility)

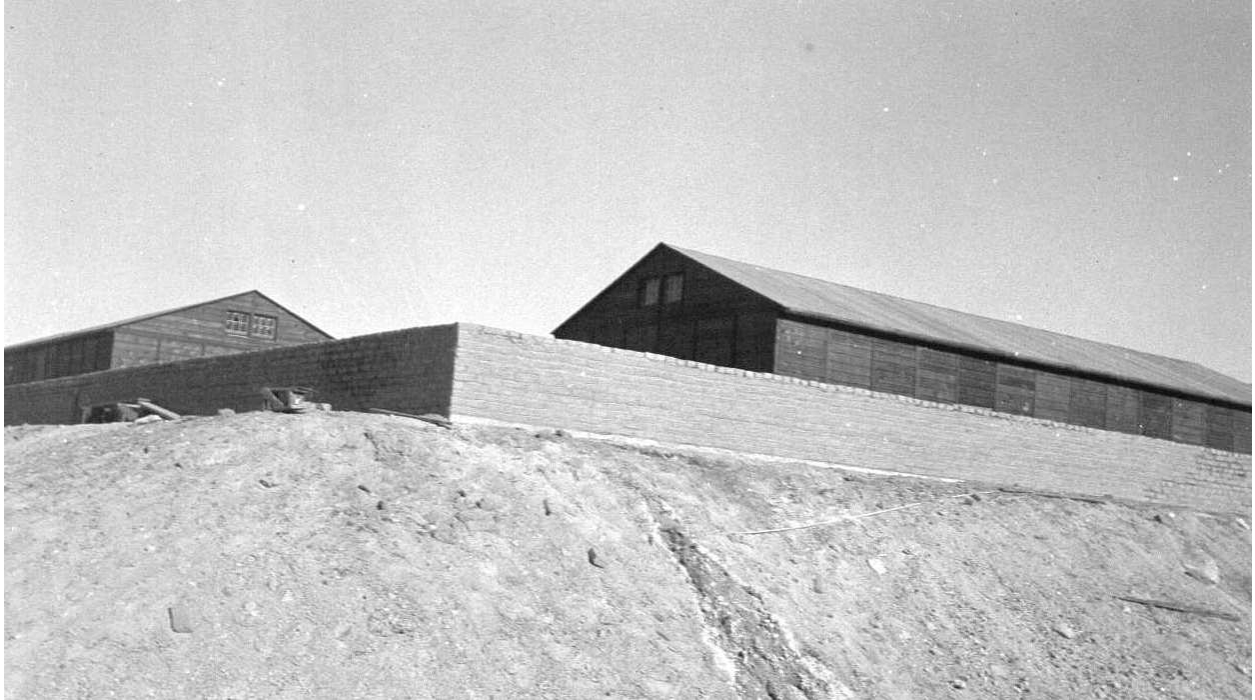
*Buildings and Structures #1: Cow Creek adobe wall, looking east. (Death Valley National Park archives, ARG digital images #27045, ca. 1940)*

feature of the utility area (see photo, Buildings and Structures #1). It encloses the area on the west side, and partially along the north and south sides. Historic plans to enclose the entire utility area within the wall were never completed. The six-foot wall is constructed in two widths of adobe brick on a concrete foundation without an exterior plaster coat. There is a waterproofing membrane between the concrete and adobe. Originally constructed with pre-cast concrete block caps, now missing, the wall has vertical breaks at grade changes. These breaks were intended to allow for a similar grade on either side of the wall in order to avoid retaining wall-type footings. The original construction drawings called for a bond course every fourth course of brick; these bond courses are evident in the remaining wall. The existing length of the wall is approximately 350 linear feet although two twenty-foot sections located immediately to the west of the utility area entrance gate and to the west of CC-303 have collapsed.

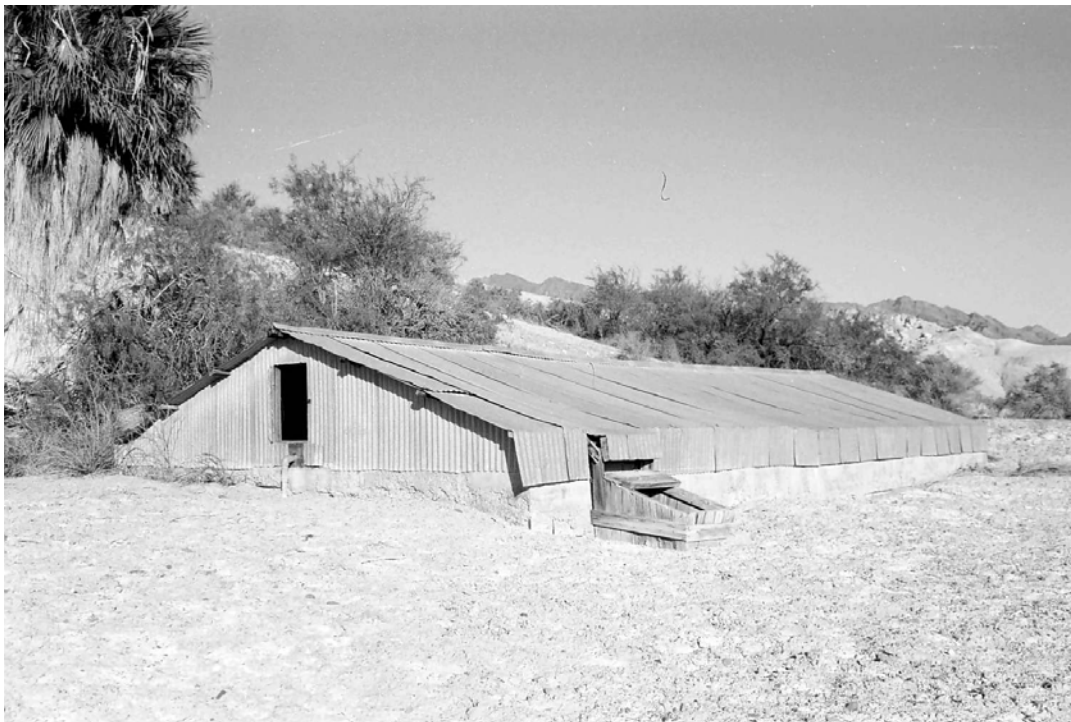
*Buildings and Structures #2: Cow Creek reservoir, looking south. (PGSO, CLI negative # DEVA-N-0006-12, 2000)*

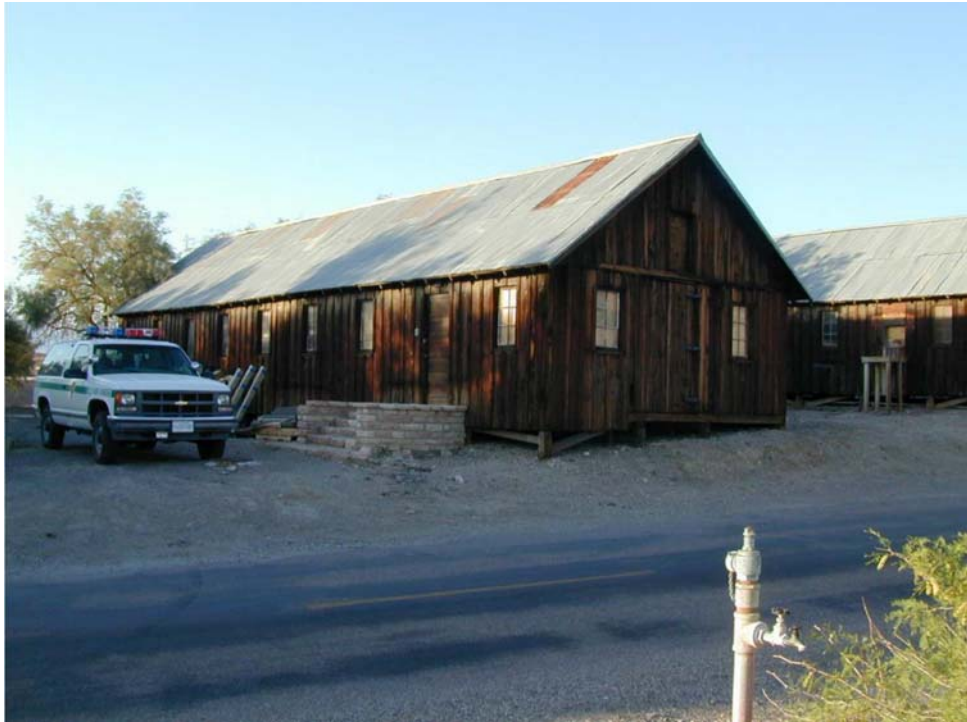
*Buildings and Structures #3: Cow Creek warehouse with stone steps, looking north. (PGSO, CLI slide #DEVA-S-0001-12, 2000)*

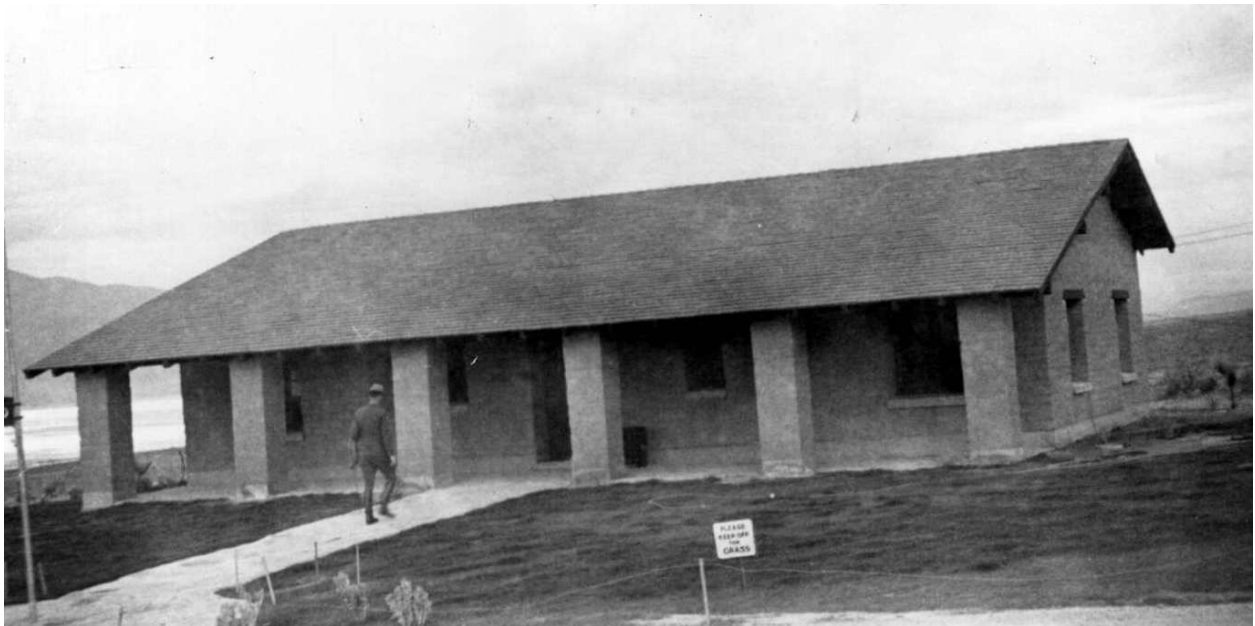
*Buildings and Structures #4: Administration Building with early landscaping, looking north. (Death Valley National Park archives, ARG digital images #46818, ca. 1940)*

Building CC-48, constructed in 1939, is a six-room adobe structure with a red transite-shingle gable roof and large covered porch (see photo, Buildings and Structures #4). A seventh room, a concrete vault with adobe exterior, was added to the rear of the building in 1940. This addition has a separate gable roof situated perpendicular to that of the rest of the building. The original six square adobe columns supporting the porch roof have been removed and replaced with wooden posts. Irrigation of the lawn adjacent to the porch resulted in the gradual destruction of the original adobe columns. Typical details similar to other adobes on the site include: wood rafters and exposed rafter tails, ridge vents at the gable end walls, and concrete sills and thick wood lintels with concrete bearing pads at the window and door openings. The two-foot-thick adobe wall sits on a low concrete stem wall. Built as the park administration office and headquarters, this structure, located at the north end of the historic district along the entry road, has housed the offices of the Resources Management Division since 1985.

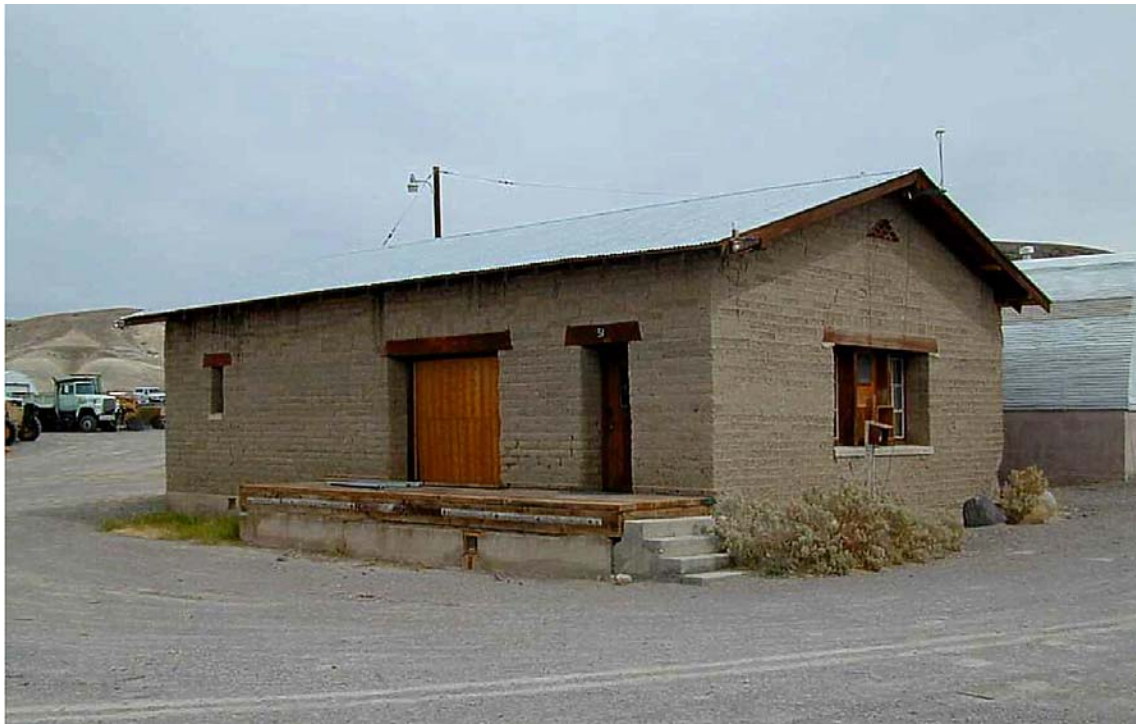
*Buildings and Structures #5: Cow Creek warehouse with loading dock, looking east. (PGSO, LCS digital file #DEVA-18, 2000)*

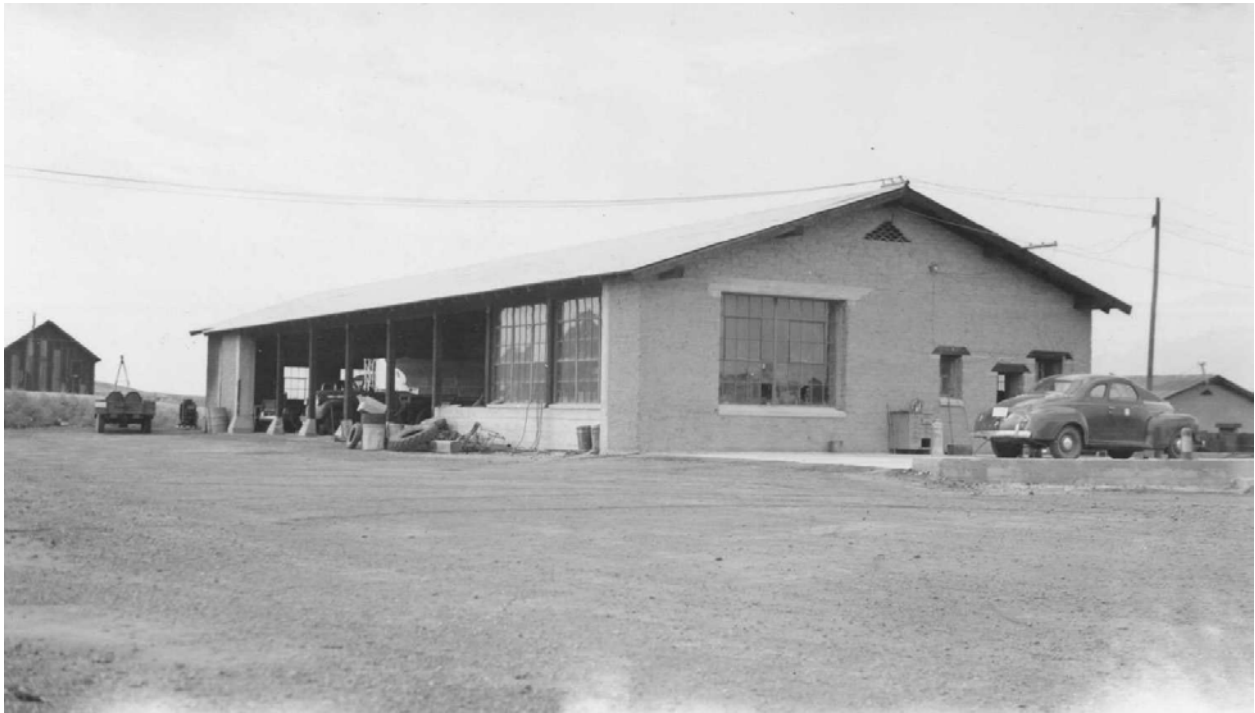
*Buildings and Structures #7: CC-54 with washrack. (Death Valley National Park archives, ARG digital images #46823, no date))*

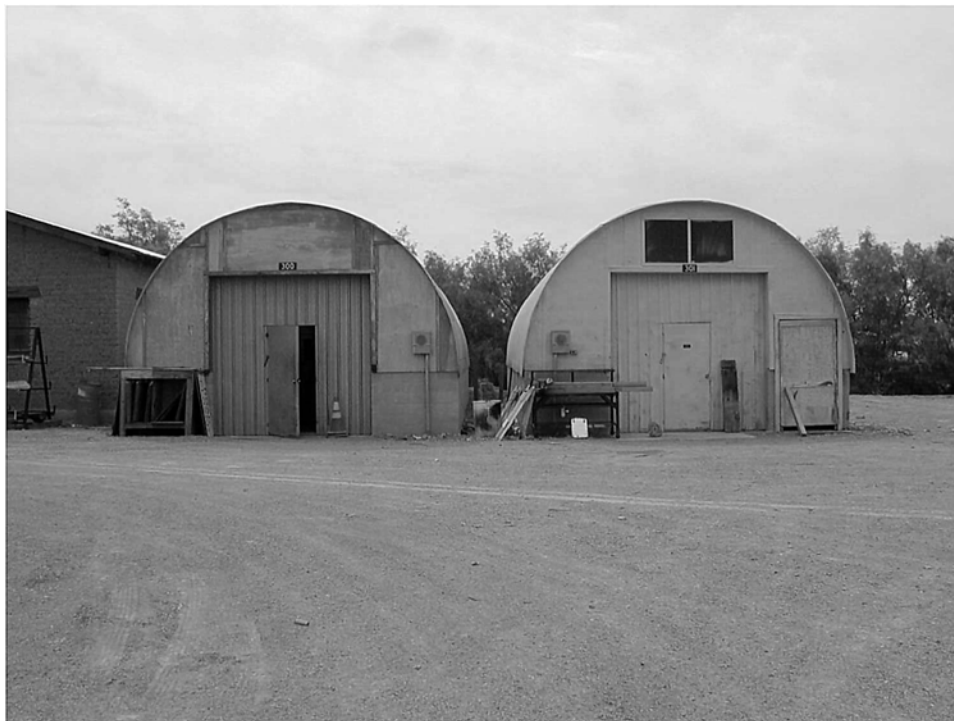
*Buildings and Structures #8: Cow Creek quonset huts, looking south. (PGSO, LCS digital file #DEVA-11, 2000)*

This is the first of seven World War II-era metal quonset huts (CC-300 – CC-306) acquired through the GSA from Camp Pendleton (see photo, Buildings and Structures #8). They were dismantled and re-erected in the Cow Creek maintenance area in 1975, and consist of arched metal frames with corrugated metal roofing on four-foot-high concrete block stem walls which rest on concrete slab foundations. The building is used for sign and tool storage.

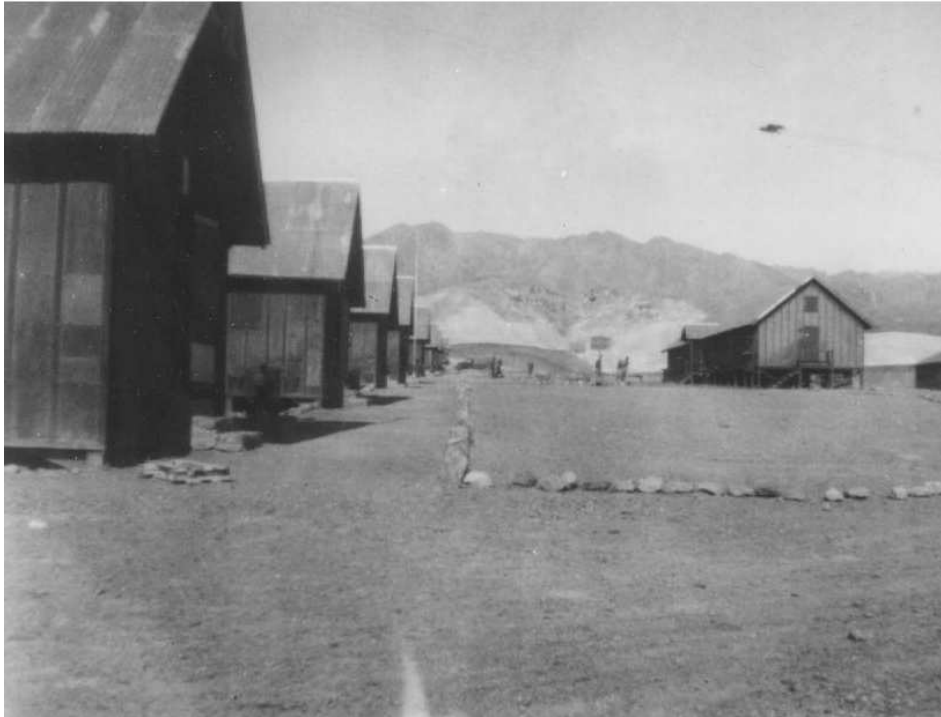
*Circulation #1: CCC Camp Funeral Range with pathways delineated by stones, looking west. (PGSO, Death Valley National Park Acc. #651.54, DEVA #4485, 1937)*

Photos, maps, and landscape architect’s reports from 1934 indicate that these roads were graded and oiled soil. The roads were raised above grade where possible, compacted, and oiled, although no road construction specifications have been located. A 1934 report states that “For surfacing...nothing so far known can compare with a good oil cake...The natural material is an almost perfect oil mix, the brownish-black color blends and harmonizes well with the surroundings and oiling is by far the cheapest method of treating these roads.” (Comments on ‘Report and Recommendations for Future Construction Projects, Goodwin, T.R., Death Valley National Park, California, Department of the Interior, Research Library and Museum Collection, Archives, Record Group 1, 1934:2) By 1937, a report states that “The new entrance r[oa]d to the Utility Area is completed, banks have been flattened and rounded, and the road surface partially oiled. More oil will be added soon and the entire surface scarified and relaid.” (Report to the Superintendent, Death Valley National Monument, through the senior project superintendent in charge, Feb. 20-March 20, Death Valley National Park, California, Department of the Interior, Research Library and Museum Collection, Archives, Record Group 1, 1937: 7) Within the camps, pedestrian routes around the structures consisted of untreated soil delineated by rows of stones (see photo, Circulation #1).

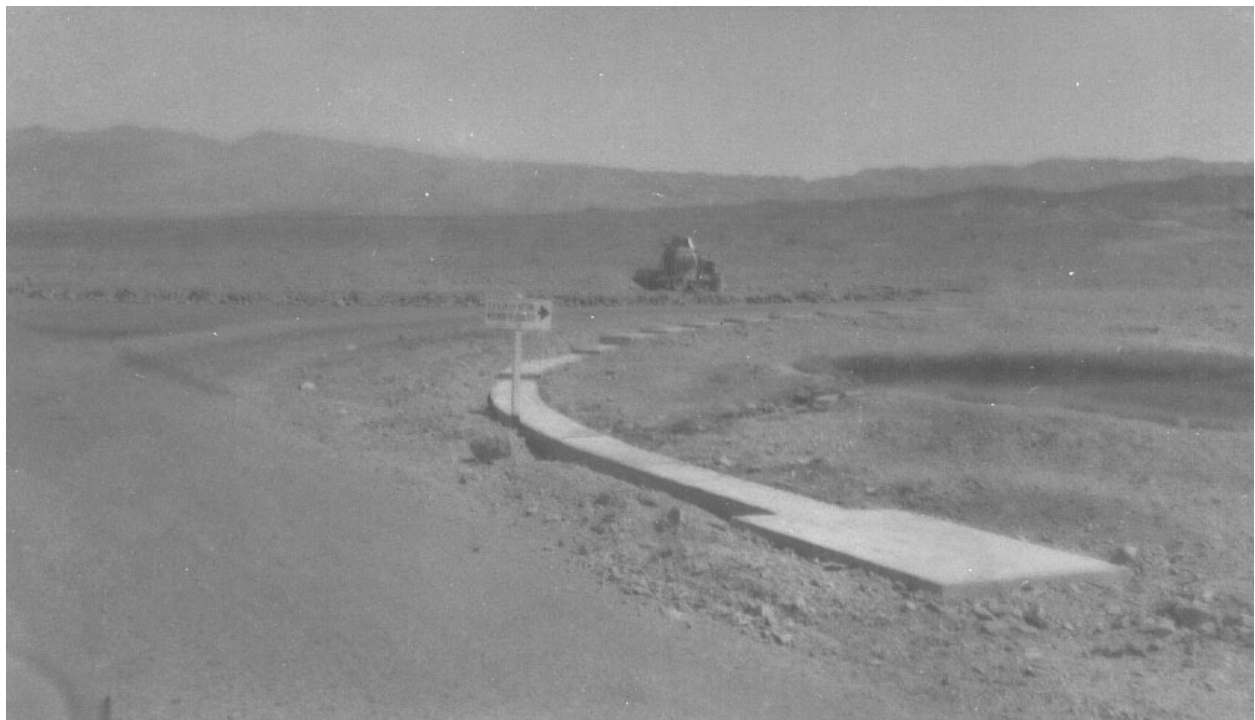
*Circulation #3: Stepped concrete entrance curbs at the junction of State Route 190 and Route 50, looking west. (PGSO, Death Valley National Park Archives Acc. #1152, DEVA #27058.A, no date)*

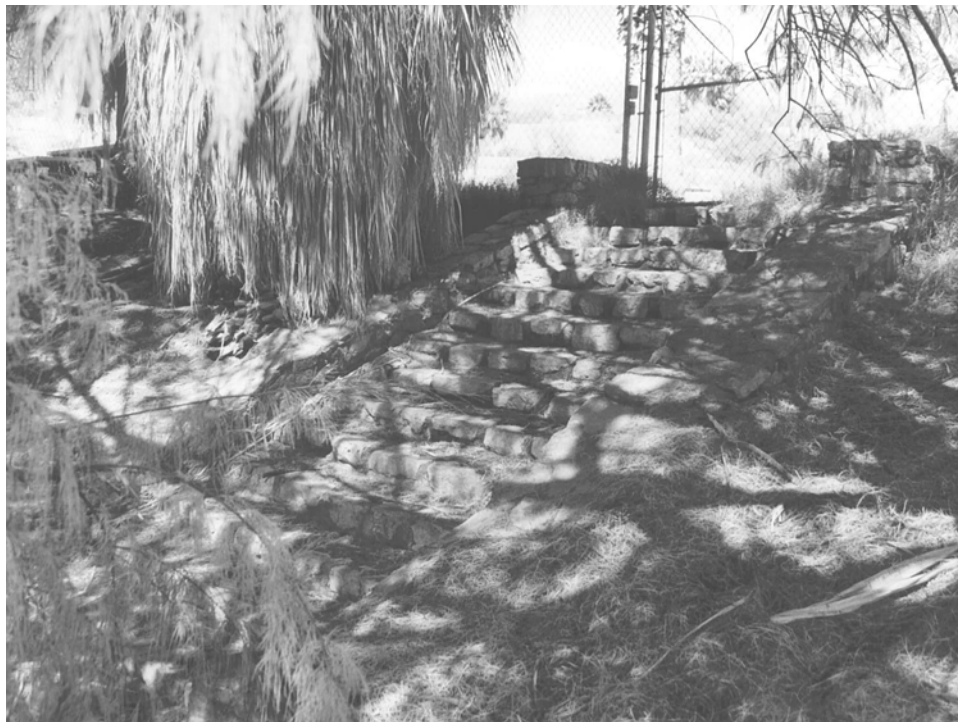
*Circulation #5: CCC-era stairs leading to pool area, looking north. (PGSO, CLI print #DEVA-P-0007-2, 2000)*

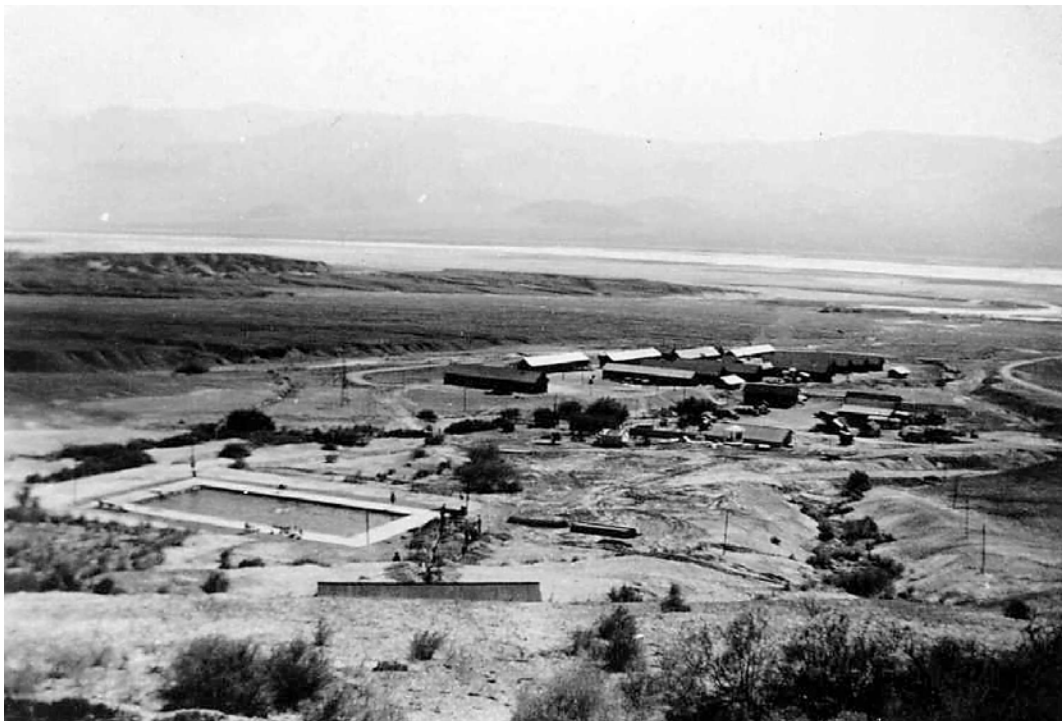
*Constructed Water Features #1: Cow Creek pool before landscaping and Camp Funeral Range, looking west.*

Although the reservoir is no longer in use, both it and the swimming pool remain intact from the period of significance. Accordingly, these constructed water features retain integrity as a contributing landscape characteristic of the historic district.

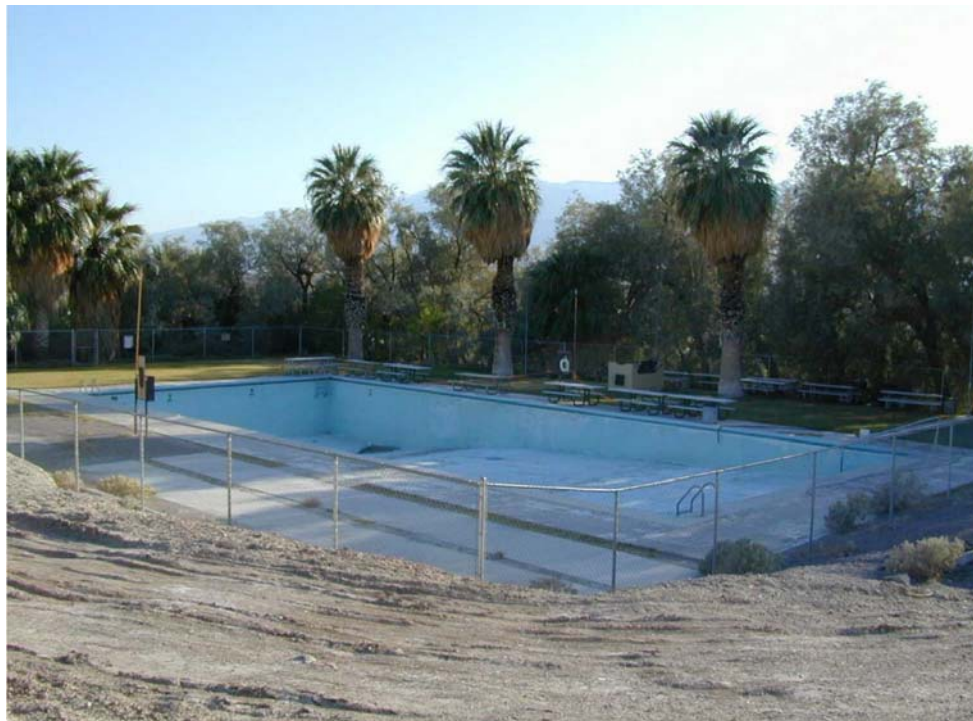
*Constructed Water Features #2: Contemporary view of the Cow Creek pool with landscaping, looking west. (PGSO, LCS digital file #DEVA-10, 2000)*

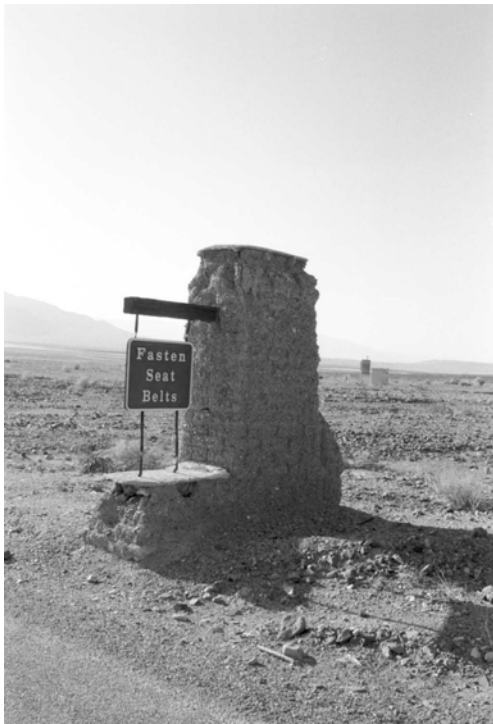
*Small Scale Features #2: Adobe entrance sign, looking west. (PGSO, CLI negative #DEVA-N-0006-3, 2000)*

This freestanding adobe signpost was built by the CCC as part of the original Cow Creek complex (see photo, Small Scale Features #2). It is located on the north side of the access road immediately east of the trailer area spur road leading south. The signpost is constructed of adobe bricks with no apparent foundation. There is a concrete cap, a later addition, at the top portion of the signpost and at the top of the base where the signage is anchored. The sign is hung from a cantilevered wooden arm. The original sign, which read "Death Valley National Monument," has been replaced with a metal sign that reads "Fasten Seat Belts."

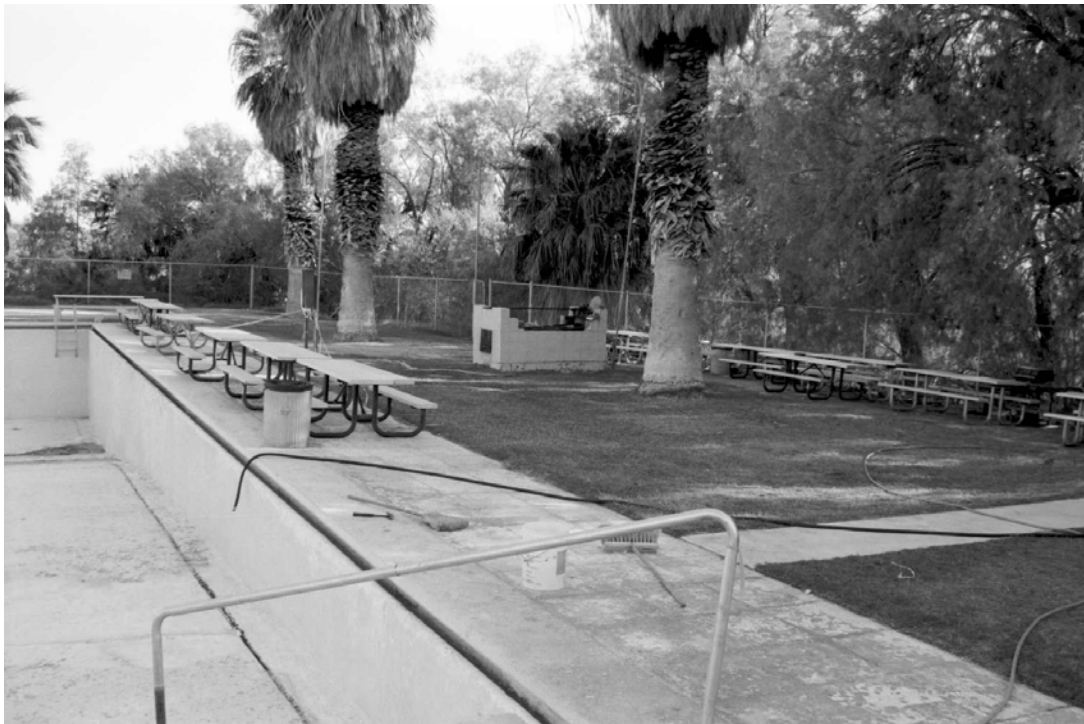
*Small Scale Features #4: Pool patio area showing swimming pool deck and barbecue, looking south. (PGSO, CLI negative #DEVA-N-0006-17, 2000)*

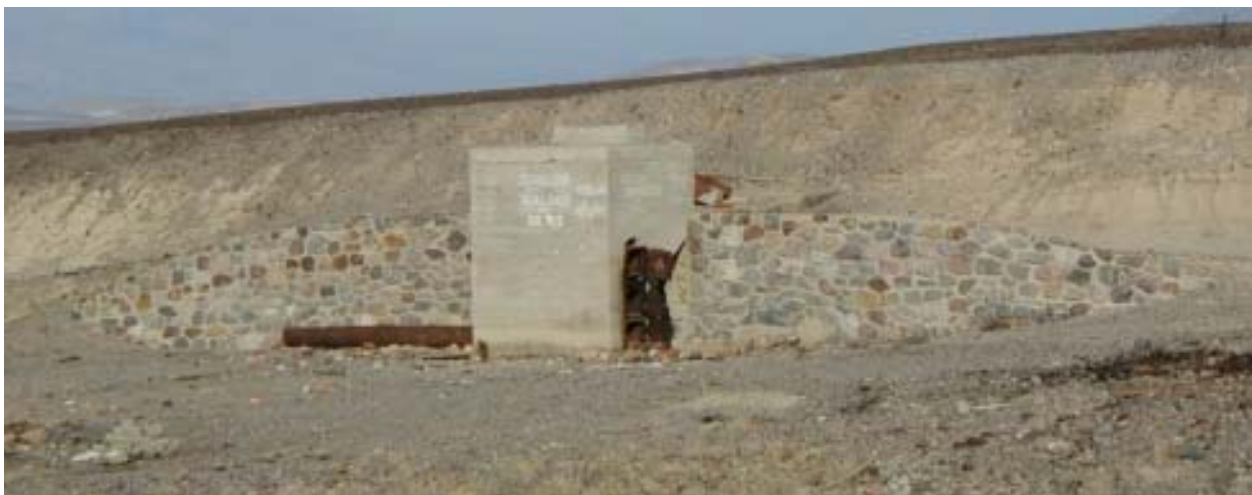
*Small Scale Features #5: CCC Incinerator with wingwalls and graffiti, looking north. (DEVA, park digital photo, no identifier, 2001)*

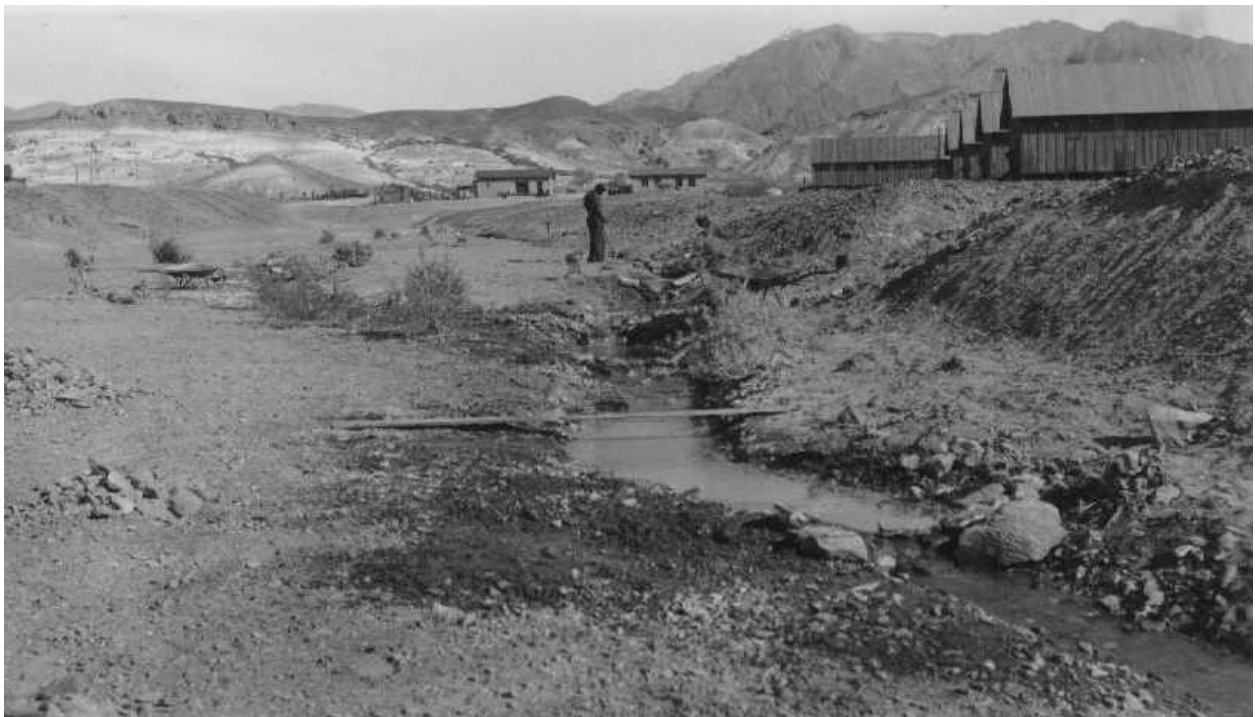
*Topography #1: Leveling the wash between Camp Cow Creek and Camp Funeral Range, looking east. (PGSO, Death Valley National Park Archives, Acc. #1240, DEVA #30524, 1936)*

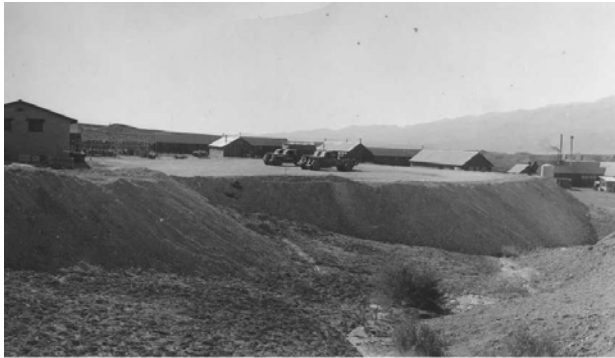
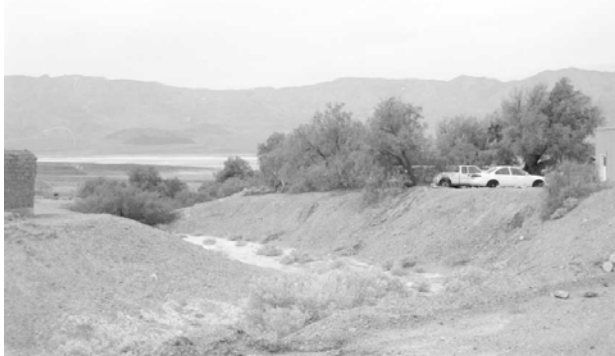
*Topography #2: Comparison of Cow Creek Wash topography from 1940 to 2000, looking west. (Top: Death Valley National Park Archives, Acc. #725.1, DEVA#620, 1940. Bottom: PGSO, CLI negative # DEVA-N-0003-14, 2000)*

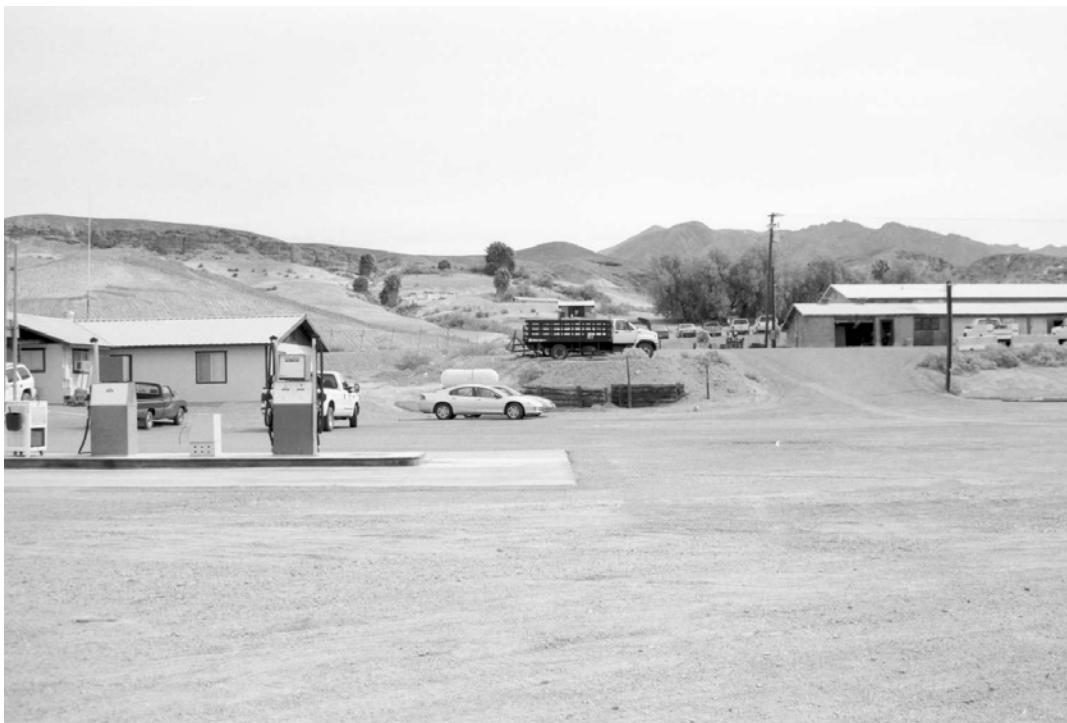
*Topography #3: Change in slope from lower to upper utility areas, looking east. (PGSO, CLI negative #DEVA-N-0004-17, 2000)*

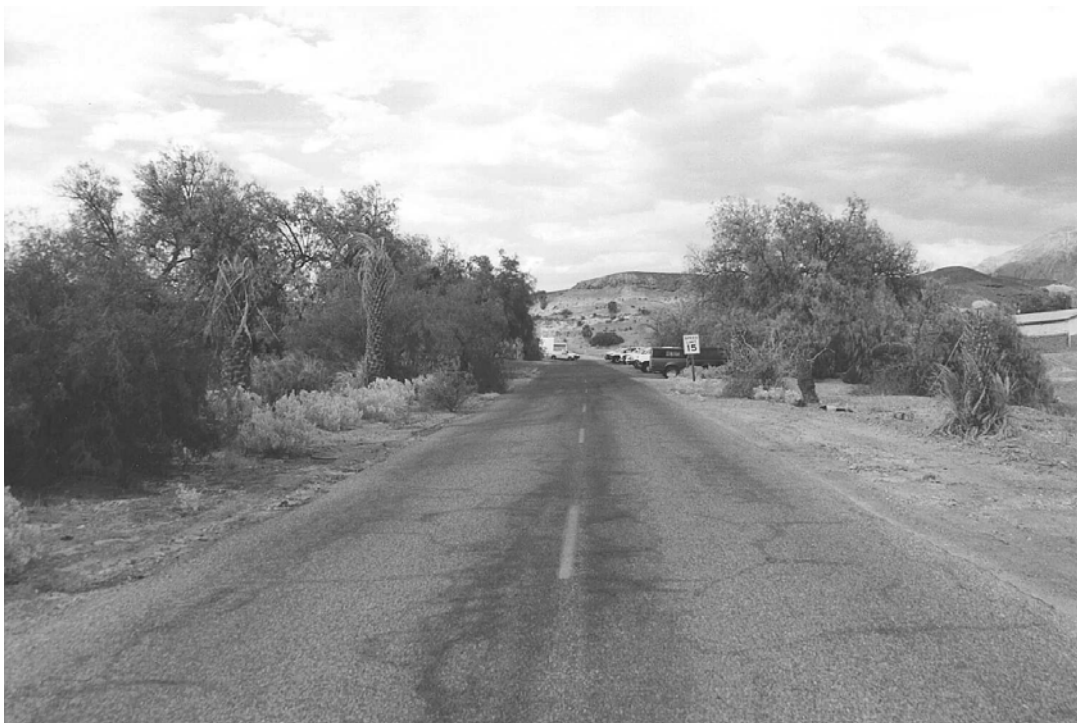
*Vegetation #3: Dead palms along Cow Creek roadside, looking east. (PGSO, CLI, Print #DEVA-P-0007-1, 2000)*

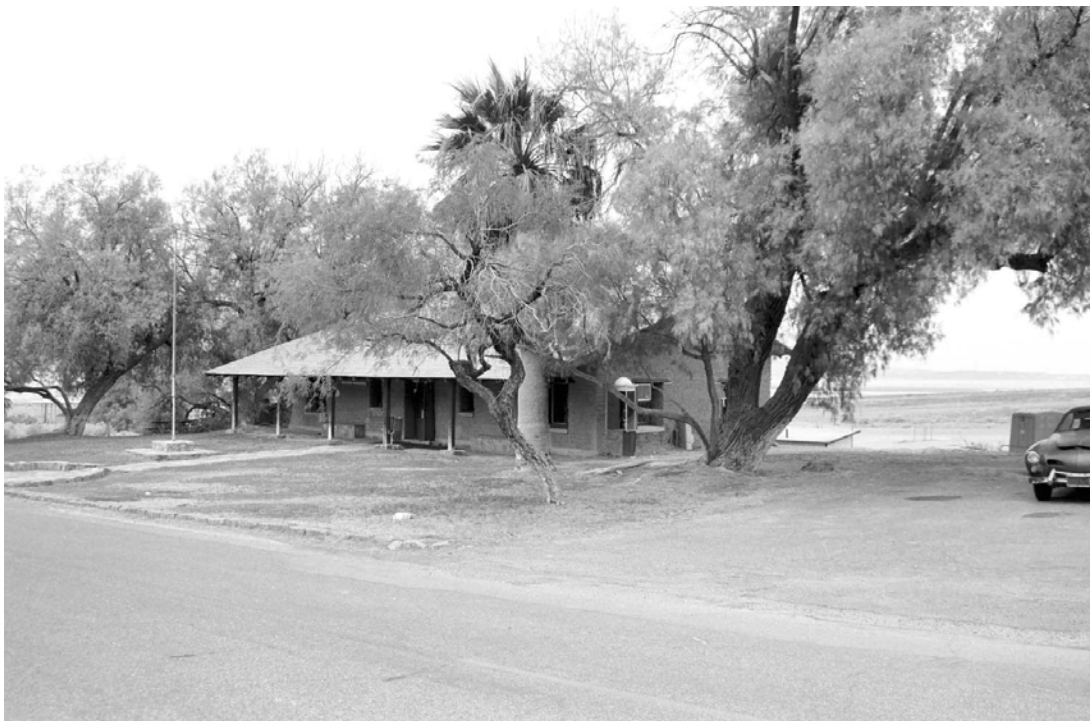
*Vegetation #5: Planted vegetation around the Administration building, looking west. (PGSO, CLI negative #DEVA-N-0003-16, 2000)*

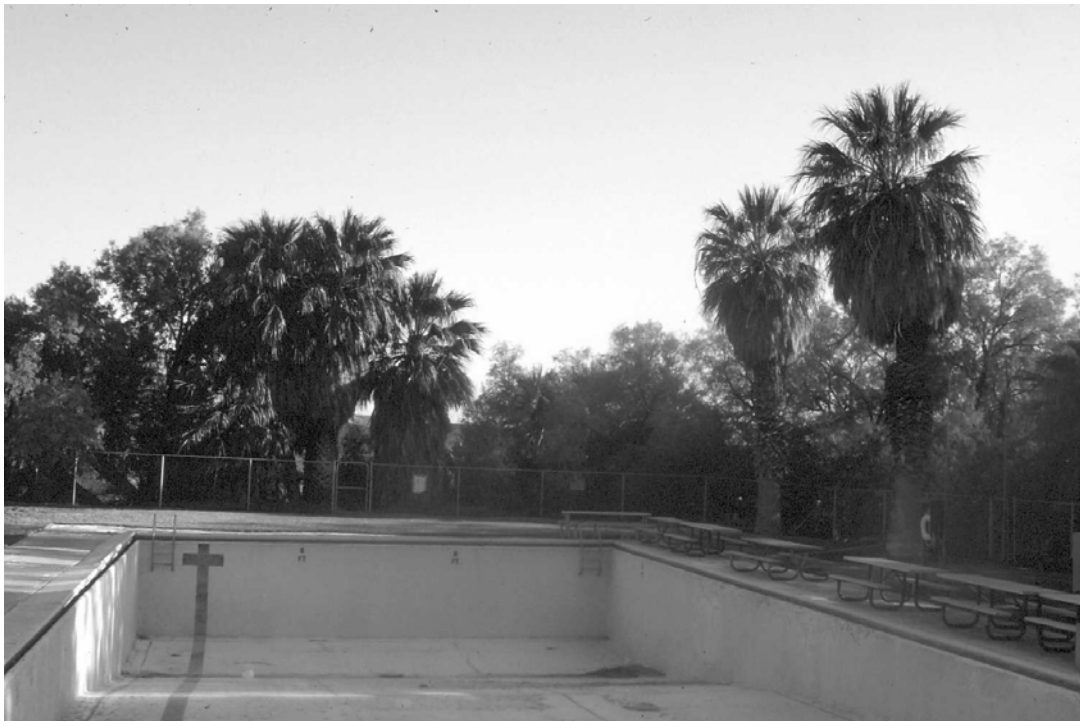
*Vegetation #7: Contemporary view of pool and mature California fan plams, looking south. (PGSO, CLI slide #DEVA-S-0002-24, 2000)*

The landscape within the Cow Creek Historic District still retains the character and feel of that planted by the CCC as reflected in photographs and plans from the period. The three primary areas which appear to have been extensively planted include the administration building, the pool area, and the embankments along the washes. Although the plantings have matured and changed over time, and all three areas appear to retain most of the larger plant material, much of the remaining landscape appears water stressed.
