National Park Service  
Cultural Landscapes Inventory

Revised: 1/2025

Isaac Van Campen Inn  
Delaware Water Gap National Recreation Area

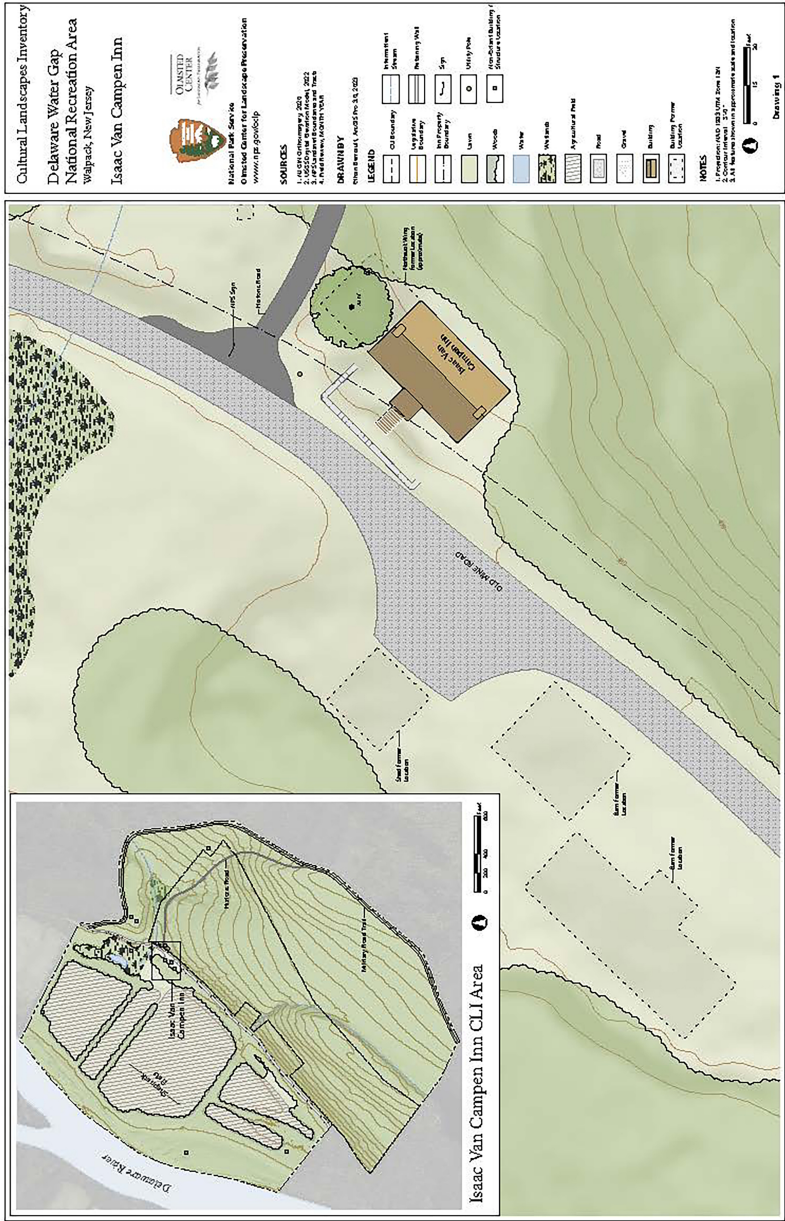
Site Plan

Site map, 2024.

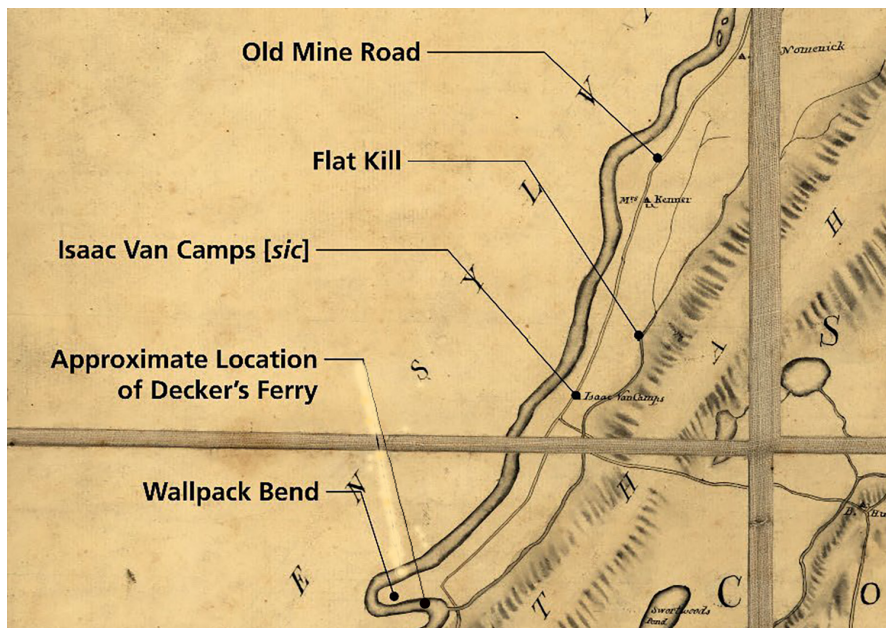
Figure 1. A 1781 map showing the location of "Isaac Van Camps" landholdings along Old Mine Road near the eastern bank of the Delaware River. (Library of Congress, <https://lccn.loc.gov/gm71005417>)

Van Campen's close association with the building is reflected to this day in the historic home's common name: the Isaac Van Campen Inn. However, despite this title, the building never operated as a commercial inn and primarily served as a single-family residence throughout the historic period. The "inn" description may stem from the building's designation during the colonial period as a "yaugh" house, a private residence along a major road that would offer accommodations to travelers in need. By 1789, a "Great Road to Minisink," possibly the former "King's Road" and predecessor of the present-day Old Mine Road, passed through Shapanack (Figure 1). (Hutson 1992: 14,35; Snook 1974: 13,24)

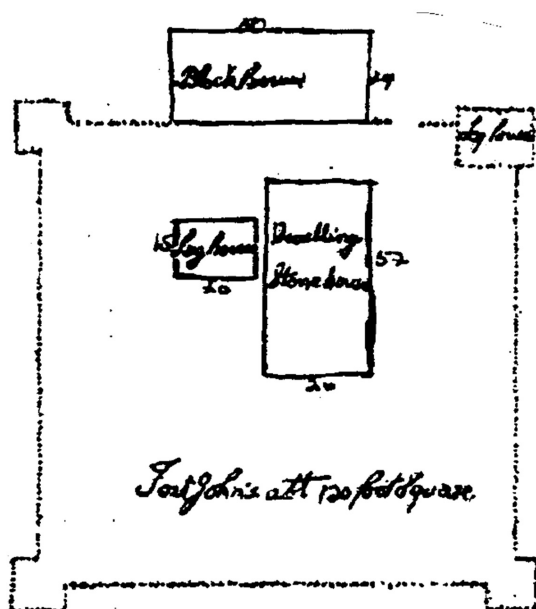
Figure 2. This sketch from Capt. Jonathan Hampton's undated map of frontier forts shows a large log palisade (dotted line), but it is uncertain if the fort was ever built on this scale. The opening just to the right of the block house (at top) may have led south down to the Isaac Van Campen House. (Military Trail brochure, n.d.: 2)

Fort Shapanack was constructed by Col. John Rosenkrans, whose residence was nearby, and included a 120-foot-square palisade, with three, 15 by 15-foot bastions. The palisade encompassed several buildings that included a 50 by 25-foot blockhouse, a 15 by 20-foot log house, and a 52 by 26 foot stone dwelling (Figure 2). The log house occupied a corner of the stockade and served as the fourth bastion. Altogether, the fortification was designed to hold 100 soldiers. In 1756, a supply road was constructed to reach Fort Shapanack from the eastern side of Walpack Ridge. (Roberts 1988: 510; Clemensen, 1996: 161)

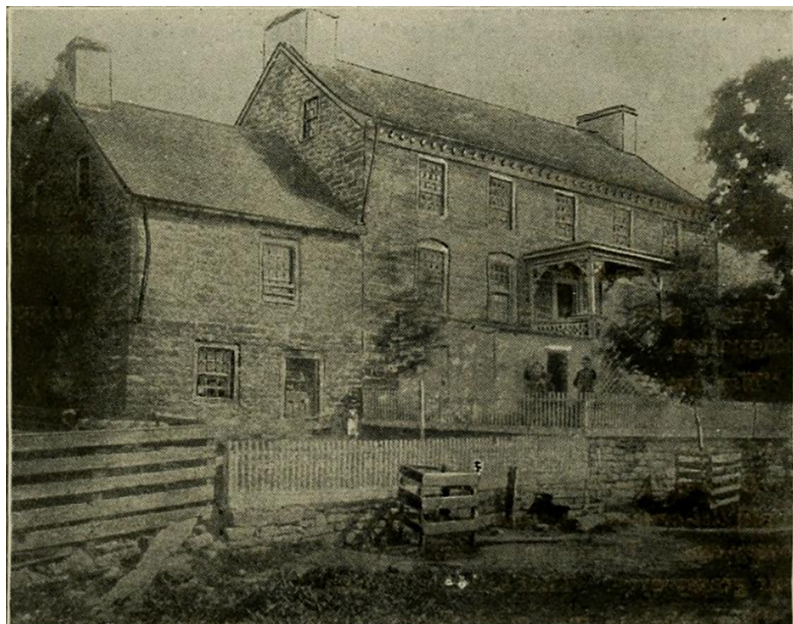
Figure 3. The earliest known photo of the Isaac Van Campen Inn, taken in the early 1890s. (Published in *A Minisink Double Wedding* by Charles E. Stickney, 1902)

The earliest known photograph of the Isaac Van Campen Inn was taken in the 1890s and published in 1902 (Figure 3). Taken from Old Mine Road, looking south toward the northwestern corner of the house, the image shows the ca.1746 building with its late eighteenth-century northeastern wing. A single-bay porch with elaborate Victorian detailing stands at the building's front entrance, and a short picket fence stands atop a retaining wall of regularly coursed stone that defines a small, rectangular yard in front of the building. The west portion of the wall parallels Old Mine Road. Another run of picket fence stands atop a lower, regularly coursed stone wall that also parallels the road's edge, and includes a set of wood steps opposite a door on the wing. Directly north of this second picket fence, a slightly taller section of board fencing runs along Old Mine Road's edge, likely enclosing a yard or pasture directly north of the building's northeast wing. Directly south of the house, a mature, deciduous tree stands beside the house, its canopy exceeding the building's roof in height. Two deciduous tree saplings are present at the eastern edge of Old Mine Road, directly in front of the home. Small pens made of wooden boards appear to offer protection for the young trees. (Hutson 1992: 52)

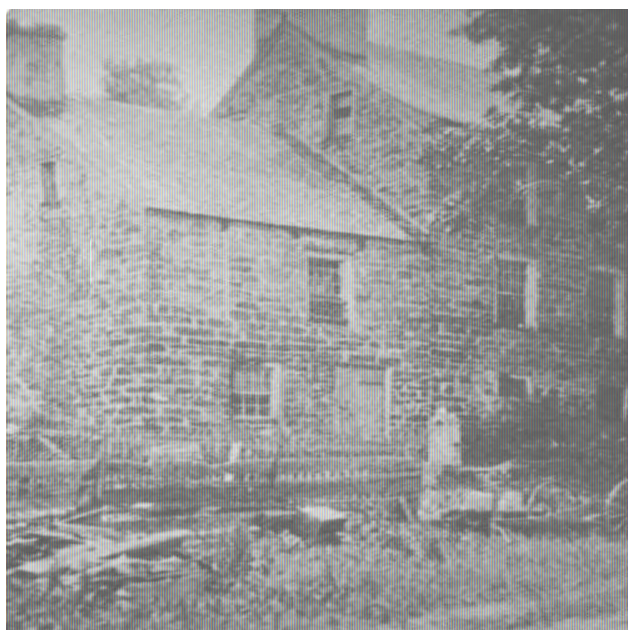
Figure 4. A 1903 photograph, taken by C.G. Hine, shows a portion of the northwestern (front) facade of the Van Campen Inn, looking southeast. (Snook 1974: 47)

By 1903, at least one of the trees (the southernmost one) at the eastern edge of Old Mine Road had survived, as depicted in a photograph taken that year by C.G. Hine (Figure 4). This photograph shows a portion of the Isaac Van Campen Inn's front façade, the picket fences depicted in the 1890s photograph are no longer extant, and stone walls partially dismantled. Generally, the landscape in front of the house displays an unkempt appearance in the 1903 image. (Snook 1974: 47)

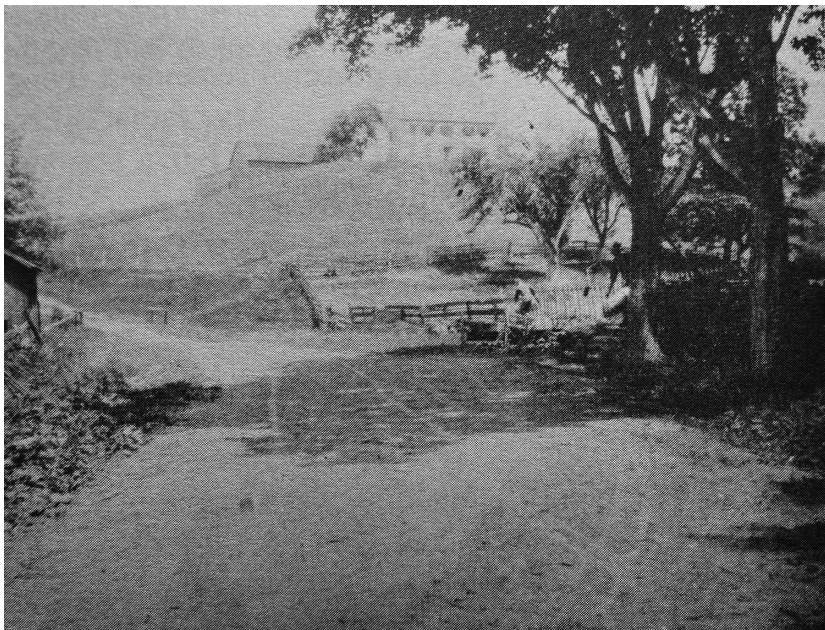
*Figure 5. A 1908 photograph taken by C.G. Hine showing a view looking north from Old Mine Road, near where it passed the Van Campen Inn. The Hull farm is visible on a knoll in the distance. (Hutson, 1992: 73)*

A slightly later photo, taken by C.G. Hine in 1908, shows a view from Old Mine Road near the Isaac Van Campen Inn, looking northwest toward the Hull Farm, which stood at the top of a knoll approximately 500 feet to the northwest (Figure 5). The steep slope leading up to the Hull Farm is cleared and may have been used as a pasture at the time. At the base of the slope, directly north of the house, a board fence encloses a yard that contains at least two small deciduous trees, potentially apples. At least two mature, deciduous, canopy trees stand at the eastern edge of Old Mine Road near the house, one of which is the southernmost tree shown in earlier photographs. In the distance are the railings for the bridge that crosses the northernmost stream from Walpack Ridge. (Hutson 1992: 73)

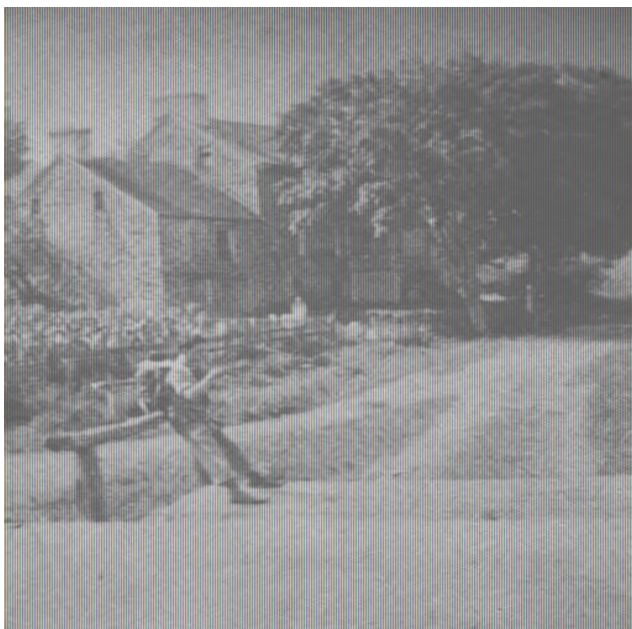
*Figure 6. A 1908 photograph shows a view looking south down Old Mine Road, toward the Van Campen Inn. (Snook 1974: 47)*

Another 1908 photograph, also taken from Old Mine Road, looks south toward the Isaac Van Campen Inn from a few hundred feet north (Figure 6). In the foreground, a small wooden bridge carries Old Mine Road over the northernmost stream. Directly north of the house, a board fence appears to enclose a field planted with crops. North of this field, a lane branches to the east from Old Mine Road, possibly to run parallel to the stream as it climbs the slope of Walpack Ridge. The northernmost roadside tree, seen in the other 1908 photo, and others to the south, shade the front of the Isaac Van Campen Inn. (Snook 1974: 47)

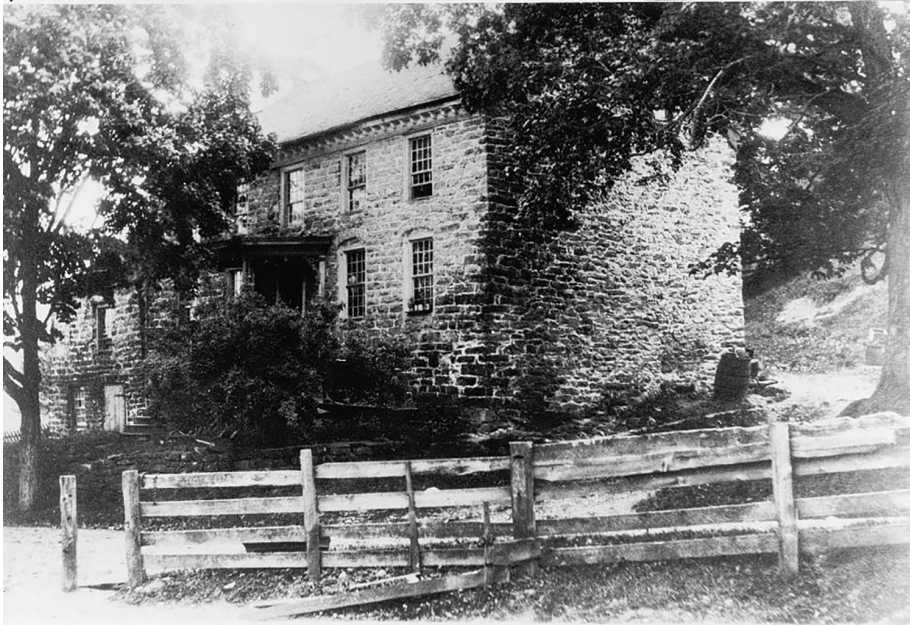
Figure 7. A photograph taken in ca.1910, showing the northwestern (front) and southwestern elevations of the Van Campen Inn. (Library of Congress. HABS NJ-436. <https://www.loc.gov/resource/hhh.nj0155.photos/?sp=14>)

The first decades of the twentieth century, after the Berk family vacated the Isaac Van Campen Inn and began renting the building and surrounding farm to tenants, appear to have been a period of changing conditions at the cultural landscape. A ca.1910 photograph shows the house from across Old Mine Road (Figure 7), which reveals some intact section of stone wall along Old Mine Road. In this photograph, a board fence runs along the western edge of Old Mine Road, likely enclosing a yard associated with the Van Campen-Dewitt Barn built by the Dewitts in the beginning of the nineteenth century. A large deciduous tree stands directly south of the house, and a smaller deciduous tree stands at the eastern edge of Old Mine Road. A glimpse of the slope behind the building shows a pasture. Another photograph taken in 1910 of the house's northeastern wing as seen from Old Mine Road reveals stone wall remnants and set of stone steps (Figure 8). In the image, the landscape immediately surrounding the house appears unkempt. (Hutson 1992: 77)

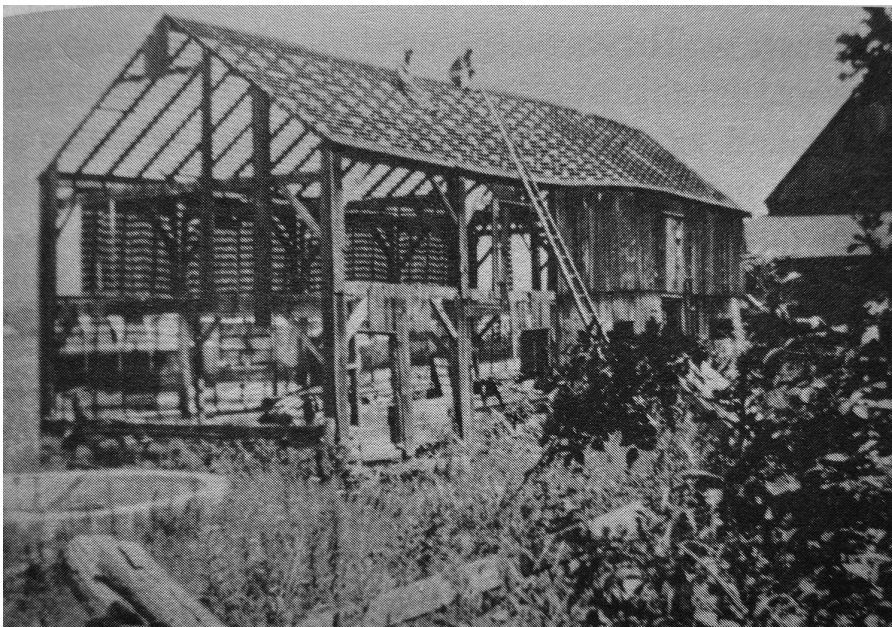
*Figure 12. Dismantling the cow barn that stood beside the Van Campen-Dewitt Barn (background image right) in July 1939, when Nat and Hilda Ludwig were tenant farmers residing at the Van Campen Inn. (Hutson 1992: 95)*

Under the Ludwigs' management, several modifications were made to the Isaac Van Campen Inn cultural landscape. In 1939, Ludwig dismantled the cow barn (Figure 12). Around the same time, he also moved an old hen house from the orchard behind the house to a location west of the Dutch-style barn to serve as a "club house" for hired help. By the 1930s, the cottage known as the "Sheep House" located on the slope east of the house was owned by the Moffett family and used as a summer cottage (Figure 13). By 1950 the farm's overall condition appears to have improved, as evidenced by a photograph from about that year that shows an elevated view of the farm, looking southwest from a location near the Hull Farm (Figure 14). (Hutson, 1992: 91,94)

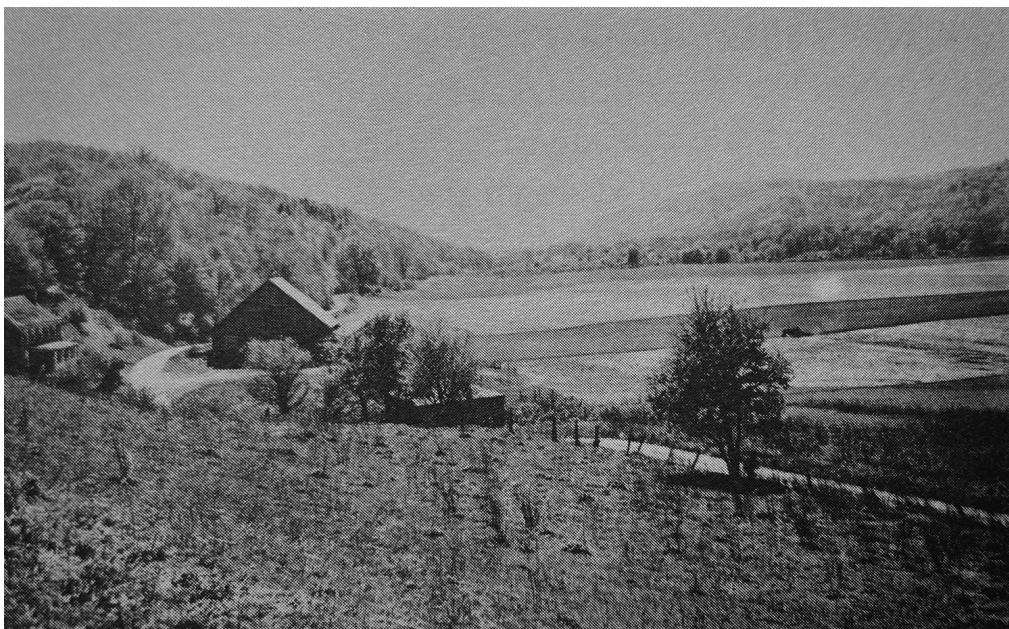
*Figure 14. An elevated view of the Van Campen Inn farm, as seen from the knoll near the Hull Farm in 1950. The Isaac Van Campen Inn (image far left) stands on the east side of Old Mine Road and the Van Campen-Dewitt Barn sits to the southwest, on the western side of Old Mine Road. (Hutson 1992: 91)*

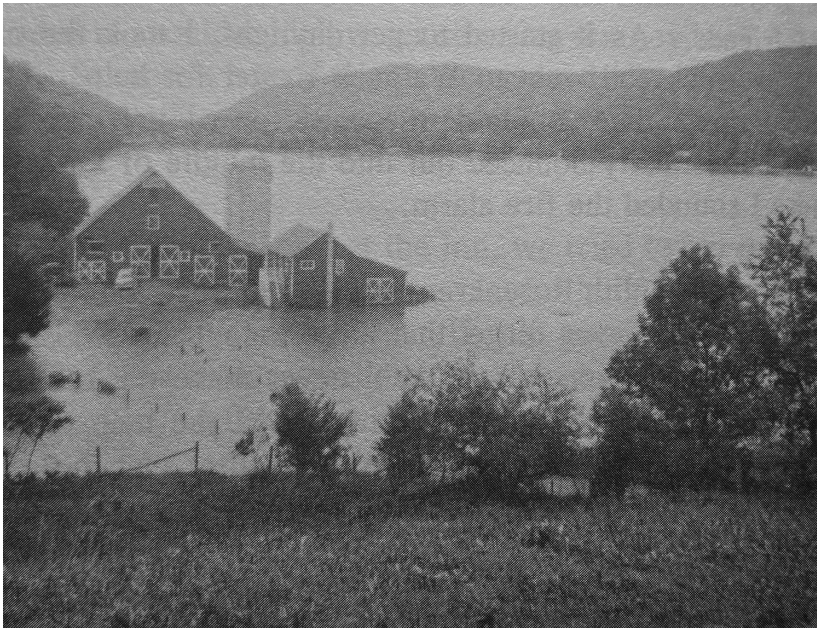
Figure 15. In 1955, a major flood inundated the low-lying areas of the farm surrounding the Van Campen Inn, as seen from the knoll near the Hull Farm, looking southwest. The tops of fence posts lining Old Mine Road are visible northeast of the Van Campen-Dewitt Barn (image left) and the carriage house. The silo was built in 1951. (Hutson 1992: 128)

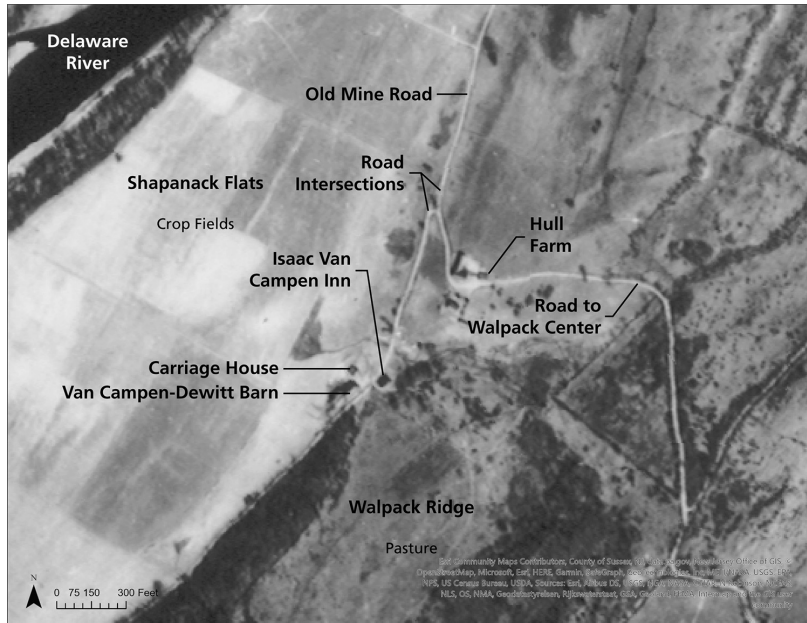
Figure 16. Annotated 1930 aerial photograph of the Van Campen Inn cultural landscape. (New Jersey Historic Preservation Office, annotated by OCLP)

Circulation refers to the spaces, features, and applied material finishes that constitute systems of movement in a landscape. During the historic period, primary circulation features at the Isaac Van Campen Inn cultural landscape included Old Mine Road, and a series of farm roads that led into fields on Shapanack Flats and into pastures on the western slope of Walpack Ridge, above the Isaac Van Campen Inn. Additionally, another road met Old Mine Road approximately eight hundred feet north of the Isaac Van Campen Inn and extended east over Walpack Ridge to Elizabeth Town, NJ, near New York City. It was built in 1756 as military road to supply Fort Shapanack. Historic aerial photographs appear to show that, during the early twentieth century, the former military road split as it approached Old Mine Road from the east, and met Old Mine Road at two distinct intersections, approximately 150 feet apart (see Figures 16 and 17).

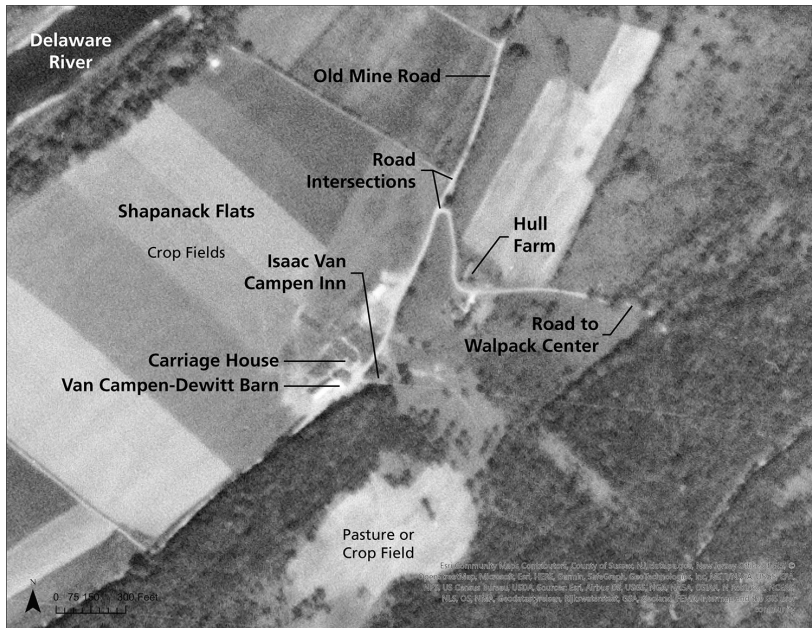
Figure 17. Annotated 1958 aerial photograph of the Van Campen Inn cultural landscape. (USGS, annotated by OCLP)

By 1958, aerial photography shows that the former pastures on top of Walpack Ridge had begun to grow up in woods and some may have been converted to crop fields, reflecting changes in land use (Figure 17). However, the floodplain crop fields on the western side of Old Mine Road remained in use, and the hill between the Isaac Van Campen Inn and the Hull Farm remained open, preserving the visual connection between the two farmsteads.

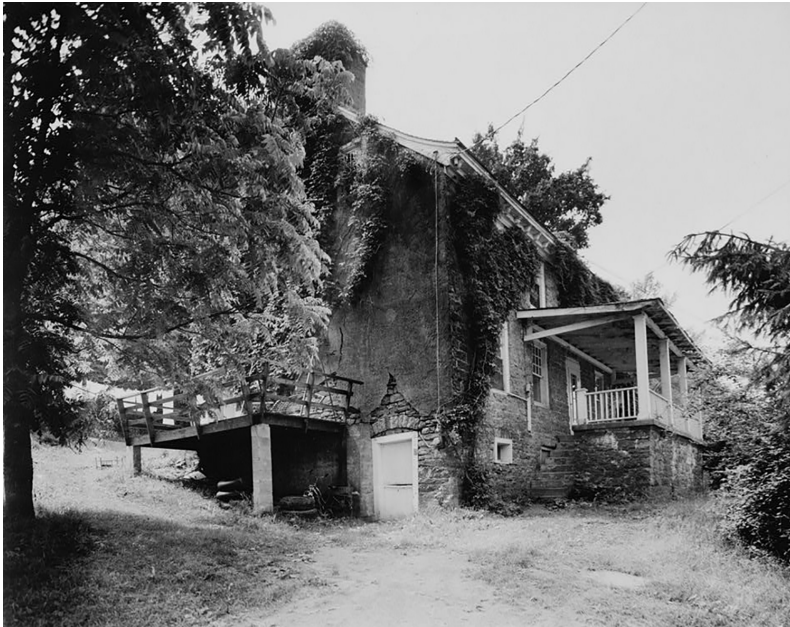
Figure 18. The northwestern (front) northeastern elevations of the Van Campen Inn in 1967, photographed by George Eisenman for the Historic American Buildings Survey. (Library of Congress. HABS NJ-436. <https://www.loc.gov/pictures/item/nj0155.photos.109974p/resource/>)

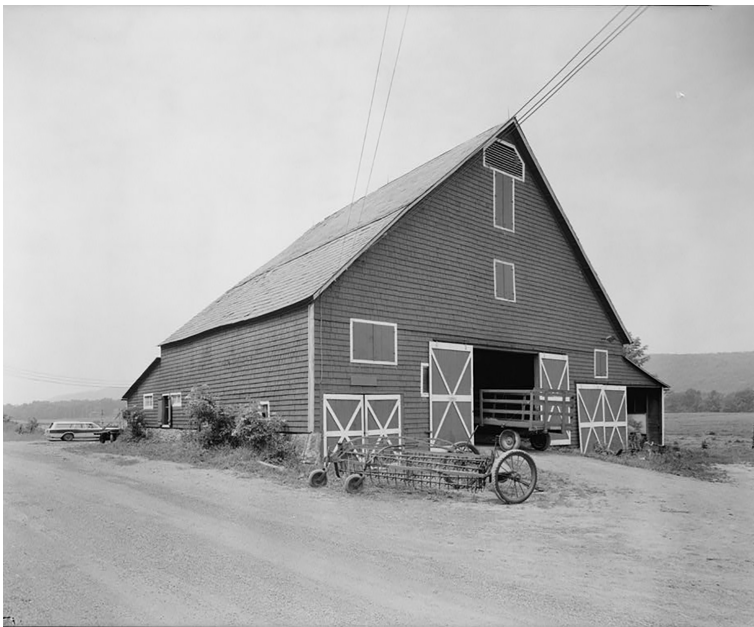
Figure 19. The northeastern (front) and southeastern elevations of the Van Campen-Dewitt Barn, photographed in 1967 by George Eisenman for the Historic American Buildings Survey. (Library of Congress. HABS NJ-736. <https://www.loc.gov/item/nj0154/>)

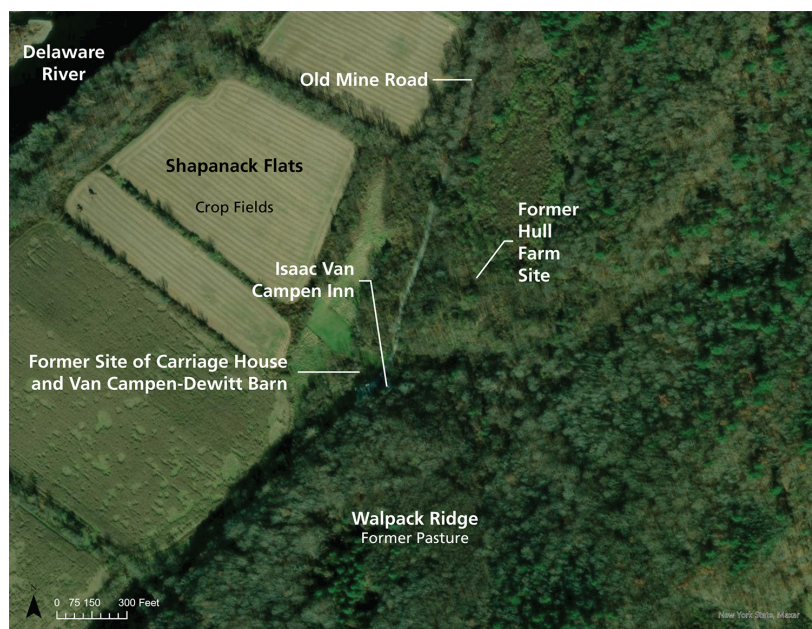
Figure 23. Annotated 2023 aerial photograph of the Van Campen Inn cultural landscape. (USGS, annotated by OCLP)

Additionally, increased woody succession, especially on the slopes east and north of the Isaac Van Campen Inn and along the western edge of Old Mine Road, have resulted in considerably more enclosure than existed during the historic period. By the 1980s, woods had begun to grow up in historic pastures and orchards (Figure 22). The new woody growth has obstructed significant historic views, including westward views of Shapanack Flats and the Delaware River from the Isaac Van Campen Inn and a northward view toward the former Hull Farm site from Old Mine Road. Enclosure due to woody growth has continued to increase in recent years (Figure 23).

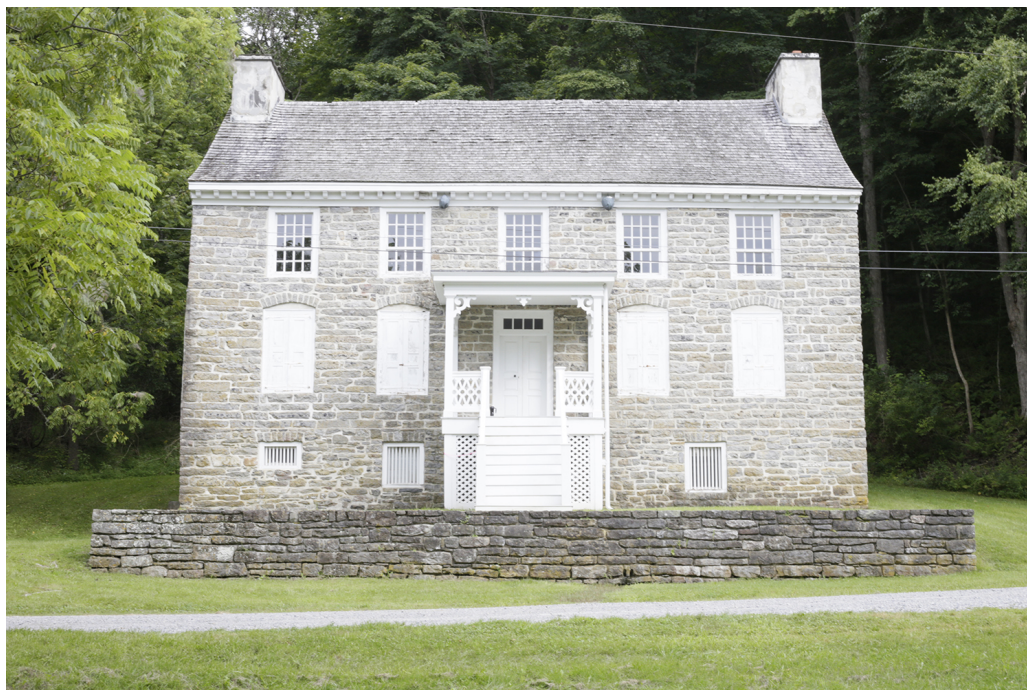
*Figure 35. The front elevation of the Isaac Van Campen Inn, looking east from across Old Mine Road, 2023. (OCLP)*

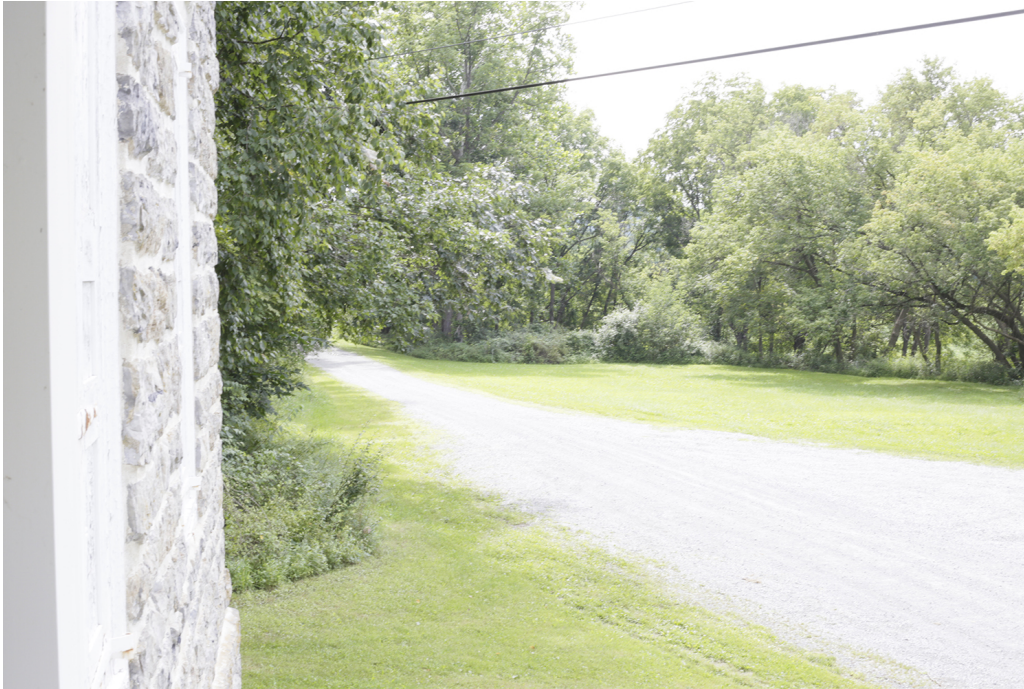
*Figure 32. Old Mine Road, as seen from the front porch of the Isaac Van Campen Inn, looking southwest, 2023. The mowed area on the opposite side of the road marks the former site of the Van Campen-Dewitt Barn. (OCLP)*

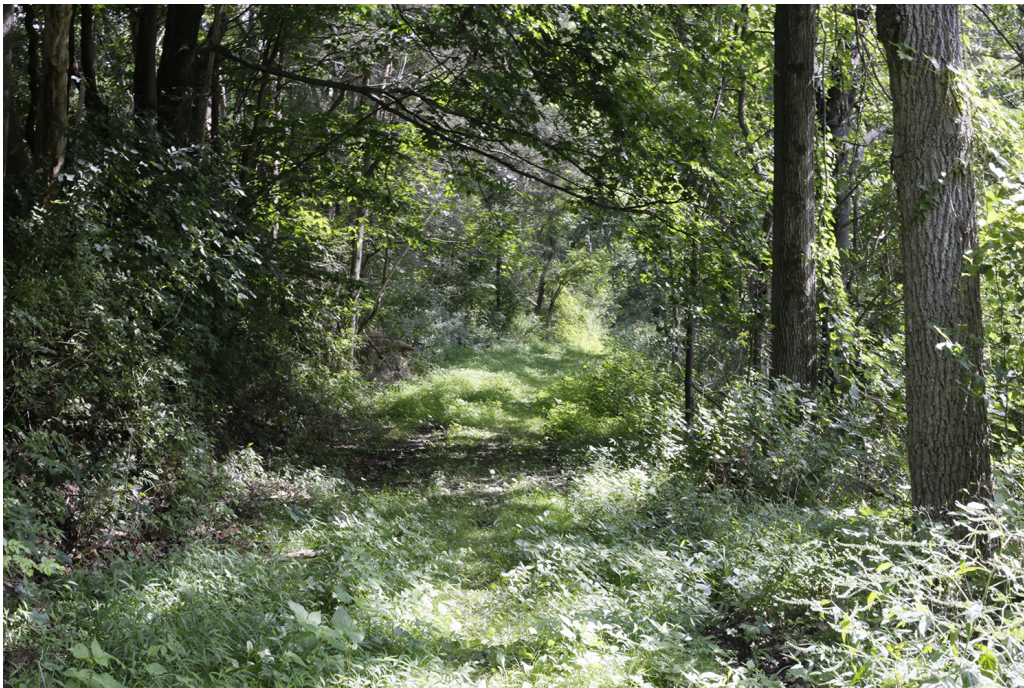
*Figure 33. A section of the park's Military Road Trail, which follows the alignment of a historic road built to supply Fort Shapanack in 1756. Looking southeast, 2023. (OCLP)*

Since the end of the historic period, most major historic circulation features, including Old Mine Road and farm roads leading into fields on Shapanack Flats, have been maintained (Figure 32). Additionally, the historic road built to supply Fort Shapanack in 1756 has been preserved as the park's Military Road Trail (Figure 33). The present-day trailhead at Old Mine Road corresponds to one of that roads' two historic intersections, but the second historic intersection, which occurred approximately 150 feet to the south, is no longer extant (Figure 34). Additionally, a short historic drive that once led to the carriage house directly across from the Isaac Van Campen Inn has been preserved, although the carriage house was dismantled in the 1970s. East of the Isaac Van Campen Inn, on the densely wooded western slope of Walpack Ridge, traces remain of a series of farm roads that historically led to outbuildings, pastures, orchards, and other features associated with the Isaac Van Campen Inn.

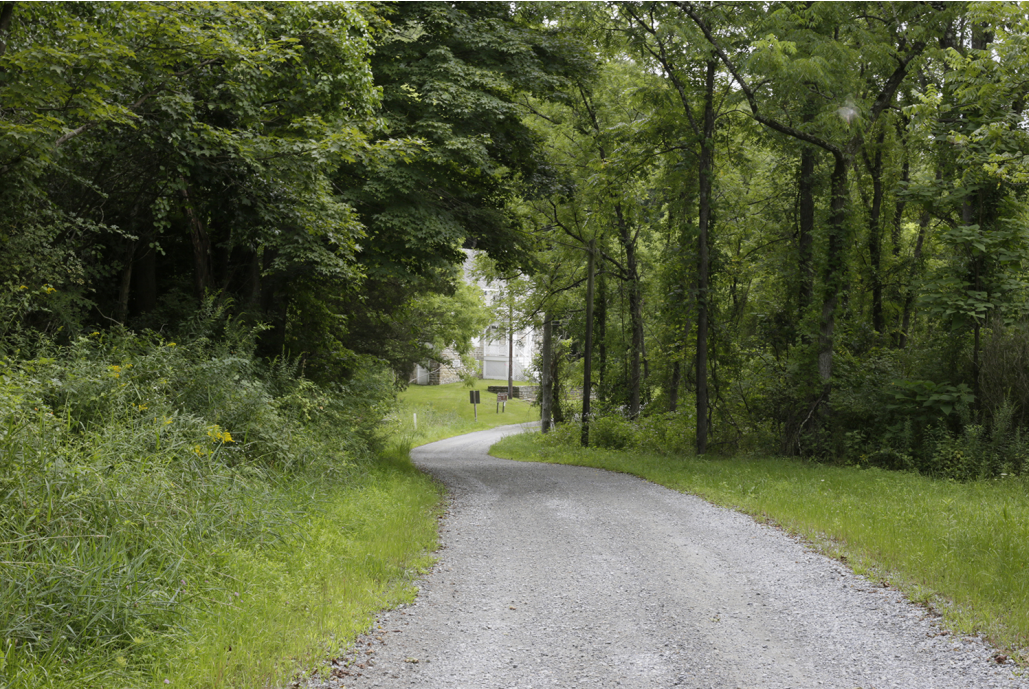
Figure 24. A glimpse of the Van Campen Inn from Old Mine Road, looking south, 2023. Growth of woods since the end of the historic period has resulted in substantially more enclosure than existed historically. (OCLP)

**Impact Narrative:** Continued encroachment of woody vegetation into historically open areas of the cultural landscape will negatively impact the landscape condition.

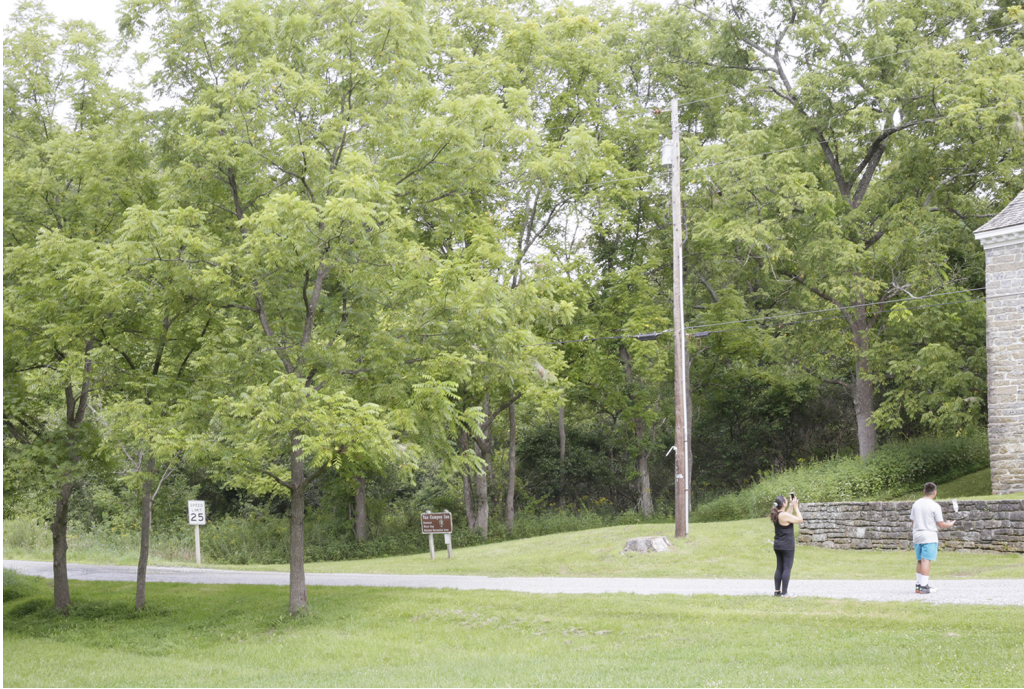
*Figure 25. Woods that have grown up in areas north and east of the Van Campen Inn since the end of the historic period do not contribute to the landscape's historic character. Looking northeast, 2023. (OCLP)*

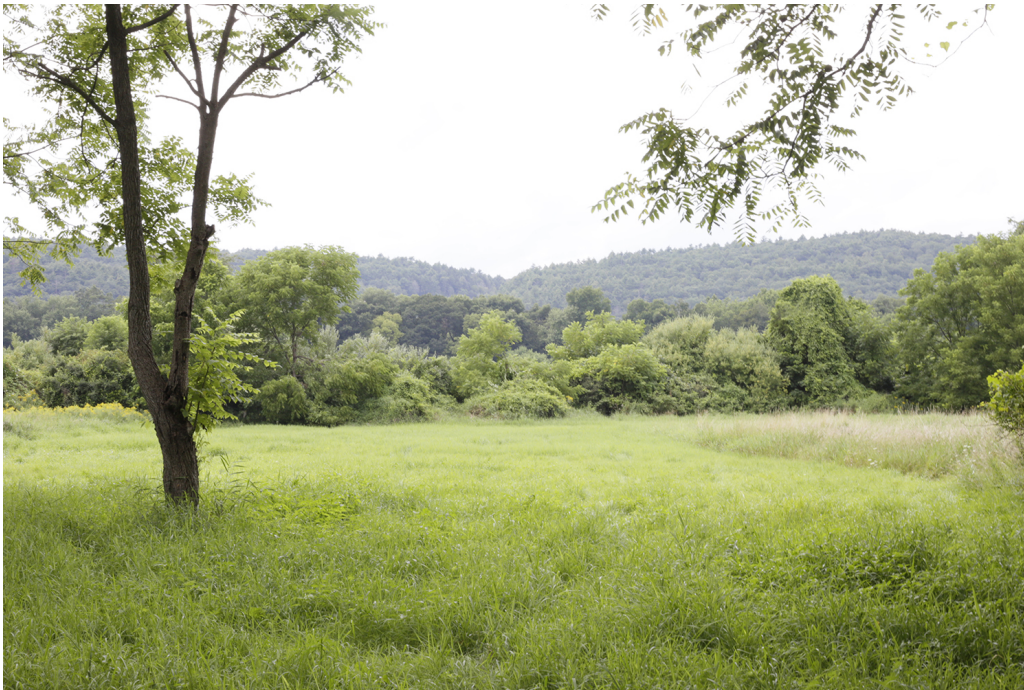
*Figure 26. An area near the eastern edge of Shapanack Flats, looking west, 2023. Beyond the line of young trees and shrubs in the middle distance, crop fields are cultivated under special use permit. The line of mature trees beyond stand along the eastern bank of the Delaware River. Ridges in the distance are on the western side of the river. Historically, this view was open to the river bank. (OCLP)*

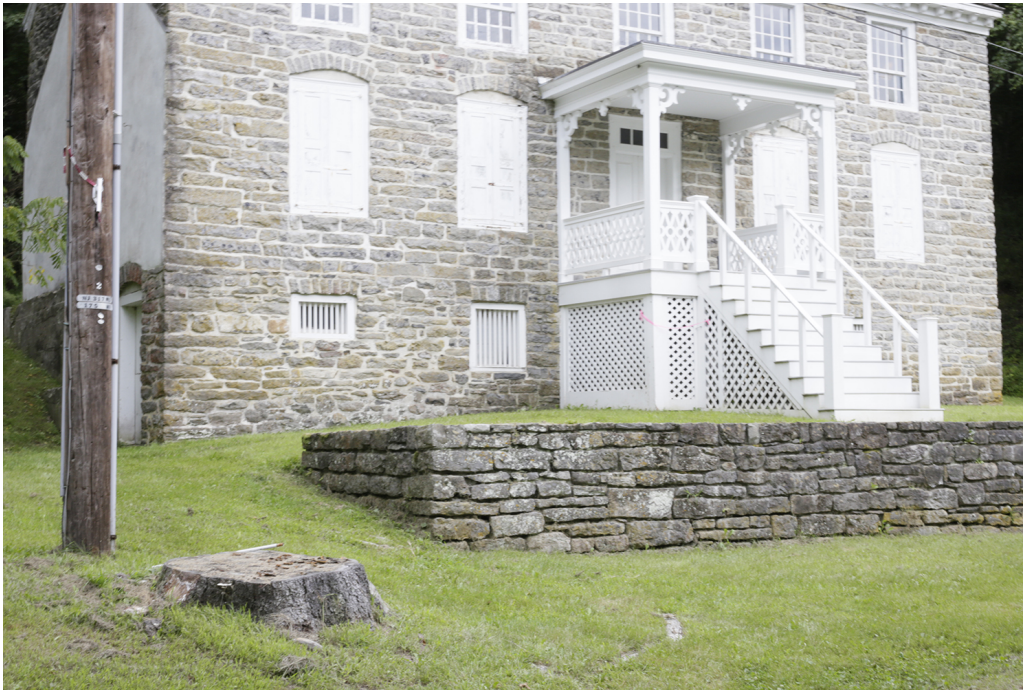
*Figure 37. A historic stone retaining wall defines a small yard at the front of the Van Campen Inn, looking southeast, 2023. (OCLP)*

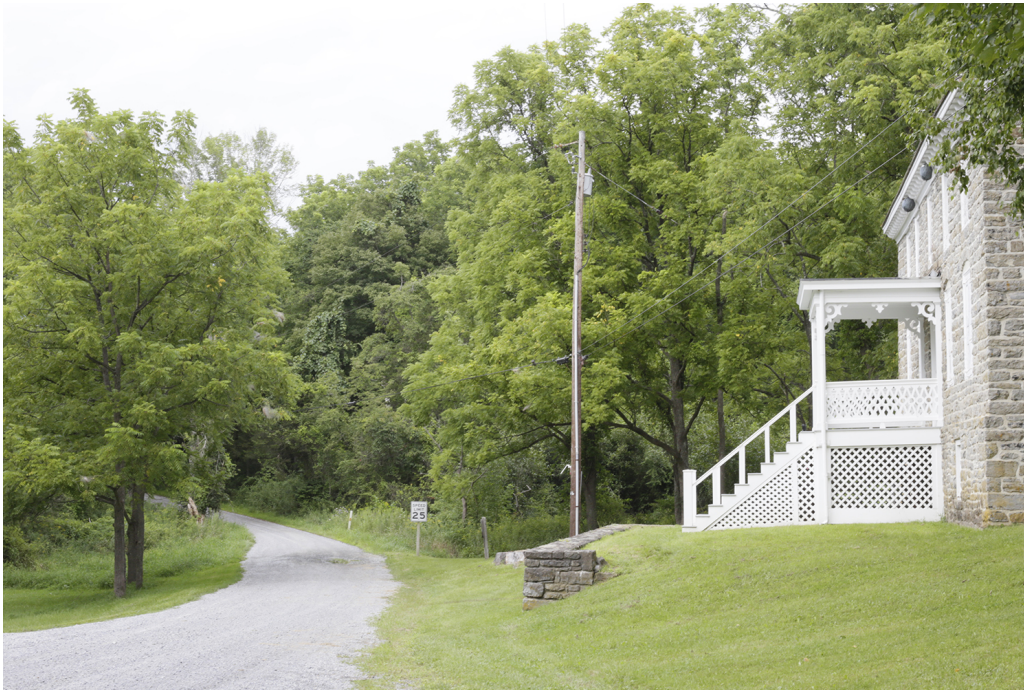
*Figure 27. The relationship between the Isaac Van Campen Inn and Old Mine Road reflects historic spatial organization of the landscape, as does the small yard defined by the historic stone retaining wall in front of the house. Looking north, 2023. (OCLP)*

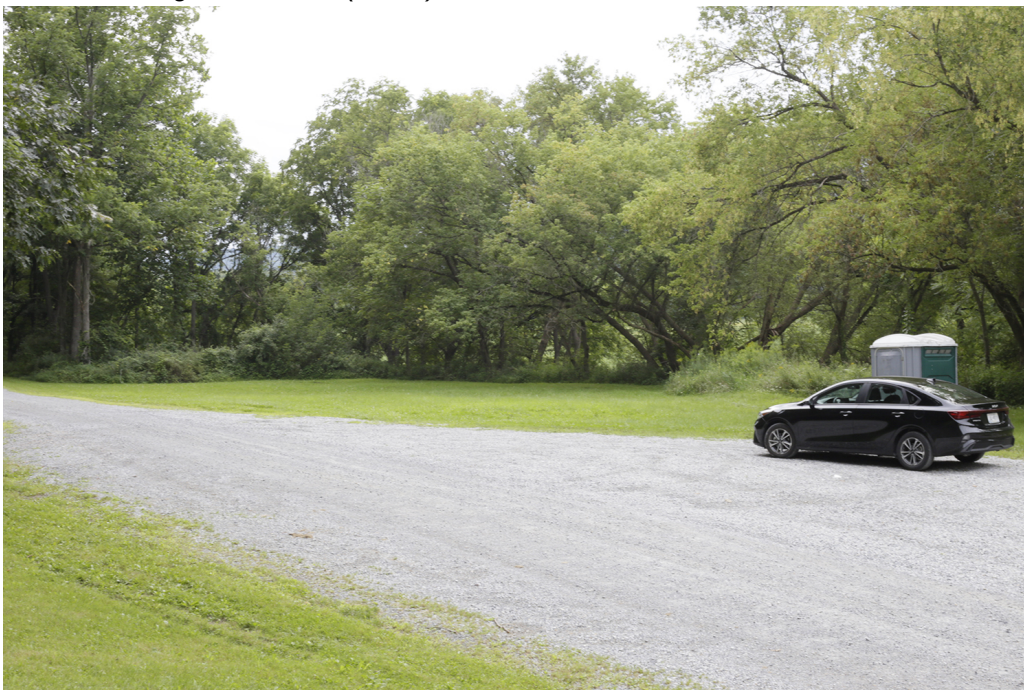
*Figure 28. A mowed area on the western edge of Old Mine Road marks the former sites of the Van Campen-Dewitt Barn and two other outbuildings, looking southwest, 2023. The historic barn was destroyed by arson in 1972. A line of stones present along the tree line are remnants from restoration work in the 1980s, and is not historic. (OCLP)*

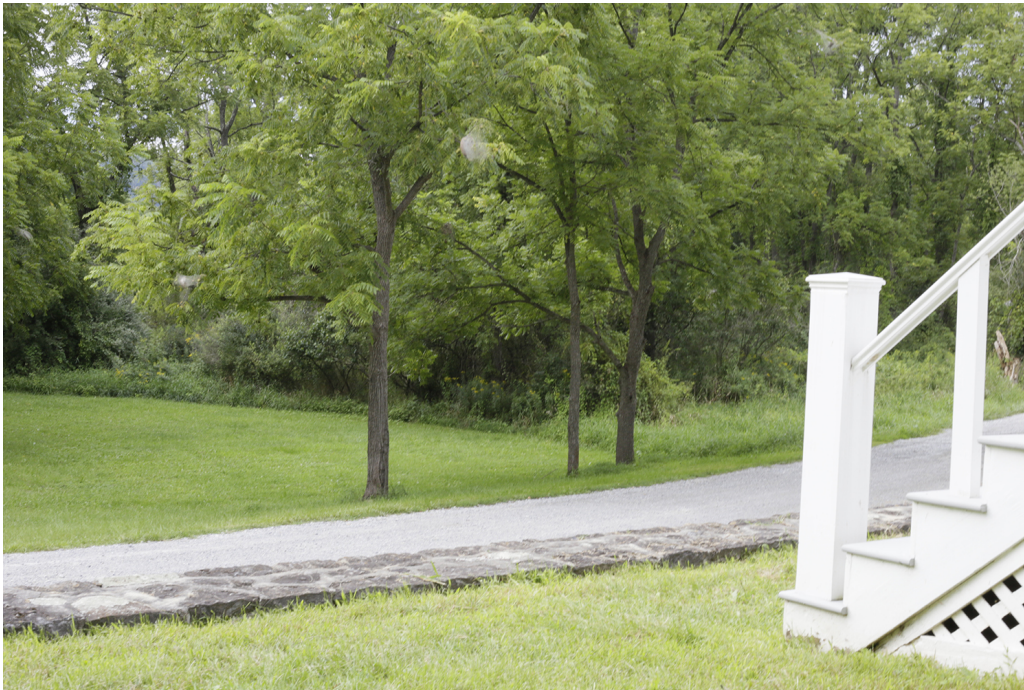
*Figure 30. A small, rectangular terraced yard (foreground) in front of the Van Campen Inn is defined by a historic stone retaining wall. The terraced yard is a contributing topography feature of the cultural landscape. Looking northwest, 2023. (OCLP)*

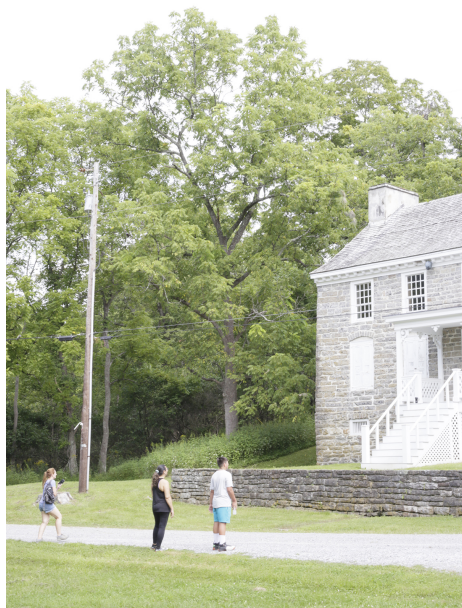
Figure 31. A contributing, mature black walnut (*Juglans nigra*) tree stands directly north of the Van Campen Inn, looking northeast, 2023. (OCLP)

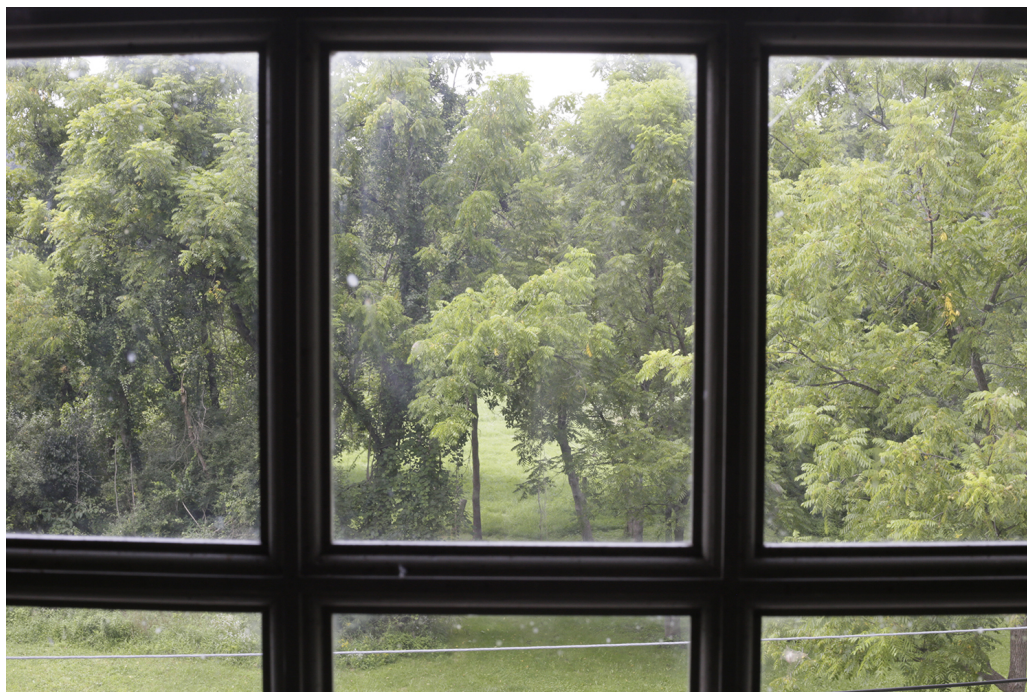
*Figure 36. Westward view toward Shapanack Flats from a second-floor window of the Van Campen Inn, 2023. Historically, the view in this direction would have been open, but it is now obstructed by woods that have grown up since the end of the historic period. (OCLP)*
