HISTORIC STRUCTURES REPORT - PART I

BUILDING NO. 13, BLACK MARIA

EDISON NATIONAL HISTORIC SITE

(ADMINISTRATIVE, HISTORICAL, AND ARCHITECTURAL DATA)

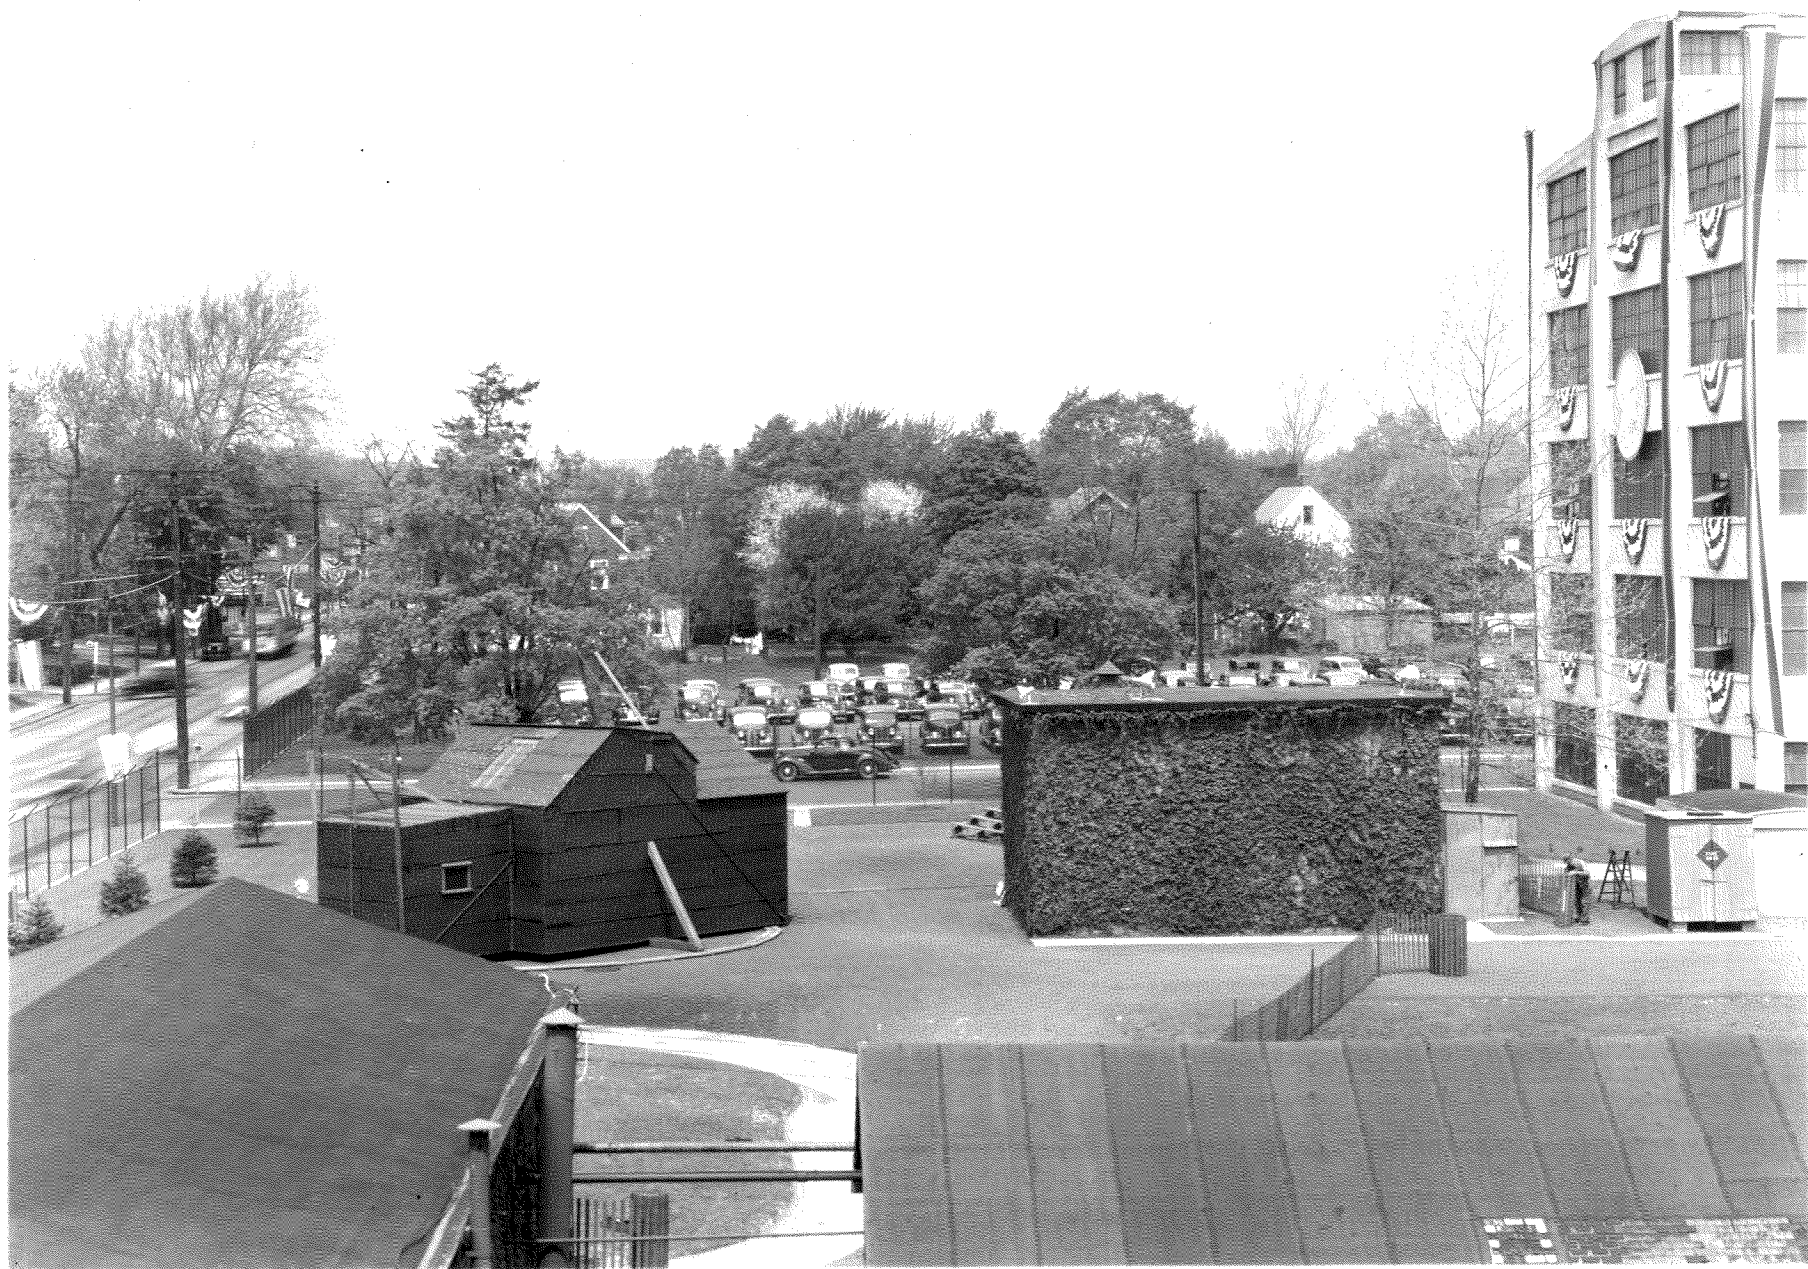
Photo No. 3  
Photo No. 5

Photo by Joseph S. Wheelan

About this time, I mentioned to Mr. Charles Edison that if the two photographs which we then had, that is, Photographs Nos. 3 and 4 of Appendix III, were put on a drawing board, by reversing the rules of perspective, I believed we could ascertain, very nearly, the proportions and size of the original structure. This project, assigned to me by Admiral Harold G. Bowen, then Director of the Thomas Alva Edison Foundation, resulted in three drawings dated September 29, 1952. Photographs of these drawings are given in Appendix IV, Photographs Nos. 6, 7, and 8.

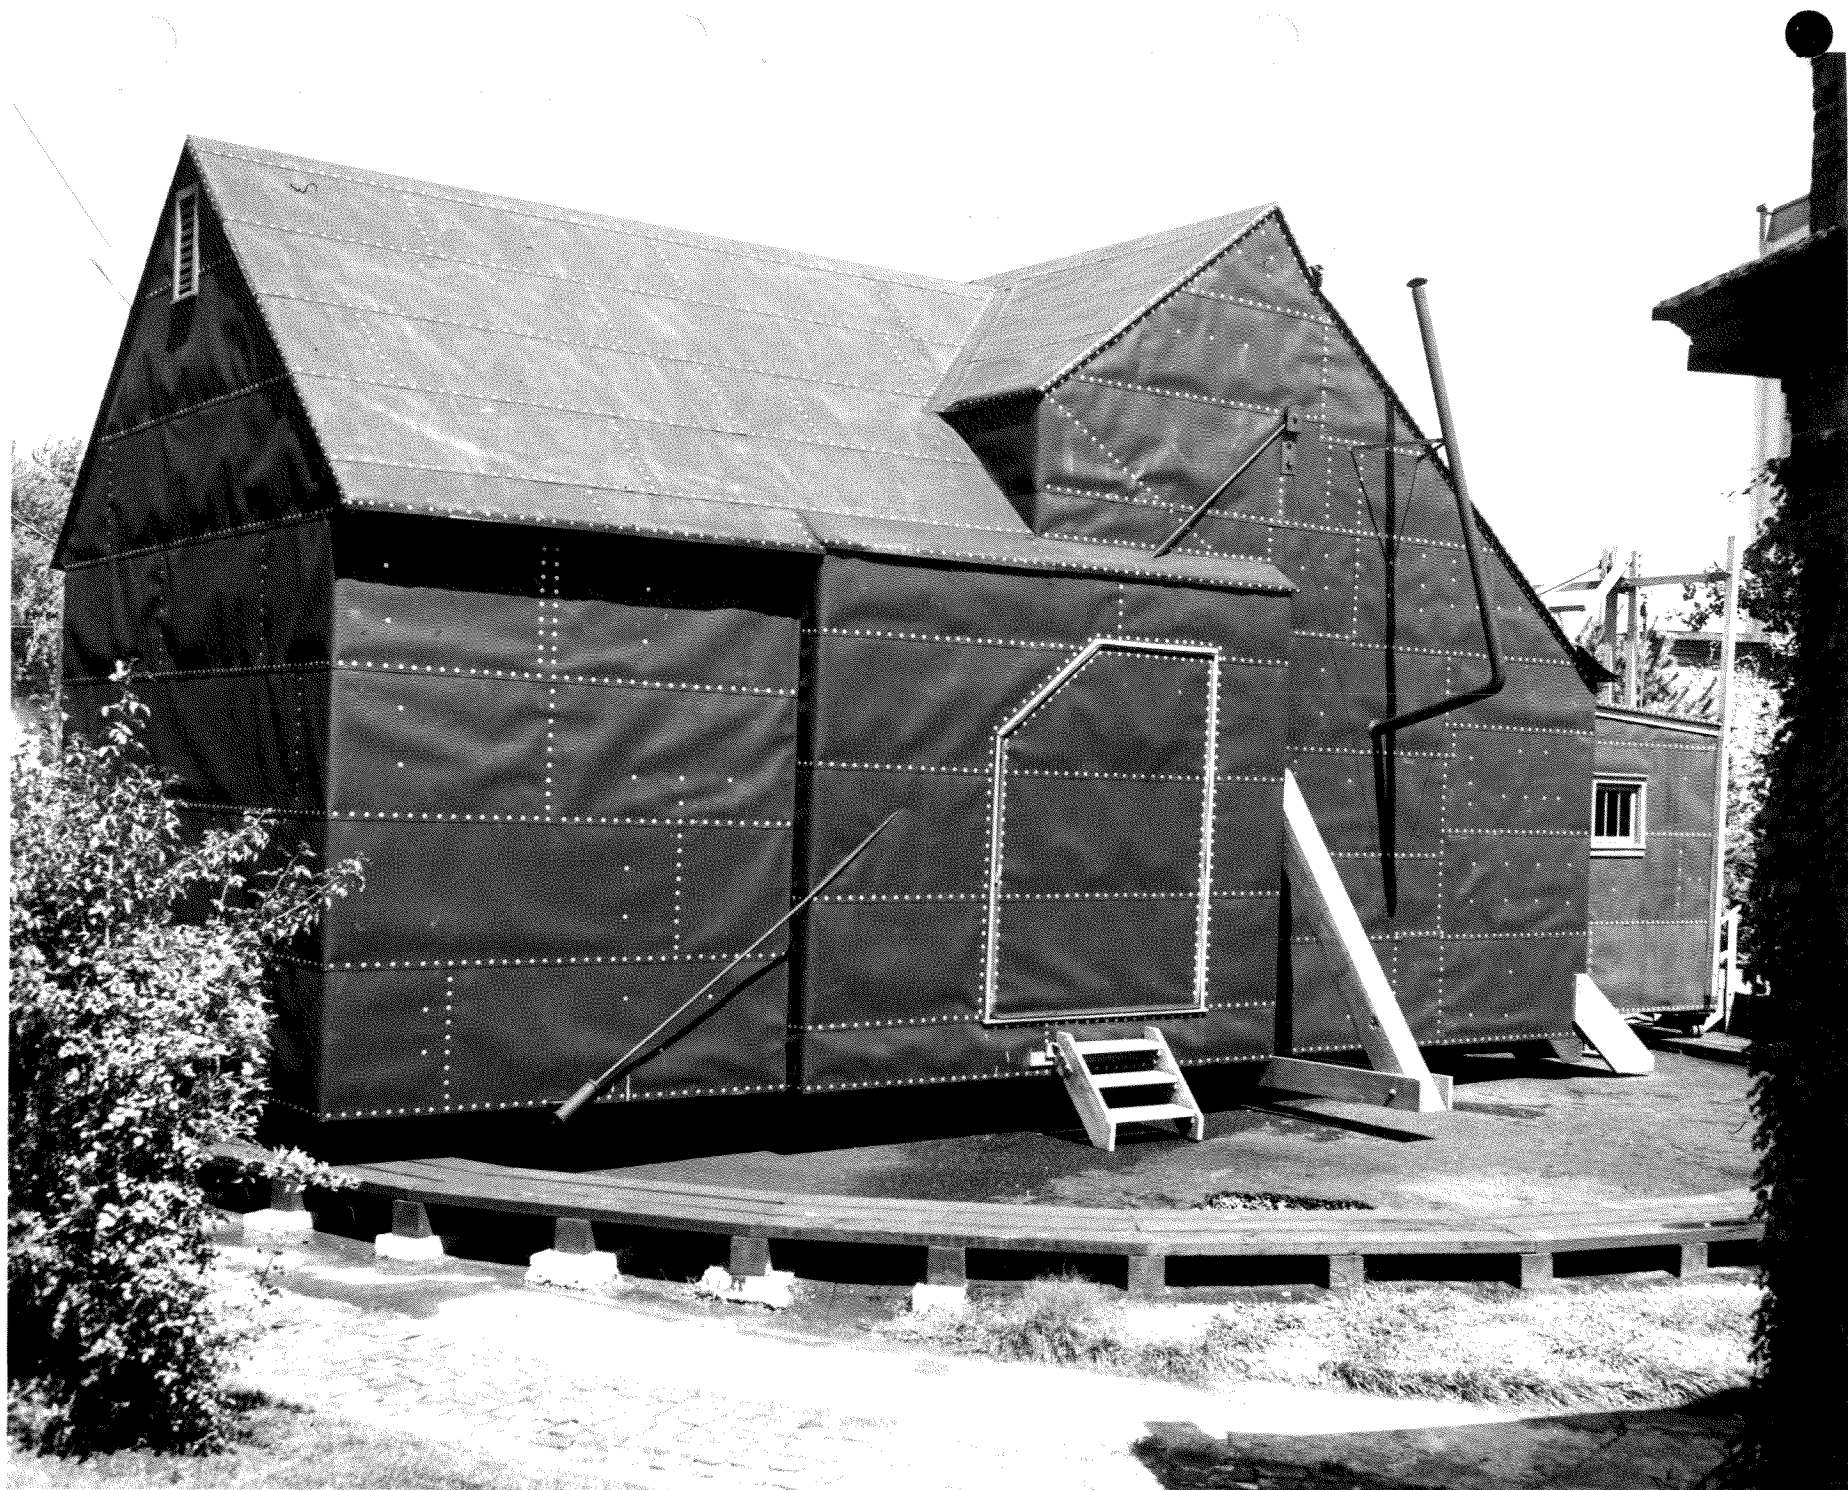
Photo No. 9

Reconstruction of the "Black Maria"  
World's First Motion Picture Studio  
built for the  
Thomas Alva Edison Foundation  
from plans by  
Frank Grad & Sons, Architects, Newark, N. J.  
August Ramsland, Builder

Photo taken at time of Dedication Ceremony  
September 22, 1954
