# FORT BOWIE

NATIONAL HISTORIC SITE / ARIZONA

HISTORIC STRUCTURES REPORT  
RUINS STABILIZATION  
ARCHITECTURAL DATA  
FORT BOWIE NATIONAL HISTORIC SITE  
COCHISE COUNTY  
ARIZONA

Prepared by  
John Robbins

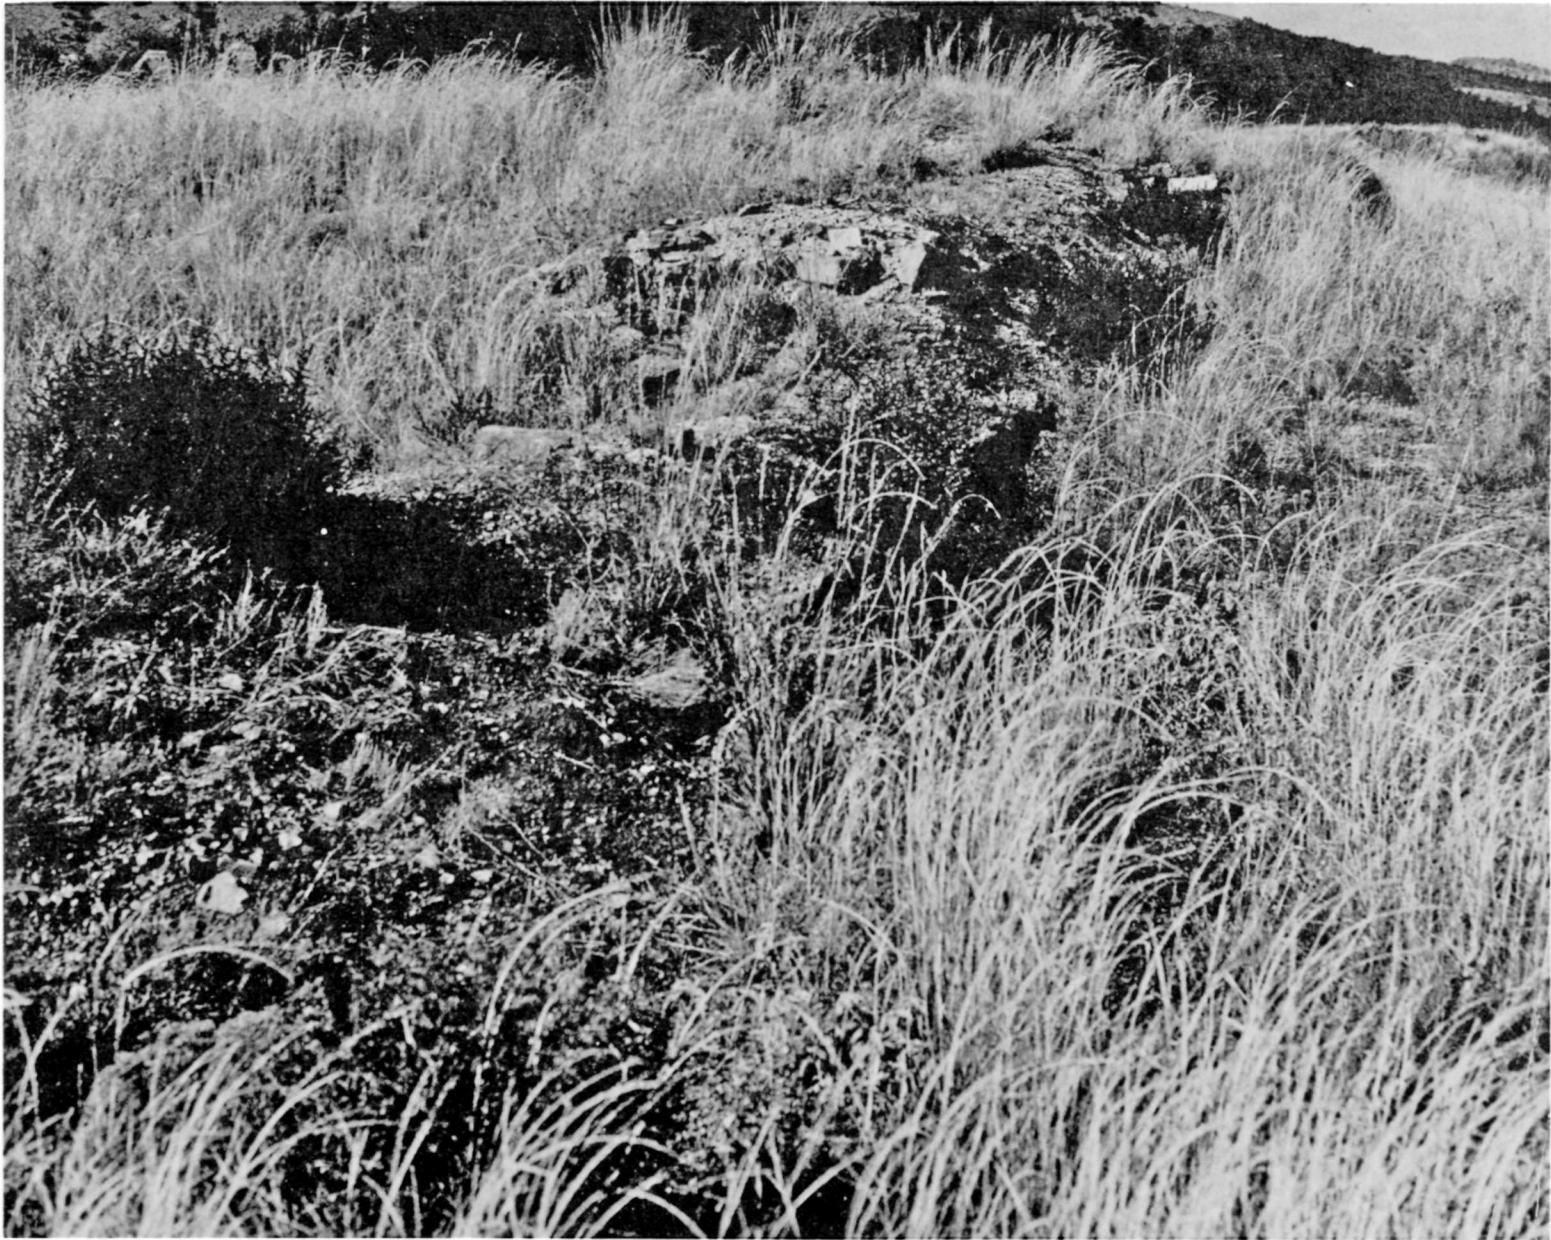
HS 006: View looking west.

HS 006 is the adobe and stone remains of a structure built by the U.S. Military ca 1870-1874. Stone foundation walls and mounds of deteriorated adobes are evident. The stones are undressed limestone rock originally laid with lime mortar. No plaster is evident. The structure is unexcavated and unstabilized.

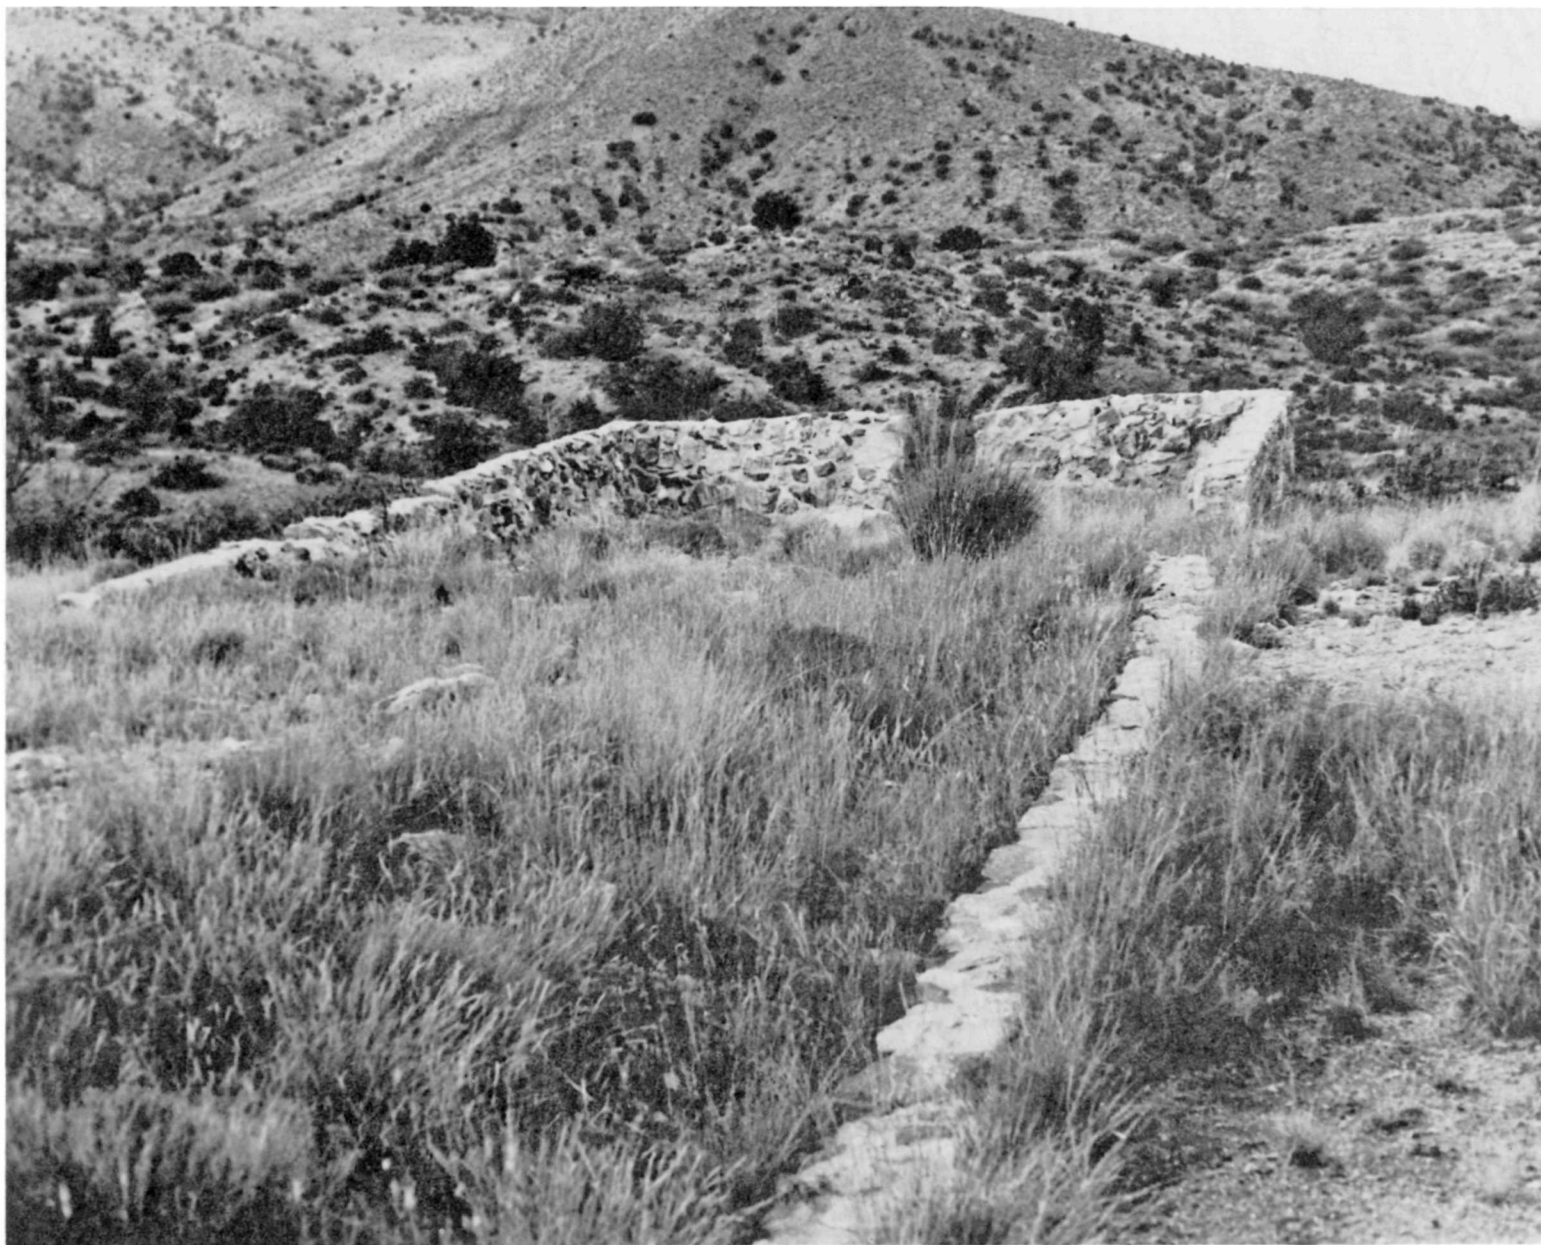
HS 019: View looking west.

HS 019 is the stone remains of a structure built by the U.S. Military in 1883. Stone foundation walls are evident. The stones are undressed, uncoursed granitic and limestone rock originally laid with lime mortar. No plaster is evident.

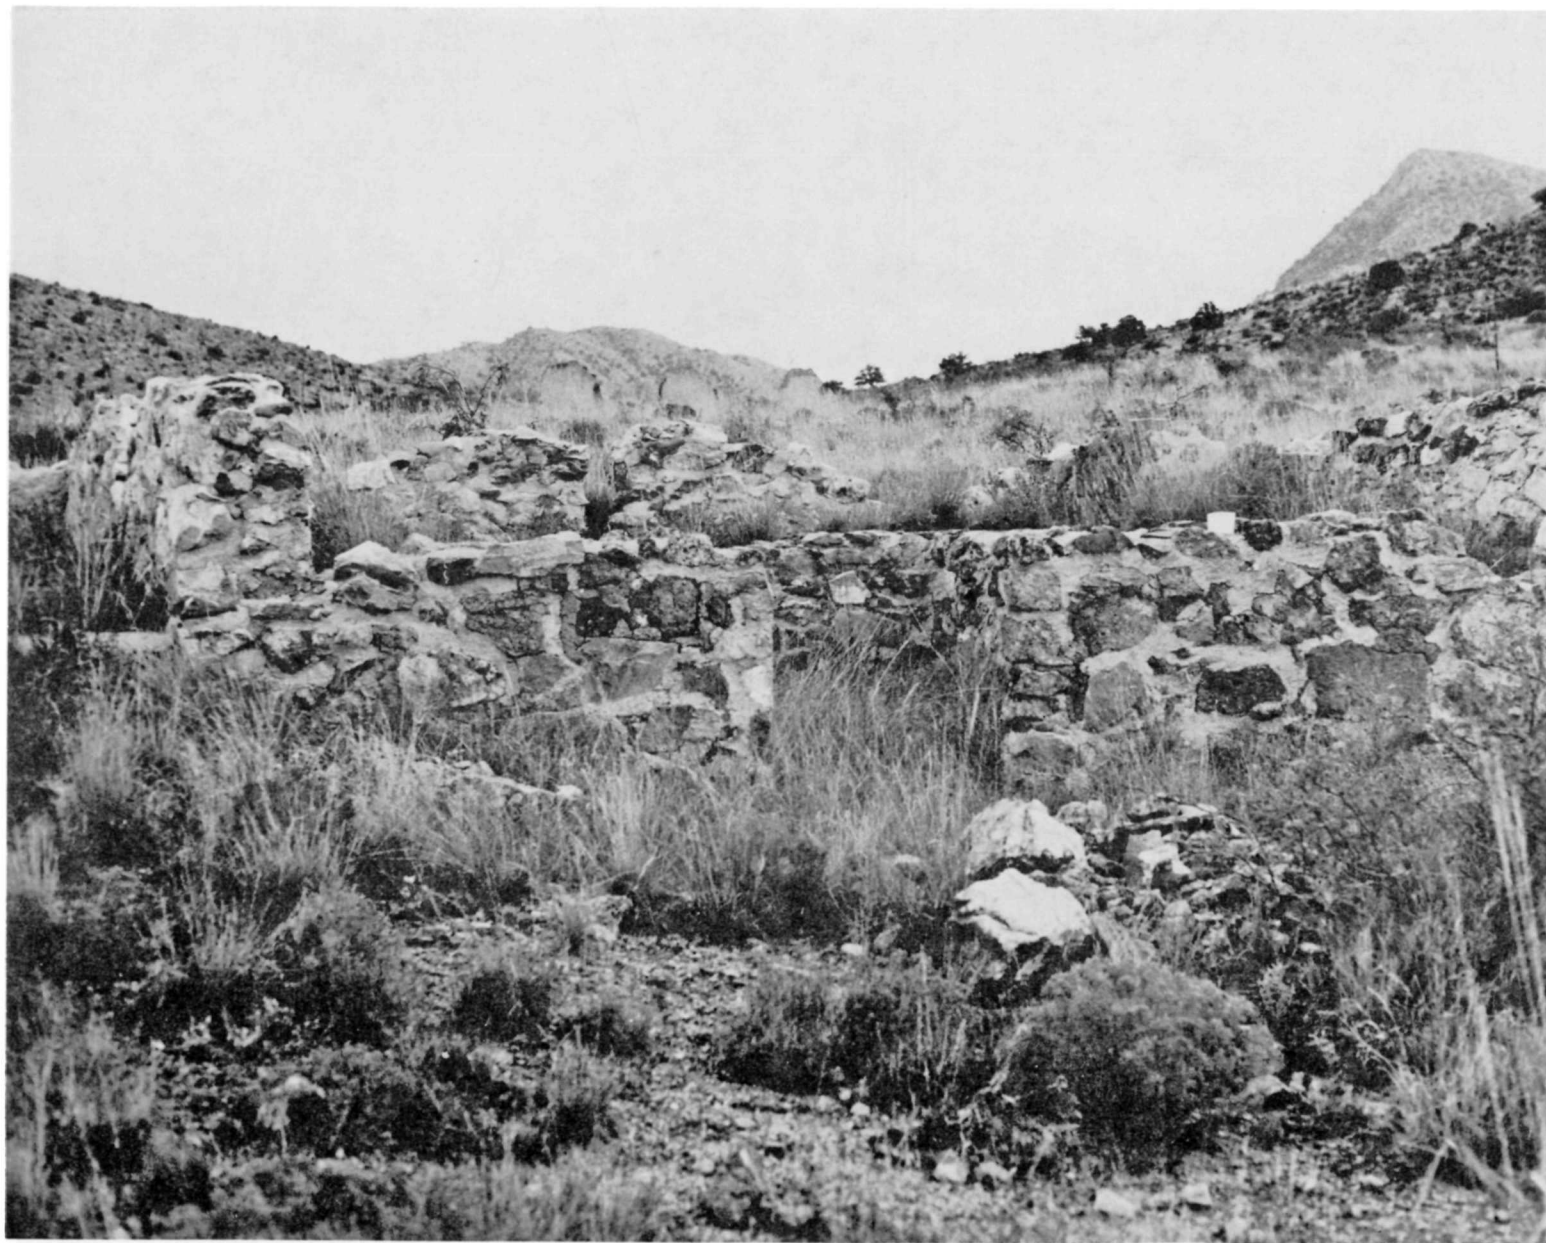
HS 020: View looking west.

HS 020 is the adobe, stone, and wood remains of a structure built by the U.S. Military in 1883. Historic adobe remains were removed by the National Park Service in 1967 and replaced with soil-cement materials which were removed and not replaced in 1978. The stones are undressed, uncoursed granitic and limestone rock originally laid with lime mortar. In 1967, historic stonework was pointed and relaid with soil-cement mortar. A single fragment of historic wood framing in the southwestern corner was reset in 1967. No plaster is evident. The structure was partially excavated in 1967.

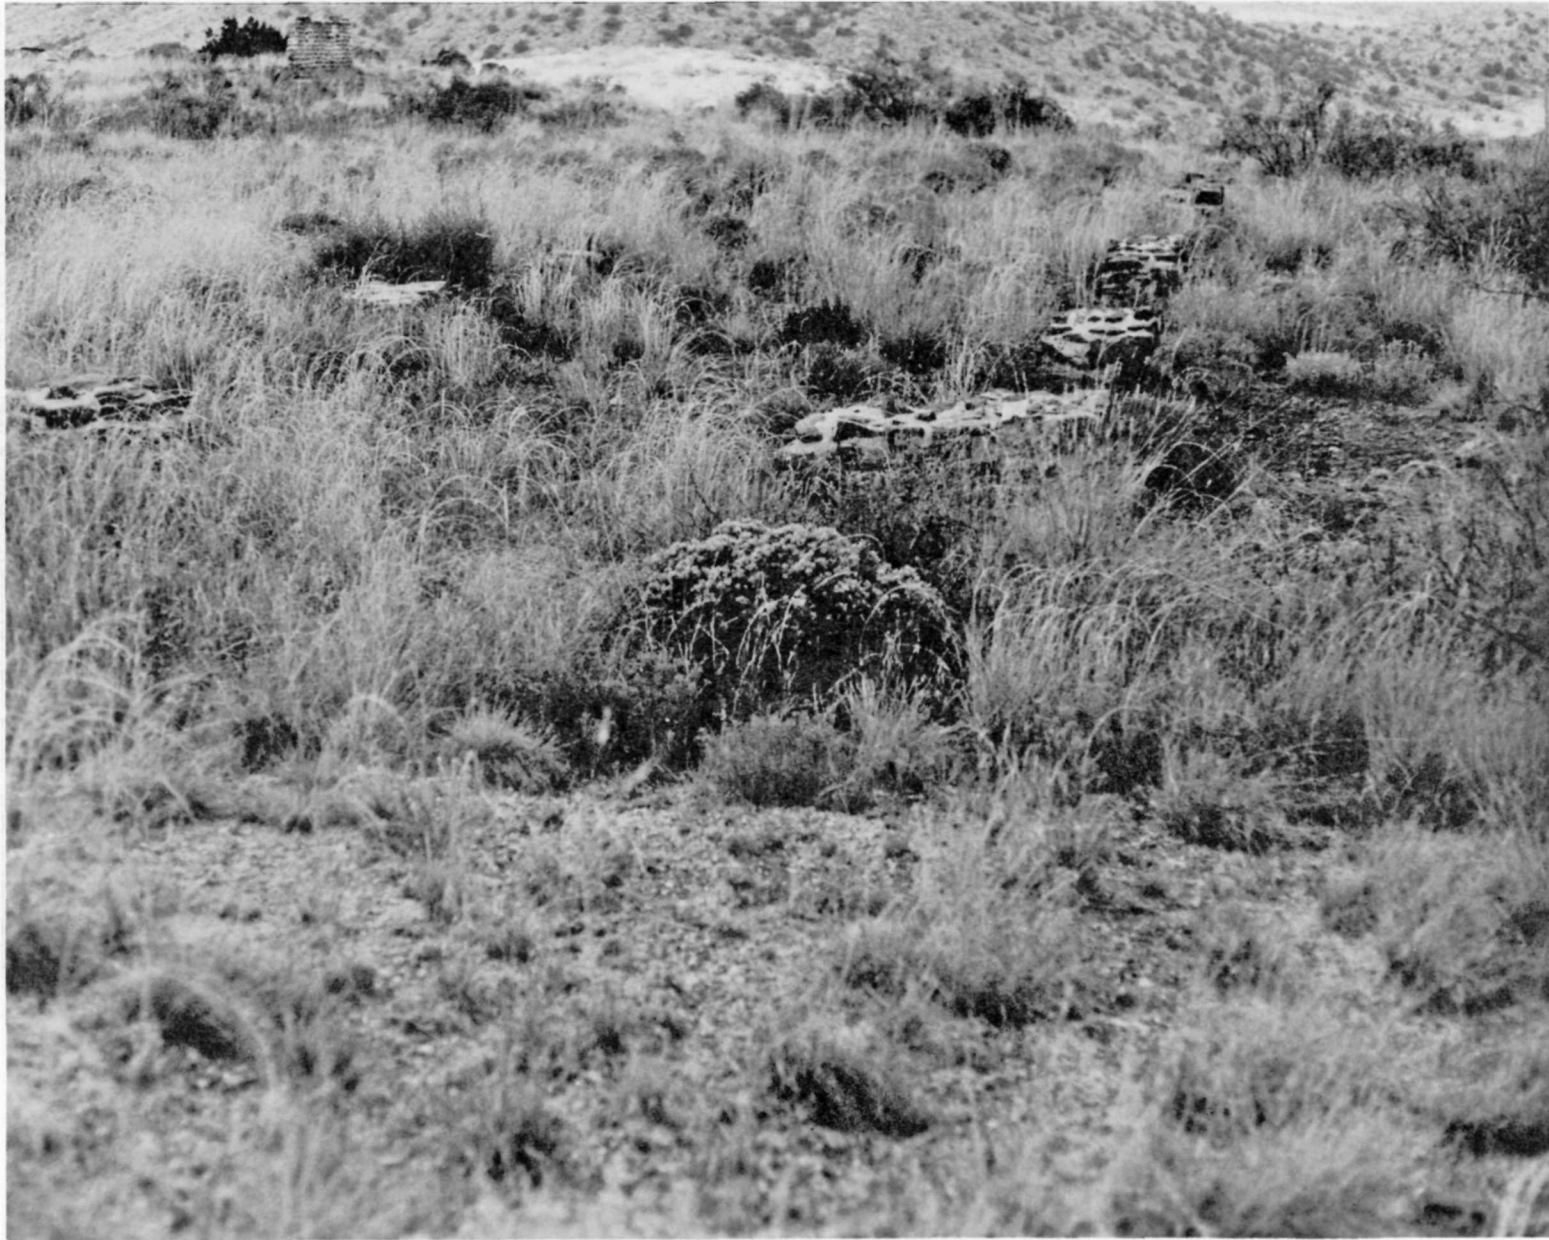
HS 022: View looking west.

HS 022 is the stone remains of a structure built by the U.S. Military in 1883. Twenty-eight stone masonry foundation piers are evident. The stones are undressed, uncoursed limestone rock originally laid with lime mortar. No plaster is evident.

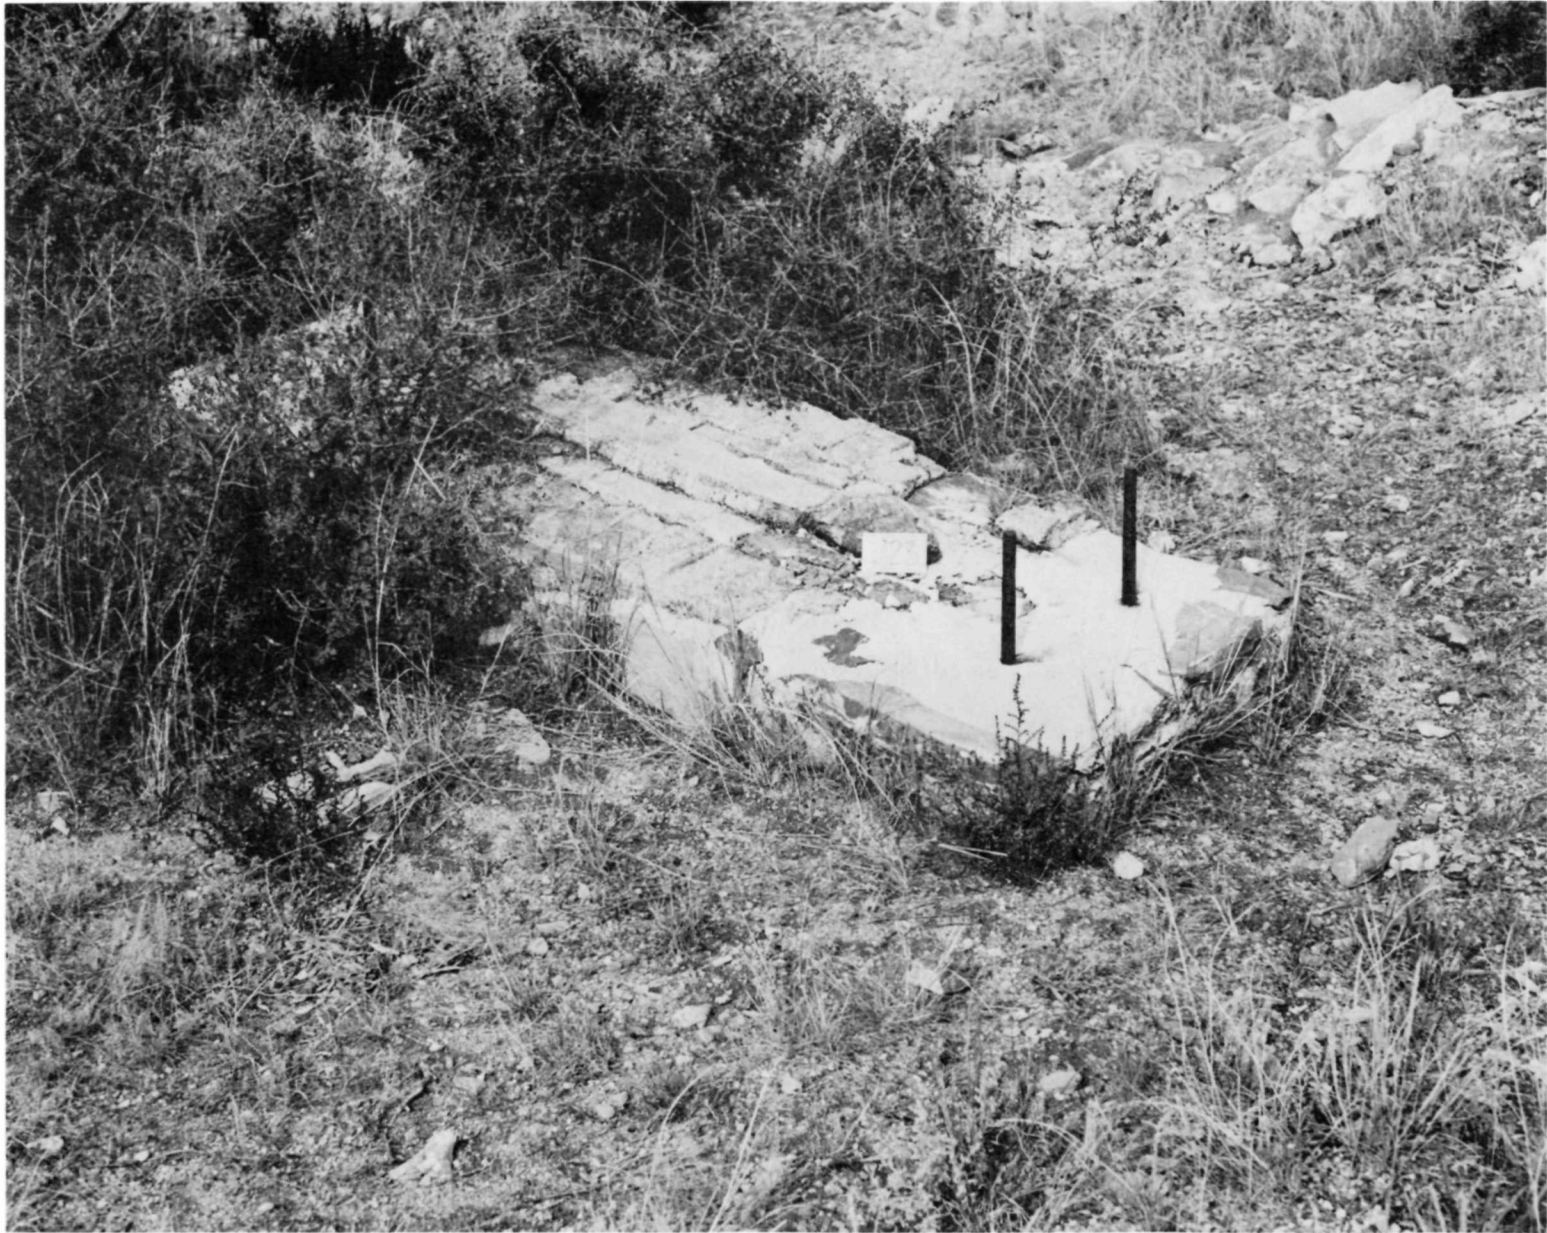
HS 023: View looking southeast.

HS 023 is the stone, brick, and metal remains of a structure built by the U.S. Military in 1886. A masonry foundation with four projecting metal rods is evident. The stones are undressed, uncoursed limestone rock originally laid with lime mortar. Historic brick fragments are evident in mortar on top of the foundation. The metal remains are 1/2-inch diameter wrought iron rods threaded at the upper end. Historic lime plaster is evident on stonework.

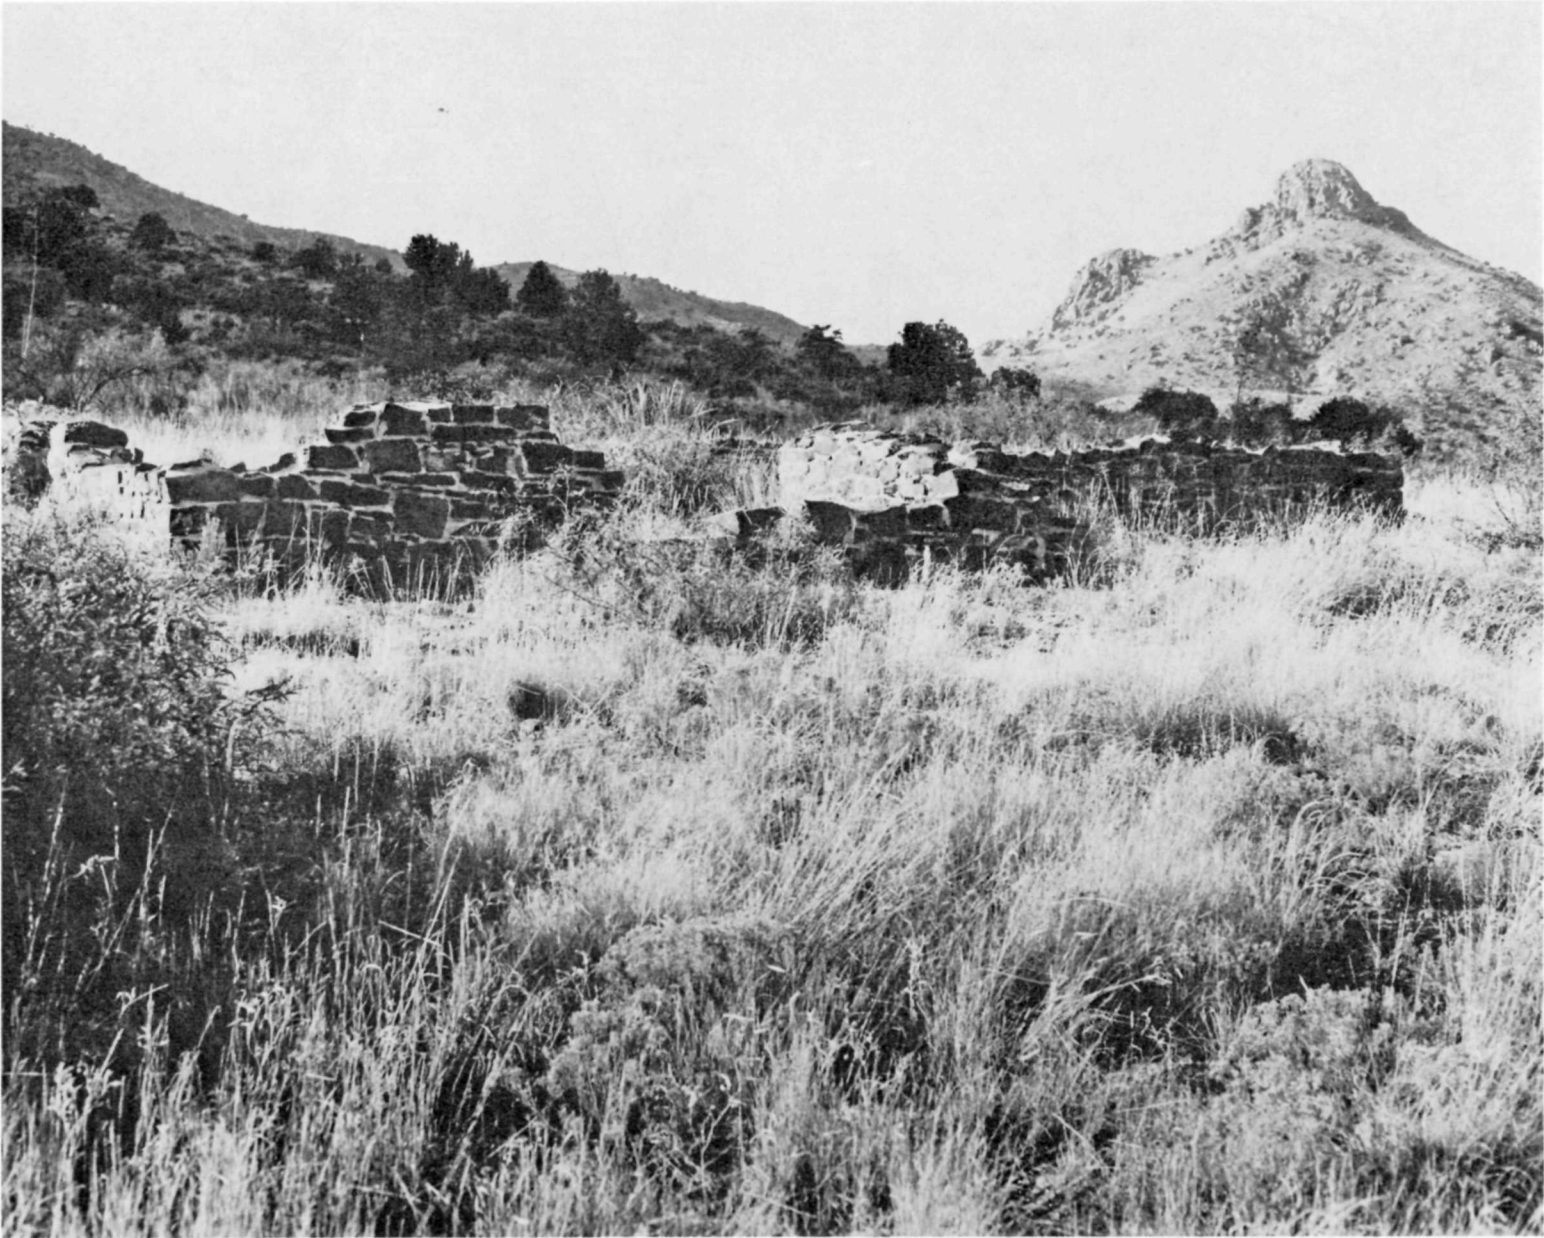
HS 025: View looking southwest.

HS 025 is the adobe, stone, and brick remains of a structure built by the U.S. Military in 1884. One adobe wall, stone chimney and perimeter foundations, and stone foundation piers are evident. Historic adobes were laid with soil mortar. The stones are undressed, uncoursed limestone rock originally laid with lime mortar. Historic bricks and brick fragments are scattered throughout the site. No plaster is evident.

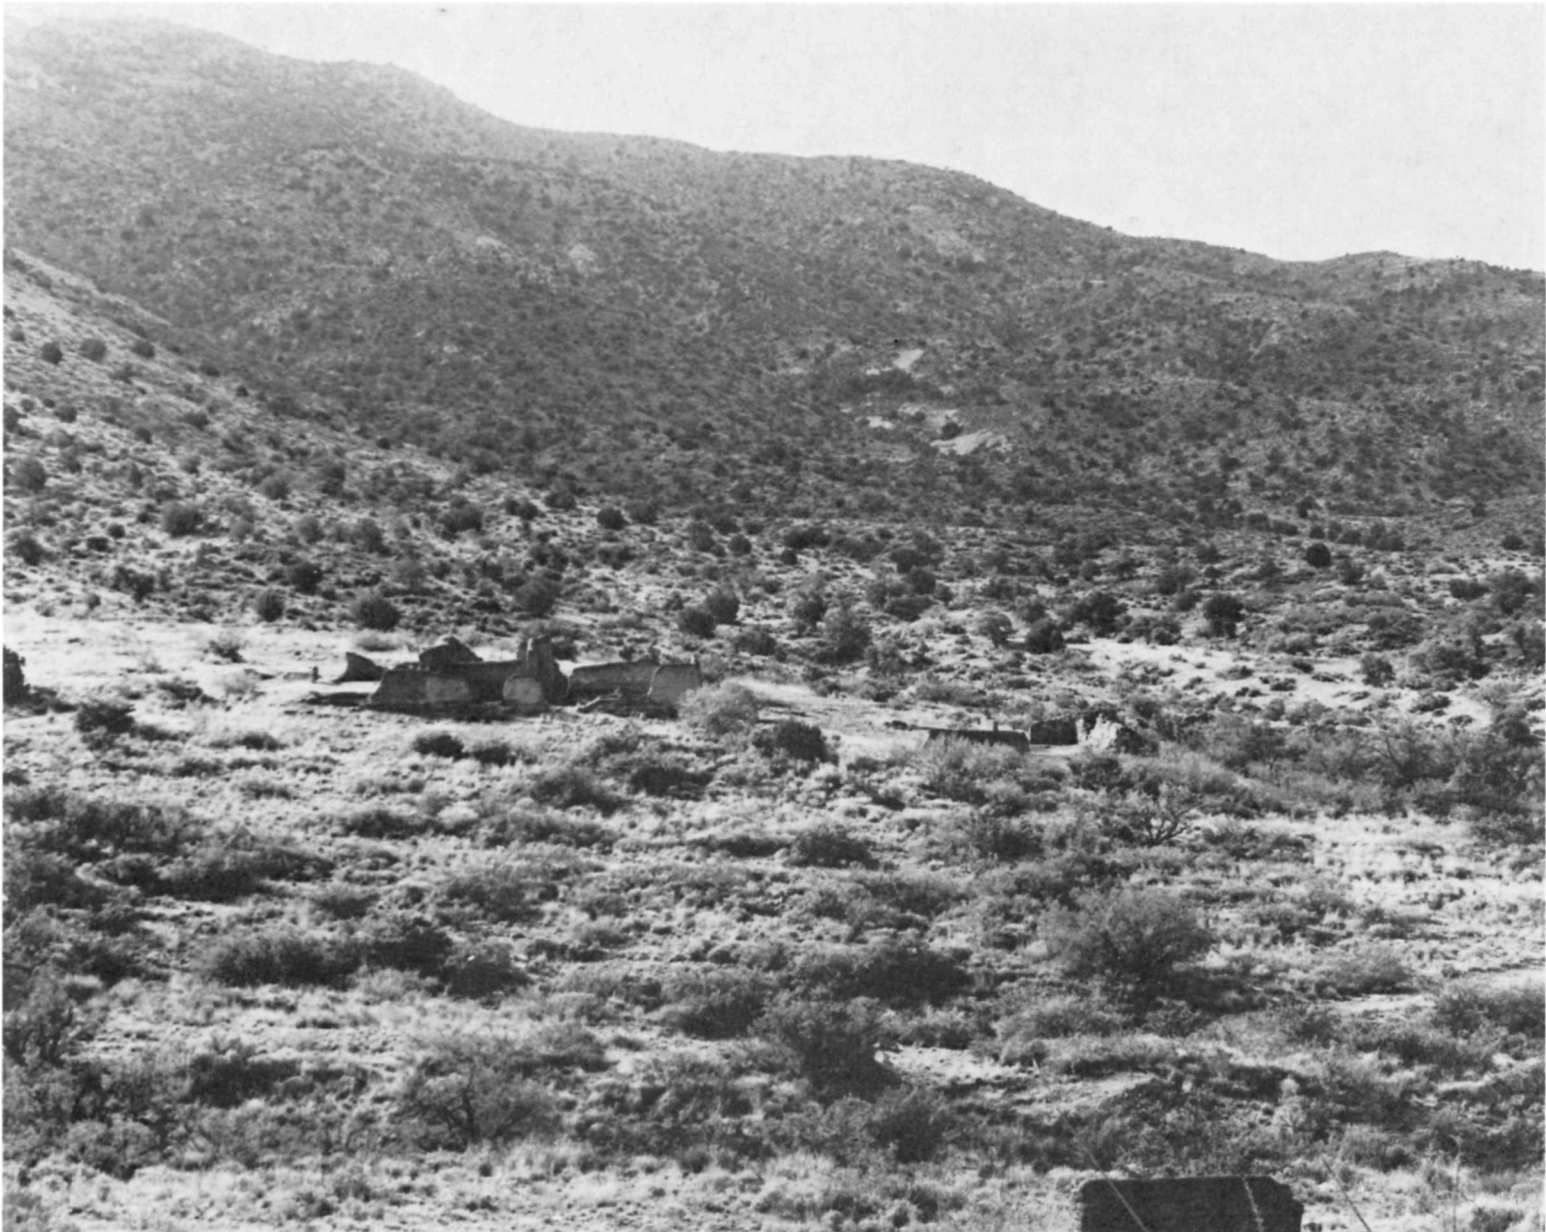
HS 034: View looking southwest.

HS 034 is the stone remains of a structure built by the U.S. Military in 1889. Stone foundation walls are evident. The stones are undressed, uncoursed limestone originally laid with lime mortar. No plaster is evident. In 1967, the National Park Service removed a small mound of deteriorated historic adobe from the northeastern corner,

replaced it with soil-cement adobes, and pointed and relaid historic stone with soil-cement mortar. In 1978, the soil-cement adobes were removed.

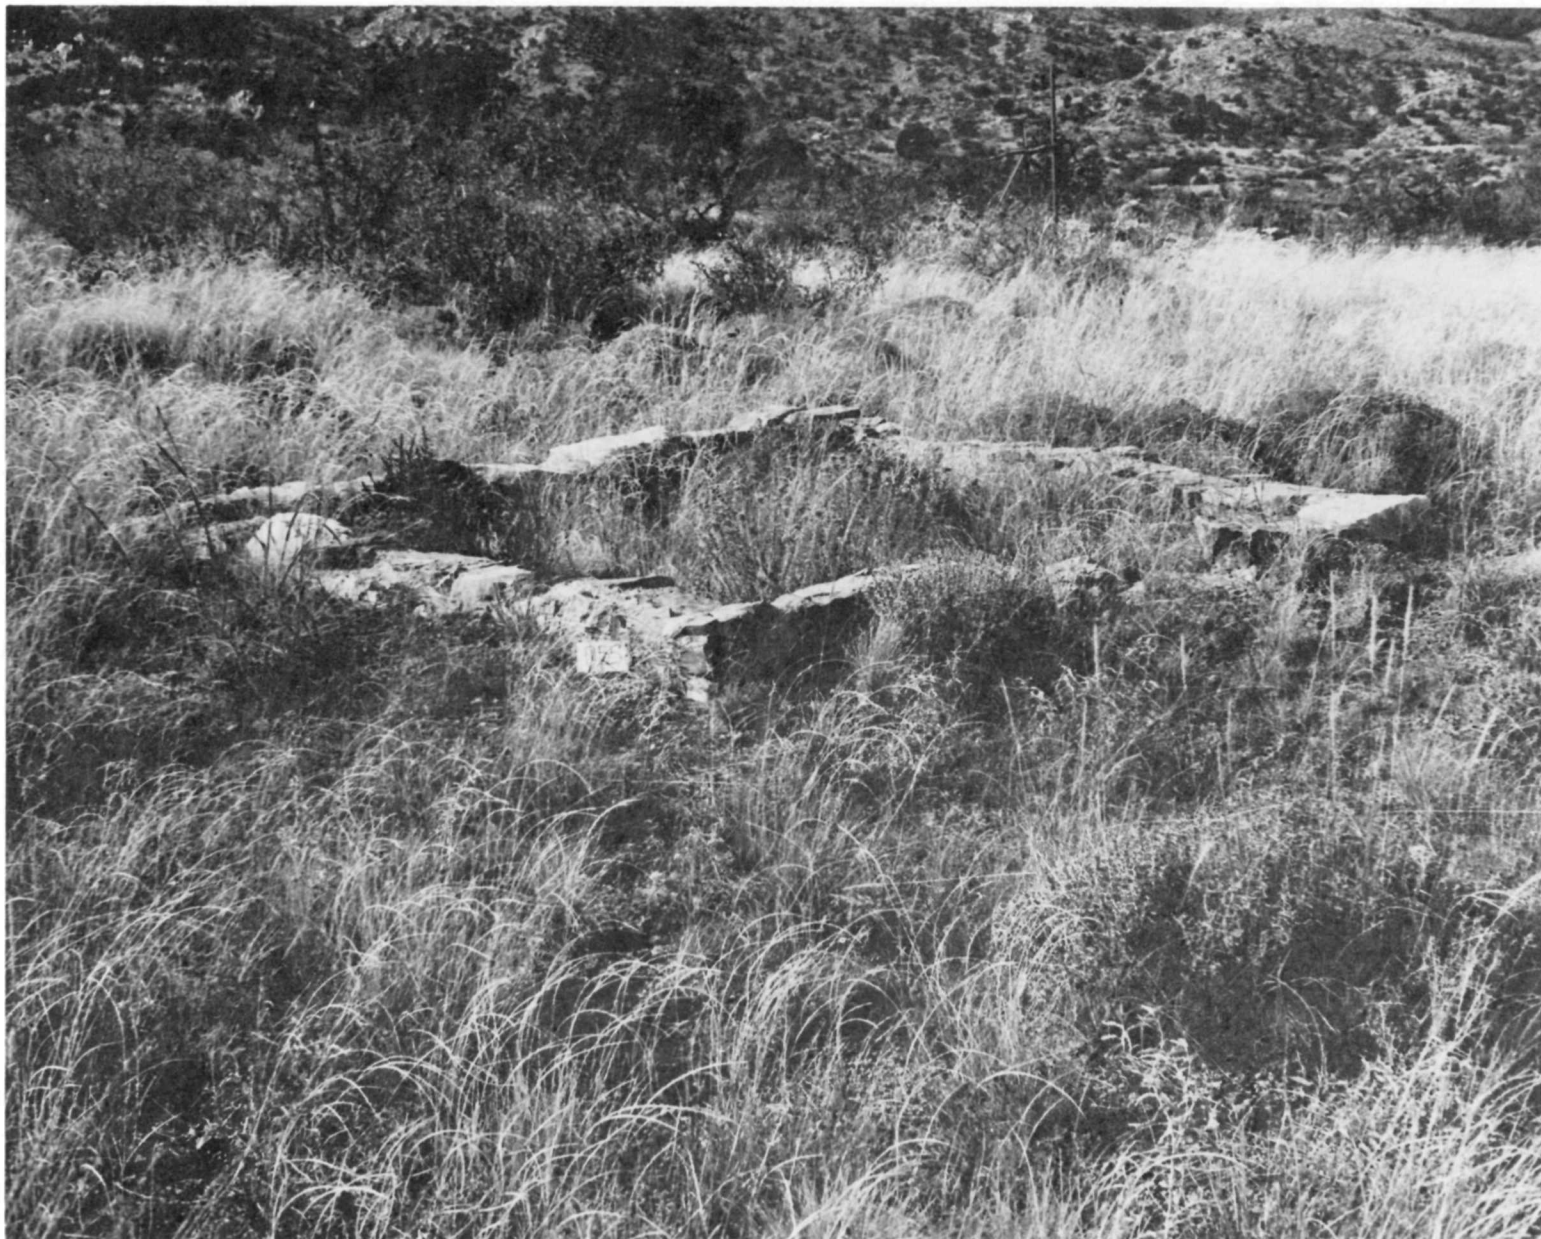
HS 051: View looking southwest. The small numbered card evident in the photograph identifies the structure incorrectly.

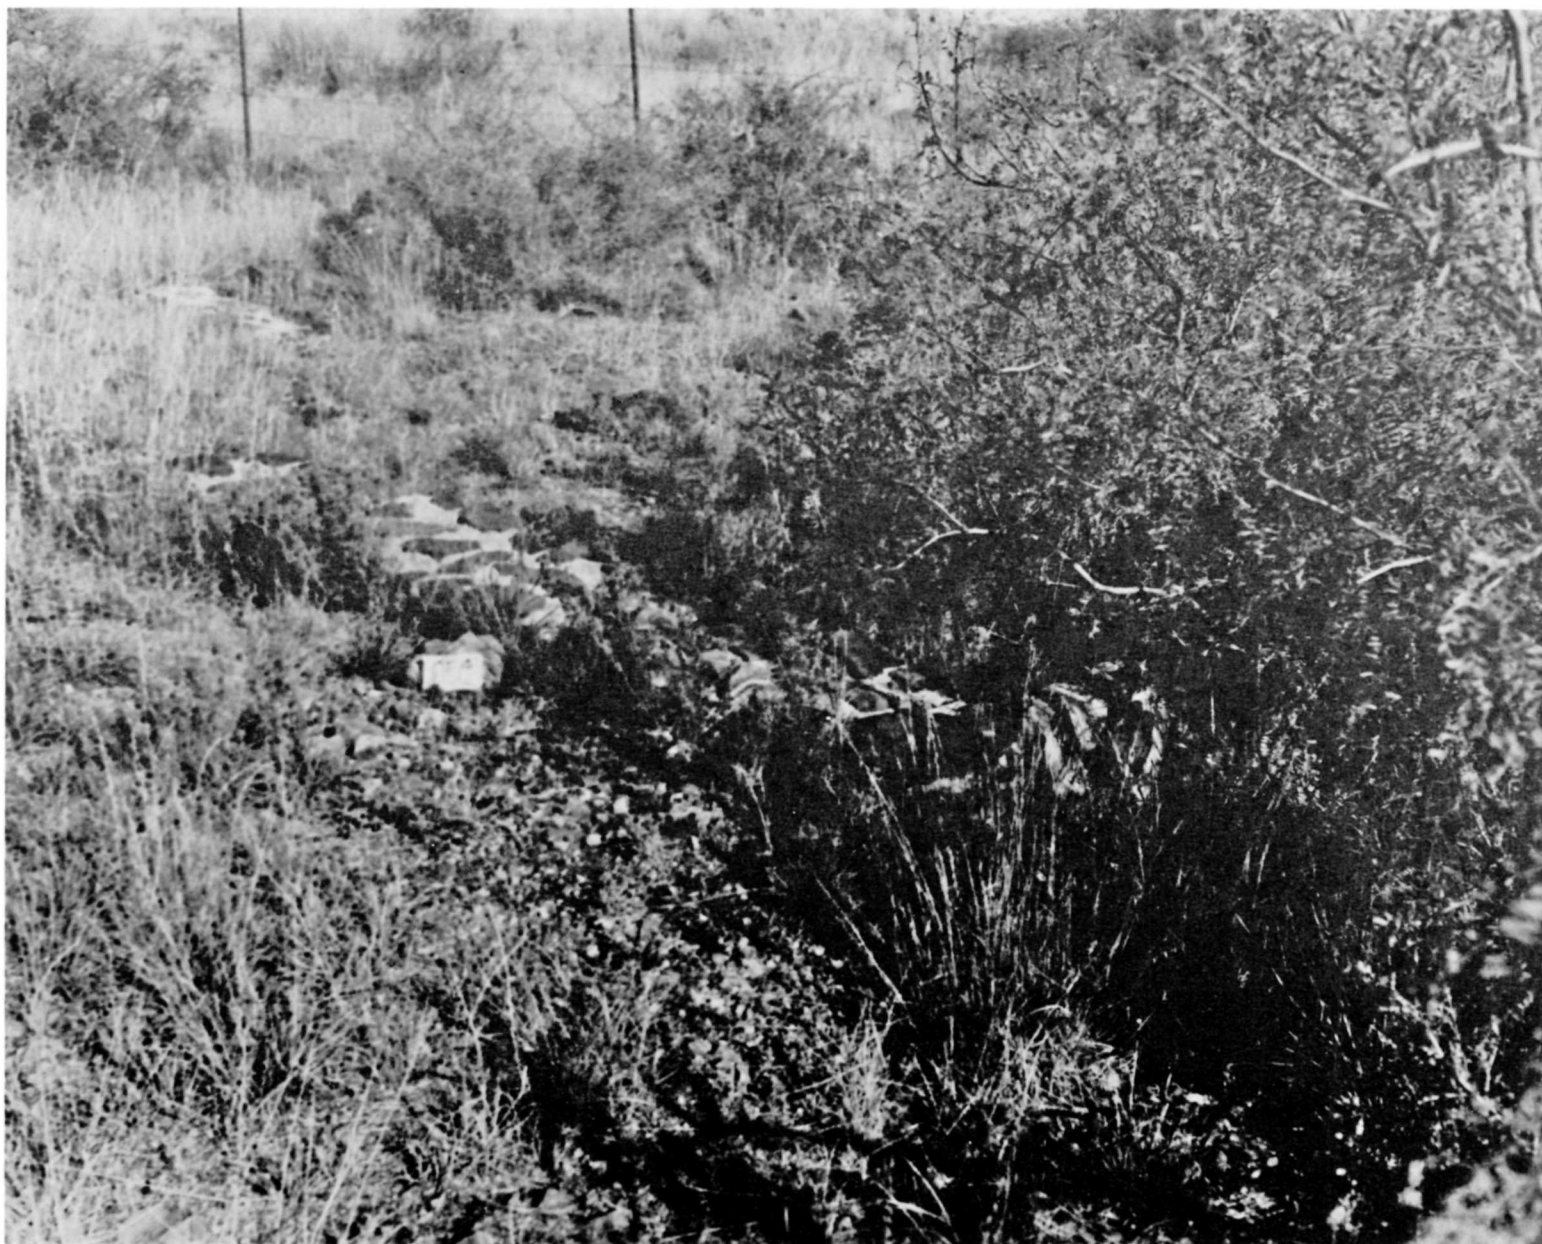
HS 052: View looking southeast. The small numbered card evident in the photograph identifies the structure incorrectly.

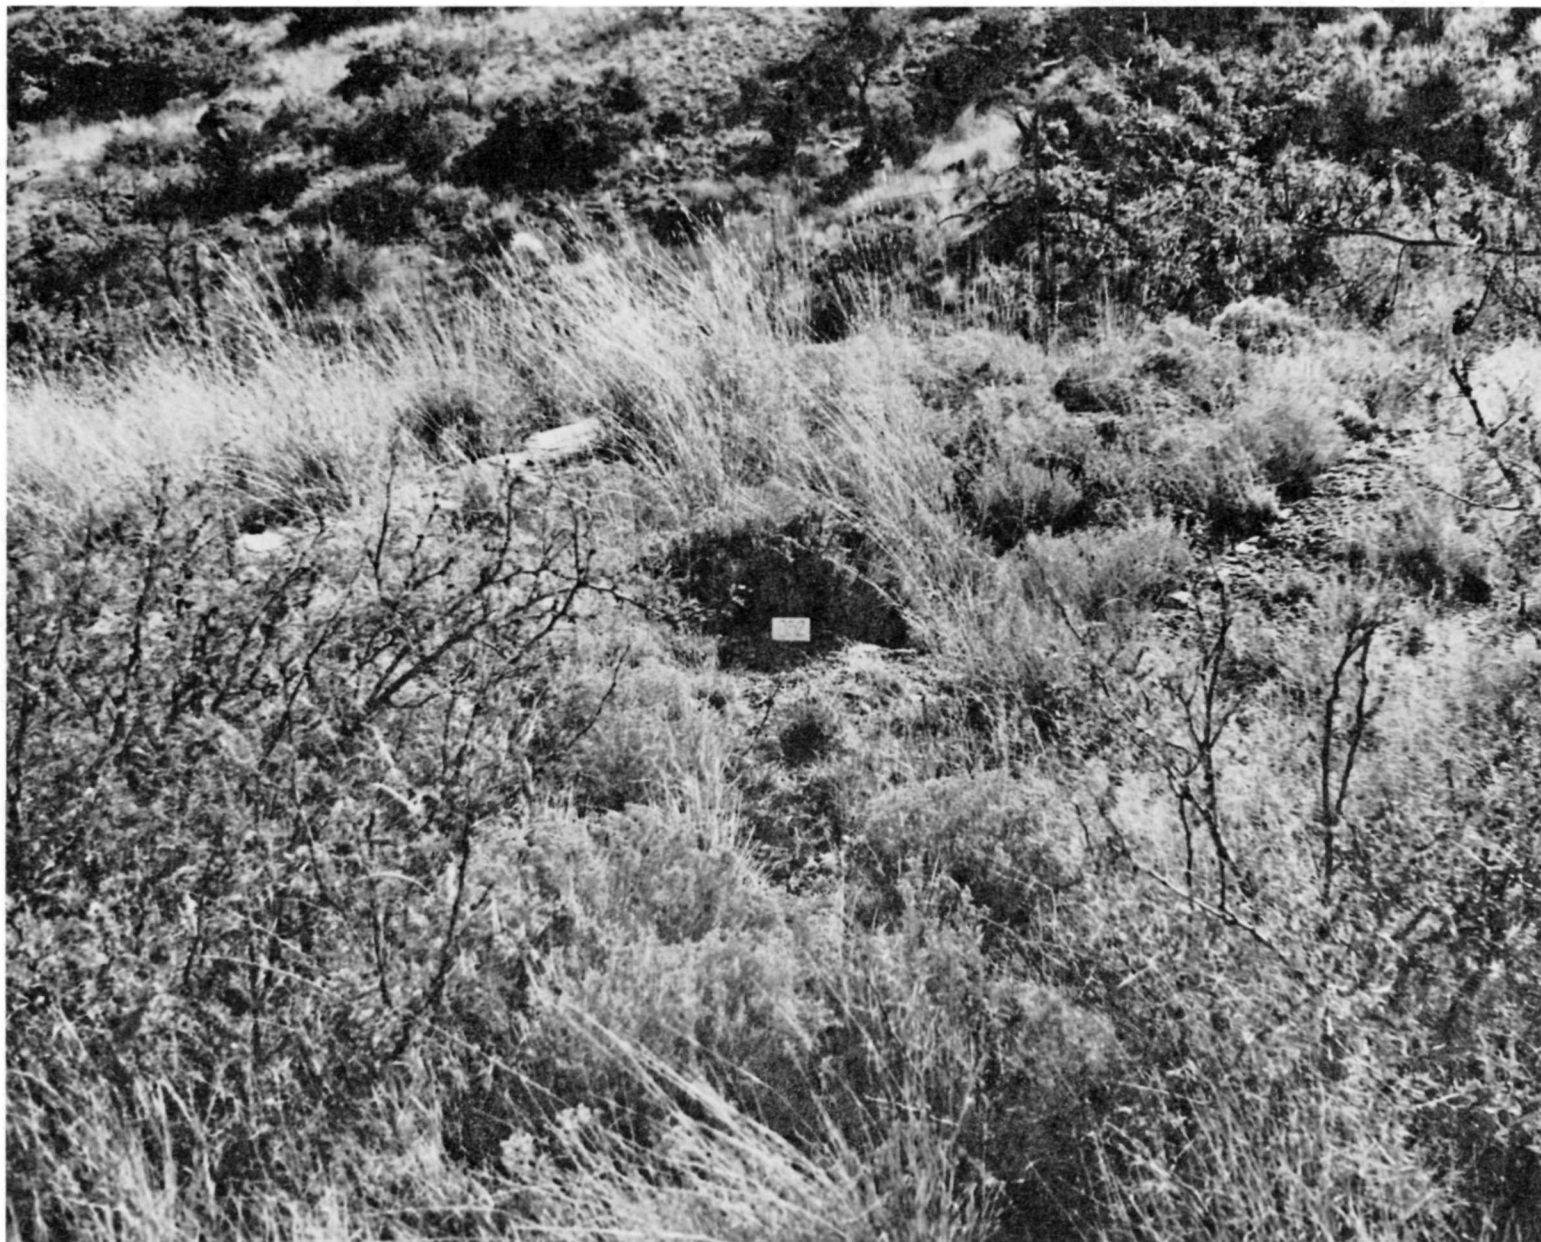
HS 054 is the adobe and stone remains of a structure built by the U.S. Military. The construction date is not documented. Historic adobe is a deteriorated and unstabilized layer along the south wall. Stone remains are undressed, uncoursed limestone originally laid with lime mortar. Historic lime plaster is evident at grade along the south wall.

HS 054: View looking southeast. The small numbered card evident in the photograph identifies the structure incorrectly.

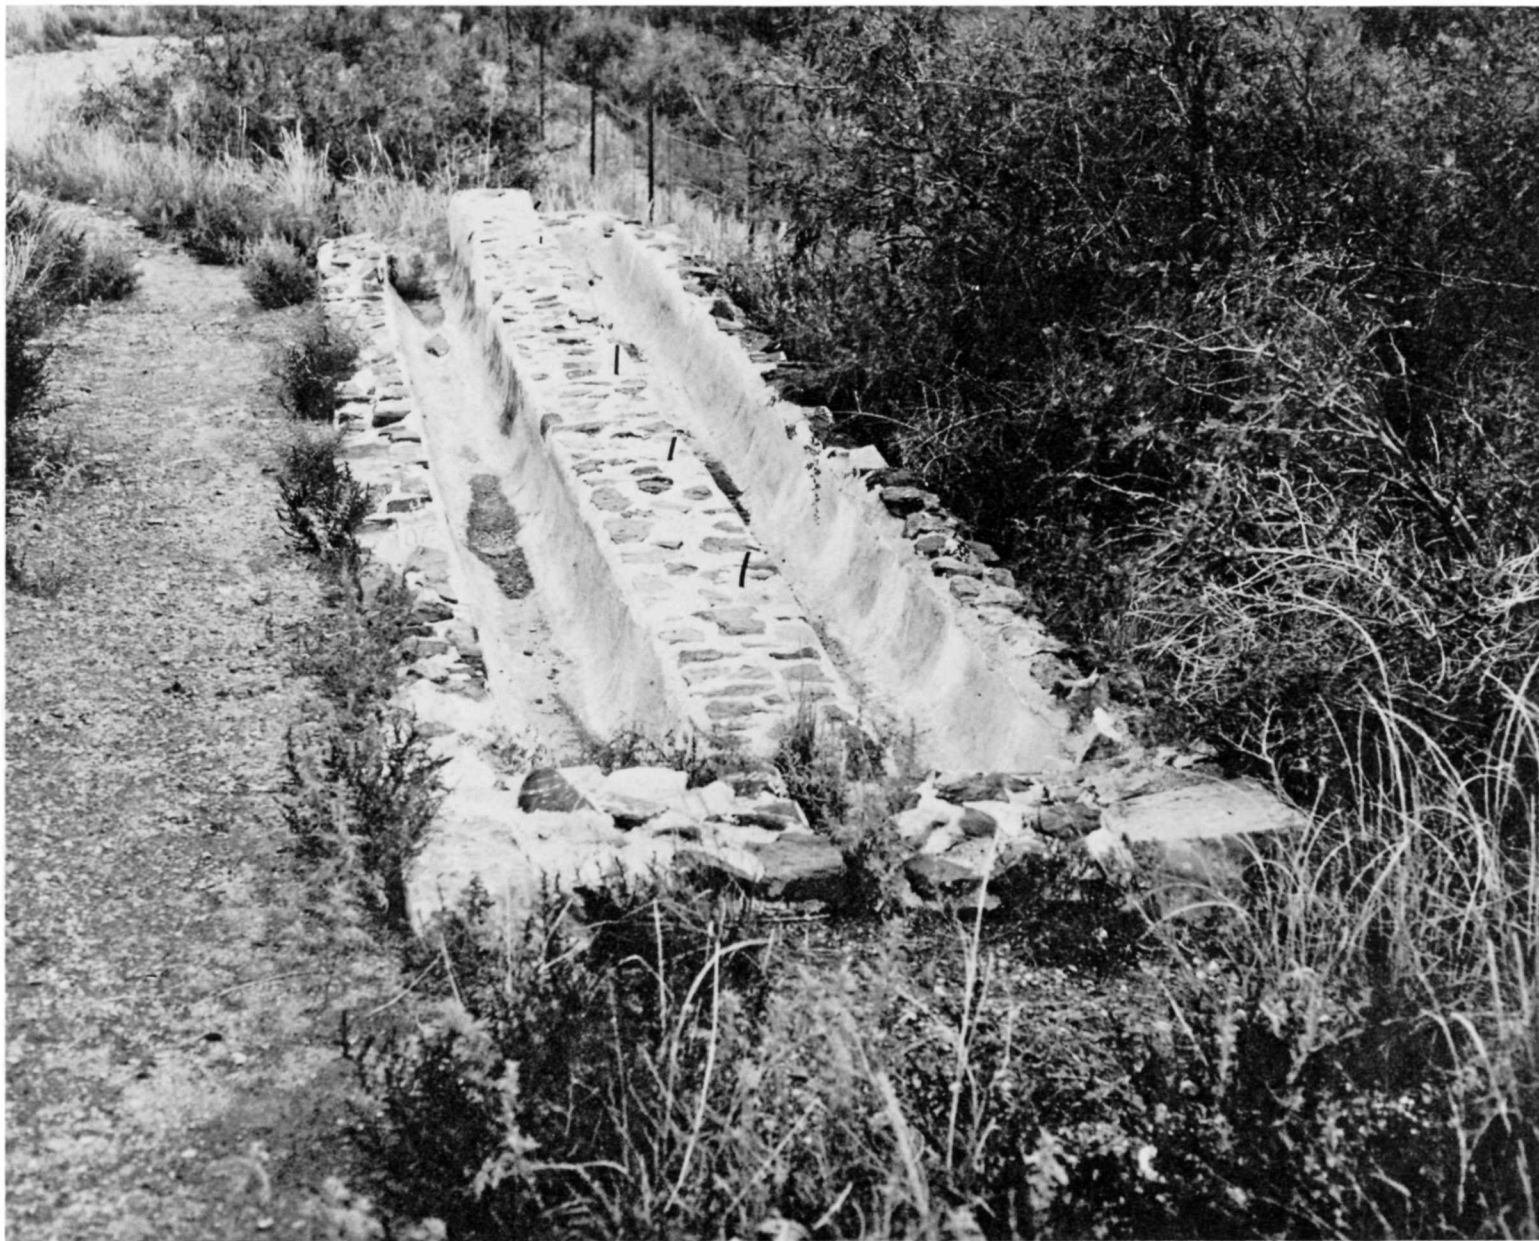
HS 073: View looking north.

HS 073 is the stone and metal remains of a structure built by the U.S. Military. The construction date is not documented. Two parallel troughs and five 1/2-inch diameter threaded metal rods are evident. The stones are undressed, uncoursed limestone originally laid with lime mortar. Historic lime plaster on the interior of the troughs is stained or painted dark red.
