# FORT BOWIE

NATIONAL HISTORIC SITE / ARIZONA

HISTORIC STRUCTURES REPORT  
RUINS STABILIZATION  
ARCHITECTURAL DATA  
FORT BOWIE NATIONAL HISTORIC SITE  
COCHISE COUNTY  
ARIZONA

Prepared by  
John Robbins

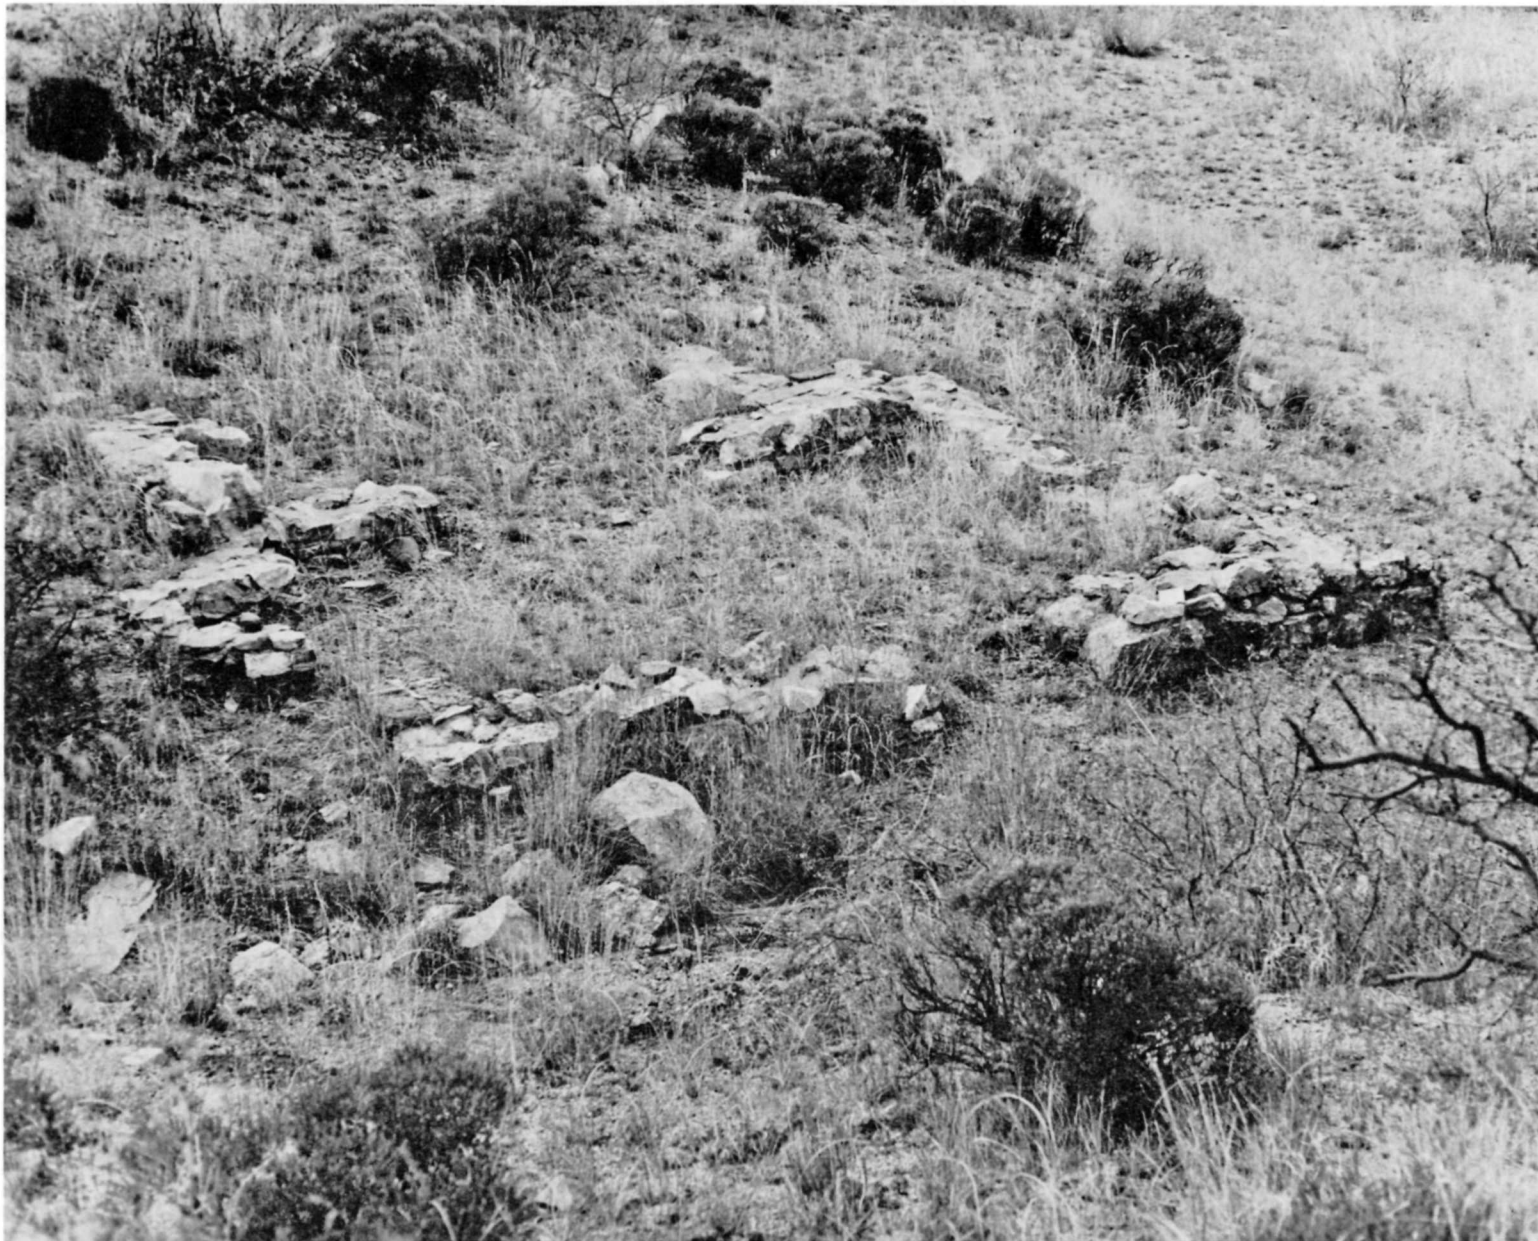
HS 116: View looking west.

HS 116 is the adobe and stone remains of a structure built during or after 1862; the construction date is not documented. Historic adobe remains were removed by the National Park Service in 1967 and replaced with soil-cement adobes which were removed in 1978 and not replaced. The stones are undressed, uncoursed granitic and limestone rock. The historic mortar is not recorded. No plaster is evident.

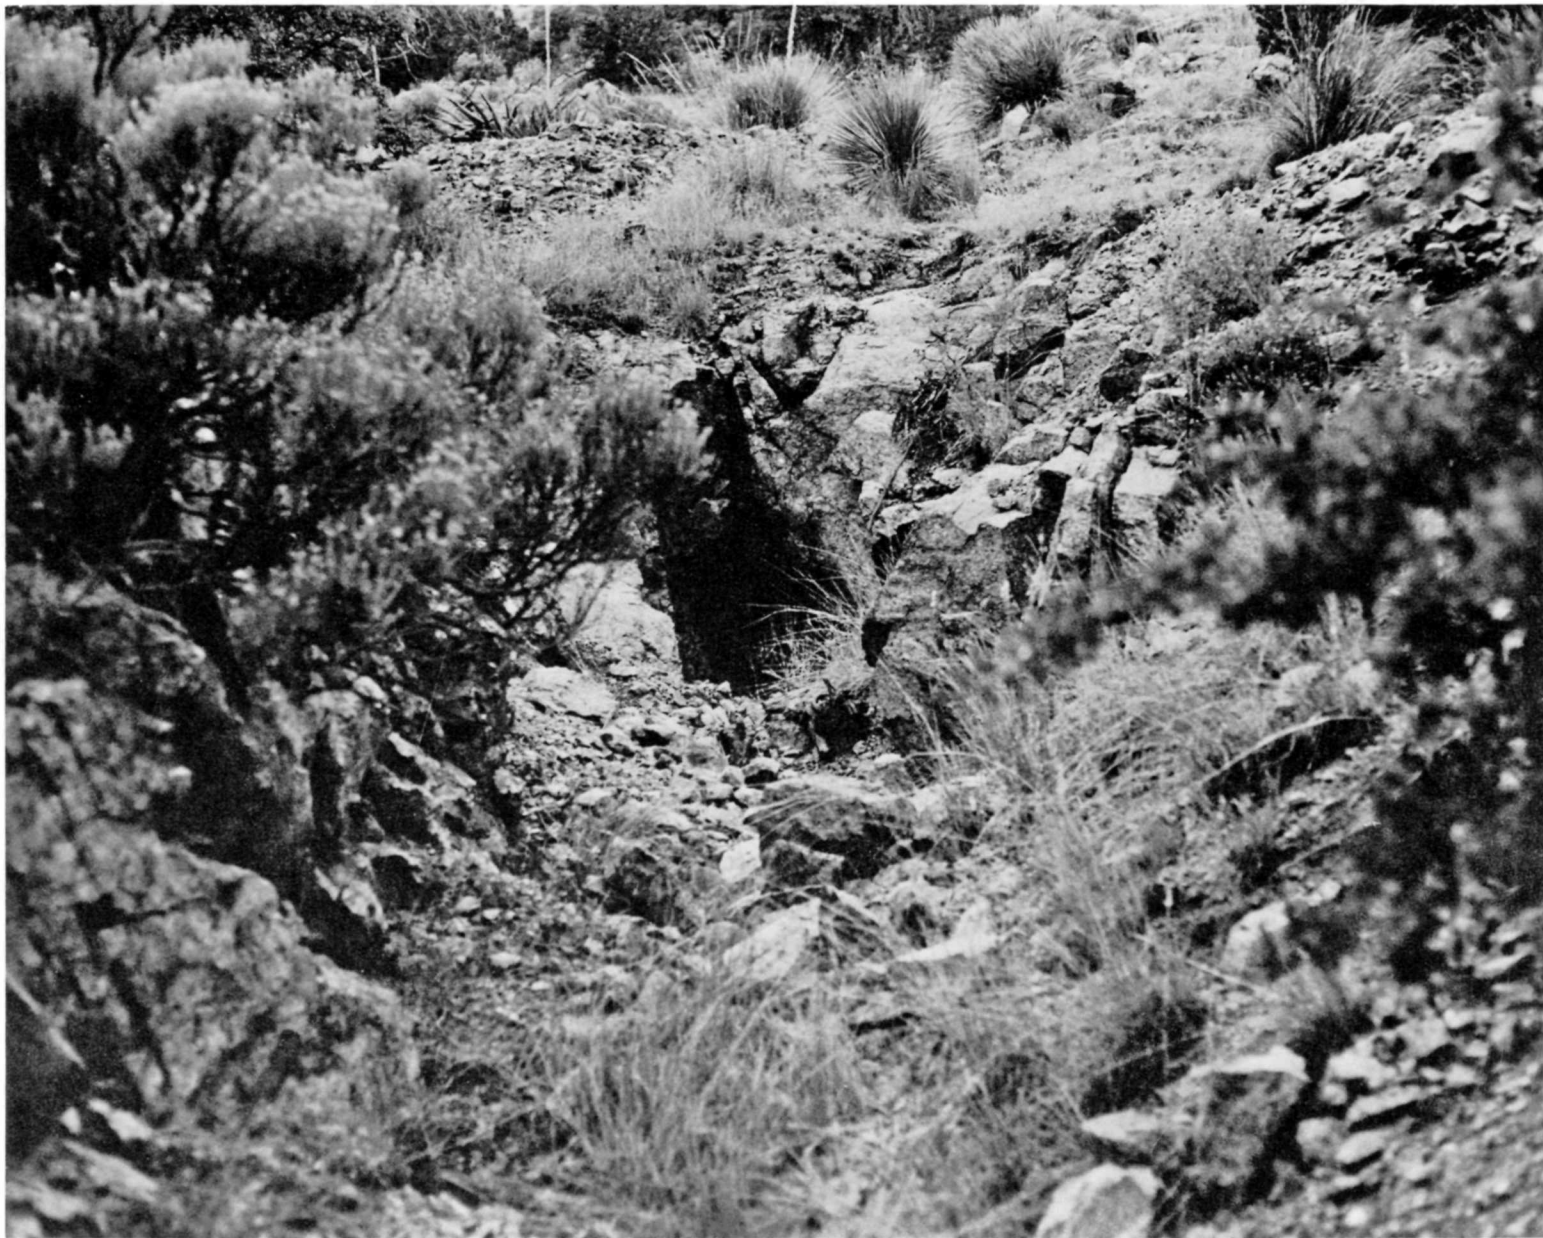
HS 213.

HS 213 is the ruined remains of late 19th or early 20th century gold mining operations. The mining area within the park boundaries includes a horizontal mine shaft, shallow prospect holes, tailings, the ruins of a residence(?), deteriorated furnishings, unidentified fragments, and the remains of low rock walls built to stabilize mining roads. All structures are unaltered and unstabilized, but probably disturbed since acquisition by the National Park Service. There is continuing grazing and mining activity in the vicinity.

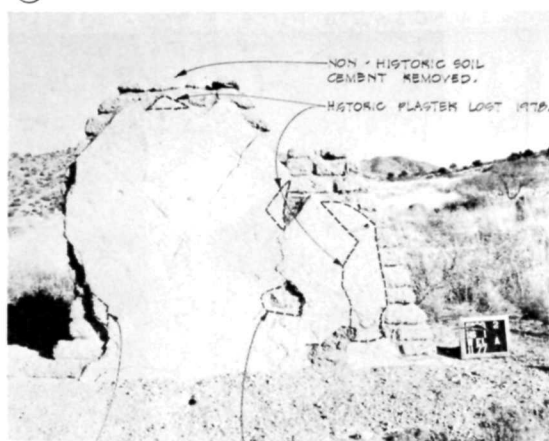
(A) HS 001 • WALL A • NORTH ELEVATION

SOIL CEMENT REMOVED & REPLACED WITH NEW UNAMENDED ADOBE.

NON-HISTORIC SOIL CEMENT REMOVED.

HISTORIC PLASTER LOST 1978.

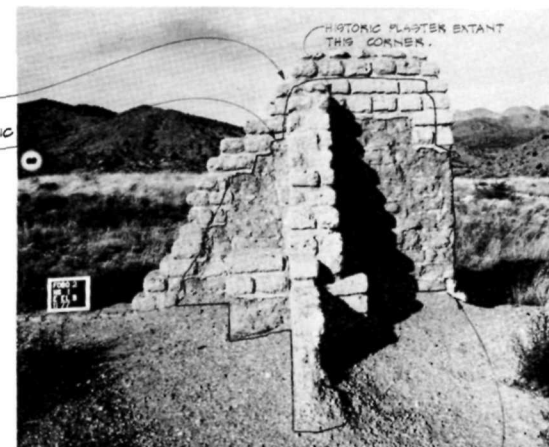
(C) HS 001 • WALL A • SOUTH ELEVATION

NON-HISTORIC SOIL CEMENT REMOVED.  
APPROXIMATE EXTANT HISTORIC FABRIC

HISTORIC PLASTER EXTANT THIS CORNER.

SOIL CEMENT REMOVED & REPLACED W/ NEW ADOBE.

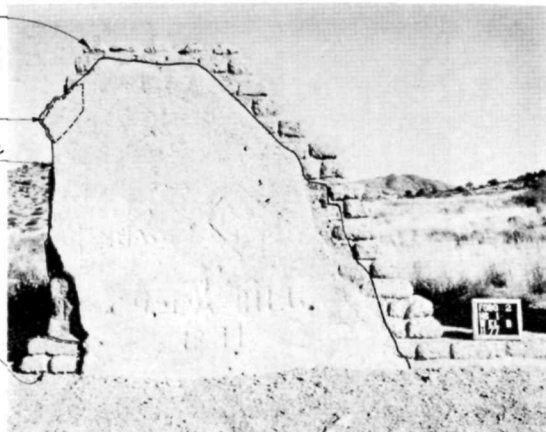
(B) HS 001 • WALL B • WEST ELEVATION

HISTORIC PLASTER LOST 1970.  
EXTANT HISTORIC FABRIC.

SOIL CEMENT REMOVED & REPLACED WITH NEW UNAMENDED ADOBE.

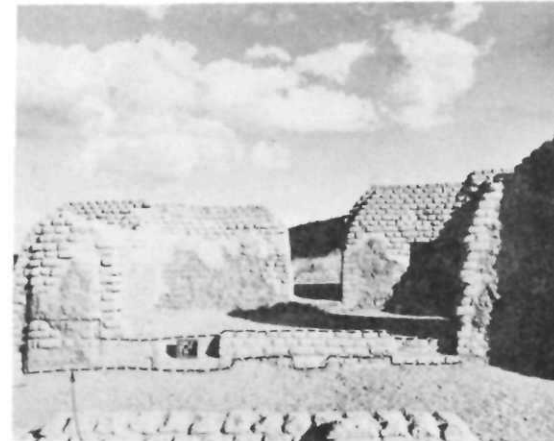
(A) HS 008 • WEST ELEVATION  
BEFORE 1967 STABILIZATION.  
SAME VIEW AS (A) (B) (C) (D)

NON-HISTORIC SOIL CEMENT REMOVED & REPLACED  
WITH UNAMENDED ADOBE EXCEPT STAKES WHICH  
WERE REPLACED WITH NEW SOIL CEMENT ADOBE.
