National Park Service  
Cultural Landscapes Inventory  
2010

Mission 66 Visitor Center Site  
Fort Union National Monument

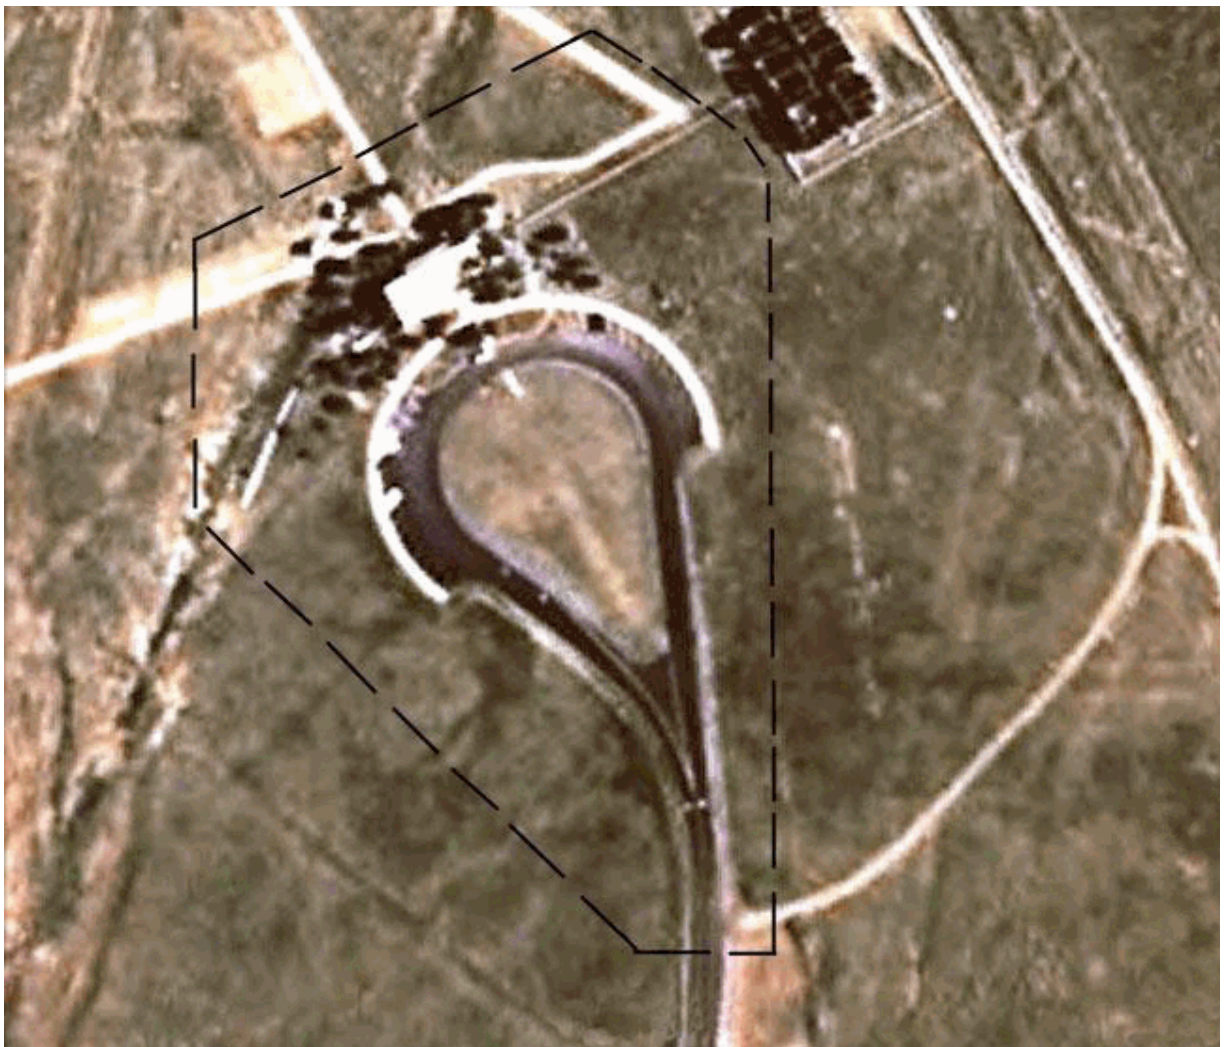
*Boundaries of the Fort Union National Monument Mission 66 Visitor Center and associated landscape features. Source: 2009 Determination of Eligibility.*

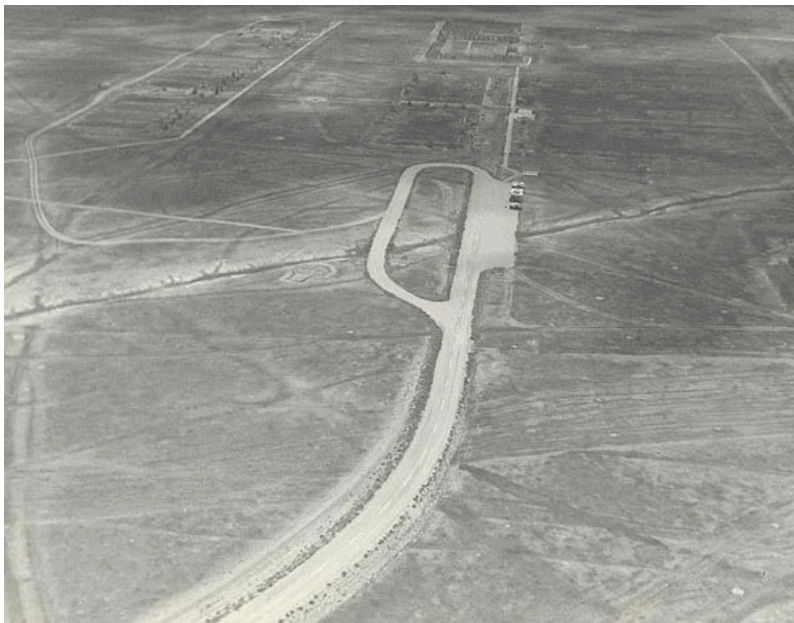
*Aerial photo, circa 1954-57, showing parking area prior to visitor center construction, located directly south on the edge of the fort ruins. (Note location of major Santa Fe Trail rut). Source: Park photo files; taken from 2009 DOE.*

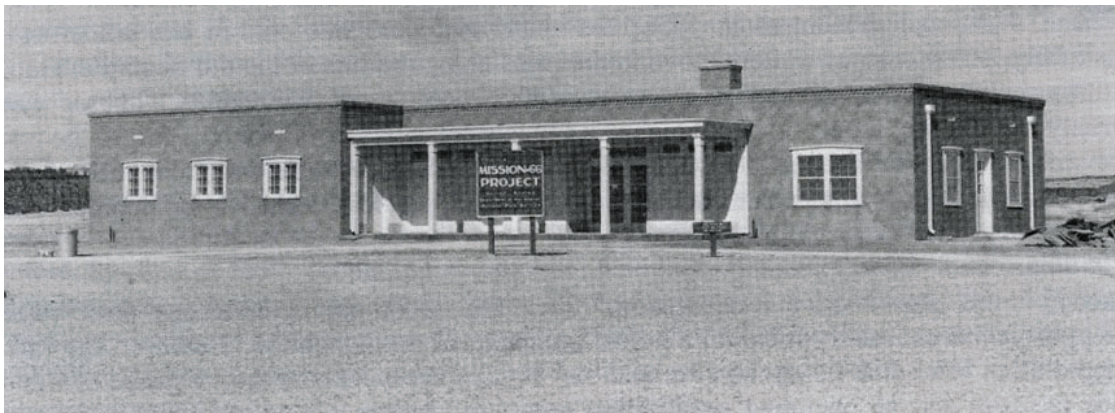
*1959 photo of southern elevation. Source: Zhu 1992, 34; taken from 2009 DOE.*

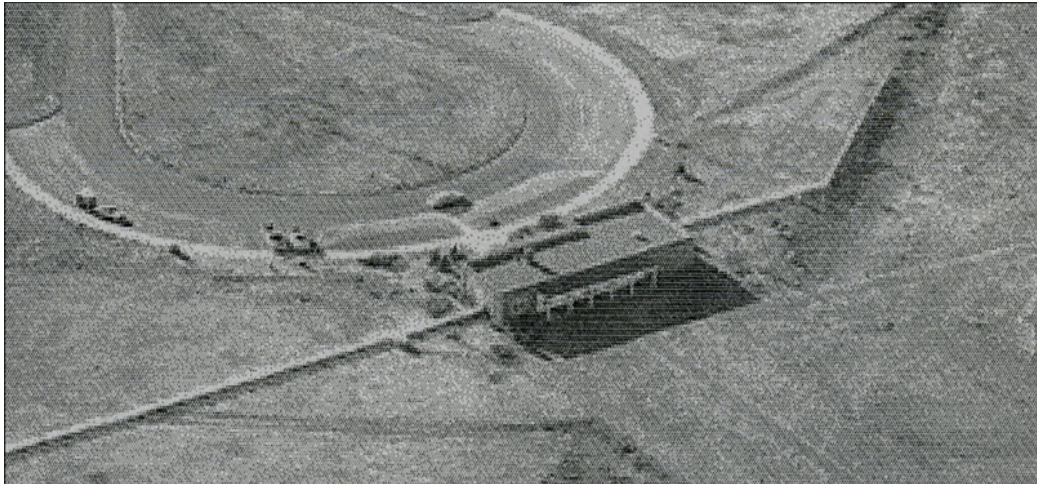
*1960 oblique aerial, showing parking area, walkways, trails, picket fences and newly planted vegetation. Source: Fort Union NM photograph files; taken from 2009 DOE.*

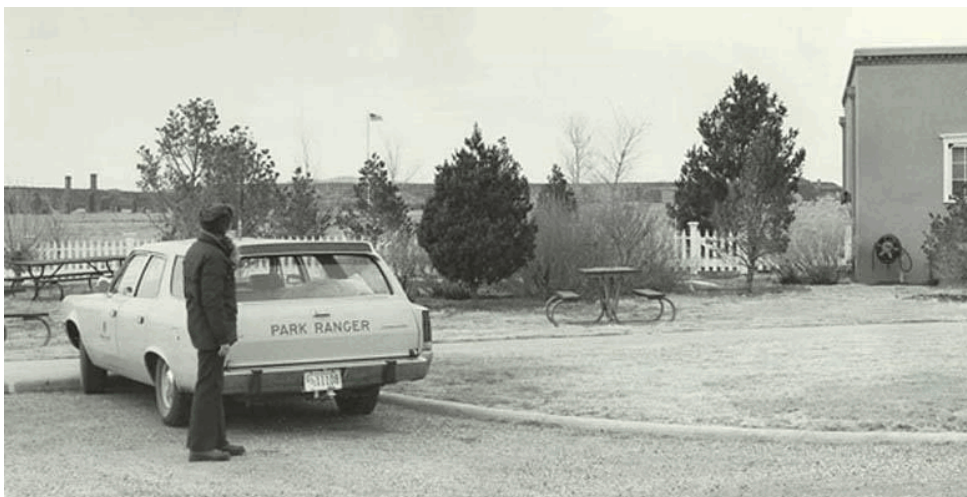
1975 photo of southwest side of visitor center. Source: Park photo files; taken from 2009 DOE.

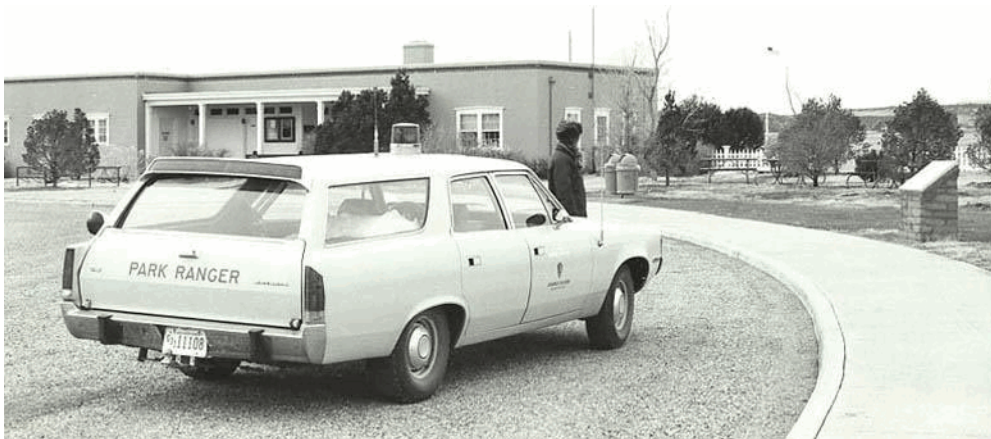
*1975 photo of east and south sides of visitor center. Source: Park photo files; taken from 2009 DOE.*

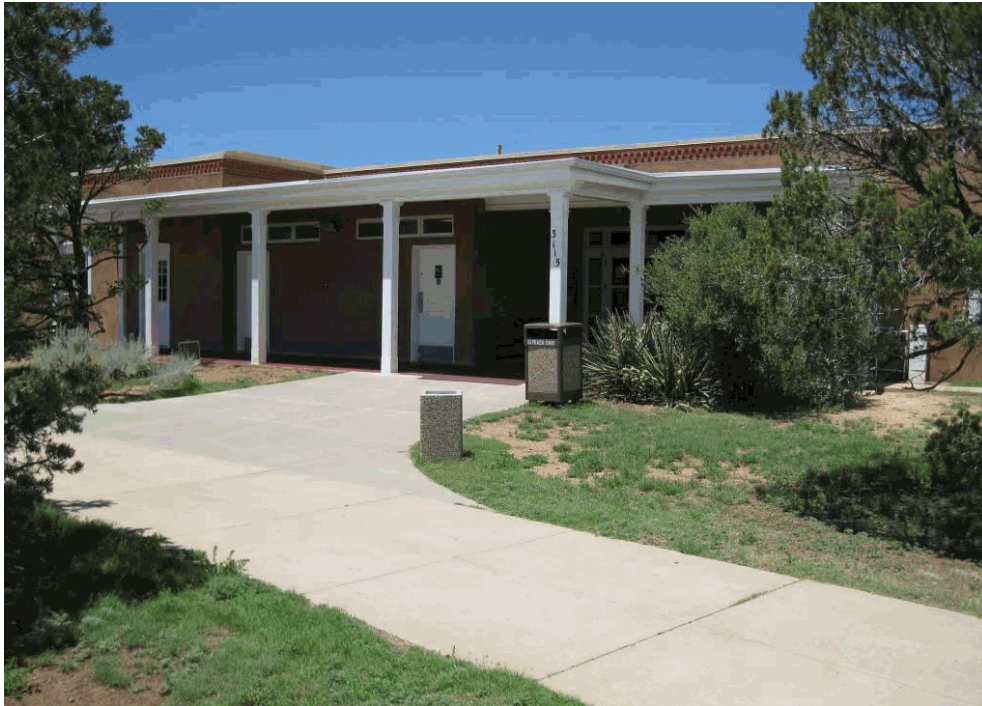
*Front entrance of the Visitor Center, facing northwest, July 2010. Source: National Park Service.*

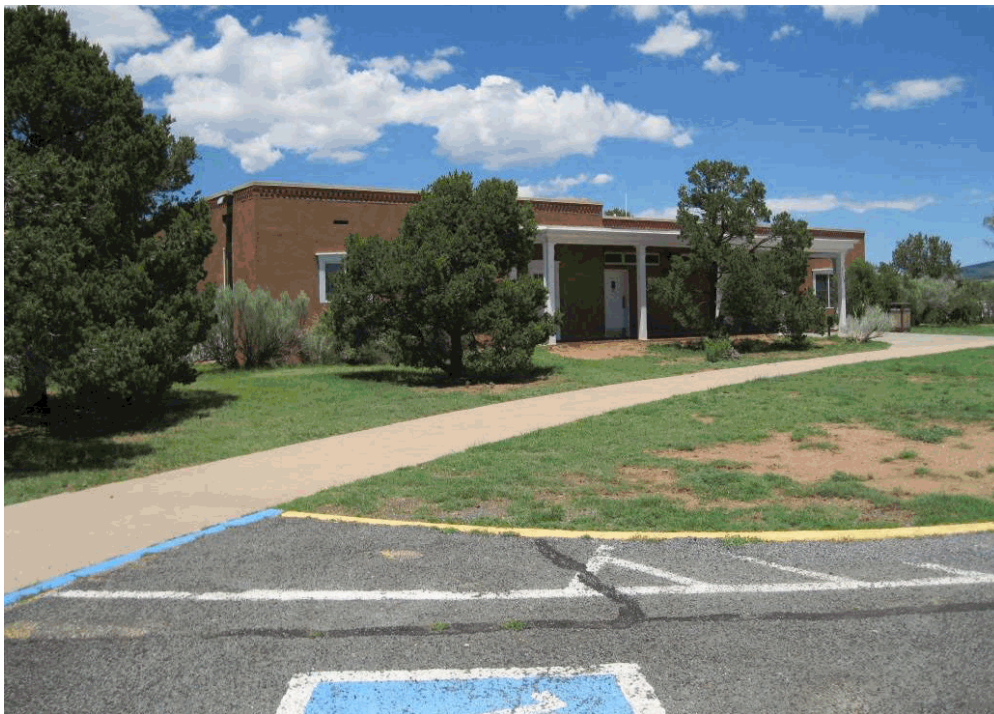
*Front façade of the Visitor Center from the western parking area, facing northeast, July 2010. Source: National Park Service.*

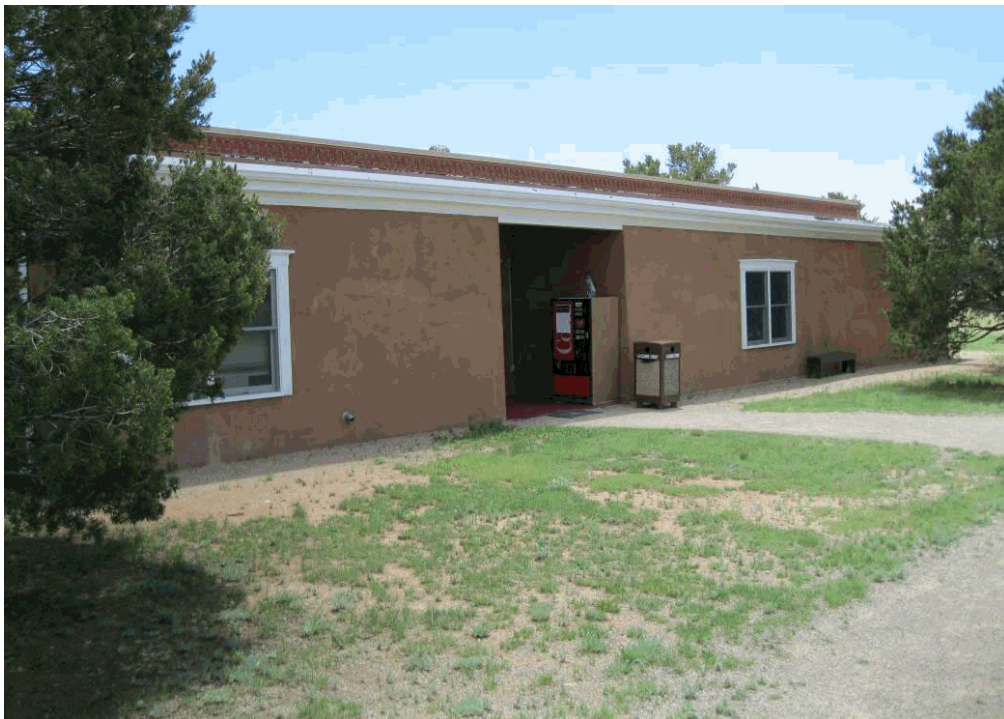
*Rear elevation of the Visitor Center with gravel pathways leading to ruins, facing south, July 2010. Source: National Park Service.*

The enclosure of most of the rear porch of the Visitor Center, while changing the effect of the long horizontal porch roof line across the rear elevation, does not significantly disturb the feeling of the building. Following this alteration, the original plate glass windows in these new walls were later replaced with pedimented wooden ones to match those in the original design.

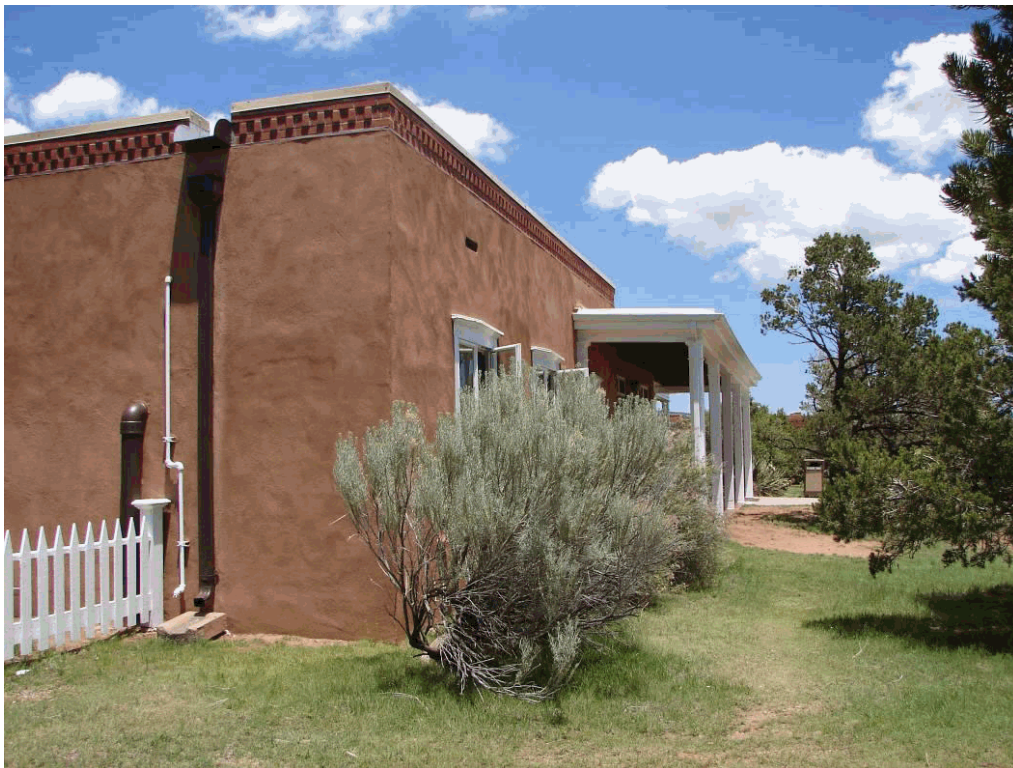
*Detail of the western elevation and southern façade of the Visitor Center, facing northeast, July 2010. Source: National Park Service.*

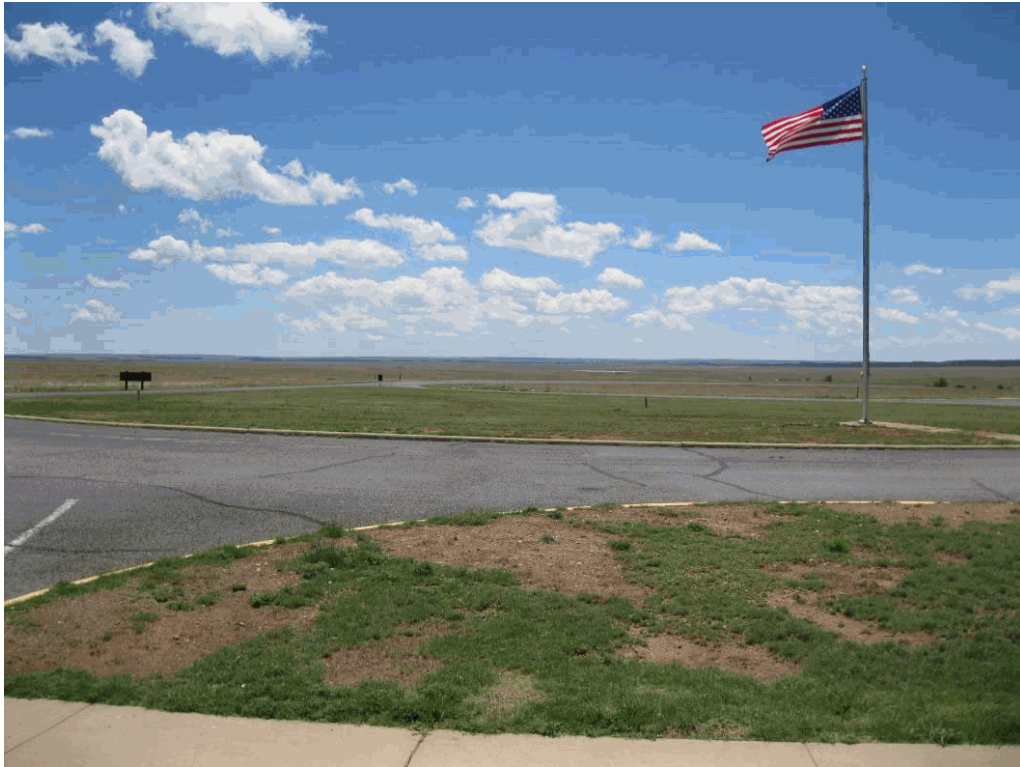
*The wide arc of the teardrop-shaped loop road, teardrop-shaped grassy island (with flagpole), and beginning of the eastern parking area, separated from the western parking area by a green space, facing southwest, July 2010. Source: National Park Service.*

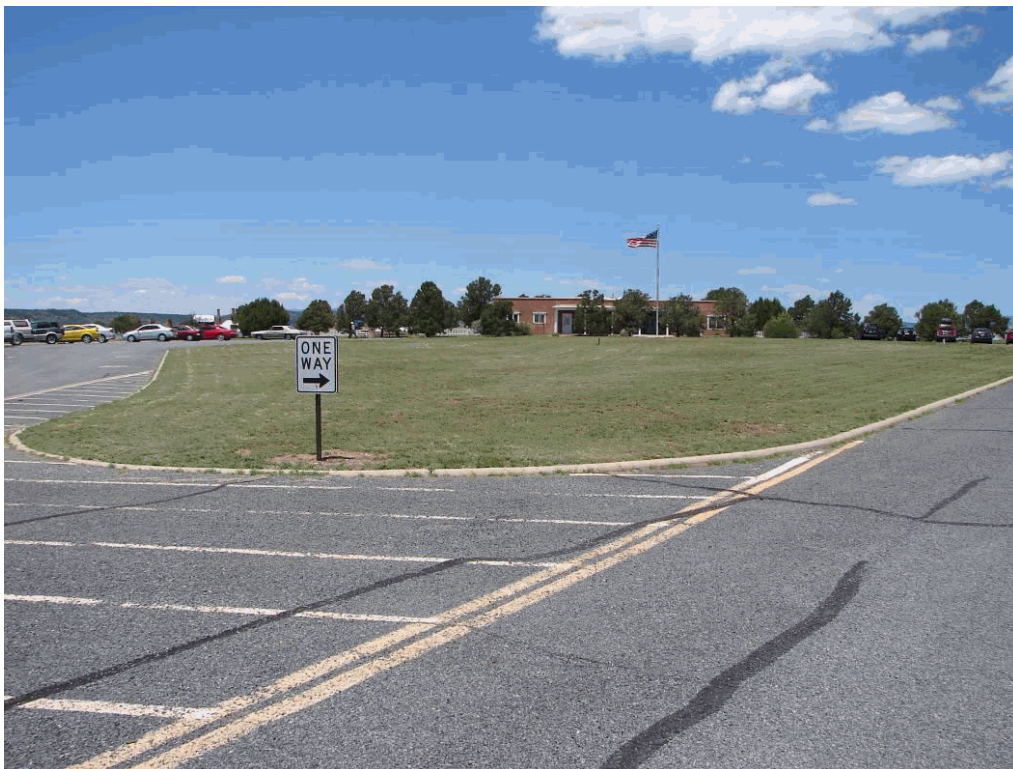
*Teardrop-shaped island with flagpole inside of loop road, facing north, July 2010. Source: National Park Service.*

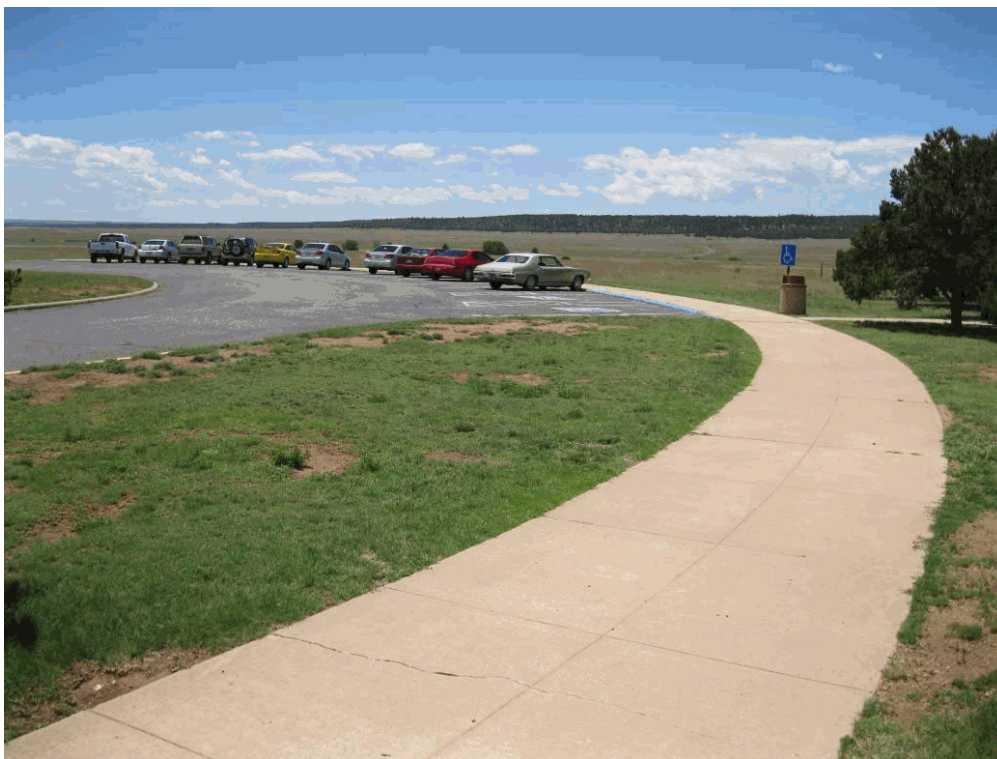
*Curved concrete sidewalk leading from western parking area to the Visitor Center main entrance.*

*The sinuous green space that separates the two parking areas is visible, facing southwest, July 2010. Source: National Park Service.*

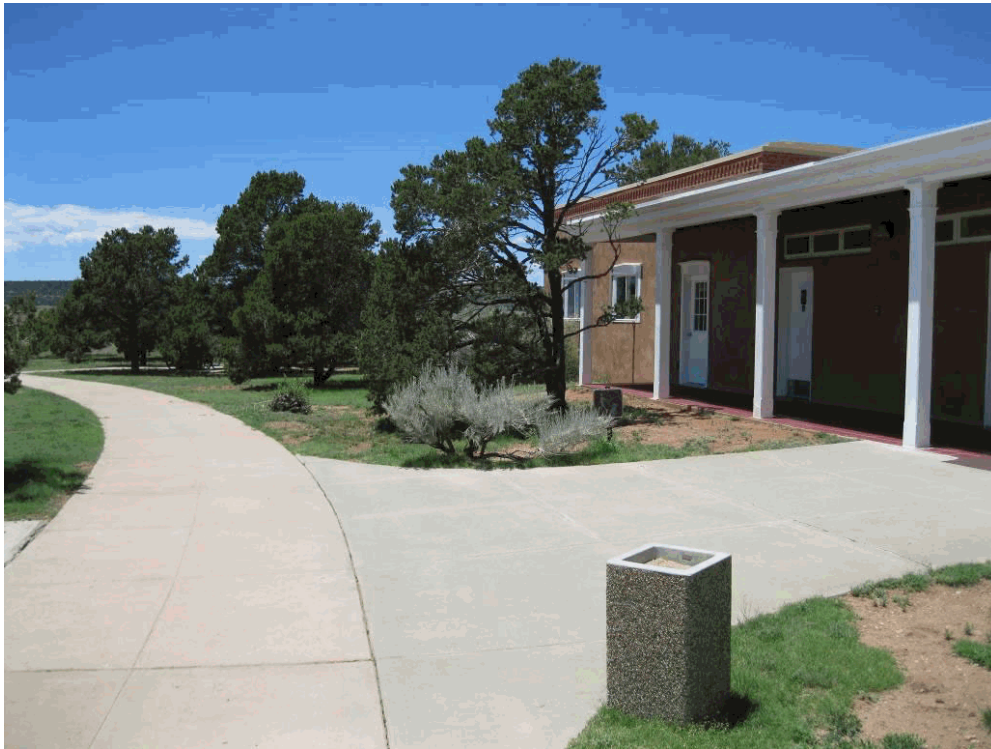
*Curved concrete sidewalk and “mini plaza” entry way leading to the Visitor Center main entrance, facing west/southwest, July 2010. Source: National Park Service.*

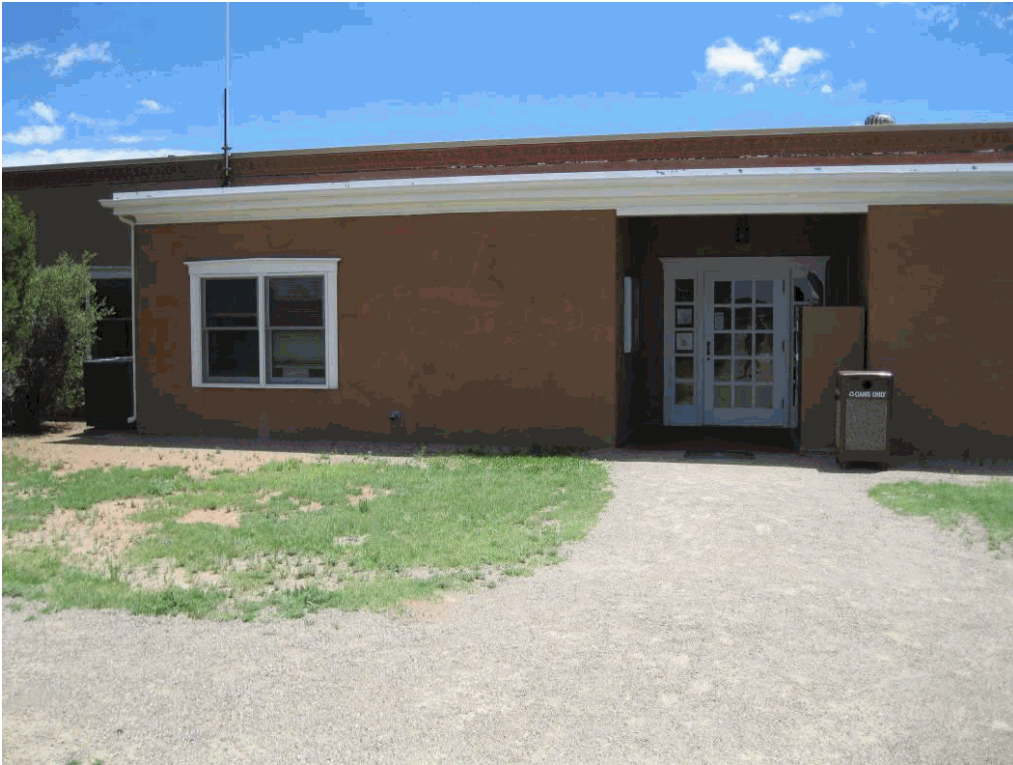
*Gravel pathway lead from rear exit of Visitor Center to fort ruins. The perpendicular gravel pathway is visible, extending east and west, facing south/southeast, July 2010. Source: National Park Service.*

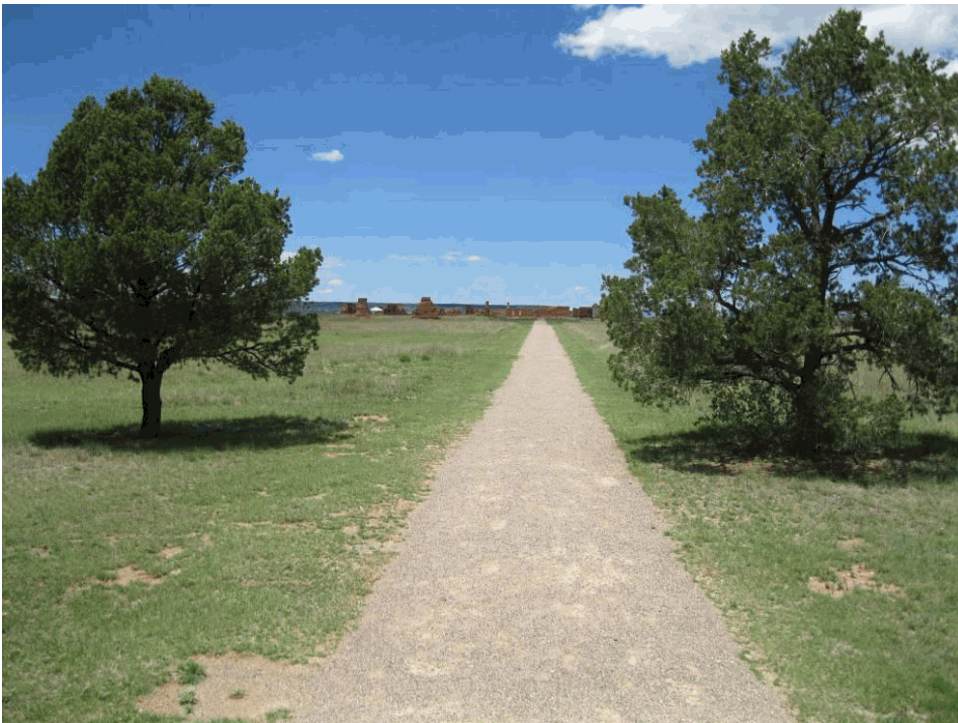
*The gravel path, framed by trees, extends directly from the rear exit of the Visitor Center to the ruins. The gravel pathways are well articulated and contrast with the surrounding grasses, facing north/northwest, July 2010. Source: National Park Service.*

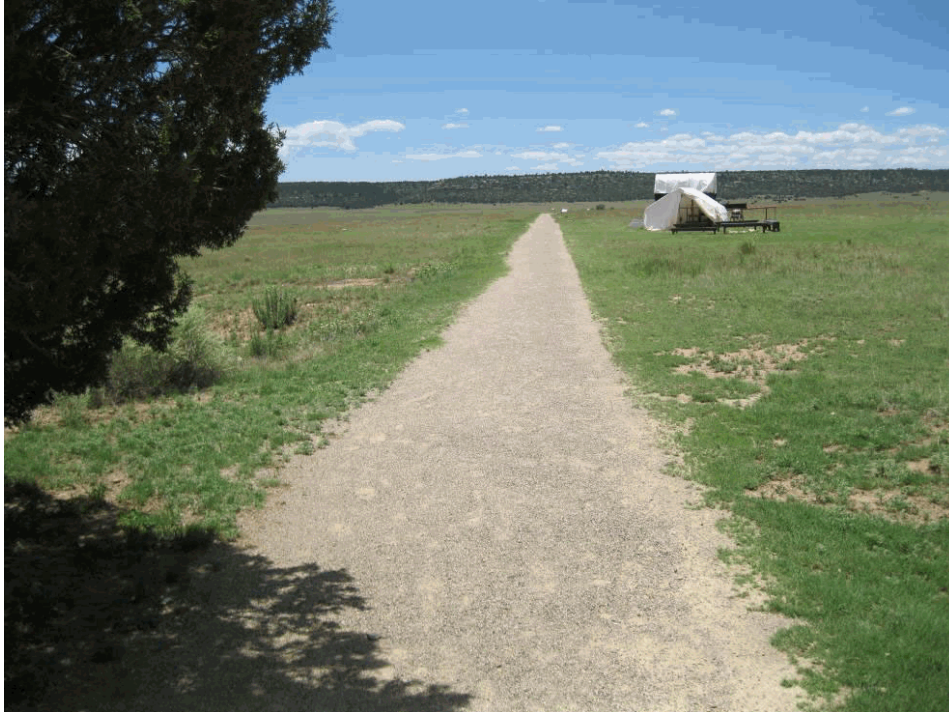
*Perpendicular to the northbound gravel path, this gravel path heads west towards the 2nd fort ruins. A tent and wagon, in addition to other wayside exhibits, are on the north side of the path, facing west, July 2010. Source: National Park Service.*

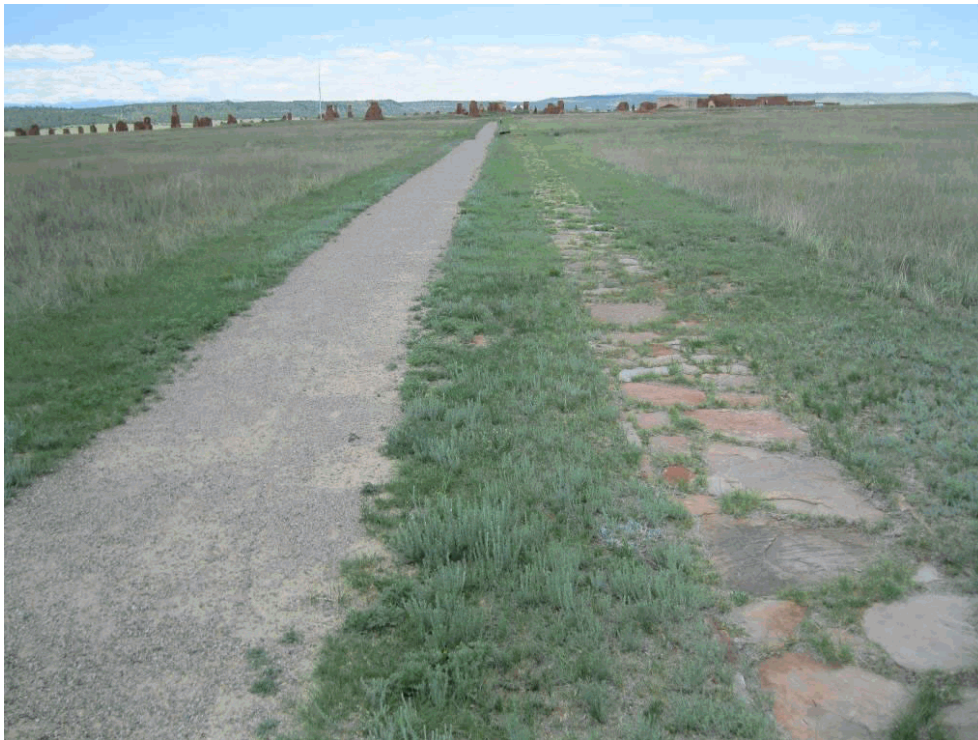
*Gravel path, grass strip, and stone path leading from the hospital ruins northwest to the fort ruins, facing northwest, July 2010. Source: National Park Service.*

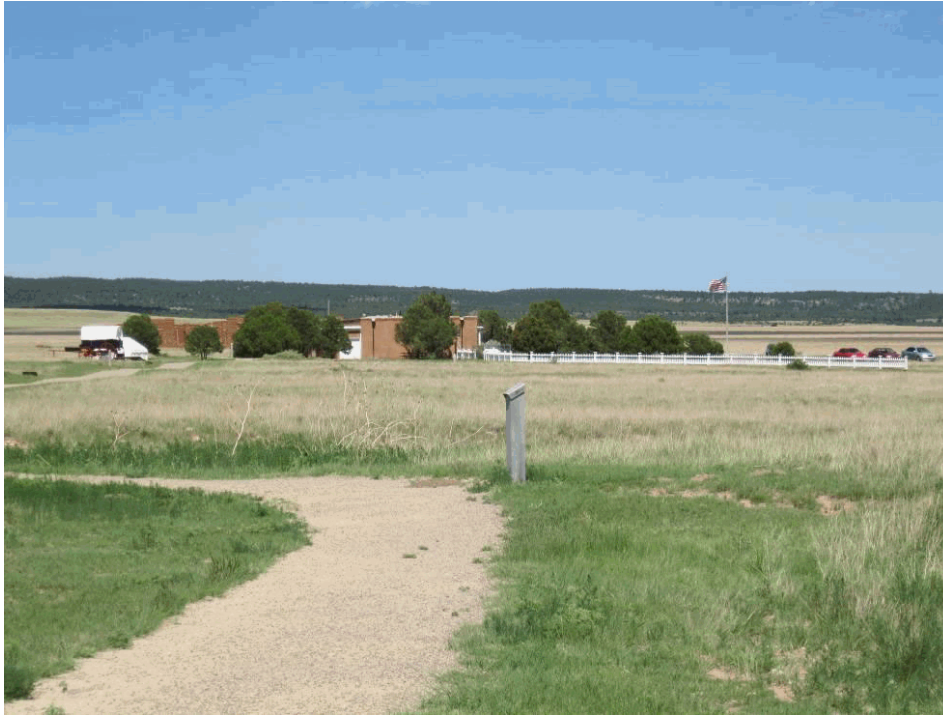
*Looking east from a gravel walkway, the proximity of the parking area/loop road, picket fence, Visitor Center, and hospital ruins (in the background) is evident, facing east, July 2010. Source: National Park Service.*

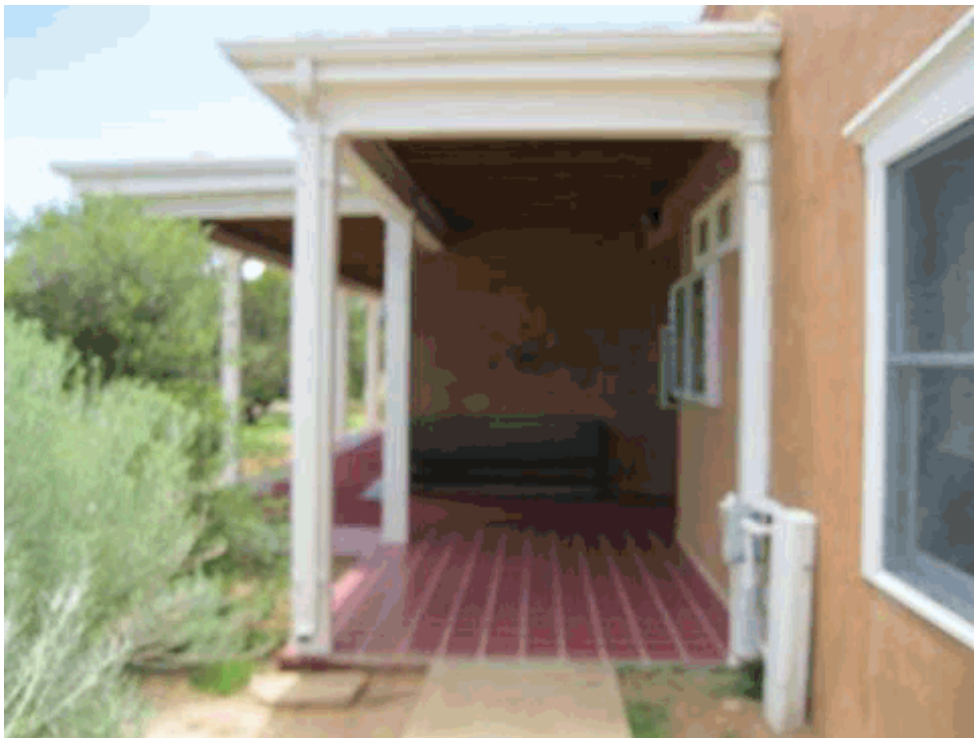
*Porch of the Visitor Center with a bench, facing east, July 2010. Source: National Park Service.*

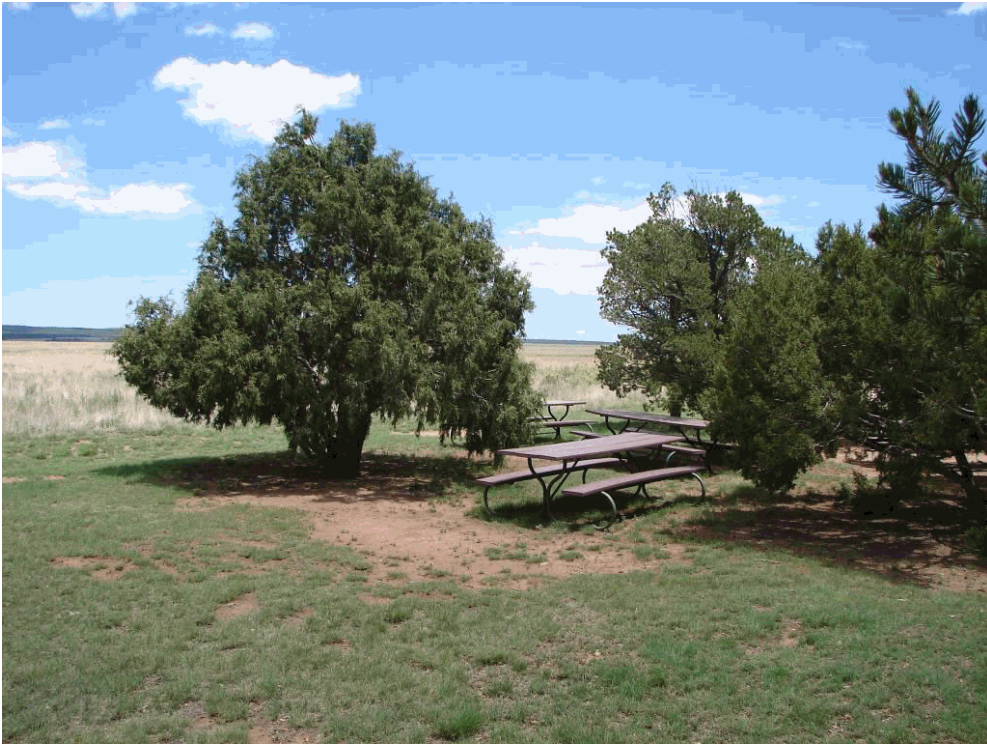
*Picnic area southeast of the Visitor Center, facing southwest, July 2010. Source: National Park Service.*

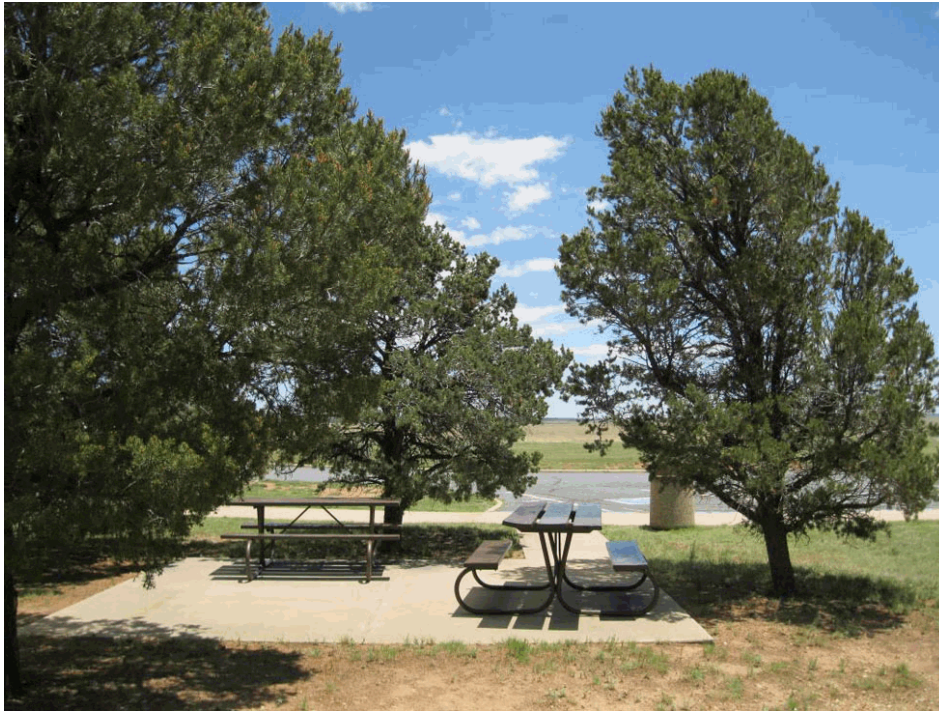
*Accessible, paved picnic area on the west side of the Visitor Center, facing south/southeast, July 2010. Source: National Park Service.*

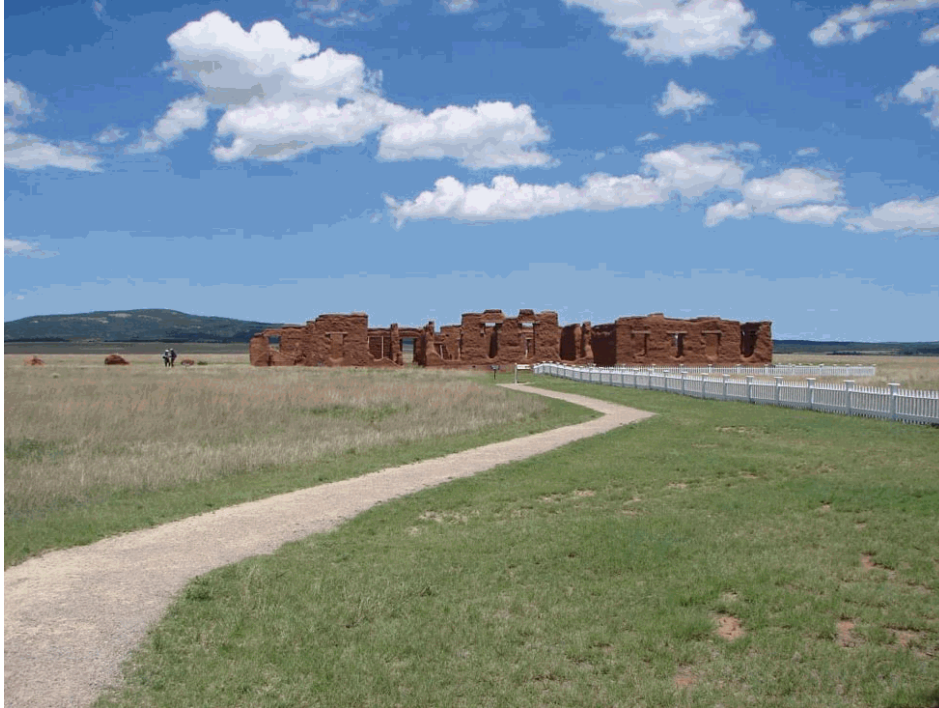
*Picket fence extending east from the Visitor Center to the hospital ruins, facing east, July 2010. Source: National Park Service.*

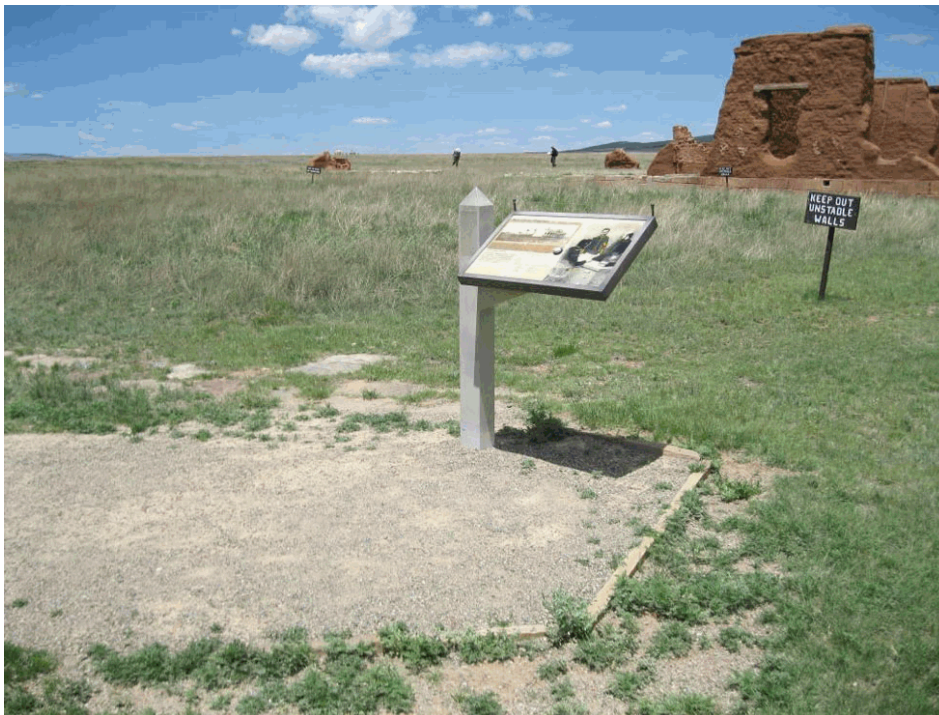
*Wayside exhibit on gravel pathway and sign in the grass, facing east/northeast, July 2010.  
Source: National Park Service.*

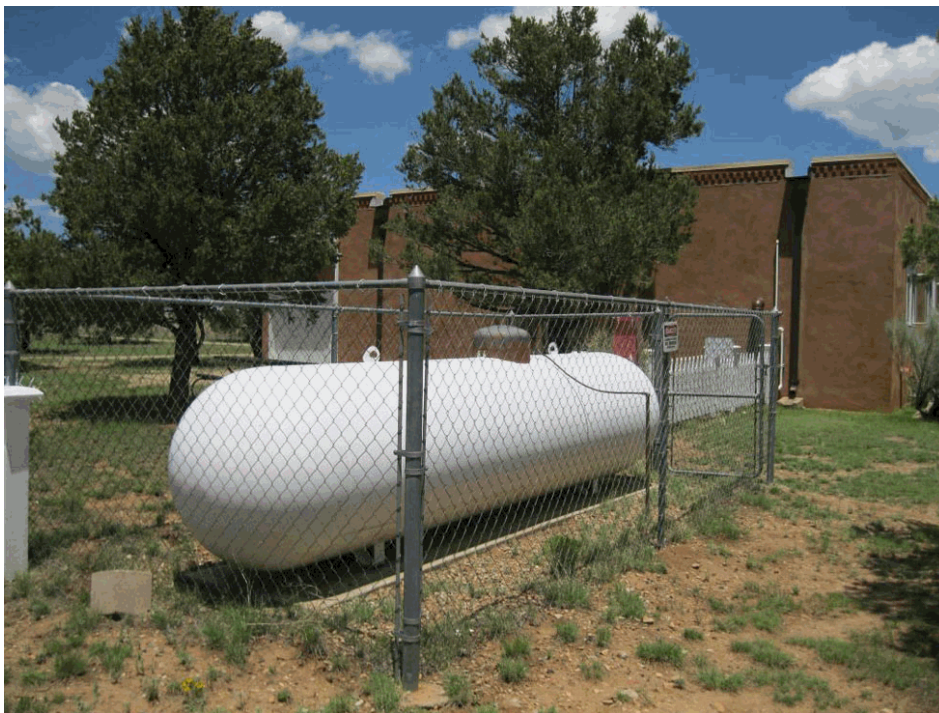
*Propane tank and chain link fence on western side of the Visitor Center. The chain link fence interrupts the white picket fence, facing northeast, July 2010. Source: National Park Service.*

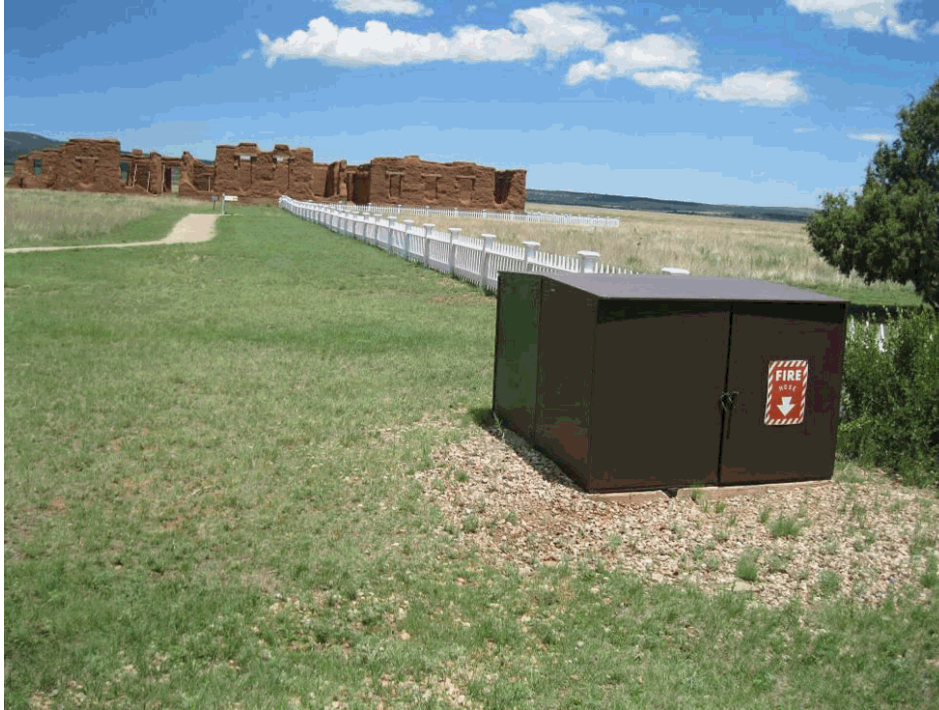
*Large brown firebox located on the north side of the white picket fence on the eastern side of the Visitor Center, facing east, July 2010. Source: National Park Service.*

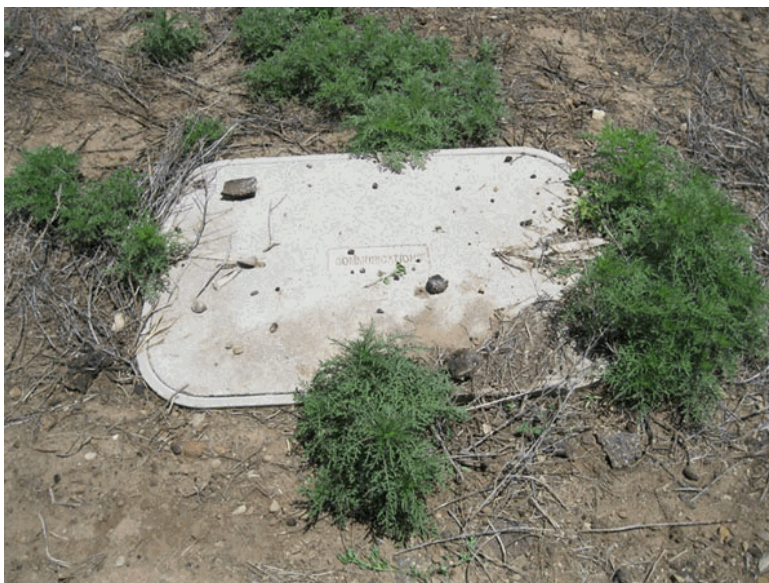
*Utility cover that reads, "Communications," July 2010, Source: National Park Service.*

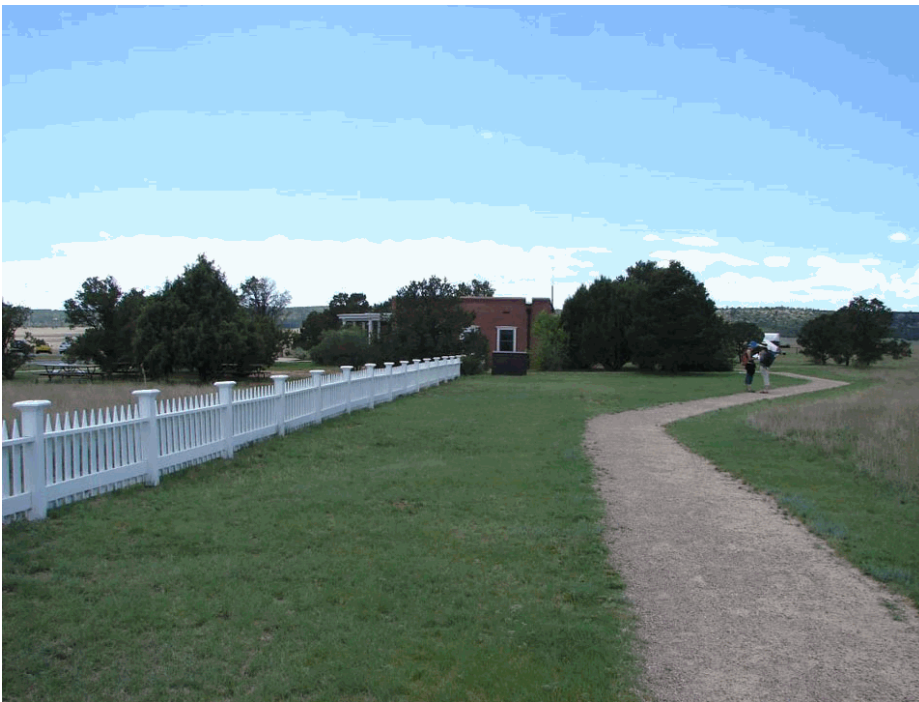
*The Visitor Center creates an “island” effect as a compact cluster of visitor amenities and as a site for receiving information before accessing the ruins by way of pedestrian pathways, facing west/southwest, July 2010. Source: National Park Service.*

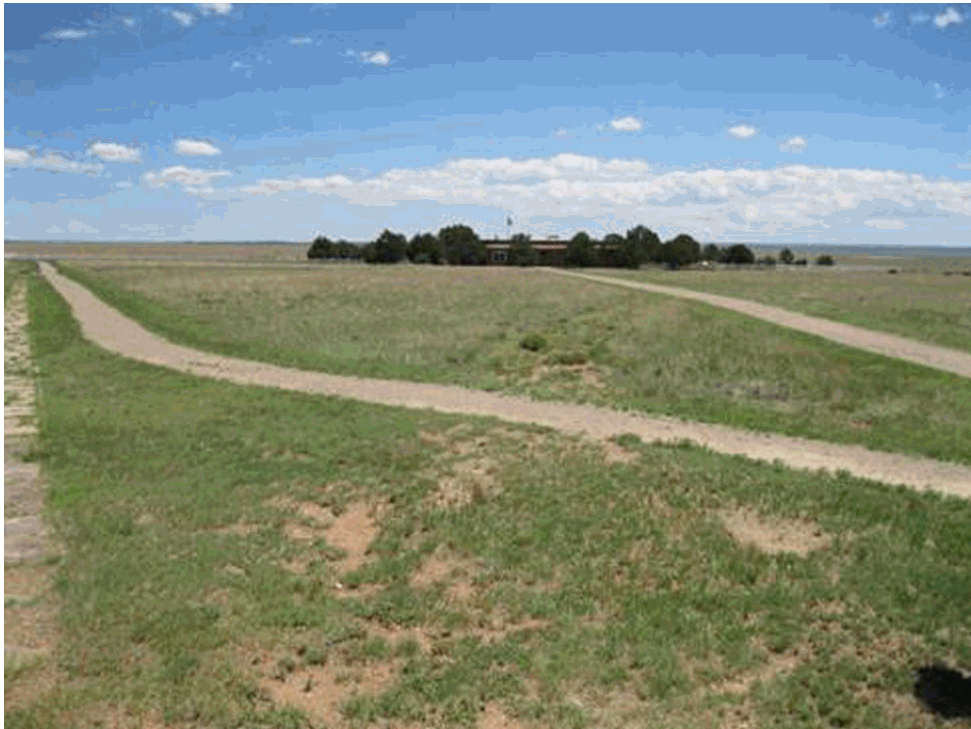
*Trees surround the Visitor Center, while the rest of the flat landscape is primarily grasses and occasional low-lying shrubs, facing south, July 2010. Source: National Park Service.*

**Impact Description:** Vegetation planted as part of the original design of the landscape is in decline due to a combination of maturity and climatic conditions.

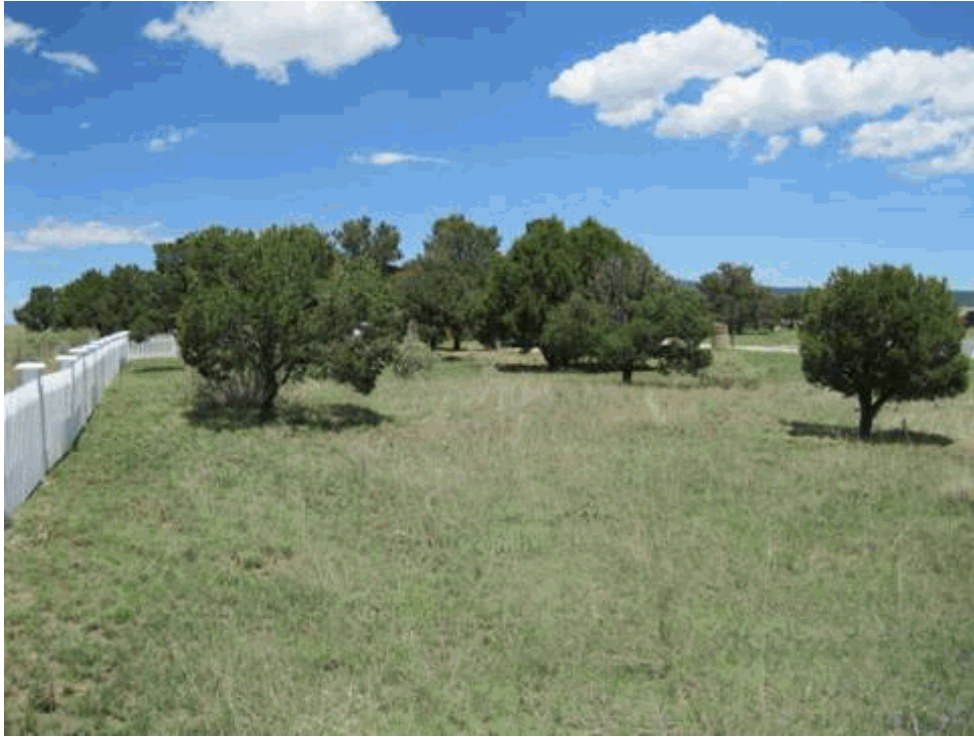
*Pinyons and junipers are the most common trees around the low-lying Visitor Center, facing east/northeast, July 2010. Source: National Park Service.*

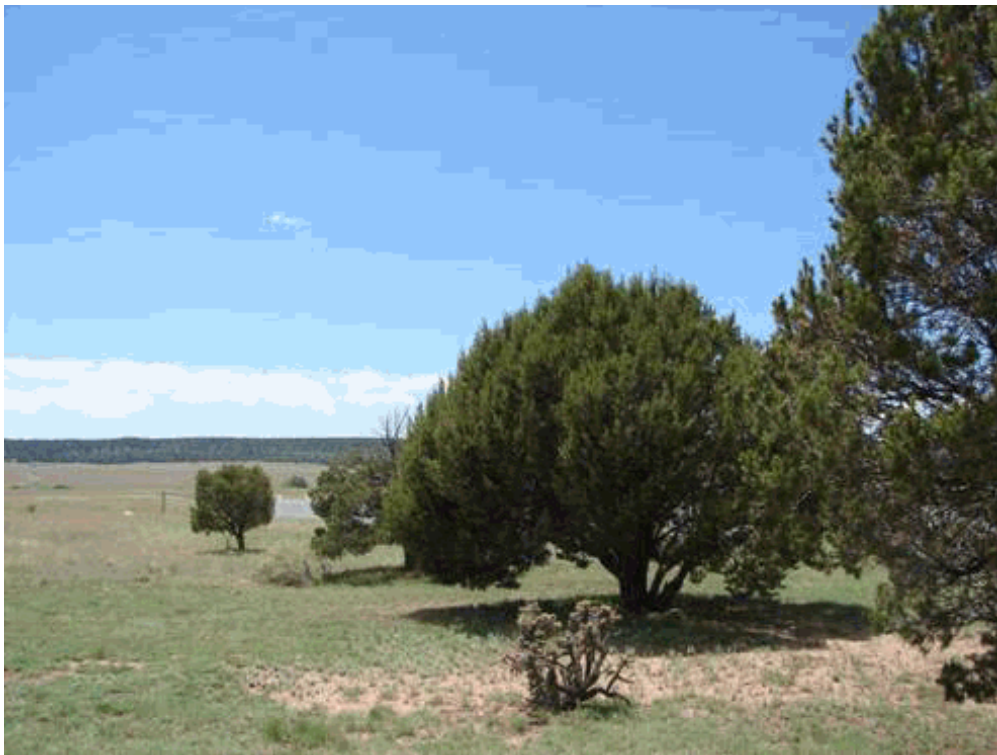
*The largest trees are clustered near the Visitor Center and are roughly the same height suggesting they were planted at the same time. The trees get smaller away from the Visitor Center, facing west/southwest, July 2010. Source: National Park Service.*
