EXPLORATORY EXCAVATIONS  
AT  
FORT VANCOUVER

VANCOUVER, WASHINGTON

1947

Louis R. Caywood  
Archeologist

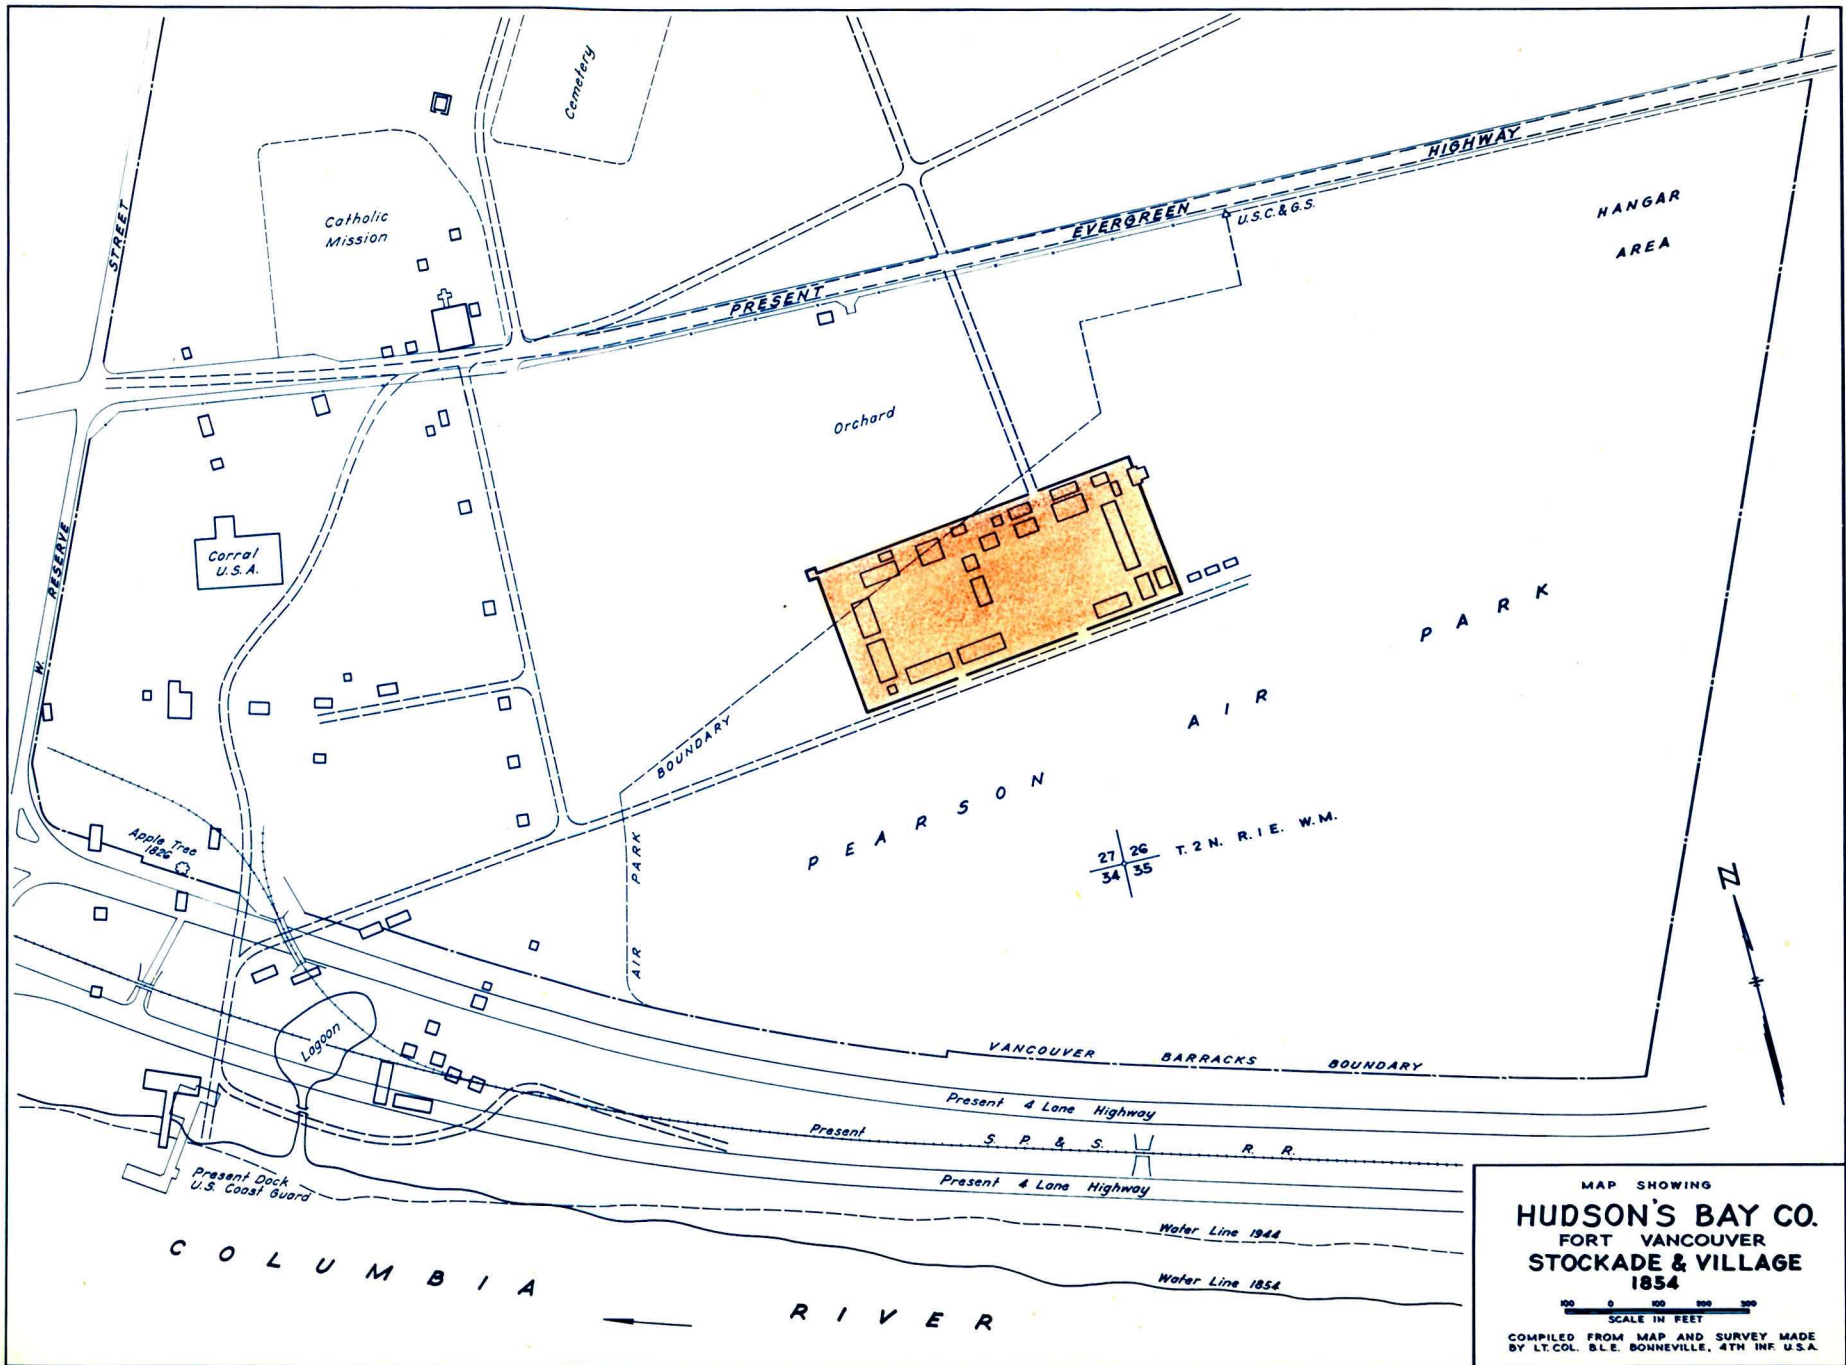
MAP SHOWING  
**HUDSON'S BAY CO.**  
 FORT VANCOUVER  
 STOCKADE & VILLAGE  
 1854

COMPILED FROM MAP AND SURVEY MADE  
 BY LT. COL. B.L.E. BONNEVILLE, 4TH INF. U.S.A.

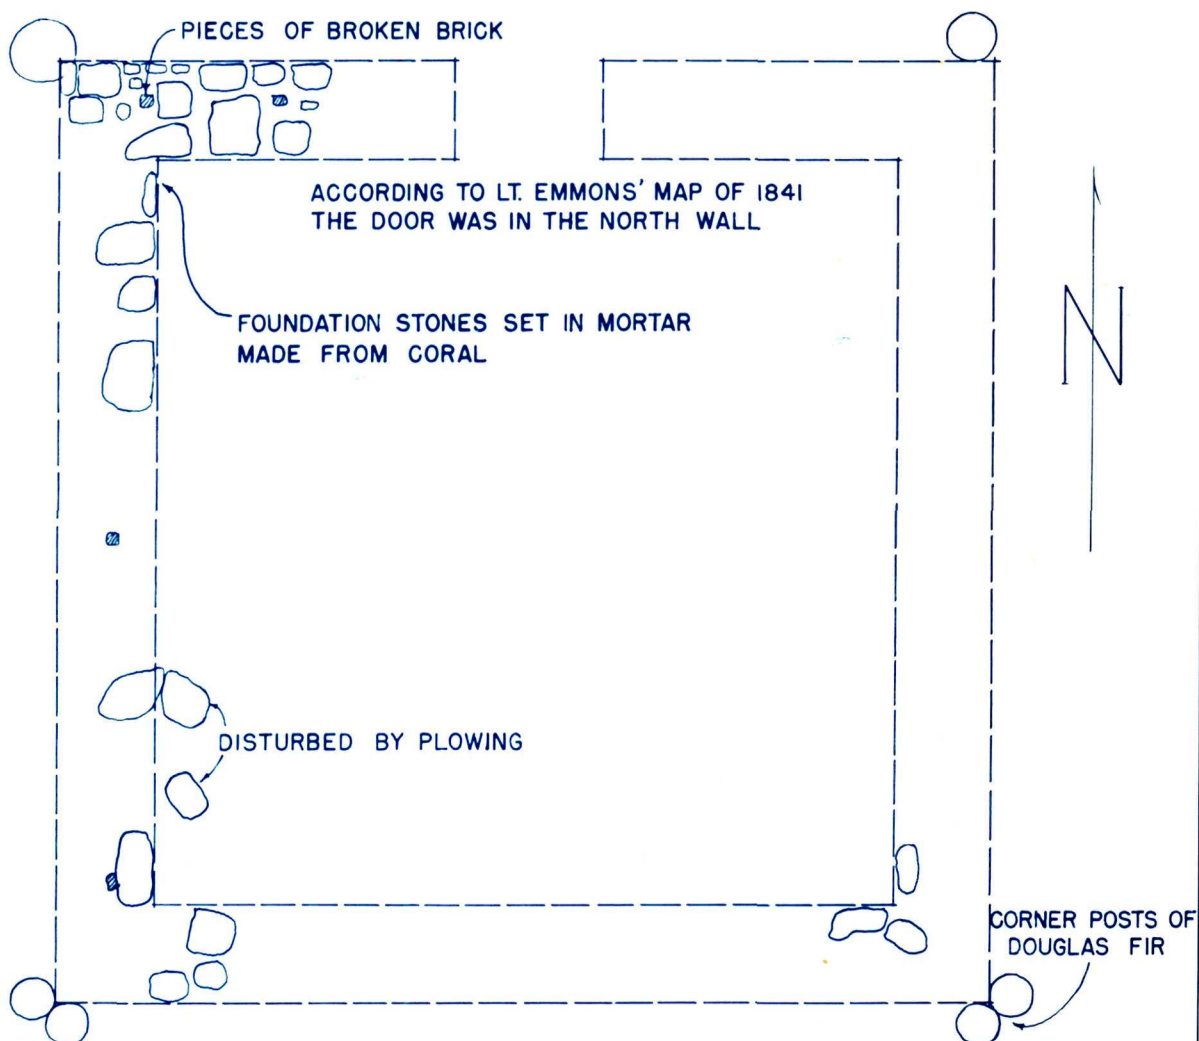
# POWDER MAGAZINE FORT VANCOUVER

Several times while walking over the area searching for clues, we had seen flat stones barely exposed on the surface. These stones were different from the round stones found in quantity everywhere. Trenches were started in this area and the discovery of definite stone foundations proved to be those of the powder magazine. After these foundations were exposed

to give the size, orientation and layout of the building, it was a simple matter to scale off from the Vavasour map the distance to the south and west stockade walls. The approximate location of the southwest corner was determined and the length of the west stockade wall was measured off. Still in search of the bastion in the northwest corner, trenches were dug in that area down to the yellow undisturbed earth which was now known to be from about eighteen inches to two feet below the surface. At 9:45 A.M. on the morning of September 25 the north and west stockade walls were found in the two trenches simultaneously. Trenching along the lines of posts, we were soon able to determine their direction and condition. The post remains on the north wall were badly charred along the tops, but below the charred area there was hardly any rotted remains left. The ground was damp and hard. On the west wall the posts showed no evidence of burning and were in better condition. Here the ground was fairly soft and dry. Objects found during this excavation included two grape shot and one cannon ball. Work was stopped here as soon as the charred remains of one of the bastion walls were found. (Plate 10)

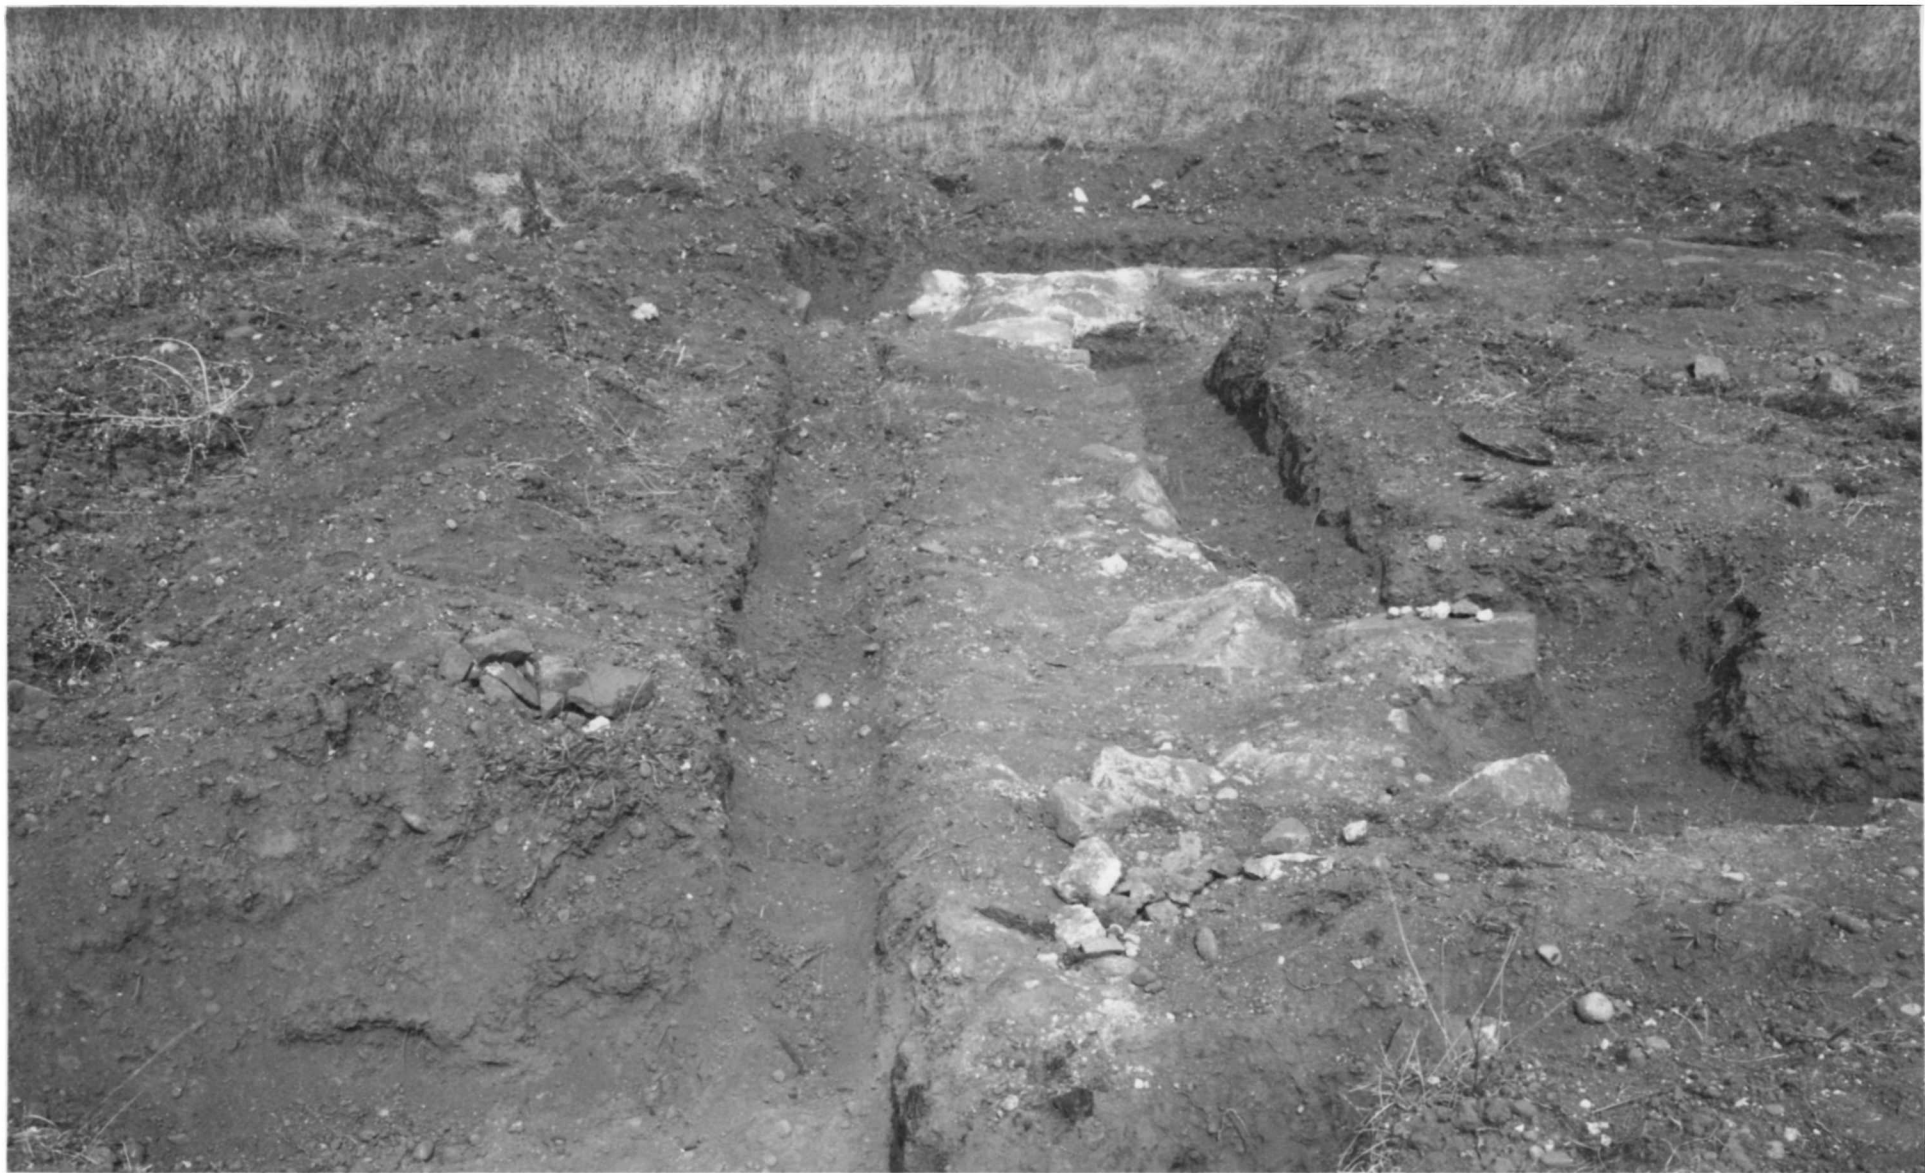
Remains of stone foundations of powder magazine.

Only a few hundred feet of the stockade walls (Plate 2) and the bastion (Plate 3) have been uncovered. The foundations of the powder magazine (Plates 4, 6, and 7) were the only remains within the stockade which were unearthed. There remain two wells and the foundations of 21 buildings yet to be uncovered. Outside the stockade area at the southeast corner, there were three small buildings, one of which was used as a cooper's shed. (Plates 2 and 9) No attempt was made to determine their exact locations.

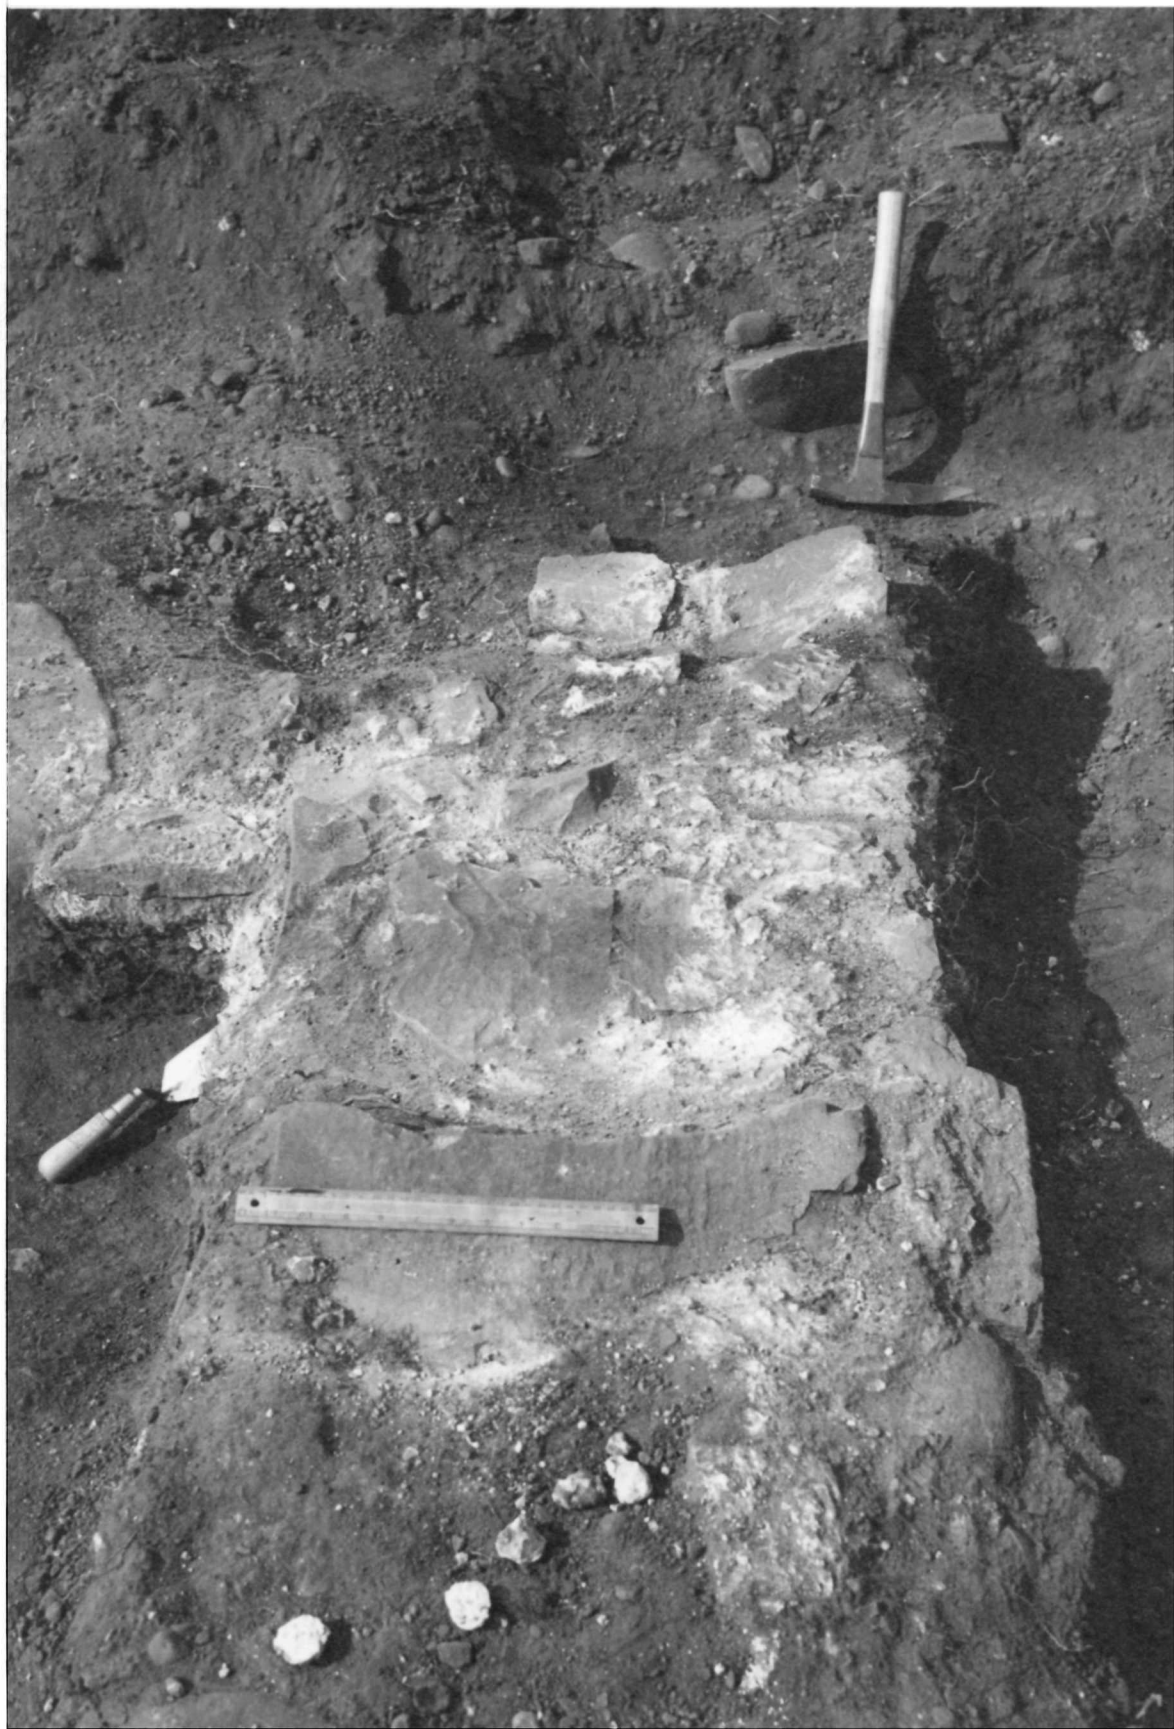
Northwest corner of powder magazine.

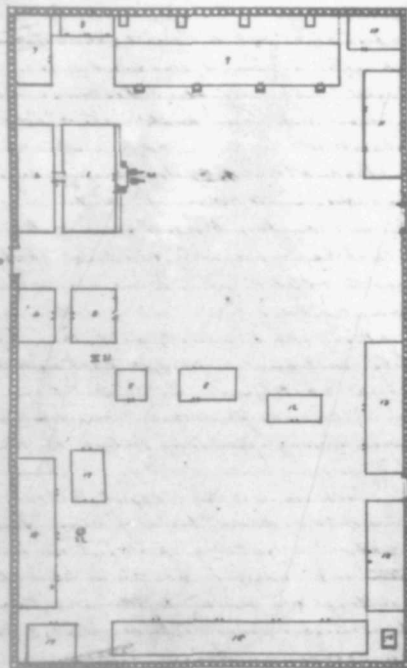
July 25<sup>th</sup> 1841. Land

sketch of the Co. fort and add a few facts in connection with a Diagram which will convey some idea of its plan & importance although I do not vouch for its being correct in every particular.

The earliest map used was that of Lieutenant George F. Emmons, a member of the U. S. Exploring Expedition of 1841, under the command of Commander Charles Wilkes. The rough diagram found in his journal 3/ gives the approximate size (700 x 400 feet) and layout of the stockade. Several particularly interesting details were noted by Lieutenant Emmons. At that time there was no bastion in the northwest corner, and the stockade posts were from eight to ten inches in diameter, 20 feet long, and buried from two to three feet in the ground. His small sketch showing the construction of a portion of the wall is both valuable and interesting (Plate 8 ).

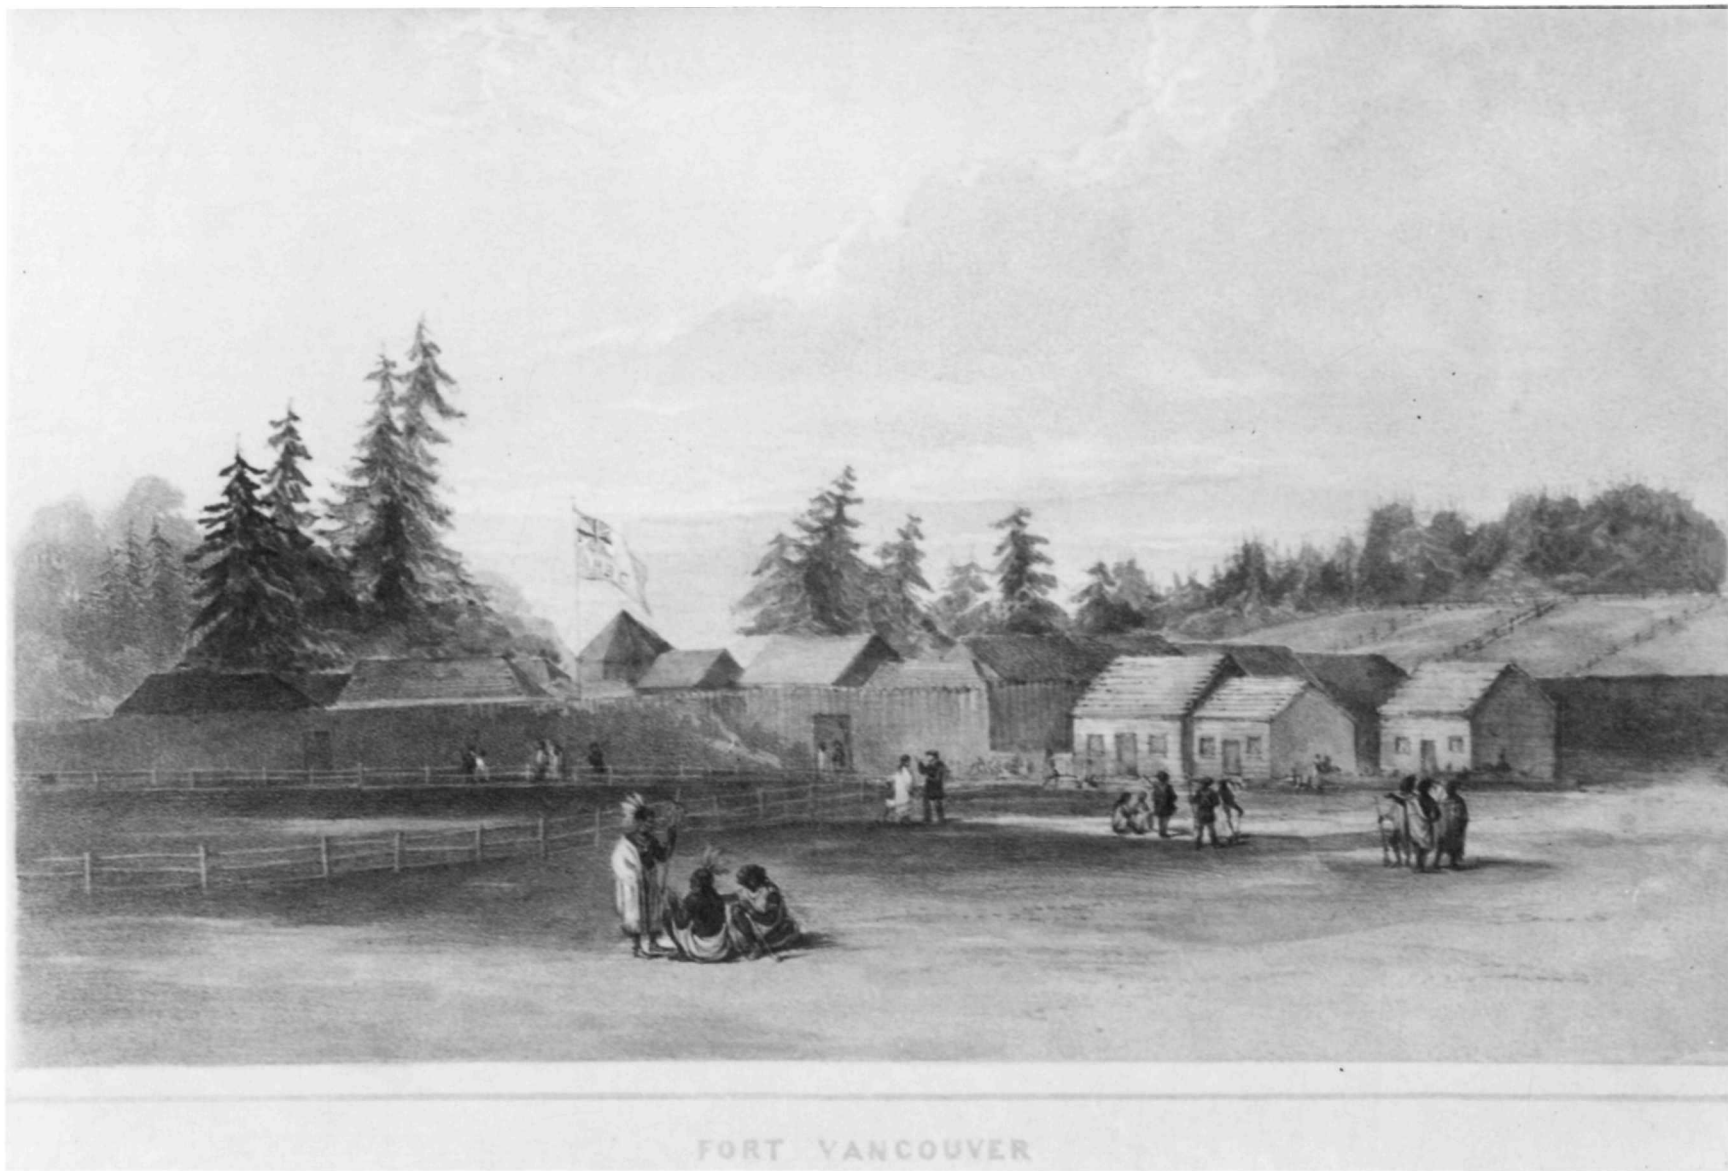
Warre drawing of the southeast corner of Fort Vancouver in 1845.

hand corner of this map is a scale plan of Fort Vancouver. The plan shows all of the buildings within the fort and the bastion on the northwest corner. According to the scale the size of the stockade was about 320 x 690 feet. Lieutenant Warre completed some fine colored drawings of scenes and forts of the Pacific Northwest of which the one of Fort Vancouver from the southeast (Plate 9) is most valuable.

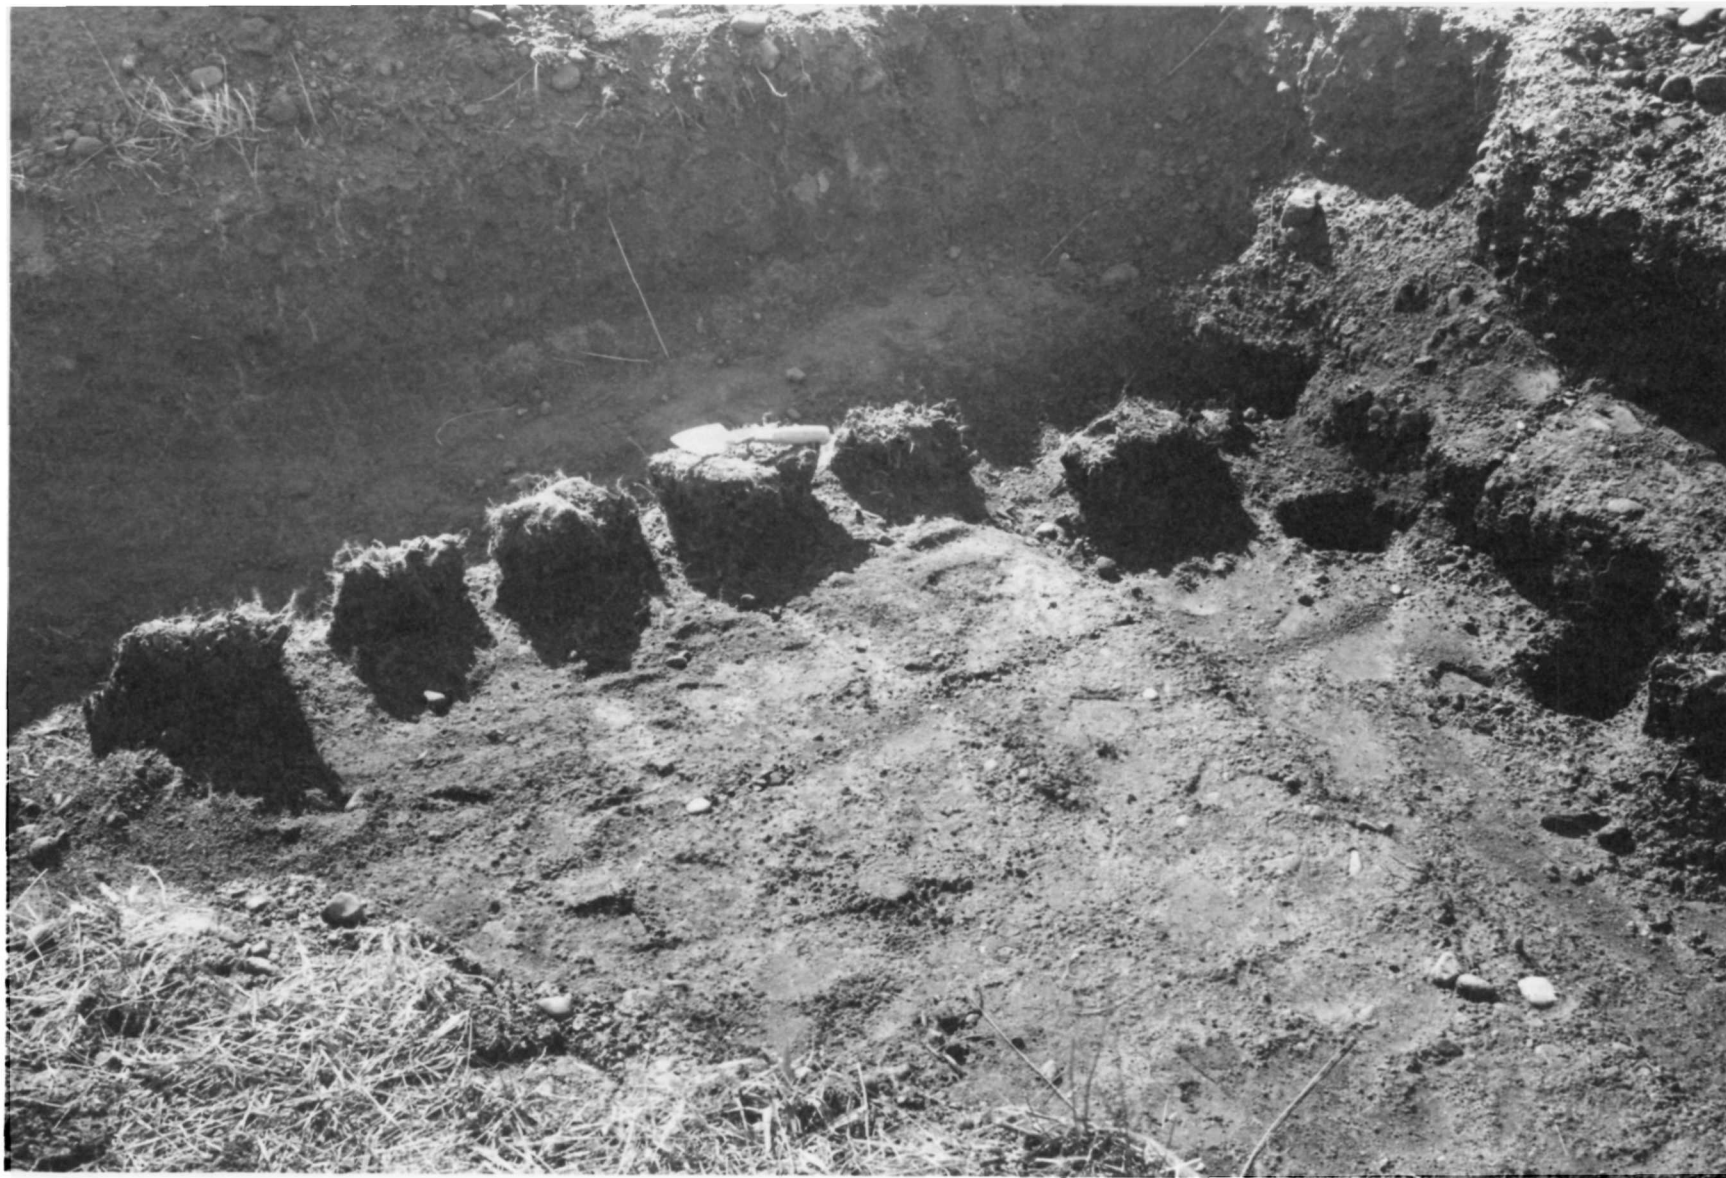
Plate 11

The southwest corner of the stockade. The posts were very rotten and some had entirely disappeared.

Work was again started in the southwest corner area. The corner was soon discovered and the west and south walls traced out far enough to determine their direction. The stockade posts in this area were badly rotted. Only occasionally was there evidence of charcoal. In one test trench on the south wall, 285 feet from the southwest corner, well preserved posts were found with charred tops about 12" below the surface.

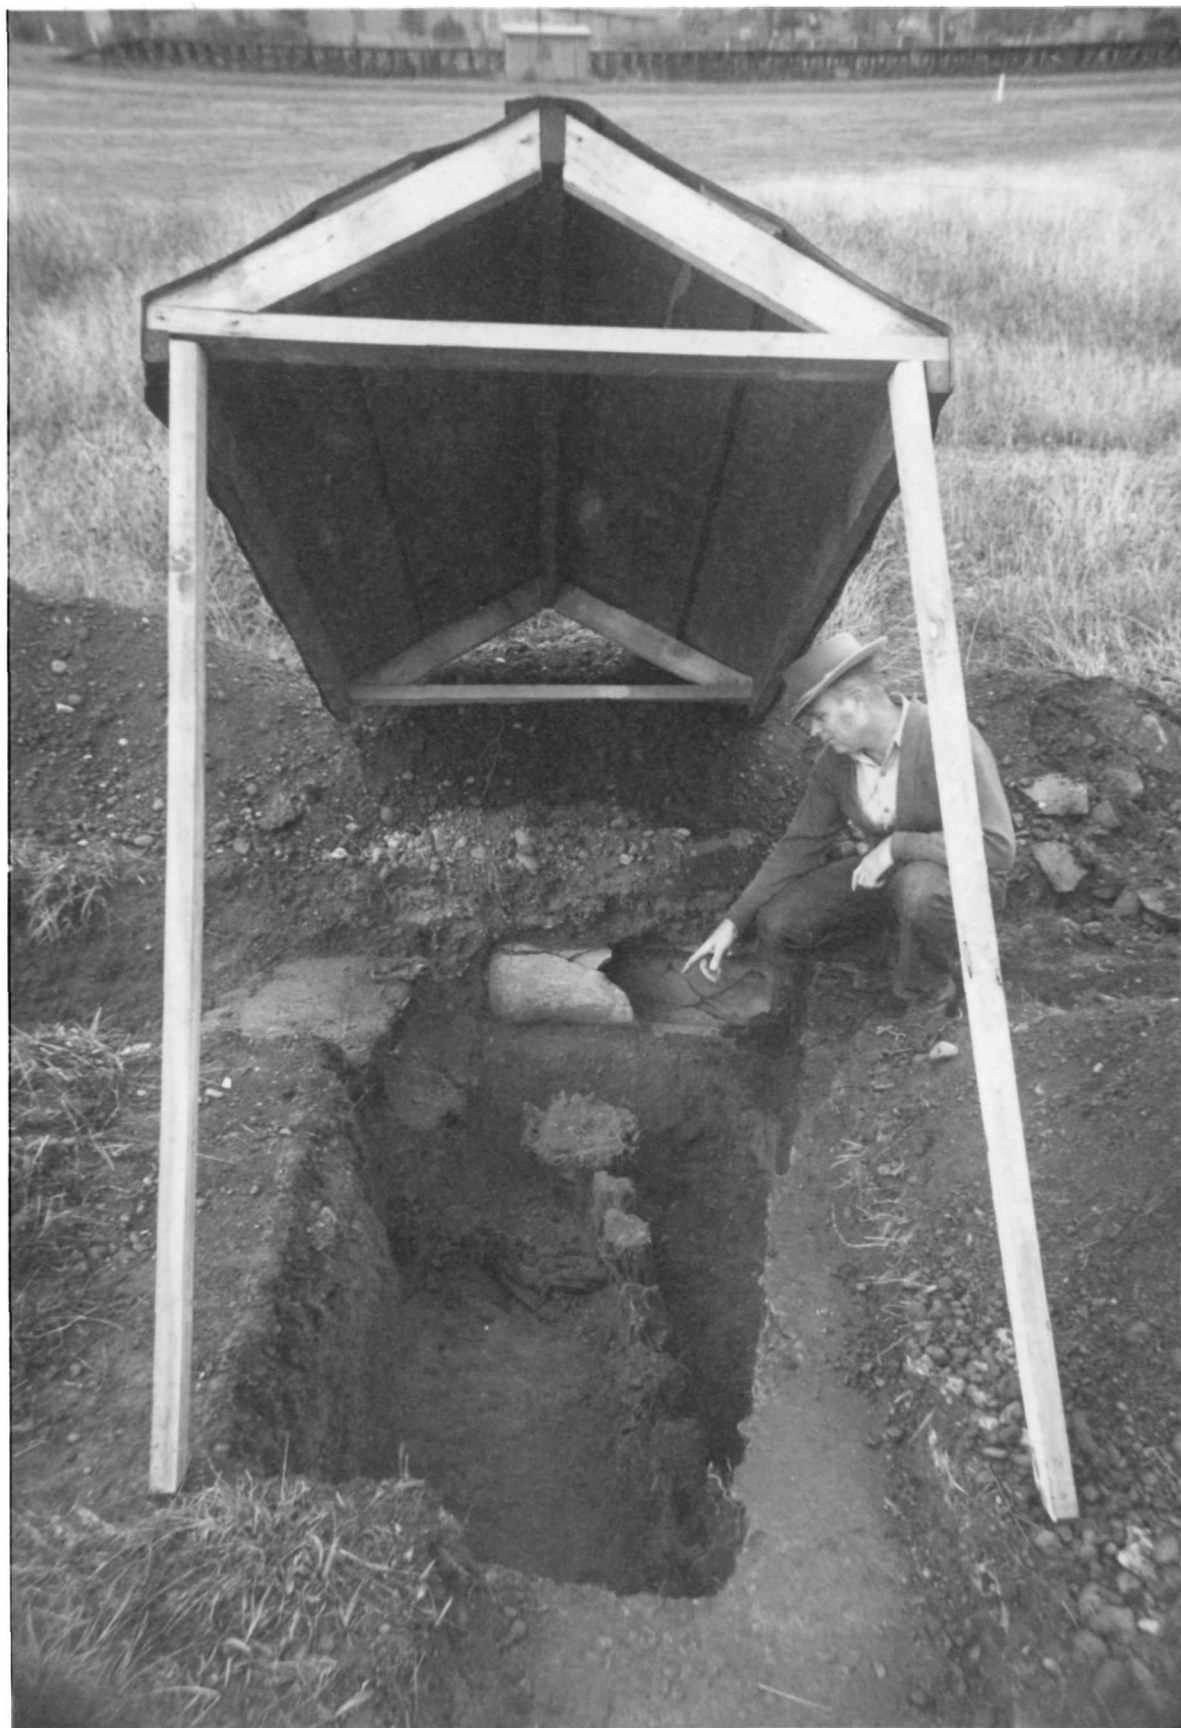
Tile and cement flooring almost destroyed the northeast corner.

Excavation was next started in the northeast area to locate the northeast corner. A double row of stockade posts was found here. This area was badly disturbed by the burial of huge blocks of reinforced concrete. This extraneous material had been placed in a hole which was deeper than the depth of the posts, thereby destroying all evidence of the stockade wall. To further hinder matters some of the concrete blocks were too heavy for our small crew to remove. The area of this excavation was about 687 feet from the northwest corner, the length of the north wall according to the Vavasour map. Excavation in this vicinity finally revealed among the broken blocks of concrete and bars of reinforcing iron a row of posts going toward the south. The corner post was gone, as well as others in the nearby area. Thinking that this was the northeast corner, a test was made to the south at 128 feet from the corner, on the line of the supposed east wall. Here a line of posts was soon found, seeming to verify the finding of the northeast corner and east stockade wall.

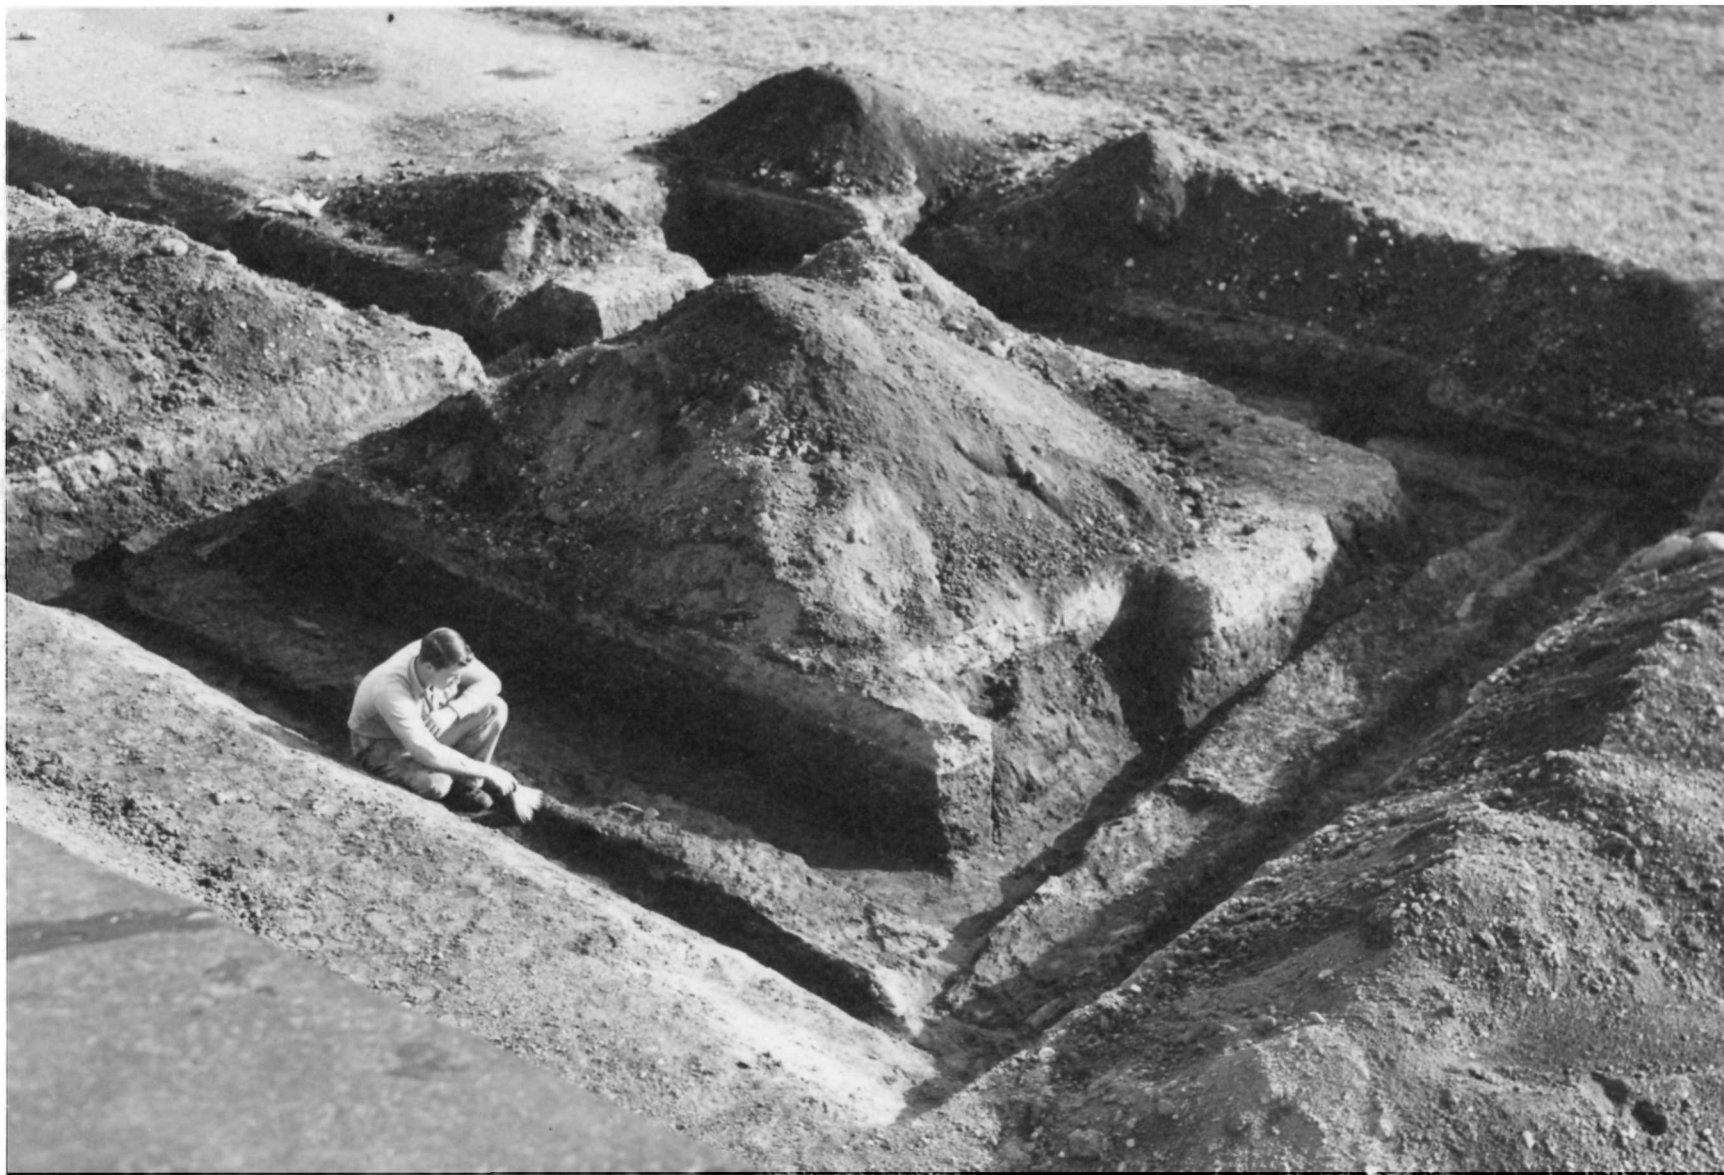
Foundation timbers of the bastion uncovered.  
These were all badly burned except those on the east wall.

Three sides of the bastion foundation showed evidence of conflagration. Only the west wall was unburned. The timbers were of eight inch square Douglas fir. The heat from the fire had been so intense that even the earth was burned to a ruddy brown. Over these charred timbers was a deposit of from four to five inches of fine ash with hardly a trace of charcoal, adding to the proof of the intense heat when the bastion was fired. The foundation timbers of the west wall, which had not burned, probably because of moisture in the ground, were so badly rotted that very

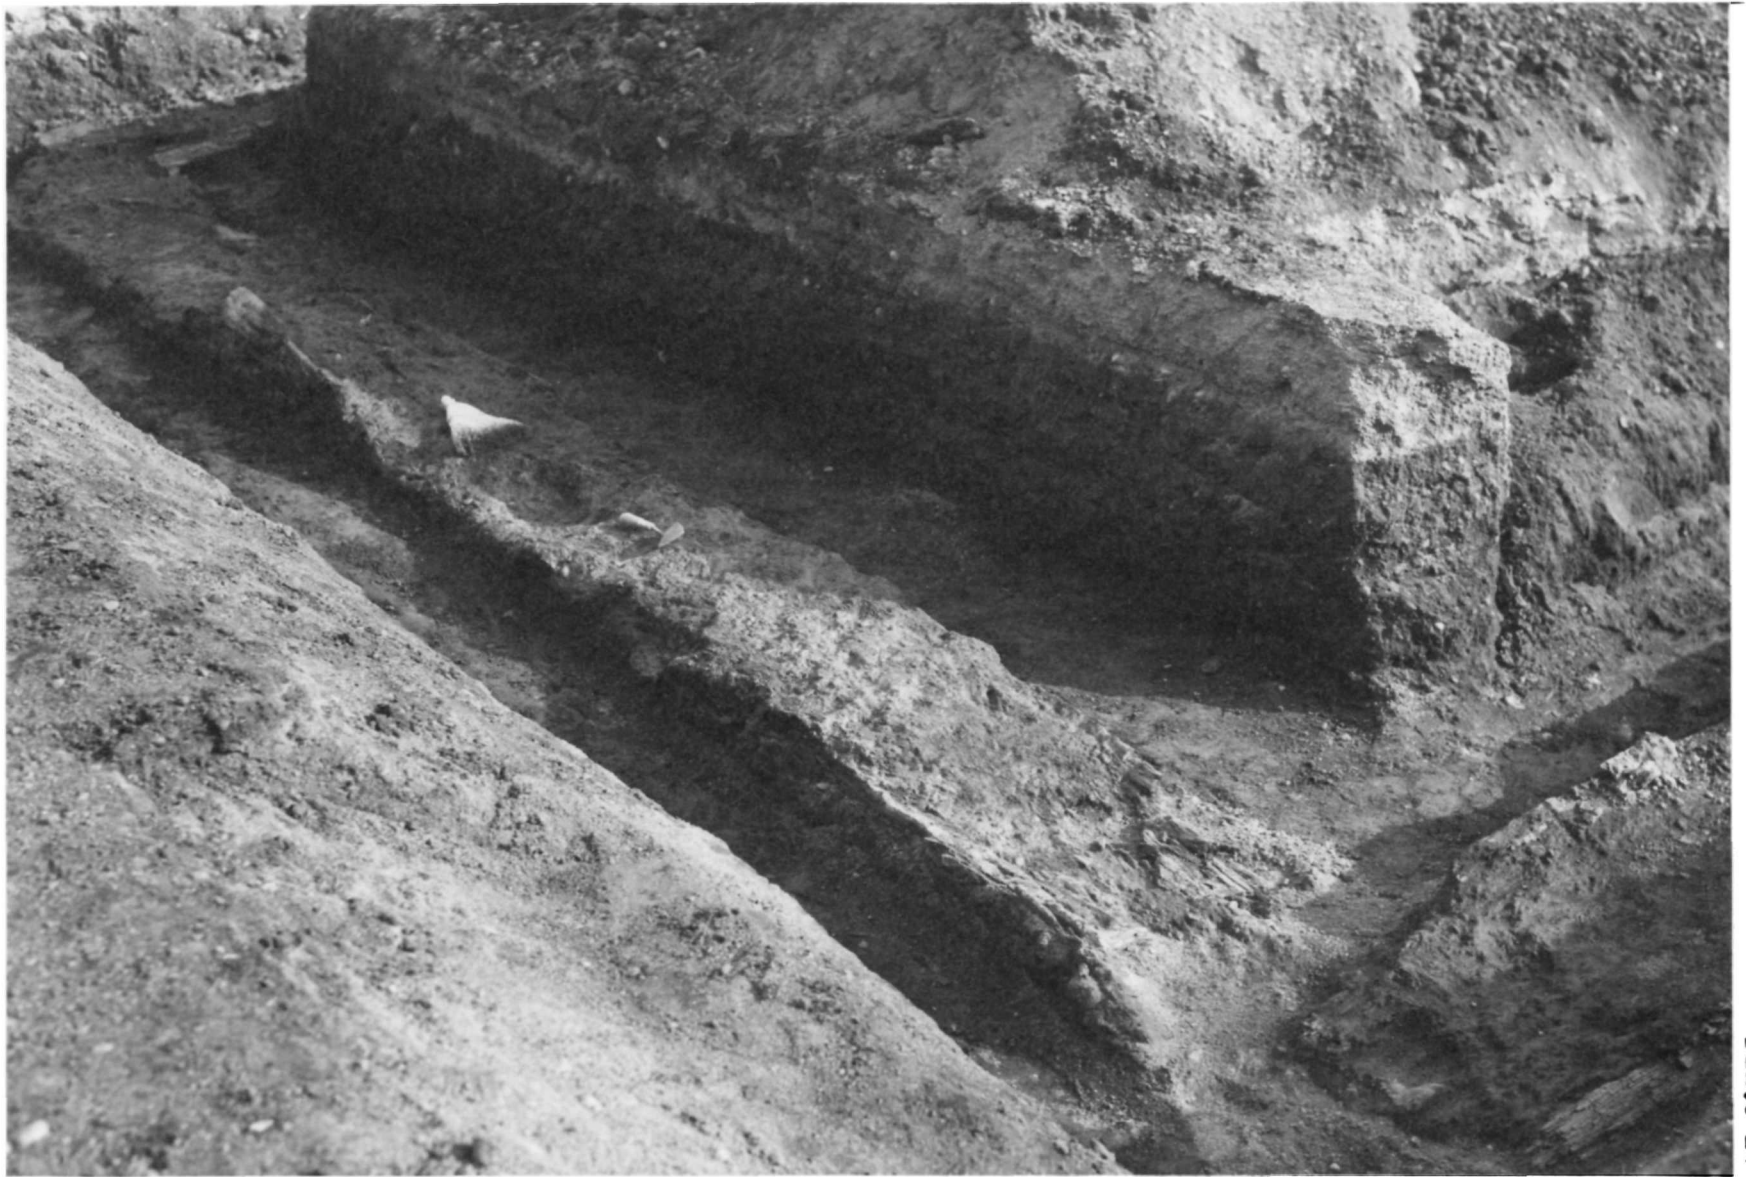
North wall of bastion showing the charred remains of foundation timbers.

According to Lieutenant Vavasour's report of 1845 and 1846, "The bastion of the northwest corner was twenty feet square, the two lower stories are loop-holed and the top story is an octagonal cap containing eight three pound iron guns. . " 7/ Measurements of the foundation of the bastion show overall dimensions of twenty feet six inches on each side. The eight inch square timbers which formed the foundation of the bastion, undoubtedly moved outward a few inches from pressure and perhaps from buckling during the fire. The distance between the parallel timbers varied from one to five inches. (Plates 4 and 13)

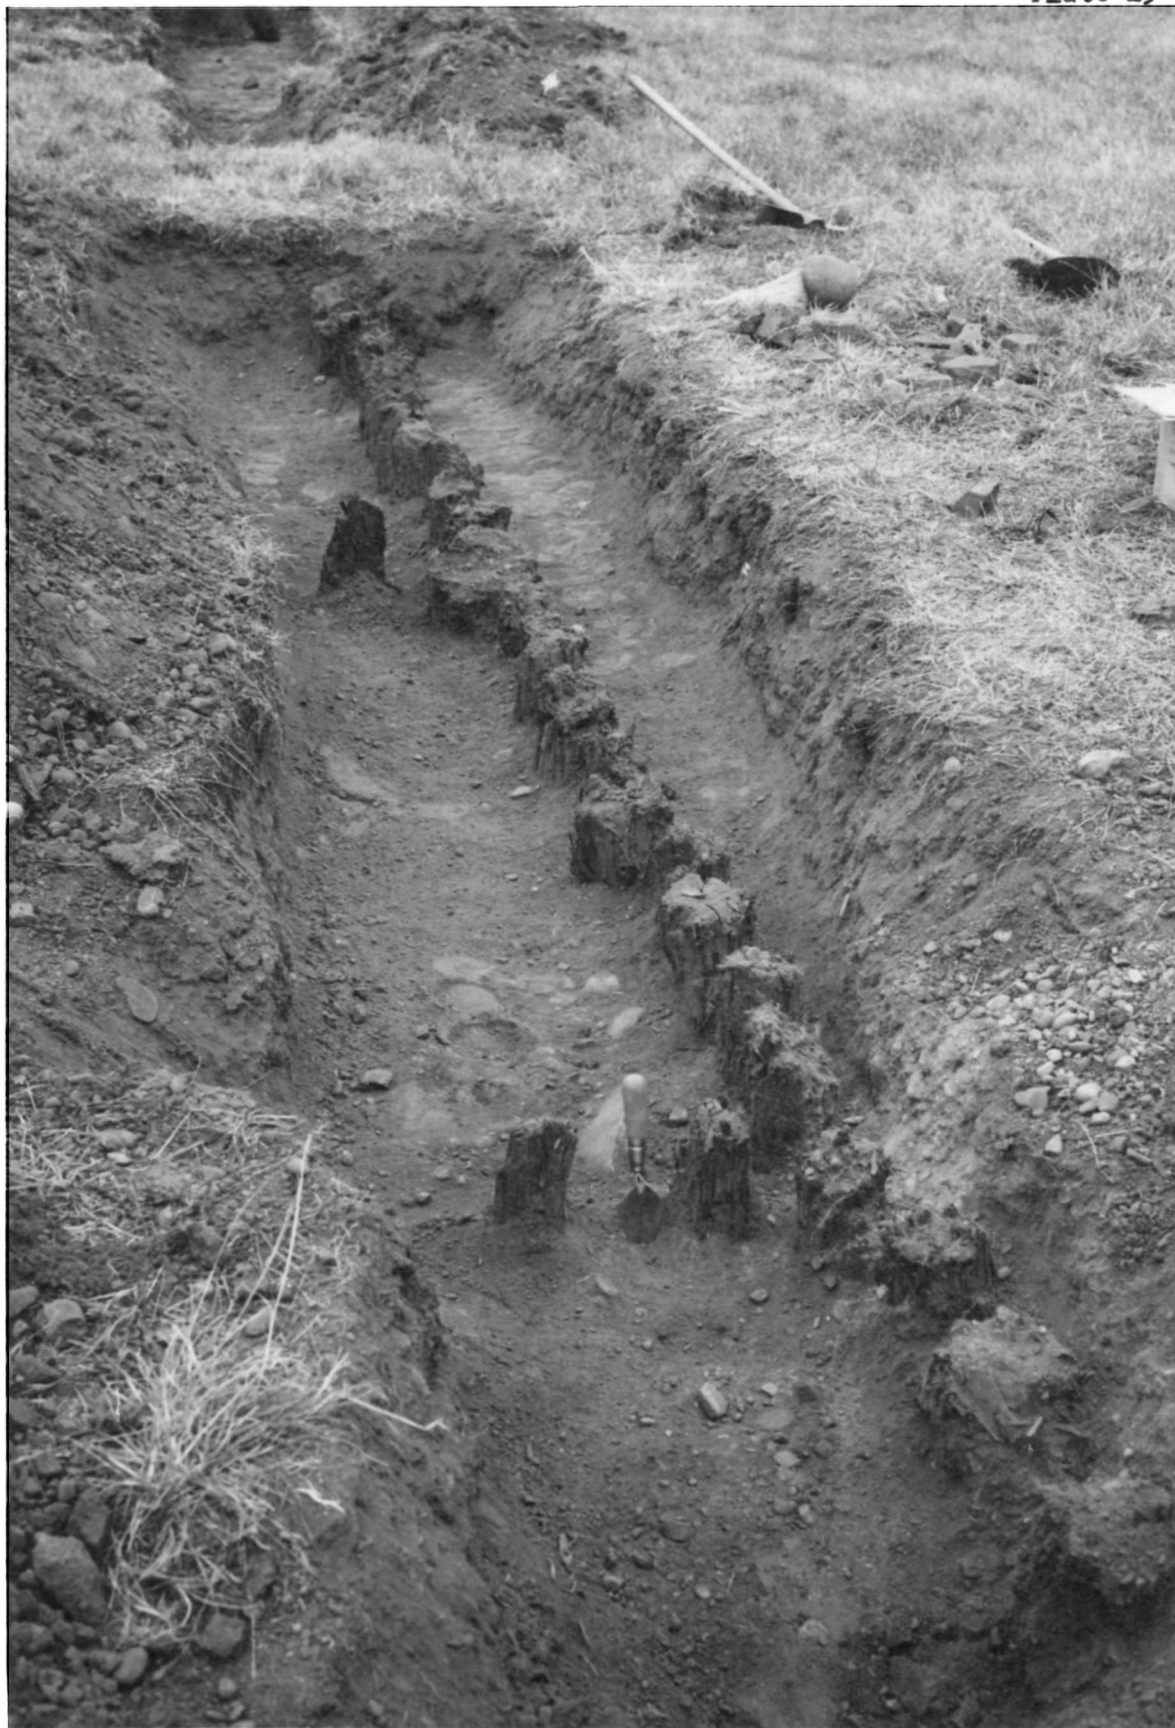
Well preserved stockade posts along south wall.
