EXPLORATORY EXCAVATIONS  
AT  
FORT VANCOUVER

VANCOUVER, WASHINGTON

1947

Louis R. Caywood  
Archeologist

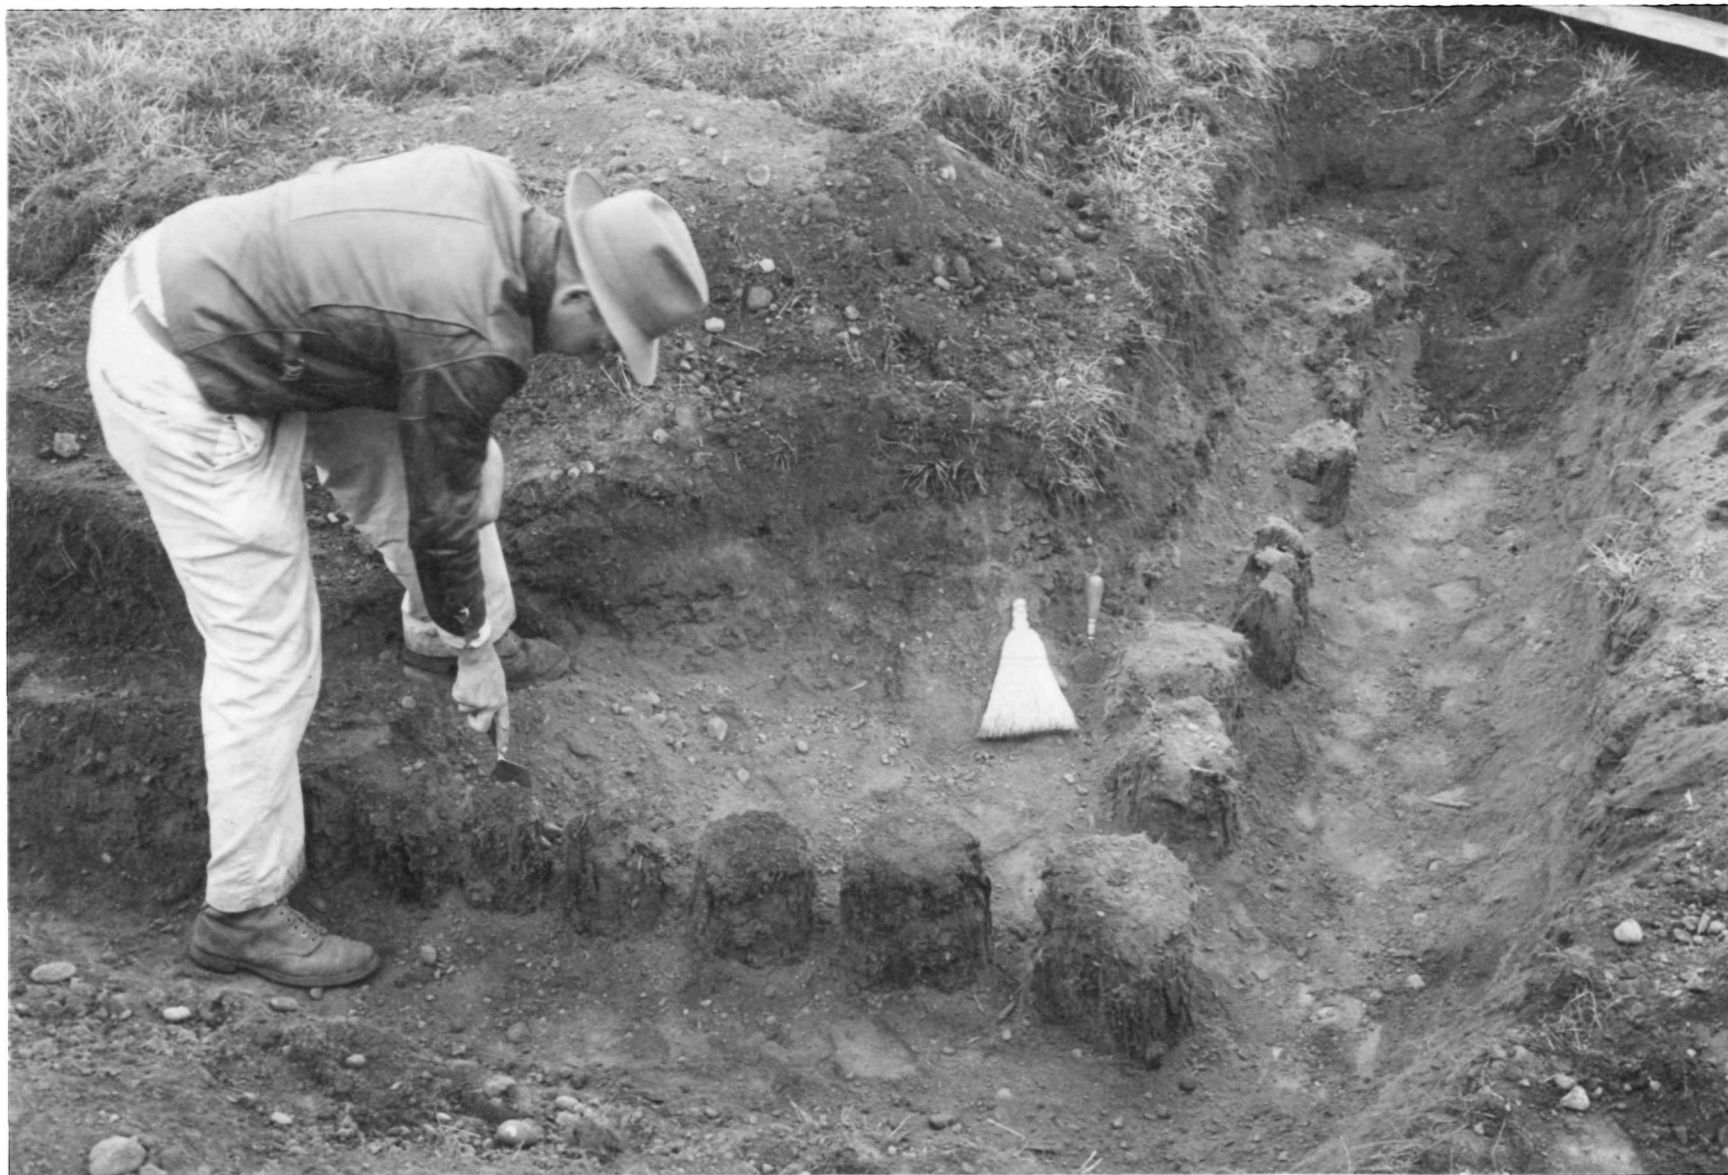
Plate 16

Custodian Tom Garth from Whitman National Monument cleaning earth away from posts in southeast corner of stockade.

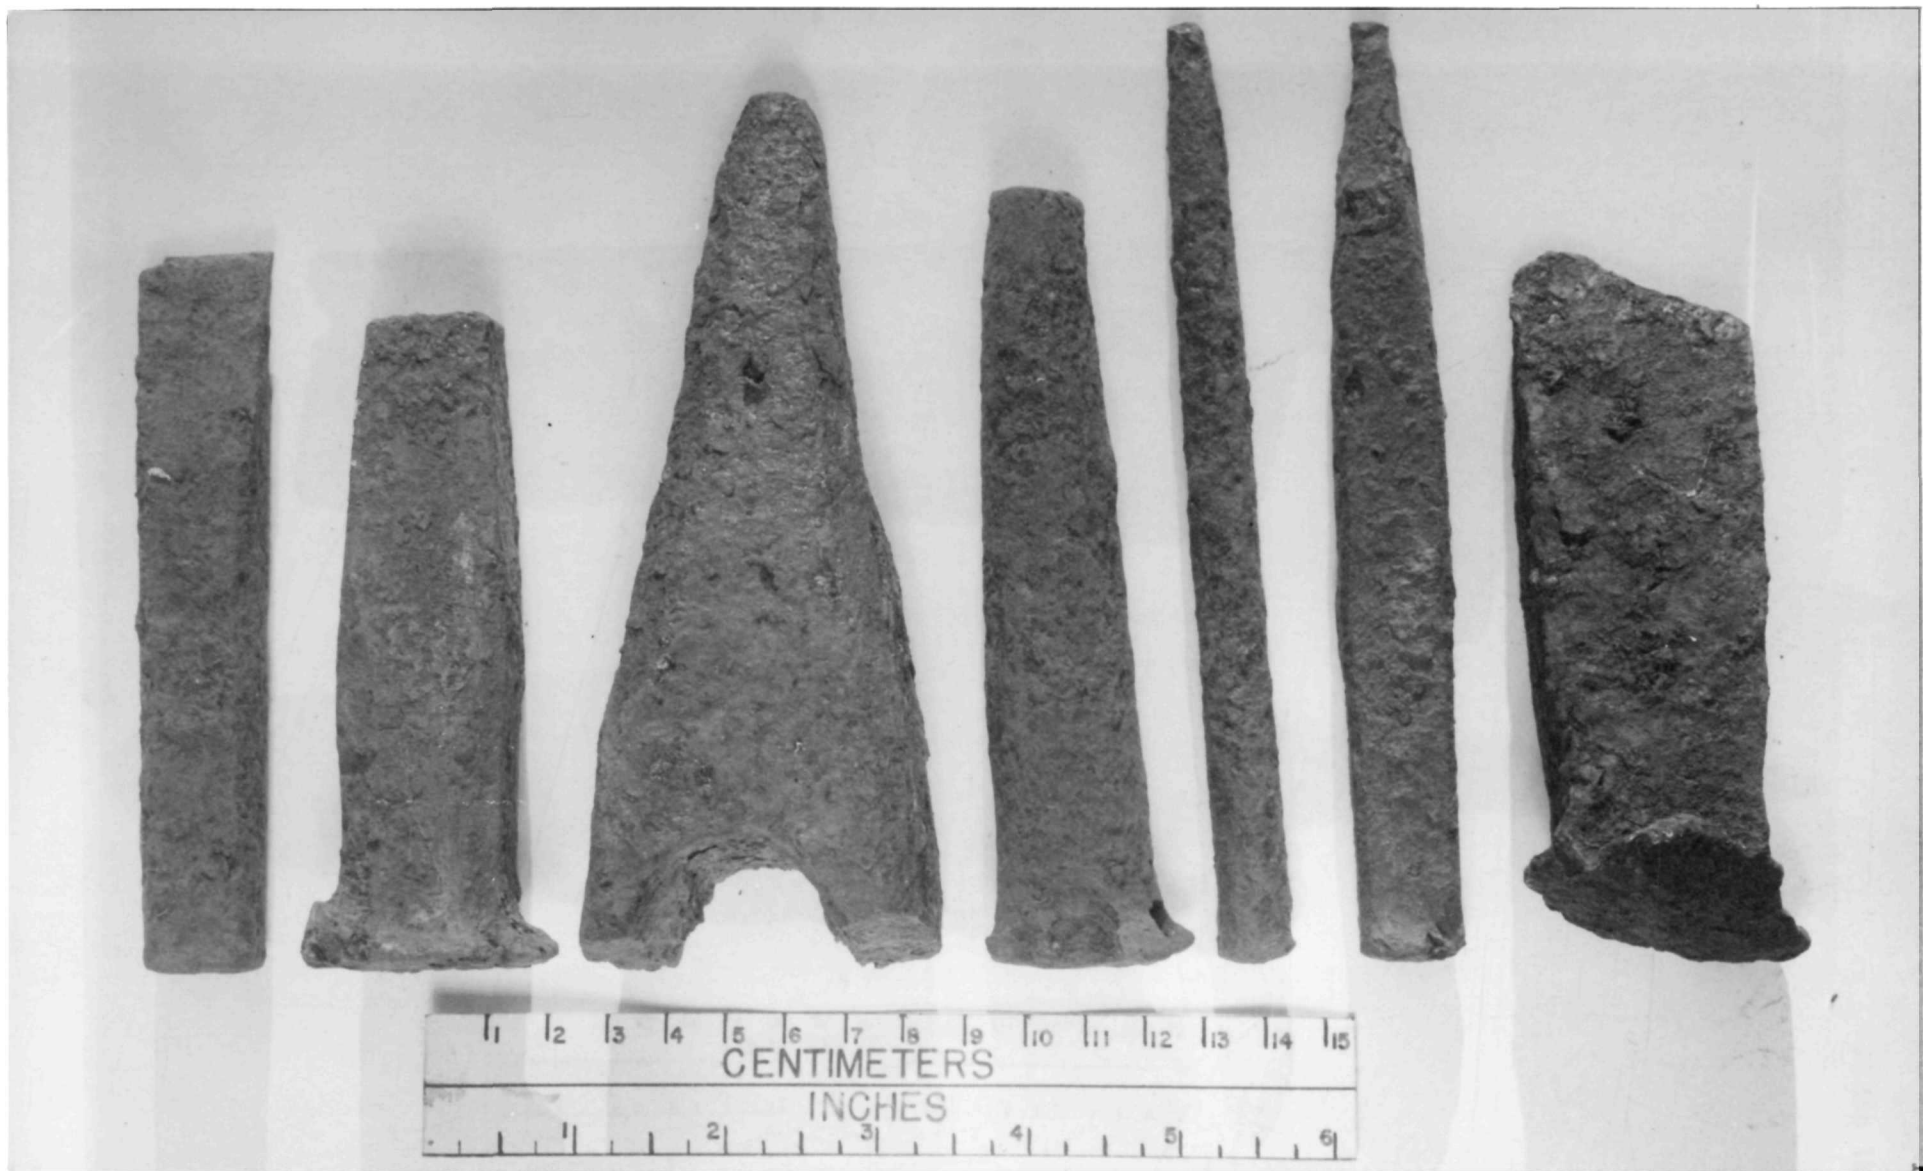
Broken blacksmith tools unearthed in southeast corner of stockade.

All iron tools found during the excavation were broken or worn out. The blacksmith tongs consisted of parts of eleven pairs. A total of eight punches and chisels which had been used in connection with the blacksmith work were uncovered. Although these tools have been buried in the damp ground for almost one hundred years, they are still in a remarkably good state of preservation. (Plate 17)

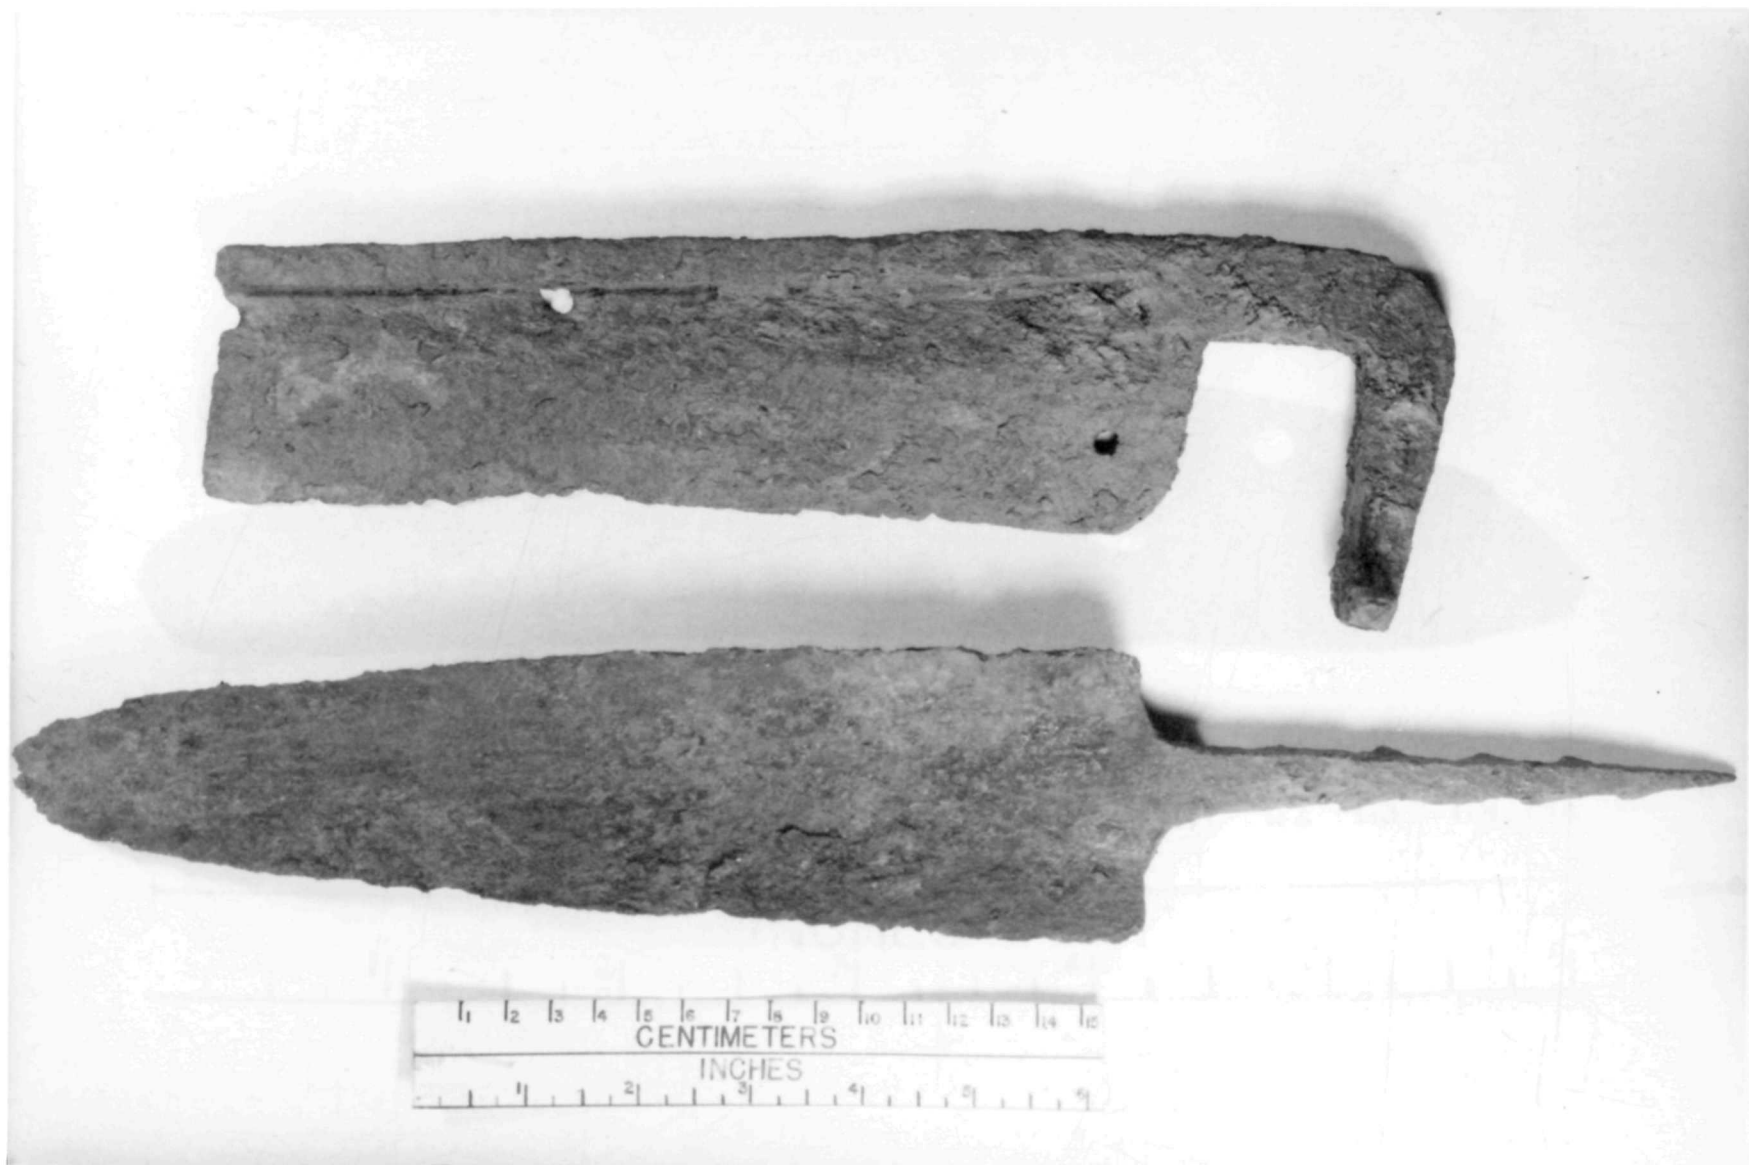
Upper. Broken scythe.

Lower. Handmade trowel with serrated handle.

One well-made hand trowel was uncovered which measured fifteen inches in total length. The blade was curved and measured ten inches long by two and one-half inches wide and the shank was serrated to take a wooden handle. (Plate 18) A section of scythe blade was found (Plate 18) which measured eleven inches long by two and one-half inches wide.

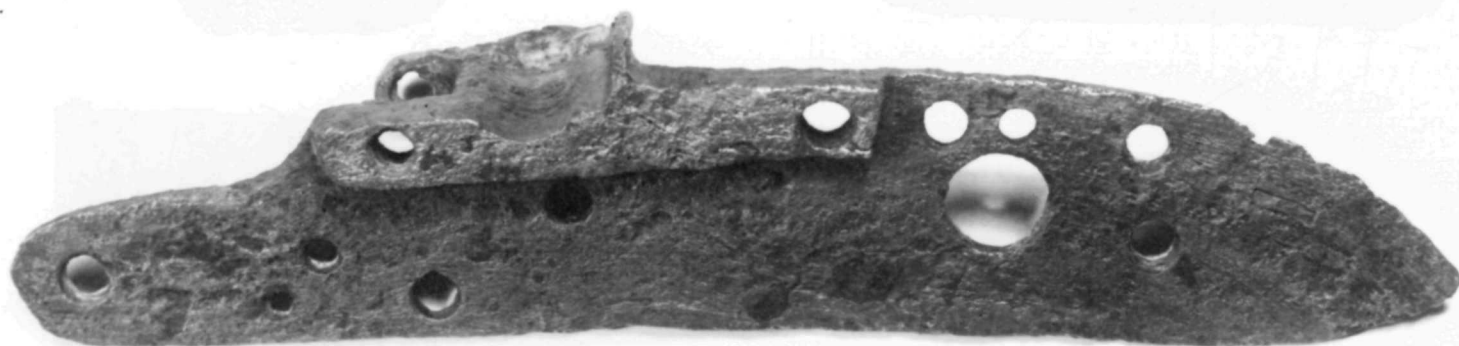
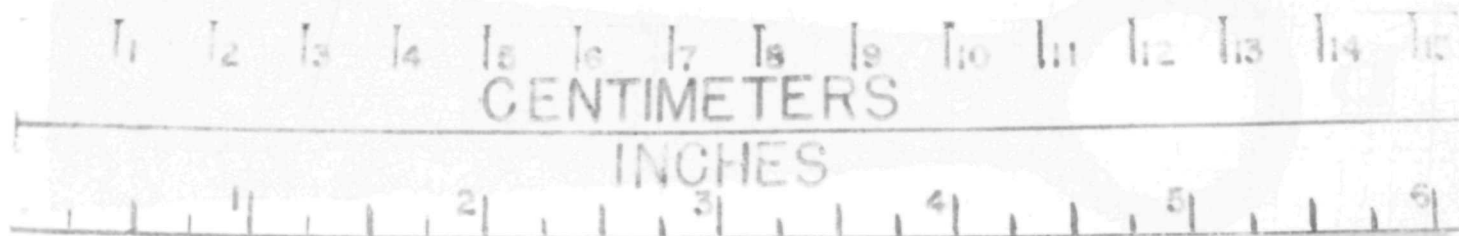
Gun lock and powder pan of 1843 Springfield flintlock rifle.

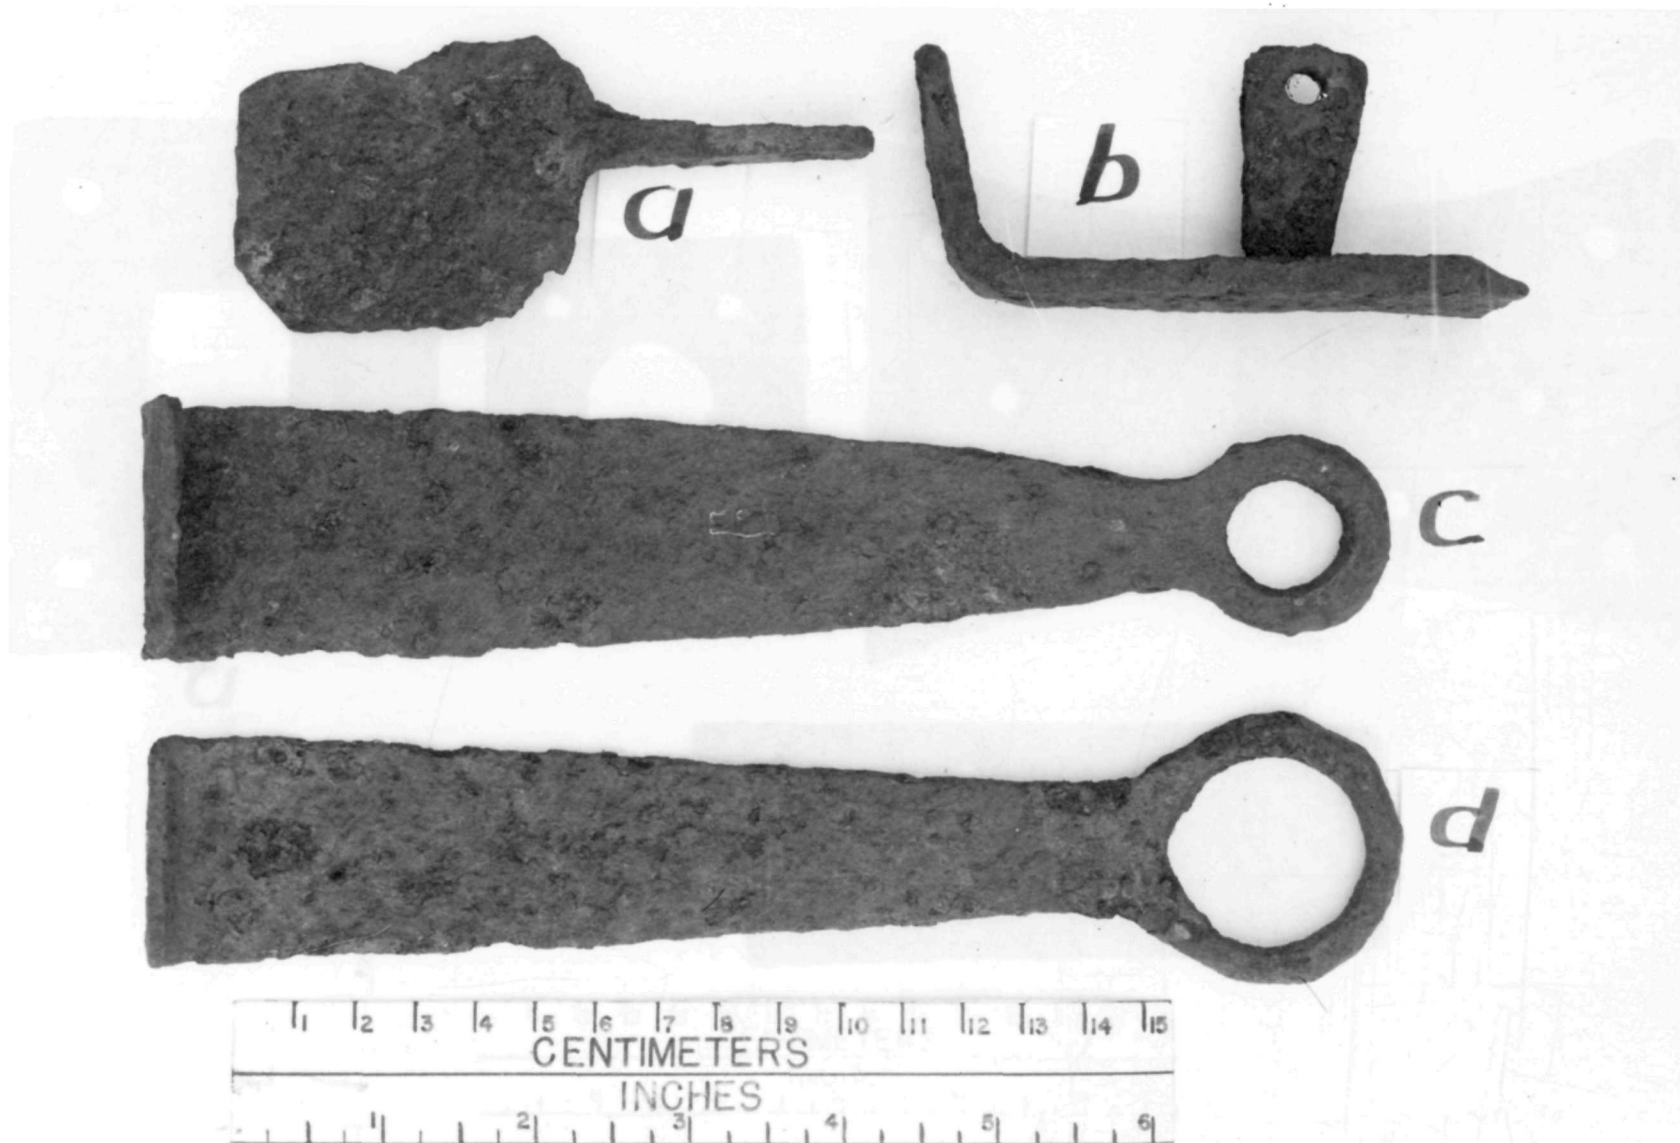
Beaver trap parts. a. Trigger pan. b. Portion in which jaw rested when trap was set.  
c and d. Broken springs.

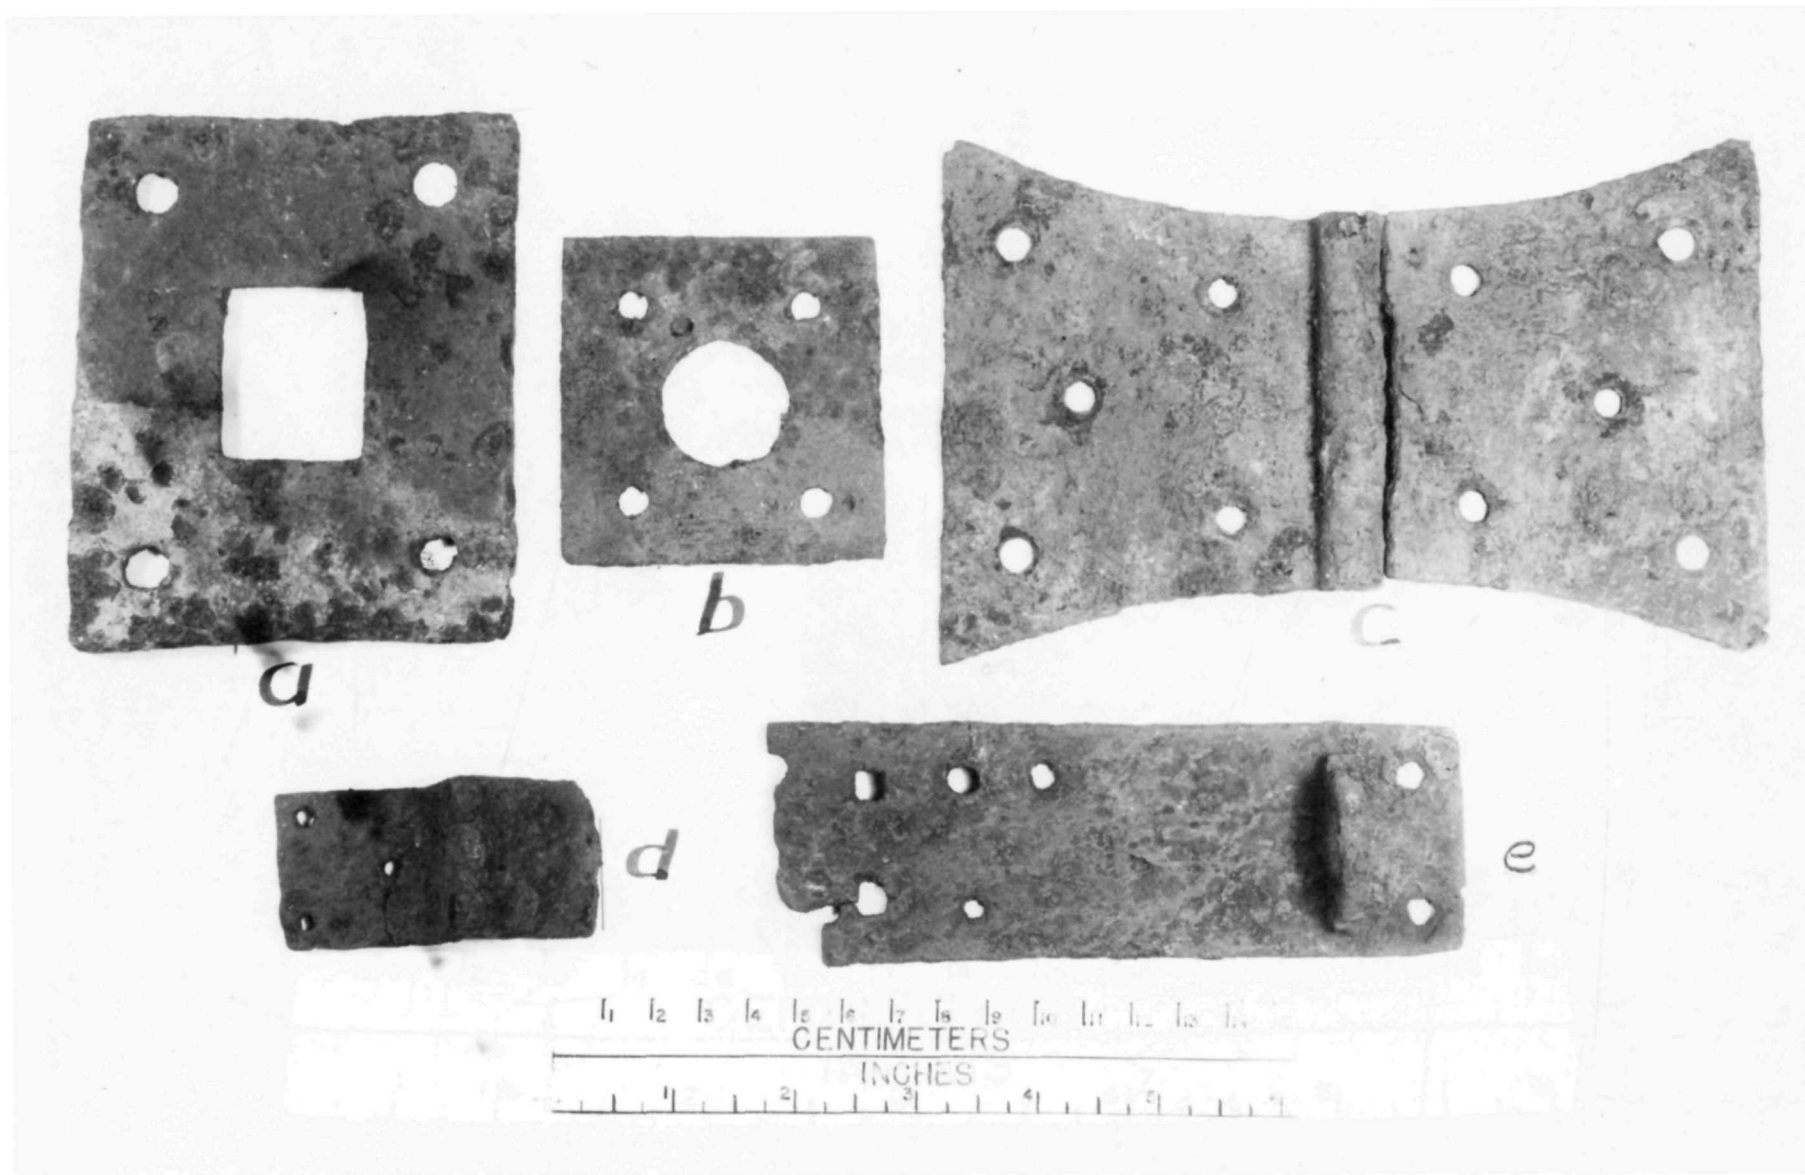
a and b. Door plates. c. Hinge found at bastion. d. Offset hinge. e. Hasp.

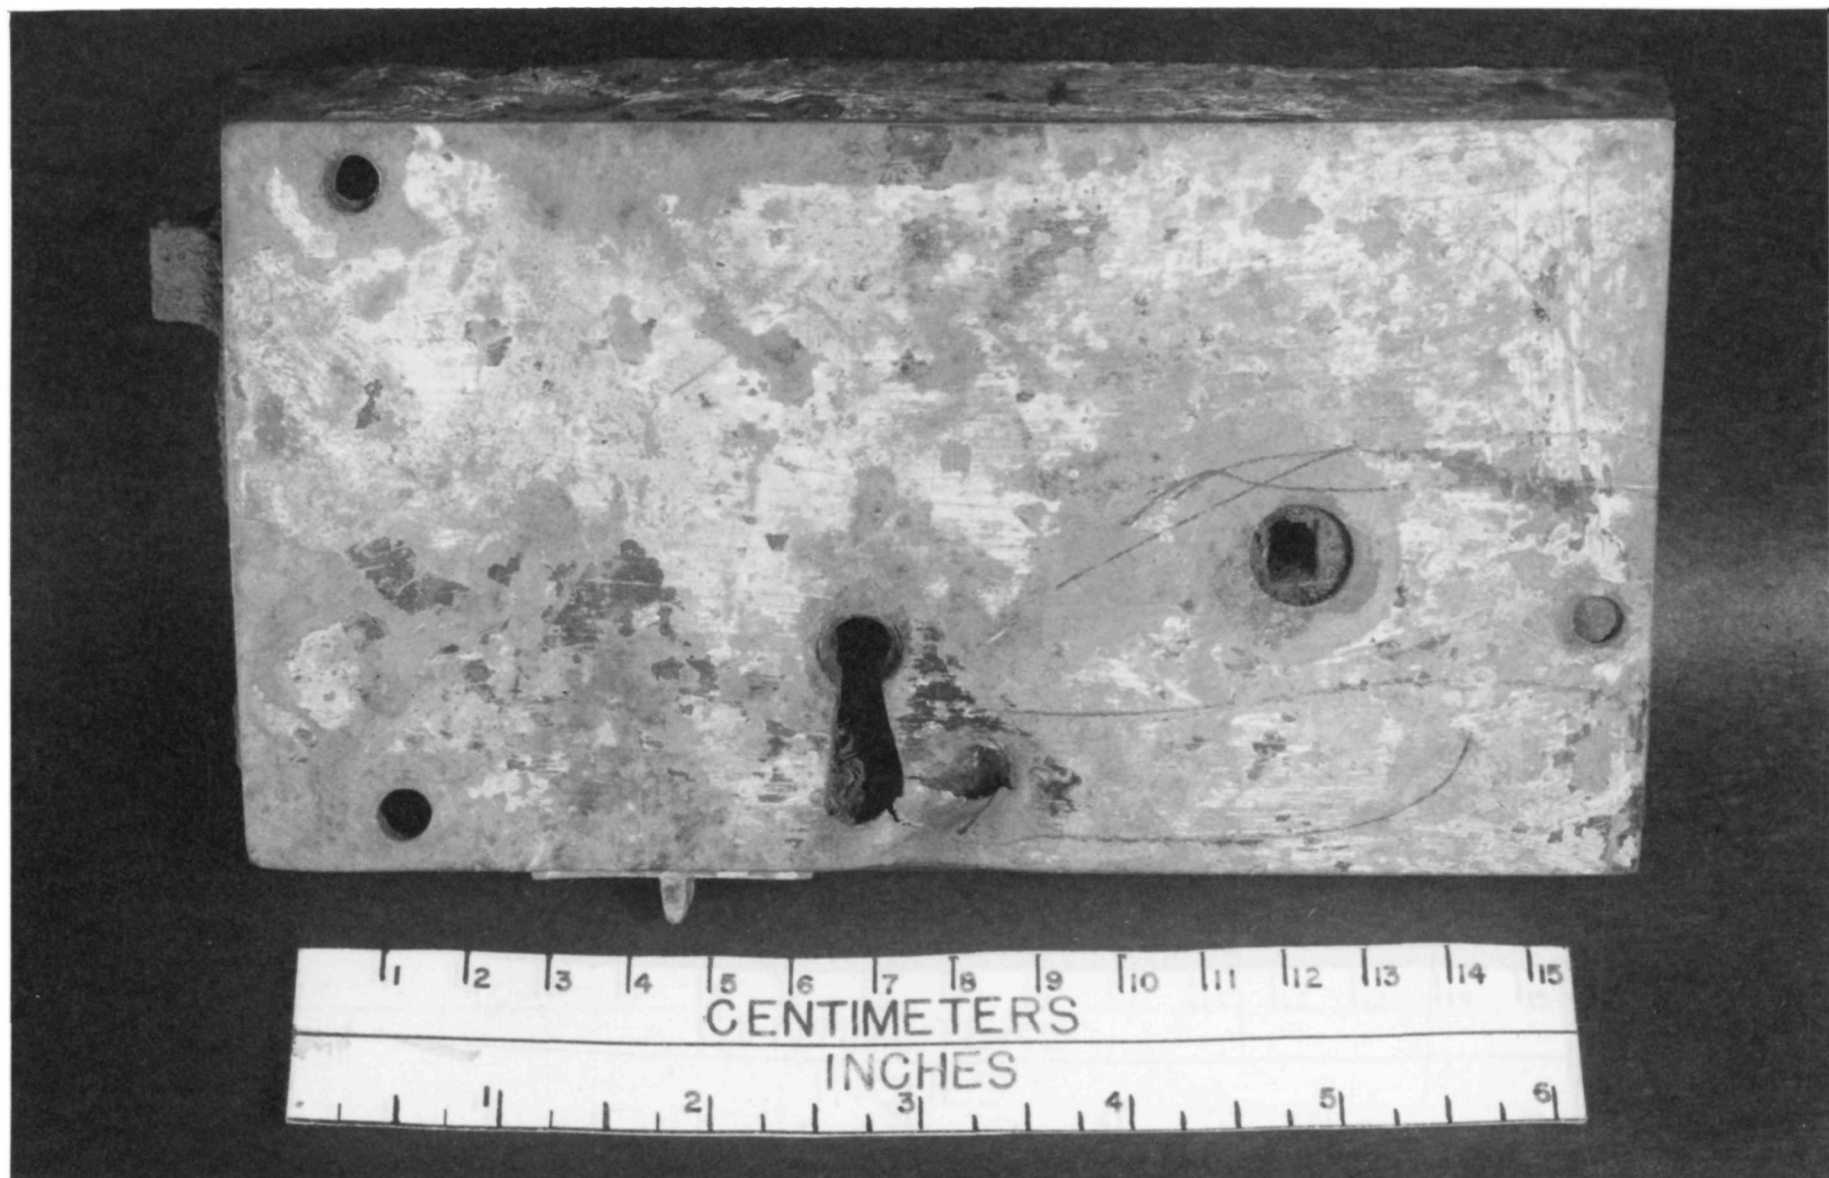
Brass door lock identical with those now on McLoughlin House at Oregon City.

The find which created the most interest was a brass door lock (Plates 22 and 23), uncovered in the northeast area. In its day it could have been part of the fixtures on the Chief Factor's house. Upon comparison with the brass locks on the McLoughlin House in Oregon City, it was found to be identical in shape and size. The locks now in use on the McLoughlin House were originally on the Barclay House.

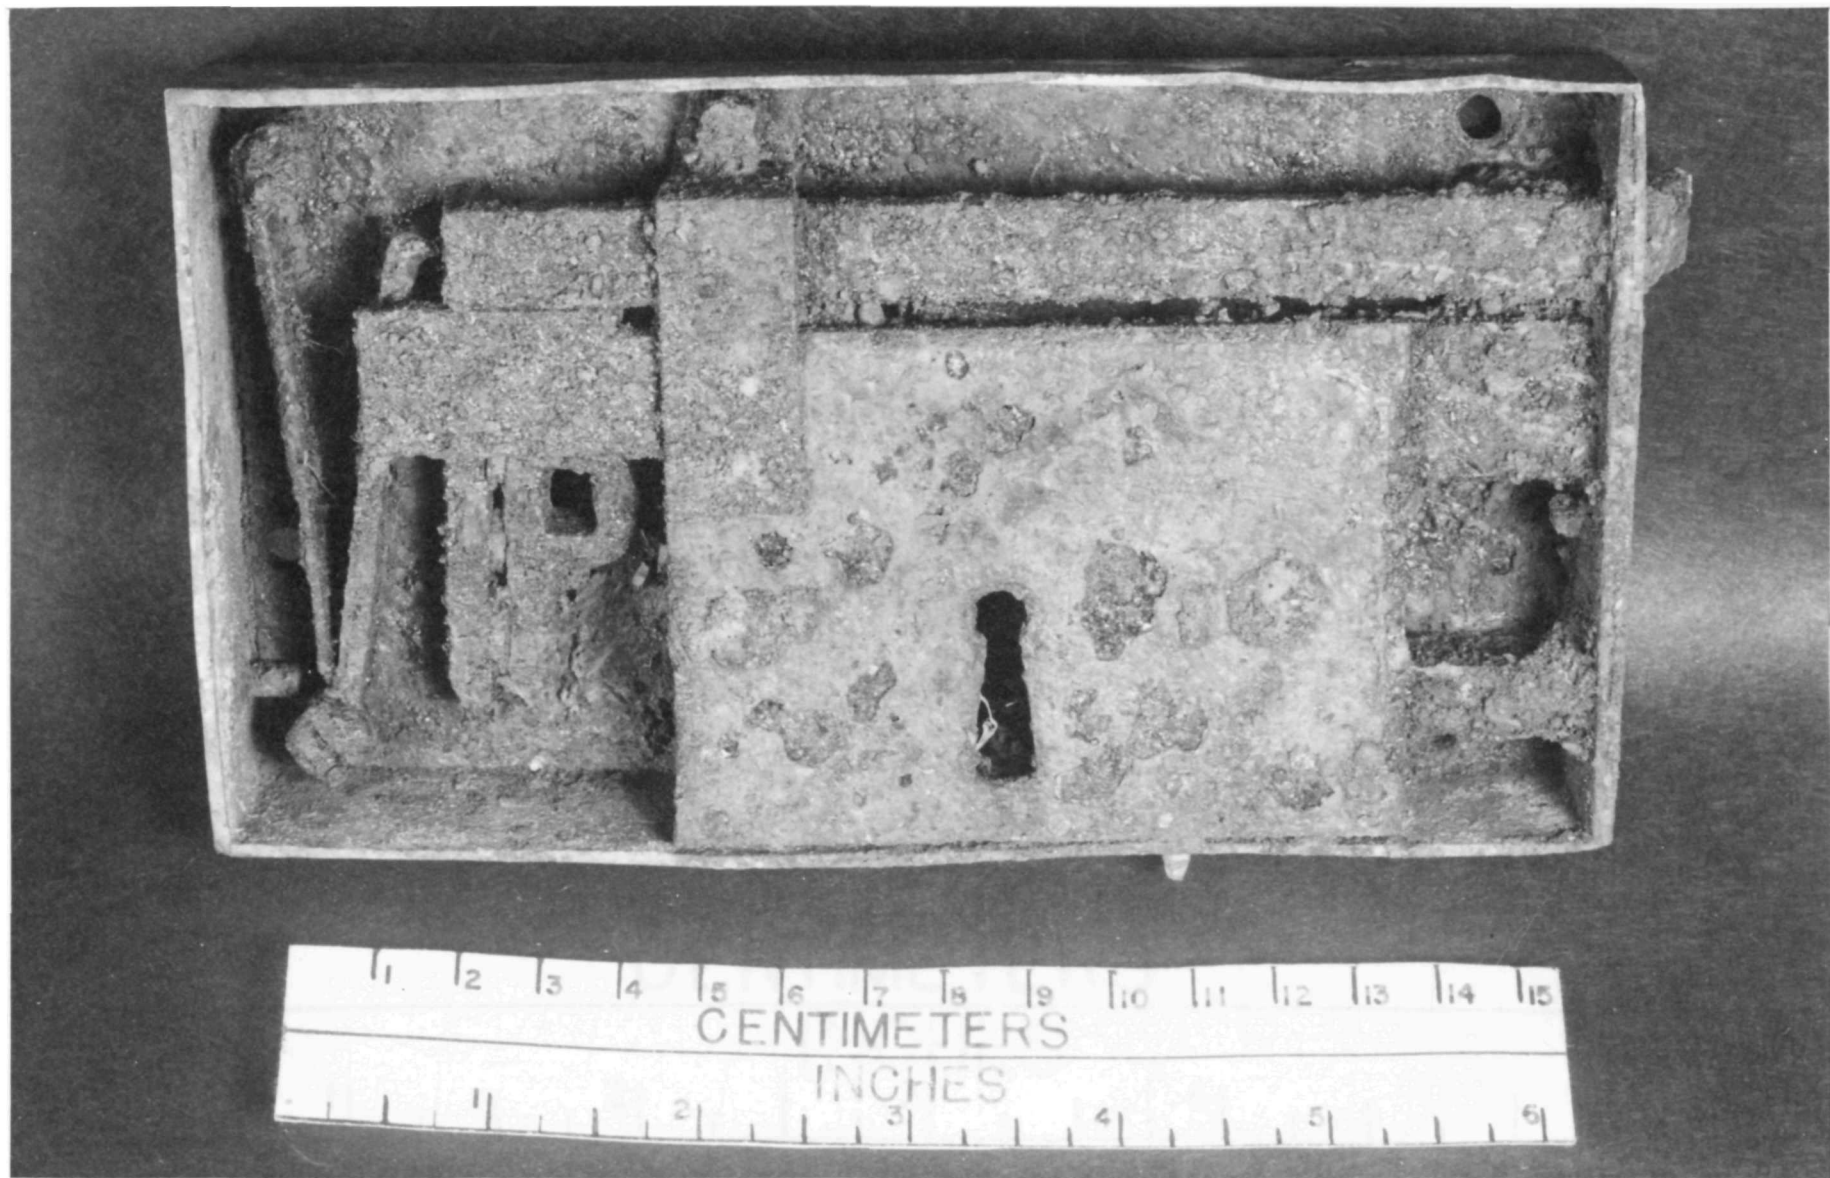
Reverse side of brass door lock.

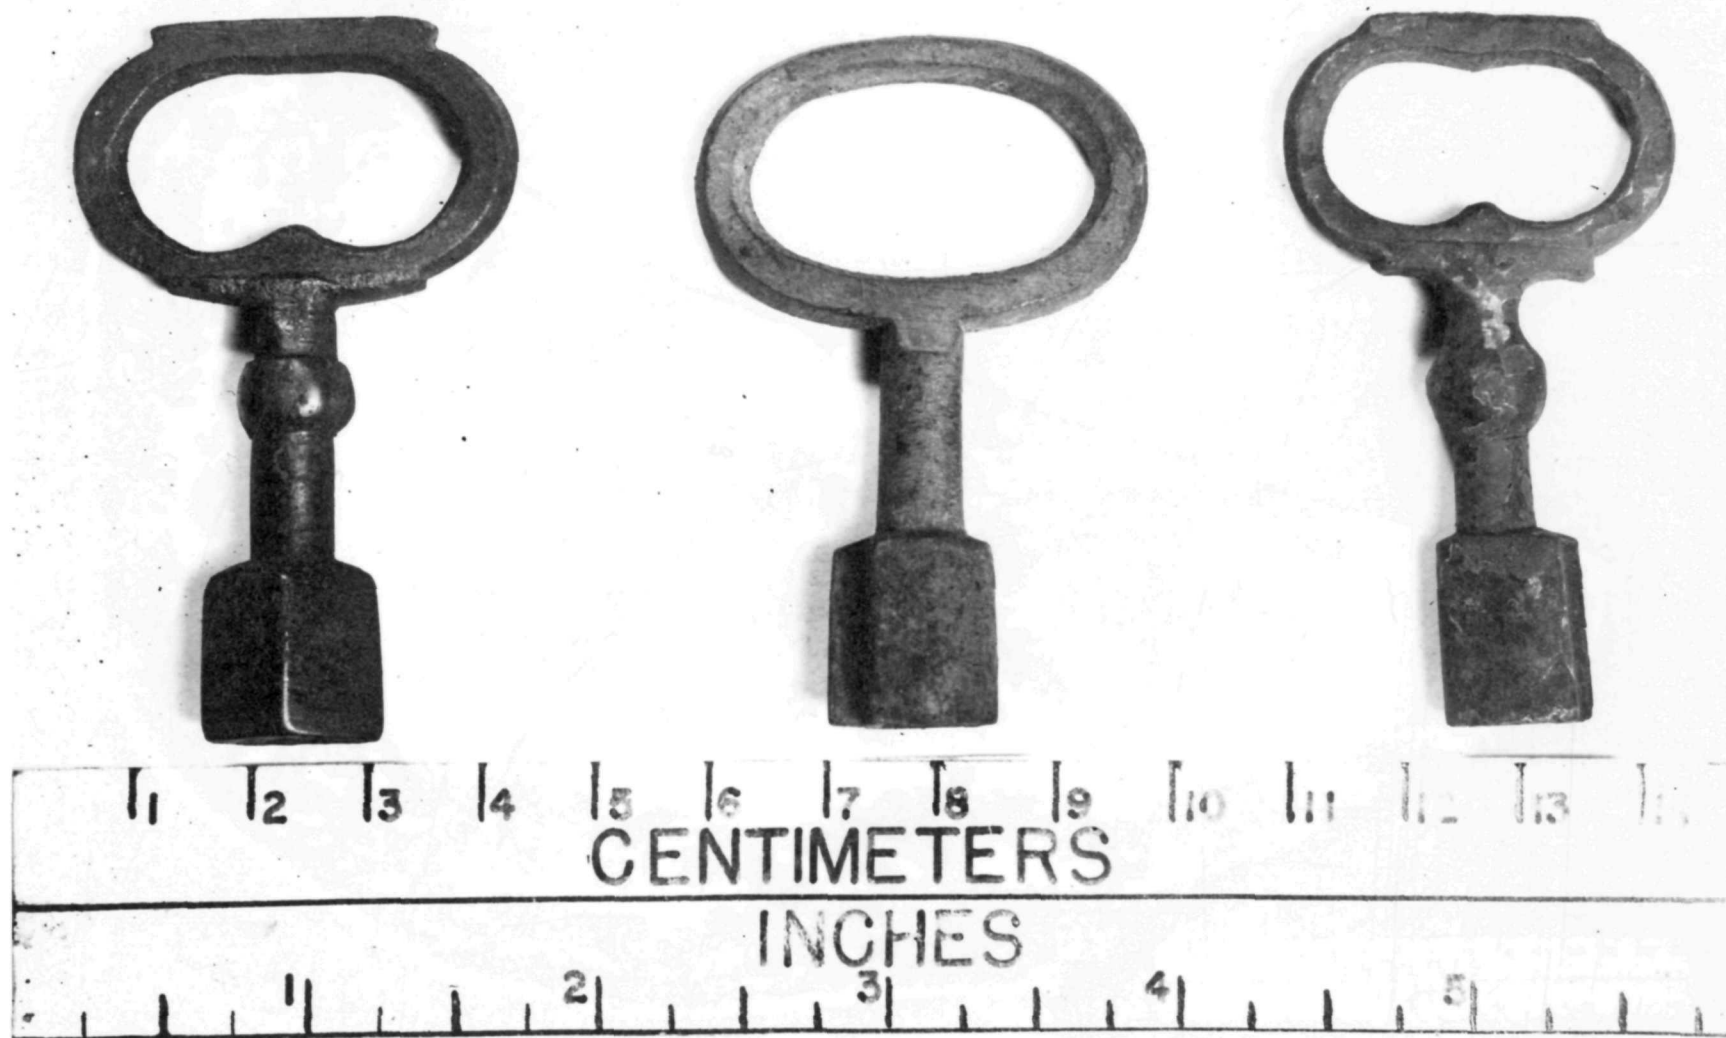
Brass keys found during excavation of bastion.

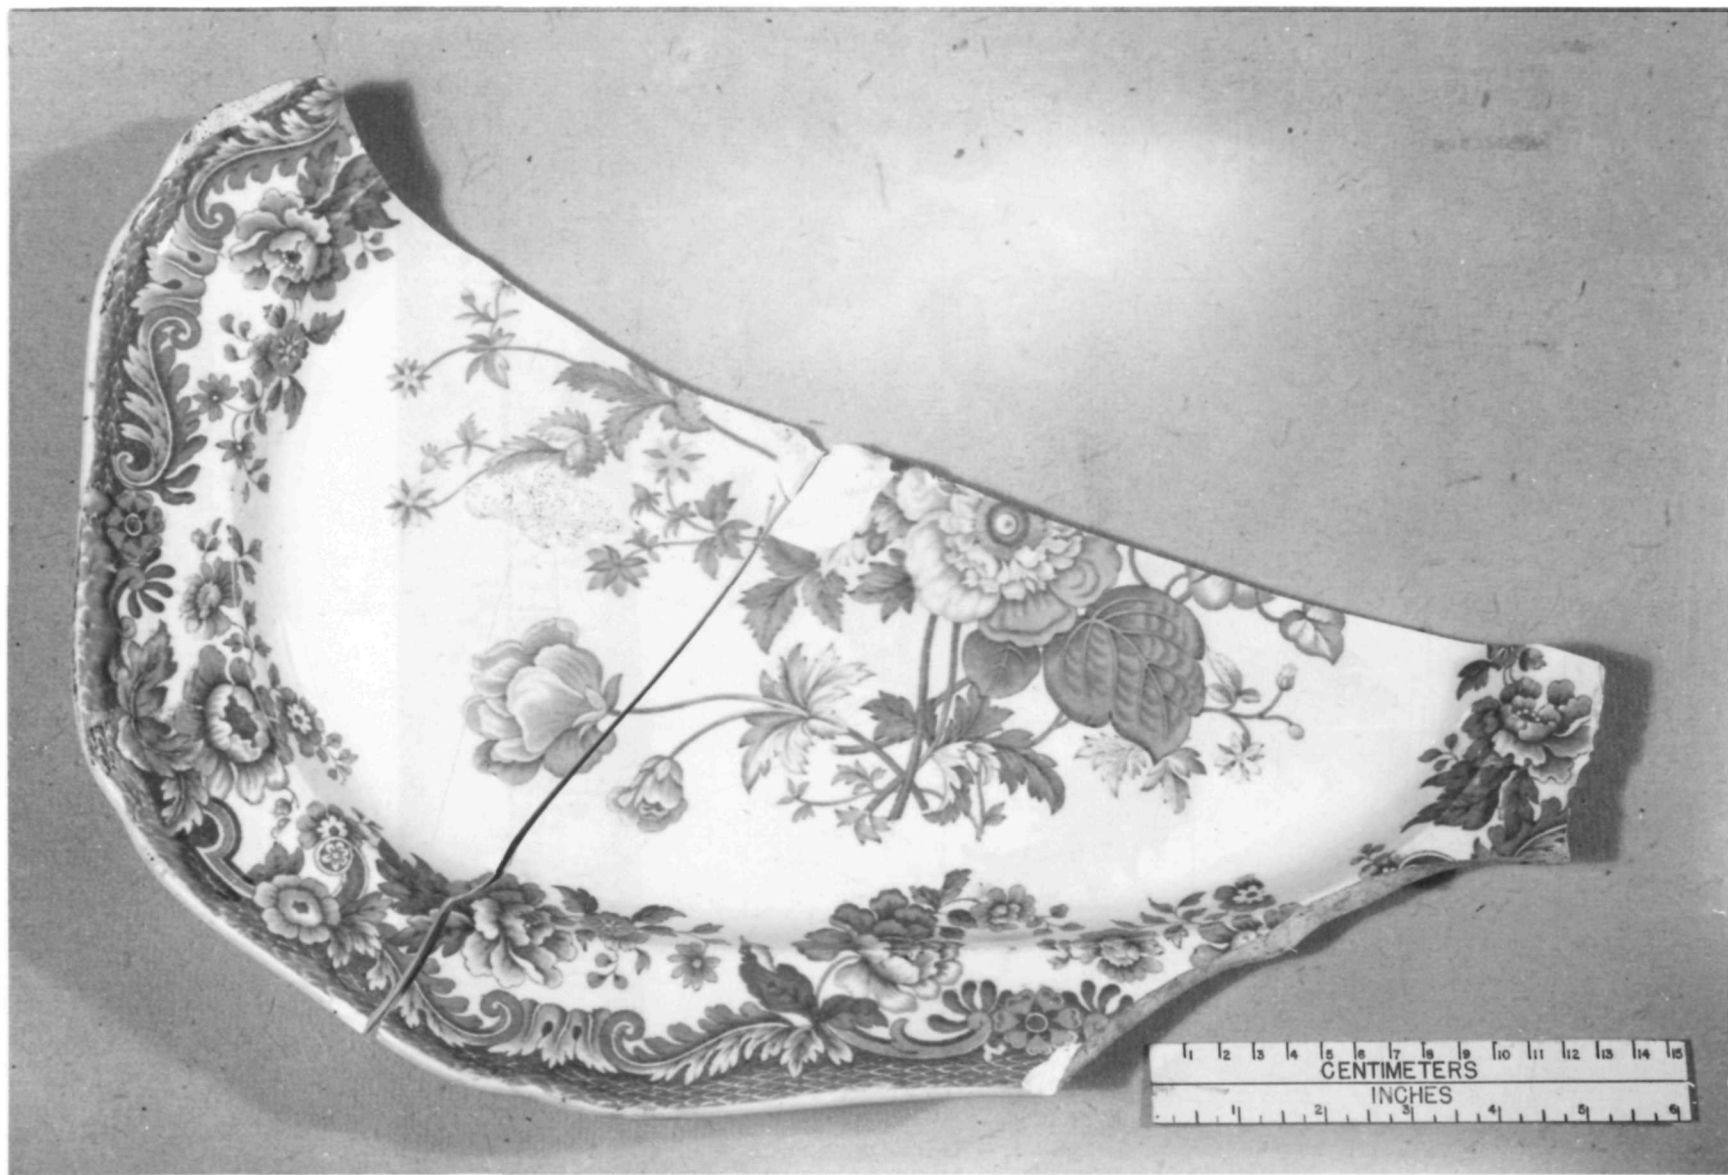
Two large fragments of Copeland and Garrett blue and white platter.

During the time that this fine china, Late Spode, was finding its way to every part of the world, the Hudson's Bay Company was buying it for the use of its employees. Fragments of broken china (Plates 25 and 26) are found in every corner of old Fort Vancouver. A total of 6,252 broken pieces were collected during the excavation. The greater percentage of this ware is Copeland and Garrett which was manufactured between the years 1833 to 1847. A number of other kinds of china have also been found, but no positive identifications have as yet been made. Sixty-four pieces were shipped to Copeland and Thompson, Inc., the Spode representative in the United States, for identification of patterns and times of manufacture.

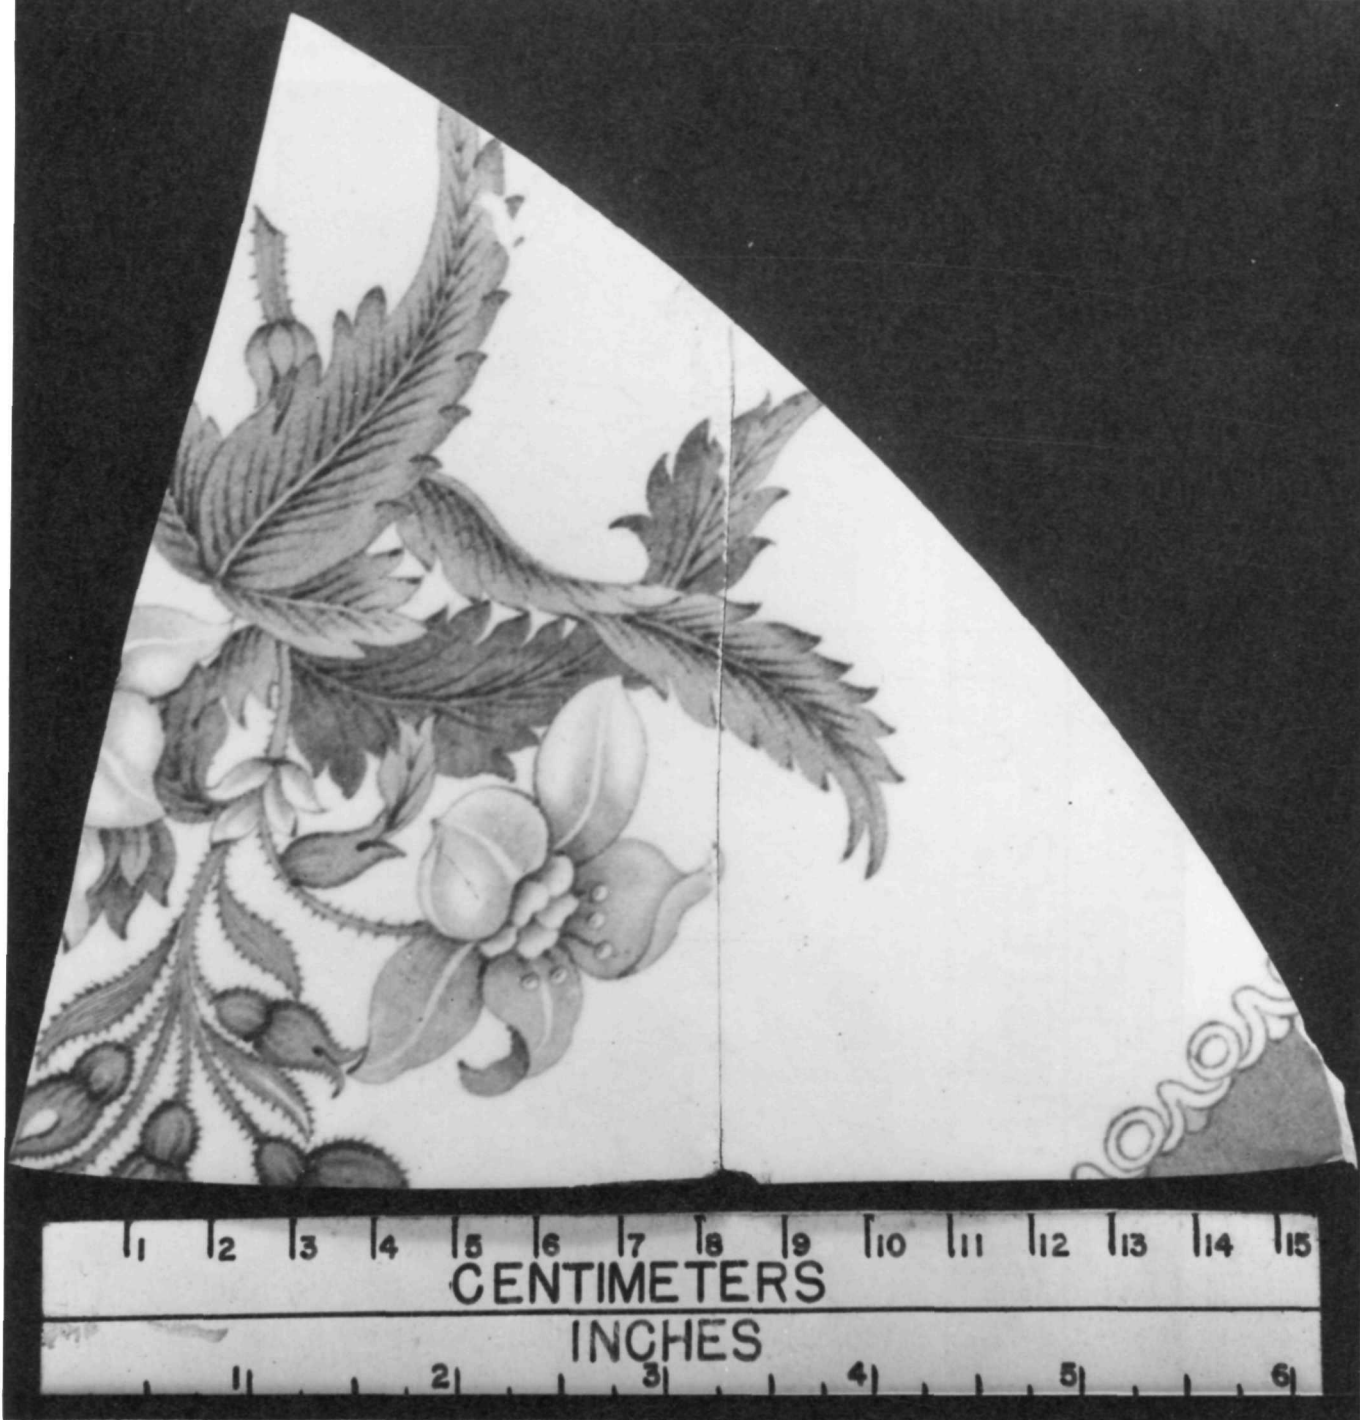
Copeland and Garrett "Late Spode", 1833-47.  
(Blue and white)
