EXPLORATORY EXCAVATIONS  
AT  
FORT VANCOUVER

VANCOUVER, WASHINGTON

1947

Louis R. Caywood  
Archeologist

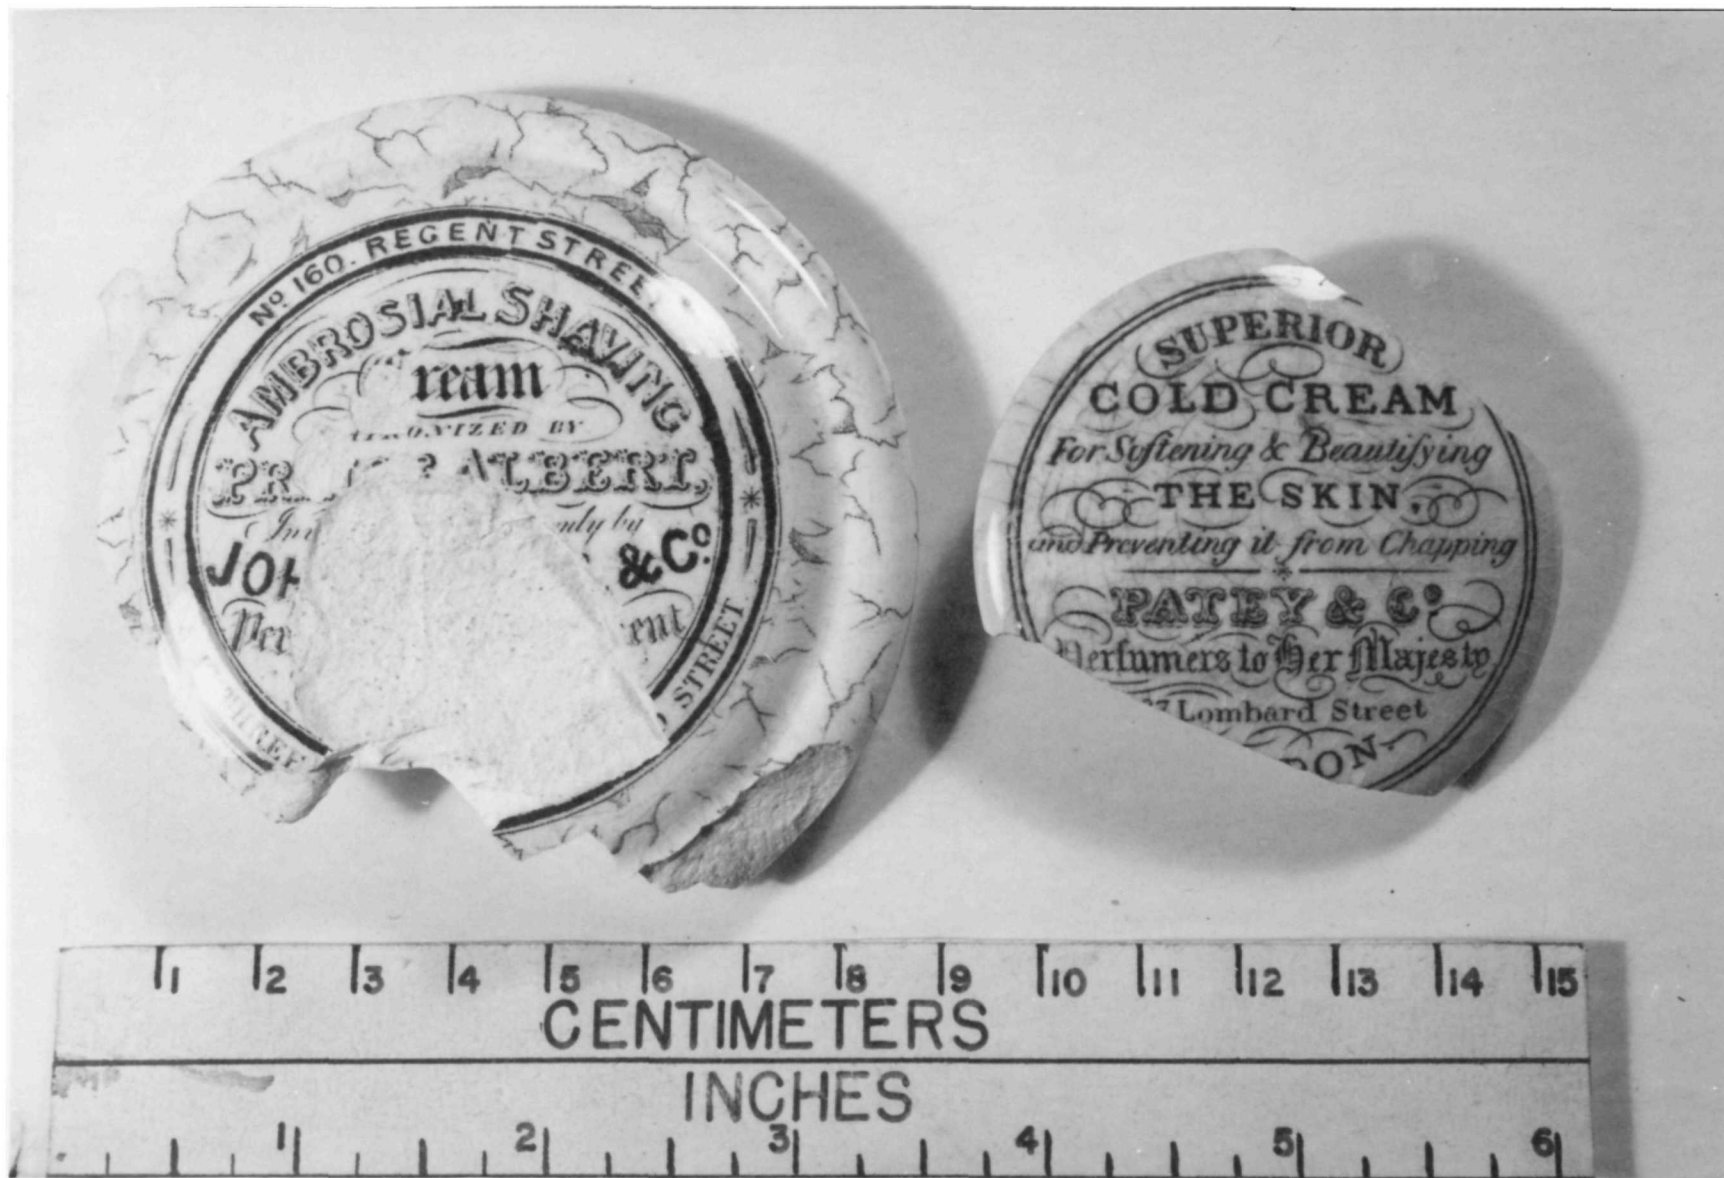
Cosmetic jar lids.

Other objects made of clay include the parts of cosmetic jar tops (Plate 27). One of these is the top belonging to a cold cream jar and the other to a shaving cream jar. The shaving cream top fits the only jar found (Plate 28). On the bottom of this jar is the imprint "COSNELL" and "1 $\frac{1}{2}$  oz."

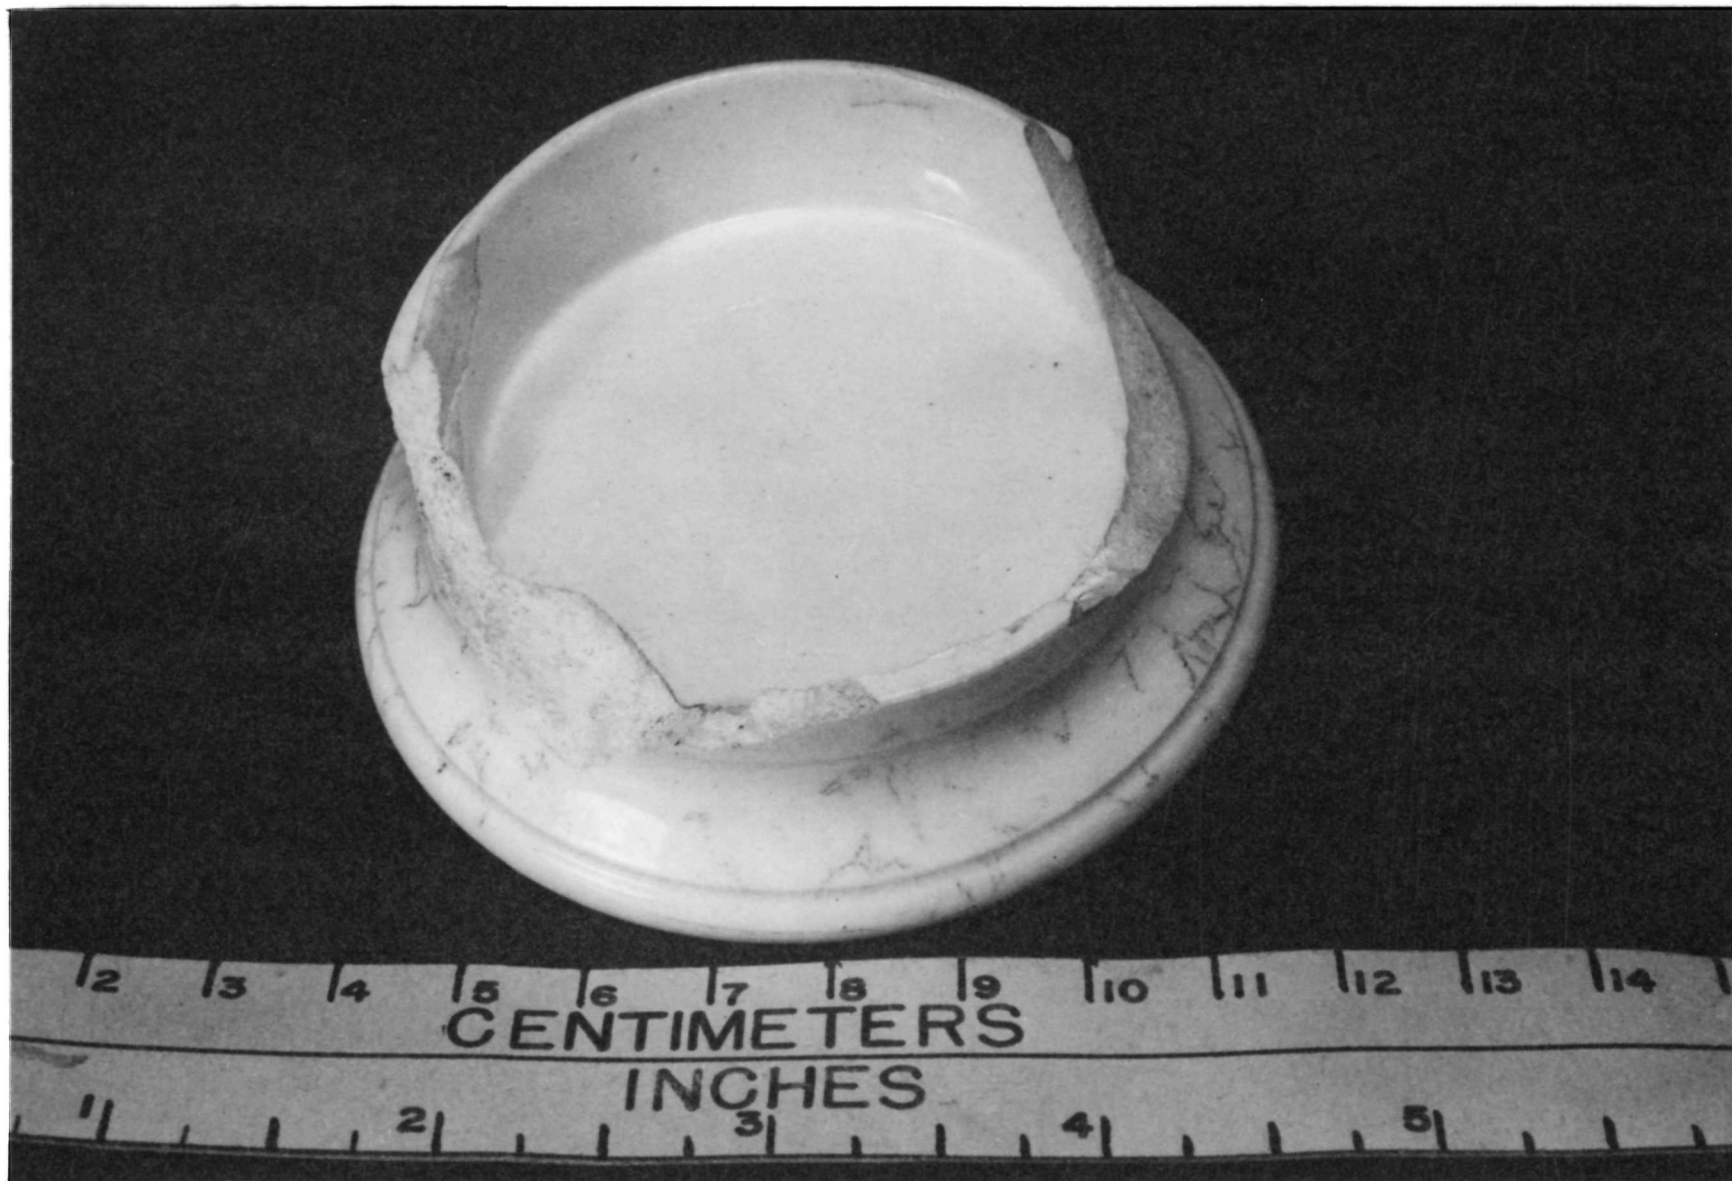
Jar in which shaving cream was originally packed.

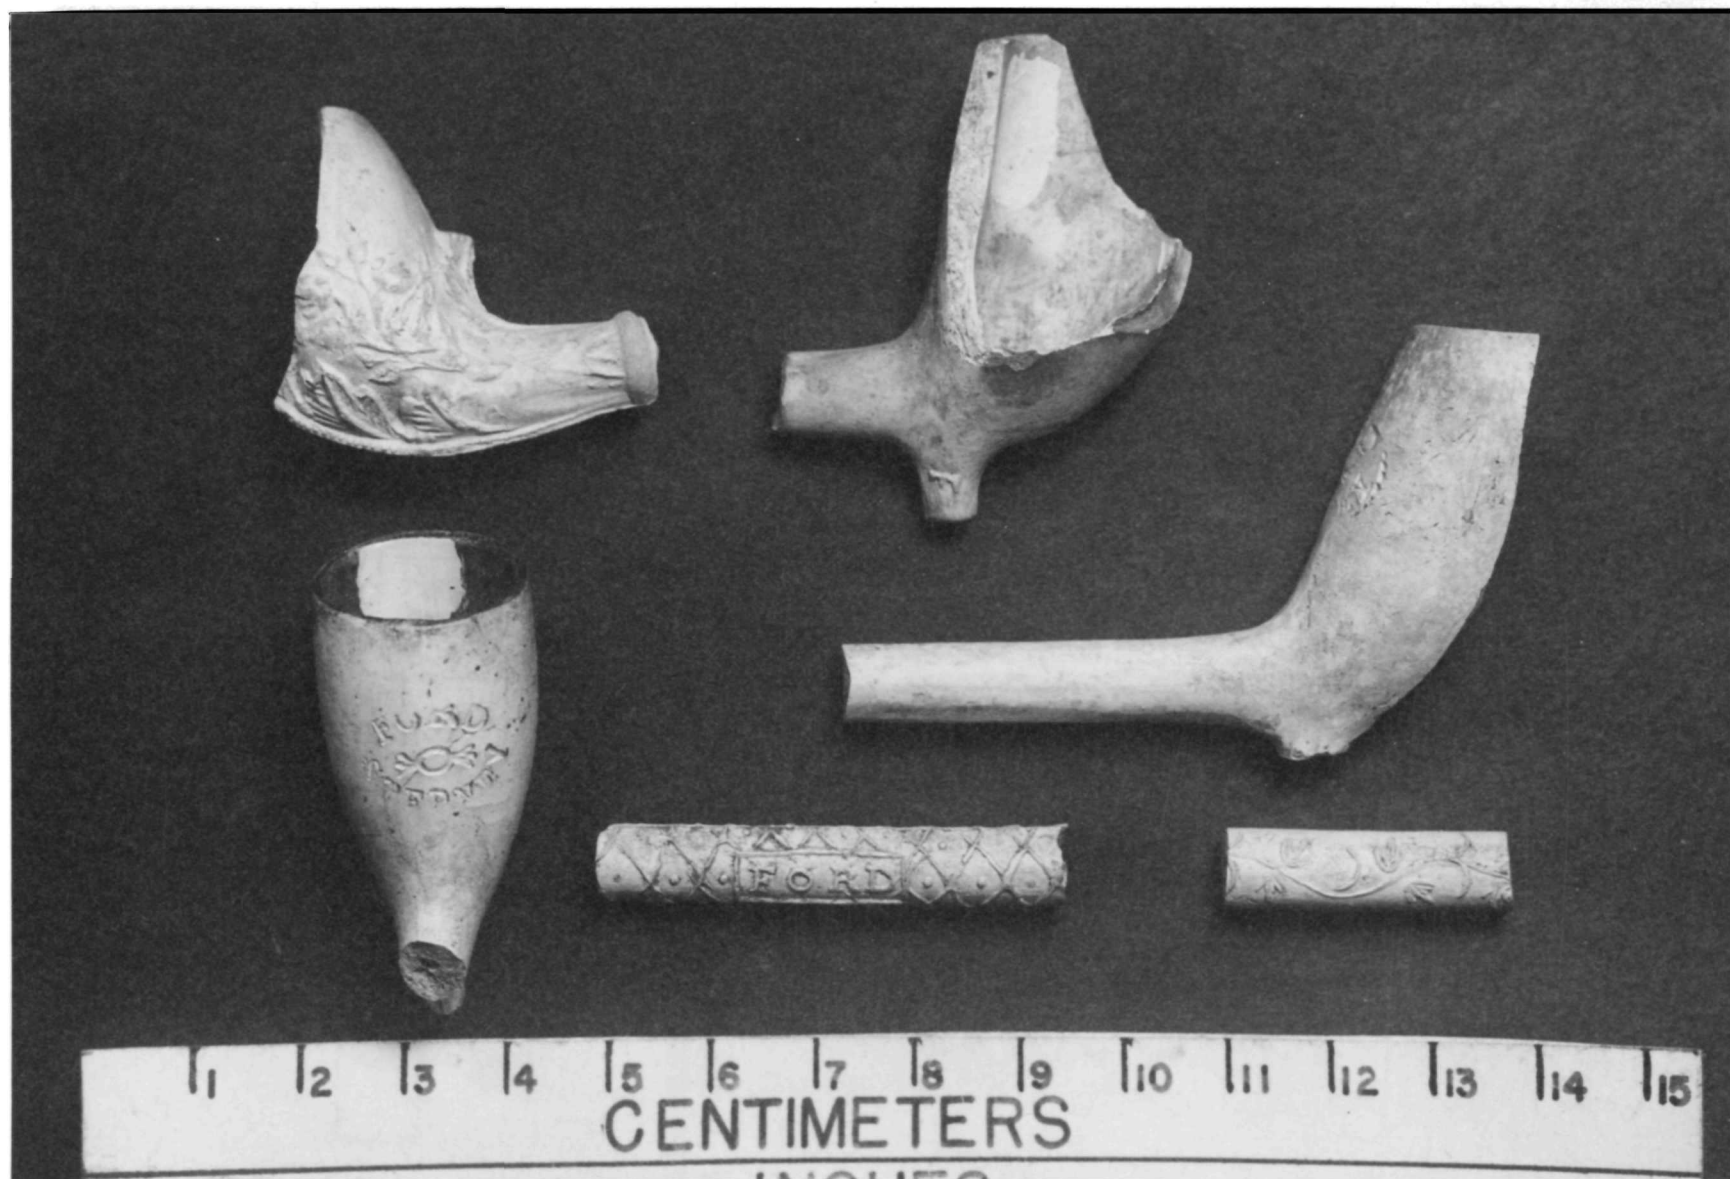
Broken clay pipes and stems.

Another very common item which was found in every section of the stockade was the broken clay pipe. A total of 904 pieces of pipe stems and bowls was cleaned and stored for study purposes. A few of the better examples (Plate 29) may be used for exhibition. The name of the manufacturer, "FORD & STEPNEY", is imprinted in the clay of the bowl of some specimens.
