National Park Service  
Cultural Landscapes Inventory  
2007

Park Headquarters  
Fort Vancouver National Historic Site

## CULTURAL LANDSCAPES INVENTORY (CLI) 2007

### Park Headquarters Fort Vancouver National Historic Site

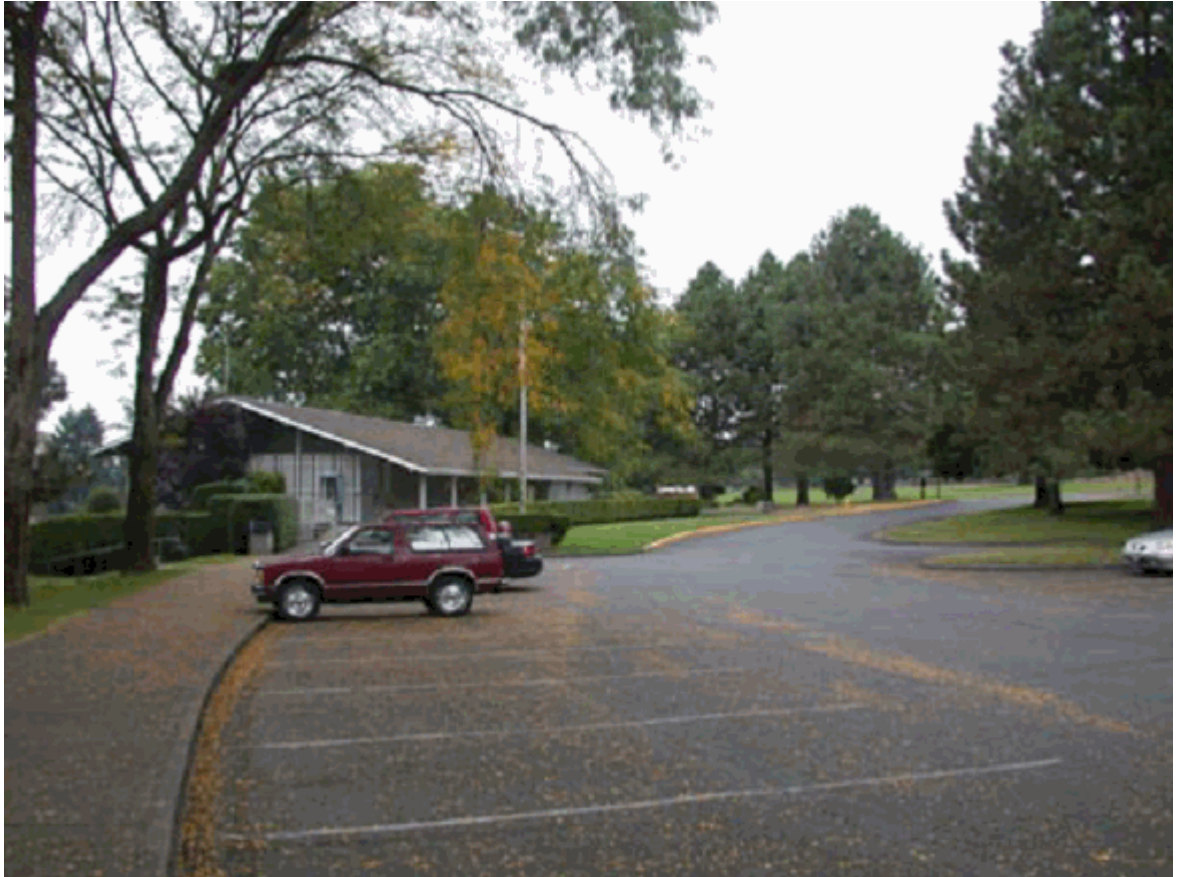
*Contemporary photo showing parking lot associated with the Mission 66 Visitor Center, looking southwest (PWRO, 2001).*

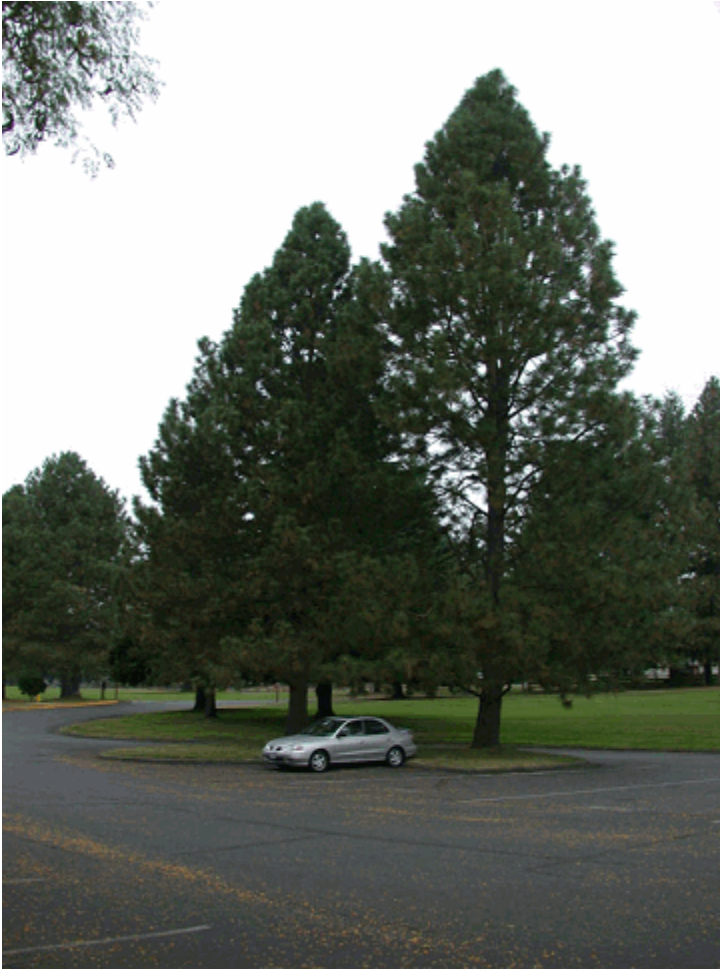
*Contemporary photo showing the parking island in the western end of the parking lot near the Visitor Center, looking northwest (PWRO, 2004).*

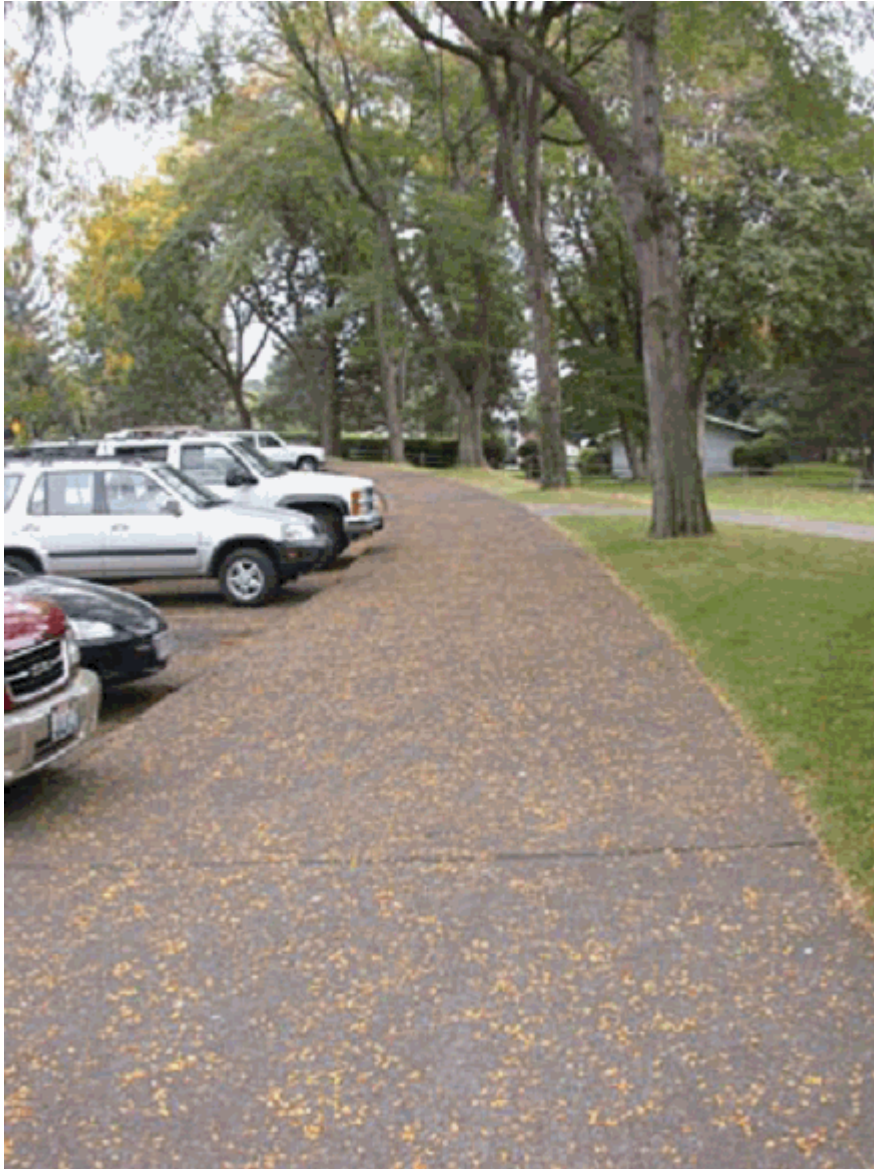
*Contemporary photo showing sidewalk associated with the Mission 66 Visitor Center (PWRO, 2001).*

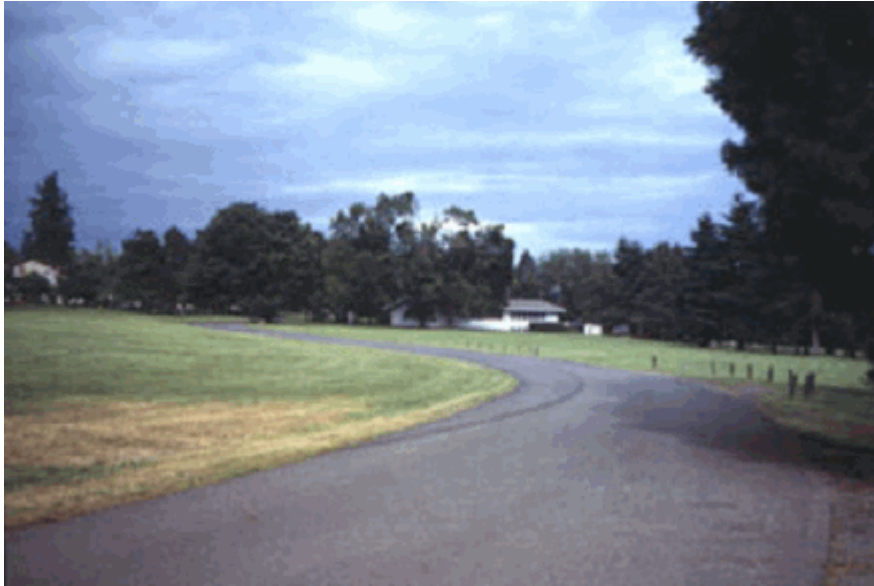
*Contemporary photo showing the Mission 66 entry road (PWRO, 2001).*

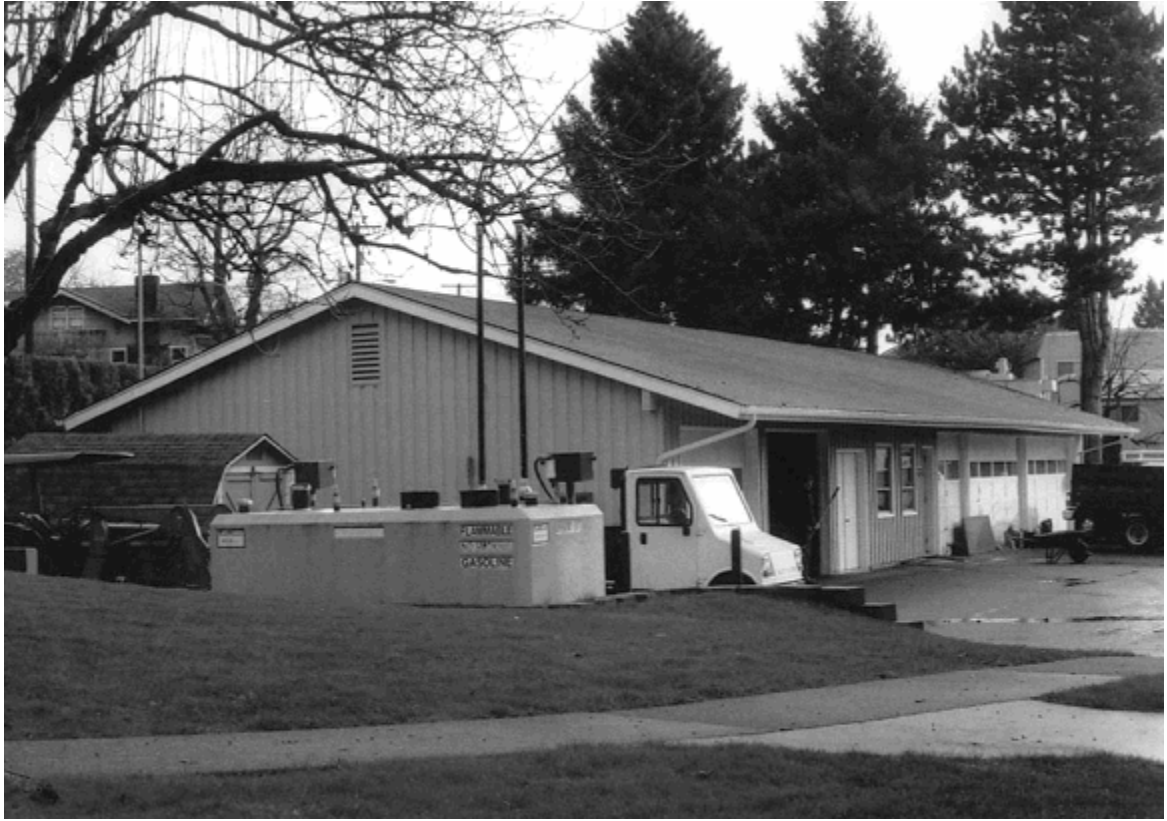
*Contemporary photo showing the Mission 66 Maintenance Shop, looking northeast (PWRO, 2004).*

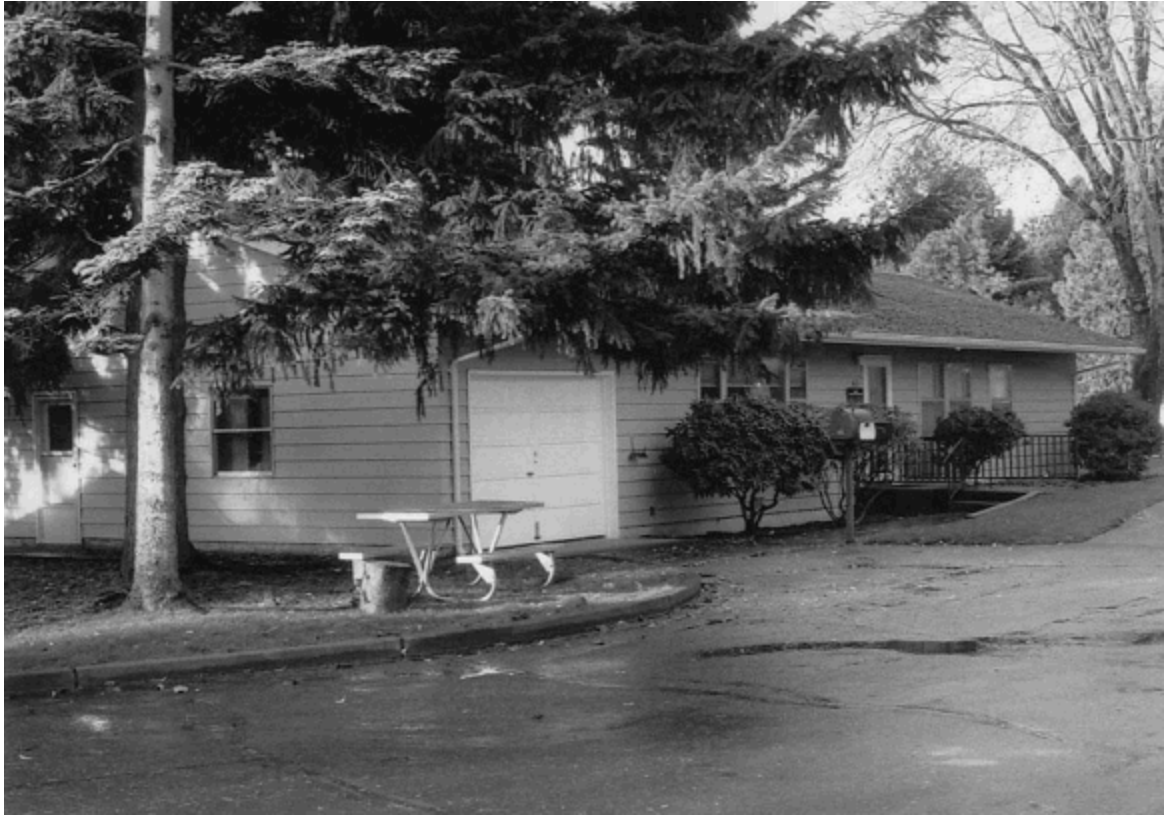
Exterior changes to the residences have been few. To accommodate the 1987 conversion of one house to administrative offices, a universally accessible ramp was added in the late 1990s. Both houses underwent utility conversion from natural gas to electric in the 1980s resulting in the removal of natural gas furnaces and the replacement with electric heat pumps.

*Contemporary photo showing Mission 66 Residence No. 1, looking southwest (PWRO, 2004).*

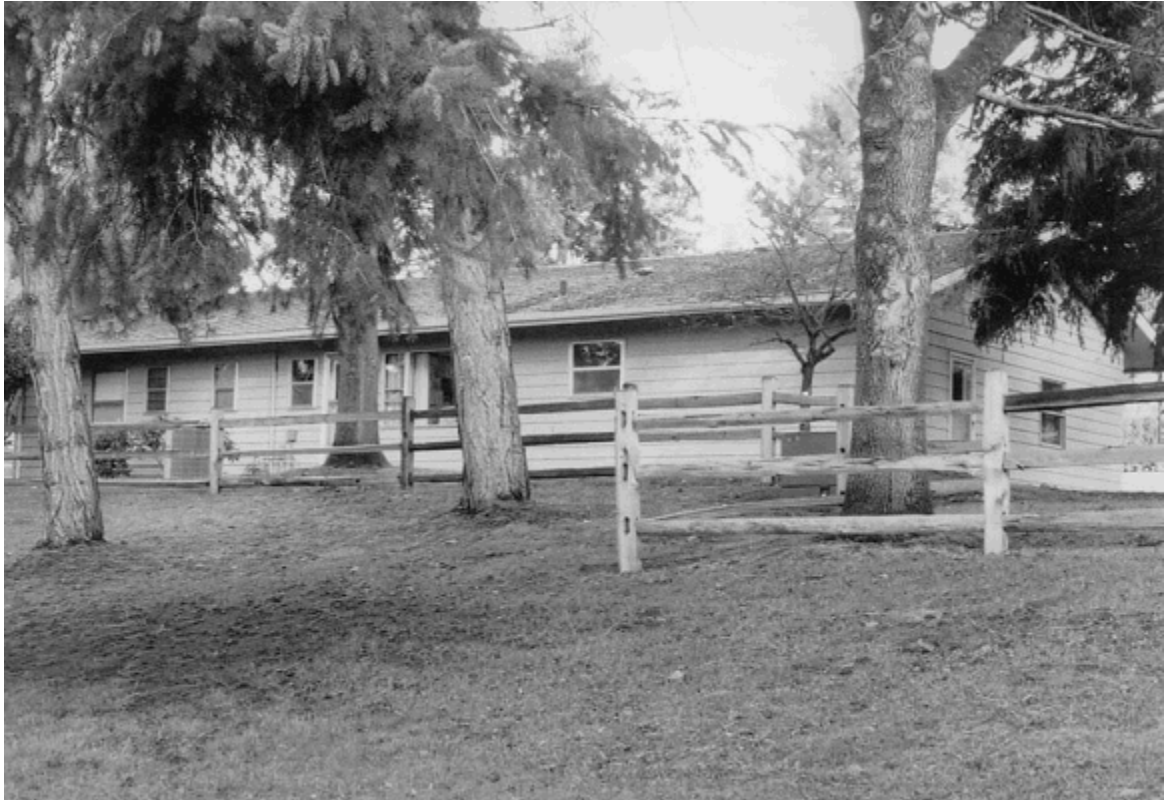
*Contemporary photo showing Mission 66 Residence No. 2. Today, this building houses the Park Headquarters/Administration (PWRO, 2004).*

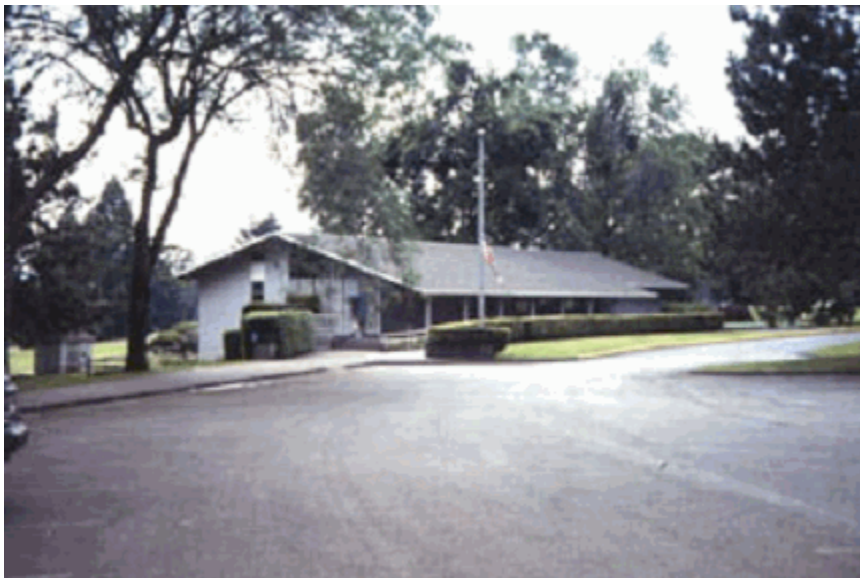
Fort Vancouver National Historic Site Visitor Center: Built in 1960-1961, the Visitor Center is a one-story plus, a partially exposed basement, rectangular-shaped, wood-frame building with a low-spreading gable roof. The foundation is concrete. The exterior is clad with Douglas fir board on board siding painted gray. The roof has composition shingles.

Exterior changes to the building have been few. The original color of the building exterior was a dark wood stain that has since been painted gray. Cedar roof shakes were replaced with composition shingles in the 1980s. When utilities were converted from natural gas to electric in the early 1980s, a louvered aluminum chimney stack was removed from the roofline and two outside electric heat pumps added. Most change has occurred to the eastern façade where a security gate was added to the east entrance corner, a concrete slab was added with a pay phone and bench/planter unit, and a universally accessible ramp, set of stairs and low retaining wall were all added in the early 1990s. The entry doors on the north façade have been altered, as well.

*Contemporary photo showing the Mission 66 Visitor Center (PWRO, 2001).*

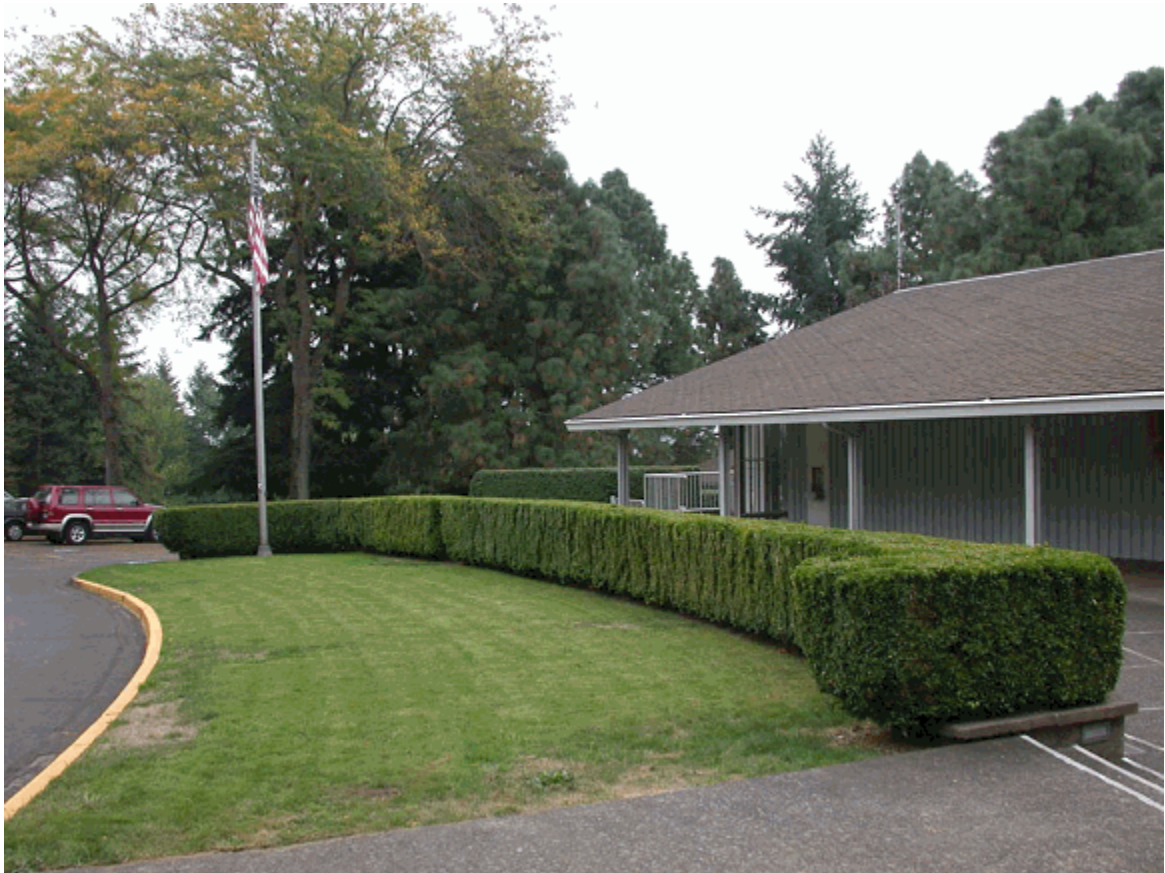
*Contemporary photo showing the boxwood hedge and lawn at the entrance to the Visitor Center, looking southeast (PWRO, 2004).*

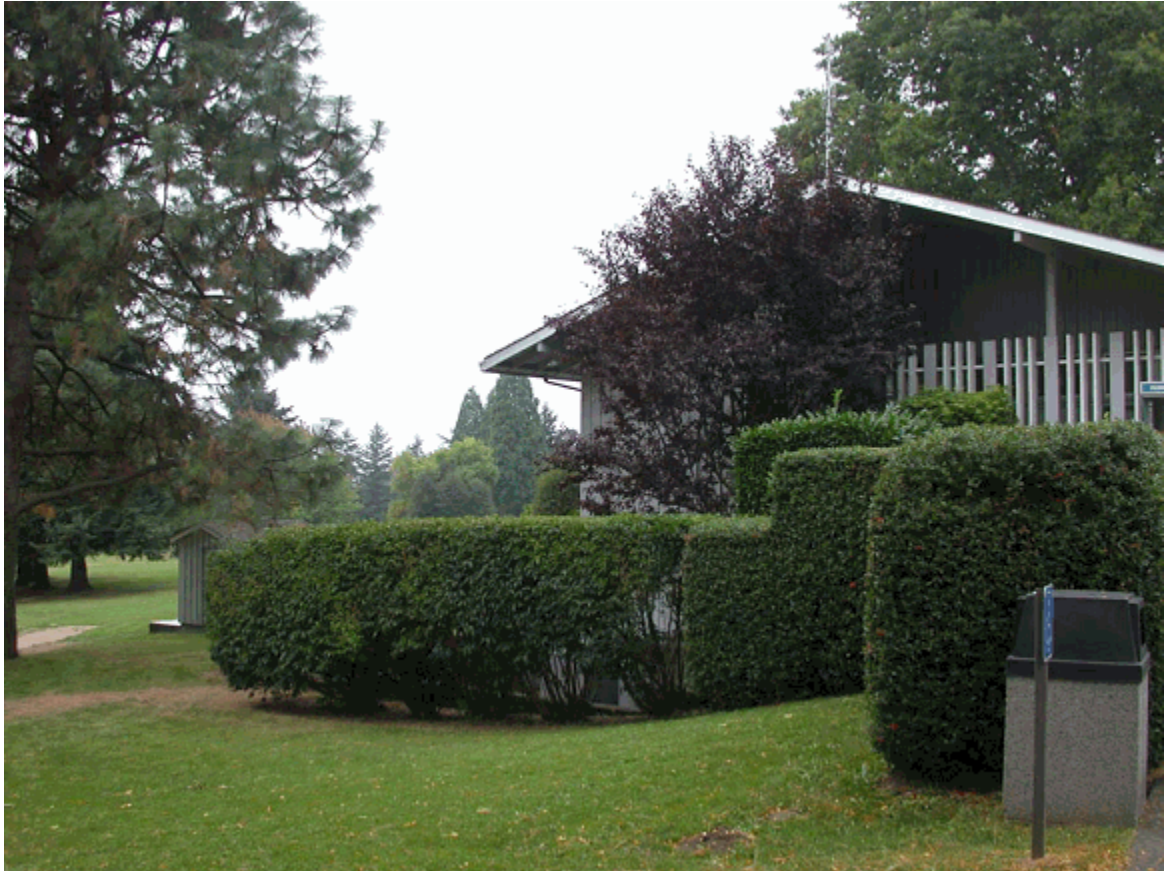
*Contemporary photo showing historic clipped hedges located at the eastern end of the Visitor Center, looking southwest (PWRO, 2004).*

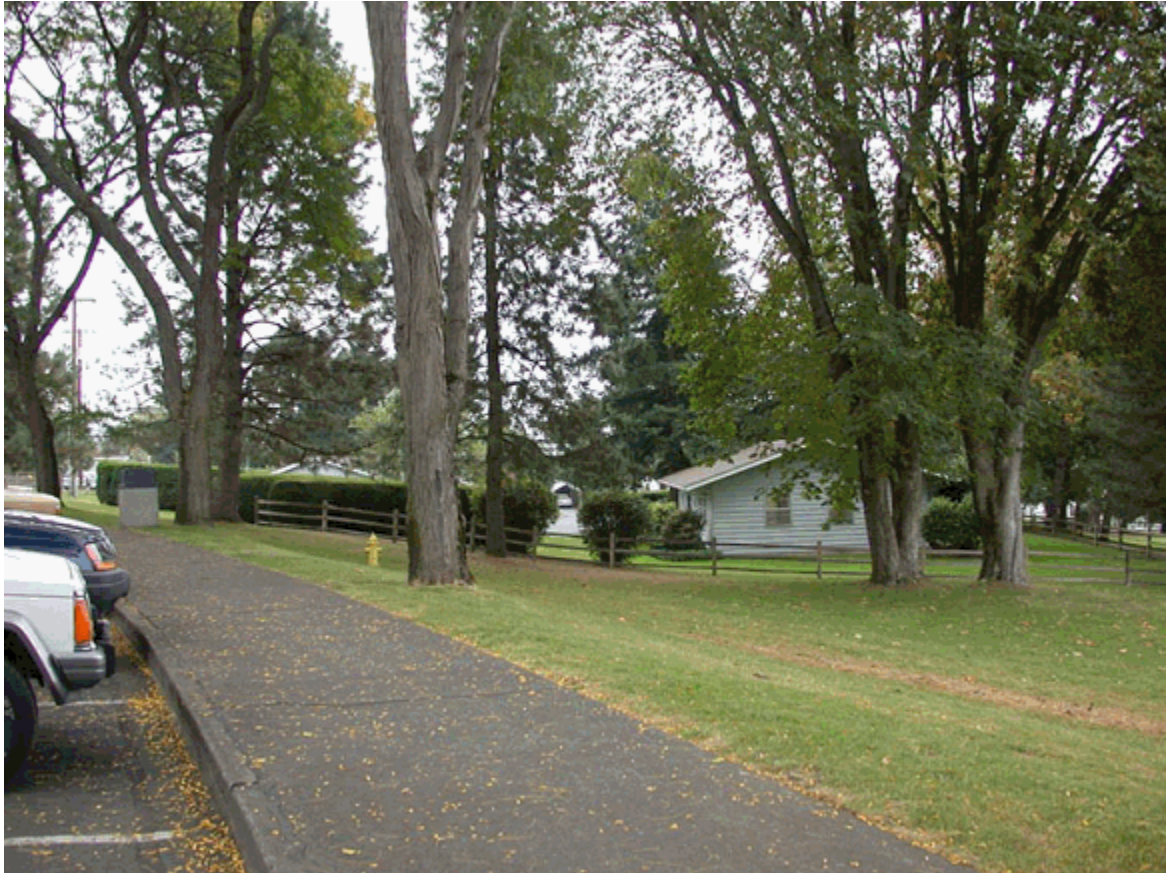
*Contemporary photo showing the historic locust trees along sidewalk and historic trimmed hedge between the parking lot and service area, looking east (PWRO, 2004).*

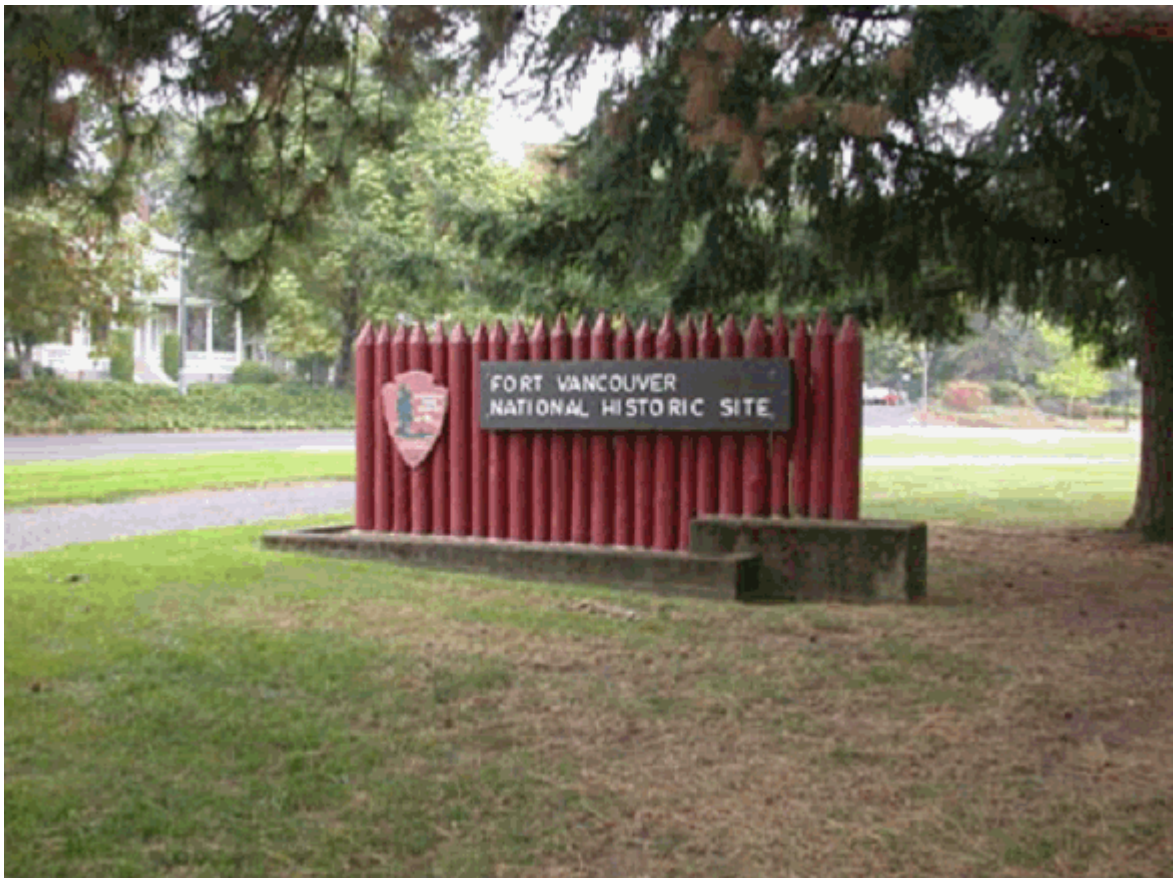
*Contemporary photo showing the park sign at the entrance to the Visitor Center, looking east (PWRO, 2004).*

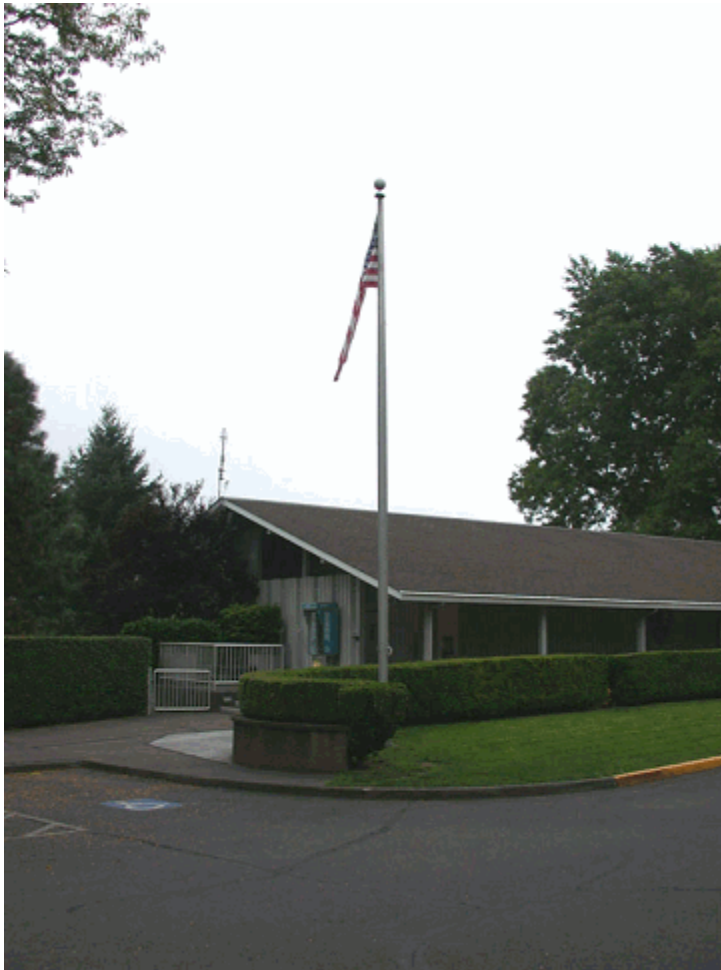
*Contemporary photo showing the flagpole in front of the Visitor Center, looking southwest (PWRO, 2004).*

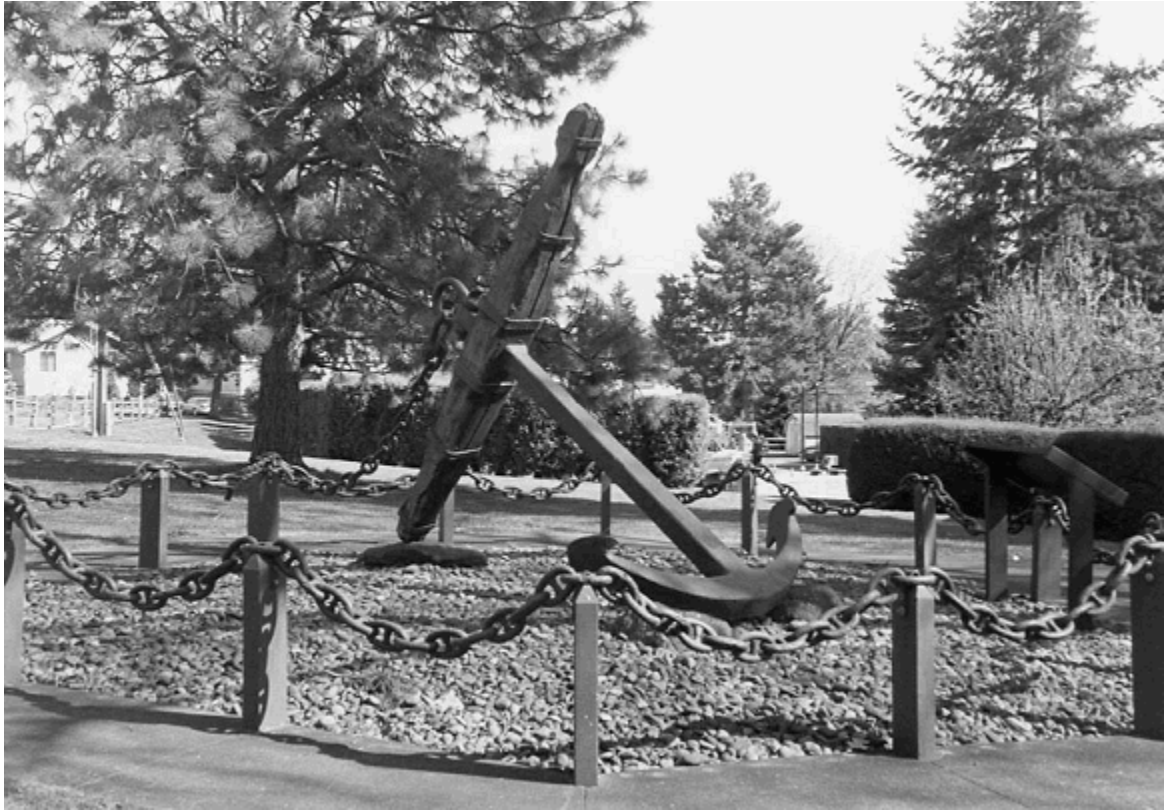
*Contemporary photo showing the British Anchor at the Visitor Center, looking norhteast (PWRO, 2004).*
