**National Park Service**  
**Cultural Landscapes Inventory**  
**2024**

**East Barracks/Parade Ground**  
**Fort Vancouver National Historic Site**

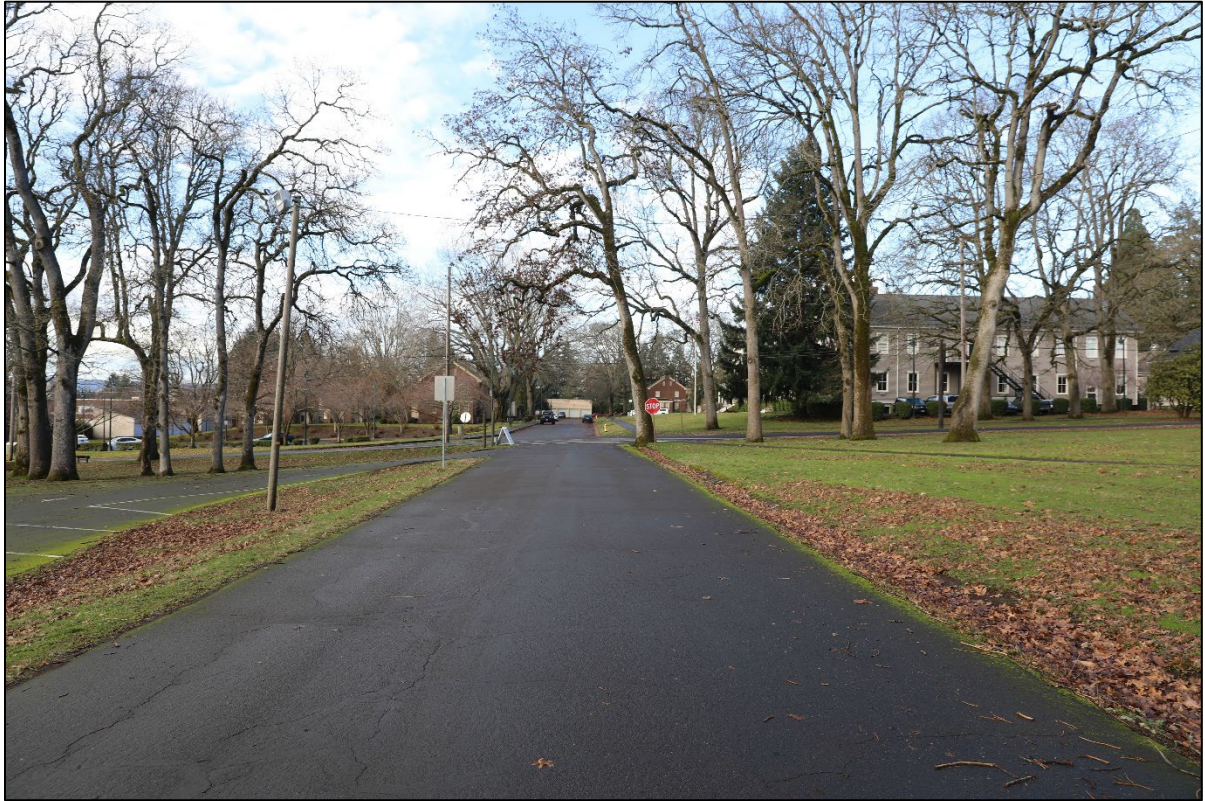
*Figure 18. Clusters of Oregon white oak trees (also known as Garry oaks) spanning Hatheway Rd. looking west towards the West Barracks. (Contributing) (MIG January 2023)*

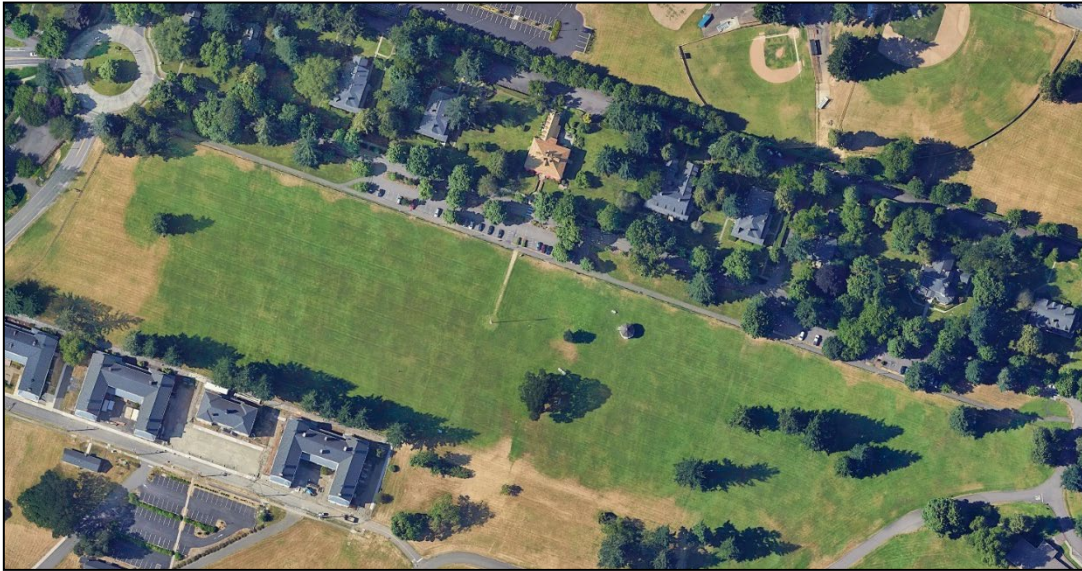
*Figure 19. Aerial of Parade Ground, lined by Officers Row to the north and the East Barracks to the south.  
(contributing) CRIS CL ID 202885. (Google Earth, June 2023)*

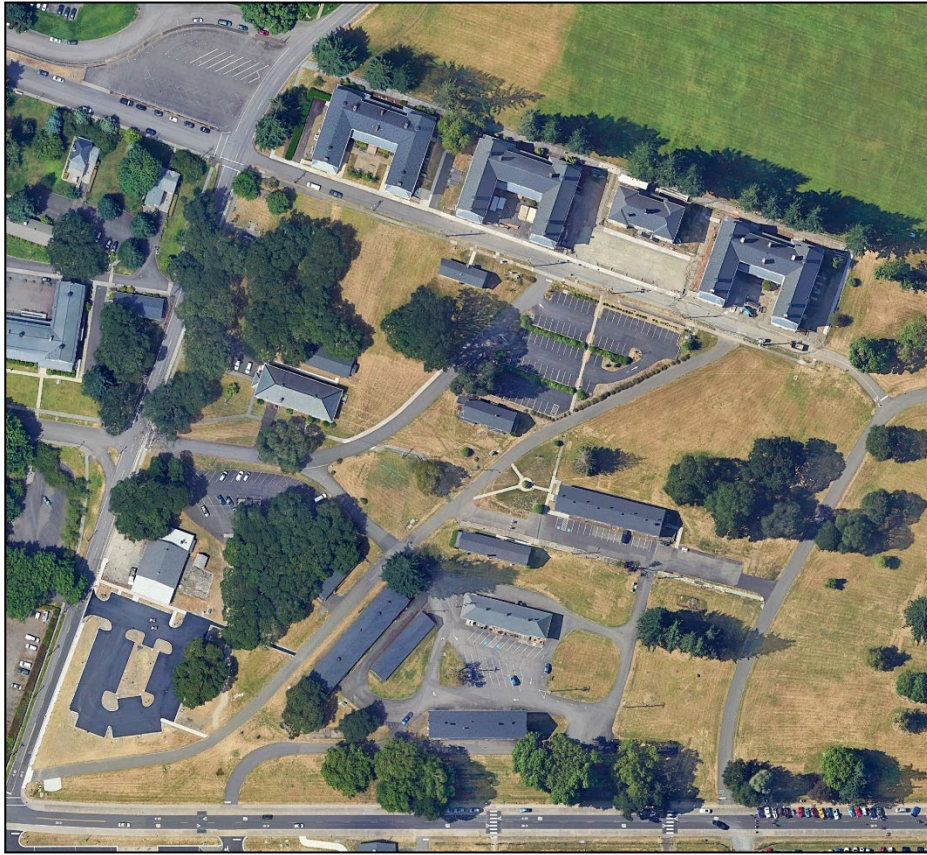
*Figure 20. Aerial of East Barracks, with a portion of the Parade Ground visible to the north. (contributing) CRIS CL ID 202886. (Google Earth, June 2023)*

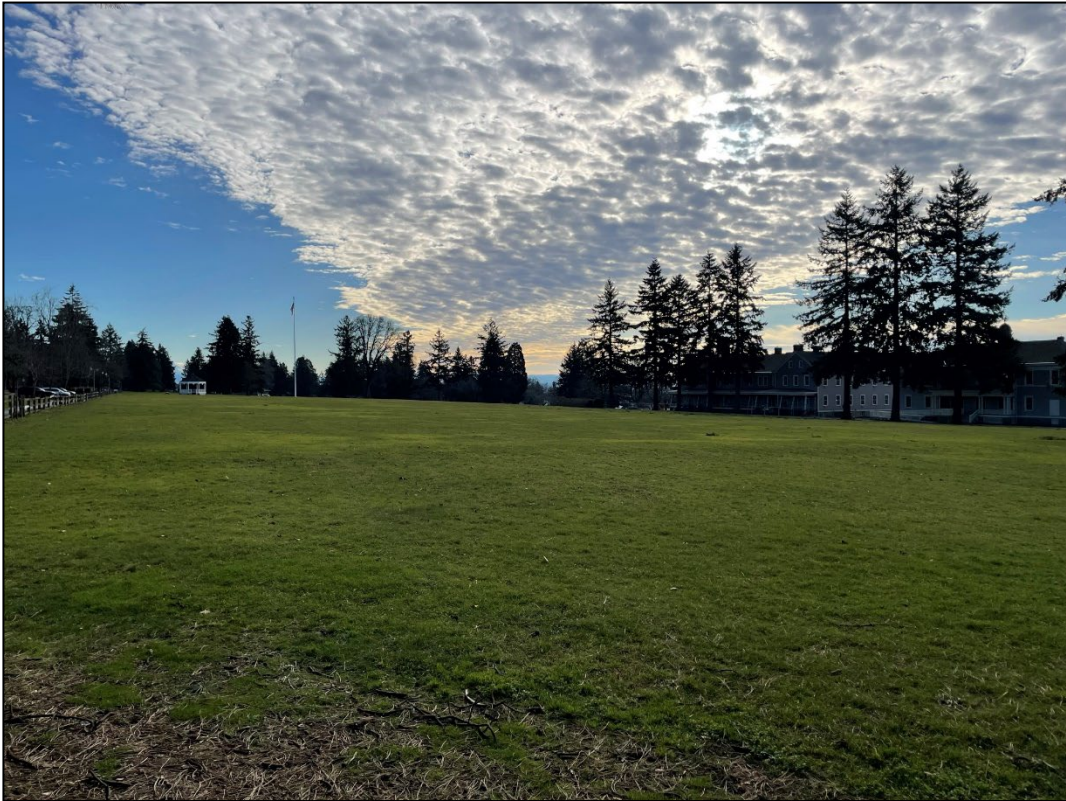
*Figure 21. Parade Ground lawn, looking east from near Fort Vancouver Way. (contributing, CRIS CL ID 192582)  
(MIG January 2023)*

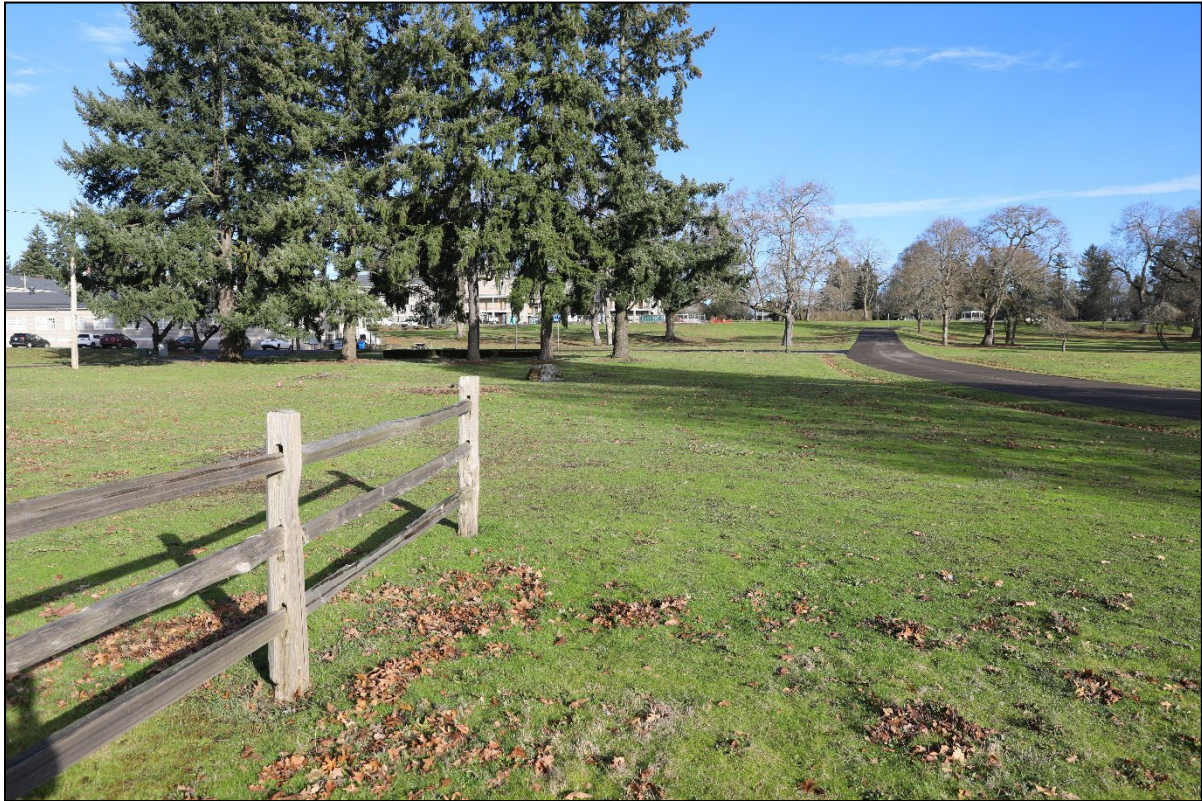
*Figure 22. Typical turf lawn near the southeast corner of the East Barracks area. (contributing, CRIS CL ID 202887)  
(MIG January 2023)*

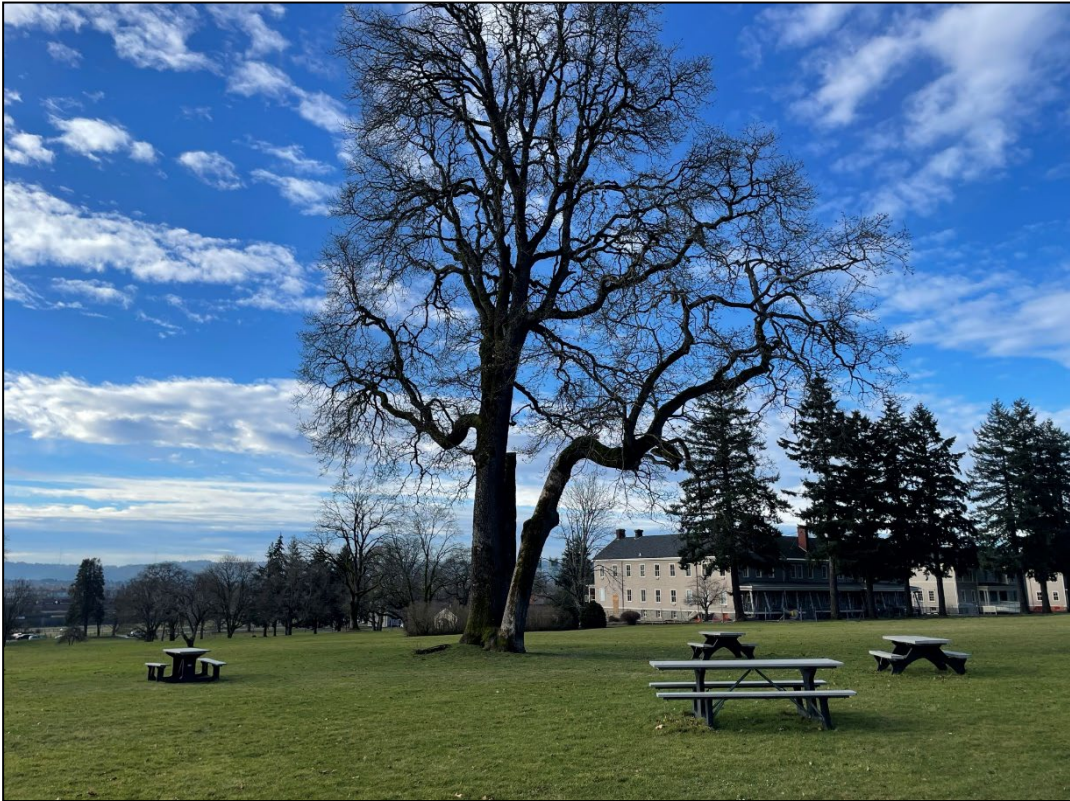
The Parade Ground (approximately 13 acres in size) consists of manicured lawn, punctuated with isolated specimen trees. In 2007, one of the more prominent specimen trees, a mature Oregon white oak located west of the bandstand, was damaged in a windstorm and split down the middle. Estimated to be about 170 years old, this tree was six trees that had grown together with one root ball. In 2008, the damaged tree was removed and replaced with a 15' tree of the same species. A second historic Oregon white oak tree remains southwest of the bandstand (CL ID 199651, see Oregon White Oaks section).

*Figure 23. An Oregon white oak tree located within the Parade Ground. (Contributing, CRIS CL ID 199651) (MIG January 2023)*

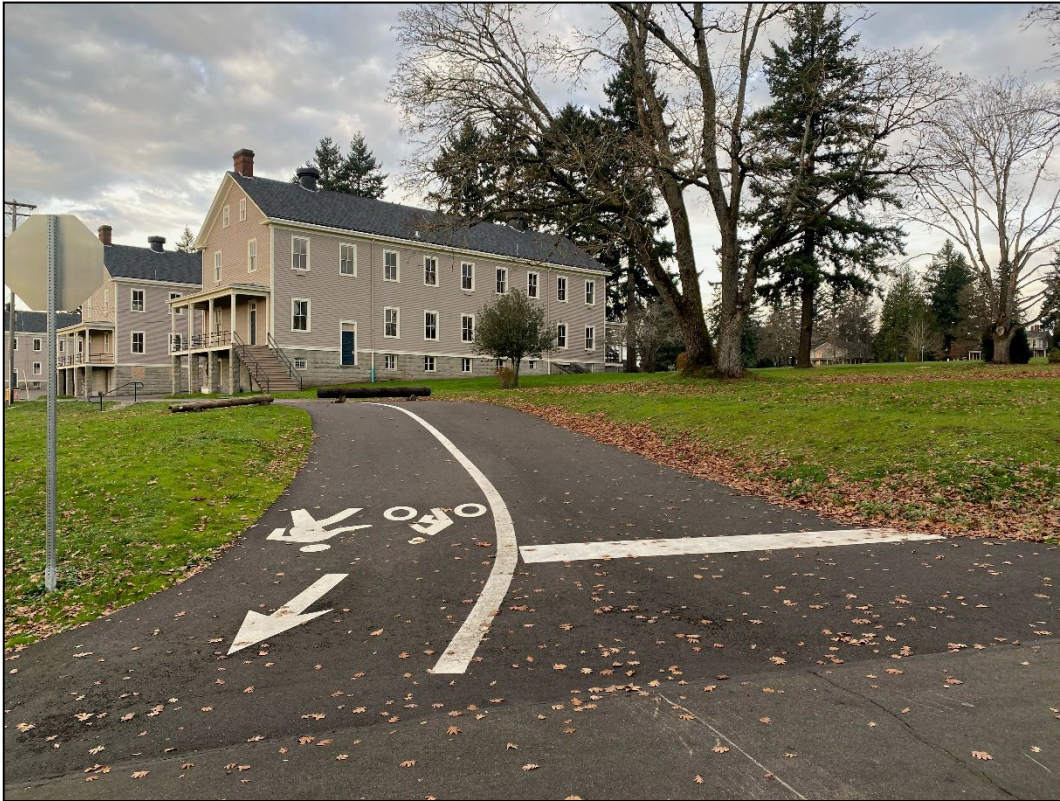
*Figure 24. Specimen Tree, Deciduous (two bigleaf maples to right of path in winter) looking northwest towards Building 993. (contributing CRIS CL ID 199649-199650) (MIG 2021)*

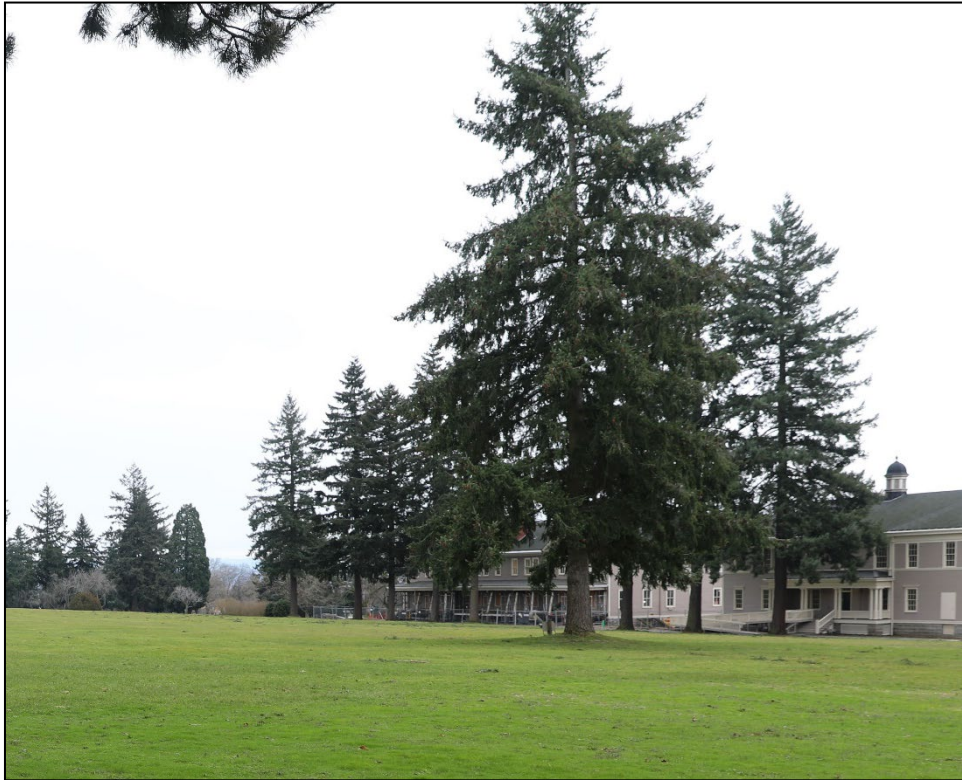
*Figure 25. Eastward view of a contributing specimen tree, coniferous (Douglas fir) in the Parade Ground, north of the double barracks and allée. (contributing, CRIS CL ID 199642) (MIG January 2023)*

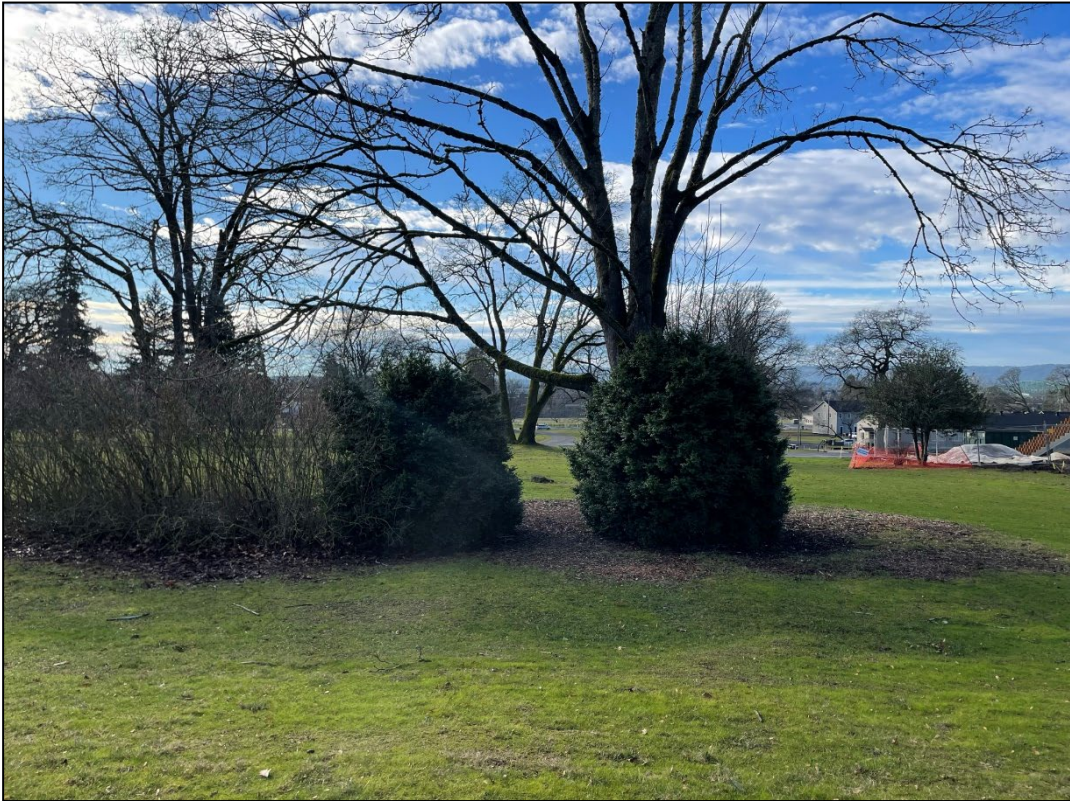
*Figure 27. Hedges and shrubs. Two boxwood shrubs and a lilac hedge near building 993 (off photo to the right). Looking south. (contributing, CRIS CL ID 199712, 199713, 199714) (MIG January 2023)*

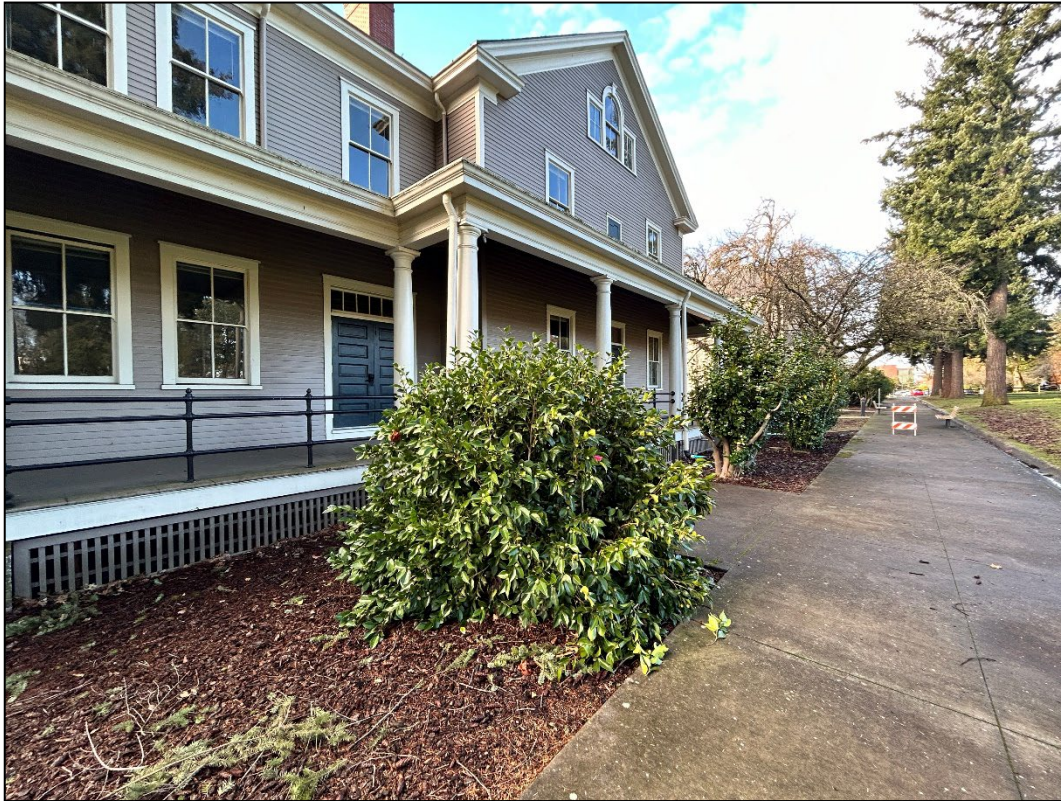
*Figure 28. Trimmed foundation plantings in front of the barracks buildings. (contributing, CRIS CL ID 199736) (MIG January 2023)*

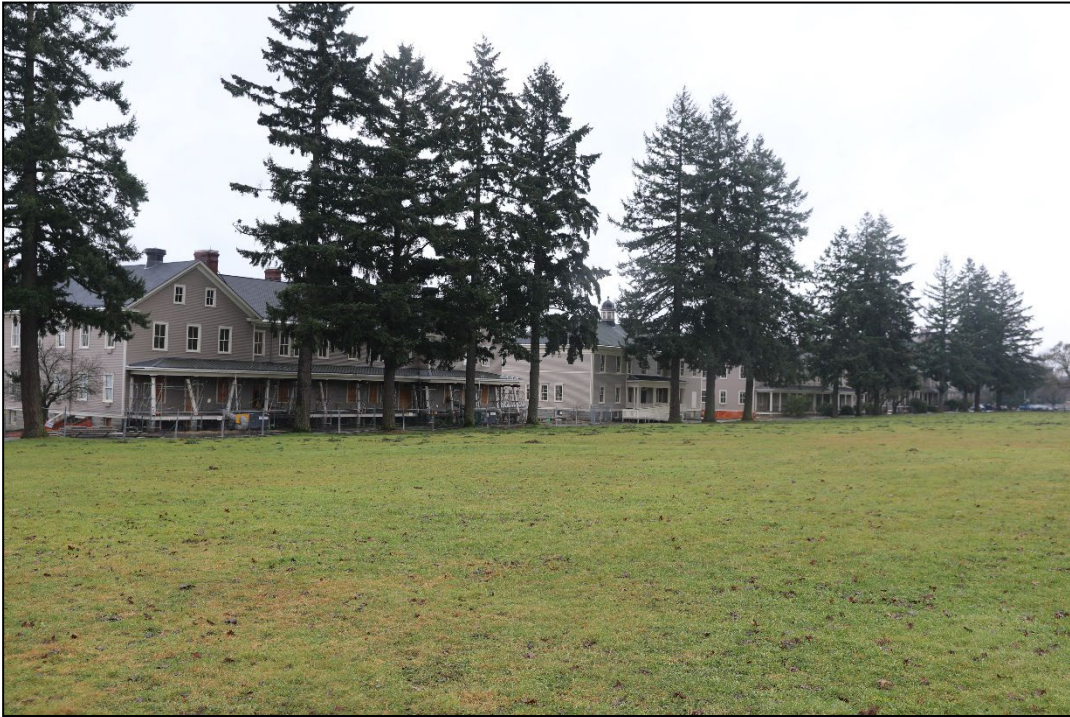
*Figure 29. Douglas fir Allée between the Parade Ground and East Barracks. (Contributing, CRIS CL ID 199594-199598) (MIG January 2023)*

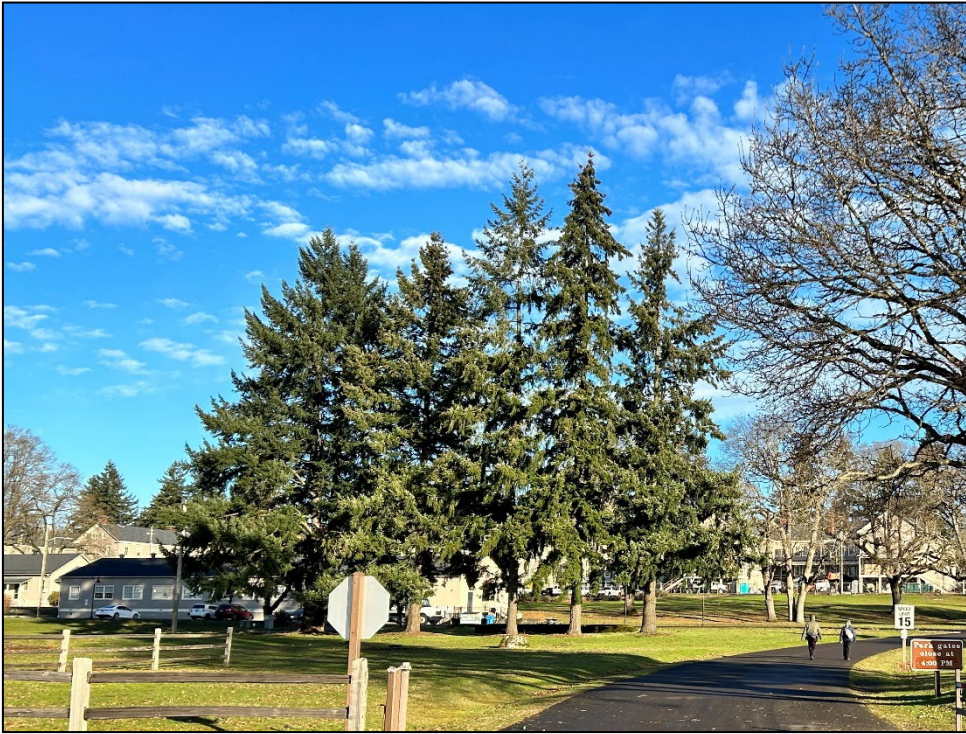
*Figure 31. Specimen trees, coniferous. A group of Douglas fir near Access Road that were planted after the period of significance. (Noncontributing, CRIS CL ID 199606, 199608, 199610, 199612, 199613) (MIG January 2023)*

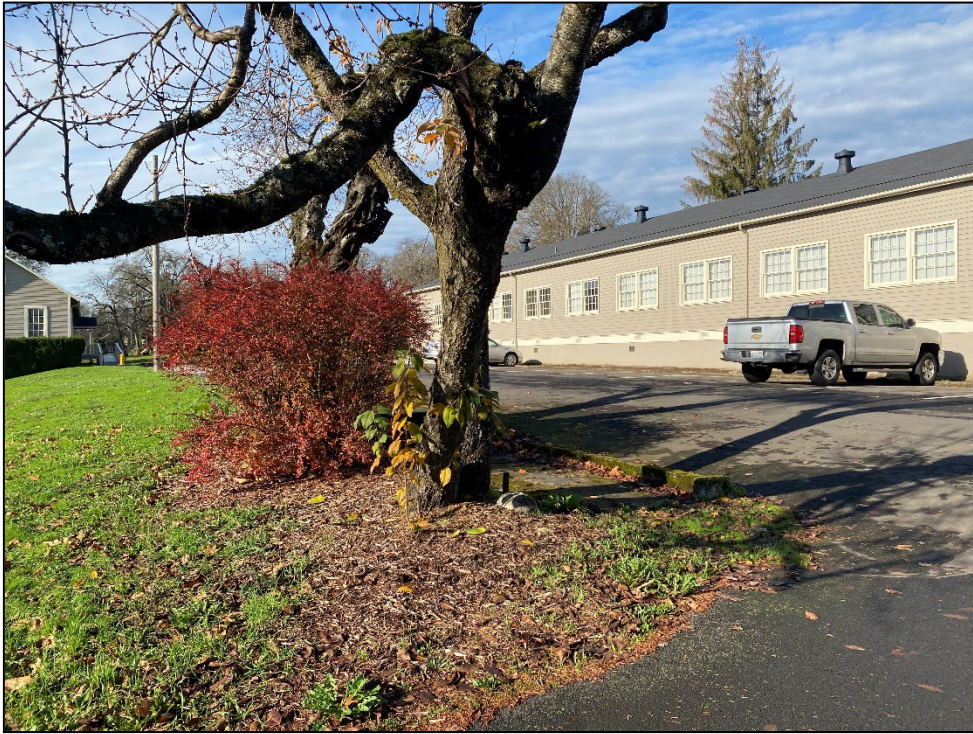
*Figure 32. Flowering cherry tree (Noncontributing, CRIS CL ID 199616) (MIG January 2023)*

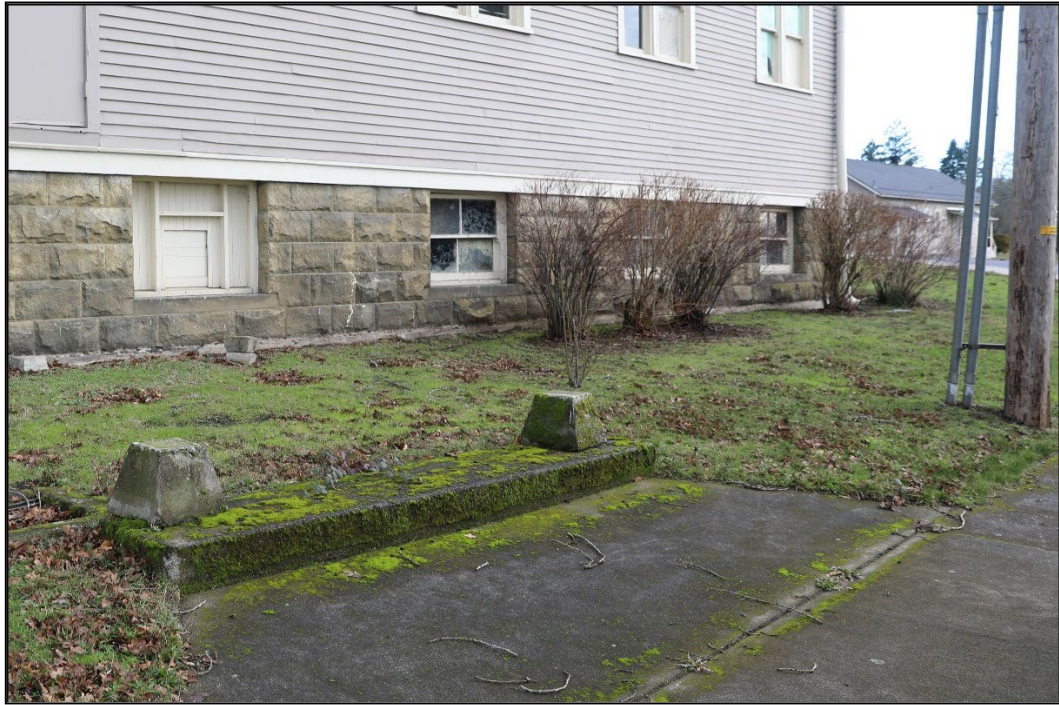
*Figure 33. Noncontributing hedges and shrubs along the south side of Building 721 (Gymnasium and Cafeteria) within the East Barracks. (Noncontributing, CRIS CL ID 199722-199725 (MIG January 2023))*

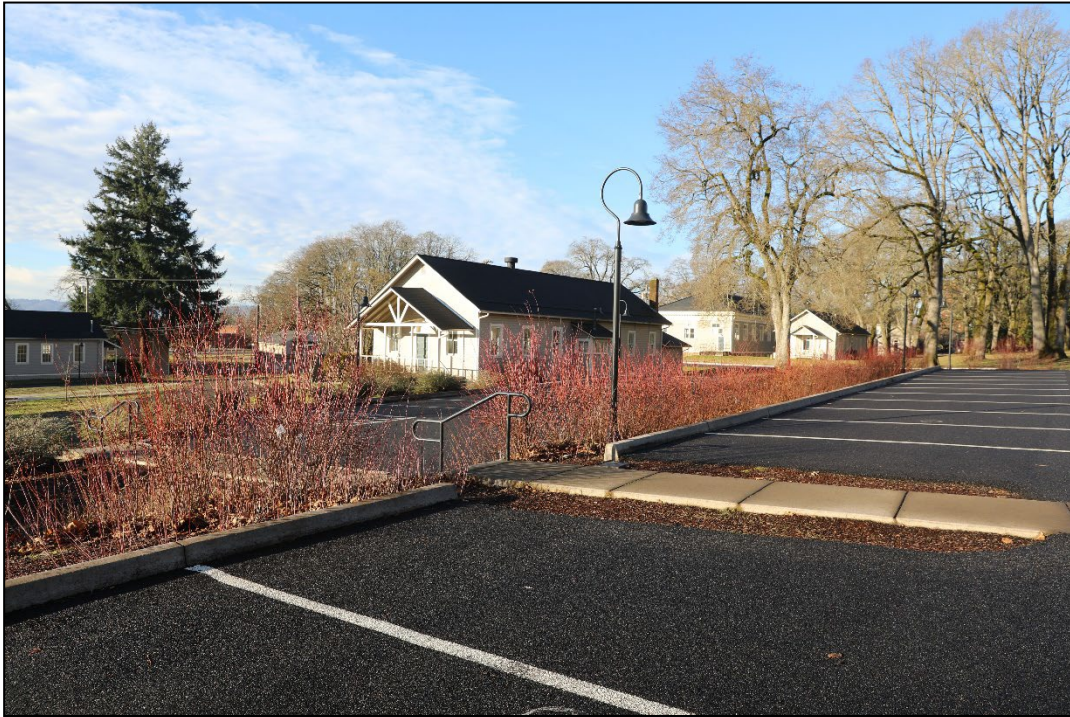
*Figure 34. Parking area plantings at the north lot. (noncontributing, CRIS CL ID 202888) (MIG January 2023)*

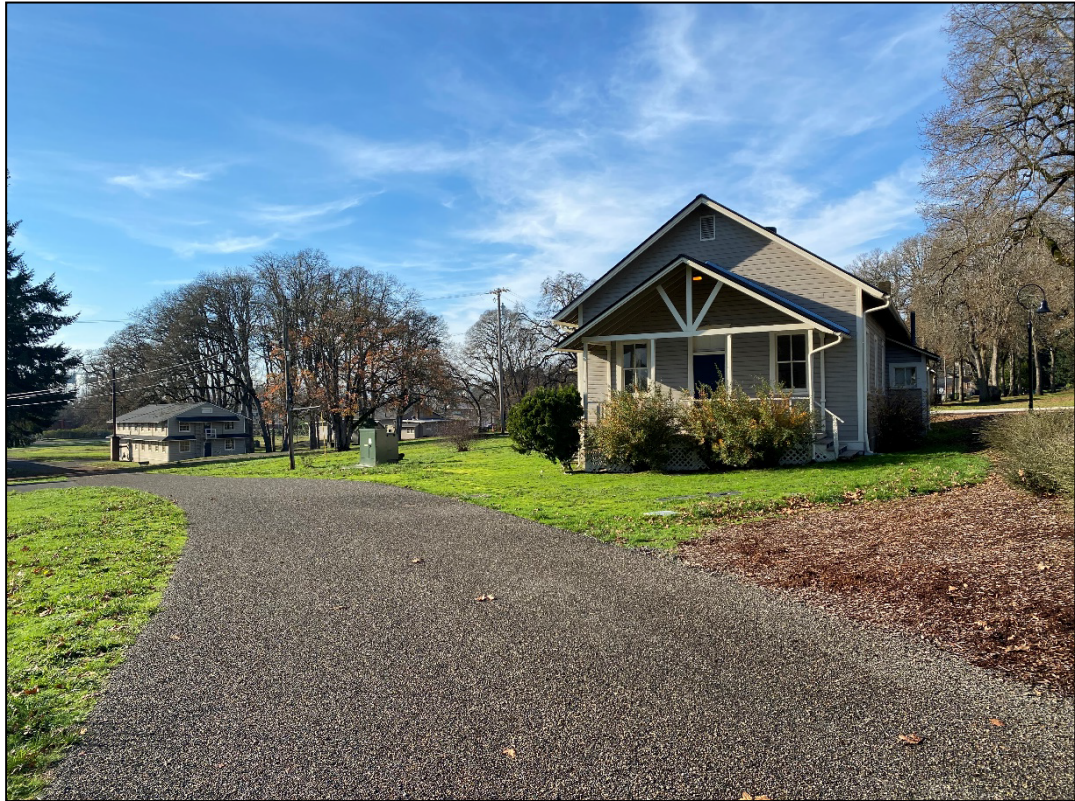
*Figure 35. Alvord Road, looking southwest. (contributing, CRIS CL ID 202889) (MIG January 2023)*

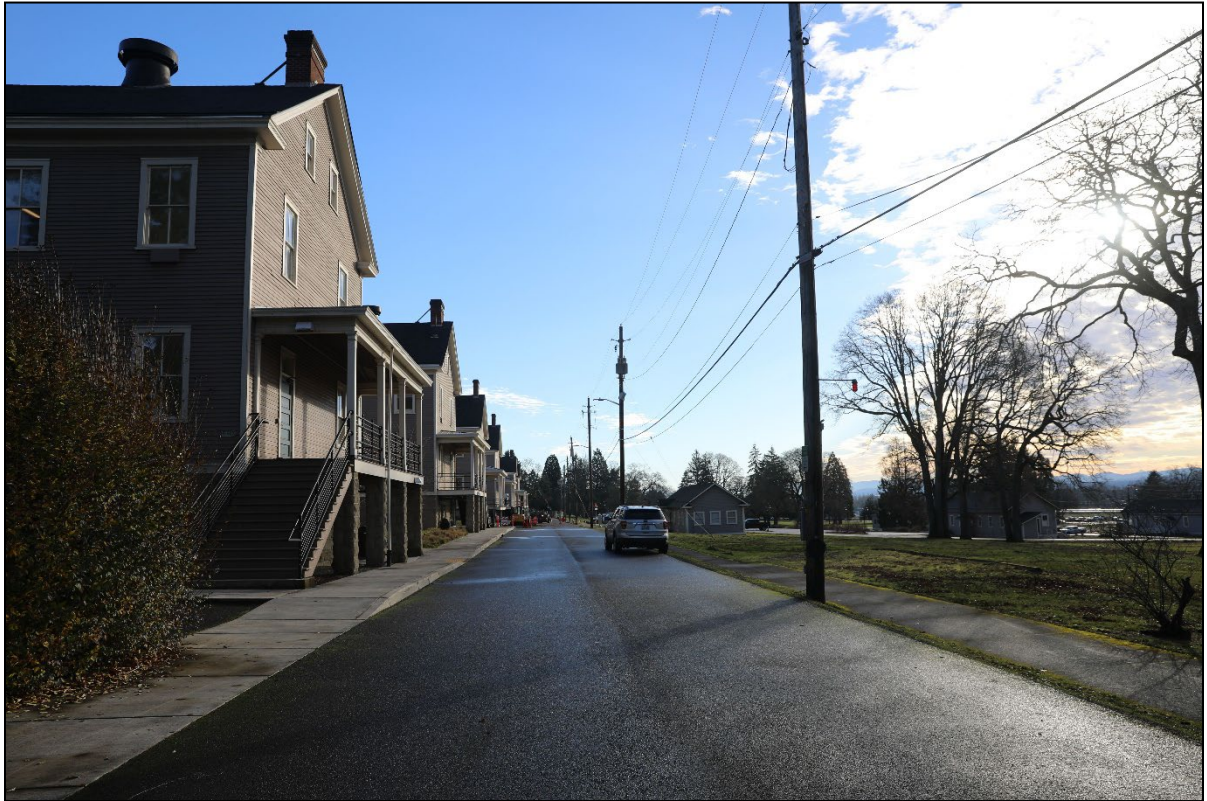
*Figure 36. McClellan Road, looking east from building 987. (Contributing, CRIS CL ID 202890) (MIG January 2023)*

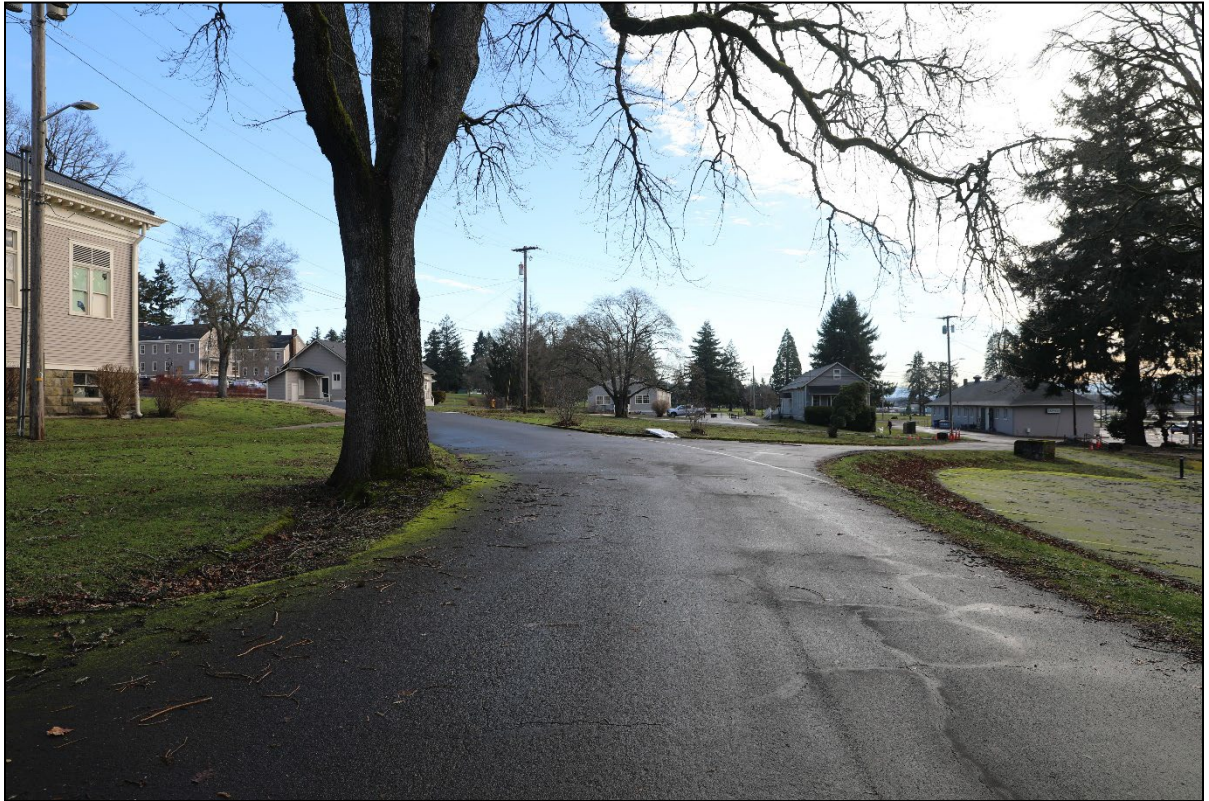
*Figure 37. Hatheway Road, looking east from building 721. (Contributing, CRIS CL ID 202891) (MIG January 2023)*

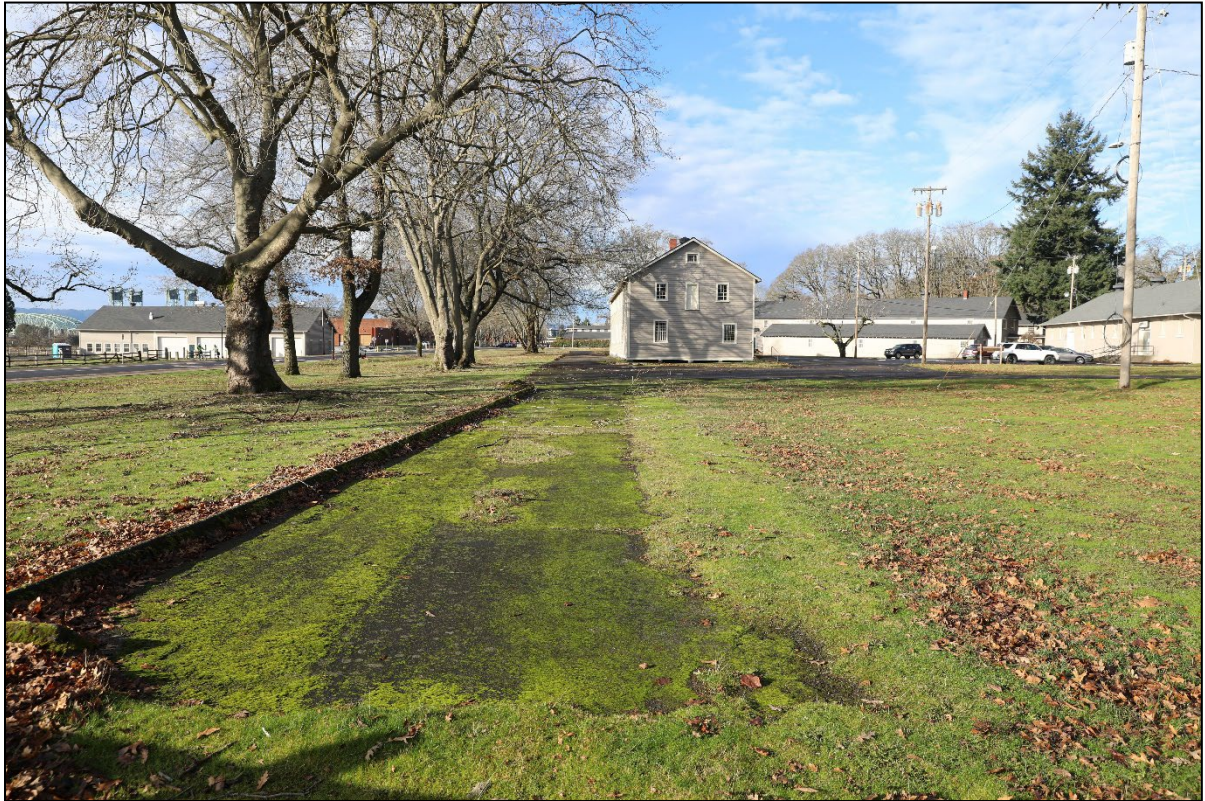
*Figure 38. Trace of former Unnamed Road, looking west from near Access Road (Contributing, CRIS CL ID 202892) (MIG 2023)*

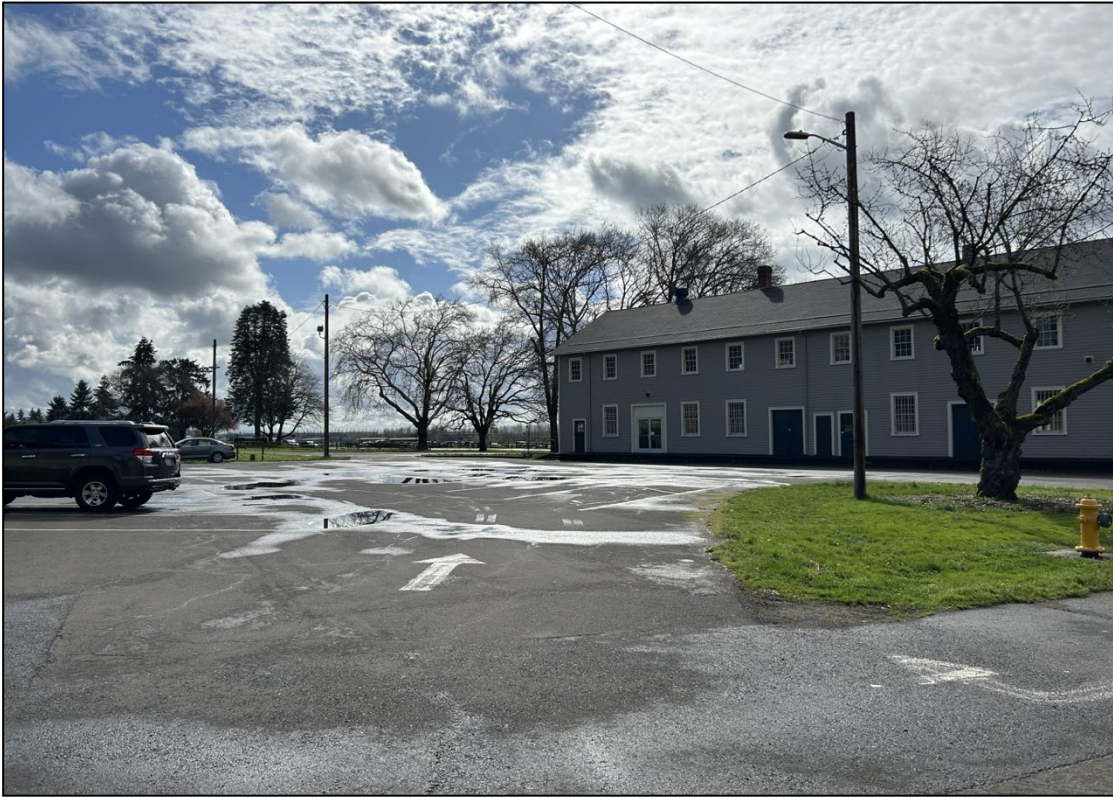
*Figure 40. Central Lot Parking Area (Contributing, CRIS CL ID 202893) (NPS 2024)*

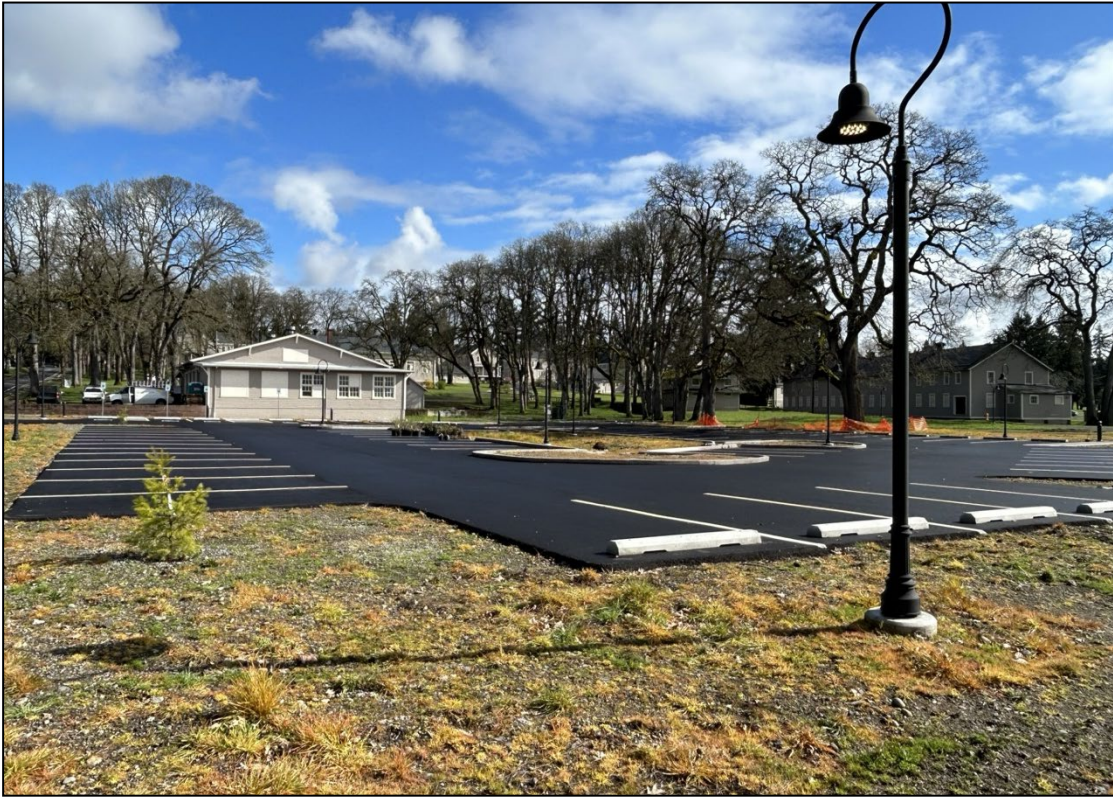
*Figure 42. Crossroads Lot Parking Area (Noncontributing, CRIS CL ID 202896) (NPS 2024)*

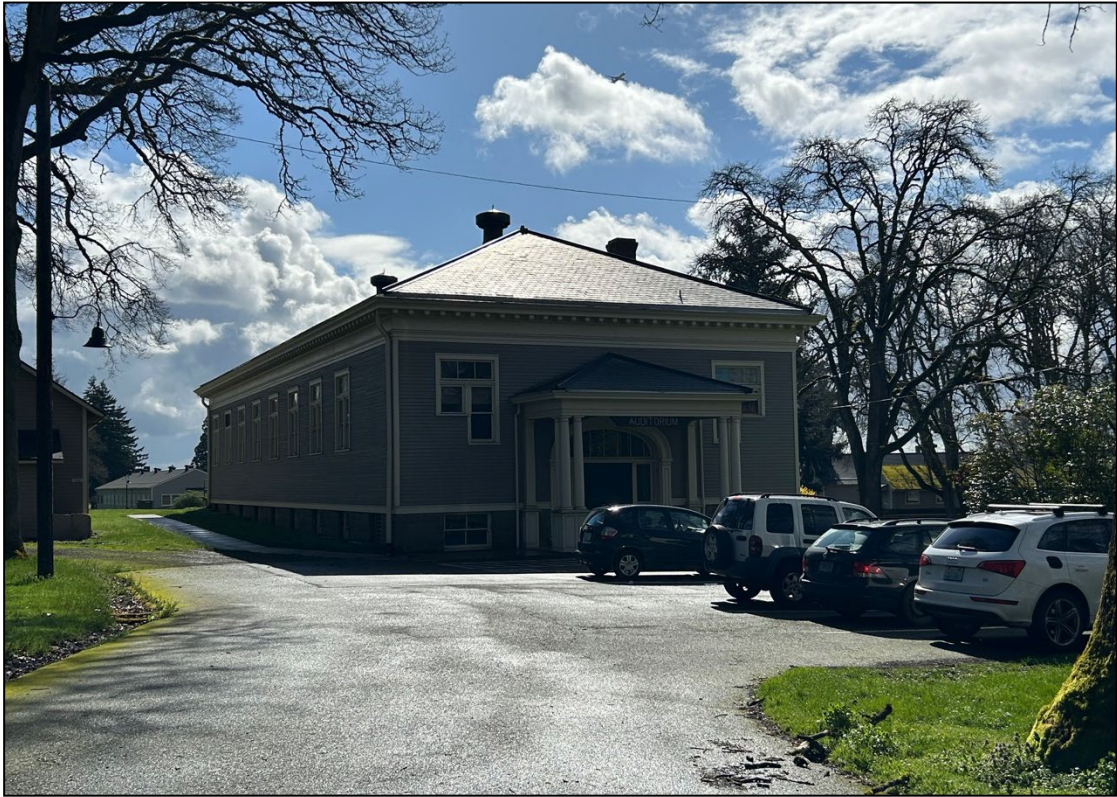
*Figure 43. Gymnasium Lot Parking Area (Noncontributing, CRIS CL ID 202897) (NPS 2024)*

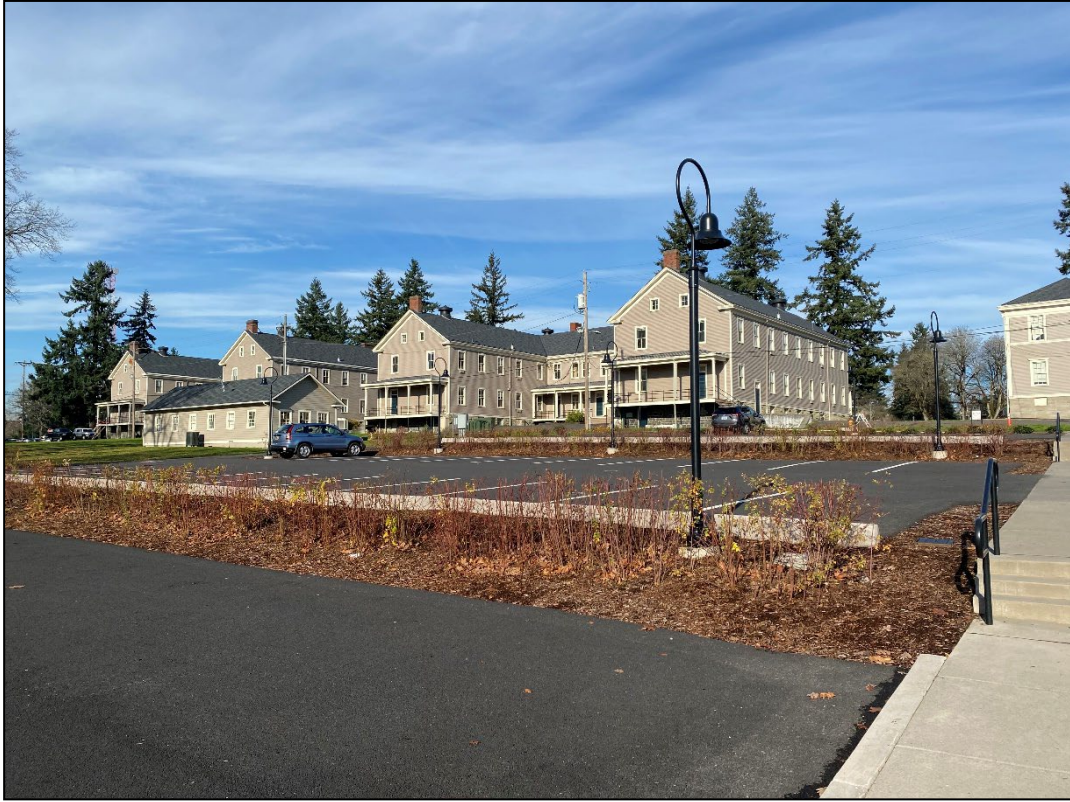
*Figure 44. The North Lot ABC parking area, looking northwest. (Noncontributing, CRIS CL ID 202899) (MIG January 2023)*

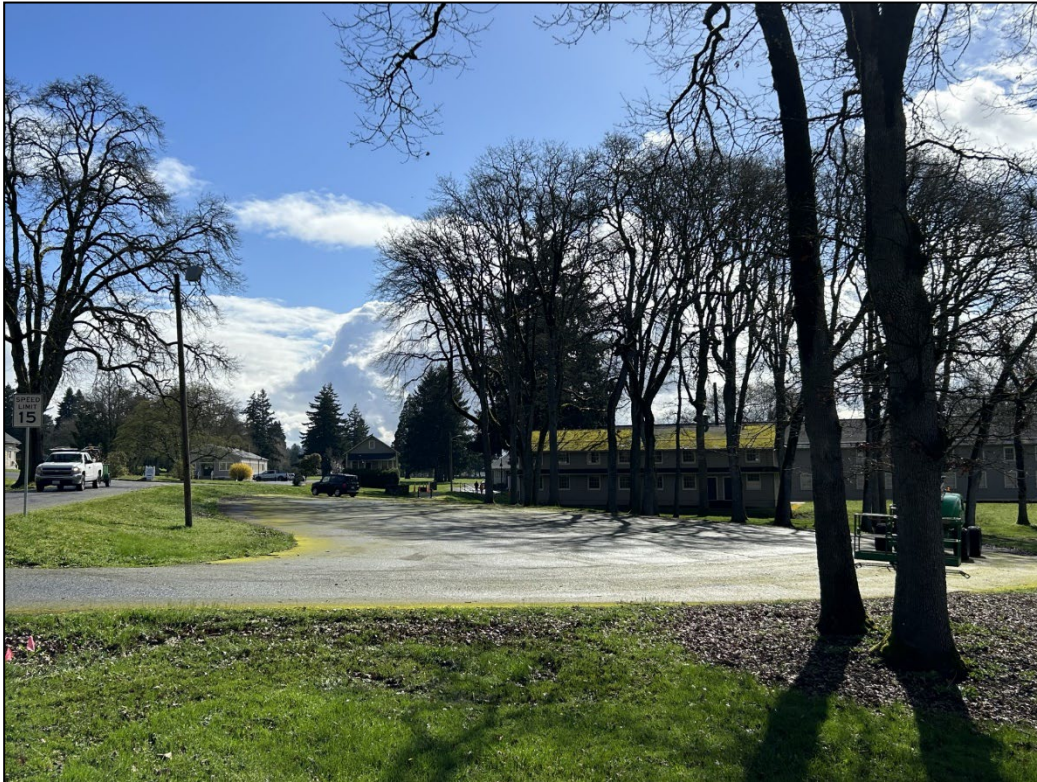
*Figure 45. Hatheway Lot (noncontributing, CRIS CL ID 202900) (NPS, 2024)*

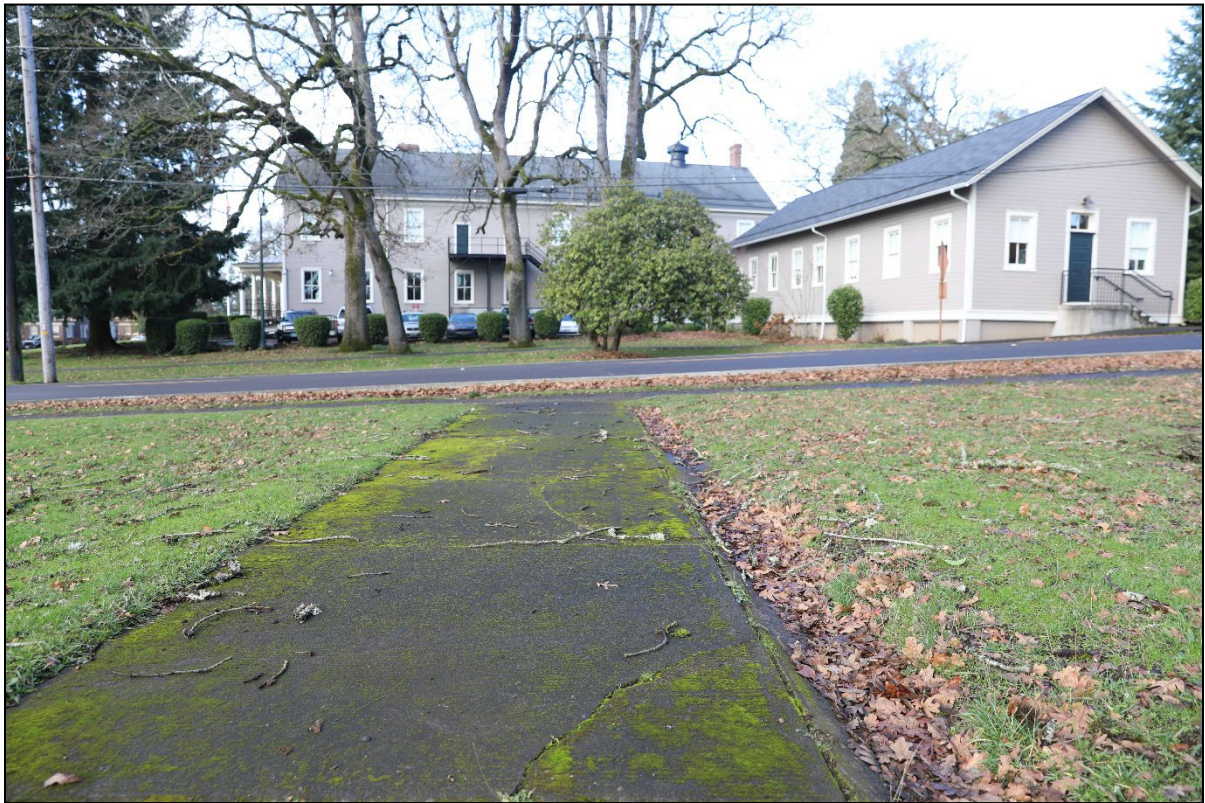
*Figure 47. View of typical pedestrian circulation: concrete sidewalks and pathways near Fort Vancouver Way.  
(contributing, CRIS CL ID 202901) (MIG January 2023)*

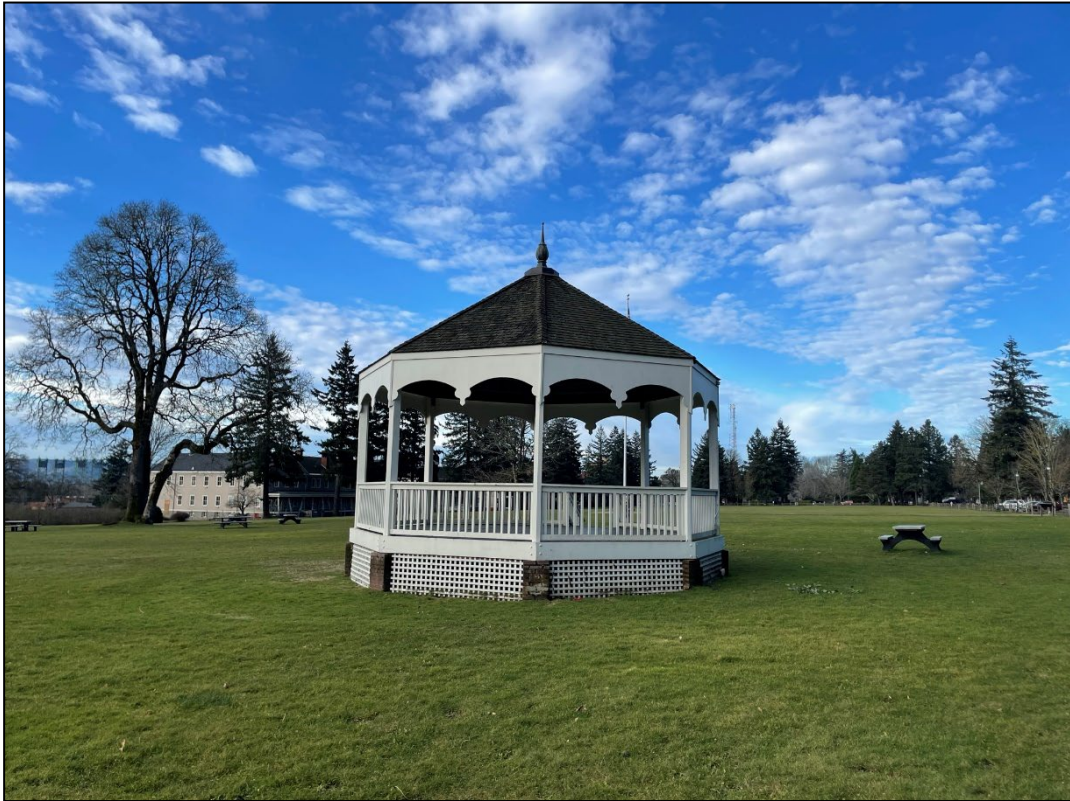
*Figure 64. Bandstand on eastern edge of Parade Ground Bandstand (Noncontributing, CRIS CL ID 104880, CRIS HS ID 1170705) (MIG January 2023)*
