**National Park Service**  
**Cultural Landscapes Inventory**  
**2024**

**East Barracks/Parade Ground**  
**Fort Vancouver National Historic Site**

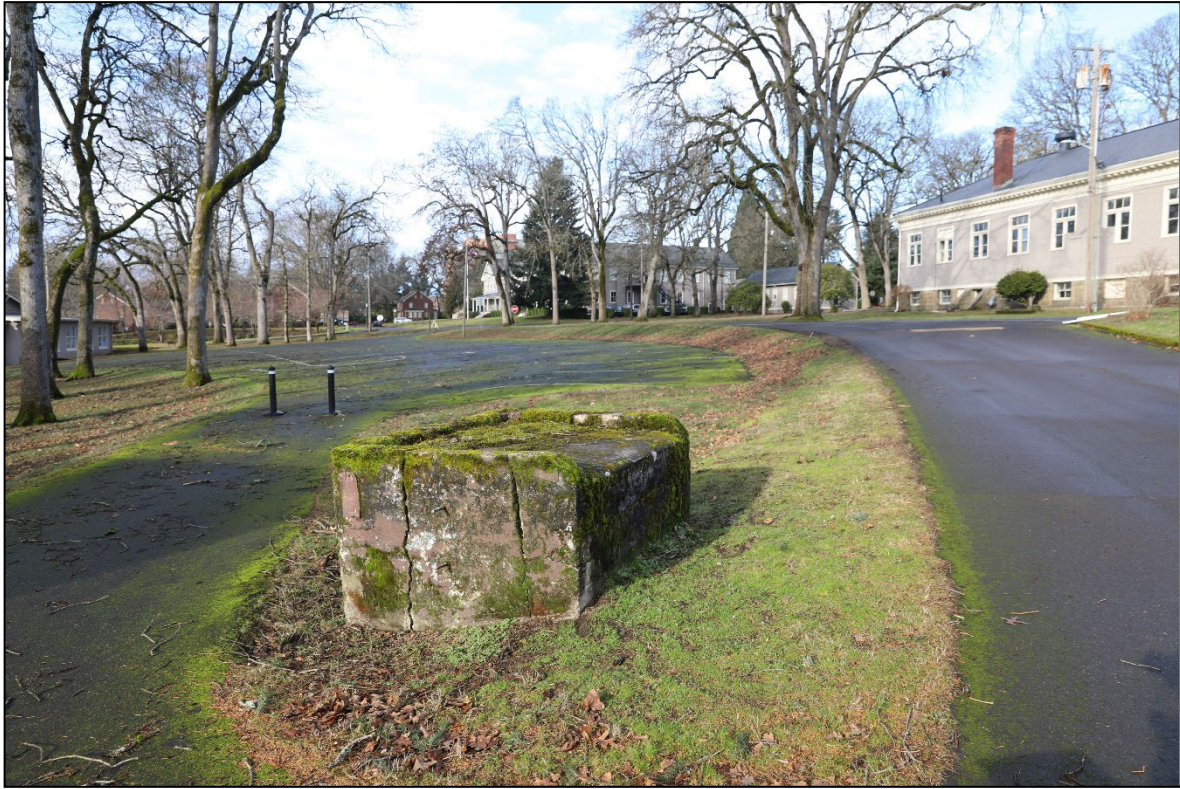
*Figure 65. Concrete Platform (contributing, CRIS CL ID 202920) (MIG January 2023)*

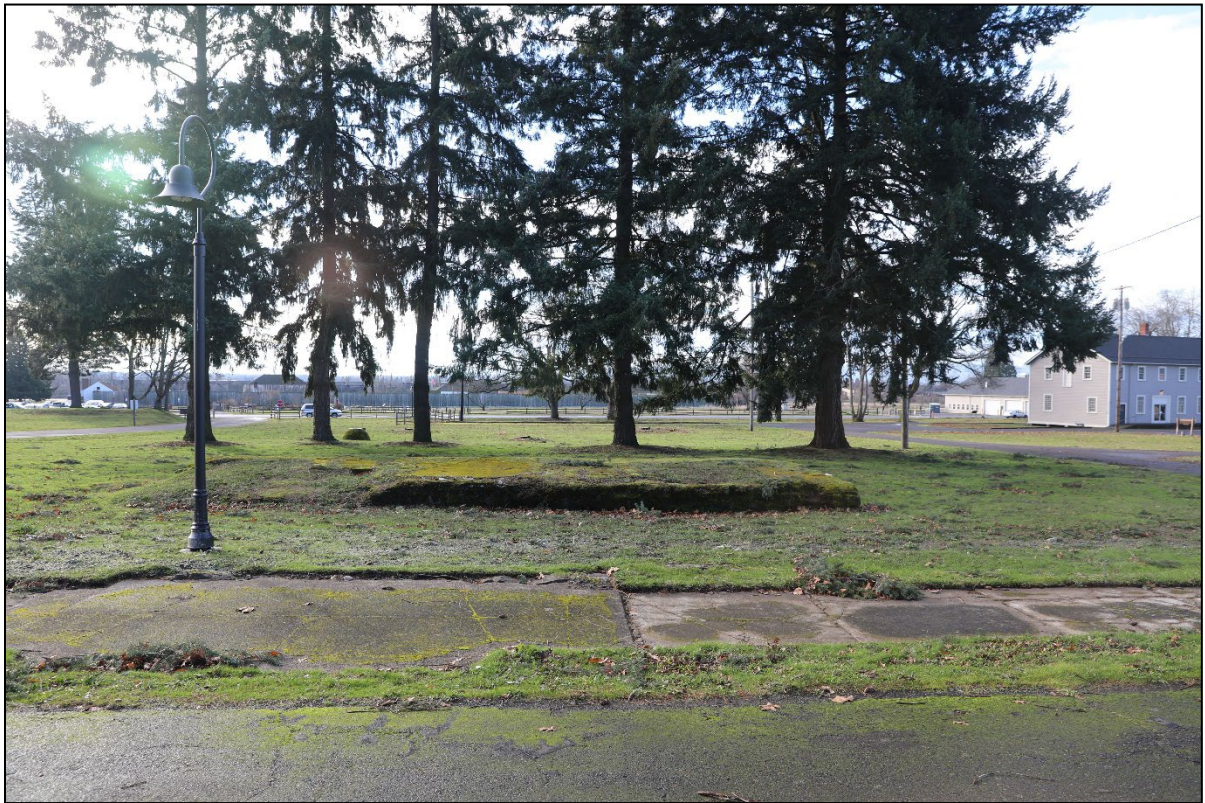
*Figure 66. Historic Bakehouse Building Foundation. (contributing, CRIS CL ID 202921 (MIG January 2023))*

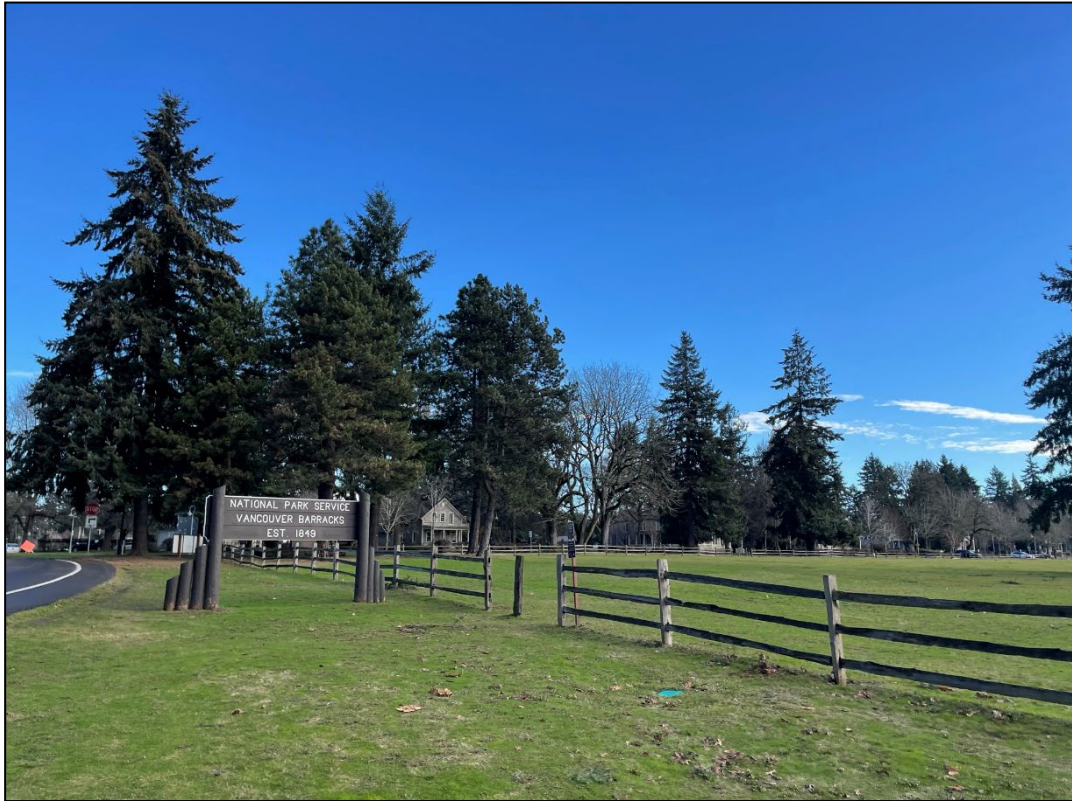
*Figure 67. Fence along the western boundary of the Parade Ground. (noncontributing, CRIS CL ID 202922) (MIG January 2023)*

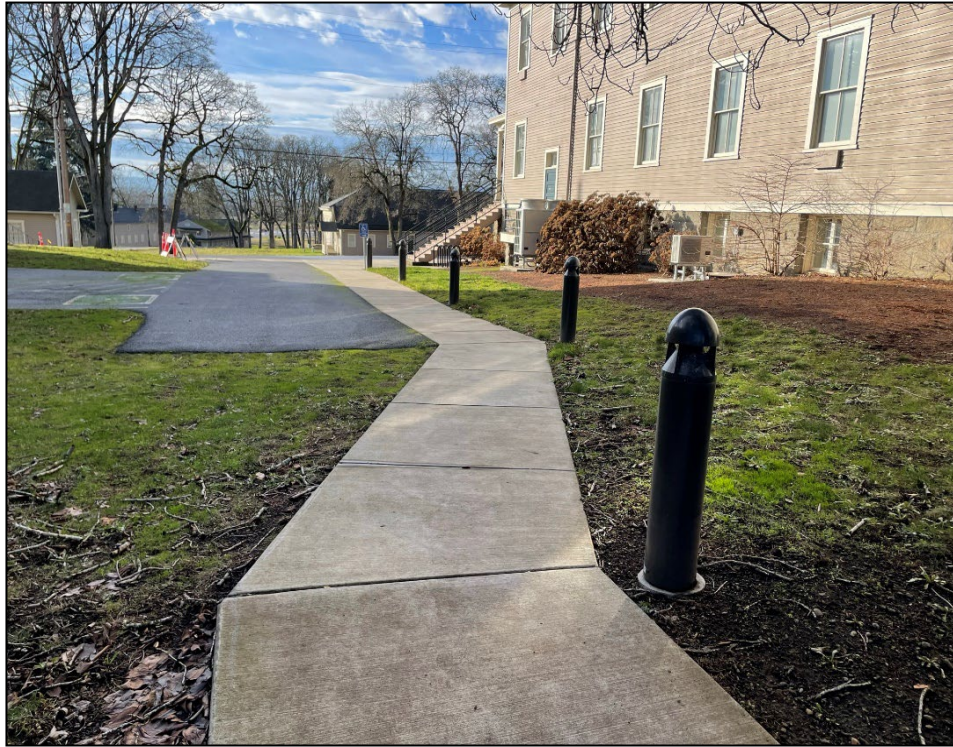
*Figure 70. Lighted bollards between buildings 987 and 989. (noncontributing, CRIS CL ID 202925) (MIG January 2023)*

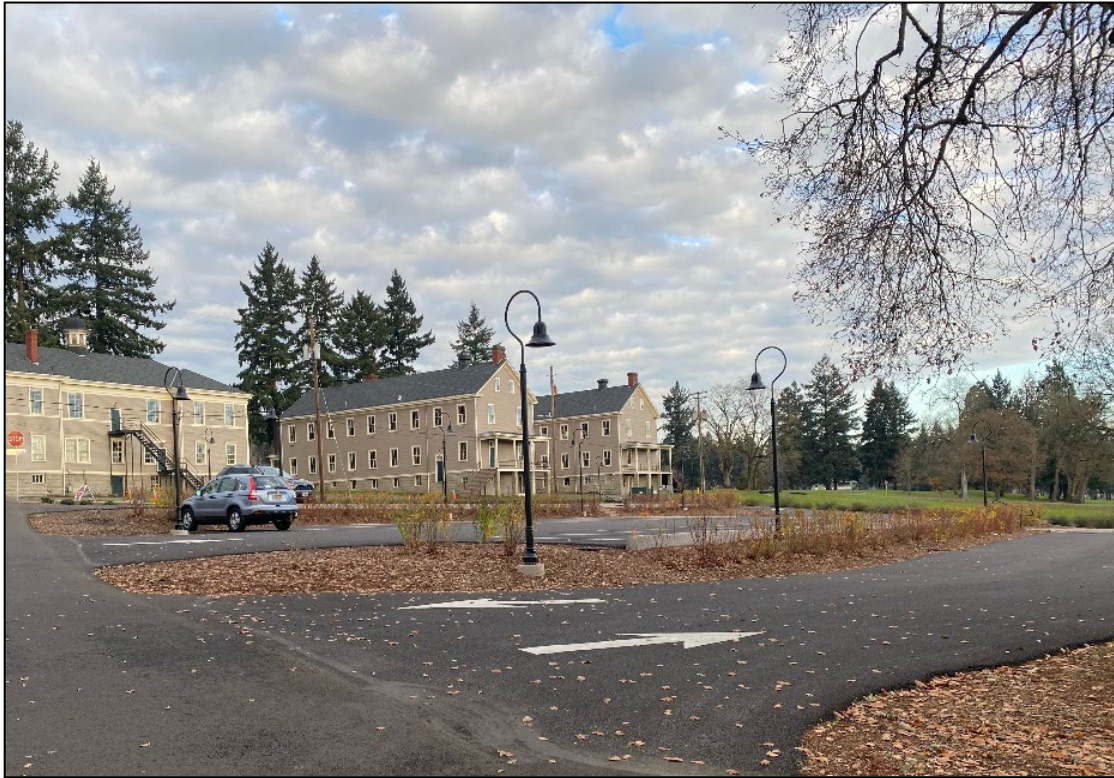
*Figure 71. Light poles with a shepherd's hook curve at the top, in the North Lot. (noncontributing, CRIS CL ID 202926) (MIG January 2021)*

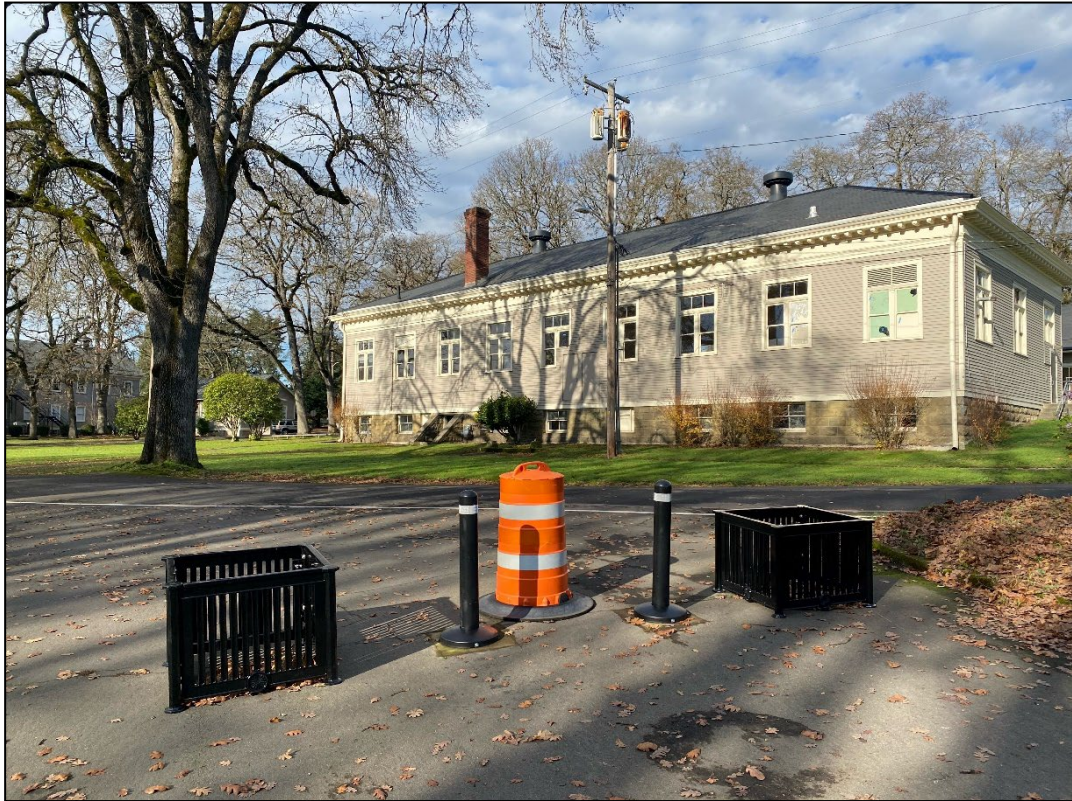
*Figure 75. Planter Bollards, with no plants. (noncontributing, CRIS CL ID 202929) (MIG January 2023)*

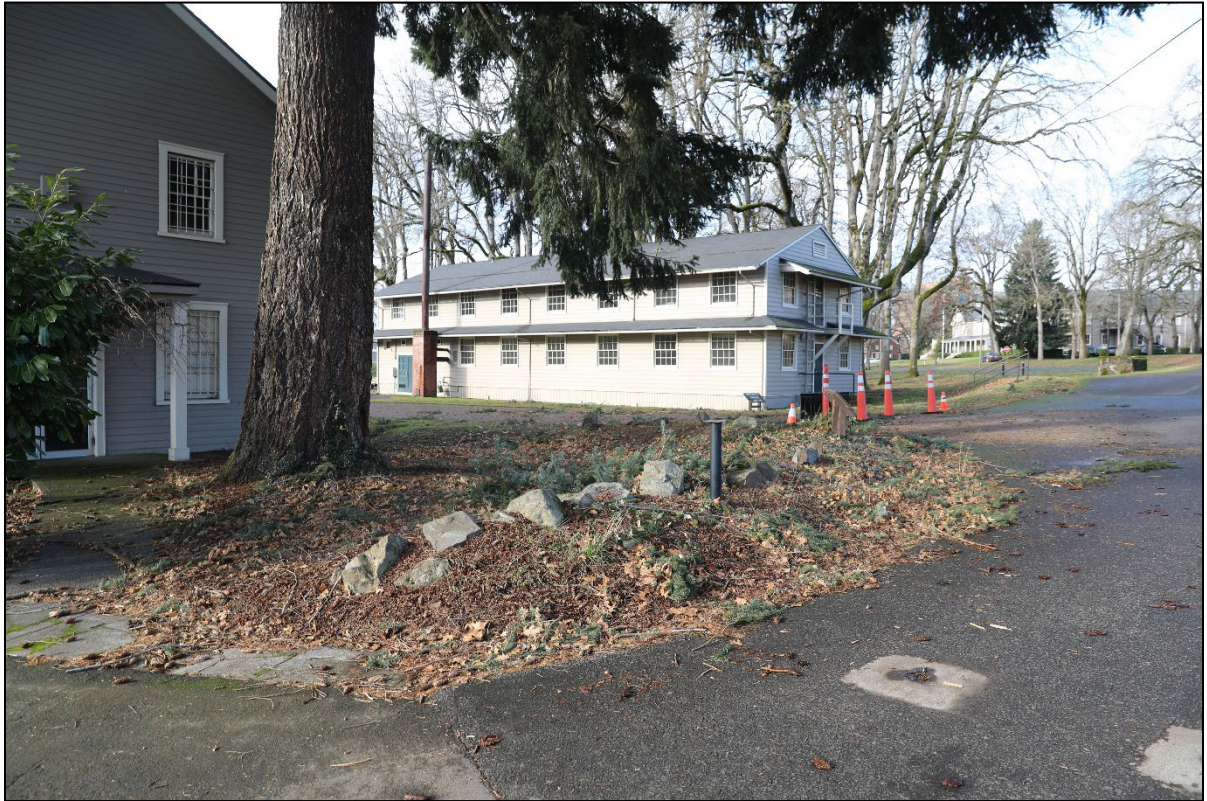
*Figure 78. Basalt Edging. (noncontributing, CRIS CL ID 202932) (MIG January 2023)*

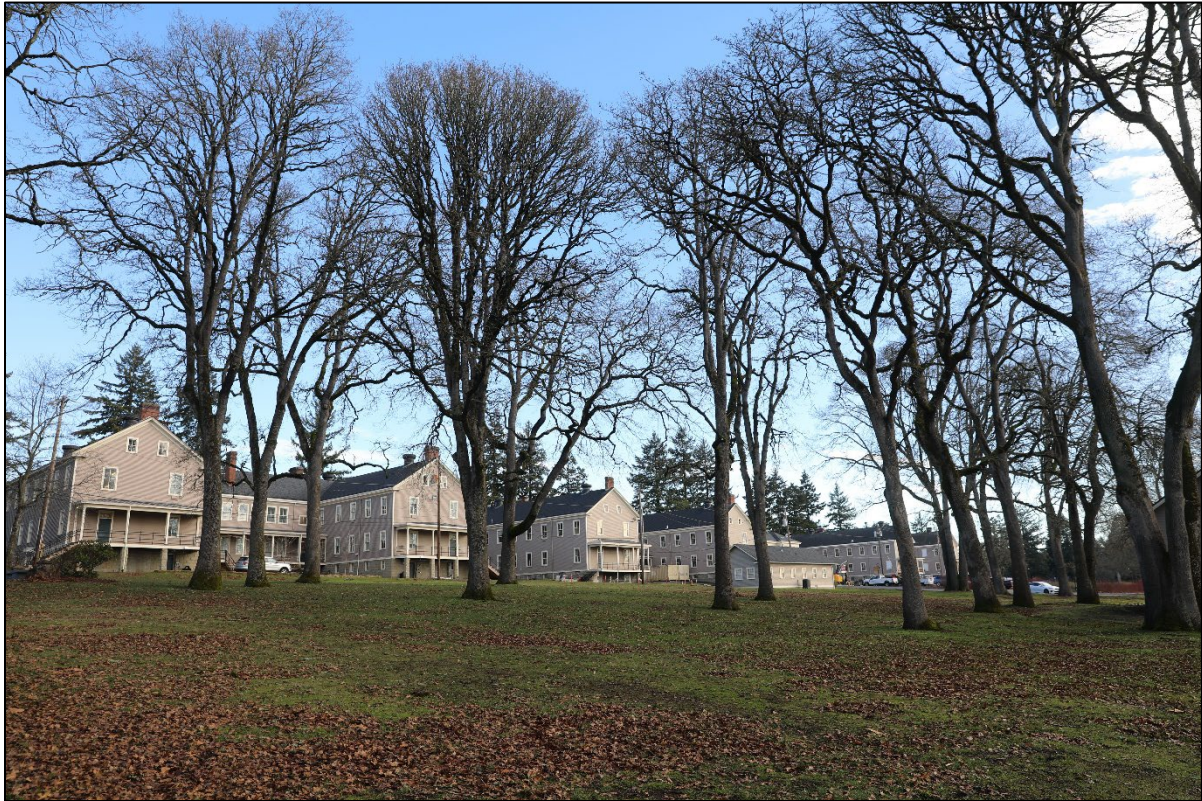
*Figure 80. The approximate site of the Hudson's Bay Company Cemetery, looking northeast towards a grove of Oregon White oaks and buildings 987 and 989. (Contributing, CRIS CL ID 202934) (MIG January 2023)*
