FORT VANCOUVER EXCAVATIONS - X

Southeastern Fort Area

National Park Service

July 1975

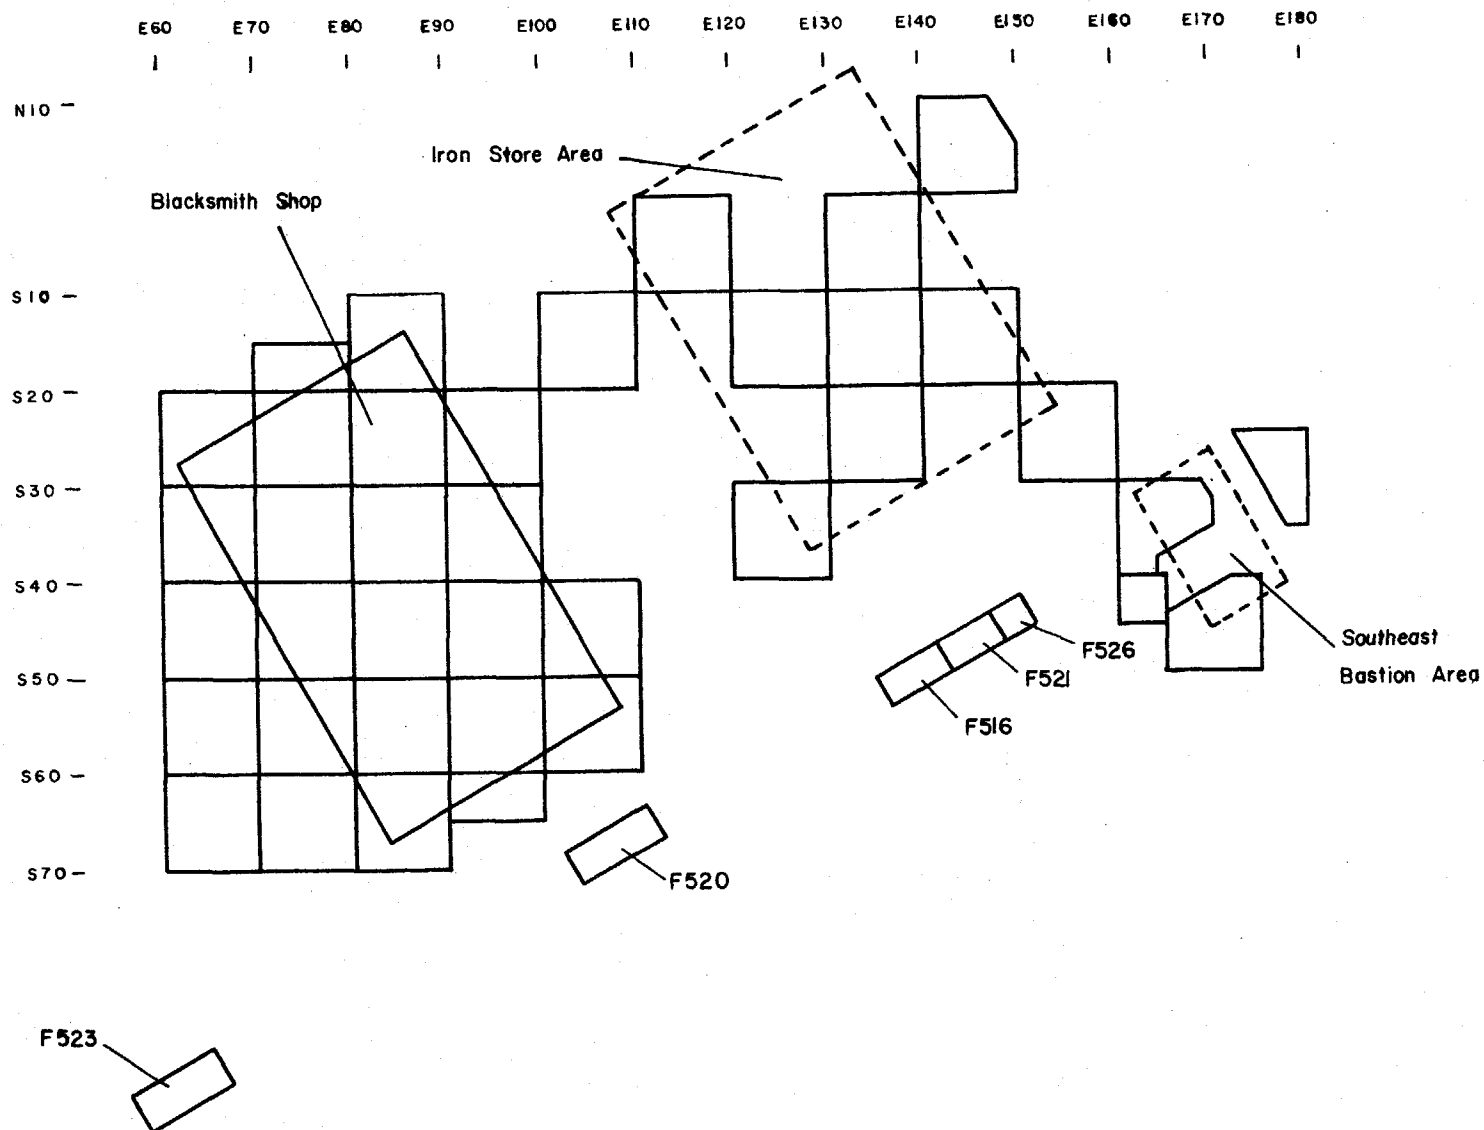
Fig. 2 -- Excavation units and HBC structural locations for the southeastern Fort area.

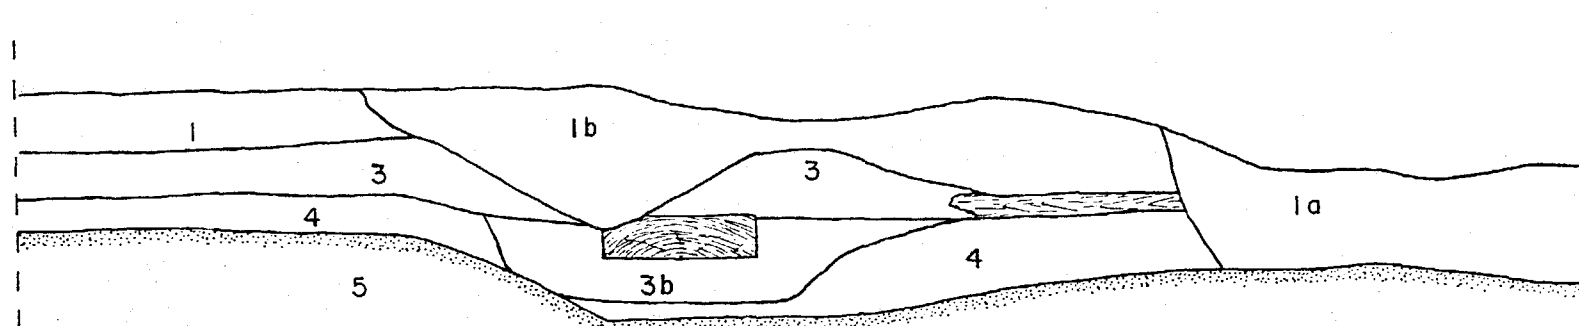
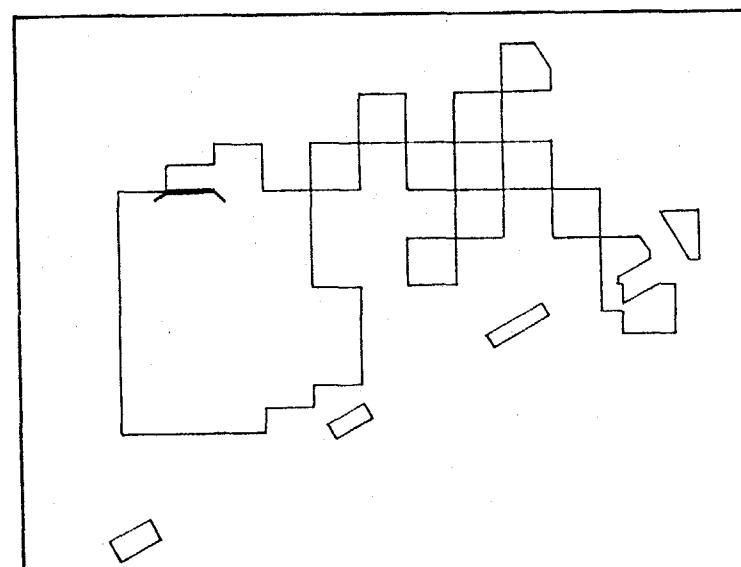
Fig. 3 -- Stratigraphic profile of the north wall of excavation unit S30 E80 in the Blacksmith Shop.

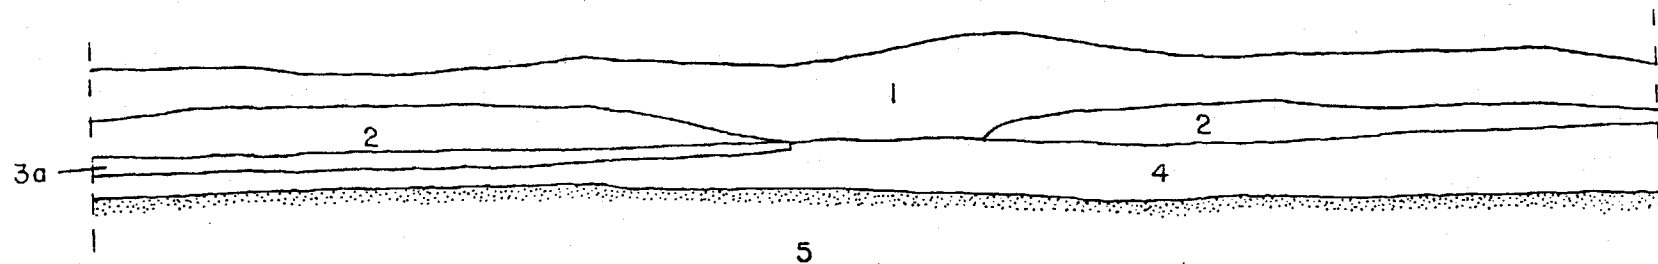
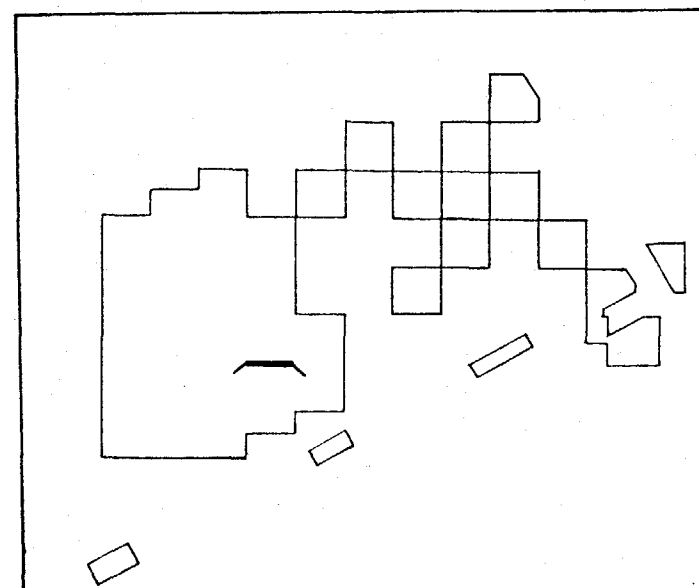
Fig. 4 -- Stratigraphic Profile of the north wall of excavation unit S60 E100 in the Blacksmith Shop.

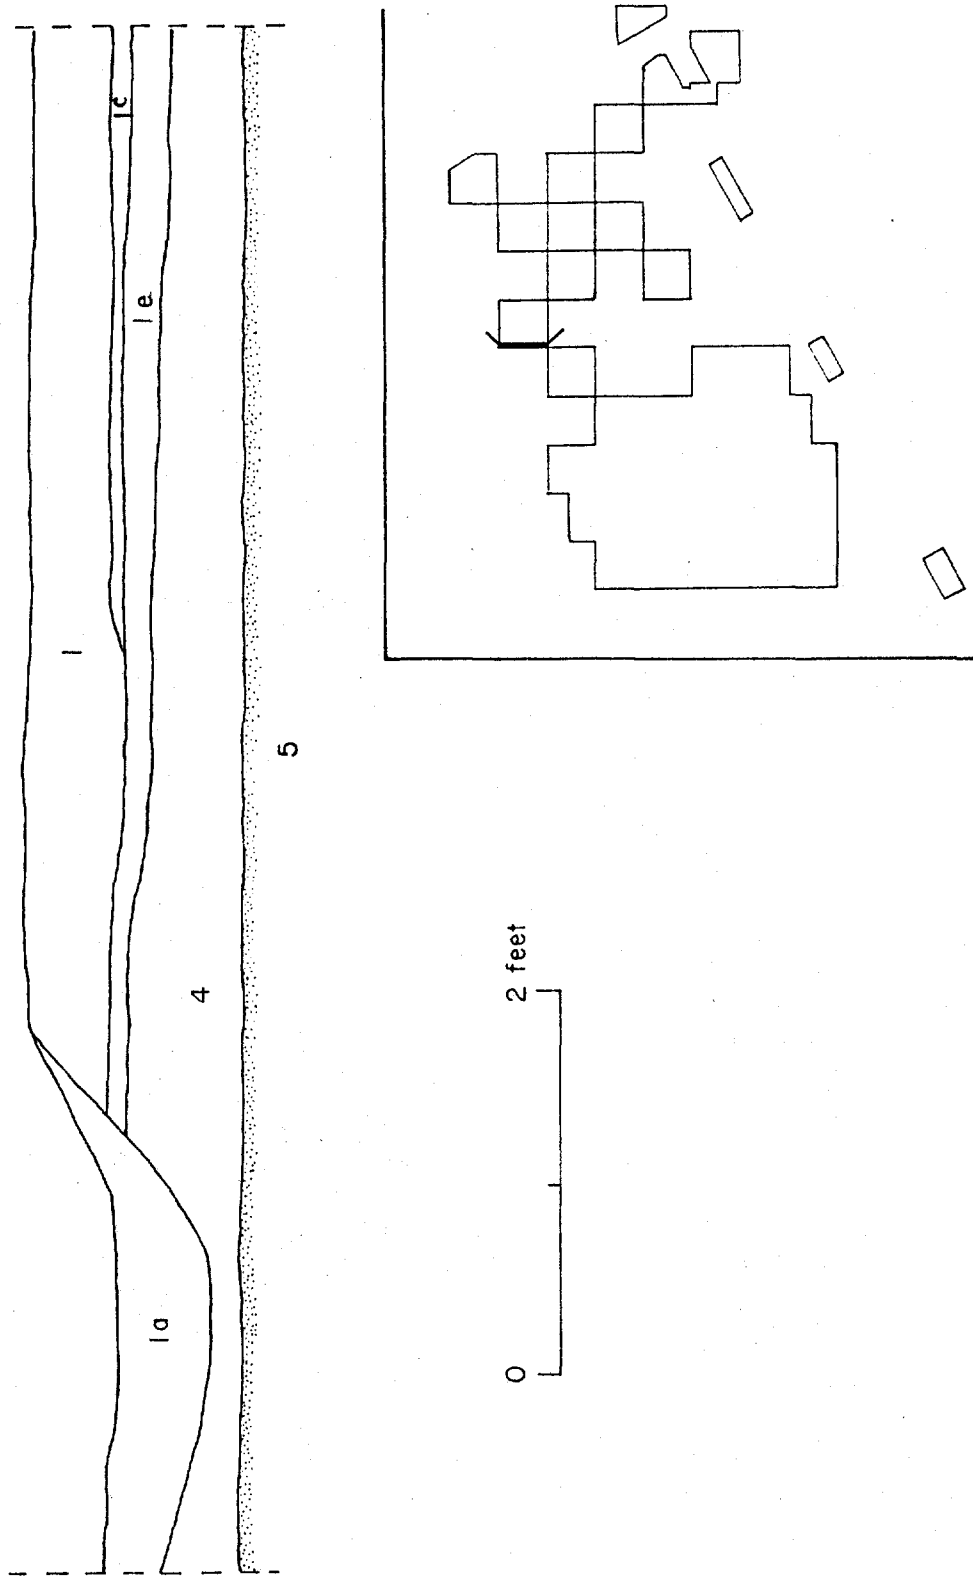
Fig. 5 -- Stratigraphic profile of the west wall of excavation unit S10 E120 in the Iron Store.

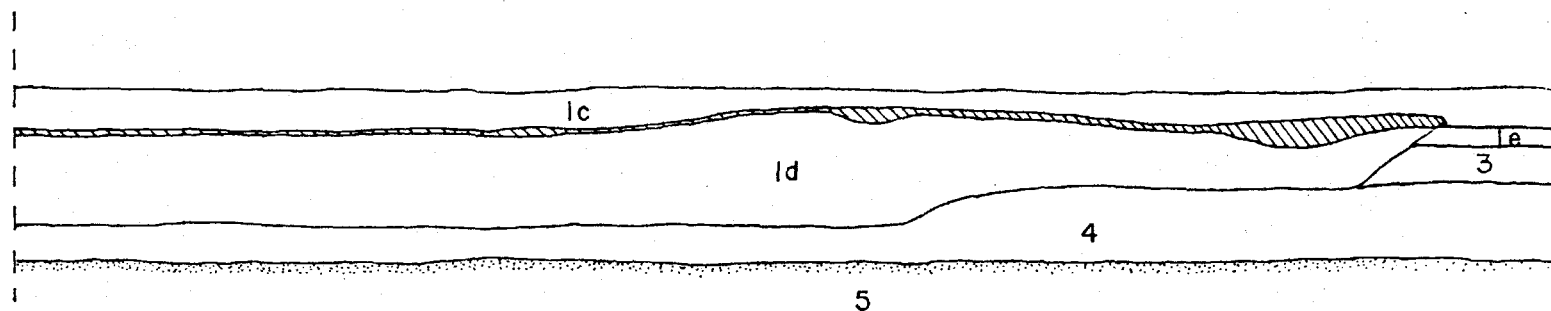
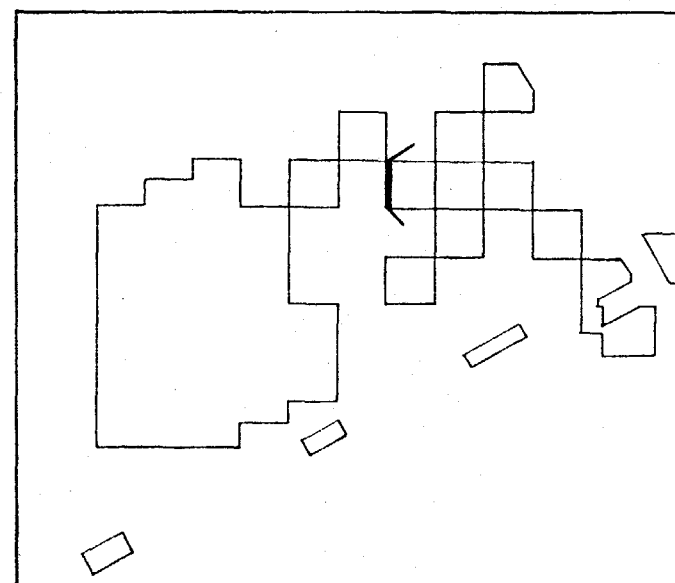
Fig. 6 -- Stratigraphic profile of the west wall of excavation unit S20 E130 in the Iron Store.

In addition to the above features, 2 USA strata (Table 2, Strata 1c-d) were observed in the Iron Store area. In a few areas these strata were separated by a layer of burned material (Fig. 6), and the lower deposit differed from the upper (1c) by the inclusion of additional silts (Stratum 1e). Within the burned zones, numerous wire nails were observed, and comparisons with a map of past excavations (Caywood 1955: sheet 6 of map 2) indicated that the deposits represented pre-NPS deposition.

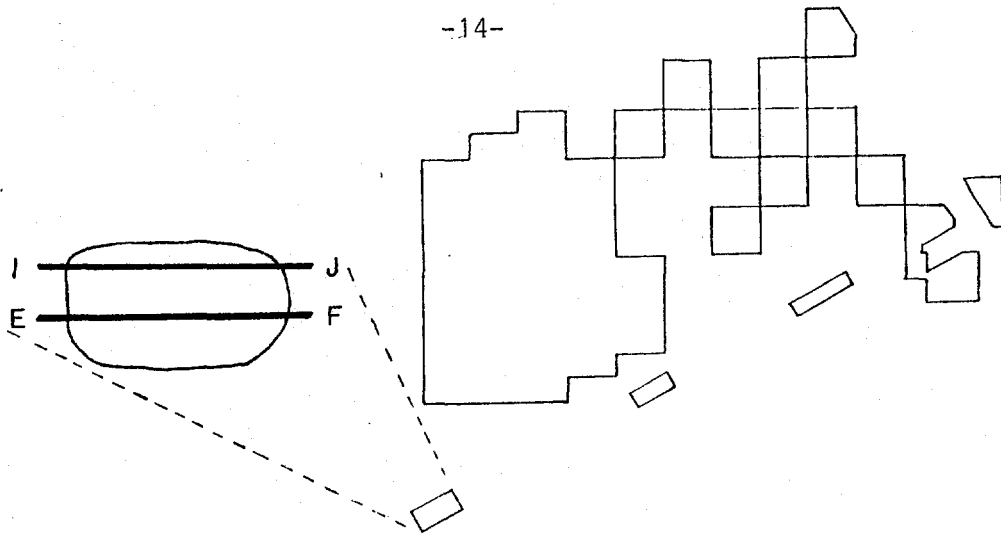
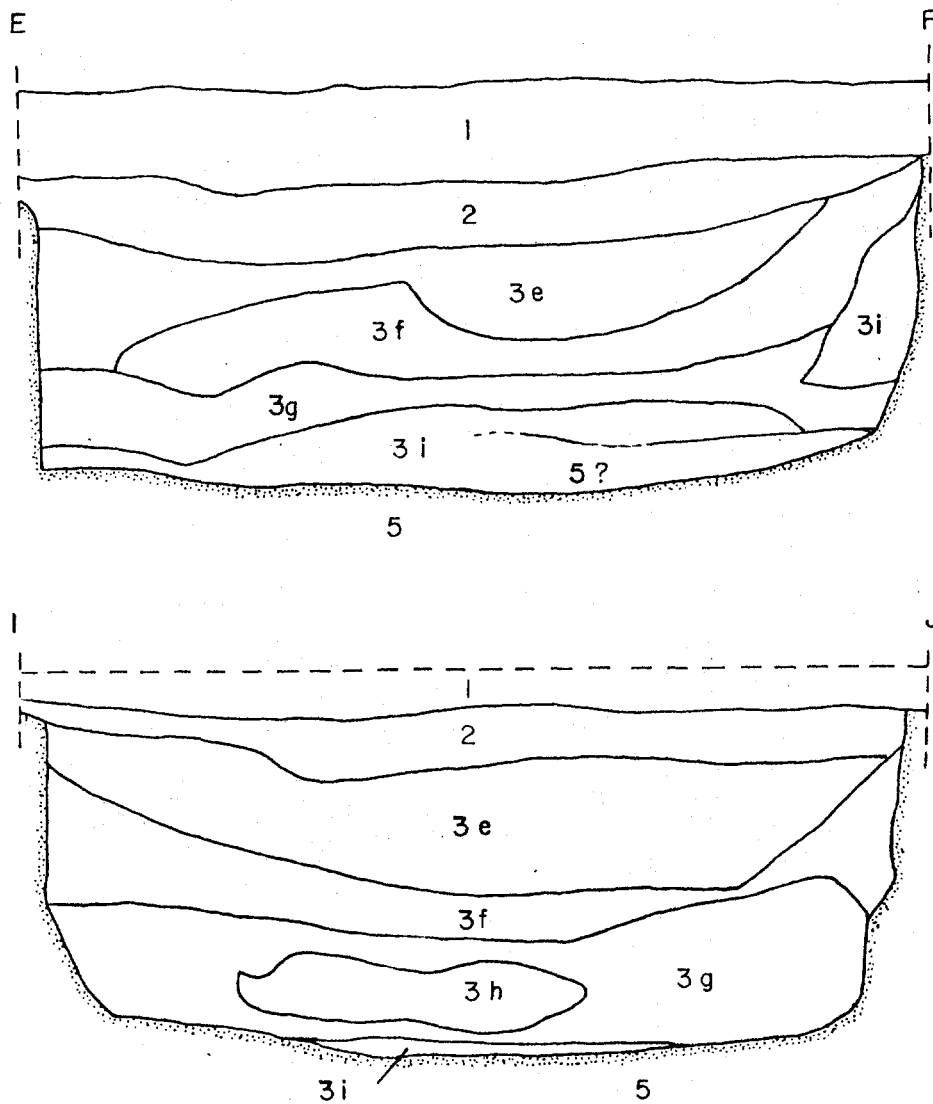
Fig. 7 -- Stratigraphic profiles in the Indian Trade Store Privy/Trash Pit (F523).

Stratum 2 of the Indian Trade Store Privy/Trash Pit was characterized by a brown soil matrix with inclusions of coal, charcoal and HBC artifacts. This stratum was a striking contrast to the heavy metal concentrations of stratum 3 found immediately beneath (Fig. 7). The distinction between Strata 1 and 2 was not as easy to observe and there was a tendency for the 2 strata to blend together.

Stratigraphically, the flood deposit was the first (or lowest) stratum in the Indian Trade Store privy (F523), a pit excavated after 1834/36; and was truncated by the 1841 East Stockade and covered by Stratum 3c, 1841-1845 stockade backfill (Figs. 7-8). Like the previously described late 19th Century flood, this ca. 1834/36-1841 flood must have been an extremely high flood; and its limited occurrence within the southeastern Fort area can be explained by the geographic position of the fort relative to the natural soil deposits (see discussion on pre-1829 Columbia River Floodplain Deposits). The natural soil deposit in the southeastern Fort area is the Sauvie silt loam (McGee et al. 1972). One soil sample was collected from Stratum 3i of F516 (Fig. 9) by Bill Alderman of the U.S. Department of Agriculture, Soil Conservation Service. A variety of tests were performed on this sample (see Appendix 1), and the mechanical sieve and hydrometer analyses documented the fact that this stratum is a silt loam composed of 21% clay, 71.5% silt, 6.5% sand and 1.0% gravel.

Archaeologically, the privy (F523) was located directly behind the southeast corner of the building known as the Indian Trade Store (Fig. 1) and adjacent to the ca. 1834/36-1854 South Stockade (Fig. 16a; see also Hoffman & Ross 1975). Elongated east-west, or parallel to the stockade, the dimensions of the upper walls of the pit were 5.00 x 9.20 ft, narrowing slightly at the base. Pit depth ranged from 0.40 to 4.50 ft. below present surface. Excluding the modern over burden (Stratum 1) there were a total of 6 distinct stratigraphic deposits, each of varying thickness (Fig. 7). Stratum 2, characterized by brown soil with inclusions of crushed coal, charcoal and HBC artifacts, was found deposited uninterrupted over the entire upper portion of the pit. Stratum 3e contained primarily HBC metal and ash, with little or no soil. Although recorded sporadically, a wooden timber with wood scraps and charred wood scraps were found deposited at the top of Stratum 3f, occasionally separating it from Stratum 3e. Stratum 3f primarily contained HBC metal, charred and uncharred wood, and crushed coal; all found in a loose crumbly brown soil matrix. Stratum 3g was characterized by fecal remains mixed with what appear to be berry seeds in a black soil matrix. The presence of HBC metal objects in this stratum indicated mixing between Strata 3f and 3g, especially toward the northern end of the pit. Completely enclosed by Stratum 3g was a lens of sterile buff and grey soil (Stratum 3h). Found in the northern end of the pit, this stratum has been interpreted as a cave-in of the north wall. Finally, a grey clay deposit with inclusions of charcoal (Stratum 3i) was found deposited over the entire base of the pit, directly upon sterile soil. This stratum was also observed in the E-F section along the east pit wall (Fig. 7).

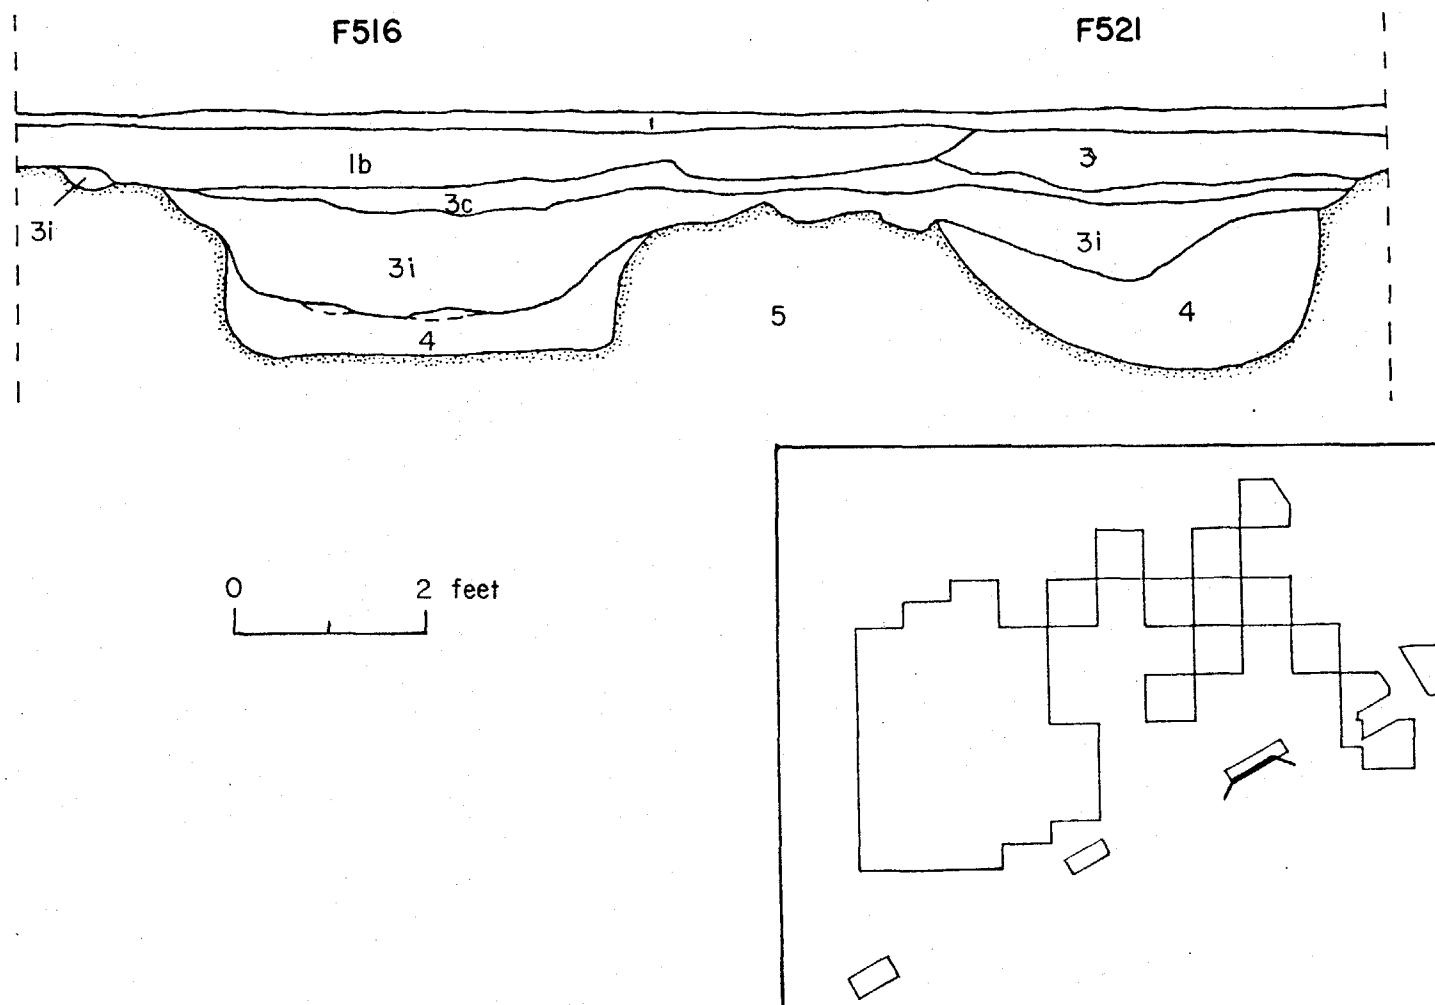
Fig. 9 -- Stratigraphic profile of the north wall of the ca. 1841-1854 South Stockade trench showing two large charred pits.

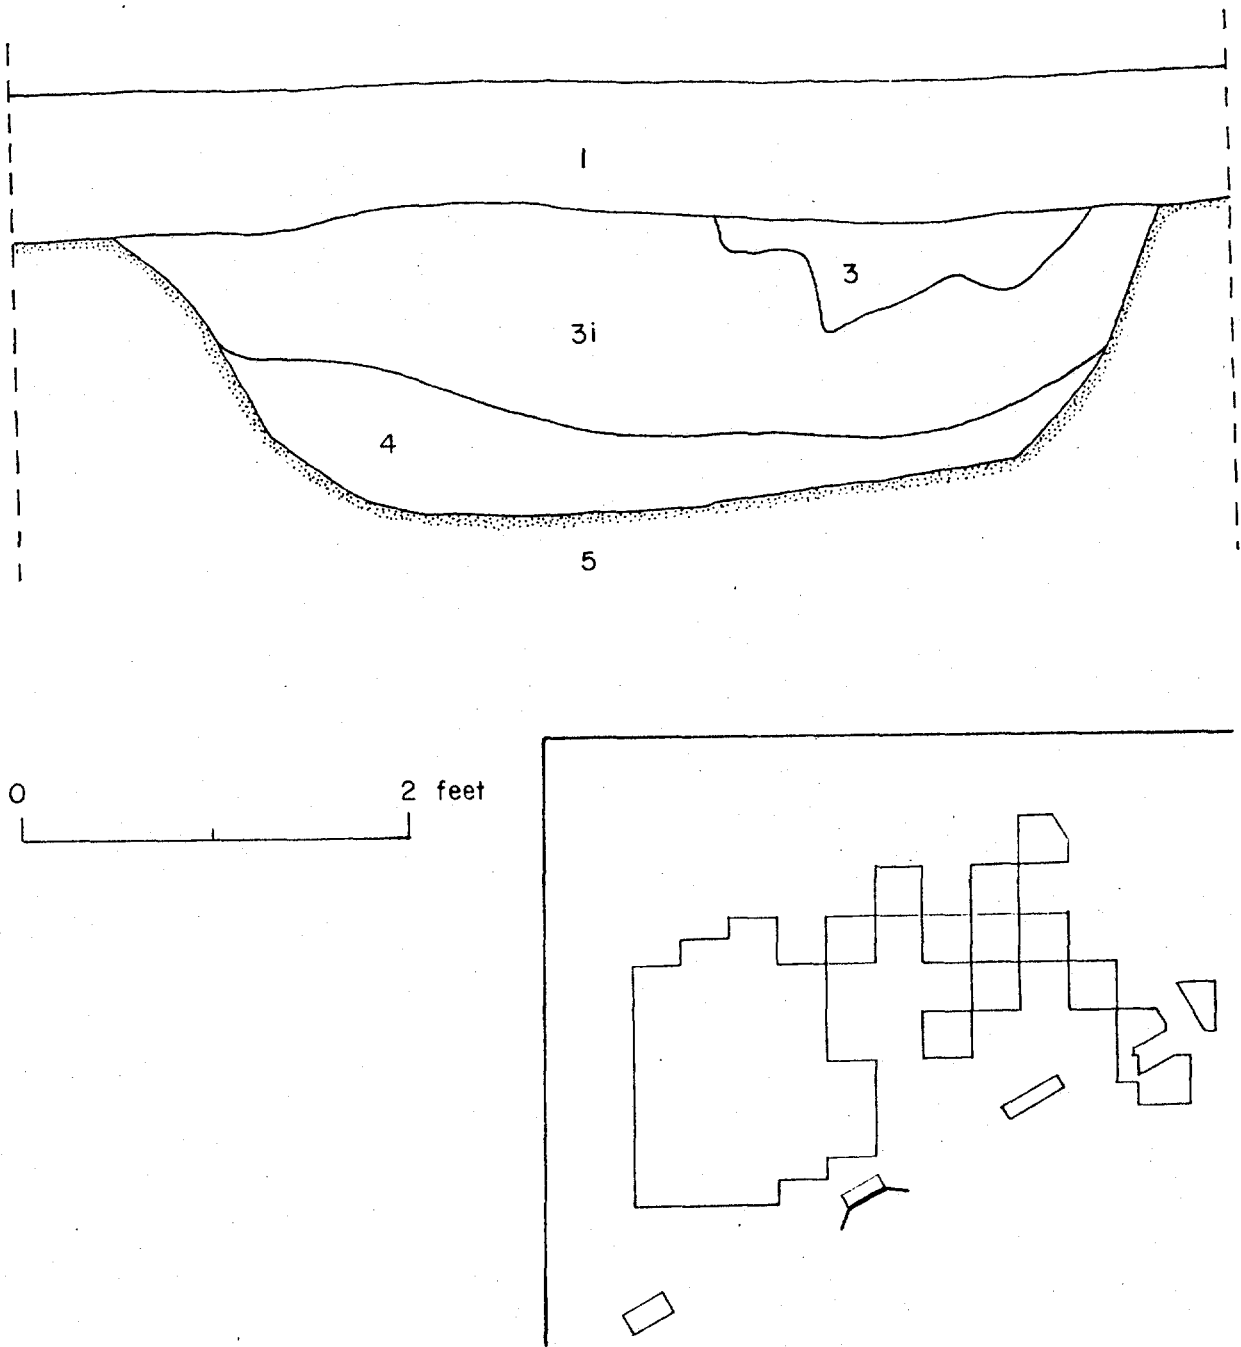
Fig. 10 -- Stratigraphic profile of a large charred pit (F520).

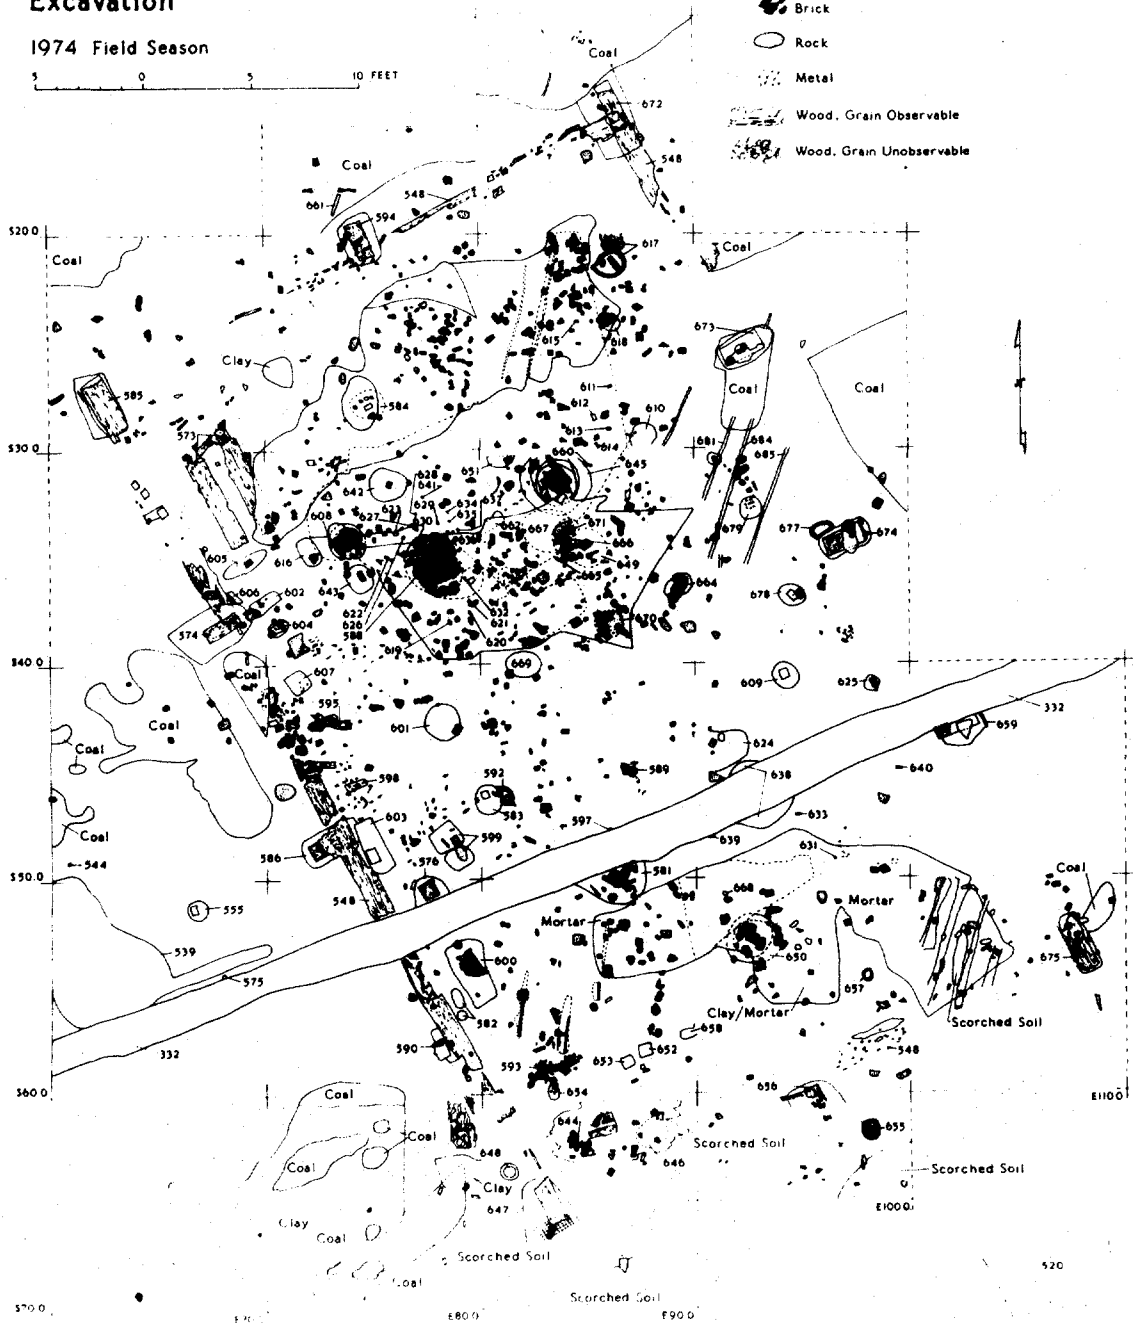
Fig. 11 -- Excavation map of the Blacksmith Shop area.

The most prominent USA feature observed was a trench prepared for a waterline (F332, Figs. 11-12). Similar trenches traversing the east-west dimension of the Fort site have been previously discussed (Hoffman & Ross 1974a:3; 1975). The second most prominent USA feature was an alignment of 5 rectangular posts (Table 3; Figs. 11-12) which were a continuation of the alignment previously reported to the west in the Indian Trade Store area (Hoffman and Ross 1975). An additional rectangular post (F680) was observed to the north of the east-west alignment in the Iron Store area (Fig. 12), but it did not appear to be associated with other USA features.

In the Blacksmith Shop area, 3 narrow linear depressions (F681, F684, F685) were observed both inside and outside the Blacksmith Shop (Fig. 11). These linear features formed parallel patterns which were skewed when contrasted with the north-south and east-west wall alignments of the Blacksmith Shop. While somewhat ambiguous, they appeared to be the remnants of plow furrows from early Army activities.

Footings were straight sided rectangular wooden blocks which, if not previously disturbed, ranged from 0.75 to 1.00 ft. in width, 1.40 to 2.00 ft. in length and 0.20 x 0.35 ft. thick. The corner footings were somewhat larger than wall footings, but they corresponded with the above dimensions, except for their lengths which ranged from 2.20 to 3.50 ft. (Table 4). Footing measurements were taken from soil casts and/or wood remains. Generally, wood preservation was better along the north, south and west walls, whereas wood of the east foundation was poorly preserved and here more emphasis had to be placed upon soil casts for measurements. As noted previously, east wall footings were the only footings in the Shop which were burned or scorched. This burning, however, was discrete and limited to areas where the east sill rested upon its footings. Orientation of all footings was perpendicular to the sill orientation (Figs. 11 and 13a).

Feature 650 consisted of a prepared pit filled with native soil and wood fragments surrounding a pit full of forging debris. Certainly the majority of the pits were located in the northern Shop half (Fig. 17). Placement of the pits was toward the center of the Shop, instead of near the walls, and roughly oriented along an east-west axis. Only 4 pits (F599, F638, F646 and F650) were located in the southern half of the Shop. Two (F638 and F650) were located in the center of the southern sector, whereas F599 and F646 were placed along the west and south walls (Fig. 11).

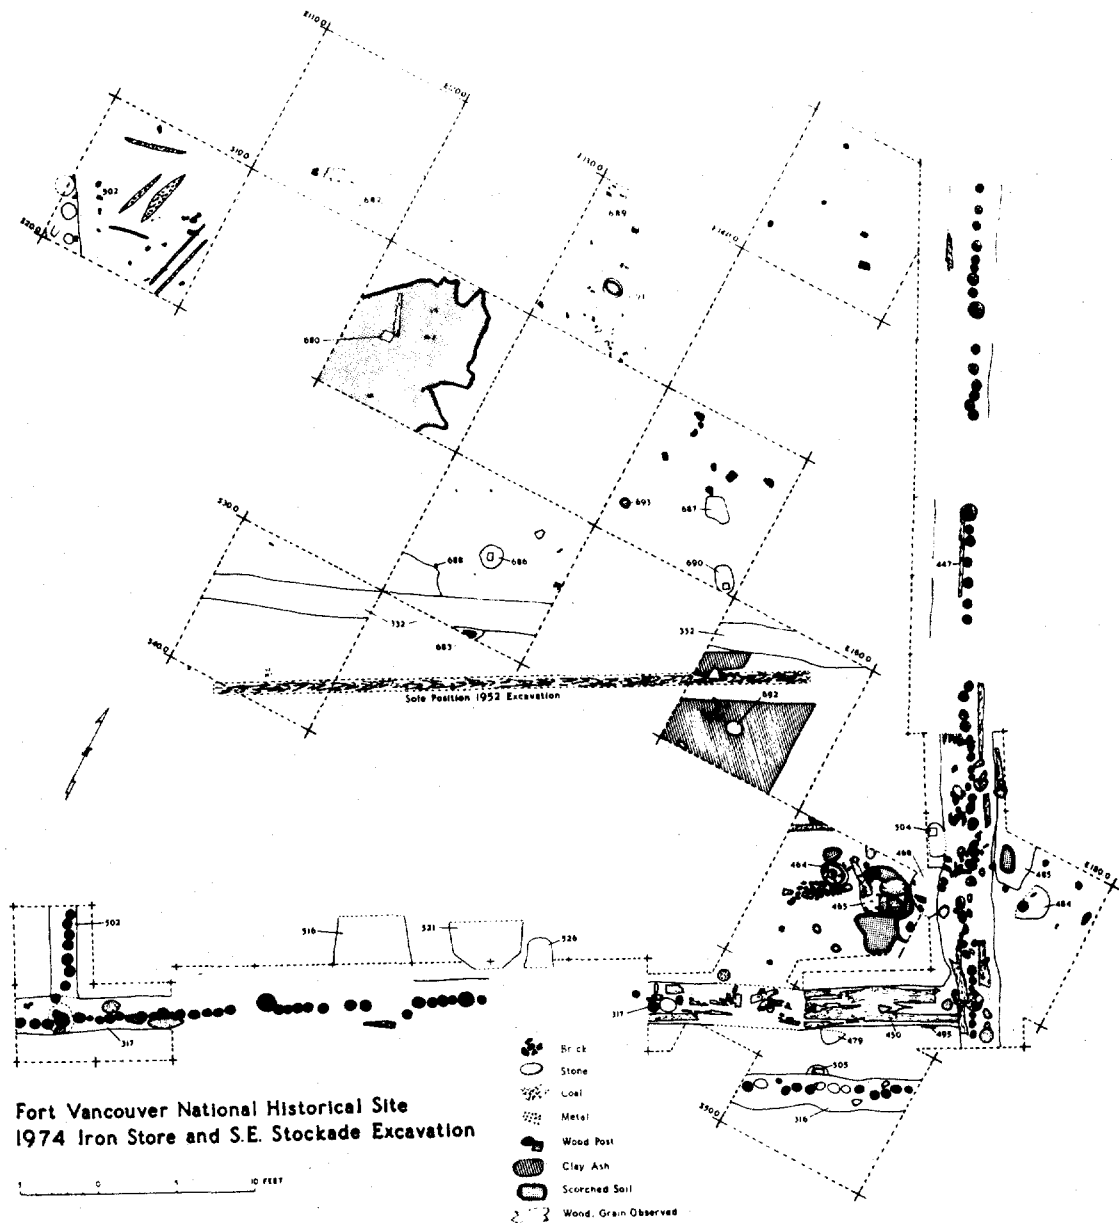
Fig. 10 Excavation map of the Iron Store and Southeast Bastion areas.

A short section of a previously unreported portion of the 1834/36 East Stockade (F502) was observed in S20 E110 (Fig. 12). This section of the stockade was located between points "F-J" of the "phase II" stockade recorded in a previous report (Hoffman 1974:37). Dimensions of the trench were 2.20 ft. wide x 5.40 ft. long x 2.80 ft. deep. Backfill in the trench was buff with black soil and stones. A single line of pickets was observed including 2 posts 0.60 ft. and 1.00 ft. in diameter and a kingpost 1.30 ft. in diameter. Posts extended between 1.6' and 3.15' below present surface, whereas the kingpost extended to 3.60 ft. below present surface. The kingpost observed in this excavation was located, on centers, 53.20 ft. north of a kingpost observed at point "J" of the phase II south stockade system.

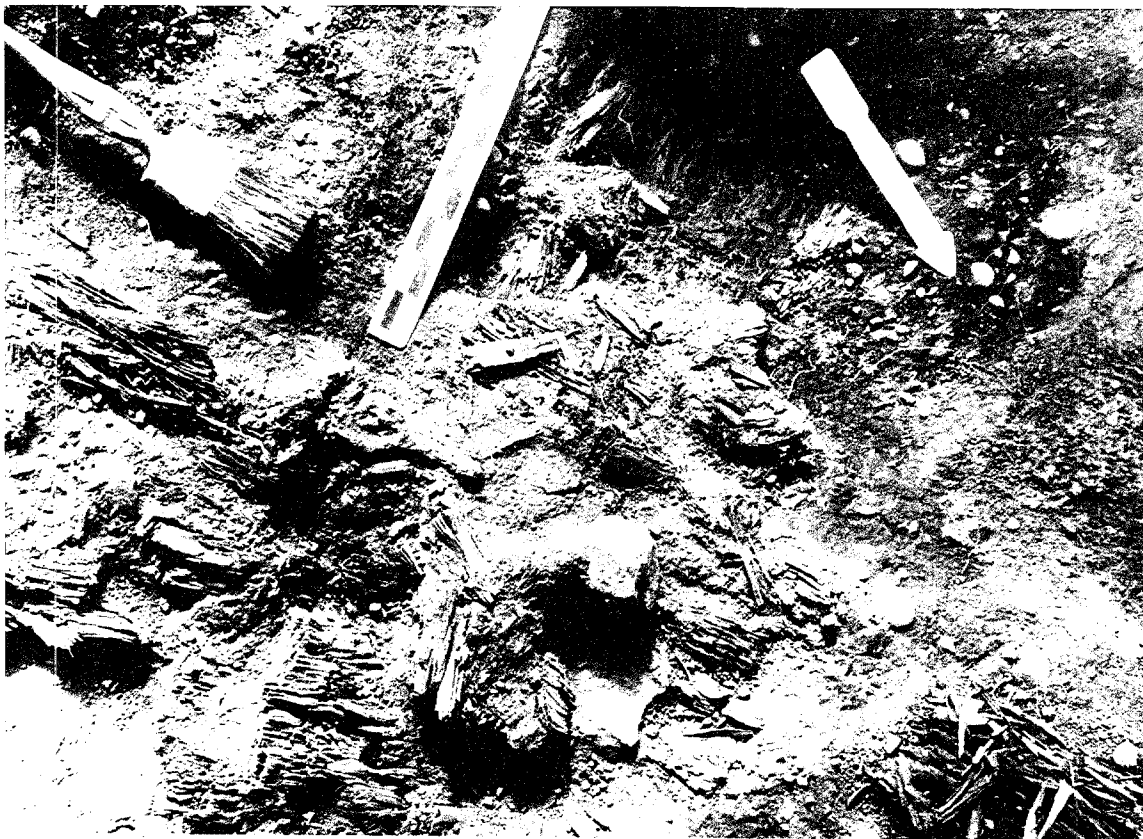
- a. Wooden remains of a West wall foundation footing (F586) and its associated sill (F548) (FOVA neg. 069.51-73/195).
- b. Interior pit (F581) interpreted as a wooden anvil base in a prepared hole (FOVA neg. 069.51-73/179).

The foundation remains of the Blacksmith Shop consisted of 12 primary footings, one repair footing and 4 sill remnants. These remains defined a rectangular structure, roughly 43 ft. (N-S) by 27 ft. (E-W), whose north and south foundation each consisted of one sill with 2 end footings and one central footing. The east and west foundations each consisted of one sill with 2 end footings (shared with the north and south foundations) and 3 central footings.

Foundation Footings. These footings were originally set in prepared rectangular holes, the mean dimensions of which were 1.75 x 2.68 x 0.43 ft. (Table 4). In footing holes, the fill varied according to their location to the interior work areas, but generally it consisted of a black or brown gravelly soil. Cultural items in the footing holes suggested that the holes were partially opened during HBC occupation.

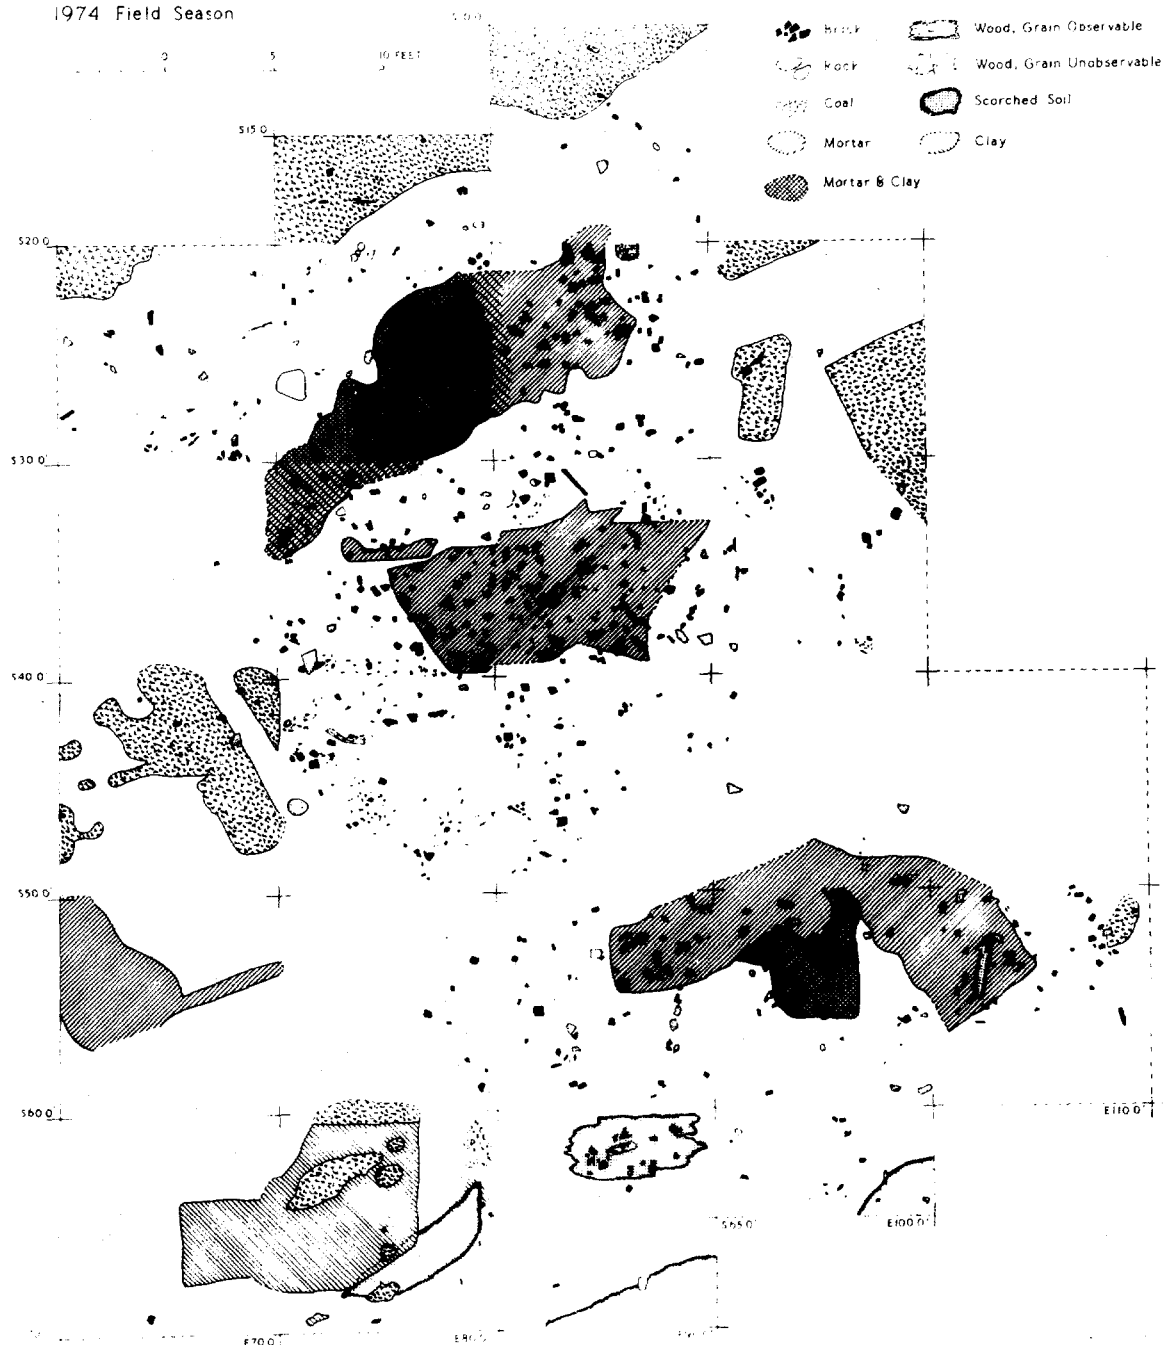
Fig. 14 -- Location of construction debris in the Blacksmith Shop area.

Of the three large amorphous mortar and masonry rubble deposits, 2 were in the northern half and one in the southern half of the Shop. All three were centered and generally oriented parallel to the shop width (Fig. 14). These deposits were characterized by coral, mortar and clay with inclusions of brick fragments, angular stones and coal, which varied within and between the three deposits. Located 0.10 to 0.40 ft. below present surface, these deposits documented Shop demolition and sealed the prepared floors and subsurface features beneath.

A single deposit of packed coral mortar was found 0.10 to 0.50 ft. below present surface to the west of the Blacksmith Shop (Fig. 14).

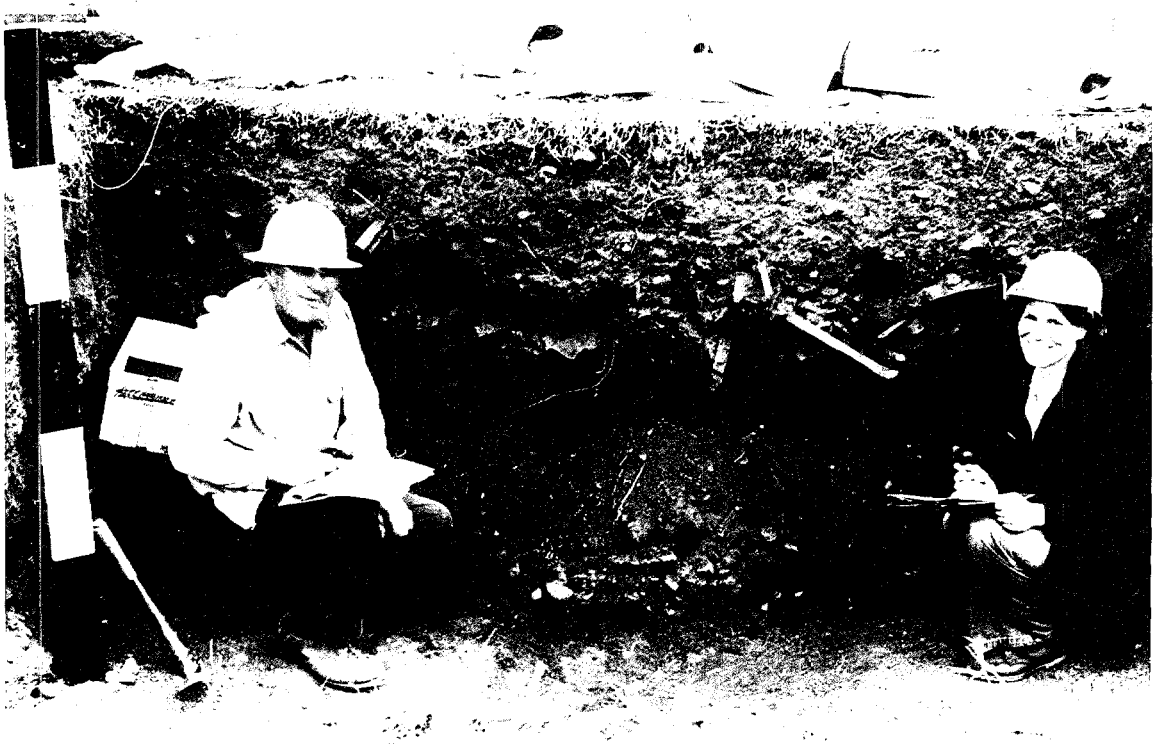
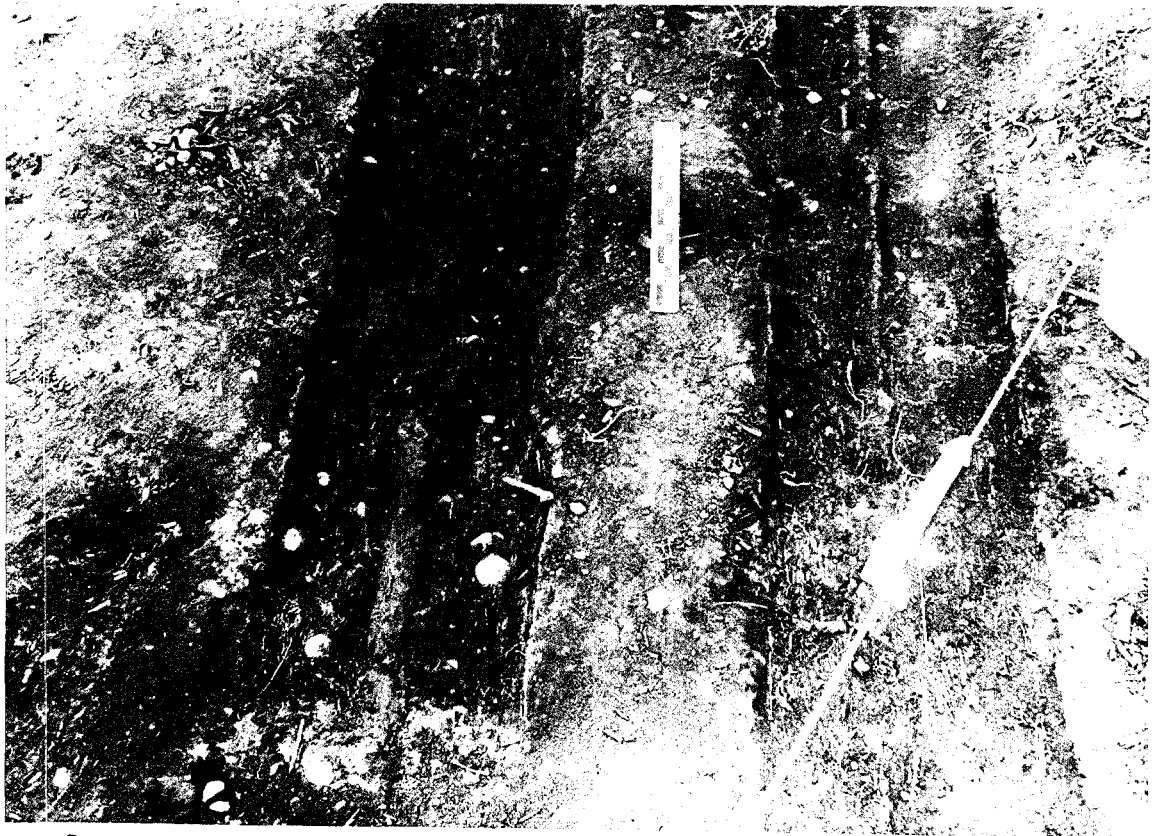
Fig. 15 -- Indian Trade Store Privy/Trash Pit and interior footings within the Blacksmith Shop.

- a. Indian Trade Store Privy/Trash Pit (F523) showing concentration of blacksmith debris in upper levels (FOVA neg. 069.51-73/148).
- b. Soil casts of a pair of interior footings (F573) within the Blacksmith Shop (FOVA neg. 069.51-74/20).

Both Type I and Type II footings were located in the northwest corner of the shop. The orientation of the former were east-west, whereas the latter was north-south. Footings were set in pairs with F595 and F598 constituting one pair separated from a second pair (F602 and F605) by a 6.01 ft. gap. The third pair of footings were recorded as one feature (F573).

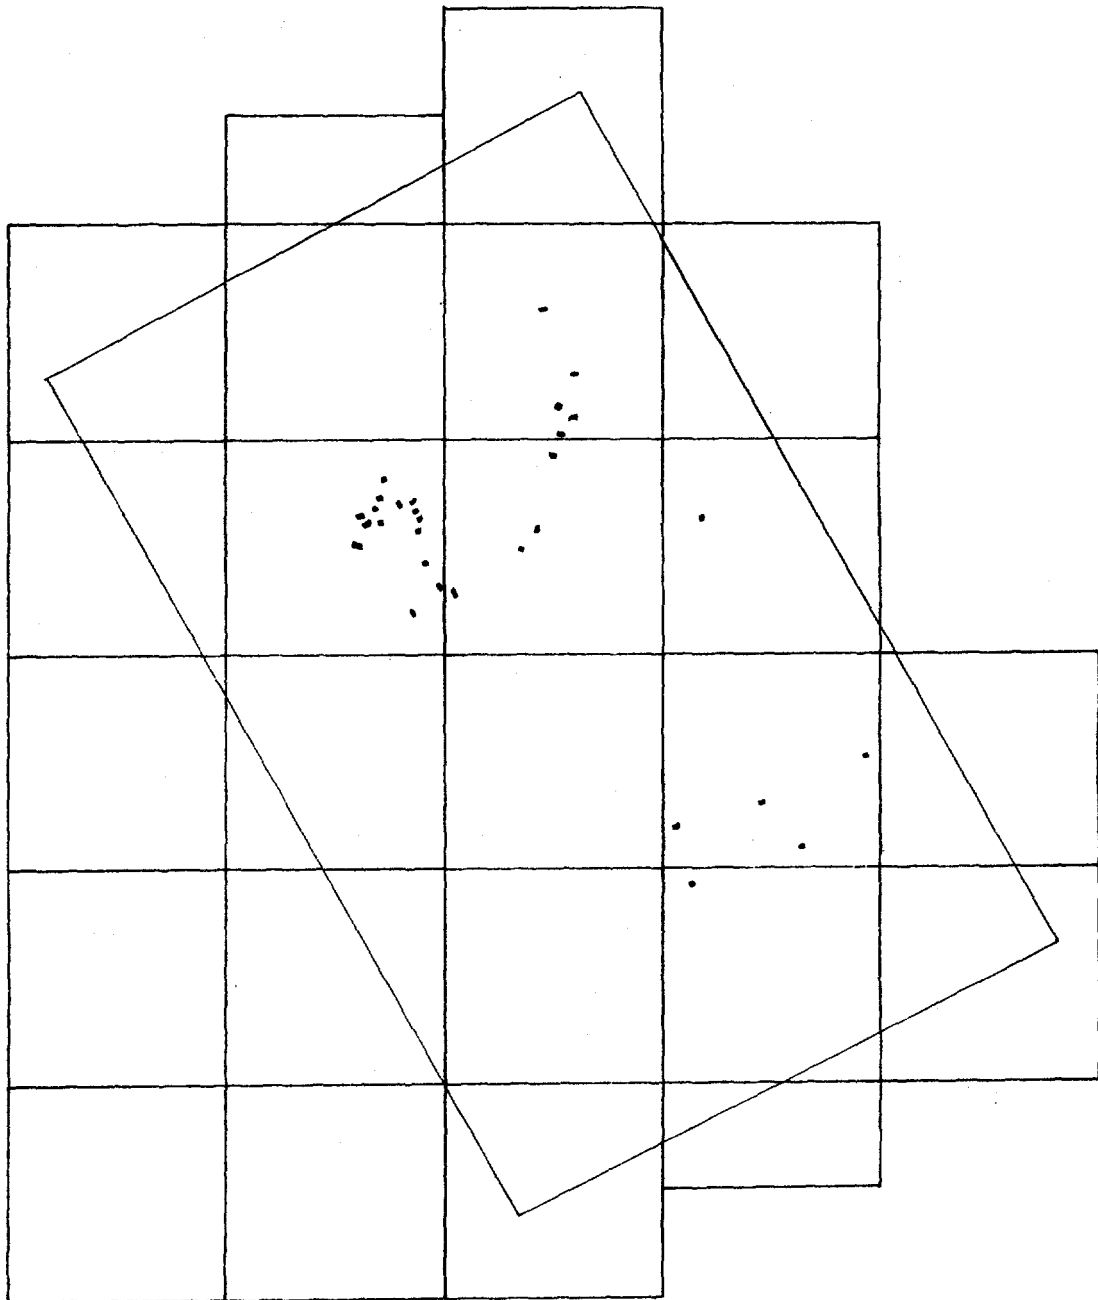
Fig. 16 -- Distribution of stakes within the Blacksmith Shop.
