FORT VANCOUVER EXCAVATIONS - X

Southeastern Fort Area

National Park Service

July 1975

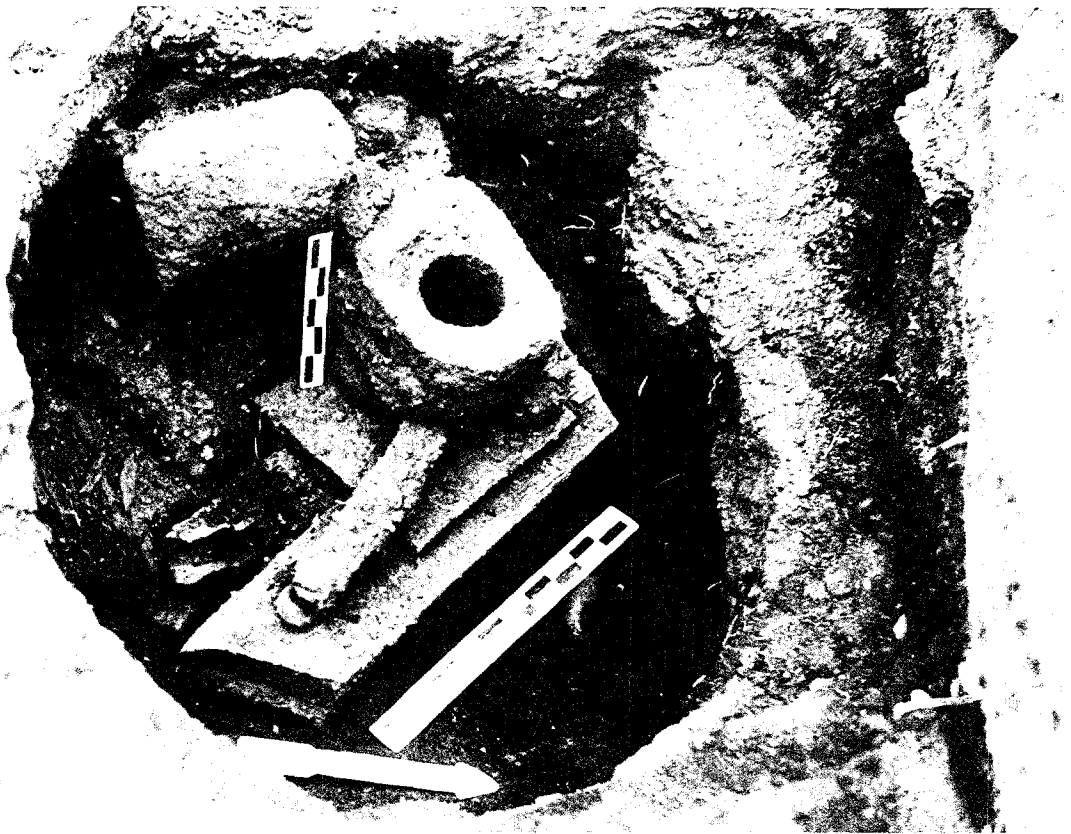
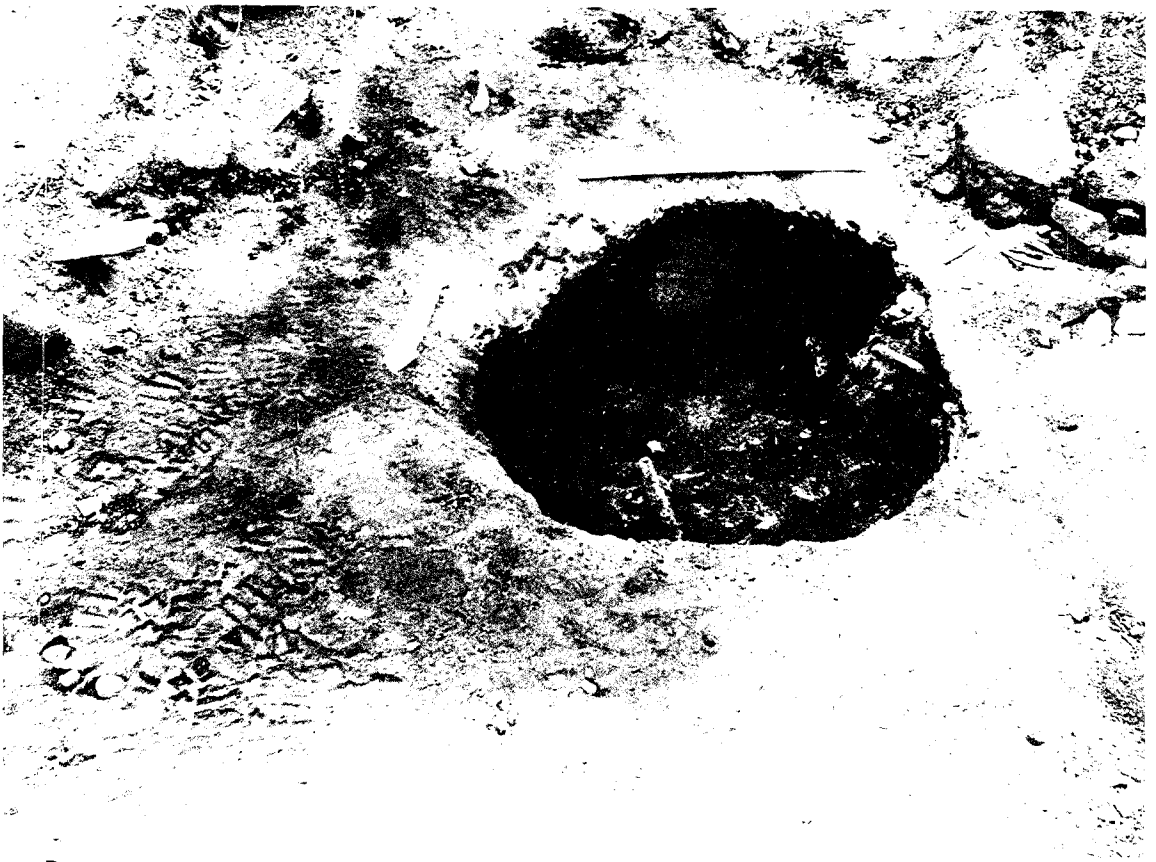
Fig. 18 -- Blacksmith Shop Features

- a. Interior pit (F645) interpreted as an accumulation of metal waste inside a slack tub cast for a quenching pit (FOVA neg. 069.51-74/38).
- b. Interior pit (F588) interpreted as an anvil base hole with a brick collar (FOVA neg. 069.51-73/197).

Feature 650 consisted of a prepared pit filled with native soil and wood fragments surrounding a pit full of forging debris. Certainly the majority of the pits were located in the northern Shop half (Fig. 17). Placement of the pits was toward the center of the Shop, instead of near the walls, and roughly oriented along an east-west axis. Only 4 pits (F599, F638, F646 and F650) were located in the southern half of the Shop. Two (F638 and F650) were located in the center of the southern sector, whereas F599 and F646 were placed along the west and south walls (Fig. 11).

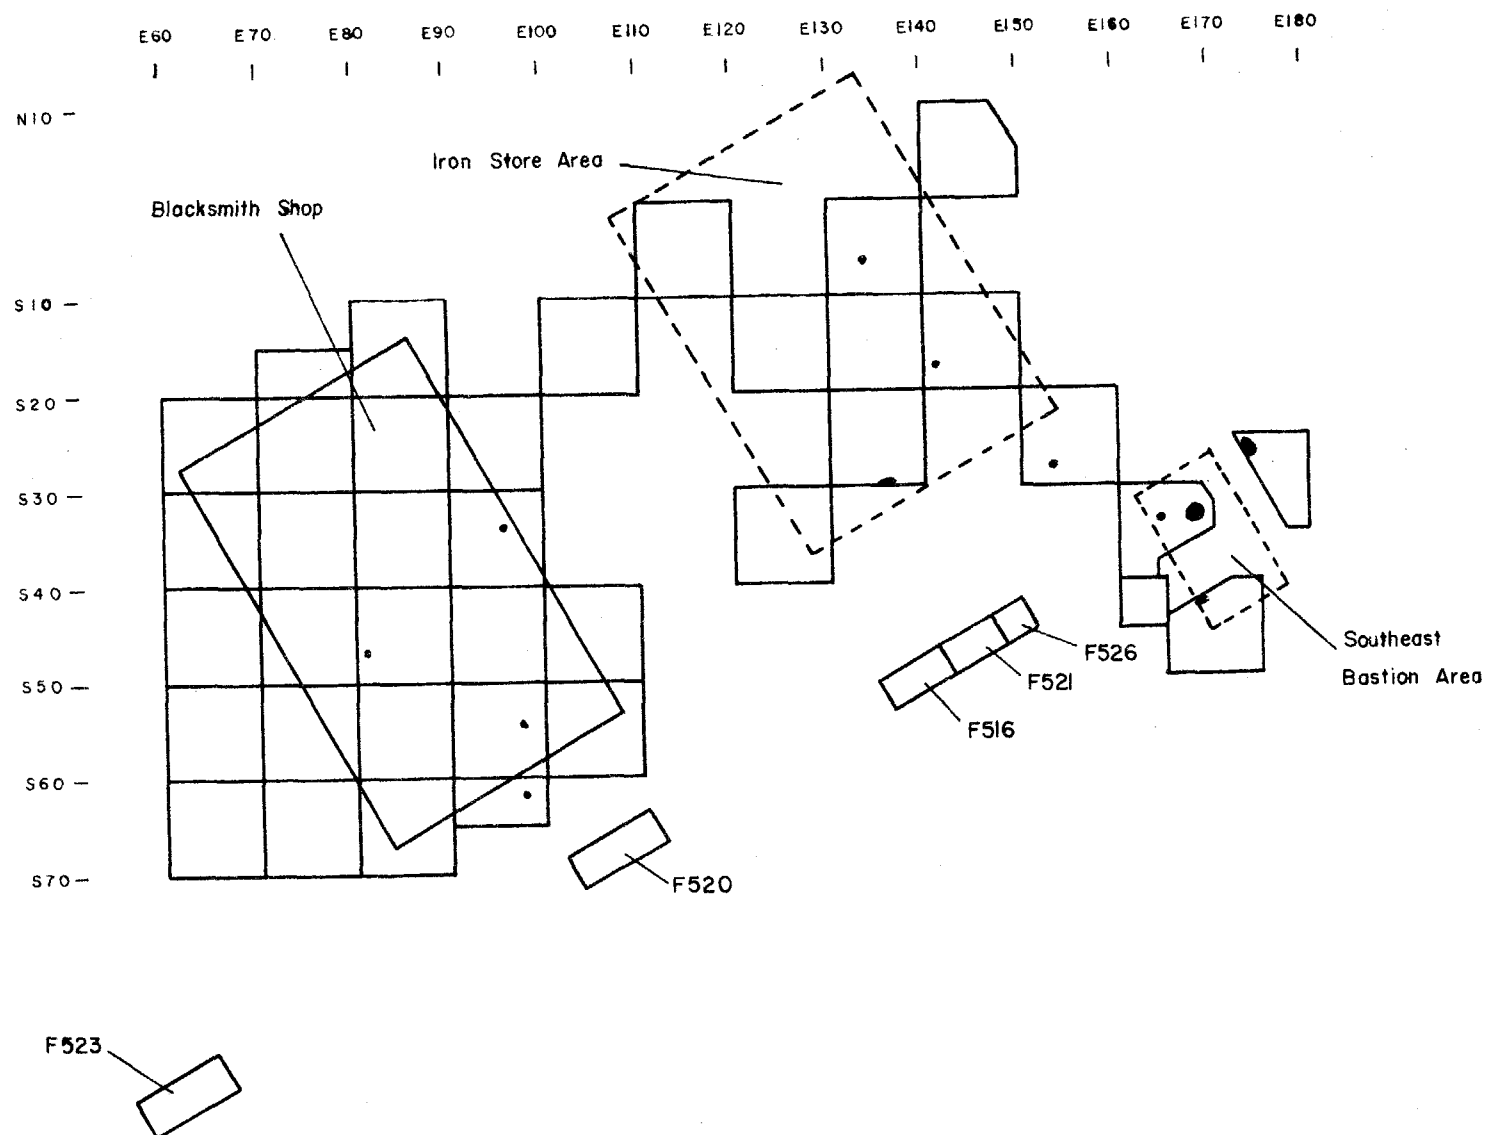
Fig. 19 -- Distribution of smudge pits in the southeastern Fort area.

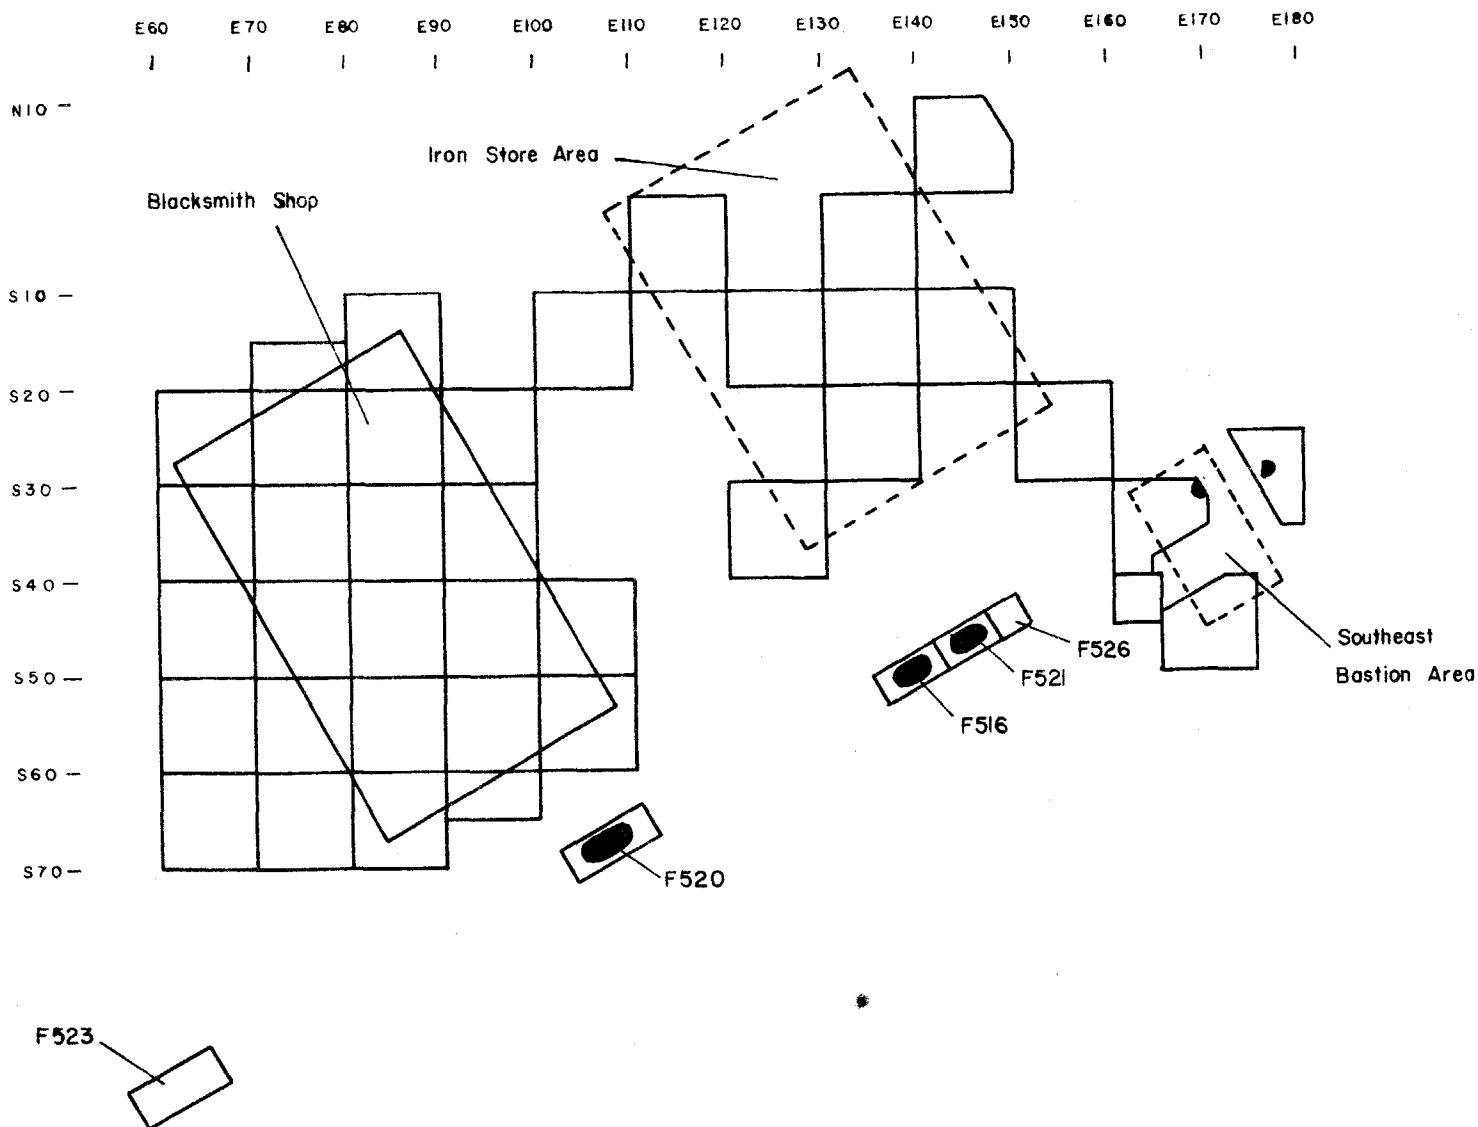
Fig. 20 -- Distribution of large charred pits in the southeastern Fort area.

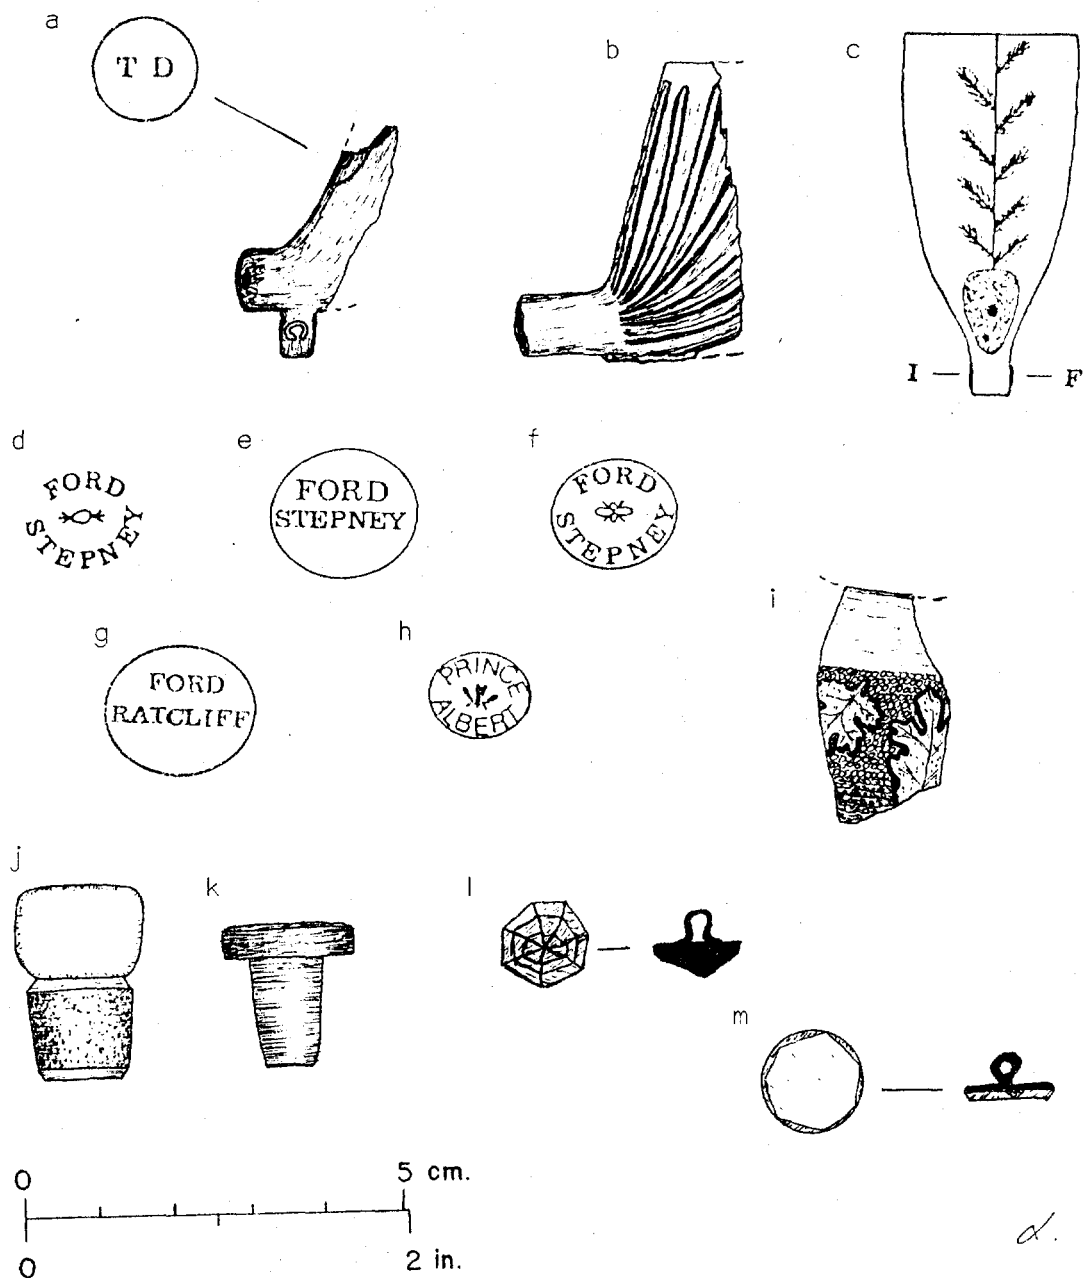
Fig. 21 -- Pipe fragments, glass stoppers and glass buttons from the Blacksmith Shop area: a). "TD" pipe fragment with "W/C" spur marks (FOVA 35410; b). unmarked fluted pipe (FOVA 34501); c-h). FORD pipe fragments; i). unmarked pipe bowl fragment (FOVA 36055); j). glass stopper (FOVA 34863); k). glass stopper (FOVA 36013); l). glass button (FOVA 34861) and m). reconstructed glass and iron button (FOVA 33724).

Two ground stoppers were recovered and have been illustrated in Figs. 21j-k.

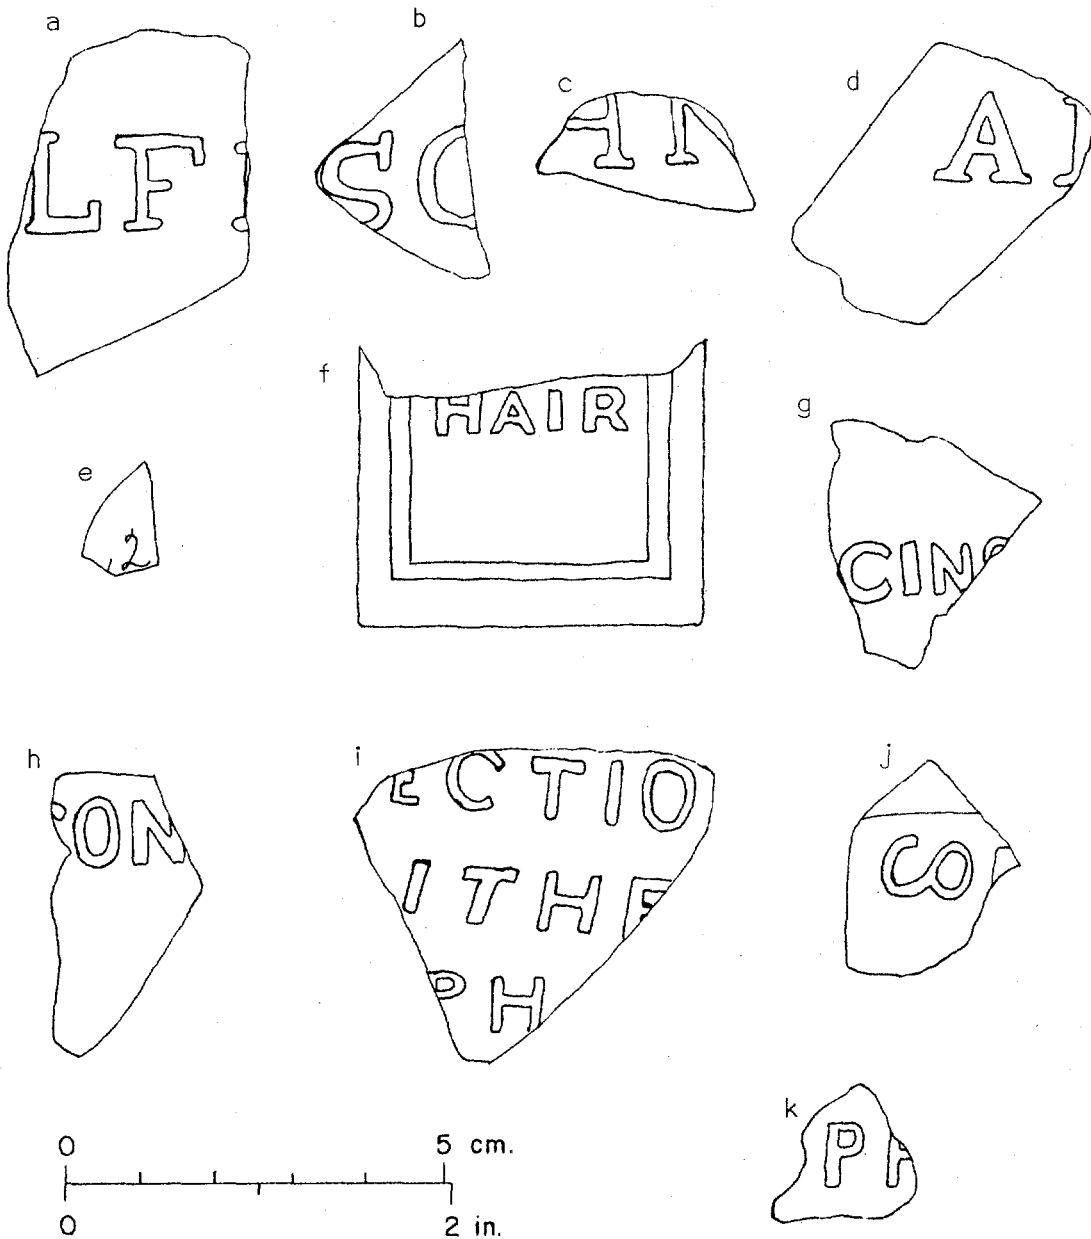
Fig. 22 -- Marked glass fragments from the Blacksmith Shop area:  
a-d). "Udolopho Wolf's Schiedam Aromatic Schnapps" (various  
FOVA numbers); e). etched glass fragments (FOVA 35053) and  
f-k). miscellaneous glass fragments (various FOVA numbers).

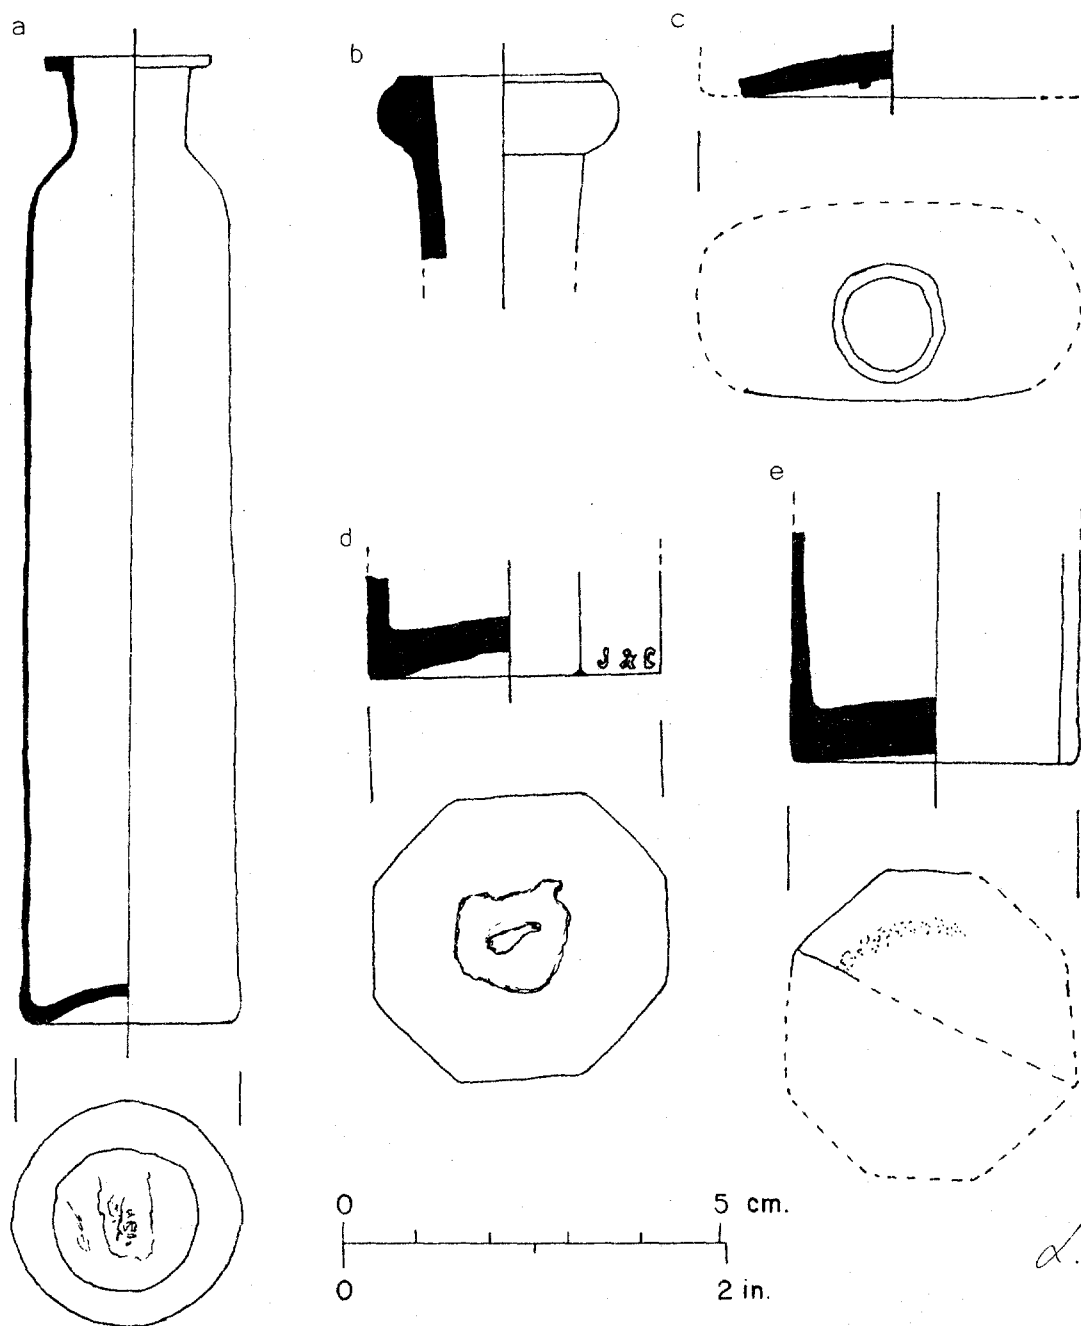
Fig. 23 -- A reconstructed pharmaceutical bottle and bottle rims and bases recovered from the Blacksmith Shop area: a). reconstructed pharmaceutical bottle (FOVA 35987); b). bottle rim Type 30 (FOVA 34276 & 35576); c). bottle base Type 60 (FOVA 34746); d). bottle base Type 66 (FOVA 34674) and e). bottle base Type 67 (FOVA 34805).

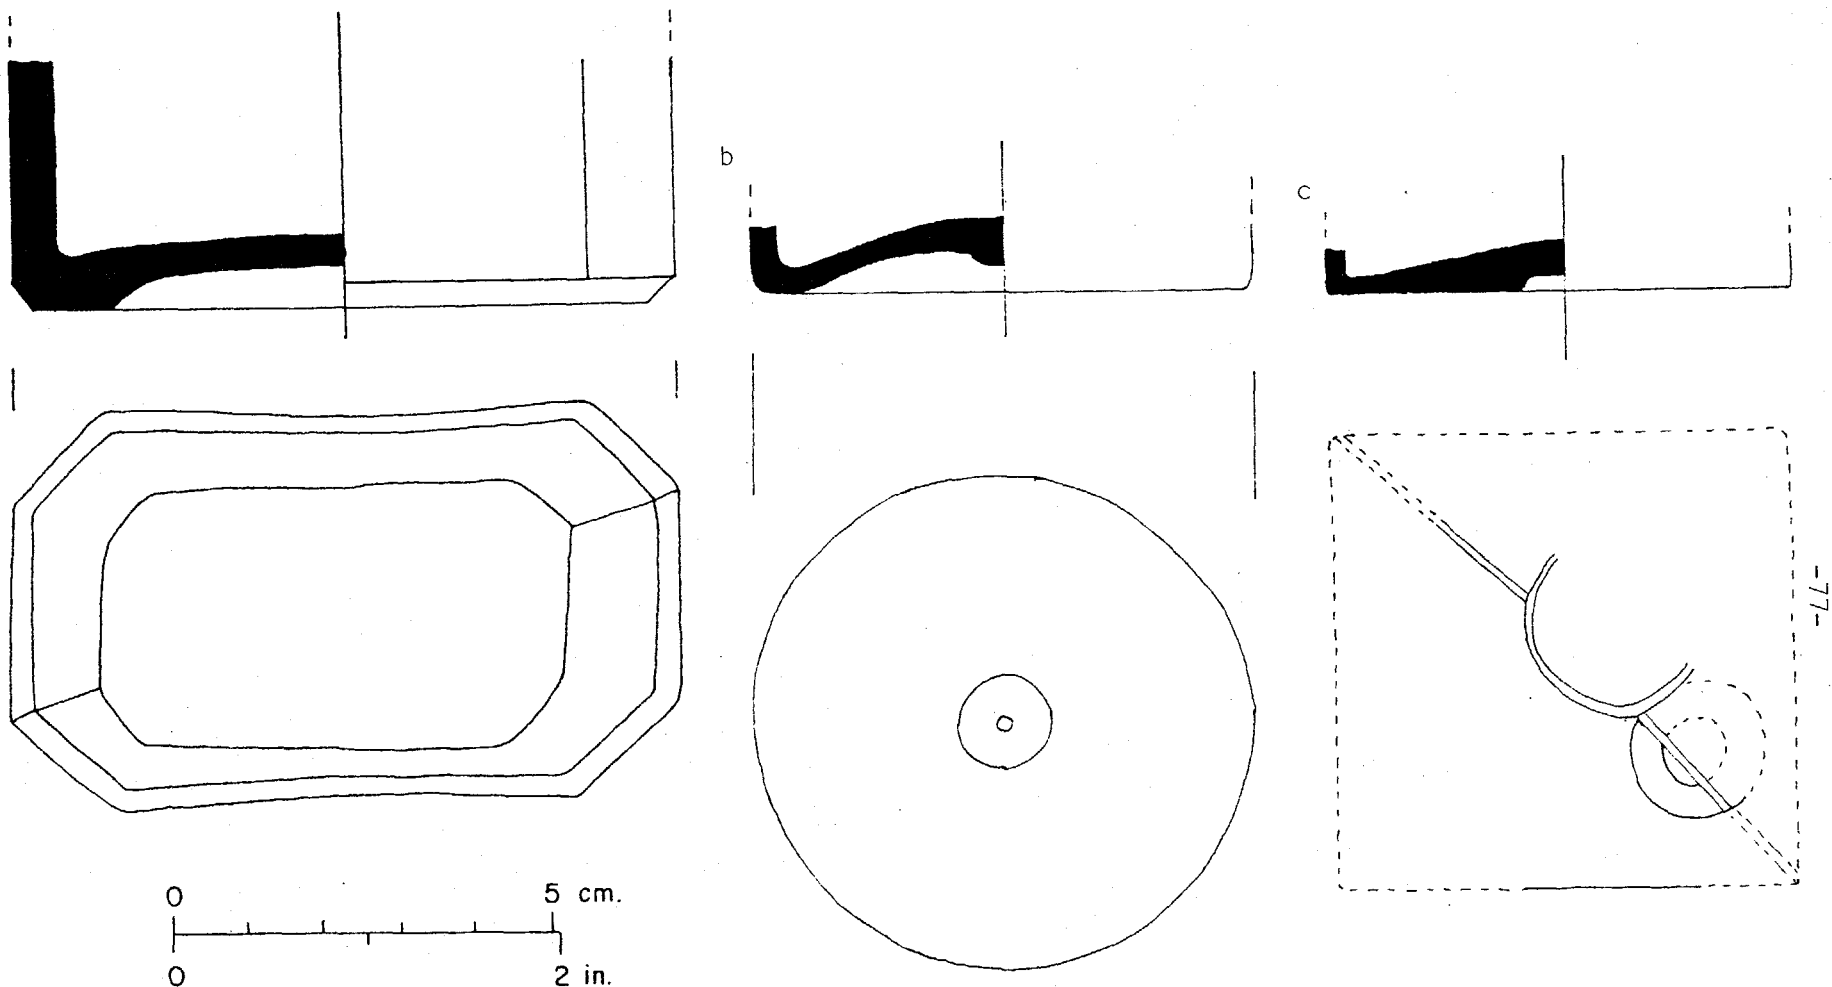
Fig. 24 -- Bottle base types found in the Blacksmith Shop area: a). base Type 65 (FOVA 34422); b). base Type 68 (FOVA 35336) and c). base Type 69 (FOVA 34243).

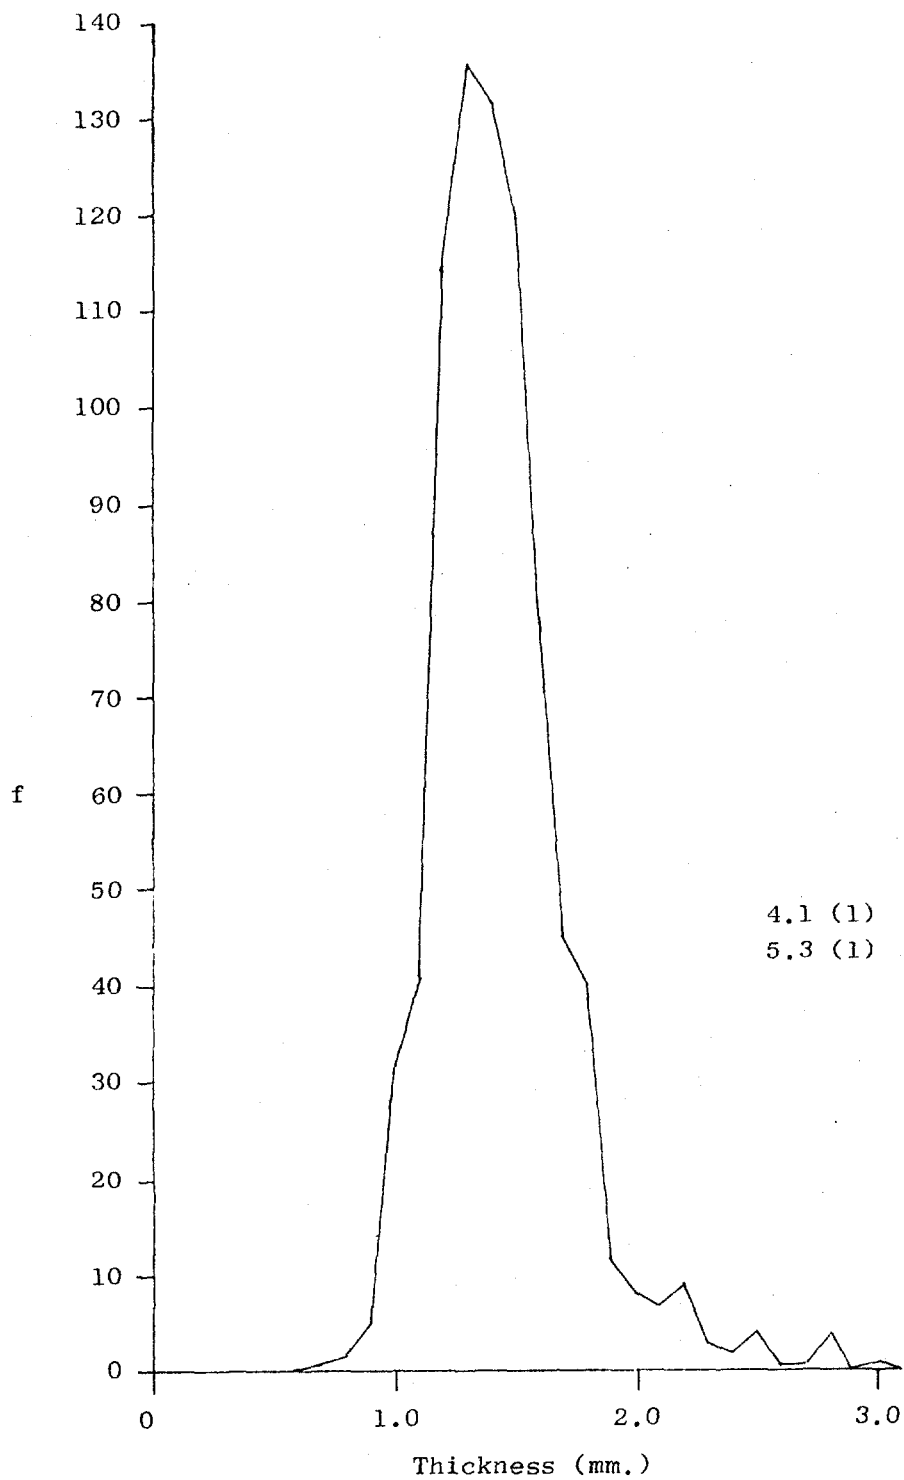
Fig. 25 -- Frequency of window glass thicknesses for the Blacksmith Shop area (N = 799).

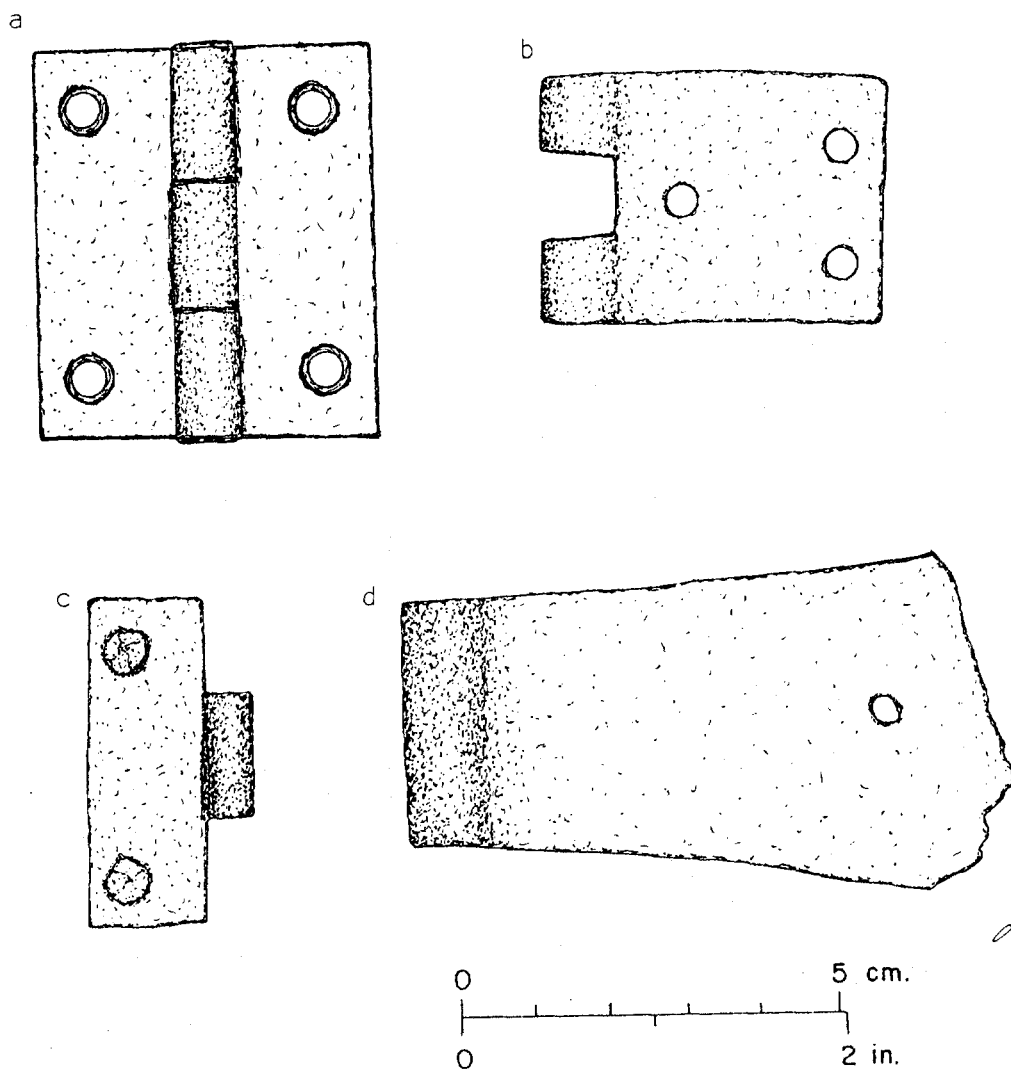
Fig. 26 -- Hinges from the Blacksmith Shop area: a). butt hinge (FOVA 34894); b). hinge (FOVA 35359); c). butt hinge w/#1002 nails (FOVA 34290) and d). butterfly hinge (FOVA 35776).

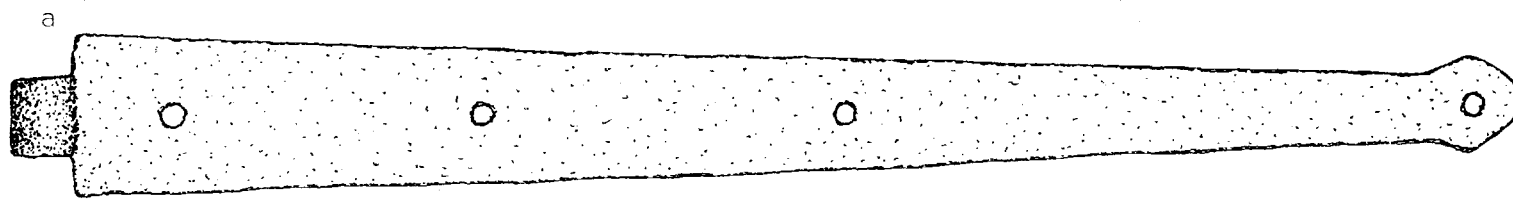
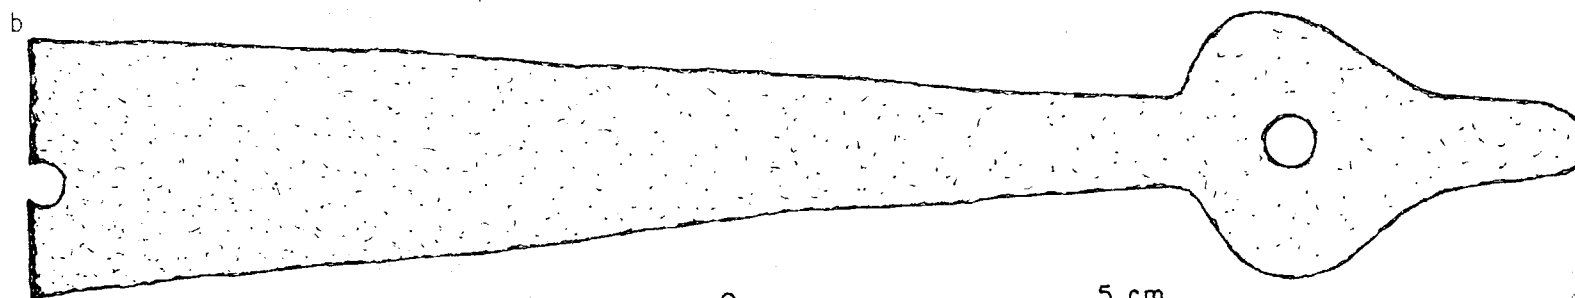
Fig. 27 -- Strap hinges from the Blacksmith Shop area: a). strap hinge (FOVA 34441) and b). strap hinge (FOVA 34549).

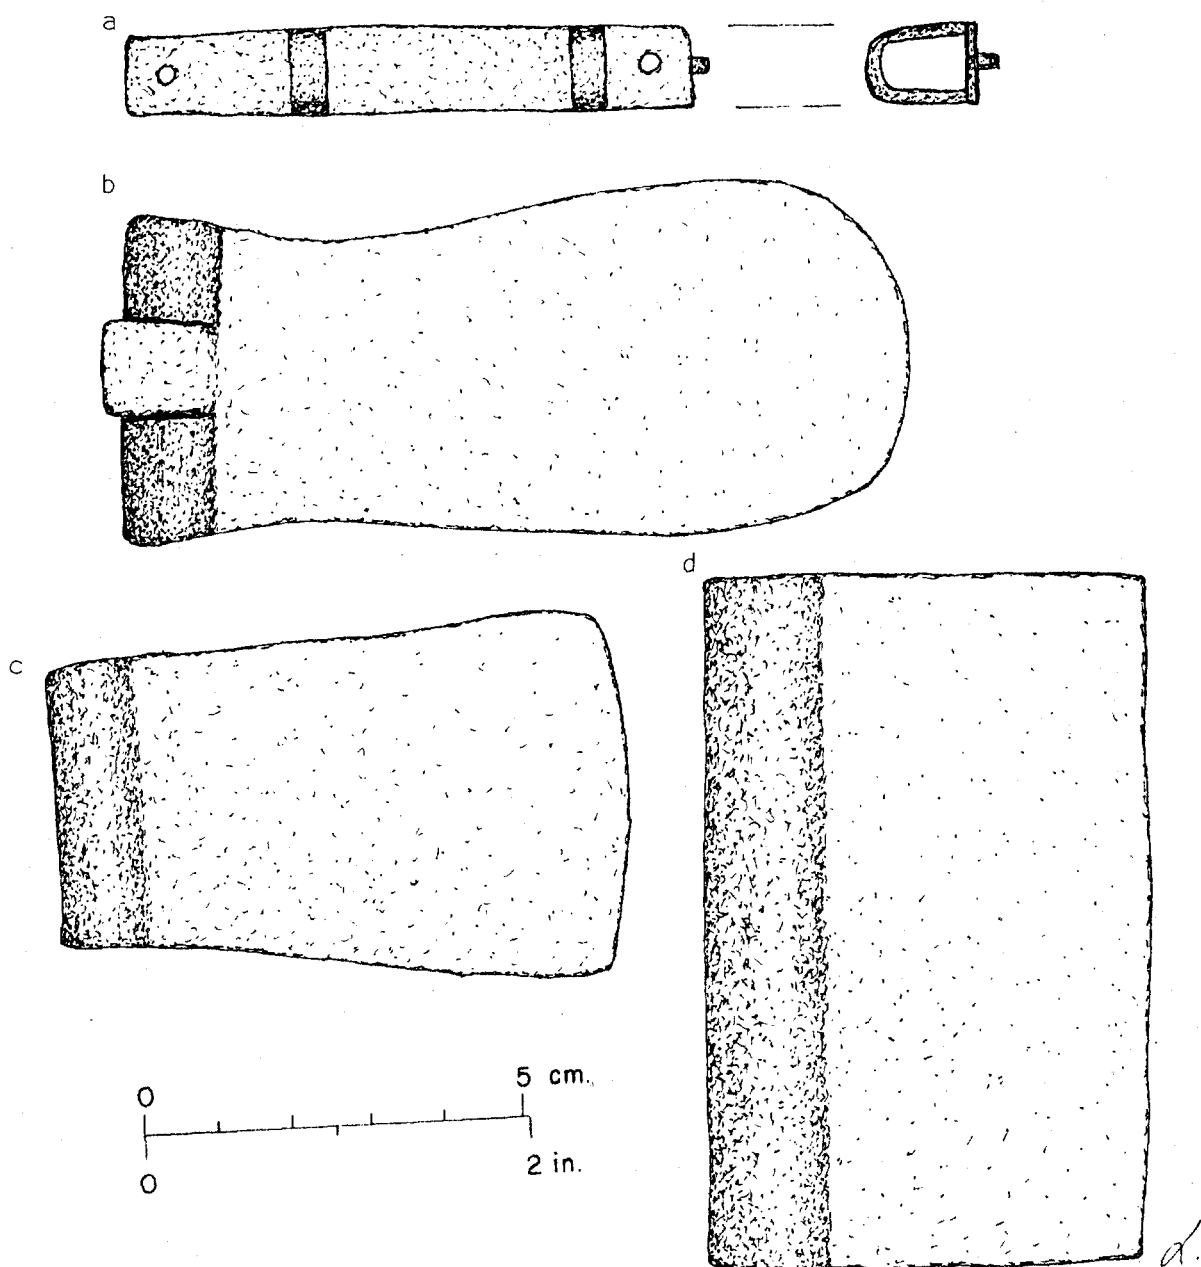
Fig. 28 -- A sliding bolt keeper and hinge preforms from the Blacksmith Shop area: a). sliding bolt keeper (FOVA 35634); b). hinge preform (FOVA 34187); c). hinge preform (FOVA 36073) and d). hinge preform (FOVA 34366).

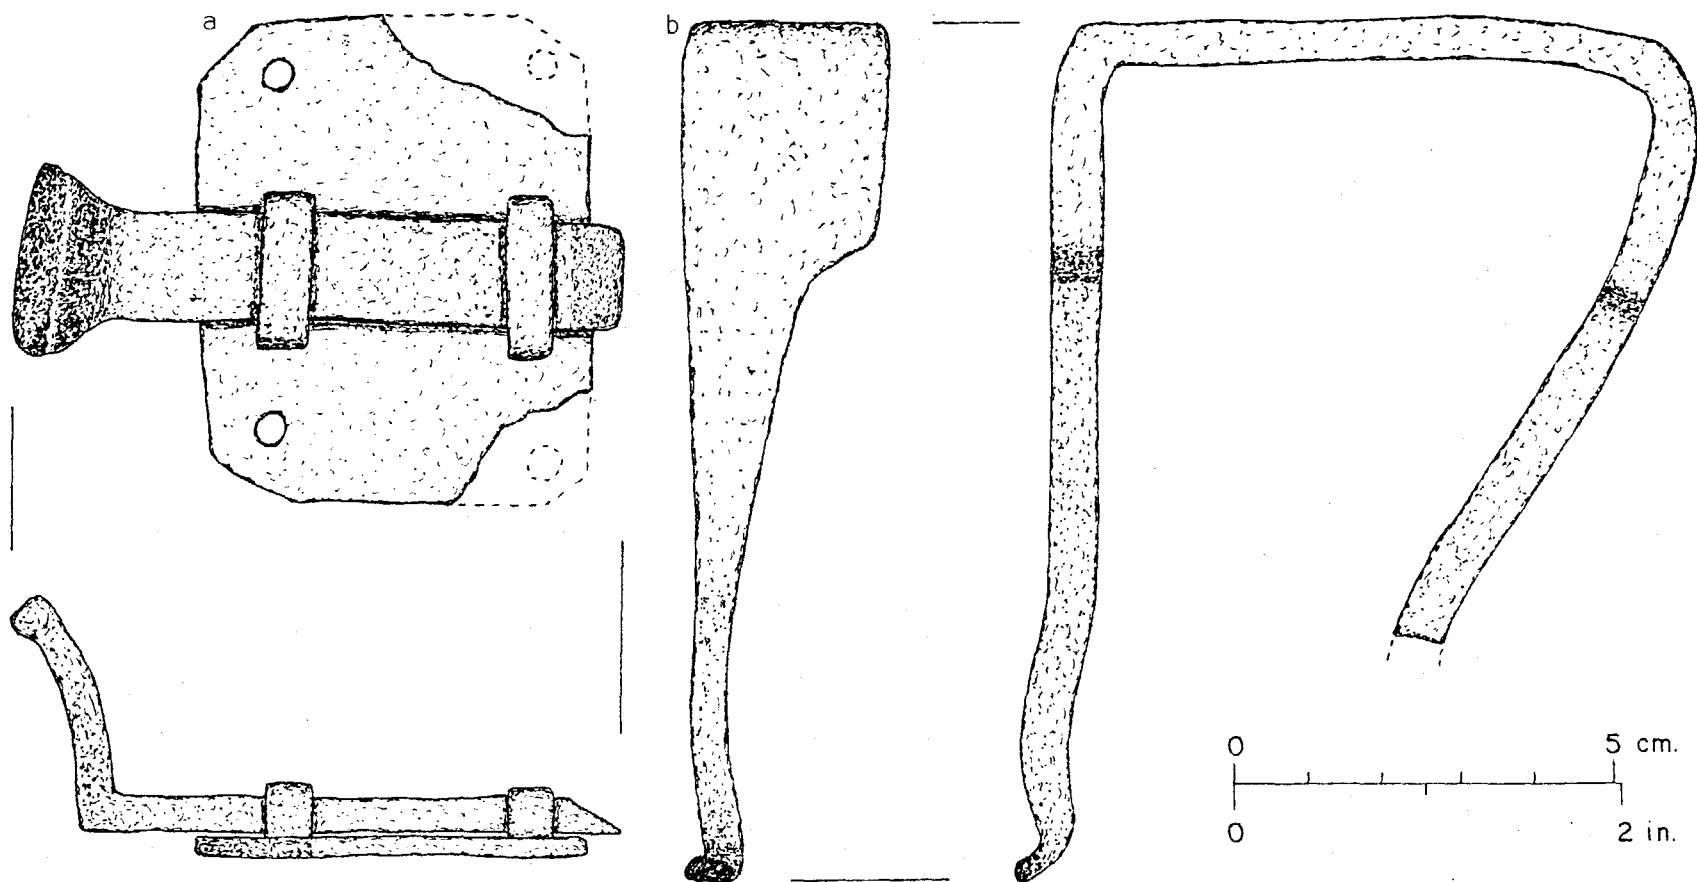
Fig. 29 -- Door latch and door latch keeper from the Blacksmith Shop area: a). door latch (FOVA 35299) and b). door latch keeper (FOVA 34442).

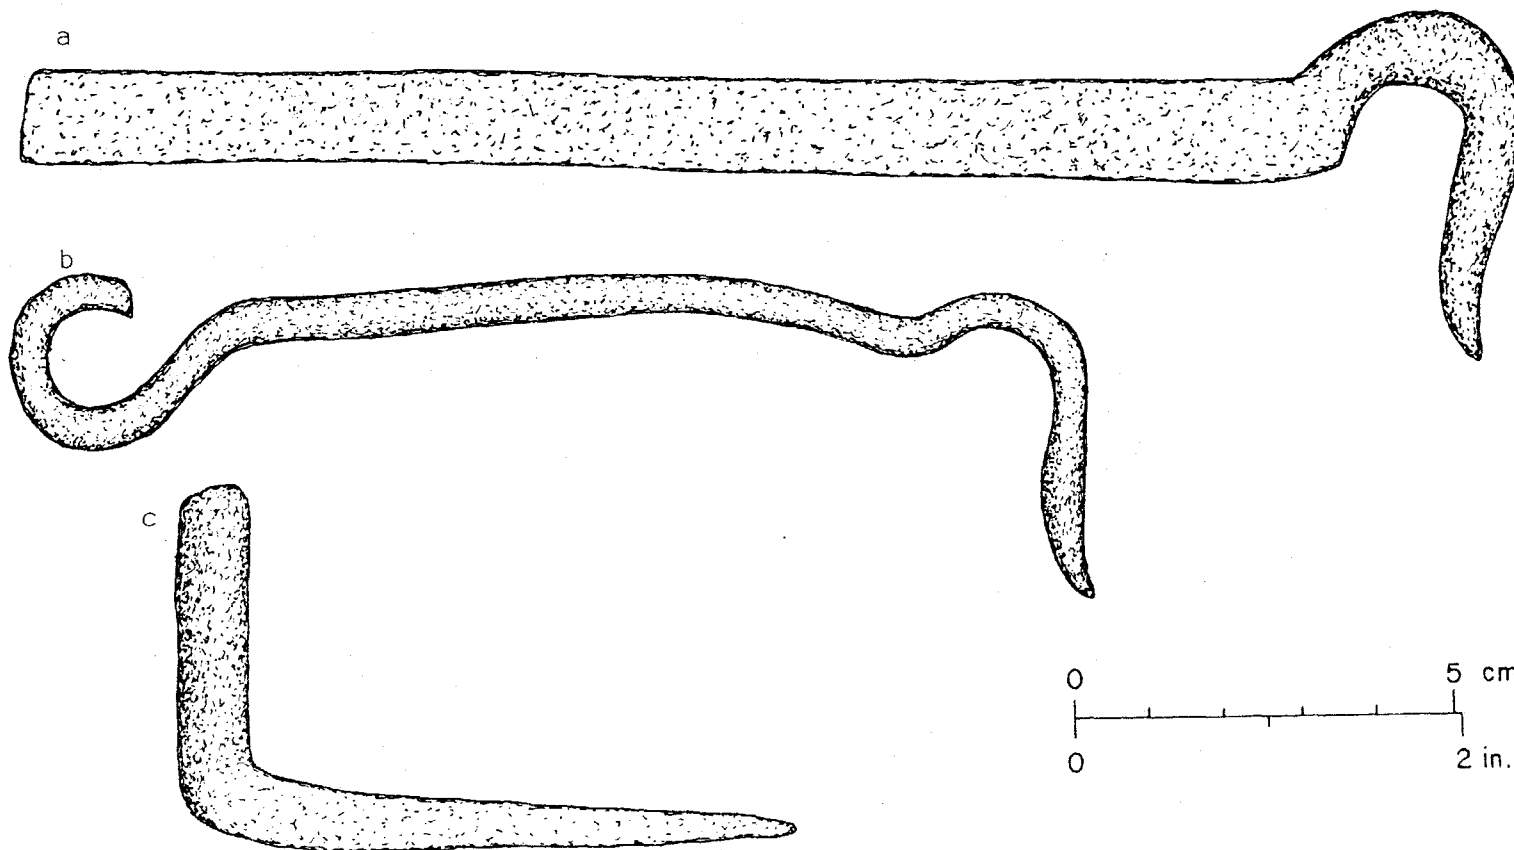
Fig. 30 -- Door hooks and a pintle from the Blacksmith Shop area: a). door hook (FOVA 35362); b). door hook (FOVA 33778) and c). pintle (FOVA 35360).

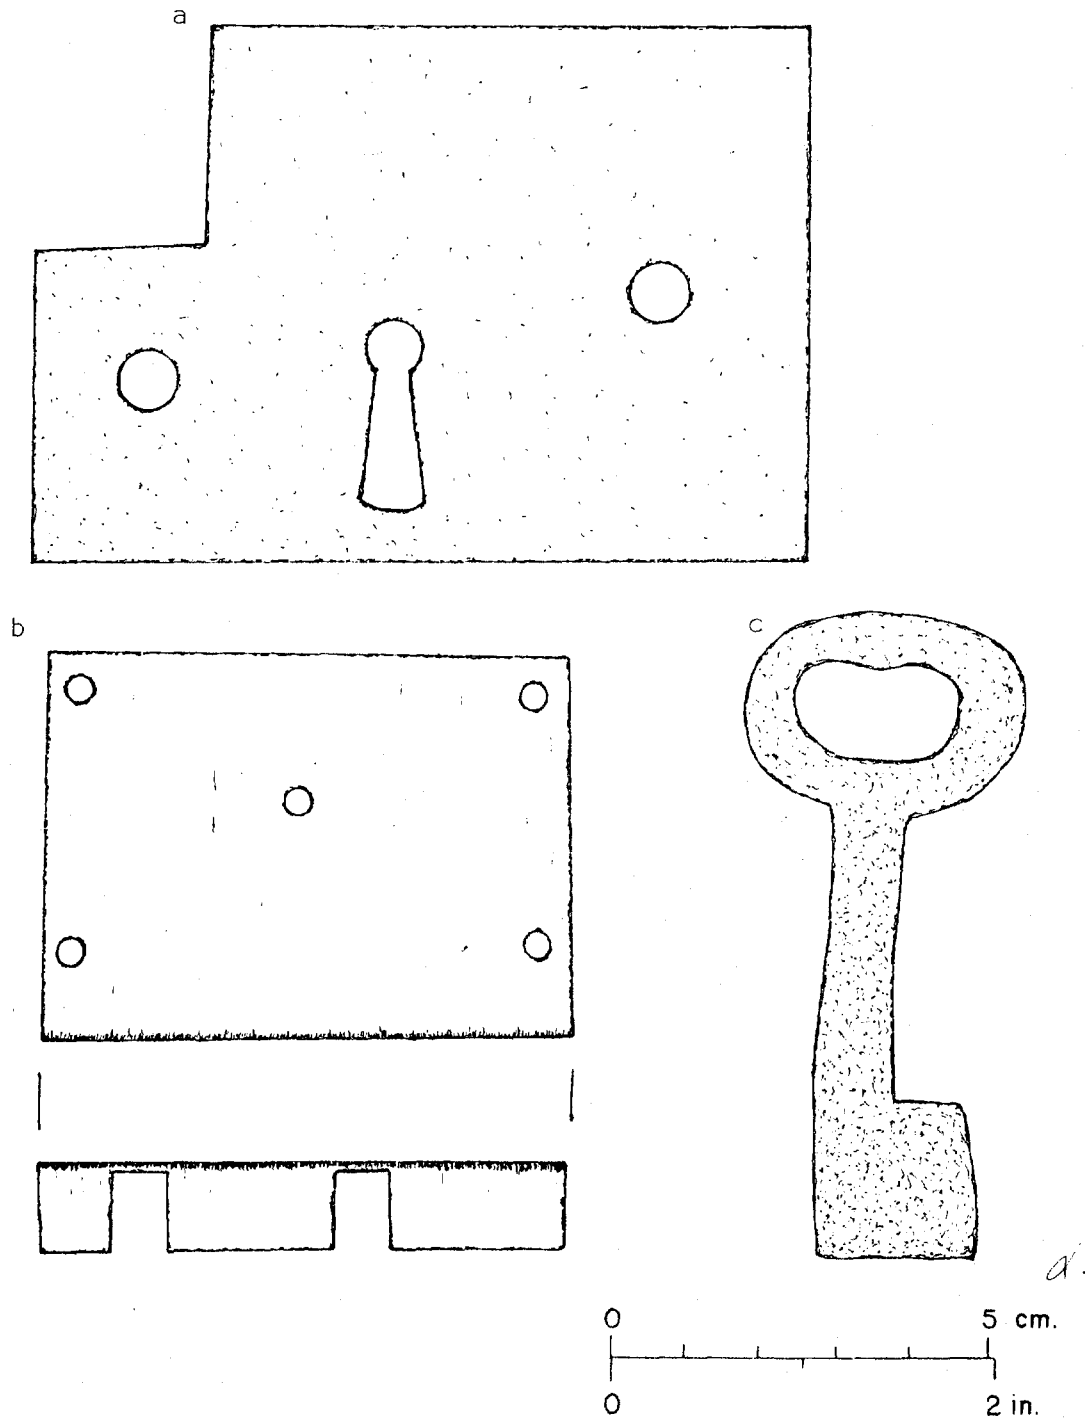
Fig. 31 -- A lock plate, furniture lock and a key preform from the Blacksmith Shop area: a). lock plate (FOVA 34074); b). furniture lock (FOVA 32805) and c). key preform (FOVA 33086).
