FORT VANCOUVER EXCAVATIONS - X

Southeastern Fort Area

National Park Service

July 1975

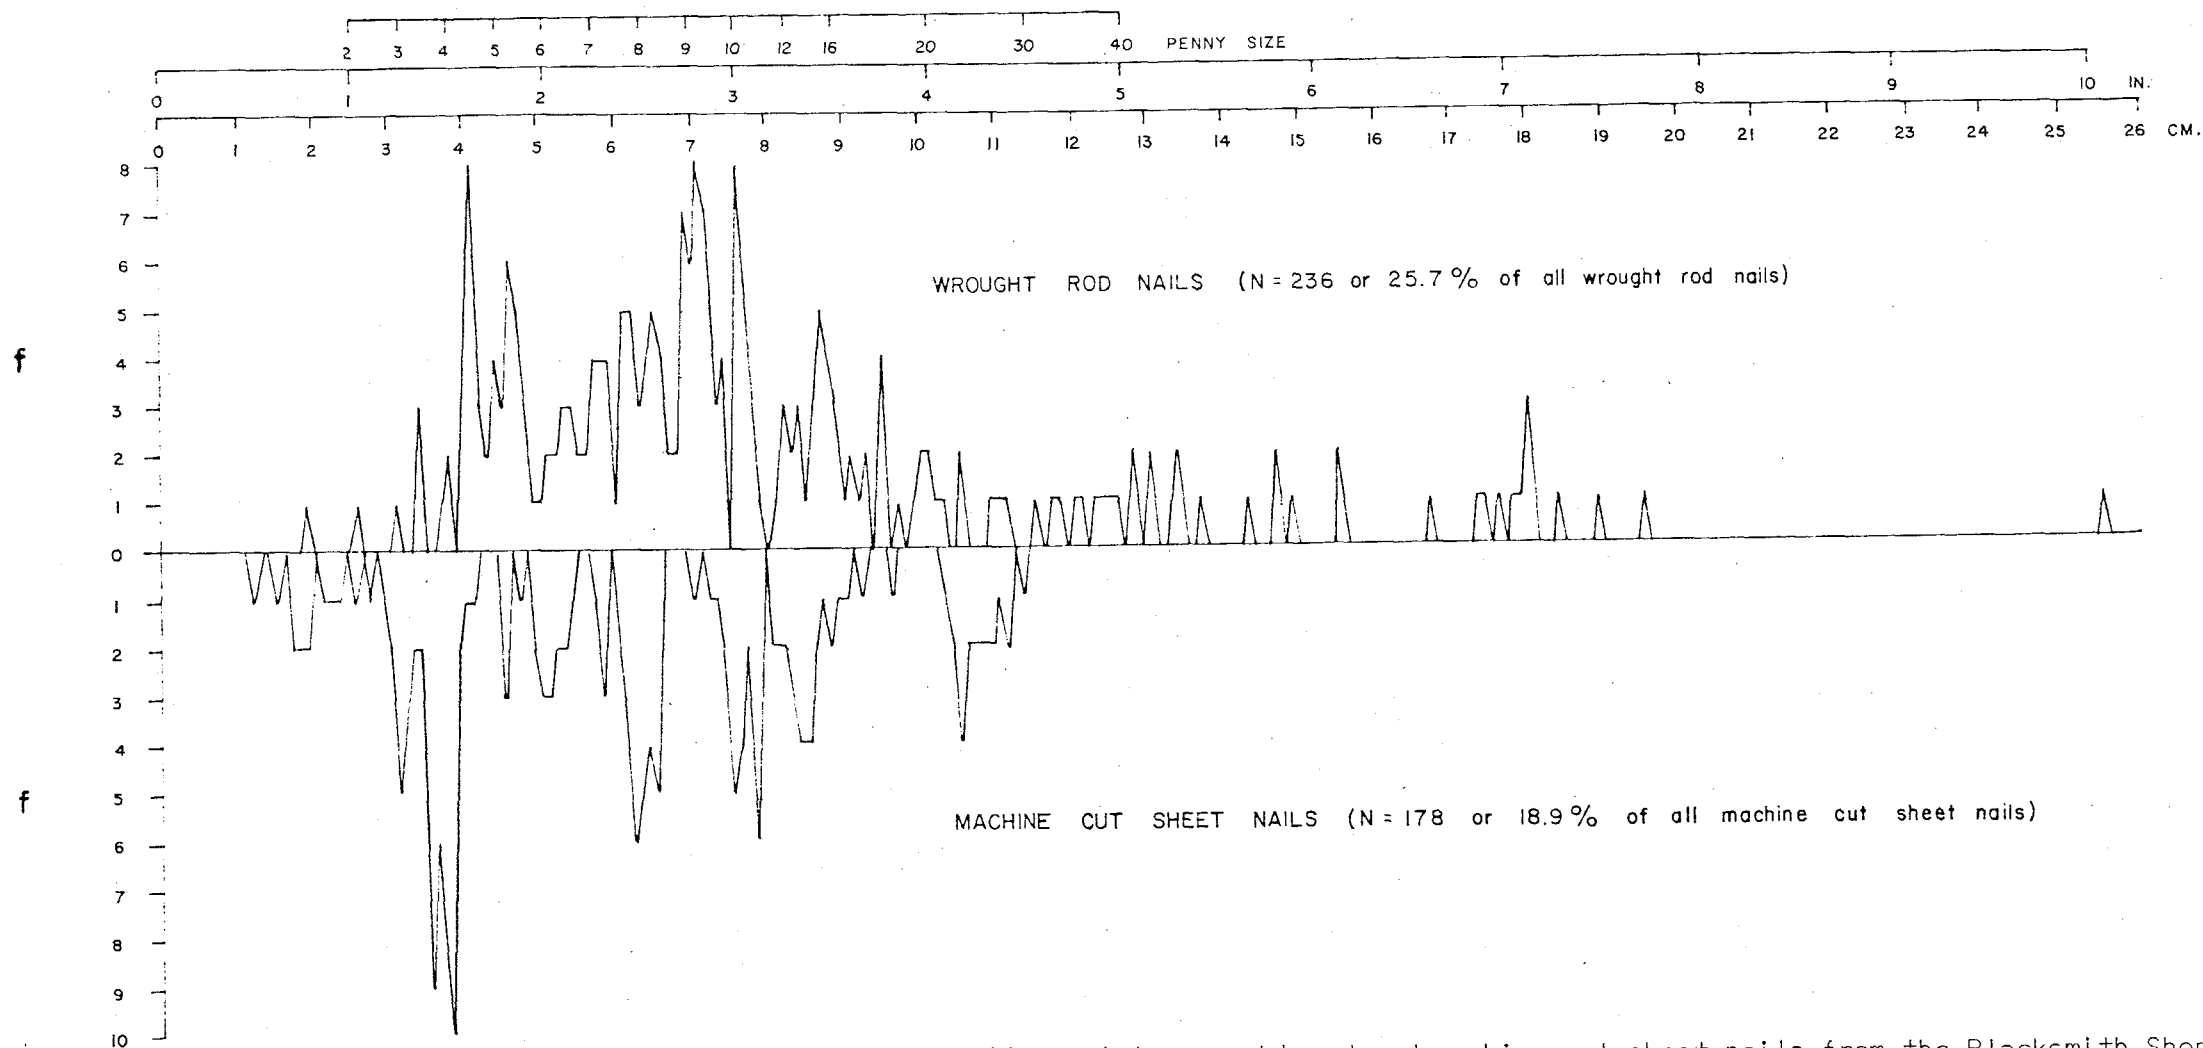
Fig. 32 -- Frequency distribution of all complete wrought rod and machine cut sheet nails from the Blacksmith Shop area.

A total of 919 wrought rod nails were recovered including 286 complete nails. Fifty-one varieties were identified, including 15 new varieties (Figs. 33 - 39); but only 5 varieties appeared to have been utilized in quantity for structural purposes. Two varieties of horseshoe nails were recovered in quantity (FOVA Varieties #1032, #1104) and have been correlated with horse/mule shoeing activities outside the southwest corner of the Blacksmith Shop. A tabulation of identified varieties together with suggested metric populations appears as Table 18. The major varieties are discussed below.

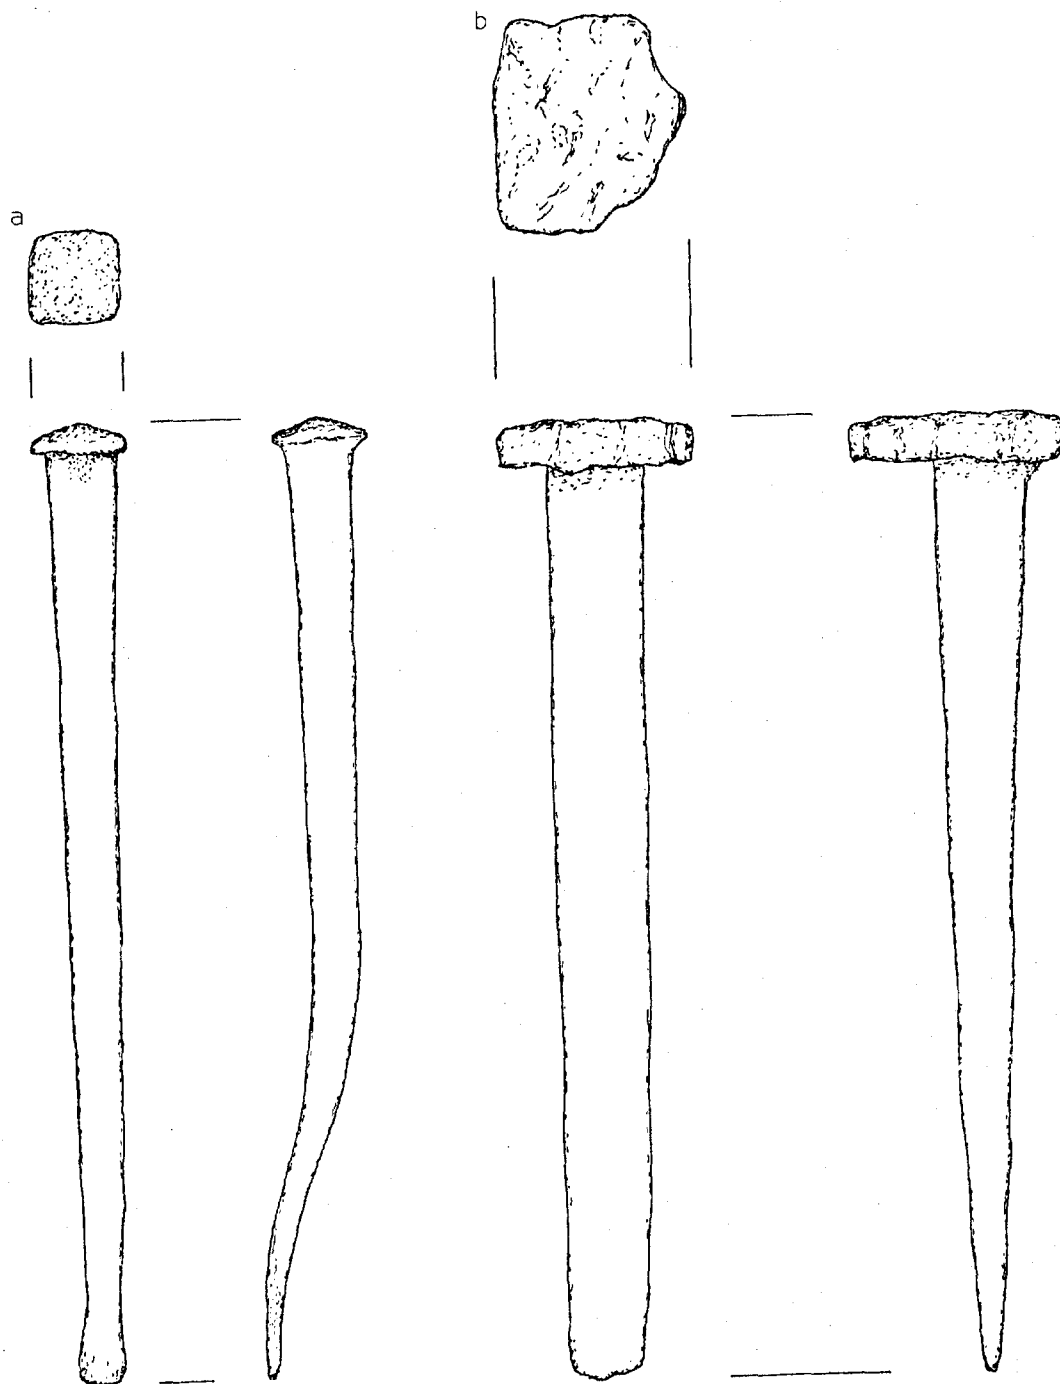
Fig. 33 -- New wrought rod nail varieties from the Blacksmith Shop area: a). nail Variety #1117 (FOVA 32295 -- L=18.9cm) and b). nail Variety #1118 (FOVA 33235 -- L=6.2cm).

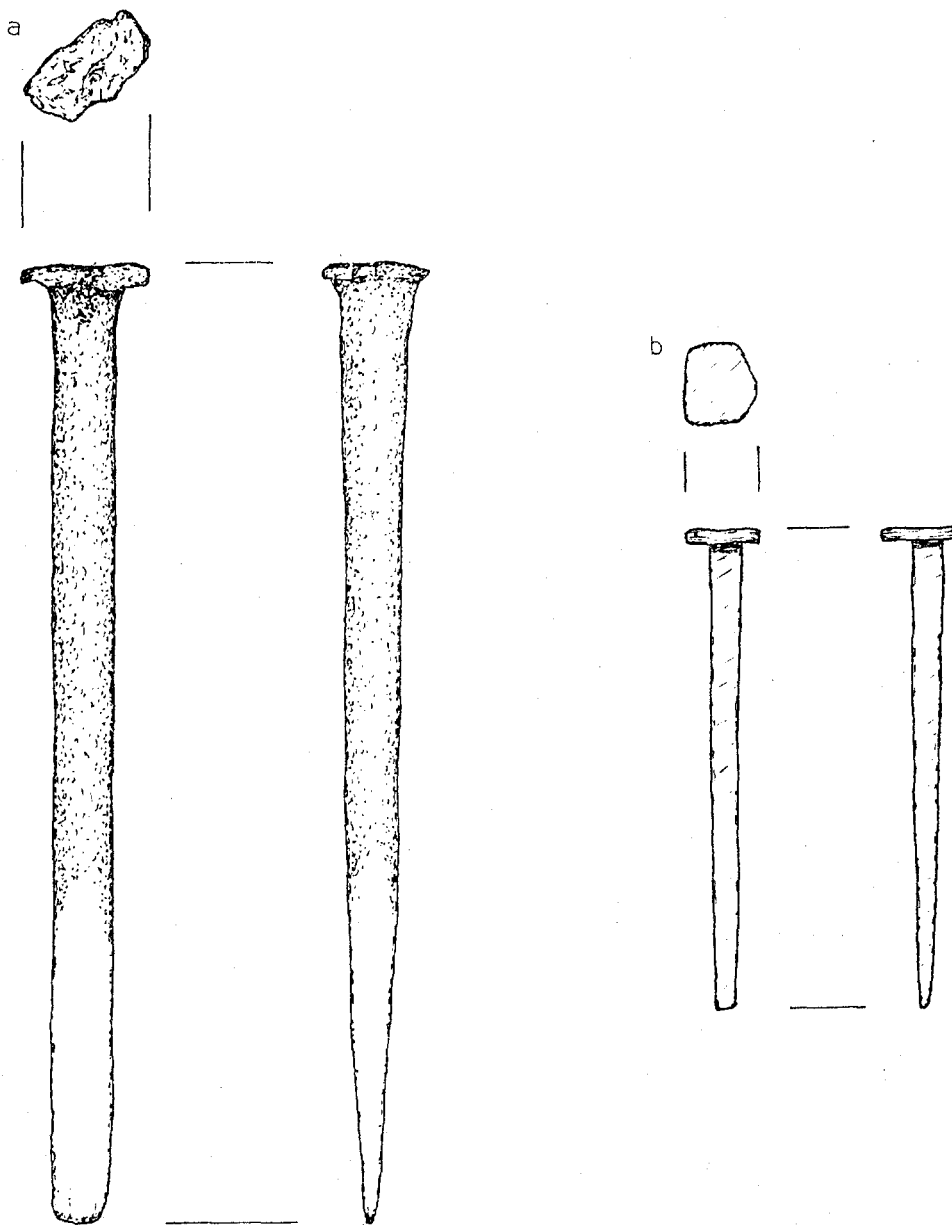
Fig. 34 -- New wrought rod nail varieties from the Blacksmith Shop area: a). nail Variety #1119 (FOVA 33328 -- L=8.93 cm.) and b). copper nail Variety #1120 (FOVA 33558 -- L=4.105 cm).

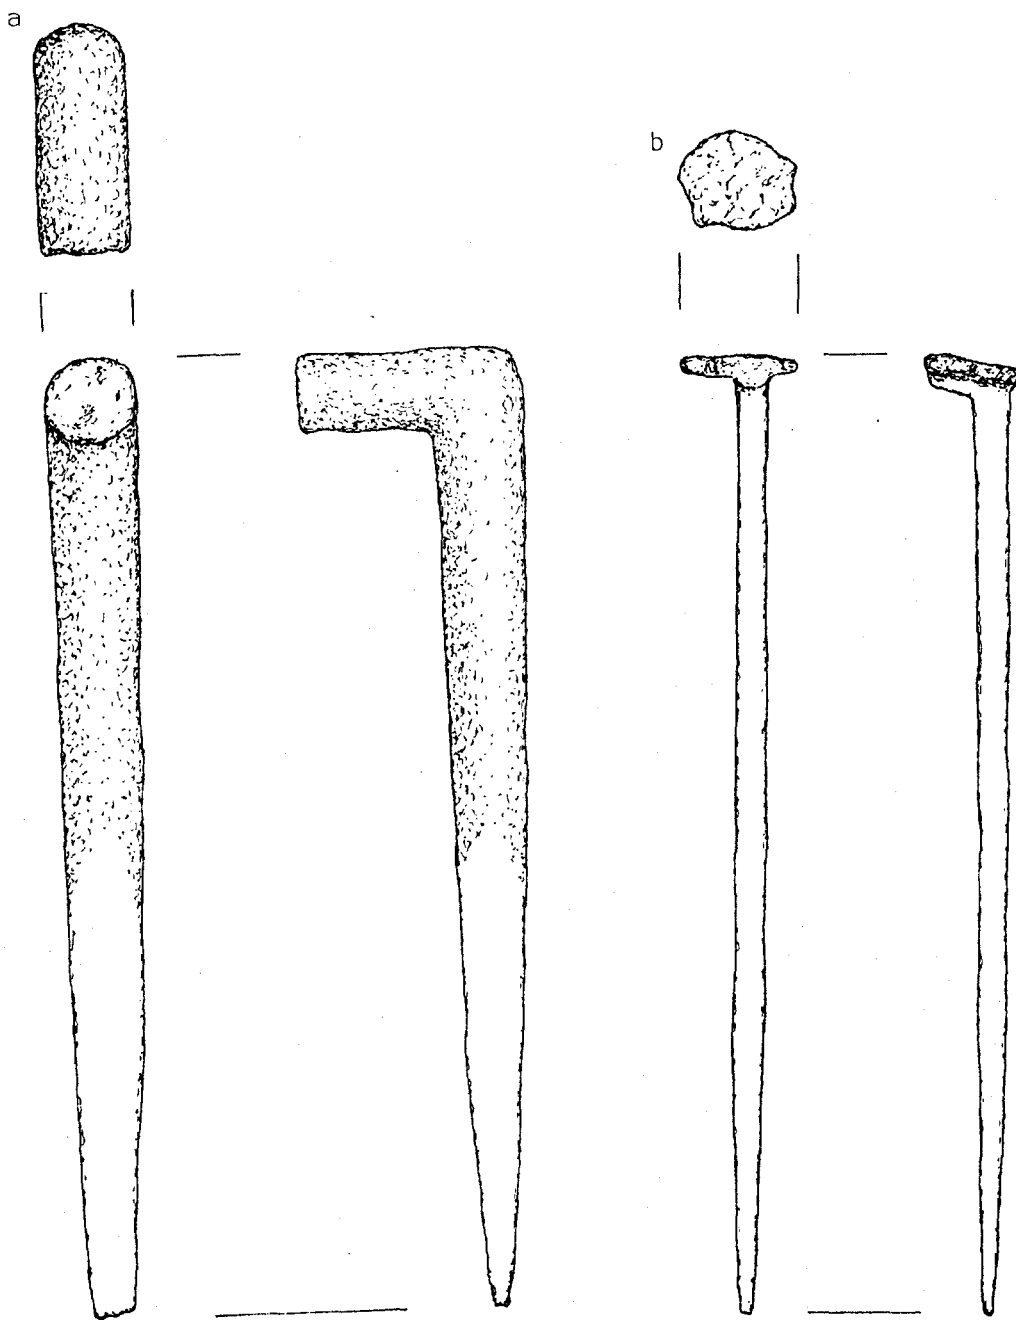
Fig. 35 -- New wrought rod nail varieties from the Blacksmith Shop area: a). nail Variety #1121 (FOVA 34162 -- L=7.21 cm.) and b). nail Variety #1123 -- L=14.72 cm.).

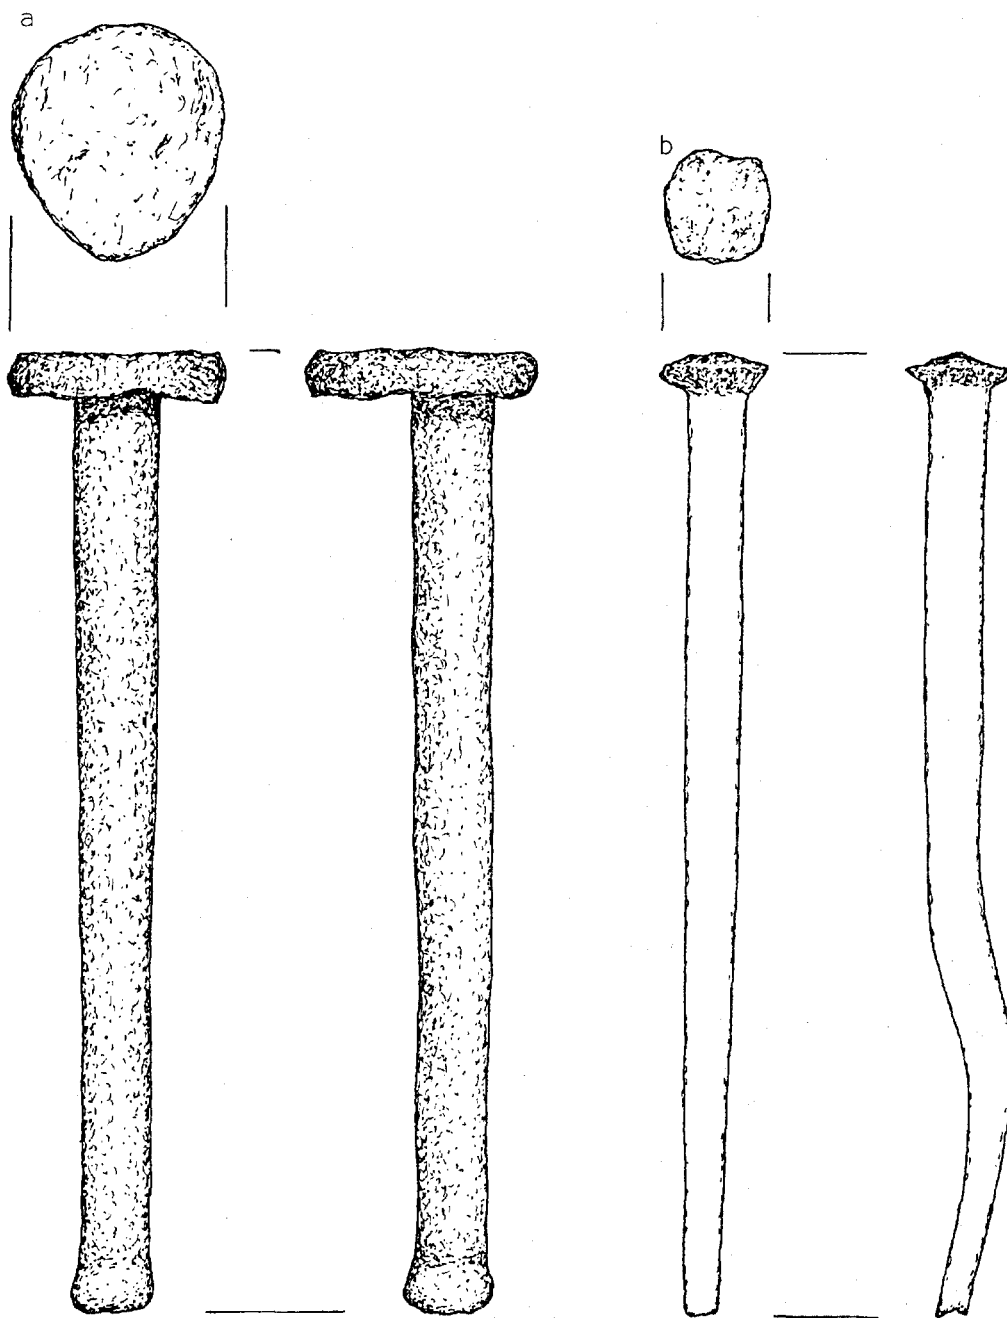
Fig. 36 -- New wrought rod nail varieties from the Blacksmith Shop area : a). nail Variety #1124 (FOVA 34524 -- L=6.92 cm.) and b). nail Variety #1125 (FOVA 34810 -- L=18.03 cm.).

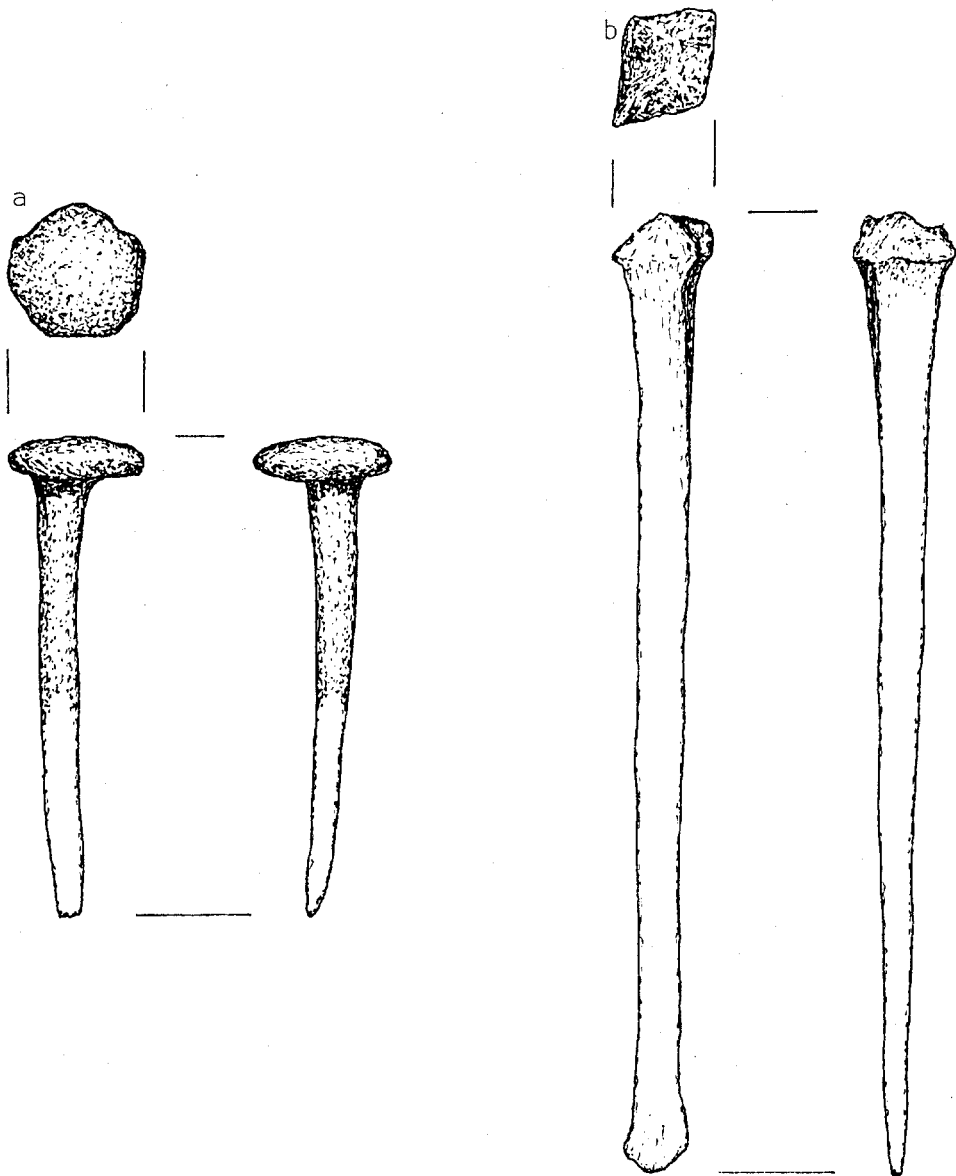
Fig. 37 -- New wrought rod nail varieties from the Blacksmith Shop area: a). nail Variety #1126 (FOVA 34868 -- L=4.125 cm.) and b). nail Variety #1127 (FOVA 34868 -- L=17.4 cm.).

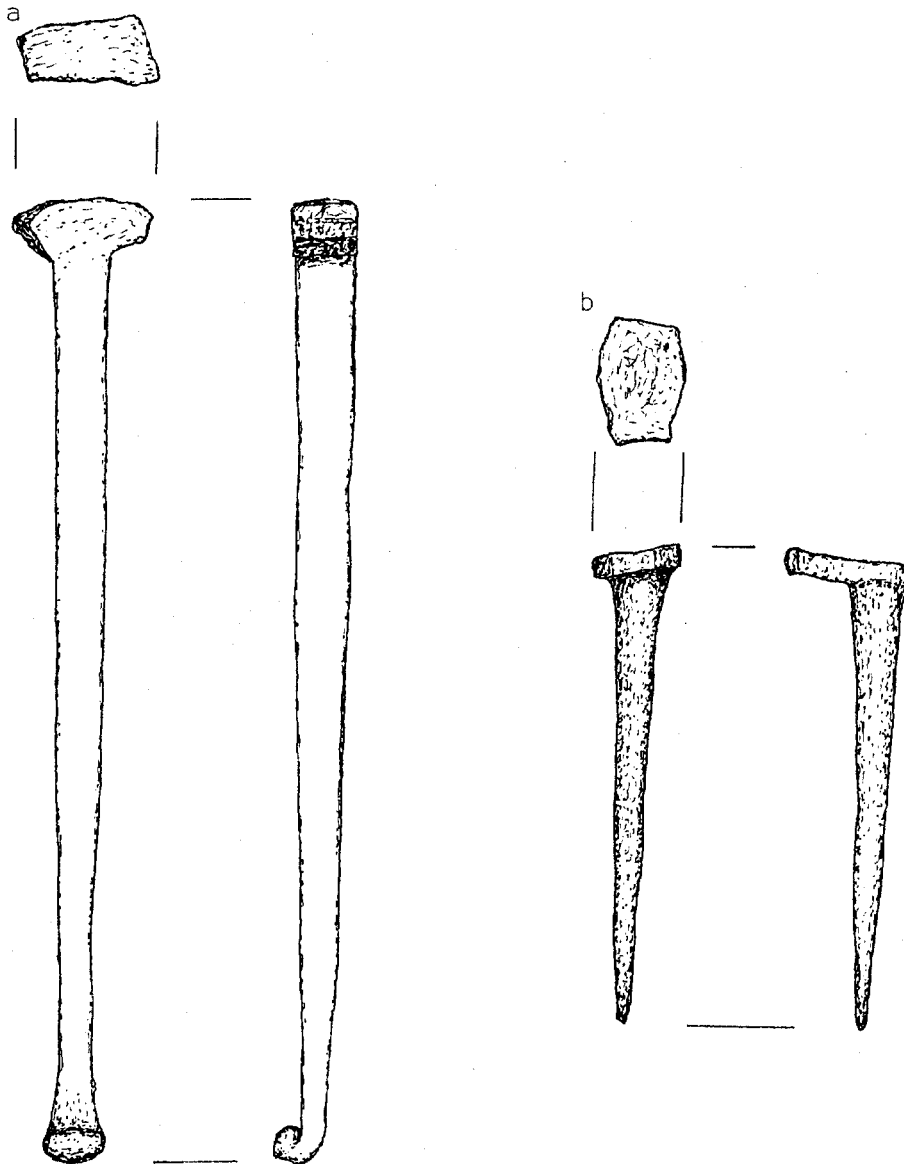
Fig. 38 -- New wrought rod nail varieties from the Blacksmith Shop area:  
a). nail Variety #1128 (FOVA 35097 -- L=17.3 cm.) and b).  
nail Variety #1129 (FOVA 35232 -- L=5.39 cm.).

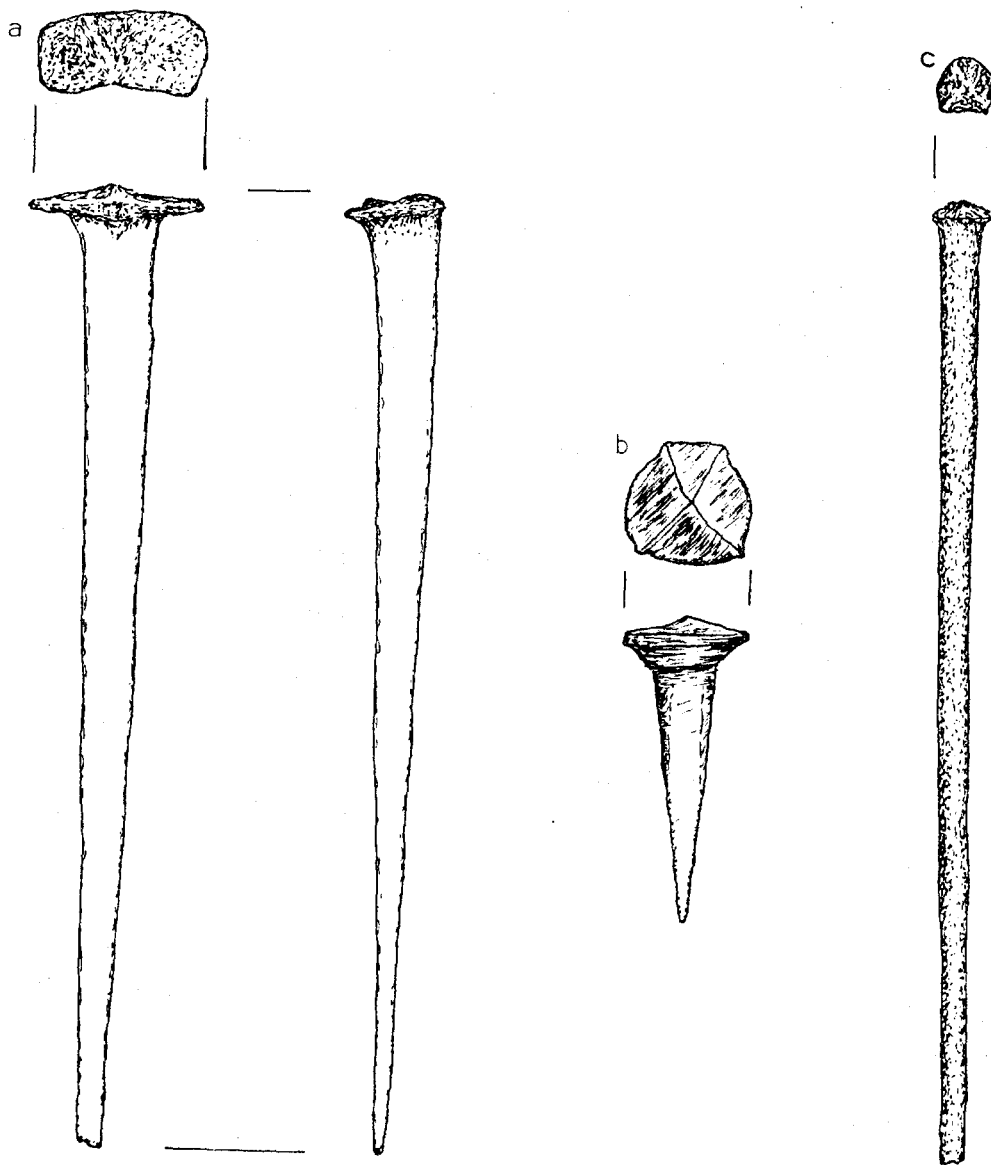
Fig. 39 -- New wrought rod nail varieties from the Blacksmith Shop area: a). nail Variety #1130 (FOVA 35286 -- L=10.3 cm.); b). copper nail Variety #1131 (FOVA 35456 -- L=3.96 cm.) and c). nail Variety #1132 (FOVA 32799 -- L=10.97cm).

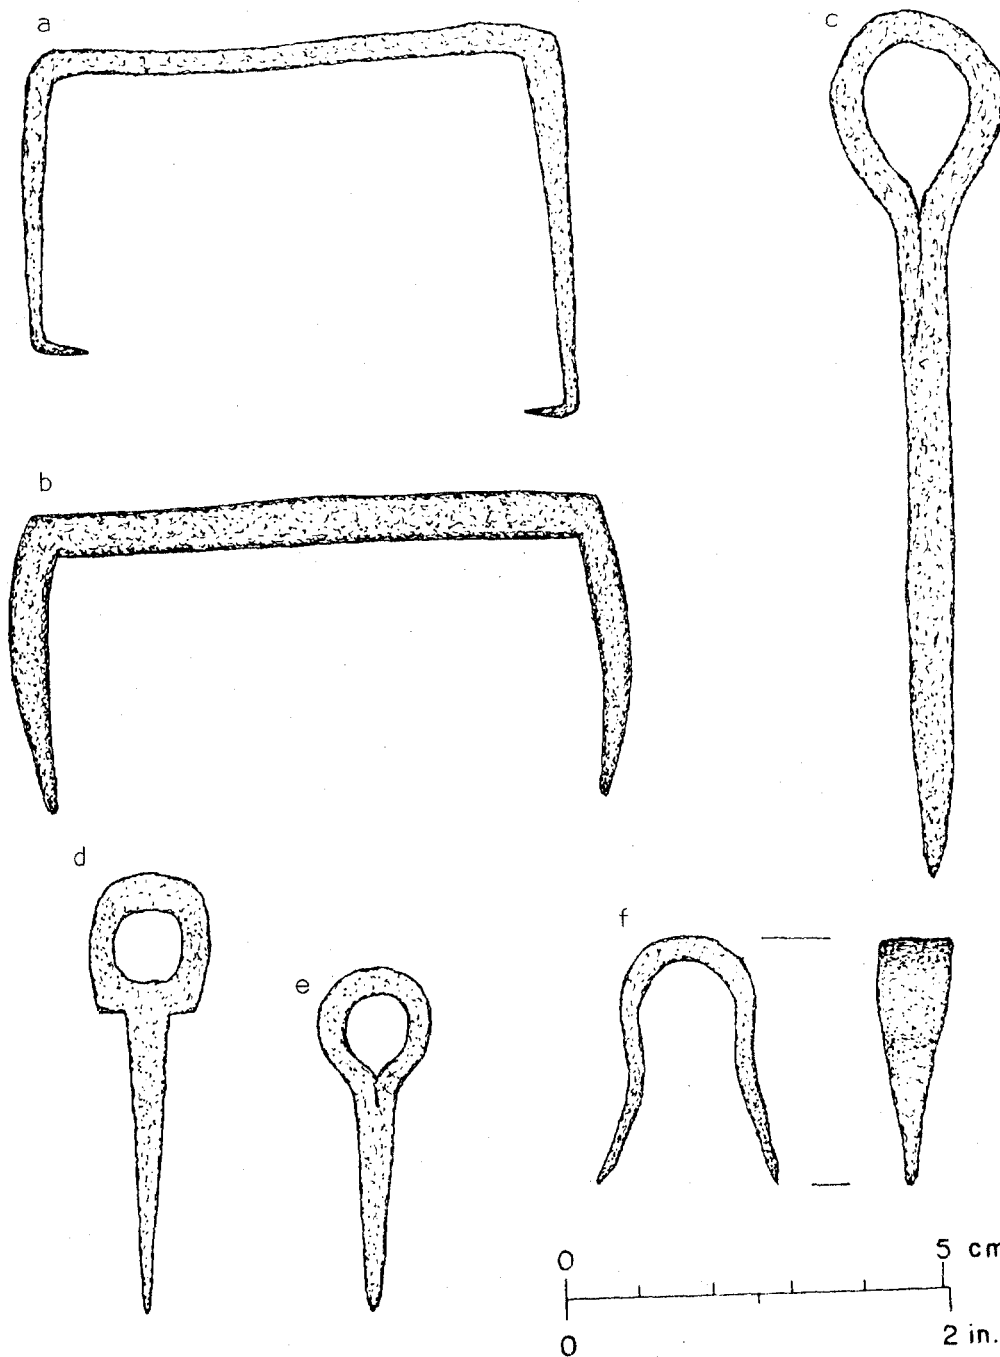
Fig. 40 -- Staples and closed eye nails from the Blacksmith Shop area: a). staple (FOVA 34873); b). staple (FOVA 35532); c). closed eye nail (FOVA 33261); d). closed eye nail (FOVA 34115); e). closed eye nail (FOVA 34115) and f). staple (FOVA 35259).

A total of 13 wrought rod and 12 machine cut wire staples were recovered from the Blacksmith Shop area. Wire cut staples appeared to have been associated with U.S. Army occupation and no new styles were identified. All wrought rod staples appeared to have been associated with HBC Blacksmith Shop activities, and 3 new styles were identified and illustrated (Figs. 40a-b and f).

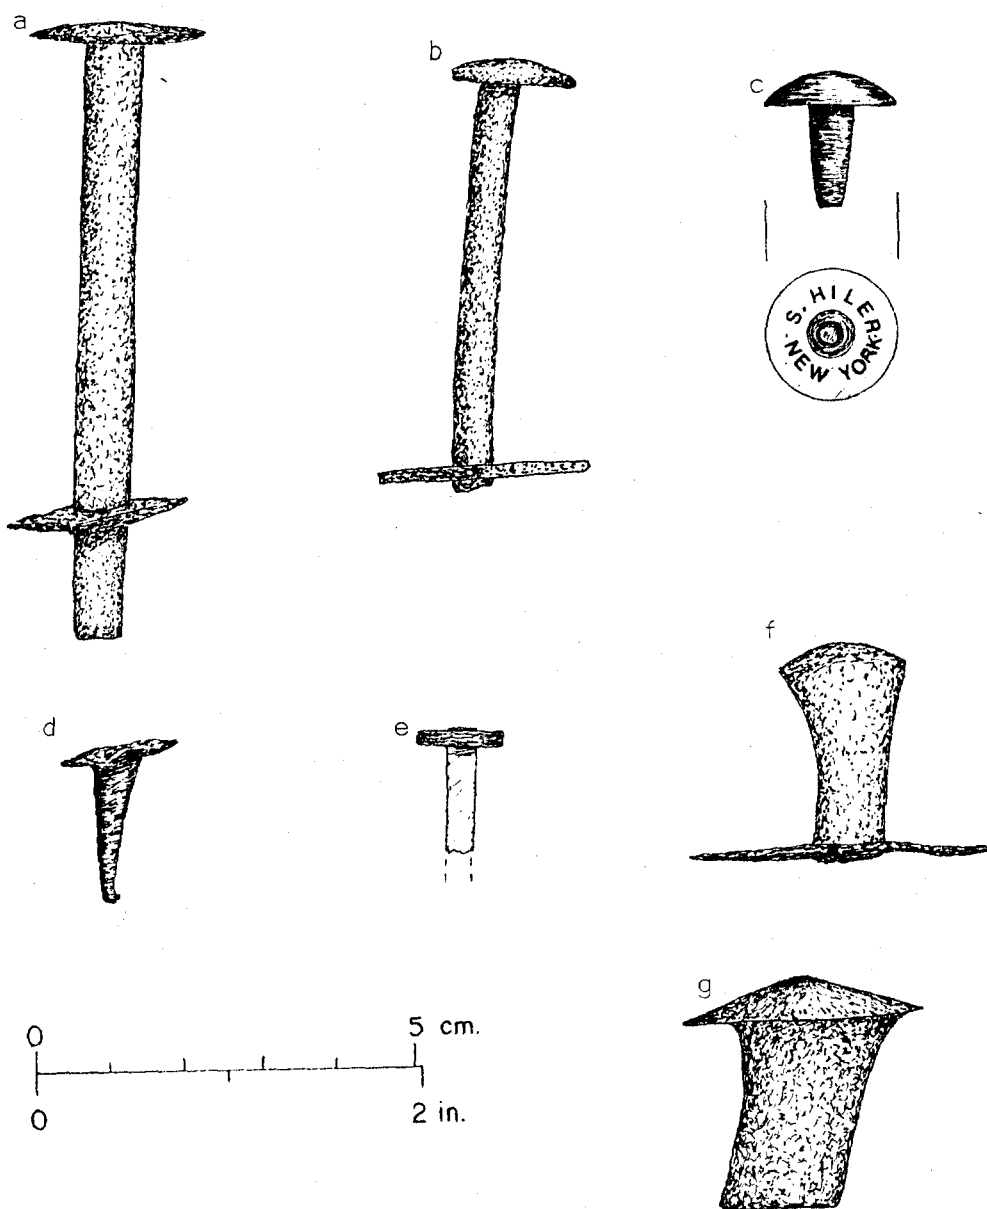
Fig. 41 -- Bolts and rivets from the Blacksmith Shop area: a). bateau bolt w/rove (FOVA 35950); b). bateau bolt w/rove (FOVA 32802); c). "S. HILER" brass rivet (FOVA 34877); d). conical copper rivet (FOVA 34960); e). copper rivet (FOVA 34285); f). rivet w/rove (FOVA 36023) and g). rivet (FOVA 34529).

A total of 129 rivets were recovered including 19 barrel rivets, 6 bateau bolts with and without roves, and 3 brass rivets marked "S.Hiler New York" (Fig. 41c). All rivets have been correlated with HBC activities (e.g., see the rivet accumulation in N.E. corner of Indian Trade Store in Hoffman & Ross 1975). The various rivet styles are illustrated in Figs. 41c-g.

Bateau bolts have been historically associated with york boat construction, but they may also have been used in any situation where layers of wood needed to be pinioned together. A bateau bolt without rove was previously illustrated and described as nail Variety #1094 (Hoffman & Ross 1974b:Fig. 64l). However they were usually used with a rove, or diamond shaped washer, over which the bateau tip was rivet splayed to provide permanent securing. Two styles of bateau bolts with roves are illustrated in Figs. 41a-b.

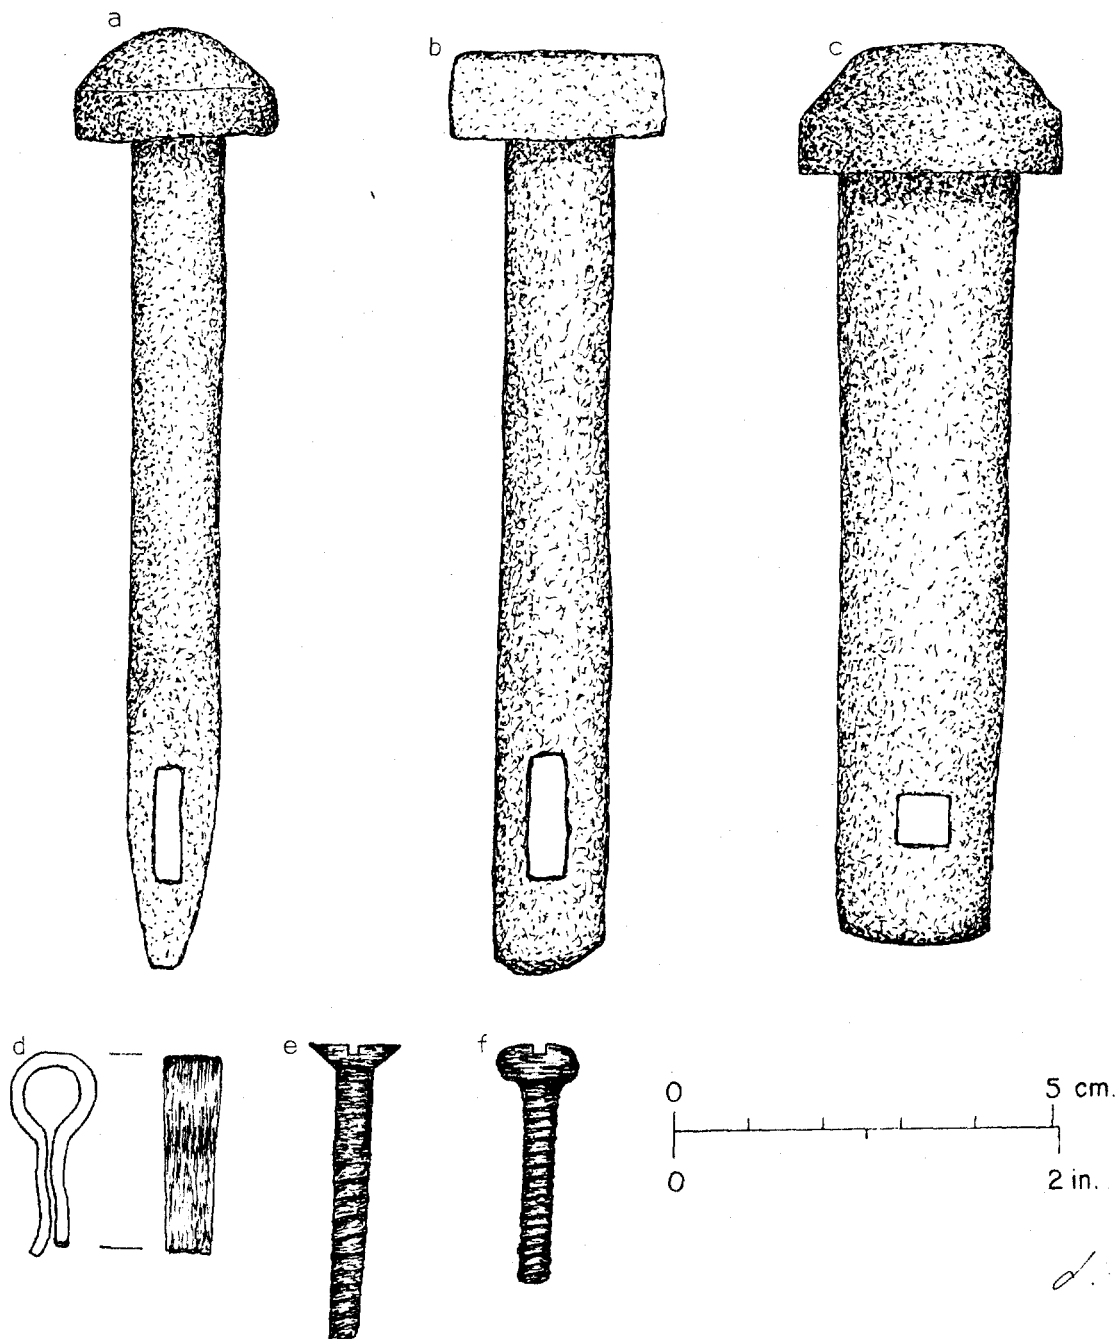
Fig. 42 -- Cotter bolts, a cotter pin and screws from the Blacksmith Shop area: a). cotter bolt (FOVA 36068); b). cotter bolt (FOVA 35629); c). cotter bolt (FOVA 33383); d). cotter pin (FOVA 35993); e). screw (FOVA 35462) and f). screw (FOVA 34961).

A total of 12 cotter bolt parts including 8 bolts, 3 cotter pins and 1 cotter key were recovered and all appear to have been utilized by the HBC. No evidence of manufacture was recovered in the way of preforms. Of the 8 cotter bolts, at least three styles have been defined (Figs. 42a-b), and 3 styles of cotter pins have been recognized. Two of the pin styles were reported and illustrated in the Indian Trade Store report (Hoffman & Ross 1975:Fig. 20i,k); and the third style is illustrated in Fig. 42d.

A total of 20 iron screws consisting of 2 stylistic varieties were recovered from the Blacksmith Shop and on the basis of stratigraphic context, 2 stylistic varieties were related to HBC activities. One style, a flat, countersunk head with a convergent to semi-convergent tip (Fig. 42a), appears to have been related to the HBC "wood screw nails" which were inventoried by "miscellaneous sizes" (Hussey 1972:222). Two sizes have been distinguished in the Blacksmith Shop-- 1 and 1½ in. lengths. The second style is a round (fillister) head with flush base screw that had a non-tapering shank (Fig. 42f). It was probably utilized with a nut for sheet metal work, and the size, measuring from the base of the screw head, was approximately 1 in.

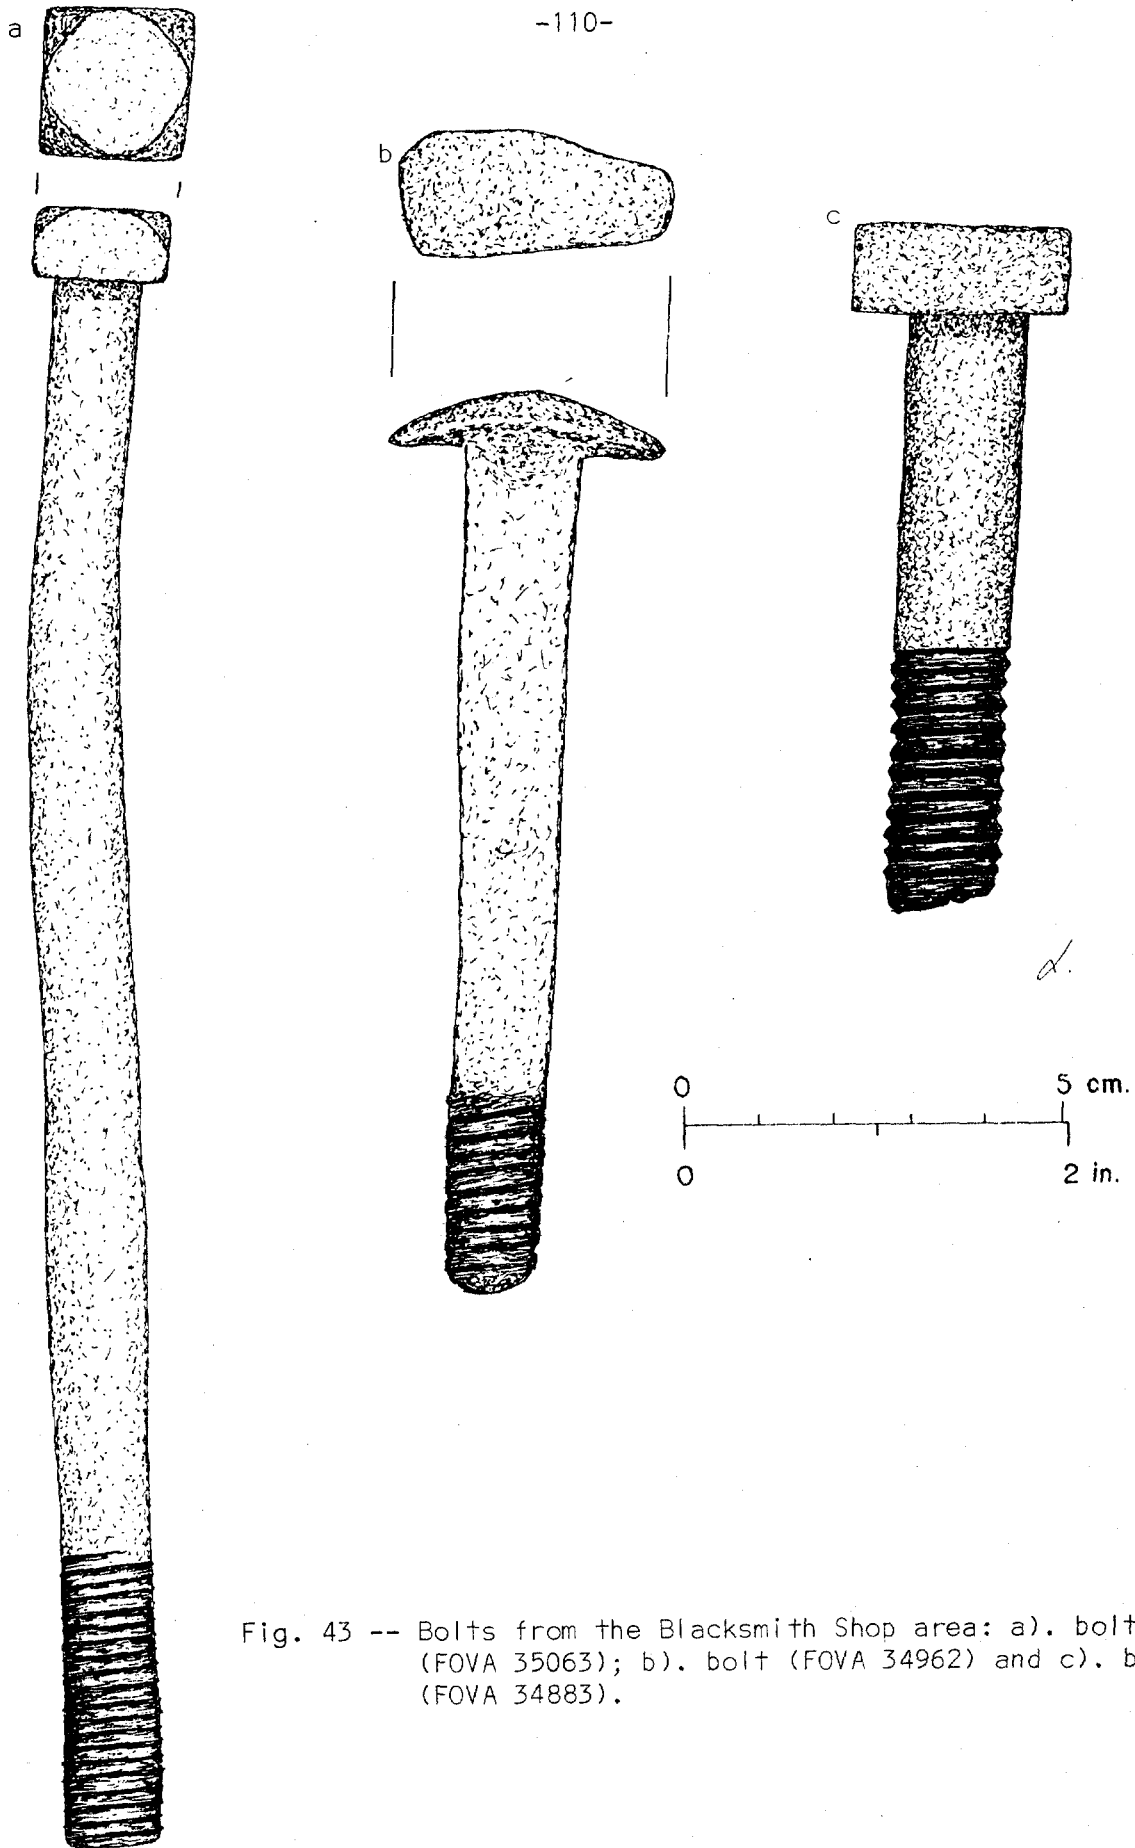
Fig. 43 -- Bolts from the Blacksmith Shop area: a). bolt (FOVA 35063); b). bolt (FOVA 34962) and c). bolt (FOVA 34883).

Forty-five finished iron bolts were recovered as well as 2 iron bolts with nuts, a brass (or copper) bolt (Fig. 48d), and an iron eye-bolt (Fig. 48e). With the exception of 2 bolt styles (not illustrated) associated with U.S. Army activities, all other bolts were feasibly related to HBC activities. Of the HBC bolts, 17 styles have been identified as being either used or manufactured at the Blacksmith Shop (Figs. 43-48a-c).

Both round and square stock were utilized in manufacturing the bolts from the Blacksmith Shop. Two modes of head manufacture were observed occurring on both types of stock, single piece heads formed from the distal end of the stock, and two-piece heads, wherein metal was wrapped around the distal stock end.

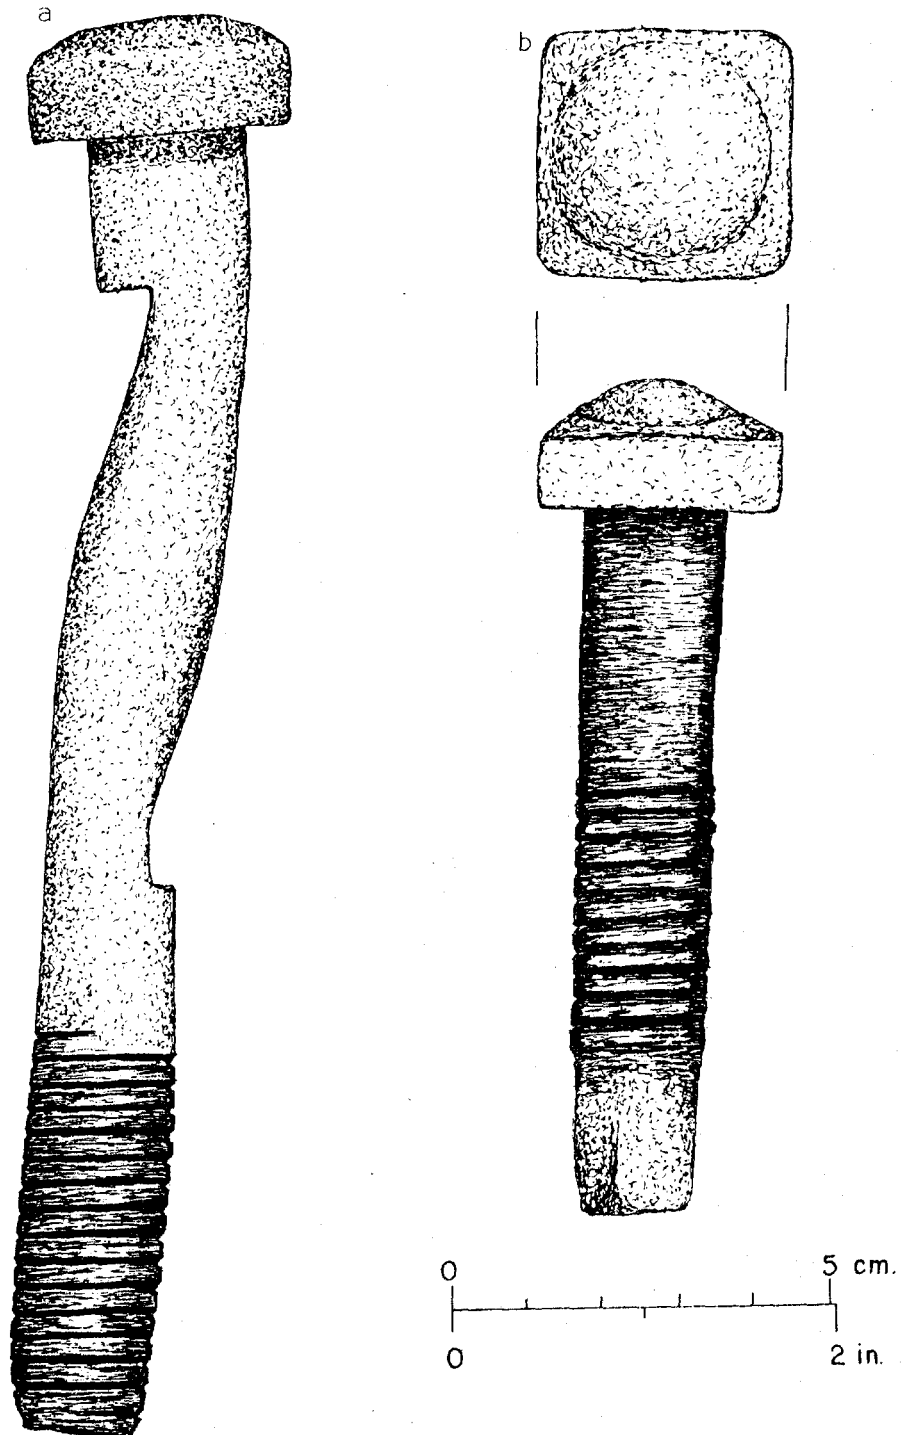
Fig. 44 -- Bolts from the Blacksmith Shop area: a). bolt (FOVA 36067) and b). bolt (FOVA 35585).

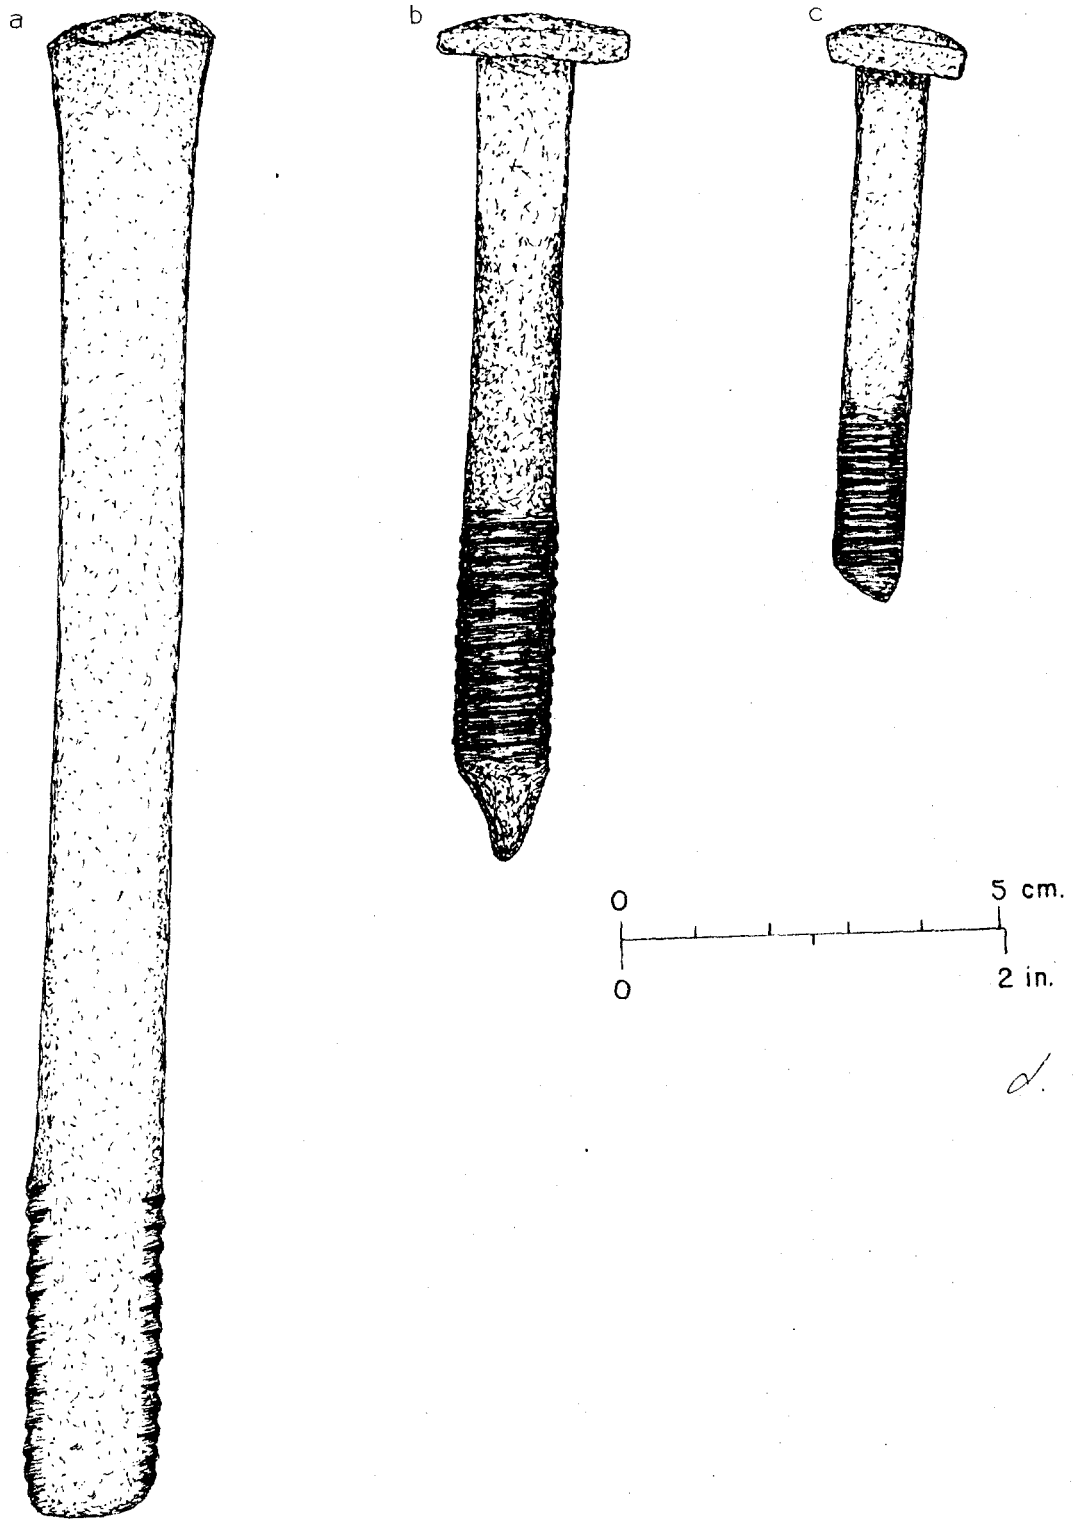
Fig. 45 -- Bolts from the Blacksmith Shop area: a). bolt (FOVA 32803);  
b). bolt (FOVA 34433) and c). bolt (FOVA 32235).

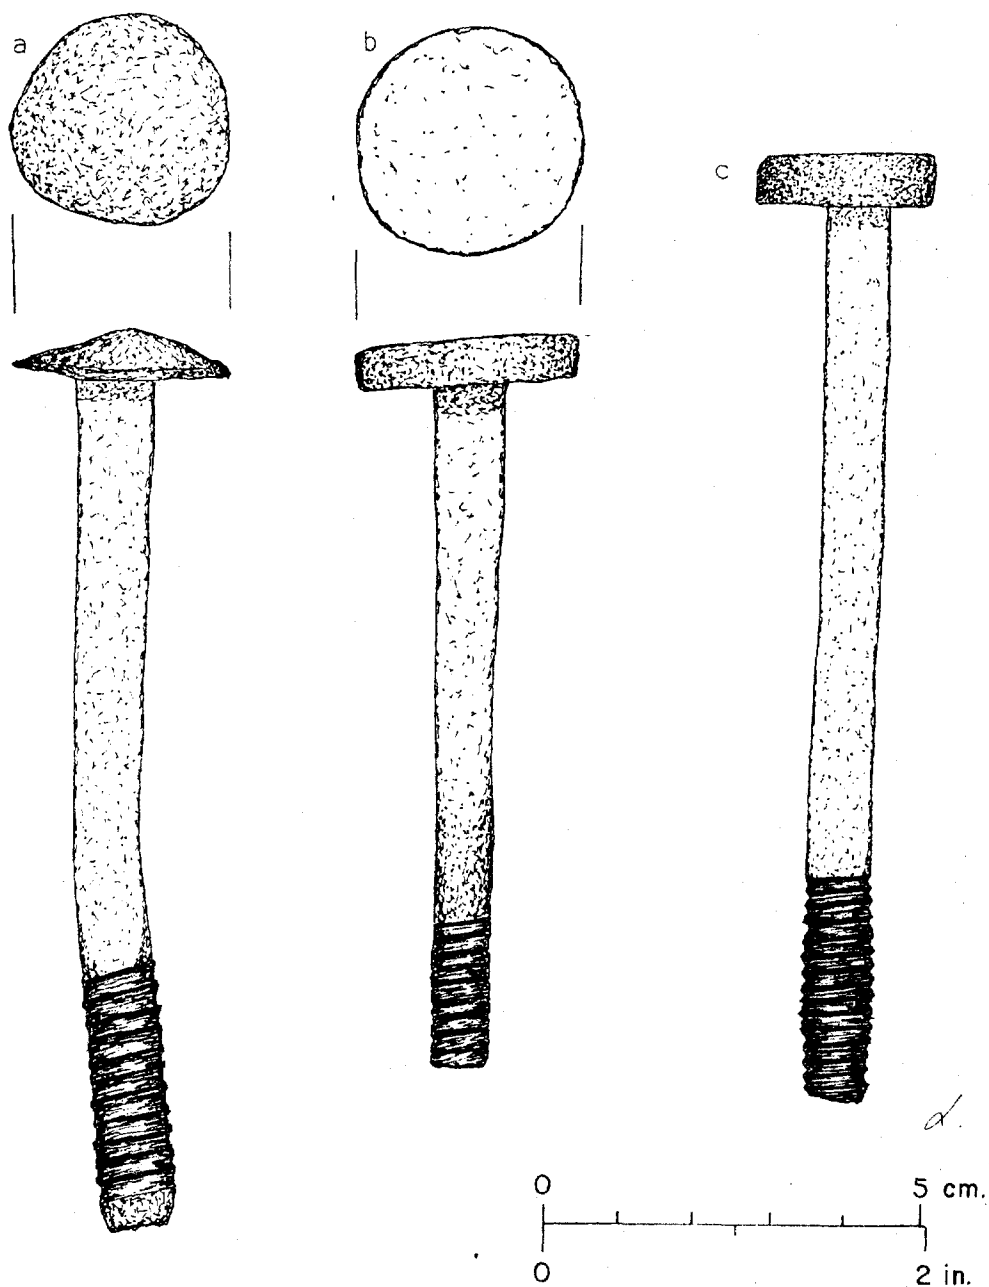
Fig. 46 -- Bolts from the Blacksmith Shop area: a). bolt (FOVA 34433);  
b). bolt (FOVA 34962) and c). bolt (FOVA 34535).
