FORT VANCOUVER EXCAVATIONS - X

Southeastern Fort Area

National Park Service

July 1975

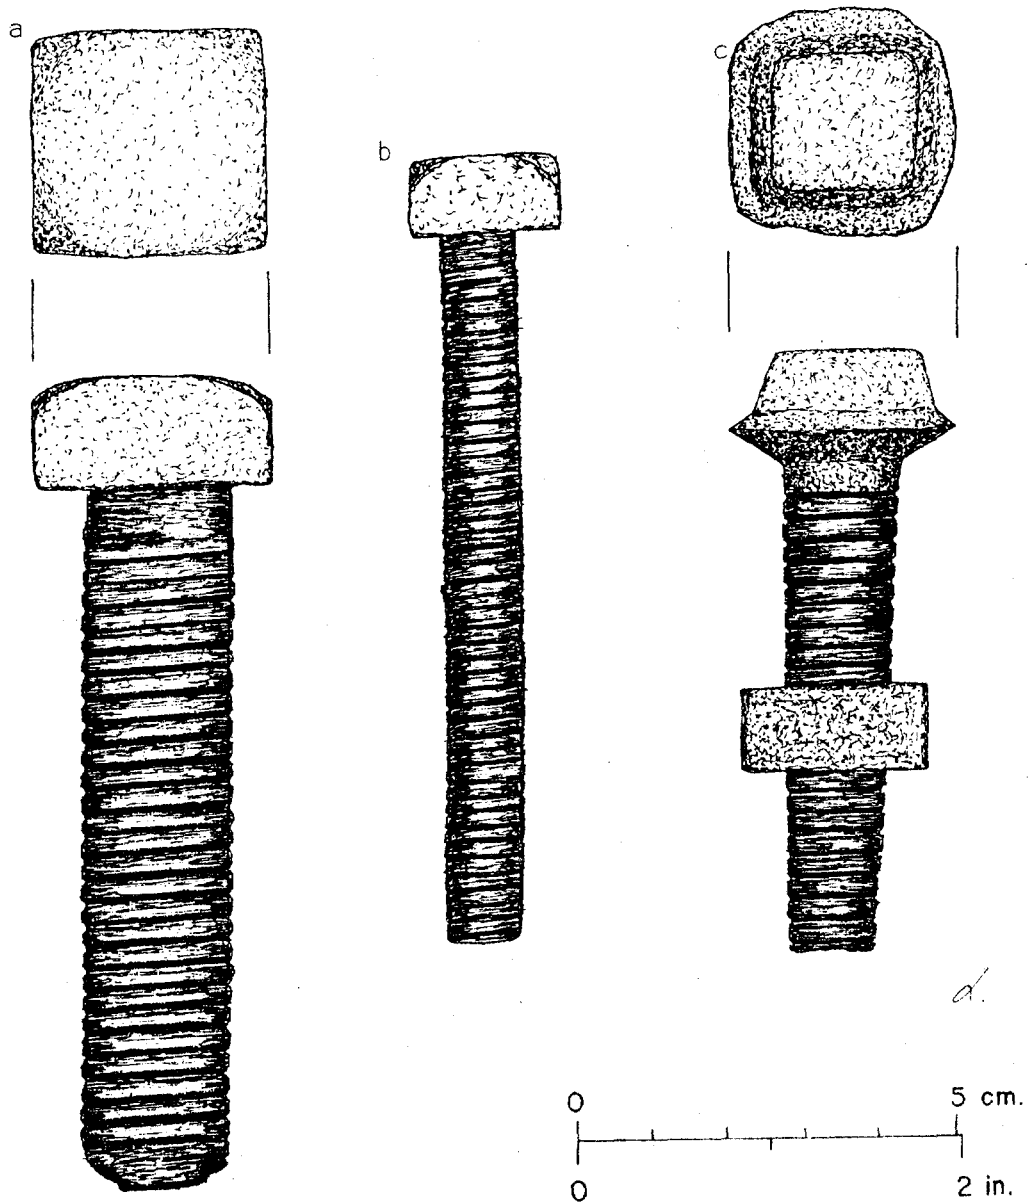
Fig. 47 -- Bolts from the Blacksmith Shop area: a). bolt (FOVA 35630);  
b). bolt (FOVA 35351) and c). bolt w/nut (FOVA 34536).

Forty-five finished iron bolts were recovered as well as 2 iron bolts with nuts, a brass (or copper) bolt (Fig. 48d), and an iron eye-bolt (Fig. 48e). With the exception of 2 bolt styles (not illustrated) associated with U.S. Army activities, all other bolts were feasibly related to HBC activities. Of the HBC bolts, 17 styles have been identified as being either used or manufactured at the Blacksmith Shop (Figs. 43-48a-c).

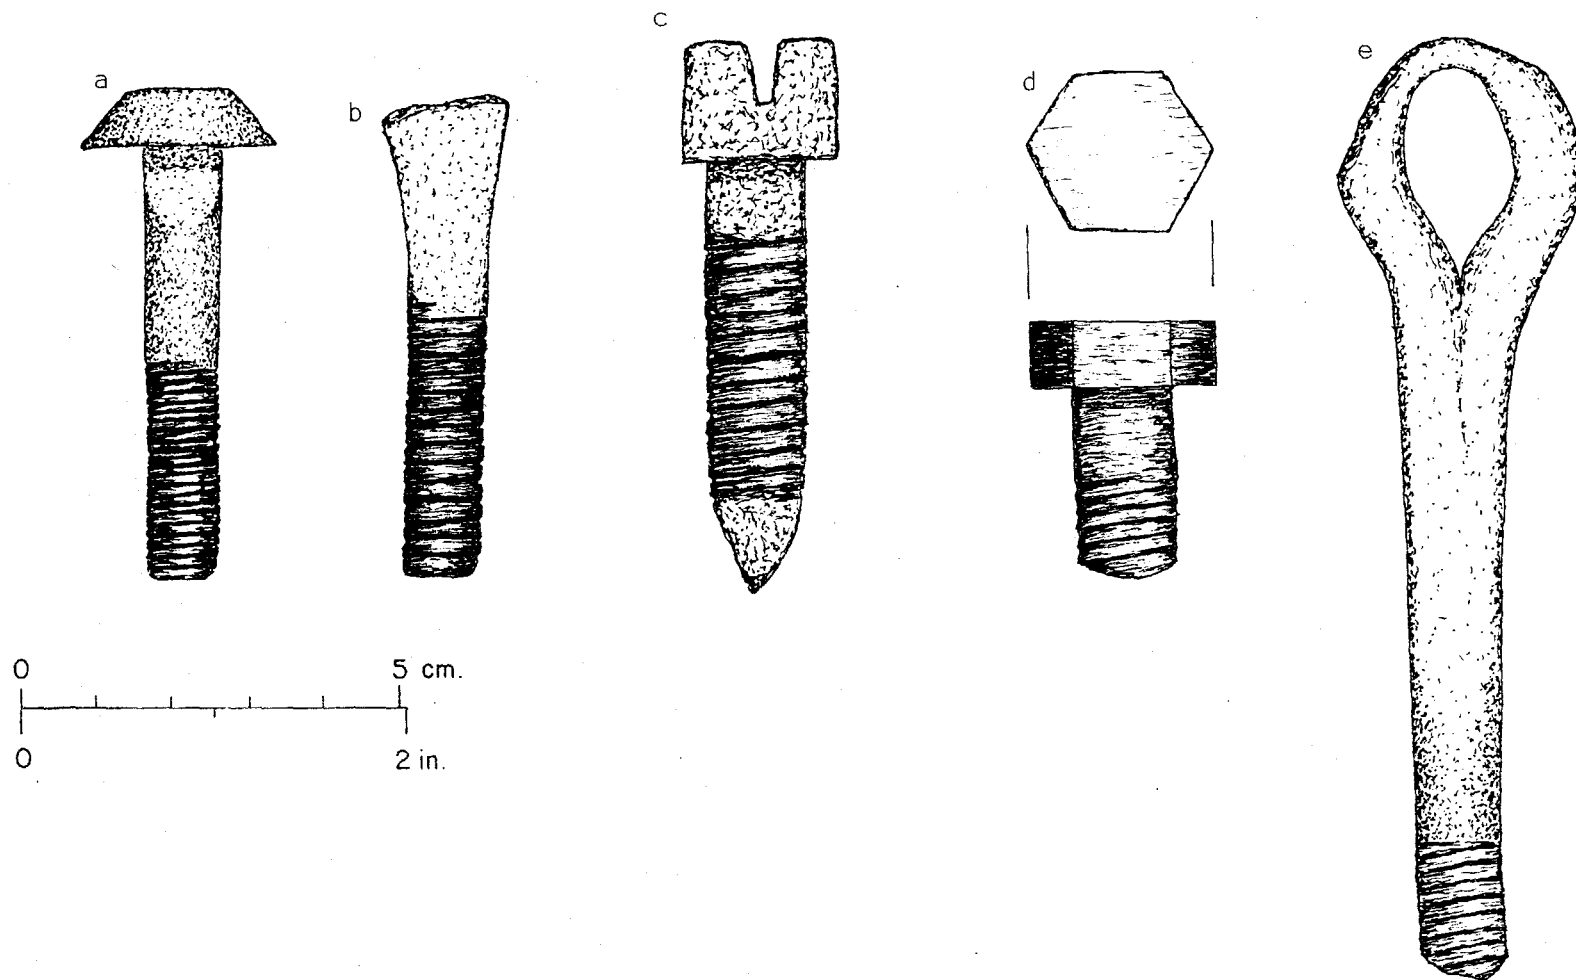
Fig. 48 -- Bolts from the Blacksmith Shop area: a). bolt (FOVA 34251); b). bolt (FOVA 35235); c). bolt (FOVA 35351); d). brass bolt (FOVA 36026) and e). closed eye bolt (FOVA 34538).

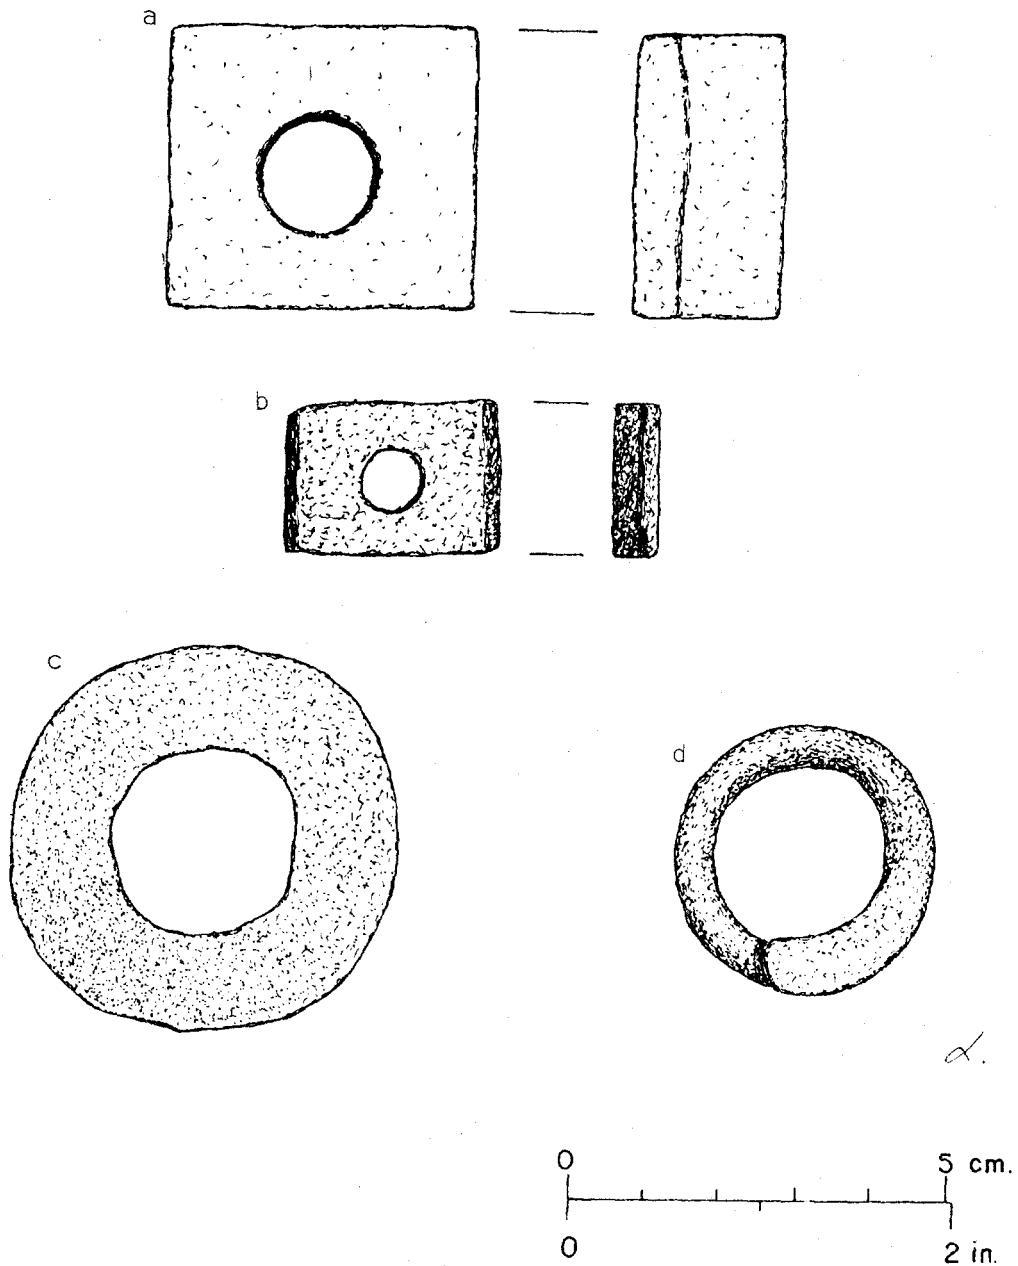
Fig. 49 -- Nuts, washer and spring washer from the Blacksmith Shop area:  
a). nut (FOVA 34884); b). nut (FOVA 34884); c). washer (FOVA 32393) and d). spring washer (FOVA 34629).

Based upon the presence of 37 nut preforms in the Blacksmith Shop, some portion of the 81 nuts recovered must have been manufactured in the Shop. Two styles of nuts appear to have been used and both were manufactured in the Blacksmith Shop. The finished styles are illustrated in Figs. 49a-b.

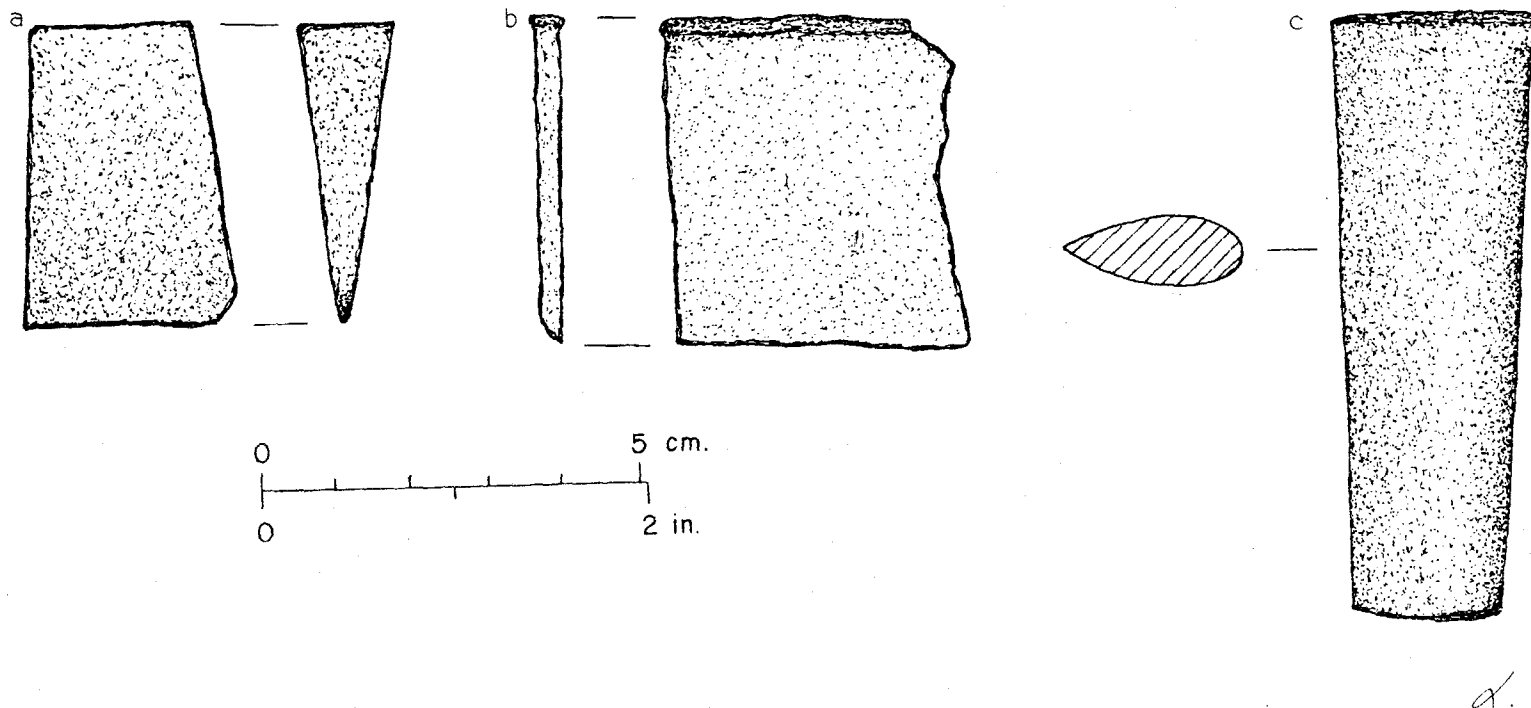
Fig. 55 -- Wedges and axe body form from the Blacksmith Shop area: a). wedge (FOVA 34555); b). wedge (FOVA 32358) and c). axe body form (FOVA 33249).

A total of 99 blacksmith tools were recovered, with file and tong fragments comprising over 80% of the identified tools. Tap and die equipment was also recovered in quantity indicating the probable manufacture of threaded fasteners. One implement tentatively identified as an axe body form (Fig. 55c) was recovered that could have been used as a mandrill over which the axe eye was formed during axe manufacture.

The axe body form has been termed an "axe swage" or "pattern" by Smith (1966:156) and may be equivalent to the HBC term "axe mandrell" (Hussey 1974:325). Axe body forms were used to form the eye on an axe, and were inserted into the eye of the axe while the blade or poll was being dressed (Smith 1966:156). One form was recovered from the Blacksmith Shop and has been illustrated in Fig. 55c.

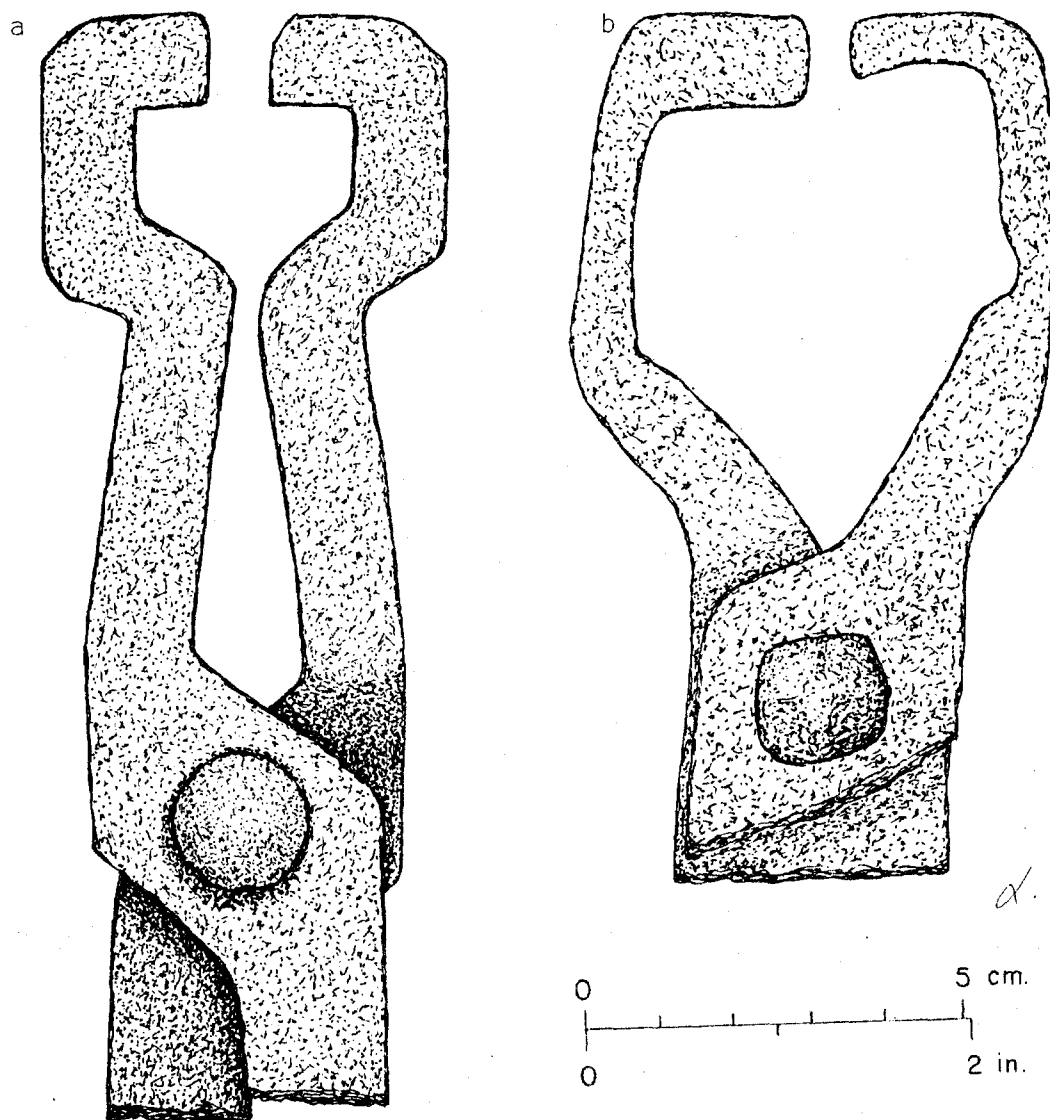
Fig. 56 -- Tongs from the Blacksmith Shop area: a). tongs (FOVA 33542)  
b). tongs (FOVA 34692).

Of the 20 tong fragments recovered, 6 styles of tong heads have been identified and illustrated (Figs. 56 - 57). Predominate styles include flat and square angle tongs for the grasping of square-rectangular stock. One manufacturing mark, a portion of an impressed letter, was observed on the handle near the hinge pin but it could not be identified. No direct evidence for the local manufacture of tongs has yet been recovered, but it could be expected that blacksmith marks on tongs probably indicated both ownership and maker, whereas marks on axes and trap springs probably denoted the actual manufacturer of the item.

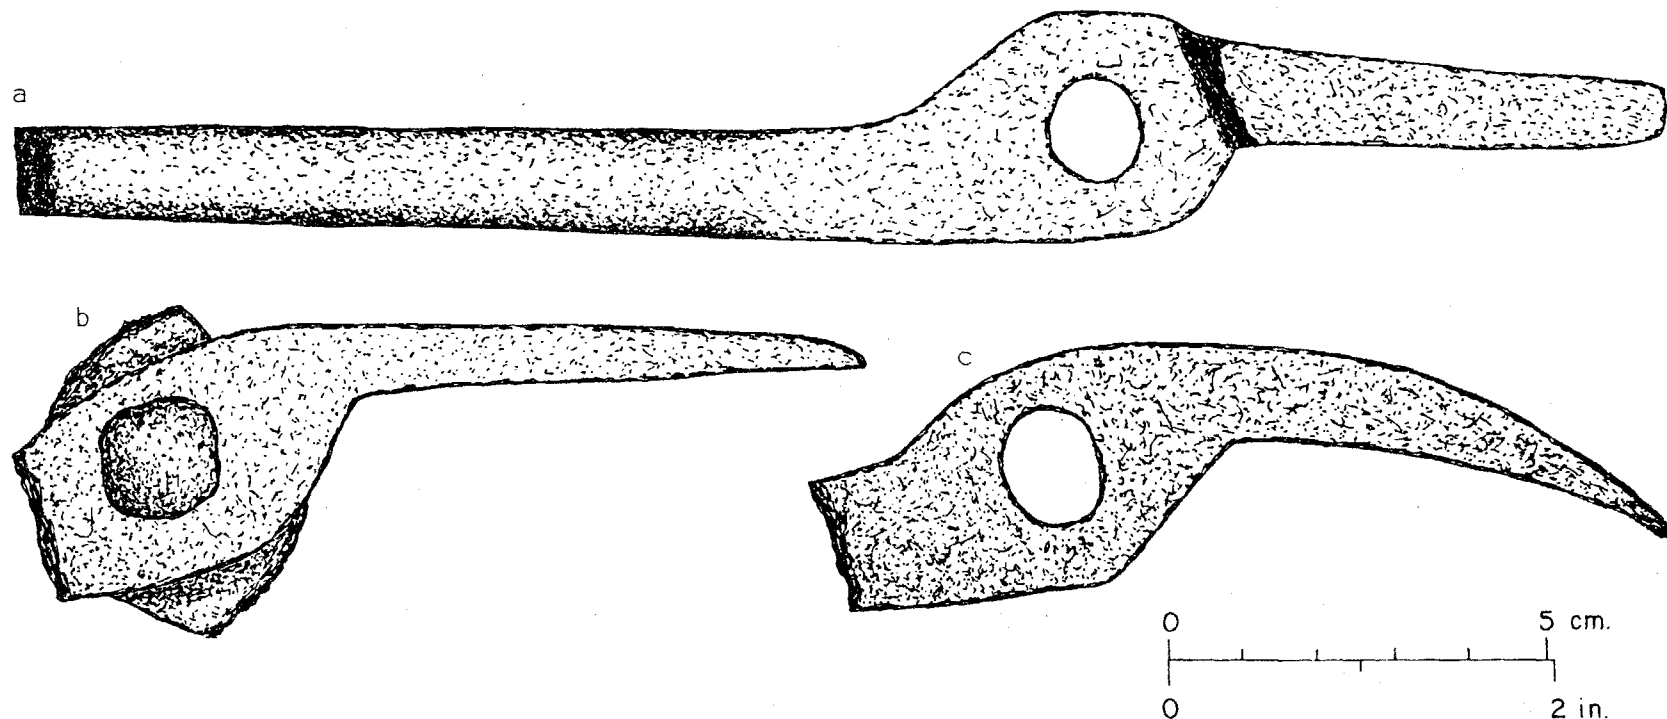
Fig. 57 -- Tongs from the Blacksmith Shop area: a). tongs (FOVA 35890) · b). tongs (FOVA 34122) and c). tongs (FOVA 33770).

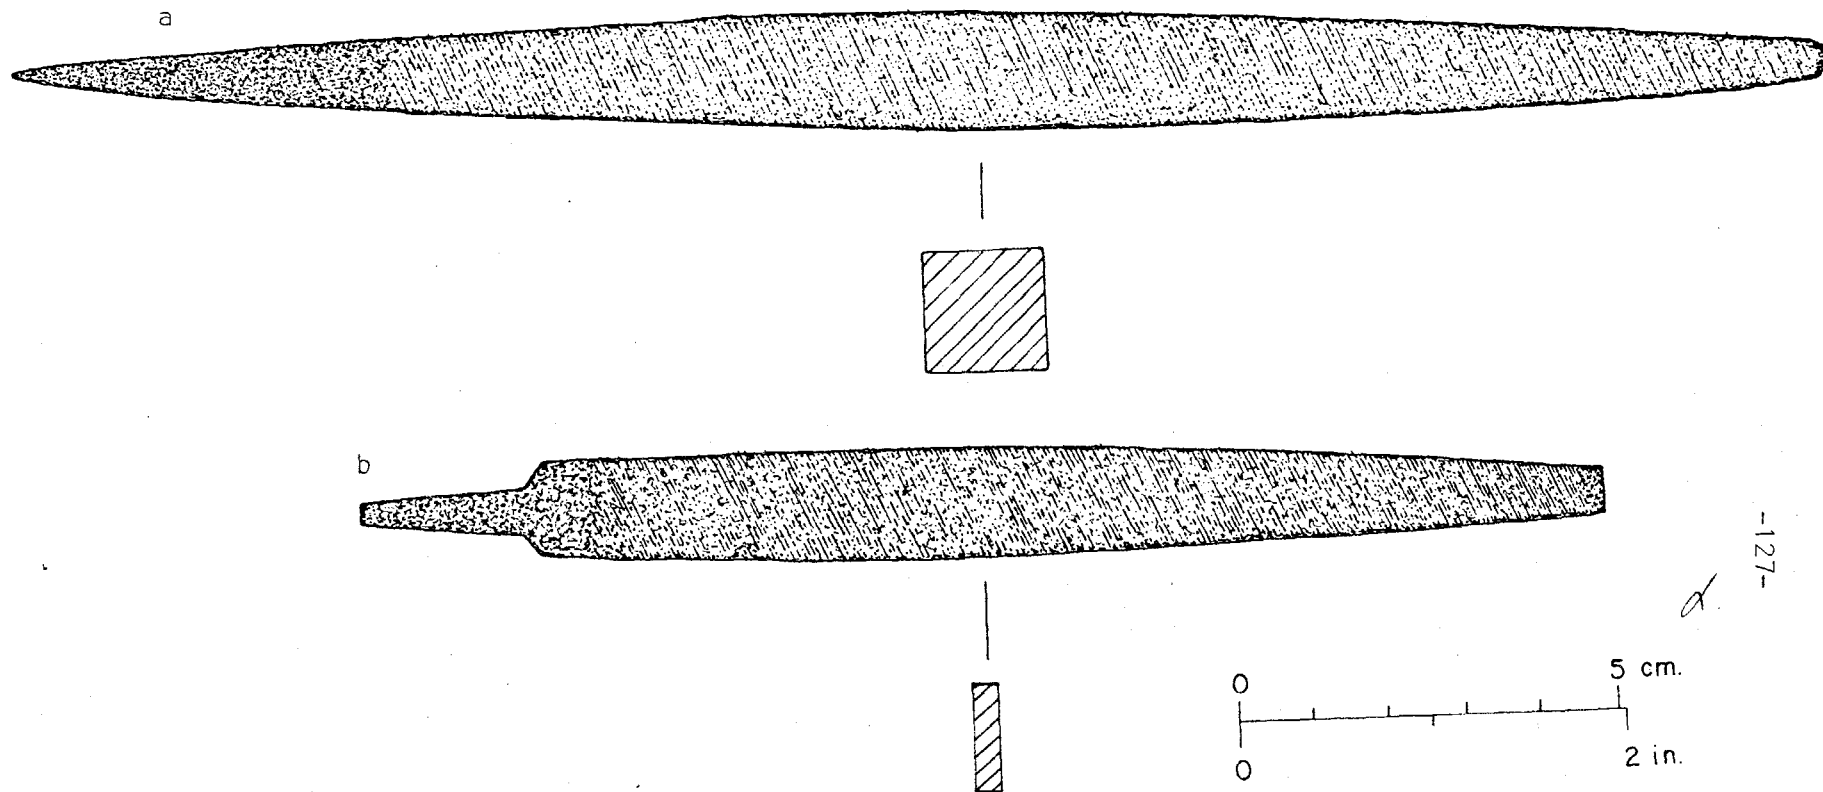
Fig. 58 -- Files from the Blacksmith Shop area: a). file (FOVA 32811) and b). file (FOVA 35369).

The types and quantities of files recovered reflect the primary responsibility of the Blacksmith Shop, in that all are functionally related to the working of metal, either in a cold or hot state. A total of 61 file fragments were recovered including 47 identifiable fragments representing at least 4 styles. "Flat bastard" (N=31) and "half-round bastard" (N=14) were the most common styles recovered. A triangular file fragment and a complete square "double ended taper" file (Schroeder 1970,353) were also recovered. Only two complete files were recovered, a 12" flat bastard, and a 19" square double ended taper file, and these have been illustrated in Figs. 58a-b.

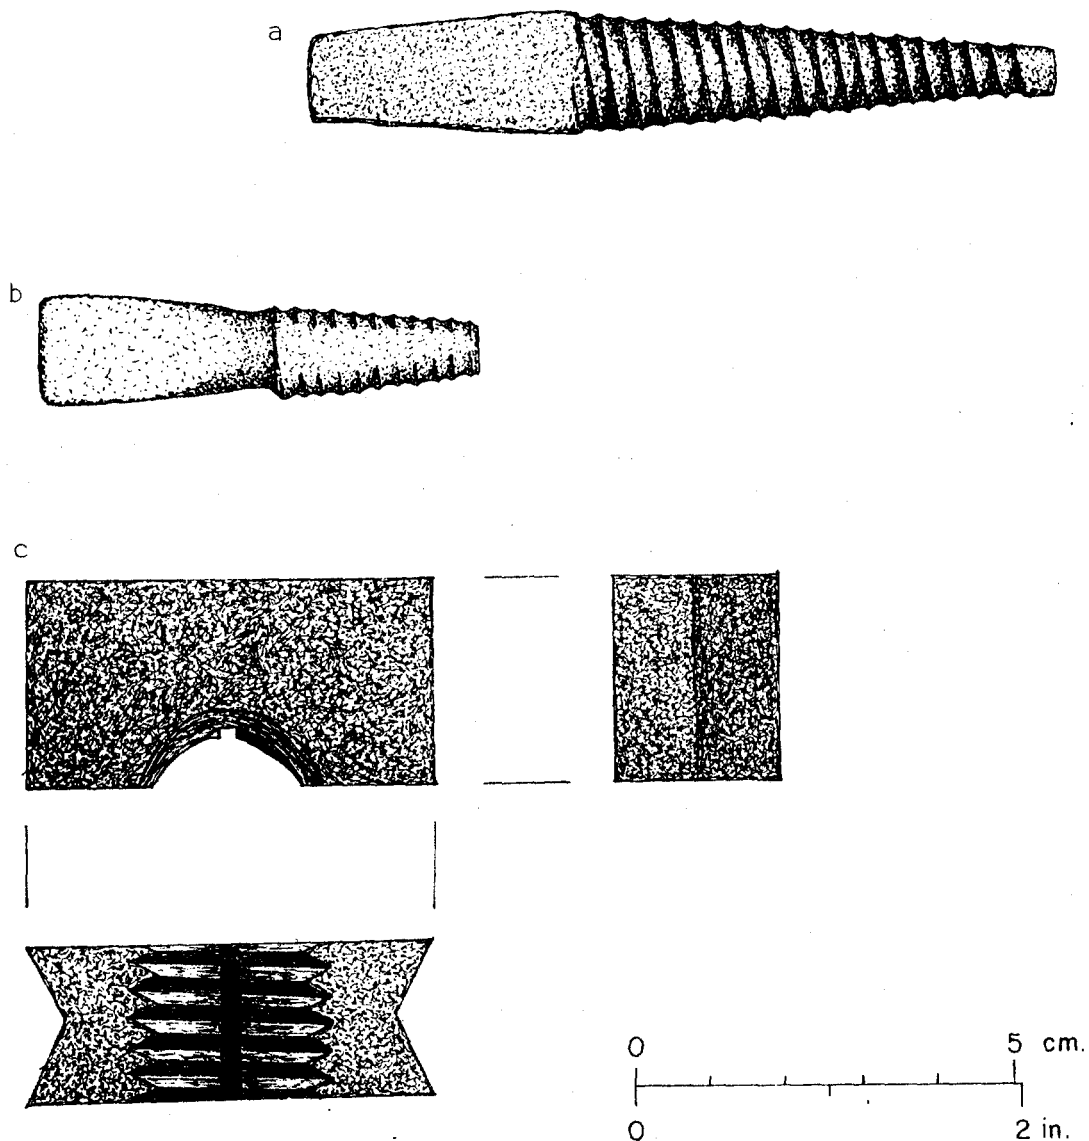
Fig. 59 -- Tap & die from the Blacksmith Shop area: a). tap (FOVA 34076);  
b). tap (FOVA 34825) and c). die (FOVA 33229).

Stock dies and taps were integral to the manufacture of threads on screws, bolts and nuts, and they were utilized in the Blacksmith Shop by at least 1845 (Hussey 1974:325). Stock dies were utilized to form the exterior threads on screws, bolts, and other threaded rod fasteners. Three specimens were recovered from the Blacksmith Shop, representing 2 styles of dies that differ in the mode of attachment to the stock, and in their thread formation. One style, illustrated in Fig. 59c, had a threading diameter of 7/8 in., and it appeared to be a counterpart to the stock die recovered from the Indian Trade Store (Hoffman & Ross 1975:Fig. 41e). This die was probably utilized for cutting threads in larger (7/8 to 1 in.) diameter bolts. A second style was represented by two dies and has been illustrated in Figs. 60a-b. The cutting surfaces of both specimens appeared to have amounted to not more the 1/3 the circumference of the surface being threaded, and it is hypothesized that they were utilized where threading was not continuous around the circumference of a shank, as in the production of threaded trap posts.

Stock taps were utilized to cut interior threads such as for nuts, and 5 taps were recovered representing 5 variations of stock attachment with at least 2 types of cutting surfaces. Two specimens had a tapered cutting section with a circular cross section and continuous thread pattern around the circumference (Fig. 59a). Both taps could cut interior threads in holes with diameters from at least 1/3 to as great as 3/4 inch. The second type of cutting surface was represented by 3 specimens (Fig. 59b) which had a tapered cutting surface with square cross section. The threads were cut into the corners of the shank and therefore discontinuous around the circumference. This type of cutting surface probably allowed the metal residue to escape, but it may also have functioned as a tap for irregular holes or where thread tolerances were not critical such as in the threading of trap post nuts. The diameter of holes that could be threaded with these dies ranged from 7/16 to 9/16 inch.

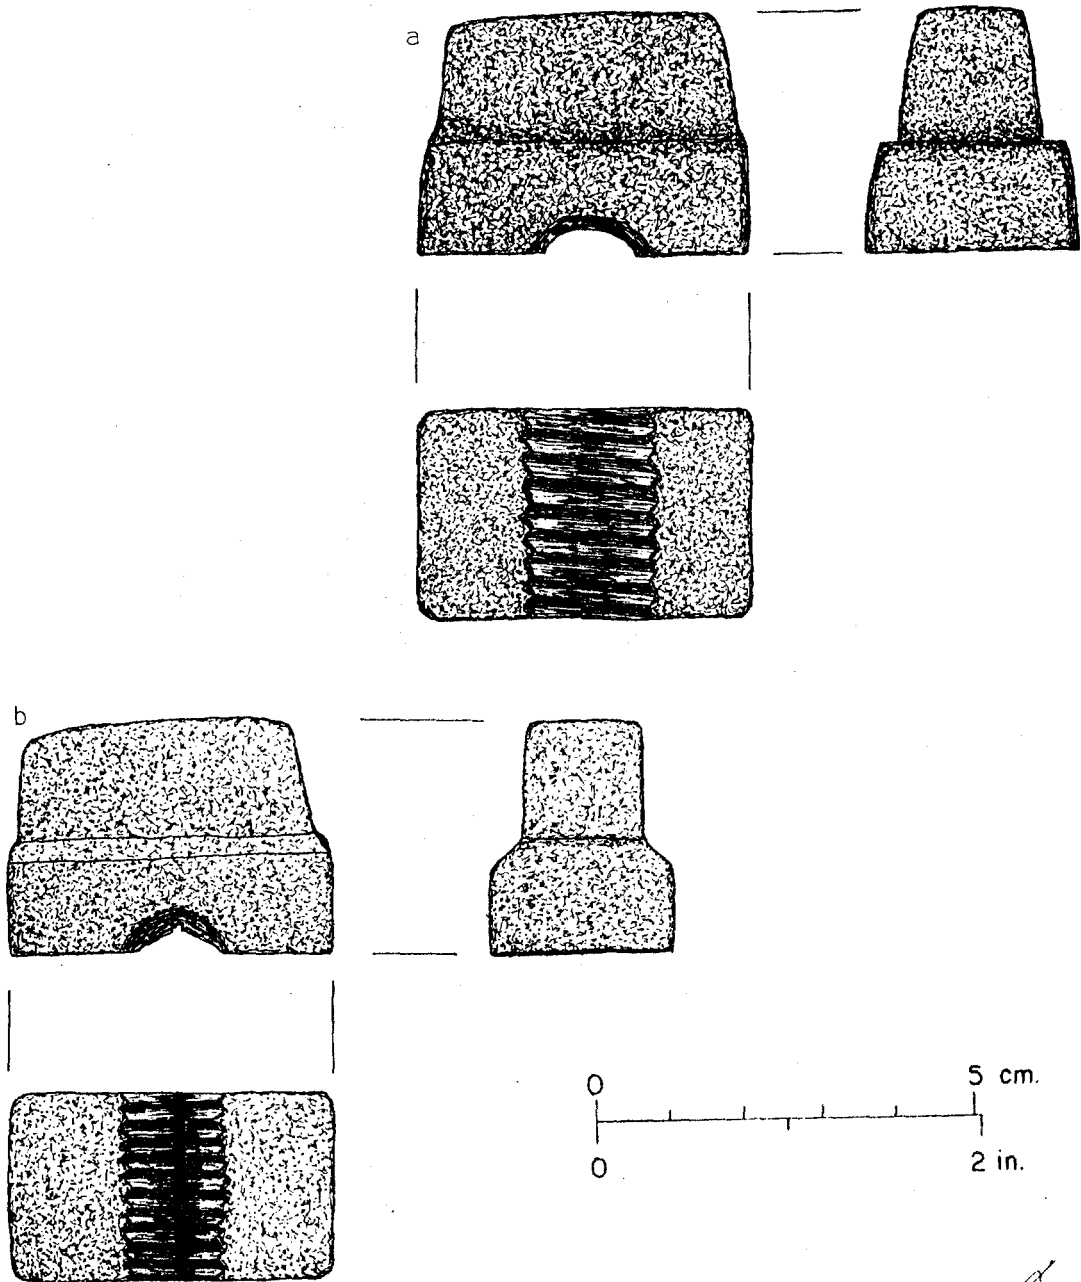
Fig. 60 -- Dies from the Blacksmith Shop area: a). die (FOVA 34377) and b). die (FOVA 34377).

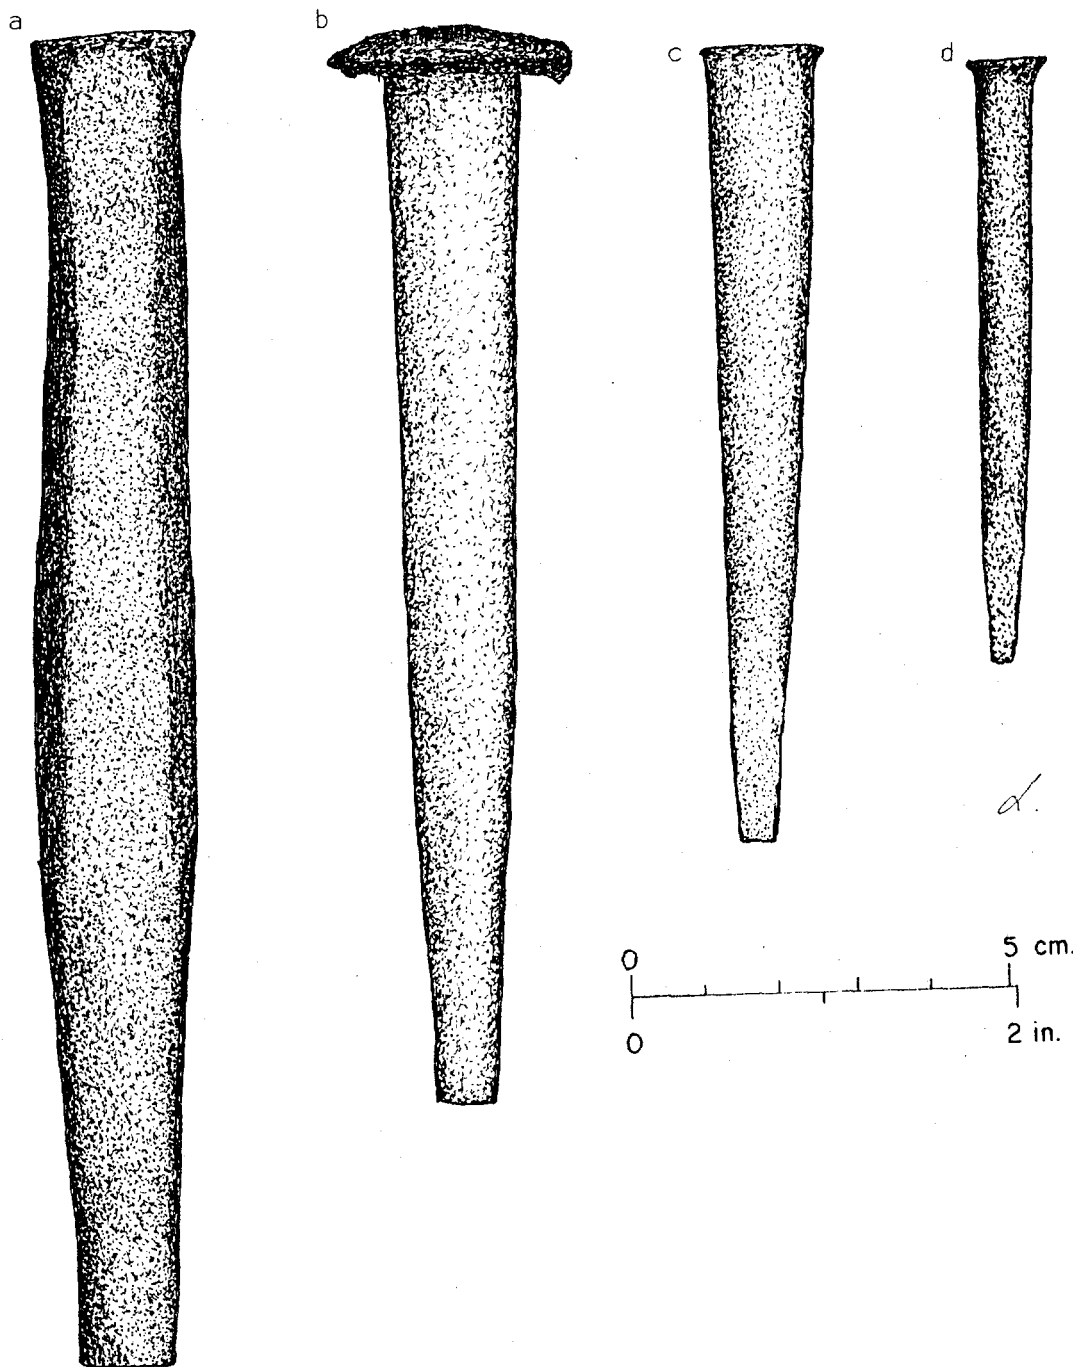
Fig. 61 -- Punches from the Blacksmith Shop area: a). punch (FOVA 35367); b). punch (FOVA 35891); c). punch (FOVA 35955) and d). punch (FOVA 34902).

A total of 8 punches were classified on the basis of the presence of a discernable shank for grasping, a semi-converging tip of generally circular shape, and a splayed or flat head region. The variations in punch shapes are illustrated in Figs. 61 - 62, and the 3 styles that were reported for the Indian Trade Store appear to be replicated by specimens from the Blacksmith Shop (Hoffman & Ross 1975: Fig. 42a,c-d).

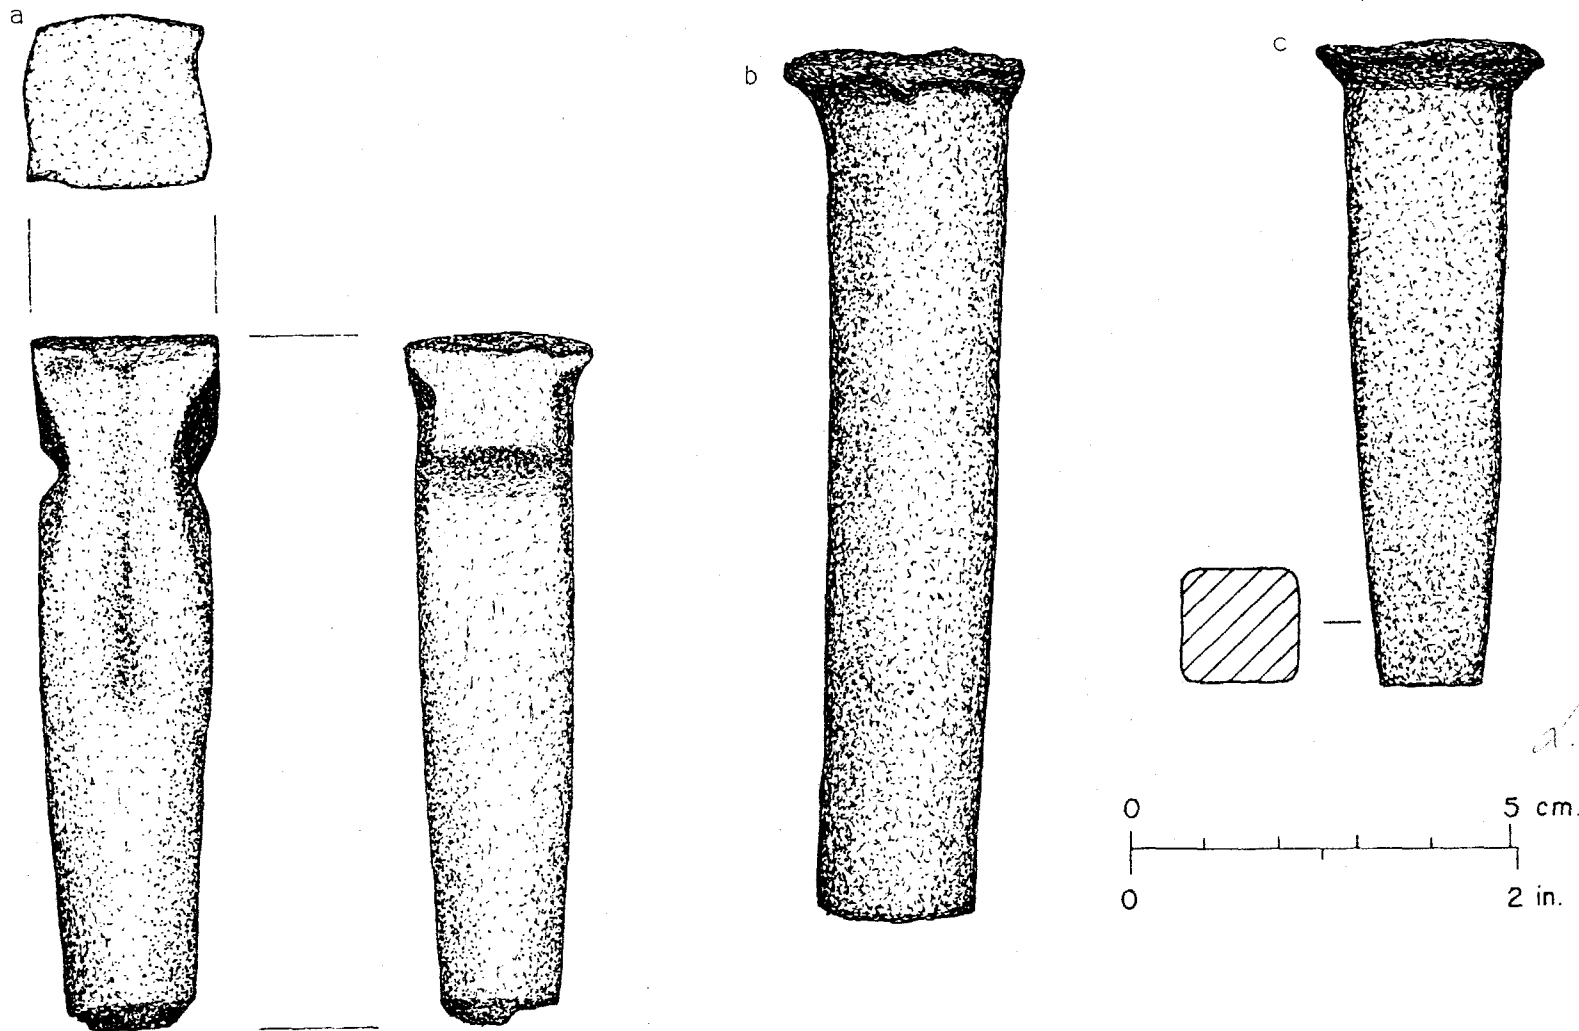
Fig. 62 -- Punches from the Blacksmith Shop area: a). punch (FOVA 34376); b). punch (FOVA 34902) and c). punch (FOVA 33240).

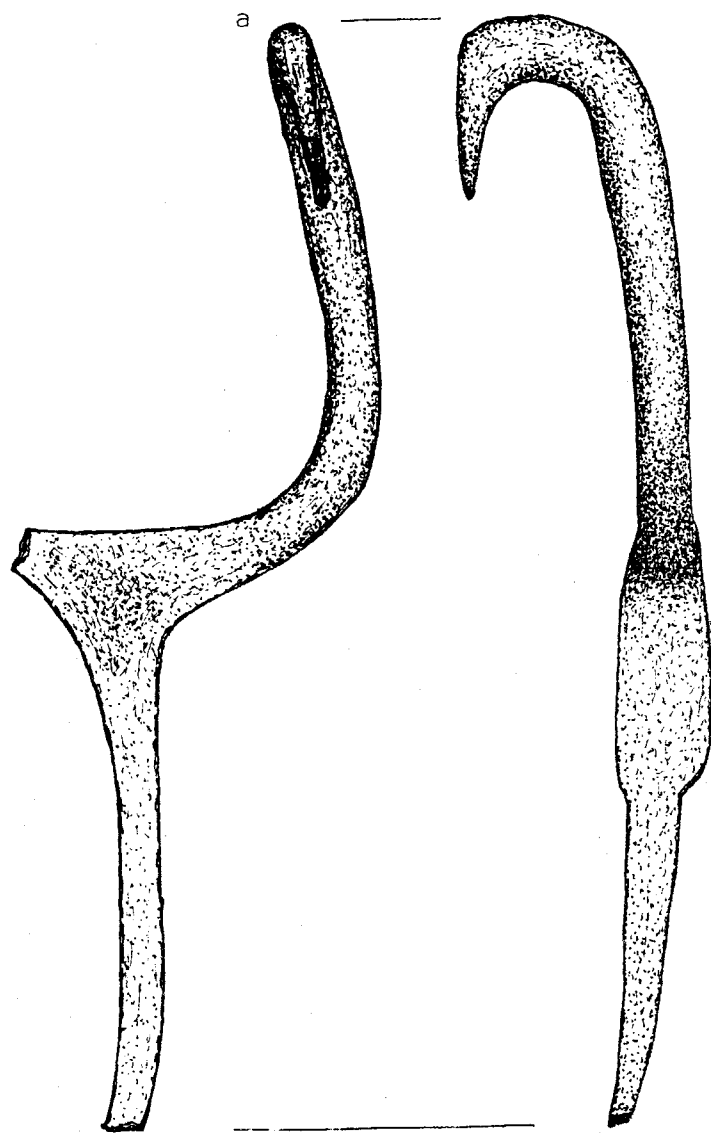
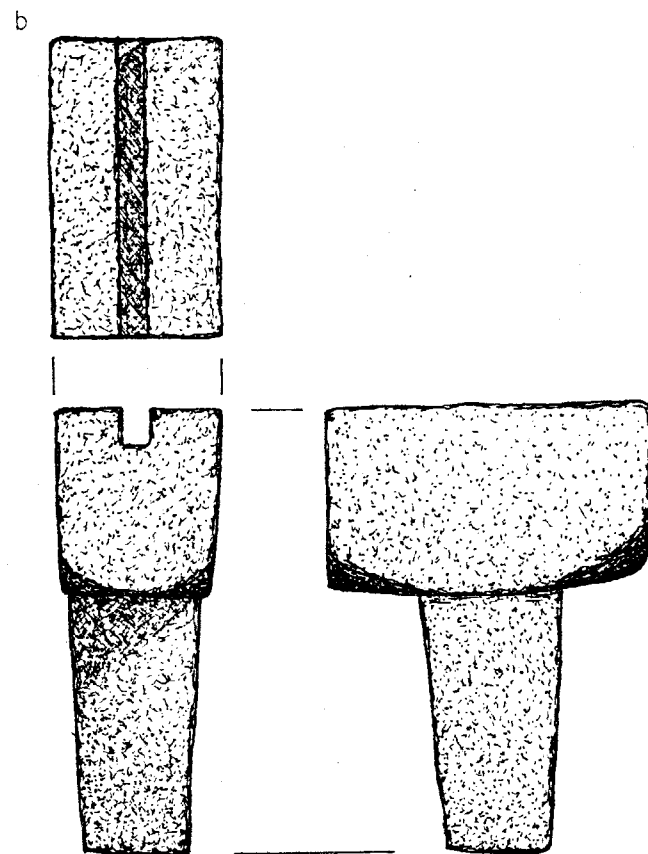
Fig. 63 -- Unid. implement and swage from the Blacksmith Shop area: a). Unidentified implement (FOVA 34557) and b). swage (FOVA 34186).

Only one tool was recovered, a bottom swage (Fig. 63b).

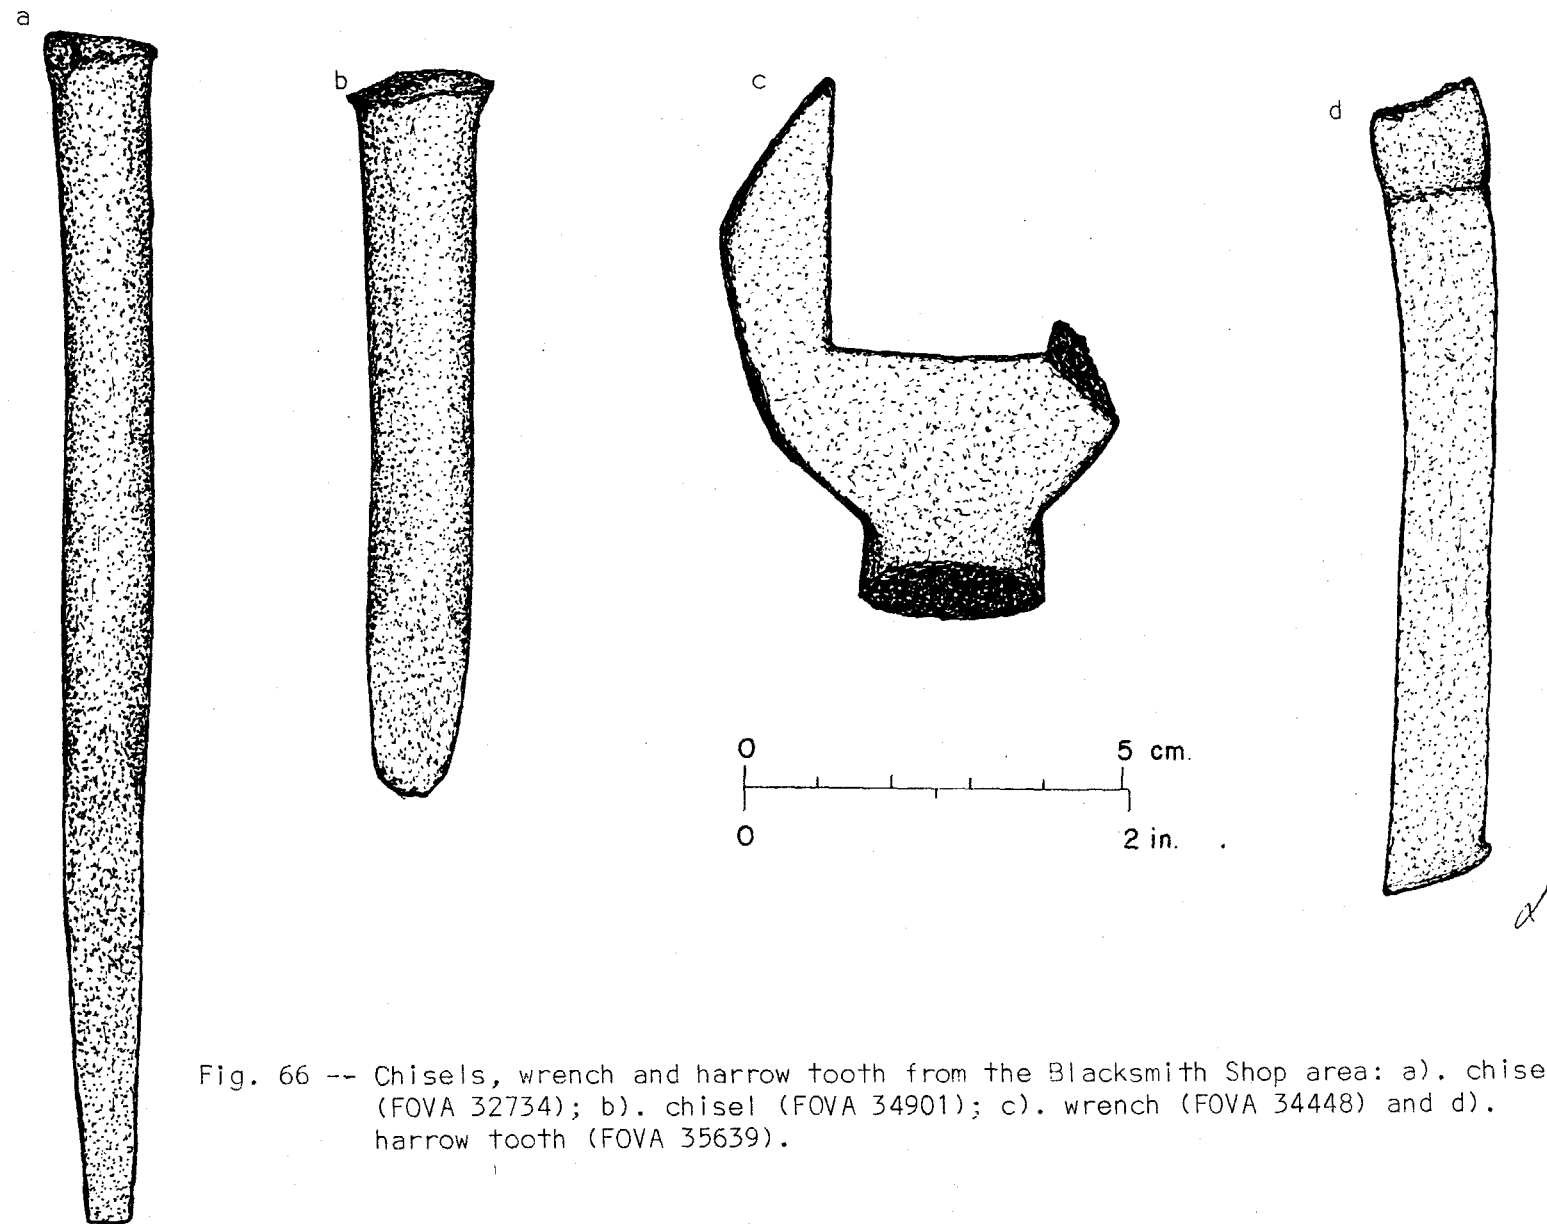
Fig. 66 -- Chisels, wrench and harrow tooth from the Blacksmith Shop area: a). chisel (FOVA 32734); b). chisel (FOVA 34901); c). wrench (FOVA 34448) and d). harrow tooth (FOVA 35639).

Fourteen harrow teeth were recovered which had been manufactured from uniformly square iron rod. To use, they were inset vertically into a wood or iron frame such that one corner formed the leading edge of the harrow tooth. All teeth recovered were worn on the leading edge and their tips were bevelled at an angle through use (Fig. 66d).

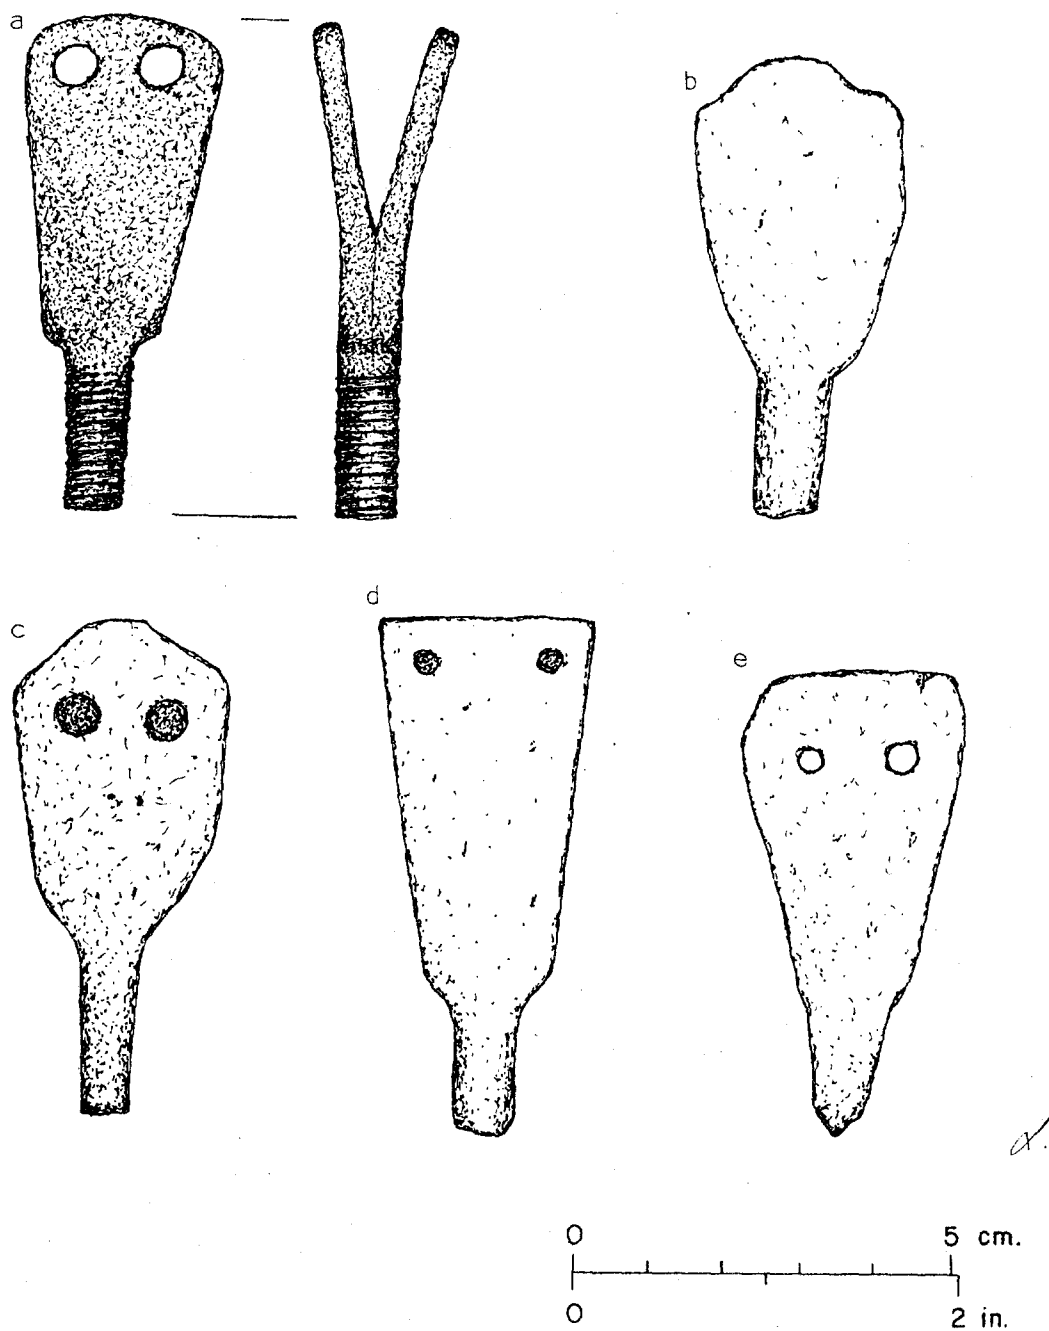
Fig. 67 -- Trap jaw posts and preforms from the Blacksmith Shop area:  
a). trap jaw post (FOVA 36077); b). jaw post preform (FOVA 36078); c). jaw post preform (FOVA 35024); d). jaw post preform (FOVA 36078) and e). jaw post preform (FOVA 36029).

Four specimens representing one style with a squared receiver were recovered. This style is only one of 4 previously reported (Hibbs: 1975:report in progress), and is identical to the jaw posts utilized with a complete trap reconstructed from F523 (Fig. 134) a representative example is illustrated in Fig. 67a.

The second style, having an oval receiver, was not recovered in finished form from the Blacksmith Shop. However, 4 preform specimens representing at least 2 stages of manufacture were observed indicating that the style was also manufactured in the Shop. The 2 stages of manufacture have been illustrated in Figs. 67b - c. Similar specimens have been recovered from the Indian Trade Store area, but a finished form has yet to be identified.

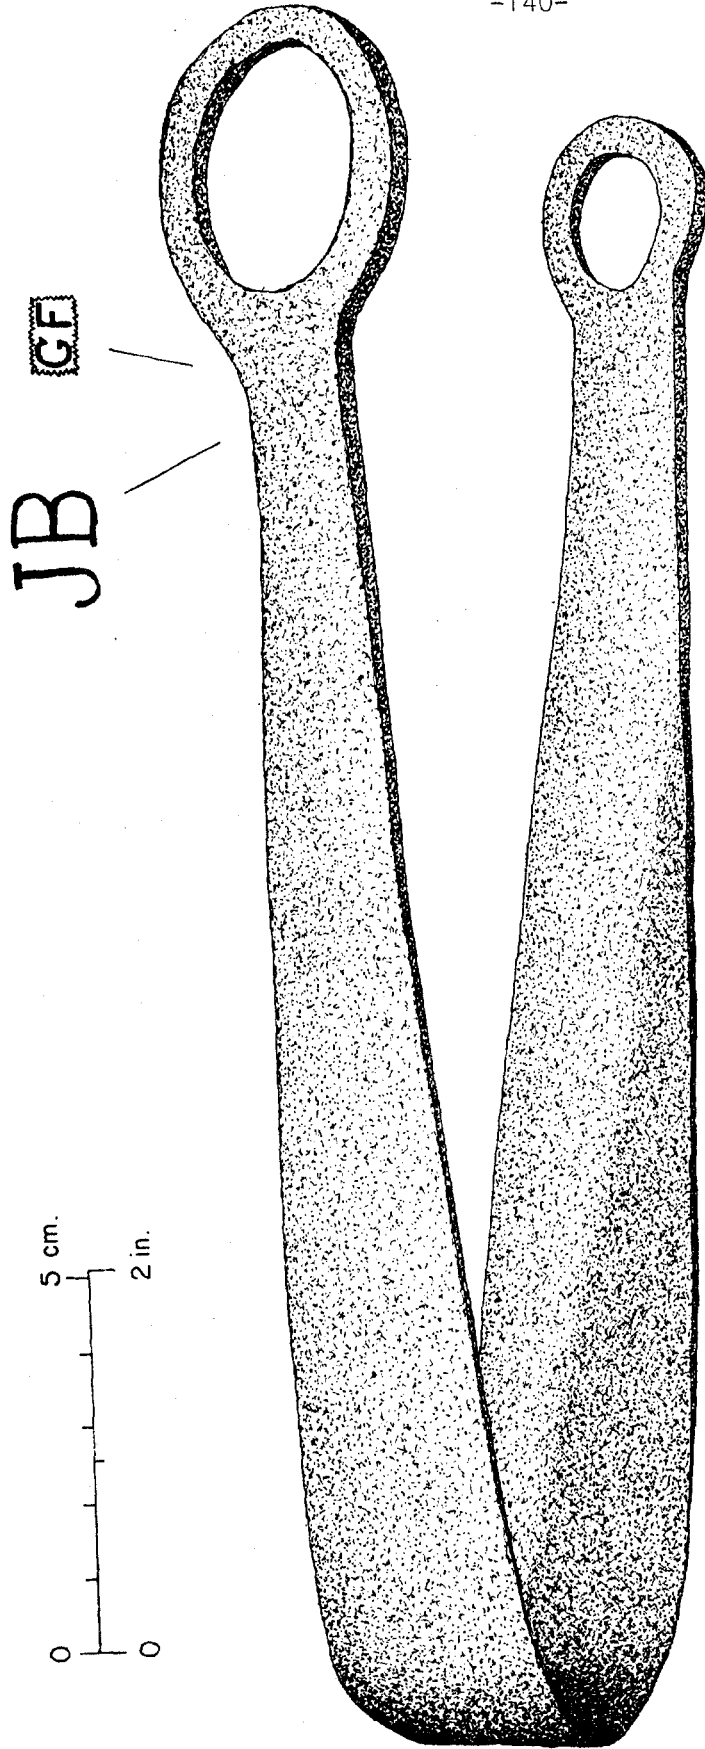
Fig. 68 -- Reconstructed trap spring with makers' marks found on springs from the Blacksmith Shop.
