FORT VANCOUVER EXCAVATIONS - X

Southeastern Fort Area

National Park Service

July 1975

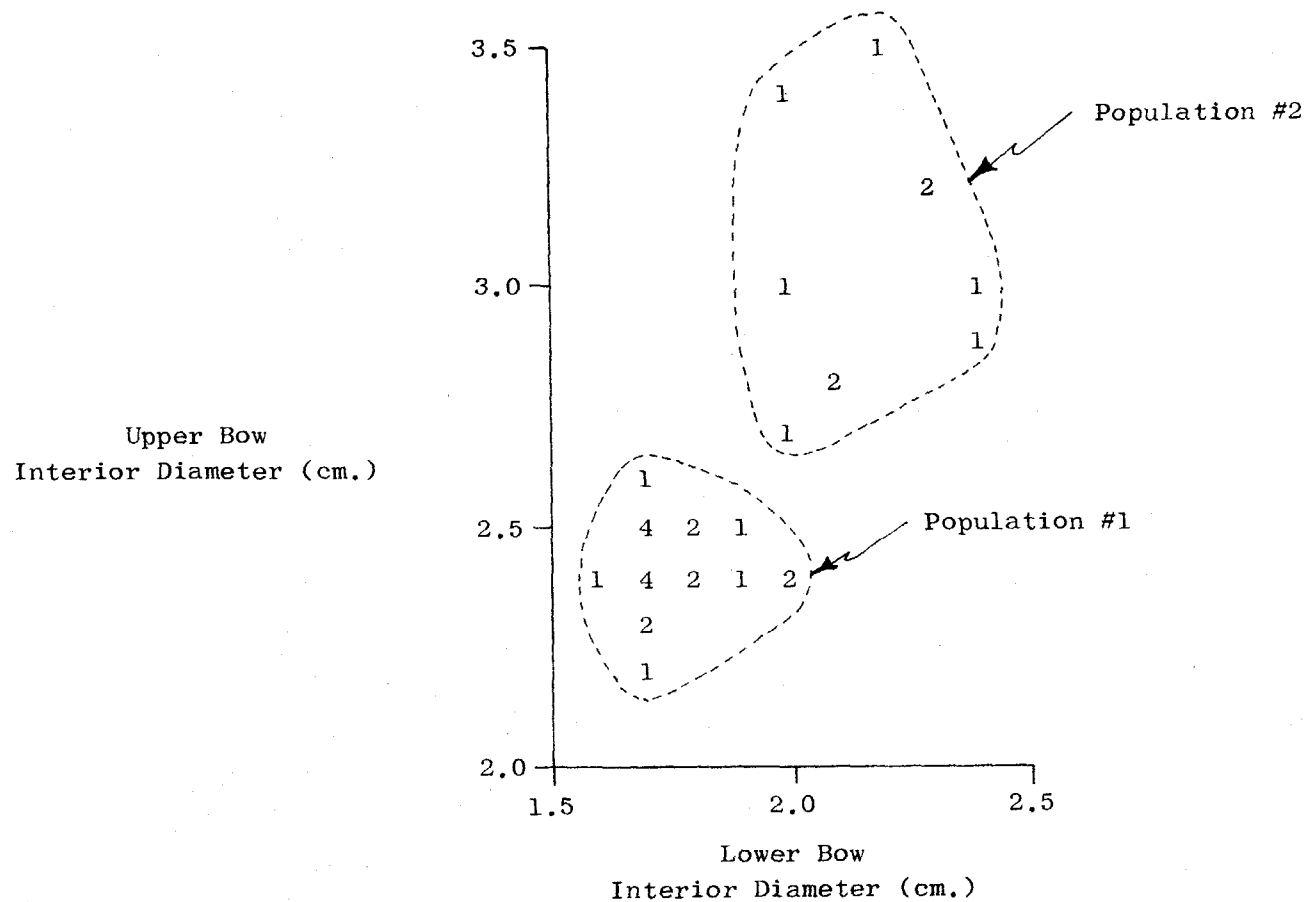
Fig. 69 -- Trap spring sizes as determined by the correlation of upper and lower bow interior diameters of complete springs from the Blacksmith Shop (N = 31).

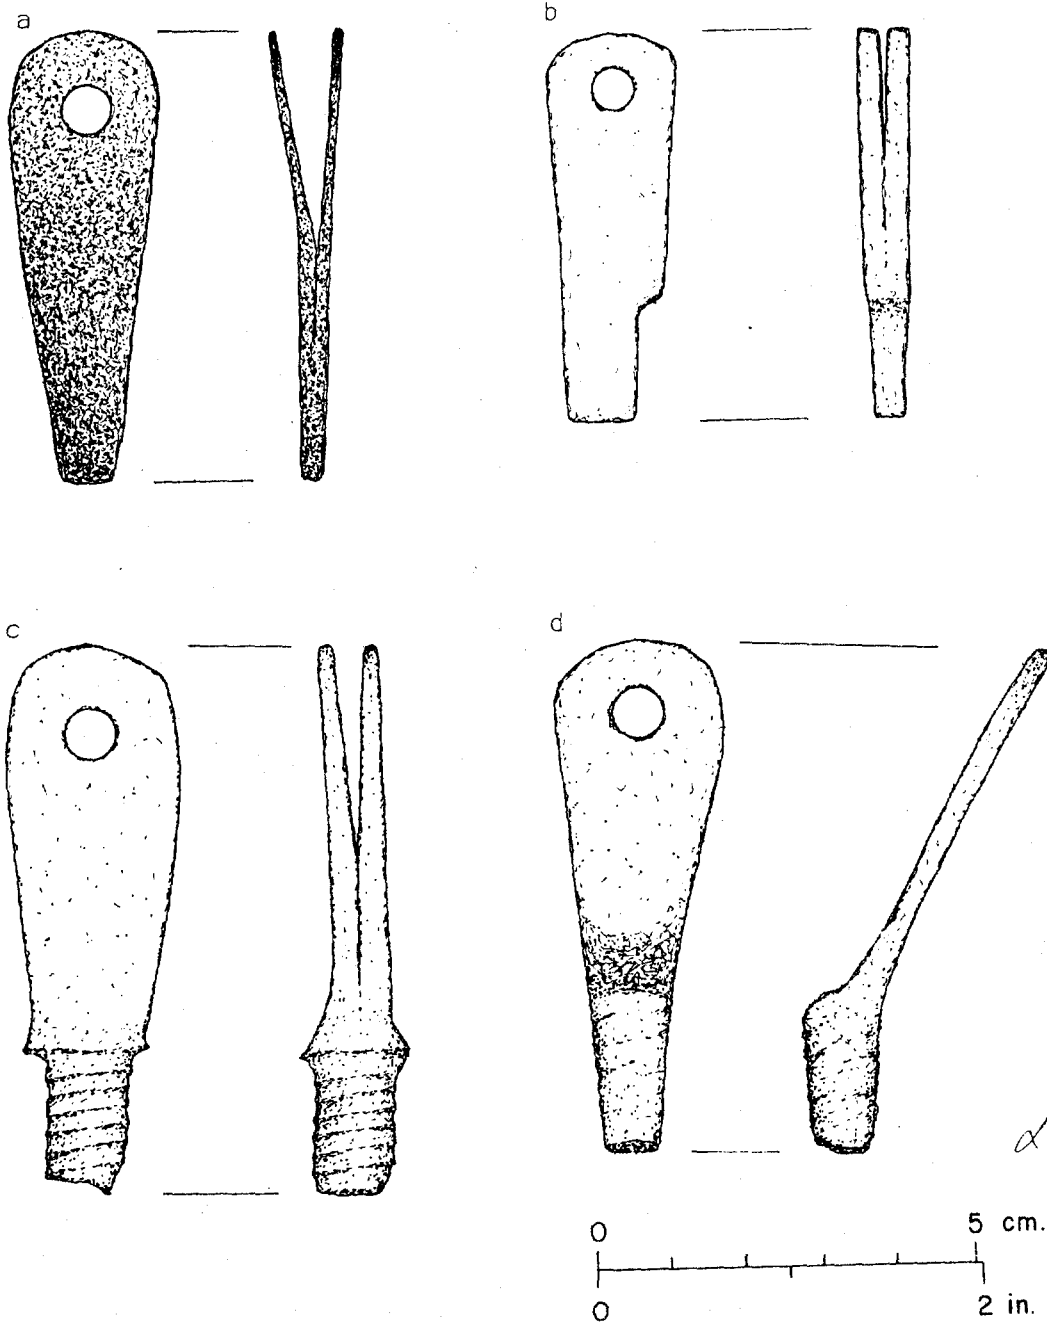
Fig. 70 -- Pan posts from the Blacksmith Shop area: a). pan post (FOVA 35168); b). pan post (FOVA 32605); c). pan post (FOVA 35777 and d). pan post (FOVA 32605).

Nineteen trap pan posts were recovered, and 2 styles were observed--posts with rectangular riveted anchors and posts with circular, threaded anchors. Rectangular, rivet anchored specimens have been recovered partially assembled with trap bases from F523 and appear in the reconstructed HBC trap illustrated in Fig. 134. The circular, threaded anchor style has yet to be found assembled with trap parts. However, on the basis of having only a single hinge hole it has been classified as a pan post. Seven specimens were identified as having rectangular anchors, while 12 circular anchor specimens were recovered. The representative variation in shape for each style has been illustrated in Figs. 70a- b and Figs. 70c- d respectively.

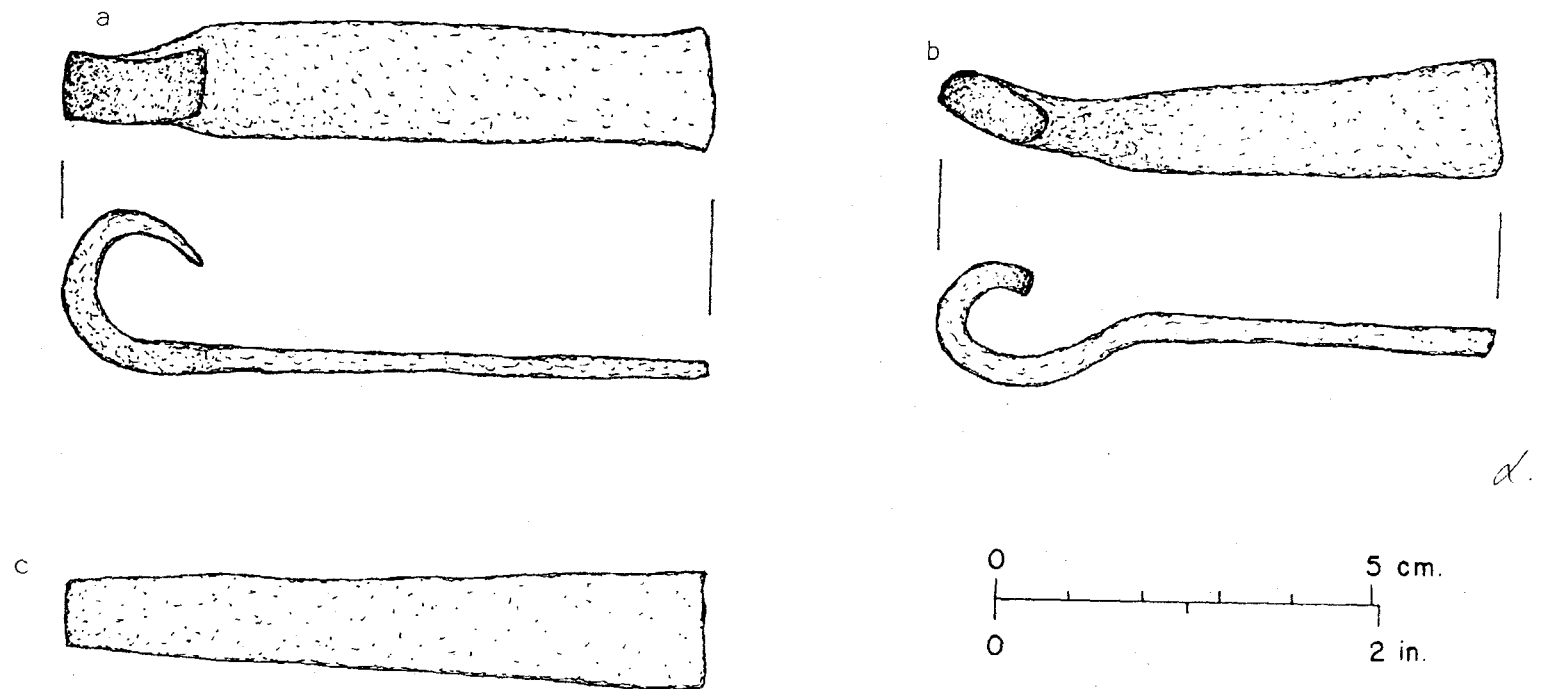
Fig. 72 -- Ketches and preform from the Blacksmith Shop area: a). ketch (FOVA 33272); b). ketch (FOVA 33546) and c). ketch preform (FOVA 32207).

Fourteen finished trap ketches were recovered from the Blacksmith Shop and 2 stylistic varieties were identified (Figs. 72a- b ). This style consisted of a simple triangular tab of iron sheet metal truncating to a semi-convergent end with a rolled eyelet for anchoring the ketch to the trap base. Examples from the Indian Trade Store and F523 found assembled with base fragments, indicate that the ketch could be attached to the base with the eyelet turned up or down, perhaps depending upon the height of the pan assembly. A similar specimen has been included in the reconstructed HBC trap from F523 (Fig. 134).

One specimen was recovered and is illustrated in Fig. 72c.

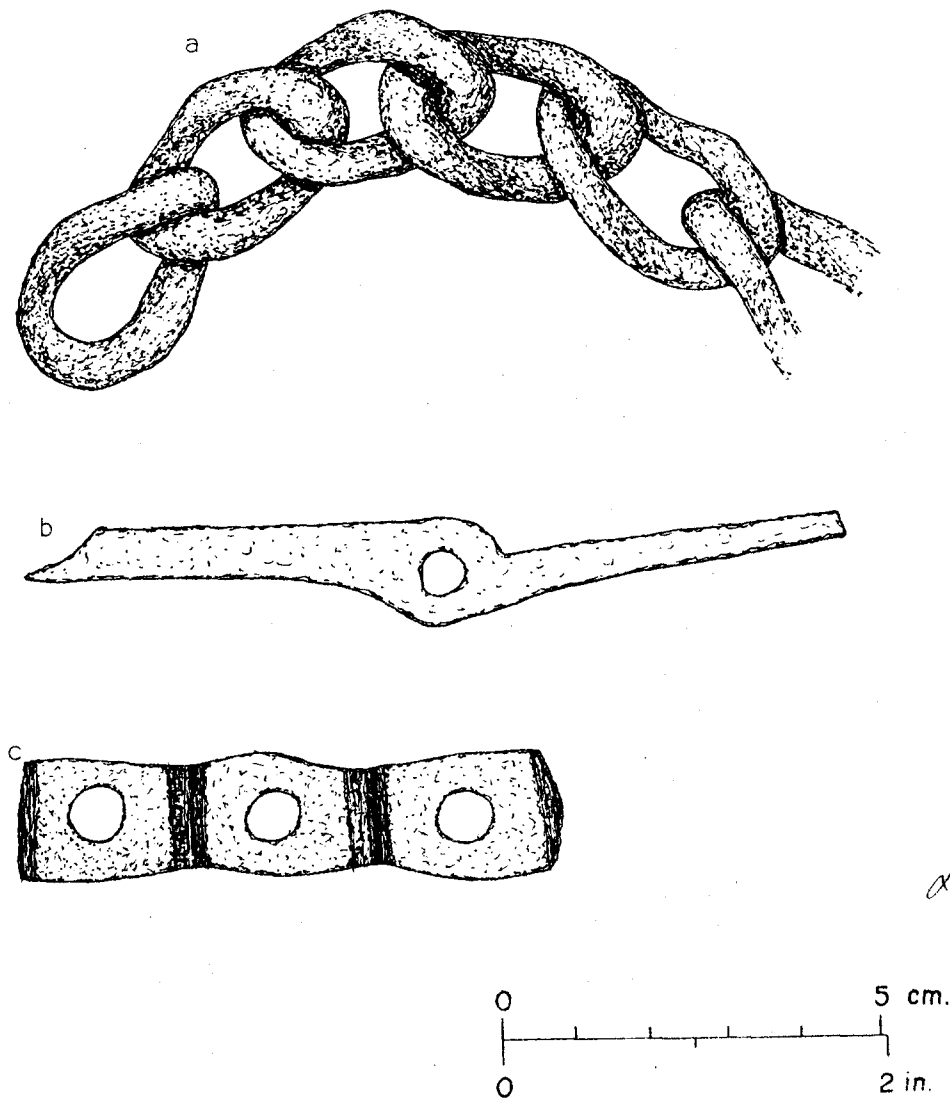
Fig. 73 -- Trap chain, swivel o-ring and trap nut preforms from the Blacksmith Shop area: a). trap chain (FOVA 34192); b). trap swivel o-ring preform (FOVA 32324) and c). trap nut preforms (FOVA 33667).

The chain utilized for anchoring traps has been identified as  $\frac{1}{4}$ -twist chain. A total of 52 chain links and 9 portions of chain were recovered and a representative specimen has been illustrated in Fig. 73a. Based upon the correlation of chain link length to stock thickness, 3 metric populations have been defined. These include both a ca.  $1\frac{1}{4}$  in. and  $1\frac{5}{8}$  in. population manufactured from ca.  $\frac{1}{4}$  in. round stock, and a ca.  $1\frac{1}{2}$  in. population manufactured from  $3/16$  in. stock (Fig. 74 ). Links within an individual chain vary in length, but stock diameter tended to remain uniform. The 2 different stock sizes observed suggest a functional difference in the use of trap chain (i.e., small diameter link utilized with lighter traps for presumably smaller animals, and large diameter links utilized with heavy duty, larger traps).

One specimen of a trap post nut template, from which the finished trap post nuts were cut, was recovered and has been illustrated in Fig. 73c.

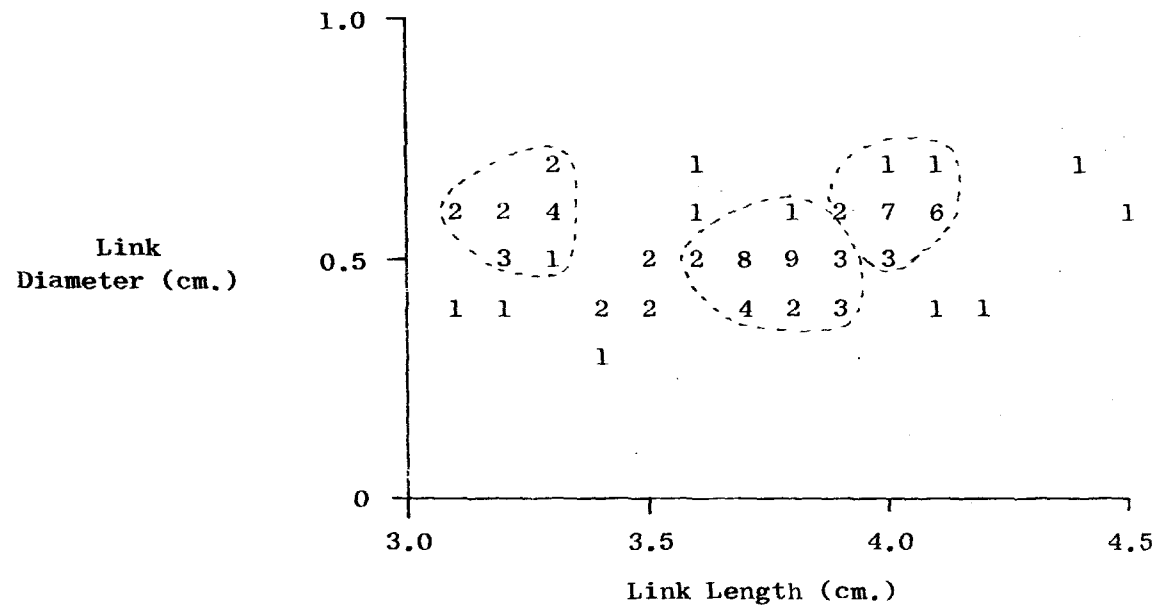
Fig. 74 -- Hypothesized  $\frac{1}{4}$ -twist "trap" chain populations as determined by the correlation of chain link length with stock diameter for the Blacksmith Shop (N = 81).

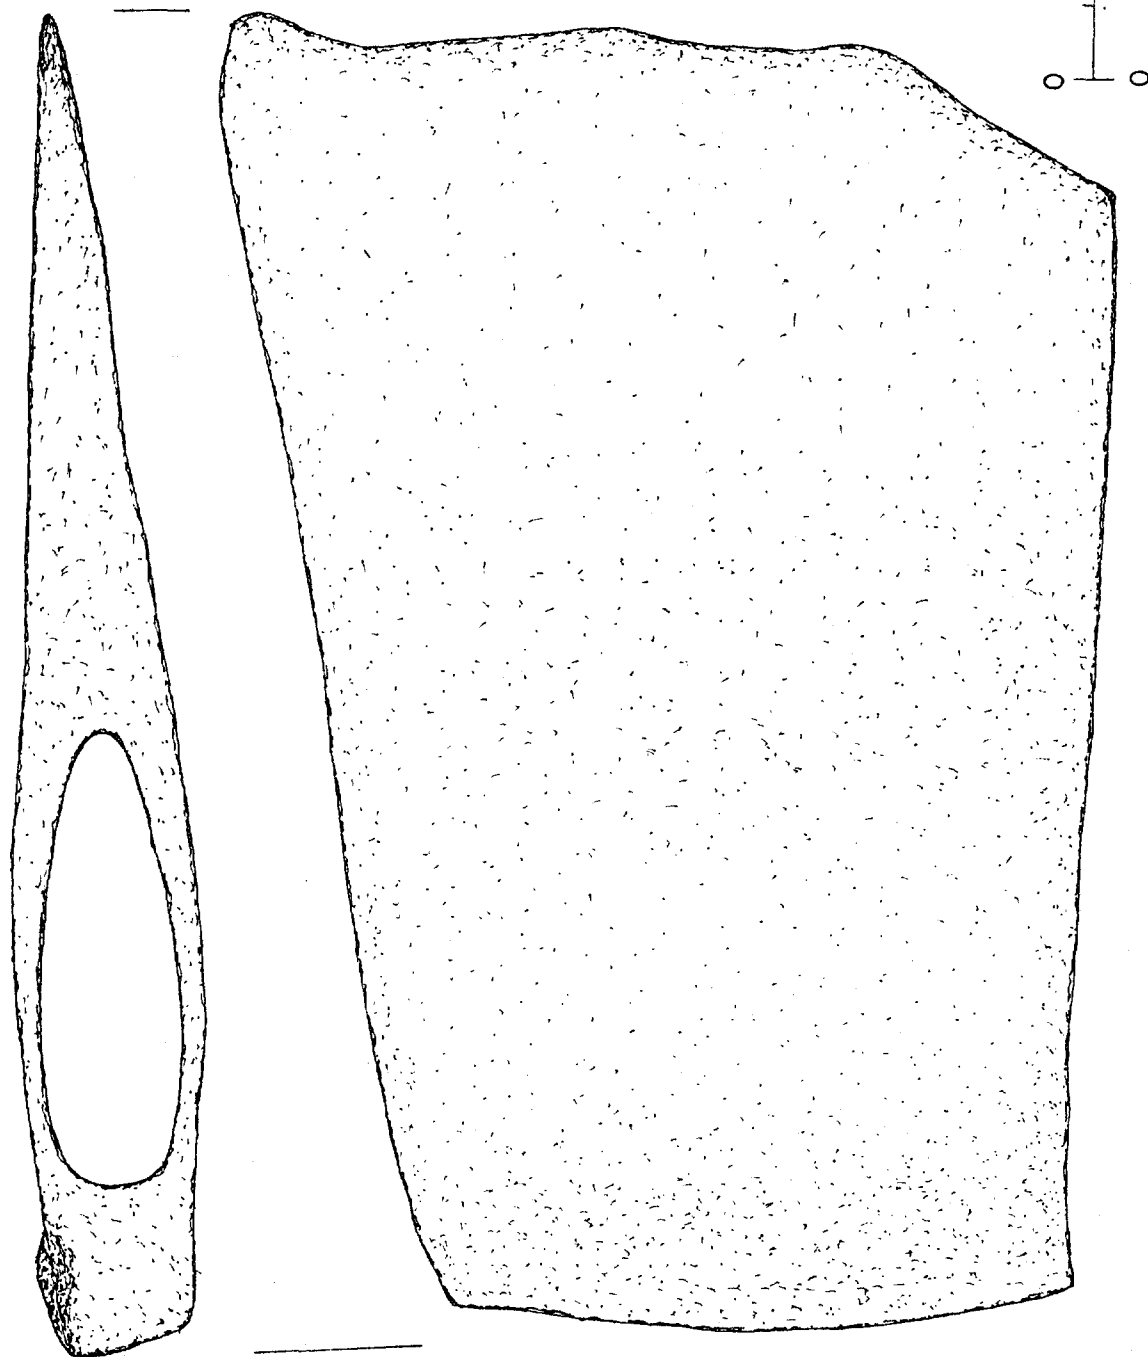
Fig. 77 --- Axe (FOVA 33228) from the Blacksmith Shop area.

All other axe parts and preforms are of the Hudson's Bay type axe described in FOVA Report VIII (Hoffman & Ross 1974b). The 4 axe body preforms recovered were of the type inventoried as "square-head axes", and 2 specimens are similar to the hypothesized Type 1 axes described and illustrated in FOVA Report VIII (Hoffman & Ross 1974b: Fig. 83). This type of axe was manufactured with a poll, and the stock extremities offset to form a one piece body and blade. Measurements of poll lengths on assembled preforms suggest that at least 2 axe sizes were being manufactured, a 1 3/8 in. size and a 1 7/8 in. size.

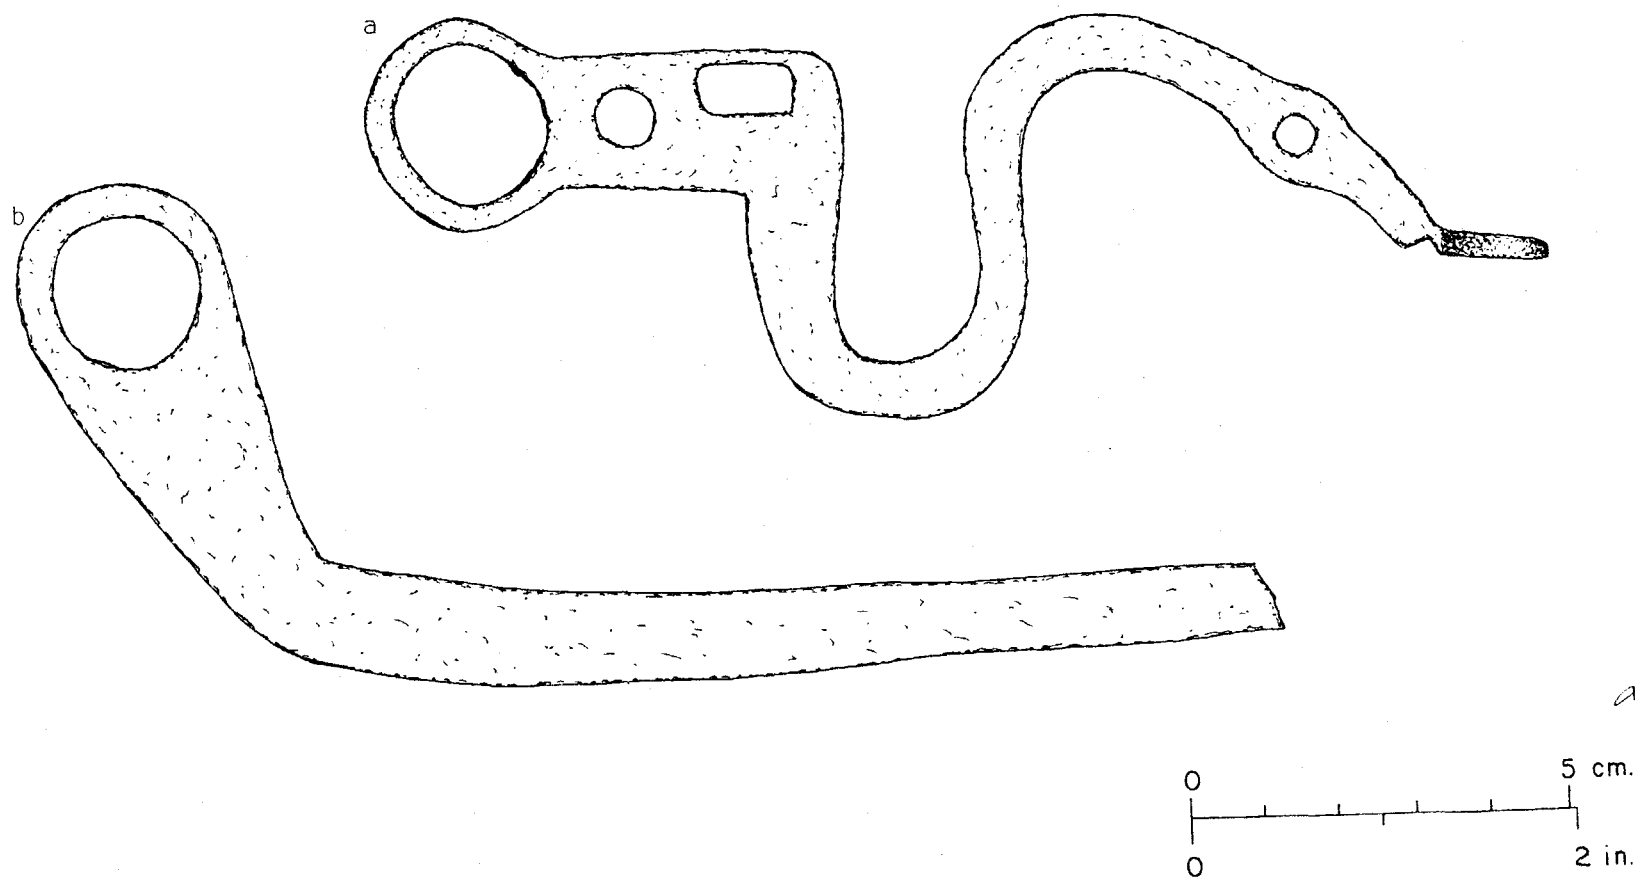
Fig. 79 -- Horse bit cheek strap and preform from the Blacksmith Shop area: a). horse bit cheek strap (FOVA 34554) and b). horse bit cheek strap preform (FOVA 35476).

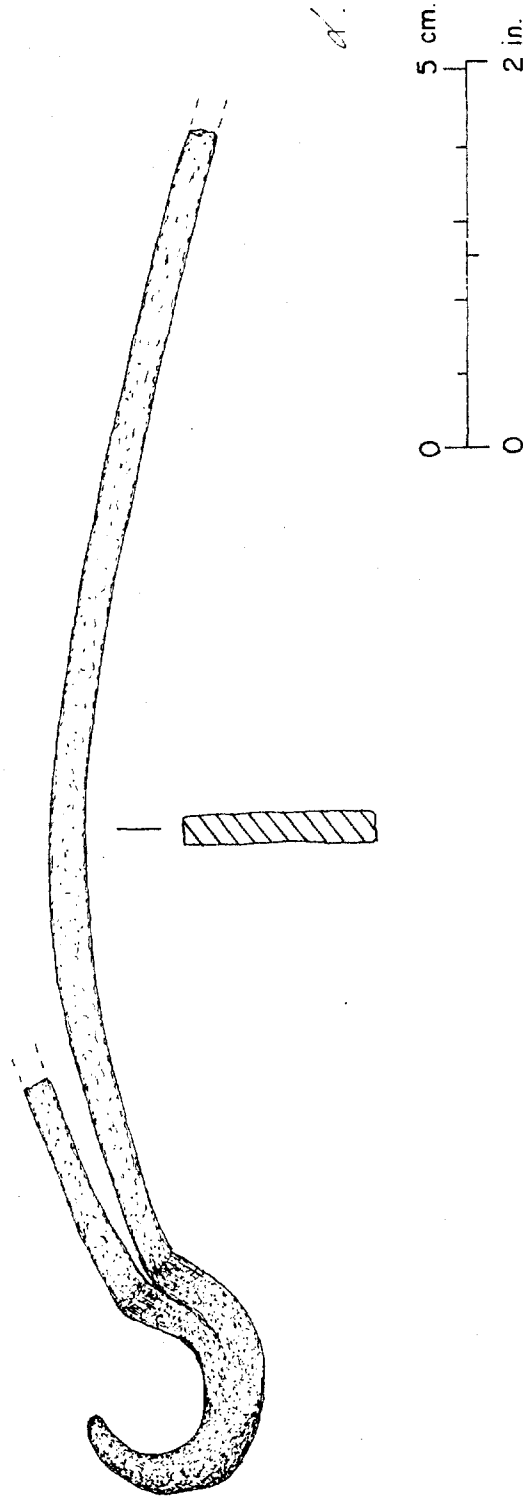
Fig. 80 -- Hame tip (FOVA 35371) from the Blacksmith Shop area.

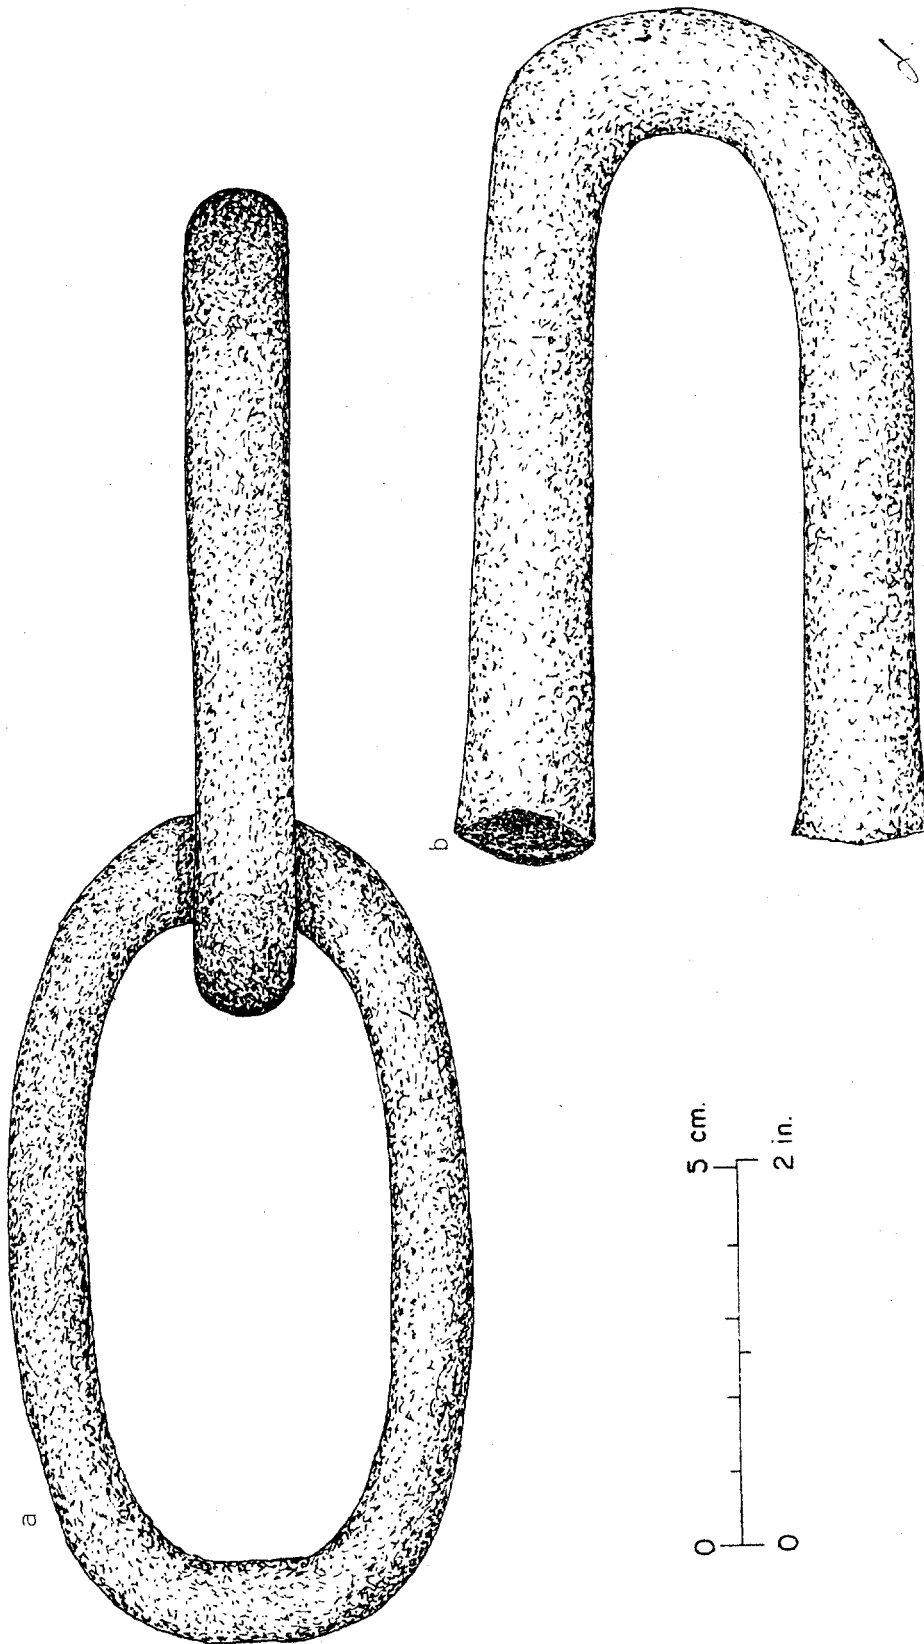
Fig. 81 -- Flat chain and preform from the Blacksmith Shop area: a). flat chain (FOVA 32632) and b). flat chain link preform (FOVA 35377).

A total of 14 flat chain link preforms were recovered from the Shop, indicating manufacture of at least a portion of the chain, representative specimens of finished flat chain, flat chain preforms and a swivel link have been illustrated in Figs. 81a-b and 82a.

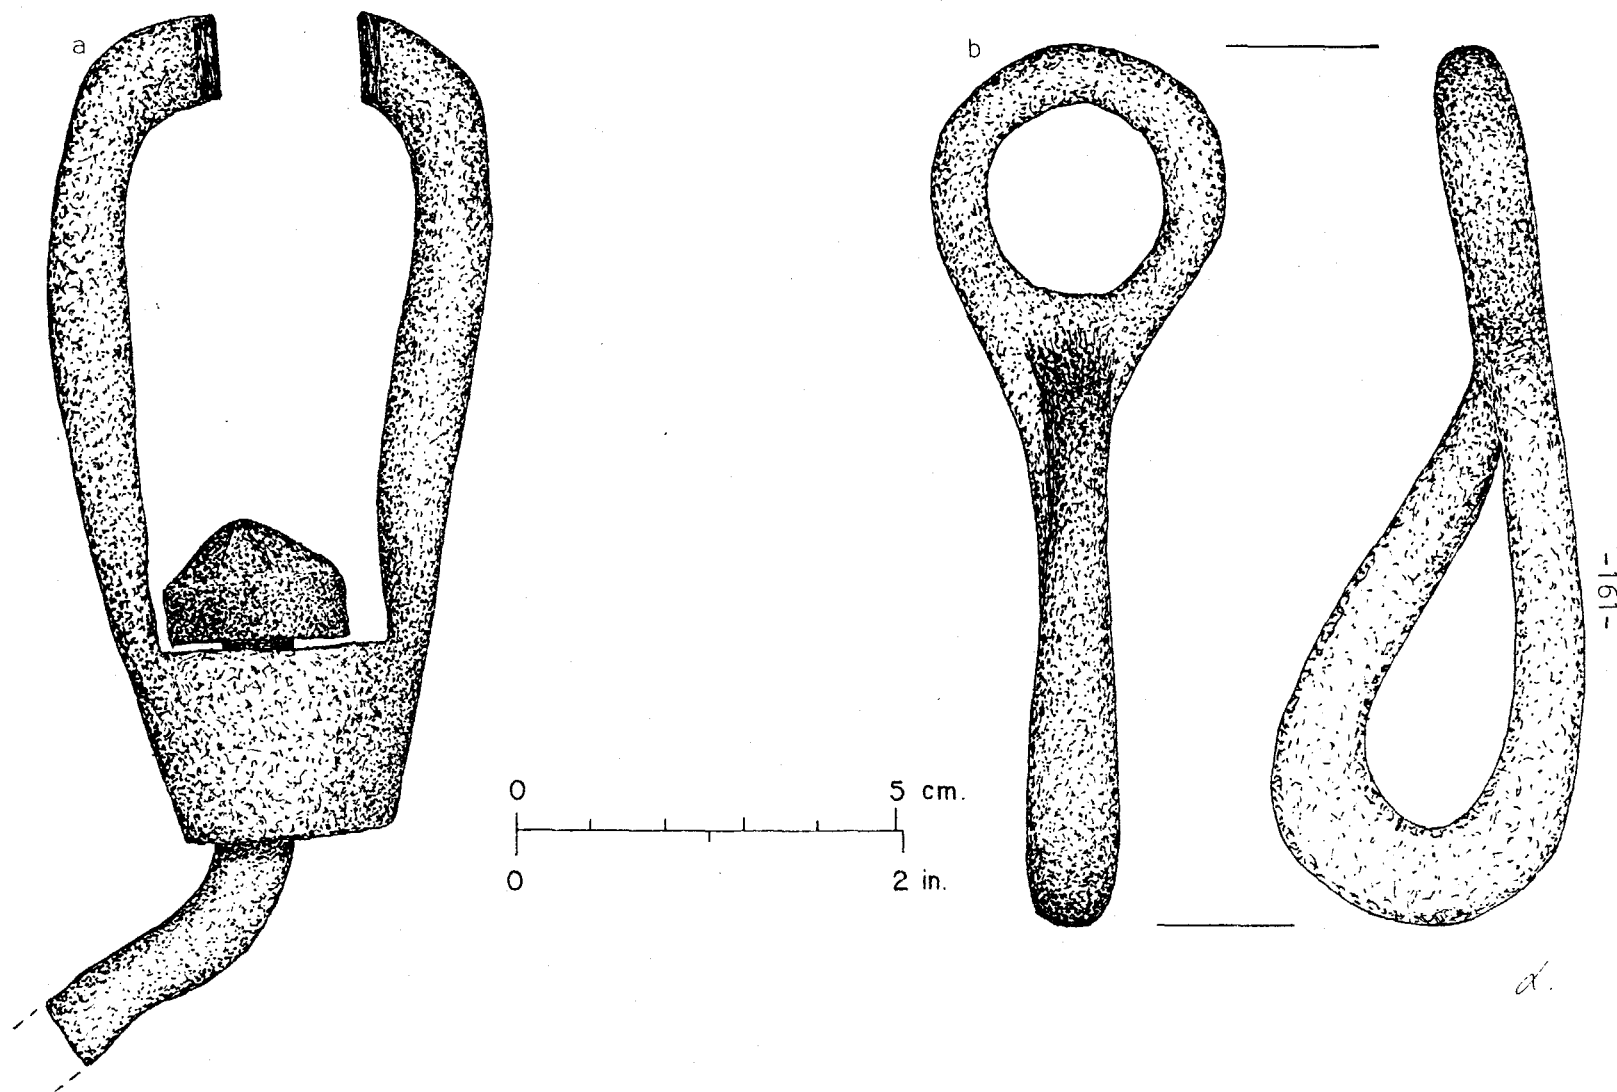
Fig. 82 -- Swivel chain link and reconstructed hook from the Blacksmith Shop area: a). swivel chain link (FOVA 34299) and b). reconstructed hook (FOVA 32812).

Of the 10 hooks recovered, 6 were complete or nearly complete, and 5 have been illustrated in Figs. 82b, 83-84.

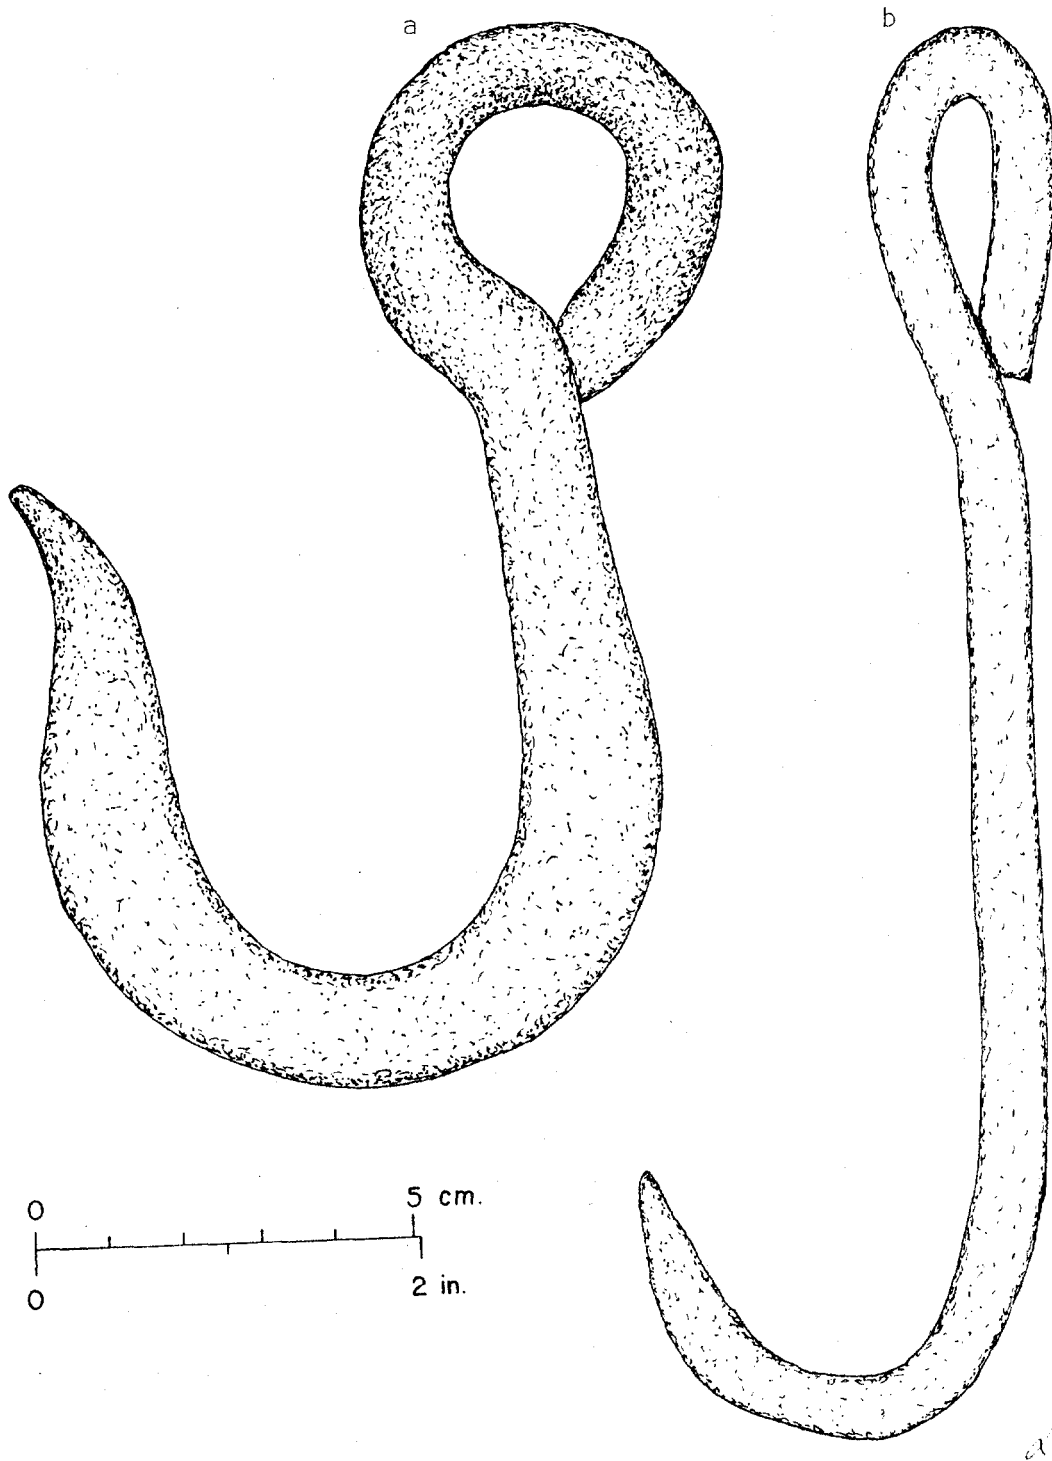
Fig. 83 -- Hooks from the Blacksmith Shop area: a). reconstructed hook (FOVA 34445) and b) hook (FOVA 34198).

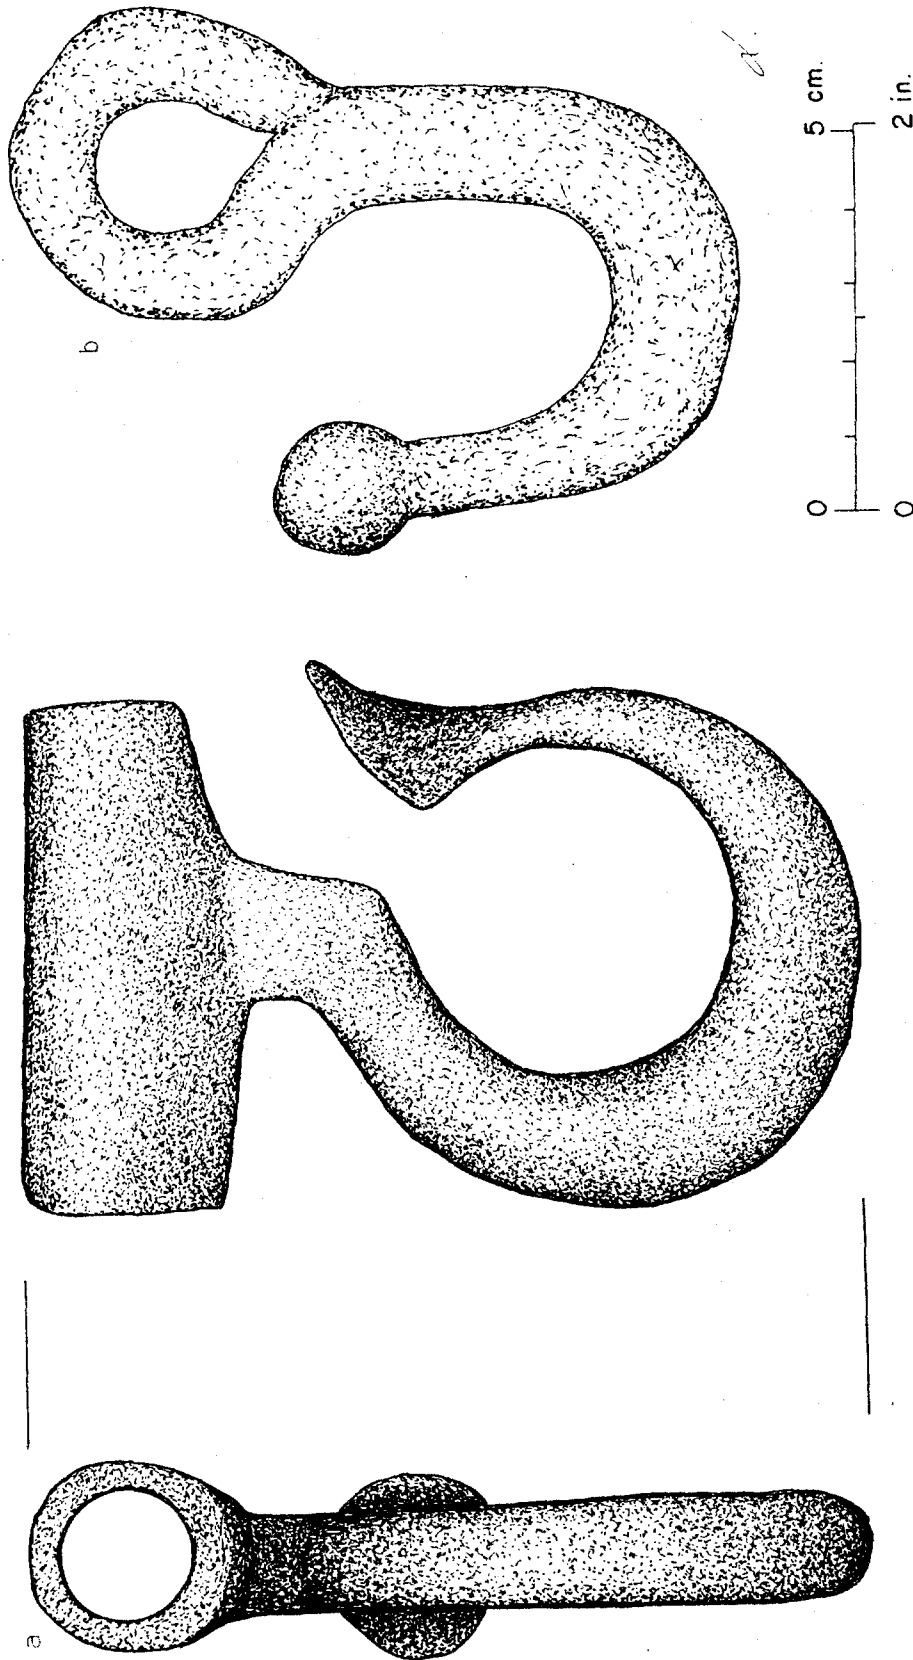
Fig. 84 -- Hooks from the Blacksmith Shop area: a). closed eye hook (broken apart) (FOVA 32377) and b). hook (FOVA 32921).

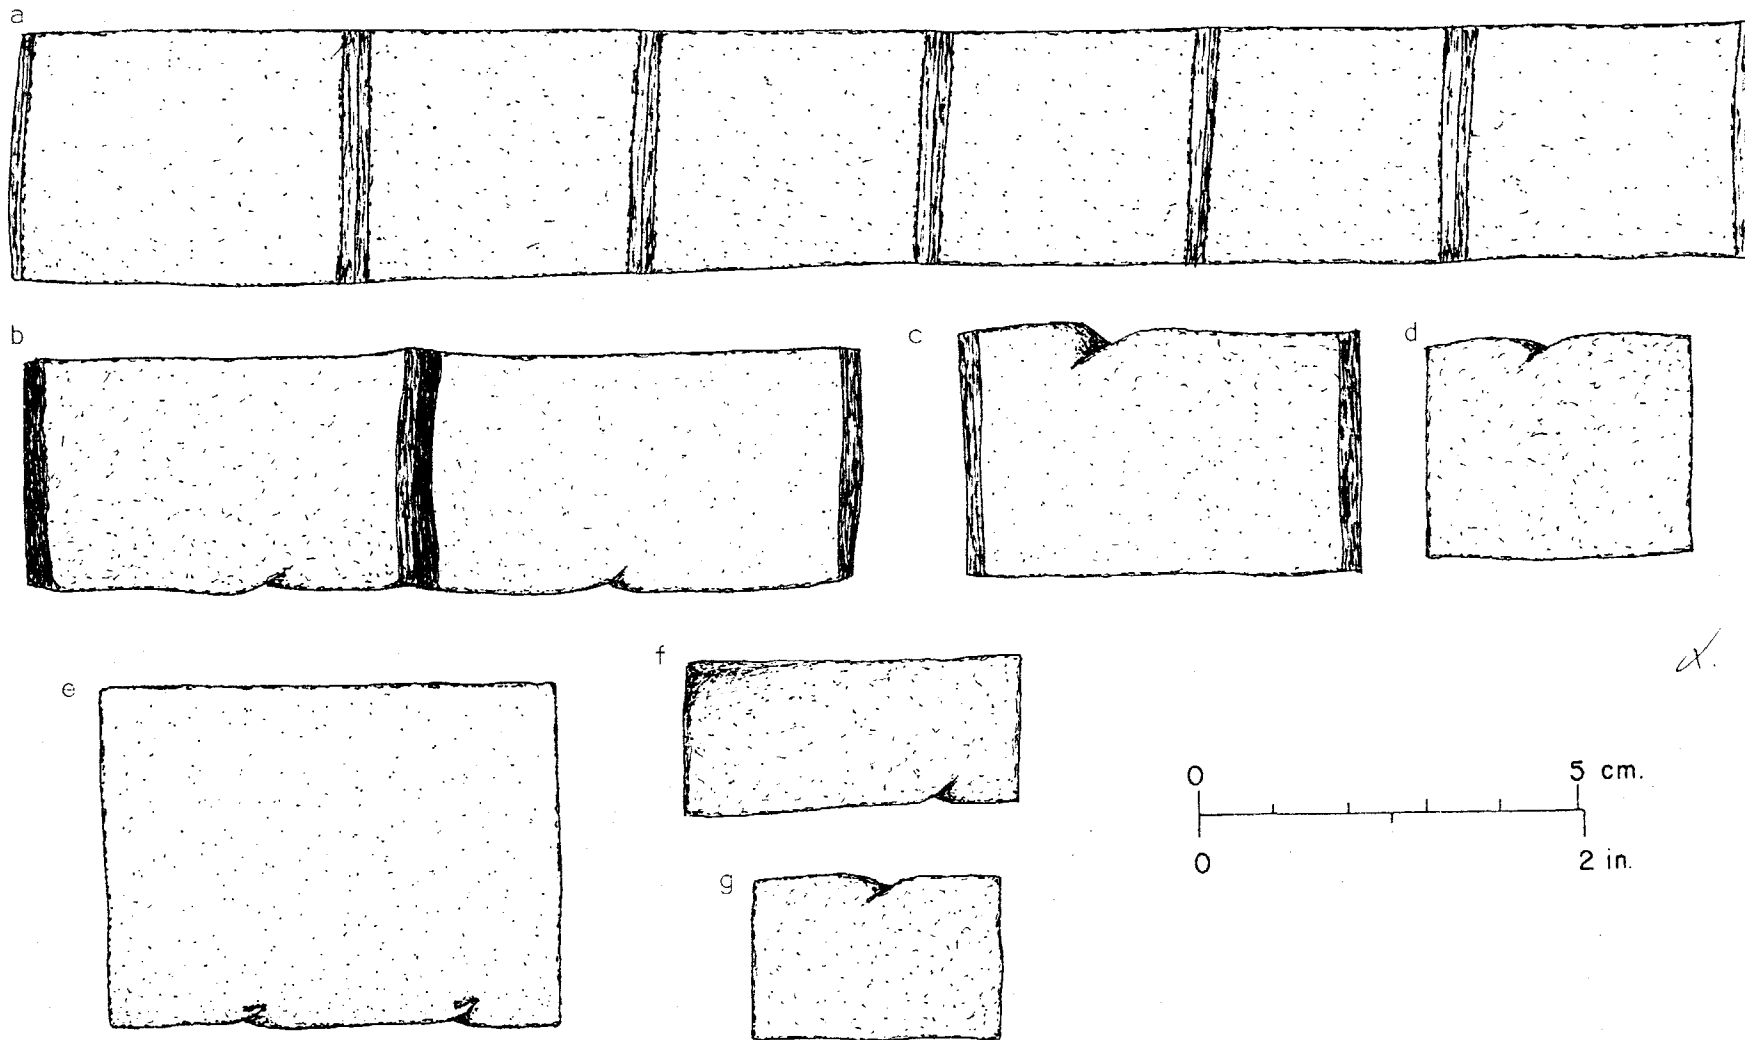
Fig. 85 -- Miscellaneous barbed wedges and preforms from the Blacksmith Shop area: a). barbed wedge preform template (FOVA 35759); b). barbed wedge preform (FOVA 33529); c). barbed wedge (FOVA 32813); d). barbed wedge (FOVA 32813); e). barbed wedge (FOVA 34917); f). barbed wedge (FOVA 34297); g). barbed wedge (FOVA 34562).

A total of 22 items descriptively termed "barbed wedges" were recovered. In addition, 15 template preforms were recovered that represented partial manufacturing stages of "barbed wedges". At the present time it is unknown how the finished wedges were utilized; however, they could represent axe wedges. Similar specimens have only been recovered from the immediate vicinity of the Shop including F523 and the Iron Store. Thus, they appear to be exclusively related to activities of the late Blacksmith Shop. The variation of shape and size of finished specimens has been illustrated in Figs. 85d-g, and the representative preform stages are illustrated in Figs. 85a-c.

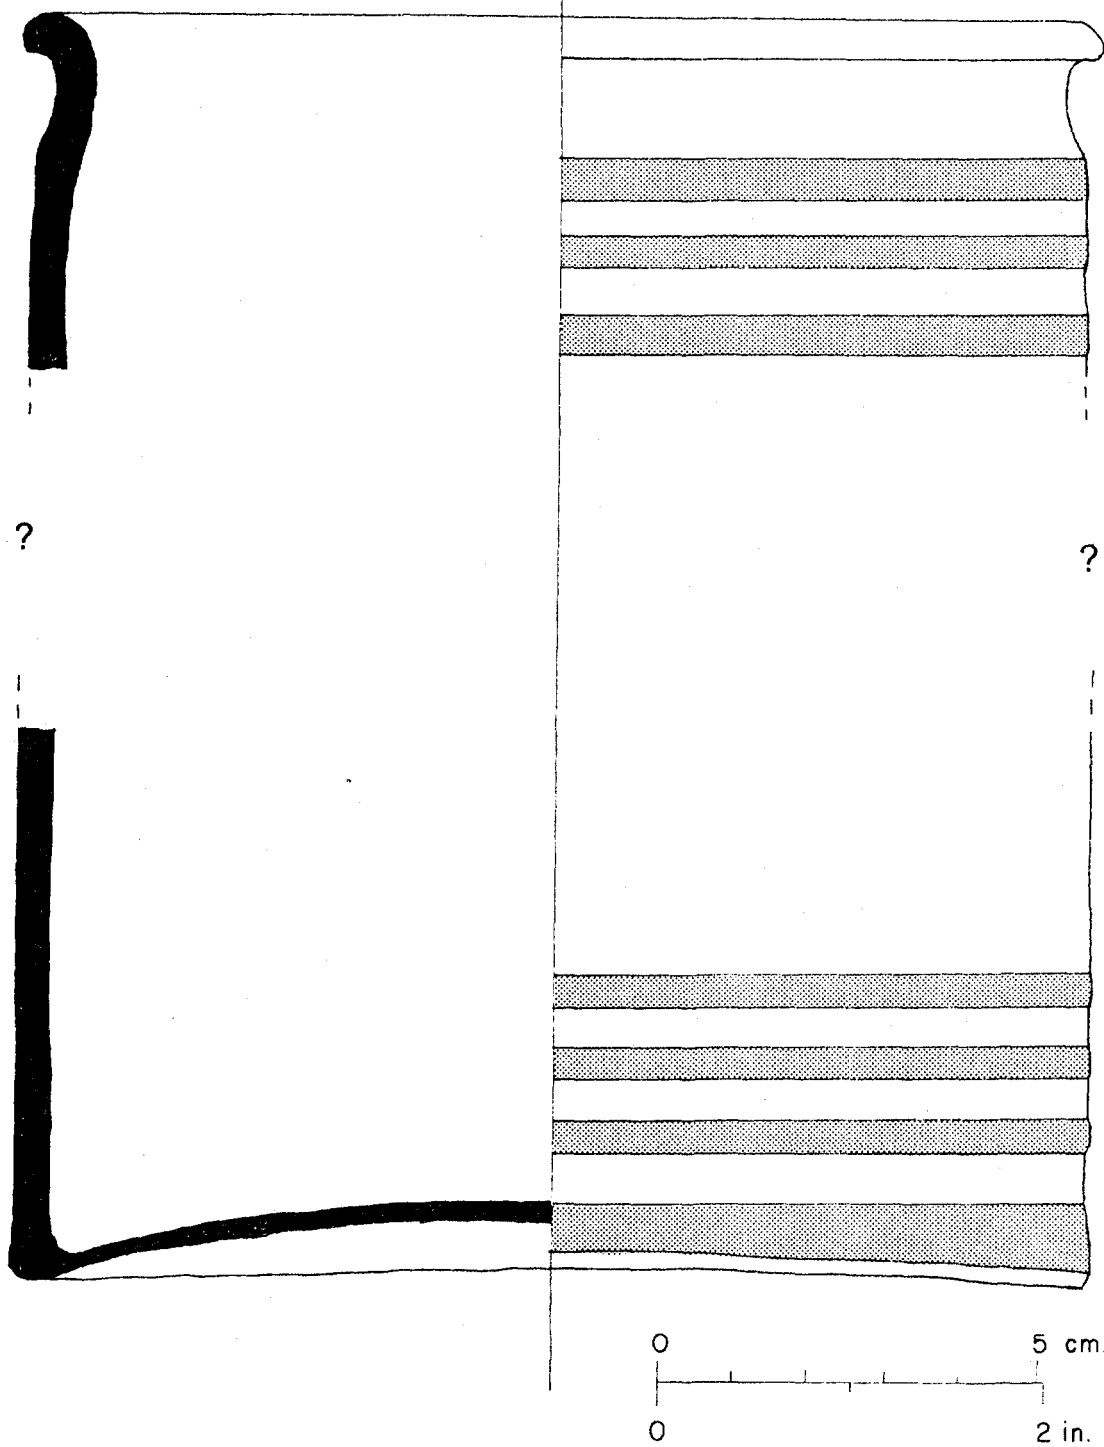
Fig. 92 -- Reconstructed "Mojolica" crock from F523 (Various FOVA numbers).

Forty-three fragments of a blue banded, greenish-blue tin glazed container were recovered (Fig. 92 ), and its outside diameter was ca. 5½ inches. The container was only partially reconstructed, and its height could not be determined. Both the inside and outside were glazed, but just inside the rim was a thin unglazed strip. No manufacturing marks were observed, and the function of the container remains unknown.

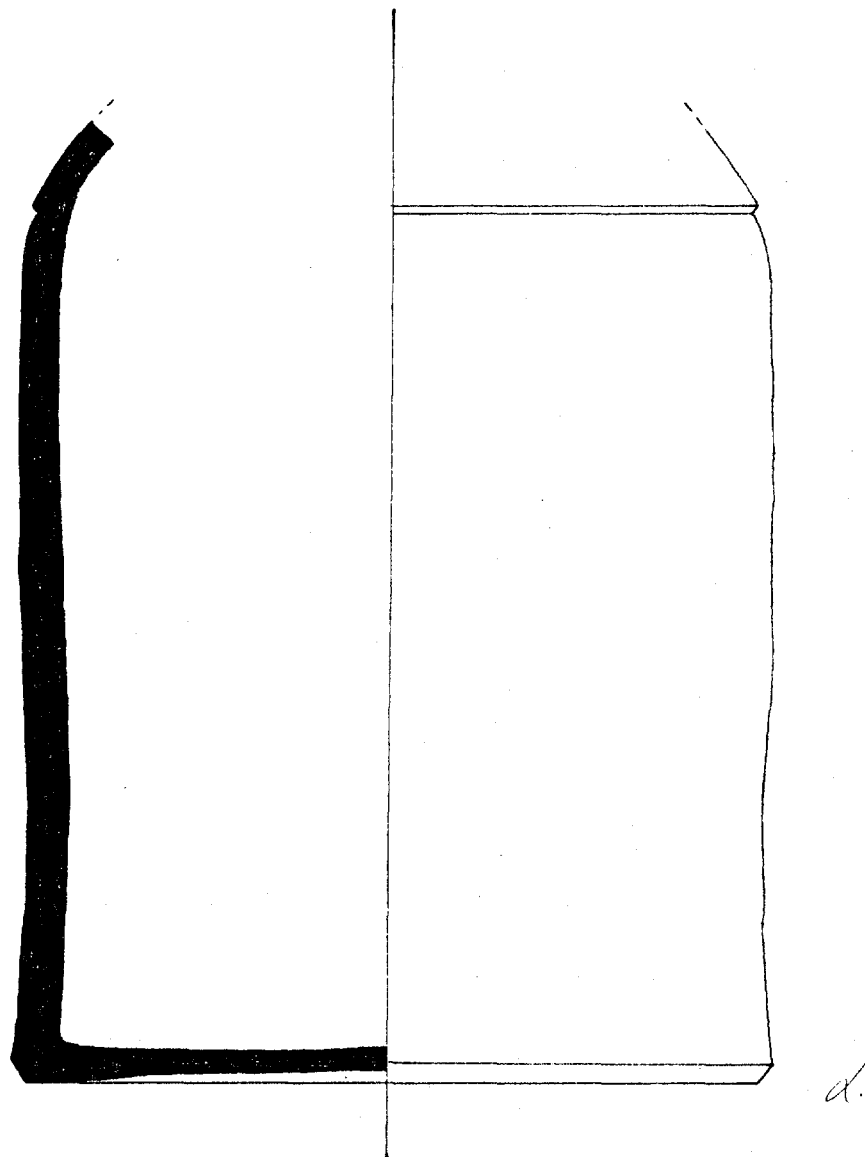
Fig. 93 -- Stoneware "crook" from F523 (Various FOVA numbers).

Unidentified Saltglazed Container Fragments. From the 246 fragments recovered, one partially complete "crock" was reconstructed (Fig. 93 ). Only the base and body could be reconstructed, but from comparisons with previously observed "crops", it was similar to the styles found in the Fur Store area (Hoffman & Ross 1974b: Figs. 12 and 13a-b). Based upon a reconstructed volume of ca. 346 cu. ins., this "crock" held 1½ gallons (within the Winchester Wine Gallon or American Liquid systems). As such, it could have been either a British or American "crock".
