FORT VANCOUVER EXCAVATIONS - X

Southeastern Fort Area

National Park Service

July 1975

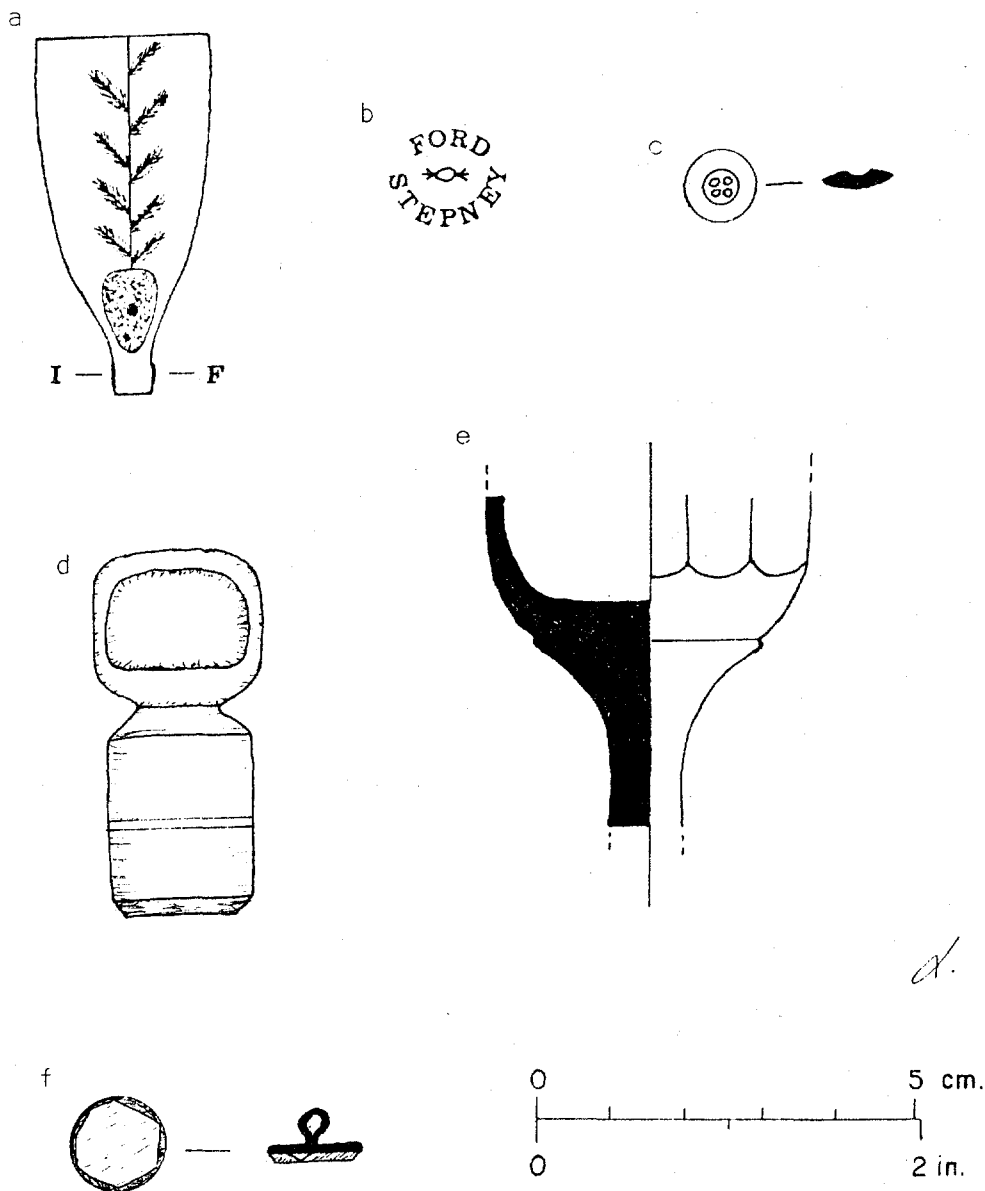
Fig. 95 -- Clay pipes, buttons and glassware from F523: a-b). FORD pipe fragments; c). 'Prosser' button (FOVA 27592); d). glass stopper (FOVA 27740); e). stemmed glassware Variety #1014 (FOVA 27135); and f). iron backed glass button (FOVA 28245).

Bowls. Two styles of "FORD" pipes were observed (Figs. 95a-b ). In addition, one fragment with a "head" bowl was observed, but it was too small for identification and description.

Two stemmed glassware fragments were recovered and have been classified as FOVA Variety #1014. The freeblown work had approximately 12 horizontally ground facets decorating the bowl. The stem and bowl appeared to be manufactured from one piece of glass (Fig. 95e).

One flat, edge faceted, iron backed glass button was recovered (Fig. 95f), and was manufactured by leading a thin sheet of transparent very dark reddish-purple glass to an iron disc with a loop-shank. The glass had 7 facets ground around its edge.

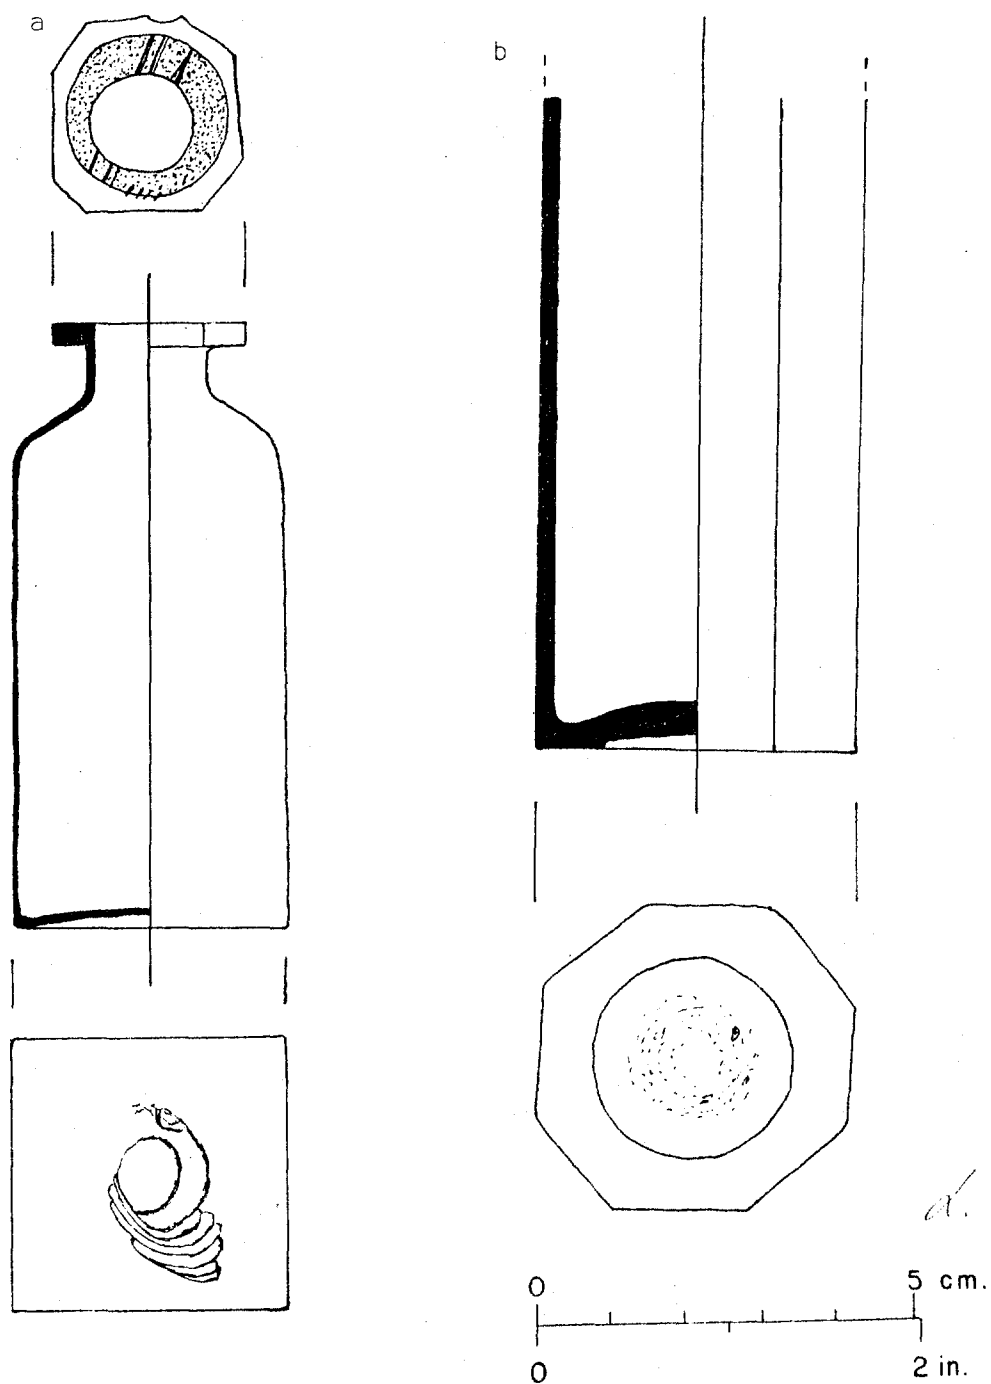
Fig. 96 -- Bottles from F523: a). bottle Type 31 (Various FOVA numbers) and b). bottle base Type 73 (FOVA 28024).

The small square bottle revealed no seam lines and therefore was probably freeformed. The square shape would have been created by slapping the cylindrical freeformed bottle with a wooden paddle called a battledore (Munsey 1970:31). Broken glass in the center of the slightly concave base (Type 72) indicated contact with a glass pontil during manufacture. An unusual characteristic of the base was the ground surface on 3 sides and 4 corners. The ground surfaces were frosty in appearance, not having been polished. The fact that the only ground or roughened surfaces on the base were those points at which the base would have come into contact with another surface may be indicative of roughing to reduce the tendency of the basal surface to slip and slide. The bottle may have been part of a doctor's carrying bag, which would have had compact compartments for storing bottles while moving from place to place. If part of such a kit, the ground surface may have resulted from an attempt to fit the bottle perfectly within an exact area, perhaps grinding was necessary to level the bottle.

The rim (Type 49) was formed from the neck glass and extended straight out from the neck. The rim was 8-sided and formed by horizontal grinding and polishing of the outside edges. Ground surfaces were also evident inside the neck area and on top of the rim. The grinding on top of the rim had been polished and formed a circle, but did not cover the entire diameter of the rim. Four grooves also existed on top of the rim (Fig. 96a). Three of these grooves were fairly deep and rough appearing as though they had been cut at some time after manufacture.

The size, color and closure device do suggest its use as an apothecary bottle. Munsey points out that reusable drug bottles were made with matching glass stoppers which were ground to insure near perfect closure. The inside of the bottle was often ground also to insure good closure (Munsey 1970:174). A bottle such as this one would probably have been reused a number of times and was most likely used for the storage and dispensing of medicine by a professional doctor or druggist.

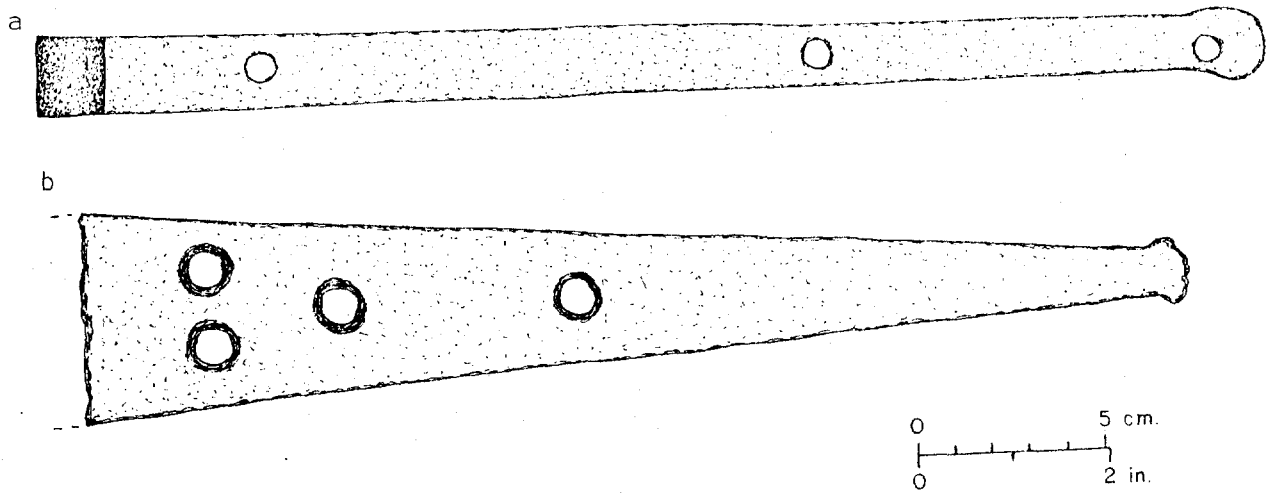
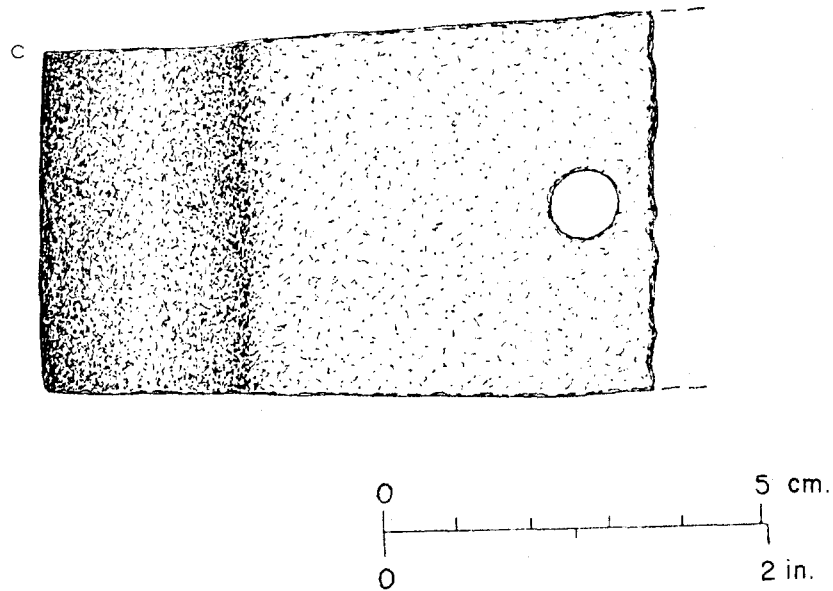
Fig. 97 -- Strap hinges from F523: a). strap hinge (FOVA 28358); b). strap hinge (FOVA 27611); and c). strap hinge (FOVA 27611).

Three varieties of strap hinges were recovered: 1). Three specimens of pintle-hung strap, with the receiver formed by recurving and laminating the stock, 2). one specimen of pintle-hung strap, with the receiver formed by recurving, but not laminating, the stock, and 3). two specimens of double interlocking, "T"-or "cross-garnet", hinge with the receiver formed by recurving and laminating the stock. The varieties are illustrated in Figs. 97a-c.

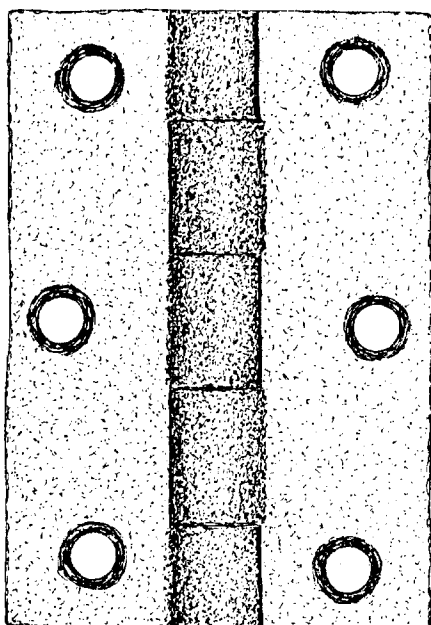
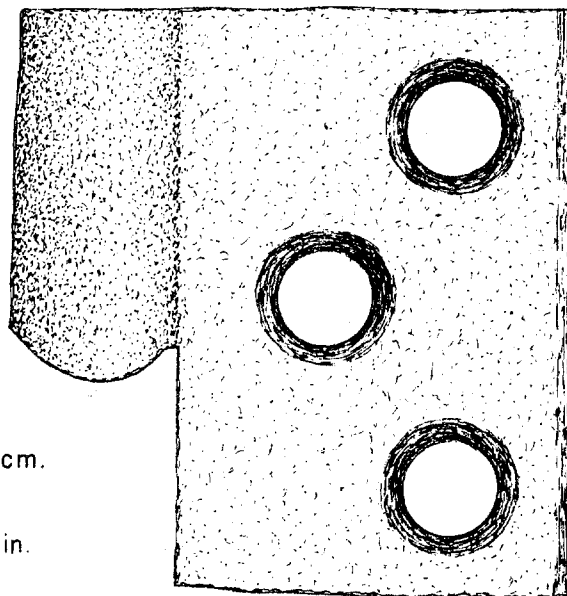
Fig. 98 -- Butt hinges from F523: a). butt hinge (FOVA 28539) and b). butt hinge (FOVA 28018).

Two butt hinges representing two stylistic varieties were recovered: 1). a triple interlocking post with three countersunk anchor eyelets, 2). a single interlocking 45° camming post with three countersunk anchor eyelets manufactured by recurving and laminating the stock. The specimens are illustrated in Fig. 98a-b.

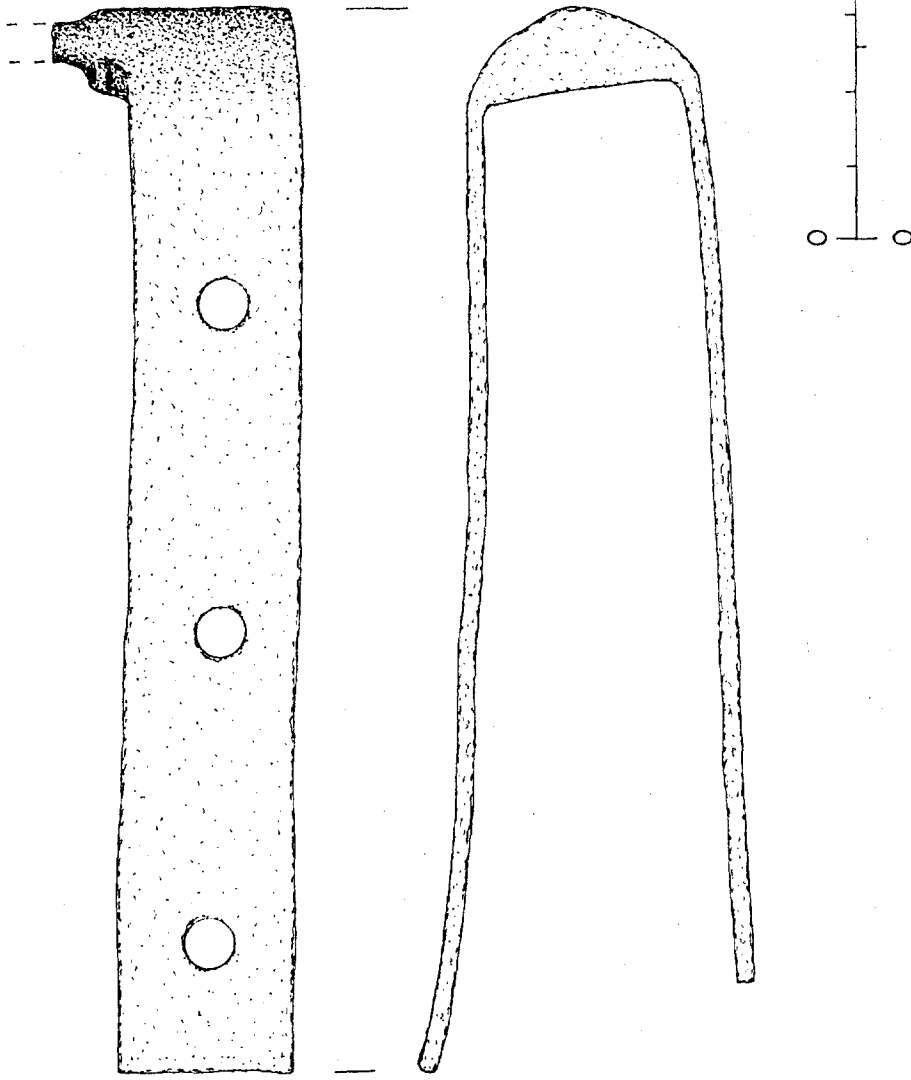
Fig. 99 -- Strap pintle (FOVA 27803) from T523.

A single specimen hypothesized as a strap anchored pintle was recovered and is illustrated in Fig. 99. The strap, forming the anchor of the post, was fastened to the side of a door or shutter of approximately 1" thickness. A similar specimen was reported and illustrated in FOVA Report #VIII (Hoffman & Ross 1974b: Fig. 78b). Seven preforms were recovered and are assumed to represent hinges manufactured at Fort Vancouver. They include one pintle-hung strap hinge, three butterfly hinges, a three holed butt hinge and two "T" or "crossgarnet" strap hinges. Four are illustrated in Figs. 100a-d.

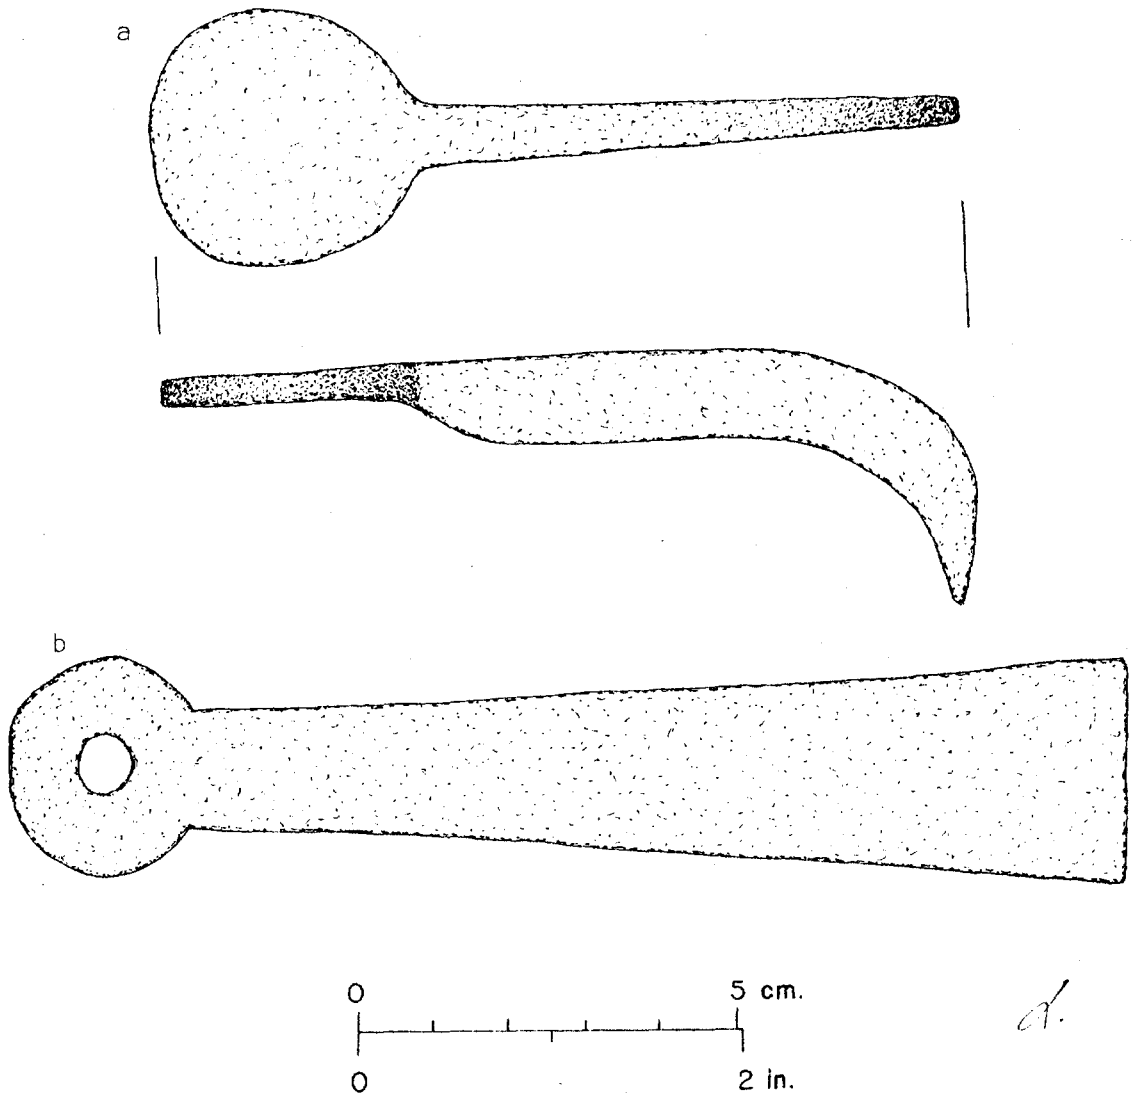
Fig. 101 -- Latching devices from F523: a). thumb latch (FOVA 28014) and b). latch bar (FOVA 28589).

Two fragments of thumb latch parts were recovered consisting of a thumb latch (Fig. 101a) and a latch bar (Fig. 101b). A shutter nail manufactured from circular stock was also recovered.

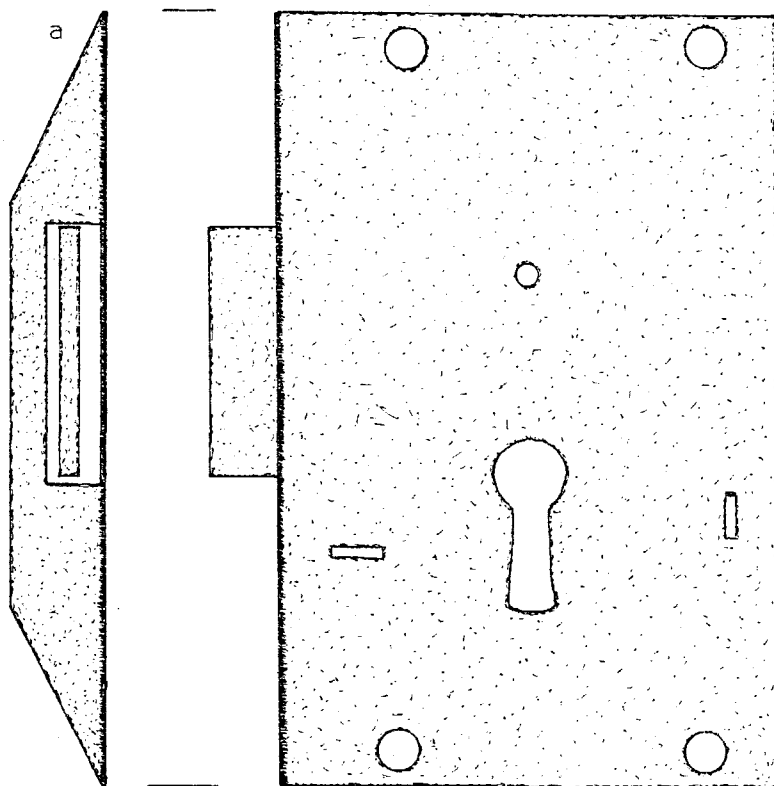
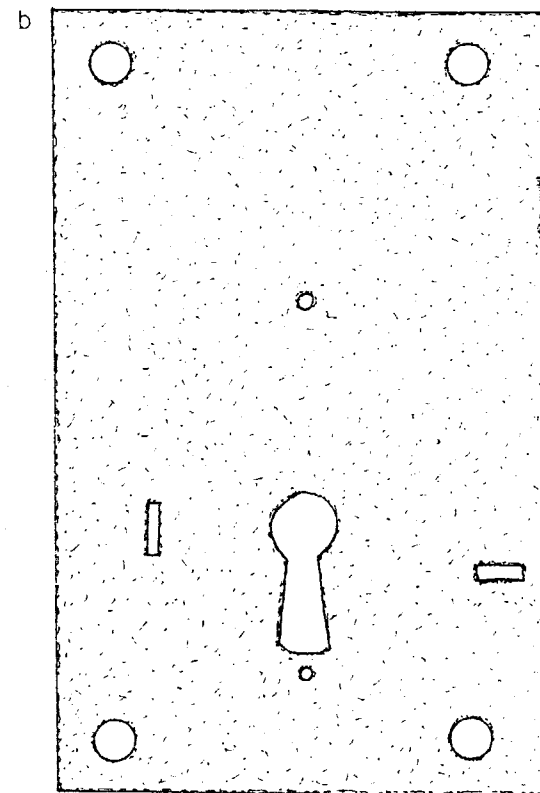
Fig. 102 -- Cassette locks from F523: a). reconstructed case lock (FOVA 28566) and b). case lock (FOVA 27967).

Four fragments representing at least 2 sizes of stock locks were recovered including 2 back plates with internal mechanisms and 2 bolts. In addition, 3 backplates with mechanisms for rectangular case--or cassette--type locks were recovered (Figs. 102a-b and 103a).

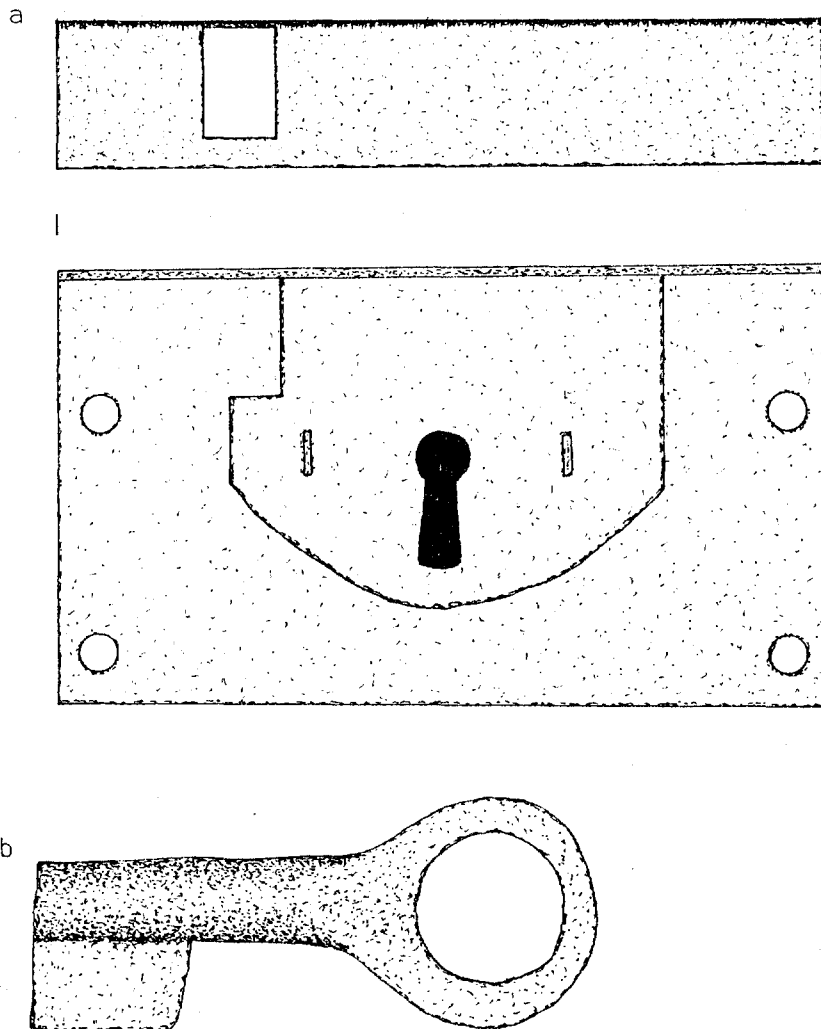
FIG. 103 -- Cassette lock and key preform from F523: a). case lock (FOVA 28214) and b). key preform (FOVA 27278).

One specimen of a key preform, similar to specimens recovered from the Blacksmith Shop (Fig. 31c) is illustrated in Fig. 103b.

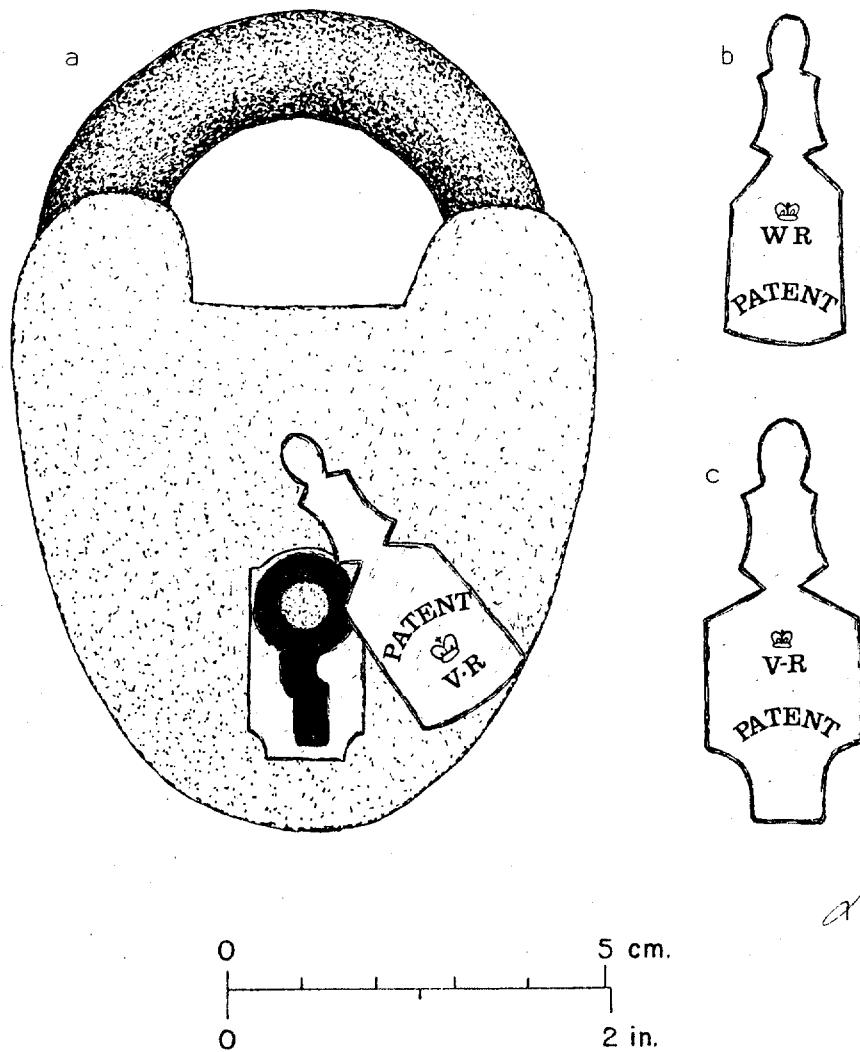
Fig. 104 -- Padlock with keyhole cover plate variations from F523: a). post-1837 Victoria padlock (FOVA 27388 and 27747); b). 1830-1837 William keyhole cover plate (FOVA 27388) and c). post-1837 Victoria keyhole cover plate (FOVA 28529).

Three nearly complete "patent" padlocks were recovered; and a representative specimen is illustrated in Fig. 104a. All were of the same size, being ca. 3" in width, and contained patent marks on the keyhole cover plate. Two styles of escutcheon and cover plate were observed and three different styles of patent marking. "WR Patent", with crown, was observed on two specimens while a "WR" or "VR" "Patent" with crown appears on the third. "WR" presumably represented William Rex or William IV (1830-1837), King of England. The variation in escutcheon/cover plate design and variation in hallmarks are illustrated in Figs. 104a-c. Stylistically, the padlocks presumably manufactured between 1830-1837, are the same as post-1837, "VR", or Victoria Regina, padlocks recovered from past Fort Vancouver excavations.

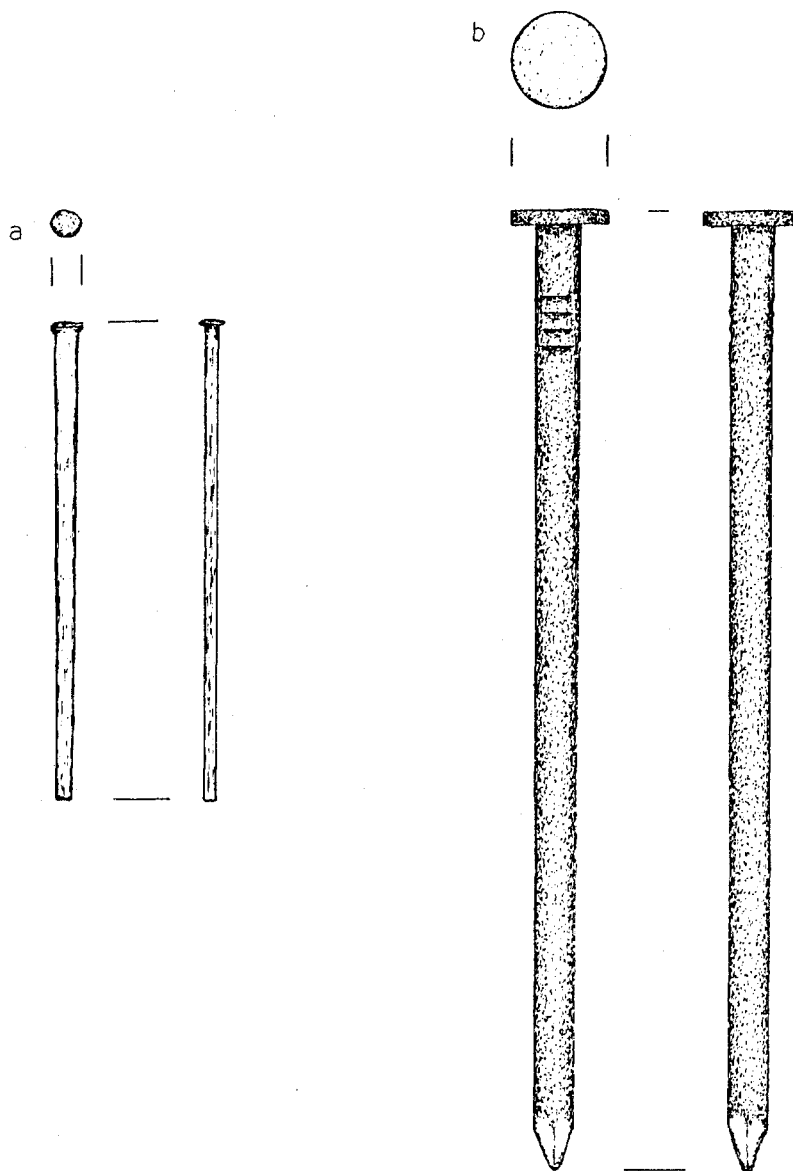
Fig. 109 -- New machine cut sheet and wire nail varieties from F523:  
a). nail Variety #2029 (FOVA 27600 L=6.94cm) and b).  
nail Variety #3004 (U.S. Army) (FOVA 27477 L=8.4 cm).

There were 309 machine cut sheet nails recovered including 78 complete specimens representing 5 stylistic varieties (Table 35). One significant population of flathead reverse crimp "shingling" (Variety #2004) nails were also recovered. They were probably derived from the deposition of shingles from the privy or adjacent Indian Trade Store (Hoffman & Ross 1975), and appear to spacially correlate with the simultaneous deposition of the wrought rod hinge nails. One new variety of machine cut sheet nail was recovered and it is illustrated in Fig. 109a.

One specimen of machine cut wire nail was recovered from a possible HBC context (Level 2) and is illustrated in Fig. 109b.

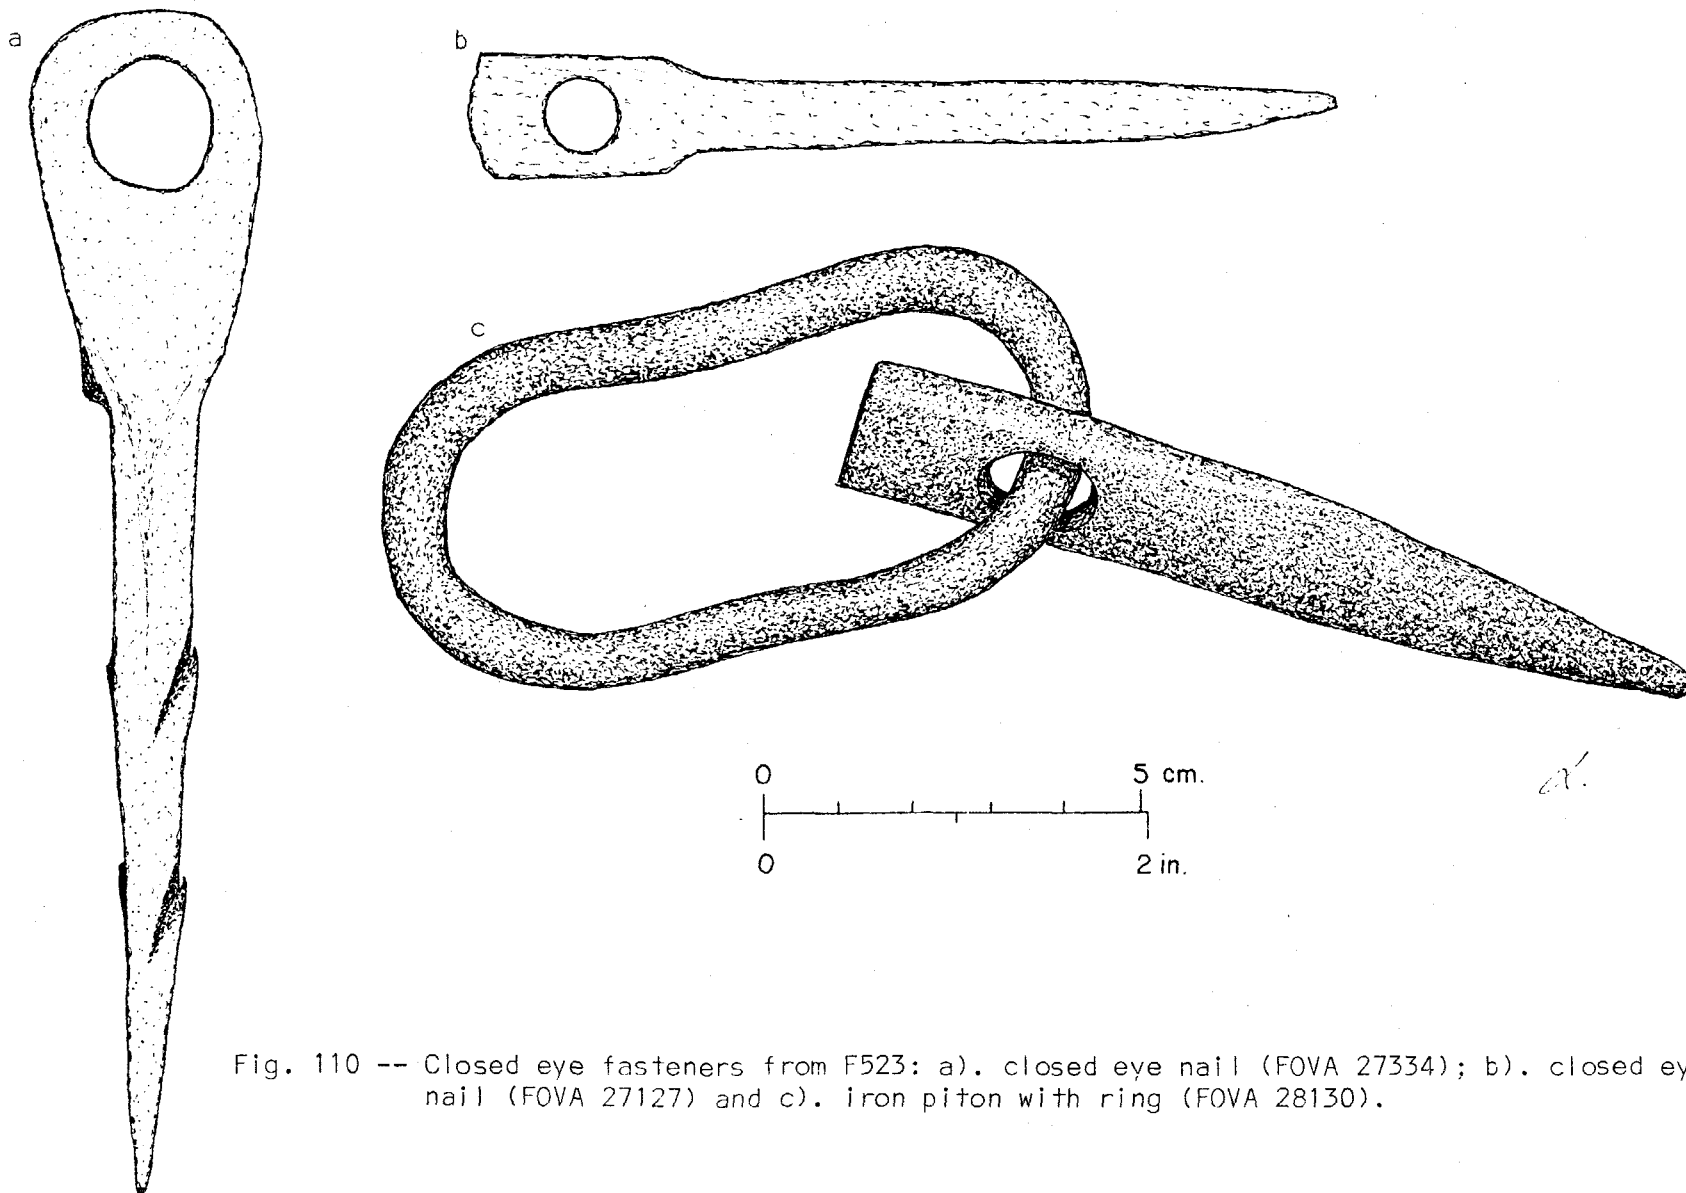
Fig. 110 -- Closed eye fasteners from F523: a). closed eye nail (FOVA 27334); b). closed eye nail (FOVA 27127) and c). iron piton with ring (FOVA 28130).

Two specimens of closed eye nails were also recovered, one having a barbed shank. They are illustrated in Figs. 110a-b.

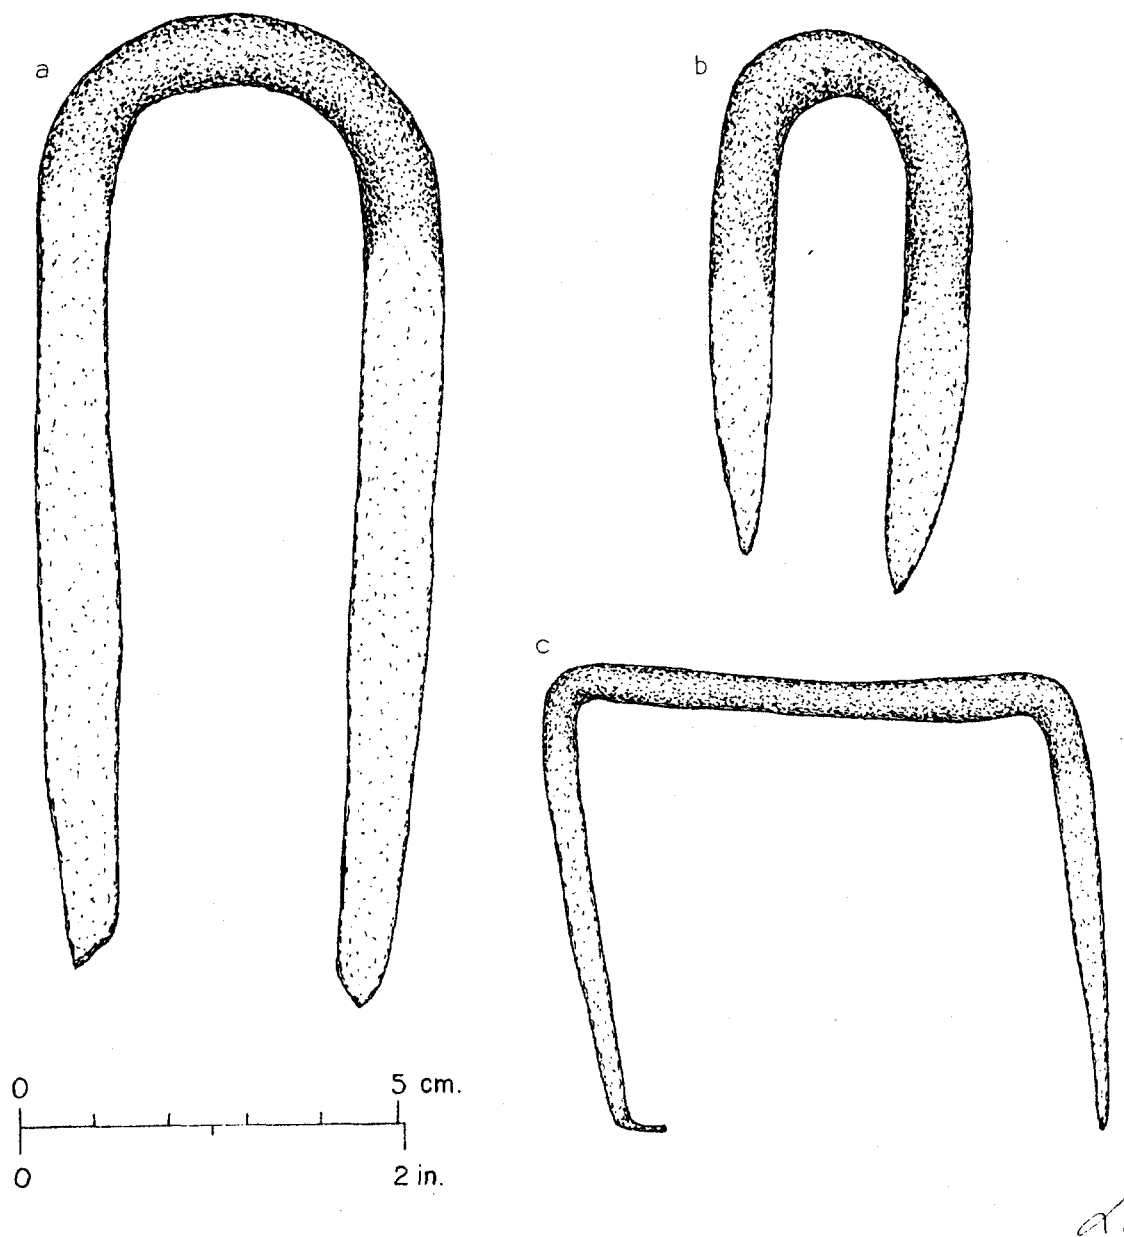
Fig. 111 -- Staples from F523: a). staple (FOVA 28184); b). staple (FOVA 27259); and c). staple (FOVA 27760).

Four wrought rod staples were recovered and 3 have been illustrated in Figs. 111a-c. In addition, a bateau bolt (Fig. 112a) made from circular stock, an iron piton with ring (Fig. 110d) of unknown function, and a variety of roves, rivets, and cotter bolt parts were recovered. The new varieties are illustrated in Figs. 113a-f. Of the 43 unidentified non-threaded fasteners recovered, 2 complete specimens are illustrated in Figs. 112a-c.

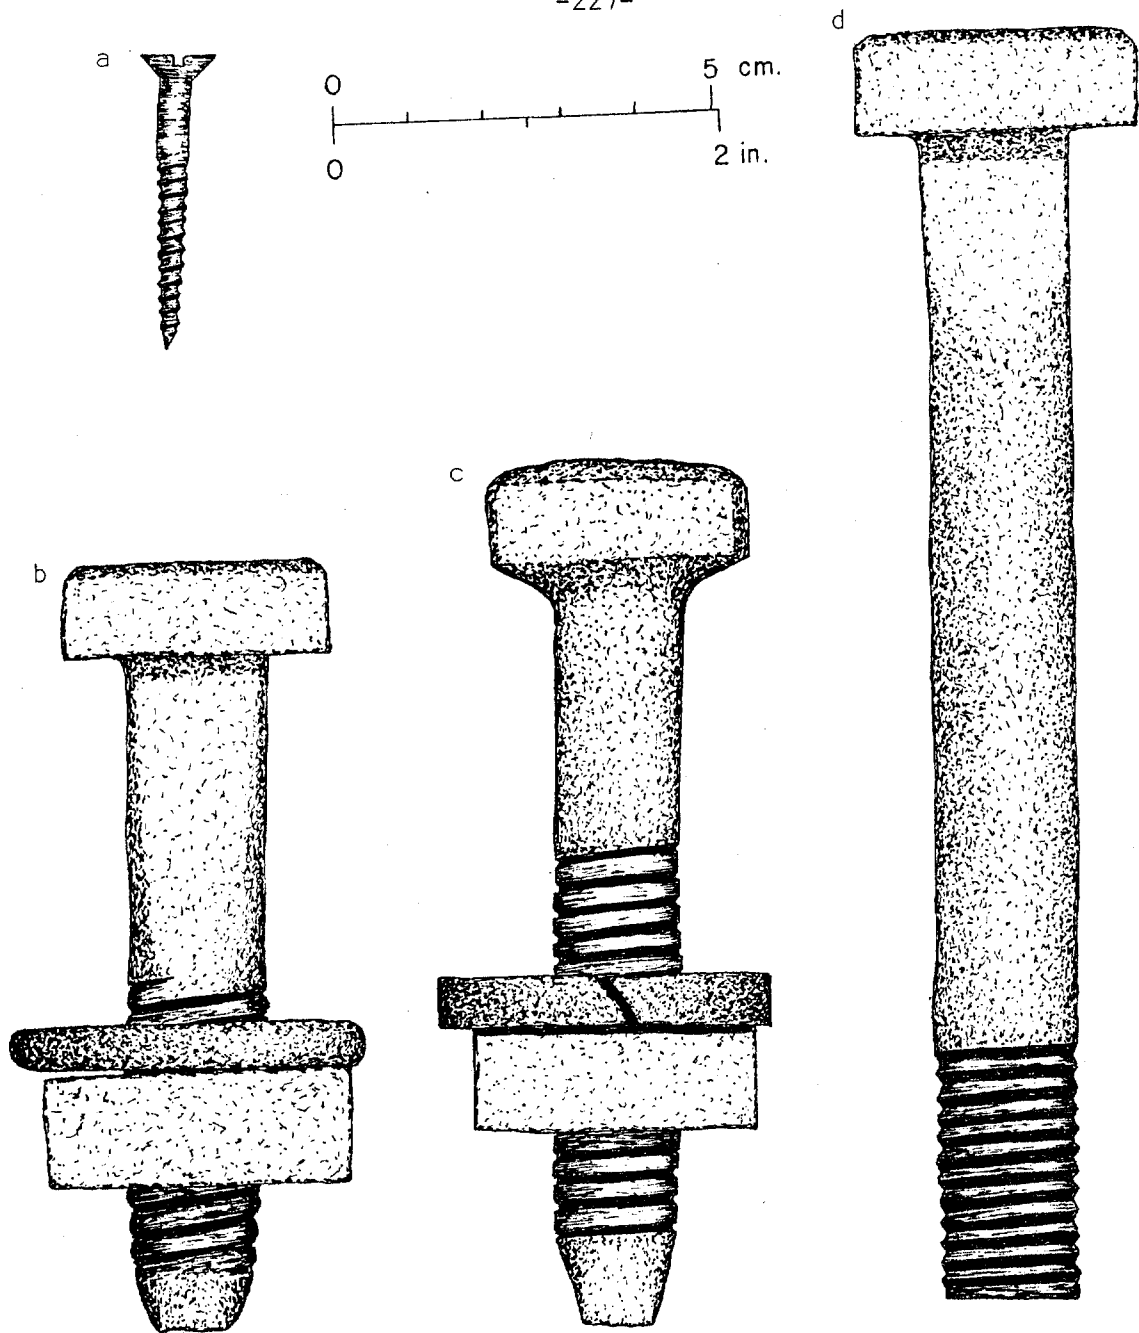
Fig. 114 -- Screw and bolts from F523: a). screw (FOVA 27322); b). bolt, nut and washer (FOVA 28196); c). bolt, nut and washer (FOVA 28532); and d). bolt (FOVA 28385).

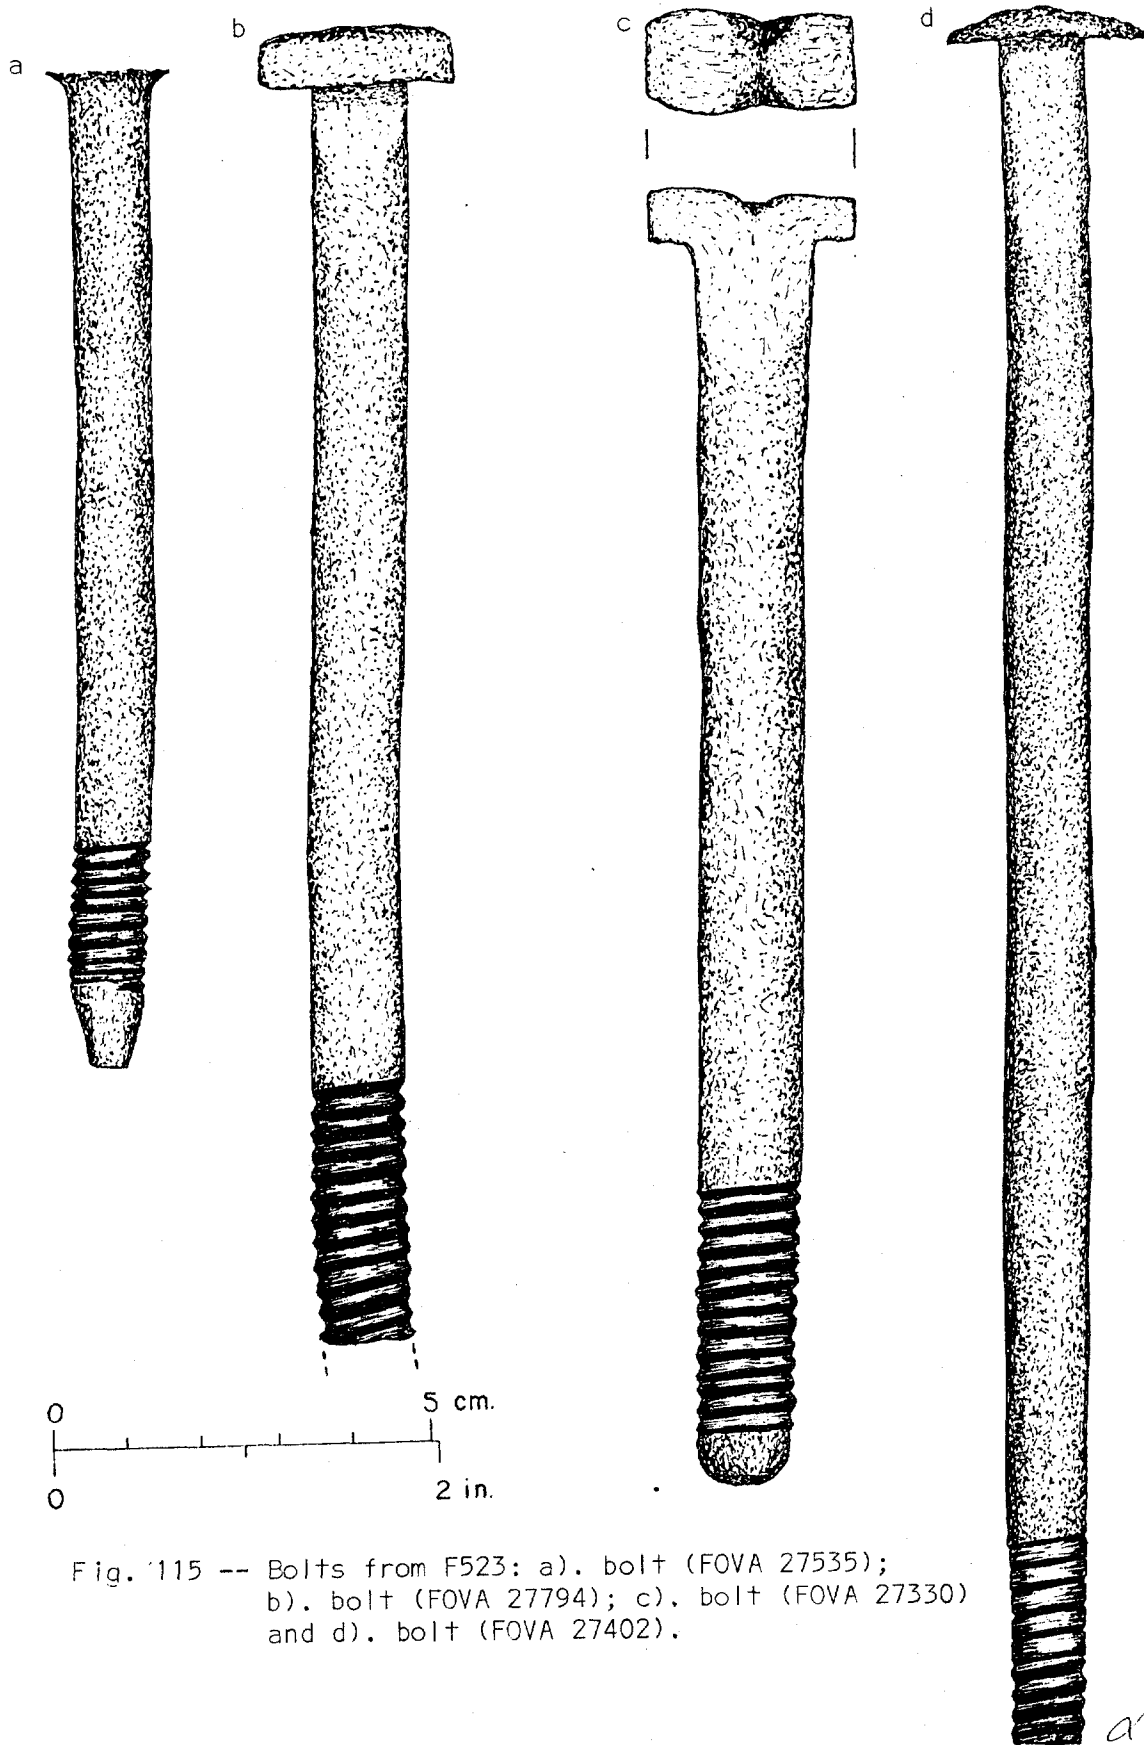
Fig. 115 -- Bolts from F523: a). bolt (FOVA 27535);  
b). bolt (FOVA 27794); c). bolt (FOVA 27330)  
and d). bolt (FOVA 27402).

A total of 84 threaded fasteners was recovered. Two screws were identified, both from HBC stratigraphic contexts, and one is illustrated in Fig. 114a. Of the 51 iron bolts recovered (including bolts with nuts, and bolts with nuts and washers), 12 styles were identified. Only one of these was duplicated in the Blacksmith Shop (Fig. 46a), but the general method for manufacturing bolts appears to be similar to those recovered from the Shop. The styles are illustrated in Figs. 114b-d, 115, 116a-d.

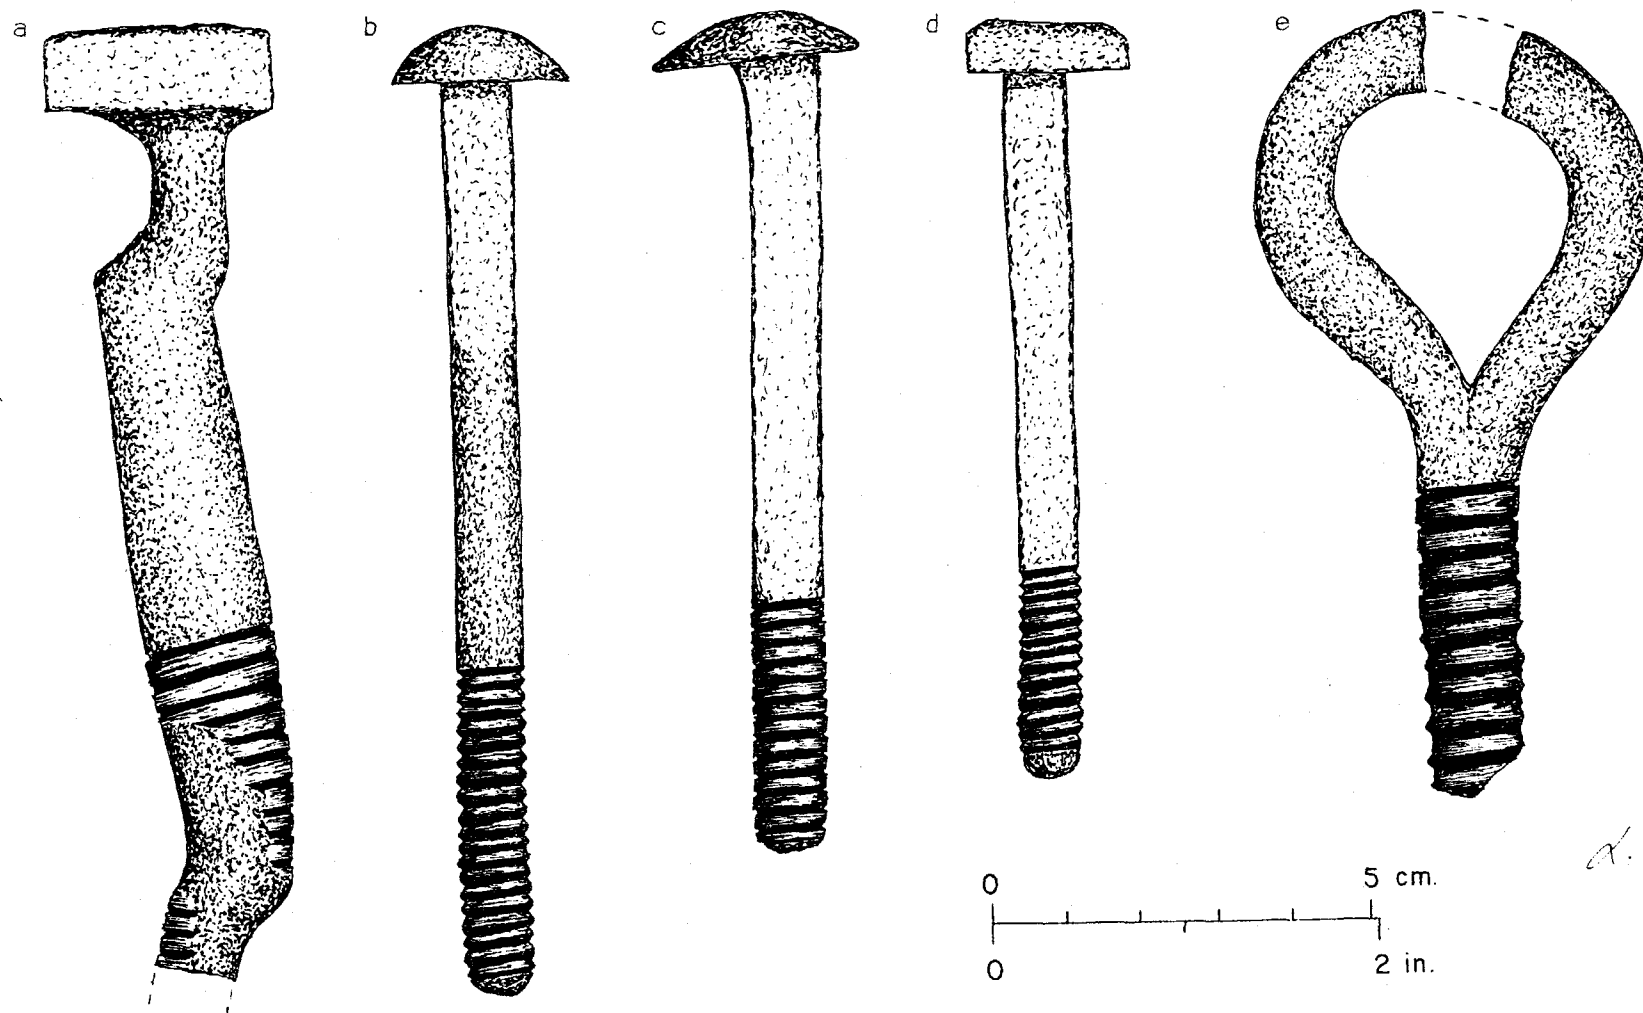
Fig. 116 -- Bolts and an eye bolt from F523: a). bolt (FOVA 28341); b). bolt (FOVA 27330); c). bolt (FOVA 27903); d). bolt (FOVA 28350) and e). closed eye bolt (FOVA 27168).

One eye bolt was recovered and it is illustrated in Fig. 116e.

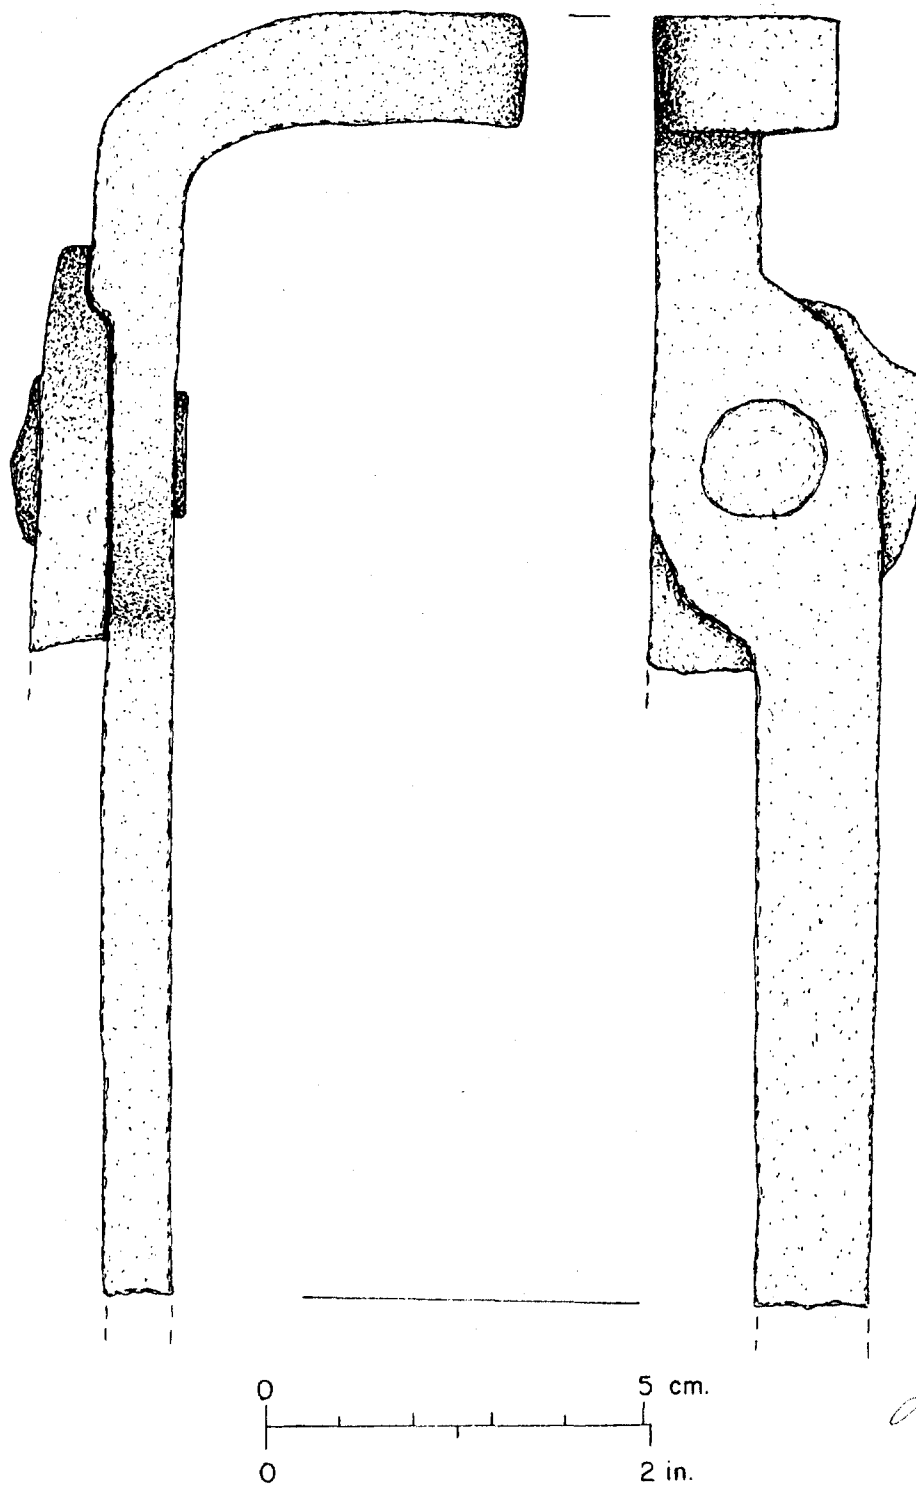
Fig. 117 -- Tong (FOVA 27166) from F523.

Of the 43 blacksmith tools recovered, 21 specimens were tongs. At least 8 styles of tong jaws have been identified, and new styles are illustrated in Figs. 117-120. Four different manufacturers (or owners) initials were observed on the shanks of jaws. These included "JB", hypothesized as the initials of Joseph Ouide Beauchamp Fort Vancouver blacksmith between 1843-1847 (Hussey 1974: 334-35); "VF", a mark that does not correlate with any known Blacksmith at Fort Vancouver; a partial mark "-L", possibly representing either Andre Lachapelle, Fort Vancouver blacksmith from 1828-1832 and 1834-1840, or Andrew Louttit, Fort Vancouver blacksmith from 1840-1844 (Hussey 1974: 331-35), and one unidentified mark. The marks and their respective tong style are illustrated in Figs. 120a-b.
