FORT VANCOUVER EXCAVATIONS - X

Southeastern Fort Area

National Park Service

July 1975

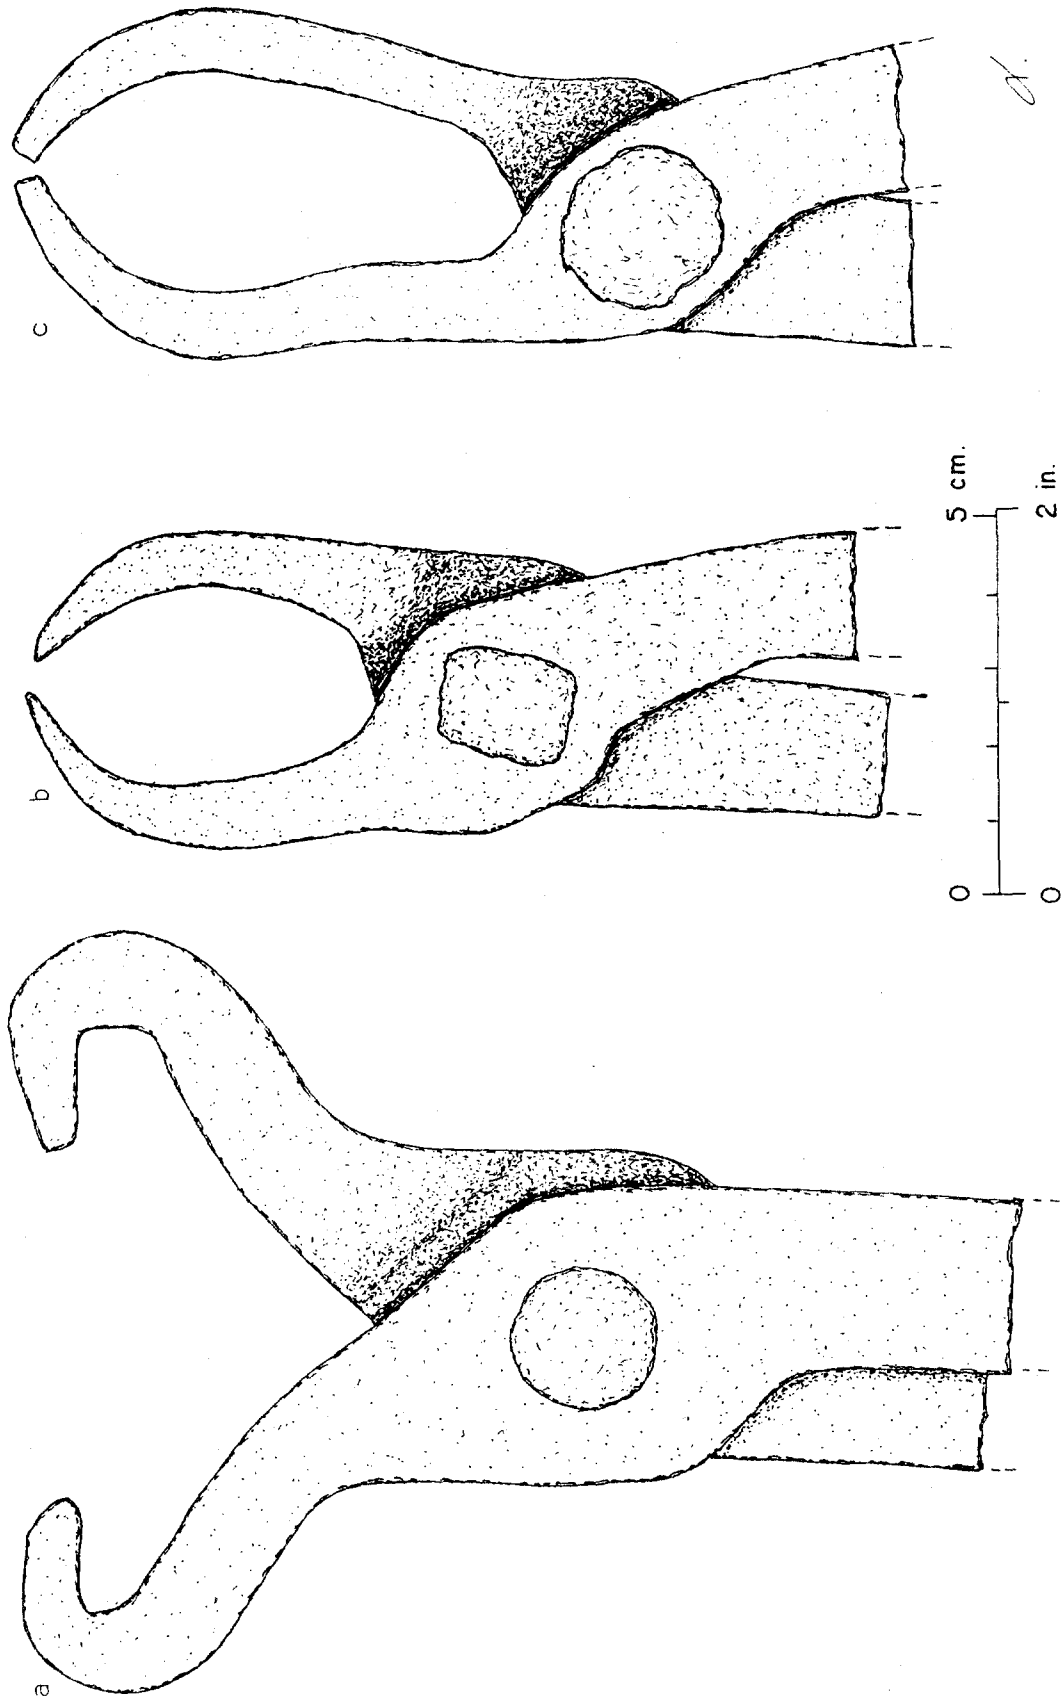
Fig. 118 -- Tongs from F523: a). tong (FOVA 27561b); b). tong (FOVA 28534) and c). tong (FOVA 27399).

Of the 43 blacksmith tools recovered, 21 specimens were tongs. At least 8 styles of tong jaws have been identified, and new styles are illustrated in Figs. 117-120. Four different manufacturers (or owners) initials were observed on the shanks of jaws. These included "JB", hypothesized as the initials of Joseph Ouide Beauchamp Fort Vancouver blacksmith between 1843-1847 (Hussey 1974: 334-35); "VF", a mark that does not correlate with any known Blacksmith at Fort Vancouver; a partial mark "-L", possibly representing either Andre Lachapelle, Fort Vancouver blacksmith from 1828-1832 and 1834-1840, or Andrew Louttit, Fort Vancouver blacksmith from 1840-1844 (Hussey 1974: 331-35), and one unidentified mark. The marks and their respective tong style are illustrated in Figs. 120a-b.

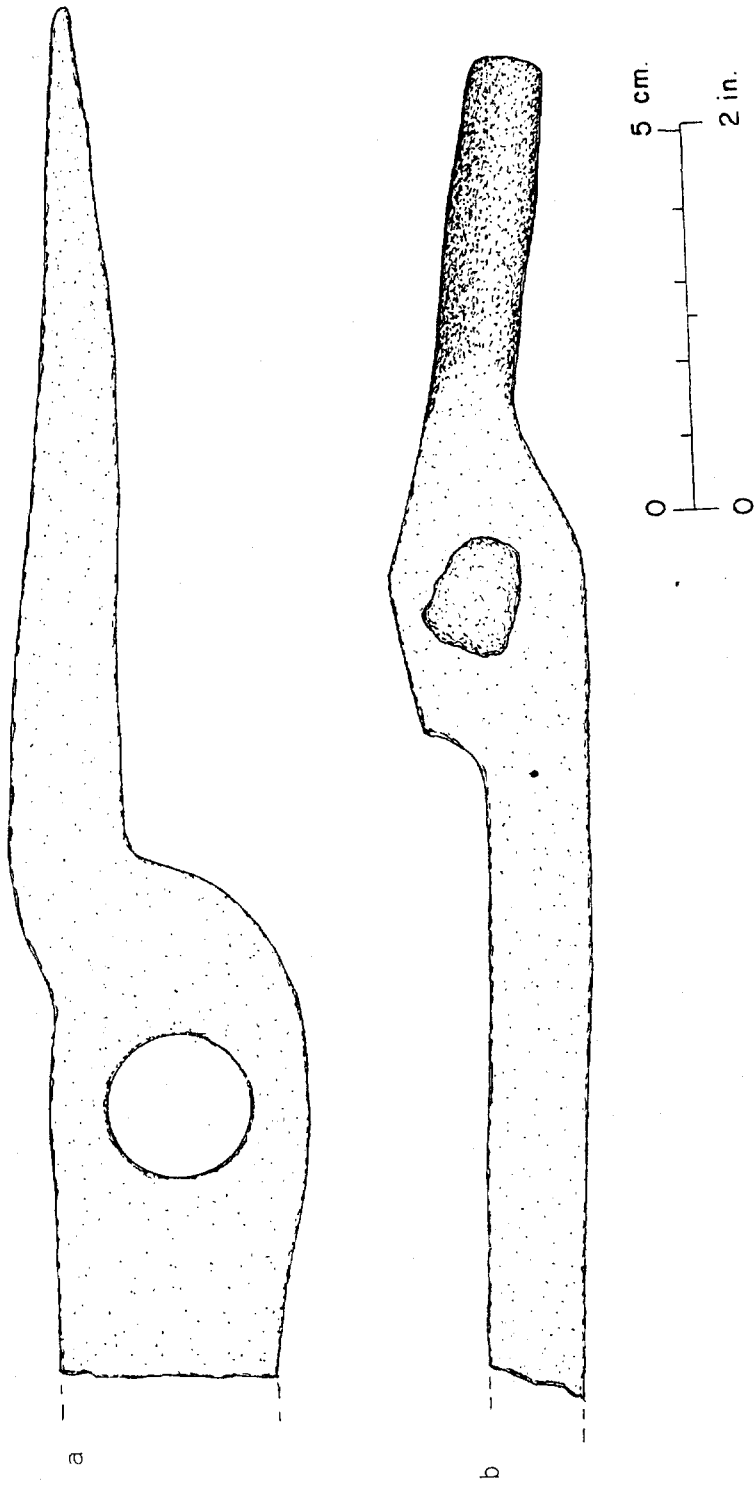
Fig. 119 -- Tongs from F523: a). tong (FOVA 27924) and b). tong (FOVA 27333).

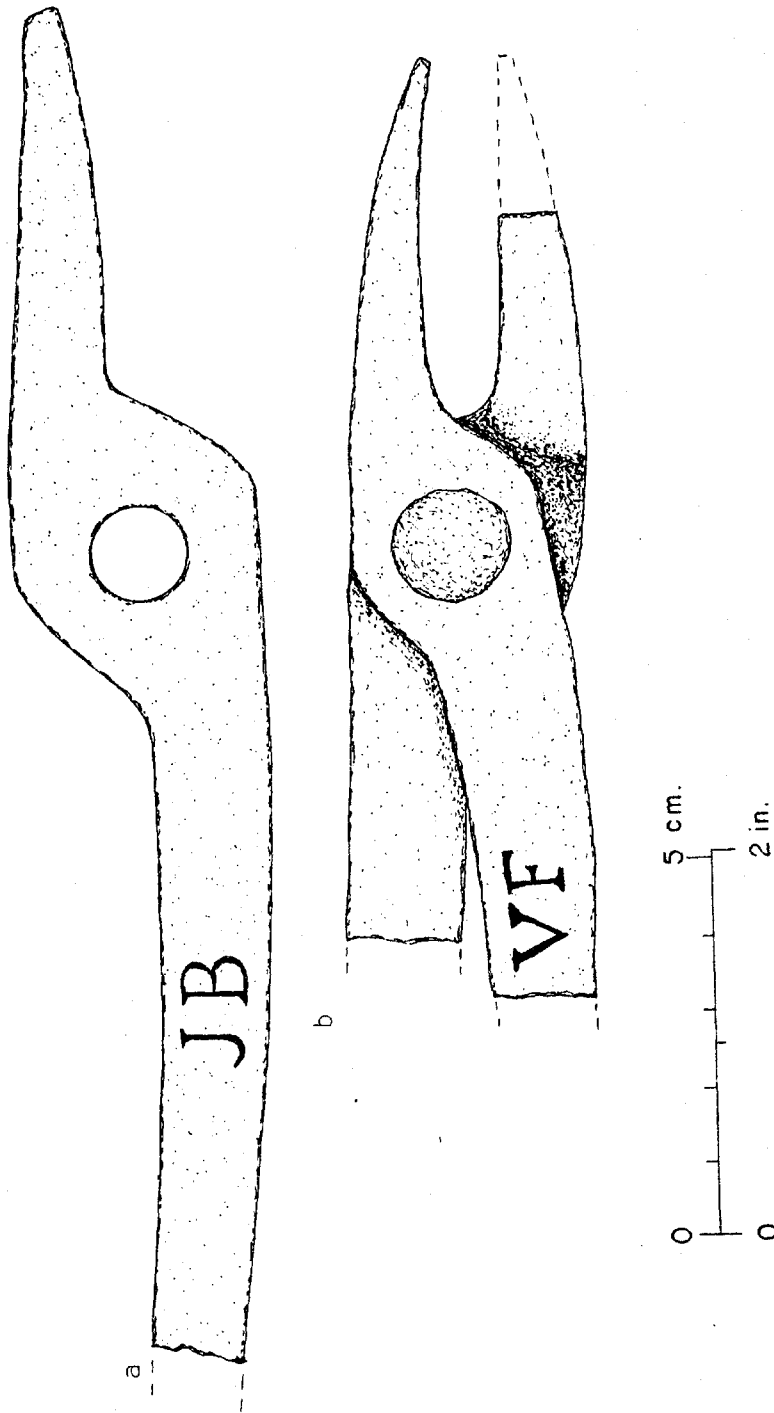
Fig. 120 -- Tongs from F523: a). tong (FOVA 28189). and b). tong (FOVA 28384).

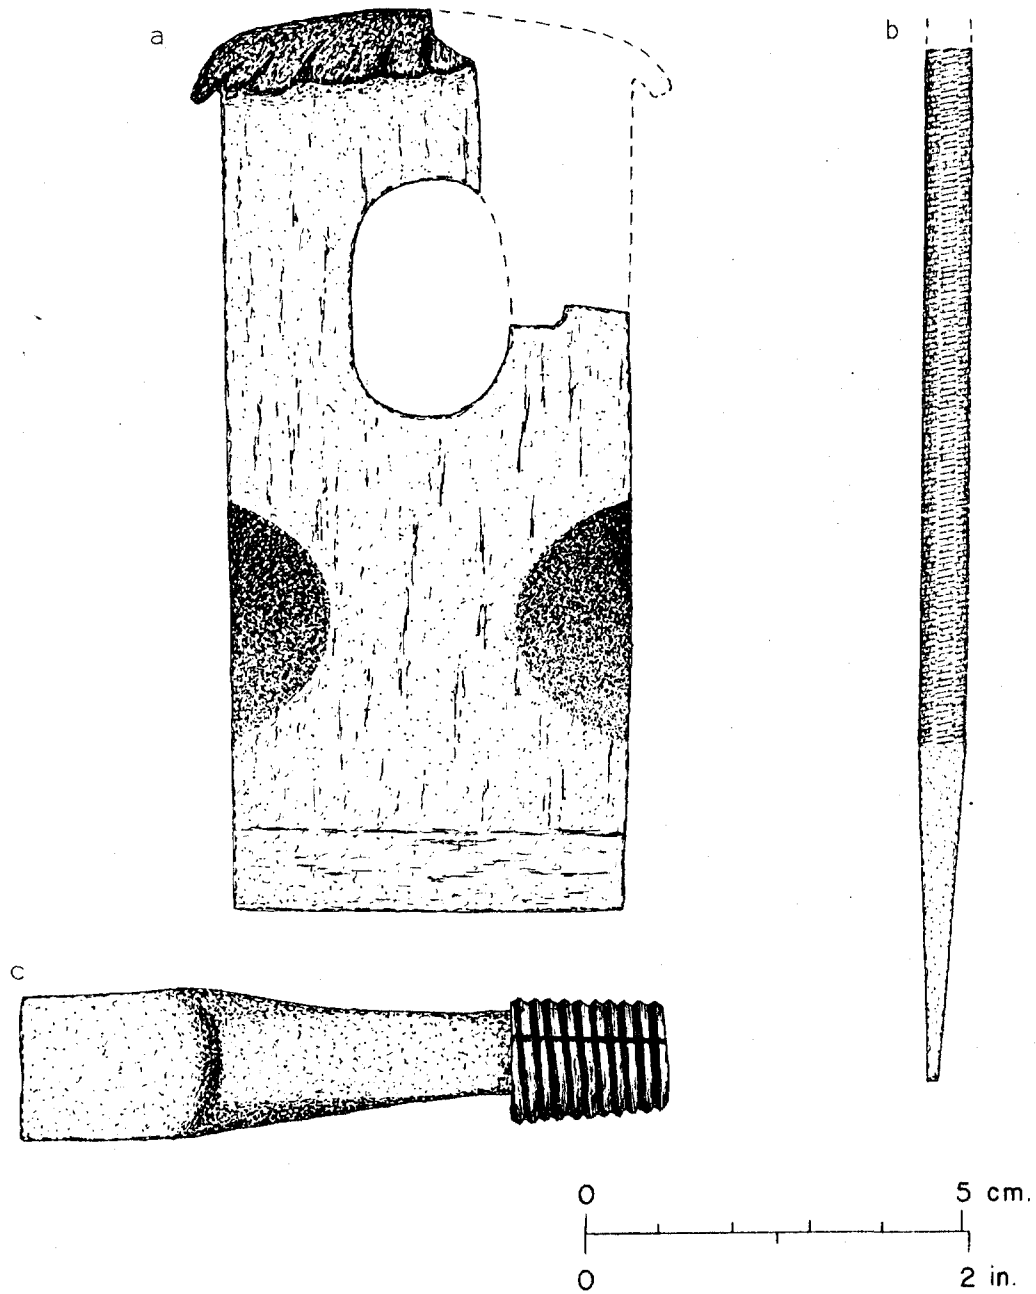
Fig. 121 -- Blacksmith tools from F523:a). flatter (FOVA 27960);  
b). round file (FOVA 27548) and c). tap (FOVA 27338).

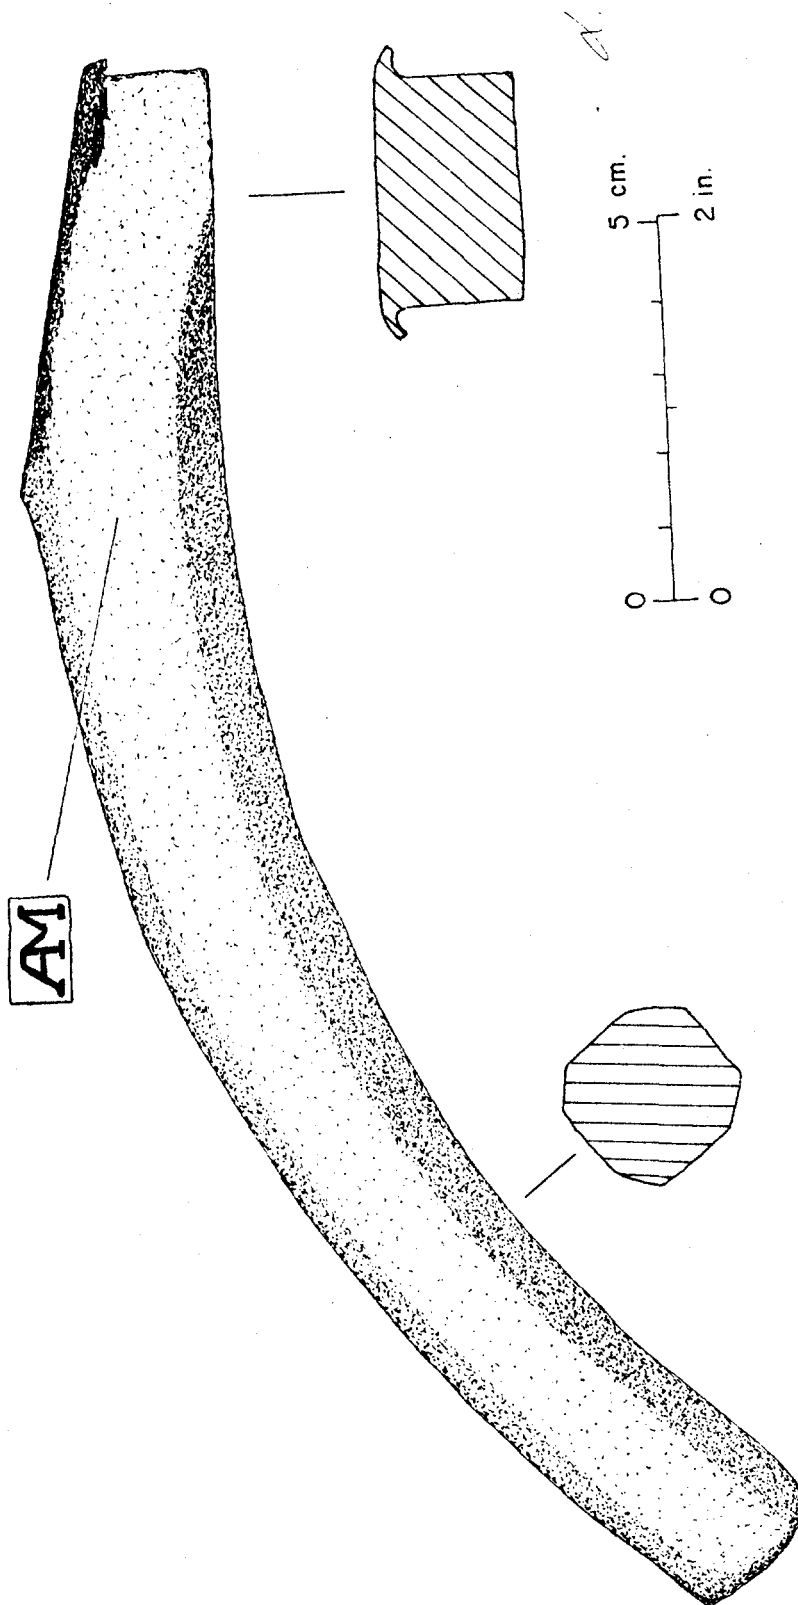
Fig. 122 --- Offset flatter (FOVA 27405) from F523.

Two styles of flatters were recovered. One style, illustrated in Fig. 121a, was hafted and a manufacturing mark, possibly "ITT" was impressed near the face. It is hypothesized as being an imported item. The second style, illustrated in Fig. 122, was a hand held offset flatter with the initials "AM" block impressed into the handle shank. Presumably the initials stood for Allan Morrison, Fort Vancouver blacksmith from 1838-1841. "AM" has also been recovered on axe bodies from the Fur Store area (Hoffman & Ross 1974b: 155).

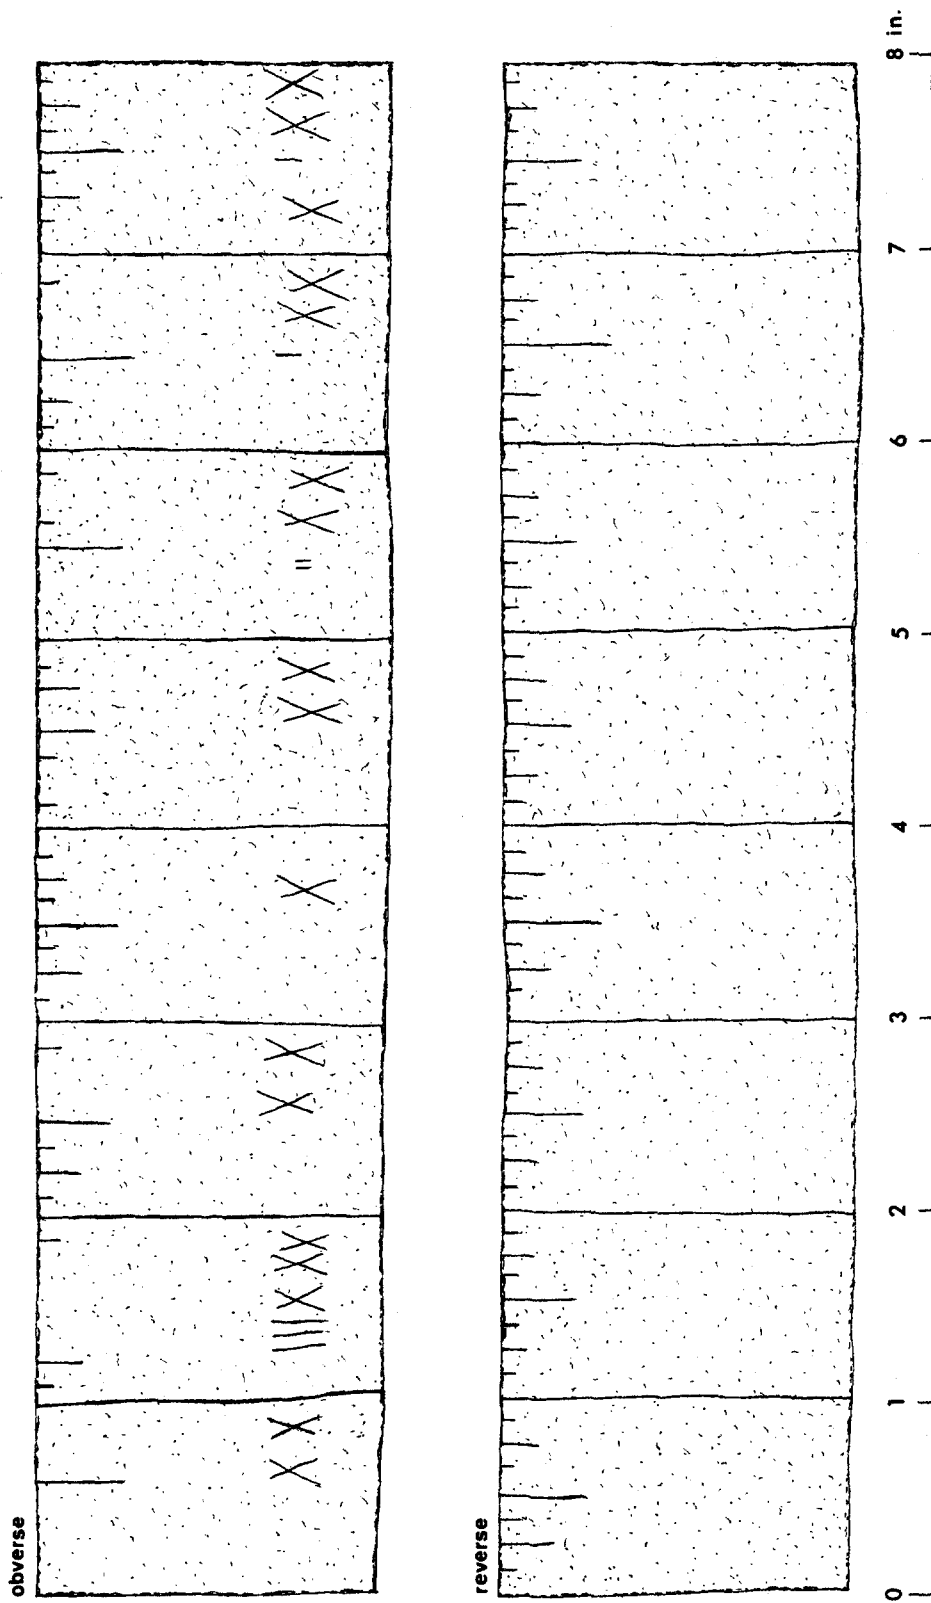
Fig. 123 -- Flat iron rule (FOVA 28158) from F523.

Twenty other blacksmith tools were recovered including an 8 inch iron ruler (Fig. 123), a new style of threading tap (Fig. 121d), an axe body form (Fig. 124a), a circular or rattail file (Fig. 121b), 3 new styles of punches (Fig. 125a-c, and a hot set hardy (Fig. 124b).

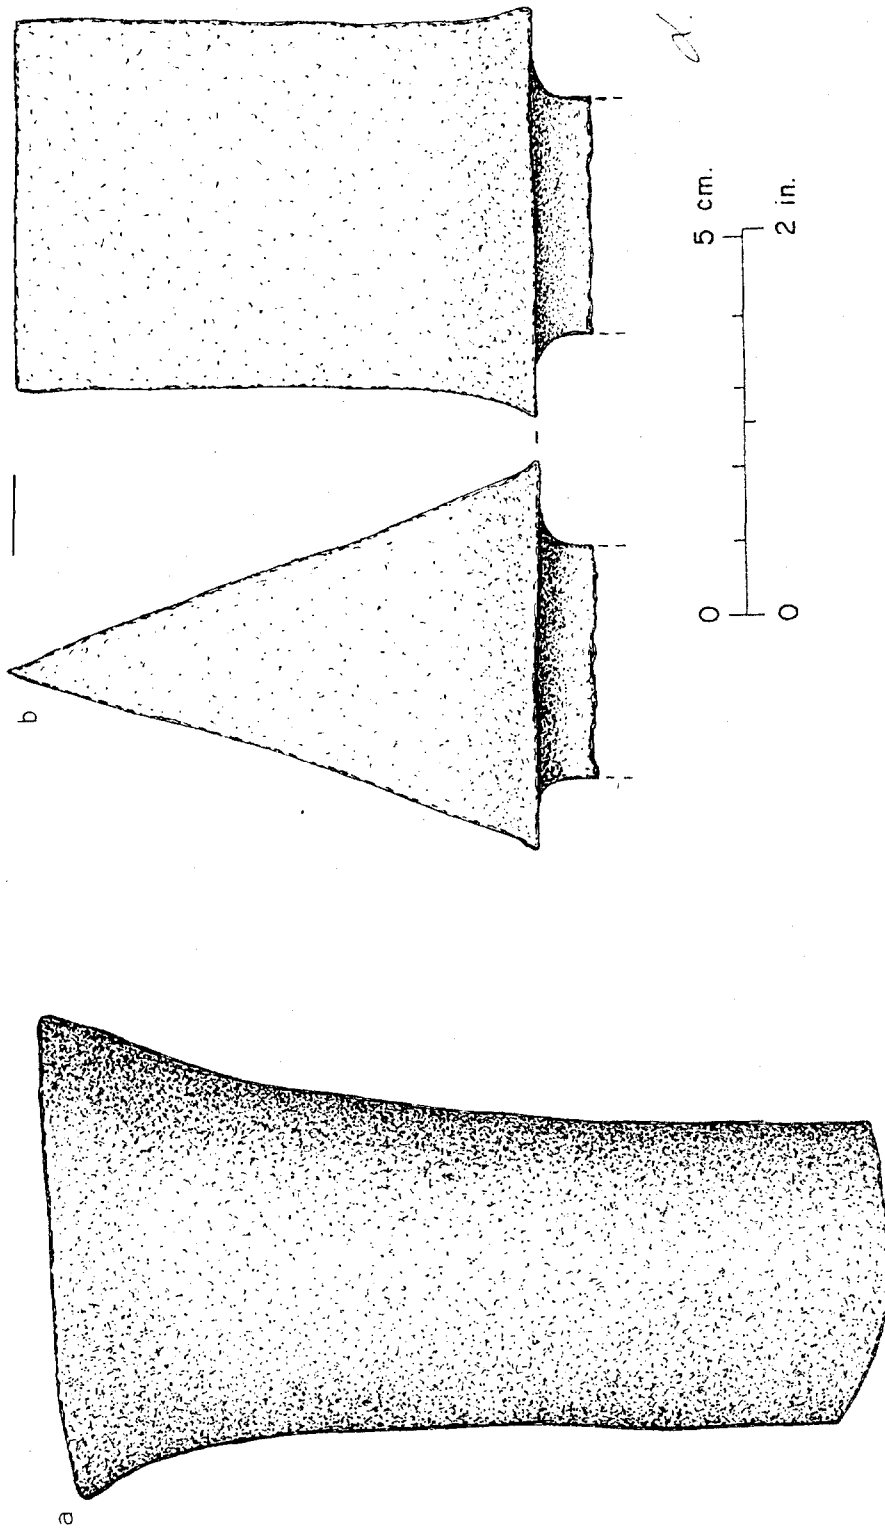
Fig. 124 -- Blacksmith tools from F523: a). axe body form ("oval punch") (FOVA 27681); b) hot set hardy (FOVA 27746).

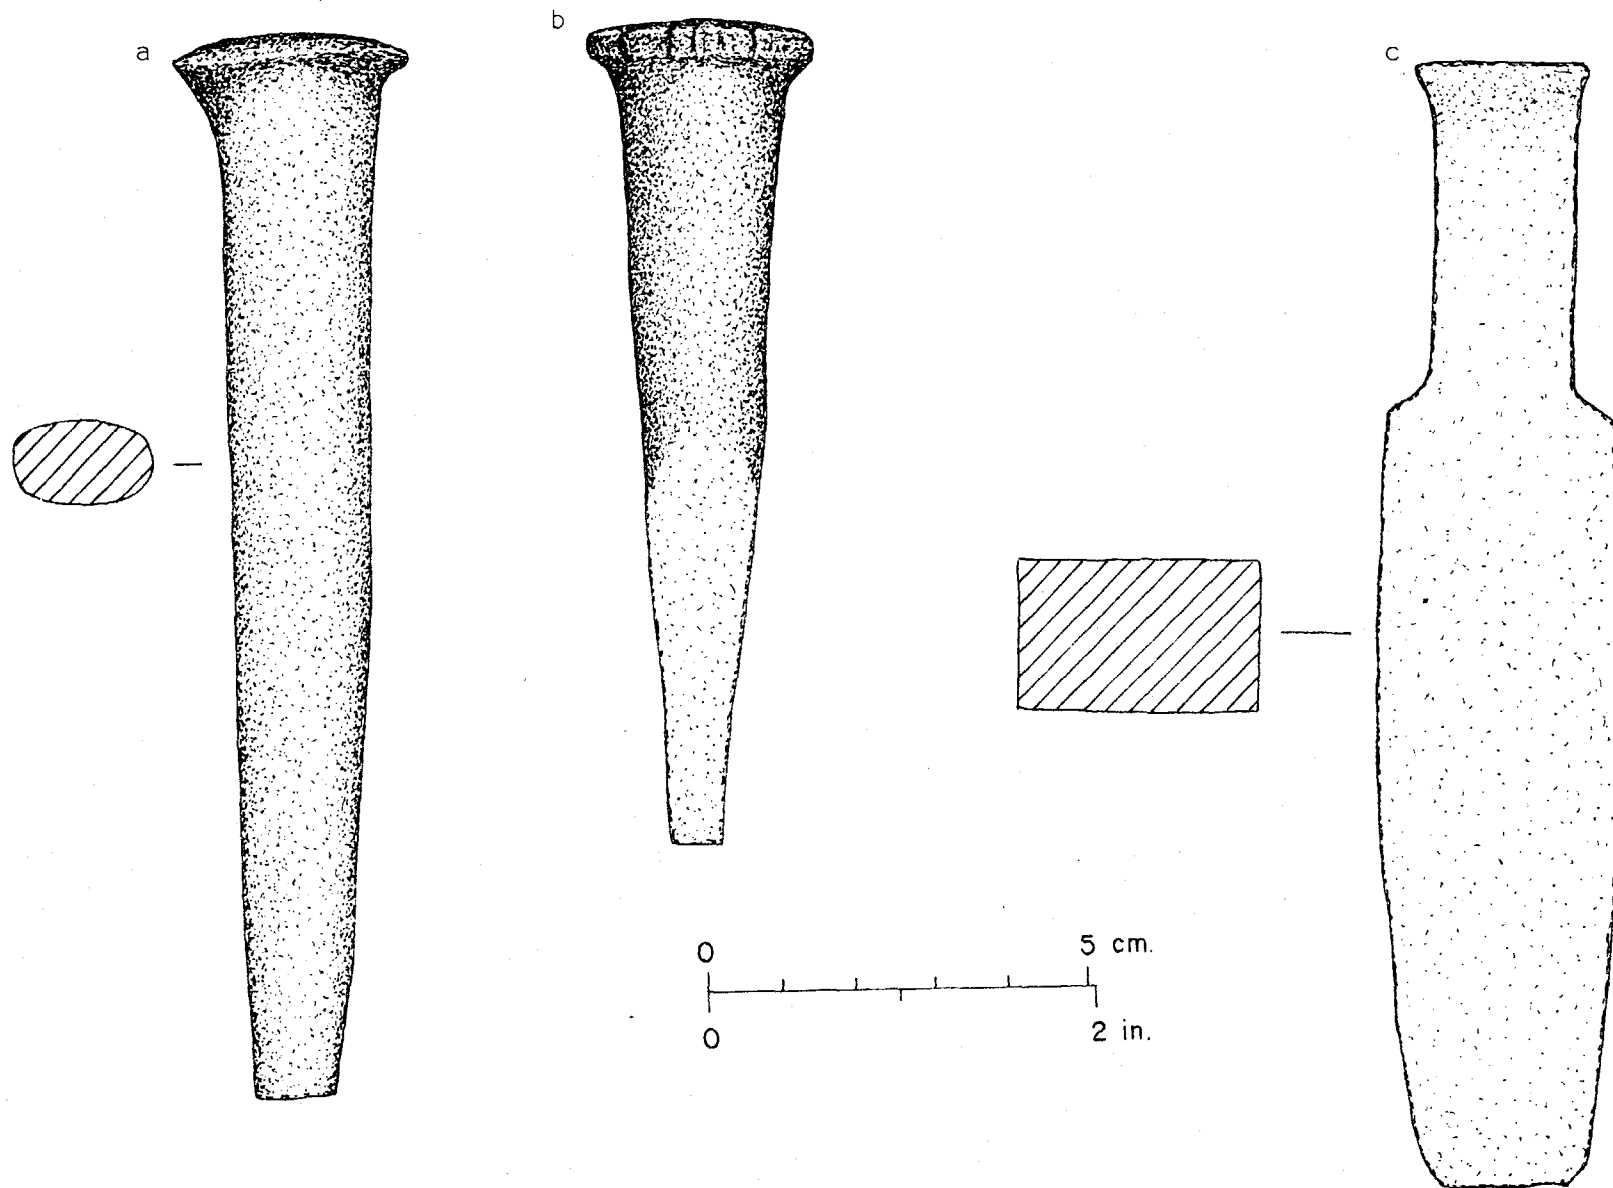
Fig. 125 -- Punches from F523: a). punch (FOVA 28263); b). punch (FOVA 27542) and c). punch (FOVA 28390).

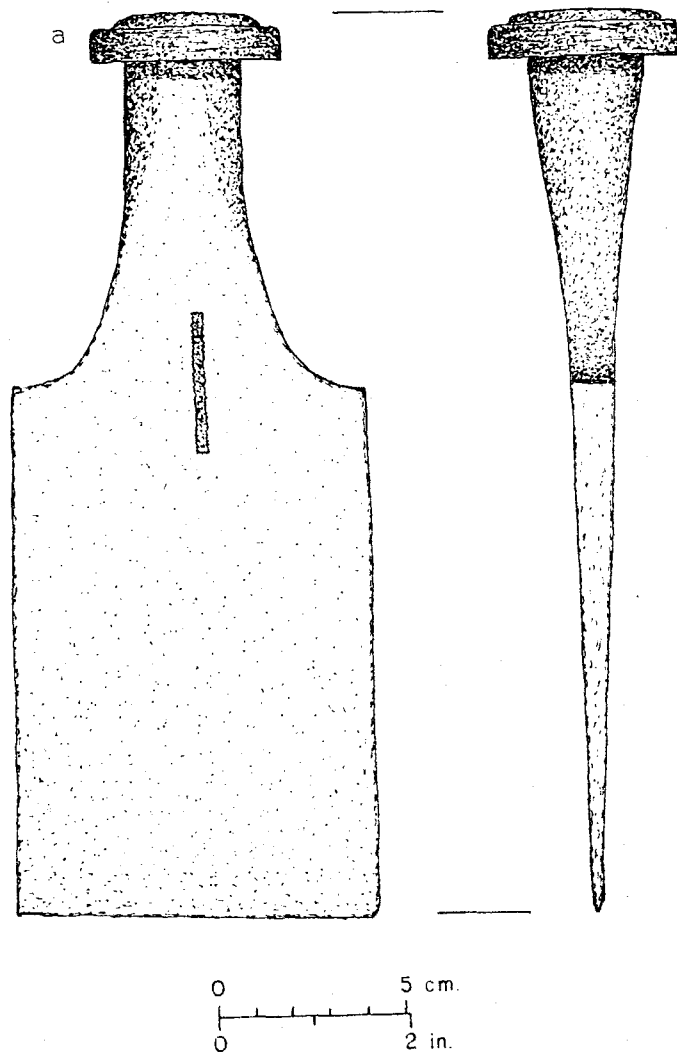
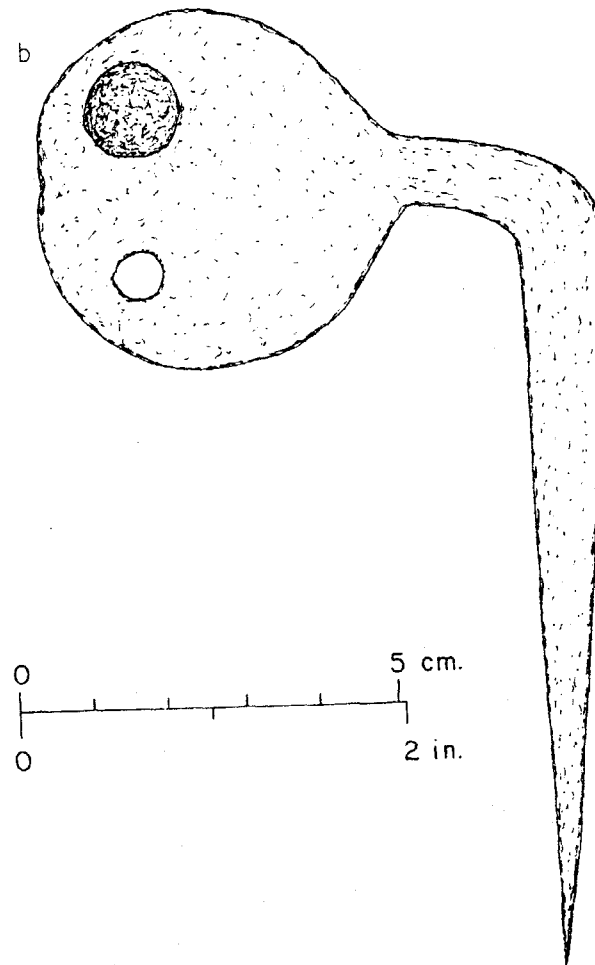
Fig. 126 -- Tools from F523: a). caulking tool (?) (FOVA 27615) and b). saw handle (FOVA 27390).

A total of 18 tools associated with woodworking and 48 agricultural implements were recovered. Unique woodworking tools included a hypothesized caulking tool with an impressed, unidentifiable, manufacturing mark (Fig. 126a), a draw knife (Fig. 127b), a saw handle (Fig. 126b), a solid plain bit (Fig. 127a) and 2 wedges (Figs. 128a-b).

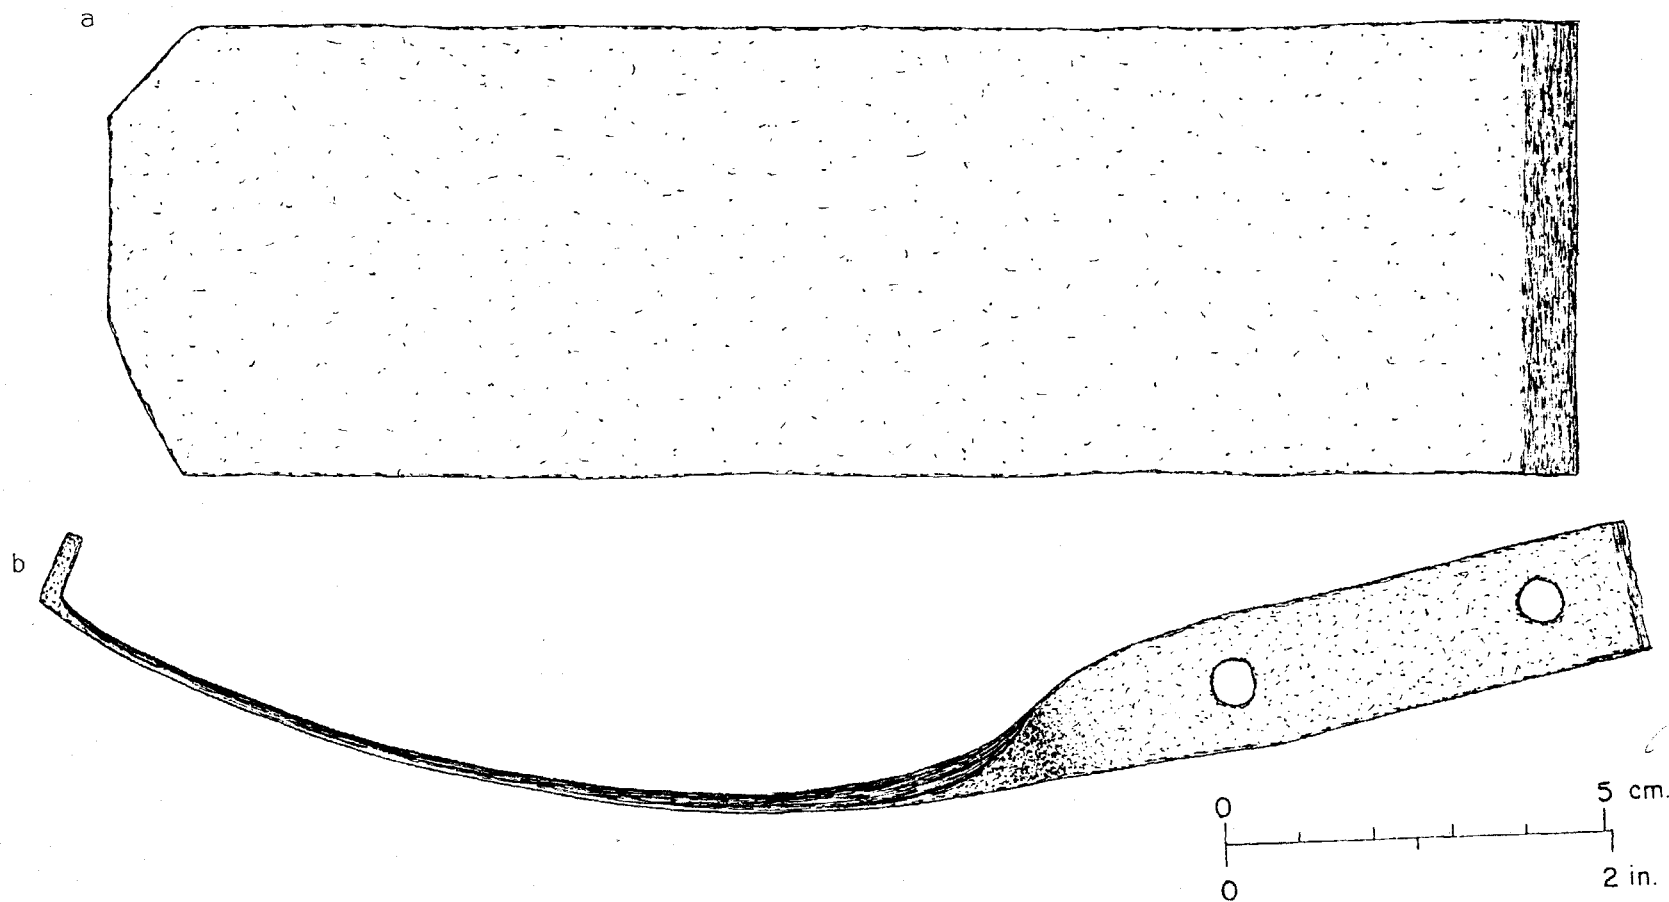
Fig. 127 -- Woodworking tools from F523: a). wood plane bit (FOVA 27973) and b). drawknife (FOVA 27973).

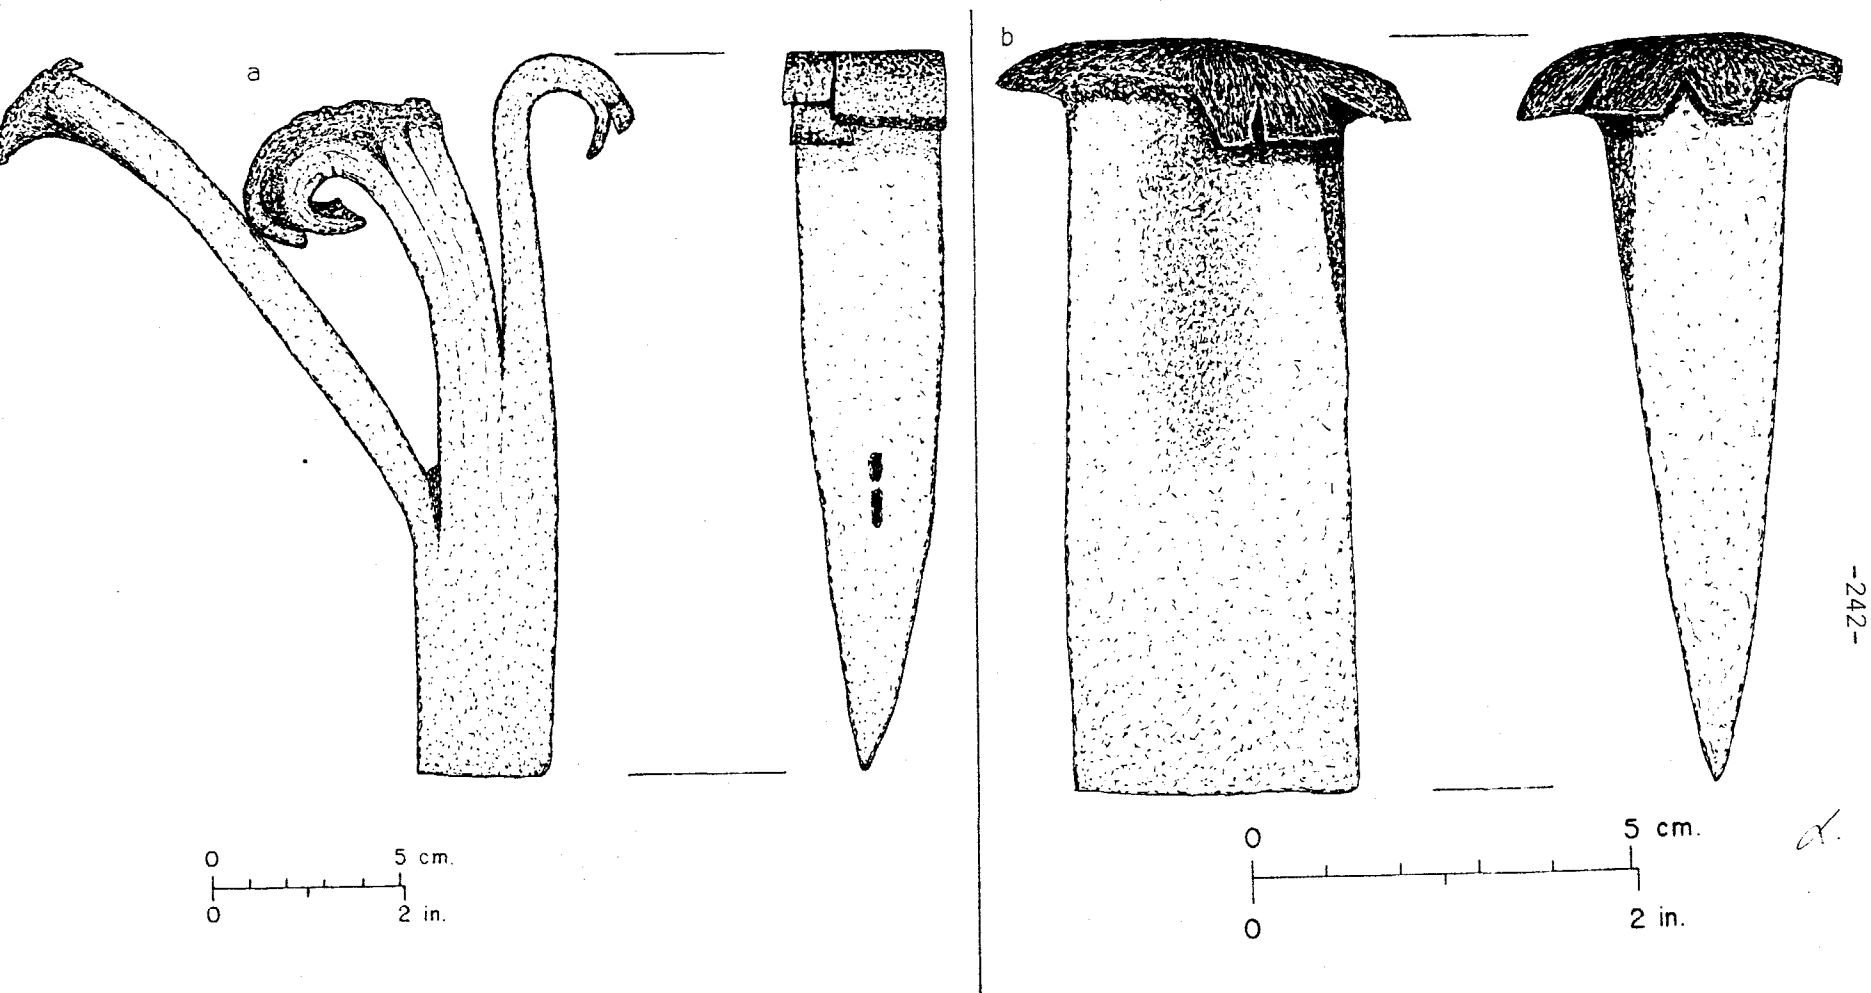
Fig. 128 -- Wedges from F523: a). wedge (FOVA 27974) and b). wedge (FOVA 27819).

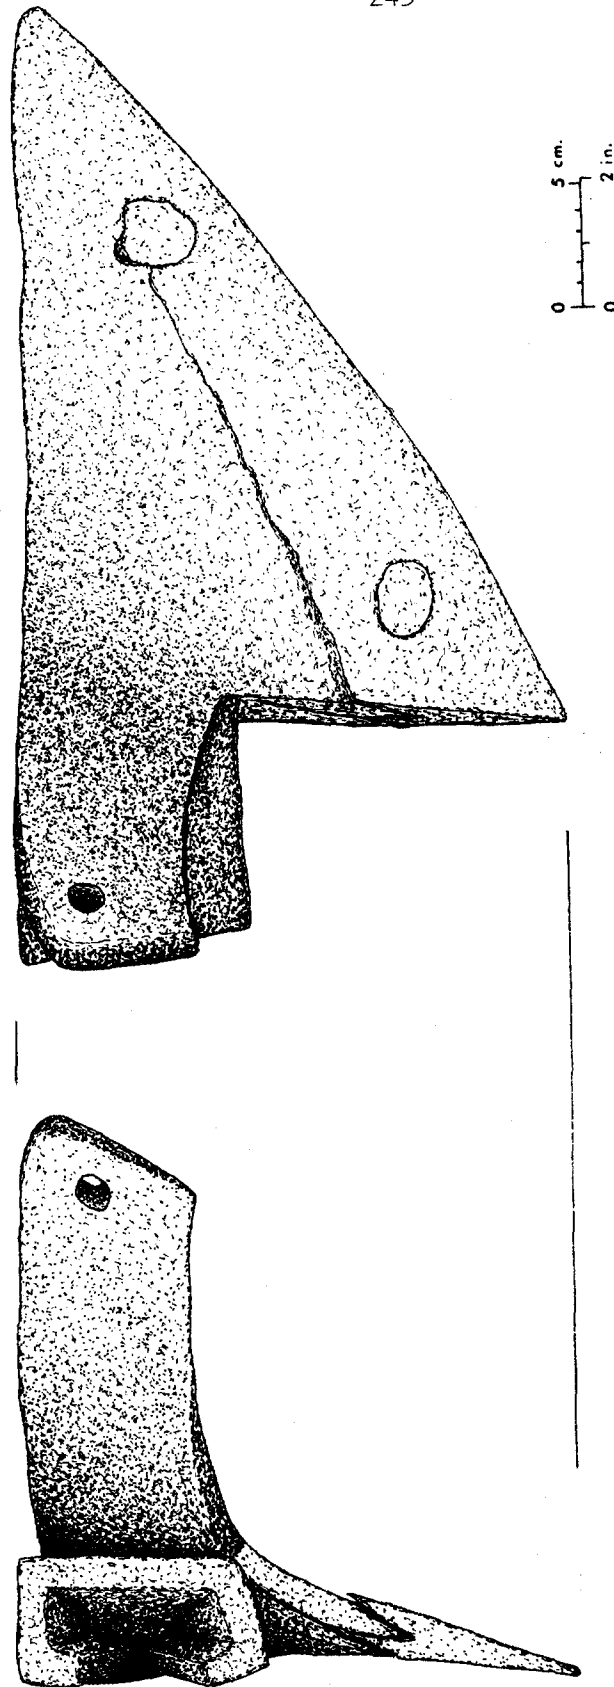
Fig. 129 --- Plow share (FOVA 27640) from F523.

Three plow parts were recovered including a plow share that appears to either have been locally manufactured or repaired (Fig. 129). The remaining two specimens, illustrated in Figs. 130a-b, were marked "RANSOME PATENT 835" and "RANSOME PATENT 836". Presumably "RANSOME" was the British manufacturer, and the parts were probably the ones listed in the 1844 Fort Vancouver Sales Shop inventory of "Goods on Hand" as #835 and #836 plough shares (Hussey 1972:222).

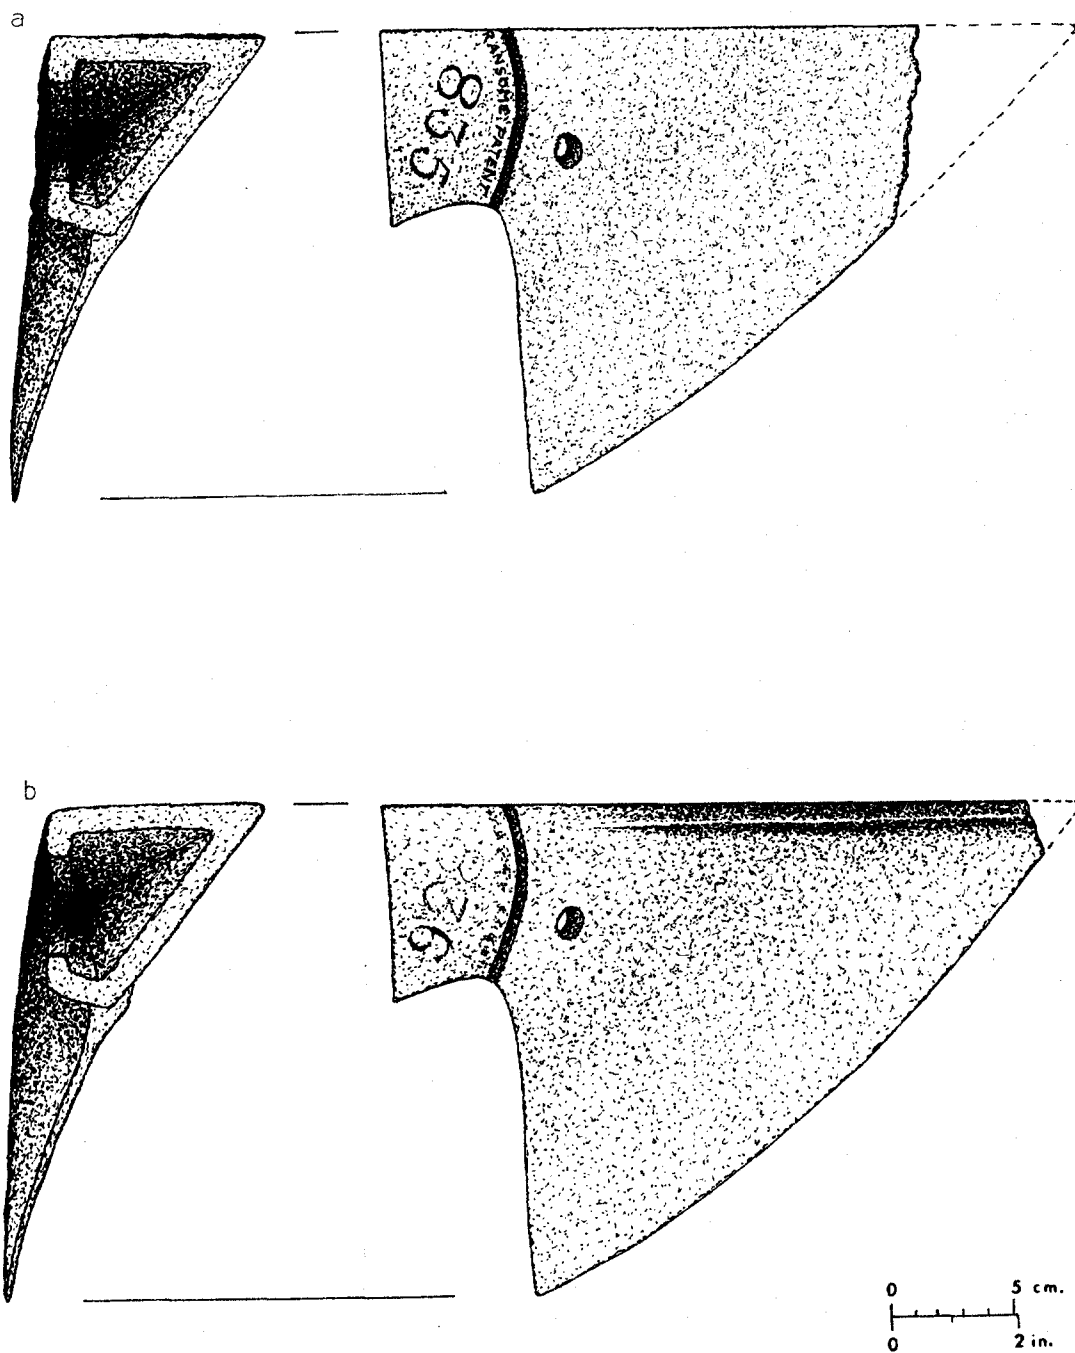
Fig. 130 -- Plow shares from F523: a). "Ransome Patent, 835" plow share (FOVA 27798) and b). "Ransome Patent, 836" plow share (FOVA 27569).

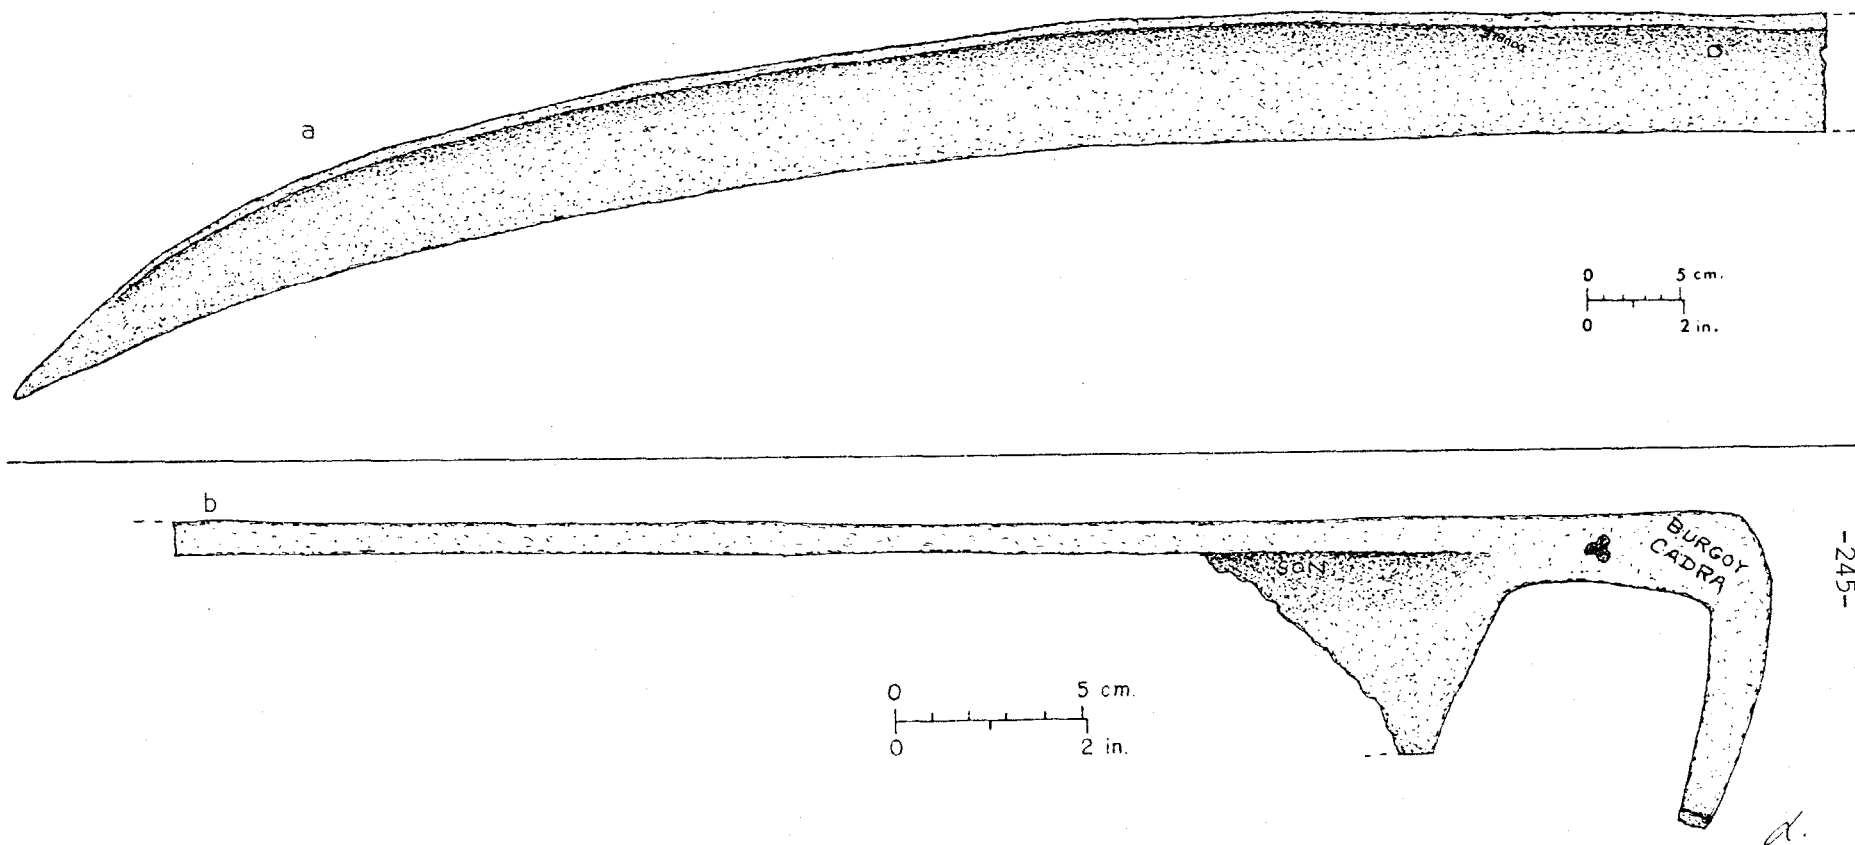
Fig. 131 -- Scythe blade from F523: a). "double" scythe blade (FOVA 27613) and b). "Burgoy Cadra" scythe fragment (FOVA 28185).

Thirty-two harrow teeth were also recovered and are identical to specimens reported from the Blacksmith Shop (Fig. 66d). Of the scythe fragments recovered, one complete blade, illustrated in Fig. 131a, was marked "DOUBLE", presumably a size or strength designation, and it was probably imported. The blade measured approximately 40 inches in length and probably was of the type inventoried in 1844 as "40 inch hay scythes" (Hussey 1972:273). Two other scythe blades were marked, one being unidentifiable and the other containing "BUR (or P) GOY\_, CADRA\_" (Fig. 131b). One scythe handle (minus wood) was also recovered (Fig. 132a), but no manufacturing marks were present.

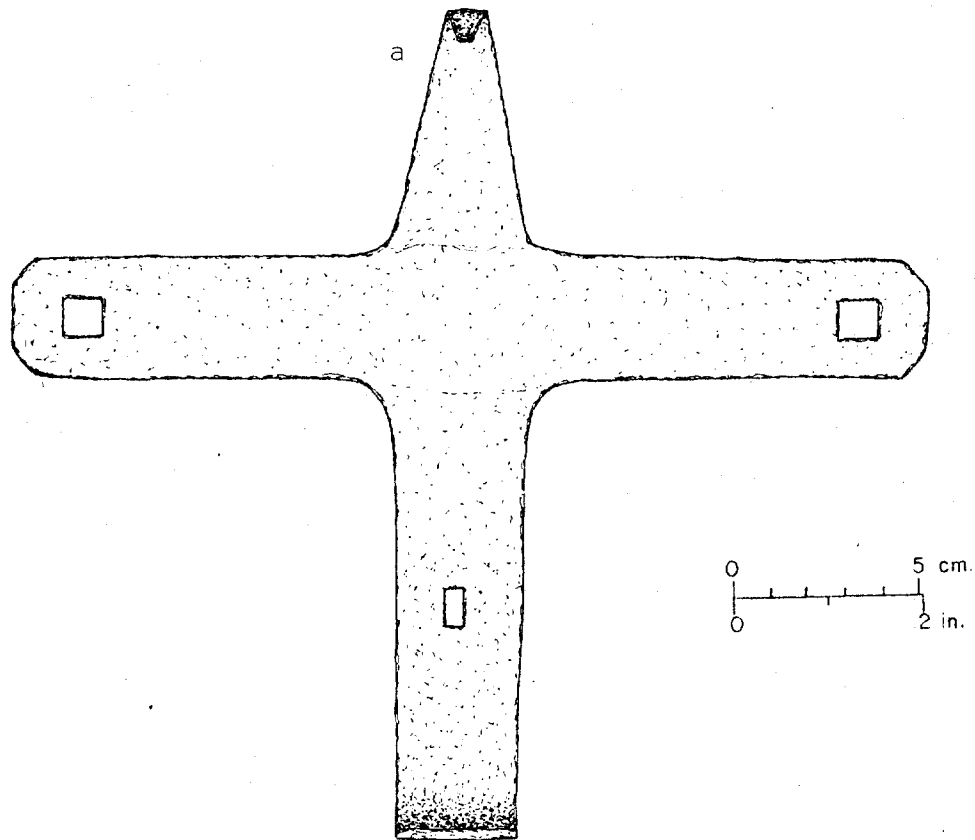
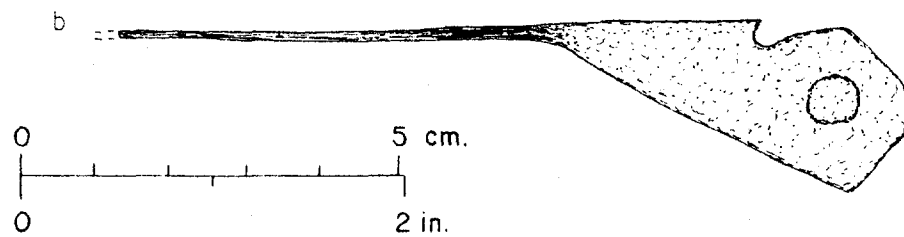
Fig. 135 -- Trap base (FOVA 27568) and trap pan preform (FOVA 28508).

One specimen of rectangular faced trap pan was recovered with a partially punched hinge hole (Fig. 135b).
