FORT VANCOUVER EXCAVATIONS - X

Southeastern Fort Area

National Park Service

July 1975

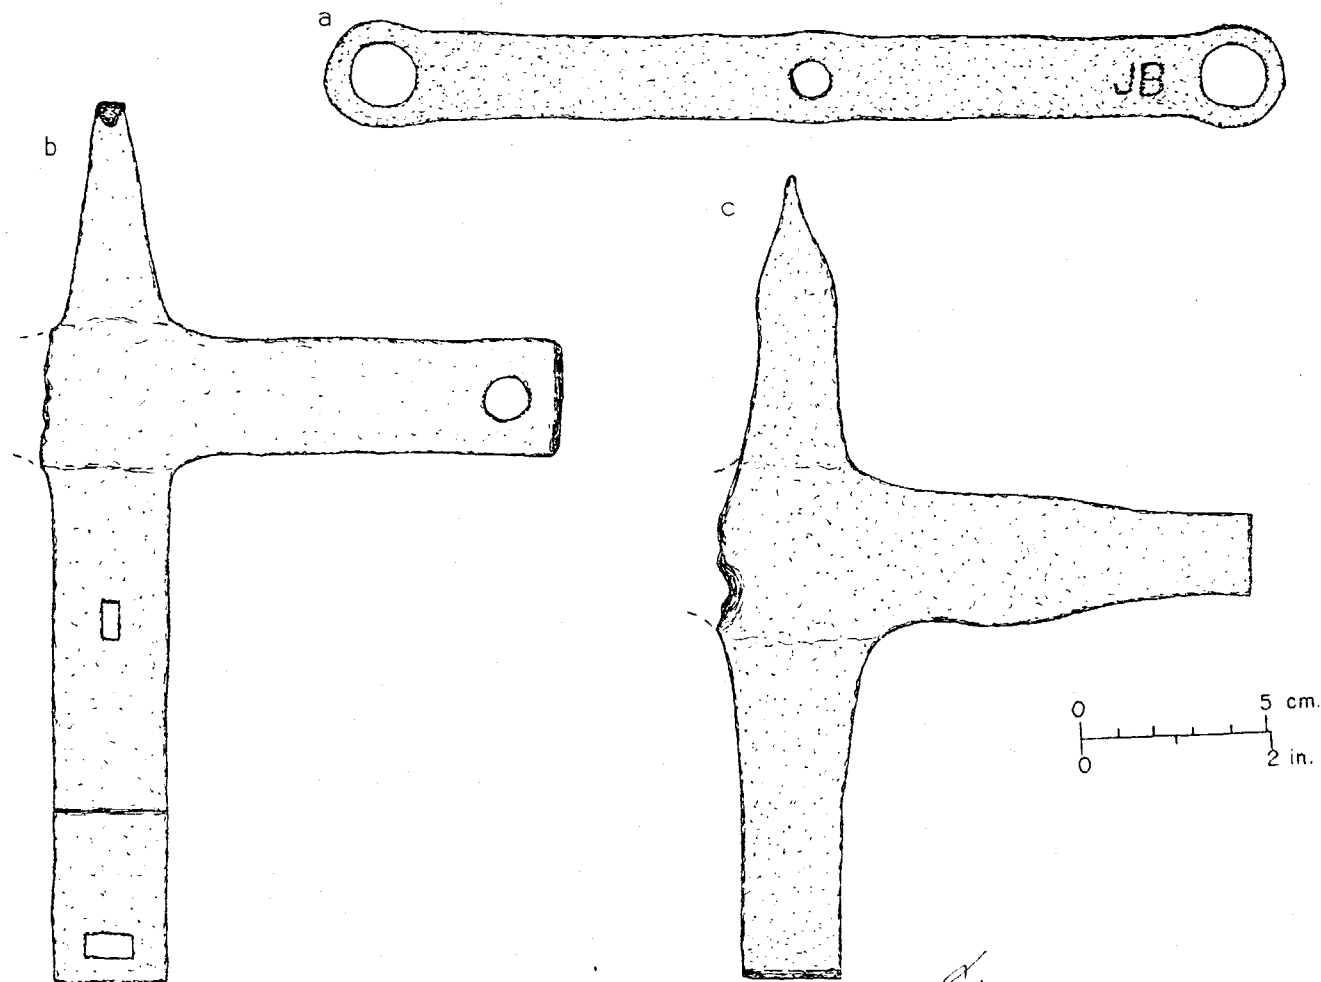
Fig. 138 -- Trap cross and base preforms from F523: a). trap cross (FOVA 28568); b). trap base preform (FOVA 27969) and c). trap base preform (FOVA 27967).

The 13 finished crosses recovered were unique, in that all specimens had a circular hole at the midpoint in addition to having circular jaw post holes at both ends. Since all assembled trap bases thus far recovered have been without the center hole, it is hypothesized that these items may be parts of folding-type traps for which the base components rotated upon one another. This type of trap has been recorded as being used by the Pacific Fur Company (Russell 1967), and in 1841 the HBC Fort Vancouver depot inventories listed "pallets" and "crosses" separately from complete traps (Hussey 1972:291). These recovered specimens may therefore represent either a folding-type trap or a component trap here-to-for not recognized at Fort Vancouver. The specimens were manufactured at the Fort as the "JB" mark of Joseph Ovide Beachamp (Fort Vancouver blacksmith, 1843-1847; Hussey 1974:334-35) occurs on one specimen. This mark has also appeared on tongs from F523 and finished trap springs from the Blacksmith Shop. To date, this type of cross has only been found in F523 and the adjacent stockade area (Fig. 138a).

Five specimens were recovered and represent at least 2 stages in the manufacture of the HBC cross and pallet trap base style. Representative specimens are illustrated in Figs. 138a-c.

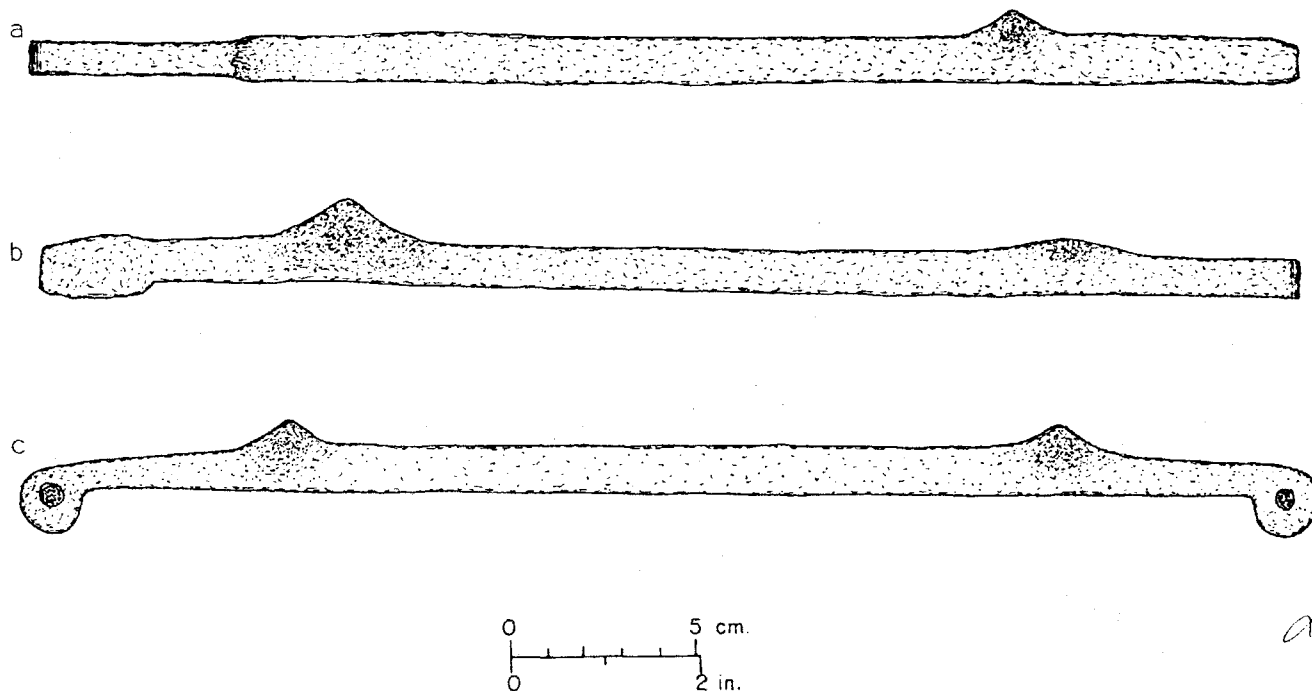
Fig. 139 -- Trap jaw preforms from F523: a). trap jaw preform (FOVA 28360); b). trap jaw preform (FOVA 27931) and c). trap jaw preform (FOVA 27335).

At least 4 stages of manufacture are represented in the 5 jaw preforms recovered, and at least 2 specimens of partially manufactured offset-hinge jaws were recovered. Finished specimens of this type were recovered from Caywood's excavations assembled with single hole jaw posts. The various preform specimens have been illustrated in Figs. 139a-c.

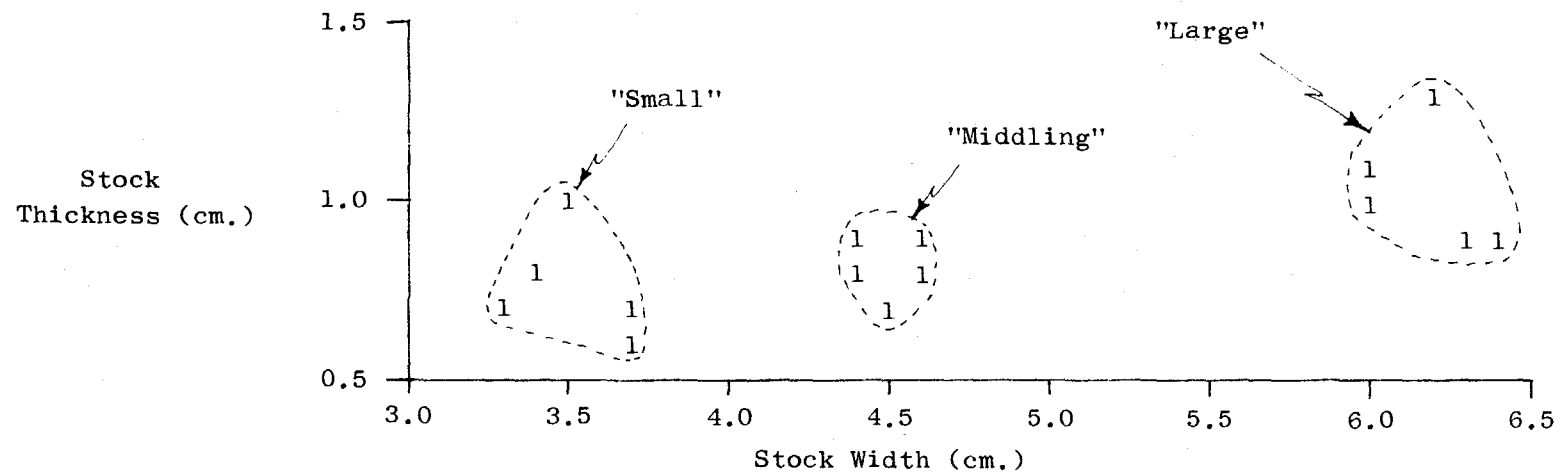
Fig. 141 -- HBC axe sizes as determined by the correlation of stock width to stock thickness on finished and preform axe bodies from F523 (N = 15).

With the exception of a 3 1/2 in. size axe recovered from the 1947-1952 NPS excavations, all axe specimens recovered have been no larger than 2 1/2 in. in head width. Present evidence suggests that the inventoried "small", "middling" and "large" axe sizes were manufactured from stock sized 1 3/8-1 1/2 in., 1 3/4 in. and 2 1/2 in. in width and 3/8 in. in thickness (see Fig. 141).

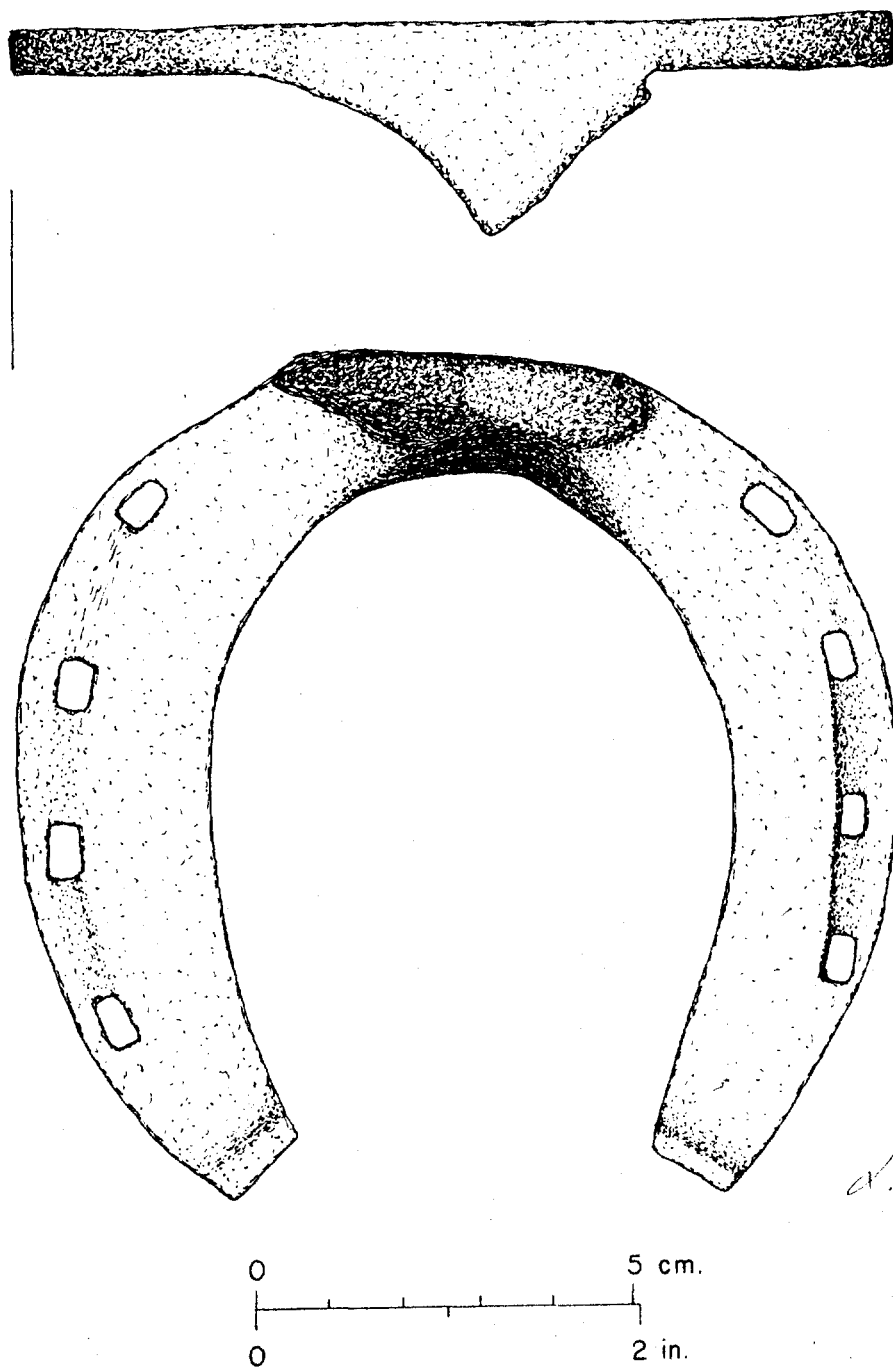
Fig. 142 -- Horseshoe (FOVA 28188) from F523.

Of the 4 horseshoes recovered, one unique repaired specimen, having a triangular caulk, has been illustrated in Fig. 142. All other specimens exhibited excessive wear, and were probably worn-out shoes.

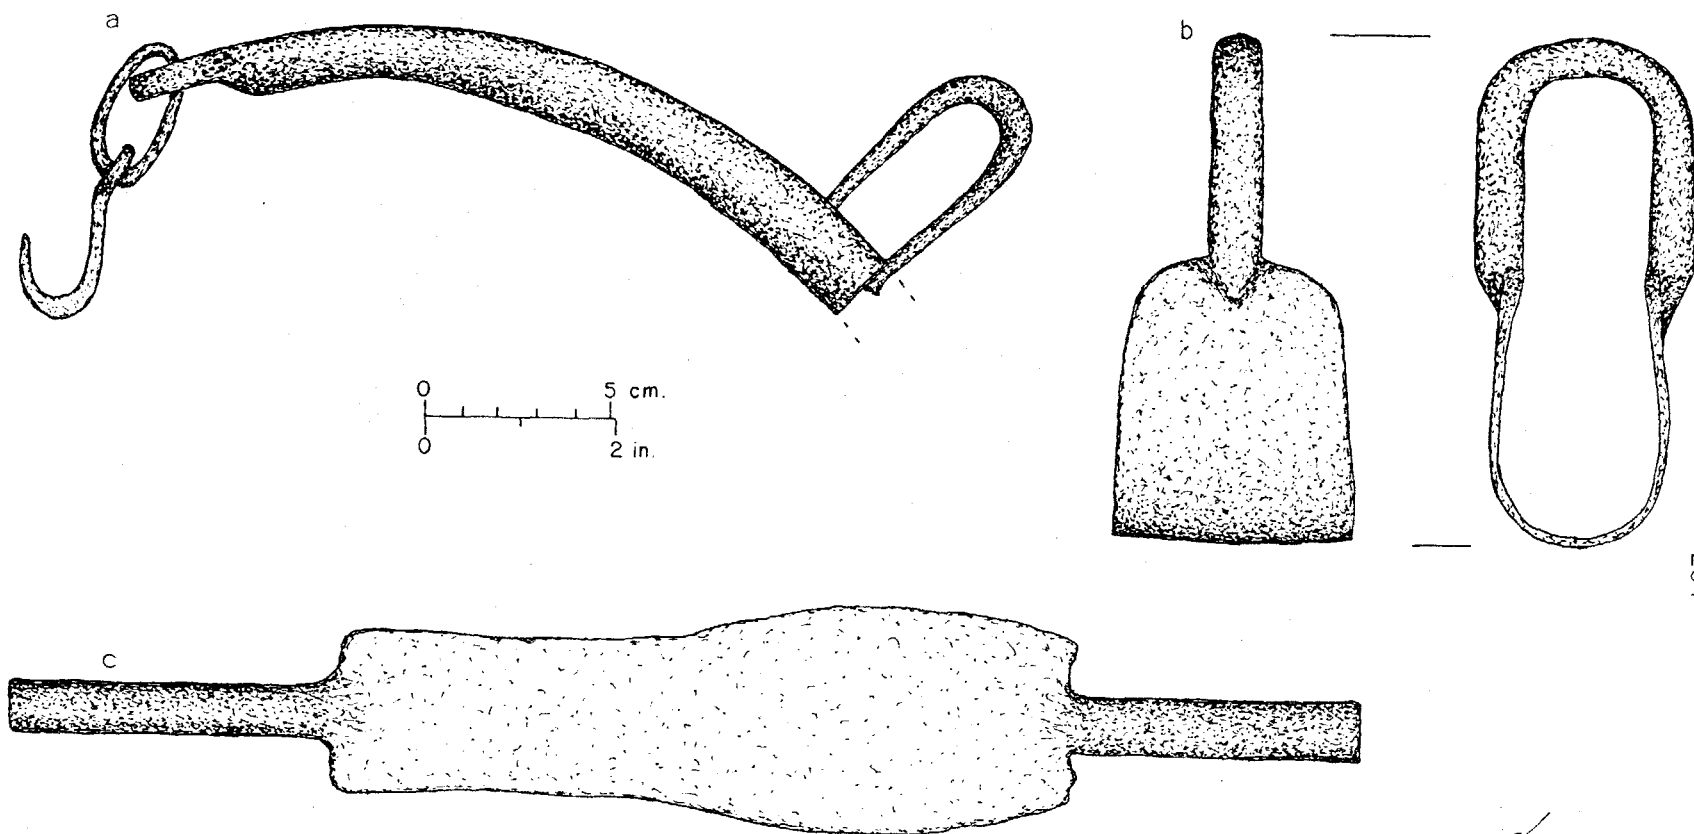
Fig. 143 -- Harness and singletree hardware from F523: a). hame tip (FOVA 27128b); b). singletree ferrule (FOVA 27724) and c). singletree ferrule preform (FOVA 27570).

Eleven specimens of singletree and harness hardware and one preform singletree ferrule were recovered. Of the finished specimens, 5 singletree ferrules and 2 hames were identified. The hames consisted of circular wrapped sheet metal with a welded eyelet end (Fig.143a). The preform singletree ferrule (Fig.143c) is thus far unique and verifies that "country-made swingle tree irons" (Hussey 1972:292) were manufactured at the Fort. A complete singletree ferrule is illustrated in Fig. 143b.

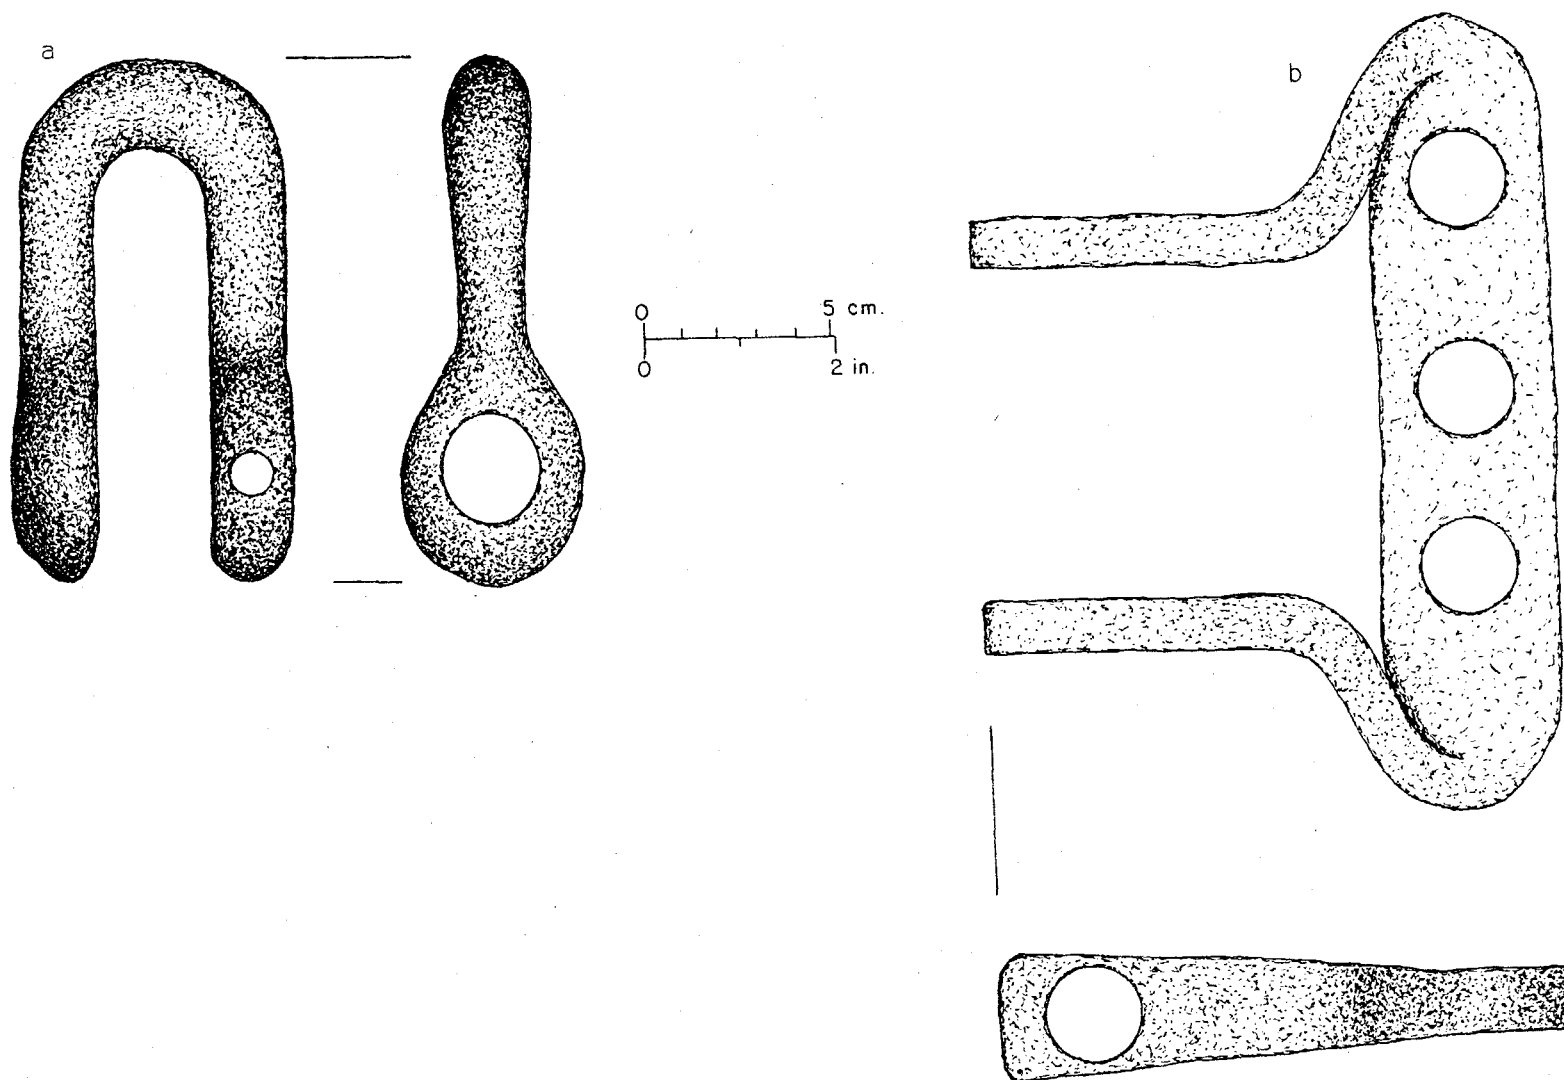
Fig. 144 -- Clevises from F523: a). single clevis (FOVA 27616) and b). adjustable clevis (FOVA 27572).

One specimen of a single clevis (Fig.144a) and 12 adjustable clevises, including one preform specimen, were recovered. Adjustable clevises have here-to-fore not been reported from the Fort. They were probably utilized with agricultural equipment, especially plows, where a height adjustment was necessary. The assemblage suggests repair and replacement of these parts at the Fort. Five styles of adjustable clevis have been identified and have been illustrated in Figs.144b-147a-b. While the preform is illustrated in Fig.147c.

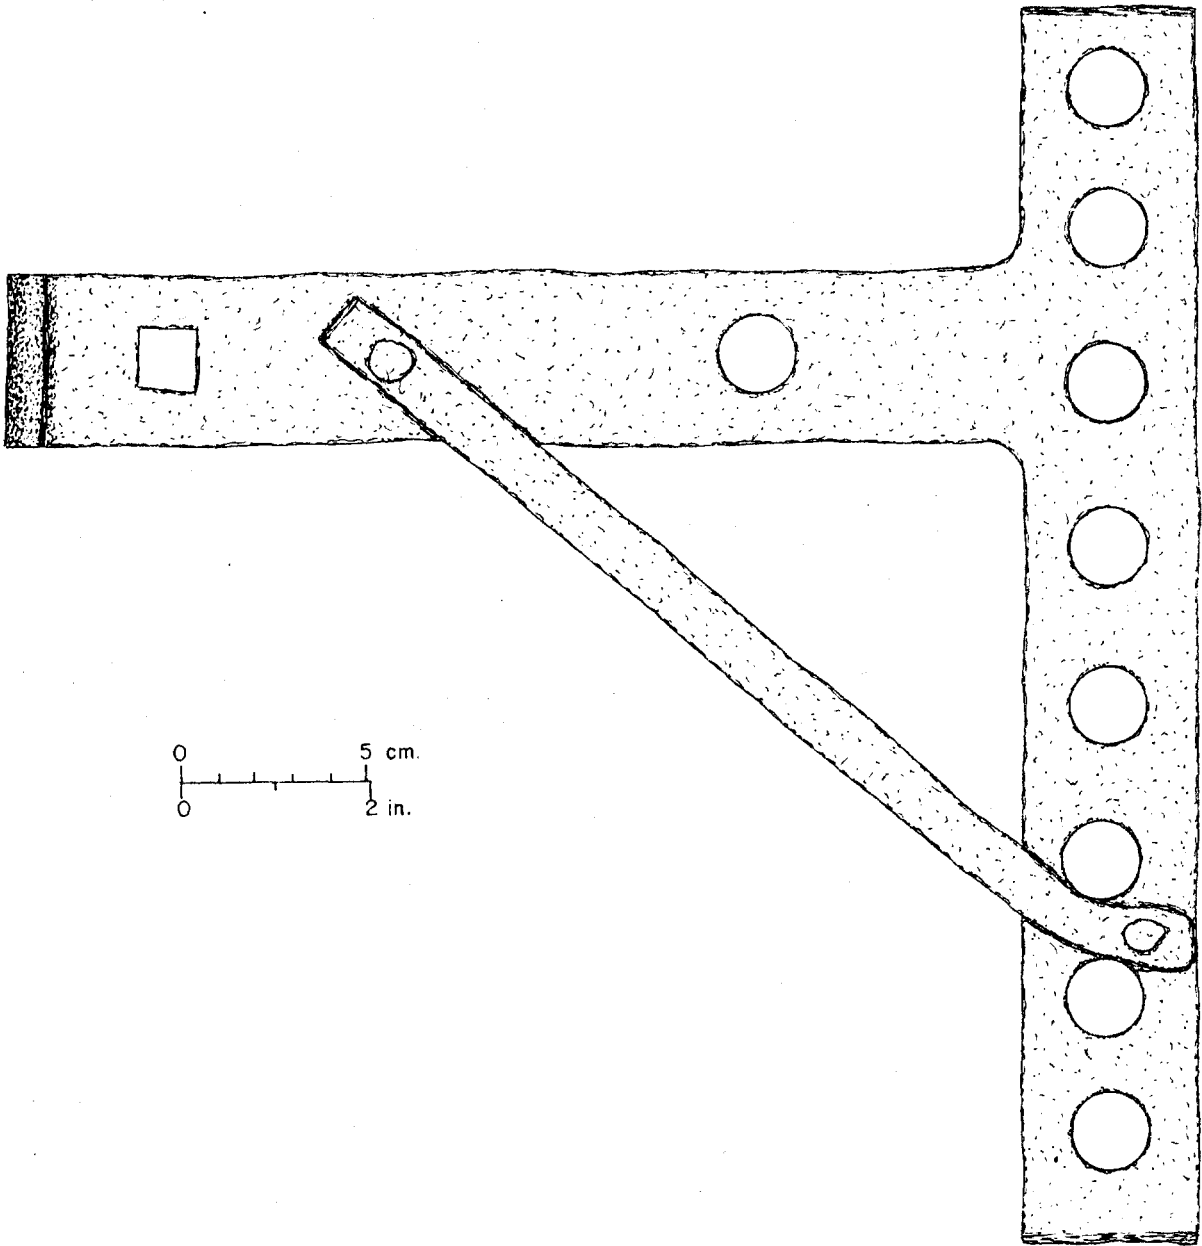
Fig. 145 -- Adjustable clevis (FOVA 27398) from F523.

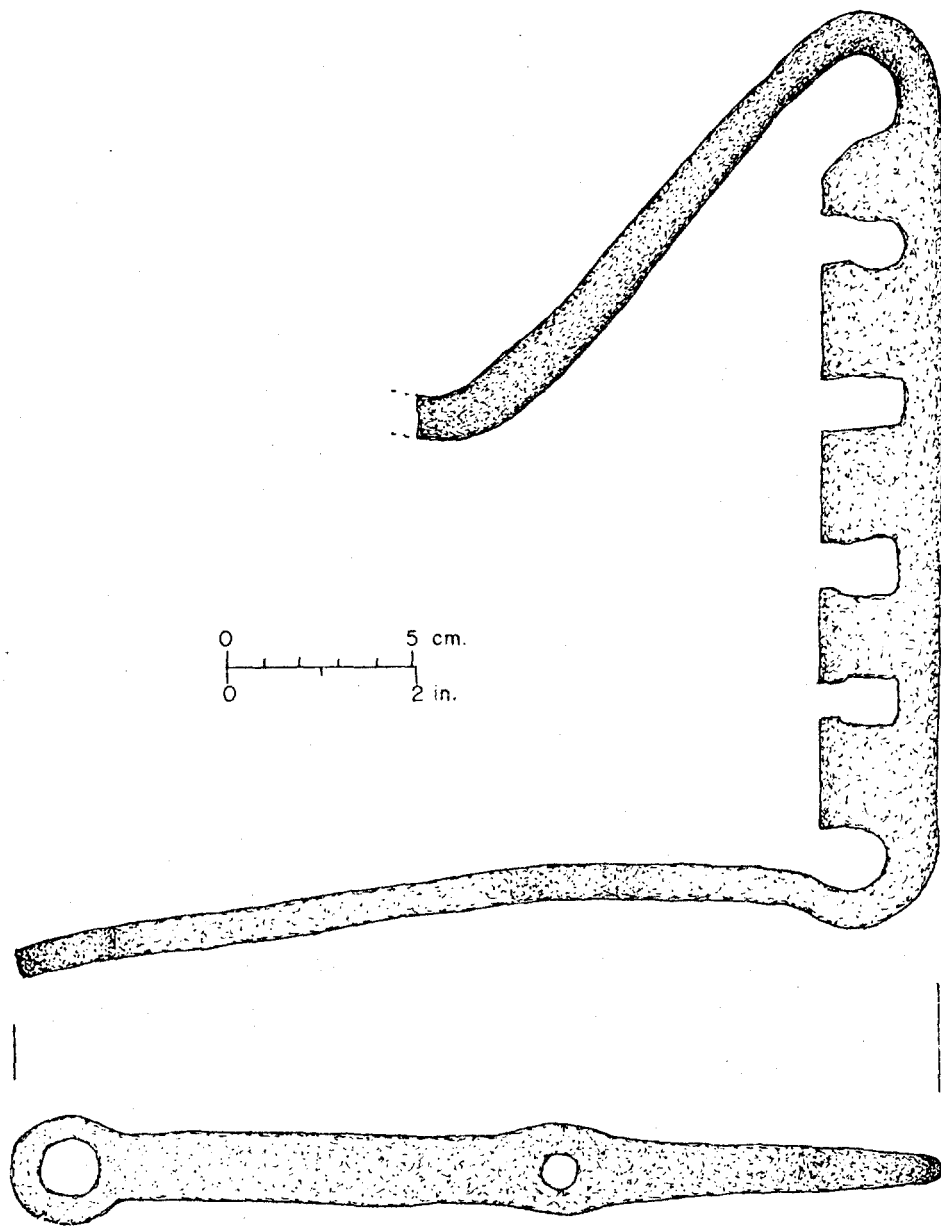
Fig. 146 -- Adjustable clevis (FOVA 27336) from F523.

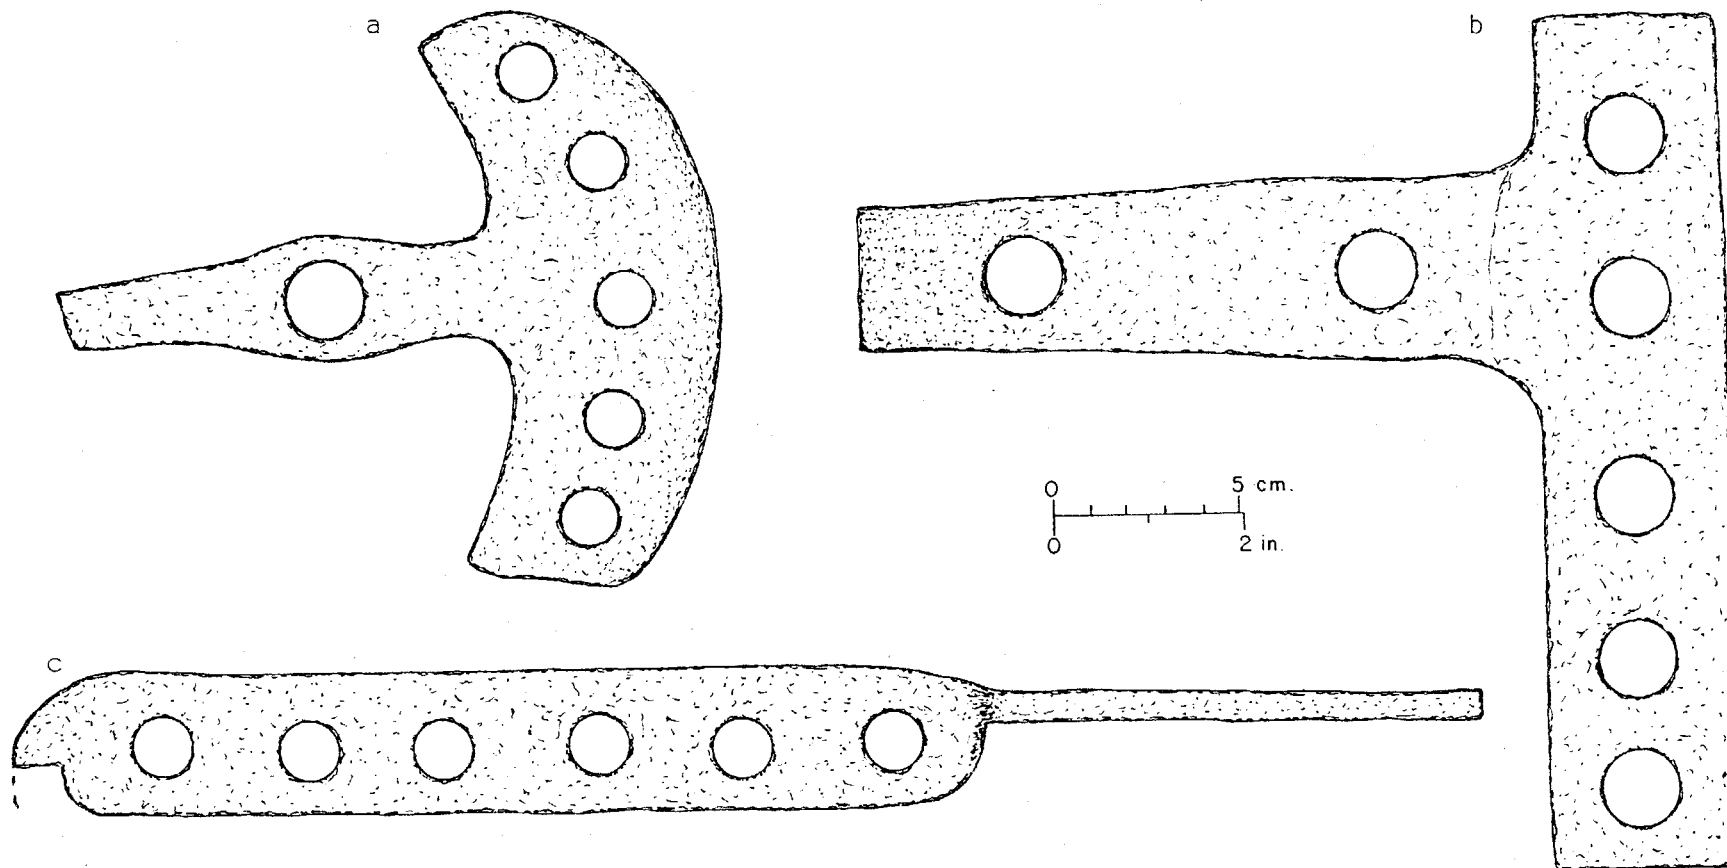
Fig. 147 -- Adjustable clevises and preform from F523: a). adjustable clevis (FOVA 27993);  
 b). adjustable clevis (FOVA 28545); and c). adjustable clevis preform (FOVA 28195).

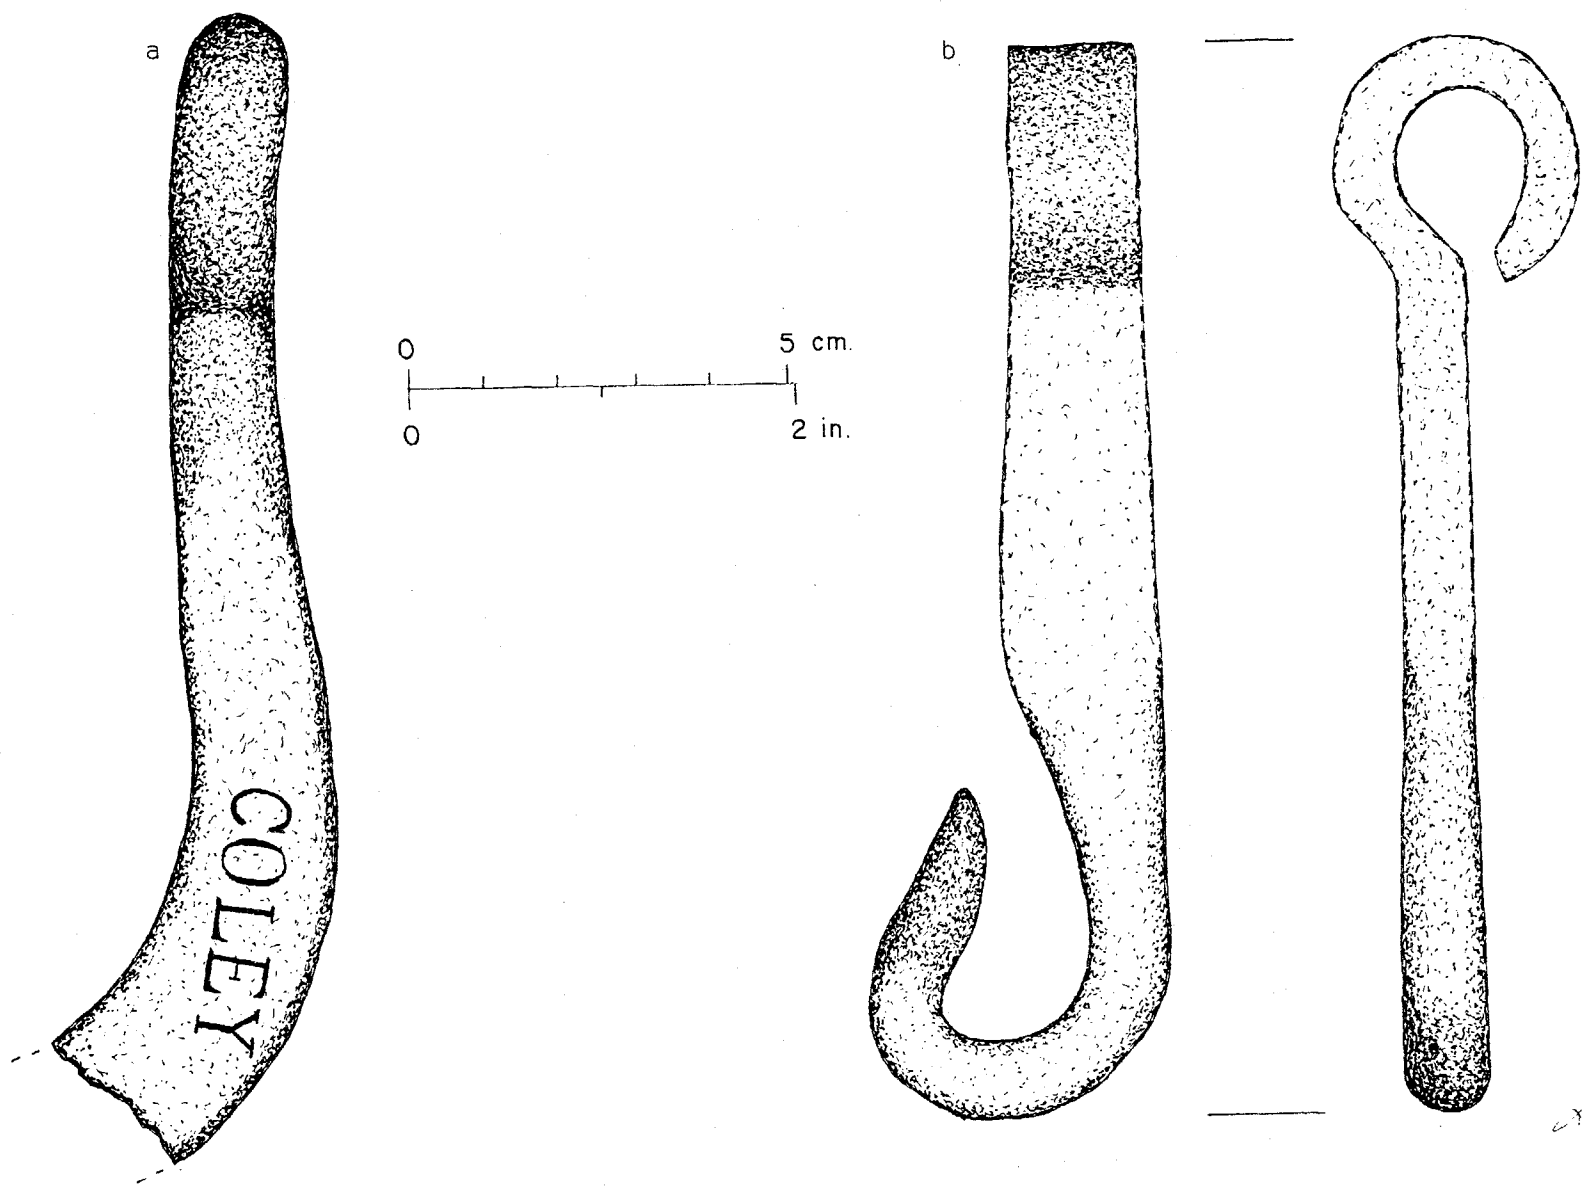
Fig. 148 -- Hooks from F523: a). "COLEY" hook fragment (FOVA 28250) and b). hook (FOVA 28342).

A total of 28 hooks were recovered including one probable imported specimen marked "COLEY" (Fig.148a). Six complete specimens were identified and are illustrated in Figs.148b-151a. Also a complete hook was recovered attached to a flat chain link and closed eye nail, and is illustrated in Fig.151b.

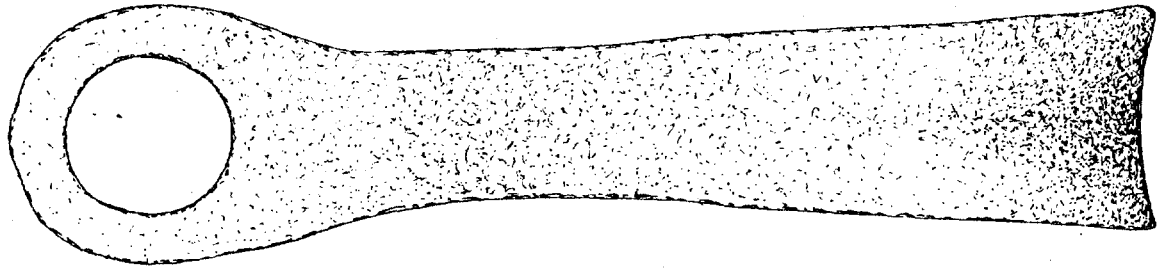
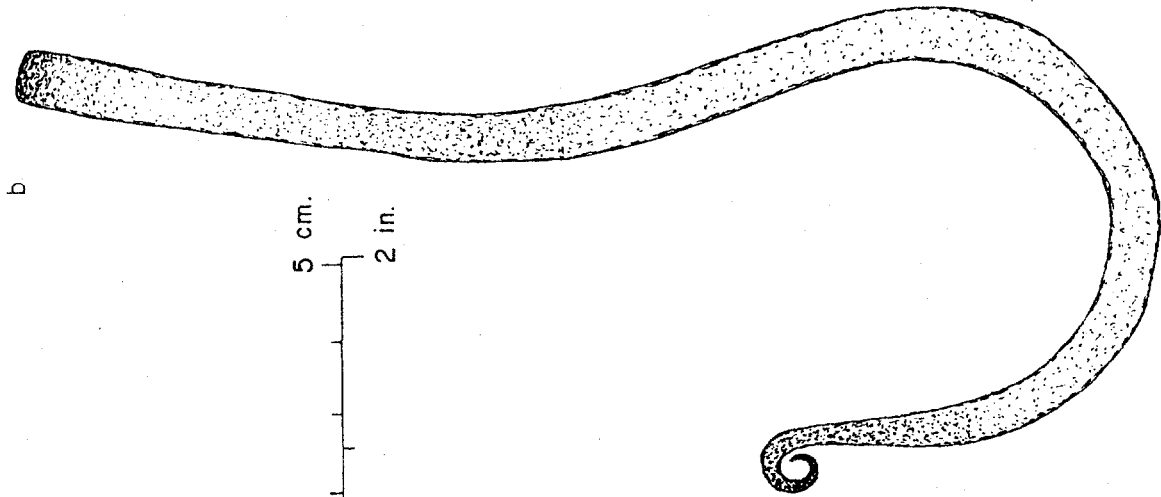
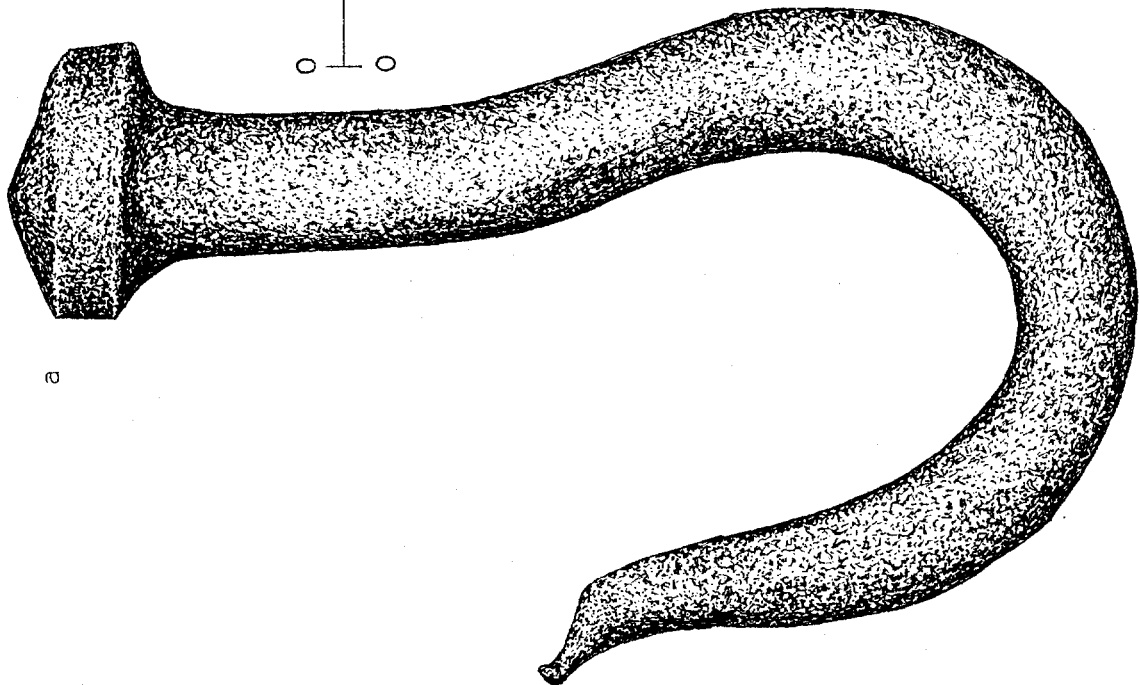
Fig. 149 -- Hooks from F523: a). hook (FOVA 28030) and b). hook (FOVA 27257).

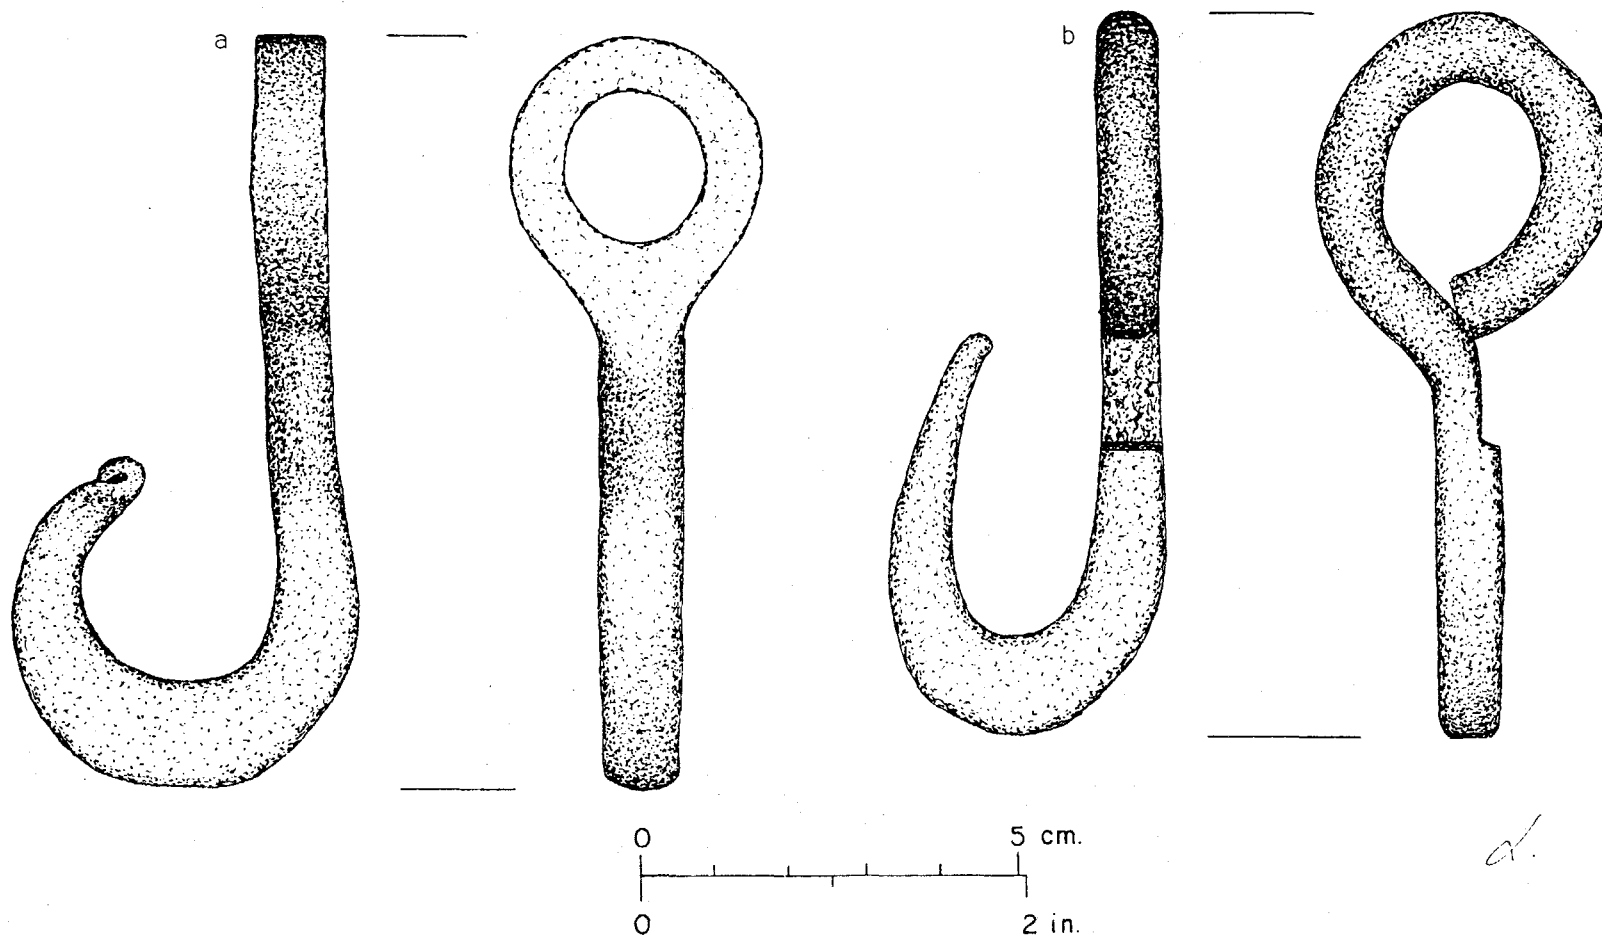
Fig. 150 -- Hooks from F523: a). hook (FOVA 28506) and b). hook (FOVA 27324).

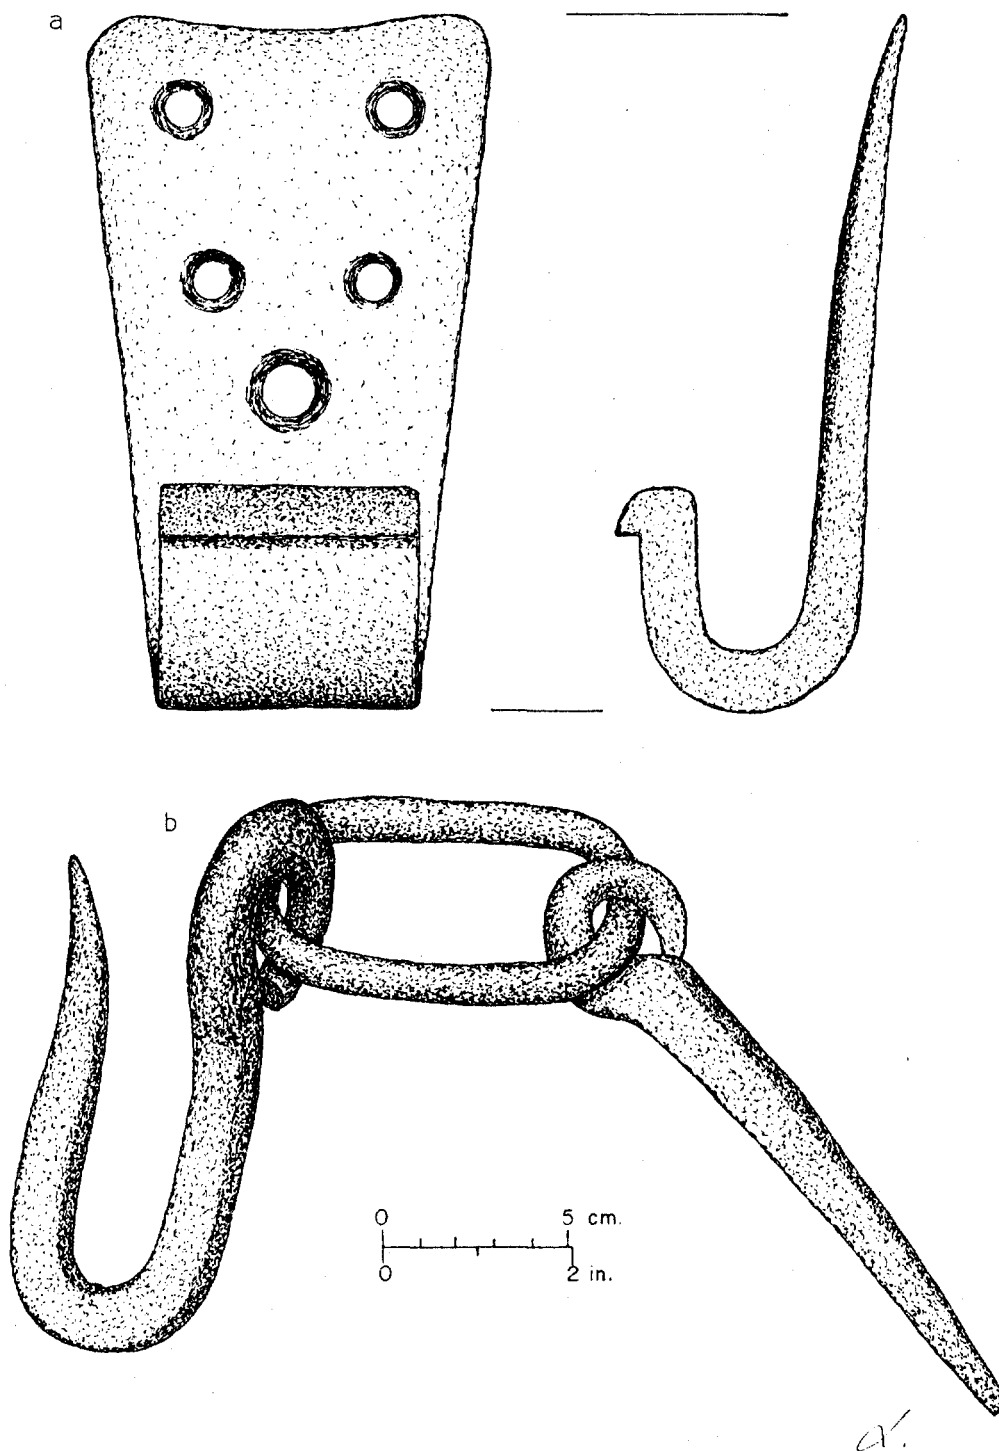
Fig. 151 -- Hooks from F523: a). hook (FOVA 27751) and b). hook, chain link and closed-eye nail (FOVA 27170).

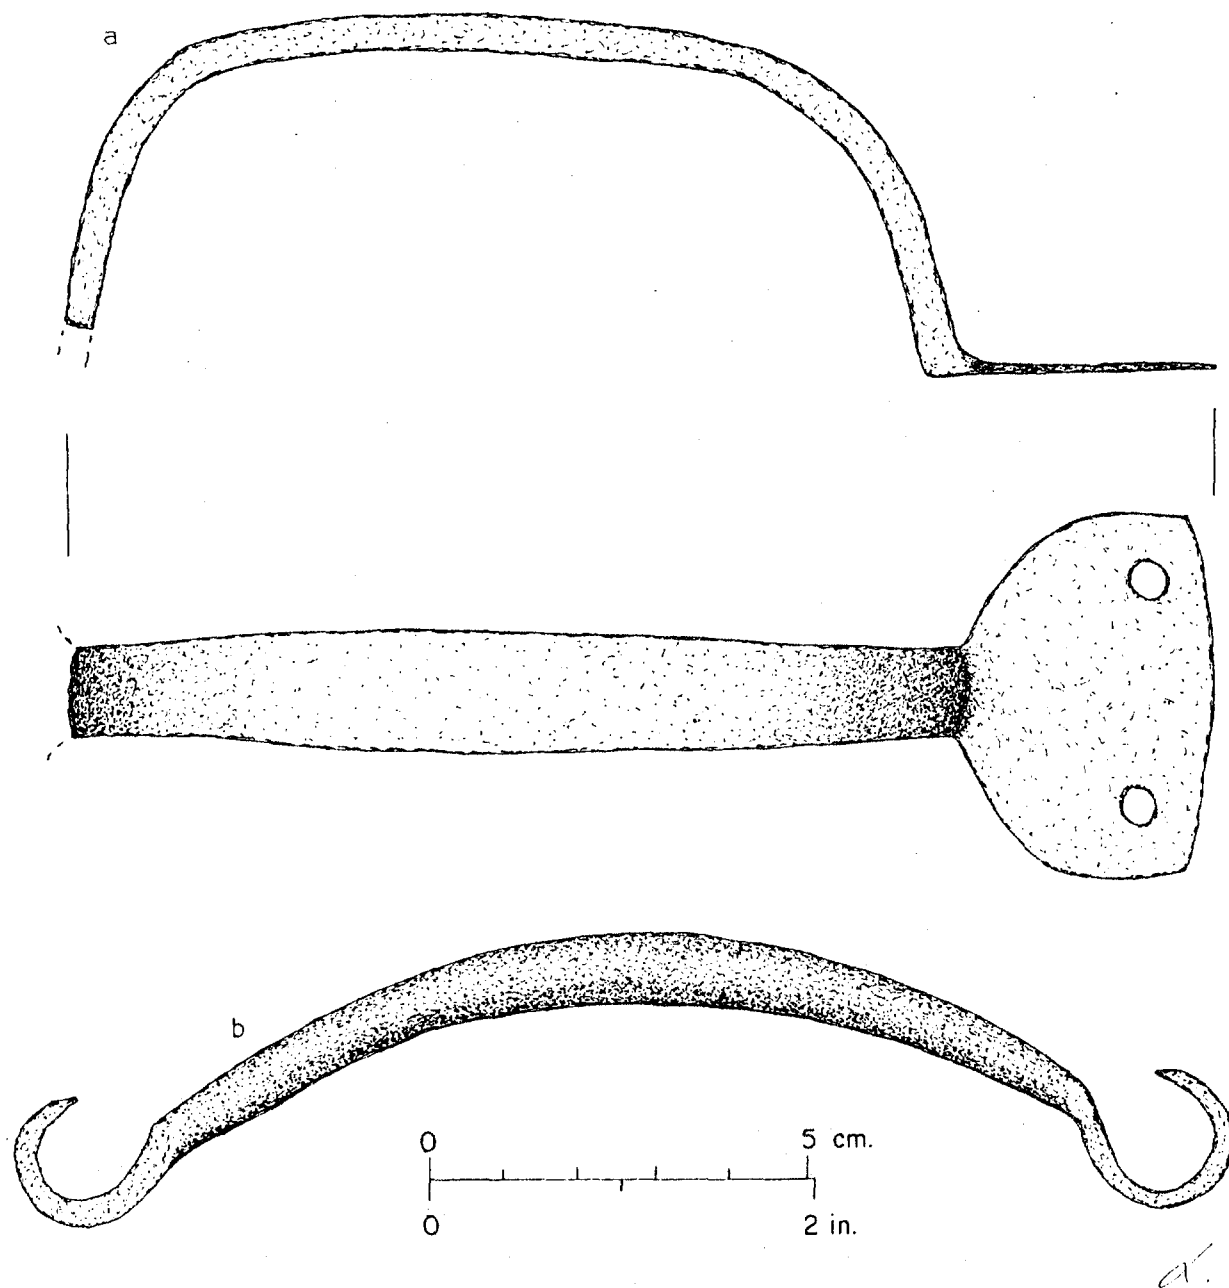
Fig. 152 -- Handles from F523: a). door handle (?) (FOVA 28265) and b). handle (FOVA 27925).

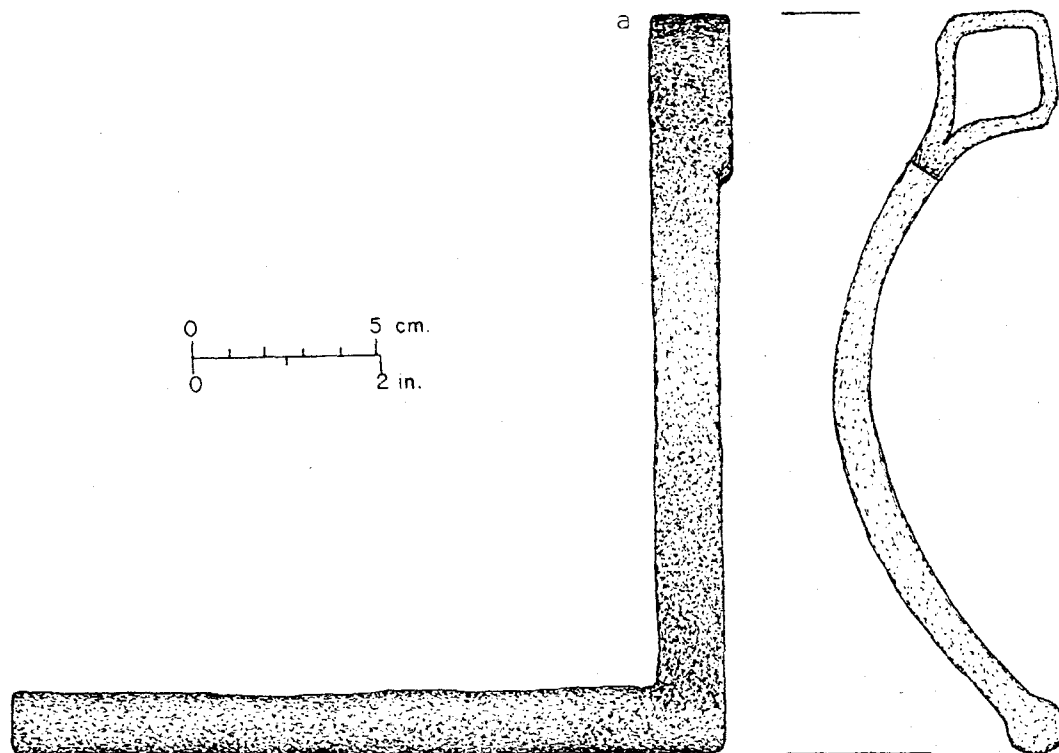
Fig. 153 -- Crank handle and belaying pin form F523: a). crank handle (FOVA 27171) and b). belaying pin (FOVA 27584).

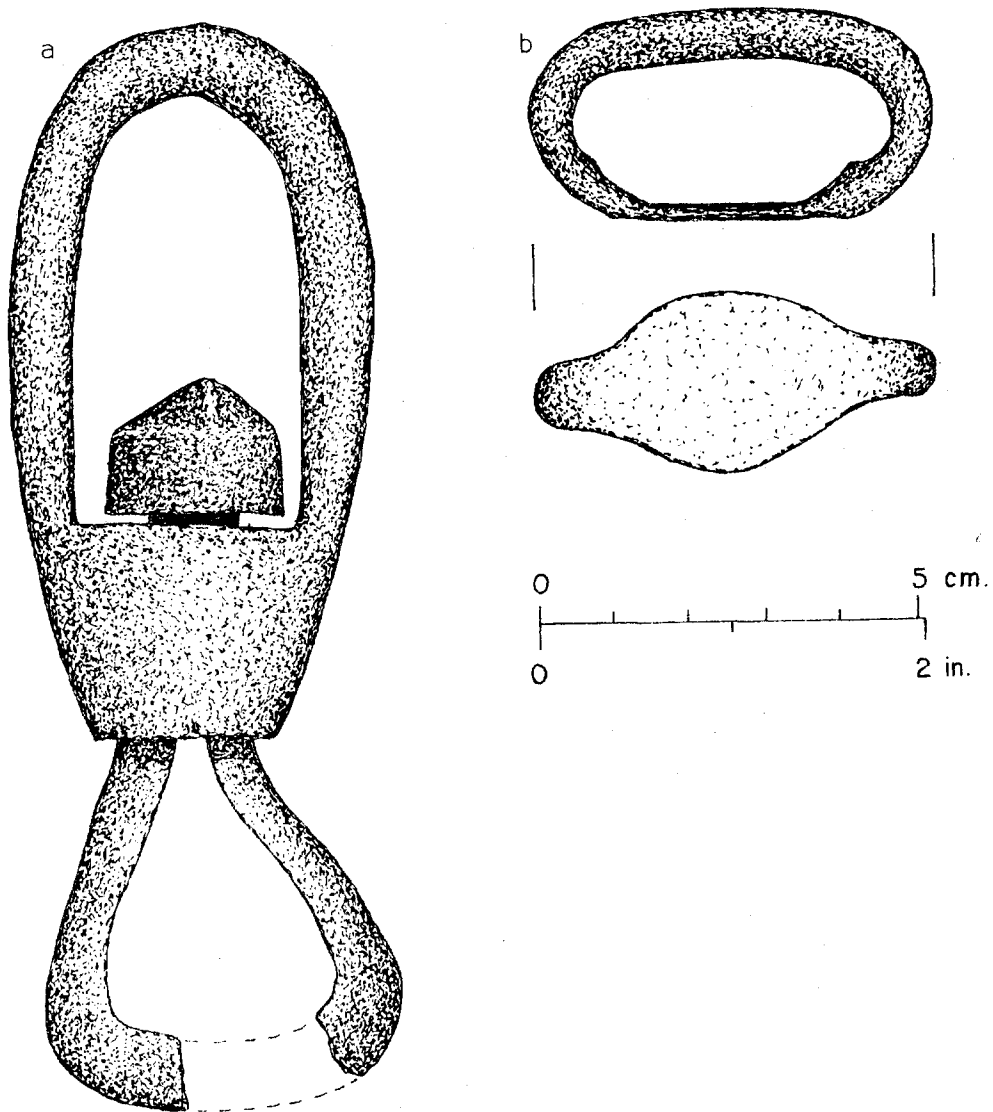
Fig. 154 -- Swivel and preform from F523: a). swivel link and eye (FOVA 27802) and b). swivel preform (FOVA 28137).
