FORT VANCOUVER EXCAVATIONS - X

Southeastern Fort Area

National Park Service

July 1975

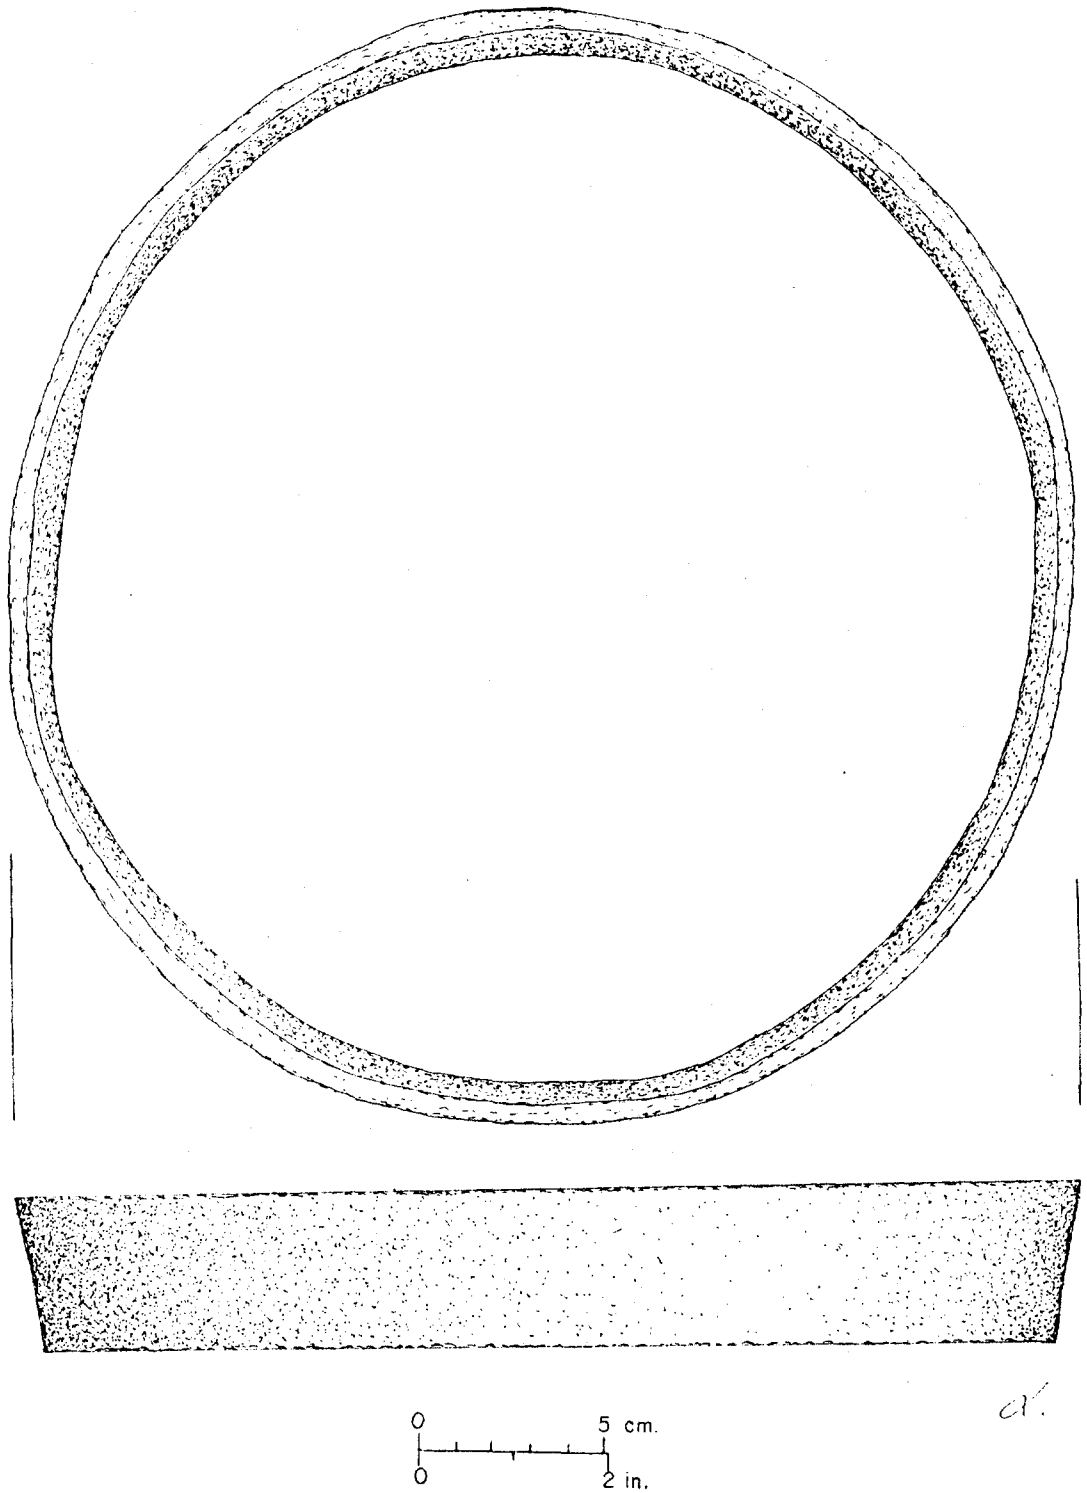
Fig. 155 -- Circular iron band (FOVA 27641) from F523.

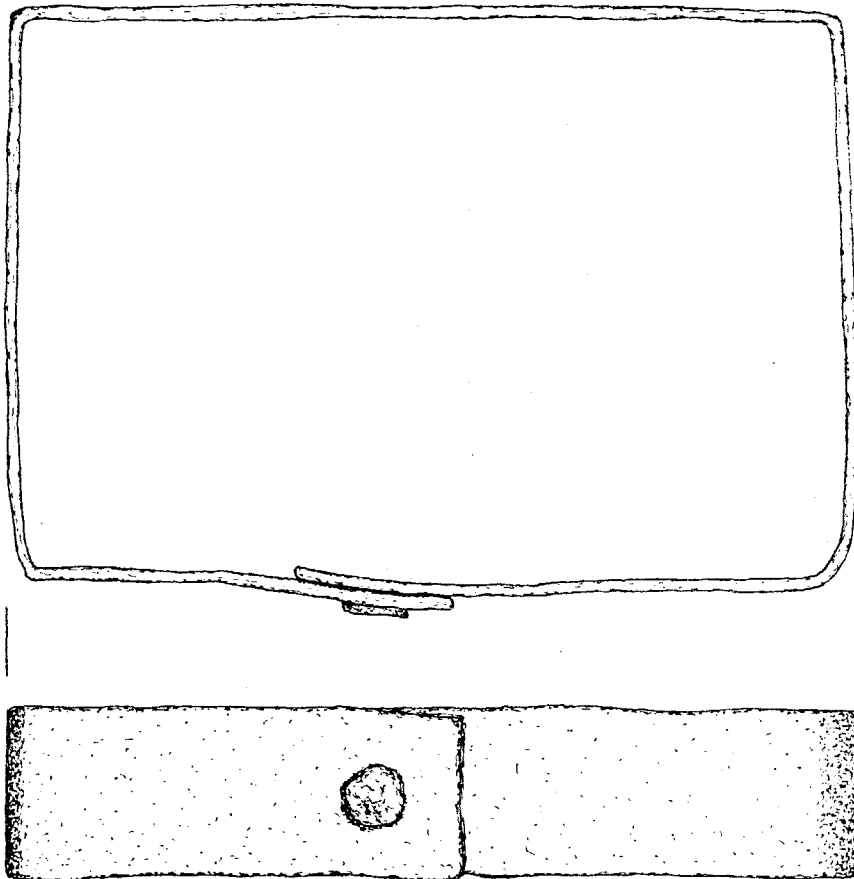
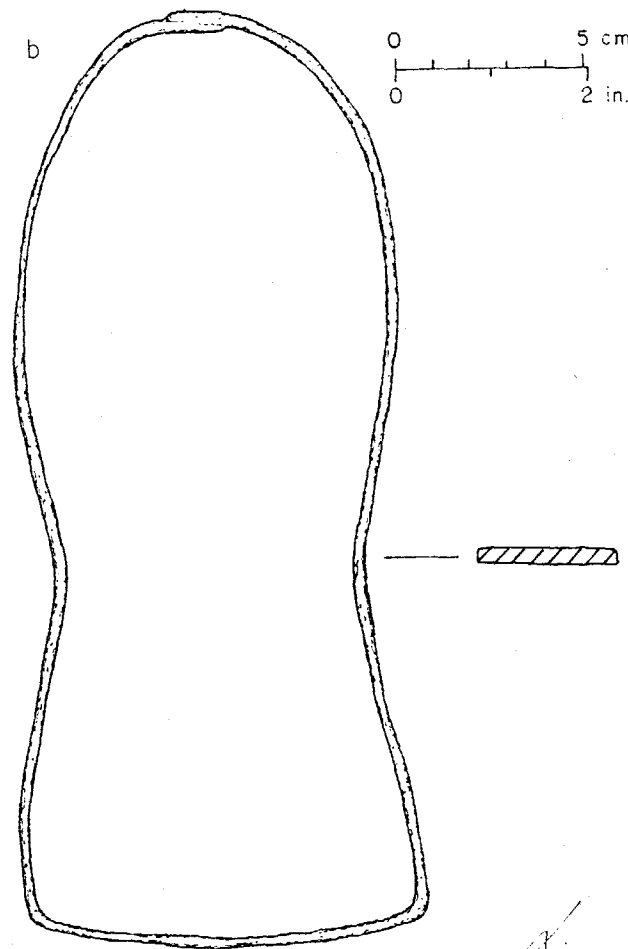
Fig. 156 -- Iron bands from F523: a). rectangular band (FOVA 27259) and b). irregular band (FOVA 27619).

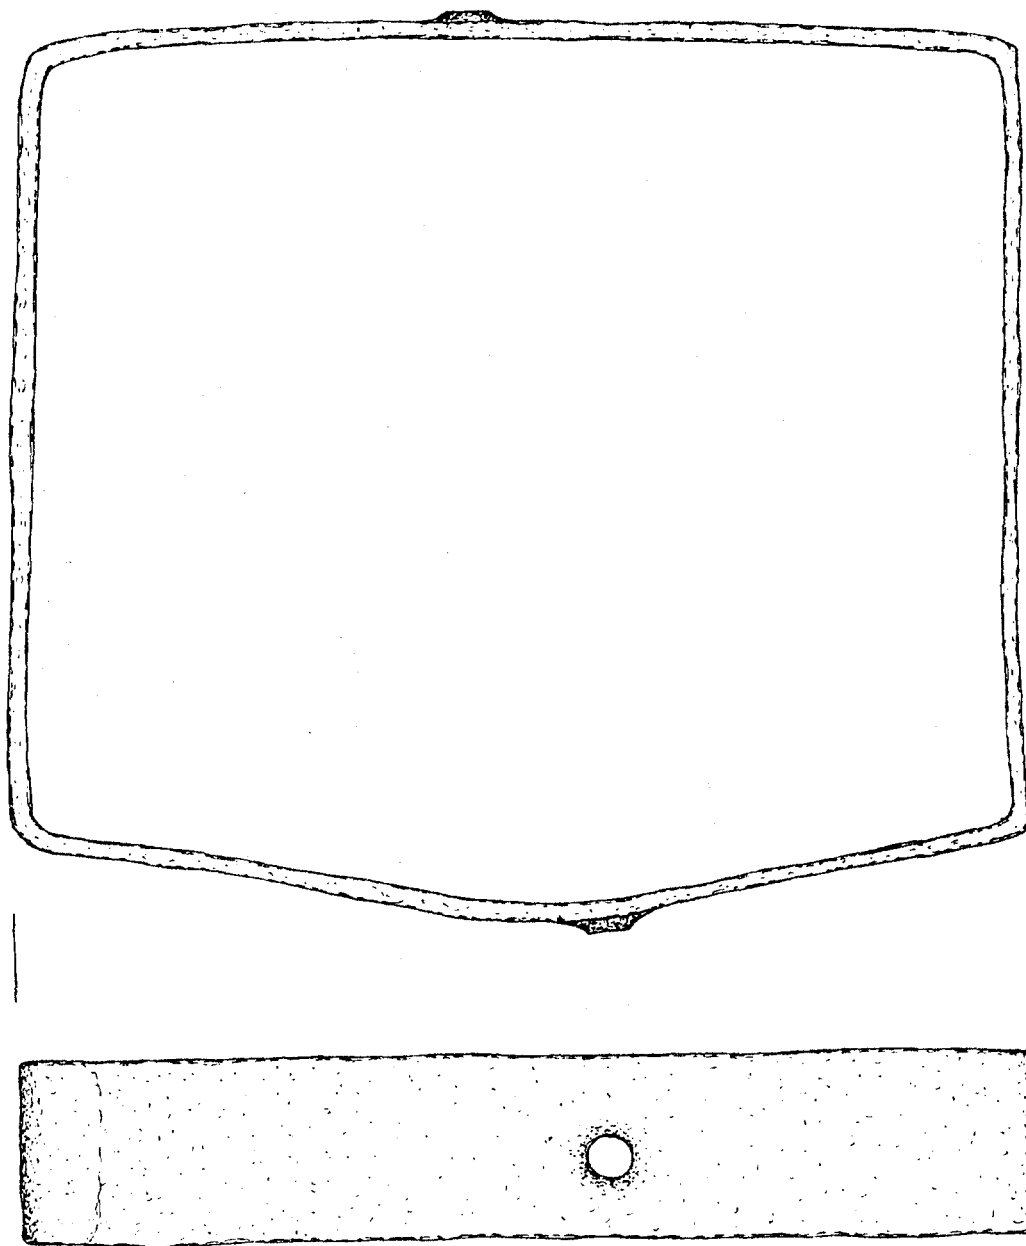
Fig. 157 -- Rectangular iron band (FOVA 27954) from F523.

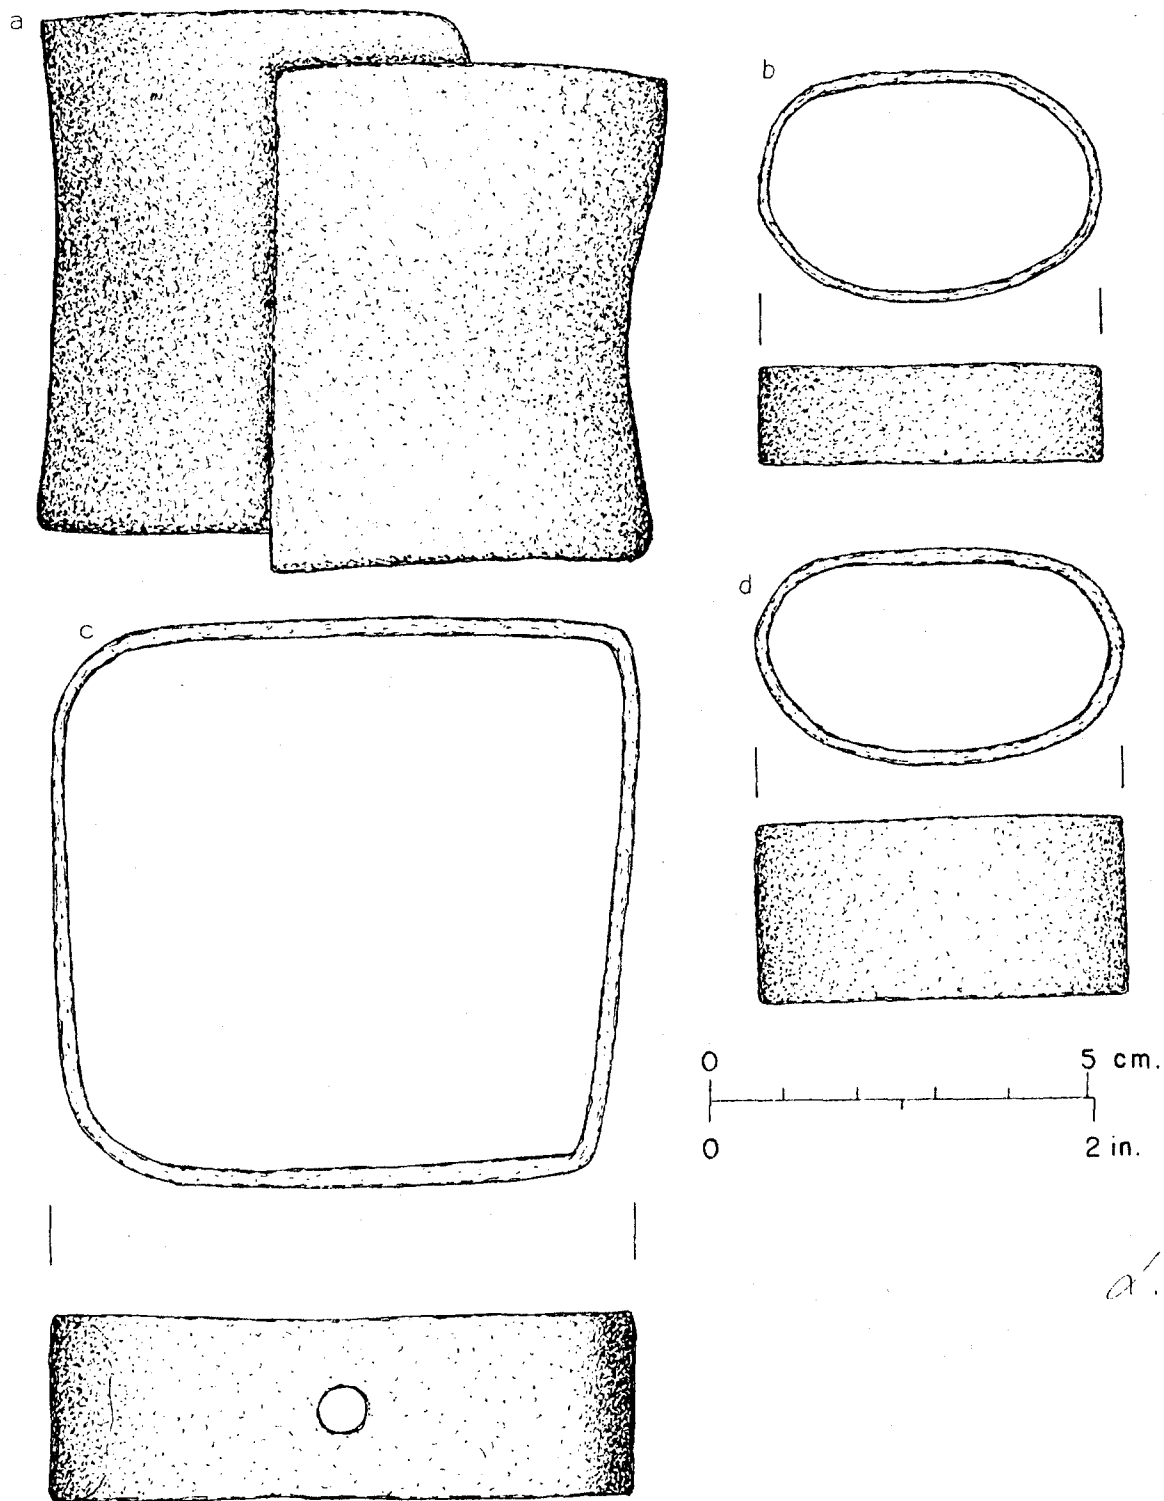
Fig. 158 -- Iron bands from F523: a). circular band securing tanged implement in wooden handle? (FOVA 28569); b). oval band (FOVA 27954); c). square band (FOVA 27326) and d). oval band (FOVA 27619).

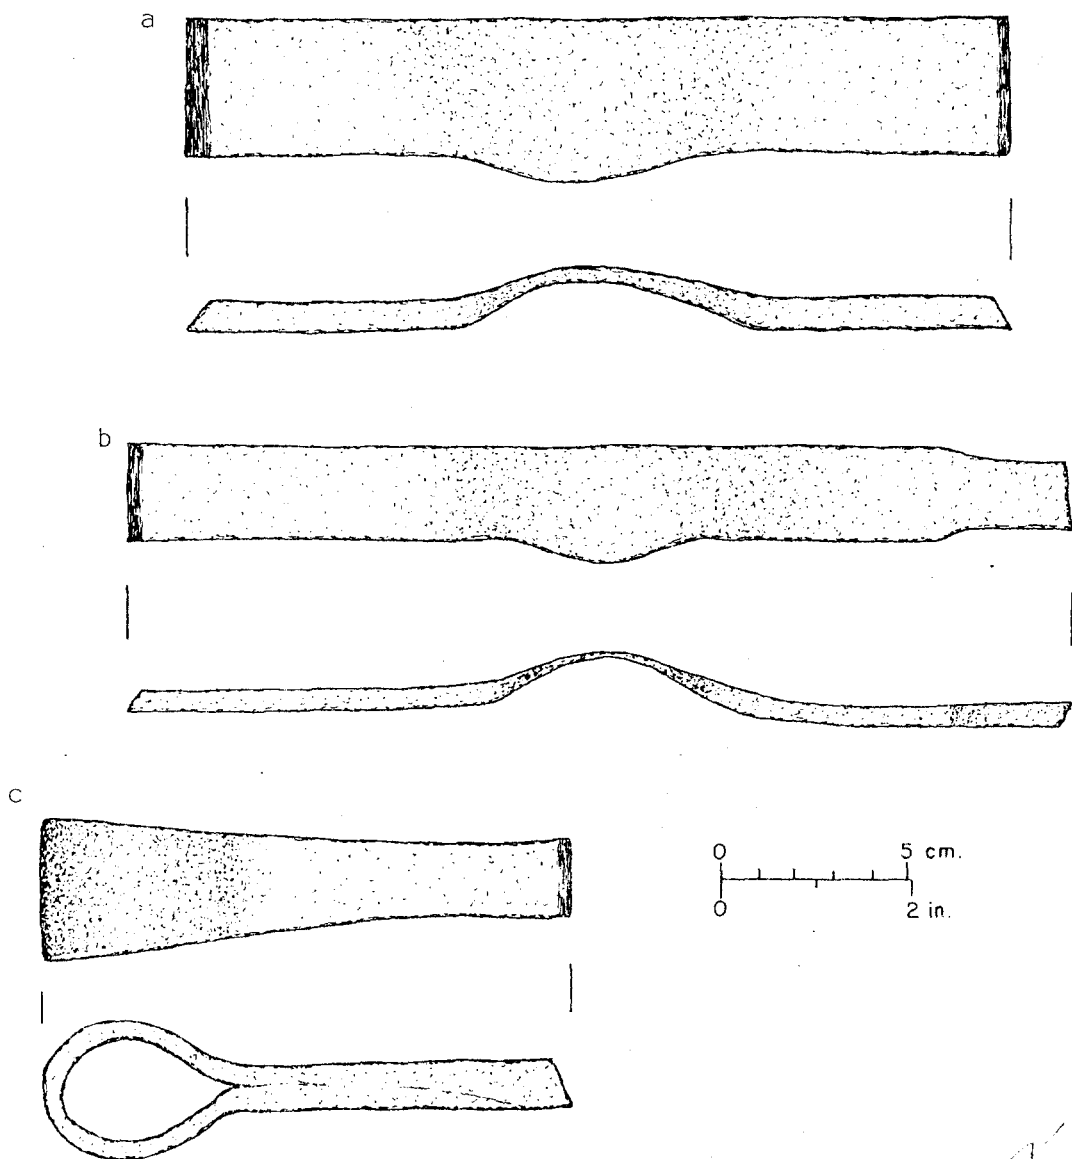
Fig. 159 -- Unidentified iron preforms: a). preform (FOVA 27617b);  
b). preform (FOVA 27336) and c). preform (FOVA 28357).

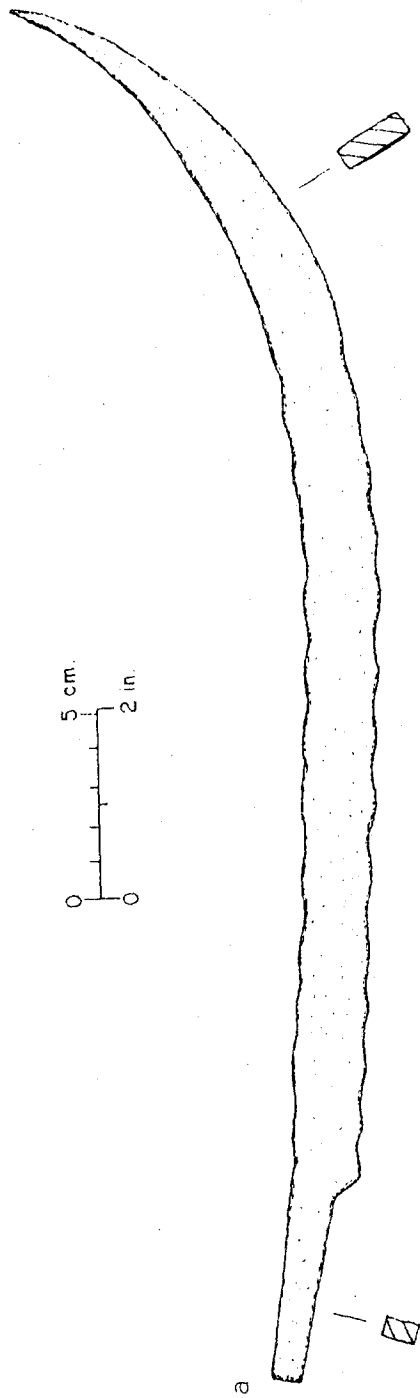
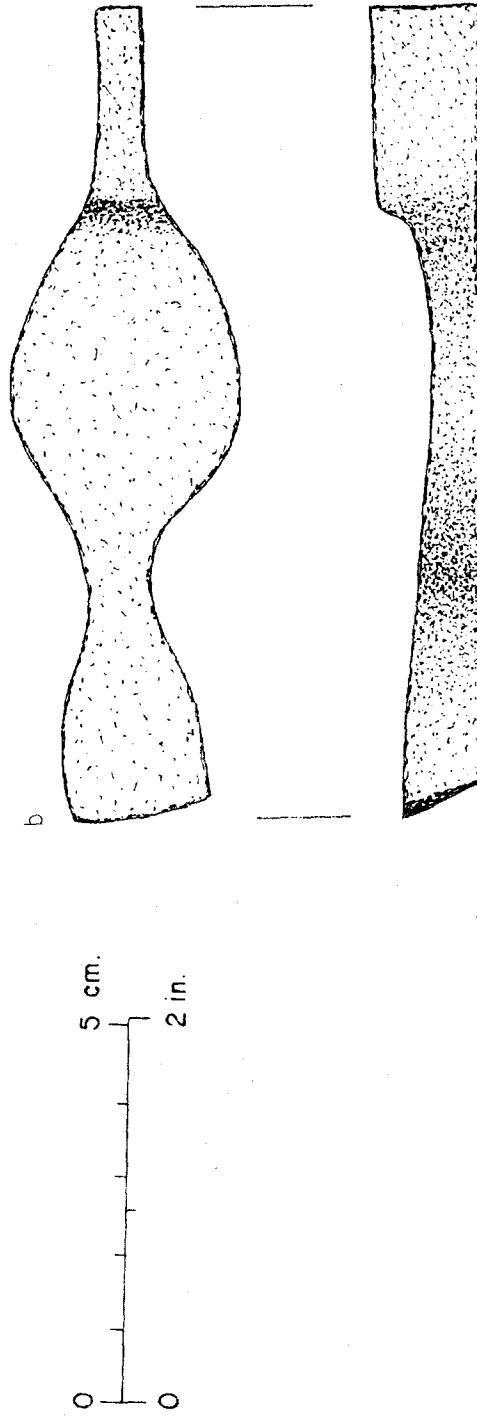
Fig. 160 -- Unidentified iron preforms: a). preform (FOVA 28266) and b). preform (FOVA 27791).

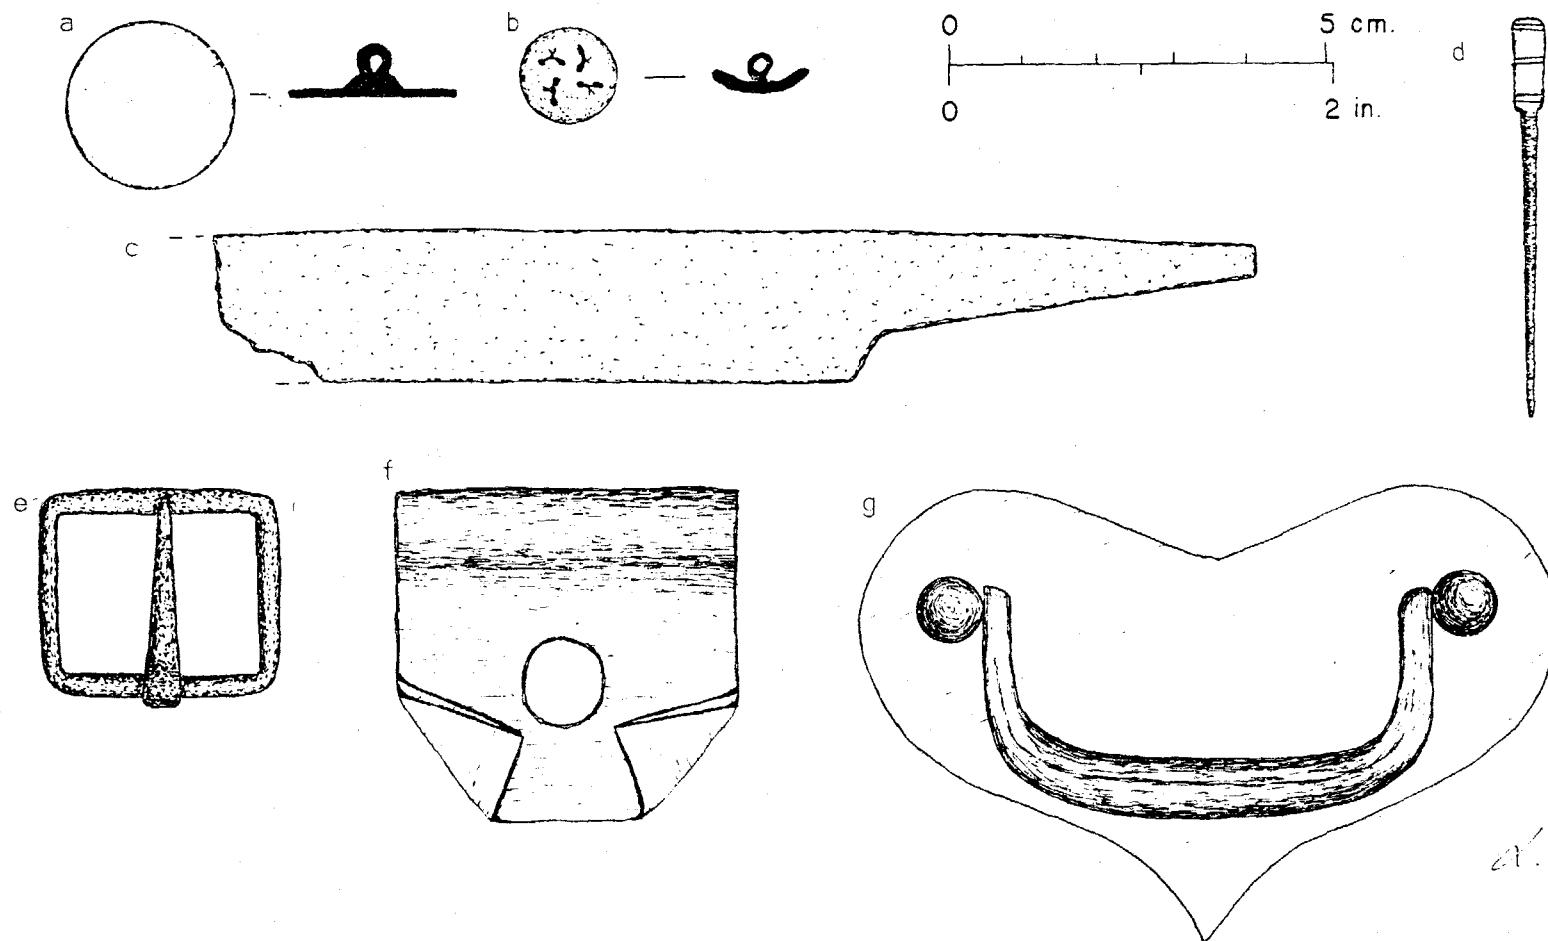
Fig. 161 -- Metal personal and household items from F523: a). button Type I BB (FOVA 28043); b). button Type I CC (FOVA 27644); c). knife blade (FOVA 28384); d). copper needle? (FOVA 27284); e). iron buckle (FOVA 27277) f). copper kettle lug (FOVA 27550) and g). cassette handle (FOVA 27354).

Of the 3 buttons recovered, 2 could be classified, and they represent styles not previously observed (Table 36 and Figs. 161a-b).

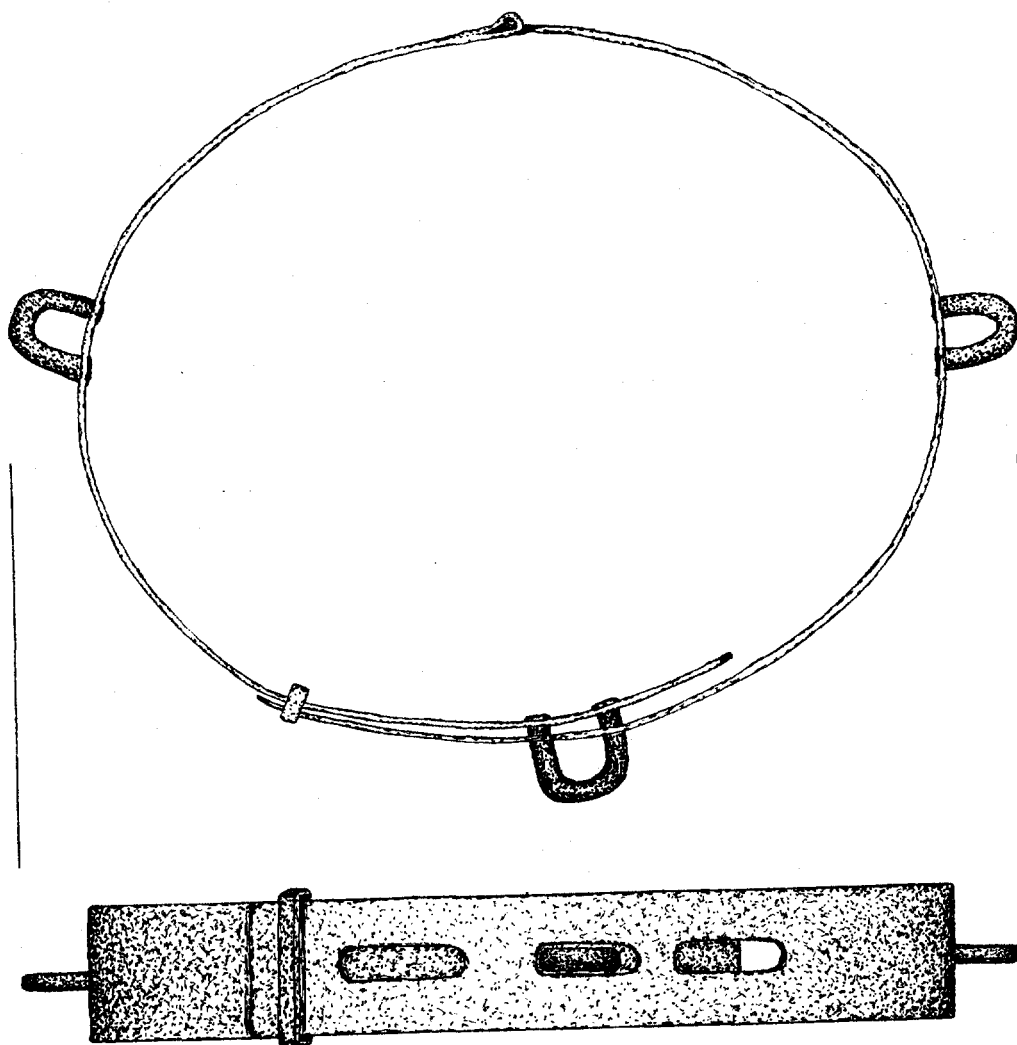
Fig. 162 -- Body shackle (FOVA 28267) from F523.

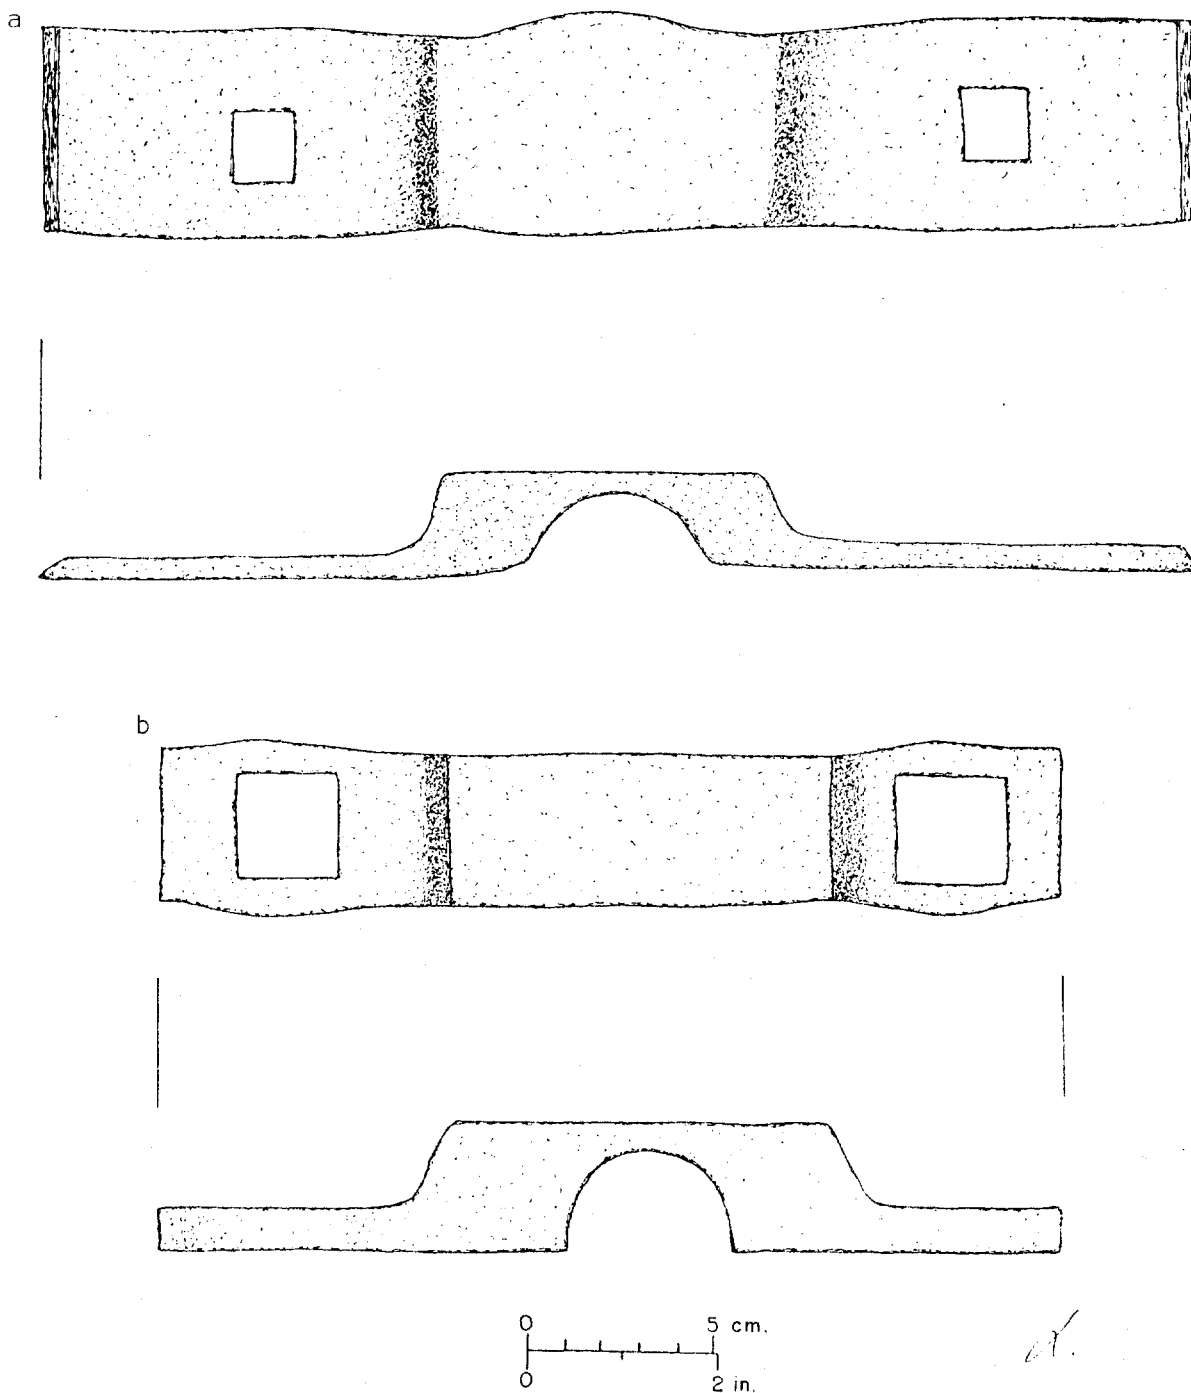
Fig. 163 -- Cannon trunnion plates from F523: a). plate (FOVA 27661) and b). plate (FOVA 28346).

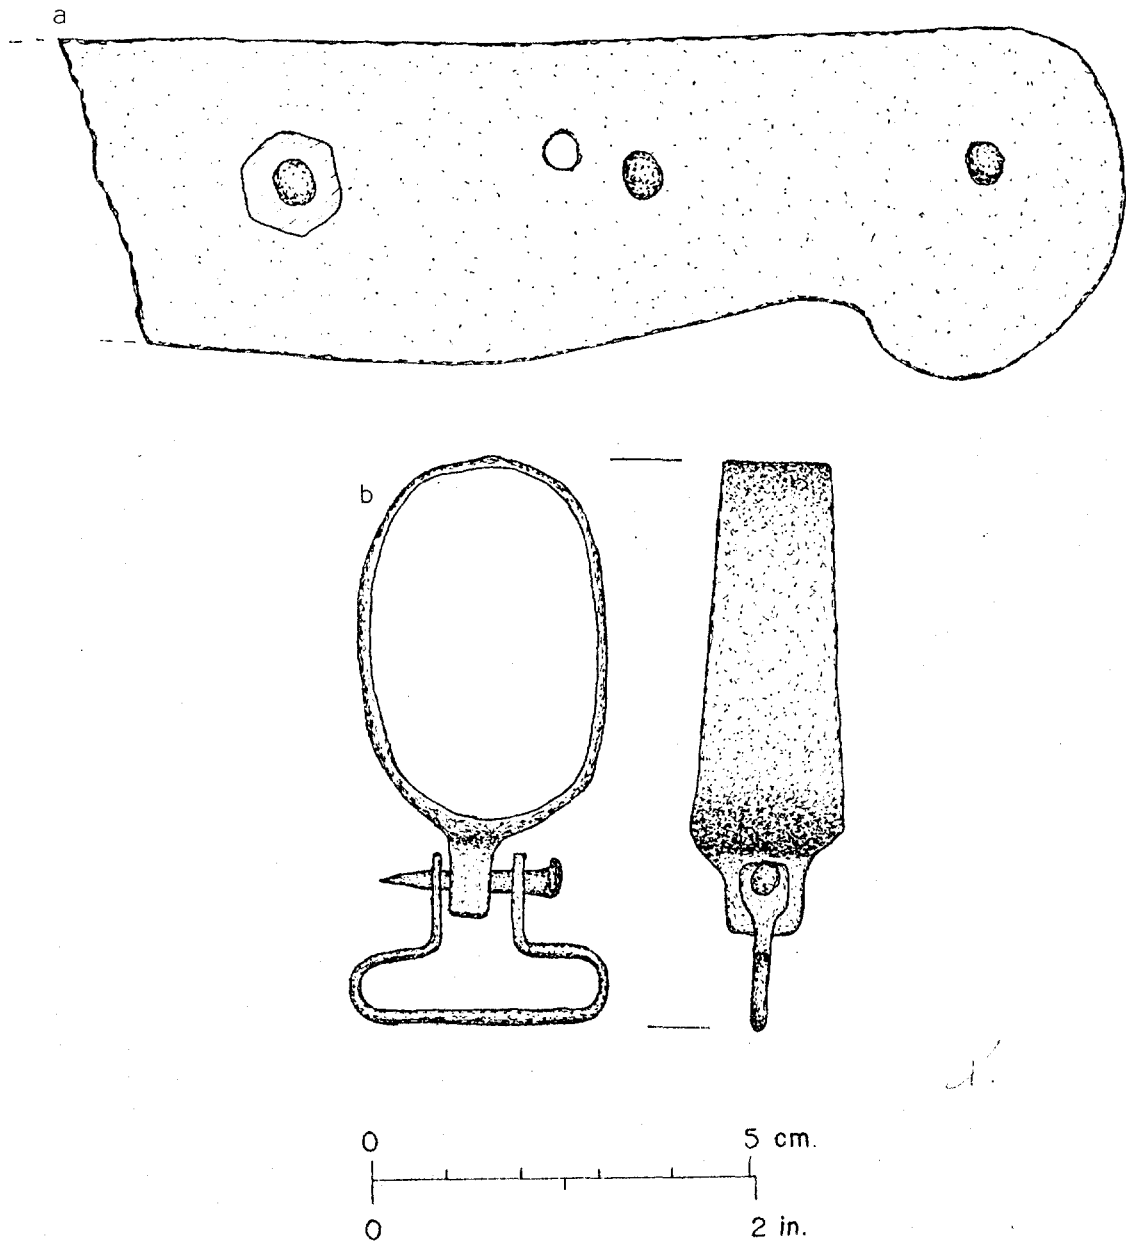
Fig. 164 -- Weaponry items from F523: a). flat iron sword handle with copper washers (FOVA 27274) and b). iron musket band with strap swivel (FOVA 27389).

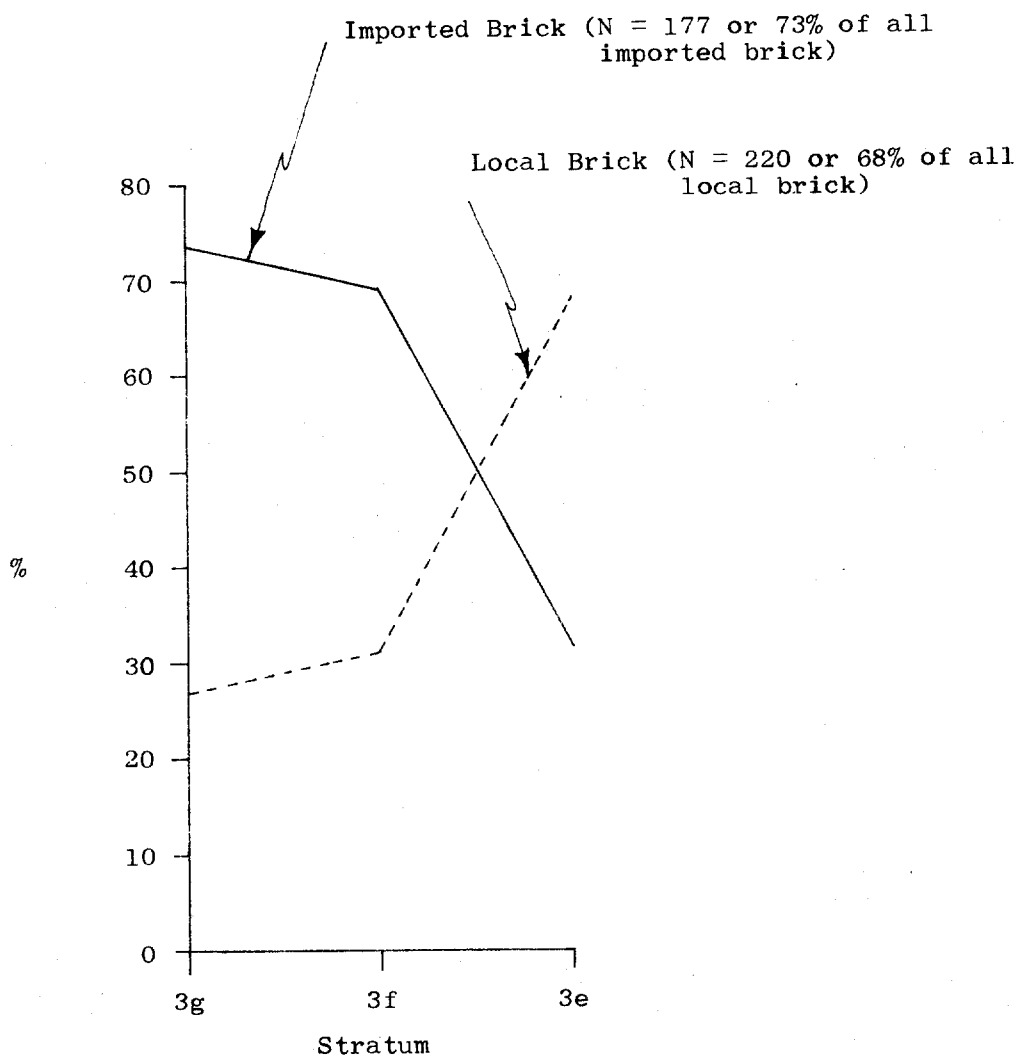
Fig. 165 -- Relative percentages by stratum of imported and local brick fragments in the ca. 1834/36 - 1860 Indian Trade Store Privy/Trash Pit.

In previous reports (Hussey 1972:48-49; Hoffman & Ross 1972:58-65, 1973a:47-49; 1973b:133-135, 163-164), it has been demonstrated that local Willamette Valley bricks were first imported to the Fort in 1844. Because of the stratified deposits within F523, and because of its initial date of ca. 1834/36, it was hypothesized that the earliest stratum would lack fragments of local bricks. When both local and imported brick fragments were plotted by stratum, it was observed that local bricks were present in the earliest stratum but at significantly lower frequencies than in later strata (Fig. 165). Local brick frequencies and relative percentages increased through time, and this increase has been interpreted as supportive of the hypothesis that local bricks were not imported until 1844.

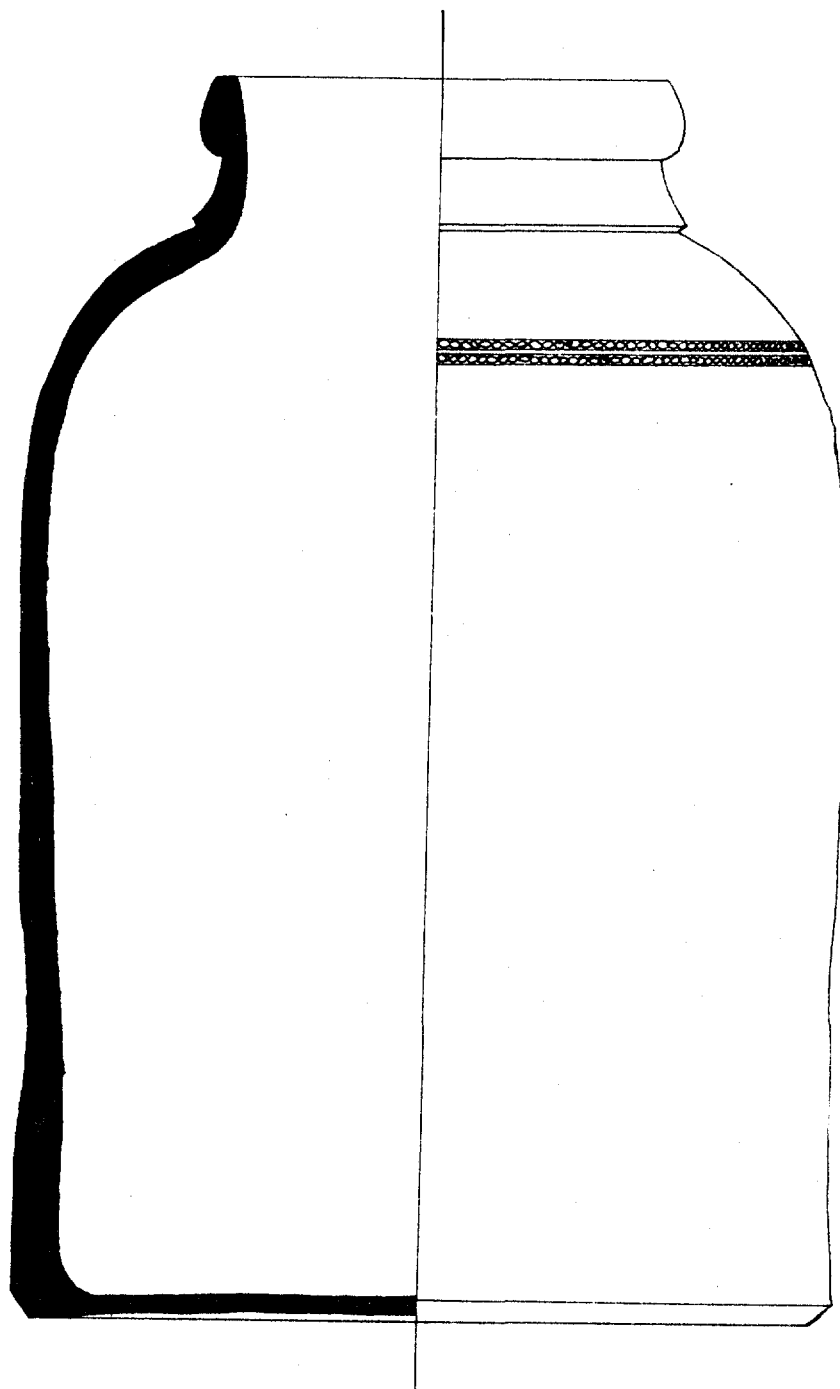
Fig. 166 -- Stoneware "crock" from the Iron Store area (FOVA IS 30).

Unidentified Saltglazed Container Fragments. From the 417 fragments recovered, 2 partially complete "crops" were reconstructed. Both "crops" were identical in manufacturing style and size, and only one has been illustrated (Fig. 166). These "crops" measured ca. 13 ins. in height, ca. 8½ ins. in diameter and had a ca. 4 in. inside rim diameter. Capacity for each "crop" was ca. 460 cu. in. (ca. 7500 ml.) and equaled 2 gallons (in both the Winchester Wine Gallon and American Liquid systems). Prior to the adoption of the Imperial system in 1824 by the British, one commonly used liquid measuring system was the Winchester Wine Gallon system based upon 231 cu. in. (3785.6 ml.) per gallon. After adoption of the Imperial system, the Winchester Wine Gallon system was still used, but primarily for imported alcoholic beverages. The American Liquid system was developed from the Winchester Wine Gallon system, and in 1830 the U.S. Senate fixed the capacity of a standard gallon at 231 cu. in., exactly copying the Winchester Wine Gallon. Thus, the 2-gallon "crops" could have been either a British or American product. The fabric of one "crop" had been stained a blackish-gray, similar to the staining exhibited by blacking bottles, but the exact product could not be determined. Both "crops" came from F687.

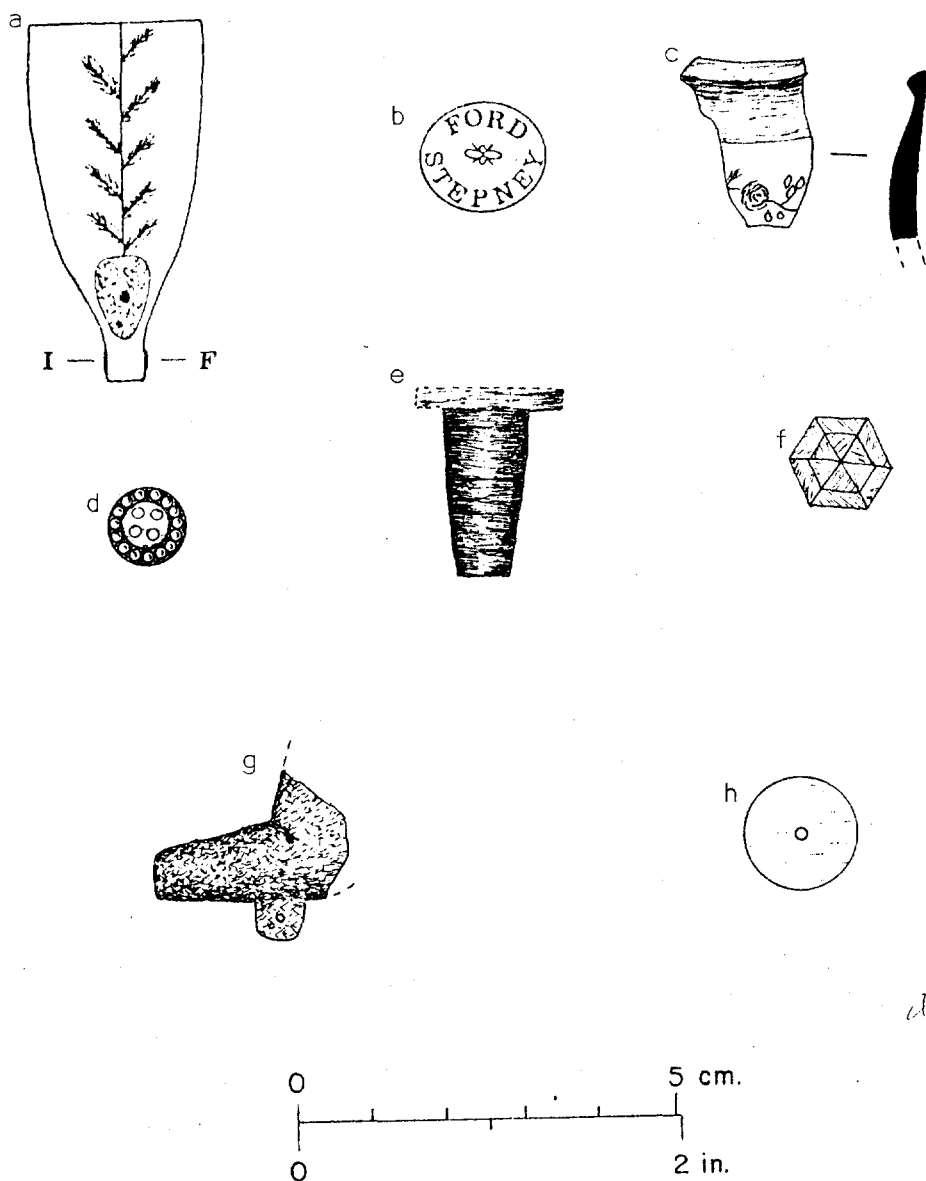
Fig. 167 -- Pipe fragments, glass stopper and buttons from the Iron Store area: a-b). "FORD" bowl marks; c). tin glaze pipe fragment (FOVA IS 47); d). "Prosser" button (FOVA IS 59); e). glass stopper (FOVA IS 37); f). molded-faceted glass button (FOVA IS 46); g). argillite pipe fragment (FOVA IS 56); and h). bone disc (FOVA IS 61).

Bowls. Two styles of "FORD" pipes were observed (Figs. 167a-b). In addition, one unidentified bowl had a ship and banner molded on the side of the bowl, and another bowl fragment had a multi-colored hand painted floral design with a white glazed flaired rim (Fig. 167c). Neither bowl was identified.

One white, 4-hole "Prosser" button was recovered with an edge decoration consisting of 15 raised hemispheres (Fig. 167d).

One small bluish green stopper fragment was recovered (Fig. 167e).

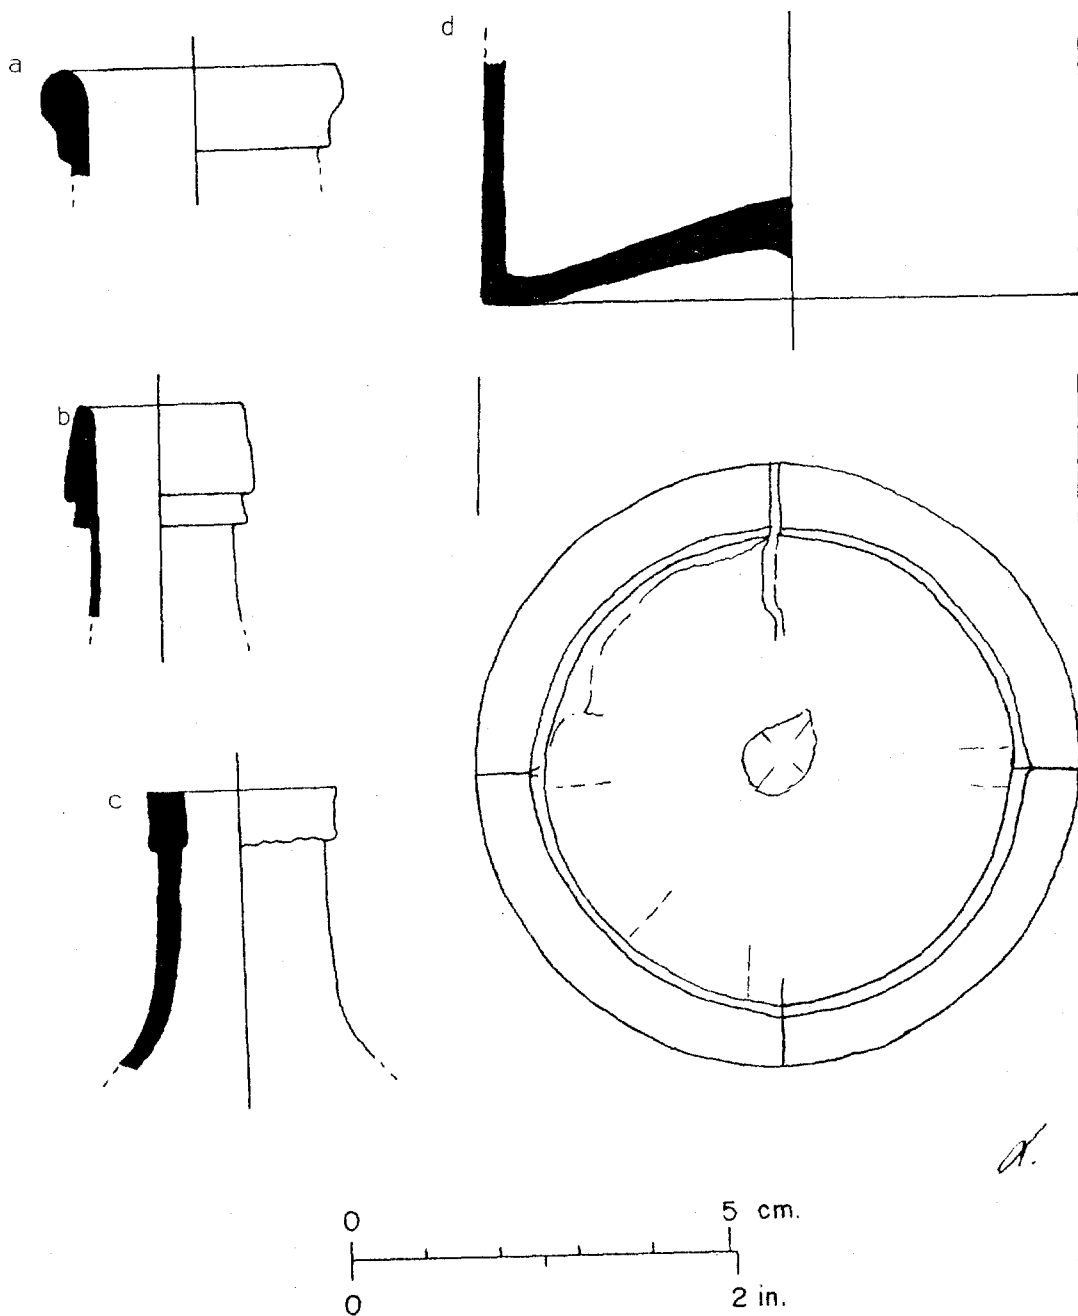
Fig. 168 -- Bottle rim and base types from the Iron Store area: a). rim Type 46 (FOVA IS 37); b). rim Type 47 (FOVA IS 37); c). rim Type 48 (FOVA IS 47) and d). base Type 39 (FOVA IS 29).

Eleven rims were reconstructed and classified onto 7 different types on the basis of their manufacturing attributes and form (Table 42). Three new rim types were identified and are graphically illustrated in Figs. 168a-c. Of special note was Rim Type 47 which was similar in manufacturing and form attributes to those rims (Type 15) generally classified as liquor bottles with cork stoppers in other areas of the fort. The new rim type had an interior ground surface used in conjunction with a glass stopper rather than a cork stopper.

Five bases were reconstructed and classified into 3 types on the basis of their manufacturing attributes and form (Table 43). No new base types were identified, but Base Type 39 revealed some unusual characteristics not noted in other base types. The base alone appeared to have 5 mold lines on it (Fig. 168d). Four seams ran across the basal area dividing it into equal quadrants, and vaguely crossed the indent to the central nipple, but not through it. An additional seam line appeared on the outer edge of the base where it merged with the body of the bottle, giving a rippled affect. The size, color and shape of the base and its possible association with Rim Type 15, suggested that it may have belonged to a liquor bottle. This base was recovered from F687 within the Iron Store.

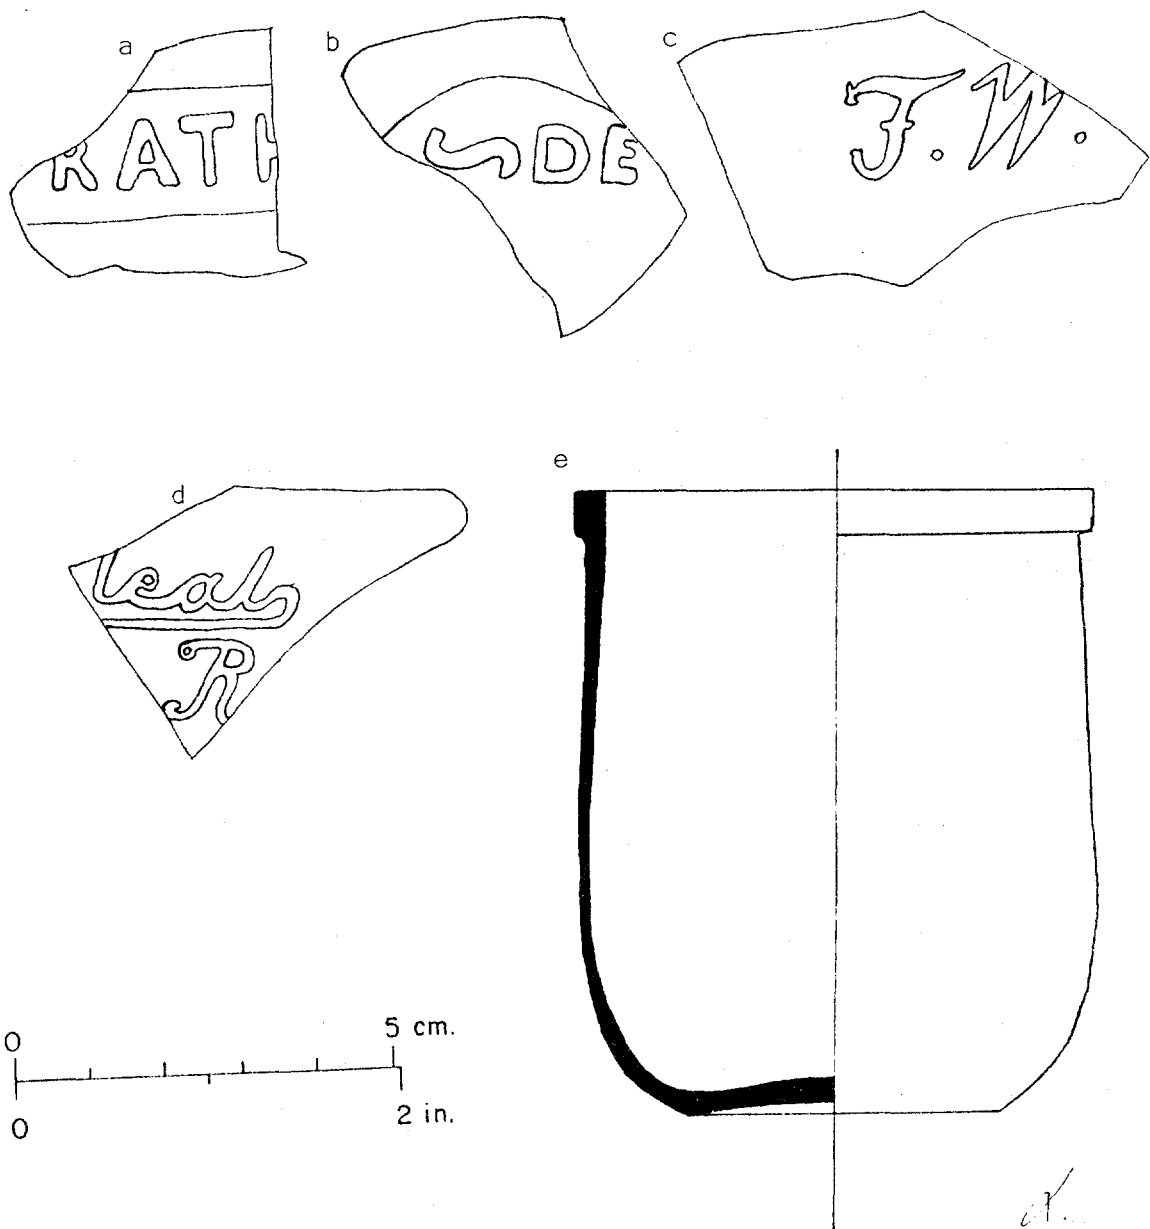
Fig. 169 -- Marked bottle fragments and jar from the Iron Store area:  
a). marked bottle fragment (FOVA IS 64); b). bottle fragment (FOVA IS 37); c). bottle base (FOVA IS 49); d). bottle fragment (FOVA IS 64); and e). "Jar" (FOVA IS 19-30).

The marked bottle fragments recovered have been illustrated in Figs. 169a-d. Though none were positively identified, the "written" rather than "printed" lettering on two fragments was suggestive of 20th Century containers. These fragments were recovered from an overburden stratum. One marked base fragment was also recovered (Fig. 169b).

A total of 175 clear glass fragments classified as "jar" fragments were recovered and reconstructed into one complete "jar" (Fig. 169e) and 5 additional "jar" bases. These small containers measured  $2\frac{1}{2}$  in. in width at the base, 3 in. in width at the rim and 3 in. in height. They were manufactured by the free blown method and the ground bases indicated the removal of a pontil mark. The flat lip was formed from the glass at the mouth by folding it outside.
