FORT VANCOUVER EXCAVATIONS - X

Southeastern Fort Area

National Park Service

July 1975

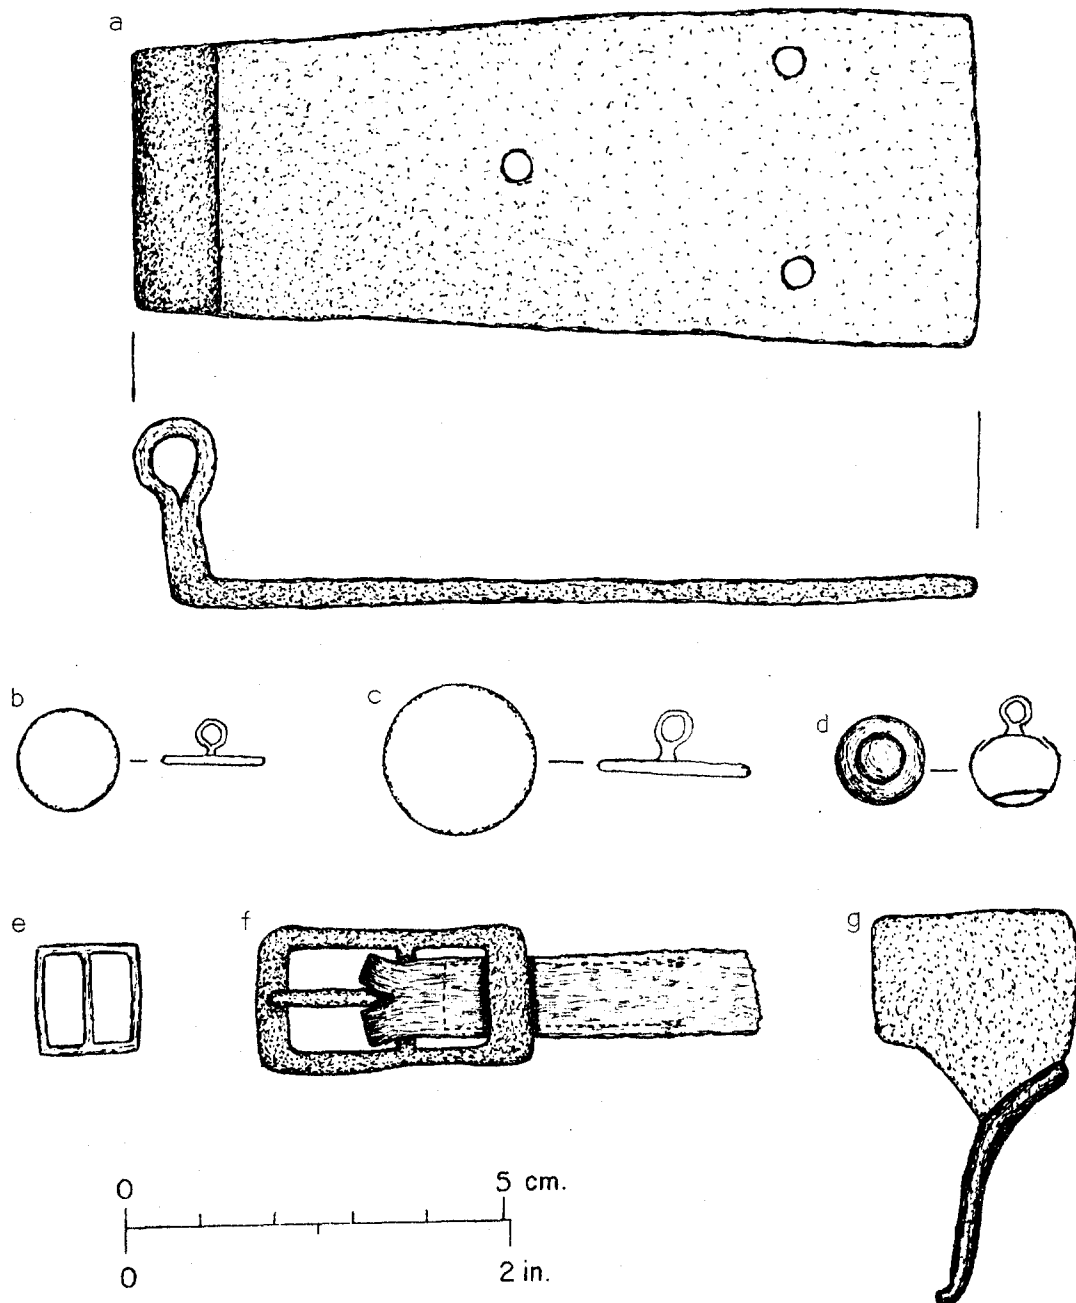
Fig. 170 -- Metal hardware, household, personal and weaponry items from the Iron Store area: a). mortice hinge (FOVA IS 56); b). metal buttons Type IW and IX (FOVA IS 61); c). metal button Type IY (FOVA IS 62); d). metal button Type IIR (FOVA IS 62); e). silver buckle (FOVA IS 9); f). buckle w/strap (FOVA IS 65) and g). trigger (FOVA IS 55).

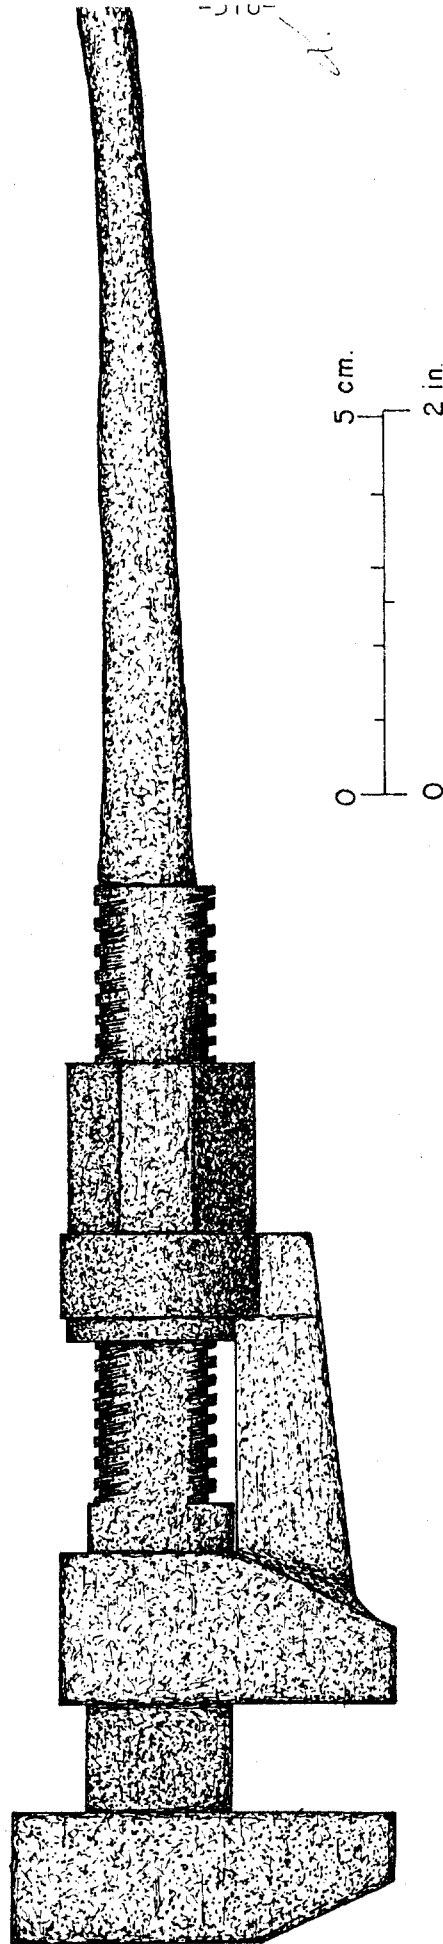
Fig. 171 -- Complete wrench from the Iron Store area (FOVA IS 56).

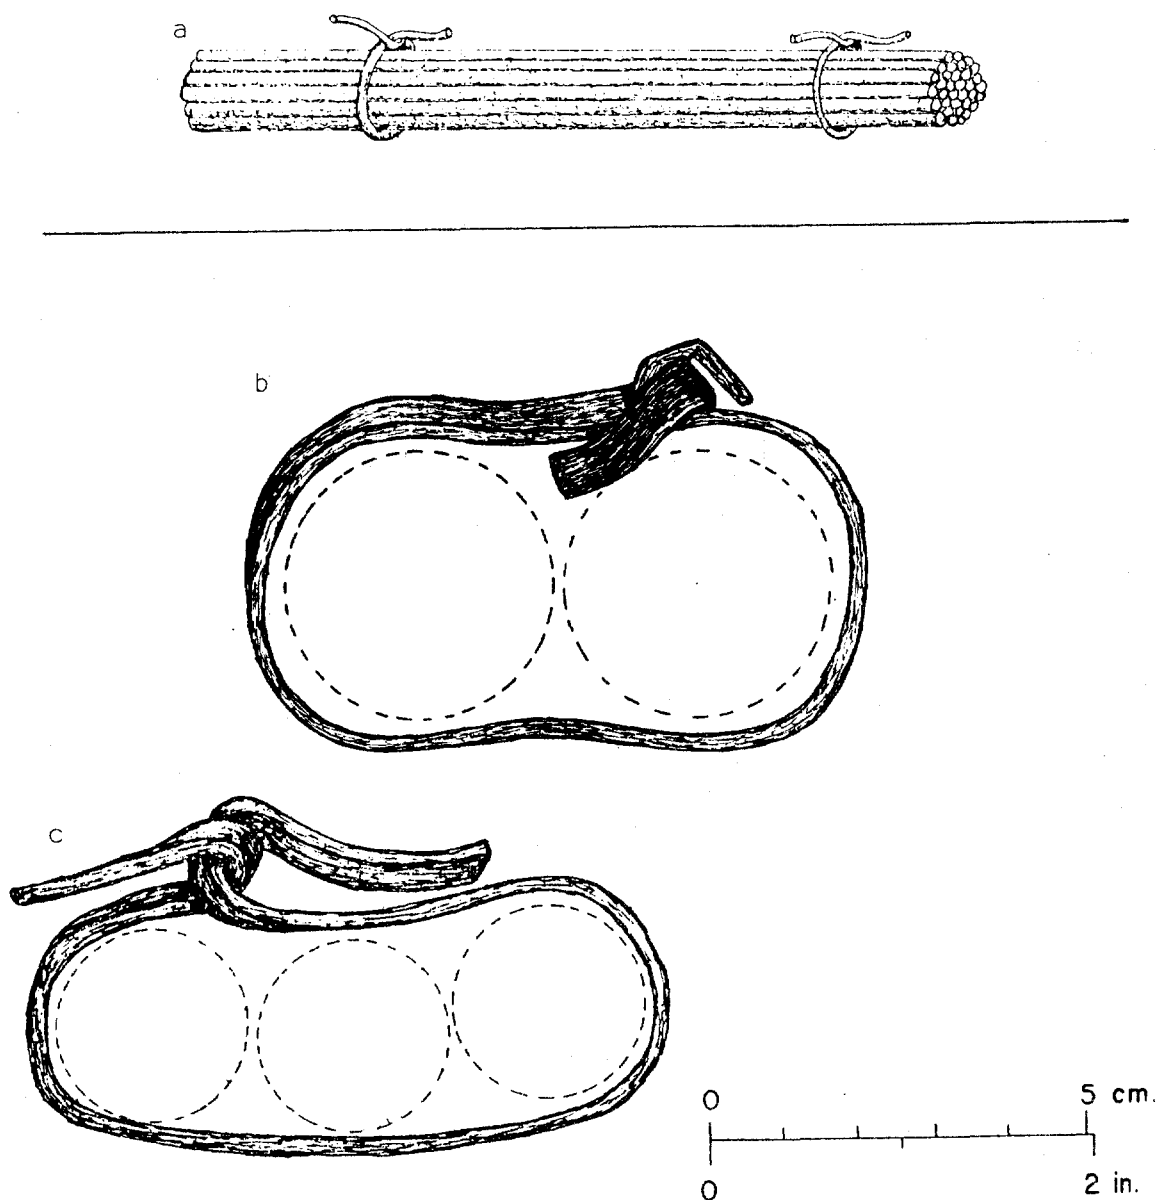
Fig. 172 -- Iron bundling strap from the Iron Store area: a). reconstructed iron bundling strap with iron stock; b). iron bundling strap (2/1" rods) (FOVA IS 60); and c). iron bundling strap (3/1" rods) (FOVA IS 66).

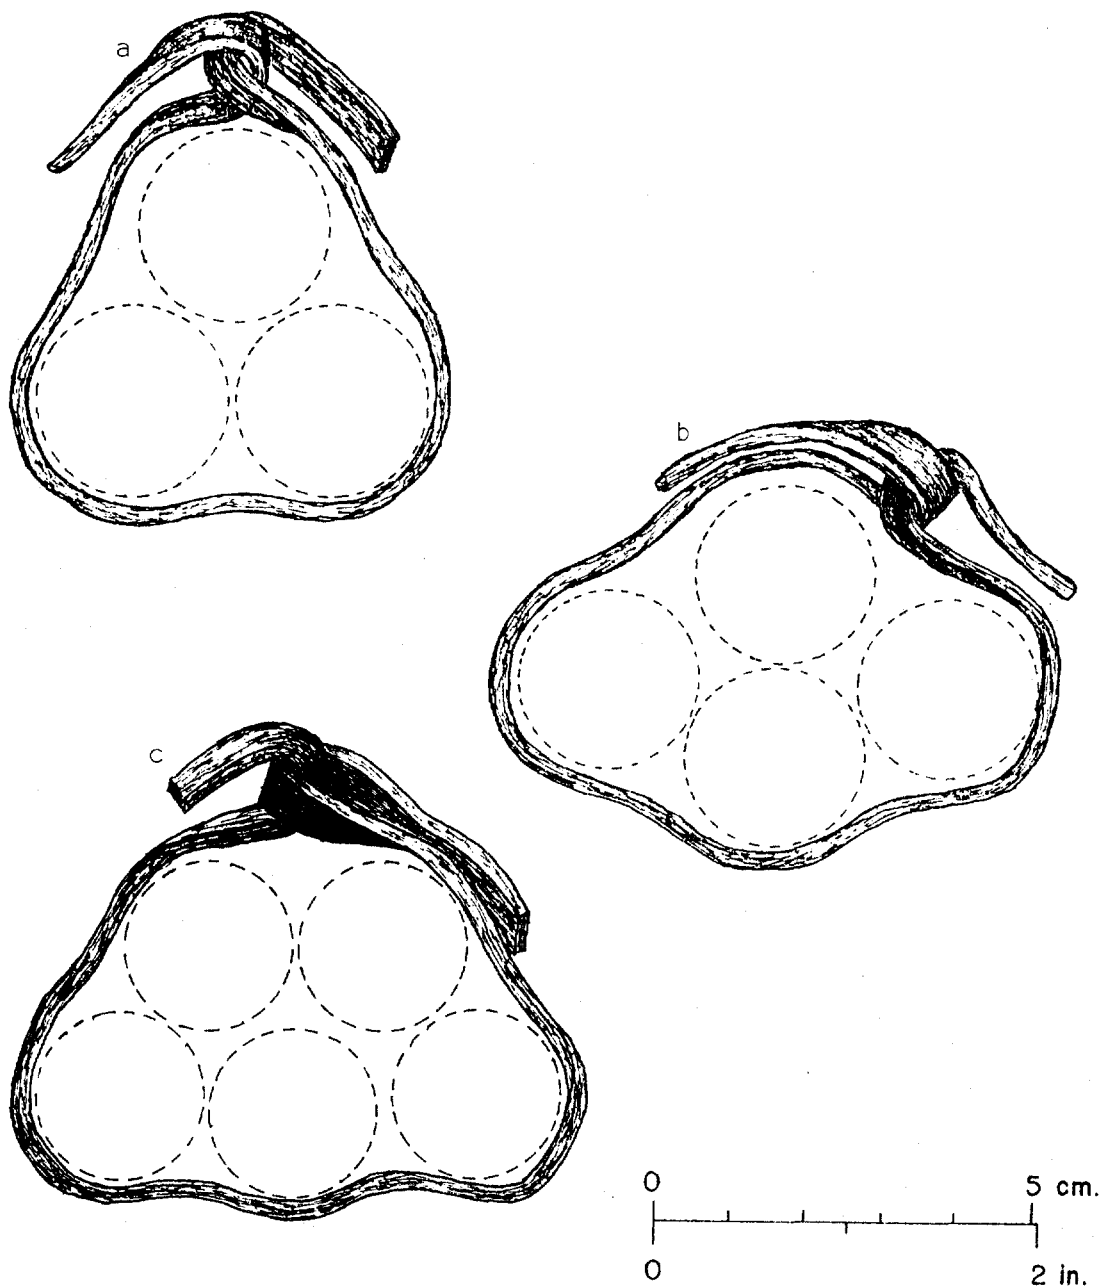
Fig. 173 -- Bundling straps from the Iron Store area: a). bundling strap for 3/1" rods (FOVA IS 66); b). bundling strap for 4/5/16" rods (FOVA IS 64) and c). bundling strap for 5/7/8" rods (FOVA IS 56).

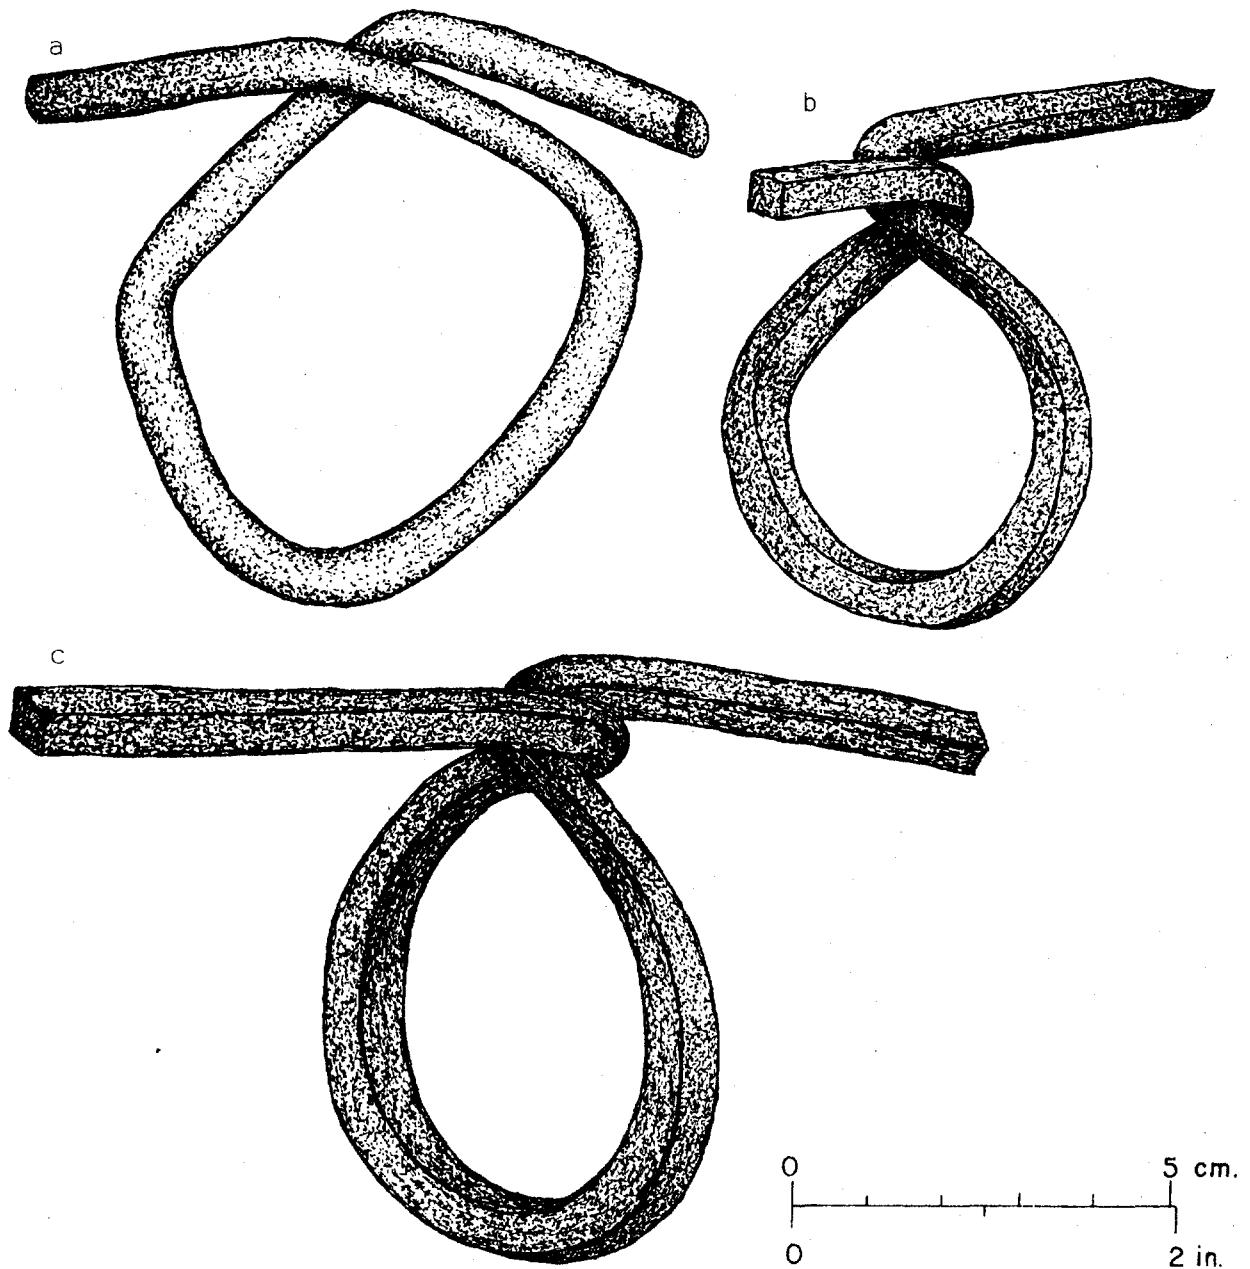
Fig. 174 -- Bundling straps from the Iron Store area: a). bundling strap (FOVA IS 37); b). bundling strap (FOVA IS 37) and c). bundling strap (FOVA IS 66).

Of the 72 specimens recovered, 9 were complete and are identical to strap type and bundle shapes reported from the Blacksmith Shop and illustrated in the variations recovered from the Iron Store (Figs. 174-175). As in the Blacksmith Shop, rectangular bands used to wrap bundles of 2, 3, 4, and 5 circular rods were absent.

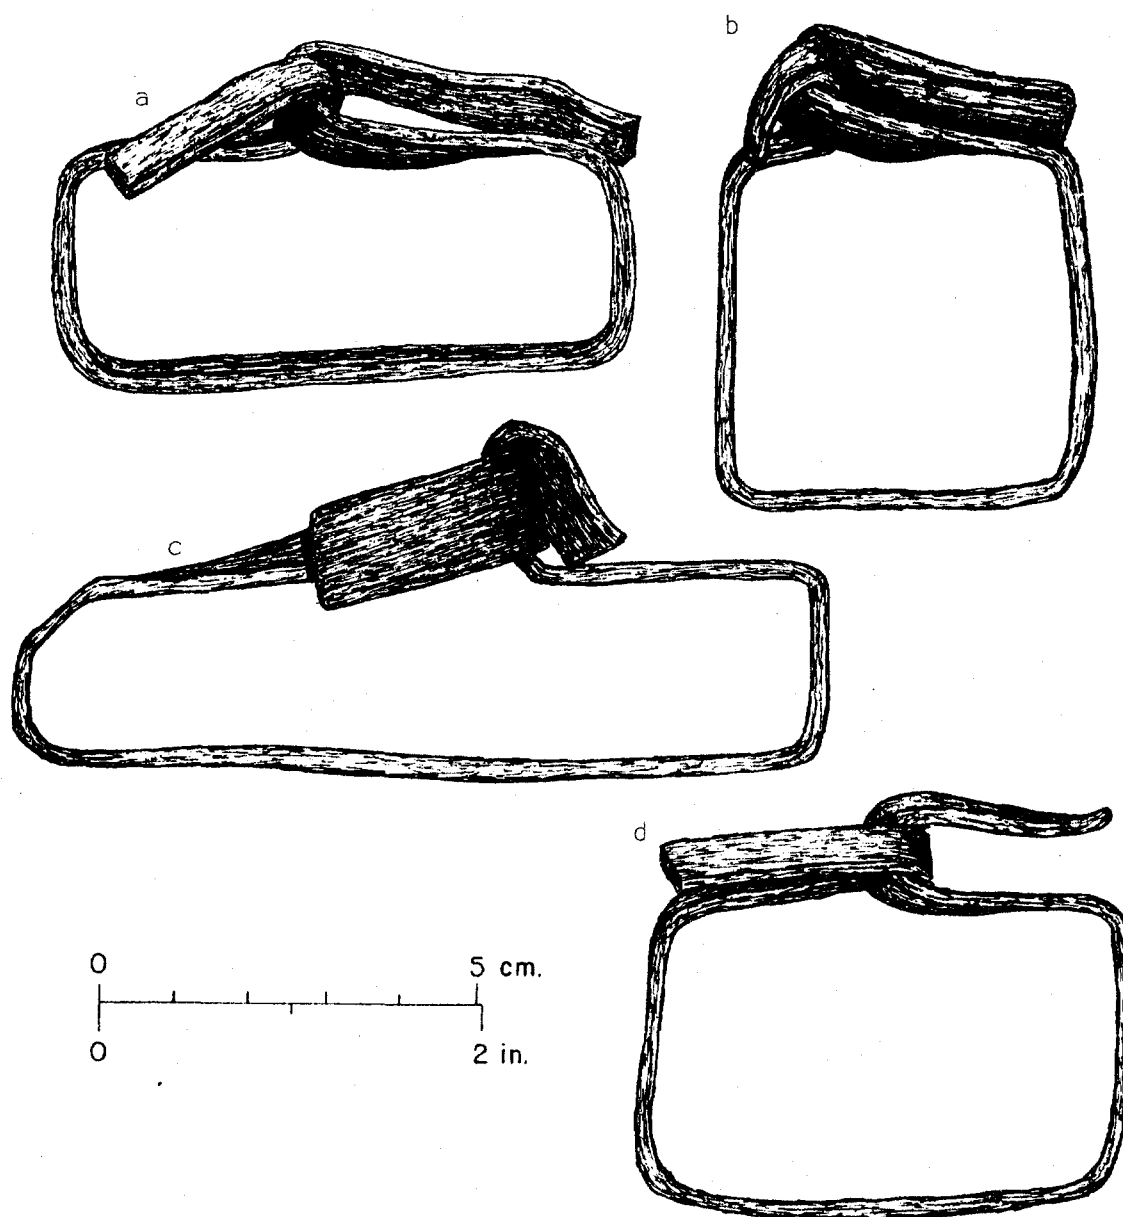
Fig. 175 -- Bundling straps from the Iron Store area: a). bundling strap (FOVA IS 44); b). bundling strap (FOVA IS 53); c). bundling strap (FOVA IS 46 and d). bundling strap (FOVA IS 54).

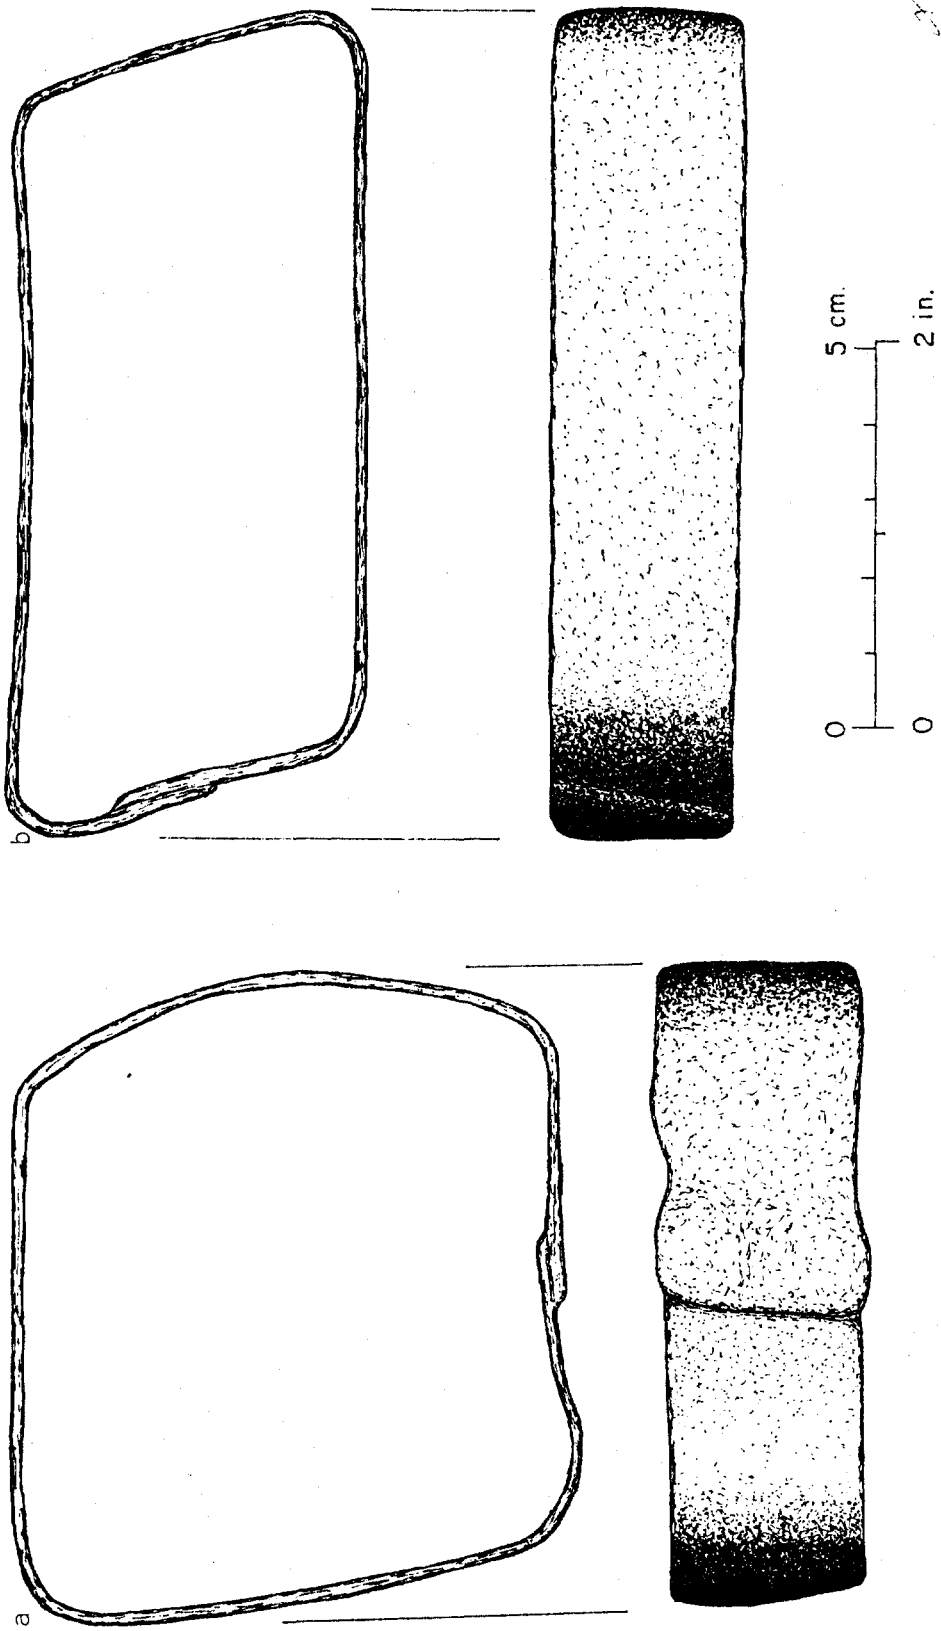
Fig. 176 -- Iron bands from the Iron Store area: a). iron band (FOVA IS 47) and b). iron band (FOVA IS 56).

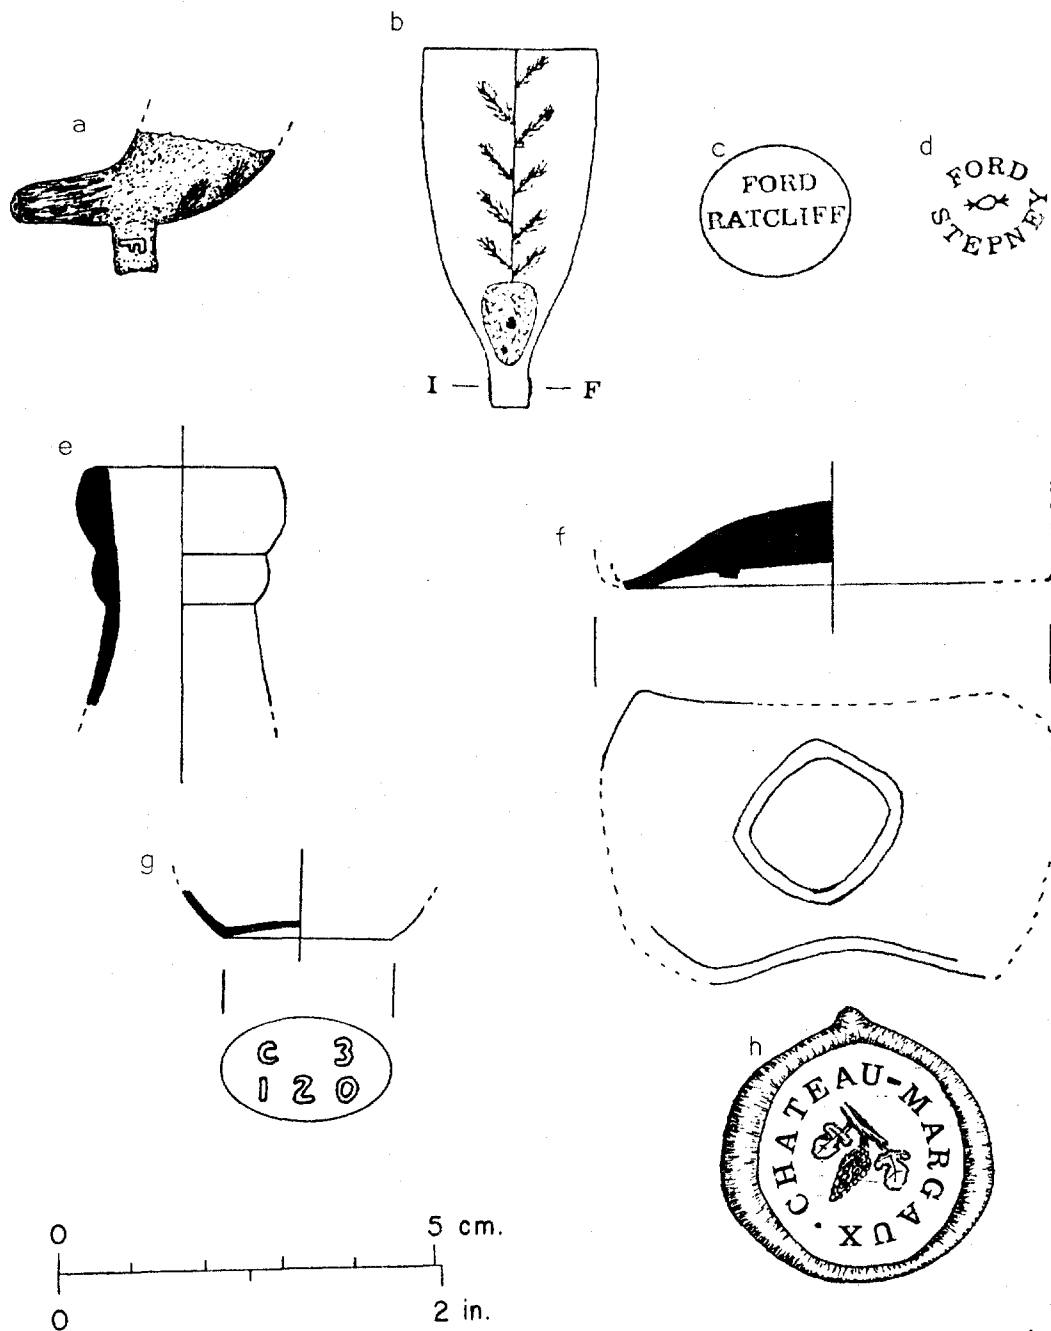
Fig. 177 -- Clay pipes and glass bottles from the SE Bastion area:  
 a). pipe fragment (FOVA 25498); b-d). "FORD" bowl marks;  
 e). bottle rim Type 45 (FOVA 26843); f). bottle base  
 Type 70 (FOVA 26870); g). bottle base Type 71 (FOVA 26928)  
 and h). wine seal (FOVA 25249).

Of the 231 pipe fragments recovered, only one "complete" pipe could be reconstructed (Fig. 177a).

Bowls. Three styles of "FORD" pipes were observed (Figs. 177b-d).

One "I/F" spur fragment had the "Ford" floral design on the bowl seams and the stem was ground to within a 1/2 in. of the spur (Fig. 177a).

One fragment recovered was an olive green glass, seal-marked "Chateau Margaux" claret bottle (Fig.177h). Claret was the British term for the red wines of Bordeaux. Attaching the shoulder seal to the bottle was done after the bottle was completed. A hot gob of glass was applied to the bottle, usually to the shoulder area, became fused, then was impressed with a stamp having the lettering and design debossed backwards on it (Munsey 1970:59).

Nine reconstructed bases were classified into 4 various types on the basis of their manufacturing attributes and form (Table 54). Two new base types were identified and have been illustrated in Figs. 177f-g. One small clear base (Type 71) had raised lettering and numbers in its central portion which read "C3/120".

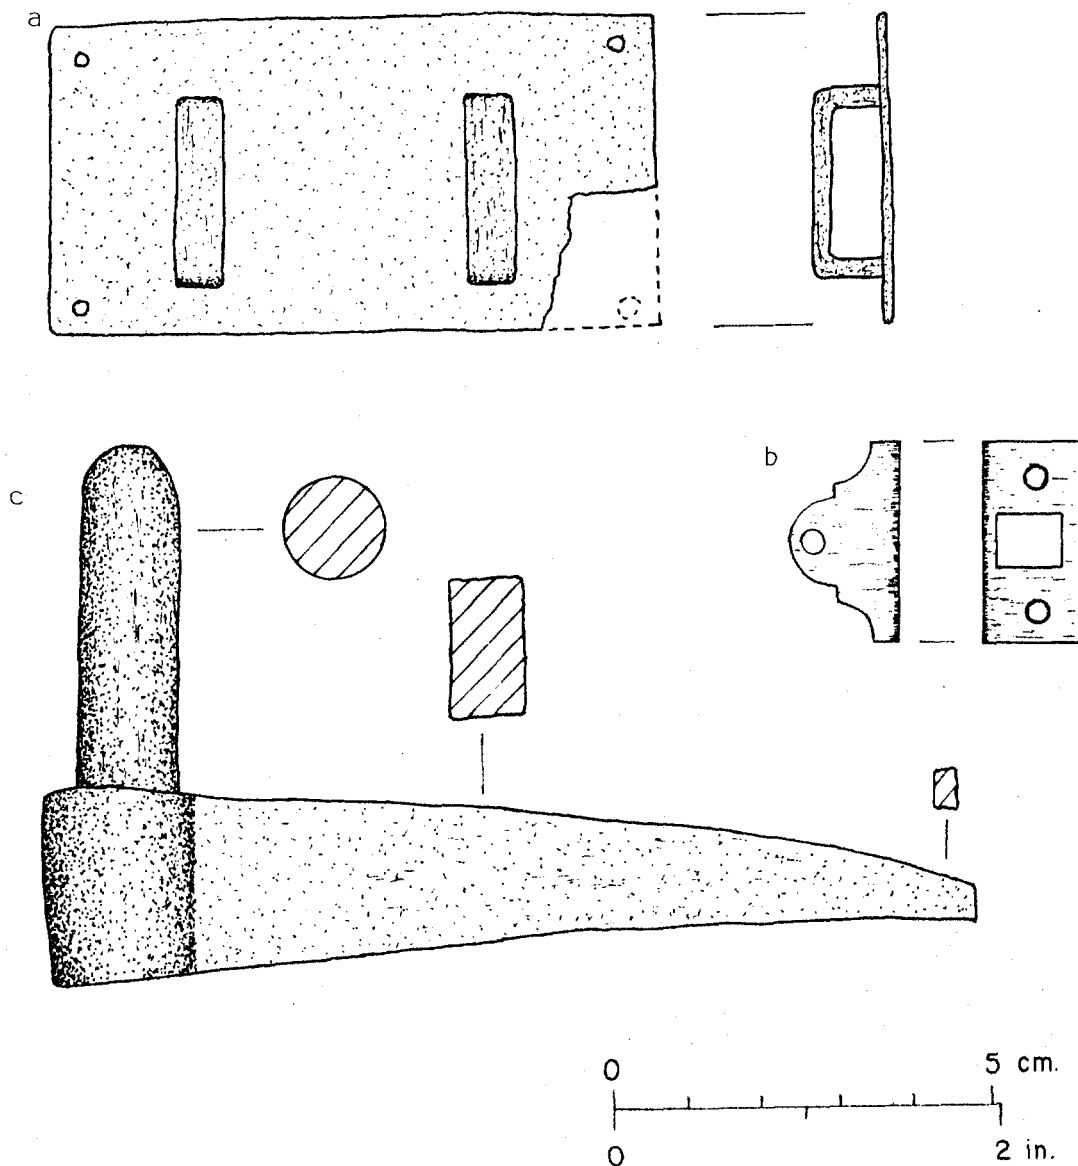
Fig. 178 -- Building hardware from the SE Bastion area: a). sliding bolt keeper (FOVA 15332); b). bolt striker plate (brass) (FOVA 15325); c). pintle (FOVA 25278).

Of the 8 specimens of building hardware recovered, 3 previously unreported specimens were identified. These include a new variety of pintle (Fig. 178c), a lightweight brass lock striker plate (Fig. 178b) and a sliding bolt keeper (Fig. 178a). In addition, a stock lock mechanism with brass escutcheon and a pintle-hung strap hinge fragment were recovered.

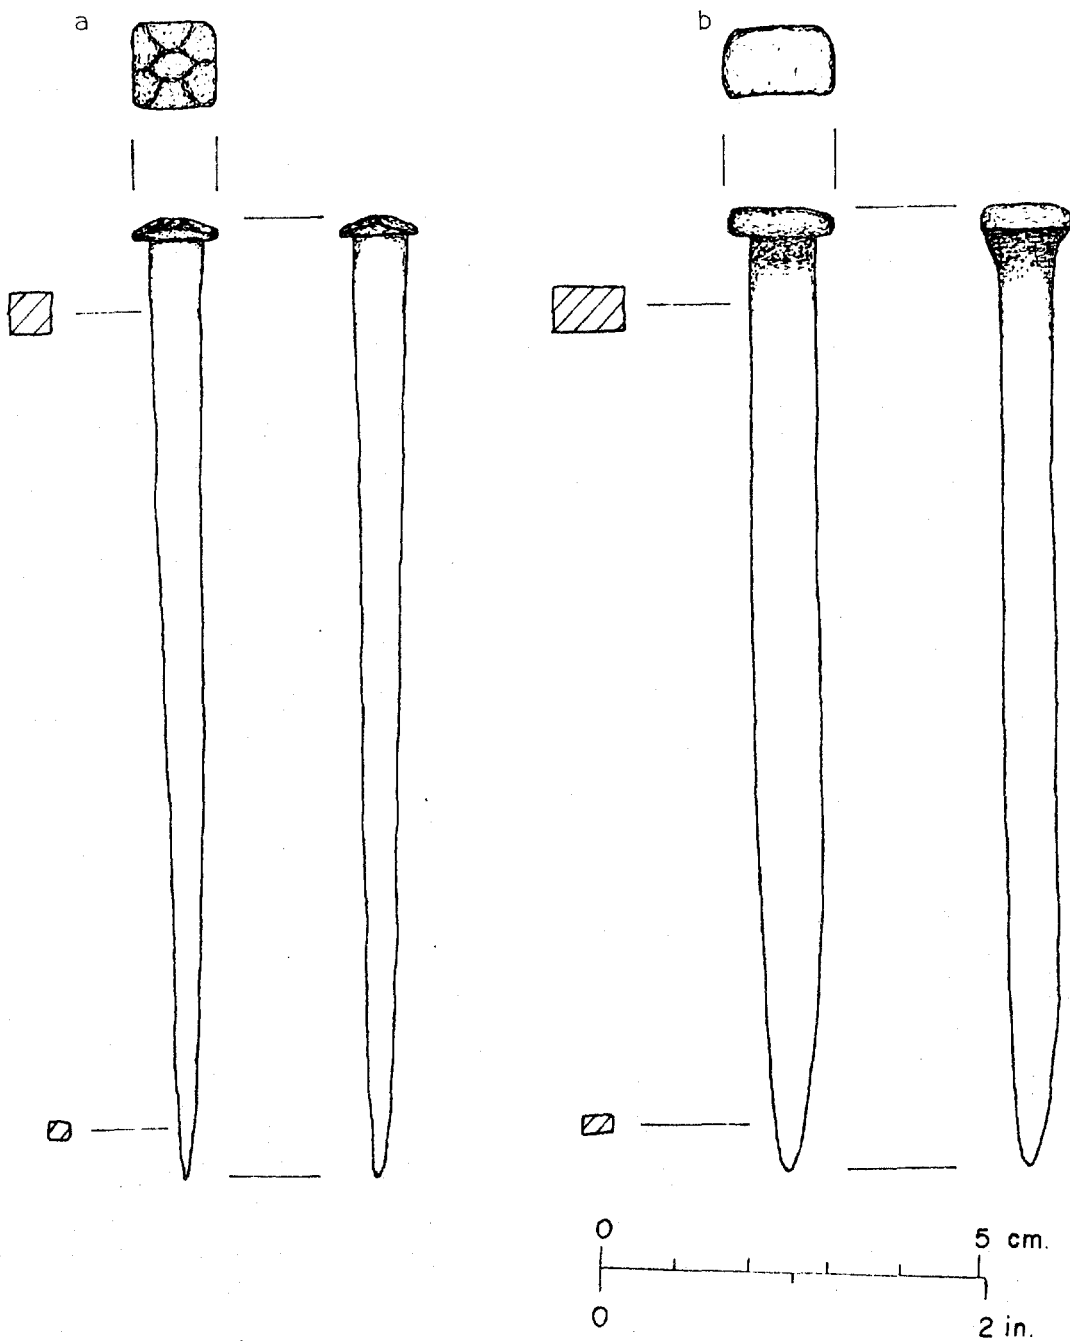
Fig. 179 -- Nails from the SE Bastion area: a). Variety #1133 -- L=10.9 cm. (FOVA 26825) and b). Variety #1134 -- L=17.0 cm. (FOVA 27017).

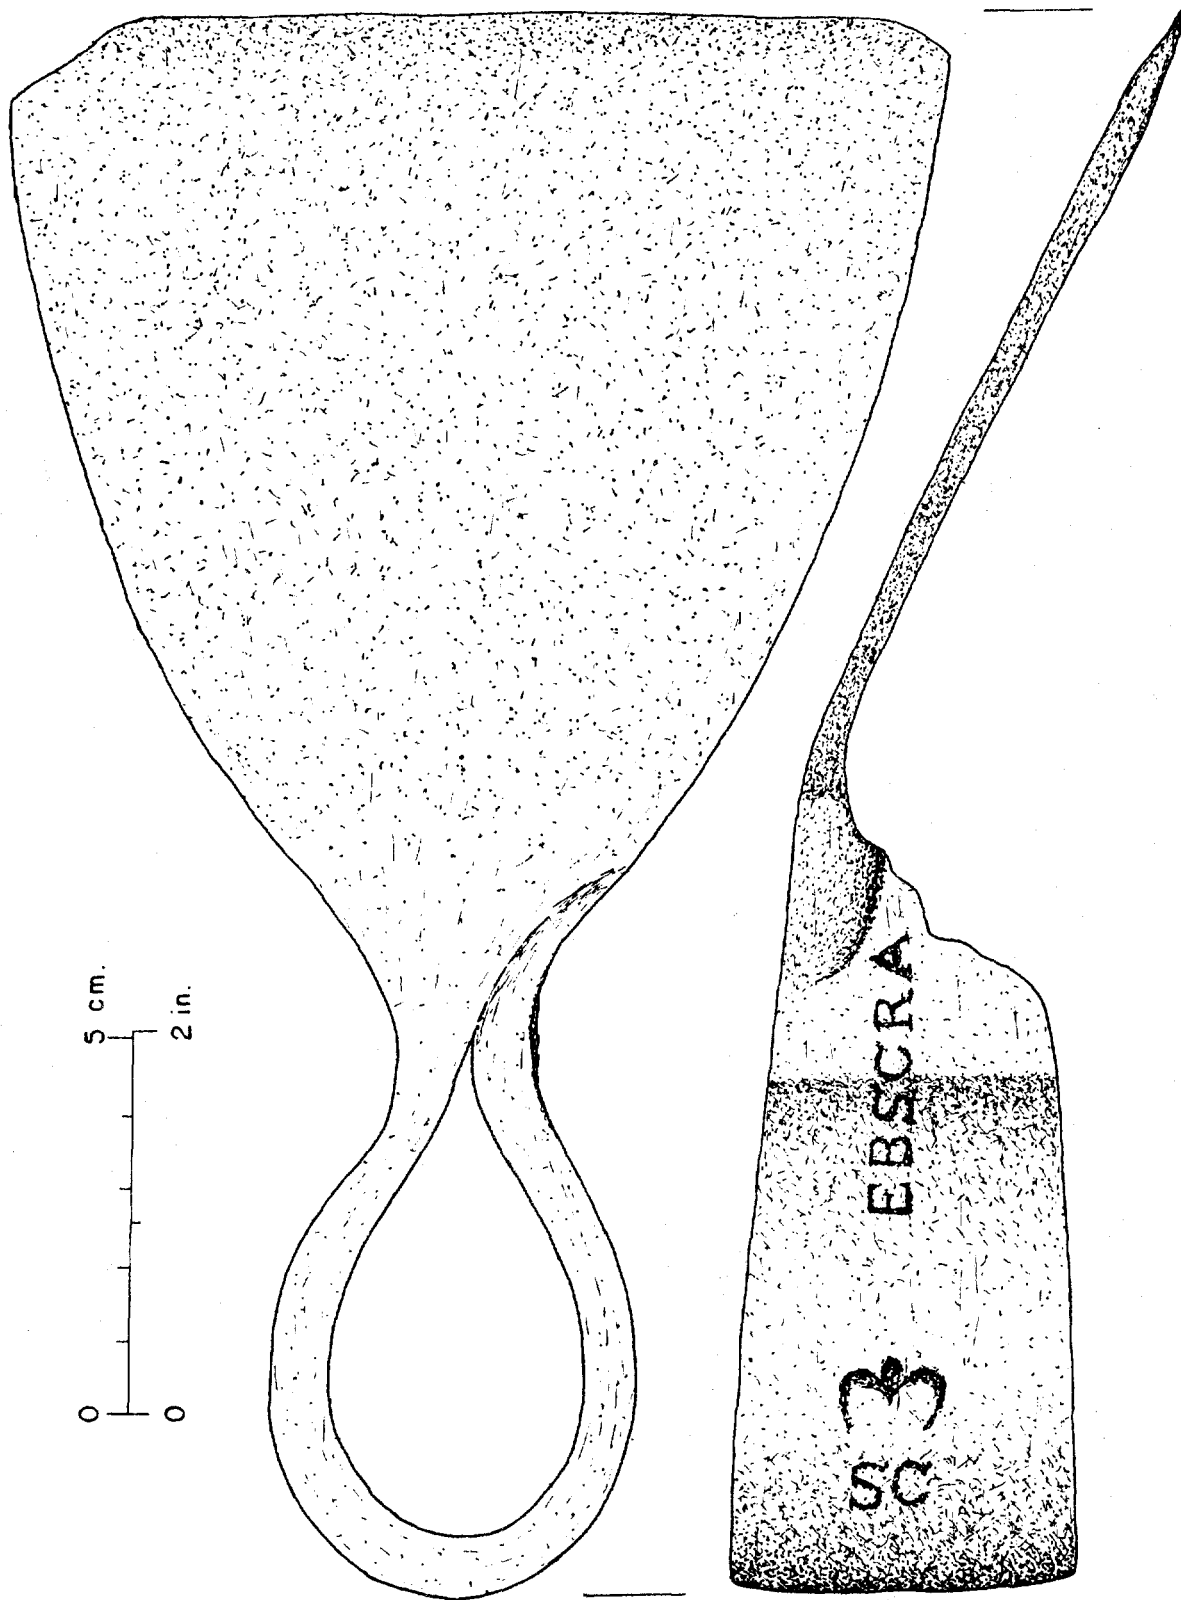
Fig. 180 -- Adze from the SE Bastion area (FOVA 27018).

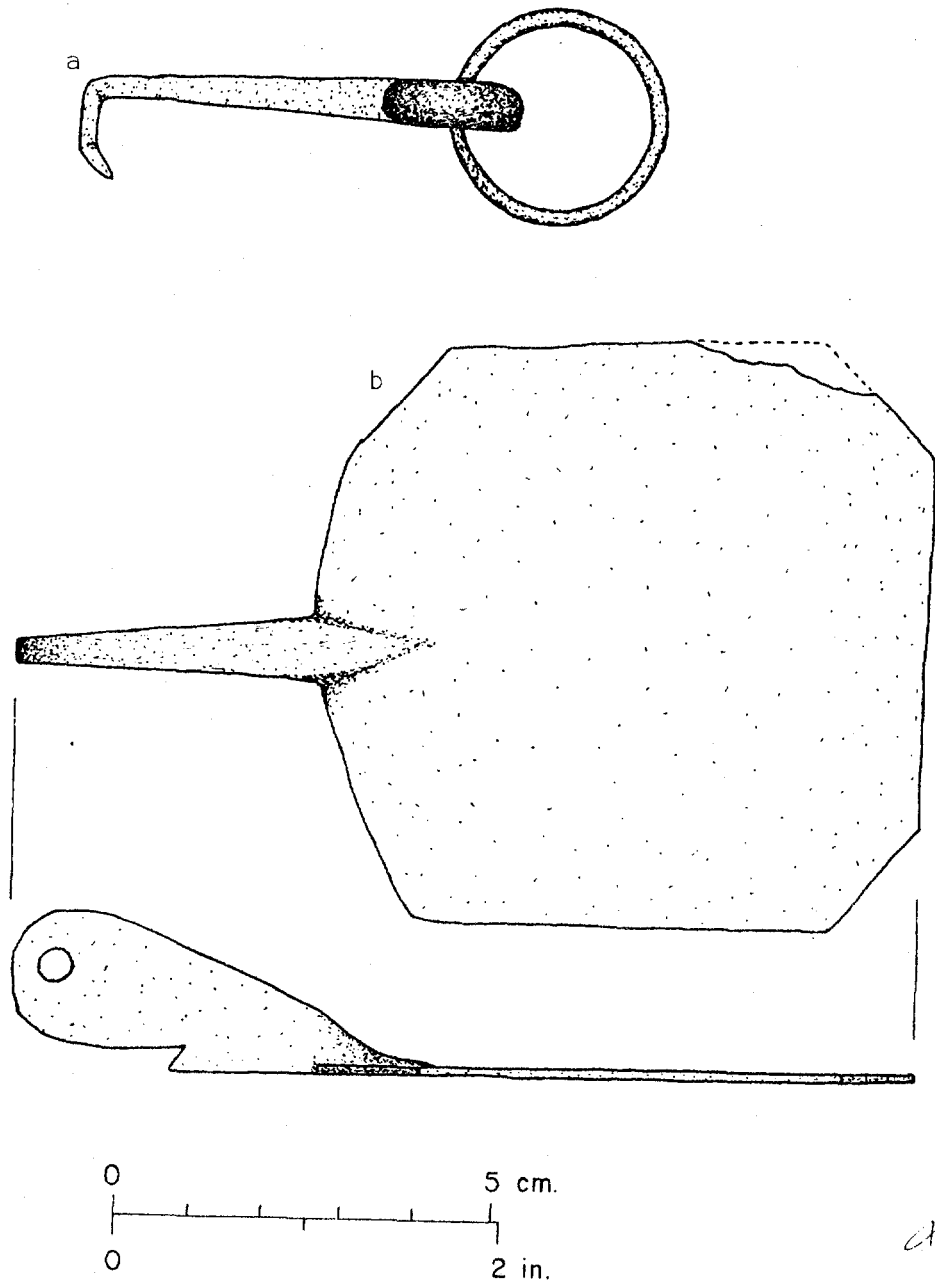
Fig. 181 -- Closed eye nail with o-ring and trap pan from SE Bastion area: a). closed eye nail with o-ring (FOVA 26829) and b). trap pan (FOVA 25288).

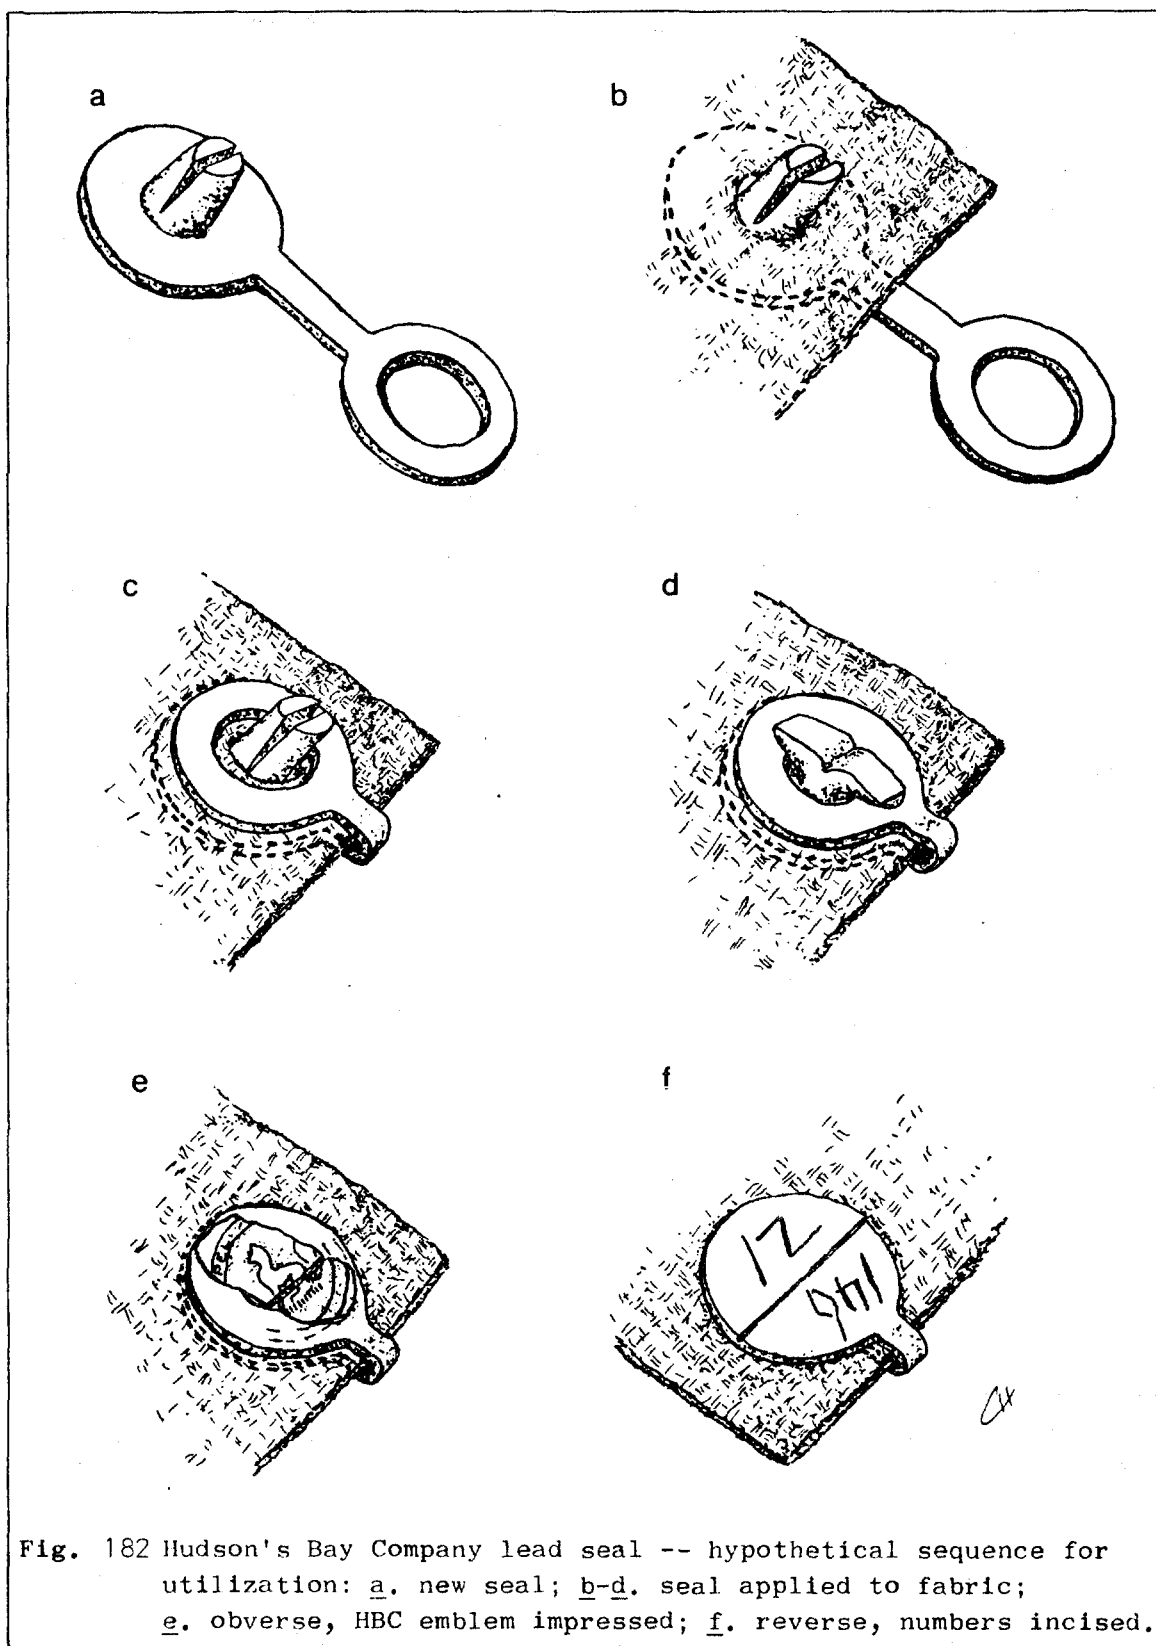
Fig. 182 Hudson's Bay Company lead seal -- hypothetical sequence for utilization: a. new seal; b-d. seal applied to fabric; e. obverse, HBC emblem impressed; f. reverse, numbers incised.

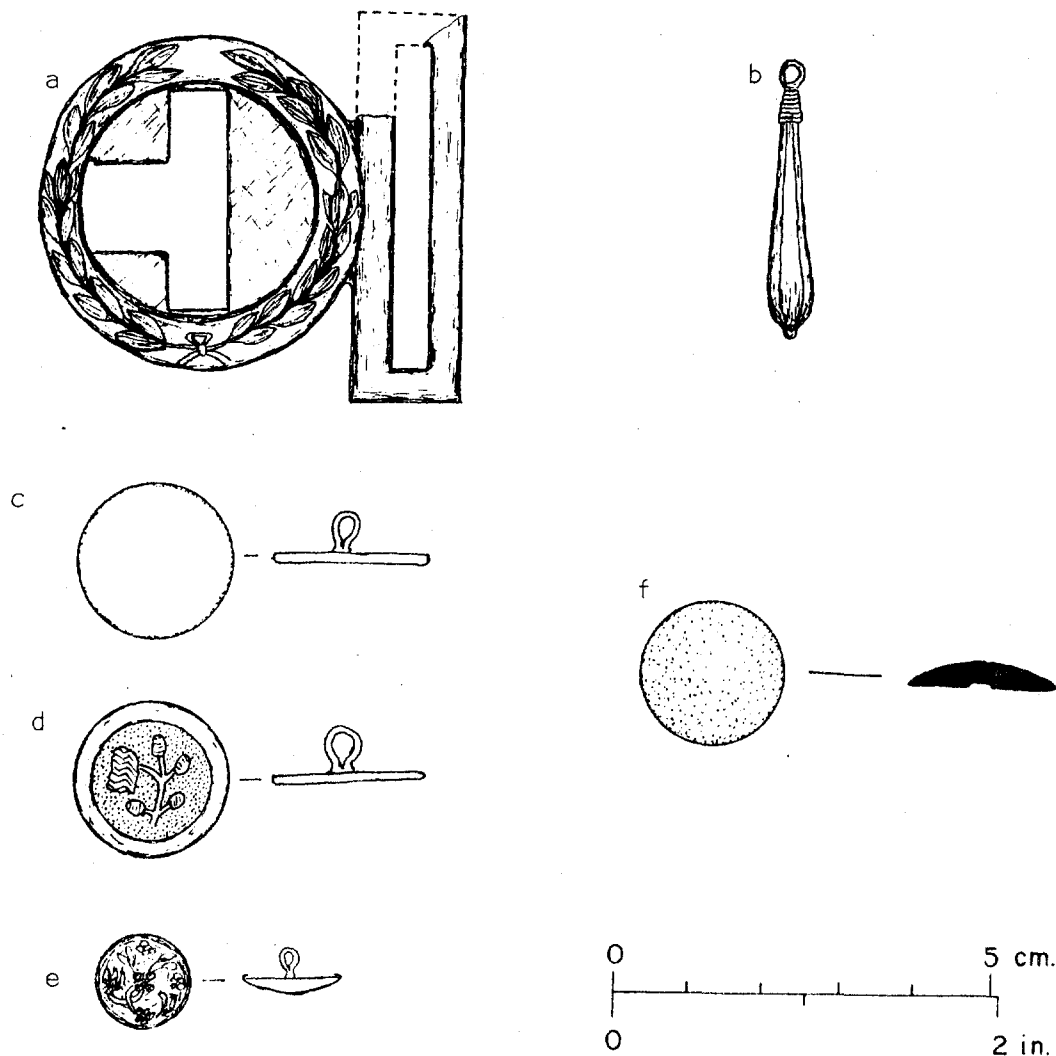
Fig. 183 -- Metal personal items and buttons from the SE Bastion area:  
a). waist belt plate (FOVA 26832); b). earring (FOVA 25512);  
c). button Type IZ (FOVA 26991); d). button Type IAA  
(FOVA 25360); e). button Type IIT (FOVA 25595); and f).  
bone button (FOVA 25314).

Of the 23 items recovered, those new or unique items not previously reported have been illustrated in Figs. 183a-e.

Of the 10 buttons recovered, all were complete and the 3 new types observed have been illustrated in Figs. 183c-e (Table 59).

The only new or unique item recovered was a bone button (Fig. 183f).

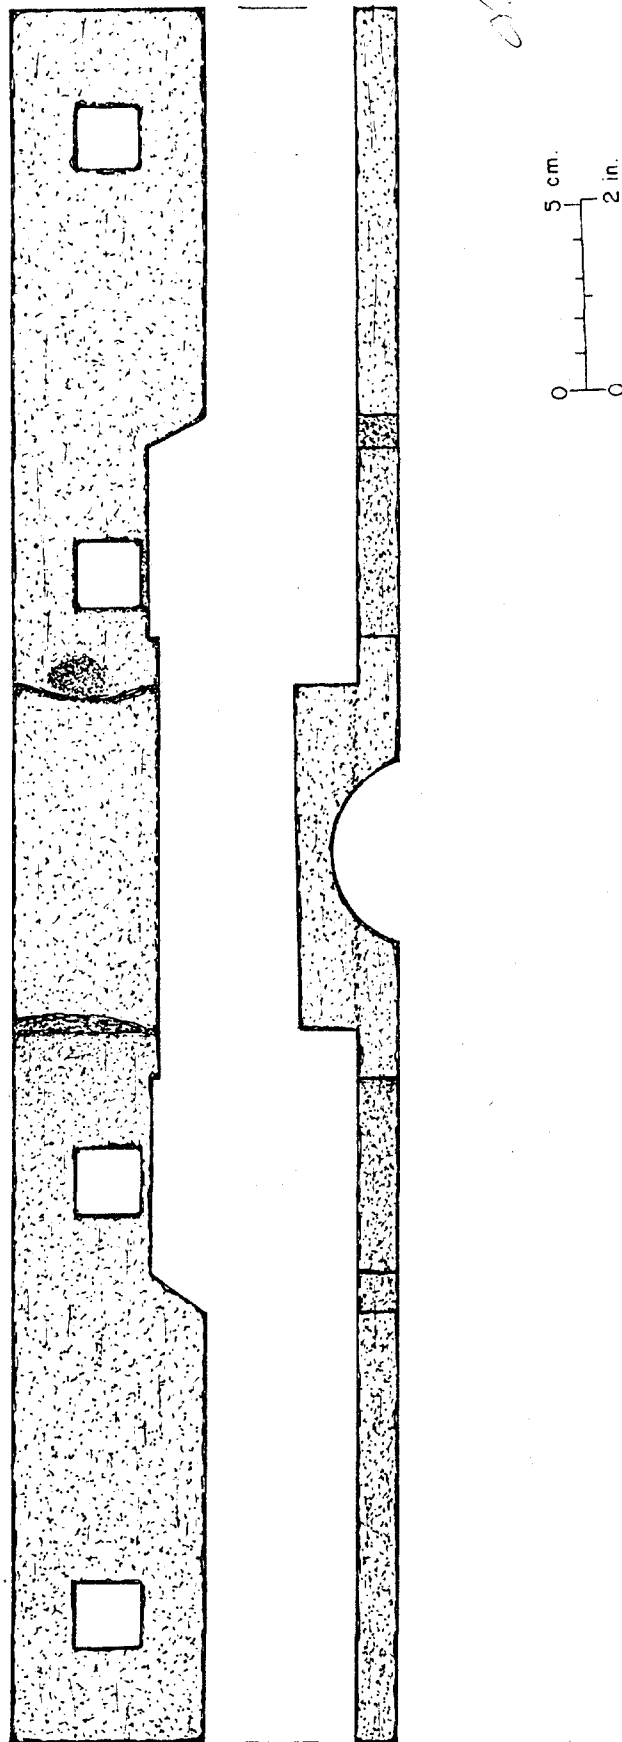
Fig. 184 -- Cannon carriage cap square from the SE Bastion area (FOVA 26891).
