FORT VANCOUVER EXCAVATIONS - X

Southeastern Fort Area

National Park Service

July 1975

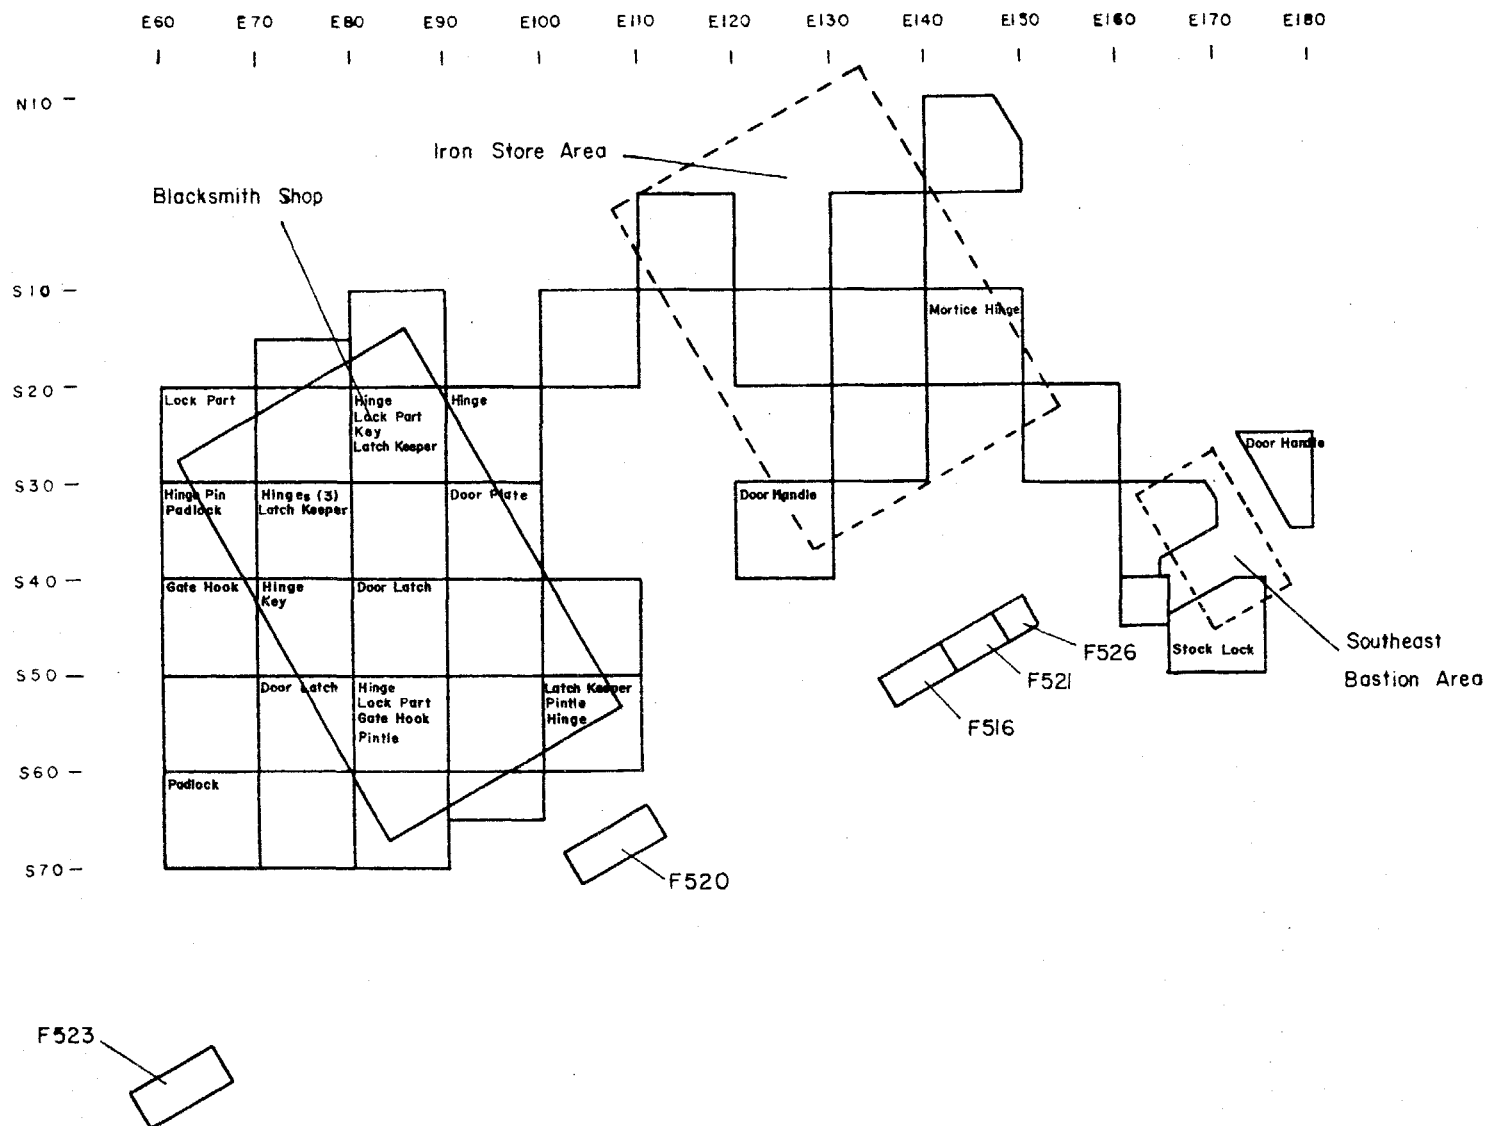
Fig.185 -- Distribution of metal building hardware for the southeastern Fort area.

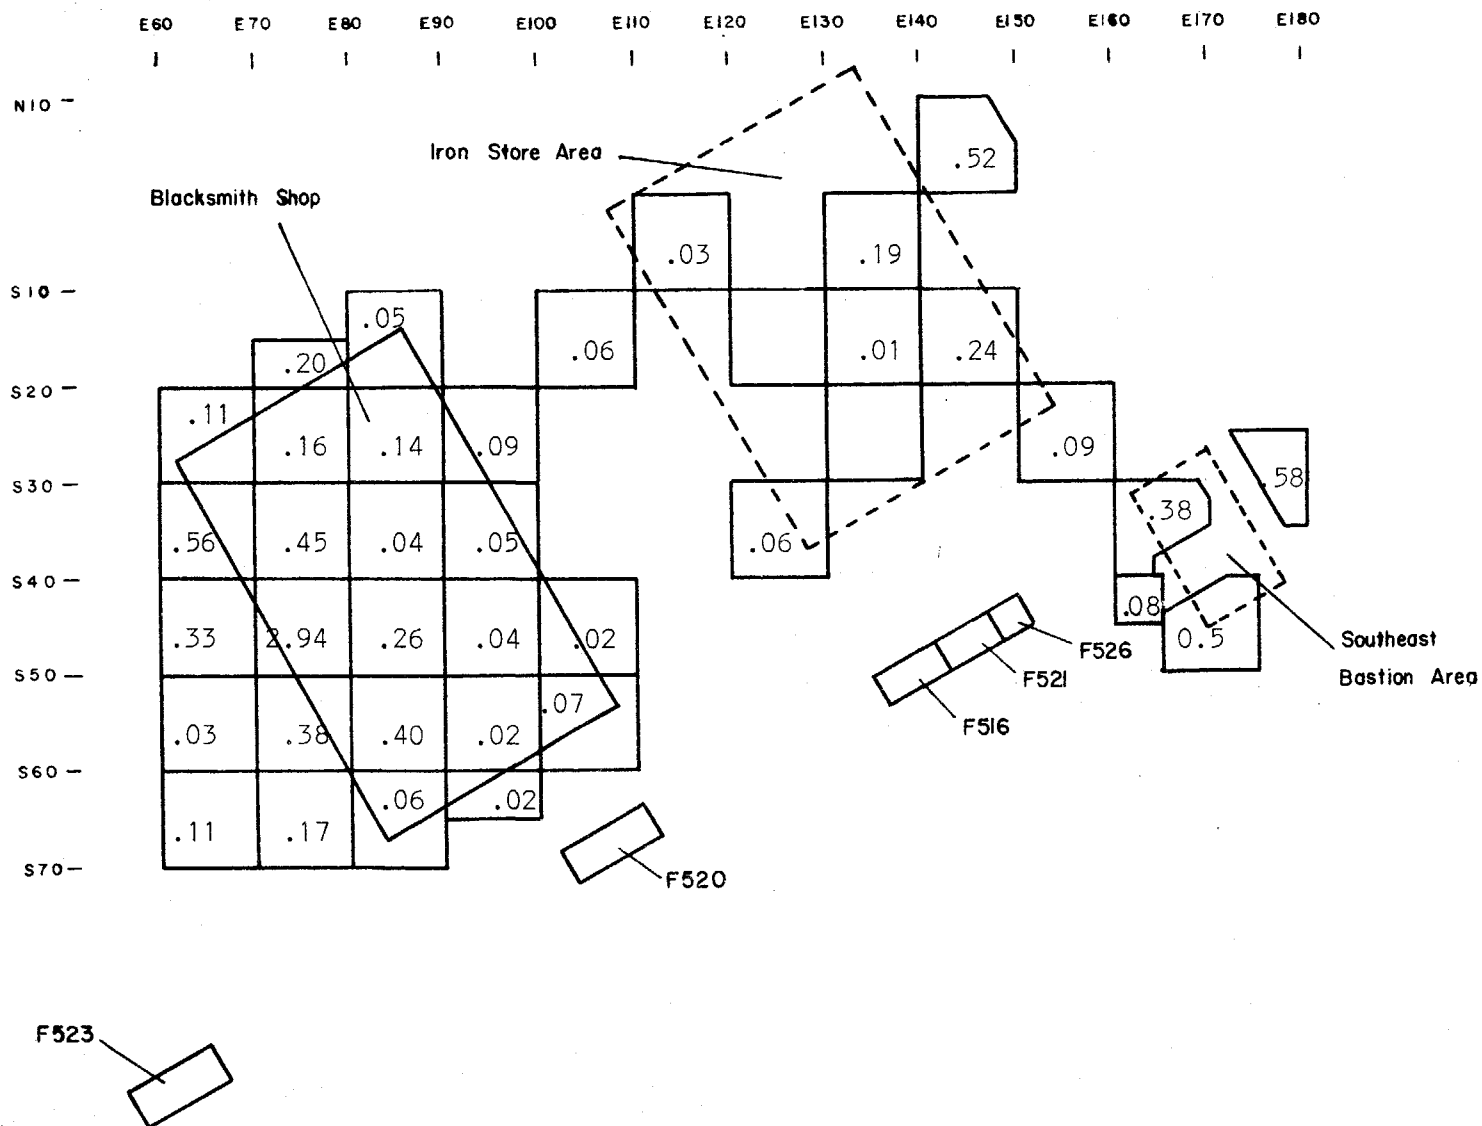
Fig. 186 -- Distribution of window glass in the southeastern Fort area (f/ft<sup>2</sup>).

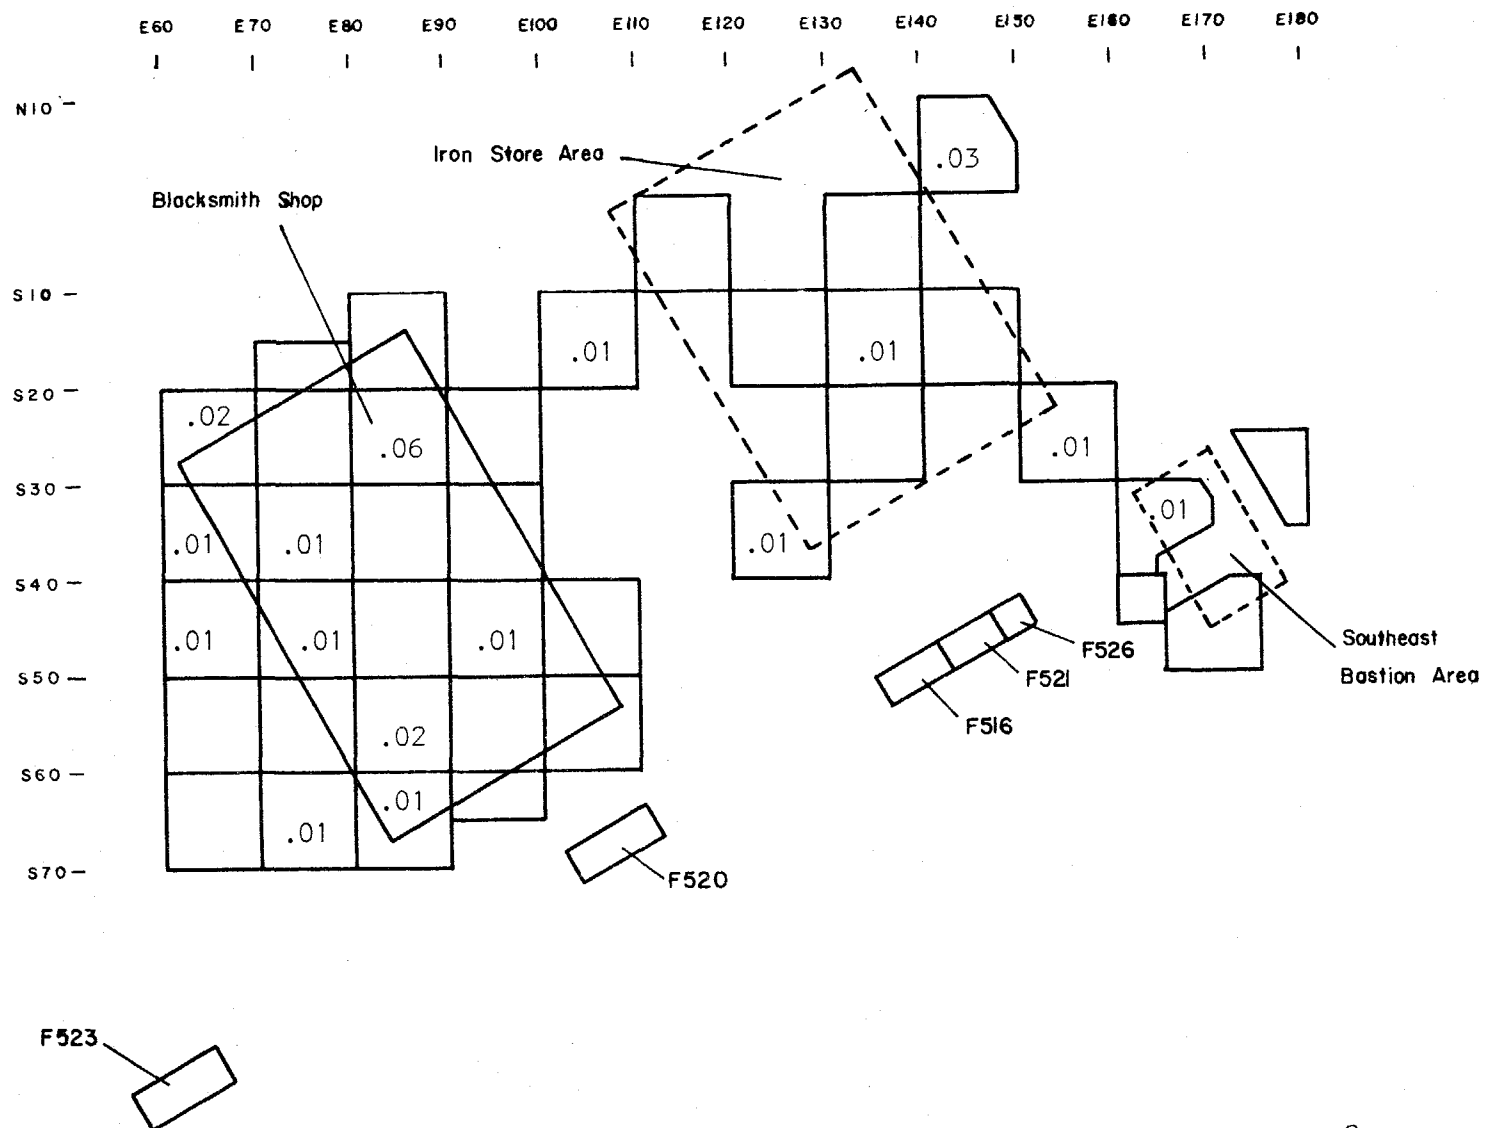
Fig.187 -- Distribution of Variety #1001 nails for the southeastern Fort area ( $f/ft^2$ ).

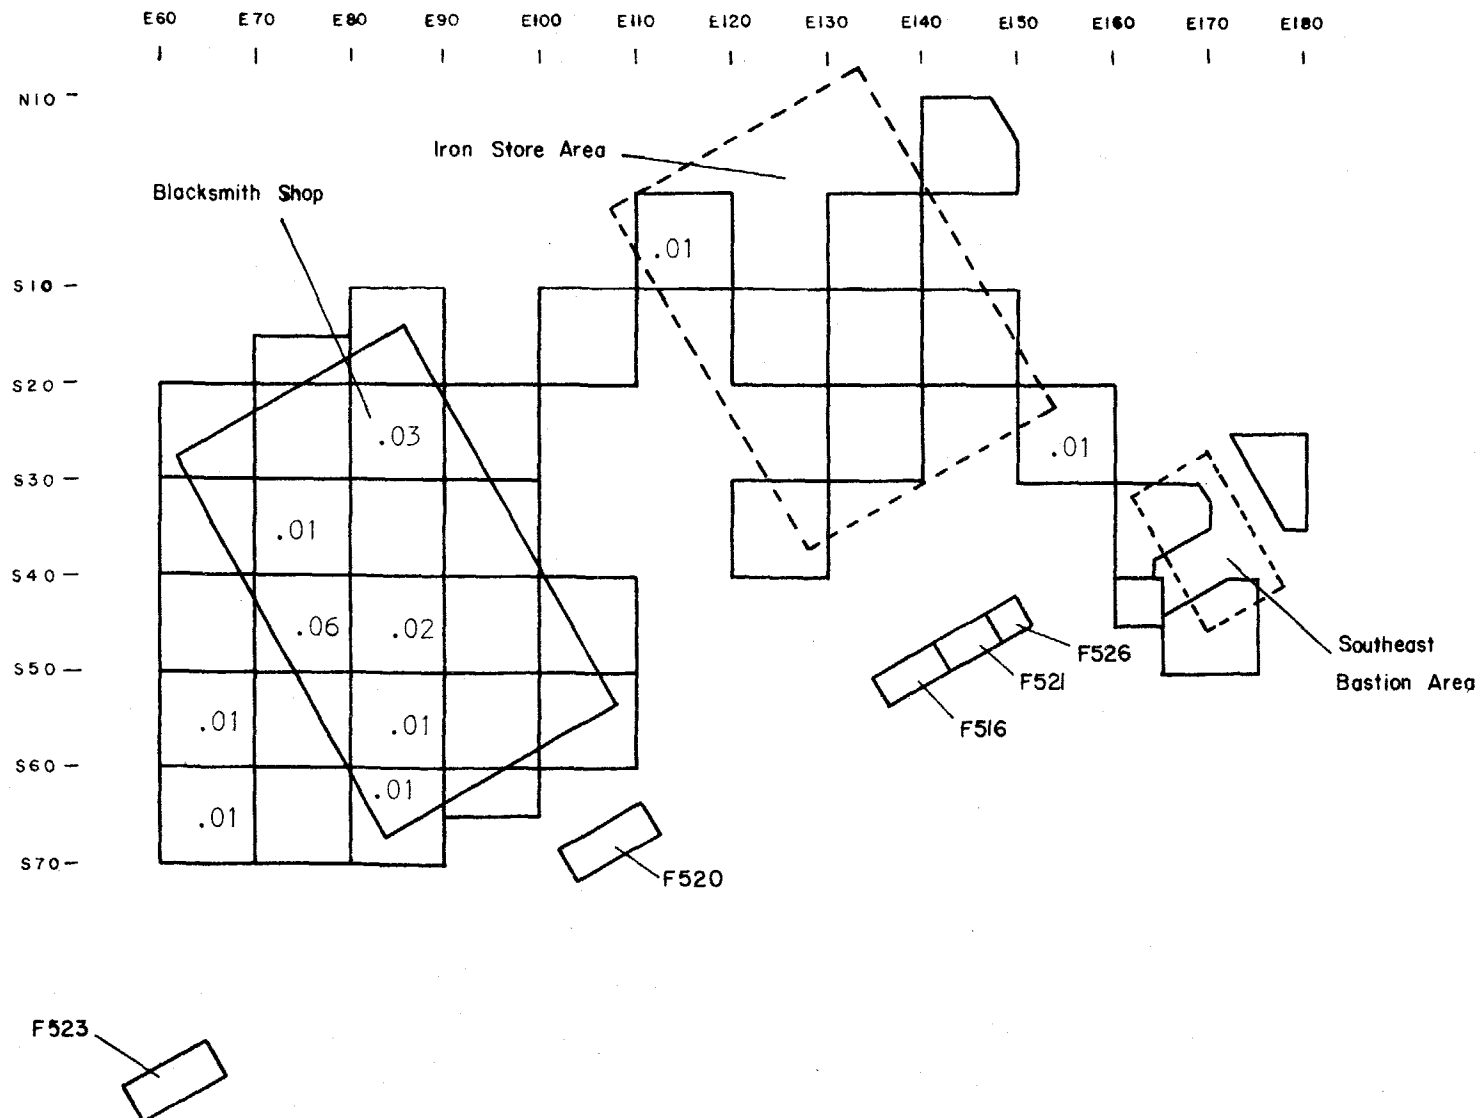
Fig. 189 -- Distribution of "Dog" nails (Varieties # 1021, 1022, 1025, 1090 & 1126) for the southeastern Fort area (f/ft<sup>2</sup>).

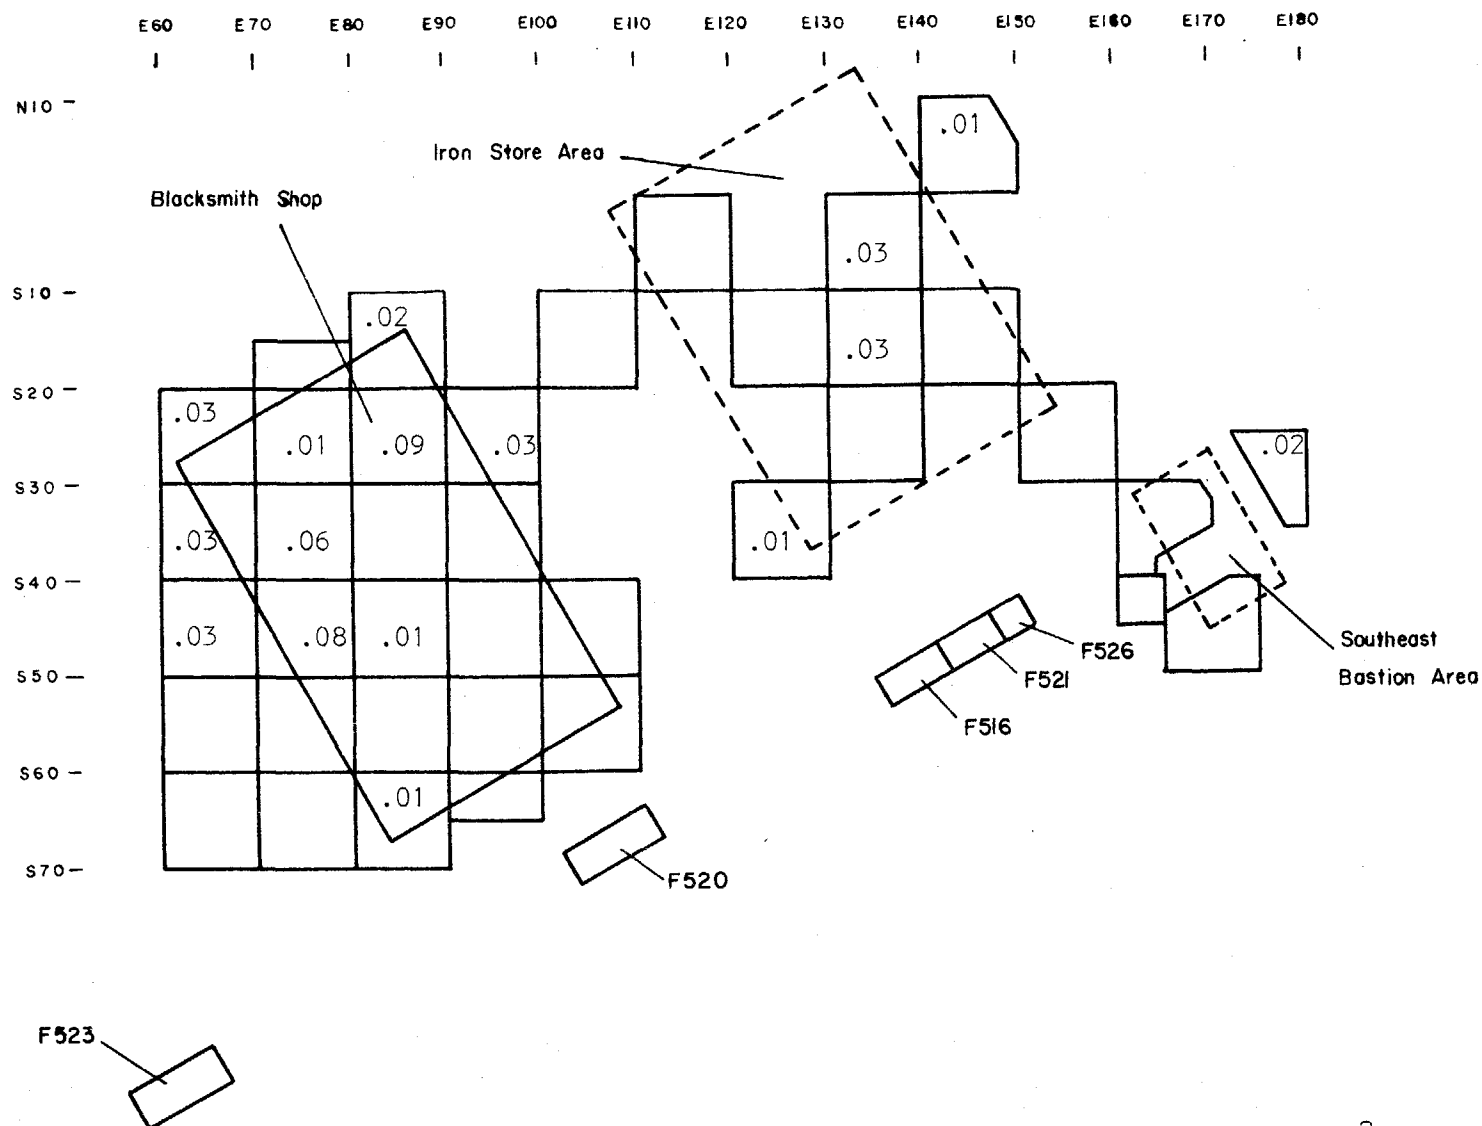
Fig.190 -- Distribution of Variety #2001 nails for the southeastern Fort area ( $f/ft^2$ ).

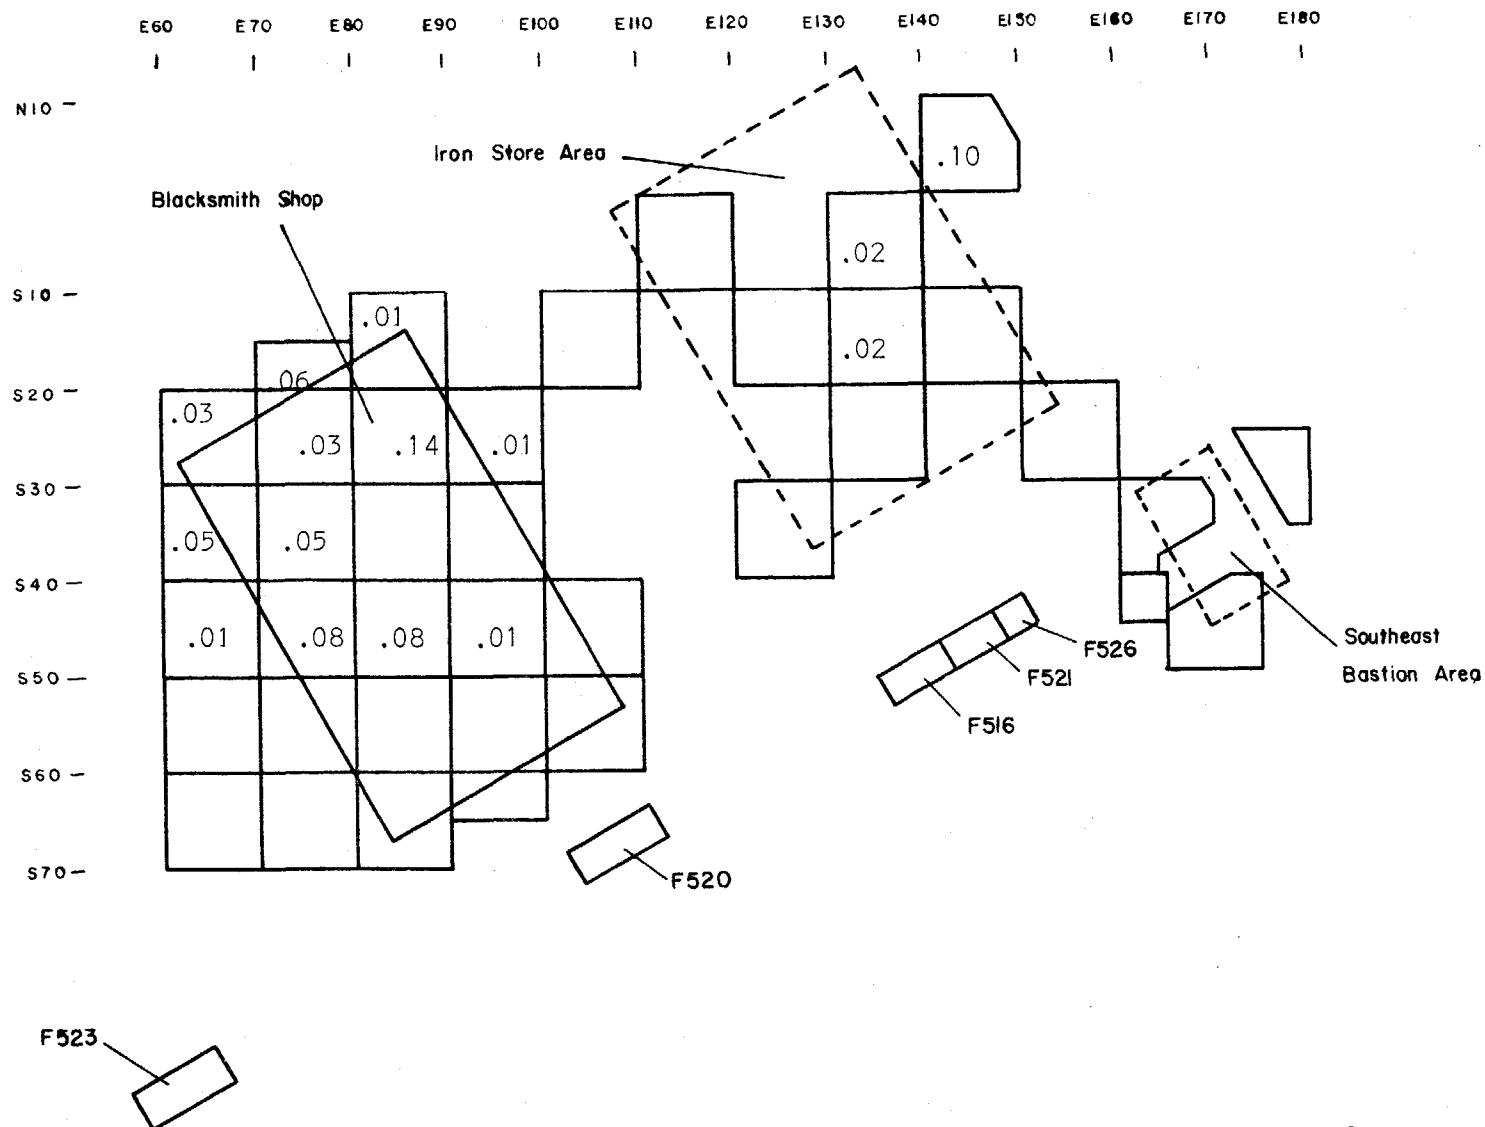
Fig. 191 -- Distribution of Variety #2002 nails for the southeastern Fort area ( $f/ft^2$ ).

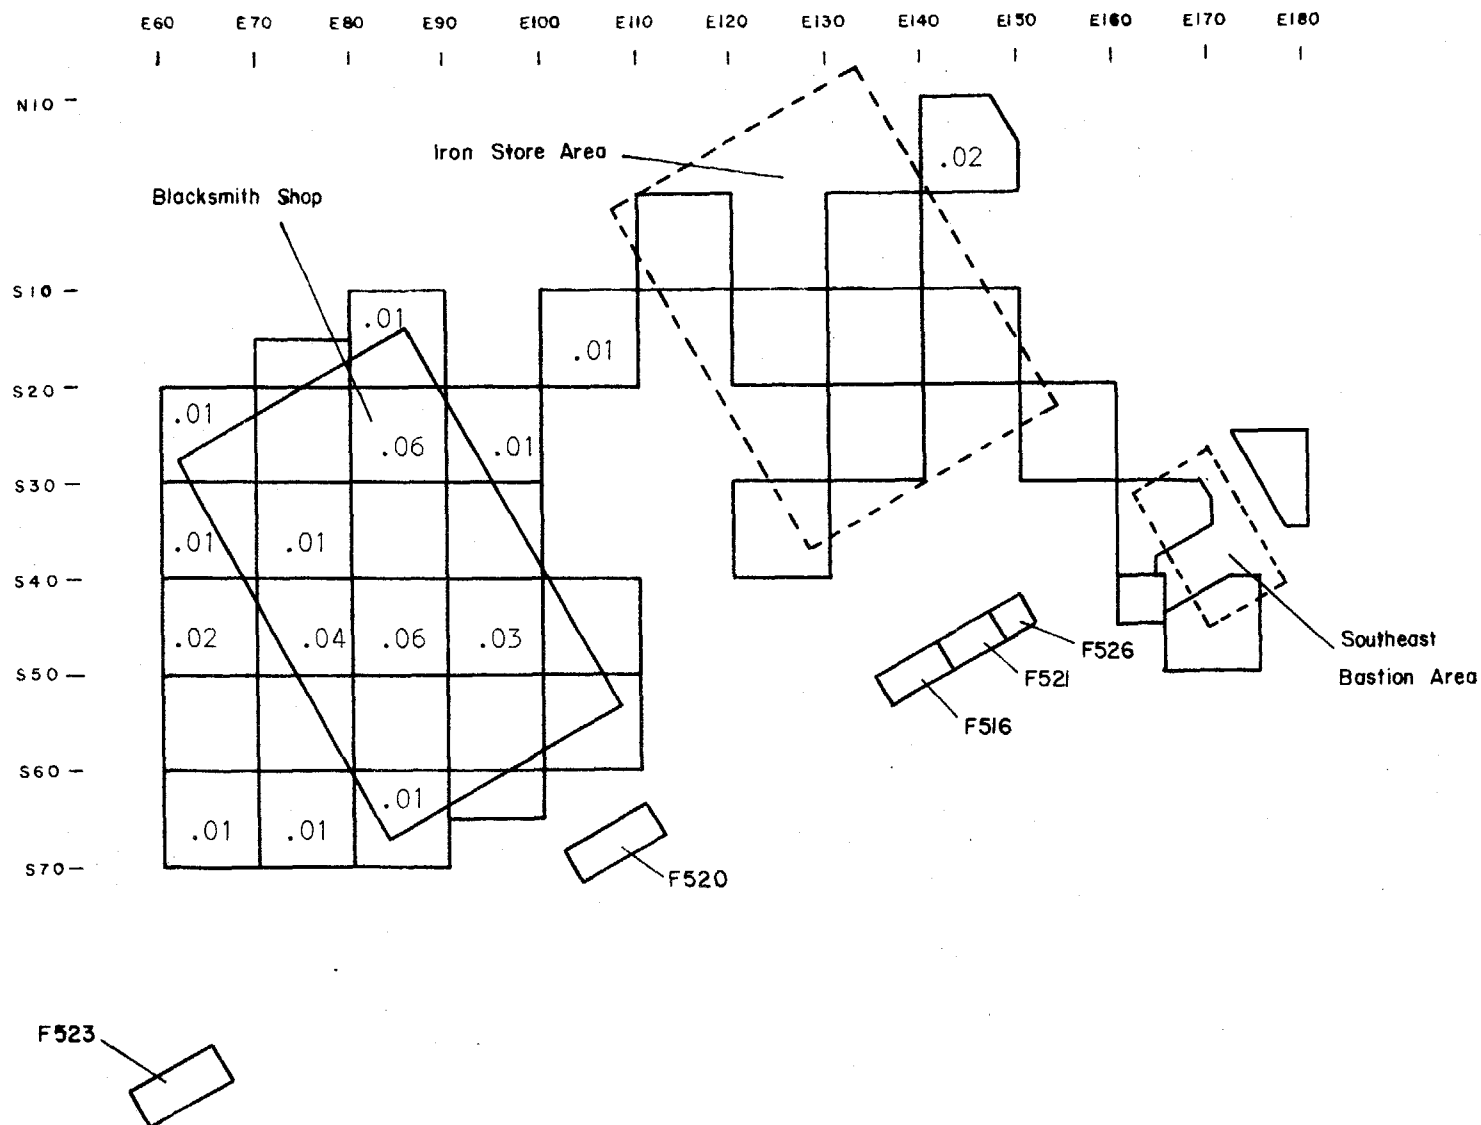
Fig.192 -- Distribution of Variety # 2004 nails for the southeastern Fort area (f/ft<sup>2</sup>).

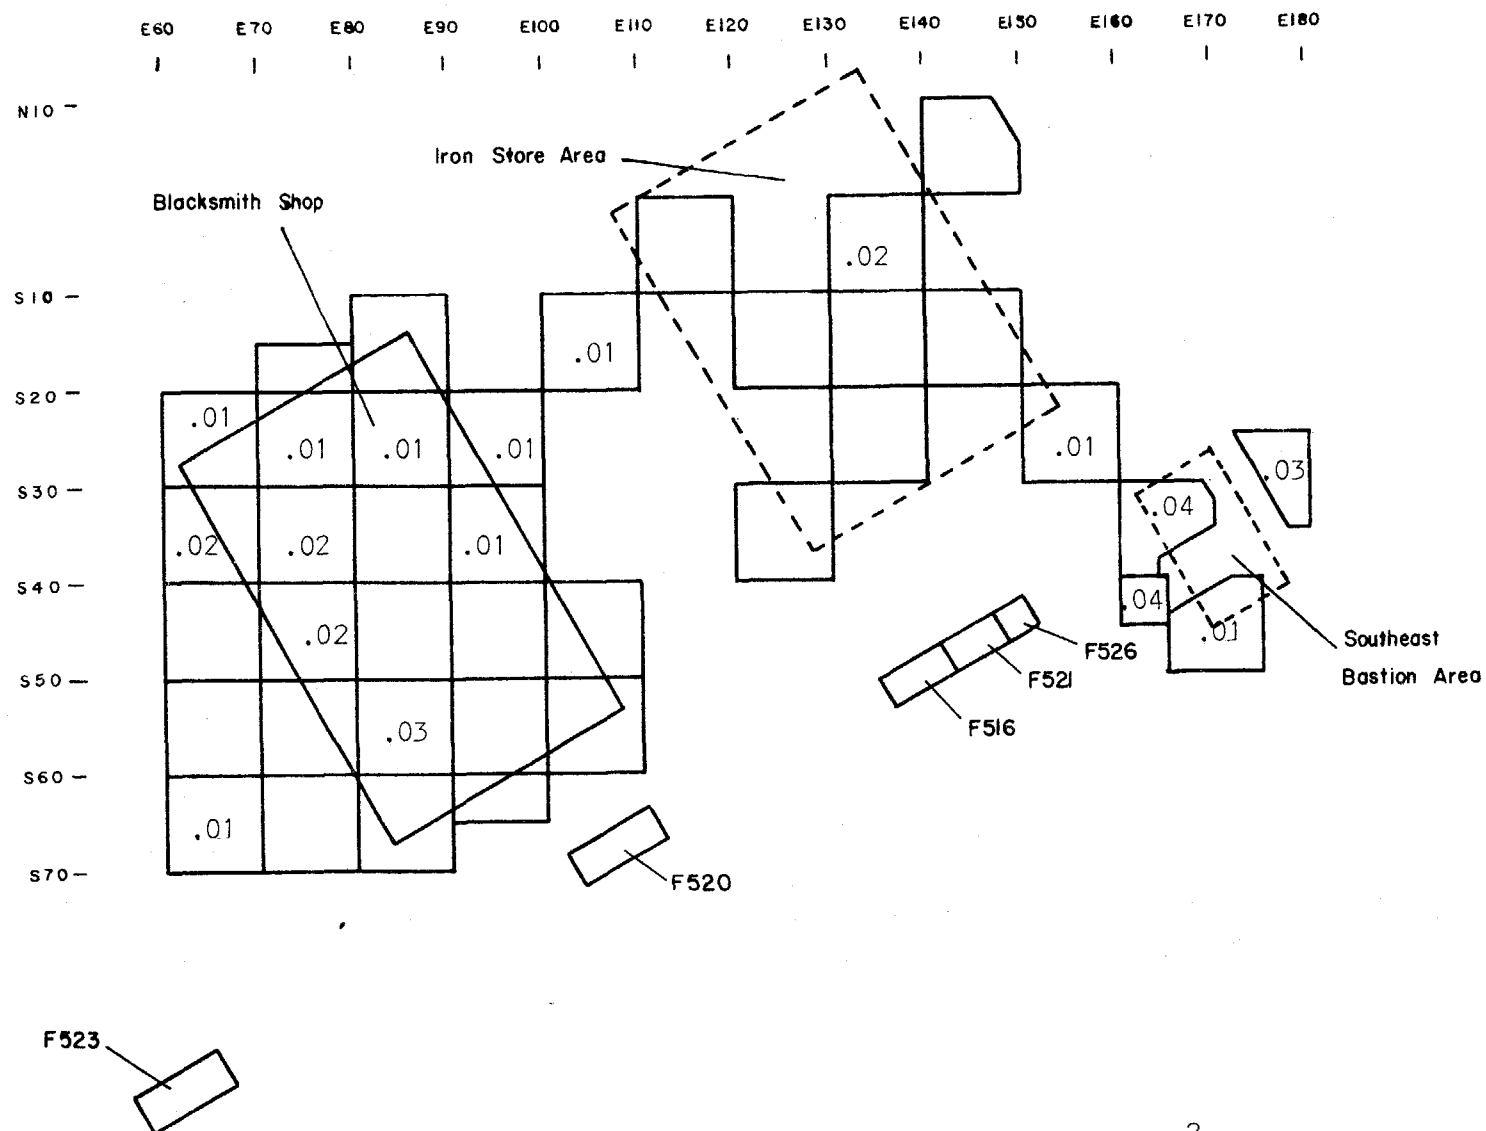
Fig.193 -- Distribution of cast nails in the southeastern Fort area (f/ft<sup>2</sup>).

Two concentrations of cast nails were observed (Fig. 193)--the Blacksmith Shop and Southeast Bastion. Cast nails within the Shop probably reflects the industrial activities of the blacksmith, whereas the nails within the Bastion area may indicate the use of zinc or copper sheeting as a fire retardant.

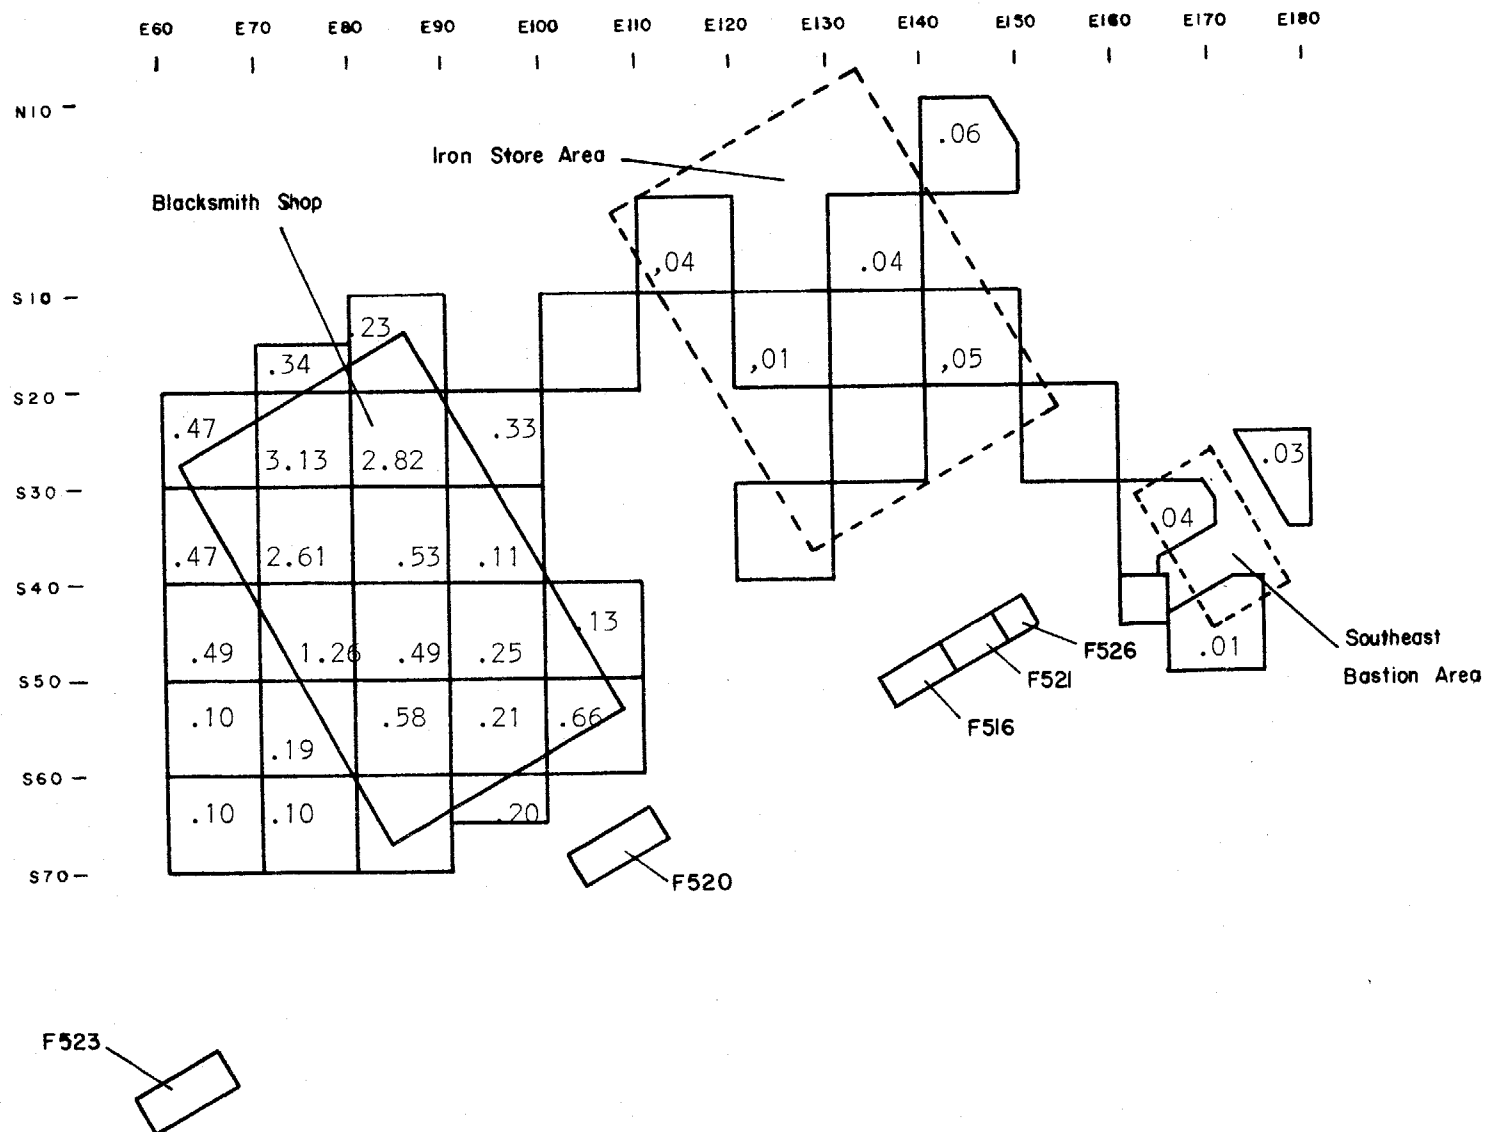
Fig.194 -- Distribution of imported firebrick in the southeastern Fort area (f/ft<sup>2</sup>).

One concentration of imported firebrick was found along the north wall of the Blacksmith Shop (Fig. 194). Firebrick undoubtedly was used in the construction of the hearth and fire box of the forge, and this concentration probably denotes the location of at least one forge.

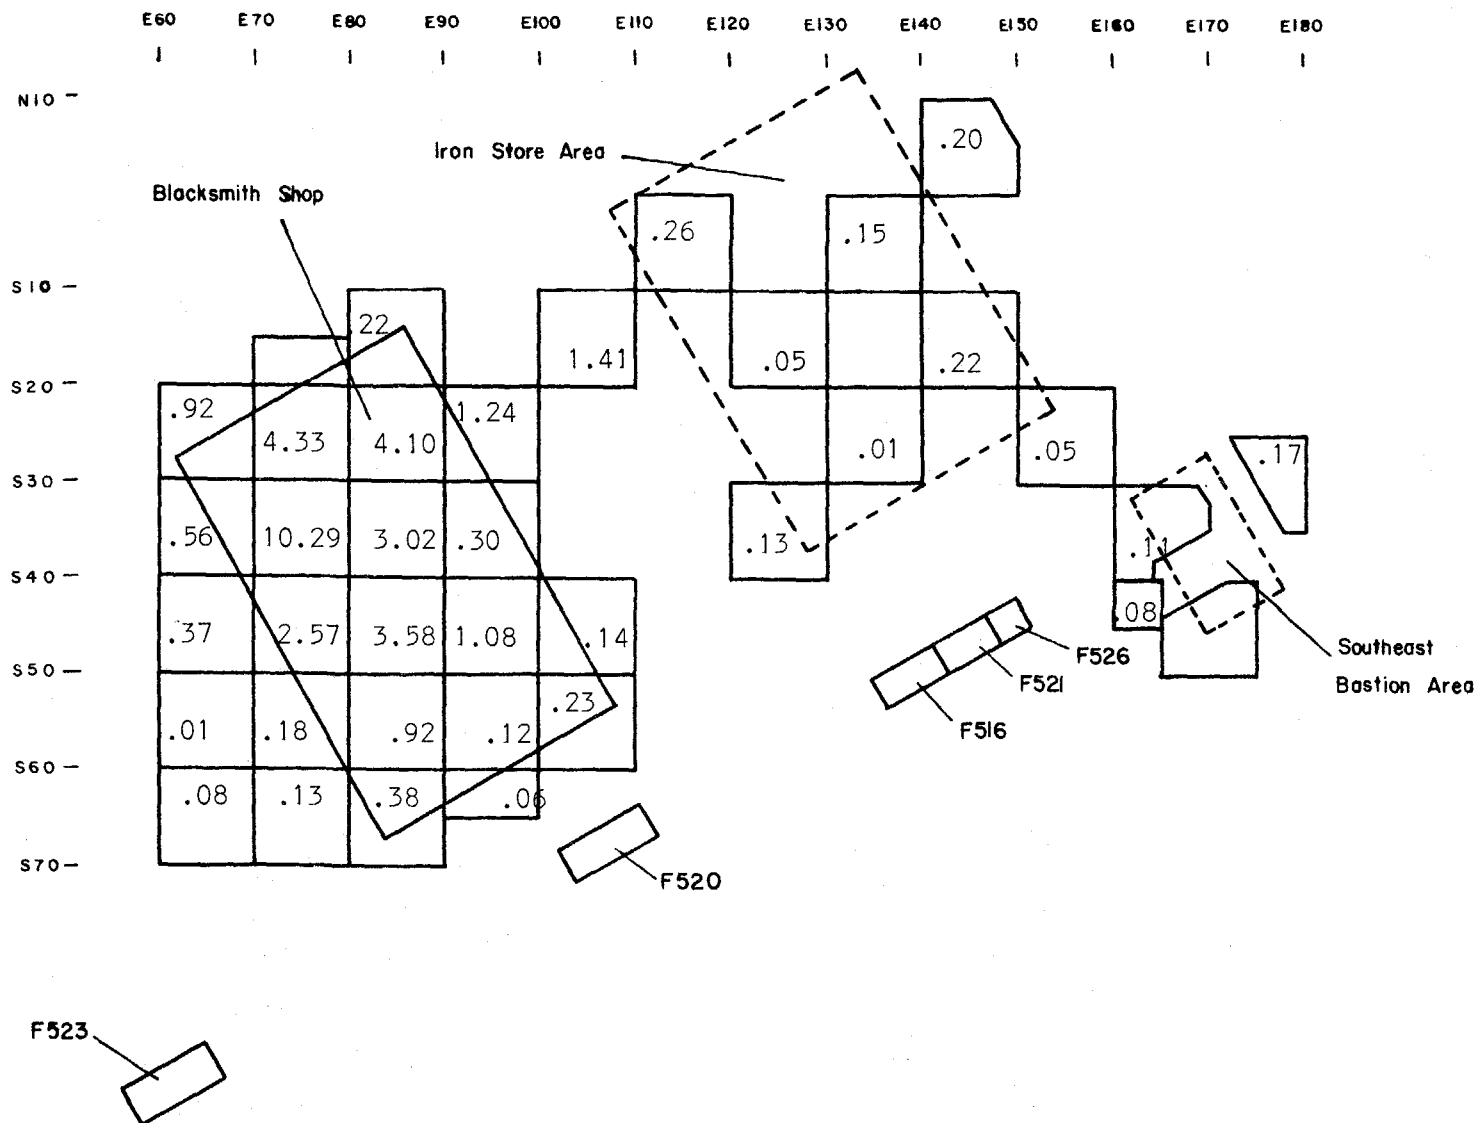
Fig. 195-- Distribution of local brick in the southeastern Fort area (f/ft<sup>2</sup>).

Local brick being of a porous nature, was probably used for chimneys and forge foundations. Only one concentration was observed in the Blacksmith Shop (Fig. 195), and may indicate post-Shop demolition rather than in situ forge or chimney locations.

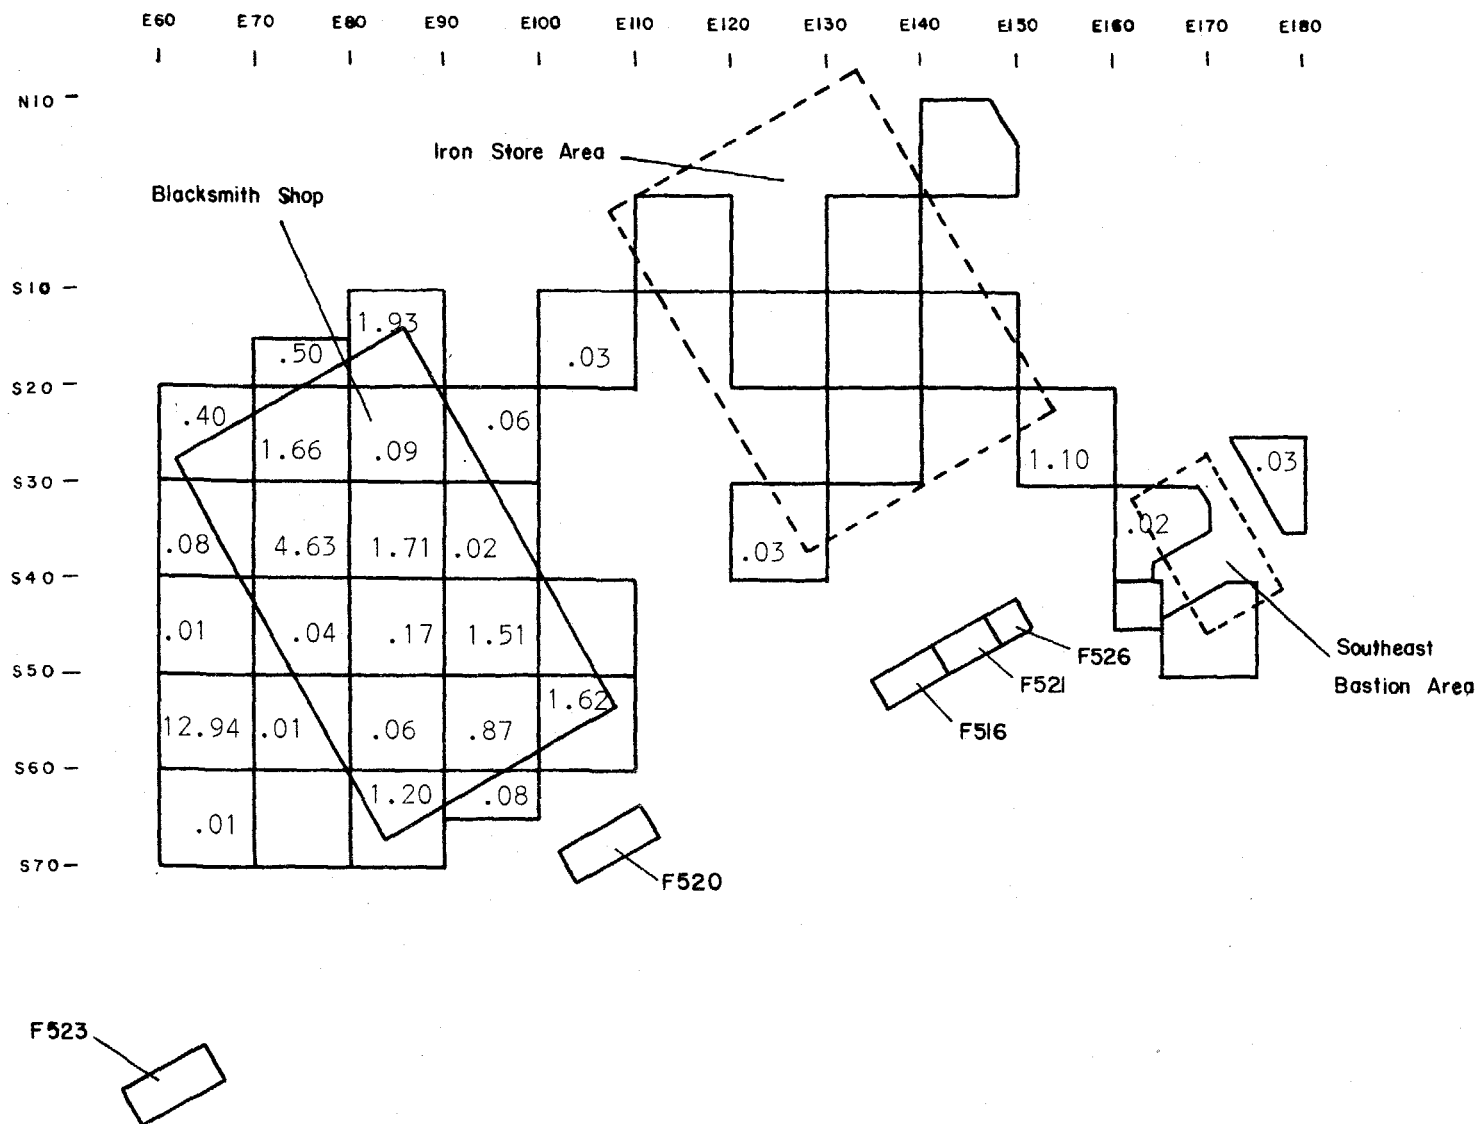
Fig.196 -- Distribution of mortar in the southeastern Fort area (f/ft<sup>2</sup>).

Three mortar concentrations were observed in the Blacksmith Shop area (Fig. 196). Two interior concentrations were observed at opposite ends of the Shop, and probably indicate the relative positions of forges. The concentration to the west of the Shop came from a mortar spill which probably represents the liming pit used to prepare the mortar for forge construction. Since mortar at Fort Vancouver was manufactured from coral, the coral concentration outside the northeastern corner of the Shop may have represented a stockpile of raw material (Fig. 197).

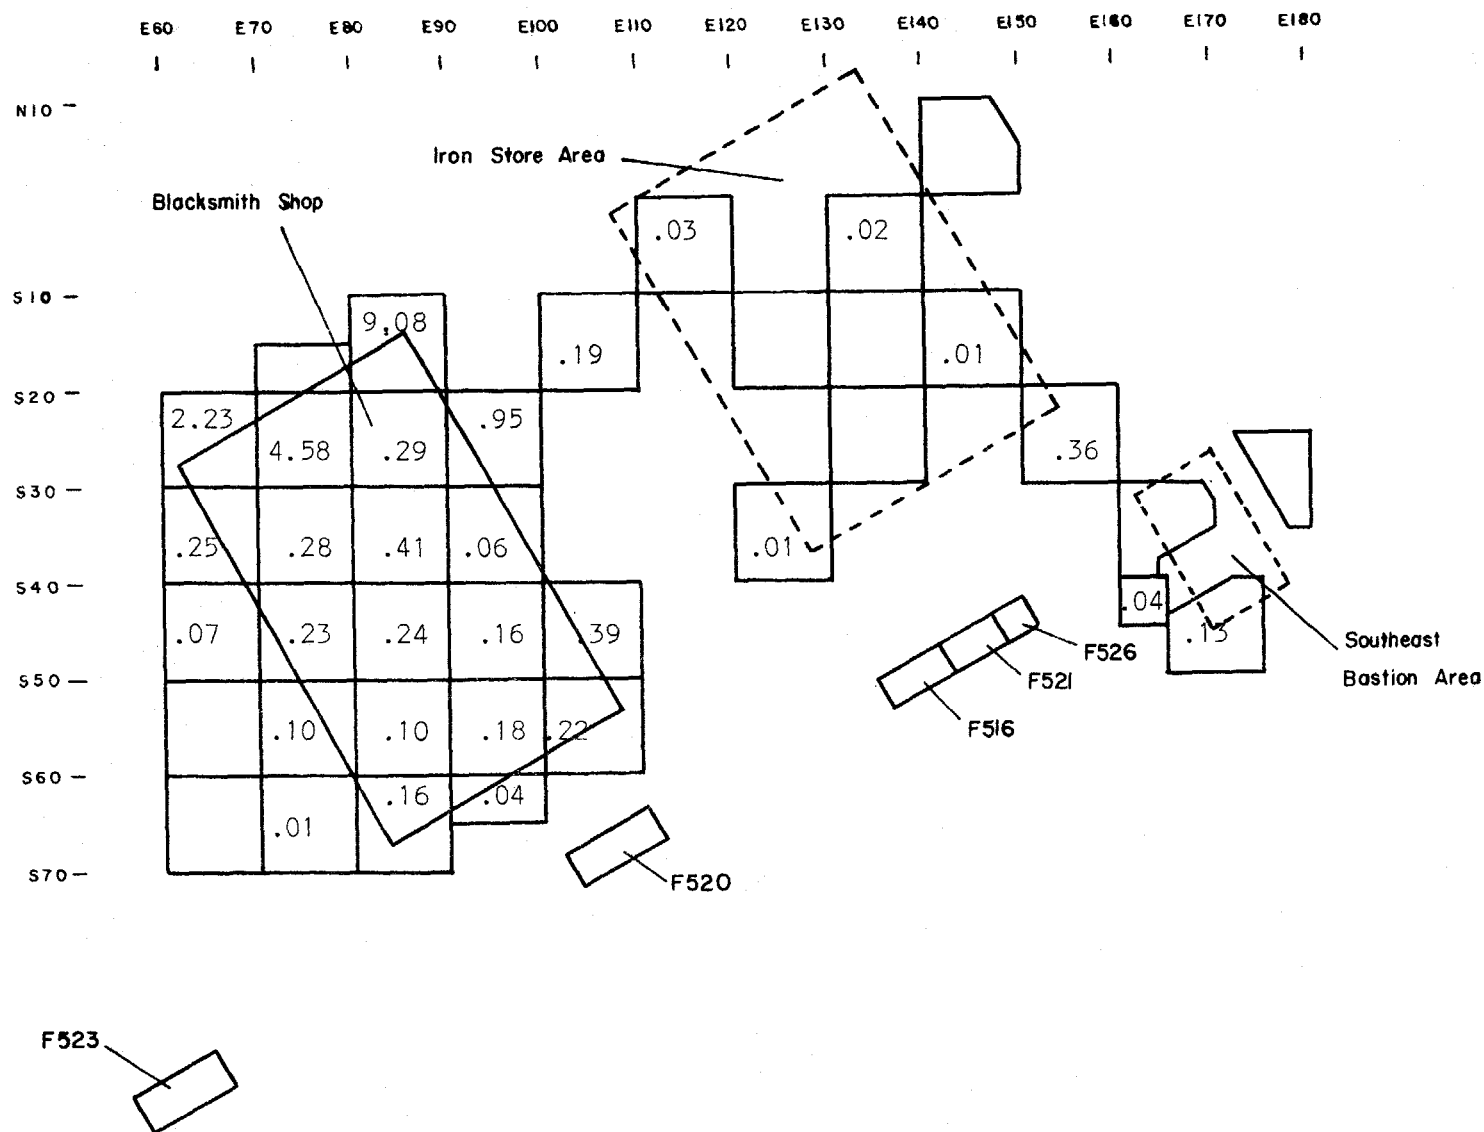
Fig. 197-- Distribution of coral in the southeastern Fort area ( $f/ft^2$ ).

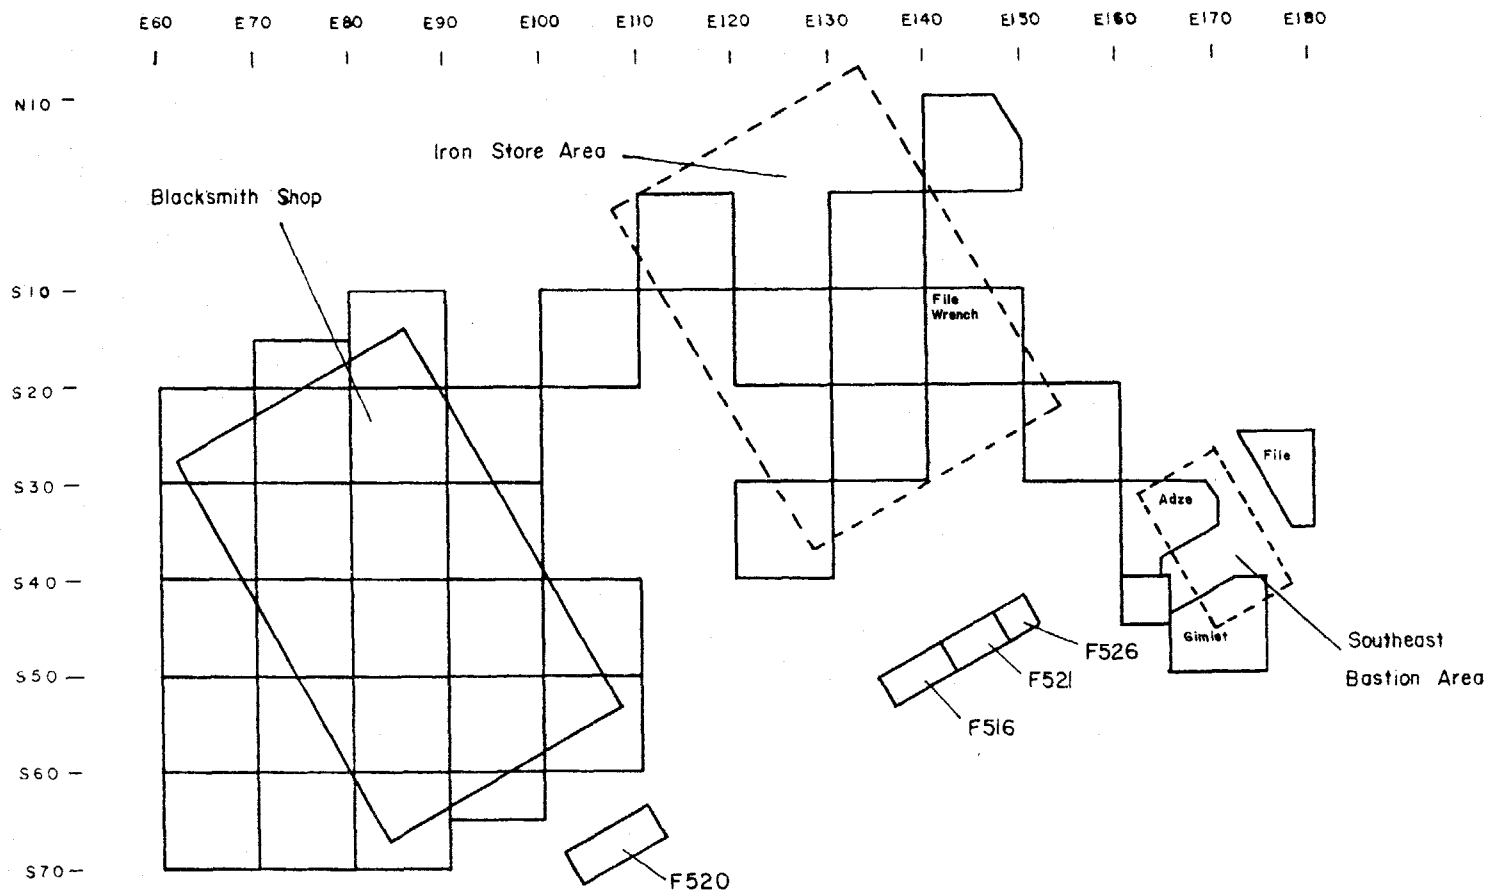
Fig. 198 -- Distribution of metal tools (excluding traps & axes) for the southeast Fort area (see next Figure for tool distribution in the Blacksmith Shop area).

The distribution of tools (Figs. 198-199) reflects both usage and repair, but primarily usage. In the Blacksmith Shop metal and wood working tools were predominant, and they were very common along the west central portion of the Shop. A second assemblage was observed in the Southeast Bastion area which documented the use of this area as a cooorage.
