FORT VANCOUVER EXCAVATIONS - X

Southeastern Fort Area

National Park Service

July 1975

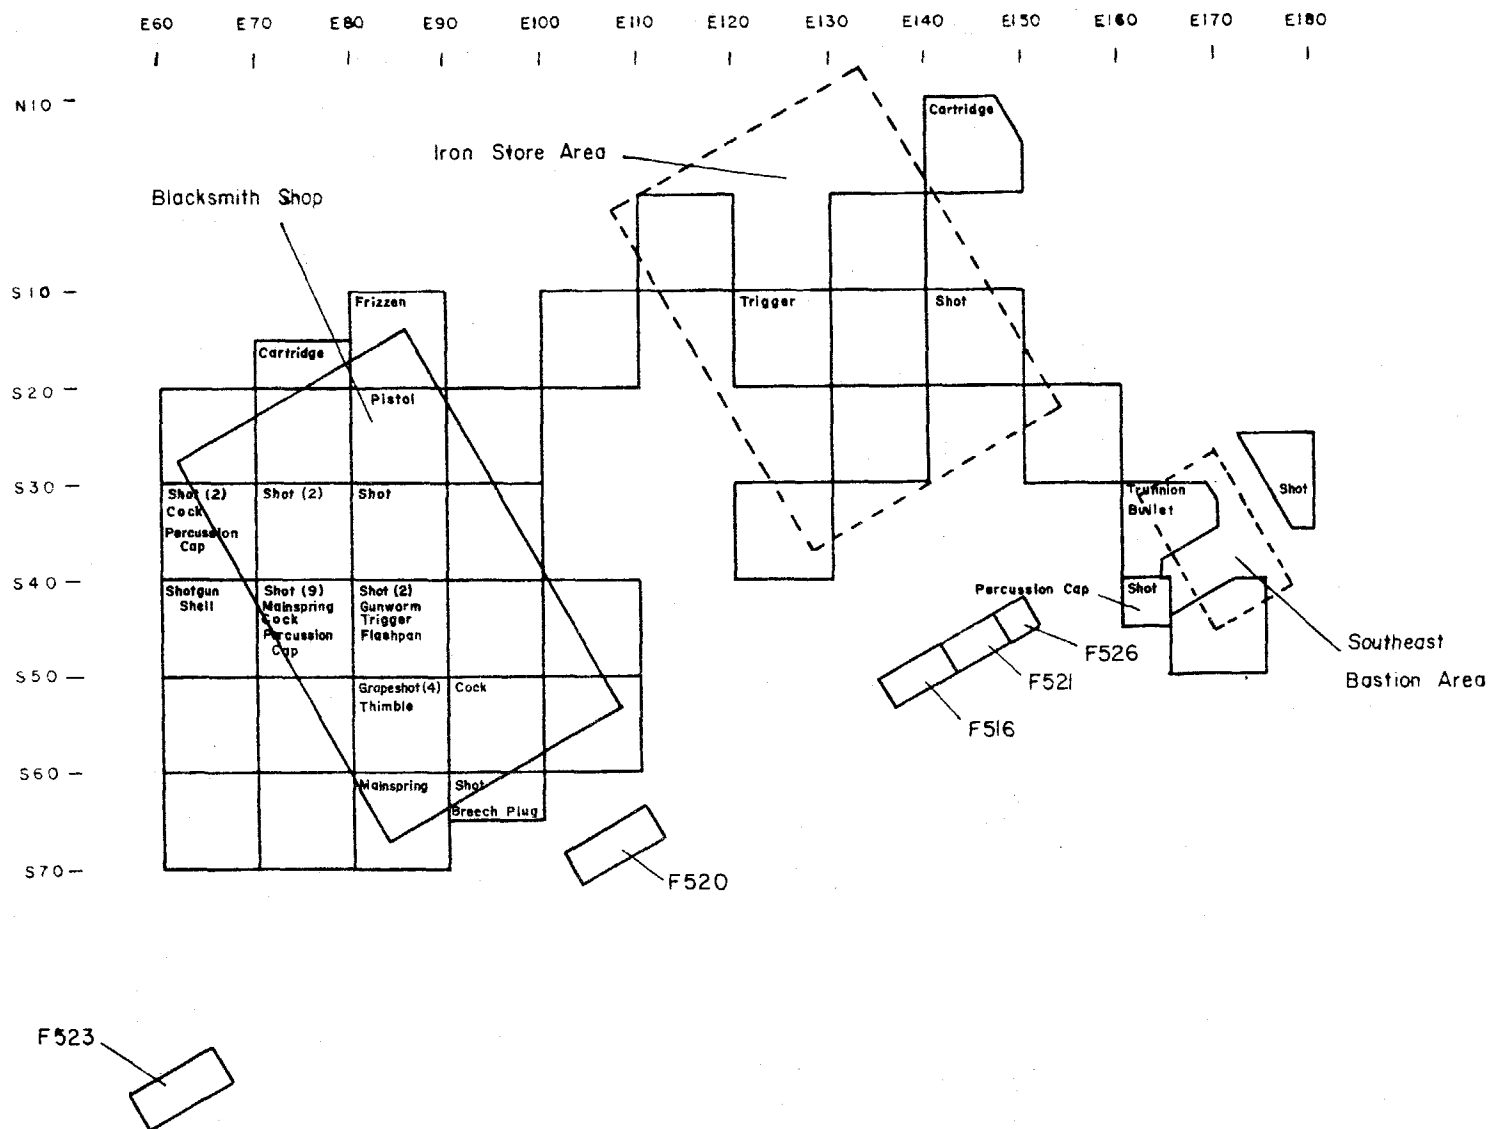
Fig. 200-- Distribution of metal weaponry items for the southeastern Fort area.

Concentrations of metal weaponry items were observed in the Blacksmith Shop and Southeast Bastion (Fig. 200). The Shop concentration reflected the repair of firearms by blacksmiths, whereas the Bastion assemblage probably reflects the functional aspect of the Bastion as a weapon storage and usage structure.

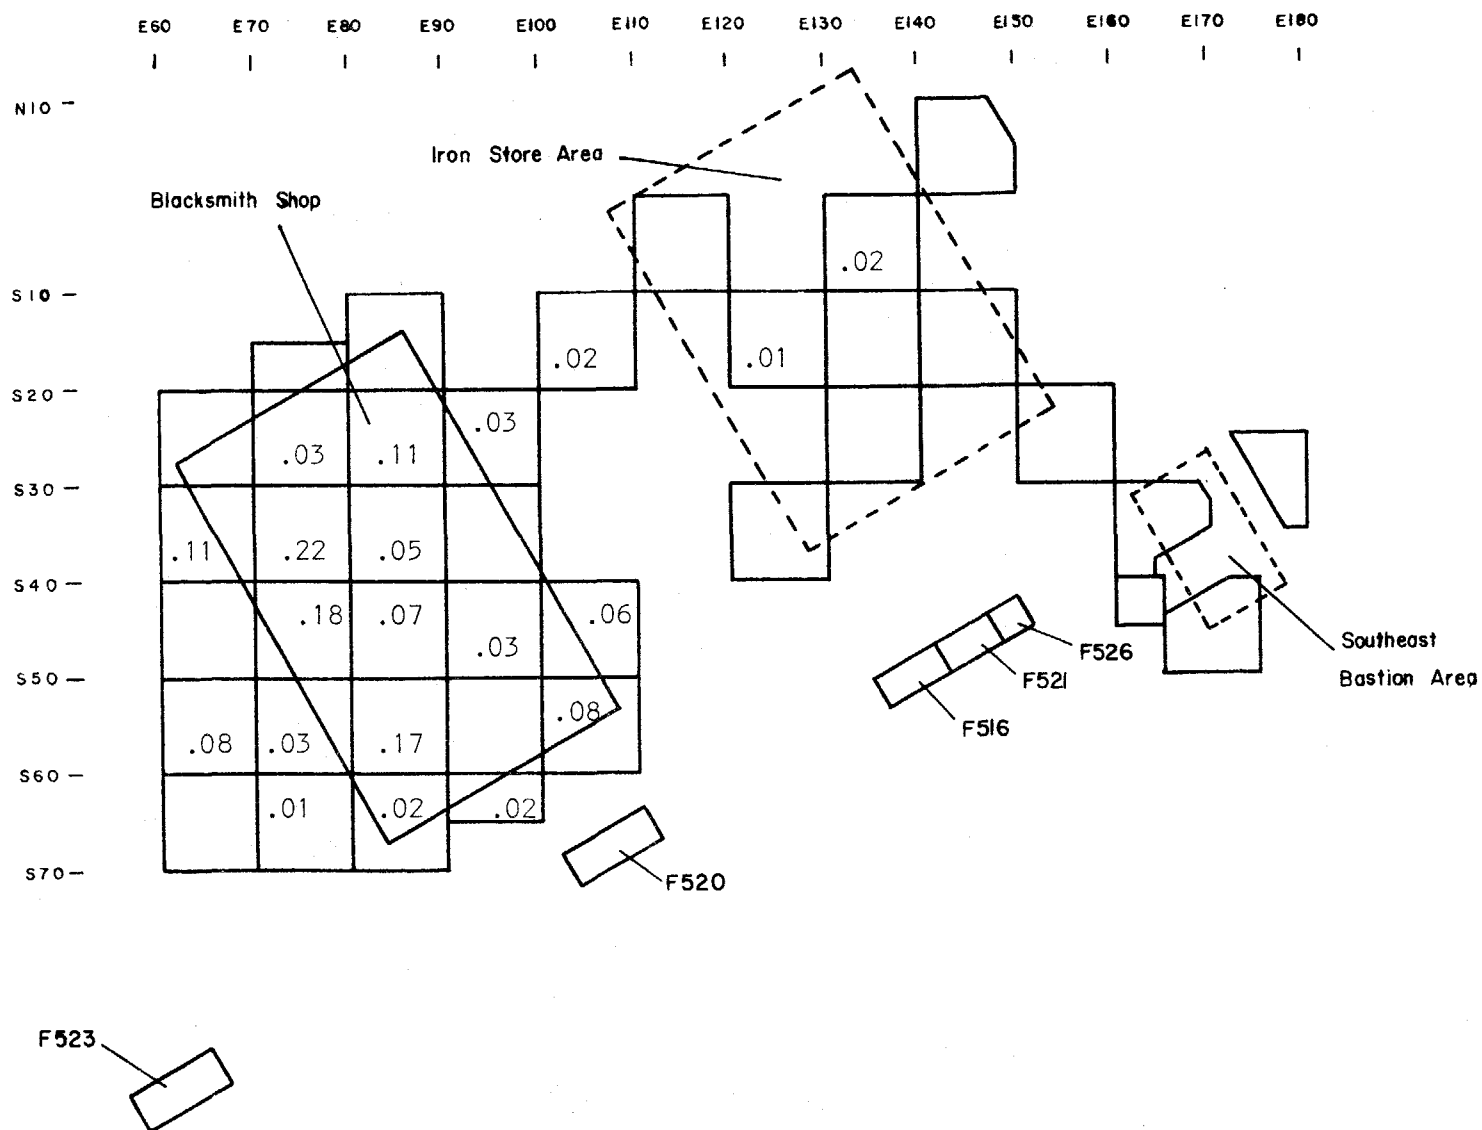
Fig.201 -- Distribution of bolt parts in the southeastern Fort area ( $f/ft^2$ ).

Bolts, washers and nuts were manufactured in the Blacksmith Shop, with the highest concentration found along the central portion of the west wall (Figs. 201-202).

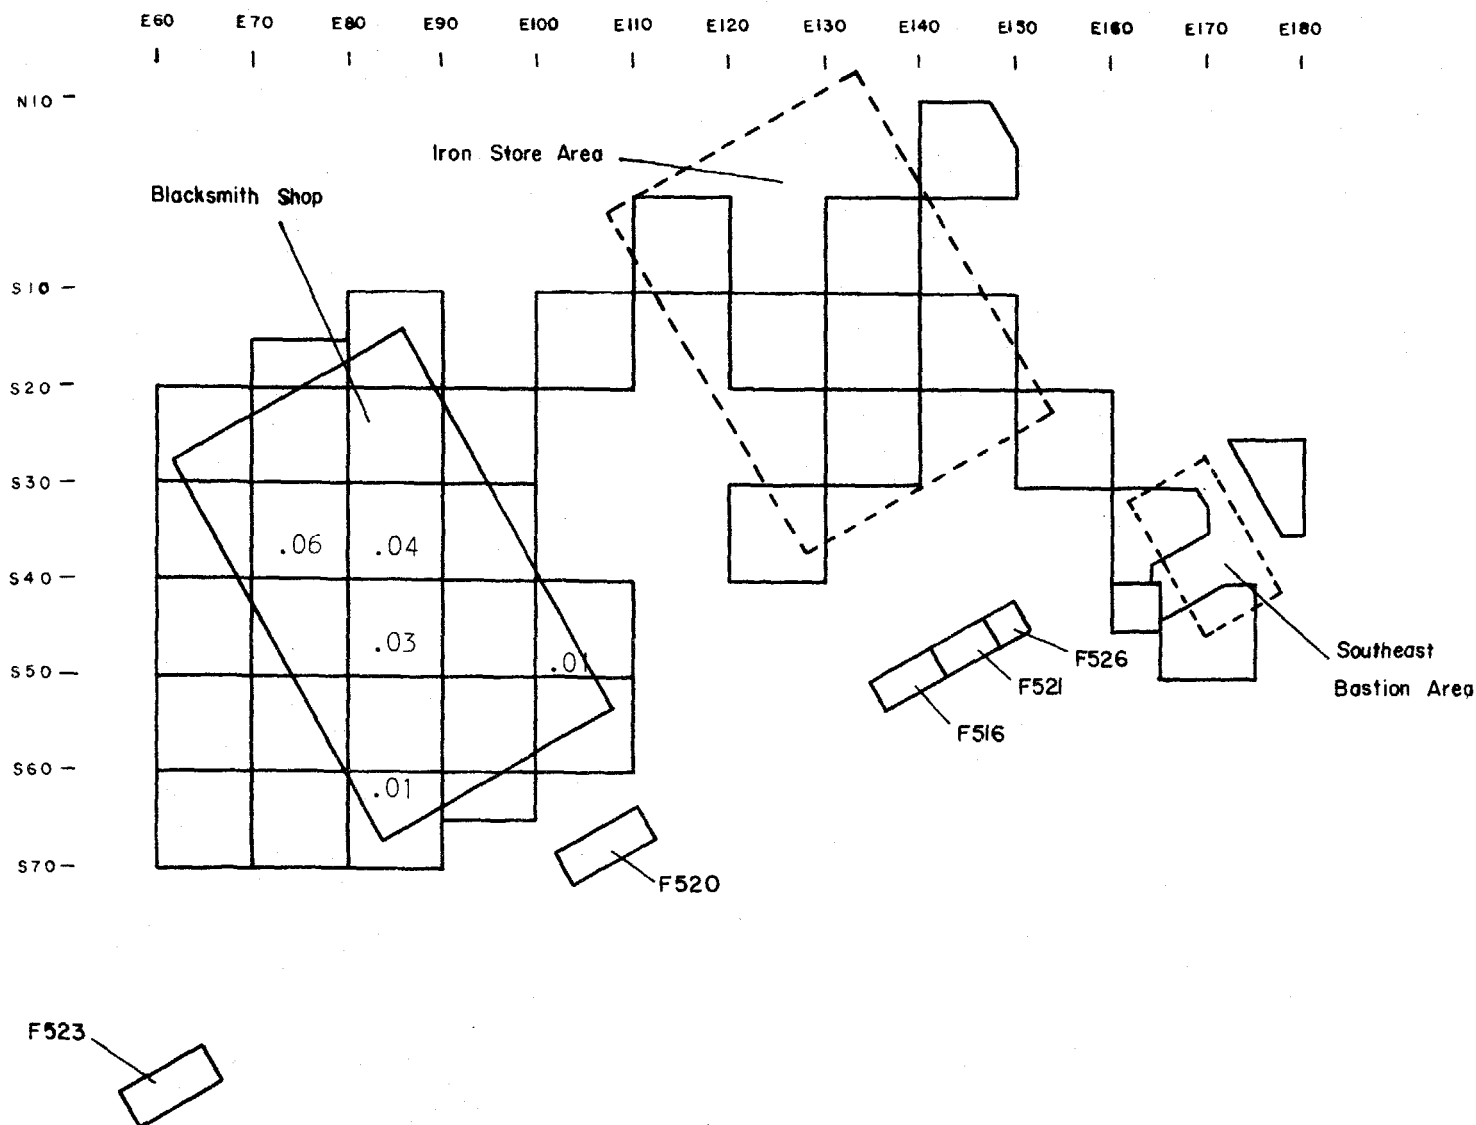
Fig.20: -- Distribution of nut preforms in the southeastern Fort area (f/ft<sup>2</sup>).

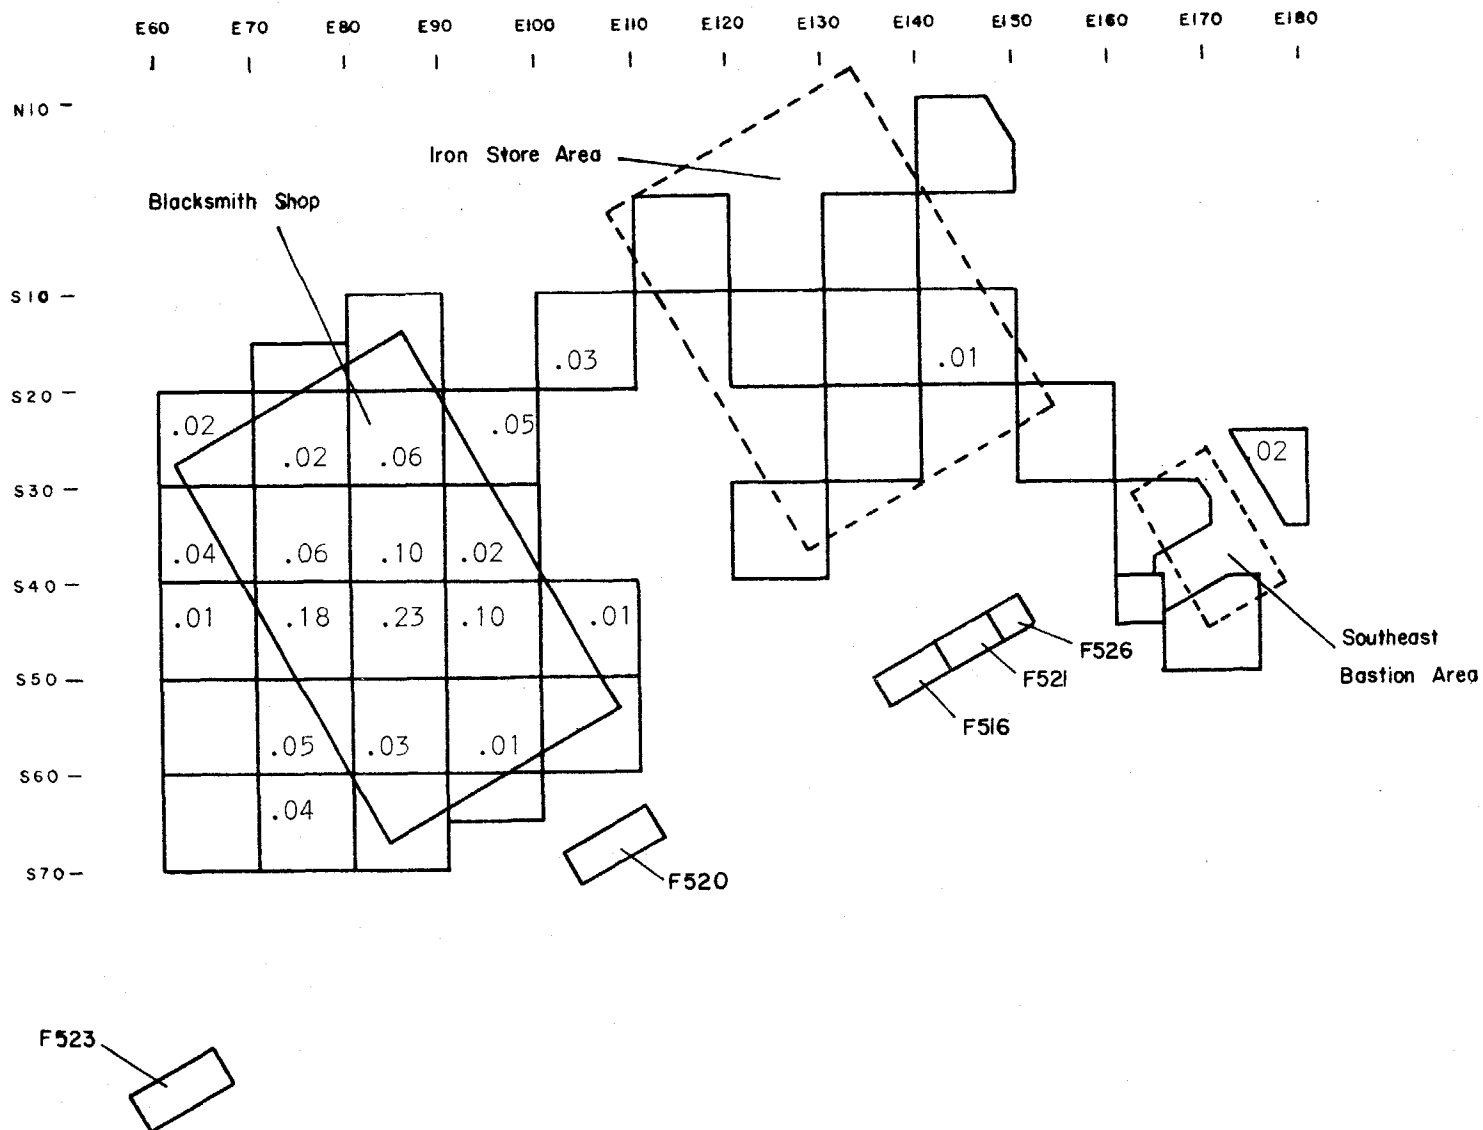
Fig.203 -- Distribution of rivets in the southeastern Fort area ( $f/ft^2$ ).

Rivets were manufactured in the Blacksmith Shop, with the highest frequency found in the west central portion of the Shop (Fig. 203).

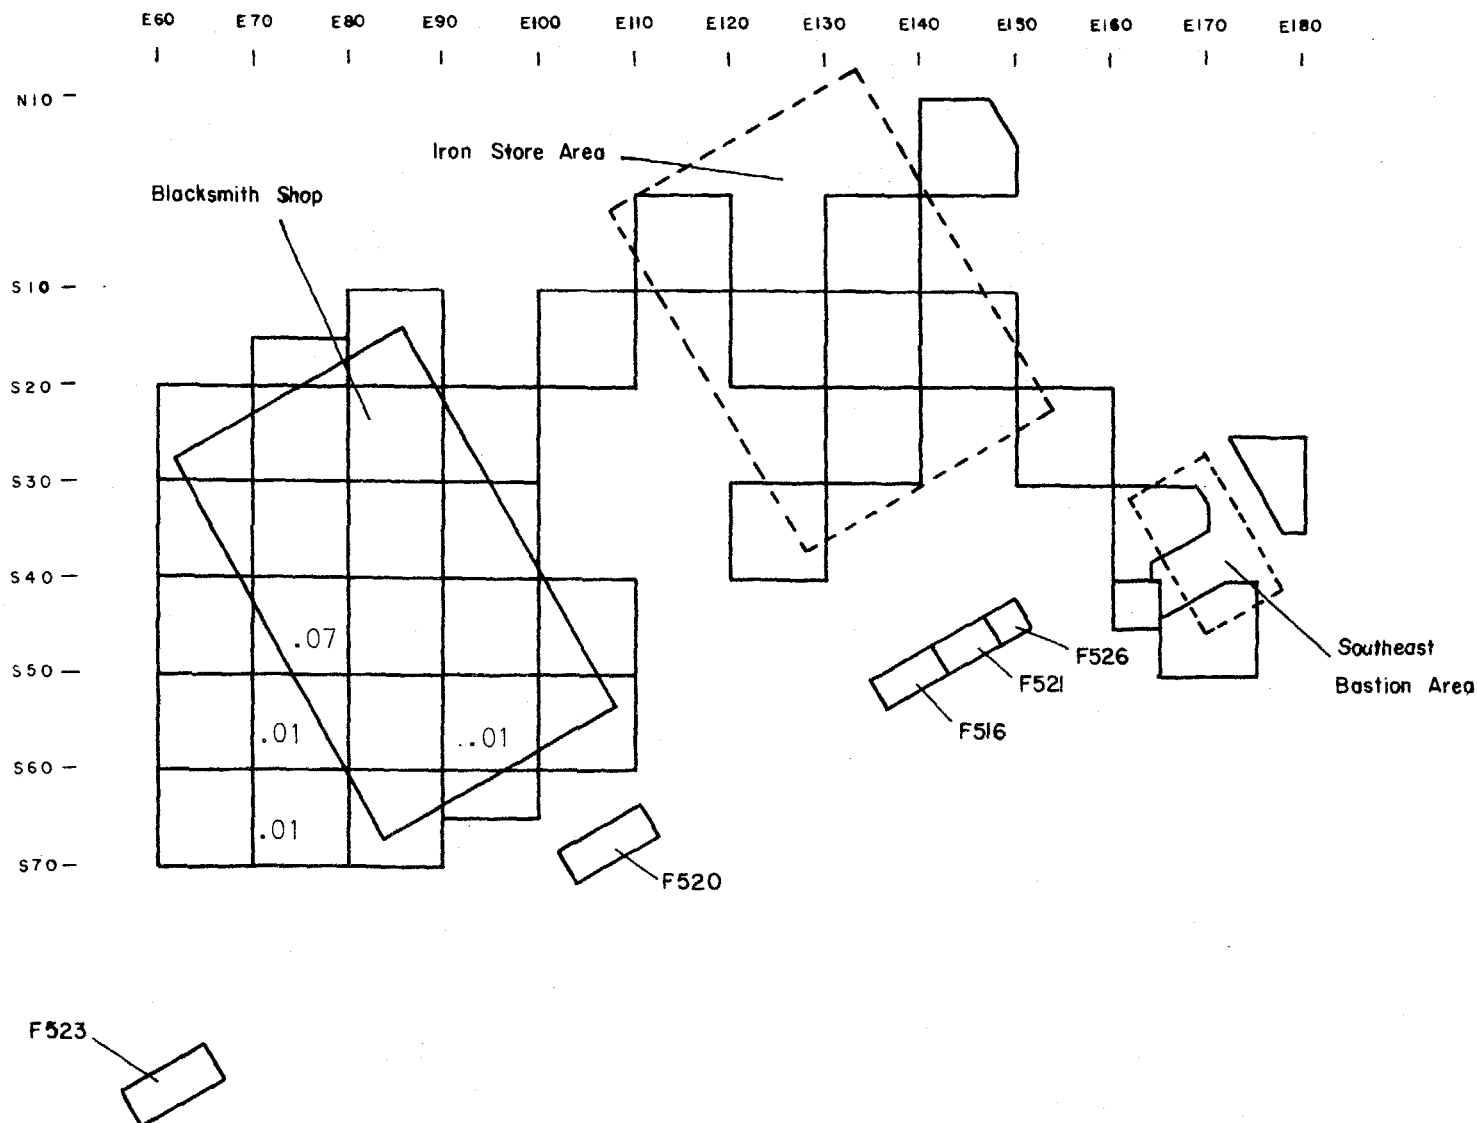
Fig.204 -- Distribution of barrel rivets in the southeastern Fort area (f/ft<sup>2</sup>).

Barrels may have been repaired in the Blacksmith Shop, but the highest concentration of barrel bands denotes the area associated with Cooper's Shed outside the southeastern stockade area (Figs. 204-205).

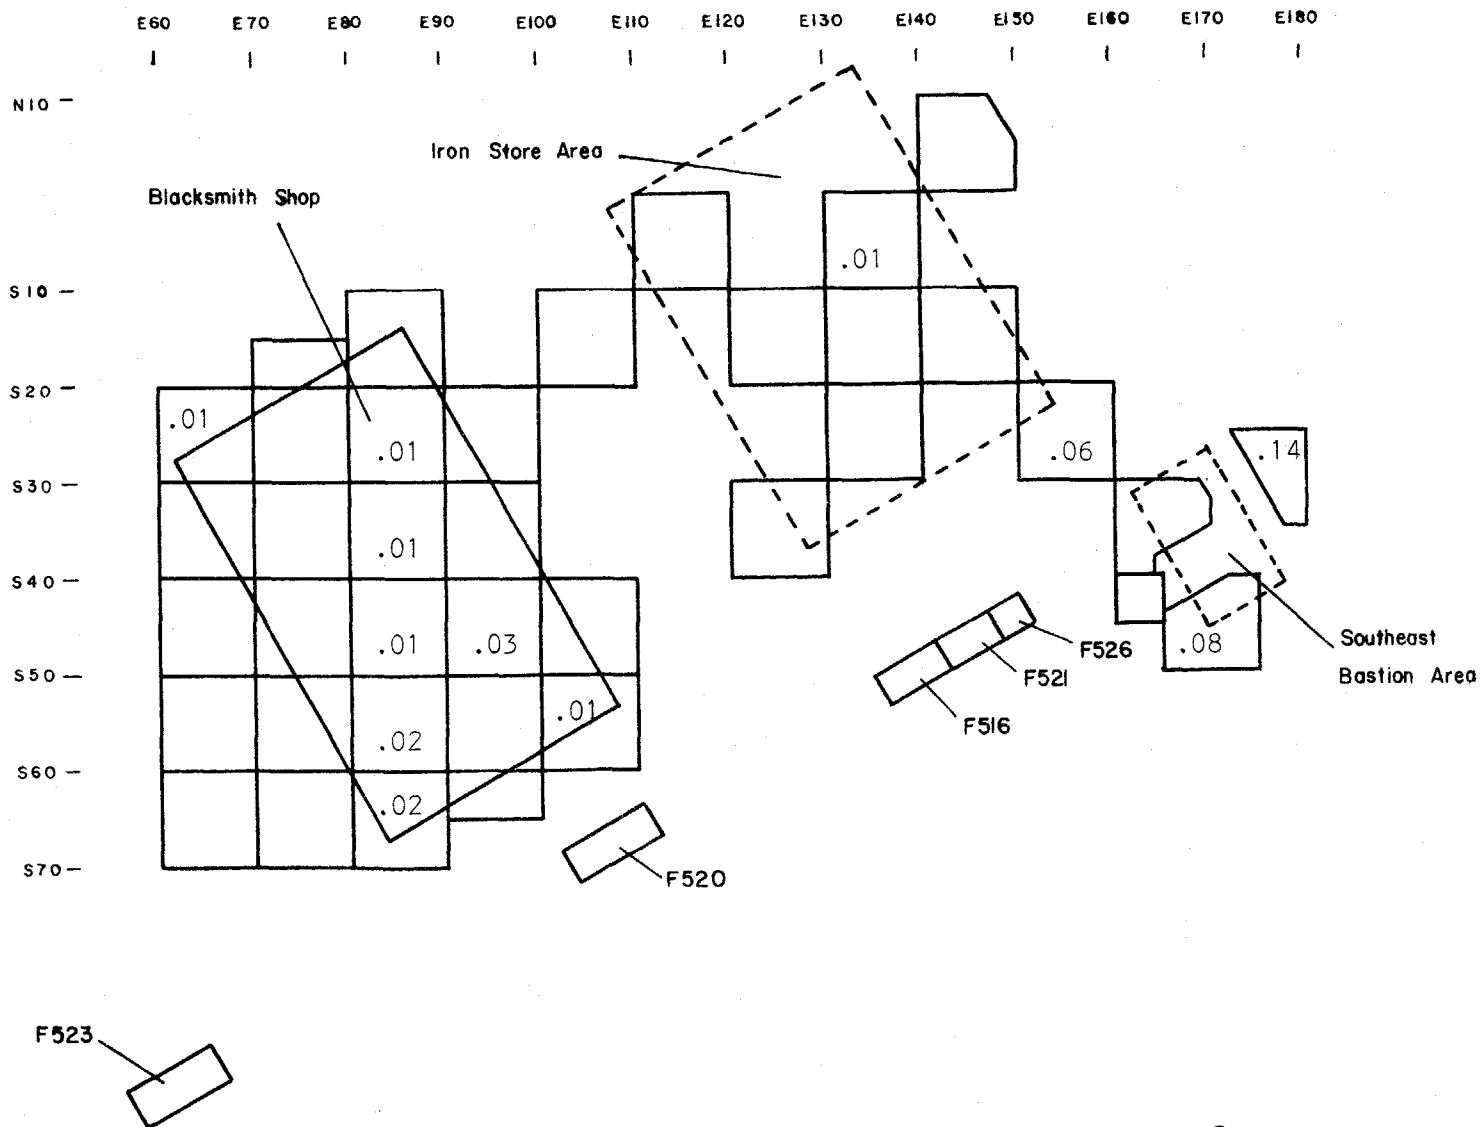
Fig. 205 -- Distribution of barrel bands in the southeastern Fort area (f/ft<sup>2</sup>).

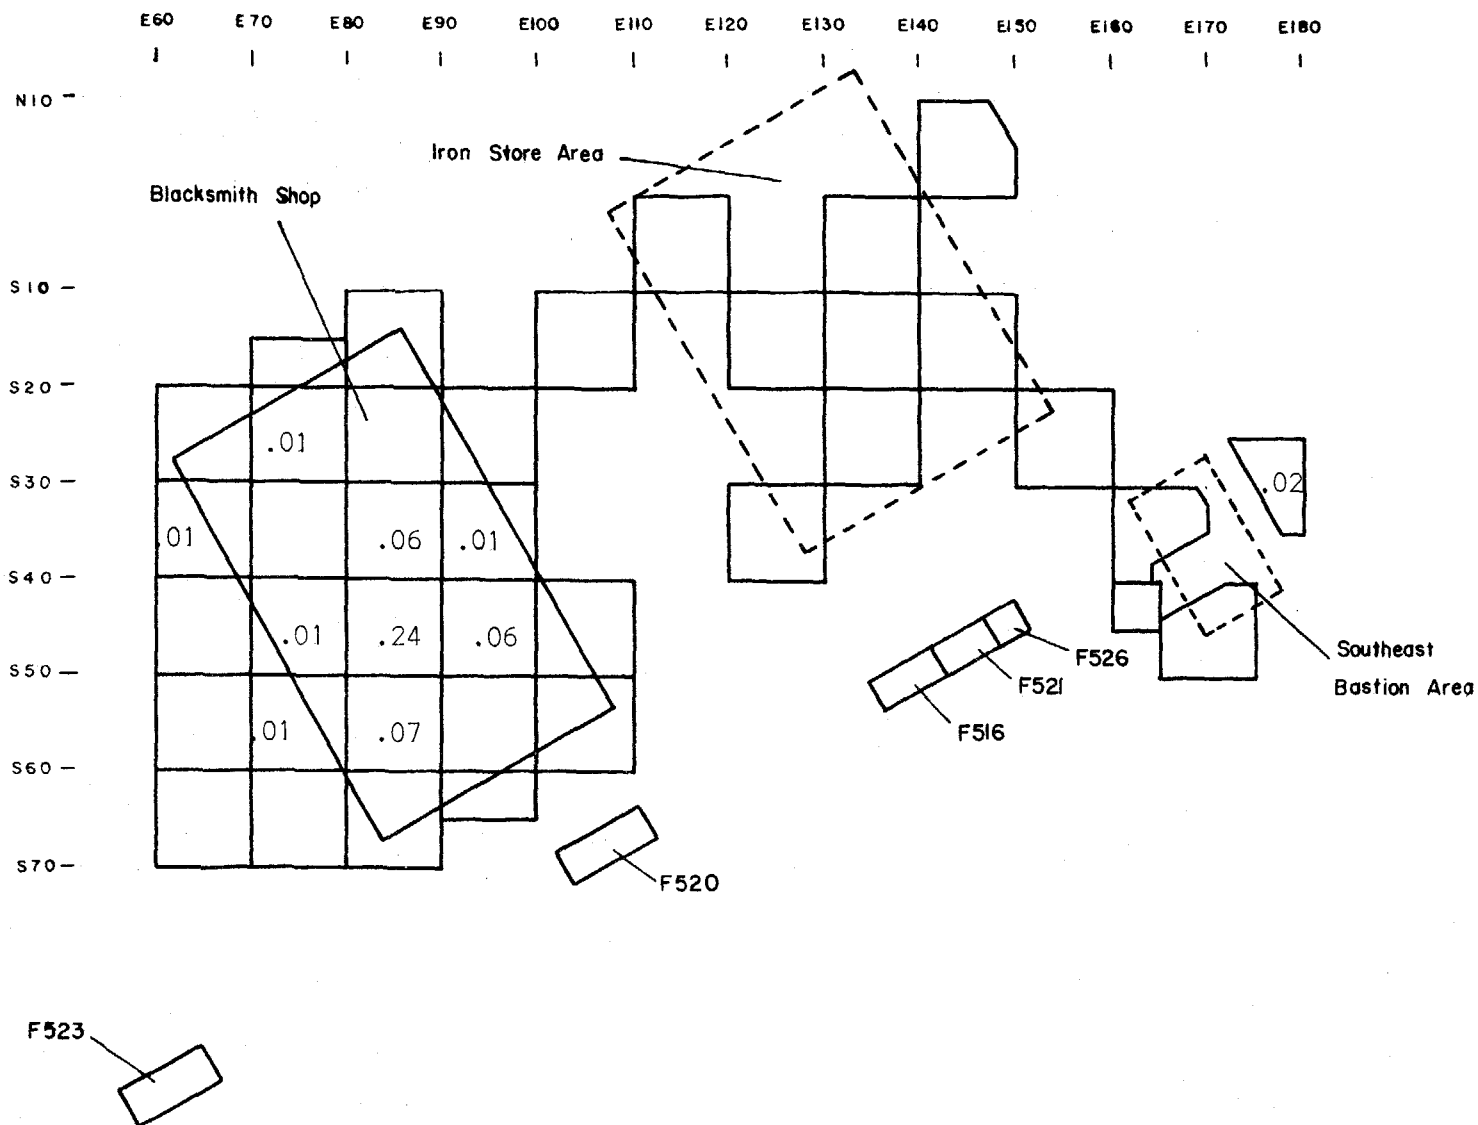
Fig.206 -- Distribution of metal container fragments in the southeastern Fort area (f/ft<sup>2</sup>).

Both copper and iron sheet metal containers were manufactured and/or repaired in the Blacksmith Shop, and from the distribution of copper and iron fragments (Figs. 206-209) there appear to be 2 work areas. Copper kettle lug cutouts together with fragments of copper sheeting (Figs. 203-209) were common along the west wall of the shop, whereas iron container and sheeting fragments (Figs. 206-207) were concentrated within the central portion of the Shop.

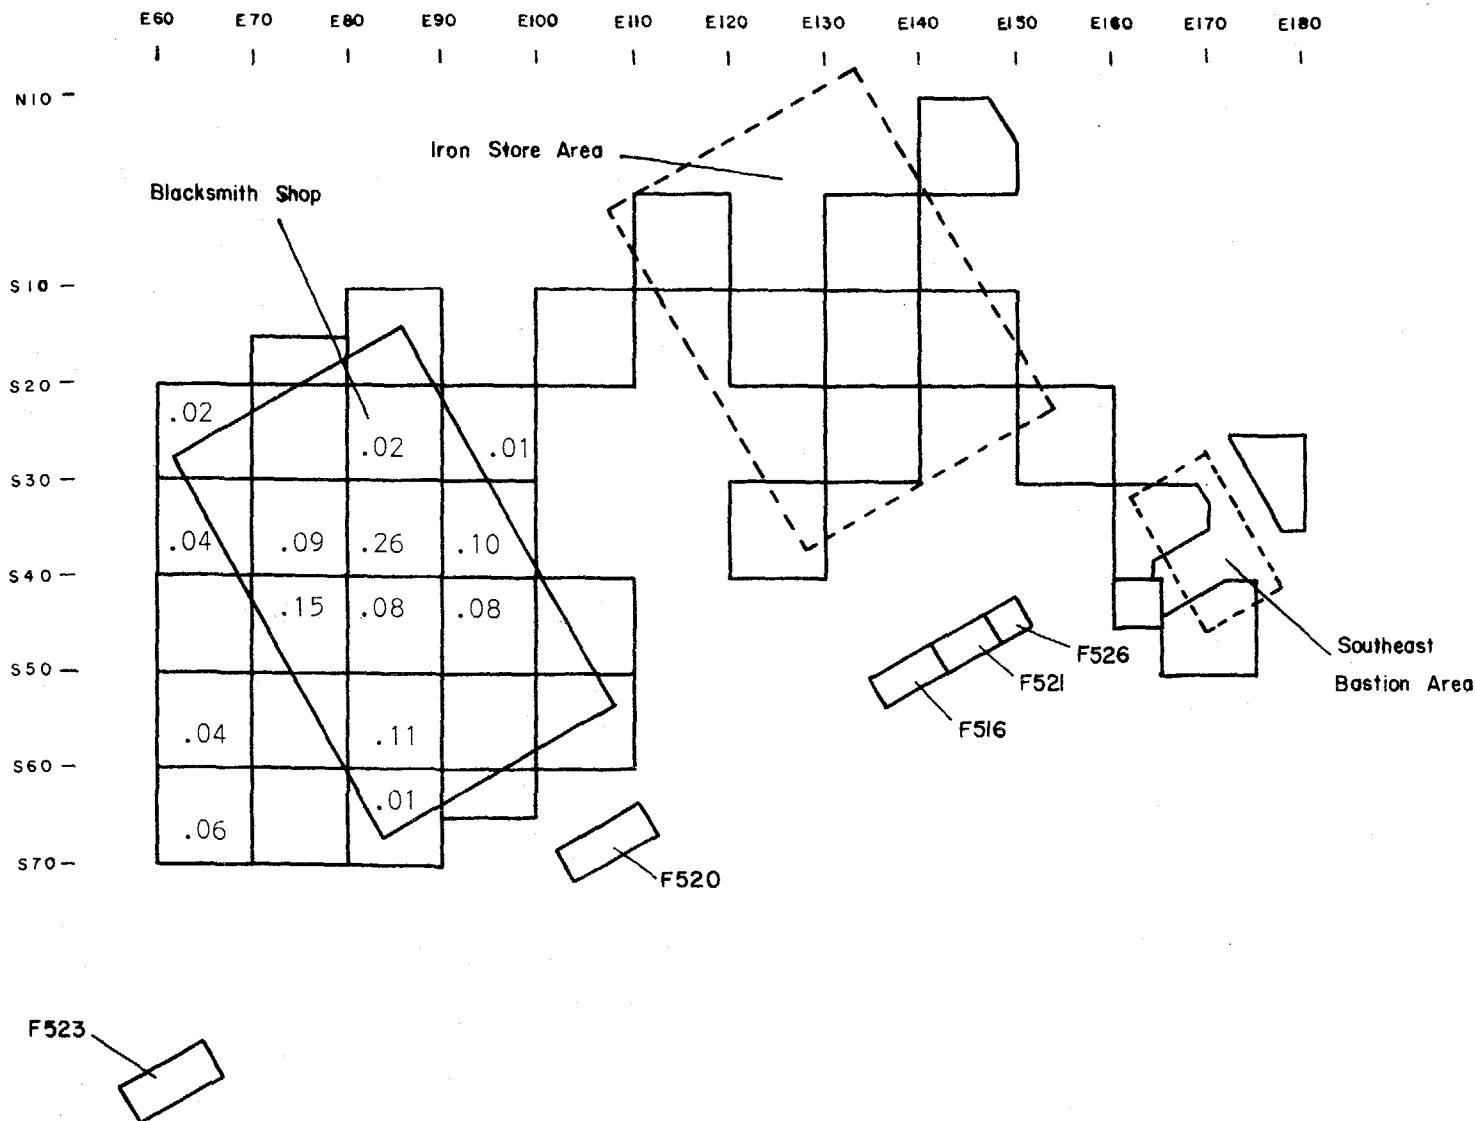
Fig.207 -- Distribution of cut iron sheeting in the southeastern Fort area (f/ft<sup>2</sup>).

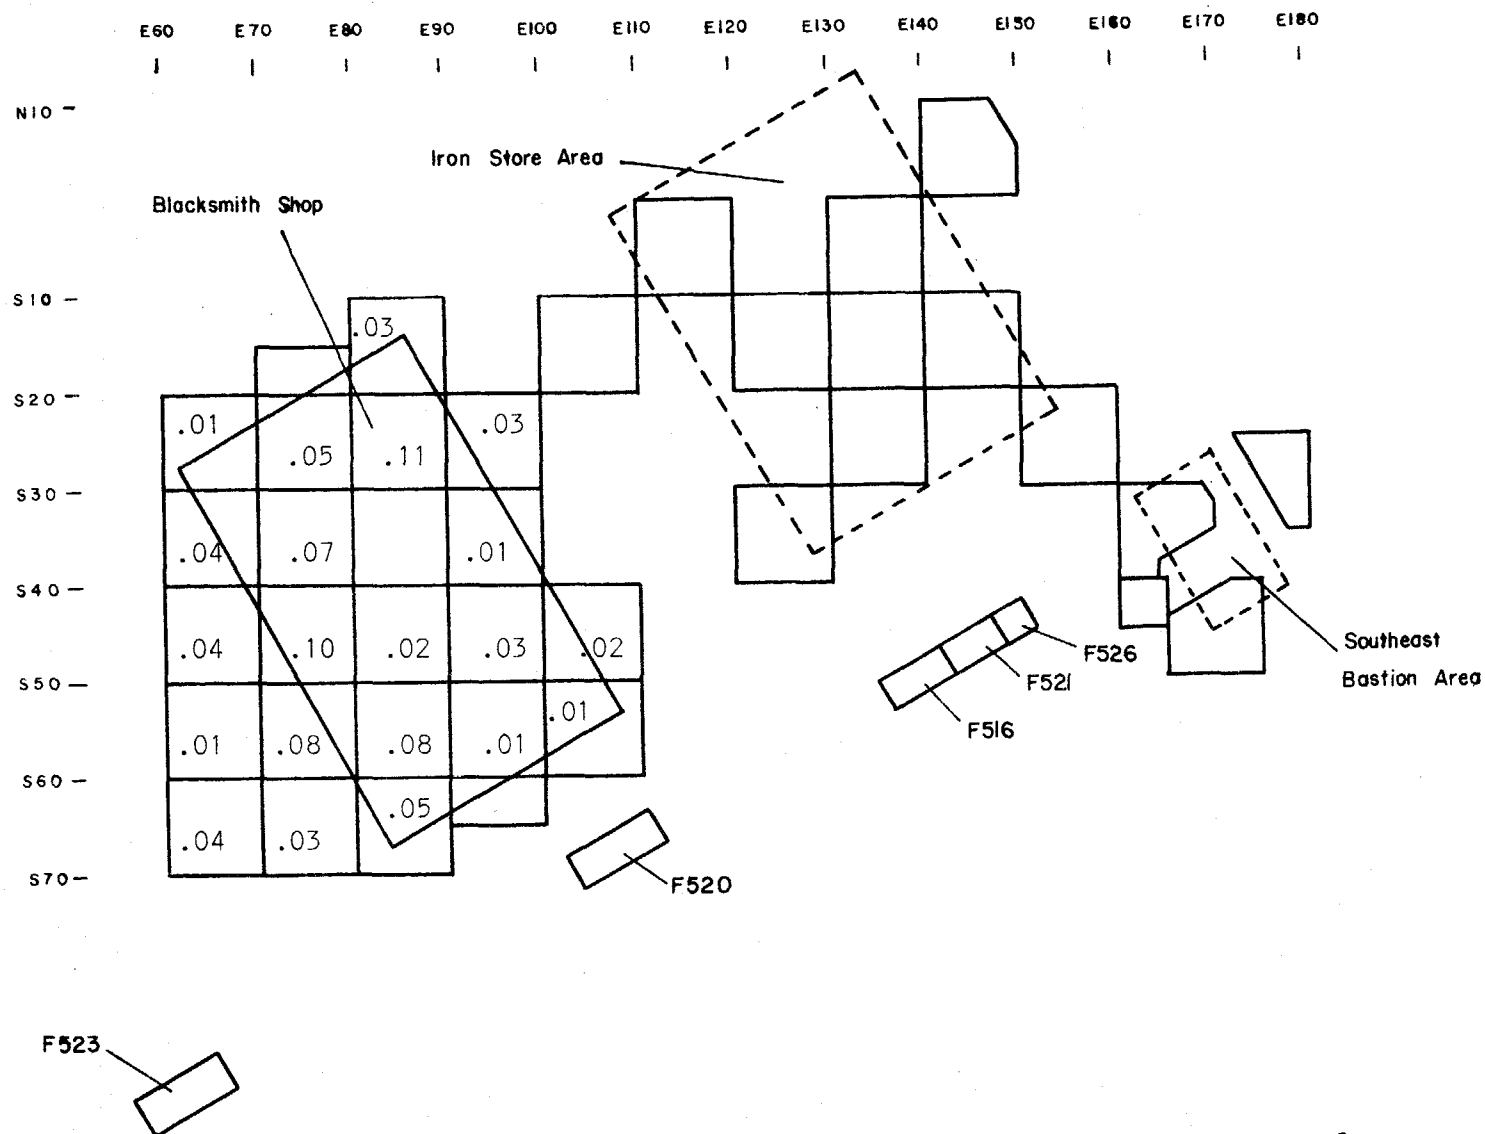
Fig.208 -- Distribution of cut copper sheeting in the southeastern Fort area (f/ft<sup>2</sup>).

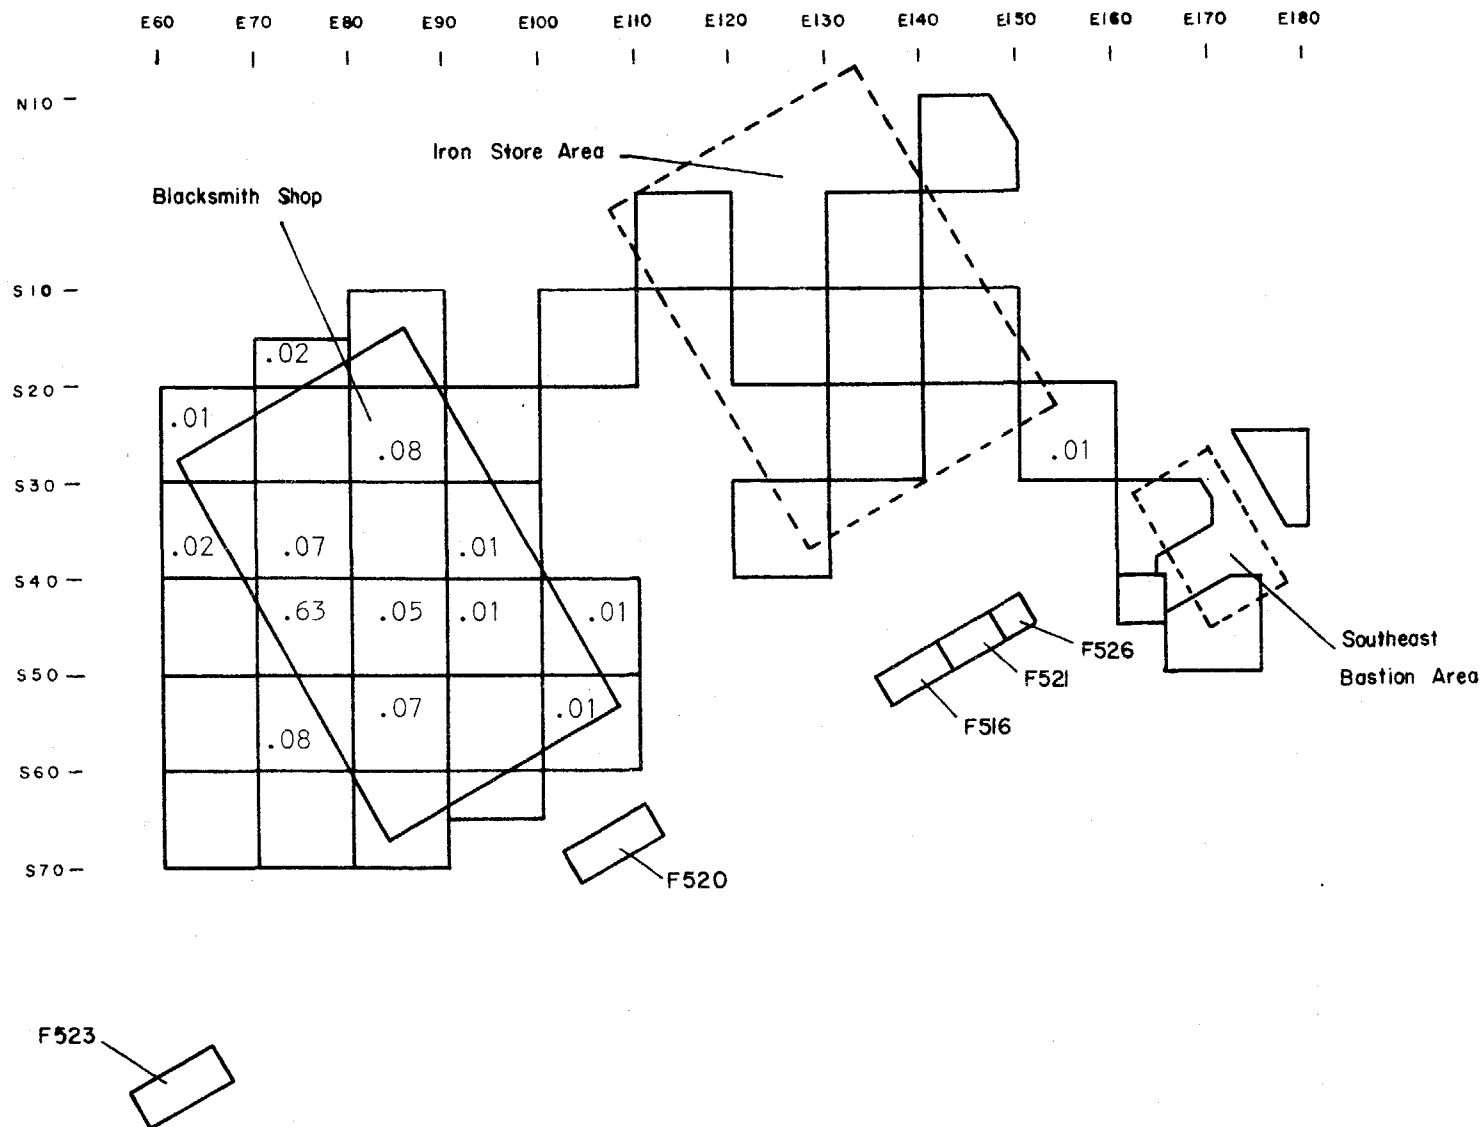
Fig. 209 -- Distribution of copper lug cutouts in the southeastern Fort area ( $f/ft^2$ ).

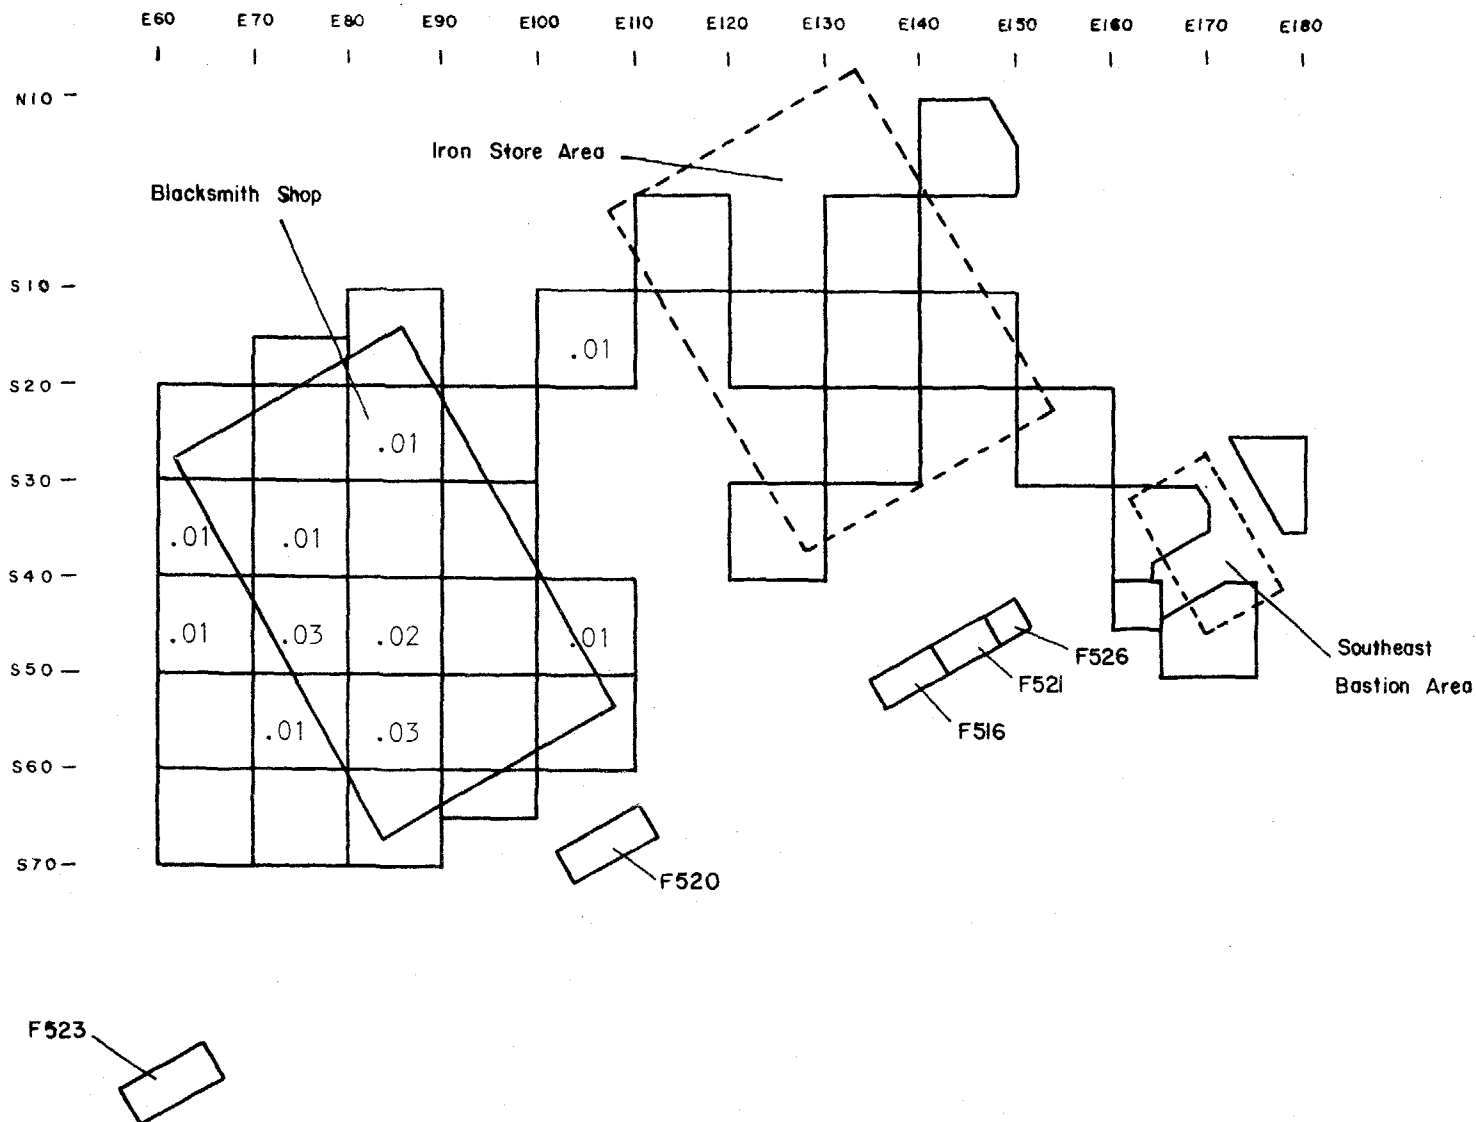
Fig.210 -- Distribution of singletree hardware in the southeastern Fort area ( $f/ft^2$ ).

Agricultural hardware for singletrees were concentrated along the west wall of the Blacksmith Shop (Fig. 210). These items probably represent repairs rather than manufactures.

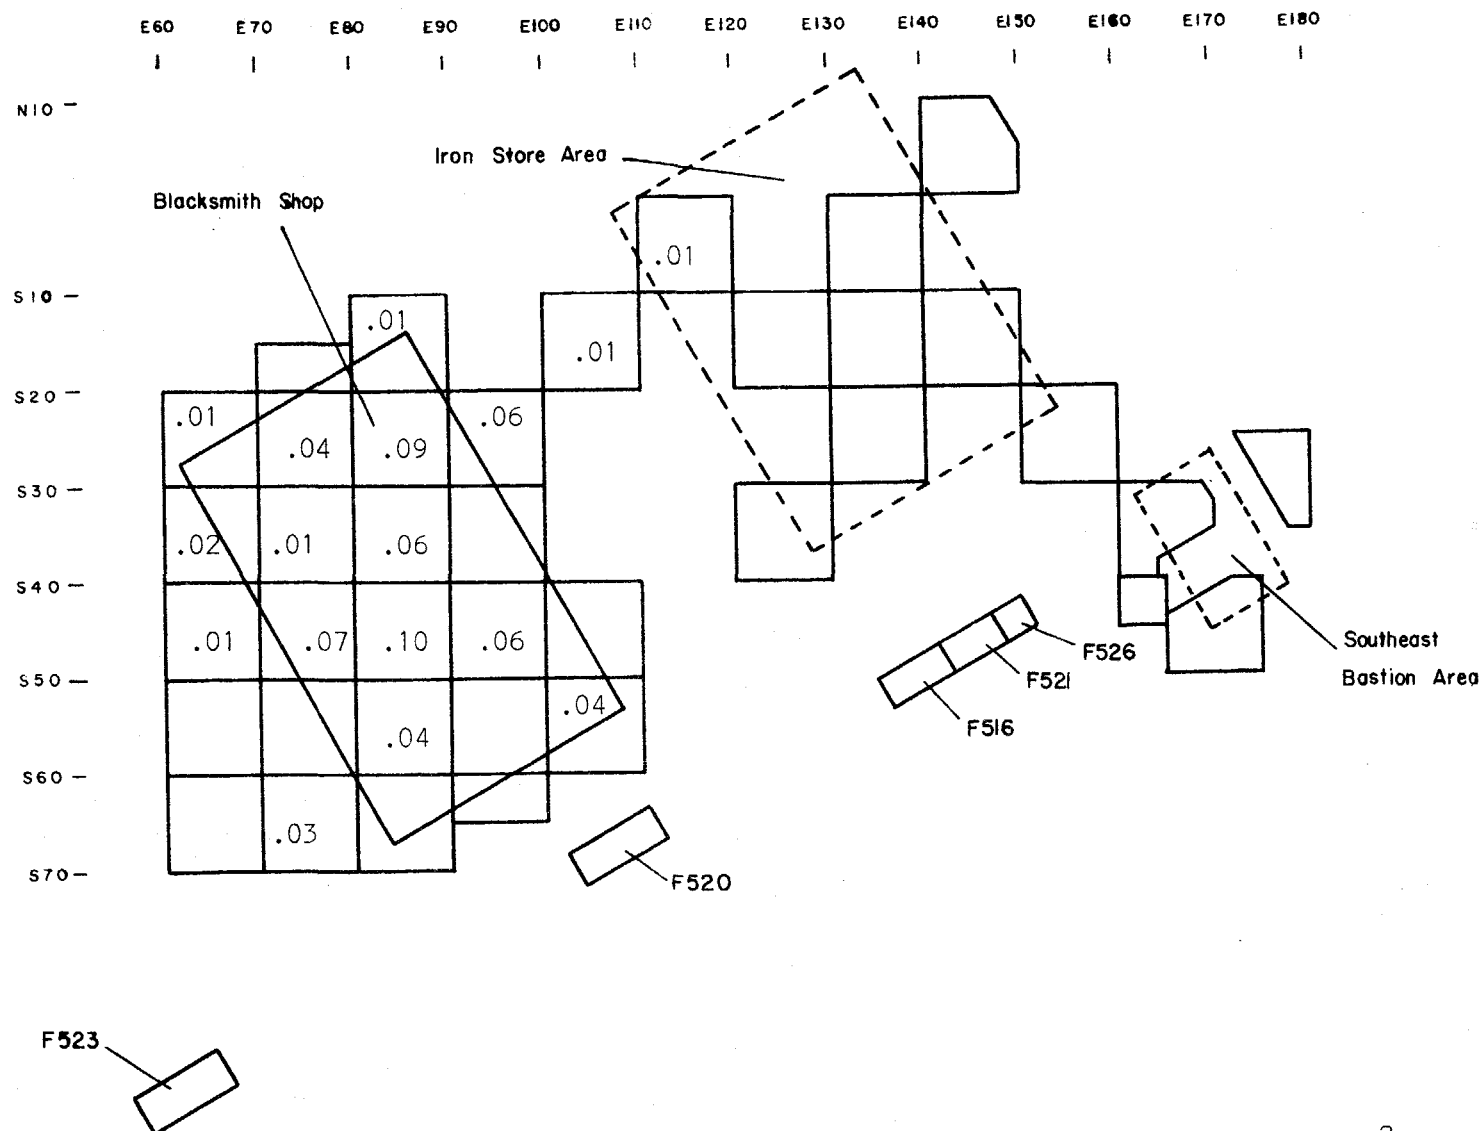
Fig. 211-- Distribution of chains and chain links in the southeastern Fort area ( $f/ft^2$ ).

Chains were repaired and links manufactured in the Blacksmith Shop, and their distribution within the Shop was generally within the central area (Figs. 211-212).

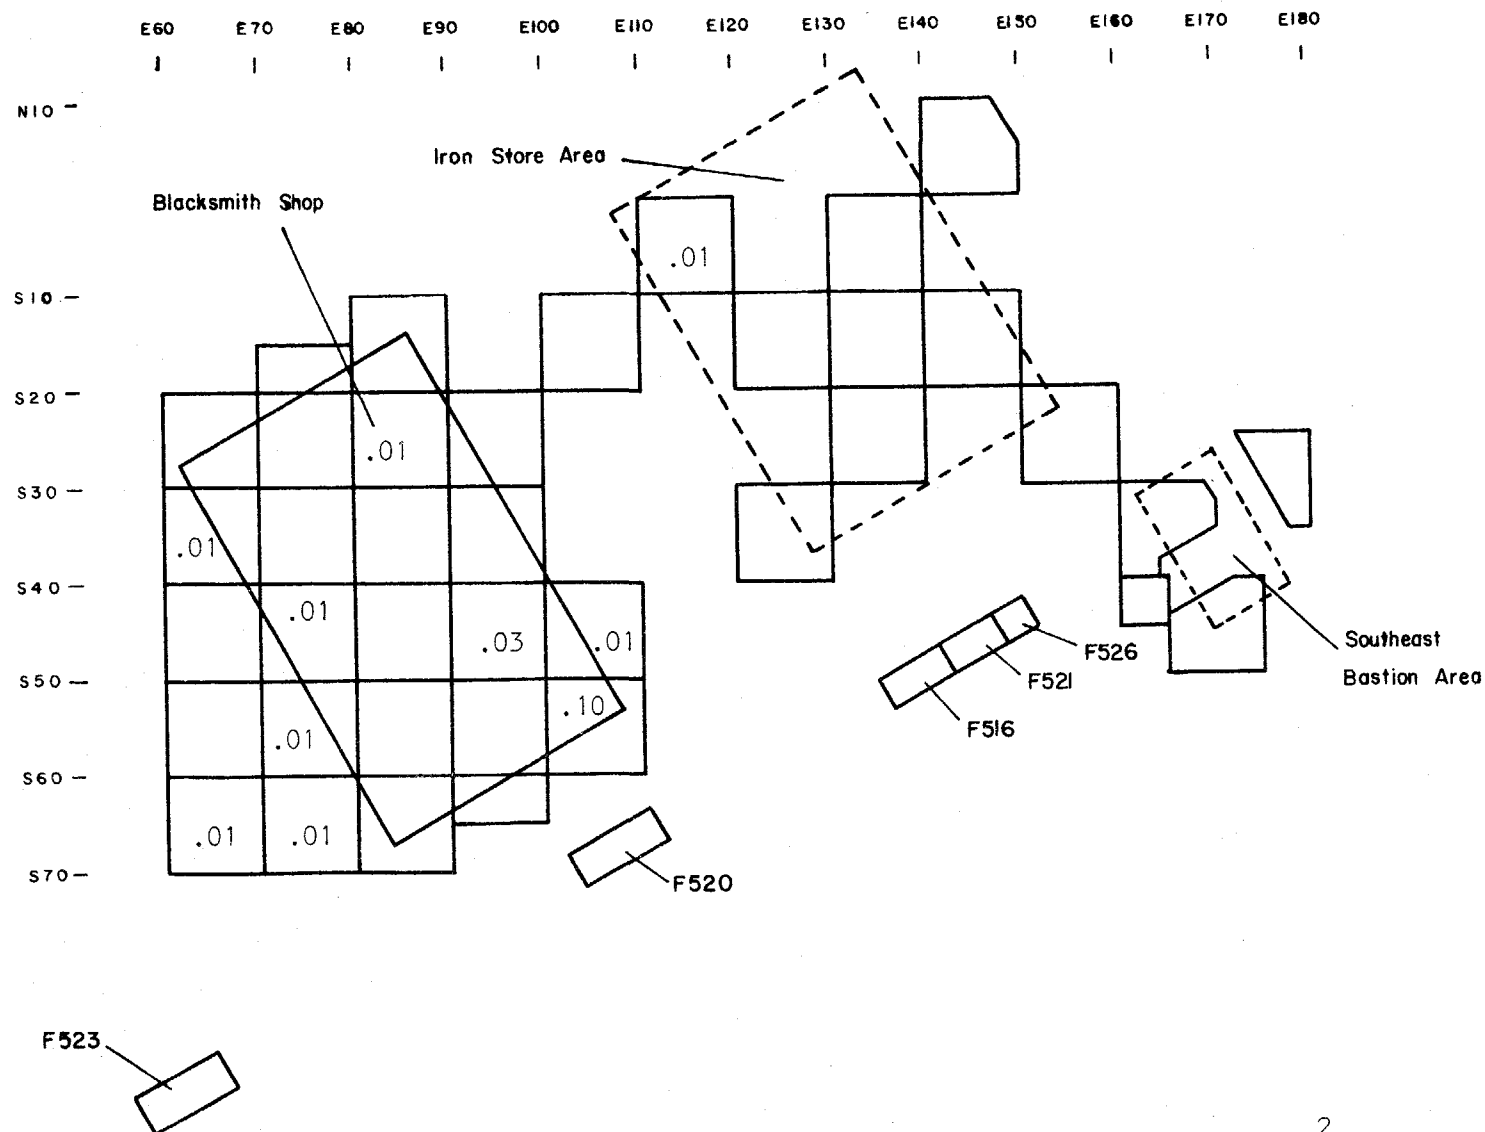
Fig.213 -- Distribution of finished axe parts in the southeastern Fort area (f/ft<sup>2</sup>).

Axes were manufactured in the Blacksmith Shop, and the only concentration of axe parts observed was in the southeastern corner of the Shop (Figs. 213-214).
