FORT VANCOUVER EXCAVATIONS - X

Southeastern Fort Area

National Park Service

July 1975

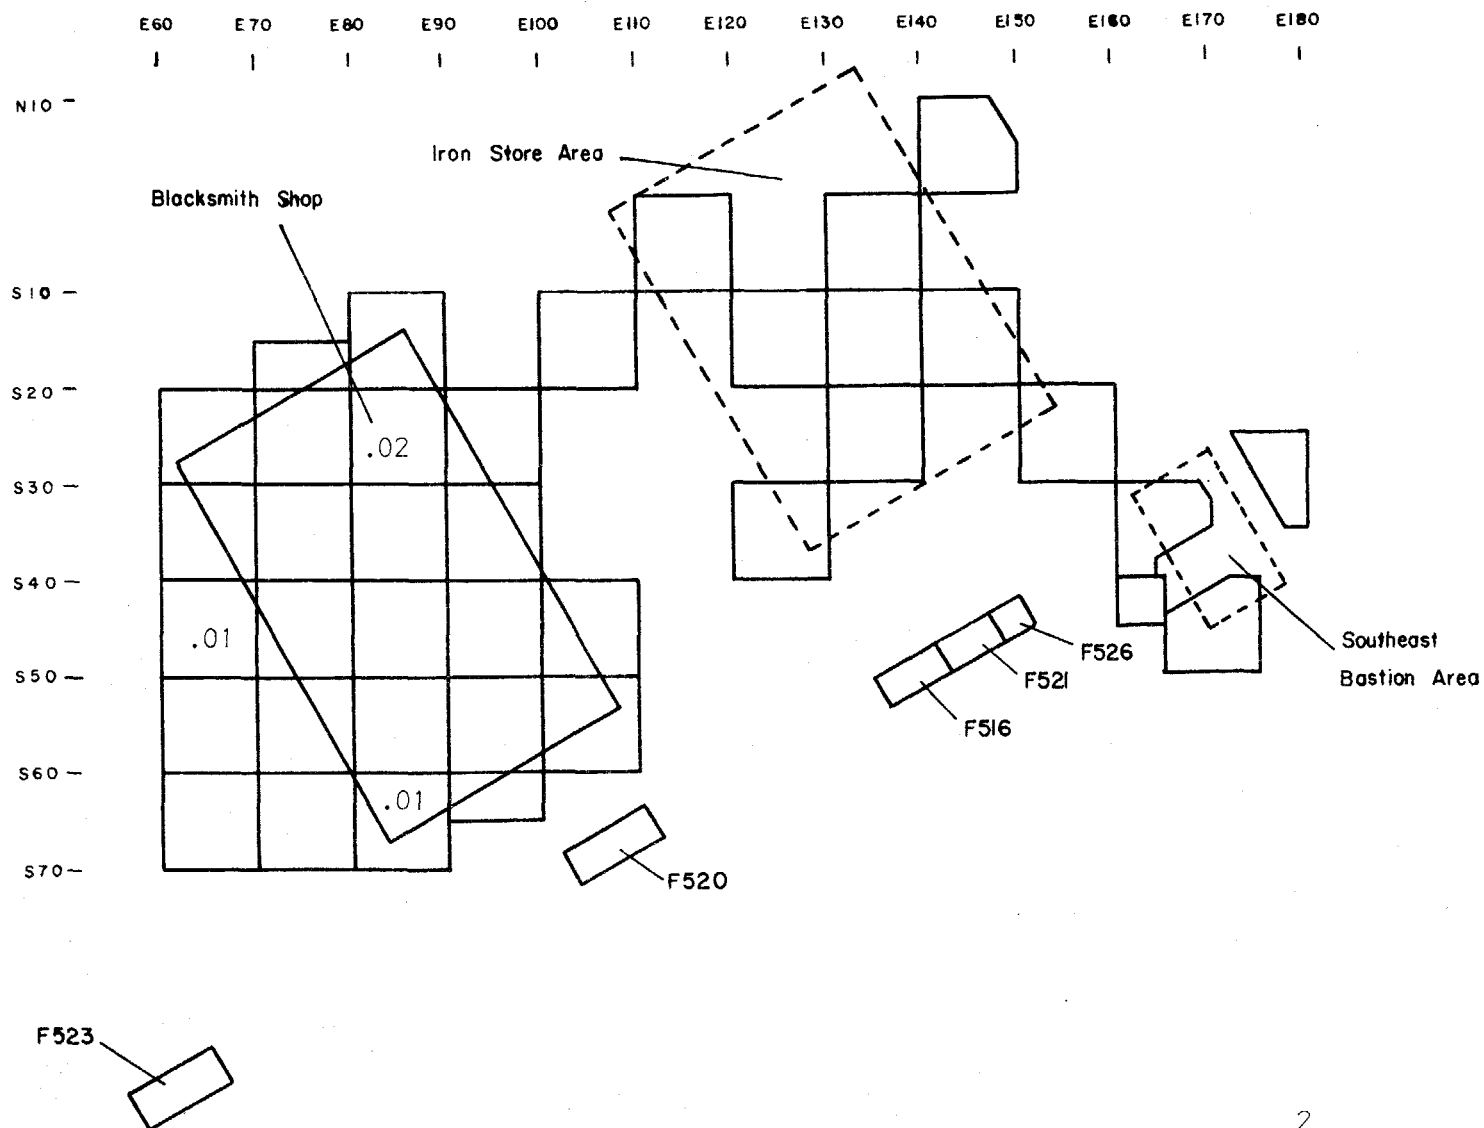
Fig.214 -- Distribution of preform axe parts in the southeastern Fort area (f/ft<sup>2</sup>).

Axes were manufactured in the Blacksmith Shop, and the only concentration of axe parts observed was in the southeastern corner of the Shop (Figs. 213-214).

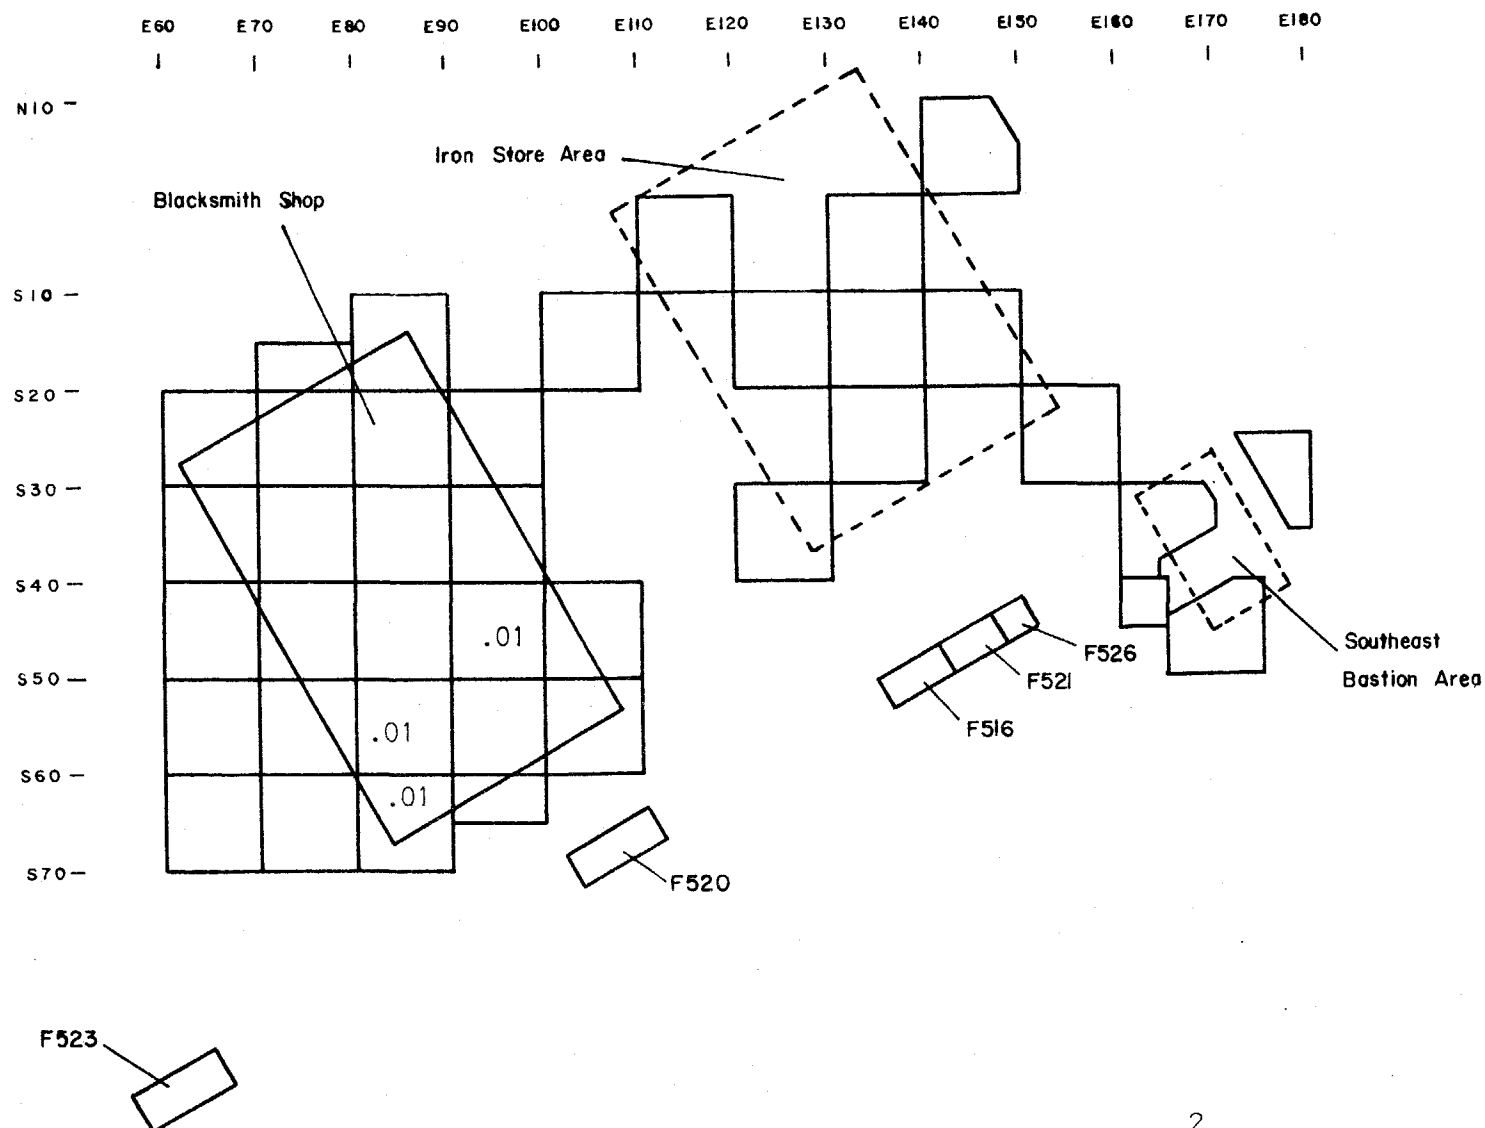
Fig.218 -- Distribution of horseshoes in the southeastern Fort area ( $f/ft^2$ ).

Horses were apparently shod at the Blacksmith Shop, and both the shoes and nails may have been manufactured in the Shop. Shoes were found in the southern half of the shop (Fig. 218) while the nails were found along the central portion of the west wall (Fig. 219).

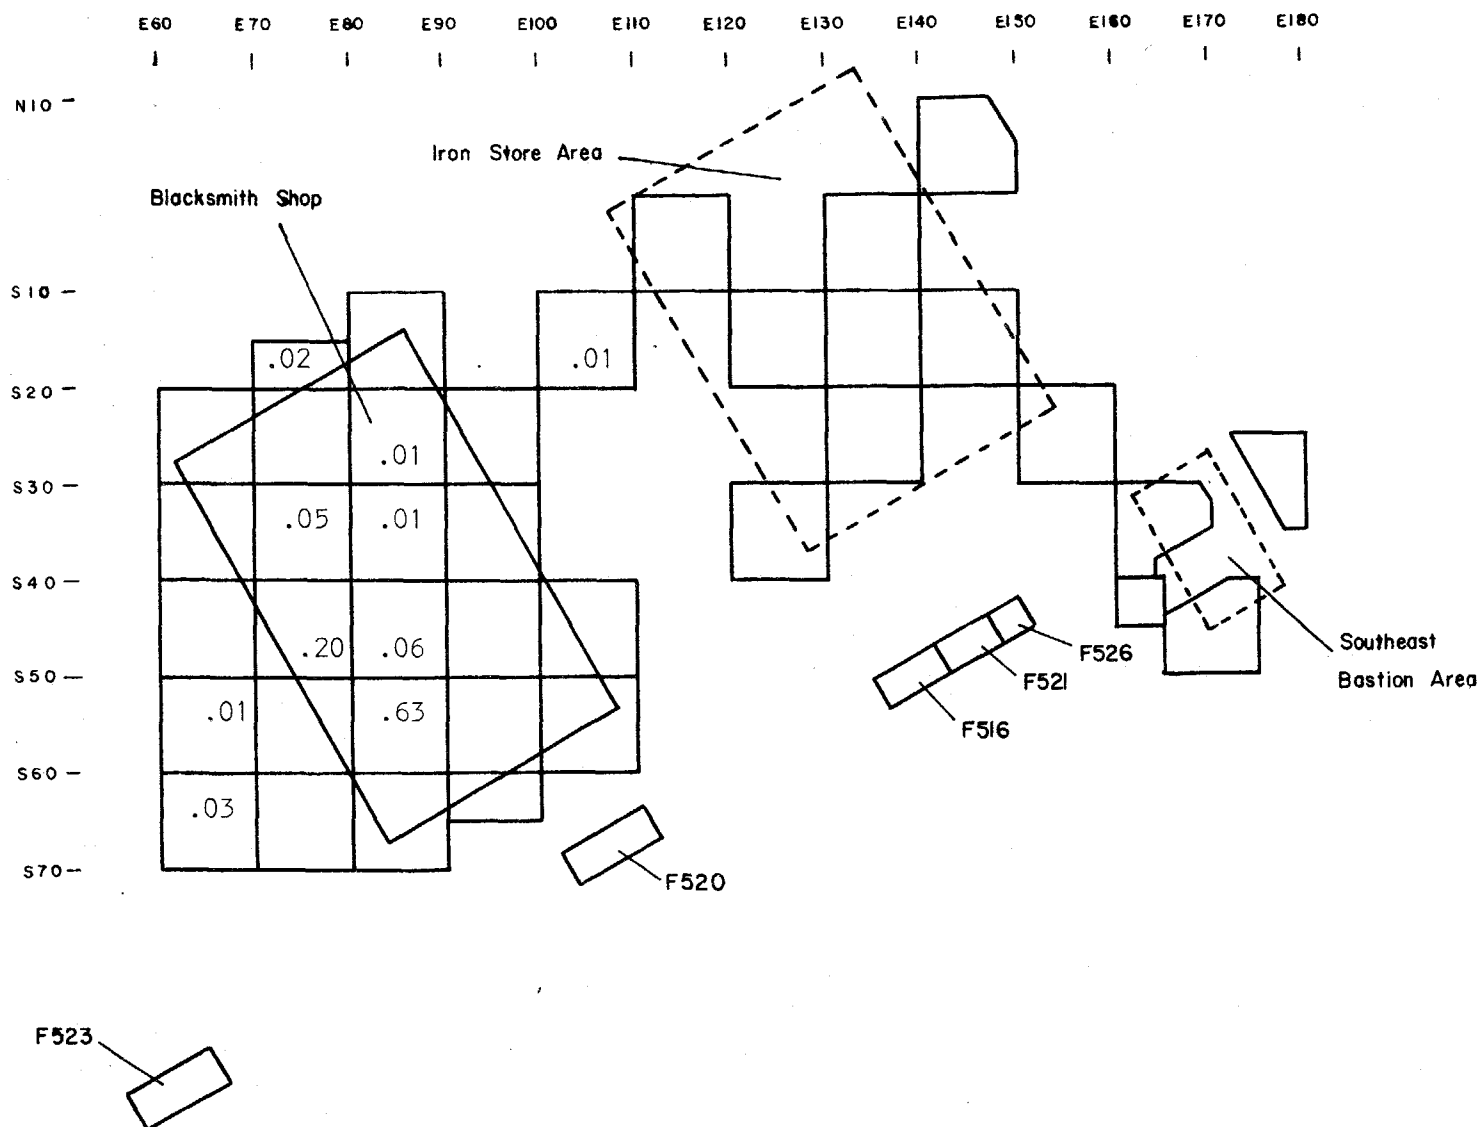
Fig. 219-- Distribution of "shoeing" nails (Varieties #1032 & 1104) for the southeastern Fort area (f/ft<sup>2</sup>).

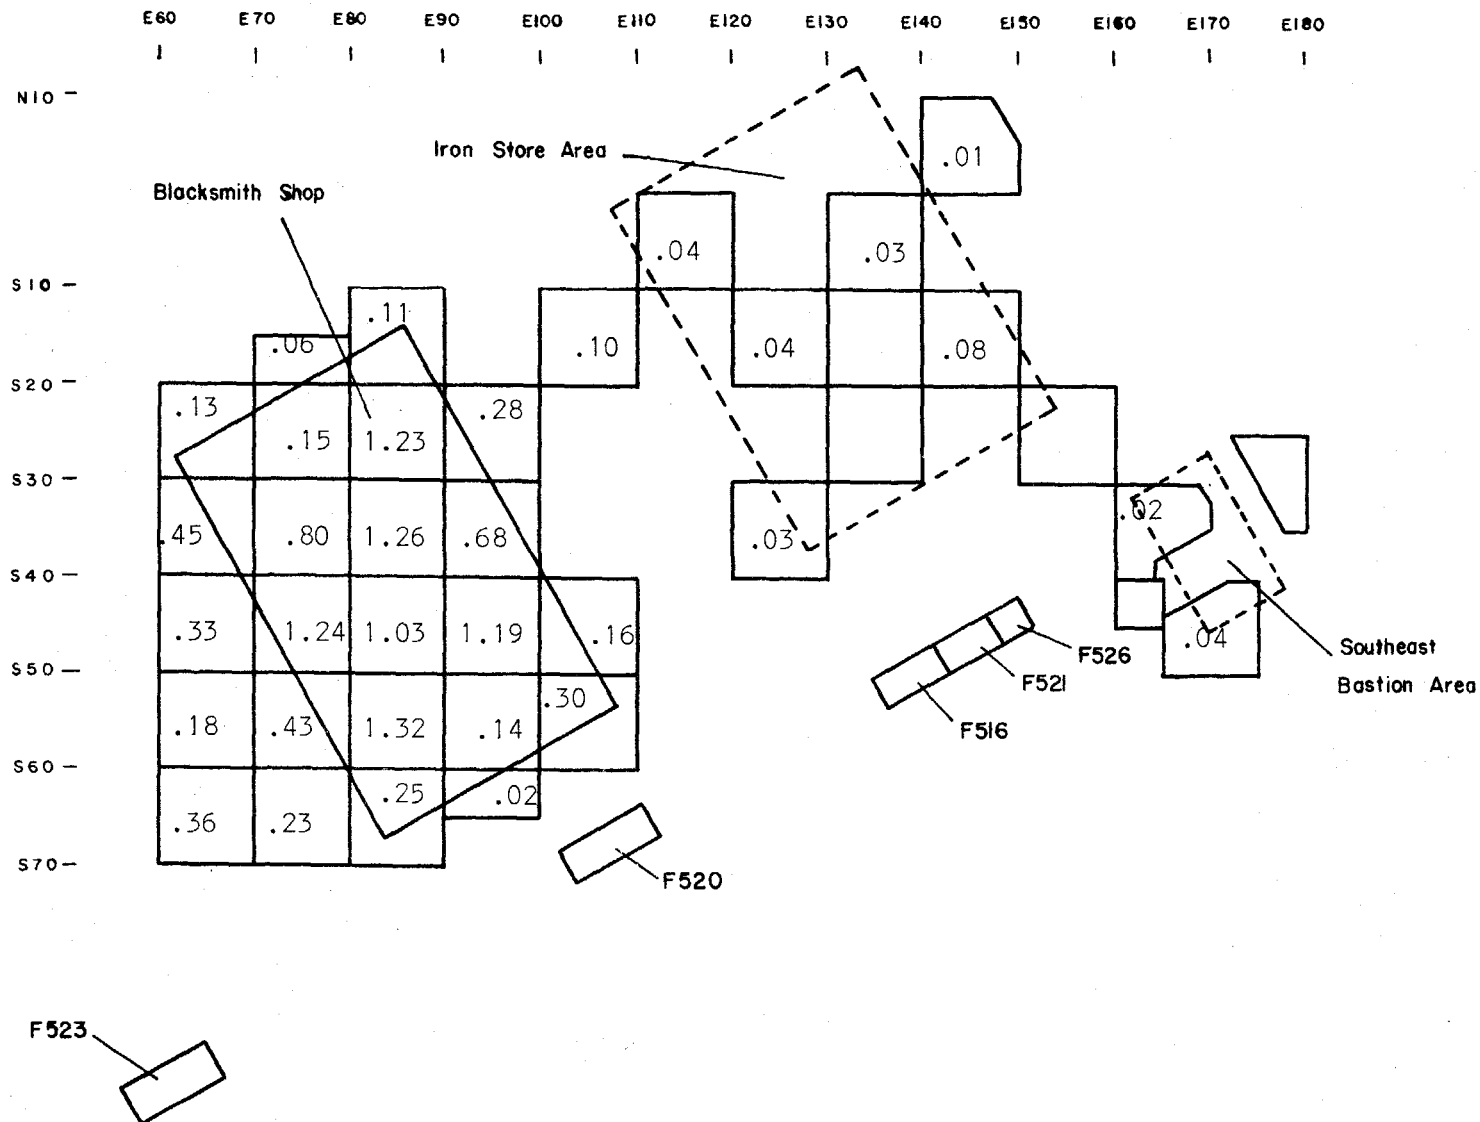
Fig. 220 -- Distribution of cut stock in the southeastern Fort area ( $f/ft^2$ ).

Cut metal stock was concentrated in the central portion of the Blacksmith Shop (Figs. 220-222) while the straps used to bundle stock were found within the Iron Store area (Fig. 223). Bundling straps were also recovered in the central portion of the Shop, but not in as high a concentration as within the Iron Store.

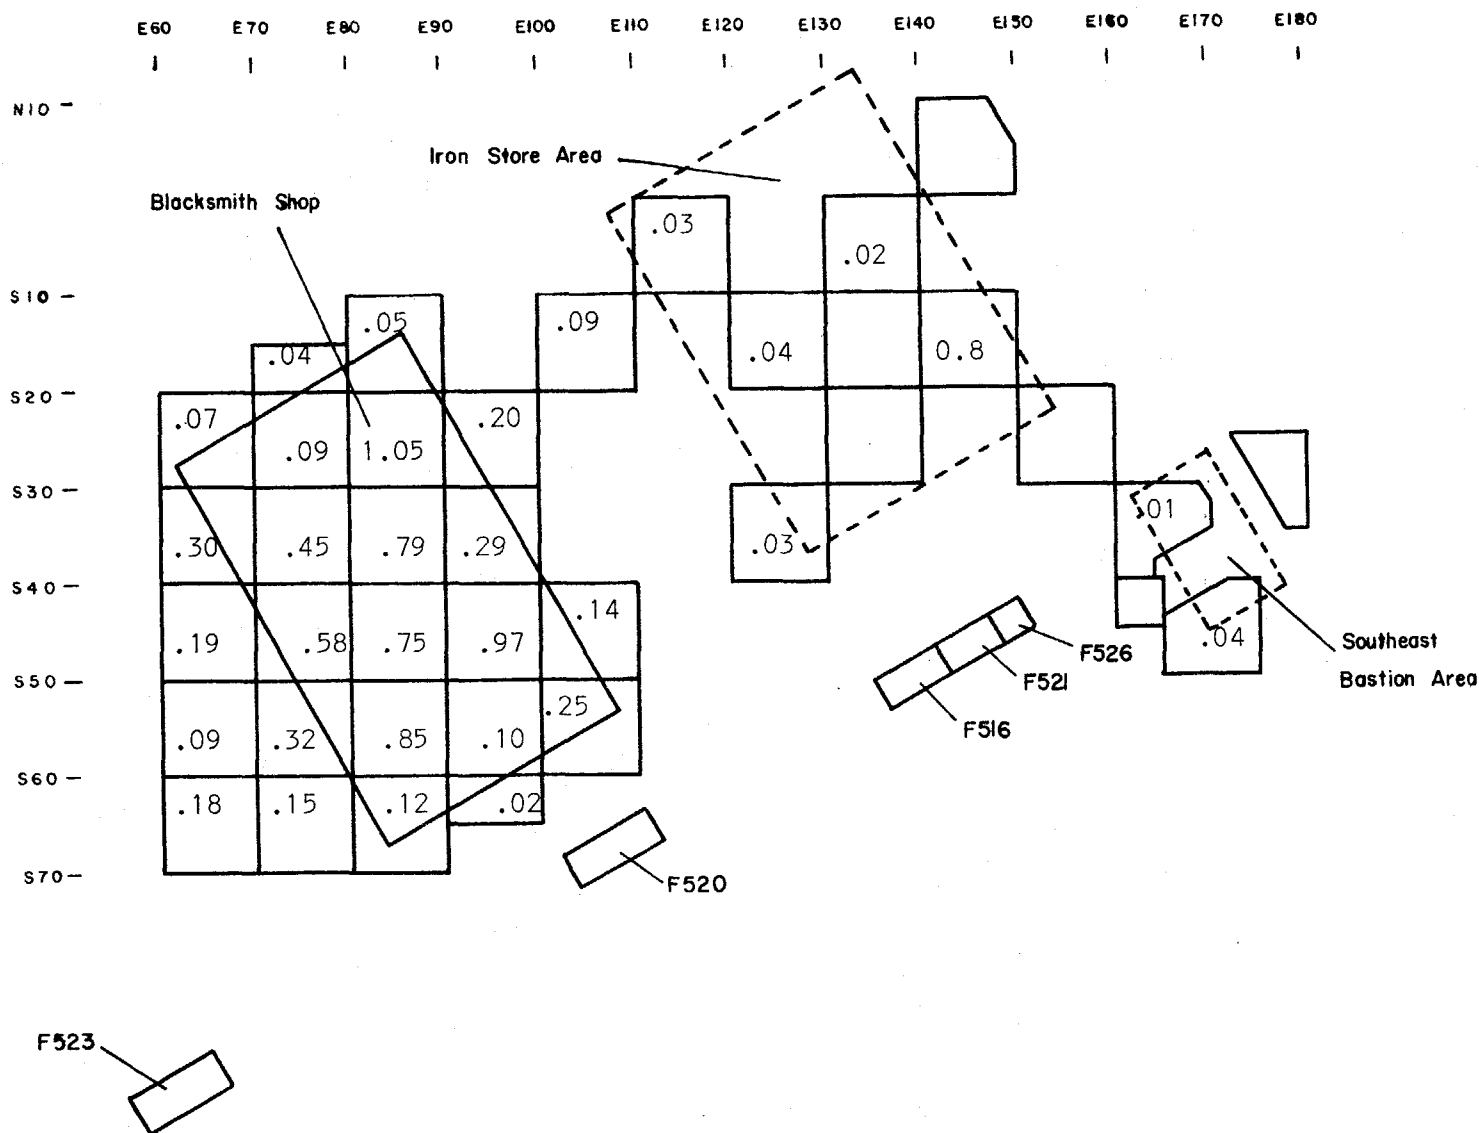
Fig. 221 -- Distribution of square rectangular iron cut stock in the southeastern Fort area ( $f/ft^2$ ).

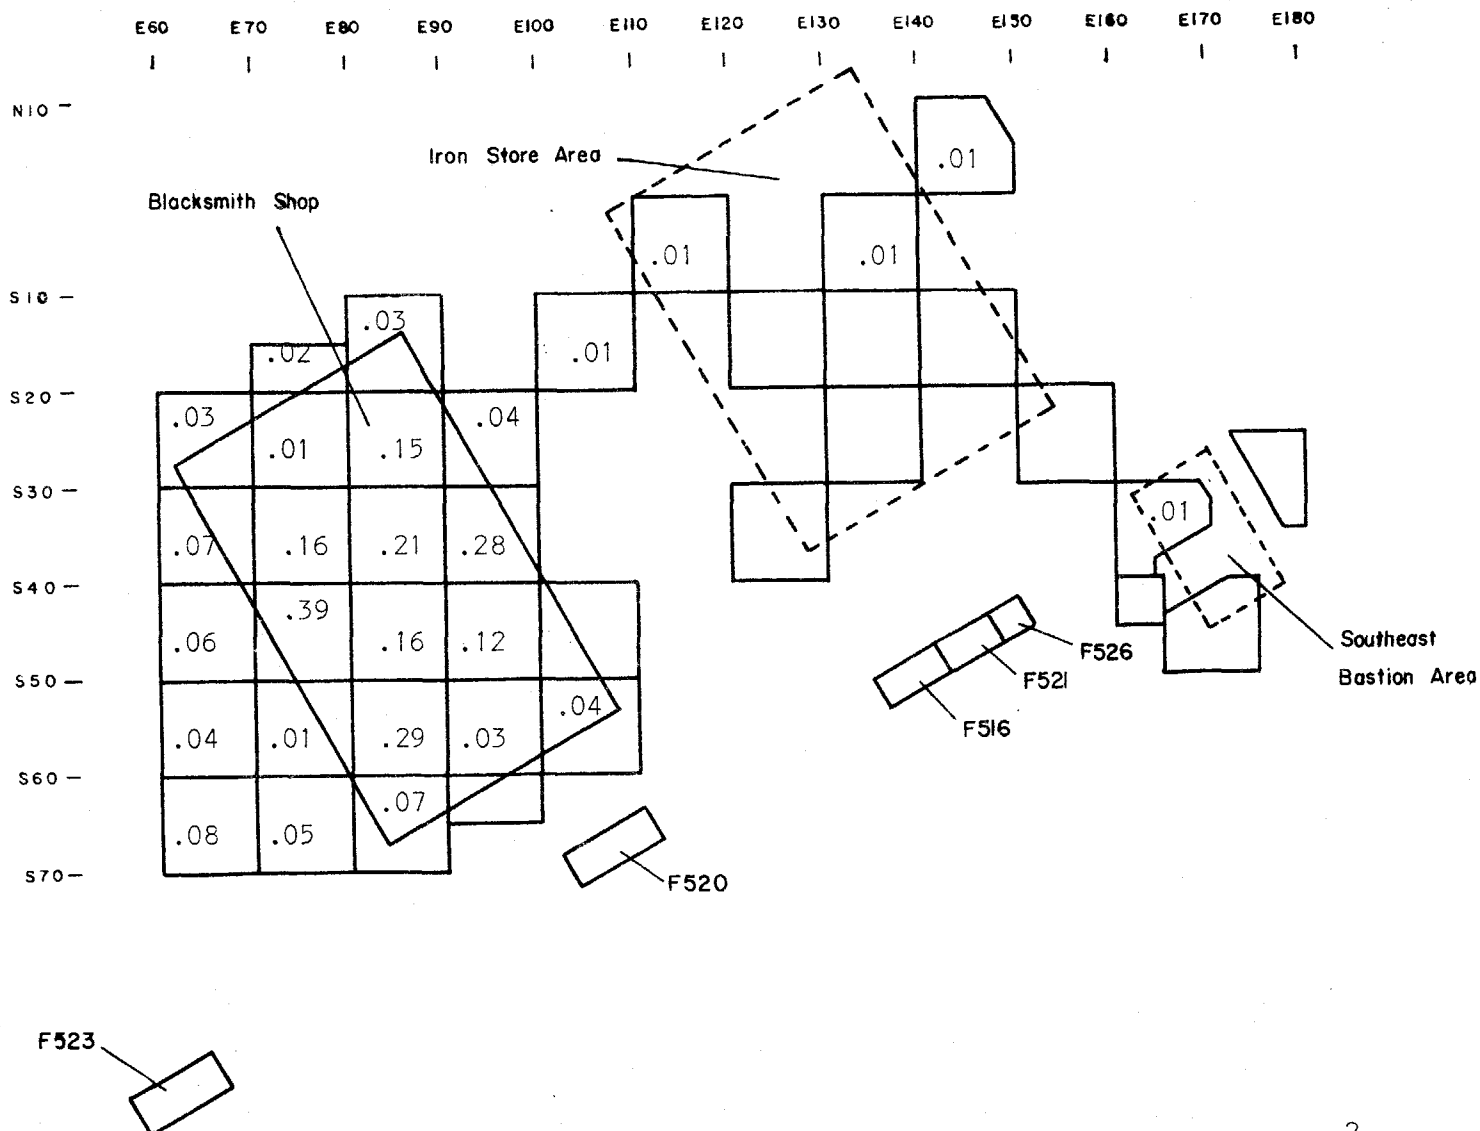
Fig.222 -- Distribution of round iron cut stock in the southeastern Fort area ( $f/ft^2$ ).

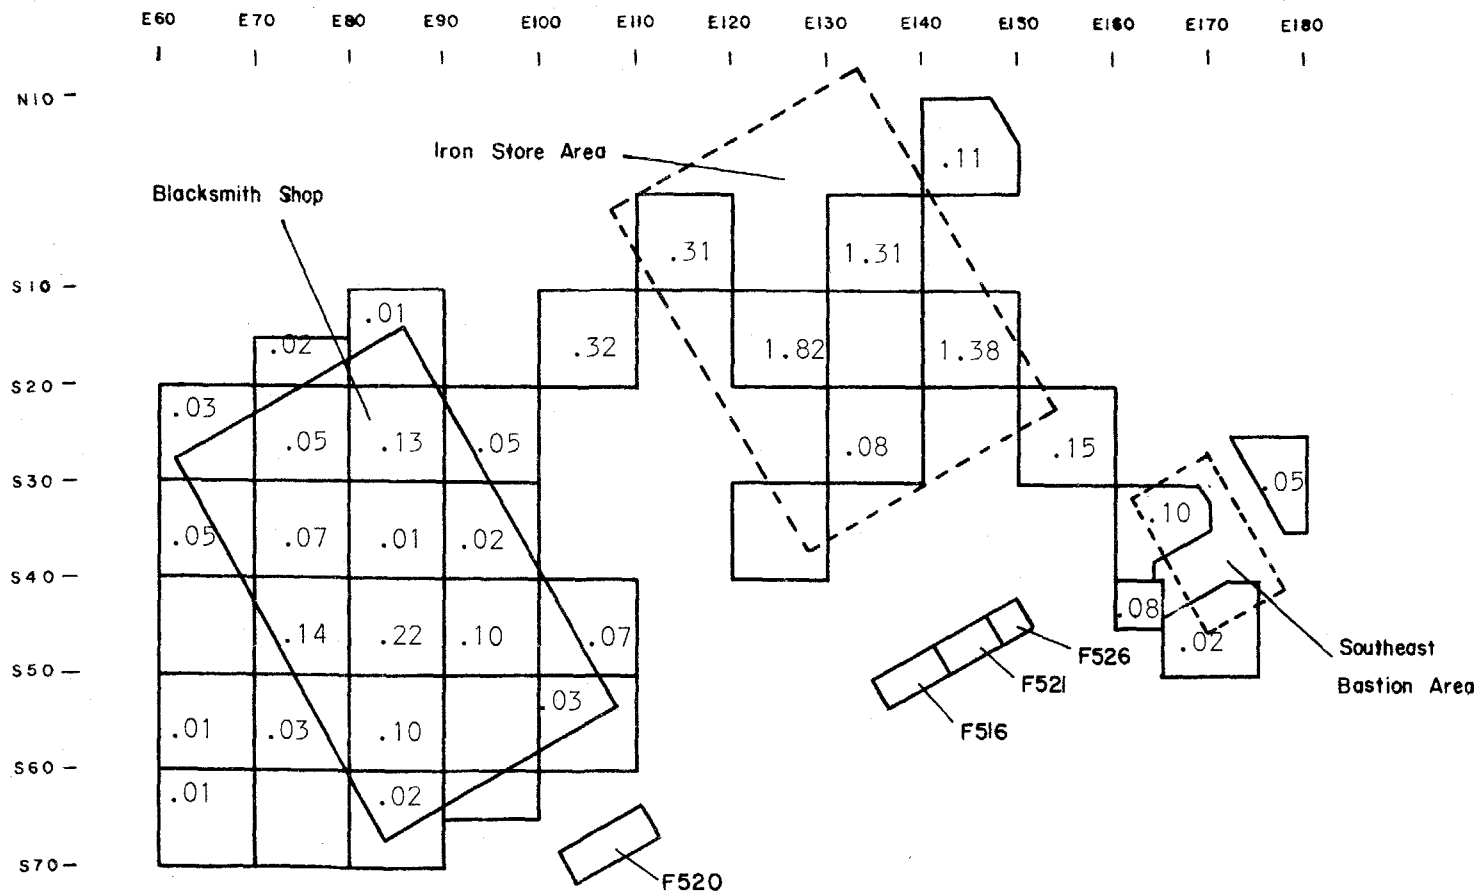
Fig.223 -- Distribution of bundling straps in the southeastern Fort area ( $f/ft^2$ ).

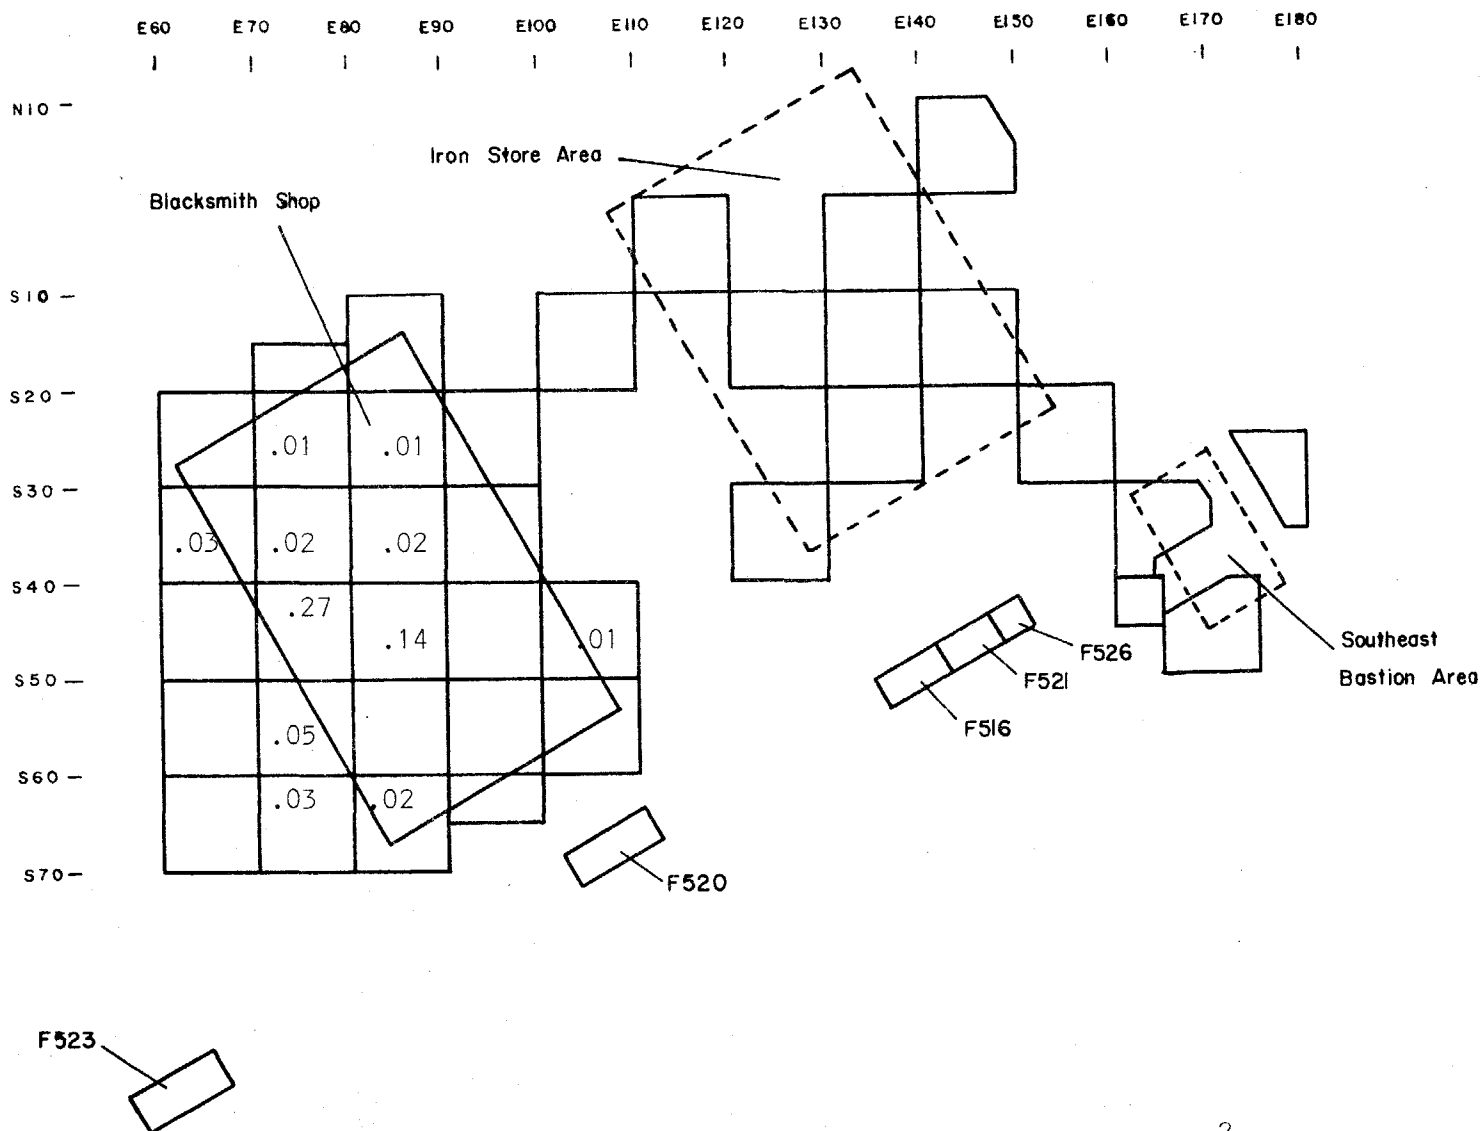
Fig. 224 -- Distribution of lead casting in the southeastern Fort area (f/ft<sup>2</sup>).

Both lead and brass/copper castings were found in the Blacksmith Shop clustering around the central portions of the west and north walls (Figs. 224-225). The west concentration of lead was in a work area, whereas the brass/copper casting came from a forge area.

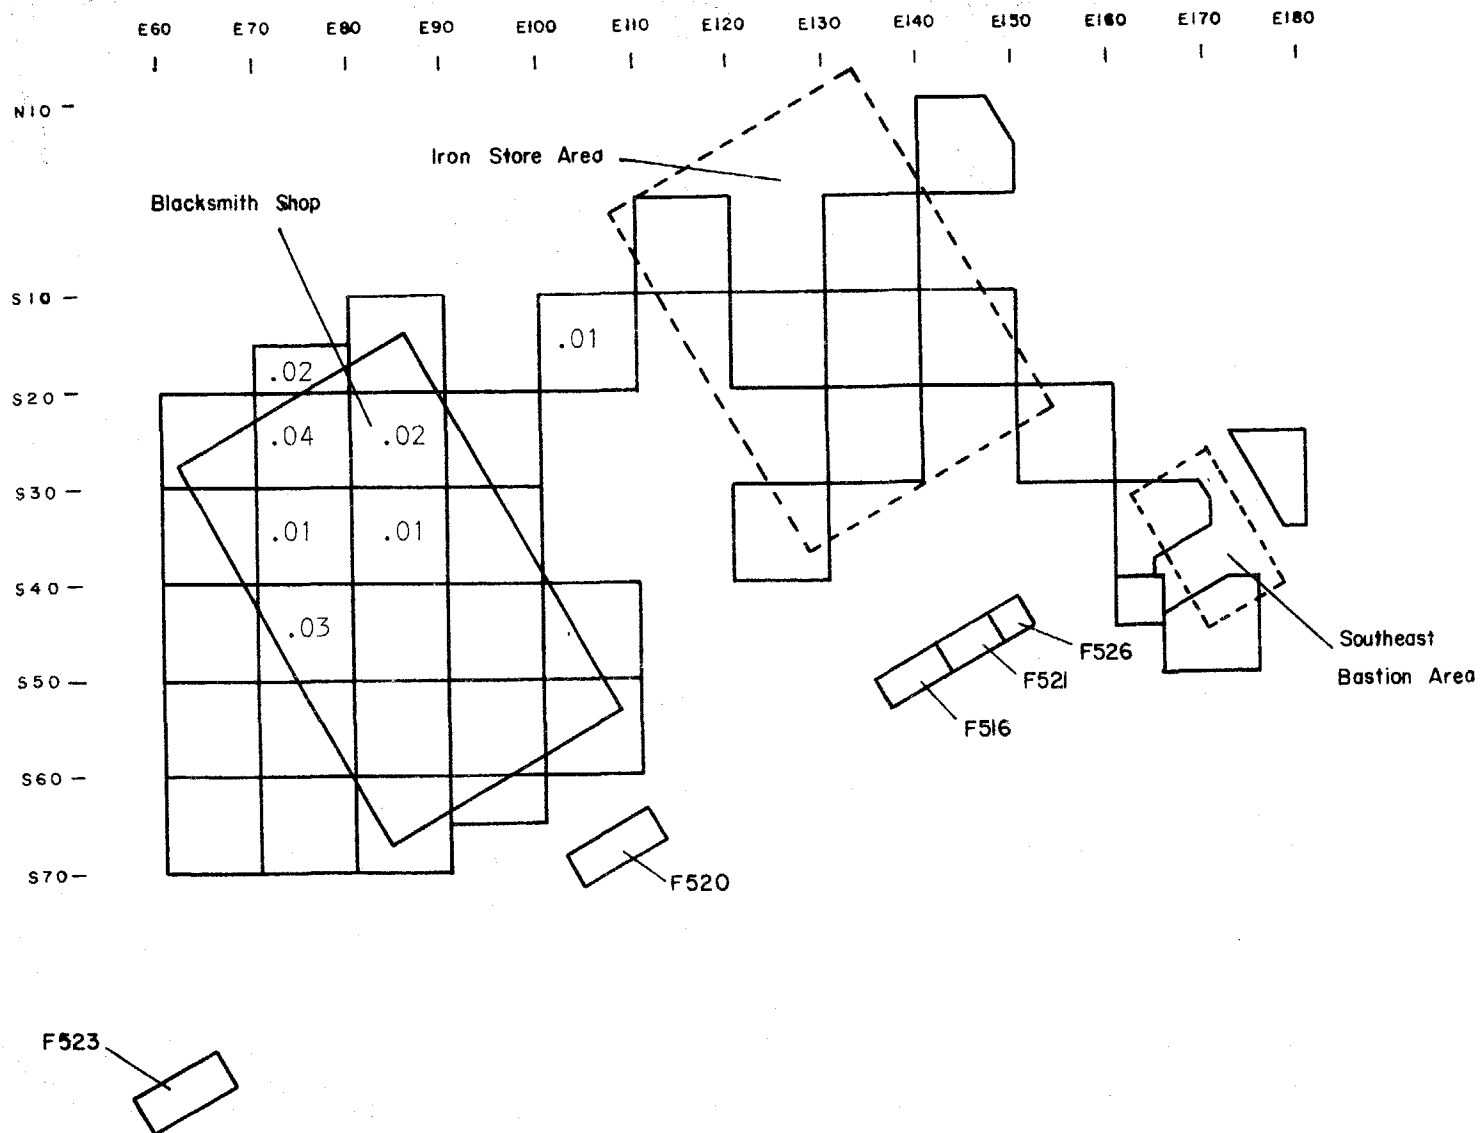
Fig.225 -- Distribution of brass-copper castings in the southeastern Fort area (f/ft<sup>2</sup>).

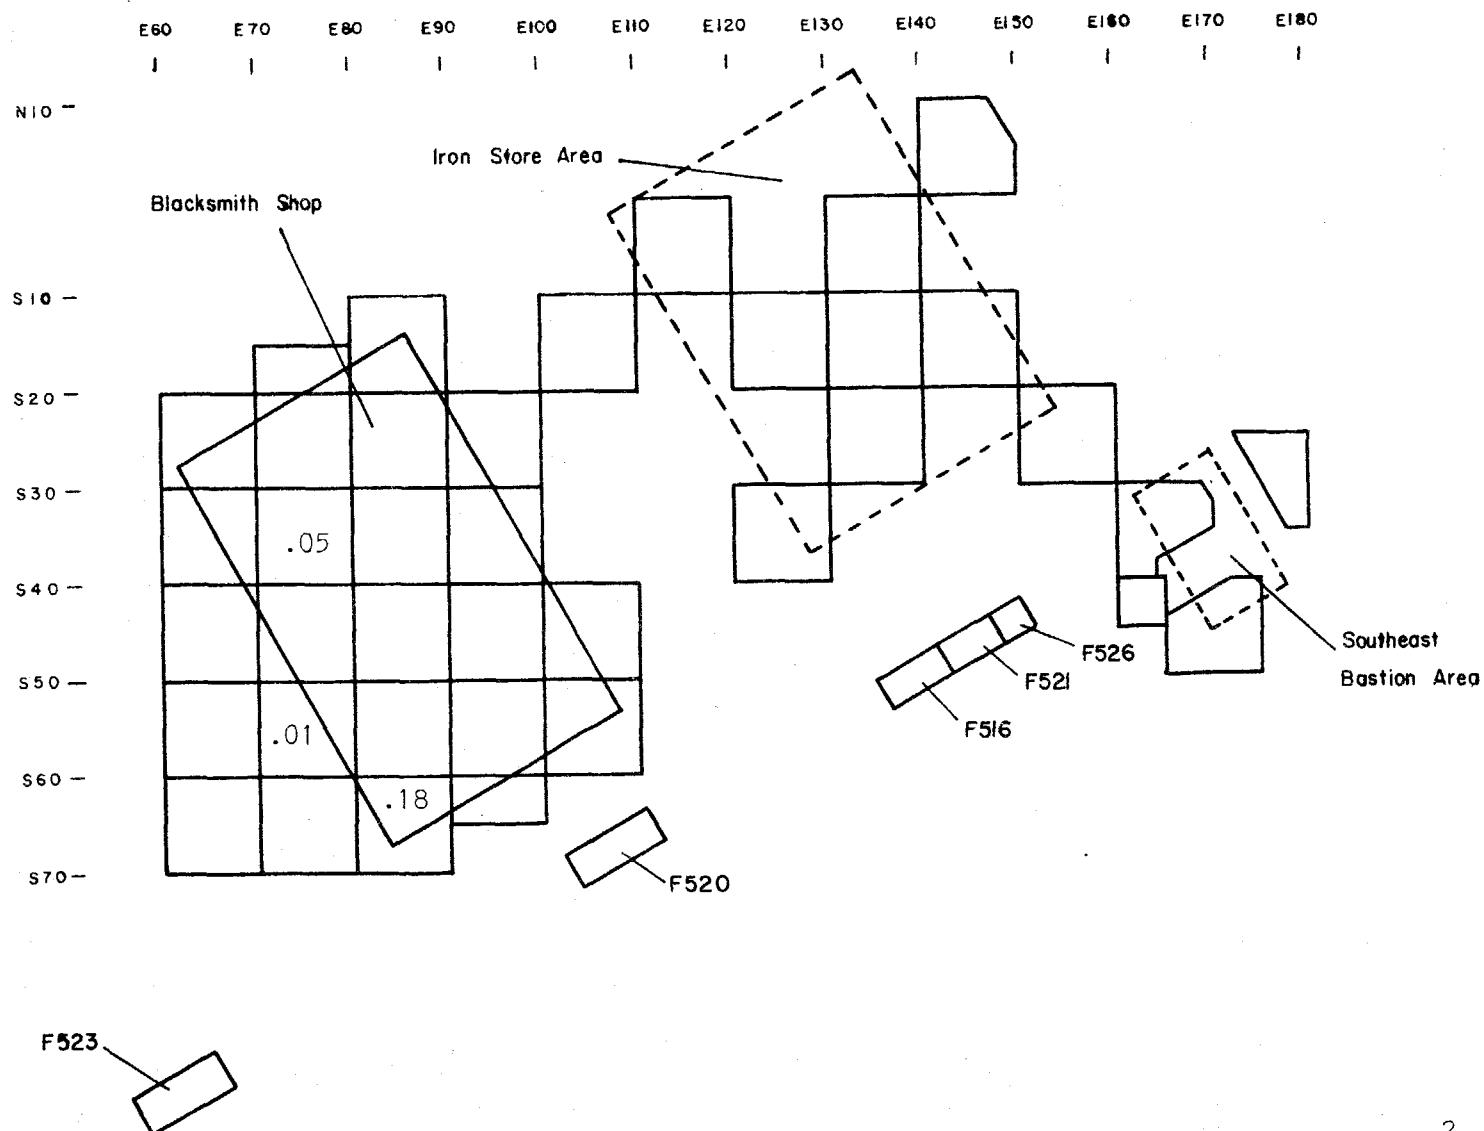
Fig.226 -- Distribution of ground sandstone fragments in the southeastern Fort area ( $f/ft^2$ ).

A concentration of ground sandstone fragments was observed in the southwestern corner of the Blacksmith Shop (Fig. 226), and may indicate a metal grinding area.

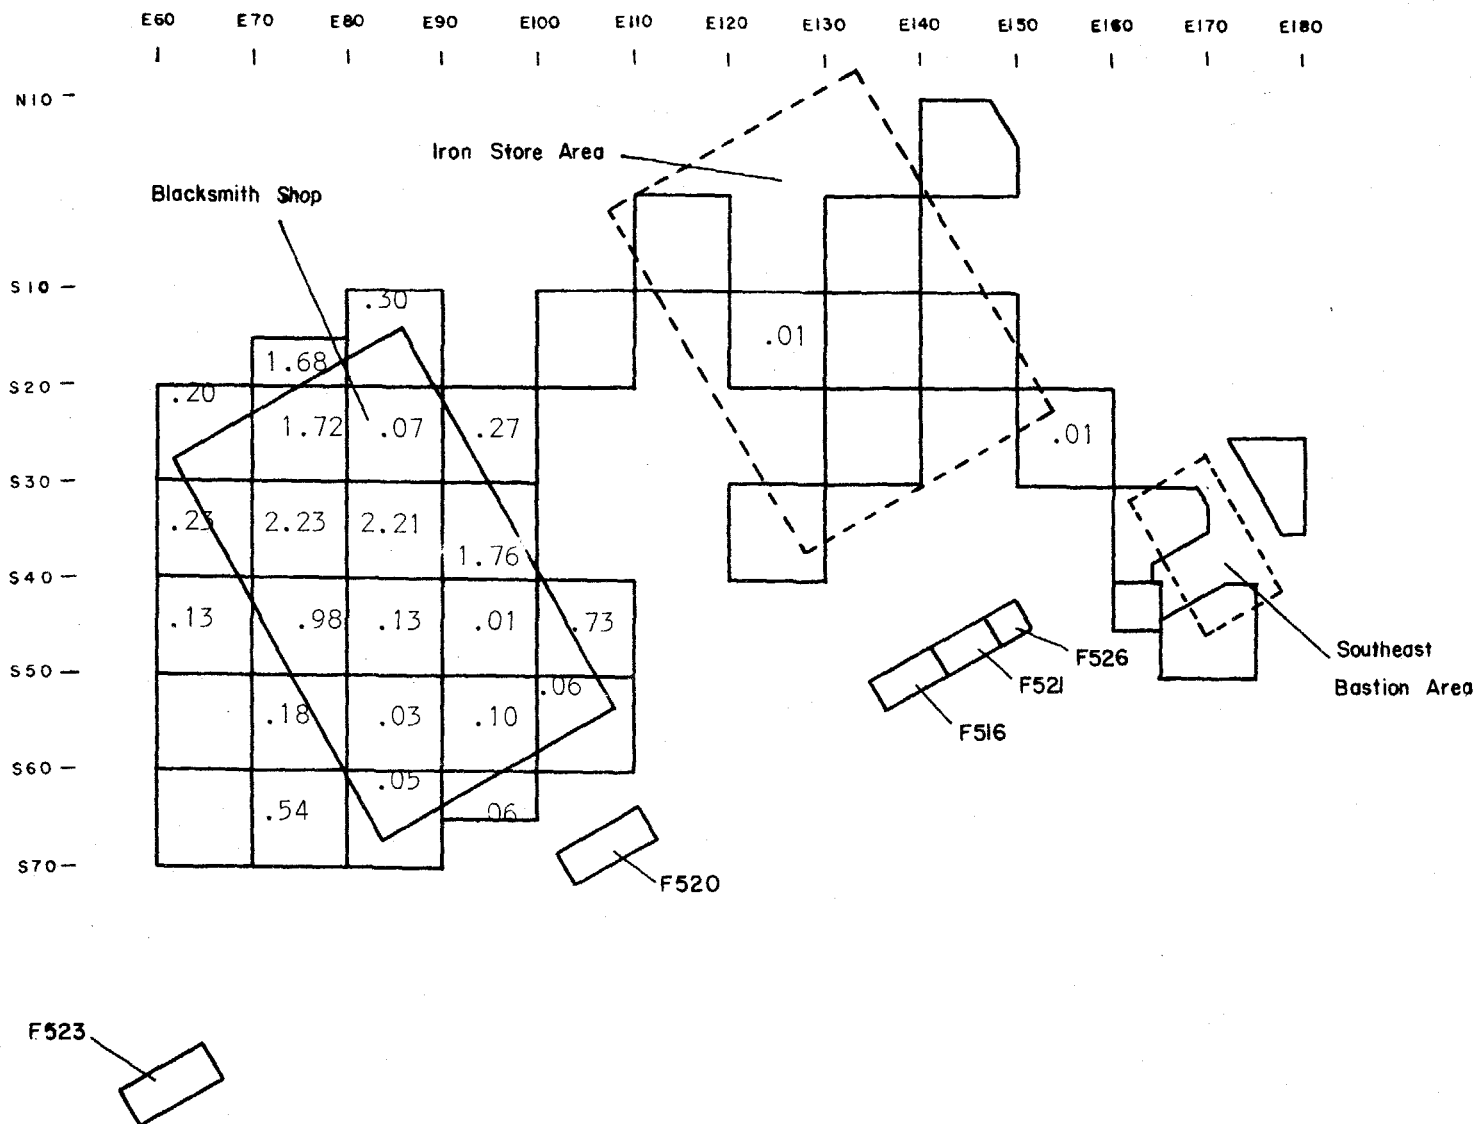
Fig.229 -- Distribution of coke in the southeastern Fort area (f/ft<sup>2</sup>).

The coke concentration within the Blacksmith Shop (Fig. 229) probably indicates a front storage area for forge fuel.

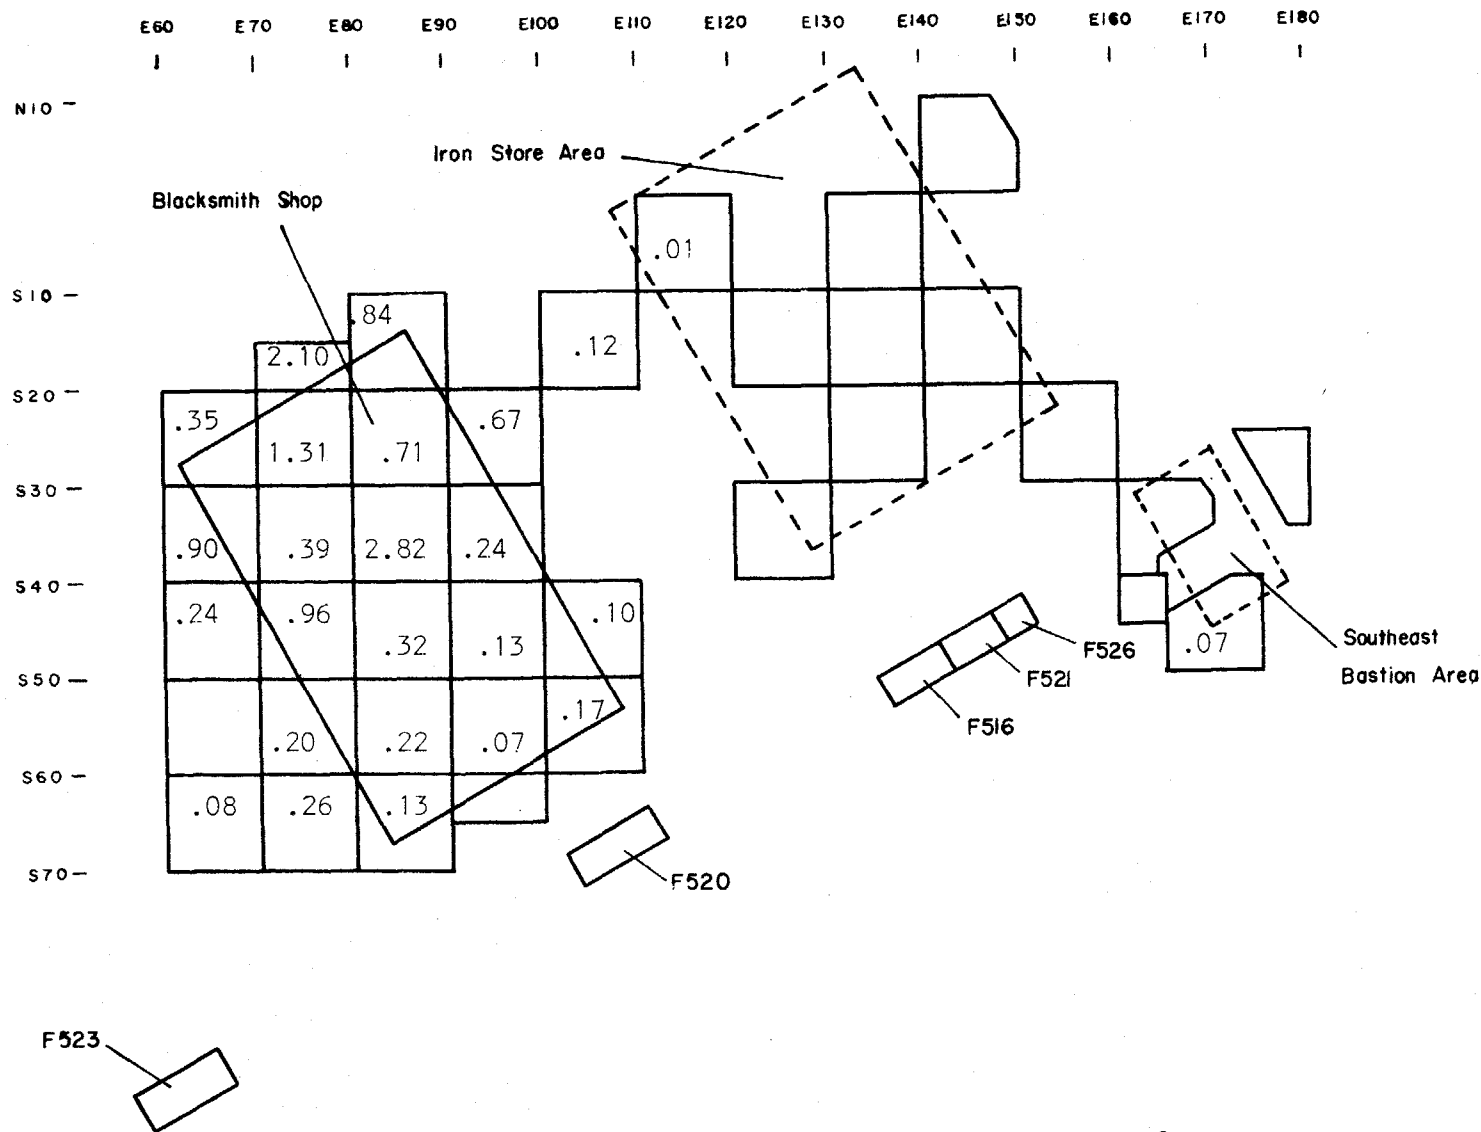
Fig.230 -- Distribution of clinkers in the southeastern Fort area ( $f/ft^2$ ).

The exhausted fuel from the forge was found in the north-central portion of the Blacksmith Shop (Figs. 230-231), and probably indicates the front of the forge.

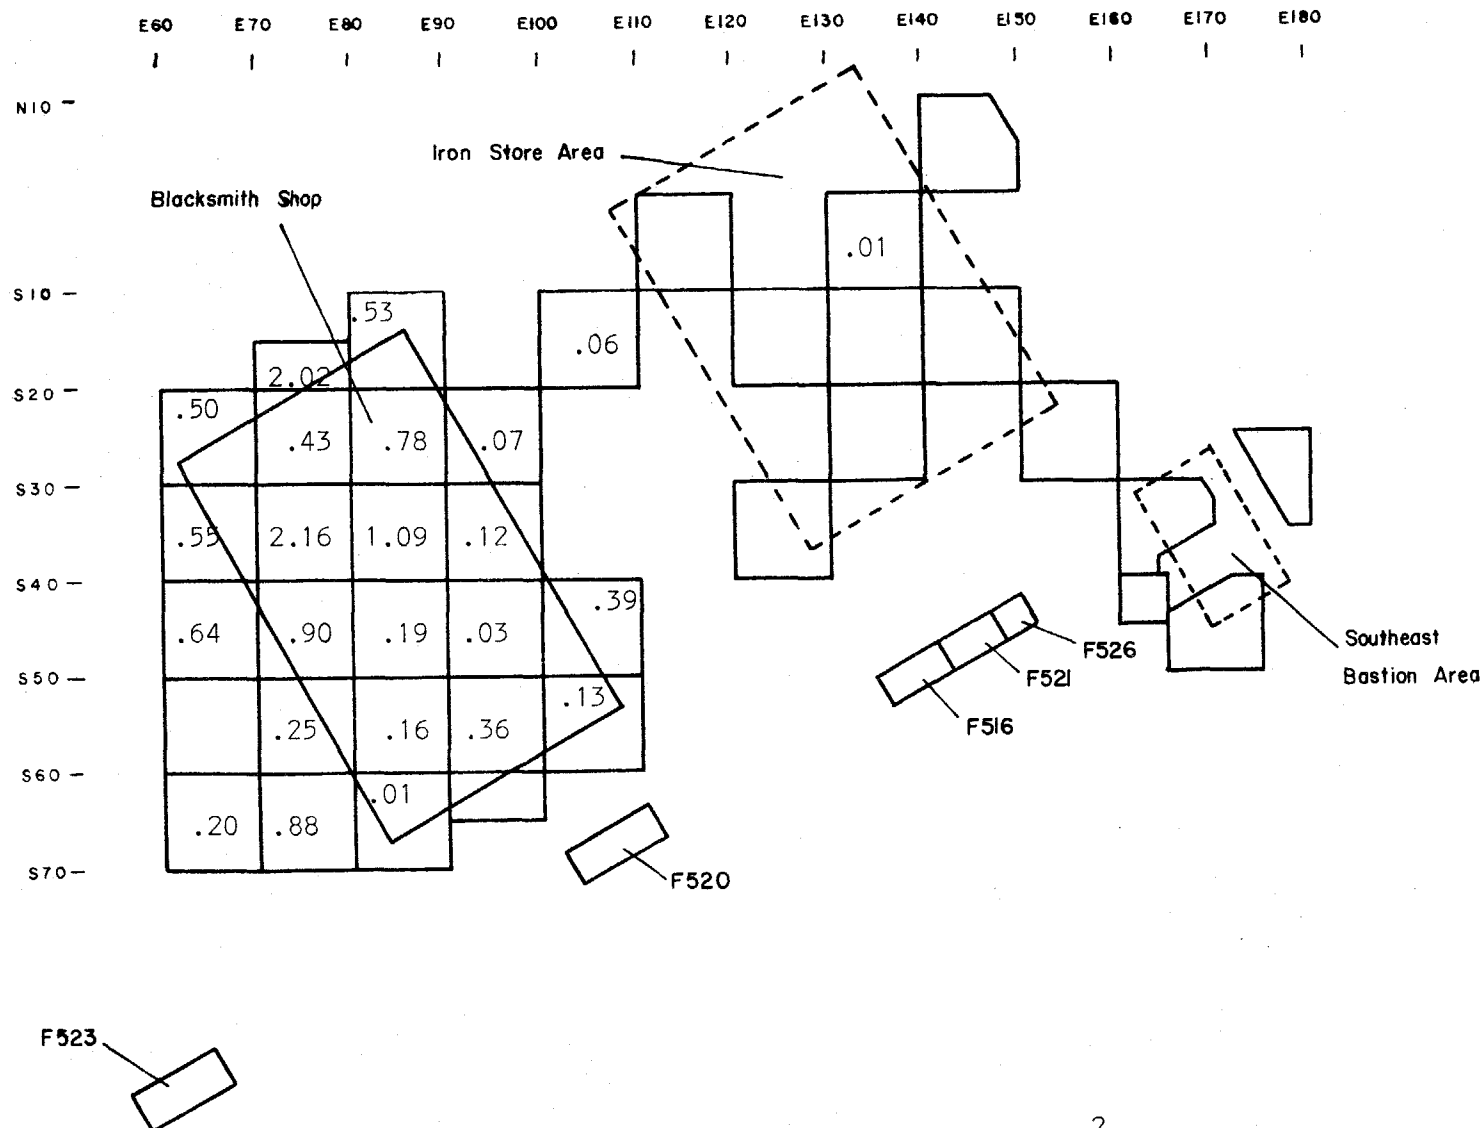
Fig.231 -- Distribution of slag in the southeastern Fort area (f/ft<sup>2</sup>).
