FORT VANCOUVER EXCAVATIONS - X

Southeastern Fort Area

National Park Service

July 1975

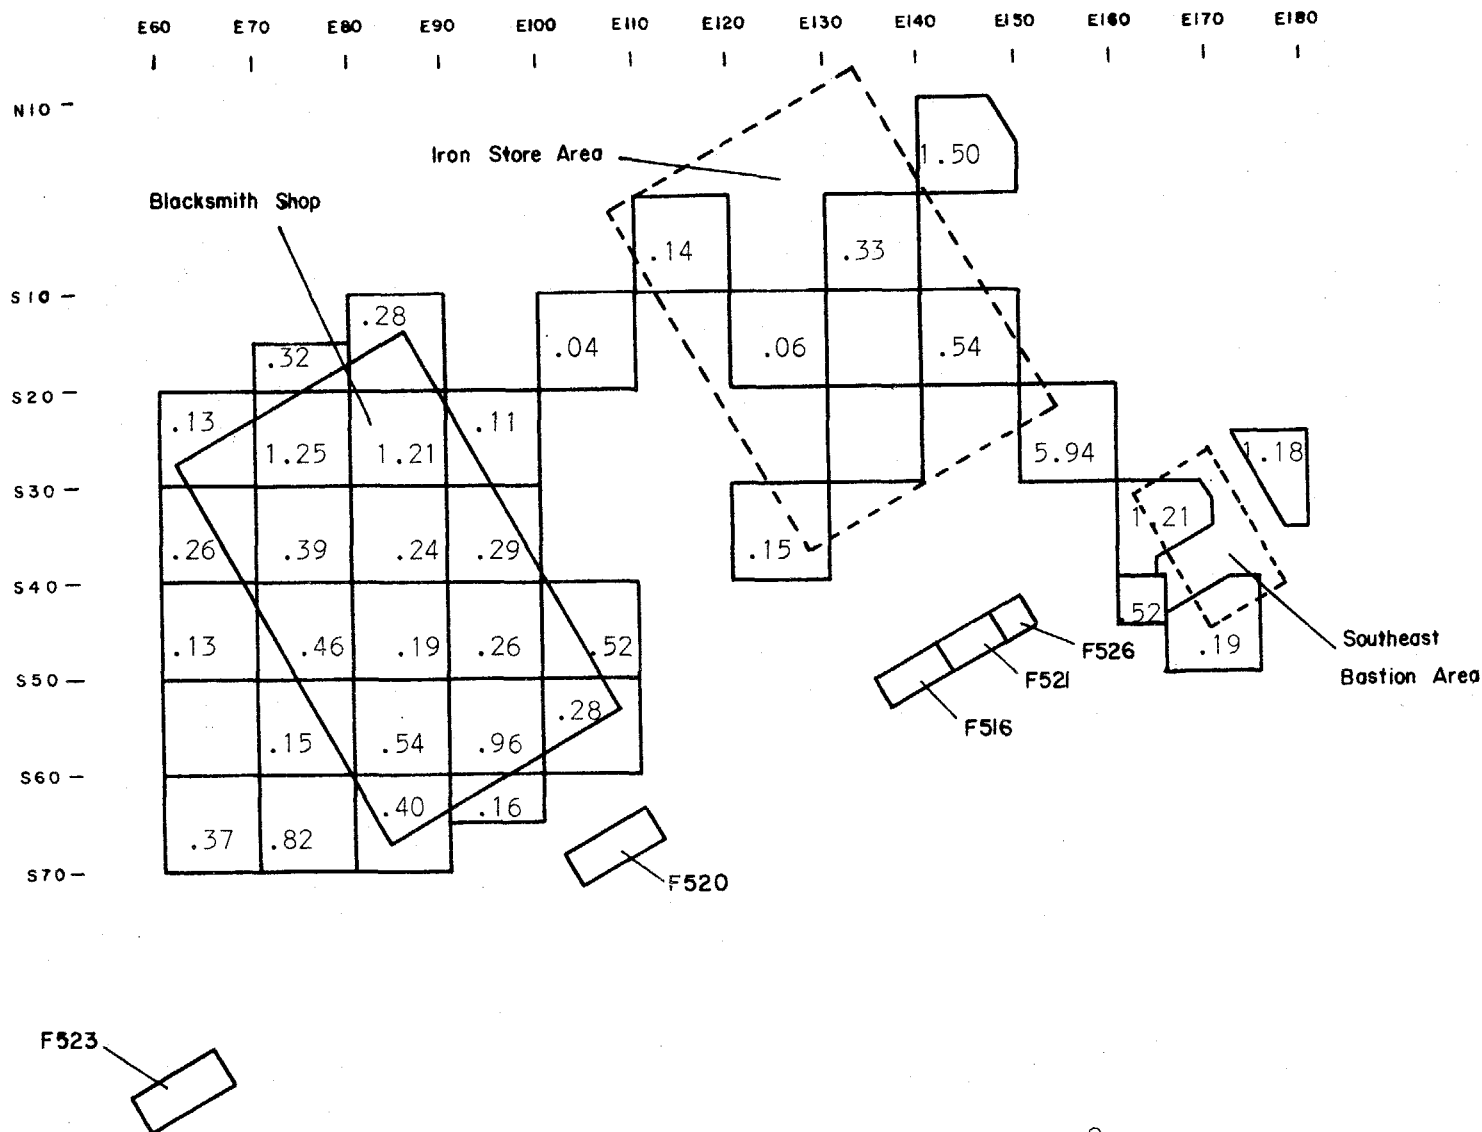
Fig.239 -- Distribution of bone in the southeastern Fort area (f/ft<sup>2</sup>).

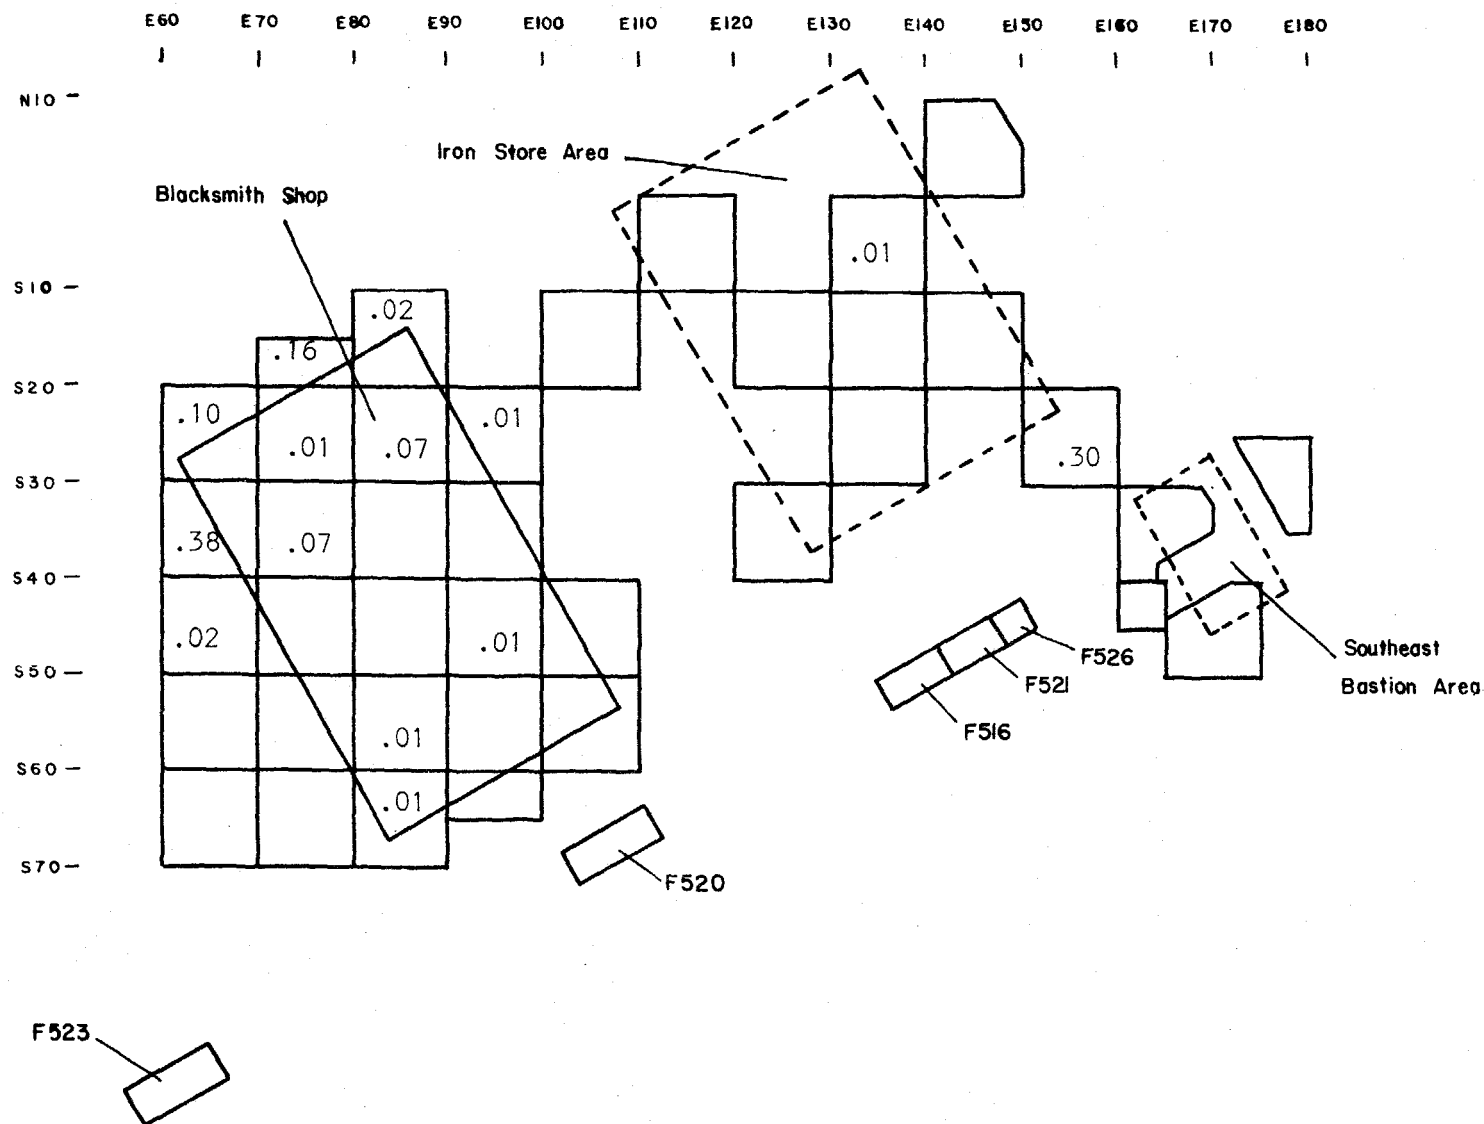
Fig.240 -- Distribution of shell in the southeastern Fort area ( $f/ft^2$ ).

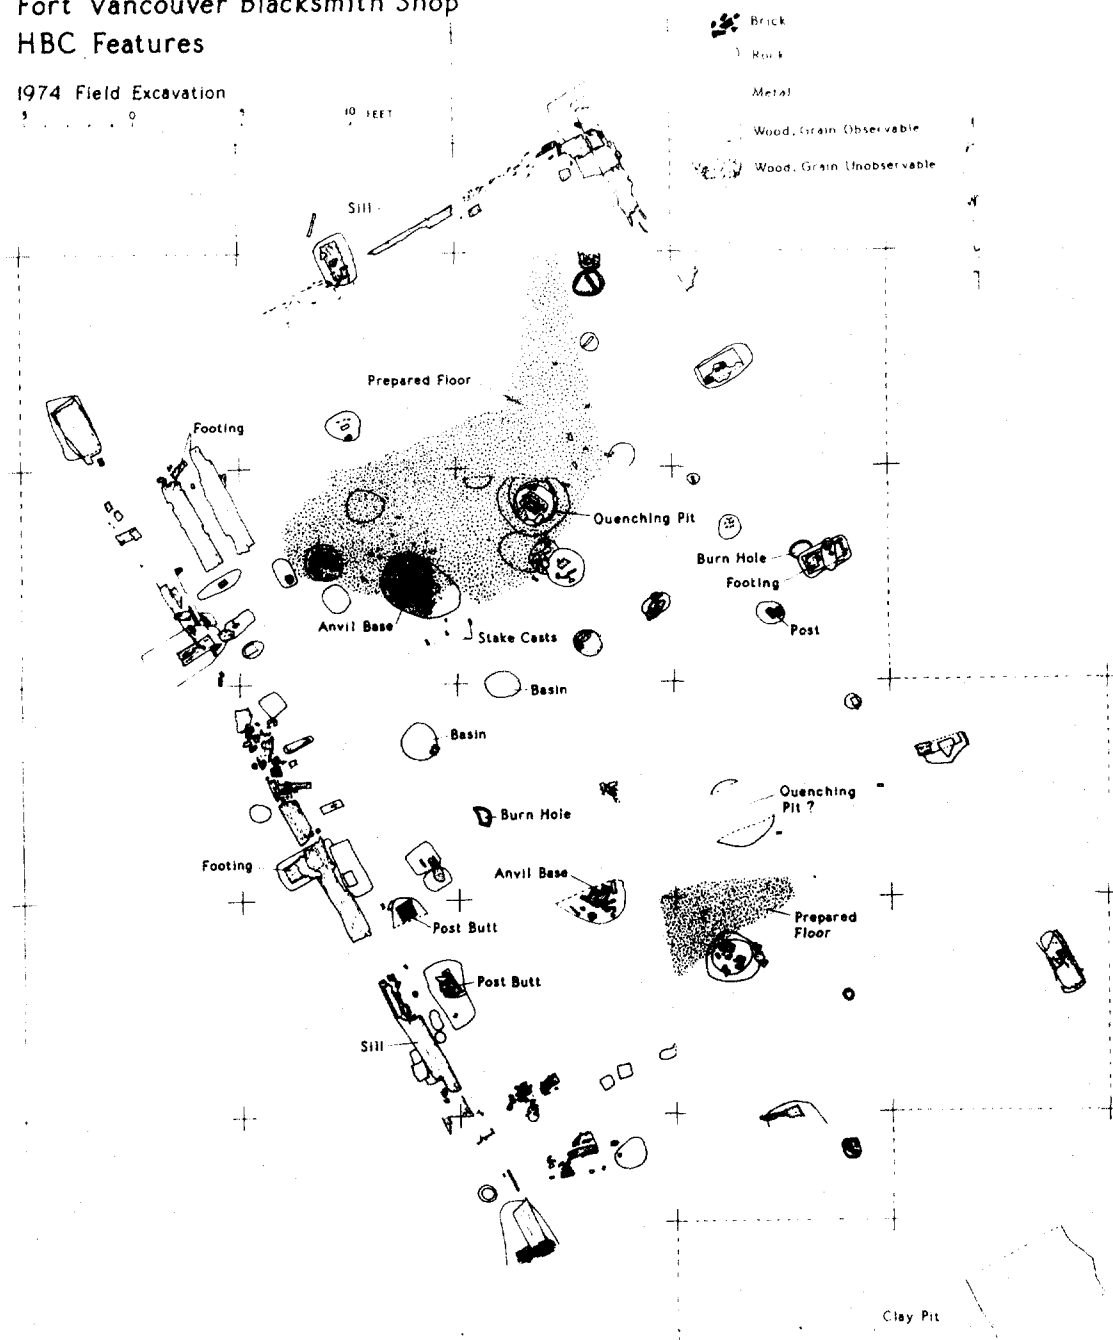
Fig. 241 -- Locations and Identification of In situ HBC Features for the Blacksmith Shop.

Reconstruction of the interior arrangement for the Blacksmith Shop has been a difficult and complex task. From historical evidence, it was known that the Shop had 4 forges, 4 bellows and at least 4 anvils; but on the basis of the archaeological evidence, only one forge location could be positively determined, only 3 anvil positions could be identified, and not one positive bellows location could be found. Those in situ HBC features associated with the Shop which were uncovered by archaeological excavations have been illustrated in Fig. 241.

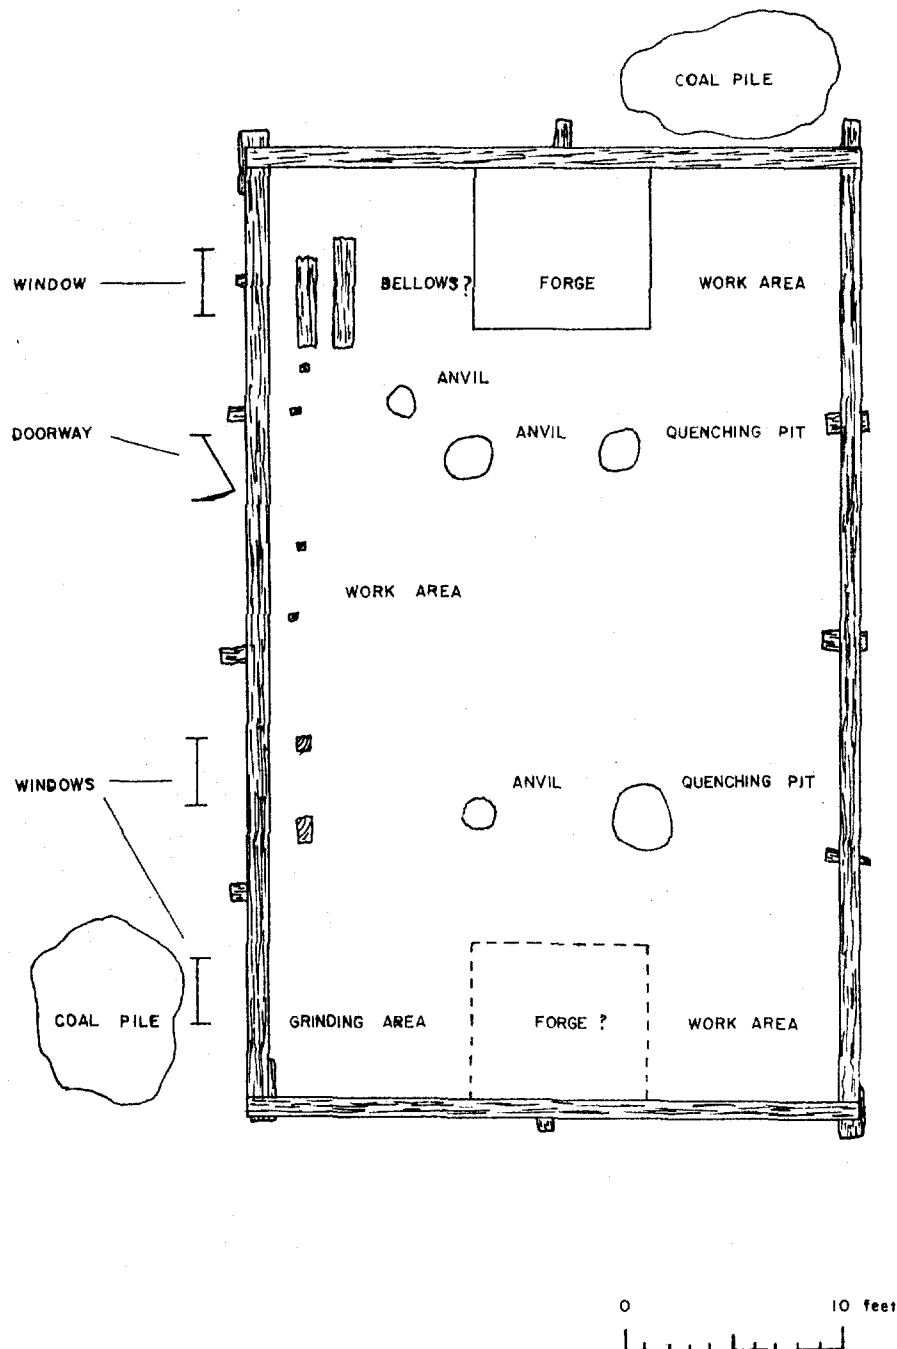
Fig. 242 -- Interpretive floor plan of the in situ HBC Features for the Blacksmith Shop.

Through comparisons of the in situ remains with the ex situ material cultural distributions, positive interpretations could be made for locating many furnishings and activity areas (Fig. 242). This interpretive illustration accurately portrays the archeological data, but does not provide solutions to a number of specific historical and technological problems (e.g. where were the 4 forges, where were the bellows, how was smoke from the forges removed, etc.?). In order to solve these questions, various hypothetical Shop arrangements were matched against the known archaeological evidence. The results of this endeavor resulted in the preparation of a hypothetical Shop arrangement which attempts to explain the known historical facts without conflicting with the archaeological remains (Fig. 243).

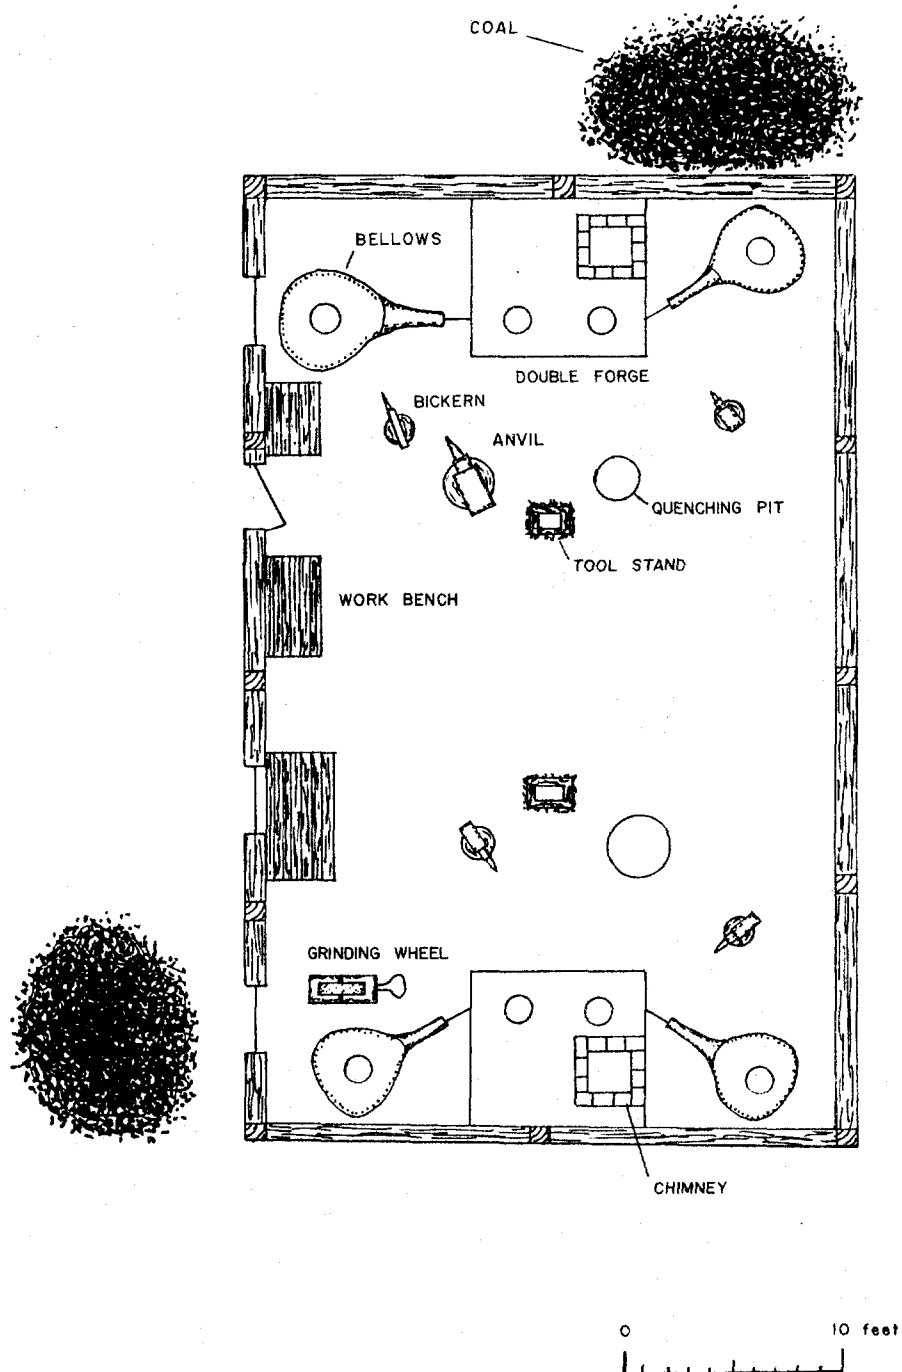
Fig. 243 -- Hypothetical reconstructed floor plan for the Blacksmith Shop (based upon currently available historical accounts together with in situ archaeological remains).

Chimneys have been included with the reconstructed view, and their placement was based upon the reconstructed interior arrangement of the forges and blacksmithing furniture (Fig. 243).
