National Park Service  
Cultural Landscapes Inventory  
2006

Fort Washington Park  
Fort Washington Park

Fort Washington Park is a 341-acre historical and recreational area located in Prince George's County, Maryland, approximately 11 miles south of Washington, D.C. The park is under the administration of National Capital Parks-East. Listed in the National Register of Historic Places, the defined period of significance for the Fort Washington landscape is 1808-1921.

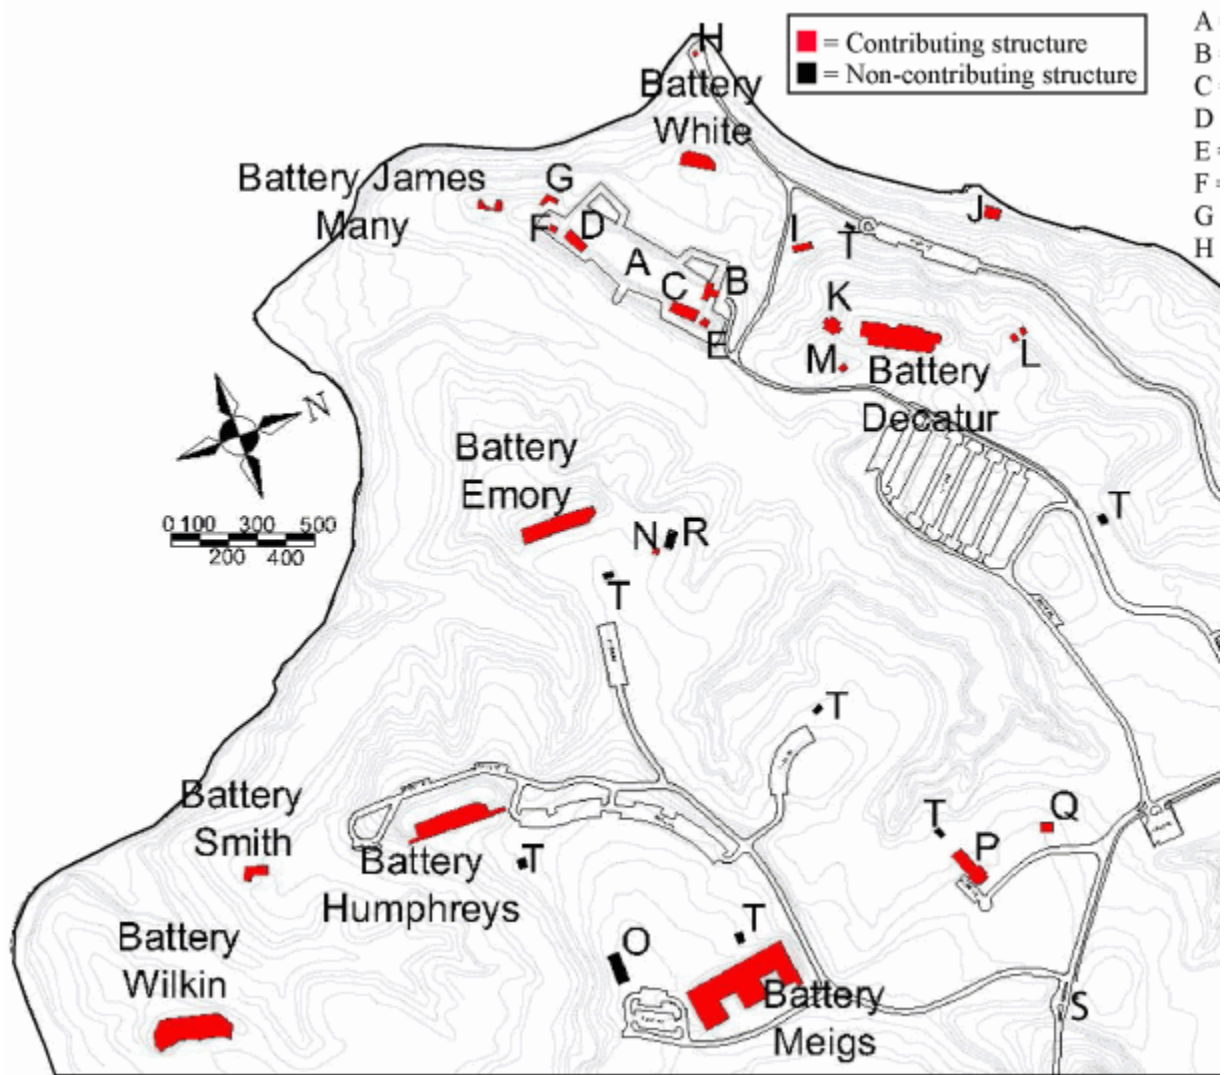
*Location of fortifications at Fort Washington Park, Site Plan, 2006 (James River Institute for Archeology)*

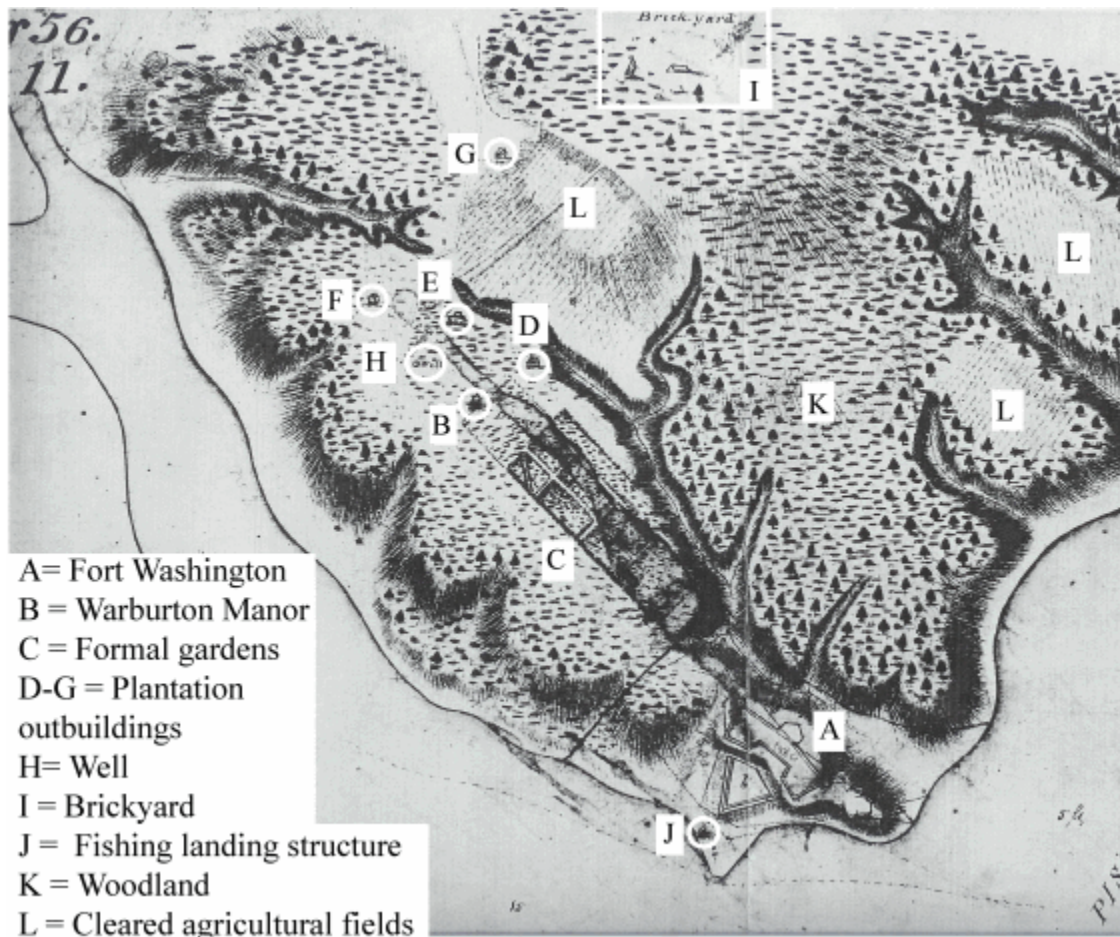
*Annotated map of the Survey of the Grounds, Rivers and Creeks in the Vicinity of Fort Washington," 1816 (Map 117 8-11, NA RG 79*

Though the 1807 and 1826 maps focus primarily on the manor house and gardens, the 1816 map prepared by T.W. Maurice is the most detailed depiction of the entire physical landscape of the property. Maurice noted the presence of a well and at least three unidentified buildings a short distance to the southeast, east, and northeast of the manor house, and another somewhat further to east, near what is now the eastern boundary of Fort Washington Park. A brickyard, probably associated with the construction of Fort Washington, is located even further to the east, probably in an area beyond the park boundary now occupied by a residential neighborhood. Another building, possibly the fishing landing warehouse described by Digges in his newspaper advertisements, was located at Digges’ Point. The main road to the property approached from the east, and passed directly north of the manor before turning southwest and terminating at Digges’ Point. In terms of the natural environment, much of the property encompassed by Fort Washington Park appears to have been wooded at this

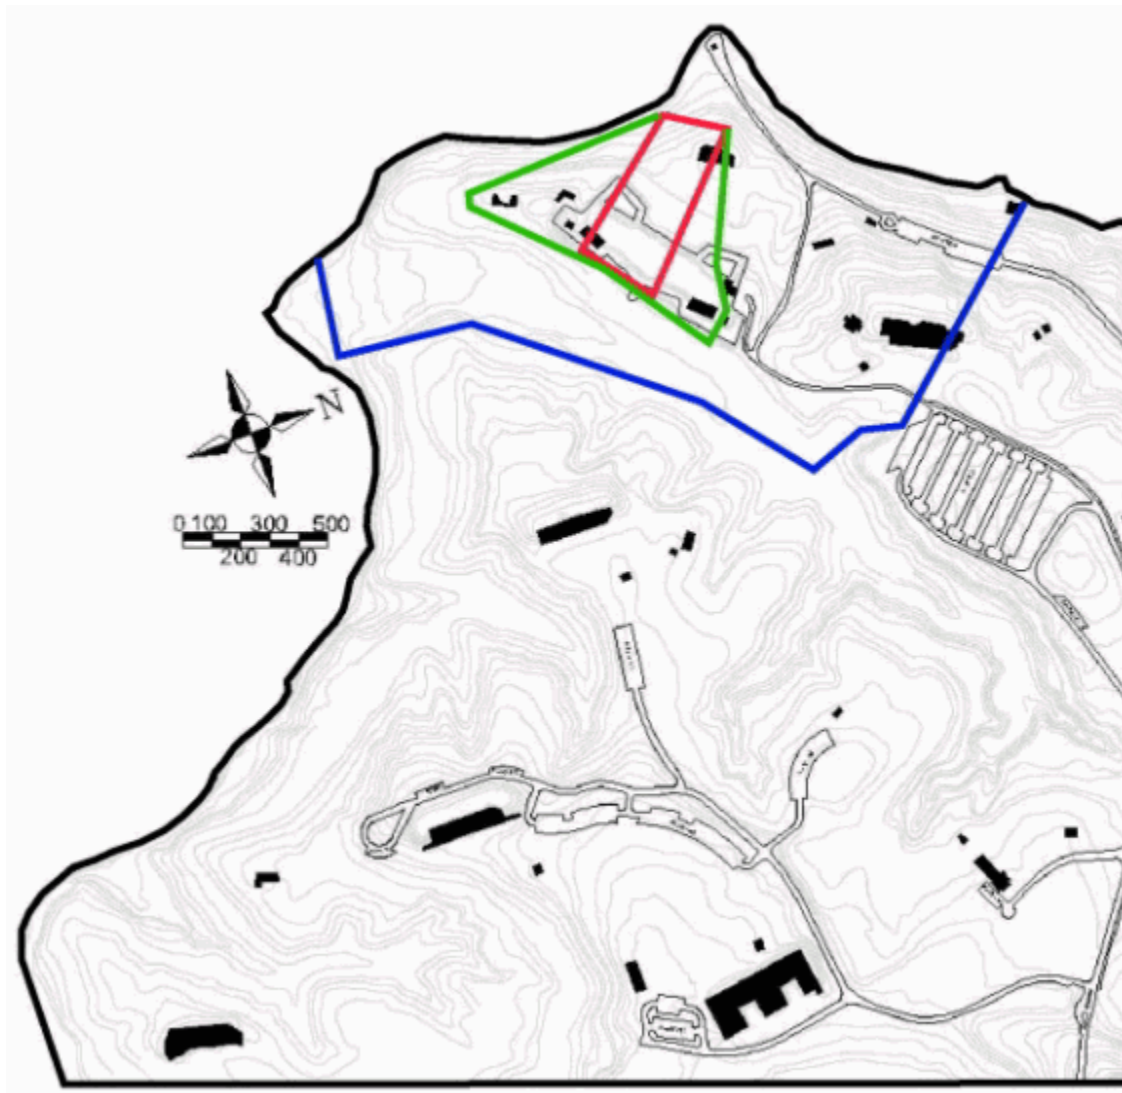
*Expansion of Fort Washington boundaries, 1806-1875*

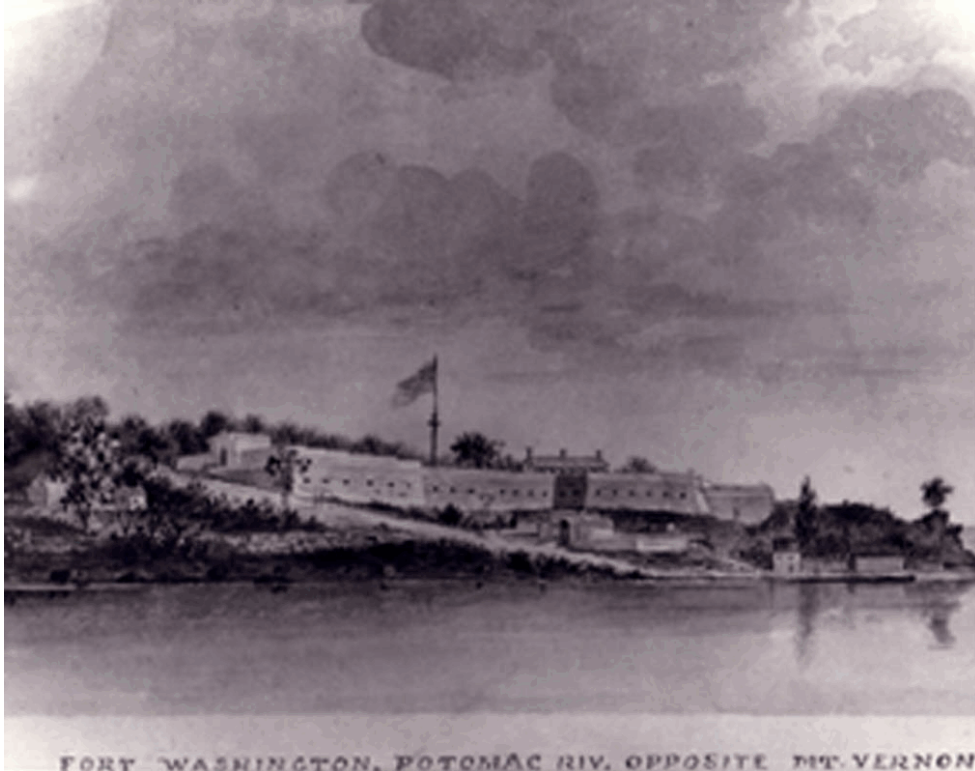
*An 1830s Andrew Jackson Davis watercolor of Fort Washington shortly after its initial construction, and prior to the subsequent modifications of the 1840s. (Fort Washington photo files).*

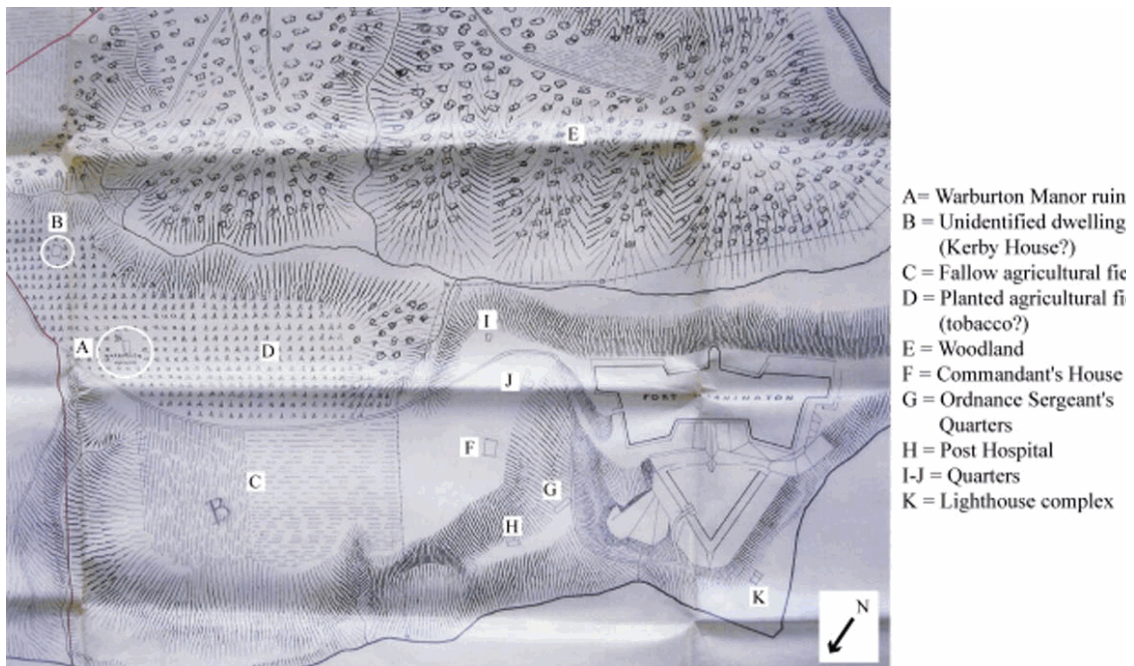
*Topographical Map of Fort Washington and Vicinity, 1872 (Chief of Engineers, Land Papers, Maryland, Fort Washington, NARA RG 77).*

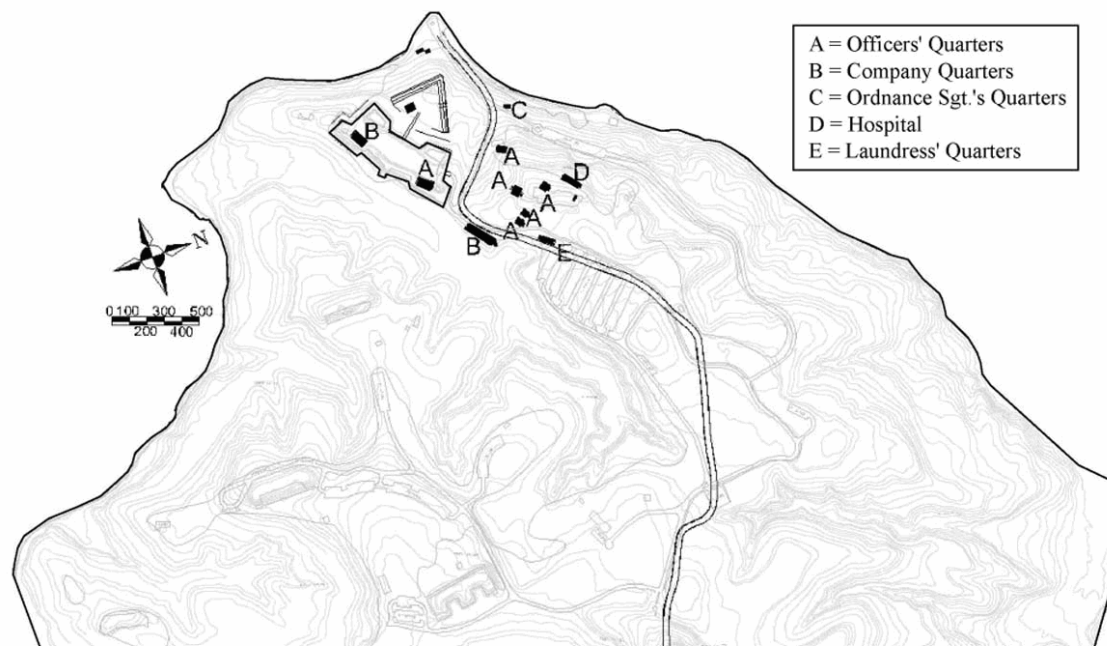
*Post layout, 1886 (source: Plat of the Government Reservation at Fort Washington, Maryland, 1886. NARA, RG 77, Map 117.8-51)*

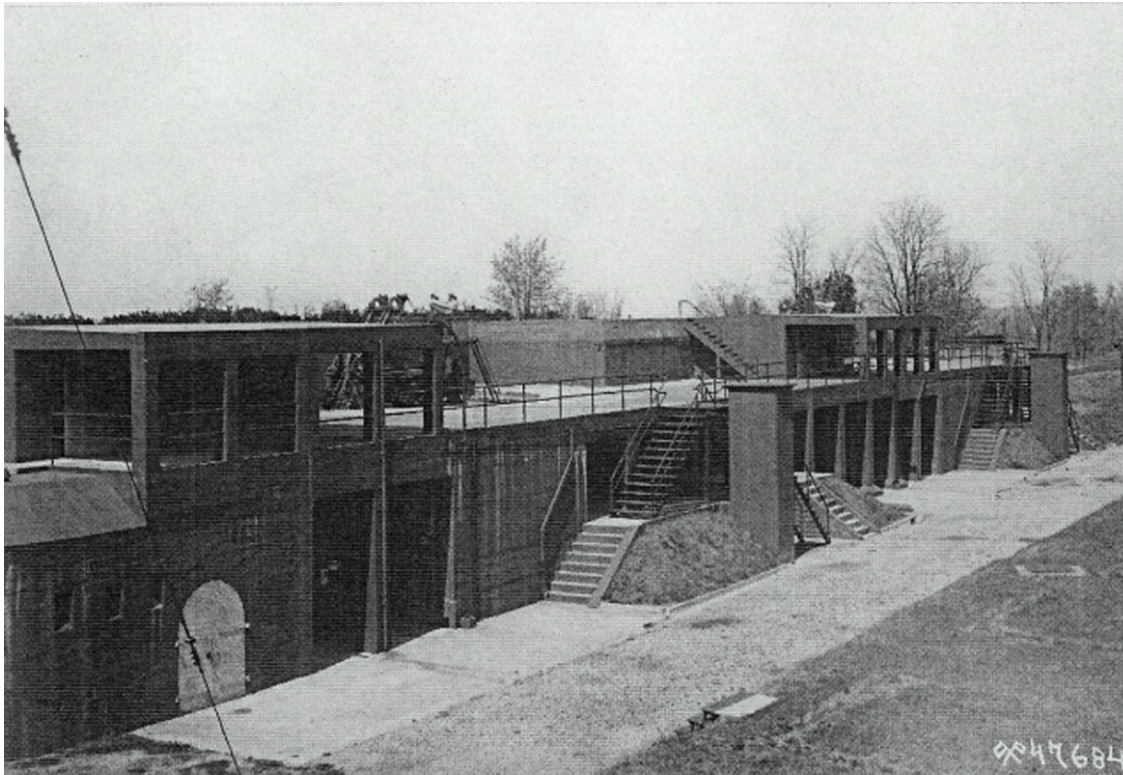
*The decommissioned Battery Decatur in 1919. One of the Buffington-Crozier disappearing carriages remained mounted, but two 10-inch guns were removed by 1917. (NARA RG 111-SC, Records of the Office of the Chief Signal Officer, Box 357, #47684).*

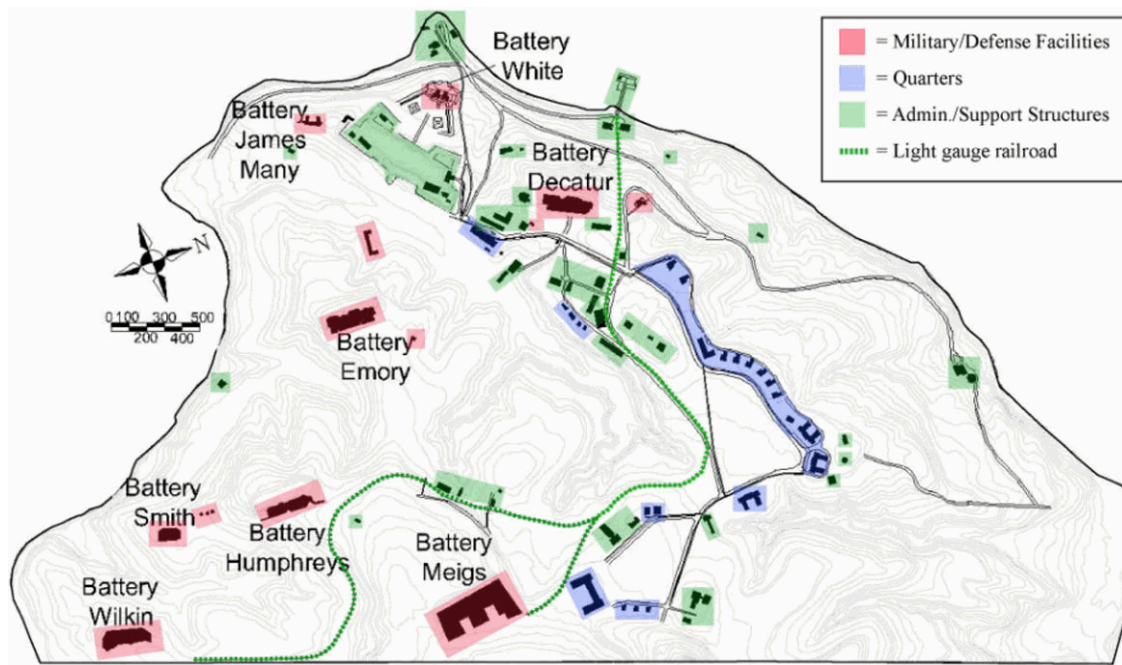
*Fort Washington Post layout, 1906. (source: Fort Washington, Maryland, General Map, 1906. NARA, RG 79, Map 117.8-85).*

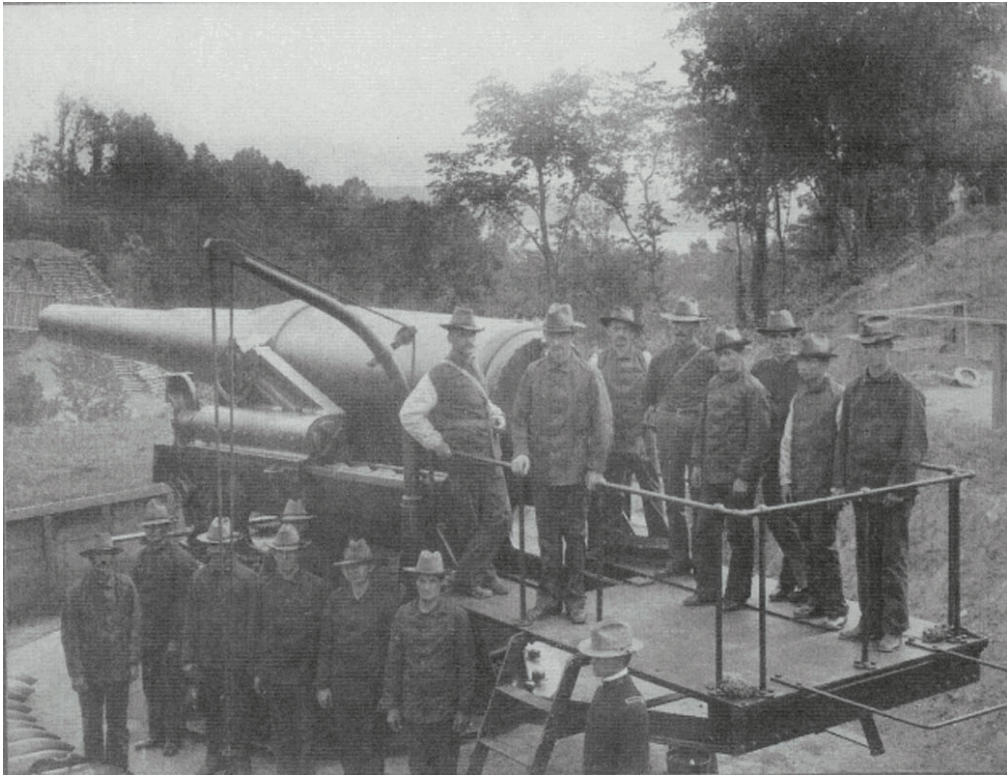
*This 10-inch gun was used in the Algiers Test of June 1899, which evaluated new forms of rifled armament used against fortifications and armored ships. (NARA RG 111-SC, Records of the Office of the Chief Signal Officer, Drawer 56, Sheet 79, 4).*

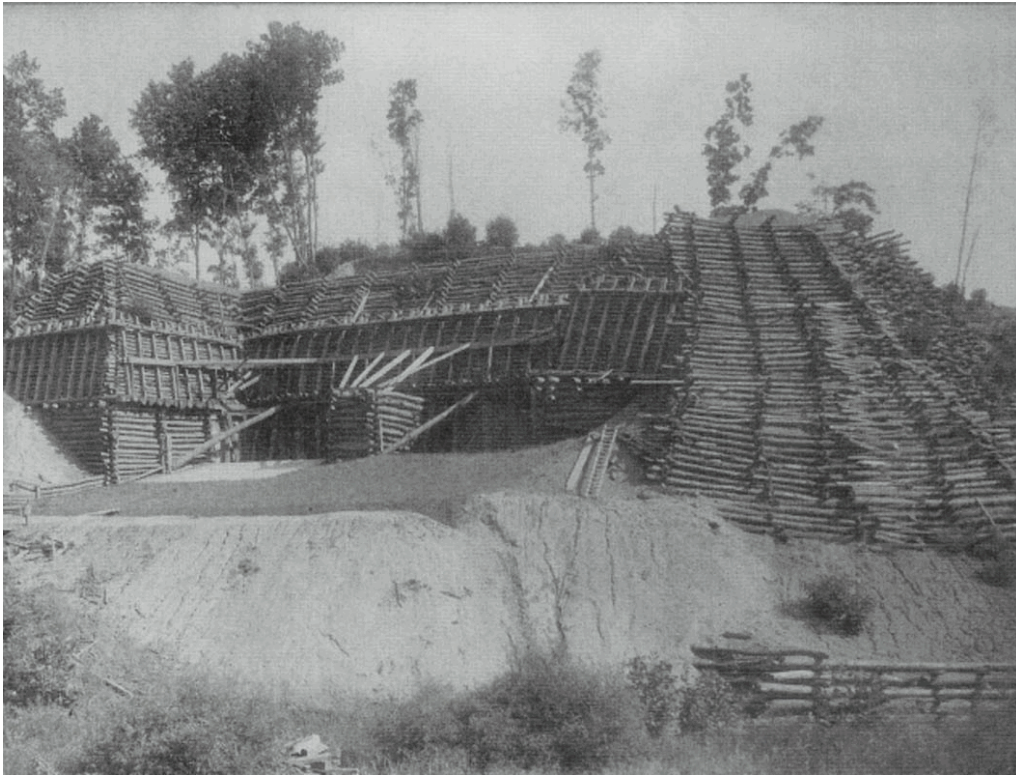
*Experimental parapet used in the Algiers Test of June 1899 was built in the ravine opposite the fort, The excavated slope is still visible(NARA RG 111-SC, Records of the Office of the Chief Signal Officer, Drawer 56, Sheet 79, 5).*

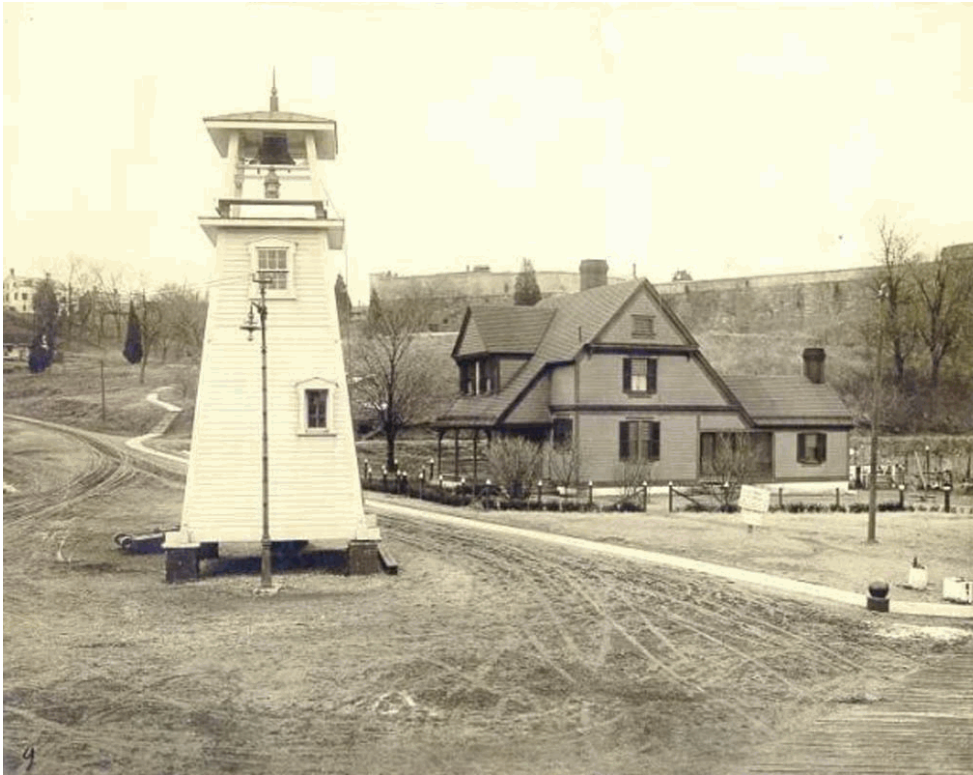
*The Light 80 (originally built as a fog bell tower in 1882), and the ca. 1885 lighthouse keeper's house at Digges' Point shown in 1912. Note the Endicott period electric lamppost adjacent to the lighthouse. (Fort Washington photo files).*

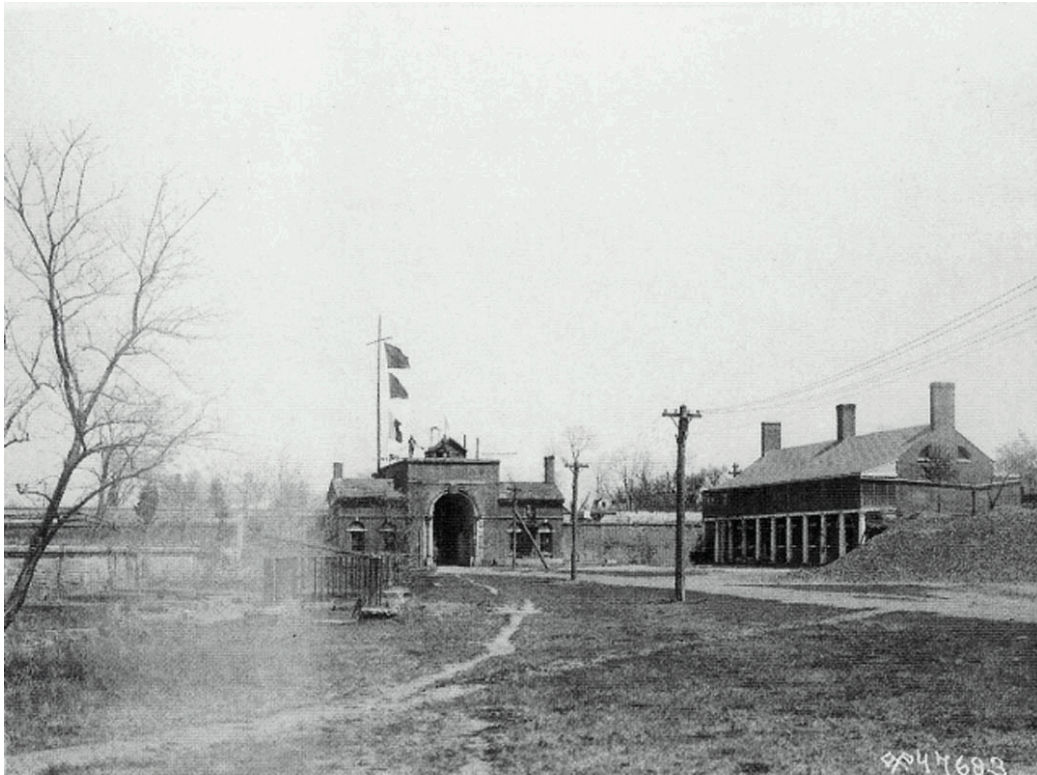
*In a 1919 image, a signal station is placed atop the gatehouse of the main fort and an overhead utility line traversed the parade, (NARA RG 111-SC, Records of the Office of the Chief Signal Officer, Box 357, #47683).*

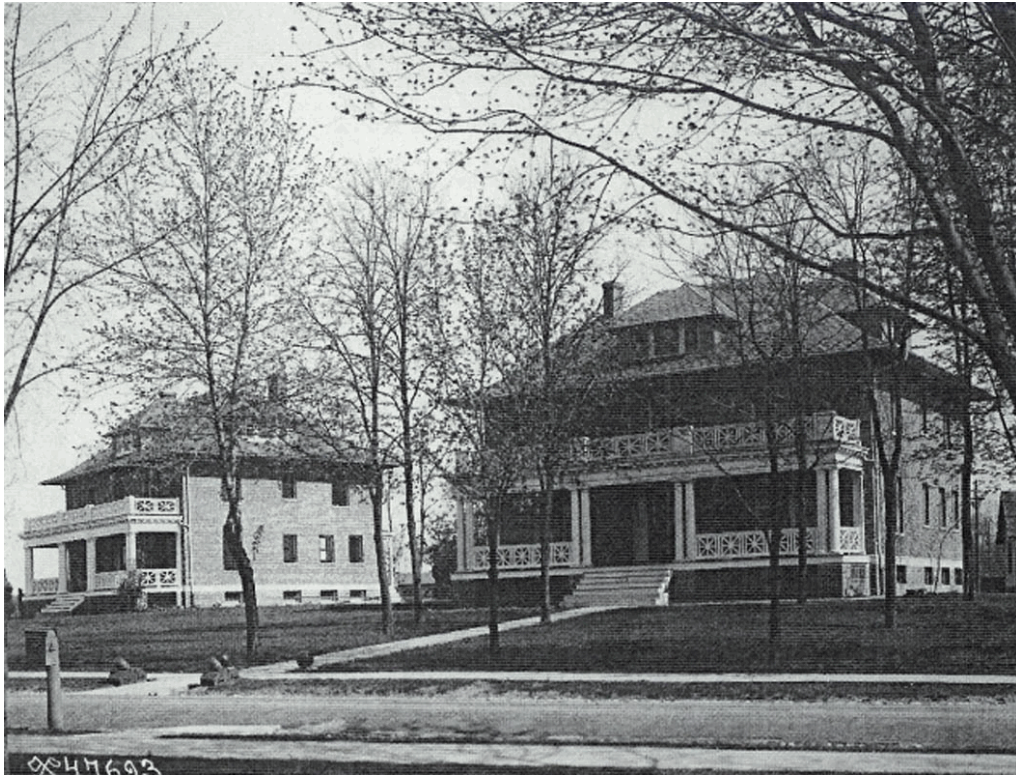
*Two former brick dwellings housed the fort's commanding officer (right) and the second-in-command (left), consisting of a lawn and trees lining the front walks, 1919 (NARA RG 111-SC, Records of the Office of the Chief Signal Officer, Box 357, #47693).*

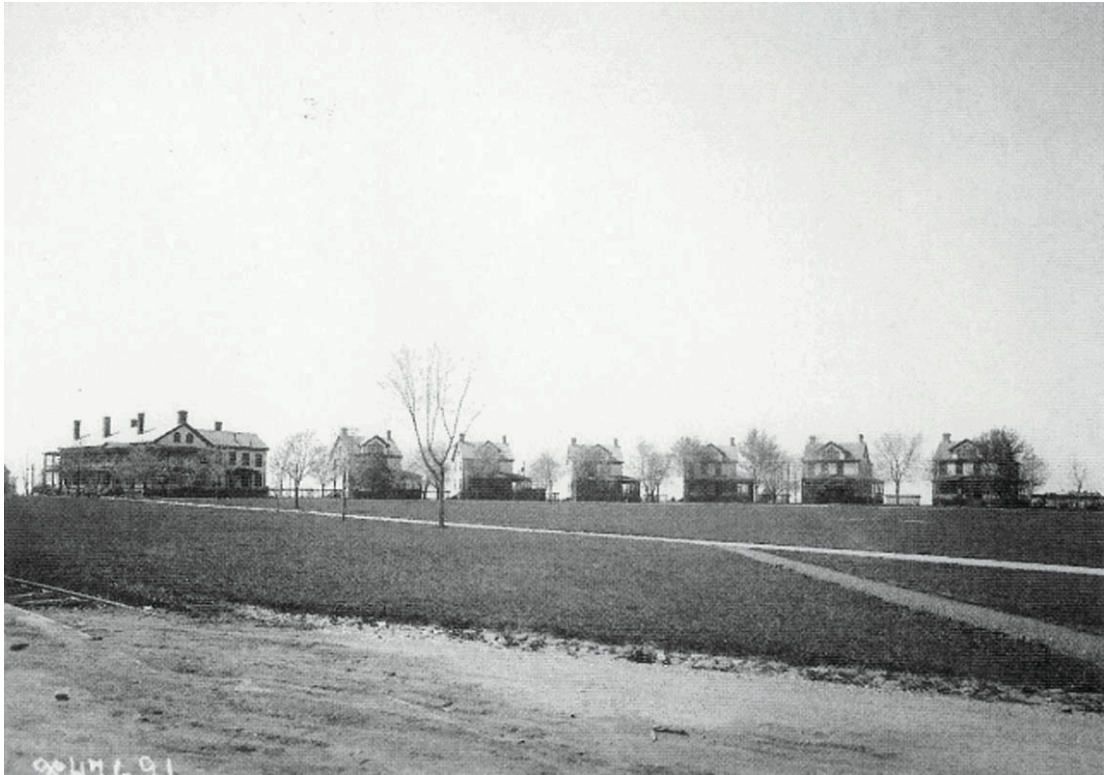
*The former large bachelor officer's quarters (left) and smaller married officers' quarters, were located in what is now an open field east of the main parking area, 1919 (NARA RG 111-SC, Records of the Office of the Chief Signal Officer, Box 357, #47691).*

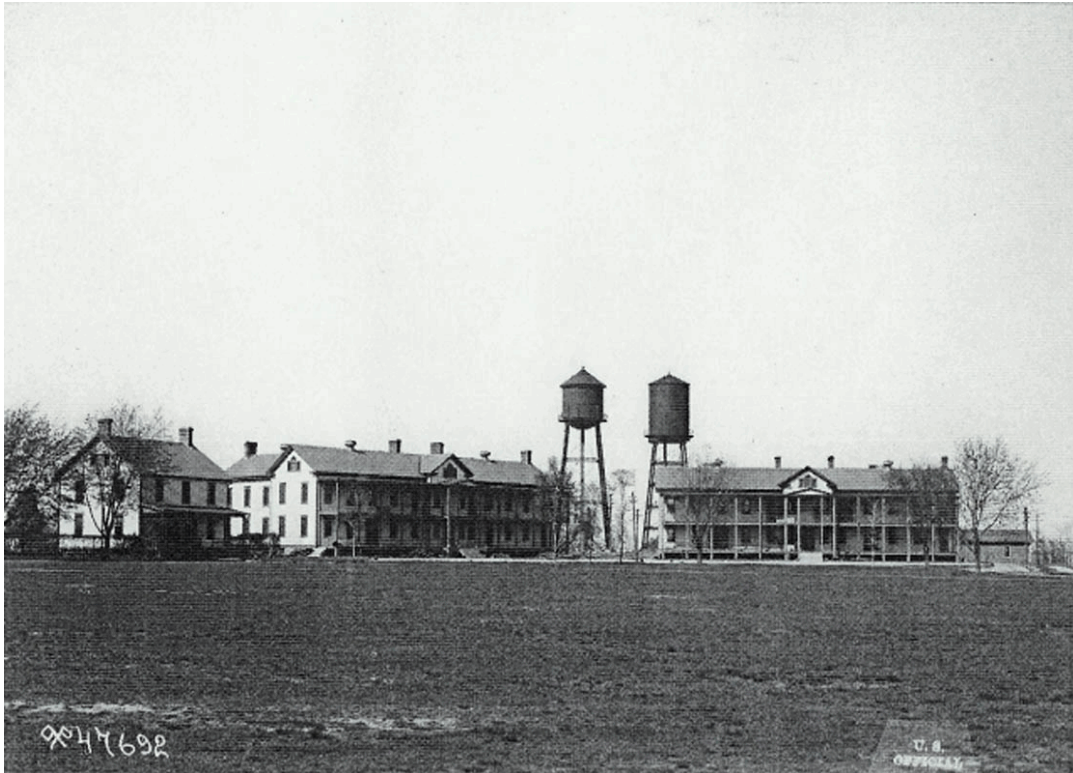
*The former admin building, Coast Defense HQ (left) and large enlisted men's barracks, were located what is now a open field by east end of the Washington Dr. loop. (NARA RG 111-SC, Records of the Office of the Chief Signal Officer, Box 357, #47692).*

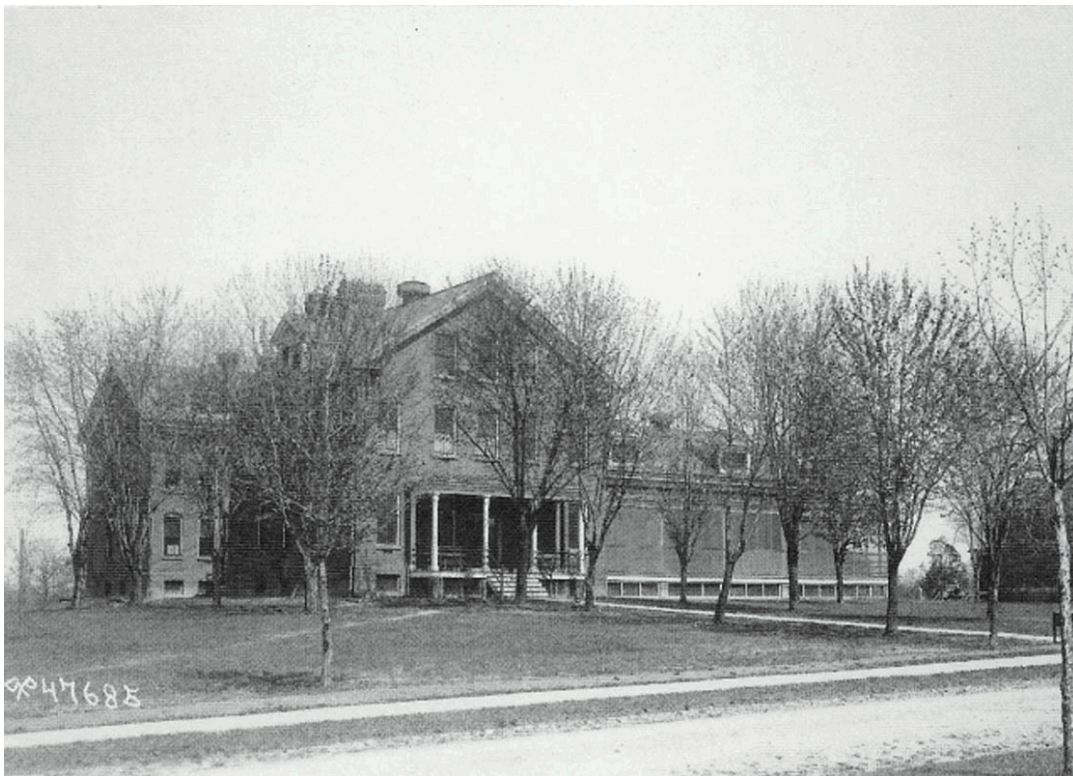
*The post hospital, formerly located on the north side of Washington Drive near the main park entrance included a concrete walk lined with rows of deciduous trees, 1919 (NARA RG 111-SC, Records of the Office of the Chief Signal Officer, Box 357, #47685).*

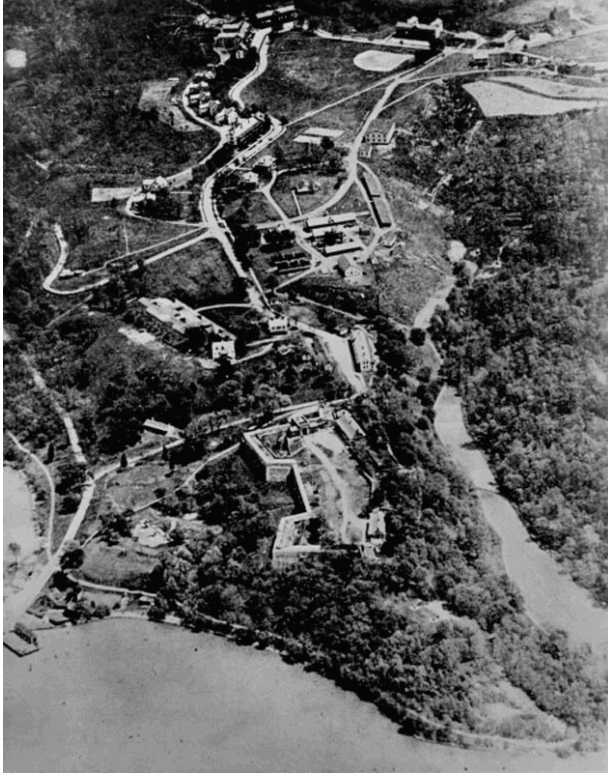
*Undated aerial view of Fort Washington most likely dates to the 1930s. The area surrounding the historic fort had become heavily wooded, but otherwise the post appears the same as the Endicott Period (Fort Washington photo file).*

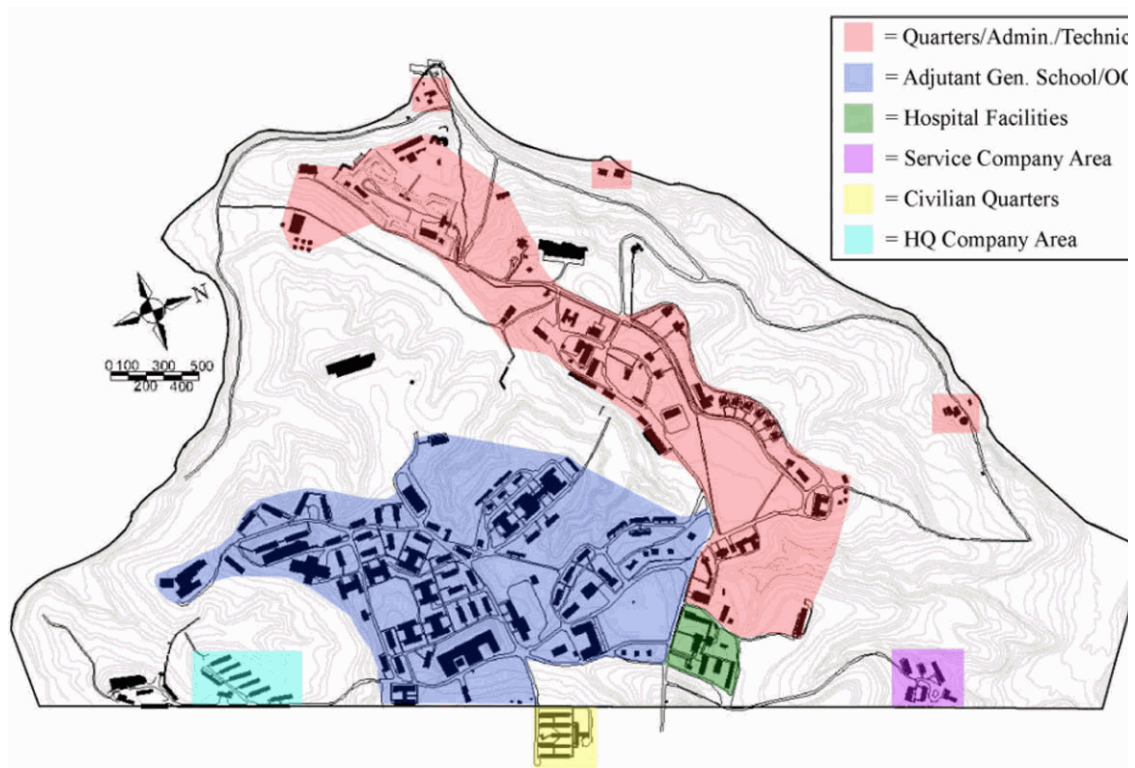
*Fort Washington Post layout, 1944. (source: Fort Washington, Maryland, Layout Plan, 1944. NARA, RG 79, Map 117.8-107).*

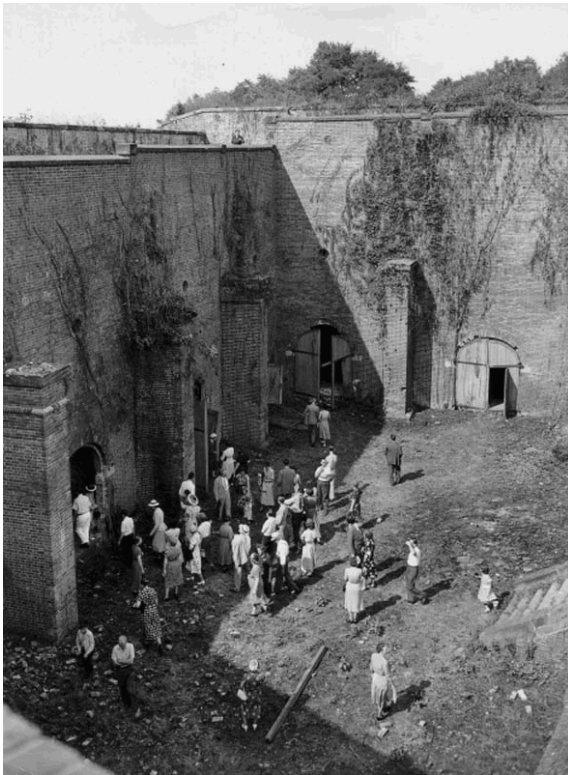
*Visitors tour the northwest demibastion casemates in this 1949 photograph. Although the fort was in a poor state of repair, the park was now beginning to experience a postwar boom in visitation (Fort Washington photo files).*

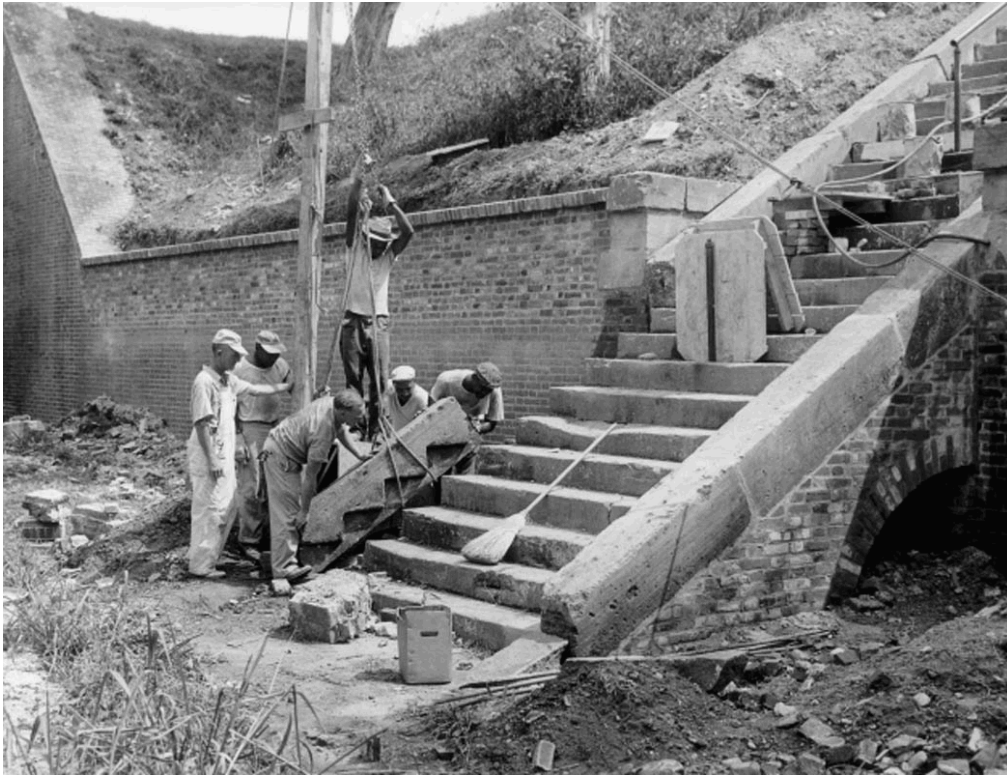
*Stone coping is replaced on steps in the southwest demibastion in 1958. Rehabilitation efforts were funded under the Mission 66 program, but were halted the following year due to budget cuts (Fort Washington photo files).*

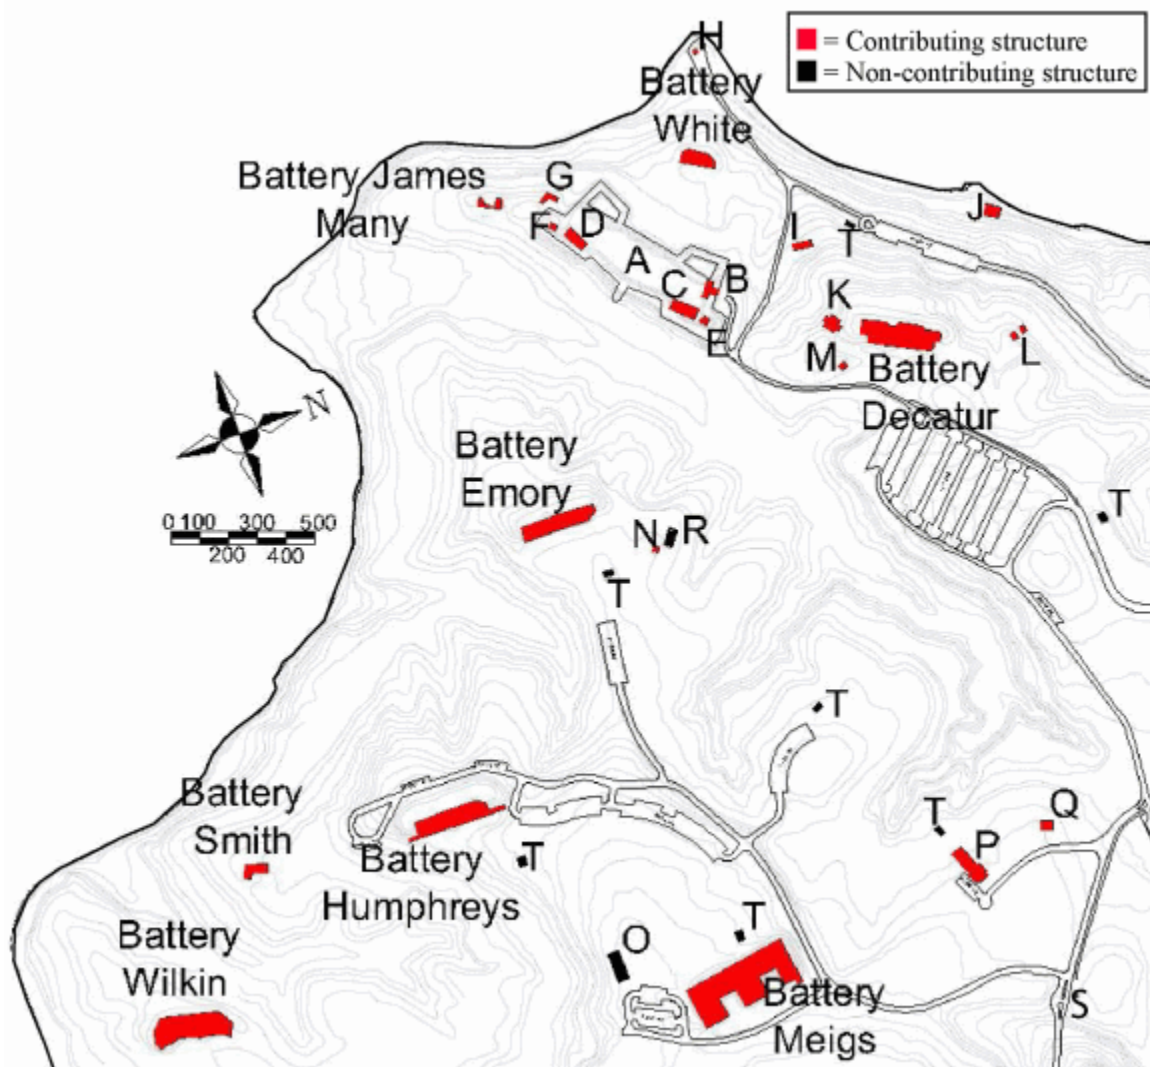
*Fort Washington Park location of fortifications, 2006 (source: Prince George's County Office of Information Technology, Geographic Information Systems Division).*

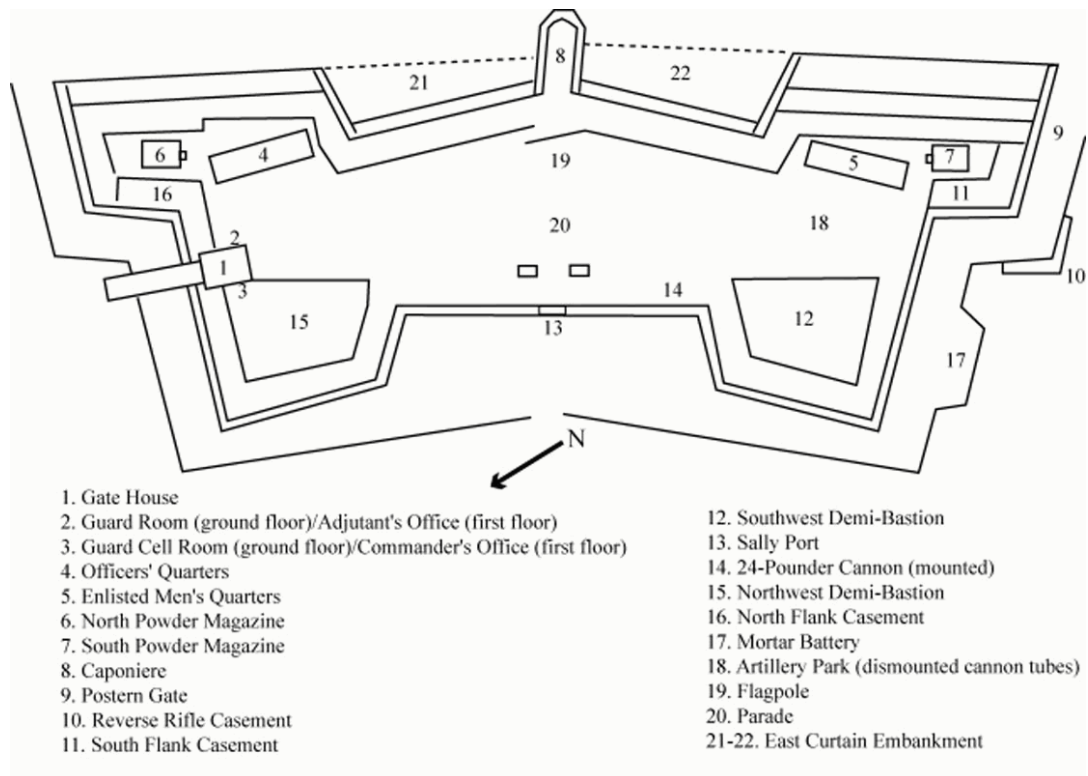
*Principal Architectural Components of Fort Washington.*

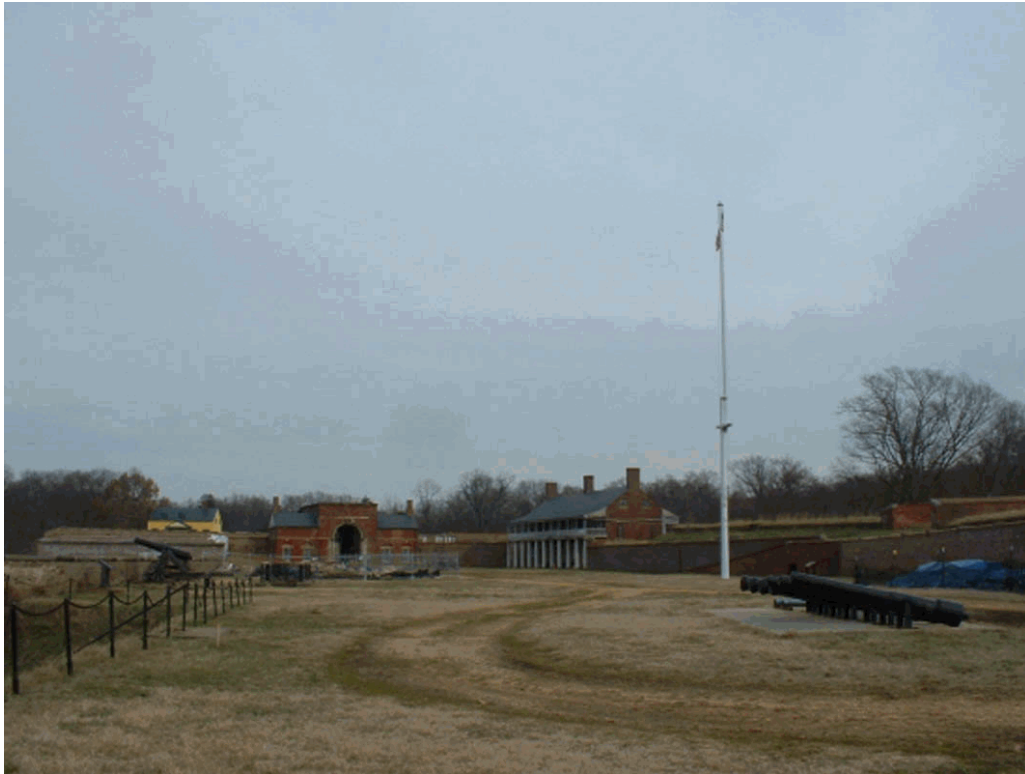
*Fort Washington Parade, view to northeast, December 2005. Visible are the gatehouse, officers' quarters, flagstaff, artillery display, and 24-pounder cannon (Laird).*

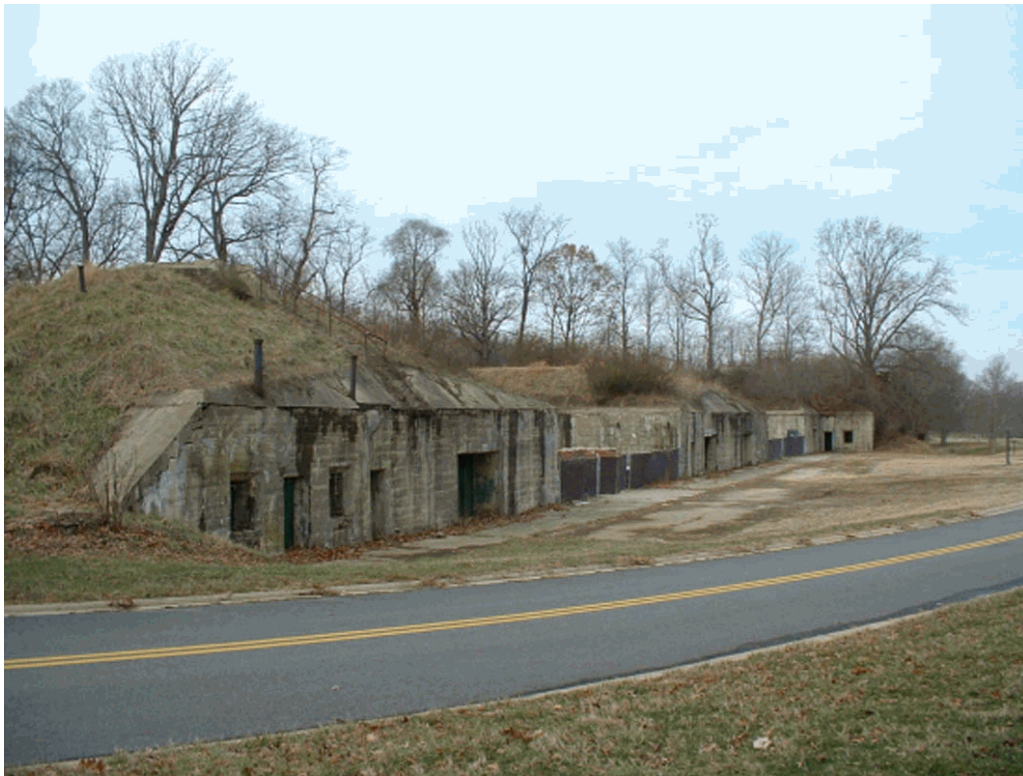
*Battery Meigs, view to north, December 2005 (Laird).*

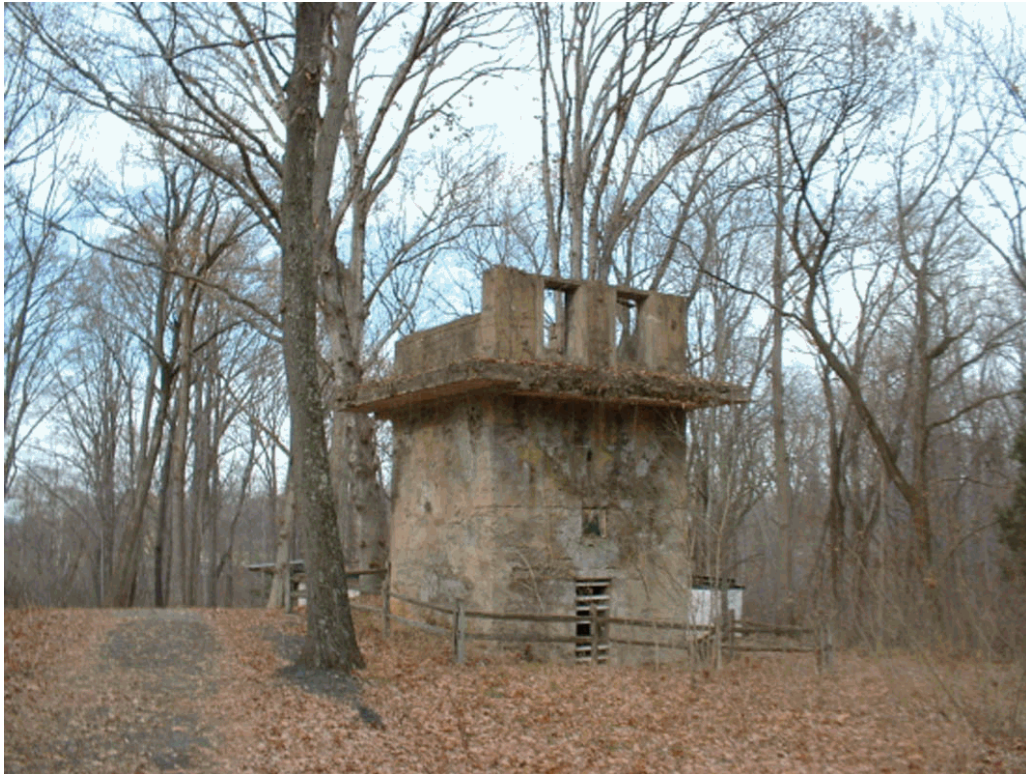
*Southeast Fire Control Tower with Paint Shop Building in background, view to north, December 2005 (Laird).*

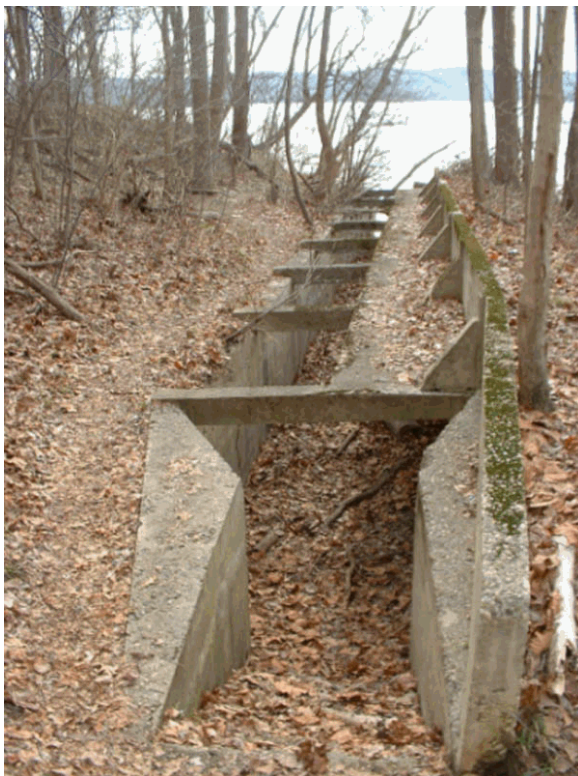
*Rifle Range Butts with Piscataway Creek in background, view to south, December 2005 (Laird).*
