National Park Service  
Cultural Landscapes Inventory  
2006

Fort Washington Park  
Fort Washington Park

Fort Washington Park is a 341-acre historical and recreational area located in Prince George's County, Maryland, approximately 11 miles south of Washington, D.C. The park is under the administration of National Capital Parks-East. Listed in the National Register of Historic Places, the defined period of significance for the Fort Washington landscape is 1808-1921.

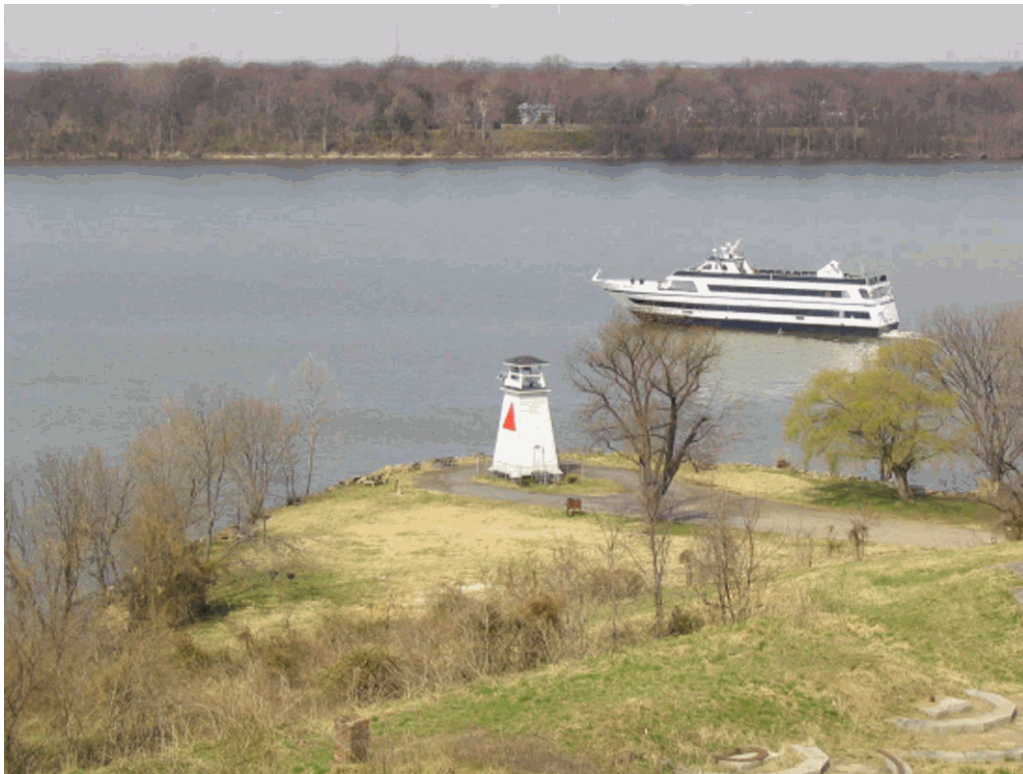
*Light 80 at Digges' Point with the Virginia shore in background, view to northwest, March 2004 (Laird).*

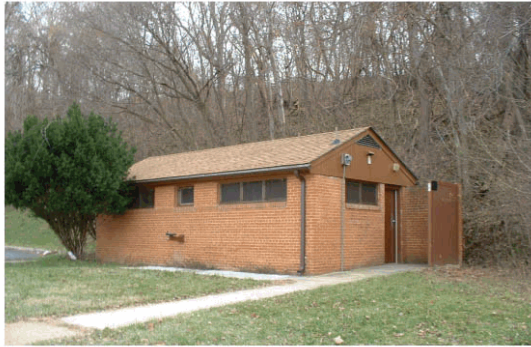
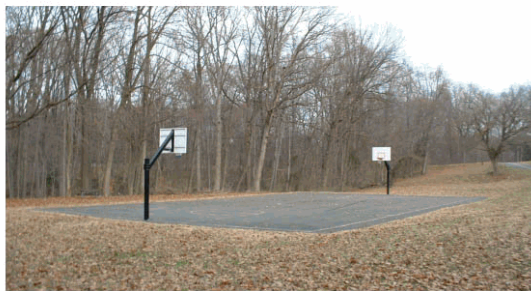
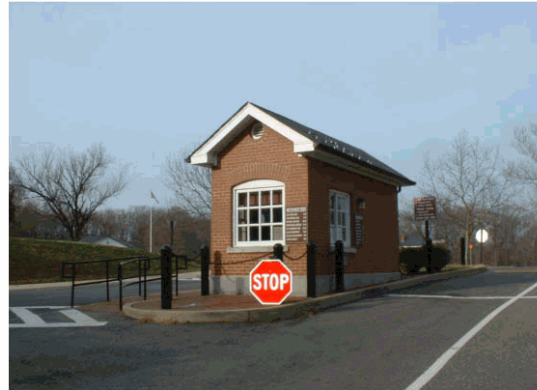
*Non-contributing structures include the comfort stations, entrance station, and basketball court, December 2005 (Laird).*

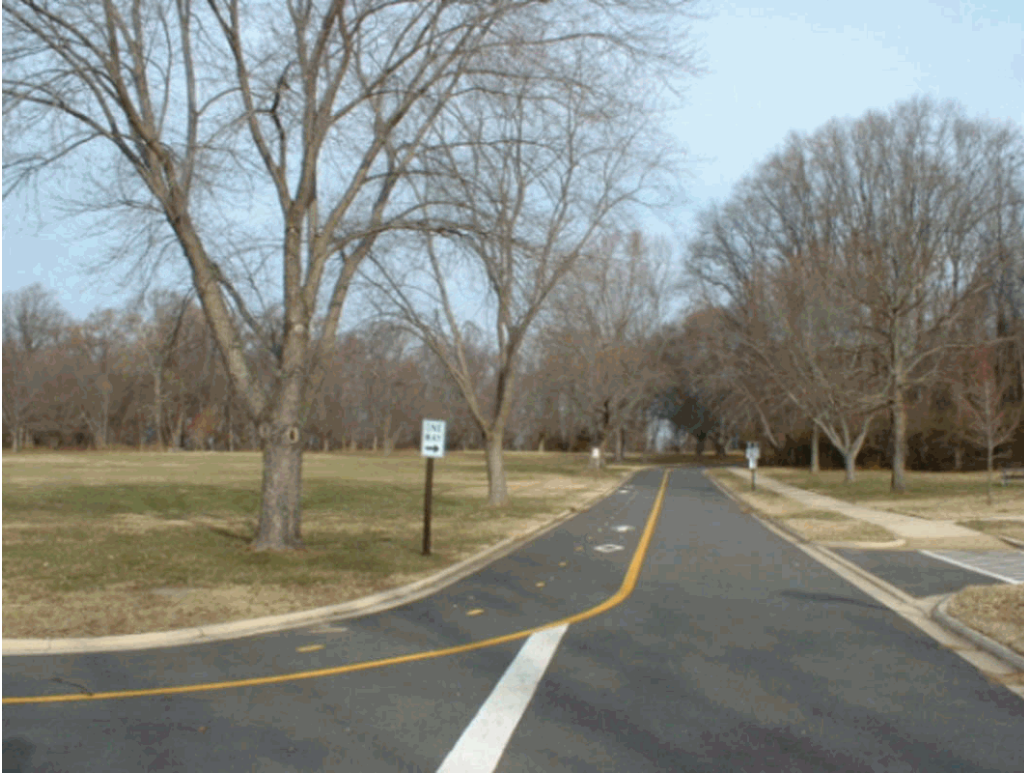
*Section of Washington Drive near Picnic Area 1, view to north, December 2005. Note marked bicycle lane (Laird).*

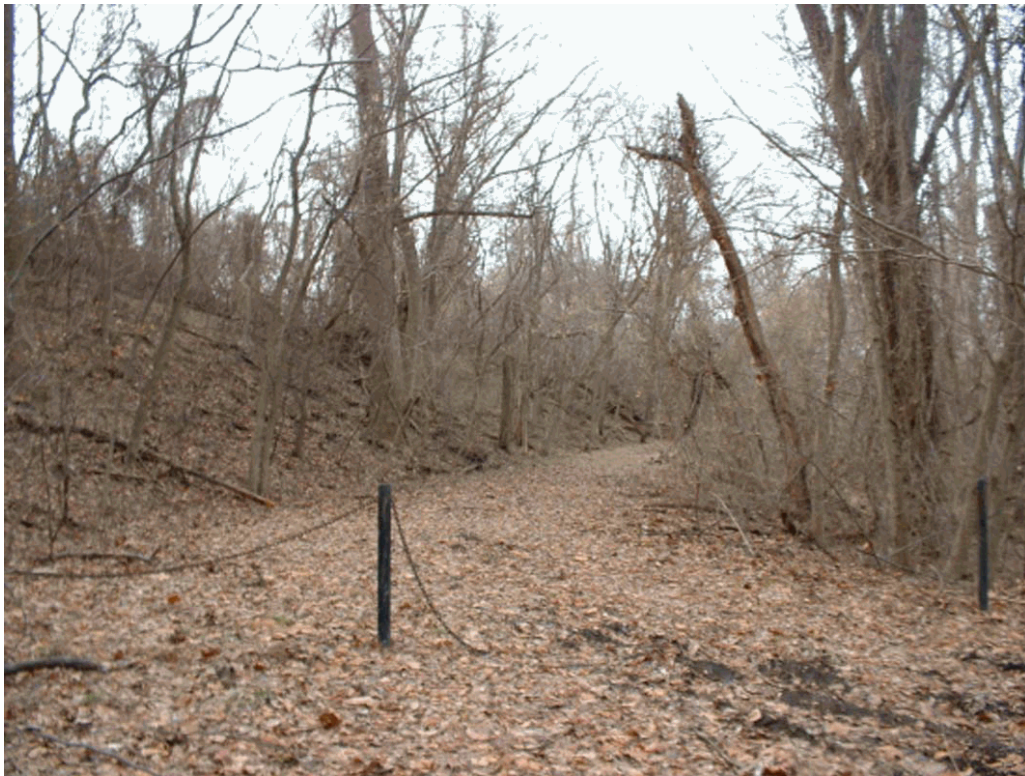
*Section of unpaved service road leading north to Command Structures, view to south, December 2005. Note chain barrier gate (Laird).*

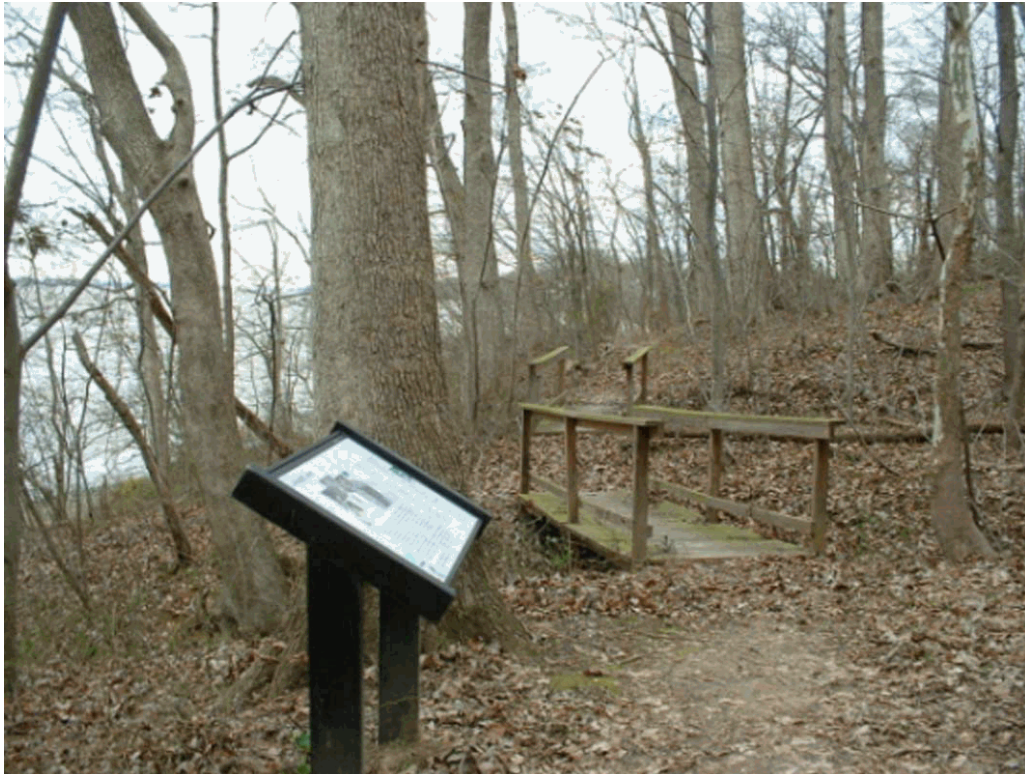
*Section of pedestrian Waterside Trail adjacent to the Potomac River shoreline, view to north, December 2005. Note interpretive signage and wooden footbridges (Laird).*

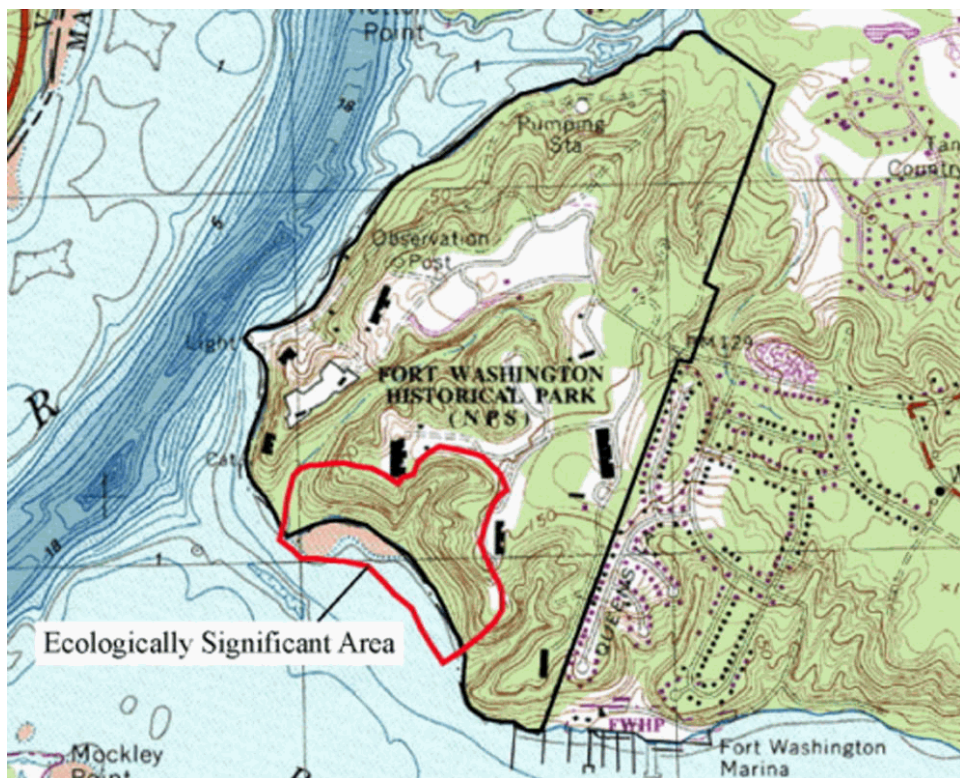
*Location of Ecologically Significant Area (Maryland Department of Natural Resources, 2005).*

In 1997, the Maryland Department of Natural Resources (DNR) surveyed the "Fort Ravine," encompassing an area of approximately 32 acres along Piscataway Creek southeast of the historic fort, and defined it as an Ecologically Sensitive Area (ESA). According to the survey report, the slopes and stream banks of the narrow ravine support an "exceptional example of a mature, mesic, deciduous forest." Given the extent of development in this region, forests of similar age are "extremely rare." Along the stream banks and lower slopes are scattered patches of Glade fern (*Diplazium pycnocarpon*), a State Threatened species that exists in less than ten sites in Maryland. More commonly found in the Piedmont and mountains than the Coastal Plain, this species requires the deep shade and organic, neutral soil of a mature forest. In addition, the mature forest provides feeding and nesting habitat for migrating songbirds.

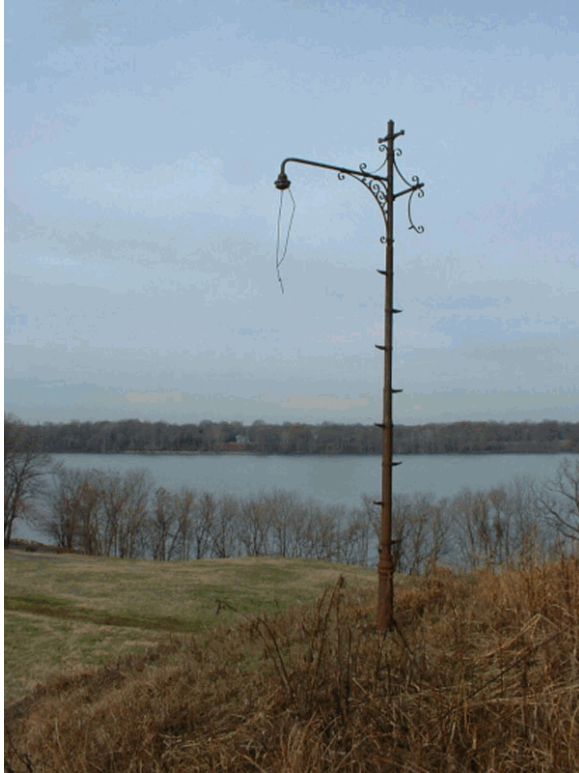
*Endicott Period electric lamppost along steps to the water battery, view to west, December 2005 (Laird).*

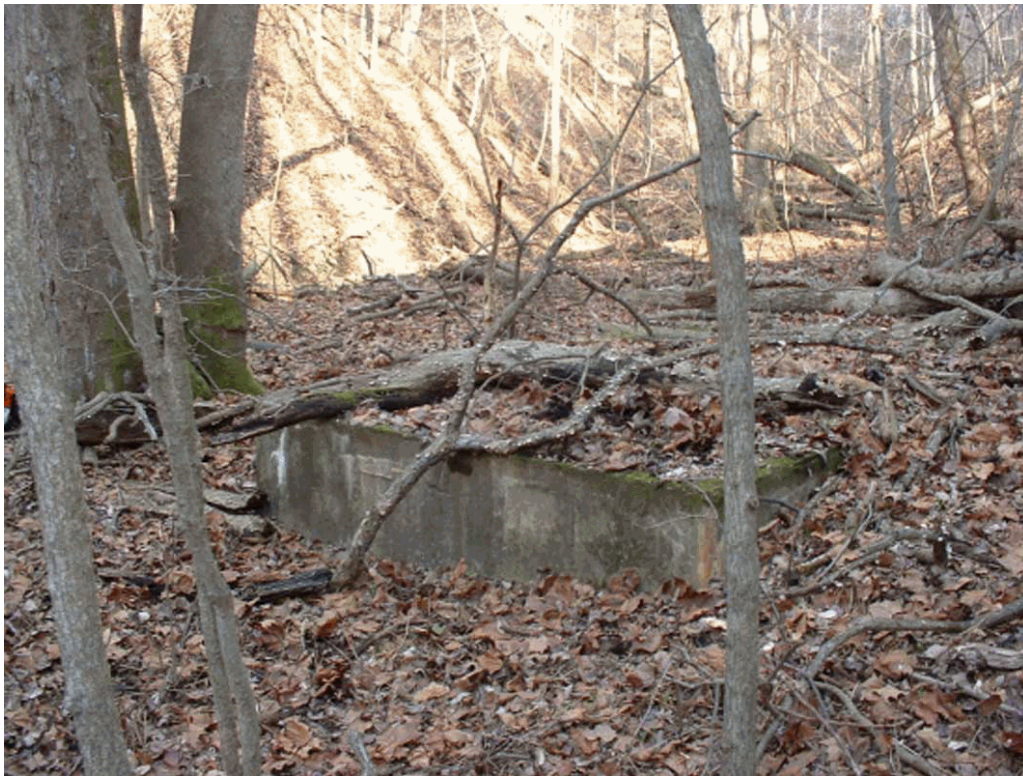
*Concrete foundation of World War II era water pumping station in ravine north of Battery Wilkin, December 2004 (Laird).*

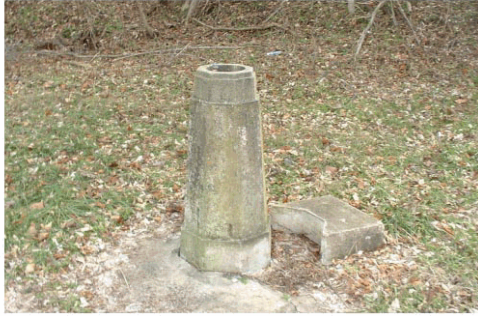
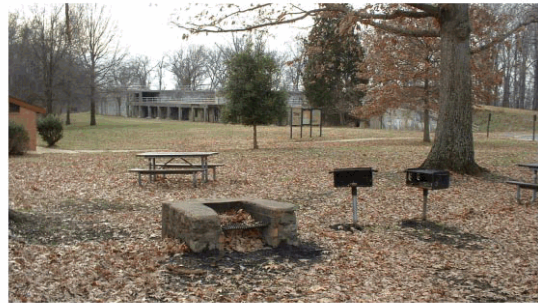
*Non-contributing National Park Service site furnishings include a NPS standard concrete drinking fountain, stone and metal grills, and picnic tables, December 2005 (Laird).*
