# CULTURAL LANDSCAPE REPORT

FORT WADSWORTH

GATEWAY NATIONAL RECREATION AREA

Prepared by PaleoWest, LLC

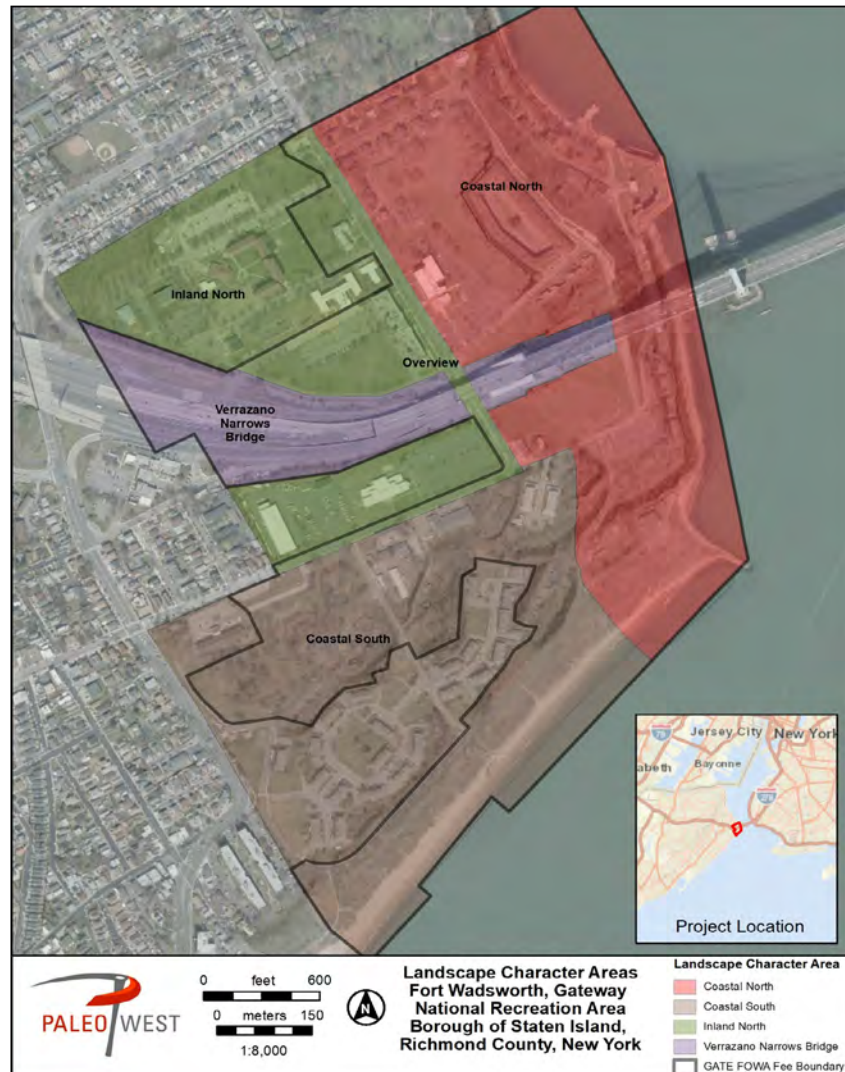
Figure 1.1. Landscape character areas of Fort Wadsworth.

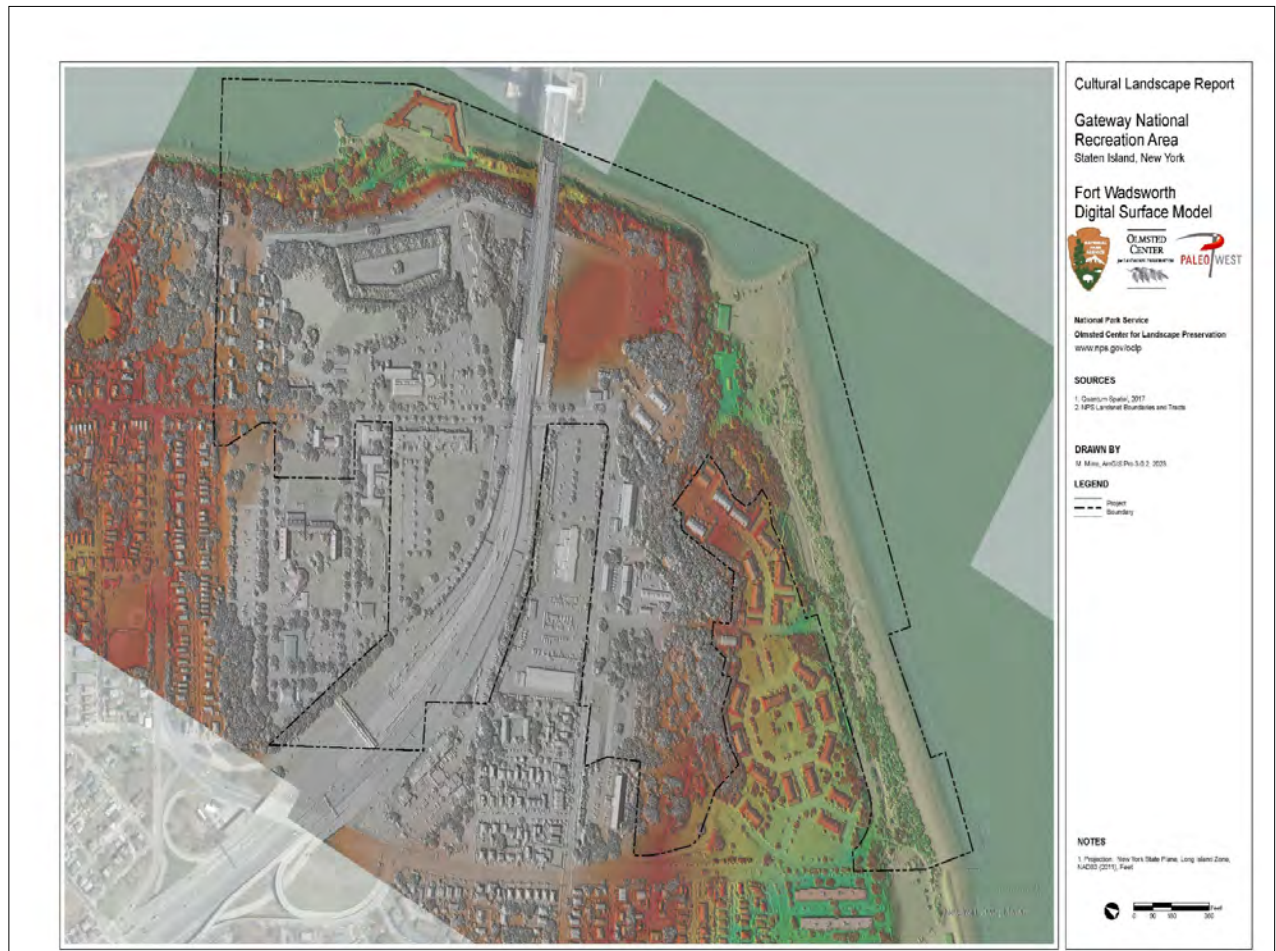
Figure 1.2. Digital surface model (DSM) of Fort Wadsworth.

For this study, LiDAR data was downloaded from the National Oceanic and Atmospheric Administration Digital Coast: Data Access Viewer. Point cloud tiles covering the study area (Quantum Spatial 2018) with an estimated point density of 1 point per square foot (10.75 points per square meter) and vertical accuracy of 0.016 feet (0.005 meter) were downloaded and mosaiced into a LASER (LAS) dataset in ArcGIS Pro. The point cloud was classified (assigning numeric values to point types such as vegetation, ground, building, etc.) to simplify processing. Using geoprocessing tools included in ArcGIS 3D Analyst, a bare earth digital surface model and digital elevation model were generated (Figure 1.2 and Figure 1.3). From these, a shaded relief model (where elevation is represented by a color gradient and vertical features are shaded by modeled source of light) was generated. These show the study area with vegetation and buildings (digital surface model) and as a digital elevation model depicting only the ground surface. A rooftop model was generated from the digital surface model, resulting in a vector layer that outlines rooftops of buildings in the area. Additionally, 1-foot contours were developed for the study area. Using these data, PaleoWest could improve upon historic map georeferencing accuracy by use of additional surface features exposed in the LiDAR data not visible due to vegetation in orthoimages.

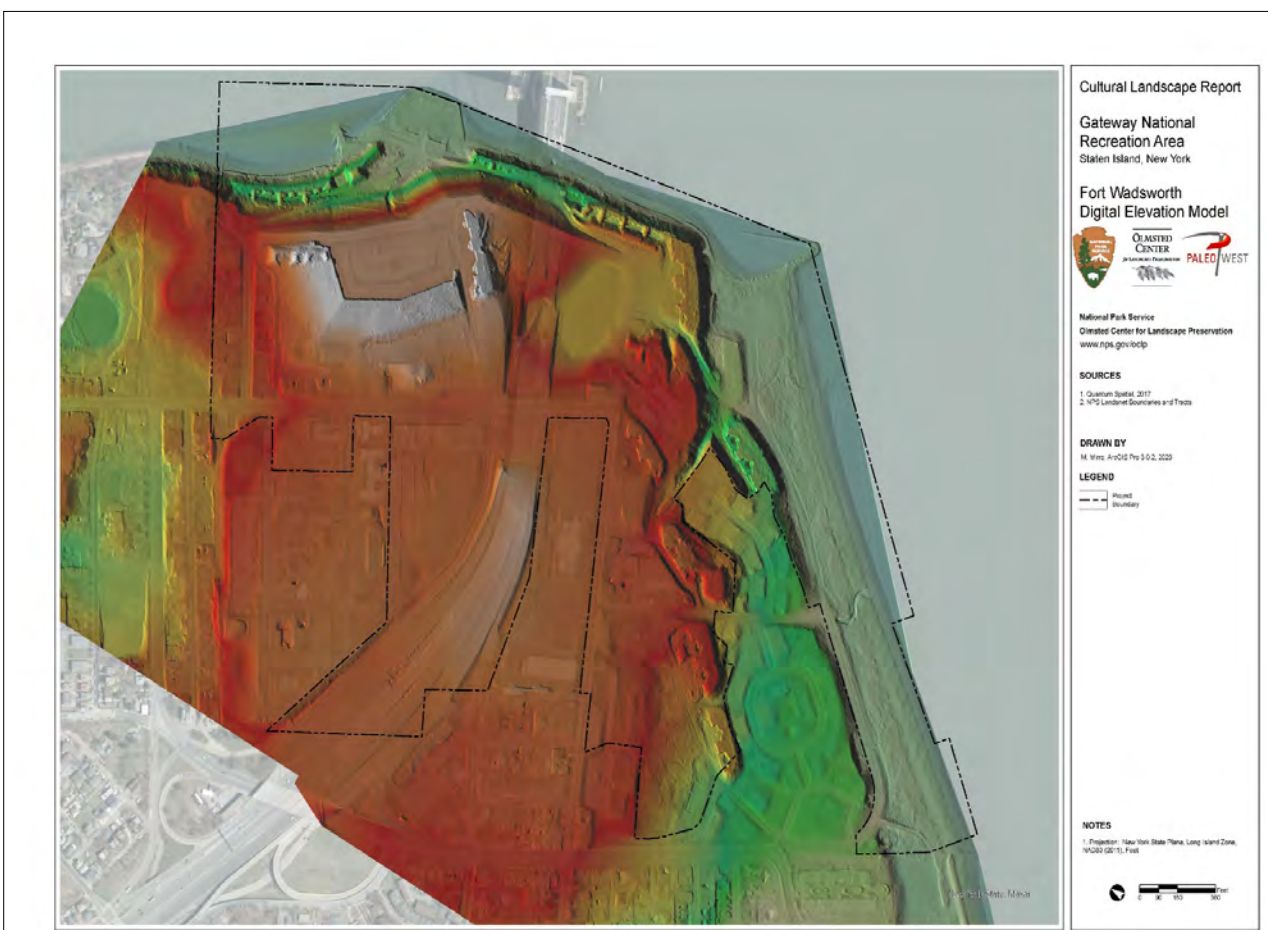
Figure 1.3. Digital elevation model (DEM) of Fort Wadsworth.

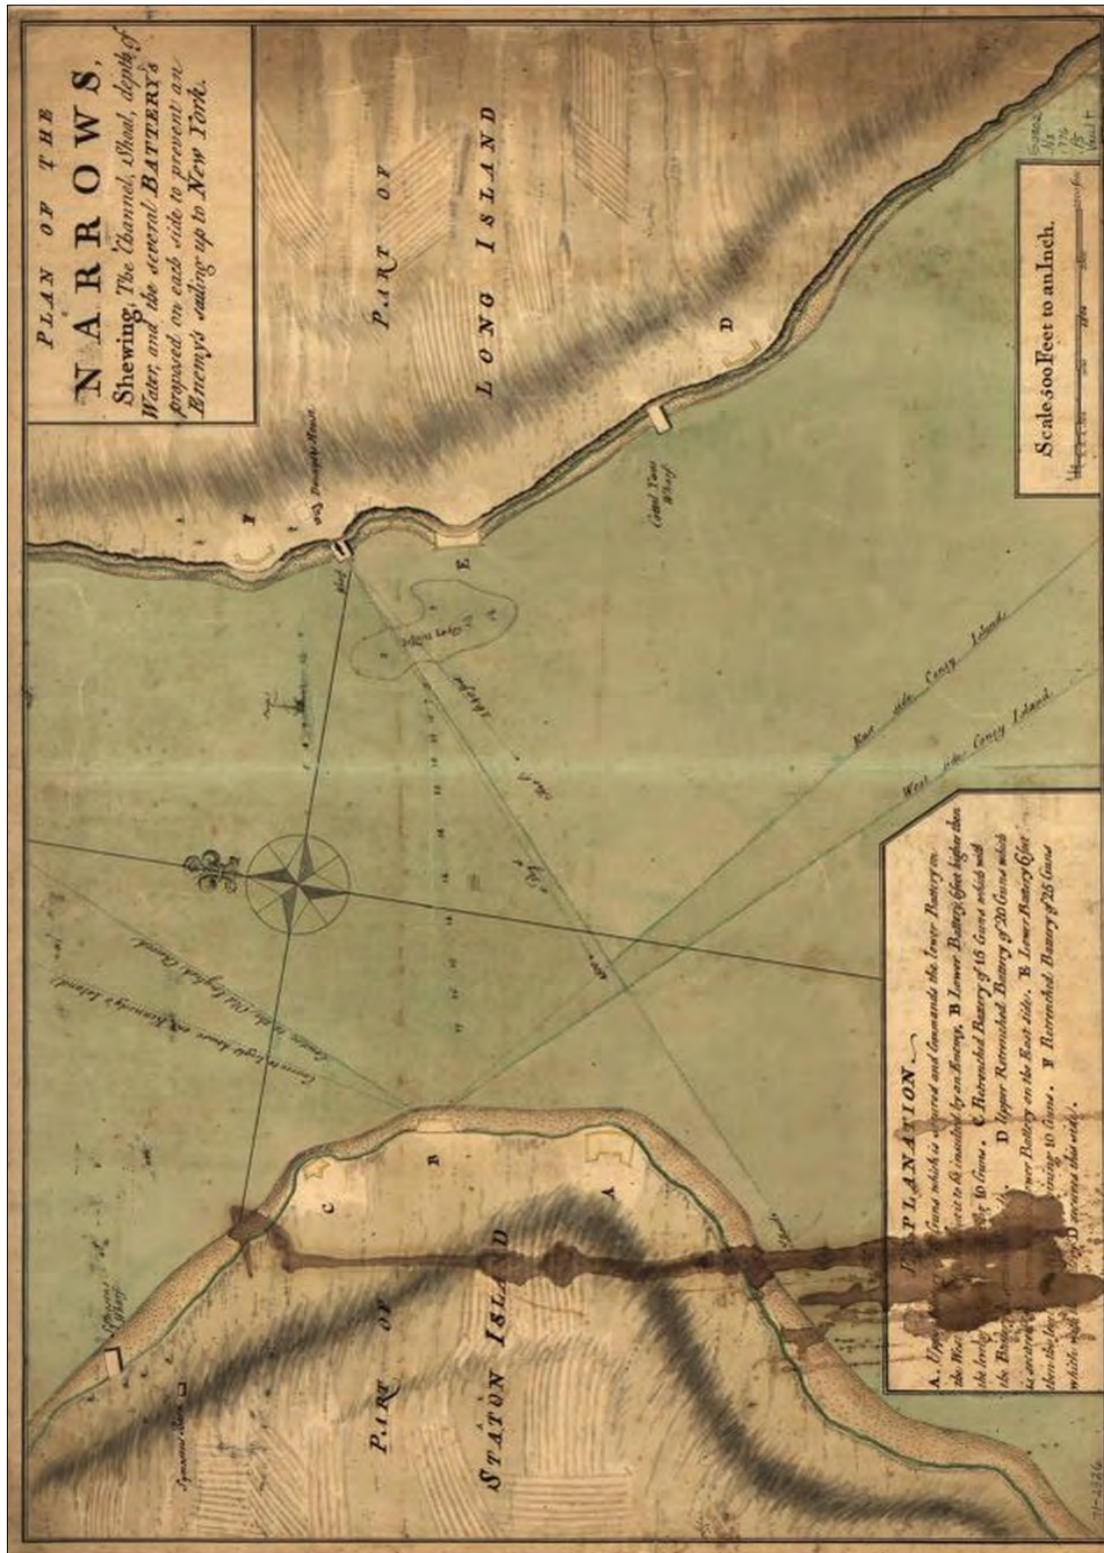
Figure 2.2. A 1776 map described as a Plan of The Narrows, shewing [sic] the channel, shoal, depth of water, and the several battery's [sic] proposed on each side to prevent an enemy's sailing up to New York. The map depicts agricultural fields adjacent two three defensive structures. The area denoted with A was the Upper Battery with 20 guns, B was the Lower Battery "Six Feet above the level of the Water" with 10 guns, and C was the Retrenched Battery with 15 guns (Library of Congress).

end of the Revolutionary War. The British presence on Staten Island resulted in construction across the island, including at the strategically important Narrows. British military planners recommended several batteries on both sides of the Narrows, including three fortifications at the future site of Fort Wadsworth. The high ground provided an ideal spot for signal towers, allowing the military to communicate and surveil over large distances. Transportation systems, including ferries, wharfs, and roadways, were established. They also used locally available firewood and foraged to support troops and civilians on Staten Island and Manhattan. The proposed British defenses comprised an “Upper Battery” with 20 guns, a “Lower Battery” near the water with 10 guns, and a “retrenched battery” with 15 guns (Figure 2.2). Within three years, the British constructed a redoubt (fort), a line of gun platforms, and a hot-shot furnace.<sup>17</sup> No battles occurred at Staten Island, and the fortifications at the Narrows remained uncontested throughout the war.

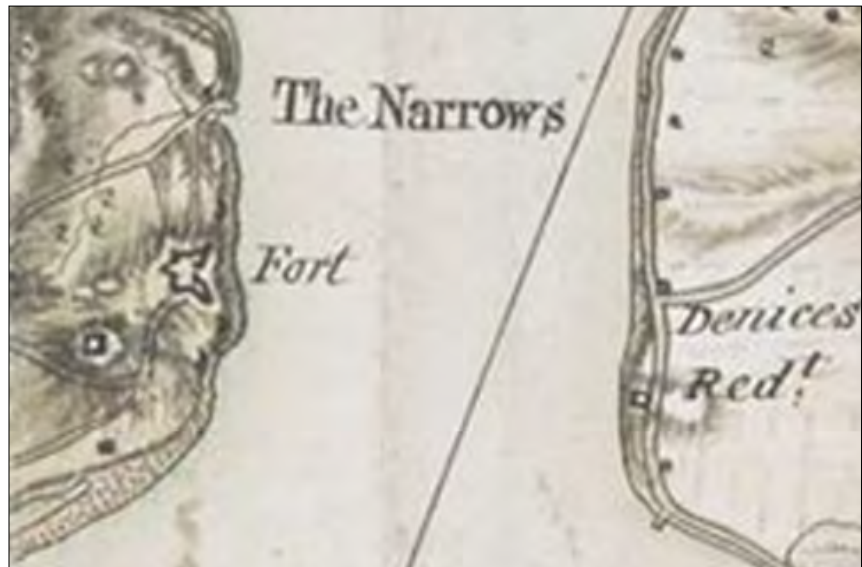
**Figure 2.3. Detail of a 1781 map of New York and Staten Island and part of Long Island, by George Taylor and William Skinner, Surveyors to his Excellency Commander and Chief. The map depicts a road network, a building, and a star-shaped fort on the bluff above the harbor (Boston Public Library).**

Maps created in 1781 and 1782 indicate varying levels of development at the Narrows. A 1781 map developed for British General Sir Henry Clinton shows a star-shaped fort, a network of roads, and a single building on the future site of Fort Wadsworth (Figure 2.3). Another map developed by German mercenaries supporting the British during the Revolutionary War, shows more detail (Figure 24). The map depicts a ferry across the Narrows approaching Staten Island just north of the area that is now Fort Wadsworth. Eight structures or buildings are depicted at water level, spanning from the ferry to the current location of Battery Weed. A road runs diagonally up a fortification and flagstaffs. The road intersects with a north/south road that runs south to a star-shaped fort, six support buildings, and a small fortification. A road to Richmond is just north of the fort. A third map from 1781 imprecisely depicts a signal house and fort on the bluffs above the water (Figure 2.5). A fourth map, based on surveys conducted in 1781 and 1782, depicts a redoubt on the east side of the Narrows but only shows a flagstaff on the west side (Figure 2.6). The map depicts two east-west trending roads or trails in what became the southern portion of Fort Wadsworth.<sup>18</sup>

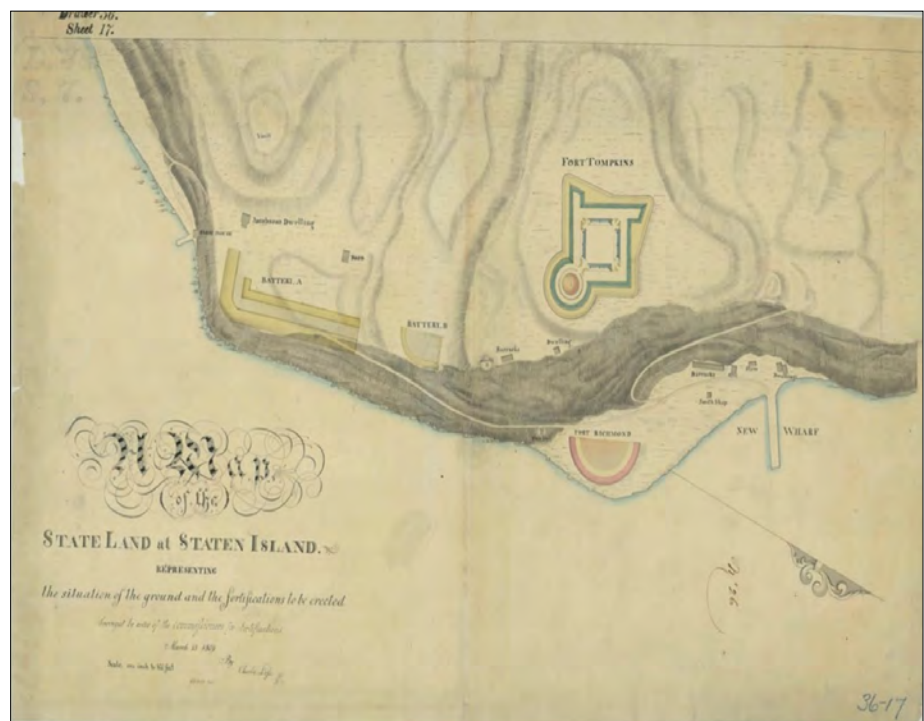
**Figure 2.7. Map titled Map of the State Land at Staten Island Representing the Situation of the Ground and Fortifications to be Erected, March 13, 1809 . The map shows state constructed fortifications near the water including Fort Richmond, small dwellings, and the proposed Fort Tompkins, the design of which was modified prior to construction; Battery A is Fort Hudson and Battery B is Fort Morton (National Archives and Records Administration**

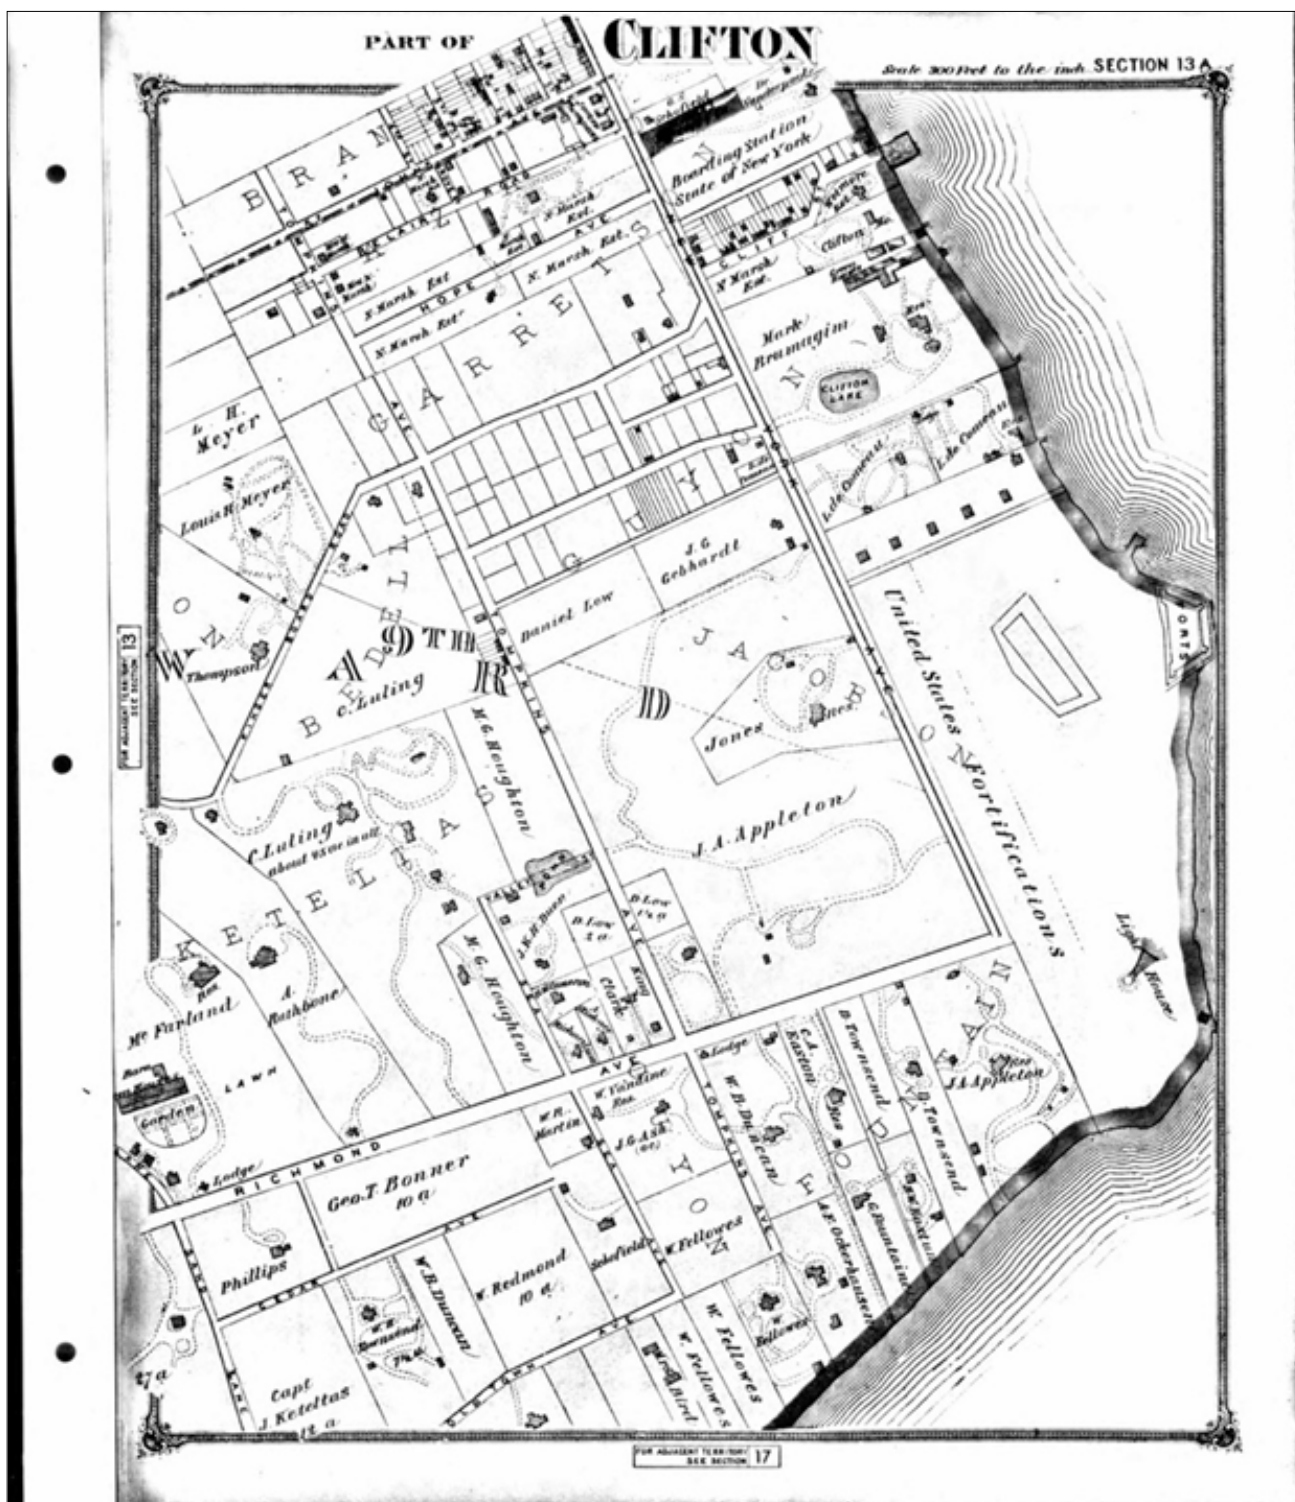
Figure 2.12. Map from Atlas of Staten Island, Richmond County, New York, 1874. Note the location of the lighthouse, Battery Weed, Fort Tompkins, post roads, and housing (Beers Atlas of Staten Island).

Officer's Quarters Road (now Mont Sec Avenue), was constructed in 1870. Six small buildings are represented on the 1874 Beers Atlas of Staten Island (Figure 2.12). It is unknown if these buildings were extant in 1874, or are representative of the future officer's quarters buildings, which were constructed over a decade later. If the map represents actual buildings, they are not the current quarters' buildings that line the street today.

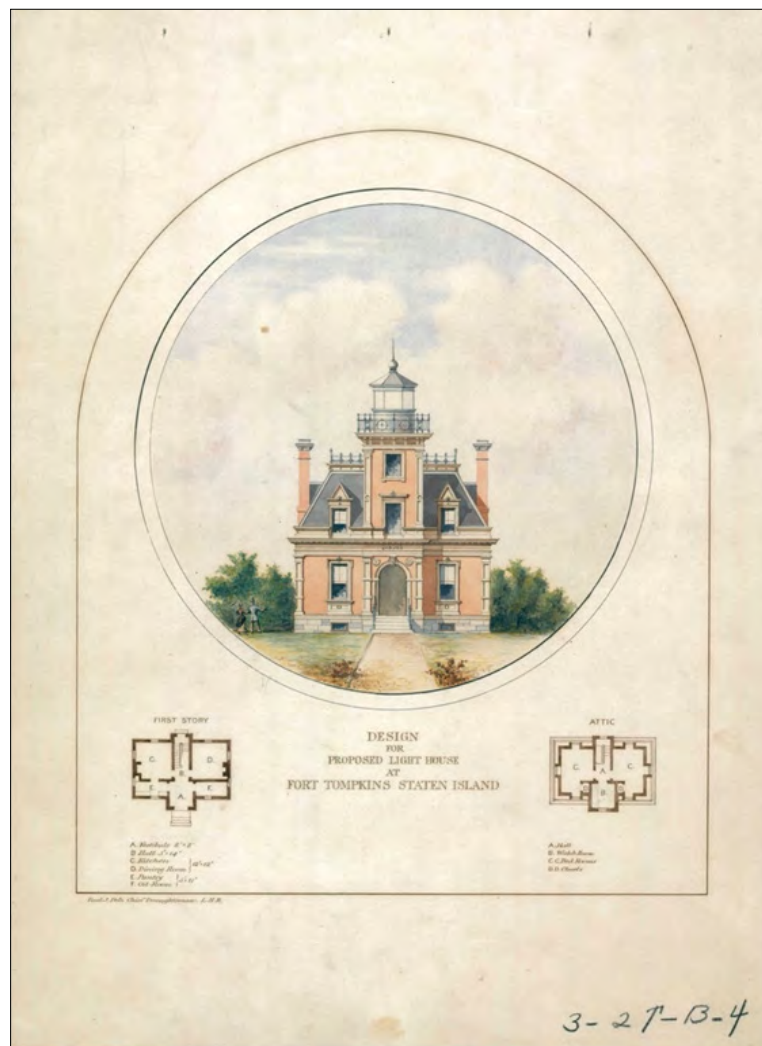
**Figure 2.13. Drawing for the proposed Light House at Fort Tompkins, circa 1869. This lighthouse was designed to combine the light and keeper's quarters and replace the original 1828 lighthouse (National Archives and Records Administration).**

Figure 2-13. Drawing for the proposed Light House at Fort Tompkins, circa 1869. This lighthouse was designed to combine the light and keeper's quarters and replace the original 1828 lighthouse (National Archives and Records Administration).

The construction of the new fortifications resulted in the relocation of the lighthouse. The Army had determined in 1869 that the original Fort Tompkins lighthouse, which featured a separate keeper's house and tower, needed to be relocated because its current site was needed for expanded defensive works. Planning for the relocation took over a year after the money was appropriated for the project. The fact that the lighthouse was within an active military installation was not lost on the planners. They noted that since the lighthouse "lies within the enclosure of the defensive works," the new facility would occupy as little space as possible. Instead of a separate keeper's quarters and tower, the design would place "the tower over the keeper's dwelling" (Figure 2.13). The new Fort Tompkins Lighthouse, which was placed further inland from its original location, was in operation by the early 1870s (Figure 2.14).<sup>46</sup> The lighthouse was on a high point just north of Battery Hudson.

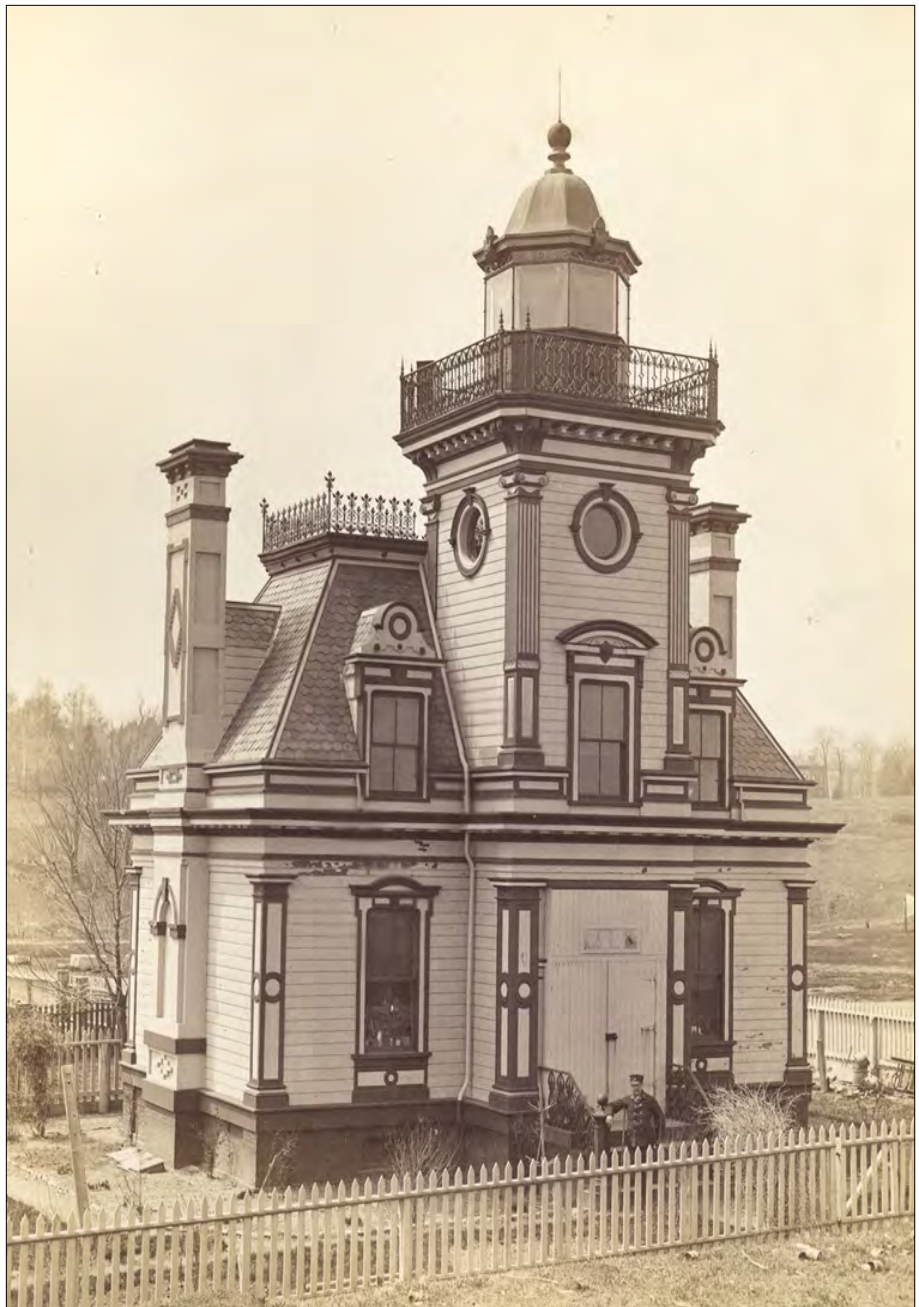
Figure 2.14. Photograph of the Fort Tompkins Lighthouse, looking north, circa 1903. Note the cleared landscape behind the building (National Archives and Records Administration).

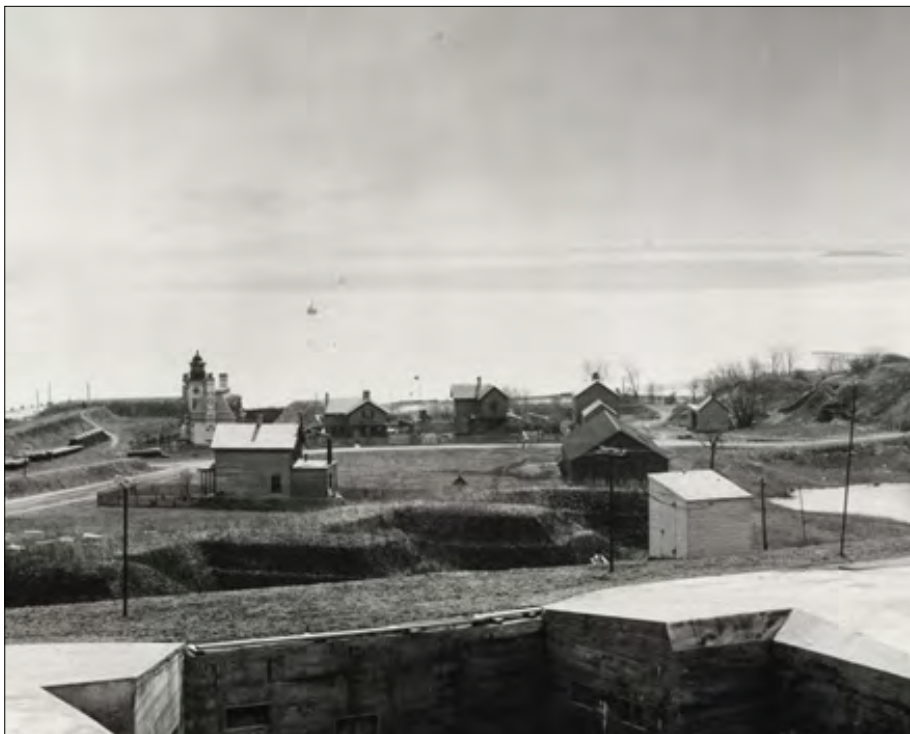
**Figure 2.17. Photograph with a view looking south from Fort Tompkins towards Battery Hudson, circa 1900. Note the lighthouse and support buildings in the mid ground with broad expansive views of the lower bay in the background (Gateway National Recreation Area, Photo 19658).**

Figure 2-17. Photograph with a view looking south from Fort Tompkins towards Battery Hudson, circa 1900. Note the lighthouse and support buildings in the mid ground with broad expansive views of the lower bay in the background (Gateway National Recreation Area, Photo 19658).

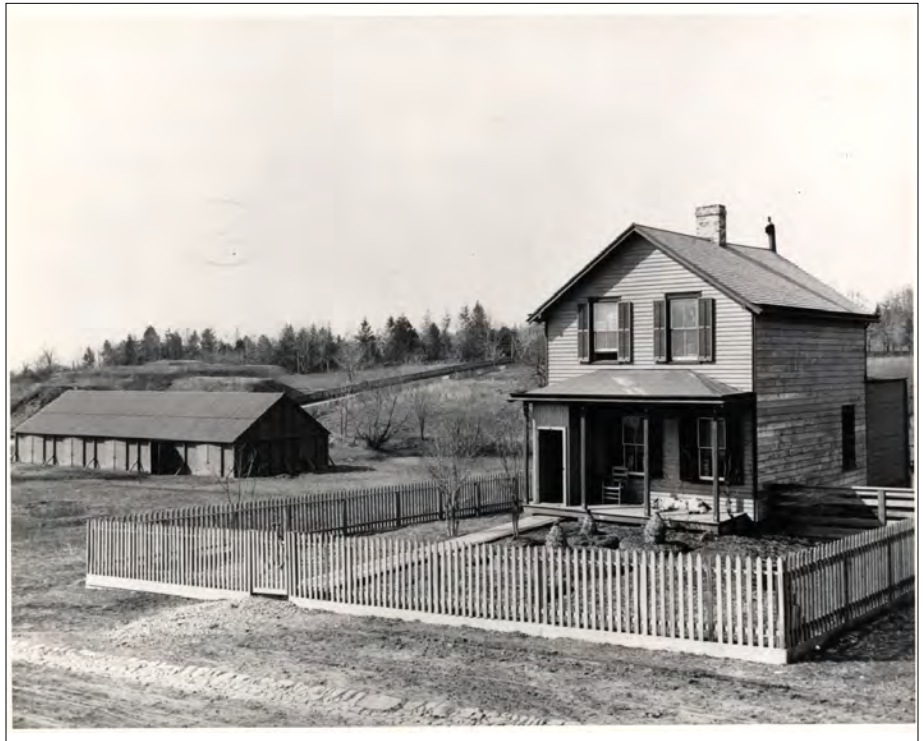
**Figure 2.18. Photograph of Fort Wadsworth in the late nineteenth century with military support buildings north of Battery Hudson, looking southwest (Gateway National Recreation Area, Photo 19657).**

Figure 2-18. Photograph of Fort Wadsworth in the late nineteenth century with military support buildings north of Battery Hudson, looking southwest (Gateway National Recreation Area, Photo 19657).

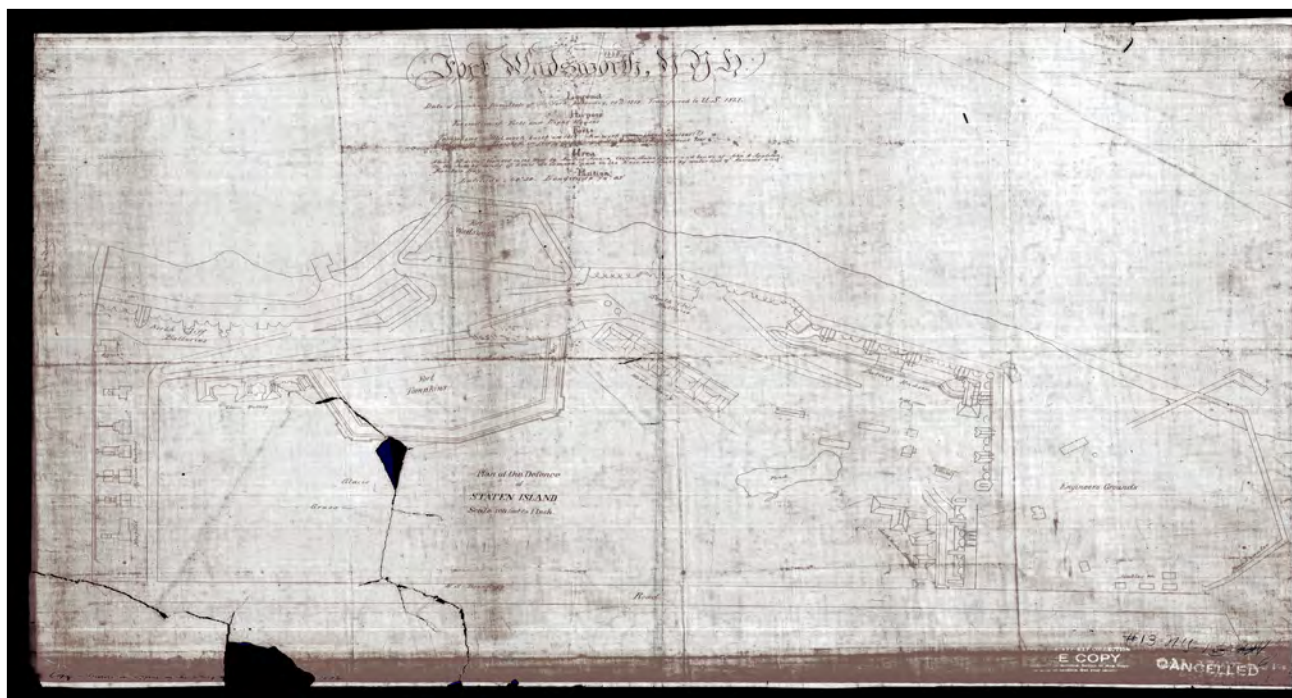
Figure 2.19. A map of Fort Wadsworth prepared by the Army, 1882. Note the housing along Officer's Quarters Road which served as a major entrance to the post (National Archives and Records Administration).

Work on Fort Tompkins slowed considerably after 1876 and was often interrupted by funding short falls. For example, work for the year 1879 was limited to repairs to roads, earthworks, stables, fences, and the blacksmith shop, minor infrastructural improvements, and the cutting of grasses on slopes.<sup>48</sup> Limited new construction occurred. Approximately 10 wood-framed buildings were erected along what is now Mont Sec Avenue, which served as a major entrance to the post. The buildings included a small hospital, officer's housing, and an administrative building. North and south roads parallel Mont Sec Avenue and added circulation in the residential area. Several military buildings were also constructed near Battery Hudson (Figure 2.17 and Figure 2.18). These included a hostler's building, blacksmith shop, cement shed, noncommissioned officers' housing, and stables. An area designated "Engineers Grounds" was at the far southern extremity of the post. These improvements are shown through a comparison of maps prepared by the Army in 1882 and 1886 (Figure 2.19; Figure 2.20).<sup>49</sup>

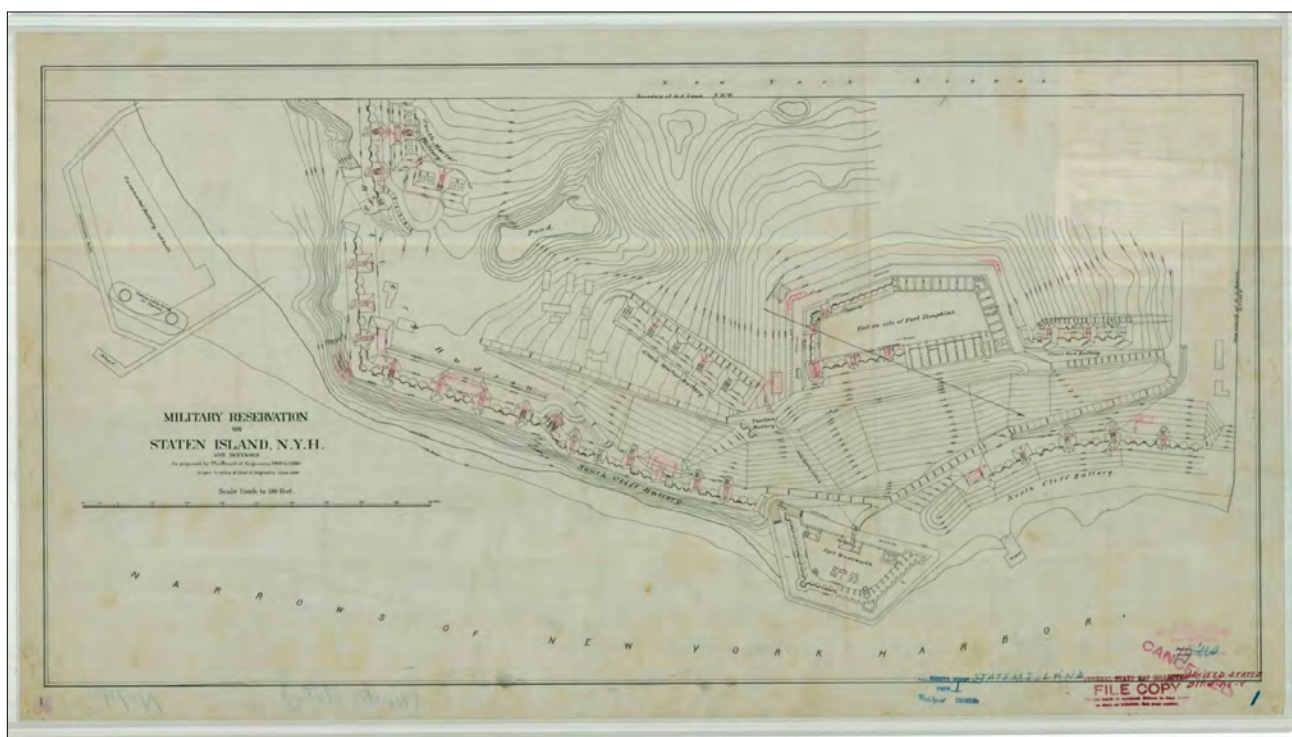
Figure 2.20. Map titled Military Reservation on Staten Island H.Y.H., June 1886. Note the support buildings north of Battery Hudson (National Archives and Records Administration).

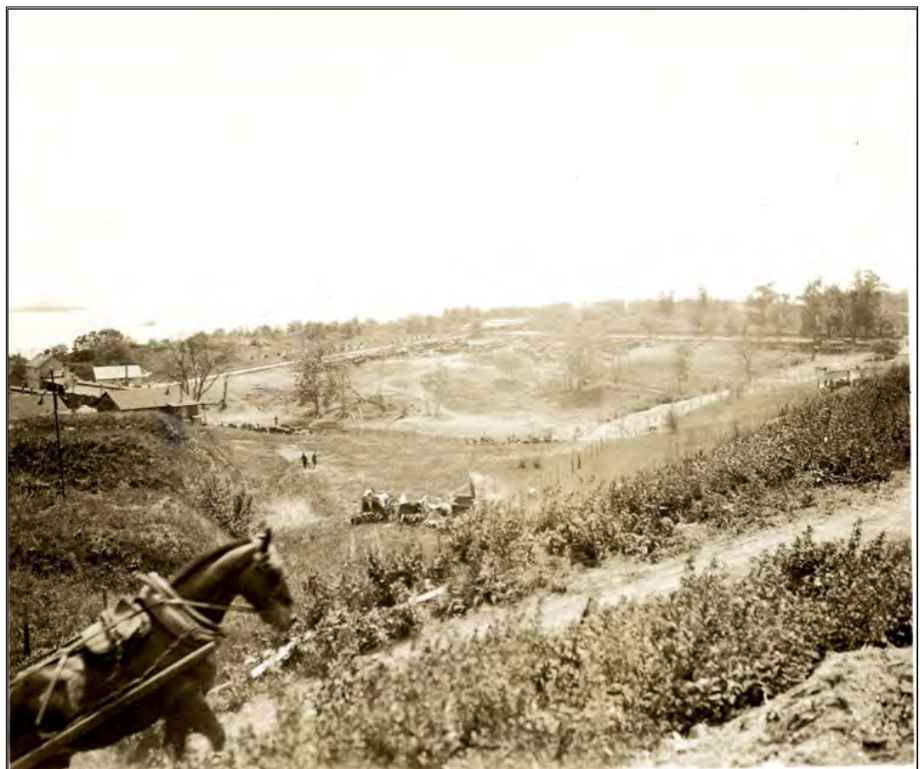
**Figure 2.21. Photograph by Carmin G. Novis titled Fort Wadsworth, view south Towards Water, late 1880s. The photograph shows the less formal landscape of the post south of Fort Tompkins (Gateway National Recreation Area Collections, Image 17127).**

Figure 2-21. Photograph by Carmin G. Novis titled Fort Wadsworth, view south Towards Water, late 1880s. The photograph shows the less formal landscape of the post south of Fort Tompkins (Gateway National Recreation Area Collections, Image 17127).

A photograph collected by post commander, Lieutenant Colonel Carmin G. Novis, presents a unique perspective on the installation (Figure 2.21). The precise vantage point of the image is not known, but it appears to show the southwestern portion of the installation as seen from New York Avenue, instead of the often-photographed Fort Tompkins and Battery Weed. In place of the maintained park-like landscape, large masonry buildings, and celebrated views, the image shows a largely agricultural landscape with horses grazing. A tent camp is visible in the center of the image, and temporary buildings are on the left. Although the location of the photograph is not readily discernable, it reveals that while the central core of Fort Wadsworth retained a very martial, maintained layout, other areas reflected a more agricultural or vernacular working landscape.

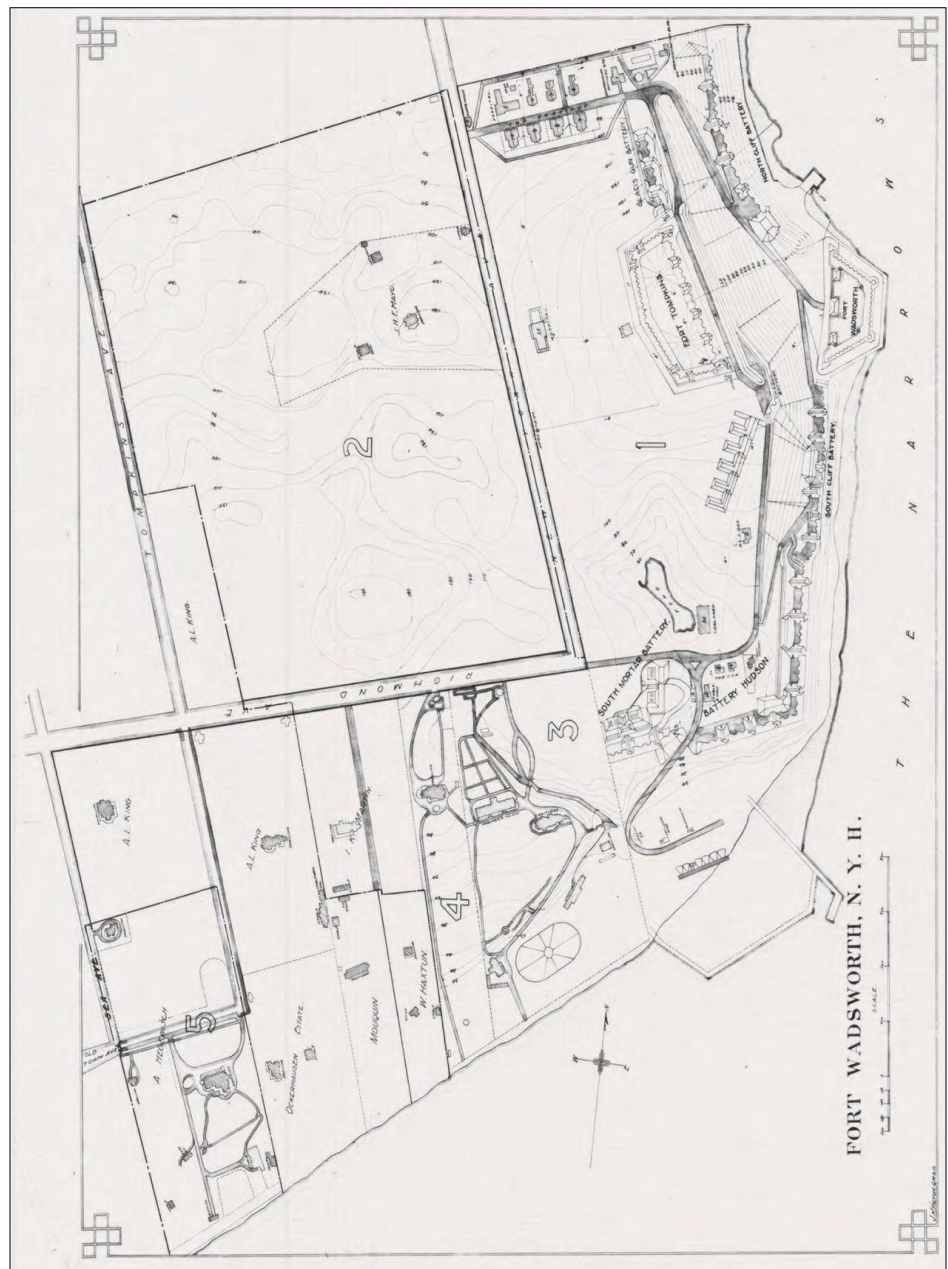
**Figure 2.25. A map titled Fort Wadsworth, N.Y.H., circa 1895. The map outlines the privately held land added to the western portion of the post (National Archives and Records Administration).**

The Endicott Board recommendations resulted in significant changes at the Staten Island post. First, the dispersed nature of the Endicott Era fortifications required more space than was within the 1880s post boundaries. Thus, the Federal Government began acquiring additional parcels from landowners bordering the Army post. The land purchases began in 1892 and were essentially complete by 1901. A circa 1895 site plan titled *Fort Wadsworth N.Y.H.* documents the fort boundaries as land purchases were proceeding (Figure 2.25). The estates that were

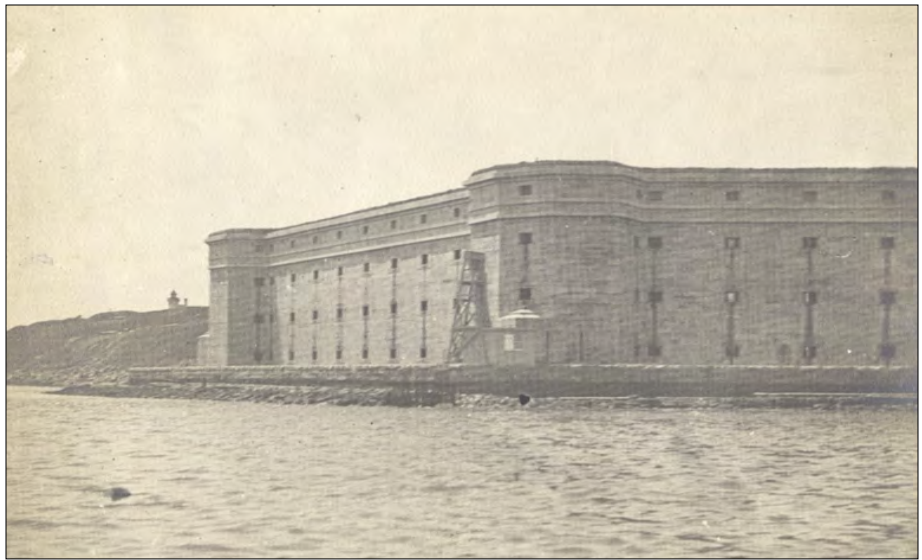
**Figure 2.26. A photograph of Fort Wadsworth taken from the Narrows, 1898. Note the lighthouse located inland on the horizon (National Archives and Records Administration).**

Meanwhile, the Department of Treasury determined that the relocated Fort Tompkins lighthouse was too far inland to be effective (Figure 2.26). Therefore, they proposed to move the lighthouse to “an angle of the stone fort at Fort Wadsworth [Battery Weed], where it will better serve as a mark to the channel leading directly into New York Harbor.” The relocation required the construction of “a lantern and watchroom on the salient of the fort and to place a fog-signal house and apparatus at the foot of the wall.”<sup>63</sup> The recommendations were not immediately acted upon. The Fort Tompkins Light continued operating from its inland site for several years before the light was finally relocated to Battery Weed in 1903 and renamed the Fort Wadsworth Light.<sup>64</sup> The existing Fort Tompkins lighthouse building was renovated, moved to New York Avenue, and converted to a single purpose building that housed the lighthouse keeper.<sup>65</sup>

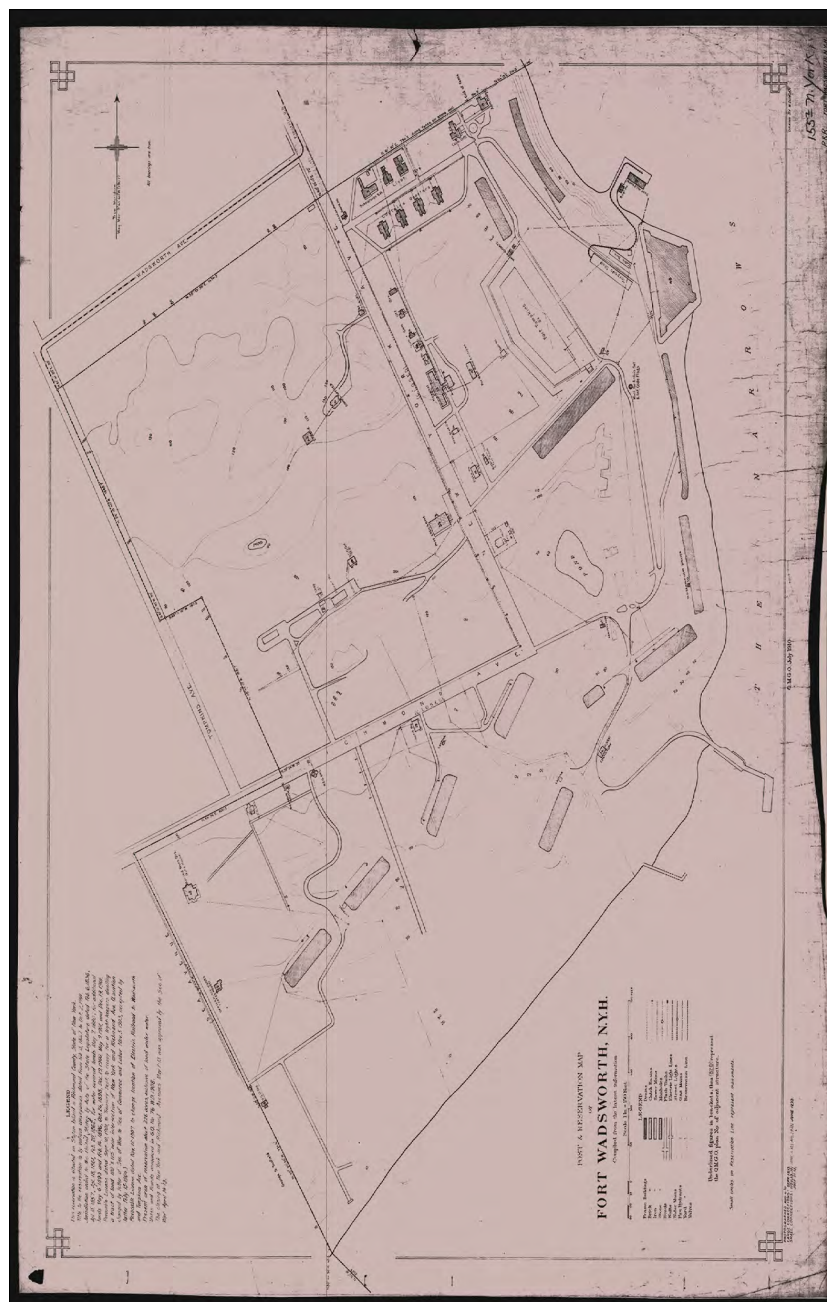
Figure 2.27. A map titled Fort Wadsworth, N.Y.H., circa 1910. The map reflects the final boundaries of Fort Wadsworth with new development in the south and west (National Archives and Records Administration).

eventually incorporated into the southwest quadrant of Fort Wadsworth were still privately owned by the Ockerhauser, King, Hauxtum, and Mouquin families. Figure 2.27 shows the final boundaries in 1910, representing the legislated boundaries of the Fort Wadsworth portion of the Staten Island Unit of Gateway National Recreation Area. This process expanded the army post from about 100 acres to 226 acres and represented the final boundaries of the installation, which was officially named Fort Wadsworth in 1902. The fortification that was previously known as Fort Wadsworth was renamed Battery Weed.

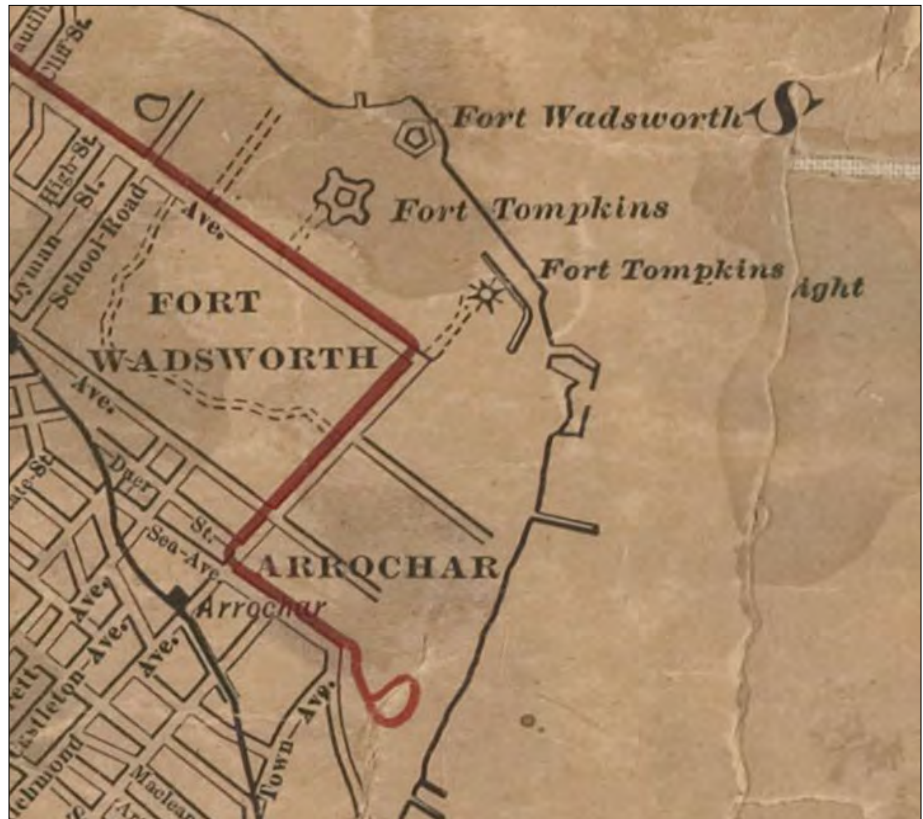
**Figure 2.28.** Detail of a 1908 Poates Map of Staten Island. A public trolley line runs through Fort Wadsworth, indicated in red (New York Public Library).

The increased construction activity at Fort Wadsworth between 1895 and 1905 did not deter the public's use of the post as a place for leisure. In fact, a trolley line ran through the post, allowing visitors to get off and take a short walk to the overlook at Fort Tompkins (Figure 2.28). The trolley, installed around the turn of the century, ran along New York Avenue before turning west up Richmond Avenue to the post exit. Fare was five cents, and according to at least one writer, the trolley was a good way for fishermen to travel to Fort Wadsworth, where they could catch blackfish and striped bass.<sup>67</sup> Trolley lines operated across Staten Island into the 1930s, with the last line discontinued in 1934.
