# CULTURAL LANDSCAPE REPORT

FORT WADSWORTH

GATEWAY NATIONAL RECREATION AREA

Prepared by PaleoWest, LLC

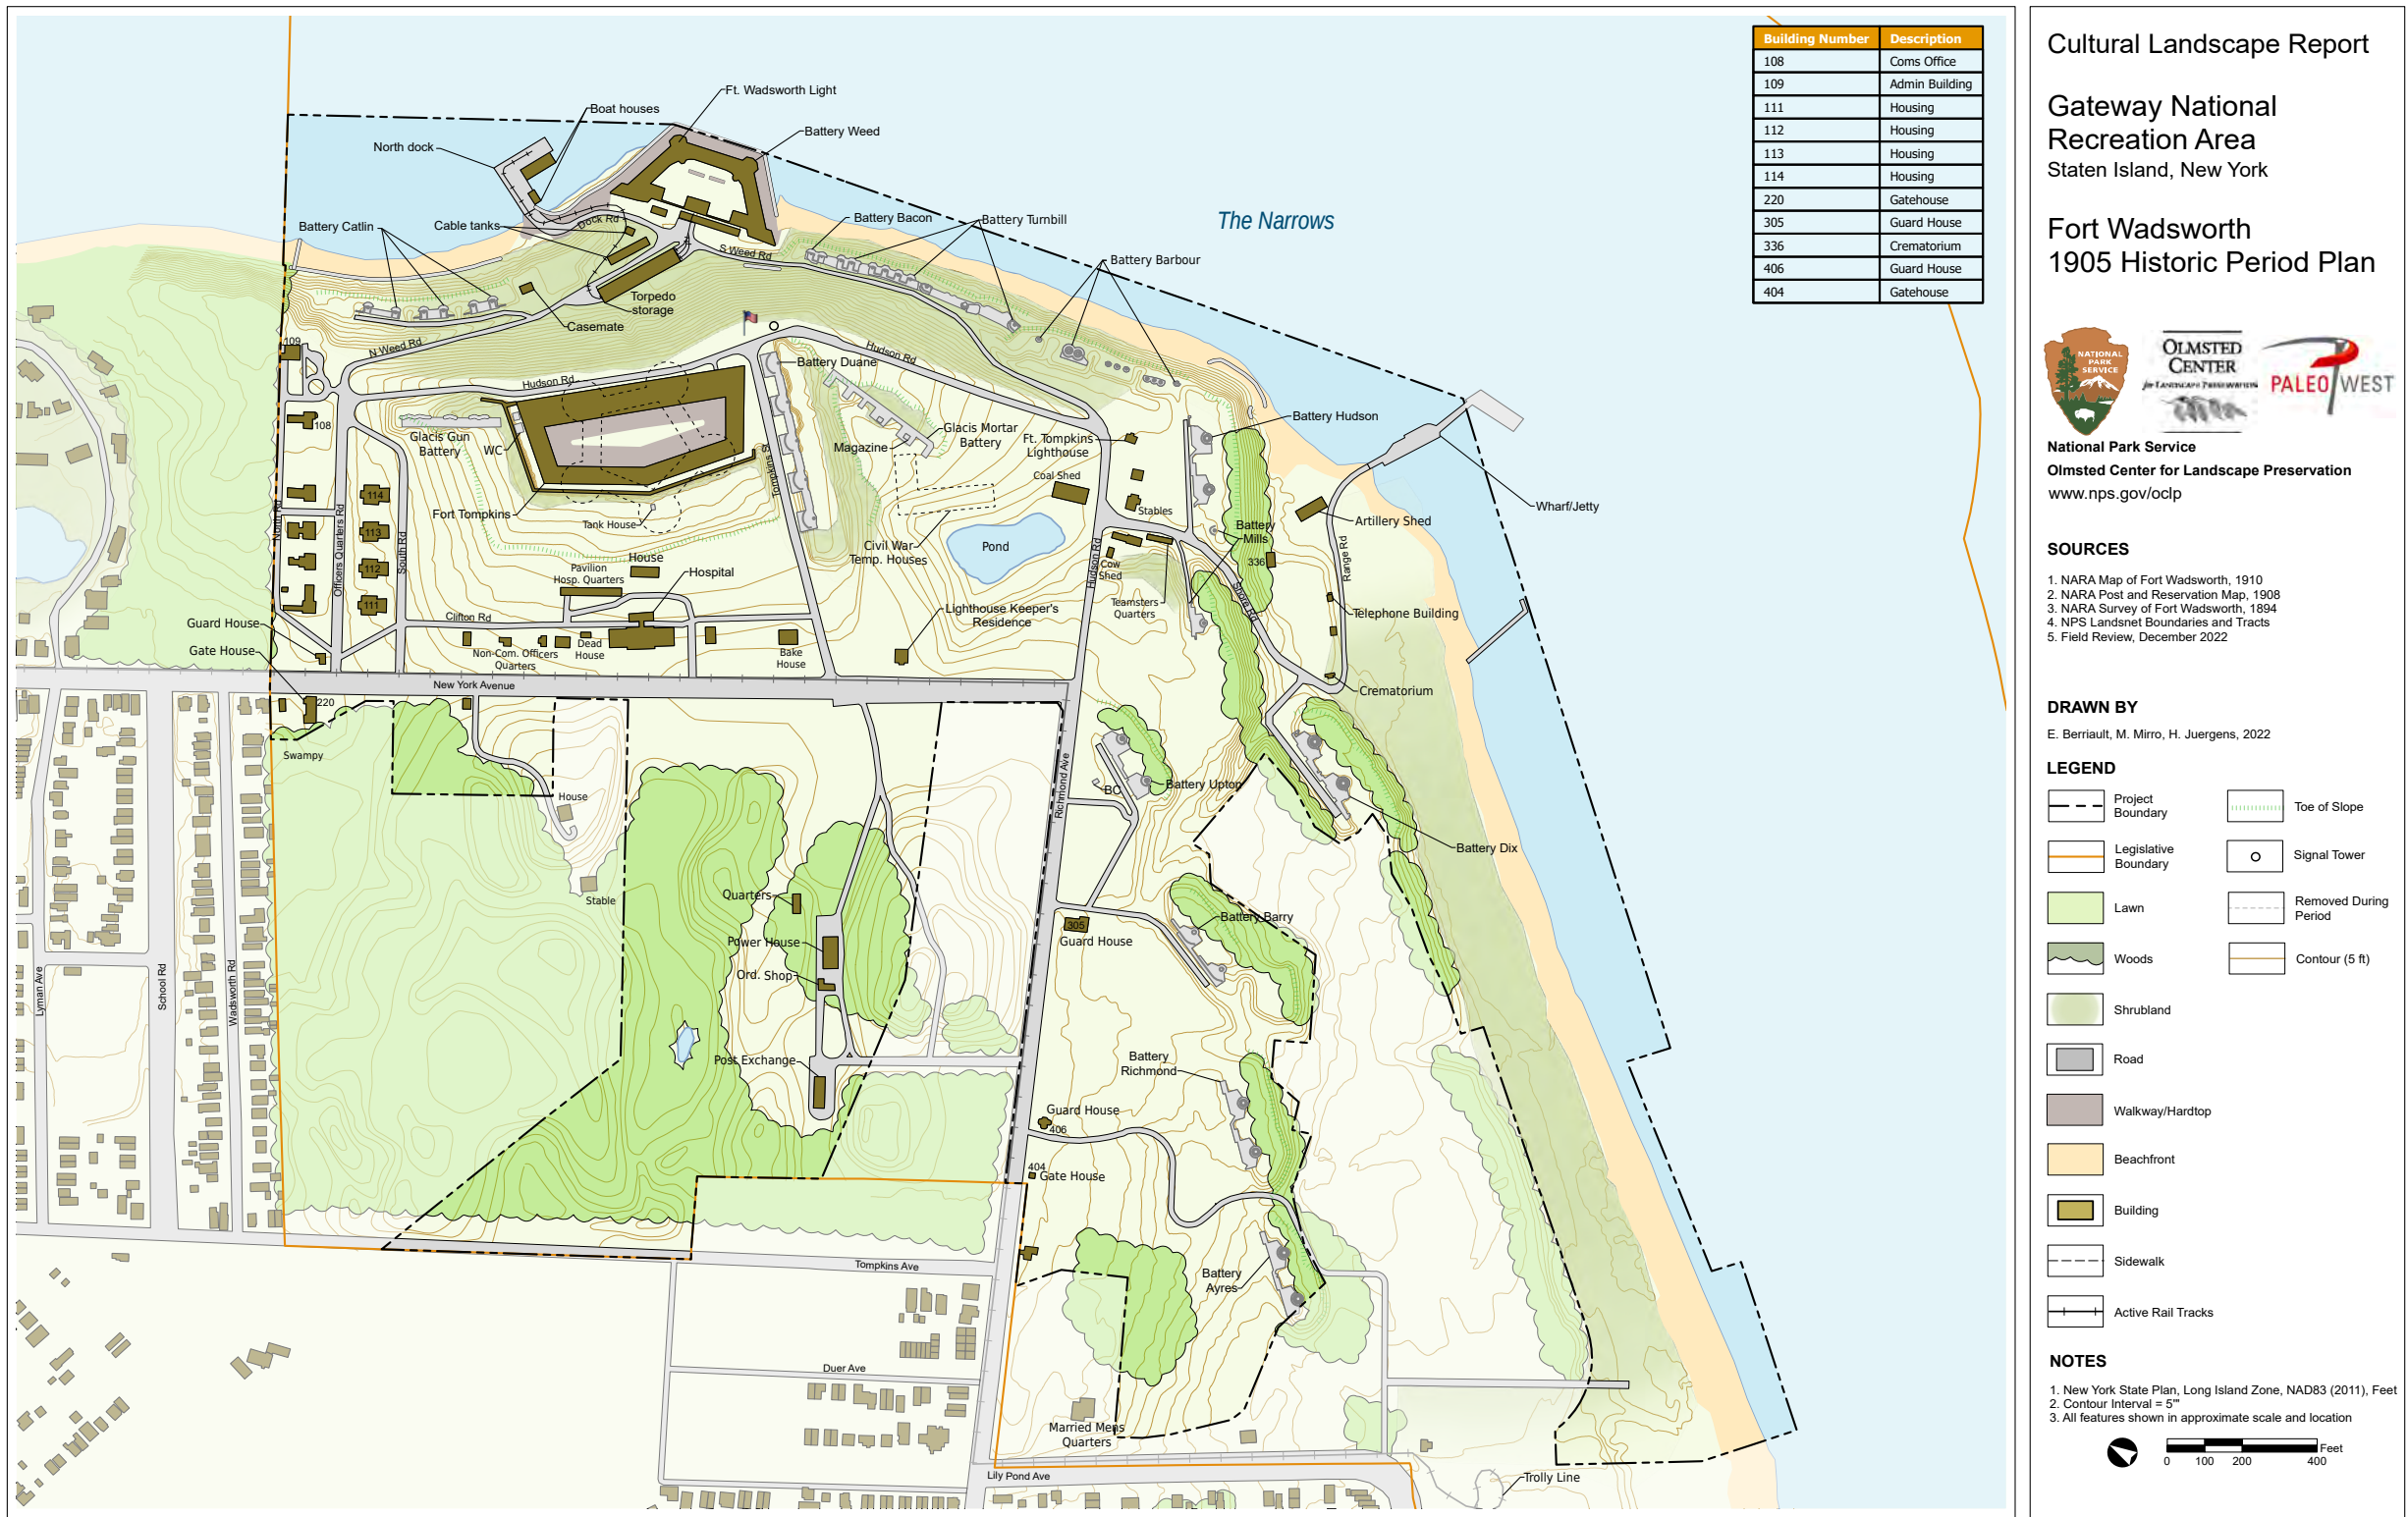
Development during this period occurred predominately in the Coastal North and Coastal South Landscape Character Areas with defensive fortifications spatially organized along the coastal perimeter and oriented towards the coastline and seaward approaches. Support buildings and structures occupy the Inland North area. The broad spatial organization remains consistent from the previous period, with fortifications occupying strategic locations on the landscape, a primary fort at the high point of the bluff, and batteries and redoubts below (Figure 2.31).

The landscape around the fort is clear of vegetation and much of the installation is sodded with grass creating an open landscape. The topography between the two forts consists of an engineered slope which is cleared of vegetation providing views and vistas for open fields of fire. A pond is a natural feature located south of Fort Tompkins at the corner of present-day Hudson Road and New York Avenue. The area west of New York Avenue is largely characterized by natural vegetation with undeveloped woodland and swampy conditions.

Along New York Avenue and Clifton Road, sits a newer hospital, housing, a bakehouse, and steward's quarters. At the south end of New York Avenue, the Fort Tompkins Lighthouse is relocated to be used as the keeper's house. The lighthouse function is replaced with a lantern and watchroom located on Battery Weed called the Fort Wadsworth Light. Temporary Civil War soldier's housing stood to the south of Fort Tompkins (demolished for the construction of the Glacis Mortar Battery). At the corner of Hudson Road sits various support buildings including stables, hostler's building, and a blacksmith shop.

In the Inland North area west of New York Avenue, buildings include a powerhouse, ordnance shop, quarters, a post exchange, and a gym (some of them are repurposed former estate houses). At the northern end of New York Avenue, a gatehouse sits to the west of the road (Building 220).

Circulation routes include both land and water access. A dock sits north of Fort Richmond, used to transport people and materials. Roads are more formal than the previous period with pavement and sidewalks. New York Avenue is the main road running north to south that divides the Coastal North from the Inland North area. Officer's Quarters Road (existing Mont Sec Avenue) is flanked by North and South Roads. Hudson Road runs north to south on the east side of Fort Tompkins. North and South Weed Roads run down the bluffs to Battery Weed. Dock Road connects from the battery to the North Dock. Shore Road and Range Road wind down from Hudson Road to the southern Warf. The main road running east to west which divides the Coastal South from the Inland North area is called Richmond Avenue (now Battery Road). The new batteries in the Coastal South area are accessed via Richmond Avenue. A public trolley line ran along New York Avenue, turning west down Richmond Avenue.

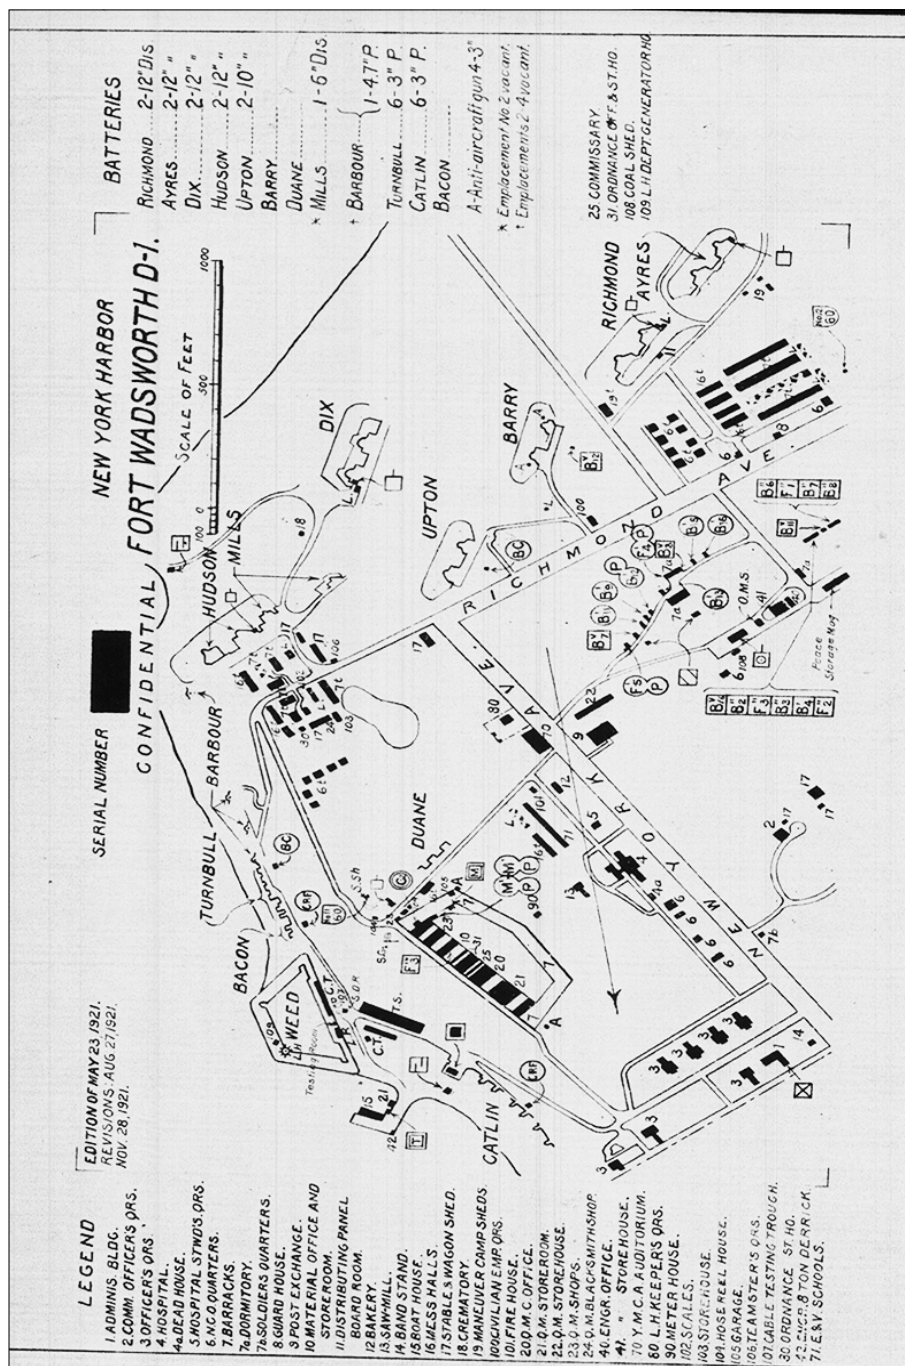
Figure 2.34. A map of Fort Wadsworth, 1921. Gun emplacements are described on the right side of the figure; note all operational guns are those facing south towards the approach (National Archives and Records Administration)

Figure 2-48. Map of Fort Wadsworth with proposed revisions, 1935. Note new construction compared to the 1921 map (Figure 2 34). Gun emplacements are described on the right side of the figure; handwriting is undated but indicates that the Army proposed to remove Battery Barbour sometime after 1935 (National Archives and Records Administration).

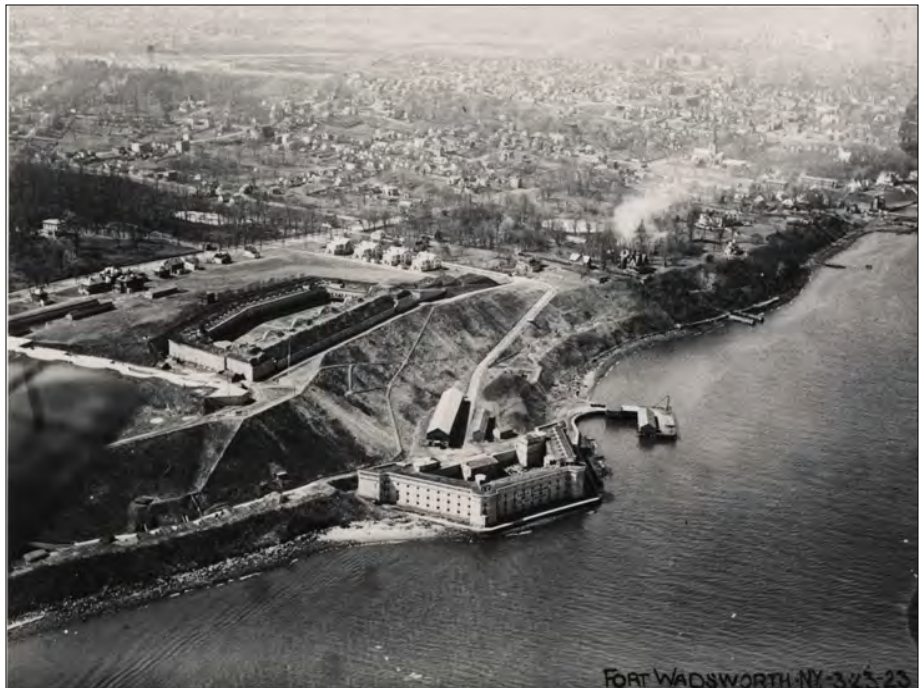
**Figure 2.35. 1923 oblique aerial photograph of Fort Wadsworth.** The central core of Fort Wadsworth was kept open and clear of woody vegetation; note the contrast between the post and neighboring parcels to the west, which appear heavily wooded (Gateway National Recreation Area Collections, Image 19397).

Fort Wadsworth began transitioning from a coastal defense installation to an infantry base in 1919, triggering major construction. Post engineers built several temporary wooden barracks in the early 1920s to house infantry units from the 1<sup>st</sup> Division, which was headquartered at Fort Hamilton. The barracks were concentrated in two complexes. One collection of temporary buildings was between Richmond Avenue (now Battery Road) and Batteries Richmond and Ayers. The other temporary buildings were north of Battery Hudson along both sides of what is now called Hudson Road. Changes at Fort Wadsworth in the early 1920s included the construction of a handful of additional support buildings and structures. For example, several stables were erected in 1921 near Hudson Road and at the intersection of Richmond Avenue (now Battery Road) and New York Avenue (Figure 2.34). The central core of Fort Wadsworth remained open and cleared of vegetation in the early 1920s (Figure 2.35). Most new construction occurred to the south of Fort Tompkins and Battery Weed.

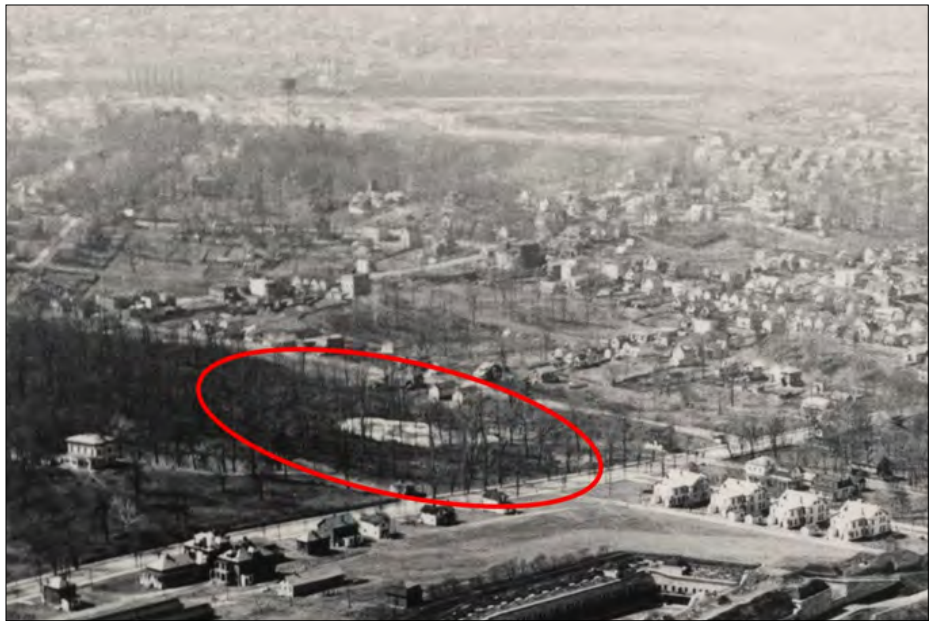
Figure 2.36. Detail of a 1923 oblique aerial photograph showing the wooded area (circled in red) that became the Parade Ground. Note the low, swampy area surrounded by trees on the west side of New York Avenue (Gateway National Recreation Area Collections, Image 19397).

Sporadic construction continued well into the 1920s. Engineers began constructing a parade ground at the northwest corner of the post in 1925.<sup>74</sup> The project required considerable effort. Workers converted a landscape of “swamp, hills, and trees” to a level, manicured grass field (Figure 2.36). Engineers drained the swamp by running a pipe from the future parade ground to the sewer line that ran along New York Avenue. Once they removed enough water, workers began filling low spots with additional soil. Finally, they cut down a number of large oak trees lining the reclaimed swamp and dynamited the stumps. The entire project took two years. The completed parade ground was immediately west of New York Avenue near the post boundary. The parade ground is not reflected on post maps from the era, but it is visible in a 1942 aerial photograph (Figure 2.37). An unpaved road called the General’s Road was built to the south of the parade ground, and the fort boundary was to the north.<sup>75</sup> The construction of utilitarian support buildings also continued, some of which remain. Current Building 310 was a storage shed constructed in 1927 near the intersection of Camp Road and Richmond Avenue.<sup>76</sup>

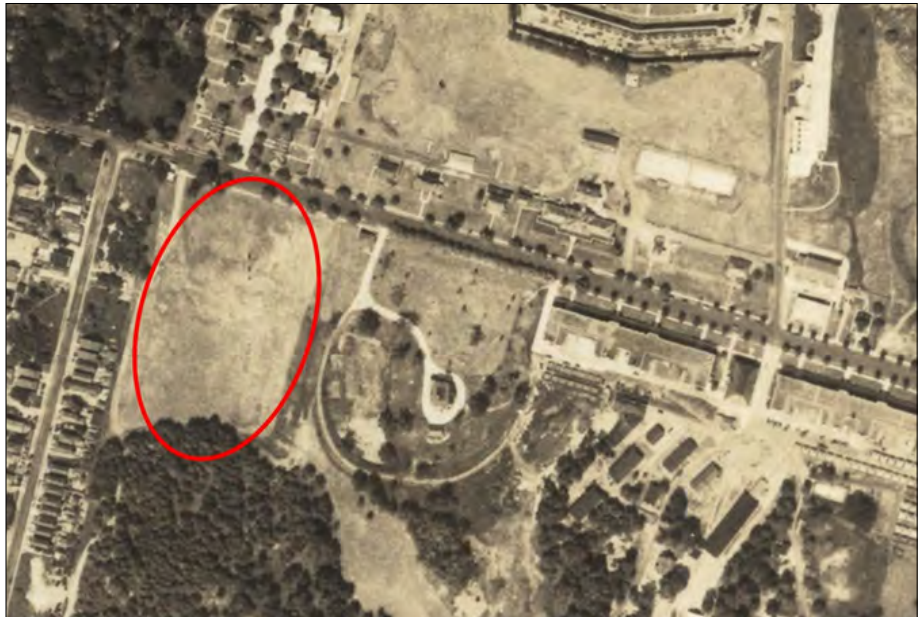
Figure 2.37. 1942 aerial photograph showing the 1920s Parade Ground at left (circled in red). Note New York Avenue running north to south across the image (Gateway National Recreation Area Collections, Image 20614).

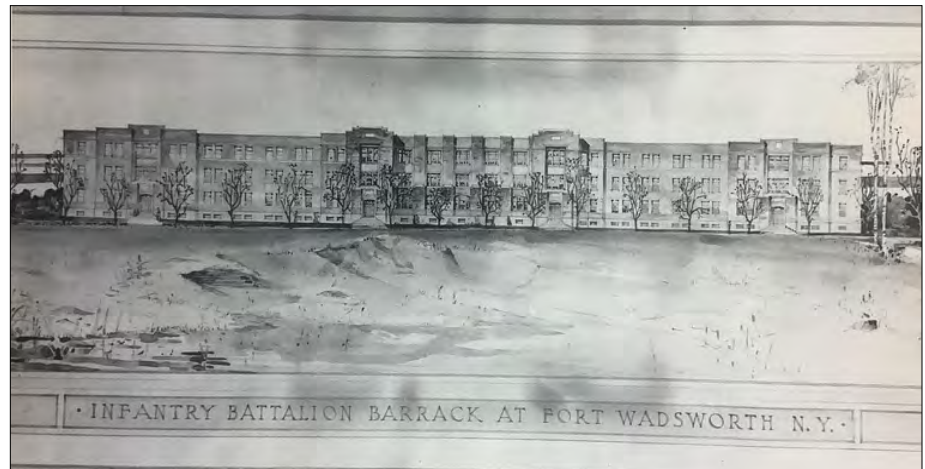
Figure 2.38. Rendering of the Infantry Battalion Barracks, circa 1929 (Gateway National Recreation Area Collections, Image 19419).

Construction of two identical large rectangular concrete and brick infantry barracks began in 1929. The buildings immediately west of New York Avenue near Tompkins Avenue were completed two years later (Figure 2.38 and Figure 2.39). Each building was designed to accommodate 602 men. Initially, the infantry barracks housed soldiers from the Second and Third battalions of the 18<sup>th</sup> Infantry of 1<sup>st</sup> Infantry Division. One of the barracks, Building 210, remains in use by Gateway National Recreation Area as park headquarters.<sup>77</sup>

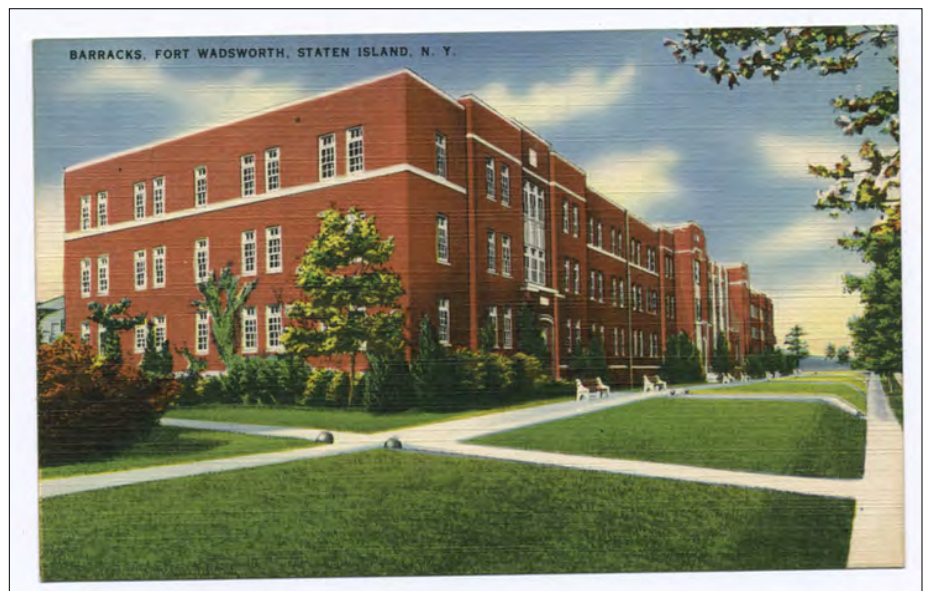
Figure 2.39. Postcard showing newly completed Barracks, early 1930s (New York Public Library).

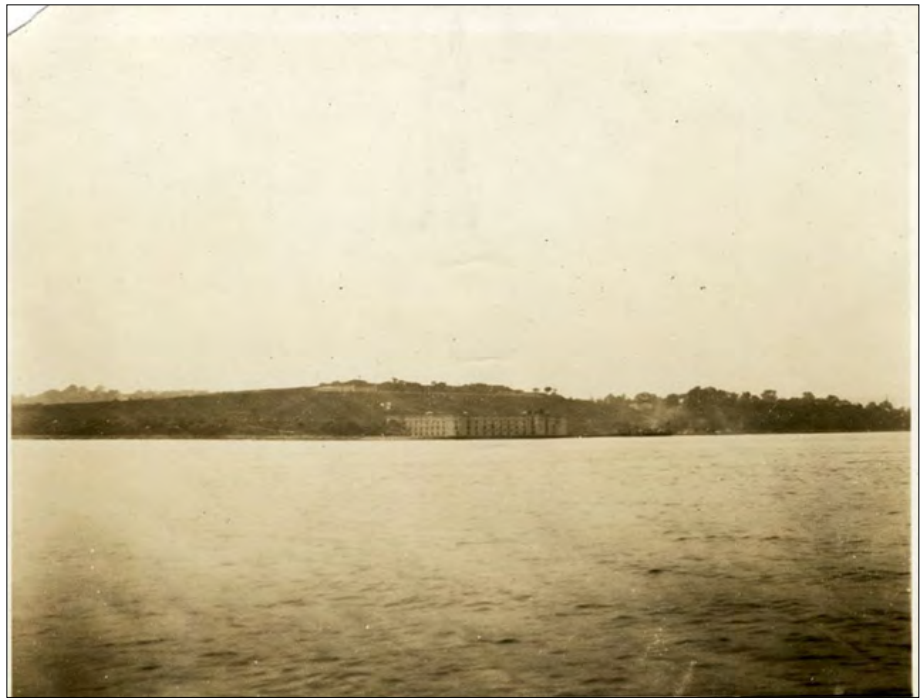
Figure 2.40. Photograph of Fort Wadsworth, August 1925. The landscape of the post is clear of woody vegetation with the slope between Fort Tompkins and Battery Weed kept mowed (New York State Historical Society).

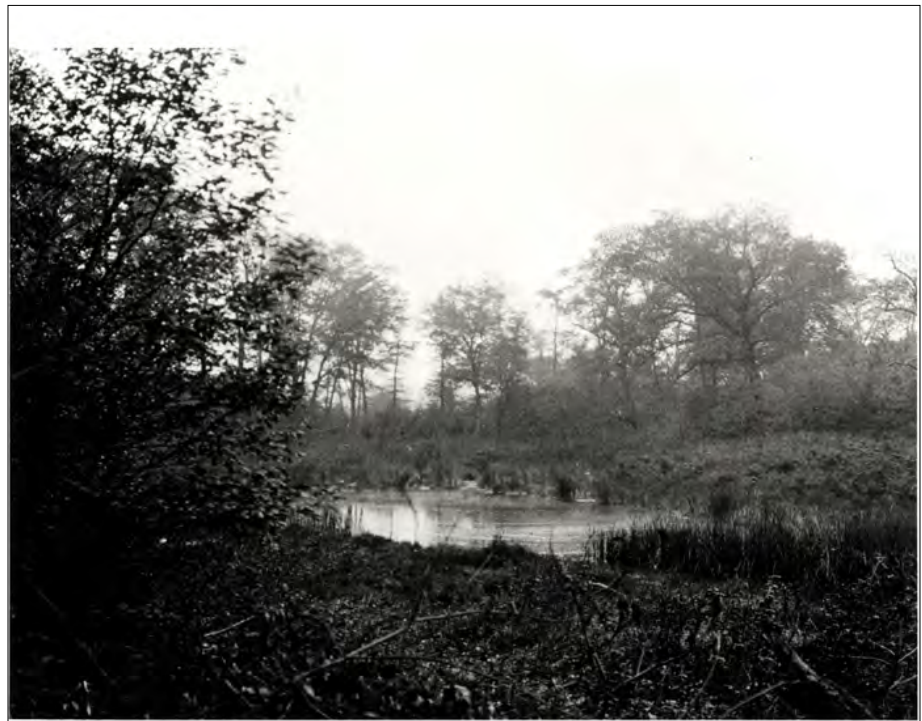
Figure 2.43. Photograph by William T. Davis, of the Fort Wadsworth Military Reservation, 1925. The photograph shows an undeveloped swampy area within Fort Wadsworth, later drained to construct the Parade Ground (New York Public Library, Sperr Collection; Gateway National Recreation Area Collections, Image 19394).

Although new buildings appeared at Fort Wadsworth in the 1920s and early 1930s, the overall landscape remained largely unchanged from previous decades. The post was kept clear of vegetation and grassy areas were routinely mowed. The hillside above Battery Weed was also cleared, and the slope and trails between the two buildings were clearly visible (Figure 2.40). This resulted in a highly manicured, expansive, park-like setting. Fort Wadsworth was picturesque enough that the post inspired the publication of another series of postcards in the 1930s. The postcards emphasized an orderly, inviting landscape cleared of trees and other woody vegetation (Figure 2.41, Figure 2.42). The contrast between the manicured Fort Wadsworth and neighboring naturalistic landscape provides some indication of the level of effort that was required to keep vegetation from encroaching into the installation. The portion of the post west of New York Avenue was left in a relatively natural state. This is reflected in a 1925 photograph of a small pond shrouded in thick vegetation that was later drained to construct the Parade Ground (Figure 2.43).

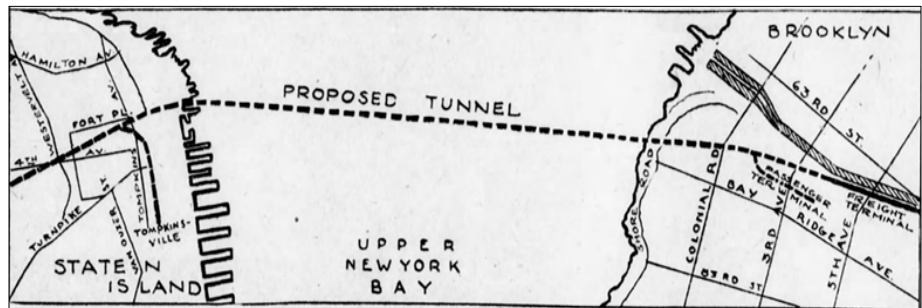
Figure 2.44. Map of a proposed tunnel under the Narrows, 1922 (Brooklyn Daily Eagle, September 3, 1922).

Staten Island as part of a plan to move people and freight more effectively to and from the Port of New York. The proposed tunnel and railroad line began at the Long Island Railroad near 7th Avenue in Brooklyn and continued west to a location near the intersection of Bay Ridge Avenue and Shore Road, where it continued under the Narrows. The planned tunnel exited the Narrows north of Fort Wadsworth near the intersection of Fort Place and Tompkins Avenue, near the current ferry terminal (Figure 2.44).

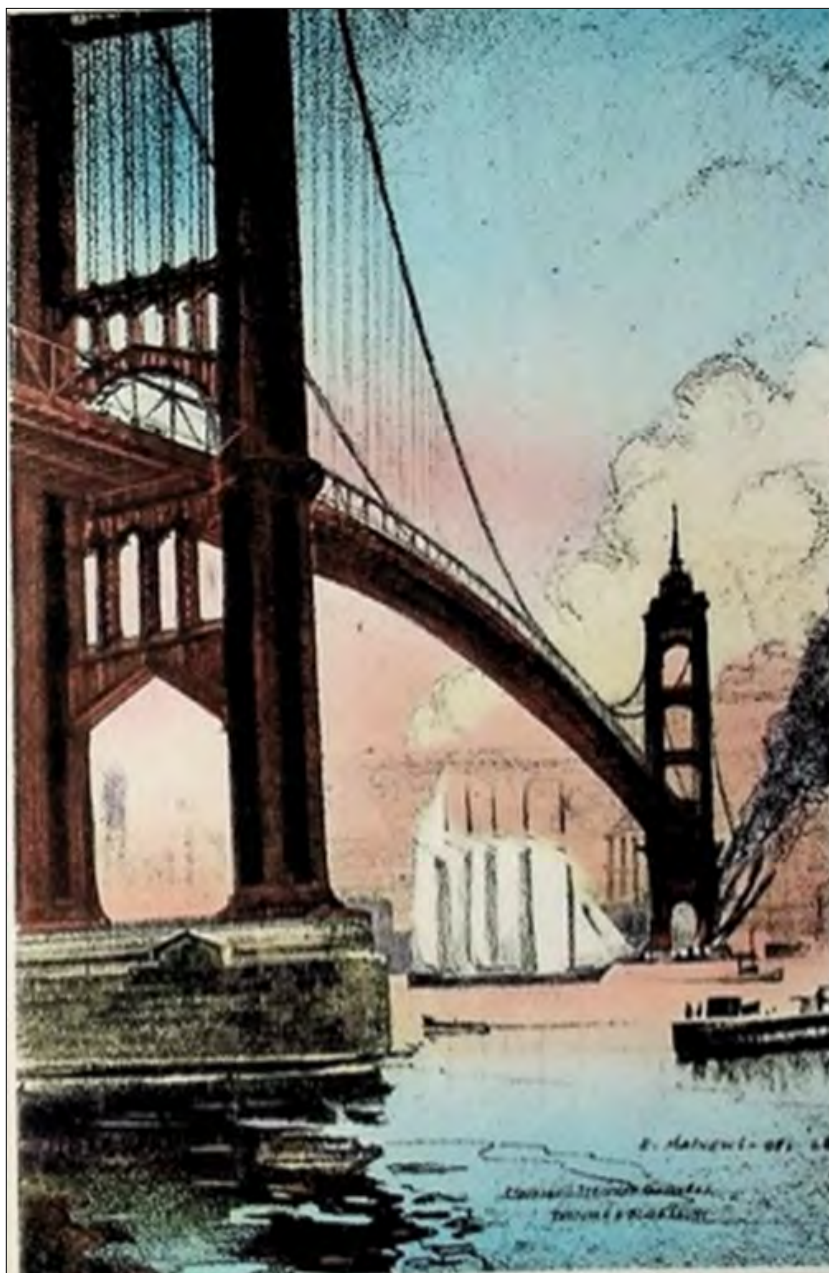
**Figure 2.45. Rendition of the proposed Liberty Bridge by D.B. Steinman titled The Narrows Bridge, no date (Metropolitan Transportation Authority Bridges and Tunnels Archives).**

Meanwhile, another plan for a fixed route crossing the Narrows was coalescing along a different track. Prominent bridge engineers, D.B. Steinman and Van Ness Bates, began collaborating on a proposed bridge over the Narrows in 1923. The project, which was named The Liberty Bridge, was replete with symbolism (Figure 2.45). The designers described the structure as a "superspan. . . with twin towers, one dedicated to Lafayette and the other to Lincoln" to memorialize "the greatest sons of liberty in both the Old World and the New."<sup>83</sup>

The structure, as proposed, was going to span over 4,600 feet and the planned roadway rose nearly 240 feet above the water surface. Lincoln and Lafayette Towers were designed to be 800 feet tall. Engineers intended to place Lafayette Tower on “a small rock (Fort Lafayette) just offshore from Fort Hamilton.” Lincoln Tower would rise from “shallow water . . . off Fort Tompkins.”<sup>84</sup> The Liberty Bridge dimensions and alignment are very similar to the Verrazzano-Narrows Bridge that was completed four decades later (Figure 2.46).

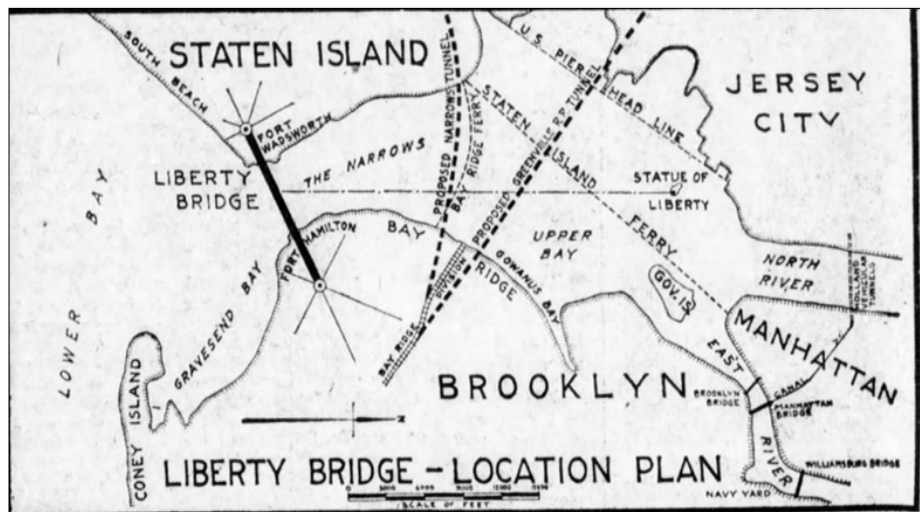
Figure 2.46. Map depicting the proposed route of the Liberty Bridge, 1926. Note that the proposed route was very similar to the current alignment of the Verrazzano-Narrows bridge (Brooklyn Daily Eagle, March 28, 1926).

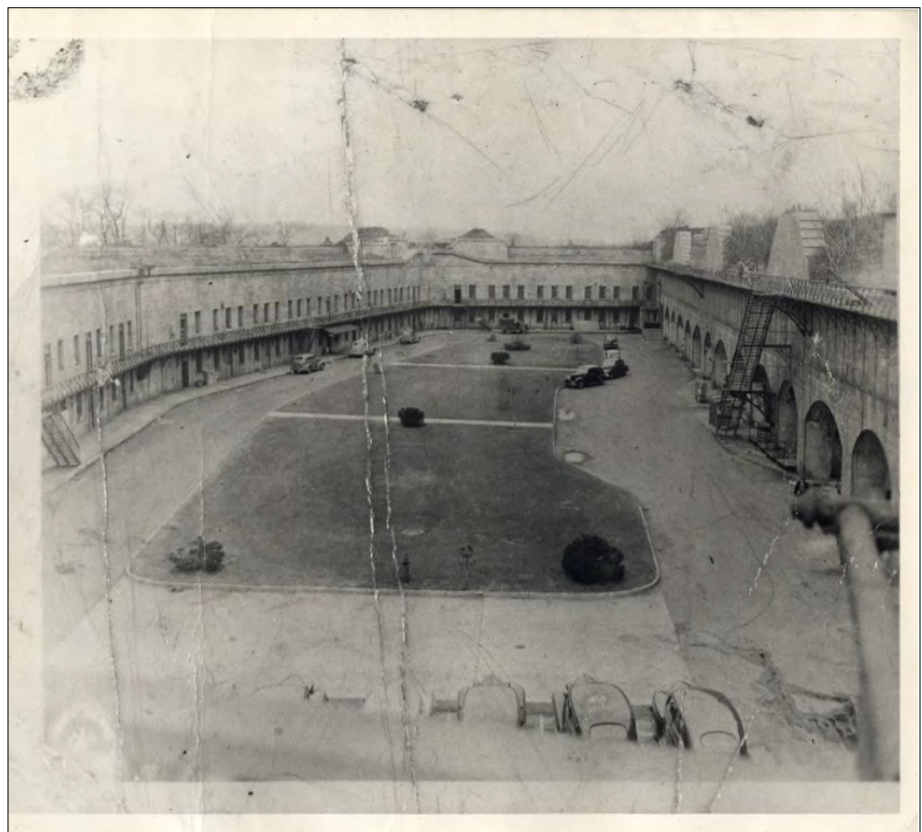
**Figure 2.47. Photograph of the interior of Fort Tompkins showing parade grounds, mid-1930s. Note the central median, curbing, and landscaping added to accommodate automobiles; the shape roughly follows an earlier tennis court design (Courtesy of Gateway National Recreation Area Collections, Image 20594).**

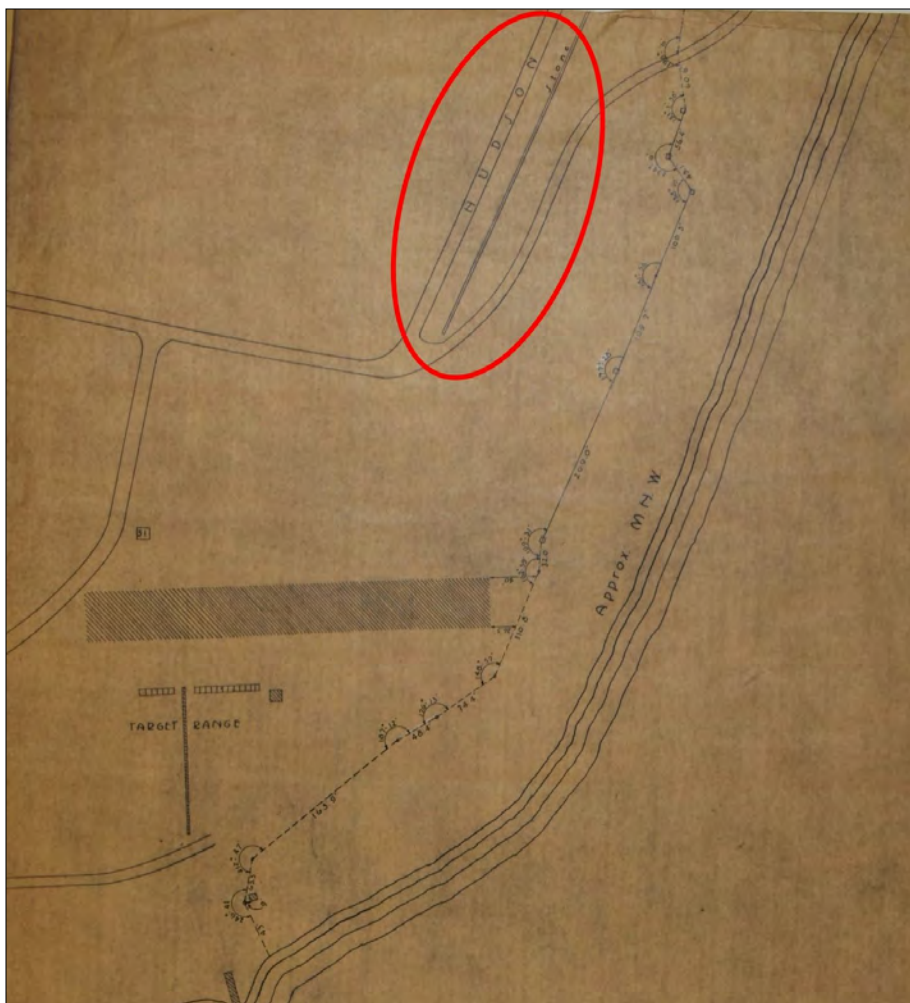
Figure 2.49. Detail of 1941 map depicting Works Progress Administration-era improvements including the stone wall along Hudson Road (noted in red) (Gateway National Recreation Area Collections, Map 2419).

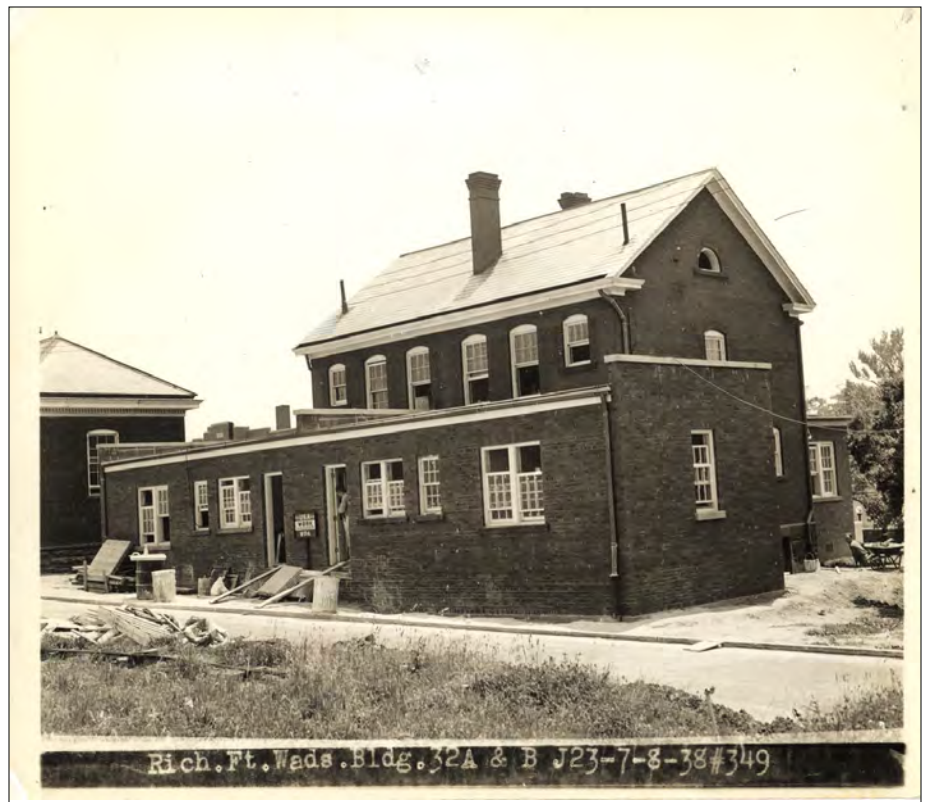
Figure 2.50. Photograph depicting an example of support buildings constructed or renovated through Works Progress Administration projects, 1930s (Gateway National Recreation Area Collections, Image 20603).

During their time at Fort Wadsworth, the Works Progress Administration and Civilian Conservation Corps crews completed nearly \$2 million worth of work. Projects included the construction of Fort Wadsworth's entry gates, the post exchange, guardhouses, garages, and a handball court.<sup>94</sup> They may have also installed a tennis court in near Fort Tompkins. The court is not shown on a map created in 1935 but appears on a later map from 1940 (Figure 2.54). Workers also widened and built a retaining wall along Hudson Road in 1938 (Figure 2.49). Crews constructed a "trespass proof jetty," repaired and rehabilitated existing buildings, seawalls, and structures. They additionally cleared trees and performed general landscaping. The men also built several support buildings and other infrastructure (Figure 2.50 and Figure 2.51).<sup>95</sup> By 1939 crews had:

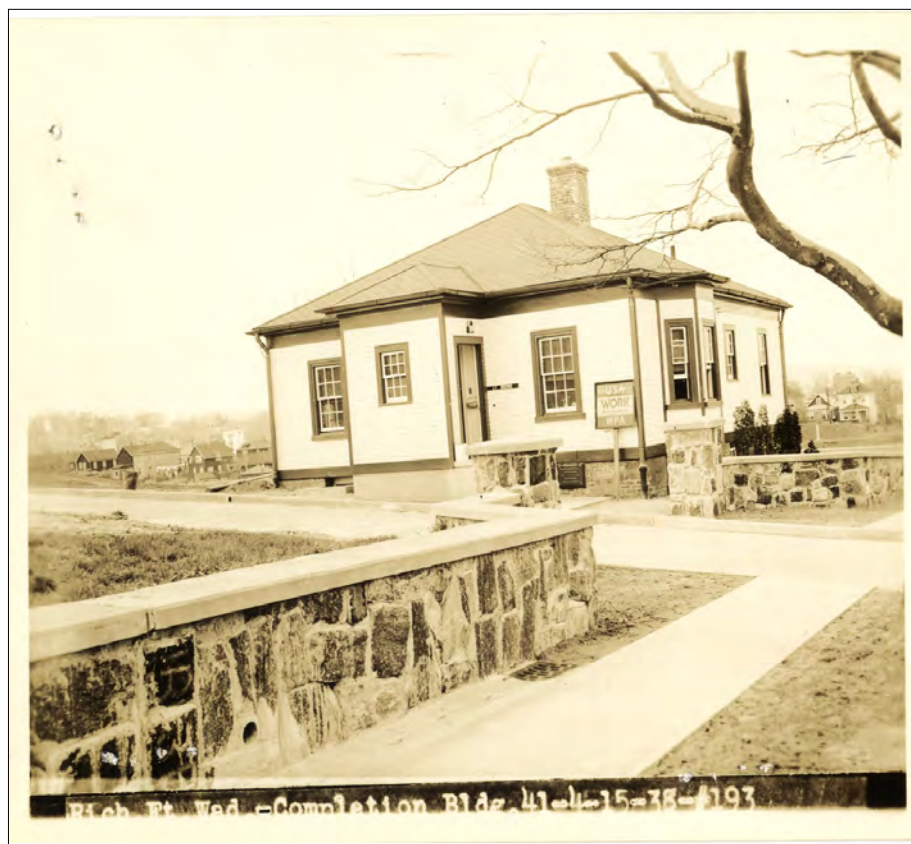
Figure 2.51. Photograph depicting an example of support buildings constructed or renovated by the Works Progress Administration, 1930s. Note the stone wall which is a similar type installed along the Battery Weed overlook, later National Park Service Terrace (Gateway National Recreation Area Collections, Image 20605).

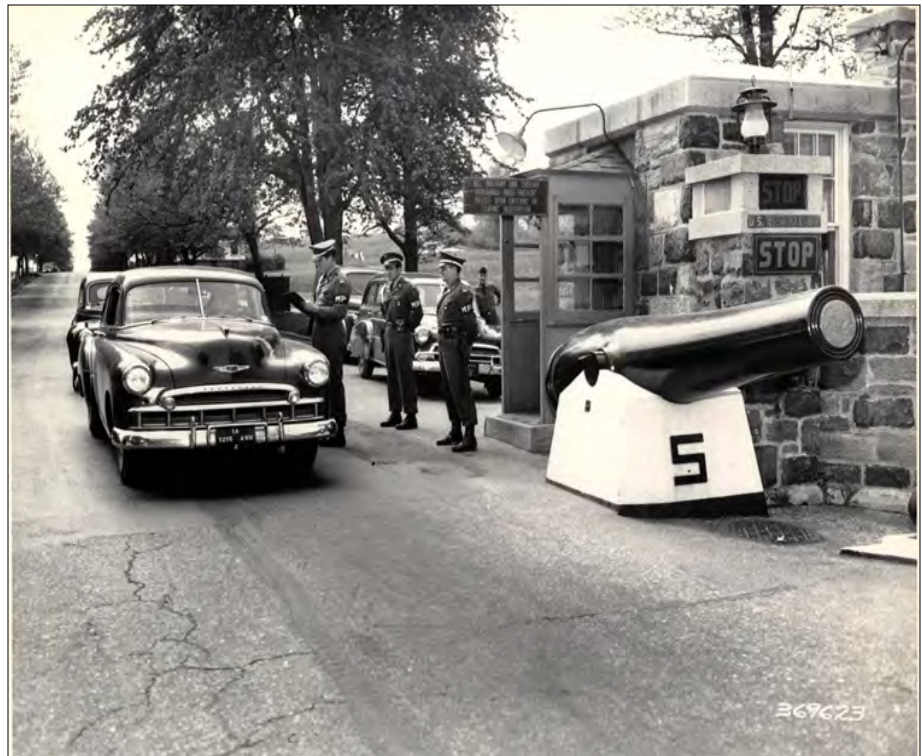
Figure 2.52. Photograph taken from Fort Wadsworth Entrance at New York Avenue, 1950s. Note the Civilian Conservation Corps-era entrance gate and row of trees lining New York Avenue (Gateway National Recreation Area Collections, Image 19376).

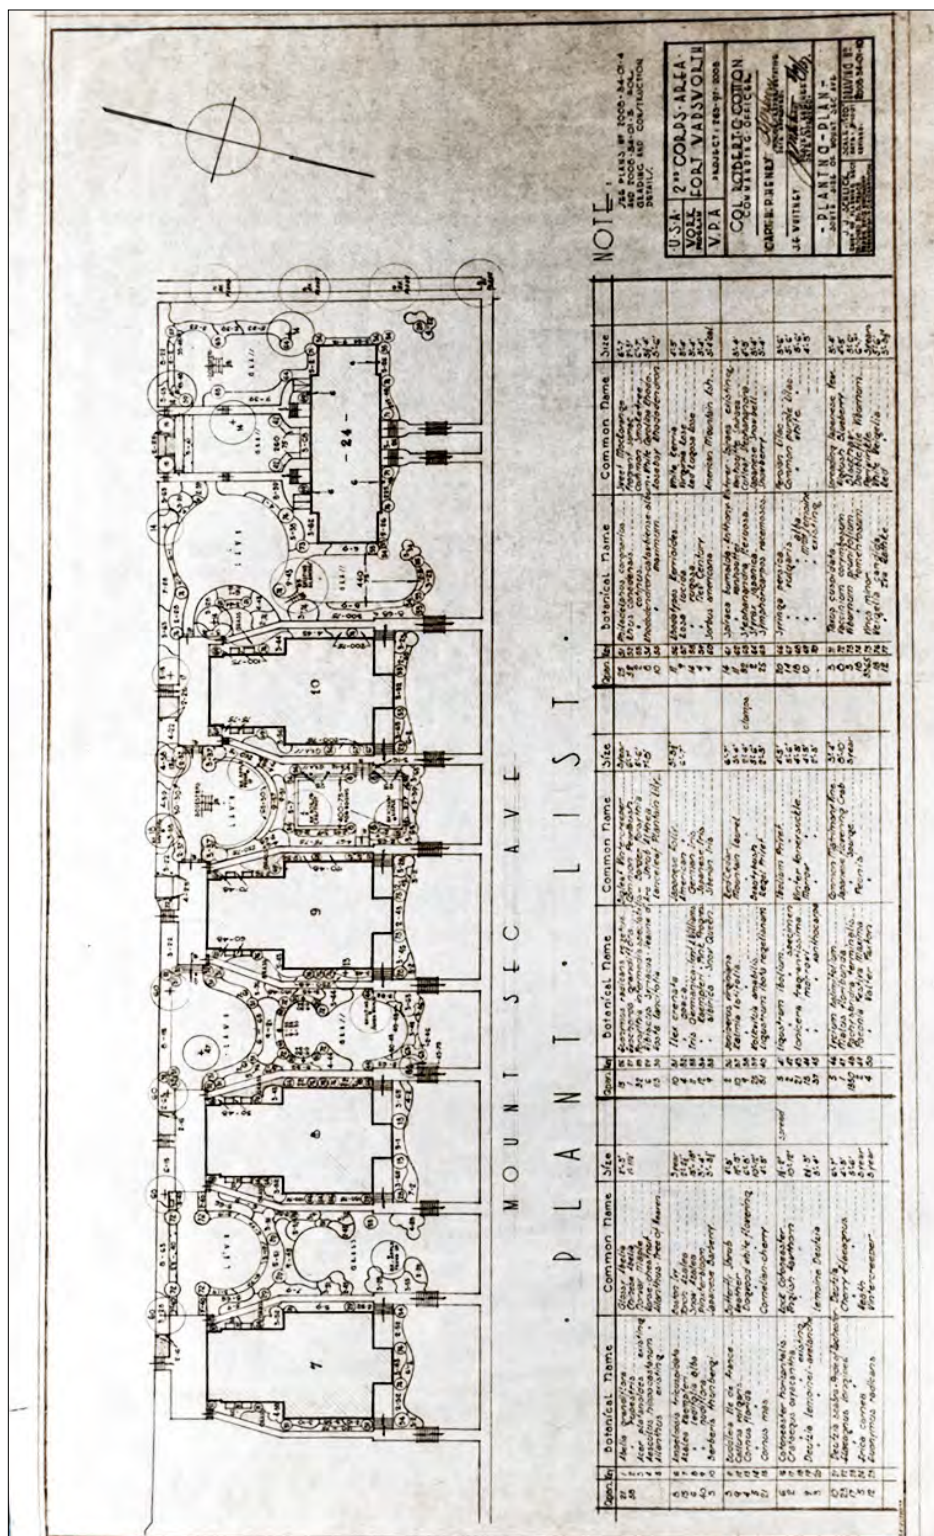
Figure 2.53. Map depicting the planting plan for the south side of Mont Sec, July 13, 1937 (Gateway National Recreation Area Collections, Map 17388).

Landscaping completed by 1939 included "lawn seeding and tree planting, "encompassing over 300,000 square feet." According to the 1937 planting plan, the tree planting included Oriental Plane (*Platanus orientalis*) placed along both sides of Mont Sec Avenue, New York Avenue, and Richmond Avenue (now Battery Road). The trees created a shaded corridor along the installation's main routes of travel and use (Figure 2.52). Much of the formal landscaping occurred along New York Avenue and Mont Sec Avenue (Figure 2.53). Finally, the workers constructed brick buildings to store firefighting equipment. The new buildings replaced "old wooden shacks."<sup>97</sup> Although it is not depicted in maps from the period, a baseball diamond was constructed by the Army or Civilian Conservation Corps in the southwestern corner of the post in the 1930s or early 1940s.

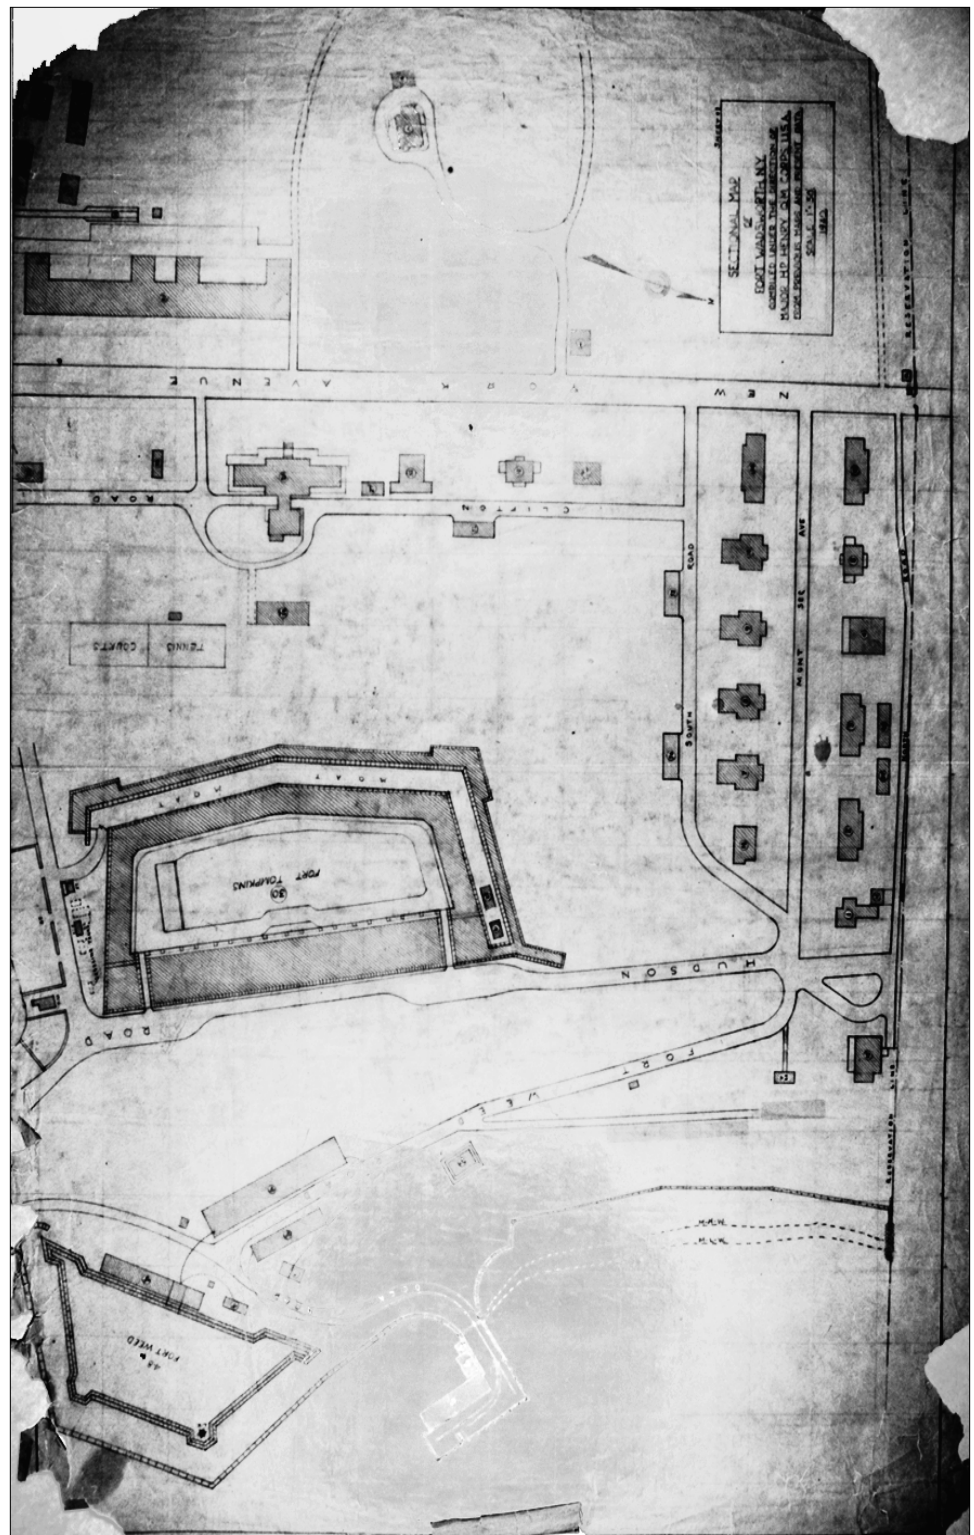
Figure 2.54. (Partial) Map of Fort Wadsworth, 1940. Note the Civilian Conservation Corps construction and tennis courts west of Fort Tompkins (Gateway National Recreation Area Collections, Map 32033).
